GEOLOGICAL SURVEY OF CANADA  
TOPICAL REPORT NO. 18

YUKON RIVER DRAINAGE BASIN  
DAM SITE INVESTIGATION

SITE NO. 11

**SELWYN DAM SITE**  
(MAP AND PRELIMINARY REPORT)

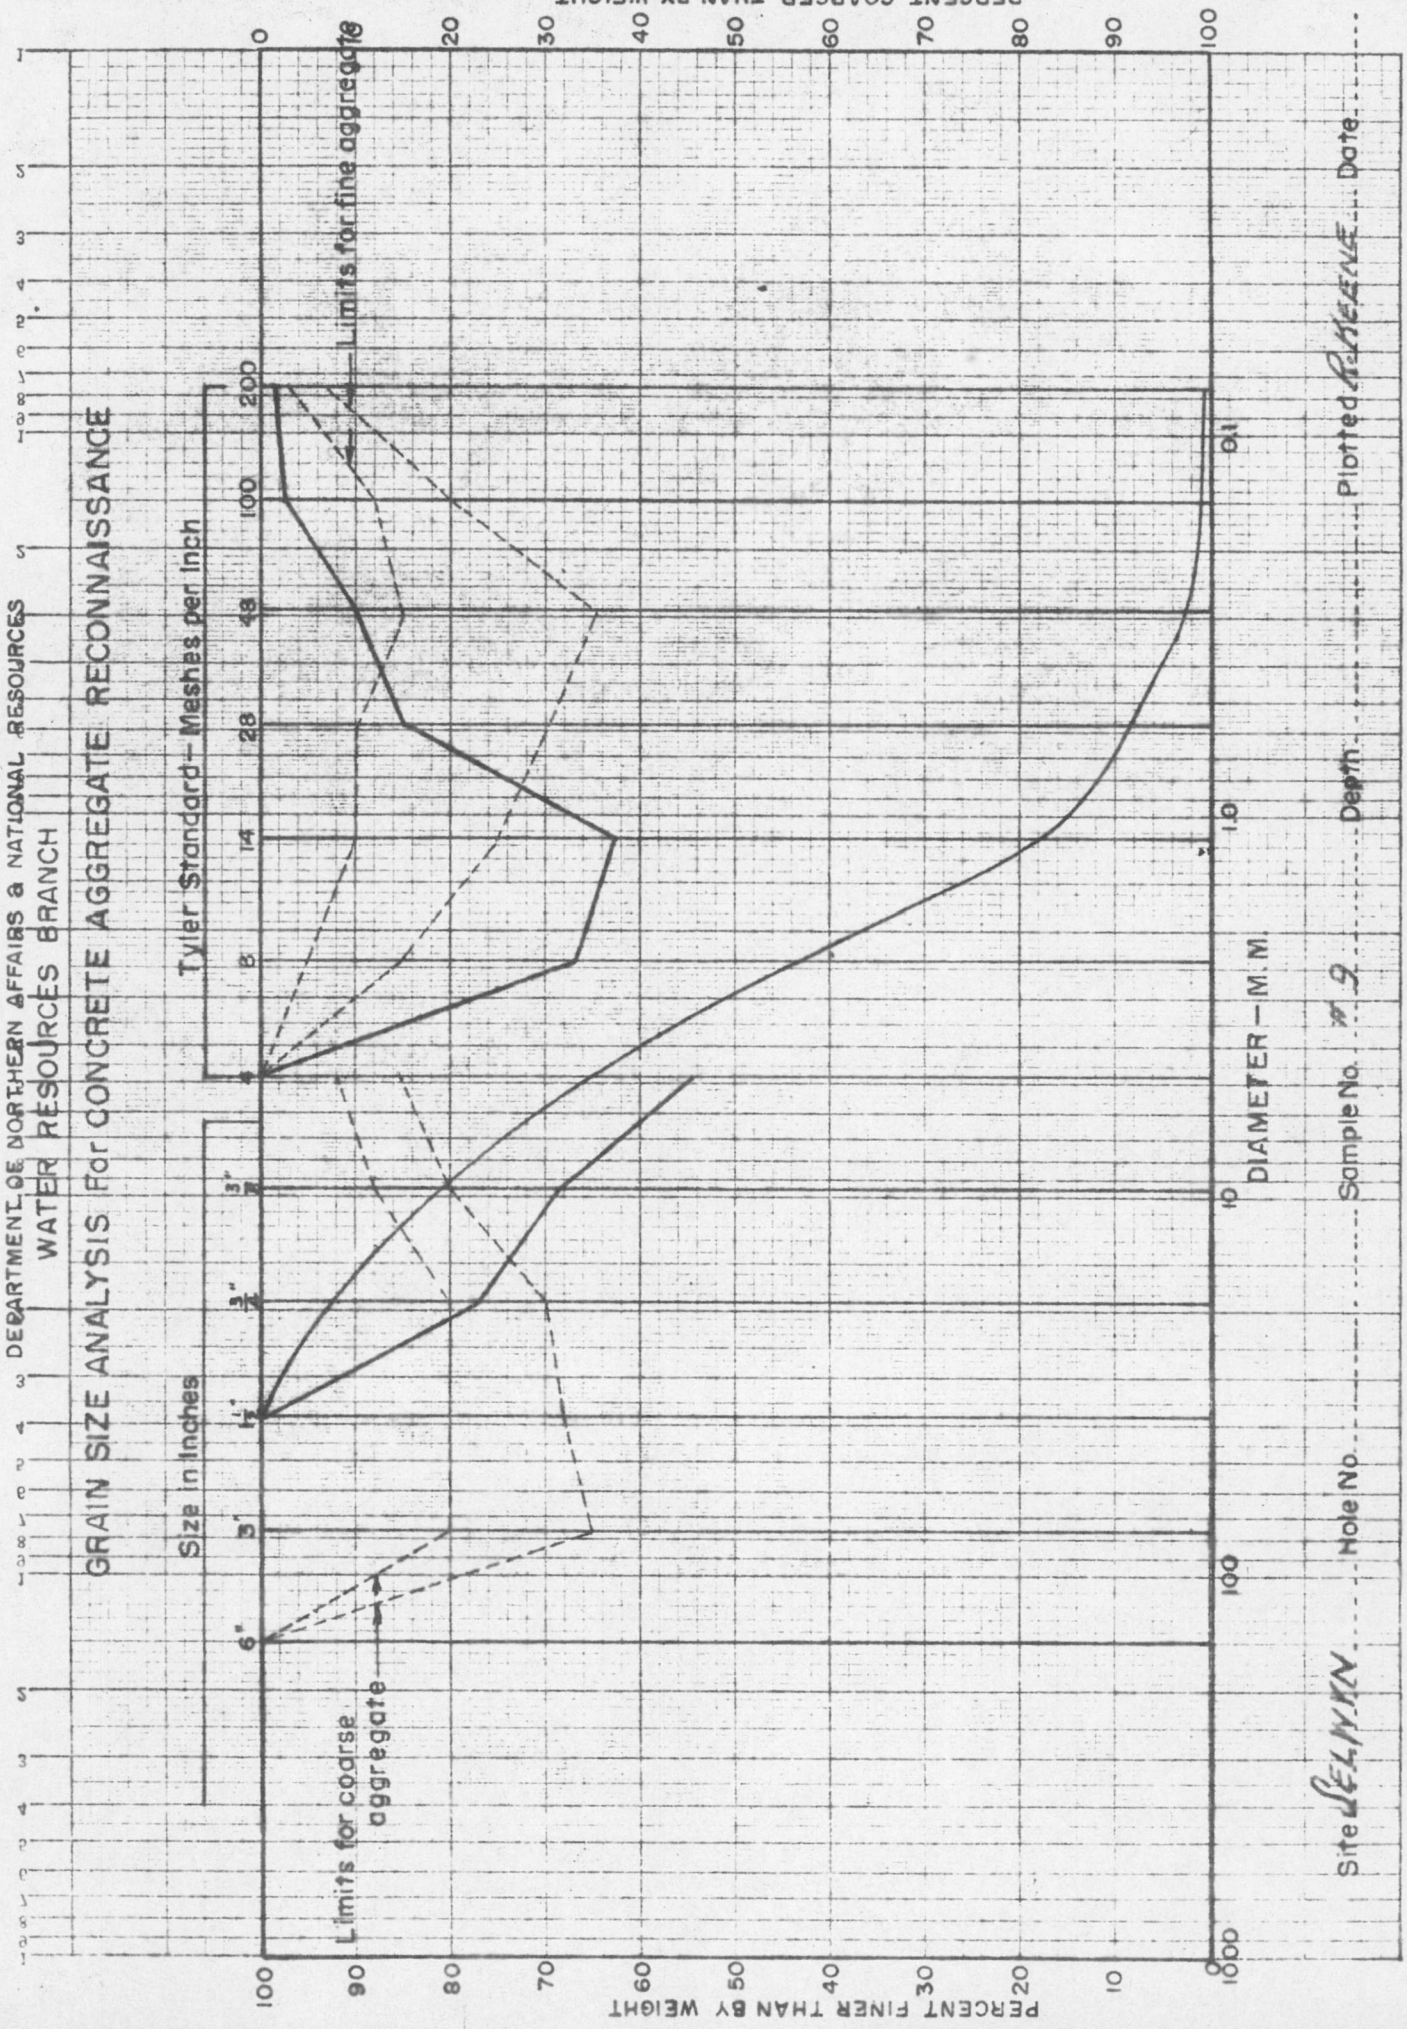
Site SELWYN Hole No. 109 Depth            Plotted            Date

GRAIN SIZE ANALYSIS FOR CONCRETE AGGREGATE RECONNAISSANCE

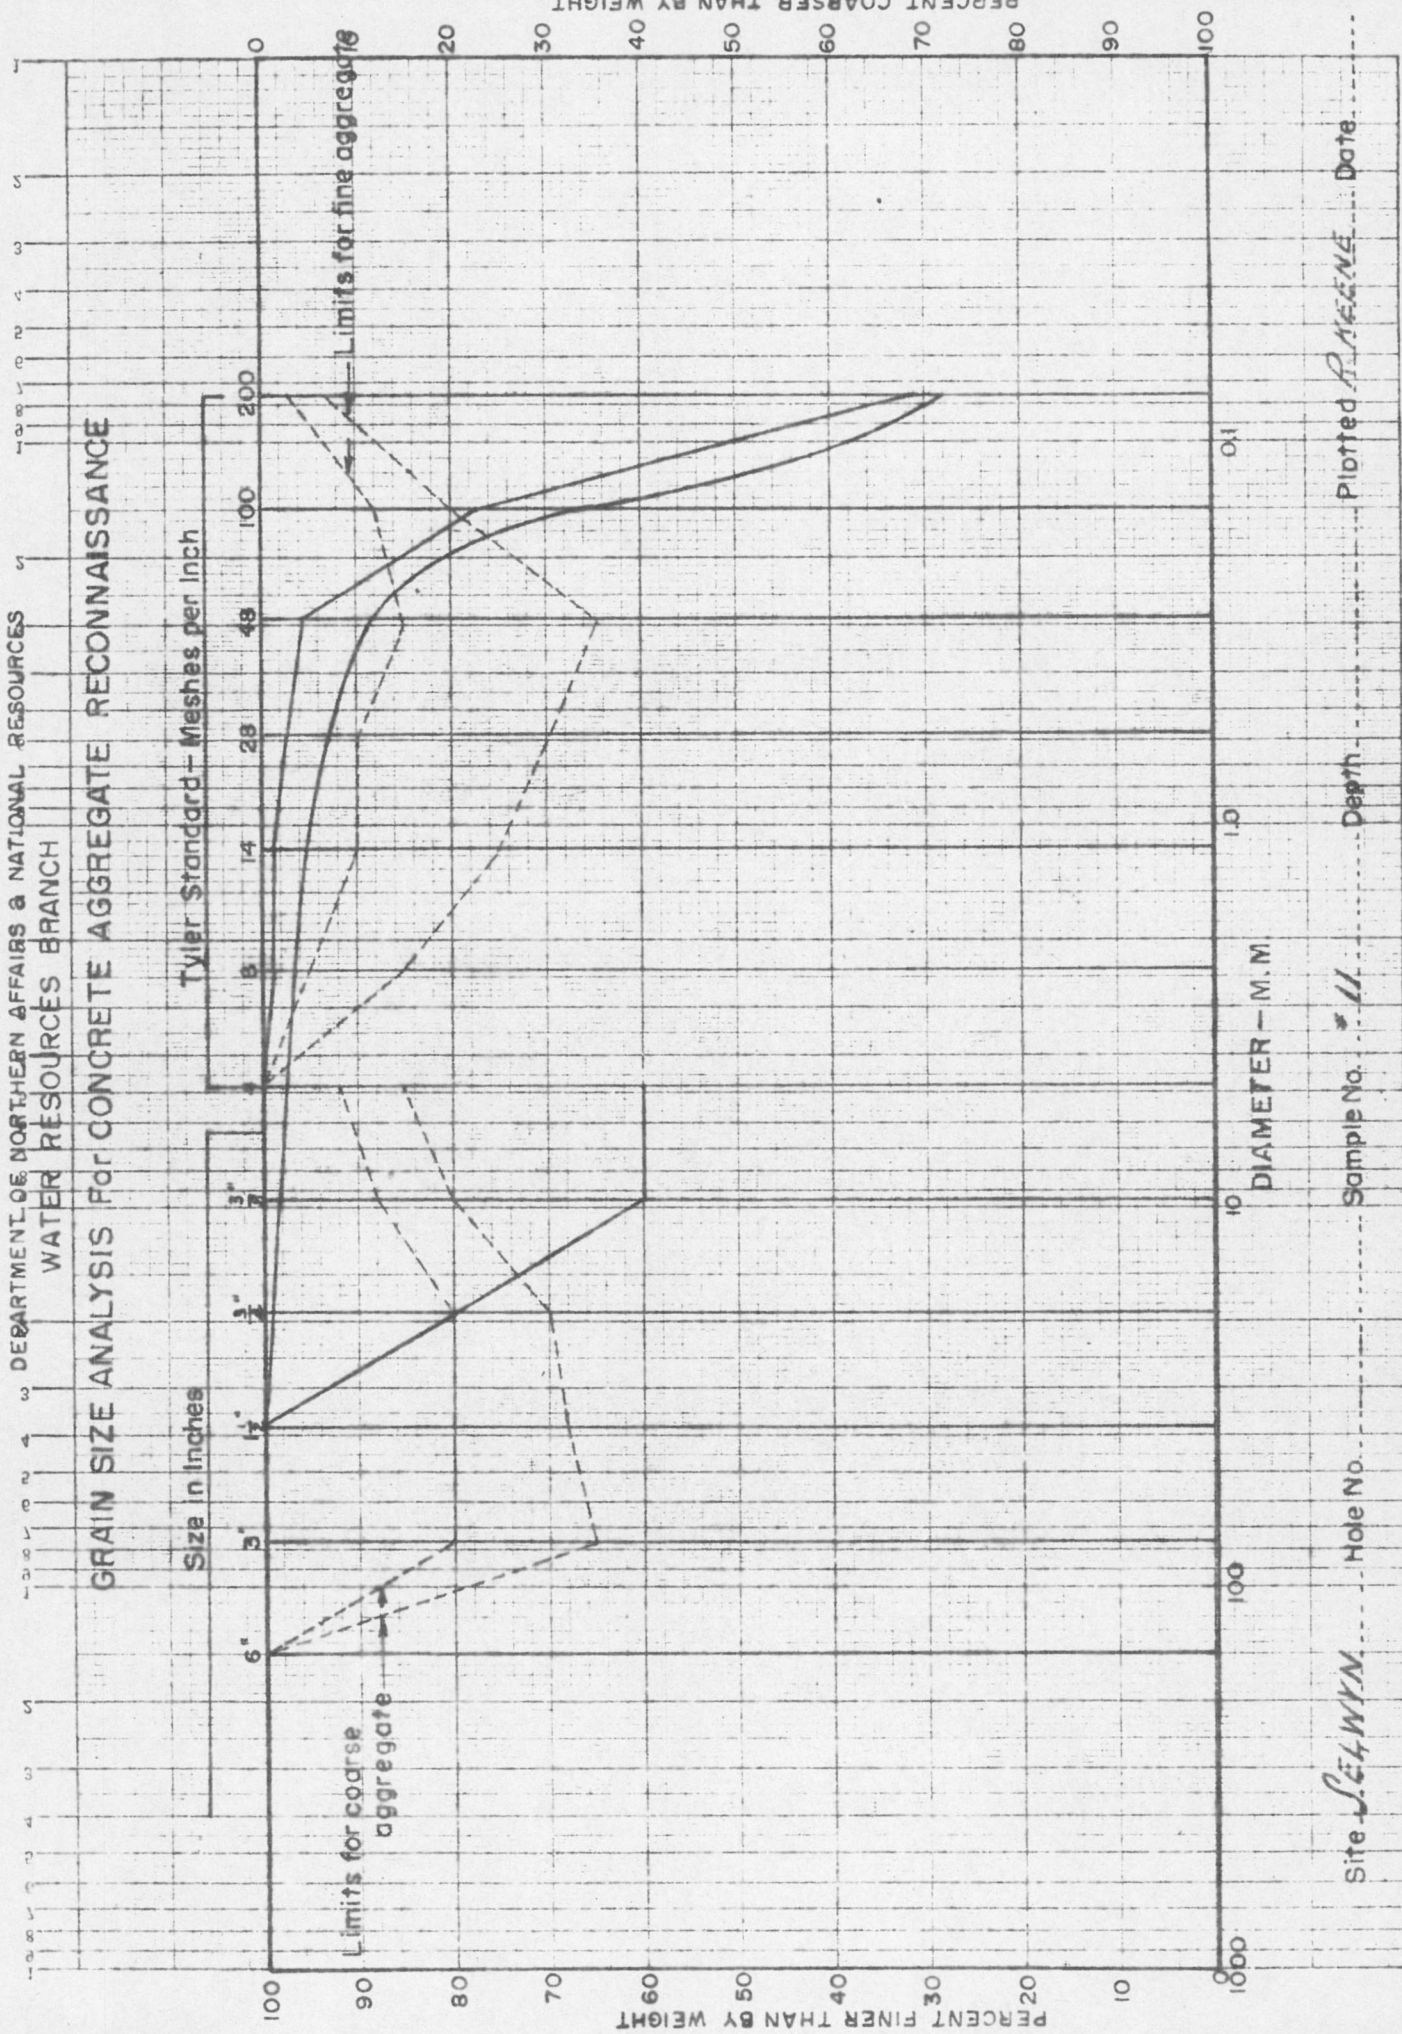
Site *S.E.4 WYN.* Hole No. *11* Depth *Plotted* *A. W. E. N. E.* Date *.....*

GRAIN SIZE ANALYSIS For CONCRETE AGGREGATE RECONNAISSANCE

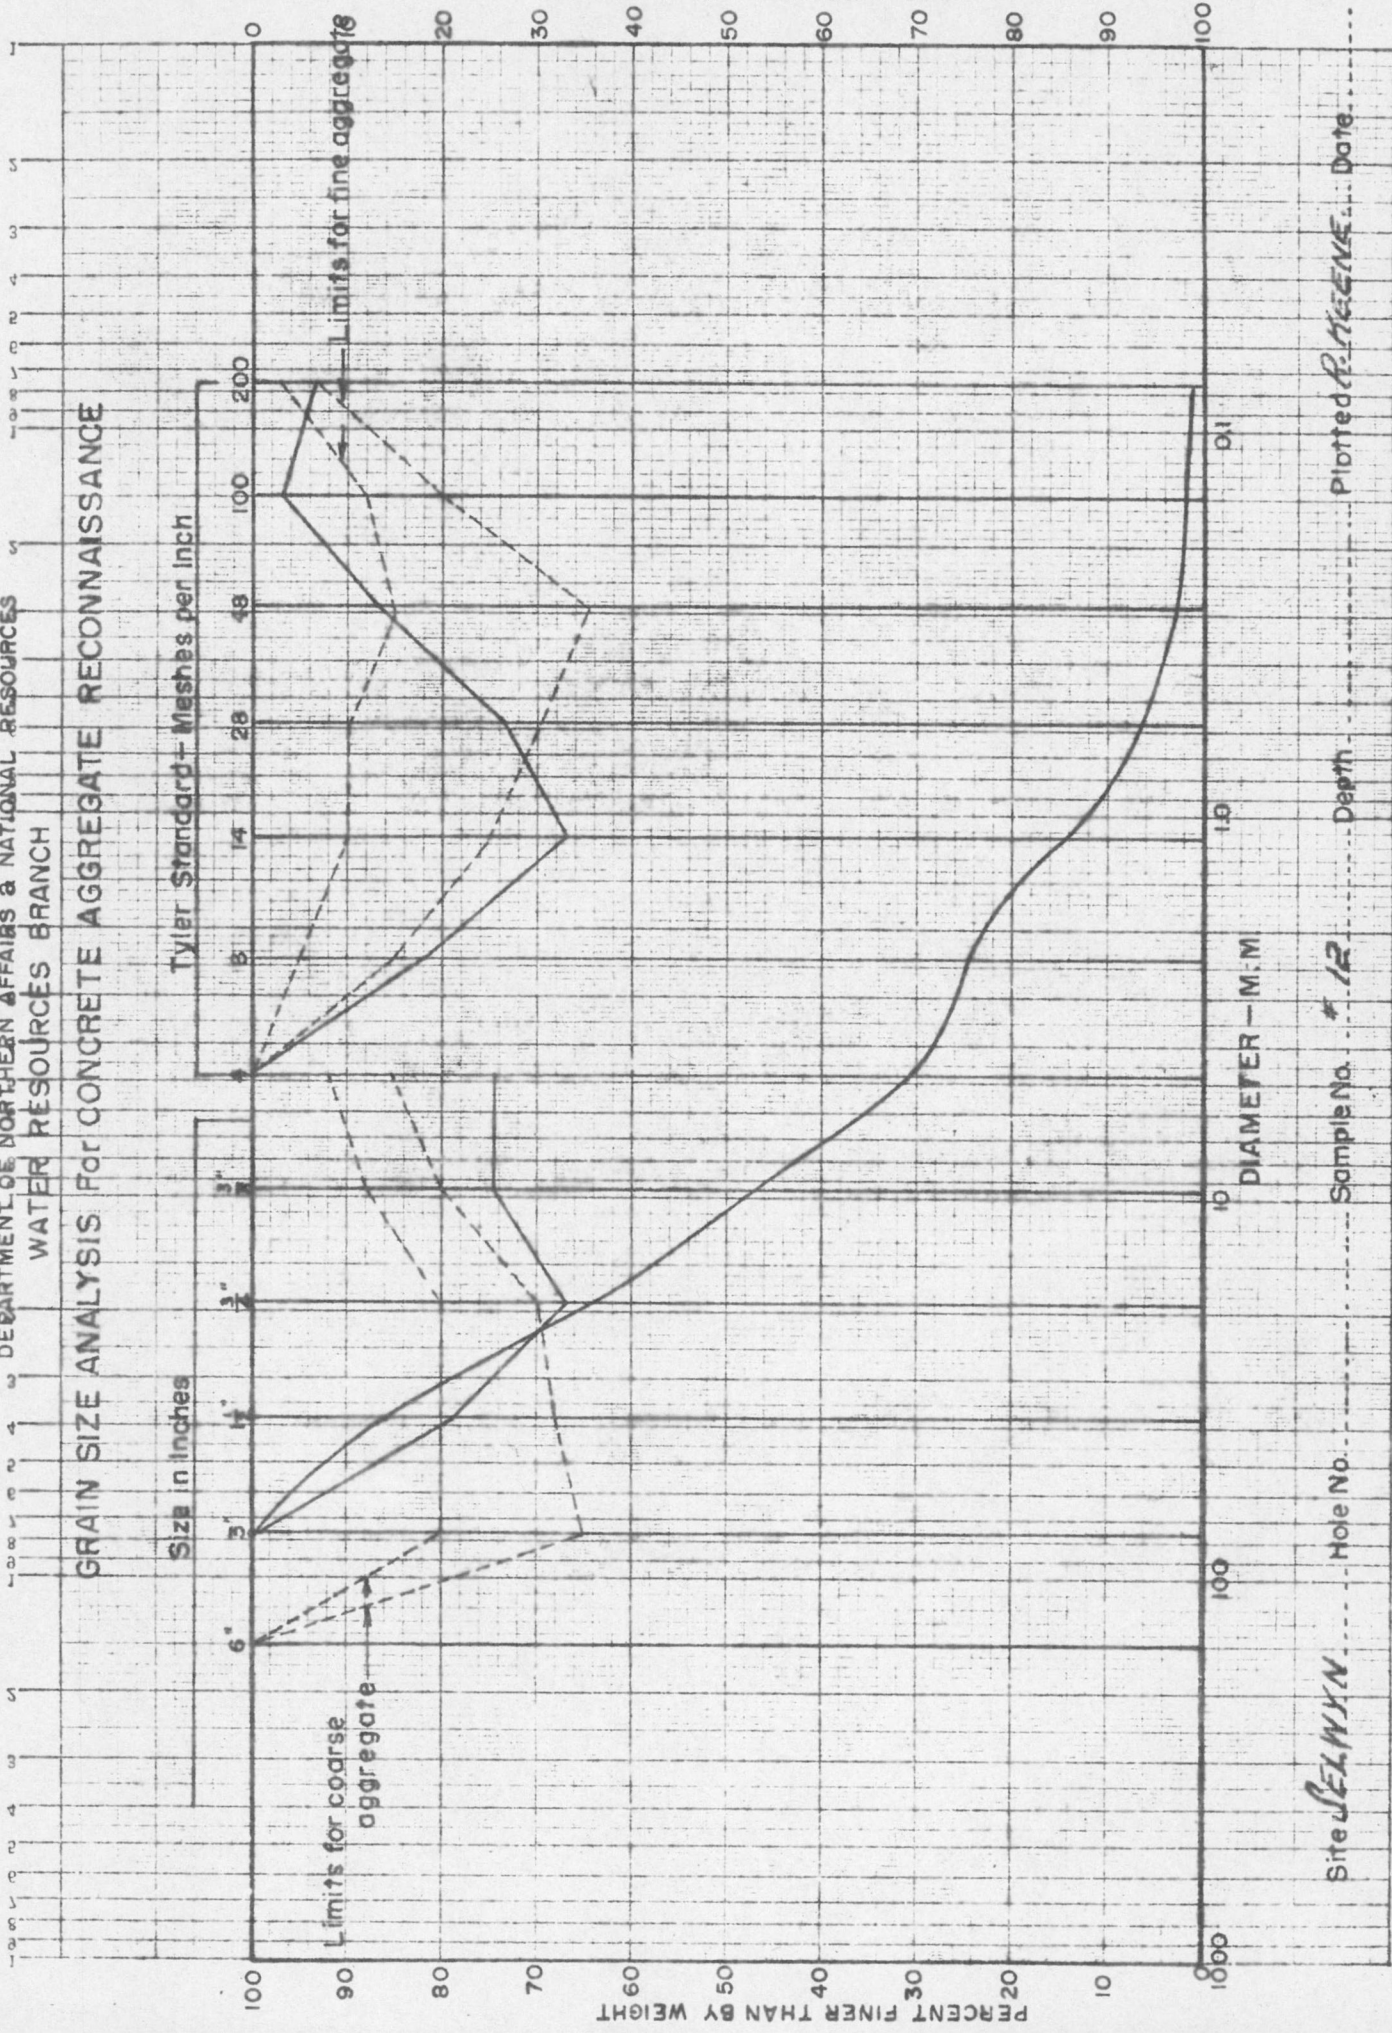
Site *SALWYN* Hole No. *12* Sample No. *12* Depth *12* Plotted *R. McENE* Date *.....*

GRAIN SIZE ANALYSIS FOR CONCRETE AGGREGATE RECONNAISSANCE

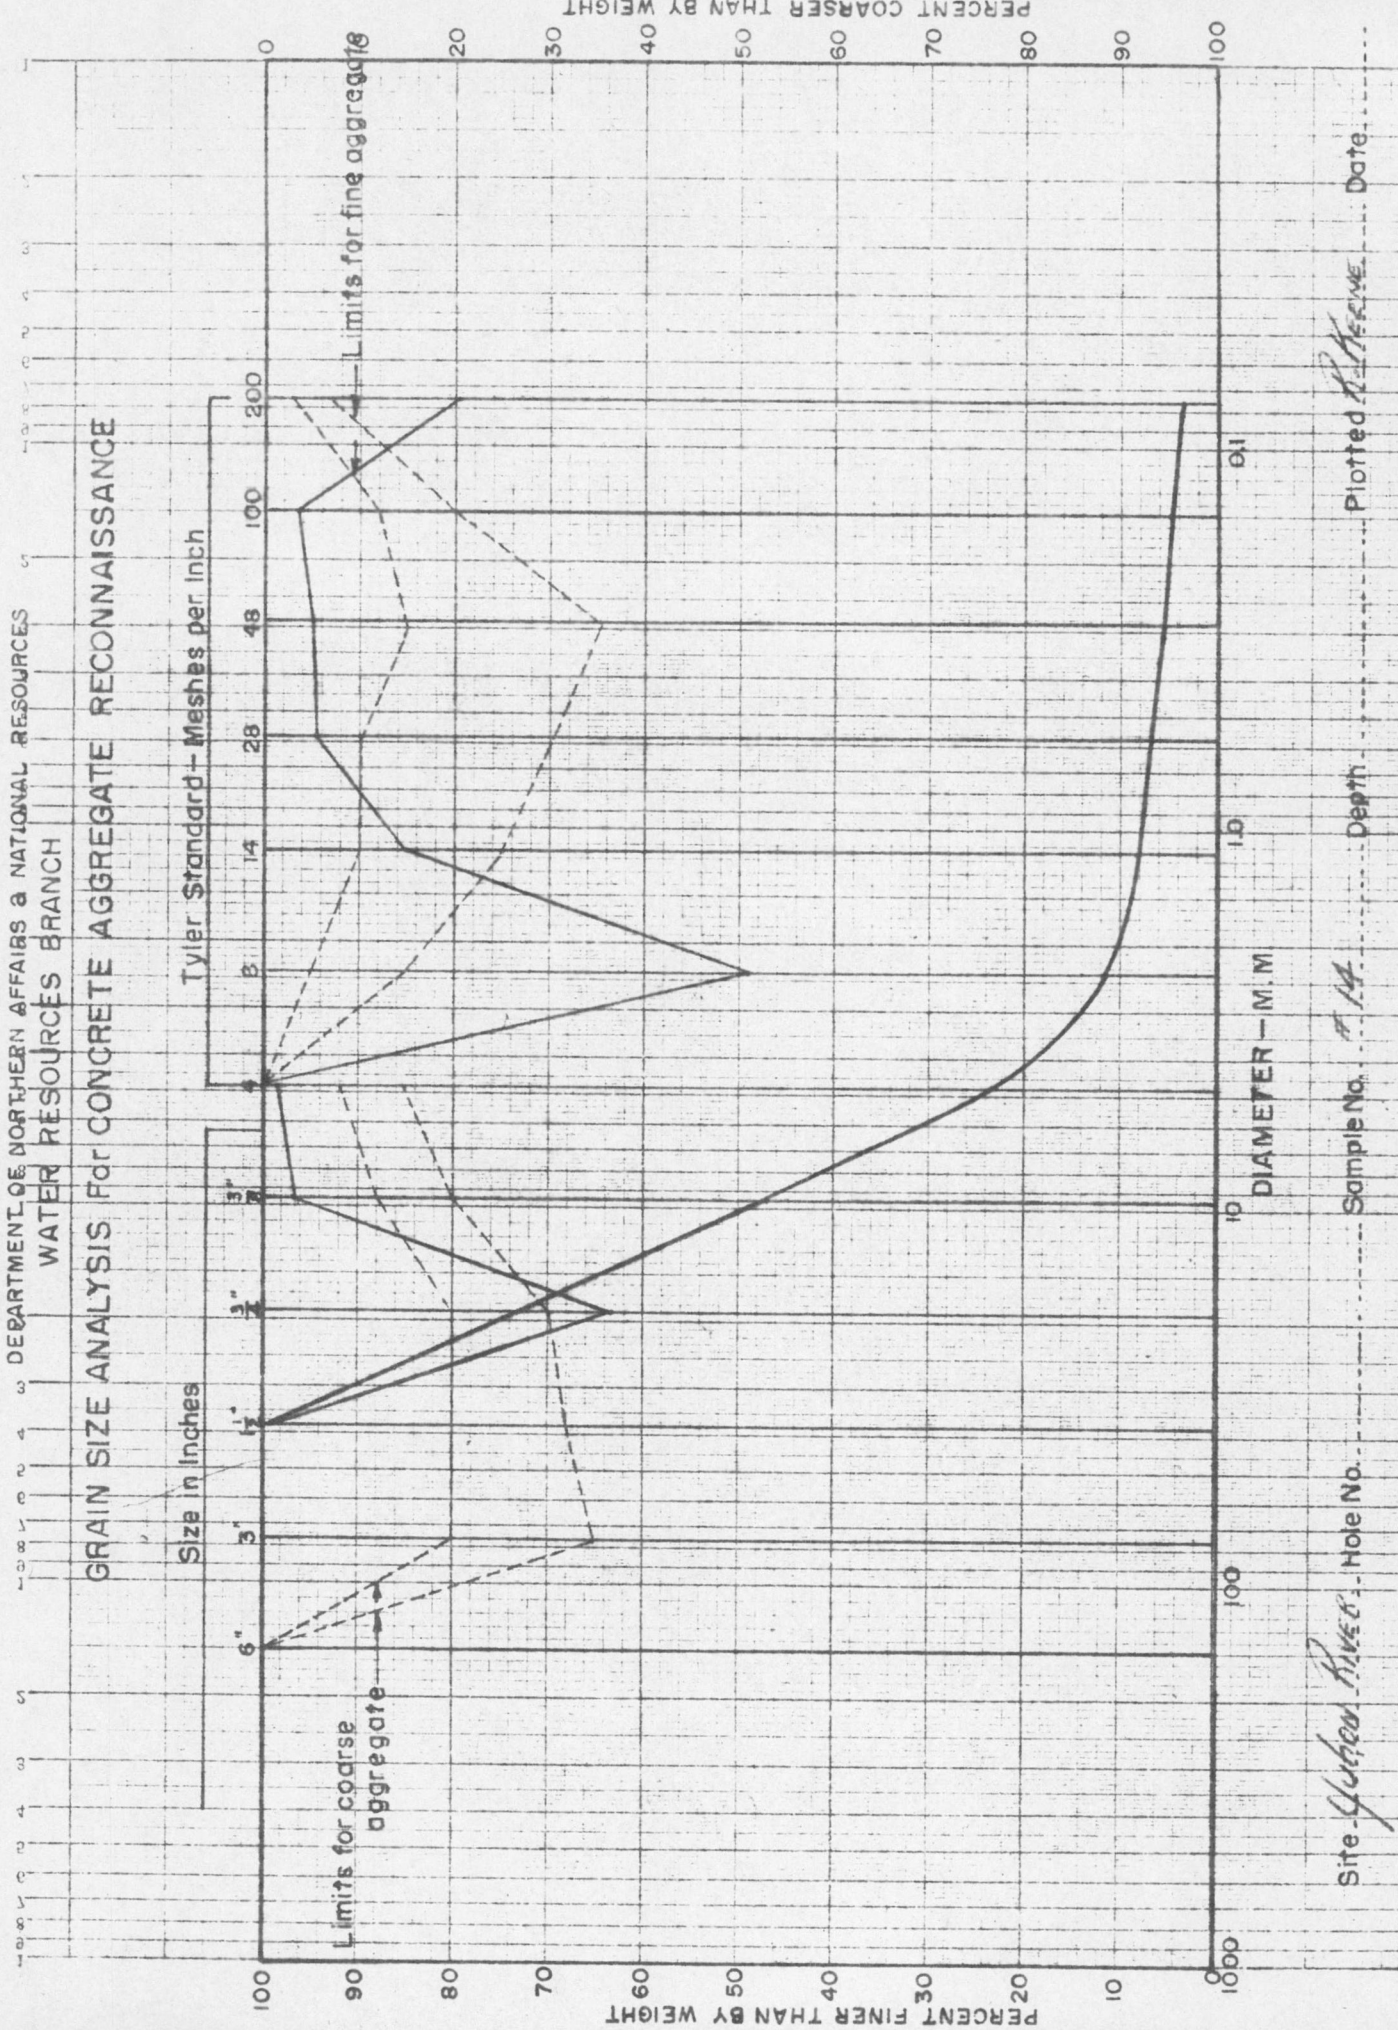
Site - Gudon River Hole No. 14 Sample No. 14 Depth          Plotted          Date

GRAIN SIZE ANALYSIS FOR CONCRETE AGGREGATE RECONNAISSANCE

14	Right side of Yukon River; 6.5 miles below site; 25 feet above River	Sandy gravel with numerous rounded to semi-rounded boulders up to 12 inches; boulders chiefly granite and other hard intrusives	2 feet of silty sand	60 feet	$\frac{1}{2}$ mile wide, $1\frac{1}{2}$ miles long	By Yukon River

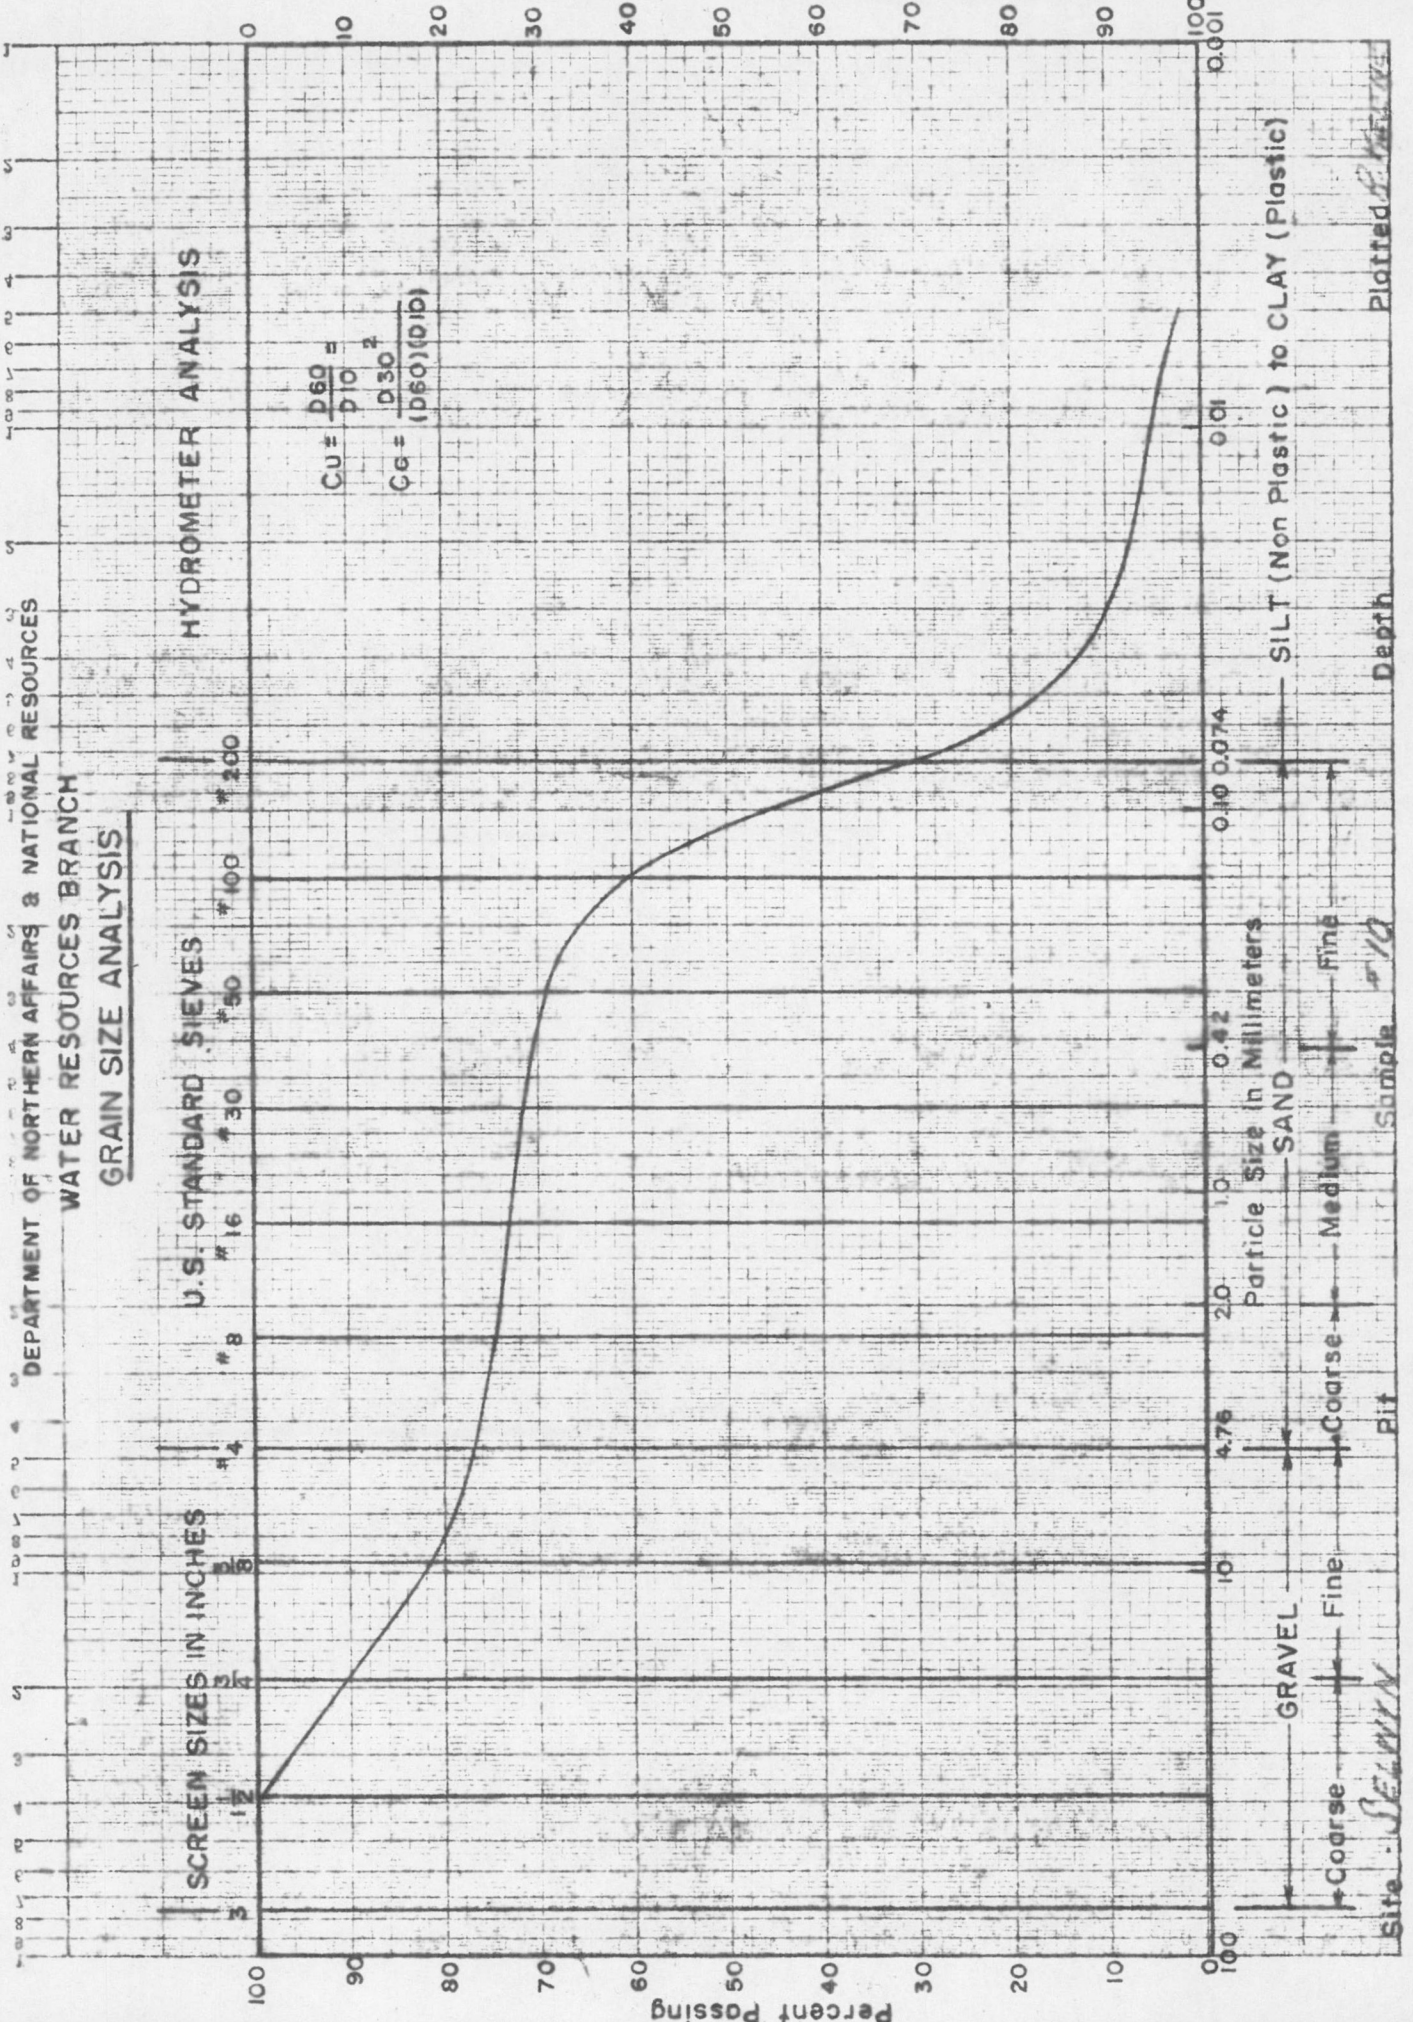
Description of Potential Impervious Material for the following Grain Size Analyses Curve

Sample Number	Location	Field Description of Material	Field Description of Overburden	Thickness of Deposit	Areal Extent (estimated)	Accessibility
10	Right side of Yukon River; 13 miles above site; 10 feet above River	Till-like, solifluction material; a soft, silty, sandy gravel; pebbles up to 3 inches; on sides and at base of large rock bluff	None	20 feet maximum	Not large	By Yukon River
