APPENDIX 10B: FREEGOLD ROAD FISH AND AQUATIC BASELINE

Casino Project

Fish and Aquatic Resources Baseline Report:

Freegold Road Extension, Freegold Road Upgrade, and Casino Airstrip and Airstrip Access Road

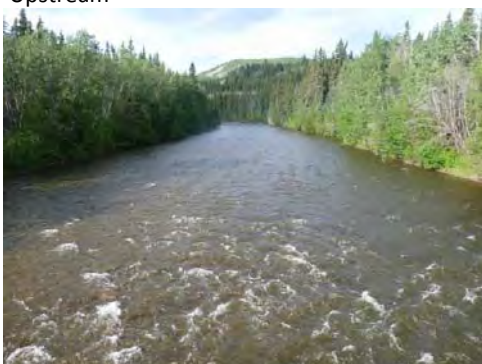
Upstream

Comments:
One and a half lane bridge with foot crossing
Depth unknown, cannot see bottom, stream not wadable
Widths large but unknown at up and downstream sites - unwadable

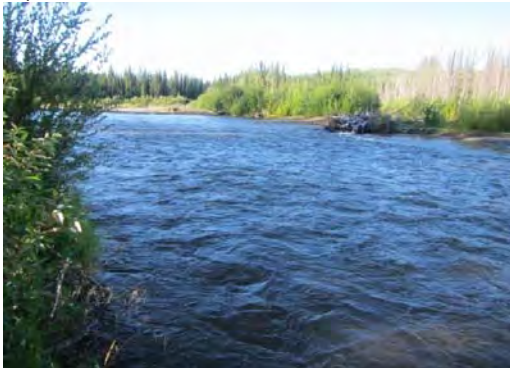
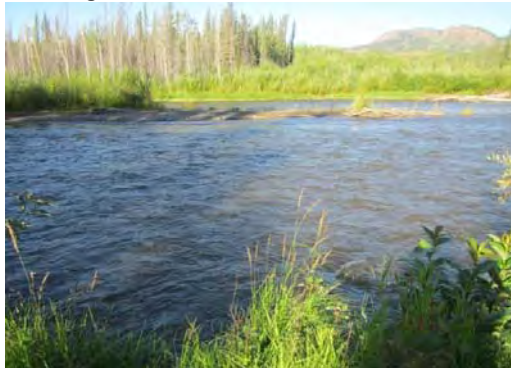
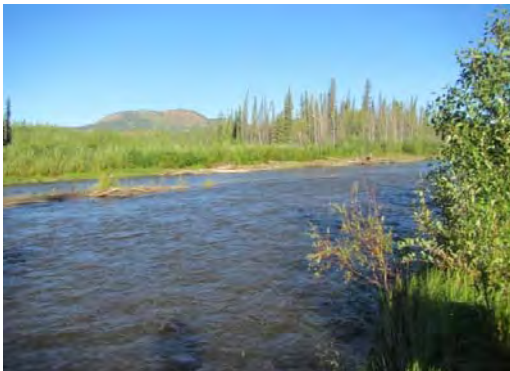
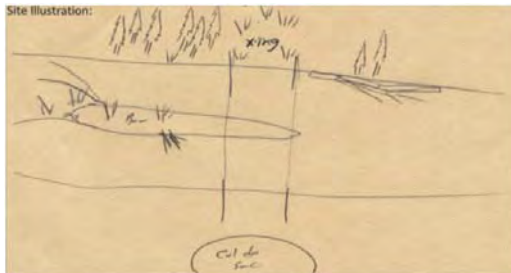
Freegold Road Upgrade Crossing # 1N - Nordenskiöld River

D/S	X	U/S	
Coordinates:	6882967 N	432195 E	Gradient (%):	-	2	-
Site Visit Date:	09-Aug-13		Bankfull Width (m):	-	53.00	-
Flow Conditions:	High		Bankfull Depth (m):	-	1.00	-
Barrier/Confirmed:	None		Wetted Widths (m):	-	53.00	-
Electrofished/Effort?:	No		Wetted Depth (m):	-	1.00	-
Gee Trapping:	No		Substrate Bed:	-	C	-
Fish Bearing?	Yes		Substrate Bank:	-	F	-
Site Length:	100 m		Riparian Vegetation:	-	WI/SP	-
			Meander Pattern:	-	SI/RM	-
			Cover:	-	20% / SUB	-
Photo #s	93 u/s	95 x	94 d/s			
Areas of Erosion:	No		Temperature:	14.76	°C	
Locations:			pH:	7.11	pH units	
			Conductivity:	153	µS/cm	
			DO:	8.85	mg/L	
				92.7	% Sat	
Comments:						
River very high, warm, and turbid during assessment						
Substrate estimated from bar material

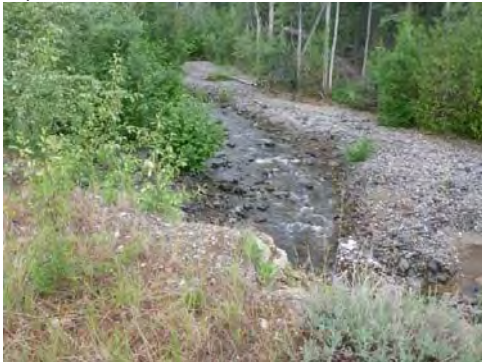
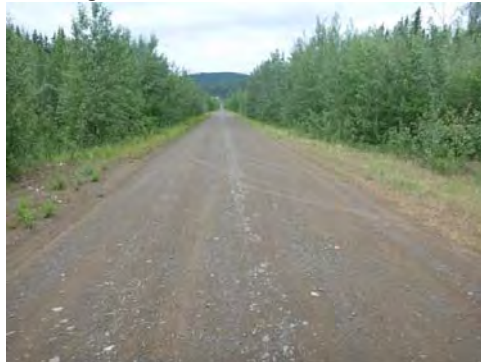
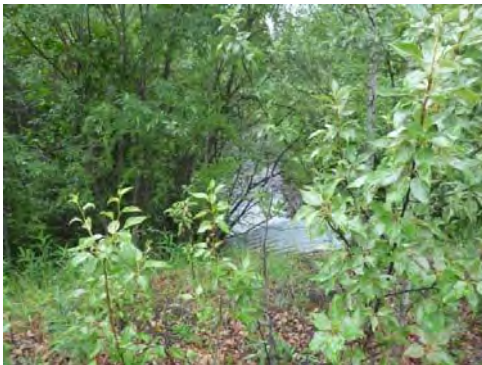
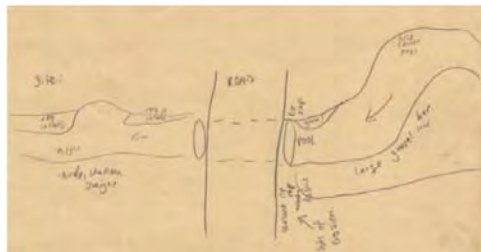
Freegold Road Upgrade Crossing # 4 - Murray Creek

D/S	X	U/S	
Coordinates:	6892374 N	428307 E	Gradient (%):	<1	2	1
Site Visit Date:	03-Jul-13		Bankfull Width (m):	7.60	8.10	6.90
Flow Conditions:	Low		Bankfull Depth (m):	0.30	0.85	0.50
Barrier/Confirmed:	None		Wetted Widths (m):	5.70	4.50	4.65
Electrofished/Effort?:	No		Wetted Depth (m):	0.15	0.10	0.23
Gee Trapping:	No		Substrate Bed:	G/C	C/G	C/G
Fish Bearing?	Yes		Substrate Bank:	F	F	F
Site Length:	100 m		Riparian Vegetation:	PO/WI/SP	SP/PO/WI/AL	SP/PO/WI/AL
			Meander Pattern:	SI	RM	SI
		Cover:	15% / OV	10% / OV	15% / OV	
Photo #s	186 u/s	187 x	188 d/s			
Areas of Erosion:	Y		Temperature:	8.31	°C	
Locations:	Erosion around culvert. Photo 189		pH:	8.45	pH units	
			Conductivity:	189	uS/cm	
			DO:	93.1	mg/L	
				10.32	% Sat	
Comments:						
Culvert is partly collapsed - not creating a barrier						
Hish quality watercourse with a gravel/cobble substrate

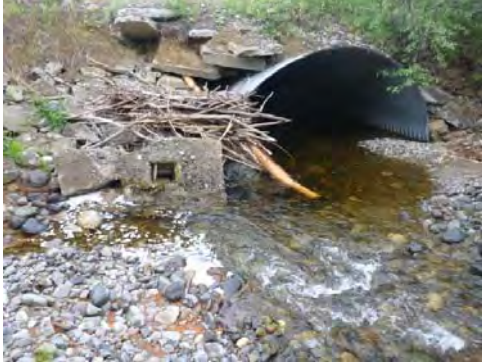
Photo 189

Freegold Road Upgrade Crossing # 4 - Pg. 2

Site 4 had a wetted width of 4.95 m, a depth of 0.16 m and a gradient of 1% (Table 2). The site had a cobble gravel substrate and small amounts of overhanging vegetation. The culvert at this location is partly collapsed, but does not appear to present a barrier to fish movement (Photo 189 – Appendix B).

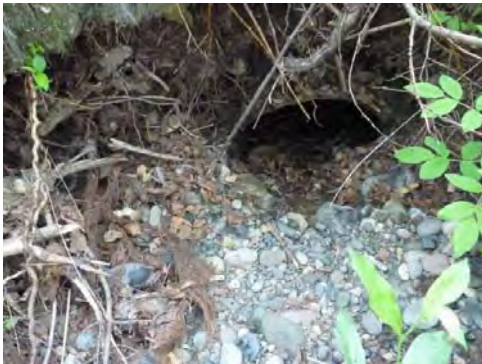
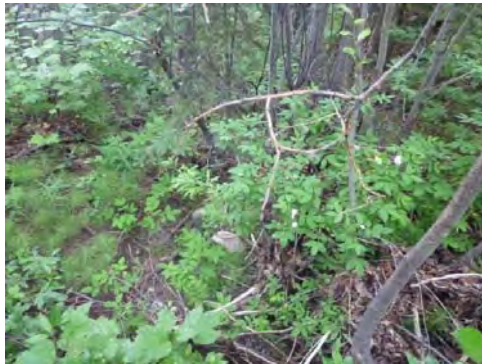
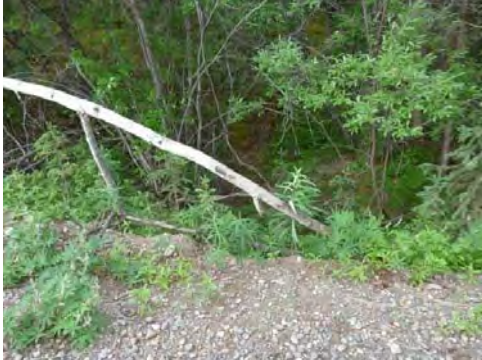
Freegold Road Upgrade Crossing # 5 - Yukon Tributary

D/S	X	U/S
Coordinates:	6897278 N	426998 E	Gradient (%):	-	-
Site Visit Date:	02-Jul-13		Bankfull Width (m):	-	-
Flow Conditions:	None		Bankfull Depth (m):	-	-
Barrier/Confirmed:	Yes		Wetted Widths (m):	-	-
Electrofished/Effort?:	No		Wetted Depth (m):	-	-
Gee Trapping:	No		Substrate Bed:	-	-
Fish Bearing?:	No		Substrate Bank:	-	-
Site Length:	100 m		Riparian Vegetation:	-	-
			Meander Pattern:	-	-
			Cover:	-	-
Photo #s	95 u/s	96 x	97 d/s		
Areas of Erosion:	No		Temperature:	-	°C
Locations:			pH:	-	pH units
			Conductivity:	-	uS/cm
			DO:	-	mg/L
				-	% Sat
Comments: No visible channel					
Many appear to be stream crossing on map, however, co-ordinates are on the existing road					
which stays on one side of the creek					
Culvert present with little evidence of flow

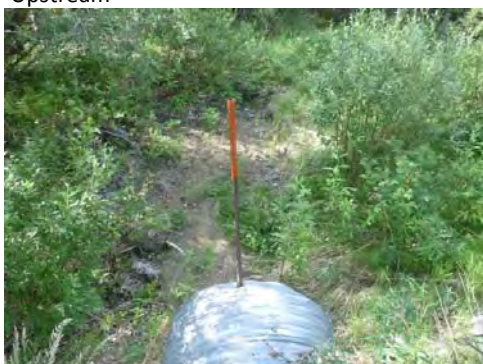
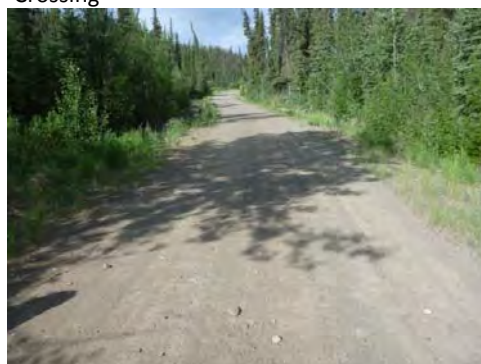
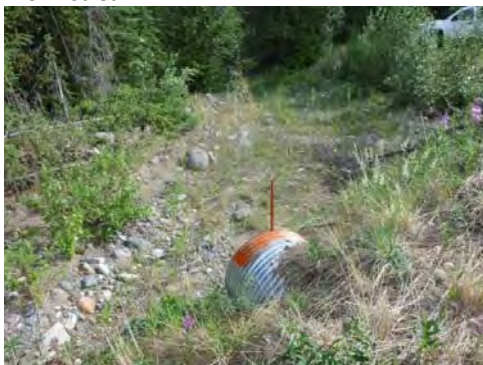
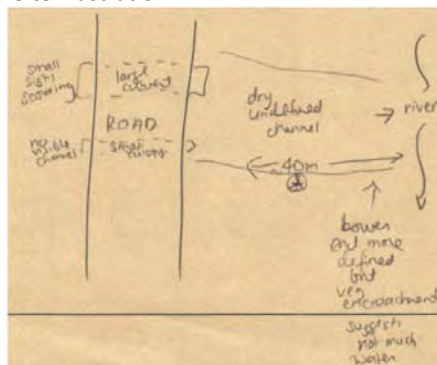
Freegold Road Upgrade Crossing # 6.5 (Unmapped Site) - Crossing Creek Tributary

D/S	X	U/S
Coordinates:	6903635 N	421706 E	Gradient (%):	-	-	-
Site Visit Date:	01-Jul-13		Bankfull Width (m):	-	-	-
Flow Conditions:	None/ Dry		Bankfull Depth (m):	-	-	-
Barrier/Confirmed:	Yes		Wetted Widths (m):	-	-	-
Electrofished/Effort?:	No		Wetted Depth (m):	-	-	-
Gee Trapping:	No		Substrate Bed:	-	-	-
Fish Bearing?:	No		Substrate Bank:	-	-	-
Site Length:	100 m		Riparian Vegetation:	-	-	-
			Meander Pattern:	-	-	-
			Cover:	-	-	-
Photo #s	101-0049 u/s	101-0050 x	101-0051 d/s			
Areas of Erosion:	No		Temperature:	-	°C	
Locations:			pH:	-	pH units	
			Conductivity:	-	uS/cm	
			DO:	-	mg/L	
				-	% Sat

Comments:	Dry channel
Two crossings close together	
Photos represent larger channel	
Smaller: no visible channel, photos: 101-0052 (downstream of culvert), 101-0053 (upstream of perched culvert)	
Lower end more defined, vegetation encroachment suggests not much water: photos 101-0054/101-0055

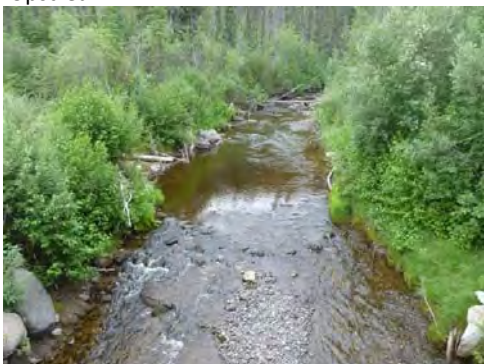
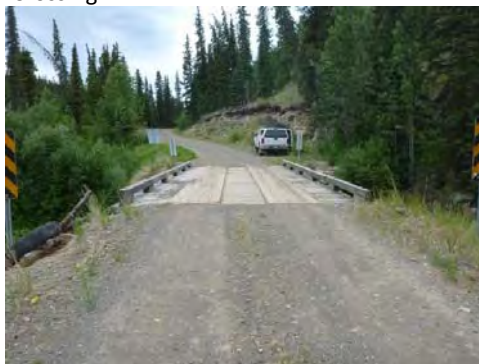
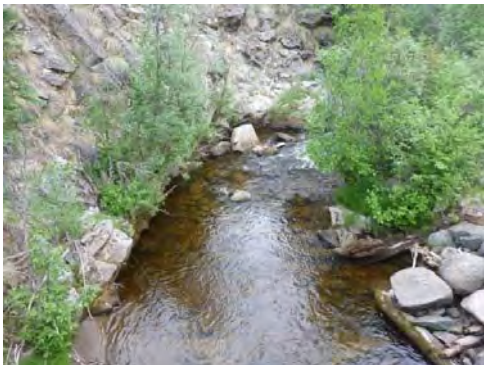
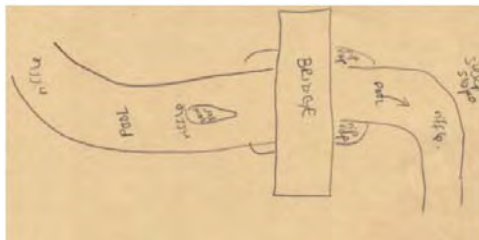
Freegold Road Upgrade Crossing # 7 - Crossing Creek

D/S	X	U/S	
Coordinates:	6903613 N	421510 E	Gradient (%):	4	3	5
Site Visit Date:	01-Jul-13		Bankfull Width (m):	5.80	7.80	8.30
Flow Conditions:	Med		Bankfull Depth (m):	0.70	0.32	0.70
Barrier/Confirmed:	None		Wetted Widths (m):	5.80	7.40	6.90
Electrofished/Effort?:	No		Wetted Depth (m):	0.26	0.12	0.34
Gee Trapping:	No		Substrate Bed:	B/C	G/C	B/C
Fish Bearing?	Yes		Substrate Bank:	F	F	F
Site Length:	100 m		Riparian Vegetation:	SP/PO/WI	SP/PO/WI	SP/PO/WI
			Meander Pattern:	SI	RM	SI
			Cover:	45% / B/OV	5% / B	20% / B
Photo #s	101-0056 u/s	101-0057 x	101-0058 d/s			
Areas of Erosion:	N		Temperature:	12.02	°C	
Locations:			pH:	8.49	pH units	
			Conductivity:	211	uS/cm	
			DO:	8.51	mg/L

85.3	% Sat	
Comments:						
Saw grayling in upstream pool						
Culvert downstream of site at 08 V 0421577 6903600, no flow, no visible channel, lots of						
vegetation - photos 15 (downstream) and 16 (upstream)

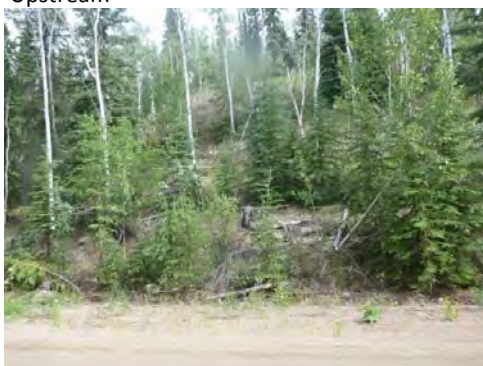
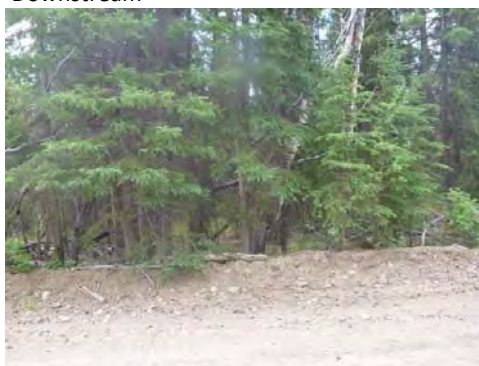
Freegold Road Upgrade Crossing # 11 - No Crossing

D/S	X	U/S
Coordinates:	6903808 N	420721 E	Gradient (%):	-	-
Site Visit Date:	02-Jul-13		Bankfull Width (m):	-	-
Flow Conditions:	None		Bankfull Depth (m):	-	-
Barrier/Confirmed:	N/A		Wetted Widths (m):	-	-
Electrofished/Effort?:	N/A		Wetted Depth (m):	-	-
Gee Trapping:	N/A		Substrate Bed:	-	-
Fish Bearing?	N/A		Substrate Bank:	-	-
Site Length:	N/A		Riparian Vegetation:	-	-
			Meander Pattern:	-	-
			Cover:	-	-
Photo #s	107 u/s	x	108 d/s		
Areas of Erosion:	N/A		Temperature:	-	°C
Locations:			pH:	-	pH units
			Conductivity:	-	uS/cm
			DO:	-	mg/L
				-	% Sat
Comments: No visible channel					
Many appear to be stream crossing on map, however, co-ordinates are on the existing road					
which stays on one side of the creek

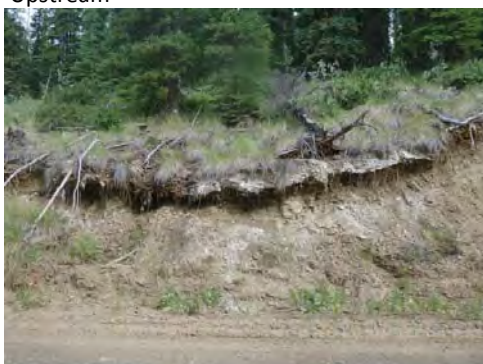
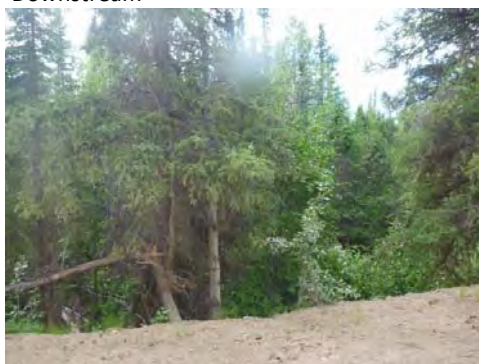
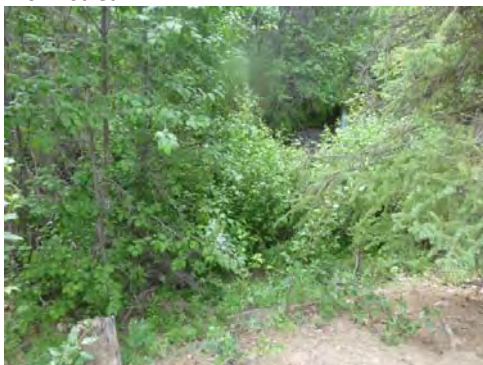
Freegold Road Upgrade Crossing # 12 - No Crossing

D/S	X	U/S
Coordinates:	6903776 N	420538 E	Gradient (%):	-	-
Site Visit Date:	02-Jul-13		Bankfull Width (m):	-	-
Flow Conditions:	None		Bankfull Depth (m):	-	-
Barrier/Confirmed:	N/A		Wetted Widths (m):	-	-
Electrofished/Effort?:	N/A		Wetted Depth (m):	-	-
Gee Trapping:	N/A		Substrate Bed:	-	-
Fish Bearing?:	N/A		Substrate Bank:	-	-
Site Length:	N/A		Riparian Vegetation:	-	-
			Meander Pattern:	-	-
			Cover:	-	-
Photo #s	109 u/s	x	110 d/s		
Areas of Erosion:	N/A		Temperature:	-	°C
Locations:			pH:	-	pH units
			Conductivity:	-	uS/cm
			DO:	-	mg/L
				-	% Sat
Comments: No visible channel					
Many appear to be stream crossing on map, however, co-ordinates are on the existing road					
which stays on one side of the creek

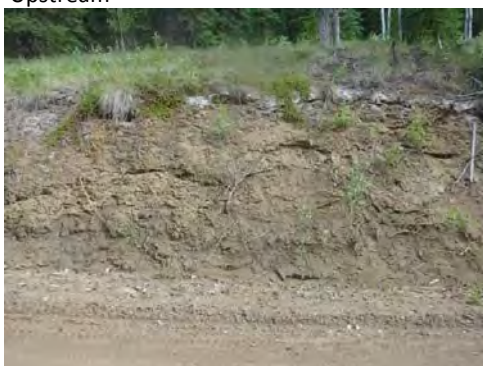
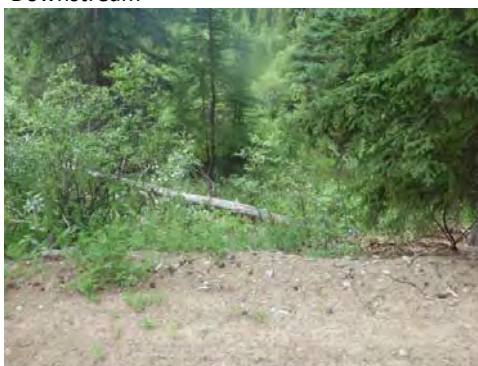
Freegold Road Upgrade Crossing # 13 - No Crossing

D/S	X	U/S
Coordinates:	6903769 N	420483 E	Gradient (%):	-	-
Site Visit Date:	02-Jul-13		Bankfull Width (m):	-	-
Flow Conditions:	None		Bankfull Depth (m):	-	-
Barrier/Confirmed:	N/A		Wetted Widths (m):	-	-
Electrofished/Effort?:	N/A		Wetted Depth (m):	-	-
Gee Trapping:	N/A		Substrate Bed:	-	-
Fish Bearing?:	N/A		Substrate Bank:	-	-
Site Length:	N/A		Riparian Vegetation:	-	-
			Meander Pattern:	-	-
			Cover:	-	-
Photo #s	112 u/s	x	113 d/s		
Areas of Erosion:	N/A		Temperature:	-	°C
Locations:			pH:	-	pH units
			Conductivity:	-	uS/cm
			DO:	-	mg/L
				-	% Sat
Comments: No visible channel					
Many appear to be stream crossing on map, however, co-ordinates are on the existing road					
which stays on one side of the creek

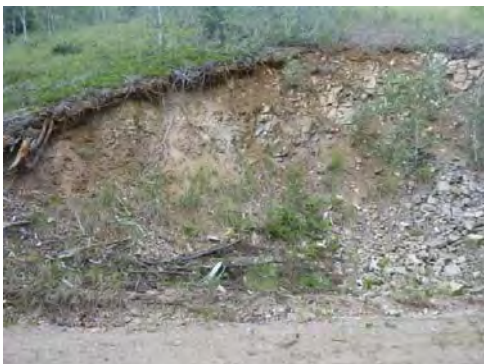
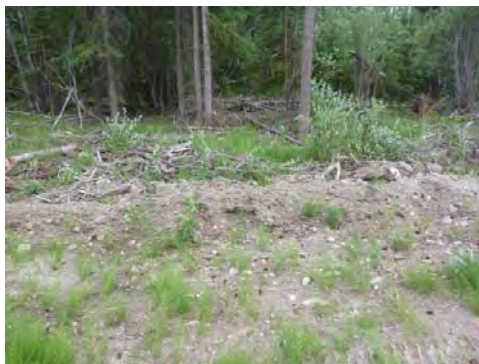
Freegold Road Upgrade Crossing # 14 - No Crossing

D/S	X	U/S
Coordinates:	6903861 N	419304 E	Gradient (%):	-	-
Site Visit Date:	01-Jul-13		Bankfull Width (m):	-	-
Flow Conditions:	None		Bankfull Depth (m):	-	-
Barrier/Confirmed:	N/A		Wetted Widths (m):	-	-
Electrofished/Effort?:	N/A		Wetted Depth (m):	-	-
Gee Trapping:	N/A		Substrate Bed:	-	-
Fish Bearing?	N/A		Substrate Bank:	-	-
Site Length:	N/A		Riparian Vegetation:	-	-
			Meander Pattern:	-	-
			Cover:	-	-
Photo #s	u/s	x	d/s		
Areas of Erosion:	N/A		Temperature:	-	°C
Locations:			pH:	-	pH units
			Conductivity:	-	uS/cm
			DO:	-	mg/L
				-	% Sat
Comments:					
No visible channel

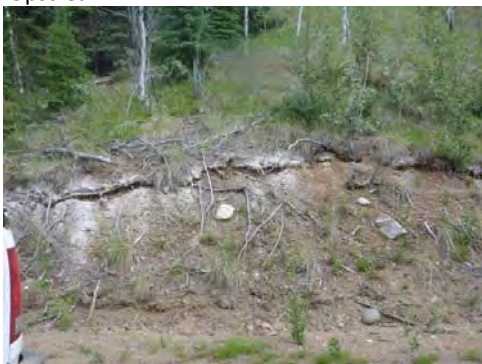
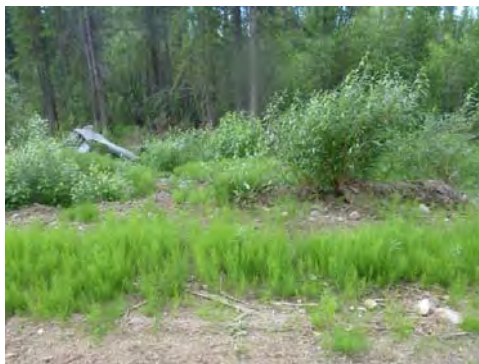
Freegold Road Upgrade Crossing # 15 - No Crossing

D/S	X	U/S
Coordinates:	6903835 N	419196 E	Gradient (%):	-	-
Site Visit Date:	02-Jul-13		Bankfull Width (m):	-	-
Flow Conditions:	None		Bankfull Depth (m):	-	-
Barrier/Confirmed:	N/A		Wetted Widths (m):	-	-
Electrofished/Effort?:	N/A		Wetted Depth (m):	-	-
Gee Trapping:	N/A		Substrate Bed:	-	-
Fish Bearing?:	N/A		Substrate Bank:	-	-
Site Length:	N/A		Riparian Vegetation:	-	-
			Meander Pattern:	-	-
			Cover:	-	-
Photo #s	114 u/s	x	115 d/s		
Areas of Erosion:	N/A		Temperature:	-	°C
Locations:			pH:	-	pH units
			Conductivity:	-	uS/cm
			DO:	-	mg/L
				-	% Sat
Comments: No visible channel					
Many appear to be stream crossing on map, however, co-ordinates are on the existing road					
which stays on one side of the creek

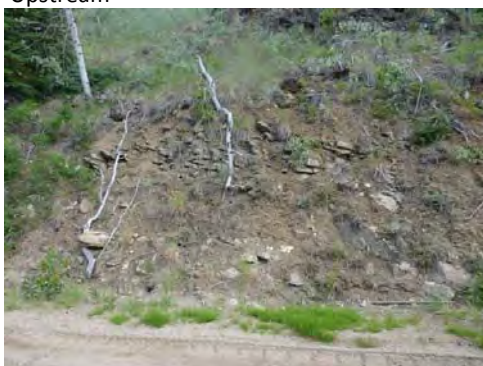
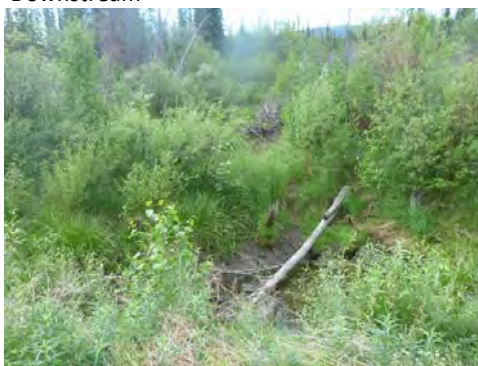
Freegold Road Upgrade Crossing # 16 - No Crossing

D/S	X	U/S
Coordinates:	6903833 N	419133 E	Gradient (%):	-	-
Site Visit Date:	02-Jul-13		Bankfull Width (m):	-	-
Flow Conditions:	None		Bankfull Depth (m):	-	-
Barrier/Confirmed:	N/A		Wetted Widths (m):	-	-
Electrofished/Effort?:	N/A		Wetted Depth (m):	-	-
Gee Trapping:	N/A		Substrate Bed:	-	-
Fish Bearing?:	N/A		Substrate Bank:	-	-
Site Length:	N/A		Riparian Vegetation:	-	-
			Meander Pattern:	-	-
			Cover:	-	-
Photo #s	117 u/s	x	116 d/s		
Areas of Erosion:	Y/N		Temperature:	-	°C
Locations:			pH:	-	pH units
			Conductivity:	-	uS/cm
			DO:	-	mg/L
				-	% Sat
Comments: No visible channel					
Many appear to be stream crossing on map, however, co-ordinates are on the existing road which stays on one side of the creek.					
Groundwater pond next to road, no connection to creek.

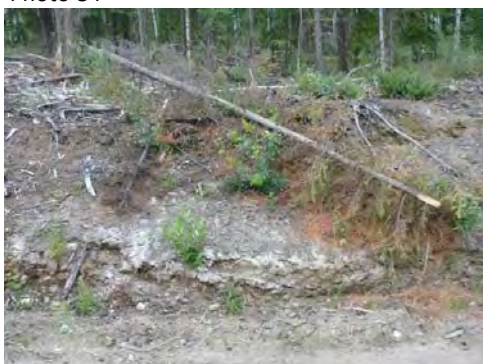
Freegold Road Upgrade Crossing # 17 - No Crossing

D/S	X	U/S
Coordinates:	6903822 N	419070 E	Gradient (%):	-	-
Site Visit Date:	01-Jul-13		Bankfull Width (m):	-	-
Flow Conditions:	None		Bankfull Depth (m):	-	-
Barrier/Confirmed:	N/A		Wetted Widths (m):	-	-
Electrofished/Effort?:	N/A		Wetted Depth (m):	-	-
Gee Trapping:	N/A		Substrate Bed:	-	-
Fish Bearing?	N/A		Substrate Bank:	-	-
Site Length:	N/A		Riparian Vegetation:	-	-
			Meander Pattern:	-	-
			Cover:	-	-
Photo #s	u/s	x	d/s		
Areas of Erosion:	N/A		Temperature:	-	°C
Locations:			pH:	-	pH units
			Conductivity:	-	uS/cm
			DO:	-	mg/L
				-	% Sat
Comments:	No visible channel

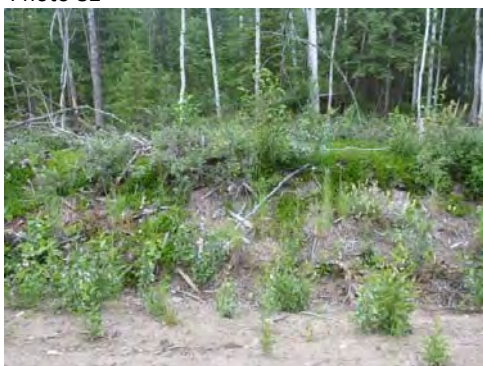
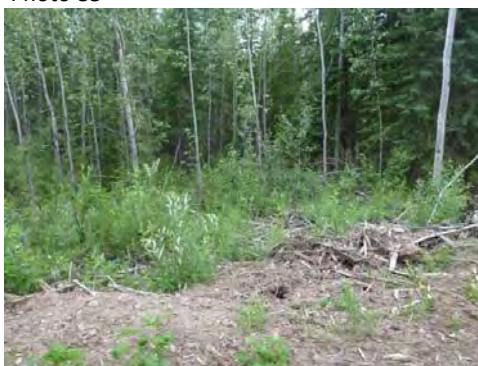
Freegold Road Upgrade Crossing # 18 - No Crossing

D/S	X	U/S
Coordinates:	6903853 N	418594 E	Gradient (%):	-	-
Site Visit Date:	01-Jul-13		Bankfull Width (m):	-	-
Flow Conditions:	None		Bankfull Depth (m):	-	-
Barrier/Confirmed:	N/A		Wetted Widths (m):	-	-
Electrofished/Effort?:	N/A		Wetted Depth (m):	-	-
Gee Trapping:	N/A		Substrate Bed:	-	-
Fish Bearing?:	N/A		Substrate Bank:	-	-
Site Length:	N/A		Riparian Vegetation:	-	-
			Meander Pattern:	-	-
			Cover:	-	-
Photo #s	u/s	x	d/s		
Areas of Erosion:	N/A		Temperature:	-	°C
Locations:			pH:	-	pH units
			Conductivity:	-	uS/cm
			DO:	-	mg/L
				-	% Sat
Comments: No visible channel

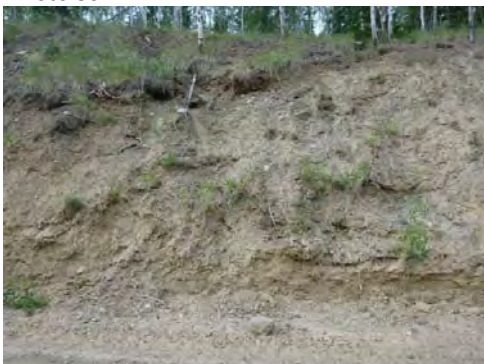
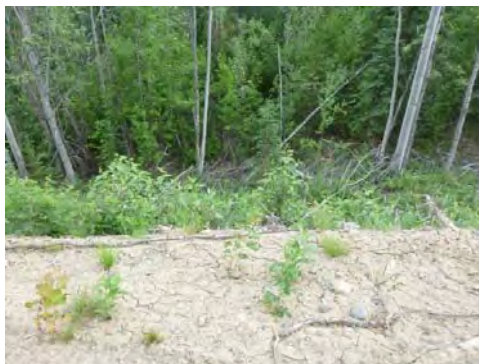
Freegold Road Upgrade Crossing # 19 - No Crossing

D/S	X	U/S
Coordinates:	6903757 N	417540 E	Gradient (%):	-	-
Site Visit Date:	01-Jul-13		Bankfull Width (m):	-	-
Flow Conditions:	N/A		Bankfull Depth (m):	-	-
Barrier/Confirmed:	N/A		Wetted Widths (m):	-	-
Electrofished/Effort?:	N/A		Wetted Depth (m):	-	-
Gee Trapping:	N/A		Substrate Bed:	-	-
Fish Bearing?	N/A		Substrate Bank:	-	-
Site Length:	N/A		Riparian Vegetation:	-	-
			Meander Pattern:	-	-
			Cover:	-	-
Photo #s	u/s	x	d/s		
Areas of Erosion:	N/A		Temperature:	-	°C
Locations:			pH:	-	pH units
			Conductivity:	-	uS/cm
			DO:	-	mg/L
				-	% Sat
Comments:					
No visible channel					
Crosses mainstem creek on map, but co-ordinates on existing road

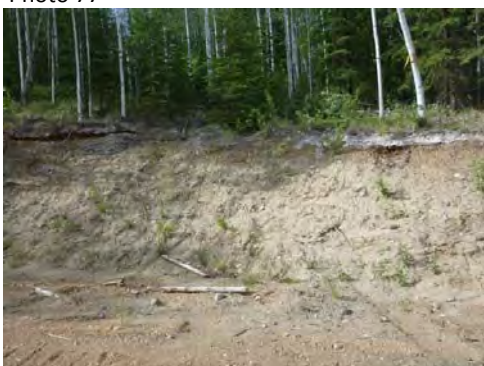
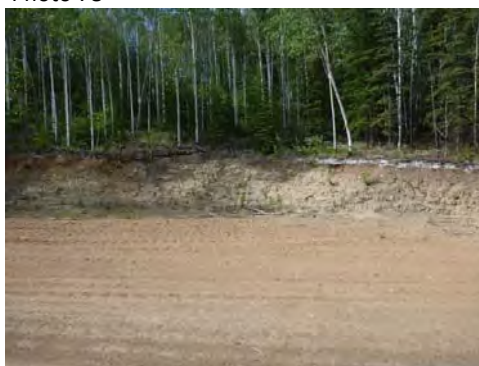
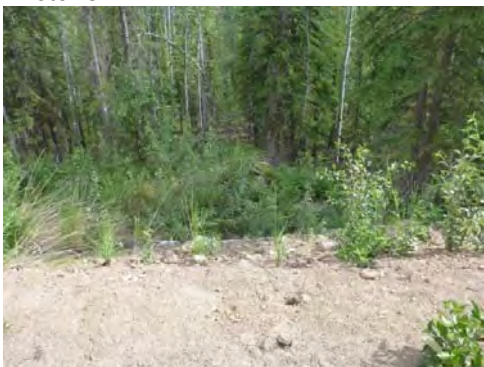
Freegold Road Upgrade Crossing # 20 - No Crossing

D/S	X	U/S
Coordinates:	6903759 N	417397 E	Gradient (%):	-	-
Site Visit Date:	01-Jul-13		Bankfull Width (m):	-	-
Flow Conditions:	None		Bankfull Depth (m):	-	-
Barrier/Confirmed:	N/A		Wetted Widths (m):	-	-
Electrofished/Effort?:	N/A		Wetted Depth (m):	-	-
Gee Trapping:	N/A		Substrate Bed:	-	-
Fish Bearing?:	N/A		Substrate Bank:	-	-
Site Length:	N/A		Riparian Vegetation:	-	-
			Meander Pattern:	-	-
			Cover:	-	-
Photo #s	u/s	x	d/s		
Areas of Erosion:	N/A		Temperature:	-	°C
Locations:			pH:	-	pH units
			Conductivity:	-	uS/cm
			DO:	-	mg/L
				-	% Sat
Comments:					
No visible channel					
Crosses mainstem creek on map, but co-ordinates on existing road

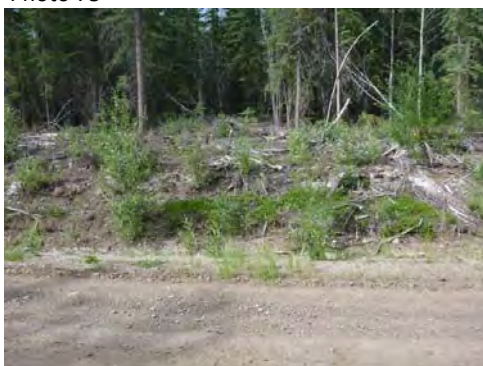
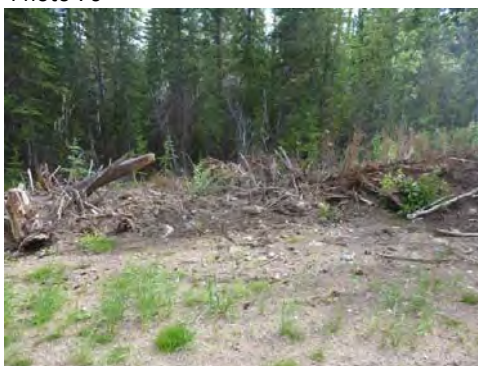
Freegold Road Upgrade Crossing # 21 - No Crossing

D/S	X	U/S
Coordinates:	6903774 N	417250 E	Gradient (%):	-	-
Site Visit Date:	01-Jul-13		Bankfull Width (m):	-	-
Flow Conditions:	None		Bankfull Depth (m):	-	-
Barrier/Confirmed:	N/A		Wetted Widths (m):	-	-
Electrofished/Effort?:	N/A		Wetted Depth (m):	-	-
Gee Trapping:	N/A		Substrate Bed:	-	-
Fish Bearing?	N/A		Substrate Bank:	-	-
Site Length:	N/A		Riparian Vegetation:	-	-
			Meander Pattern:	-	-
			Cover:	-	-
Photo #s	u/s	x	d/s		
Areas of Erosion:	N/A		Temperature:	-	°C
Locations:			pH:	-	pH units
			Conductivity:	-	uS/cm
			DO:	-	mg/L
				-	% Sat
Comments:	No visible channel

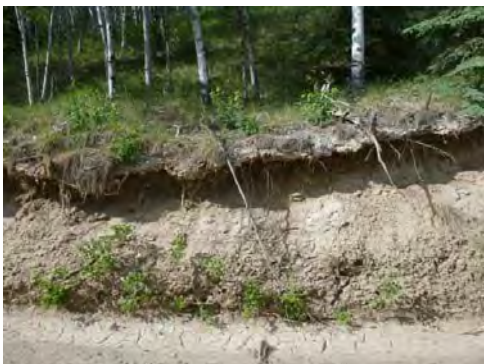
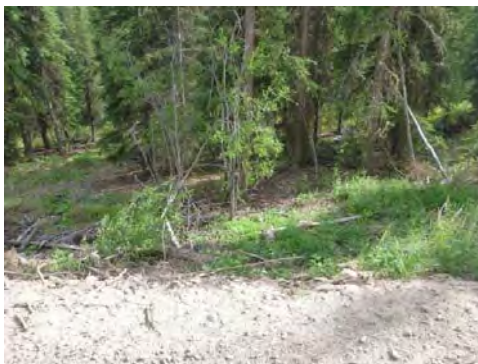
Freegold Road Upgrade Crossing # 22 - No Crossing

D/S	X	U/S
Coordinates:	6903880 N	416439 E	Gradient (%):	-	-
Site Visit Date:	01-Jul-13		Bankfull Width (m):	-	-
Flow Conditions:	None		Bankfull Depth (m):	-	-
Barrier/Confirmed:	N/A		Wetted Widths (m):	-	-
Electrofished/Effort?:	N/A		Wetted Depth (m):	-	-
Gee Trapping:	N/A		Substrate Bed:	-	-
Fish Bearing?	N/A		Substrate Bank:	-	-
Site Length:	N/A		Riparian Vegetation:	-	-
			Meander Pattern:	-	-
			Cover:	-	-
Photo #s	u/s	x	d/s		
Areas of Erosion:	N/A		Temperature:	-	°C
Locations:			pH:	-	pH units
			Conductivity:	-	uS/cm
			DO:	-	mg/L
				-	% Sat
Comments:	No visible channel

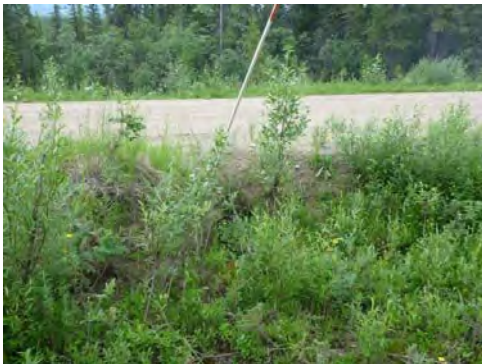
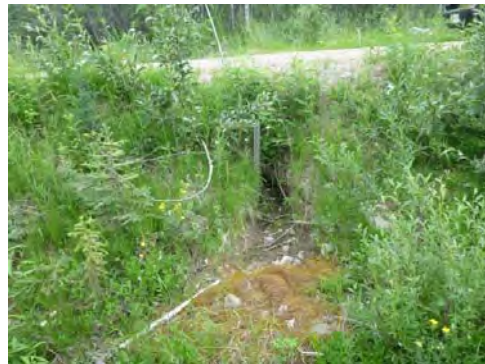
Freegold Road Upgrade Crossing # 22.5 (Unmapped Site) - Crossing Creek Tributary

D/S	X	U/S
Coordinates:	6903942 N	415607 E	Gradient (%):	-	-
Site Visit Date:	01-Jul-13		Bankfull Width (m):	-	-
Flow Conditions:	None		Bankfull Depth (m):	-	-
Barrier/Confirmed:	Yes		Wetted Widths (m):	-	-
Electrofished/Effort?:	No		Wetted Depth (m):	-	-
Gee Trapping:	No		Substrate Bed:	-	-
Fish Bearing?:	No		Substrate Bank:	-	-
Site Length:	100 m		Riparian Vegetation:	-	-
			Meander Pattern:	-	-
			Cover:	-	-
Photo #s	u/s	x	d/s		
Areas of Erosion:	No		Temperature:	-	°C
Locations:			pH:	-	pH units
			Conductivity:	-	uS/cm
			DO:	-	mg/L
				-	% Sat
Comments:					
No visible channel					
No culvert but hole running under the road

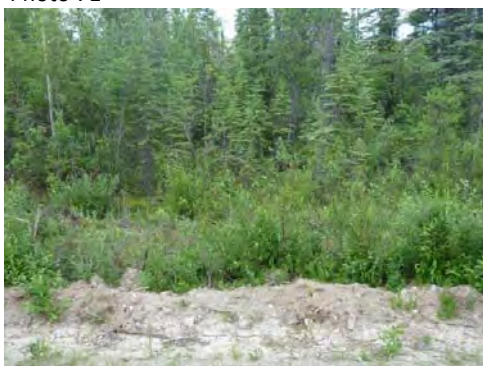
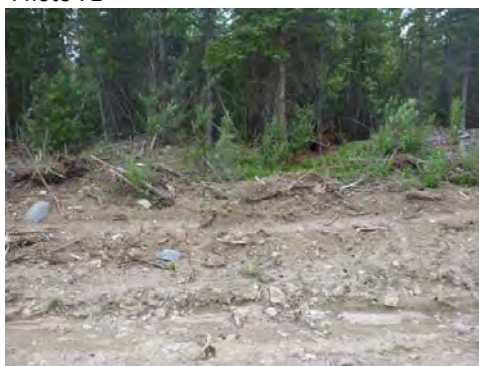
Freegold Road Upgrade Crossing # 23 - No Crossing

D/S	X	U/S
Coordinates:	6904009 N	415443 E	Gradient (%):	-	-
Site Visit Date:	01-Jul-13		Bankfull Width (m):	-	-
Flow Conditions:	None		Bankfull Depth (m):	-	-
Barrier/Confirmed:	N/A		Wetted Widths (m):	-	-
Electrofished/Effort?:	N/A		Wetted Depth (m):	-	-
Gee Trapping:	N/A		Substrate Bed:	-	-
Fish Bearing?:	N/A		Substrate Bank:	-	-
Site Length:	N/A		Riparian Vegetation:	-	-
			Meander Pattern:	-	-
			Cover:	-	-
Photo #s	u/s	x	d/s		
Areas of Erosion:	N/A		Temperature:	-	°C
Locations:			pH:	-	pH units
			Conductivity:	-	uS/cm
			DO:	-	mg/L
				-	% Sat
Comments:	No visible channel

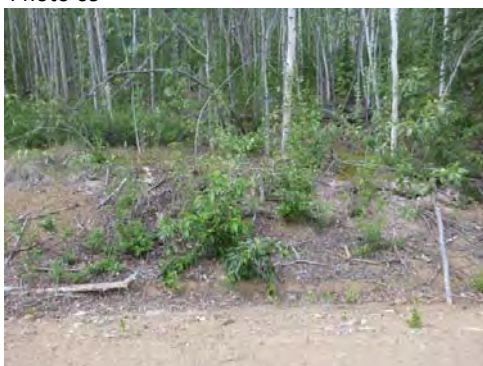
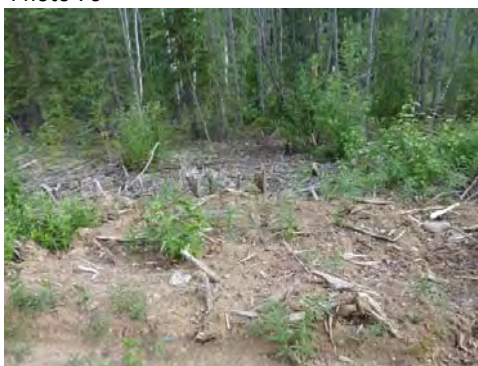
Freegold Road Upgrade Crossing # 24 - No Crossing

D/S	X	U/S
Coordinates:	6904045 N	414979 E	Gradient (%):	-	-
Site Visit Date:	01-Jul-13		Bankfull Width (m):	-	-
Flow Conditions:	None		Bankfull Depth (m):	-	-
Barrier/Confirmed:	N/A		Wetted Widths (m):	-	-
Electrofished/Effort?:	N/A		Wetted Depth (m):	-	-
Gee Trapping:	N/A		Substrate Bed:	-	-
Fish Bearing?:	N/A		Substrate Bank:	-	-
Site Length:	N/A		Riparian Vegetation:	-	-
			Meander Pattern:	-	-
			Cover:	-	-
Photo #s	u/s	x	d/s		
Areas of Erosion:	N/A		Temperature:	-	°C
Locations:			pH:	-	pH units
			Conductivity:	-	uS/cm
			DO:	-	mg/L
				-	% Sat
Comments:	No visible channel

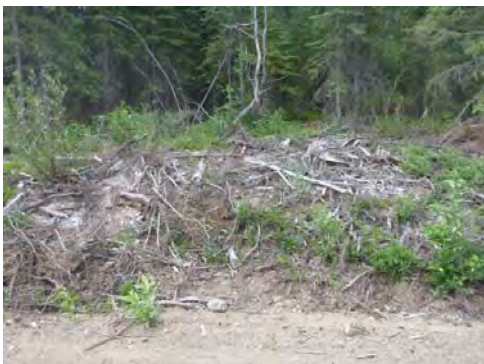
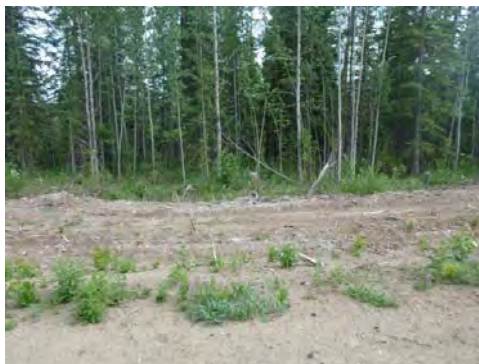
Freegold Road Upgrade Crossing # 25 - No Crossing

D/S	X	U/S
Coordinates:	6903767 N	414012 E	Gradient (%):	-	-
Site Visit Date:	01-Jul-13		Bankfull Width (m):	-	-
Flow Conditions:	None		Bankfull Depth (m):	-	-
Barrier/Confirmed:	N/A		Wetted Widths (m):	-	-
Electrofished/Effort?:	N/A		Wetted Depth (m):	-	-
Gee Trapping:	N/A		Substrate Bed:	-	-
Fish Bearing?:	N/A		Substrate Bank:	-	-
Site Length:	N/A		Riparian Vegetation:	-	-
			Meander Pattern:	-	-
			Cover:	-	-
Photo #s	u/s	x	d/s		
Areas of Erosion:	N/A		Temperature:	-	°C
Locations:			pH:	-	pH units
			Conductivity:	-	uS/cm
			DO:	-	mg/L
				-	% Sat
Comments:	No visible channel

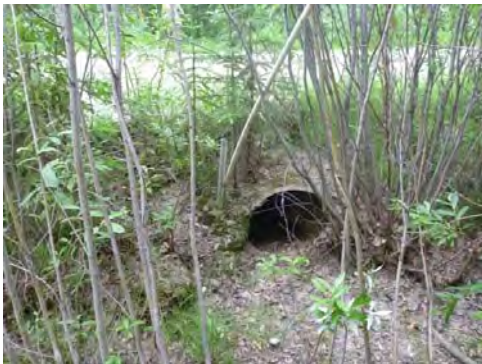
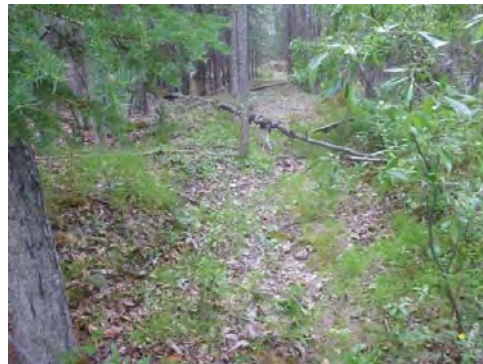
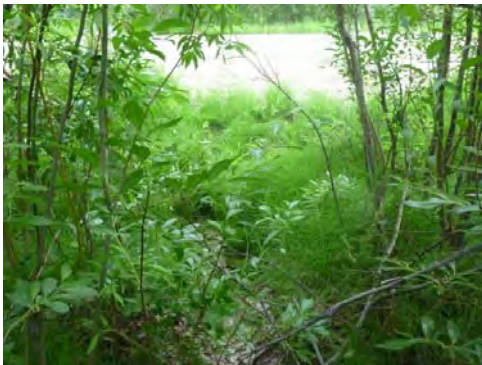
Freegold Road Upgrade Crossing # 25.5 (Unmapped Site) - Crossing Creek Tributary

D/S	X	U/S
Coordinates:	6903328 N	413448 E	Gradient (%):	-	-
Site Visit Date:	01-Jul-13		Bankfull Width (m):	-	-
Flow Conditions:	None		Bankfull Depth (m):	-	-
Barrier/Confirmed:	Yes		Wetted Widths (m):	-	-
Electrofished/Effort?:	No		Wetted Depth (m):	-	-
Gee Trapping:	No		Substrate Bed:	-	-
Fish Bearing?:	No		Substrate Bank:	-	-
Site Length:	100 m		Riparian Vegetation:	-	-
			Meander Pattern:	-	-
			Cover:	-	-
Photo #s	19 u/s	20 x	21 d/s		
Areas of Erosion:	No		Temperature:	-	°C
Locations:			pH:	-	pH units
			Conductivity:	-	uS/cm
			DO:	-	mg/L
				-	% Sat
Comments:					
Culvert on one side of the road, looked through and was blocked					
No culvert found on the other side					
No visible channel

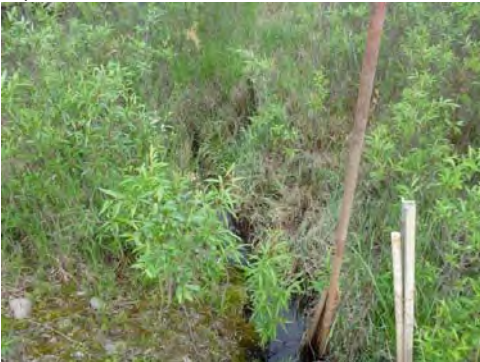
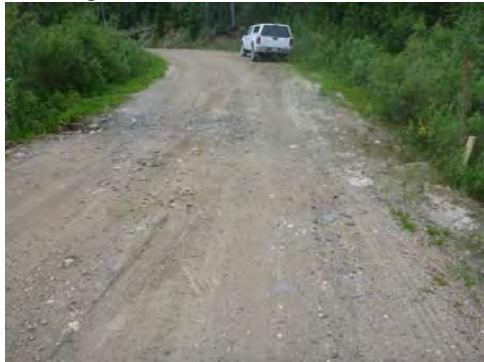
Freegold Road Upgrade Crossing # 26 - Crossing Creek Tributary

D/S	X	U/S
Coordinates:	6903472 N	412617 E	Gradient (%):	-	2	3
Site Visit Date:	01-Jul-13		Bankfull Width (m):	-	0.62	0.55
Flow Conditions:	Low		Bankfull Depth (m):	-	0.15	0.19
Barrier/Confirmed:	None		Wetted Widths (m):	-	0.55	0.55
Electrofished/Effort?:	No		Wetted Depth (m):	-	0.07	0.10
Gee Trapping:	No		Substrate Bed:	-	G/F	F
Fish Bearing?	Yes		Substrate Bank:	-	F	F
Site Length:	100 m		Riparian Vegetation:	-	SP/WI/GR	SP/WI/GR
			Meander Pattern:	-	IM	IM
			Cover:	-	75% / OV	85% / OV
Photo #s	22 u/s	23 x	24 d/s			
Areas of Erosion:	No		Temperature:	6.91	°C	
Locations:			pH:	8.12	pH units	
			Conductivity:	126	uS/cm	
			DO:	2.93	mg/L	
				26.3	% Sat

Comments:
Very little flow
Winds through grasses, channel definition lost in areas
Fans out into ground at downstream site, no channel

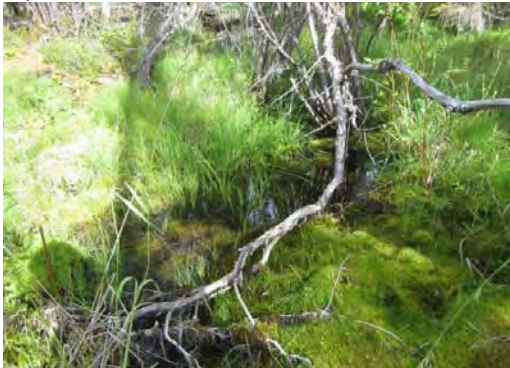
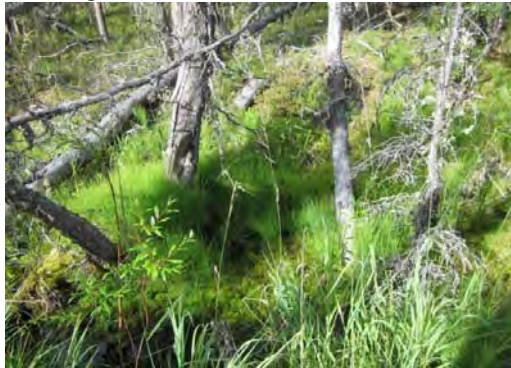
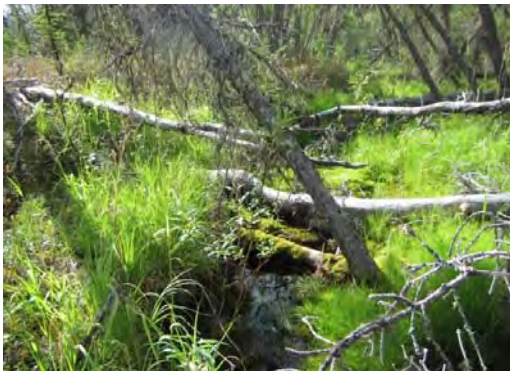
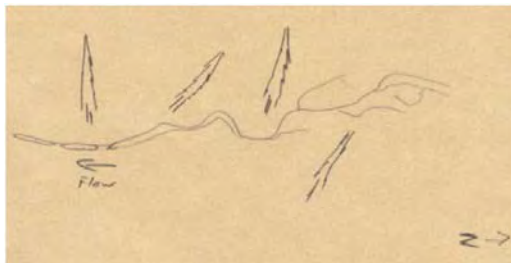
Freegold Road Upgrade Crossing # 26 - 35.33 - Crossing Creek Tributary

D/S	X	U/S
Coordinates:	6903230 N	412716 E	Gradient (%):	2	1
Site Visit Date:	08-Aug-13		Bankfull Width (m):	-	-
Flow Conditions:	Low		Bankfull Depth (m):	-	-
Barrier/Confirmed:	None		Wetted Widths (m):	0.49	0.70
Electrofished/Effort?:	No		Wetted Depth (m):	0.08	0.16
Gee Trapping:	No		Substrate Bed:	F	F
Fish Bearing?:	Yes		Substrate Bank:	F	F
Site Length:	100 m		Riparian Vegetation:	SP/WI	SP/WI
			Meander Pattern:	SI	SI
			Cover:	40% / OV	50% / OV
Photo #s	61 u/s	63 x	62 d/s		
Areas of Erosion:	No		Temperature:	9.43	°C
Locations:			pH:	7.18	pH units
			Conductivity:	159	µS/cm
			DO:	4.19	mg/L
				39.6	% Sat
Comments:					
No defined channel					
Flows through trees, discontinuous through moss					
No direct fish habitat

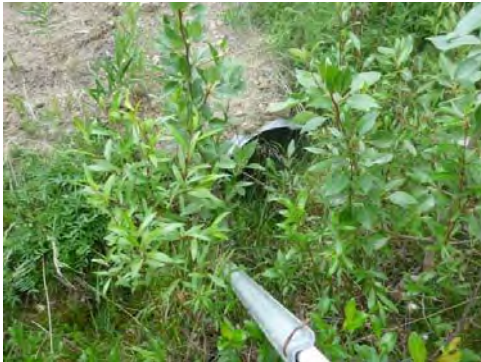
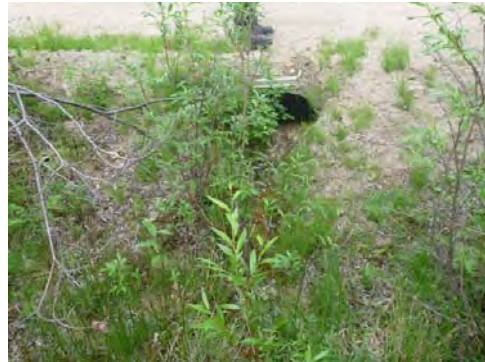
Freegold Road Upgrade Crossing # 26.5 (Unmapped Site) - Crossing Creek Tributary

D/S	X	U/S
Coordinates:	6903211 N	411995 E	Gradient (%):	-	-
Site Visit Date:	01-Jul-13		Bankfull Width (m):	-	-
Flow Conditions:	None		Bankfull Depth (m):	-	-
Barrier/Confirmed:	Yes		Wetted Widths (m):	-	-
Electrofished/Effort?:	No		Wetted Depth (m):	-	-
Gee Trapping:	No		Substrate Bed:	-	-
Fish Bearing?:	No		Substrate Bank:	-	-
Site Length:	100 m		Riparian Vegetation:	-	-
			Meander Pattern:	-	-
			Cover:	-	-
Photo #s	25, 26 u/s	x	d/s		
Areas of Erosion:	No		Temperature:	-	°C
Locations:			pH:	-	pH units
			Conductivity:	-	uS/cm
			DO:	-	mg/L
				-	% Sat
Comments:					
No visible channel					
Culvert present

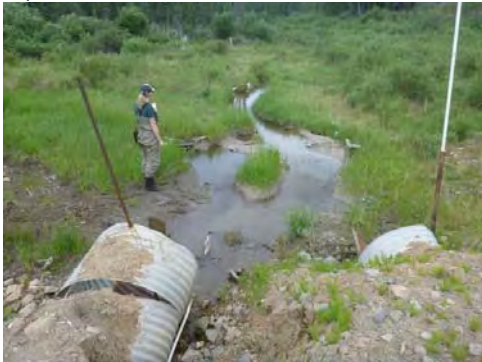
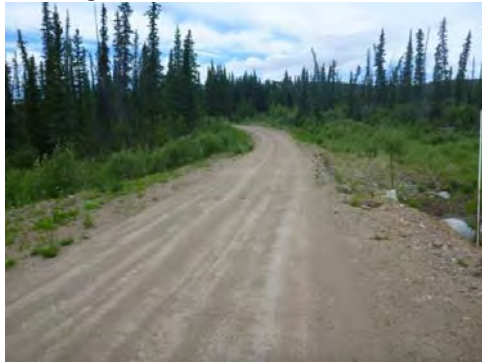
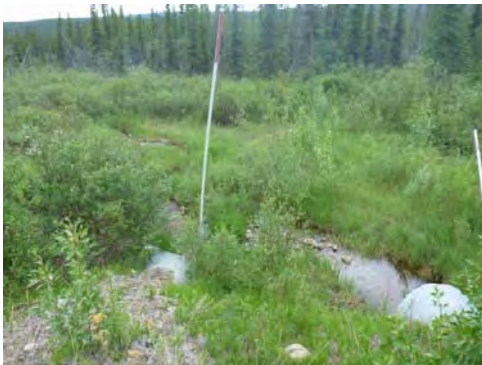
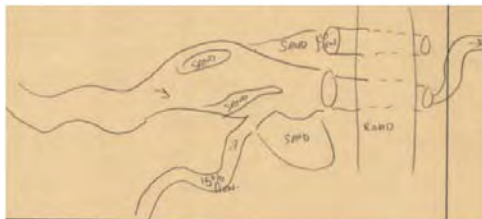
Freegold Road Upgrade Crossing # 27 - Crossing Creek Tributary

D/S	X	U/S	
Coordinates:	6903150 N	411811 E	Gradient (%):	3	1	1
Site Visit Date:	01-Jul-13		Bankfull Width (m):	0.60	4.70	1.23
Flow Conditions:	Low		Bankfull Depth (m):	0.16	0.24	0.36
Barrier/Confirmed:	Yes		Wetted Widths (m):	0.60	1.50	0.86
Electrofished/Effort?:	No		Wetted Depth (m):	0.08	0.14	0.20
Gee Trapping:	No		Substrate Bed:	G/F	G/F	G/F
Fish Bearing?	Yes		Substrate Bank:	F	F	F
Site Length:	100 m		Riparian Vegetation:	GR/WI/SP	GR/WI/SP	GR/WI/SP
			Meander Pattern:	IM	SI	IM
			Cover:	50% / OV	5% / OV	5% / OV
Photo #s	27 u/s	28 x	29 d/s			
Areas of Erosion:	Y		Temperature:	7.62	°C	
Locations:	Erosion on the downstream side		pH:	8.5	pH units	
	of the culvert		Conductivity:	496	uS/cm	
			DO:	8.52	mg/L	
				78.1	% Sat	
Comments:						
Perched culvert downstream of existing road creating a fish passage barrier

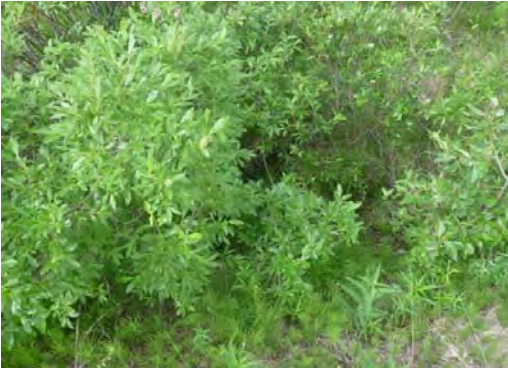
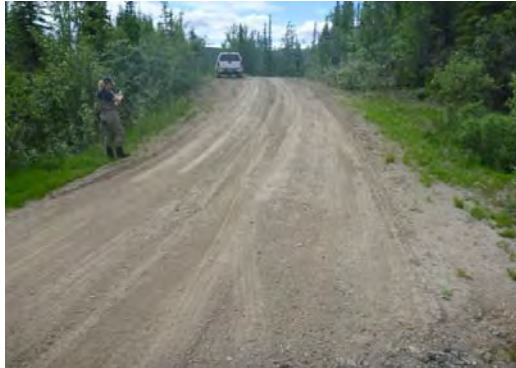
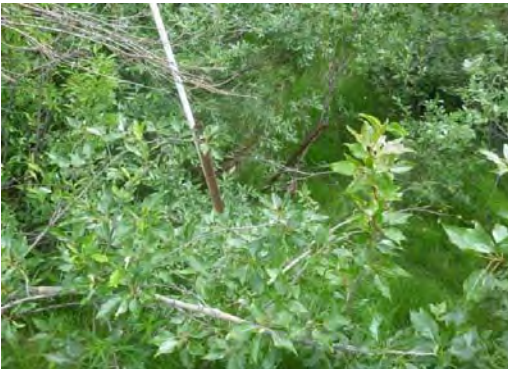
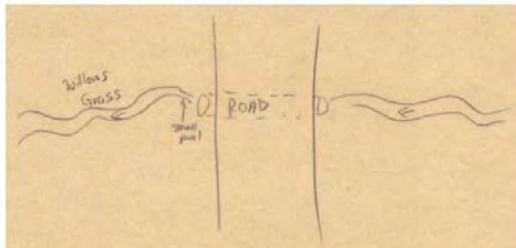
Freegold Road Upgrade Crossing # 28 - Crossing Creek Tributary

D/S	X	U/S	
Coordinates:	6901780 N	409548 E	Gradient (%):	4	5	6
Site Visit Date:	01-Jul-13		Bankfull Width (m):	0.34	0.78	0.43
Flow Conditions:	Low		Bankfull Depth (m):	0.23	0.37	0.16
Barrier/Confirmed:	None		Wetted Widths (m):	0.34	0.58	0.36
Electrofished/Effort?:	No		Wetted Depth (m):	0.10	0.27	0.07
Gee Trapping:	No		Substrate Bed:	F	F/G	F
Fish Bearing?	Yes		Substrate Bank:	F	F/G	F
Site Length:	100 m		Riparian Vegetation:	GR/WI/SP	GR/WI/SP/P O	SP/WI
		Meander Pattern:	IM	IM	IM	
		Cover:	95% / OV	85% / OV	90% / OV	
Photo #s	31 u/s	32 x	33 d/s			
Areas of Erosion:	No		Temperature:	5.88	°C	
Locations:			pH:	7.92	pH units	
			Conductivity:	211	uS/cm	
			DO:	5.37	mg/L	
				47.3	% Sat

Comments:
Small drop pool at culvert outlet

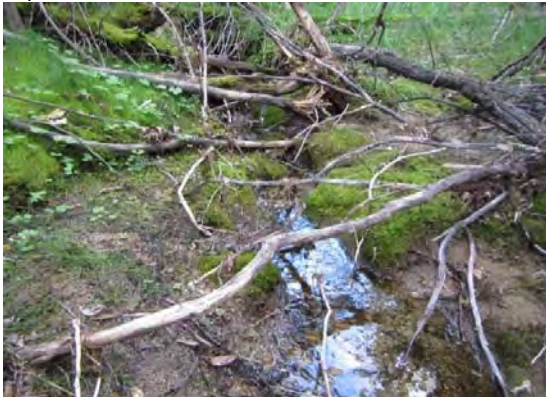
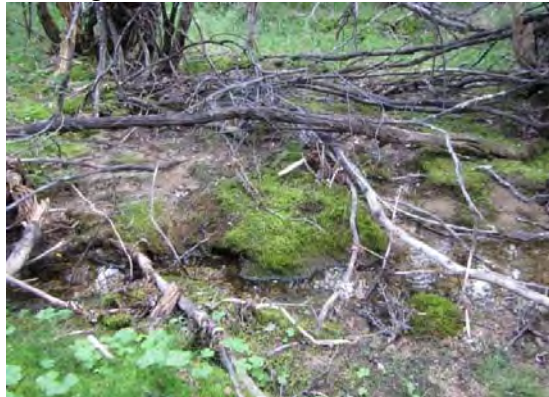
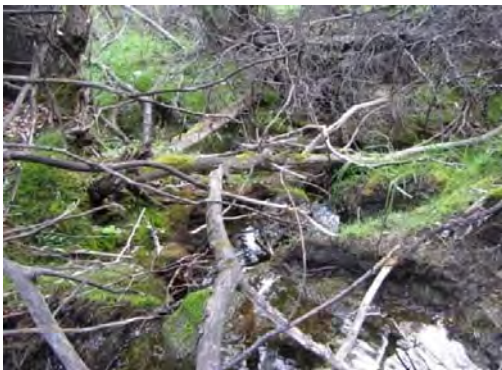
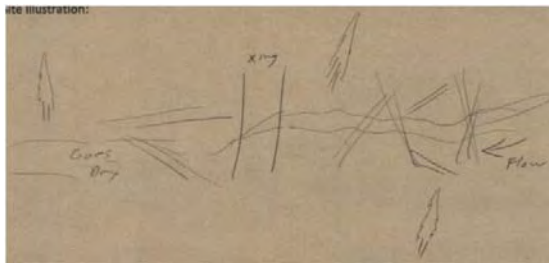
Freegold Road Upgrade Crossing # 29N (Unmapped Site) - Crossing Creek Tributary

D/S	X	U/S	
Coordinates:	6901667 N	407836 E	Gradient (%):	-	9	8
Site Visit Date:	01-Jul-13		Bankfull Width (m):	-	0.19	0.93
Flow Conditions:	Low		Bankfull Depth (m):	-	0.08	0.09
Barrier/Confirmed:	Yes		Wetted Widths (m):	-	0.14	0.93
Electrofished/Effort?:	No		Wetted Depth (m):	-	0.04	0.09
Gee Trapping:	No		Substrate Bed:	-	G/S	G/S
Fish Bearing?:	No		Substrate Bank:	-	F	F
Site Length:	100 m		Riparian Vegetation:	-	WI/SP	WI/SP
			Meander Pattern:	-	SI	SI
			Cover:	-	60%/LWD	20% / LWD
Photo #s	87 u/s	89 x	88 d/s			
Areas of Erosion:	Yes		Temperature:	6.98	°C	
Locations:	Sand and gravel from existing		pH:	7.7	pH units	
	road have partly infilled channel		Conductivity:	204	µS/cm	
			DO:	7.39	mg/L	
				66.8	% Sat

Comments:
Large amounts of woody debris (glaciation / flood damage)
High amounts of sand/ gravel have filled in channel downstream of the crossing
forcing the creek to go underground.

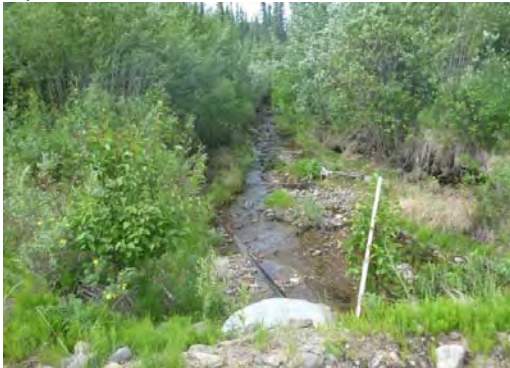
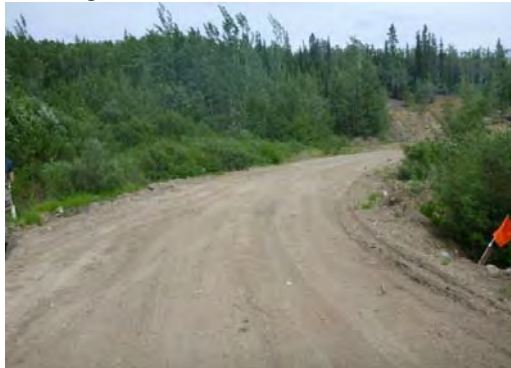
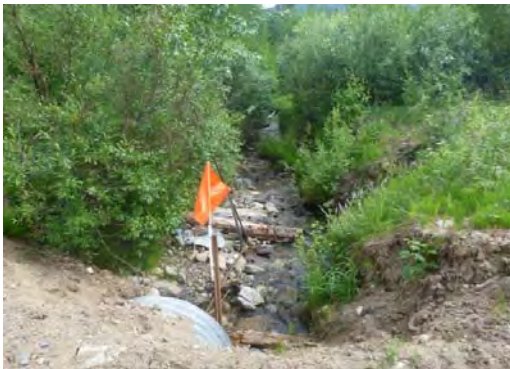
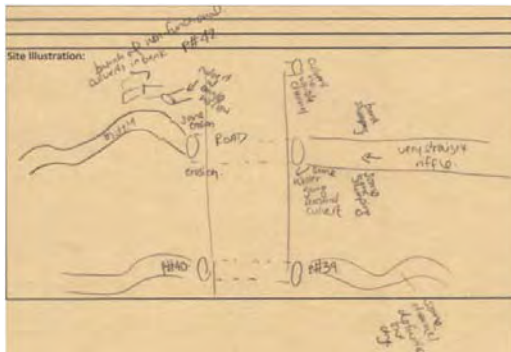
Freegold Road Upgrade Crossing # 30 - Crossing Creek

D/S	X	U/S
Coordinates:	6901568 N	407285 E	Gradient (%):	2	3
Site Visit Date:	01-Jul-13		Bankfull Width (m):	1.50	3.10
Flow Conditions:	Med		Bankfull Depth (m):	0.26	0.18
Barrier/Confirmed:	None		Wetted Widths (m):	1.12	3.10
Electrofished/Effort?:	No		Wetted Depth (m):	0.07	0.11
Gee Trapping:	No		Substrate Bed:	G/C	G/C
Fish Bearing?	Yes		Substrate Bank:	F	F
Site Length:	100 m		Riparian Vegetation:	WI/AL/SP	WI/SP
			Meander Pattern:	SI	SI
			Cover:	85% / OV	15% / OV
Photo #s	36 u/s	37 x	38 d/s		
Areas of Erosion:	Yes		Temperature:	6.19	°C
Locations:	US and DS of culverts		pH:	8.01	pH units
			Conductivity:	147	uS/cm
			DO:	9.33	mg/L
				83.8	% Sat
Comments:					
Straight riffle section both upstream and downstream

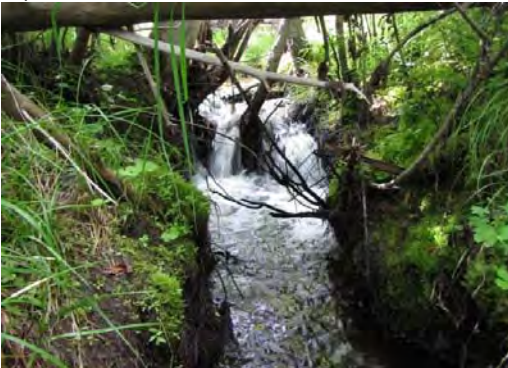
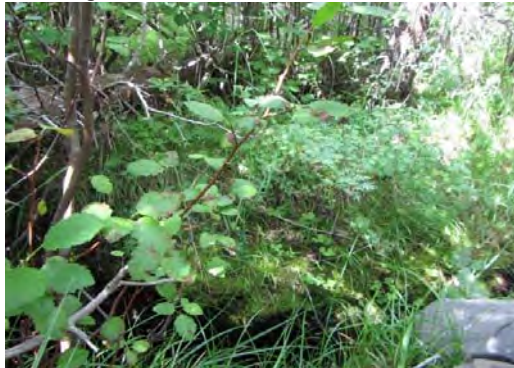
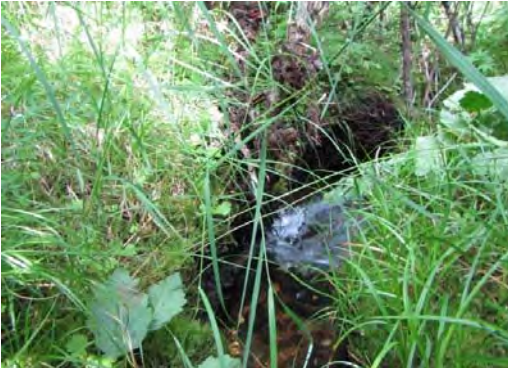
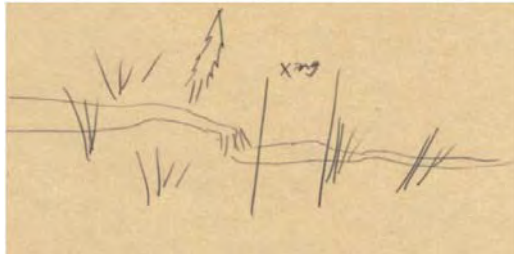
Freegold Road Upgrade Crossing # 30 (Unmapped Site) - Crossing Creek Tributary

D/S	X	U/S	
Coordinates:	6901519 N	407416 E	Gradient (%):	2	4	6
Site Visit Date:	08-Aug-13		Bankfull Width (m):	0.64	0.40	0.90
Flow Conditions:	Low		Bankfull Depth (m):	0.25	0.58	0.33
Barrier/Confirmed:	None		Wetted Widths (m):	0.48	0.37	0.89
Electrofished/Effort?:	No		Wetted Depth (m):	0.15	0.45	0.26
Gee Trapping:	No		Substrate Bed:	G/S	S/G	G/S
Fish Bearing?	Yes		Substrate Bank:	F	F	F
Site Length:	100 m		Riparian Vegetation:	AL/SP	AL/SP	AL/SP
			Meander Pattern:	SI	SI	SI
			Cover:	40% / OV	70% / OV	20% / LWD
Photo #s	84 u/s	86 x	85 d/s			
Areas of Erosion:	No		Temperature:	7.13	°C	
Locations:			pH:	7.64	pH units	
			Conductivity:	132	µS/cm	
			DO:	9.48	mg/L	
				86.4	% Sat

Comments:
Small waterfall upstream of crossing

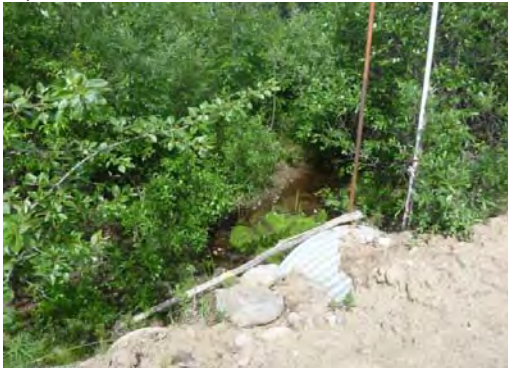
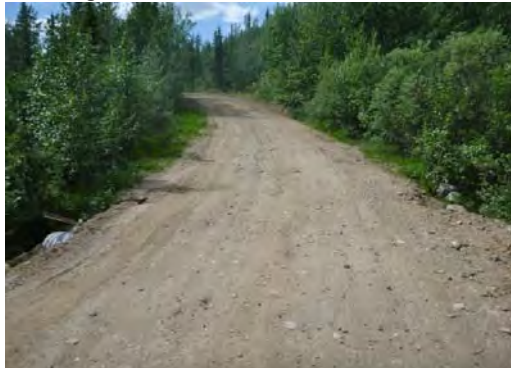
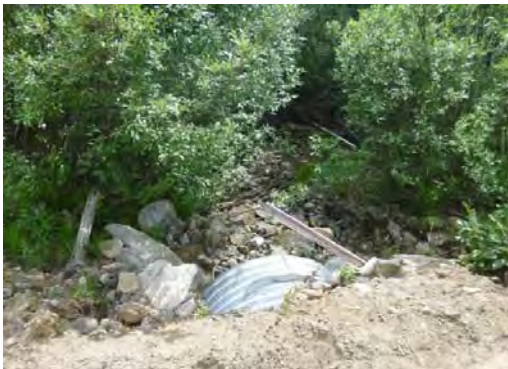
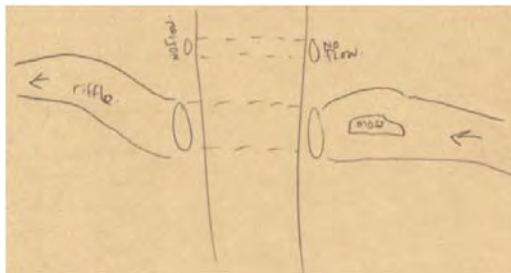
Freegold Road Upgrade Crossing # 31 - Crossing Creek Tributary

D/S	X	U/S
Coordinates:	6900480 N	402734 E	Gradient (%):	0	3
Site Visit Date:	01-Jul-13		Bankfull Width (m):	1.09	0.85
Flow Conditions:	Med		Bankfull Depth (m):	0.15	0.20
Barrier/Confirmed:	None		Wetted Widths (m):	0.51	0.50
Electrofished/Effort?:	No		Wetted Depth (m):	0.07	0.10
Gee Trapping:	No		Substrate Bed:	G/F	F/G
Fish Bearing?	Yes		Substrate Bank:	F	F
Site Length:	100 m		Riparian Vegetation:	WI/PO/SP	WI/PO/SP
			Meander Pattern:	IM	IM
			Cover:	80% / OV	80% / OV
Photo #s	43 u/s	44 x	45 d/s		
Areas of Erosion:	Yes		Temperature:	4.49	°C
Locations:	Both banks above and below culvert		pH:	8.78	pH units
	are eroded		Conductivity:	99	uS/cm
			DO:	9.33	mg/L
				80.9	% Sat
Comments:					
Riffle sections US and DS of culvert
