APPENDIX 10B: FREEGOLD ROAD FISH AND AQUATIC BASELINE

Casino Project

Fish and Aquatic Resources Baseline Report:

Freegold Road Extension, Freegold Road Upgrade, and Casino Airstrip and Airstrip Access Road

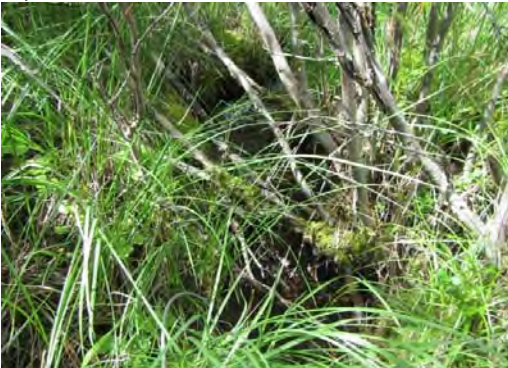
Freegold Road Upgrade Crossing # 31N - Crossing Creek Tributary

D/S	X	U/S
Coordinates:	6900377 N	402782 E	Gradient (%):	2	7
Site Visit Date:	08-Aug-13		Bankfull Width (m):	0.51	0.39
Flow Conditions:	Low		Bankfull Depth (m):	0.12	0.26
Barrier/Confirmed:	None		Wetted Widths (m):	0.49	0.37
Electrofished/Effort?:	No		Wetted Depth (m):	0.10	0.22
Gee Trapping:	No		Substrate Bed:	S	G
Fish Bearing?	Yes		Substrate Bank:	F	F
Site Length:	100 m		Riparian Vegetation:	WI/SP	WI/SP
			Meander Pattern:	SI	SI
			Cover:	60% / OV	80% / OV
Photo #s	77 u/s	79 x	78 d/s		
Areas of Erosion:	No		Temperature:	5.44	°C
Locations:			pH:	7.29	pH units
			Conductivity:	97	µS/cm
			DO:	9.13	mg/L
				80.6	% Sat

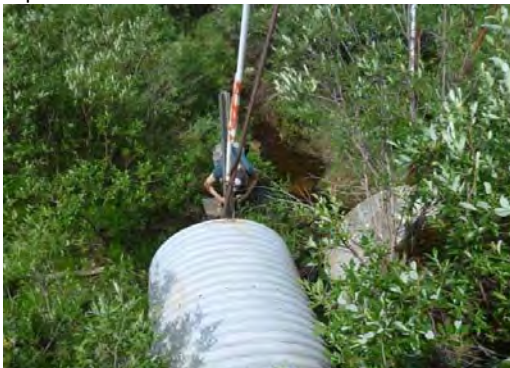
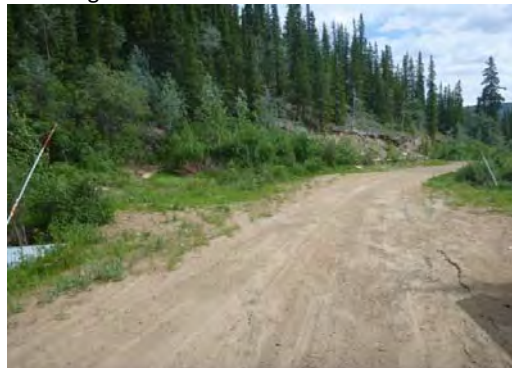
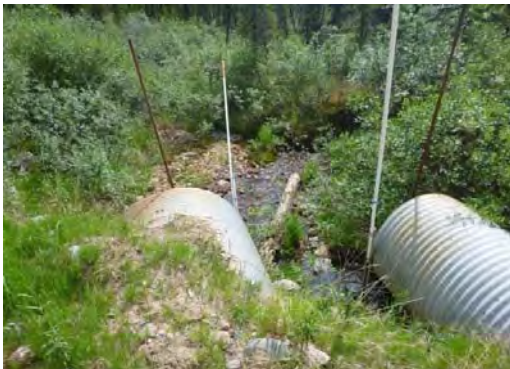
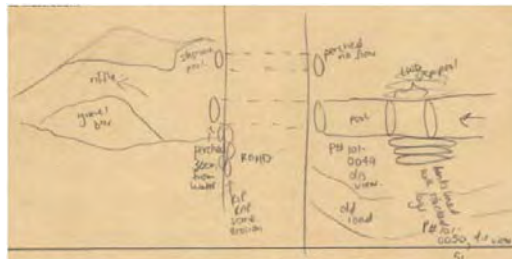
Freegold Road Upgrade Crossing # 31.5 (Unmapped Site) - Crossing Creek Tributary

D/S	X	U/S	
Coordinates:	6900139 N	401843 E	Gradient (%):	2	3	4
Site Visit Date:	01-Jul-13		Bankfull Width (m):	1.30	1.30	1.13
Flow Conditions:	Med		Bankfull Depth (m):	0.43	0.34	0.33
Barrier/Confirmed:	None		Wetted Widths (m):	1.08	1.10	0.48
Electrofished/Effort?:	No		Wetted Depth (m):	0.22	0.19	0.11
Gee Trapping:	No		Substrate Bed:	G/F	F	F/G
Fish Bearing?	Yes		Substrate Bank:	F	F	F
Site Length:	100 m		Riparian Vegetation:	WI/SP	WI/SP	WI/SP
			Meander Pattern:	IM	SI	SI
		Cover:	90% / OV	15% / OV	15% / OV	
Photo #s	46 u/s	47 x	48 d/s			
Areas of Erosion:	Yes		Temperature:	4.48	°C	
Locations:	Erosion at culvert crossing		pH:	7.9	pH units	
			Conductivity:	98	uS/cm	
			DO:	7.24	mg/L	
				62.7	% Sat

Comments:
Downstream site runs through willows, channel may have moved

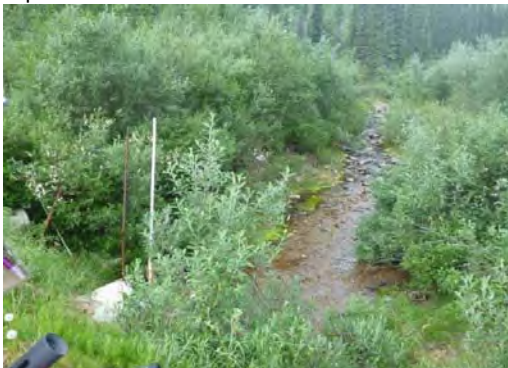
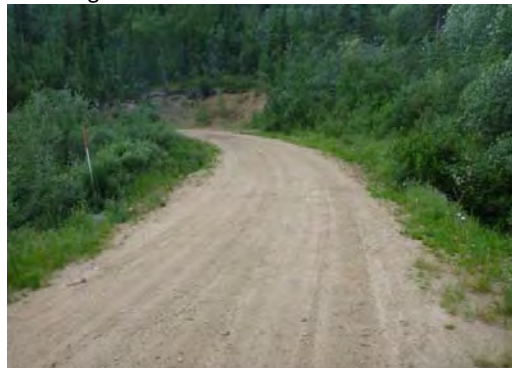
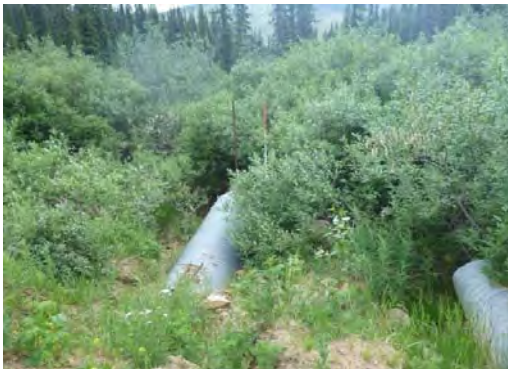
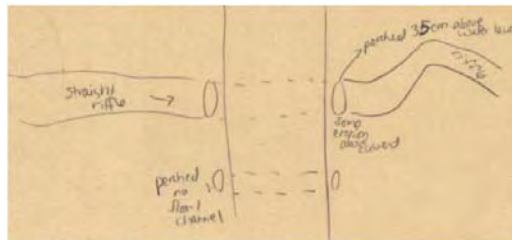
Freegold Road Upgrade Crossing # 33 - Seymour Creek Tributary

D/S	X	U/S	
Coordinates:	6901099 N	397330 E	Gradient (%):	4	3	4
Site Visit Date:	01-Jul-13		Bankfull Width (m):	1.80	3.15	0.94
Flow Conditions:	Low		Bankfull Depth (m):	0.26	0.23	0.43
Barrier/Confirmed:	Yes		Wetted Widths (m):	1.15	1.90	0.42
Electrofished/Effort?:	No		Wetted Depth (m):	0.10	0.08	0.10
Gee Trapping:	No		Substrate Bed:	G/F	G/F	C/G
Fish Bearing?	Yes		Substrate Bank:	F	F	F
Site Length:	100 m		Riparian Vegetation:	WI/SP	WI/SP	WI/SP
			Meander Pattern:	IM	SI	SI
			Cover:	100% / OV	5% / OV	95% / OV
Photo #s	54 u/s	55 x	56 d/s			
Areas of Erosion:	Yes		Temperature:	2.49	°C	
Locations:	Downstream of culvert		pH:	8.41	pH units	
			Conductivity:	82	uS/cm	
			DO:	9.7	mg/L	
				80.5	% Sat	
Comments:						
perched culvert on downstream side of crossing

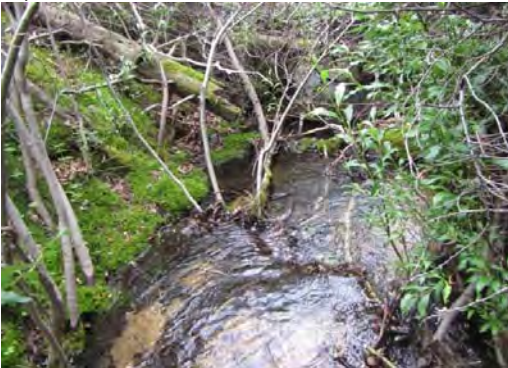
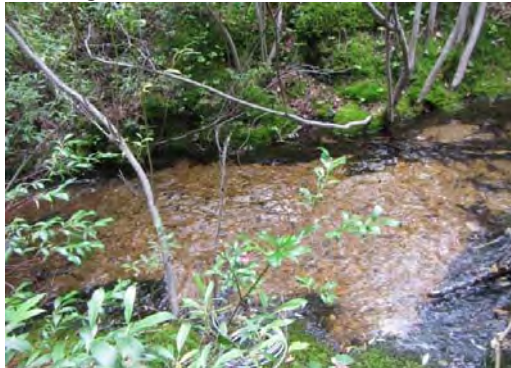
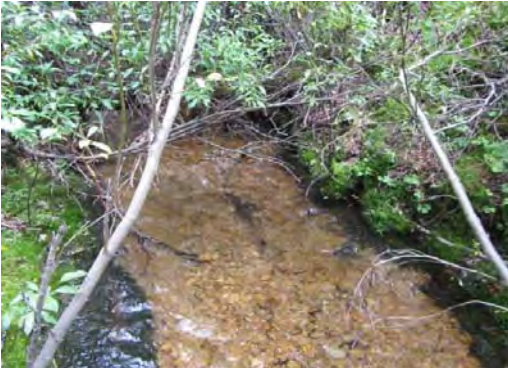
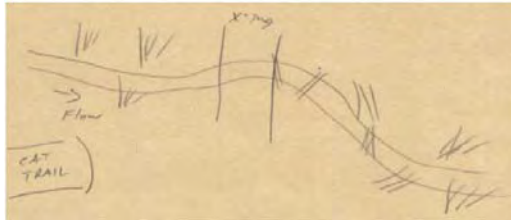
Freegold Road Upgrade Crossing # 33N - Seymour Creek Tributary

D/S	X	U/S	
Coordinates:	6900693 N	397146 E	Gradient (%):	3	1	6
Site Visit Date:	08-Aug-13		Bankfull Width (m):	0.87	1.35	1.27
Flow Conditions:	Medium		Bankfull Depth (m):	0.17	0.22	0.32
Barrier/Confirmed:	None		Wetted Widths (m):	0.87	1.35	1.13
Electrofished/Effort?:	No		Wetted Depth (m):	0.13	0.14	0.32
Gee Trapping:	No		Substrate Bed:	G/C	G	G
Fish Bearing?	Yes		Substrate Bank:	F	F	F
Site Length:	100 m		Riparian Vegetation:	WI/PO	WI/PO	WI/PO
			Meander Pattern:	SI	SI	SI
			Cover:	-	50% / OV	80% / OV
Photo #s	72 u/s	74 x	73 d/s			
Areas of Erosion:	No		Temperature:	2.73	°C	
Locations:			pH:	7.87	pH units	
			Conductivity:	73	µS/cm	
			DO:	10.05	mg/L	
				83.2	% Sat	
Comments:						
riffle-run section

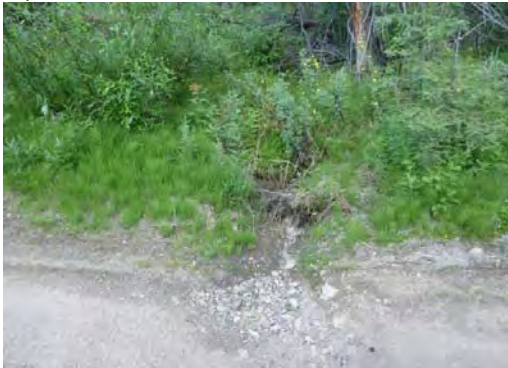
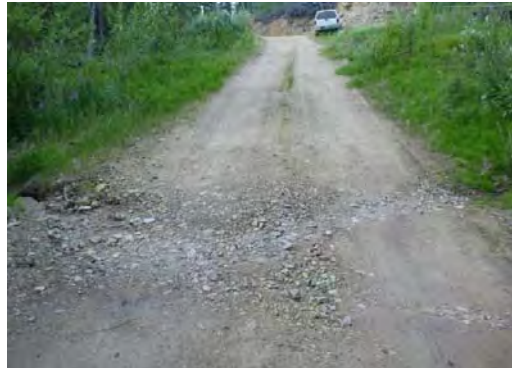
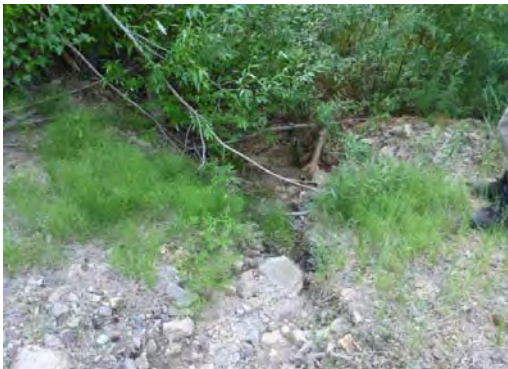
Freegold Road Upgrade Crossing # 37 - Seymour Creek Tributary

D/S	X	U/S
Coordinates:	6906565 N	387569 E	Gradient (%):	-	-
Site Visit Date:	01-Jul-13		Bankfull Width (m):	-	-
Flow Conditions:	None		Bankfull Depth (m):	-	-
Barrier/Confirmed:	Yes		Wetted Widths (m):	-	-
Electrofished/Effort?:	No		Wetted Depth (m):	-	-
Gee Trapping:	No		Substrate Bed:	-	-
Fish Bearing?:	No		Substrate Bank:	-	-
Site Length:	100 m		Riparian Vegetation:	-	-
			Meander Pattern:	-	-
			Cover:	-	-
Photo #s	64 u/s	65 x	66 d/s		
Areas of Erosion:	No		Temperature:	-	°C
Locations:			pH:	-	pH units
			Conductivity:	-	uS/cm
			DO:	-	mg/L
				-	% Sat
Comments:					
Channel dry					
Upstream - some scouring but not defined channel					
Downstream - more defined, cuts down and gravel substrate					
Water flows over road, no culvert

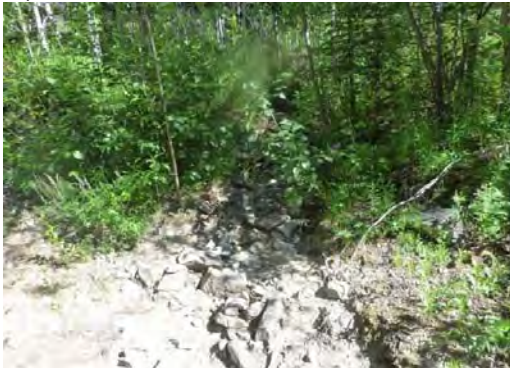
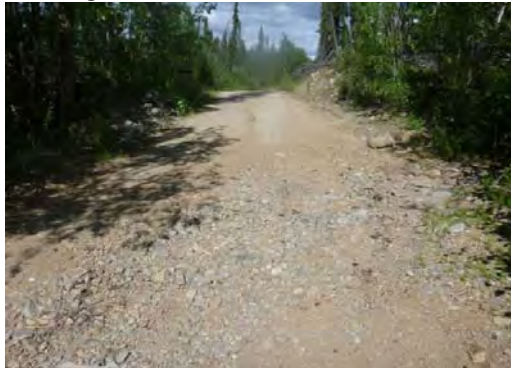
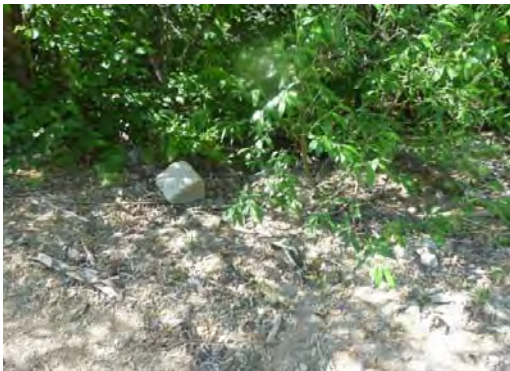
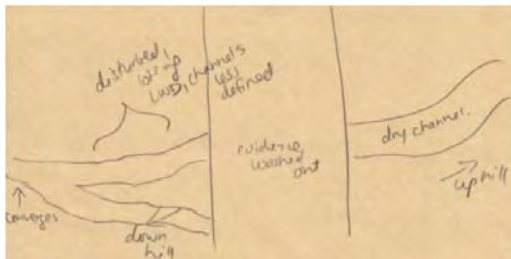
Freegold Road Upgrade Crossing # 39 - Seymour Creek Tributary

D/S	X	U/S
Coordinates:	6907392 N	387074 E	Gradient (%):	3	10
Site Visit Date:	02-Jul-13		Bankfull Width (m):	0.45	0.76
Flow Conditions:	None		Bankfull Depth (m):	0.48	0.49
Barrier/Confirmed:	Yes		Wetted Widths (m):	-	-
Electrofished/Effort?:	No		Wetted Depth (m):	-	-
Gee Trapping:	No		Substrate Bed:	C/G	C/G
Fish Bearing?:	No		Substrate Bank:	F	F
Site Length:	100 m		Riparian Vegetation:	SP/PO/WI	SP/PO/WI
			Meander Pattern:	IM	IM
			Cover:	60% / U	80% / OV
Photo #s	120 d/s	121 x	122 u/s		
Areas of Erosion:	Yes		Temperature:	-	°C
Locations:	Existing road is partly washed out		pH:	-	pH units
			Conductivity:	-	uS/cm
			DO:	-	mg/L
				-	% Sat
Comments:					
Visible channel - dry					
Road washed out previously - no culvert

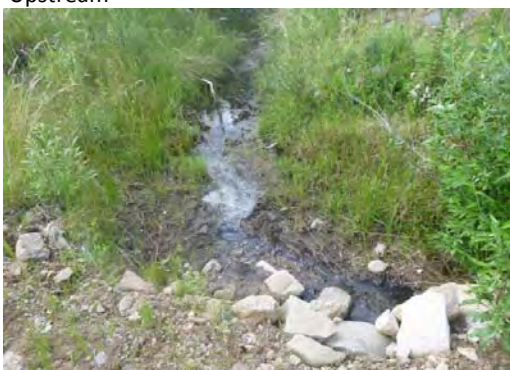
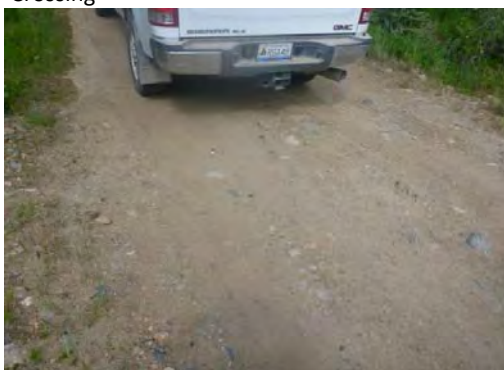
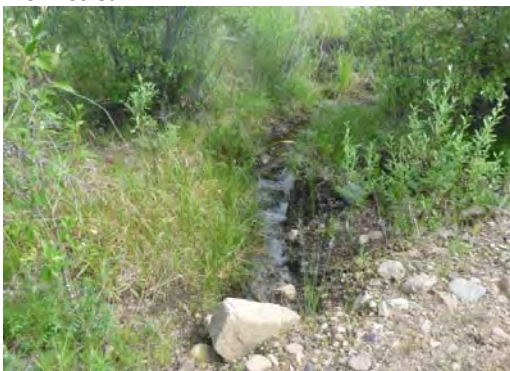
Freegold Road Upgrade Crossing # 39.5 (Unmapped Site) - Seymour Creek Tributary

D/S	X	U/S
Coordinates:	08 V 0386827 6913577	Gradient (%):	-	-	-
Site Visit Date:	02-Jul-13	Bankfull Width (m):	-	-	-
Flow Conditions:	Low	Bankfull Depth (m):	-	-	-
Barrier/Confirmed:	Yes	Wetted Widths (m):	-	-	-
Electrofished/Effort?:	No	Wetted Depth (m):	-	-	-
Gee Trapping:	No	Substrate Bed:	-	F	-
Fish Bearing?:	No	Substrate Bank:	-	-	-
Site Length:	100 m	Riparian Vegetation:	-	-	-
		Meander Pattern:	-	-	-
		Cover:	-	-	-
Photo #s	147 u/s	148 x	149 d/s		
Areas of Erosion:	Yes	Temperature:	-	°C	
Locations:	Both US and DS of crossing	pH:	-	pH units	
		Conductivity:	-	uS/cm	
		DO:	-	mg/L	
			-	% Sat	
Comments:					
Originates as a groundwater pond 20m above the road - photo 150					
Disturbed downstream of the road - photo 151

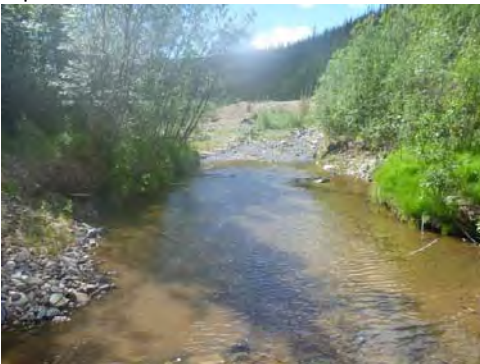
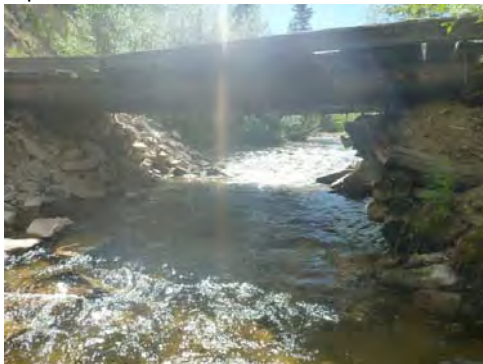
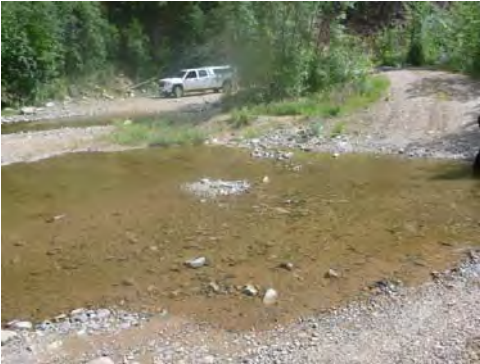
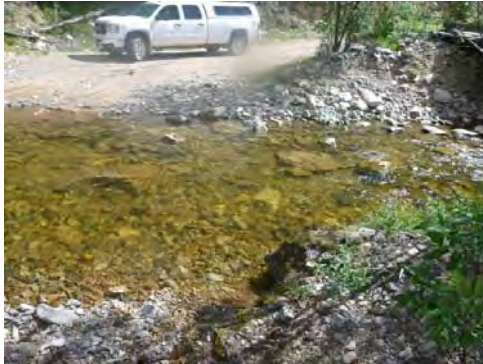
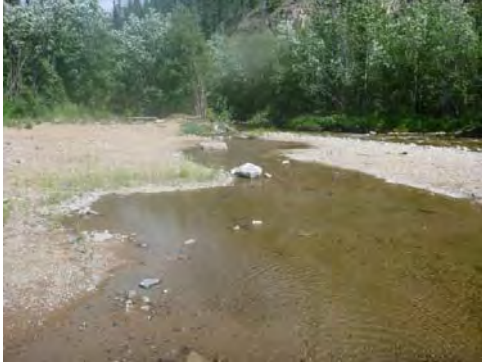
Freegold Road Upgrade Crossing # 40 - Seymour Creek

D/S	X	U/S	
Coordinates:	6909633 N	385203 E	Gradient (%):	1	1/1	1
Site Visit Date:	02-Jul-13		Bankfull Width (m):	9.80	8.50 / 7.30	21.50
Flow Conditions:	Low		Bankfull Depth (m):	0.49	0.32 / 0.84	0.67
Barrier/Confirmed:	None		Wetted Widths (m):	8.20	5.00 / 5.10	11.90
Electrofished/Effort?:	No		Wetted Depth (m):	0.19	0.07 / 0.43	0.22
Gee Trapping:	No		Substrate Bed:	C/G	G/F / C/B	C/G
Fish Bearing?	Yes		Substrate Bank:	F	F	F
Site Length:	100 m		Riparian Vegetation:	WI/PO/SP	SP/PO/WI	SP/PO/WI
			Meander Pattern:	SI	IM	IM
		Cover:	10% / OV	5% / OV	5% / B	
Photo #s	123/126 u/s	124/127 x	125/128 d/s			
Areas of Erosion:	Yes		Temperature:	9.86	°C	
Locations:	Area around road eroded, also banks		pH:	7.99	pH units	
	on small channel u/s of the road		Conductivity:	195	uS/cm	
	and at the ford		DO:	9.61	mg/L	
				92	% Sat

Comments:
Two channels: approximately 9m bar, partly vegetated between two. Large sand piles upstream, also placer ponds further upstream, heavily disturbed: photos 129 (upstream) and 130 (downstream)
Potential for re-vegetation, bank stabilization, pools, instream habitat. U/s site assessed at main channel, 90% of flow. 2 arctic grayling spotted, 2 more upstream of the bridge and 2 downstream

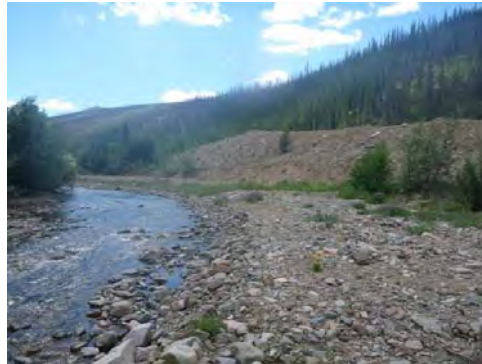
Photo 129

A photograph of a river flowing through a forested area. The river is shallow and clear, revealing a rocky bed. The left bank is composed of light-colored, rounded stones and pebbles. The right bank is covered in dense green vegetation, including tall trees and shrubs. In the background, a mountain range is visible under a cloudy sky.

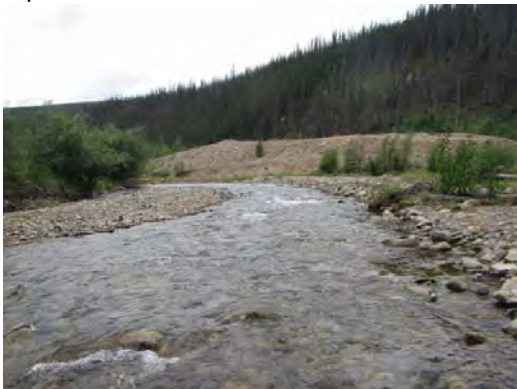
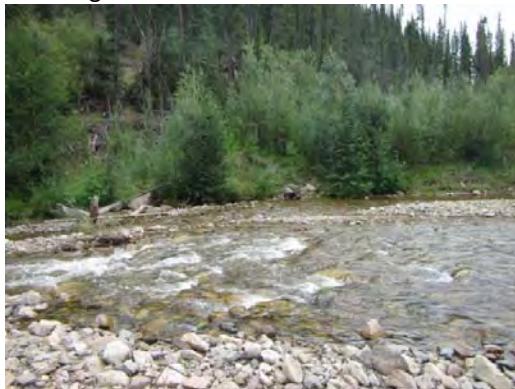
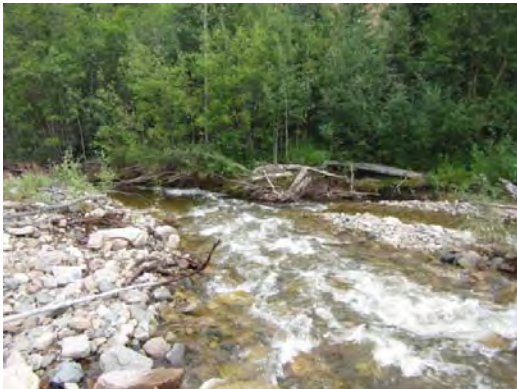
Freegold Road Upgrade Crossing # 40N - Seymour Creek

D/S	X	U/S	
Coordinates:	6909572 N	385205 E	Gradient (%):	2	1	3
Site Visit Date:	08-Aug-13		Bankfull Width (m):	42.00	45.00	45.00
Flow Conditions:	Low		Bankfull Depth (m):	0.85	1.00	1.00
Barrier/Confirmed:	None		Wetted Widths (m):	6.00	16.00	9.00
Electrofished/Effort?:	/		Wetted Depth (m):	0.32	0.25	0.35
Gee Trapping:			Substrate Bed:	C/G	C/G	C/G
Fish Bearing?:	Y/N		Substrate Bank:	F/C	F/C	F/C
Site Length:			Riparian Vegetation:	WI	WI	WI
	(200m)		Meander Pattern:	SI	SI	SI
			Cover:	10% / SUB	10% / SUB	10% / SUB
Photo #s	63 u/s	65 x	64 d/s			
Areas of Erosion:	Y		Temperature:	5.9	°C	
Locations:	Old Placer mine just upstream		pH:	8.12	pH units	
	of crossing location		Conductivity:	151	µS/cm	
			DO:	10.06	mg/L	
				87.3	% Sat	
Comments:	Non-specific conductivity: 236 µS/cm					
	Braided channel at crossing, will need to be trained to bridge

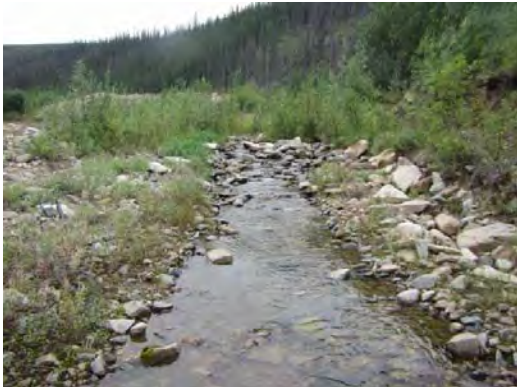
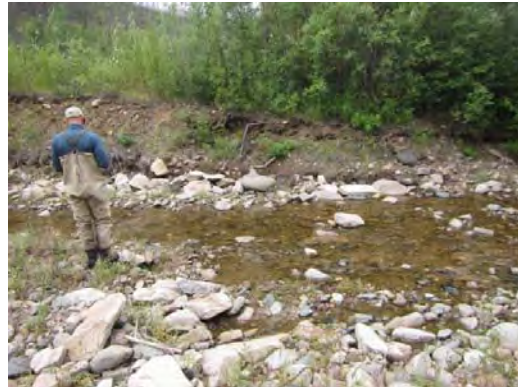
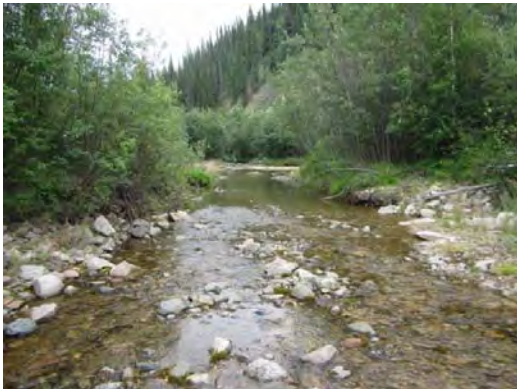
Freegold Road Upgrade Crossing # 40NN - Seymour Creek Side Channel

D/S	X	U/S	
Coordinates:	-	-	Gradient (%):	-	4	-
Site Visit Date:	08-Aug-13		Bankfull Width (m):	-	5.00	-
Flow Conditions:	Low		Bankfull Depth (m):	-	1.00	-
Barrier/Confirmed:	None		Wetted Widths (m):	-	2.00	-
Electrofished/Effort?:	No		Wetted Depth (m):	-	0.14	-
Gee Trapping:	No		Substrate Bed:	-	C/G	-
Fish Bearing?	Yes		Substrate Bank:	-	G/F	-
Site Length:	50 m		Riparian Vegetation:	-	WI	-
			Meander Pattern:	-	SI	-
			Cover:	-	10% / SUB	-
Photo #s	67 u/s	69 x	68 d/s			
Areas of Erosion:	Yes		Temperature:	5.4	°C	
Locations:	both LHB and RHB		pH:	7.96	pH units	
			Conductivity:	143	µS/cm	
			DO:	8.54	mg/L	
				73.4	% Sat	
Comments:						
Side channel most likely originating in settling ponds upstream

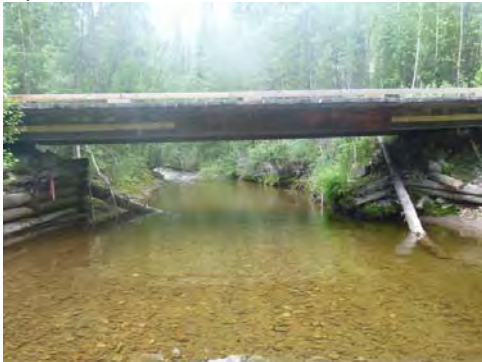
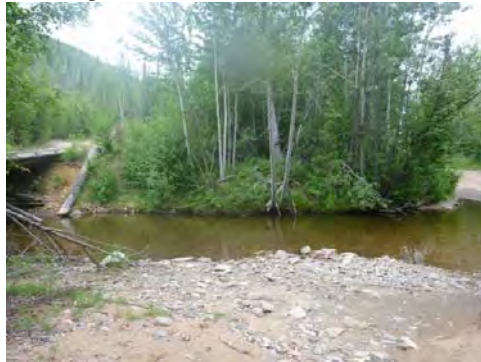
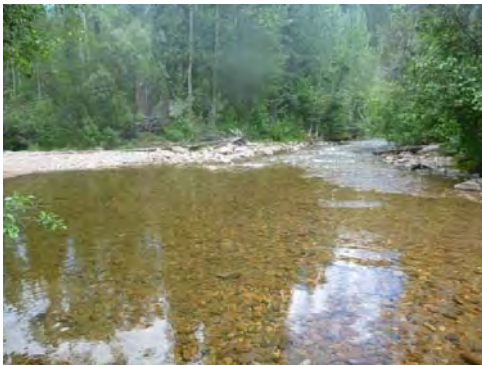
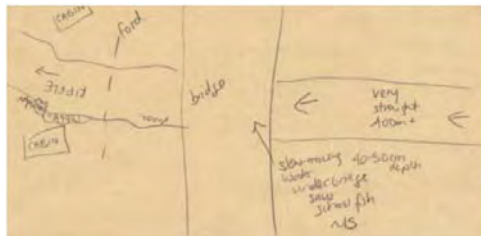
Freegold Road Upgrade Crossing # 41 - Bow Creek

D/S	X	U/S
Coordinates:	6910209 N	385089 E	Gradient (%):	1	1
Site Visit Date:	02-Jul-13		Bankfull Width (m):	7.00	9.00
Flow Conditions:	Low		Bankfull Depth (m):	0.62	0.48
Barrier/Confirmed:	None		Wetted Widths (m):	6.40	7.40
Electrofished/Effort?:	Yes (2010)		Wetted Depth (m):	0.32	0.36
Gee Trapping:	No		Substrate Bed:	C/G	G/C
Fish Bearing?	Yes		Substrate Bank:	F	F
Site Length:	100 m		Riparian Vegetation:	SP/PO/WI	PO/WI/SP
			Meander Pattern:	SI	SI
			Cover:	10% / OV	10% / OV
Photo #s	131 u/s	132 x	133 d/s		
Areas of Erosion:	Yes		Temperature:	7.18	°C
Locations:	Under bridge and at ford		pH:	7.98	pH units
			Conductivity:	107	uS/cm
			DO:	9.57	mg/L
				863	% Sat
Comments:					
4 grayling spotted under bridge					
Saw school of fish (approximately 15) just by the bridge					
High quality habitat lacking deep pools

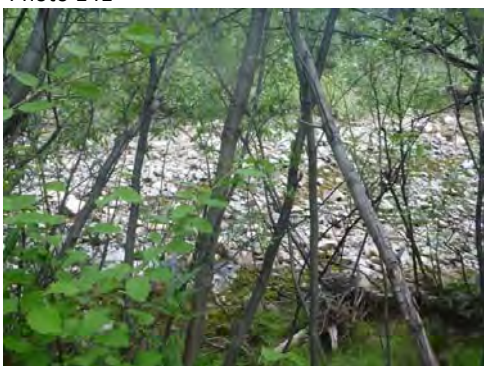
D/S	X	U/S
Coordinates:	6911857 N	385925 E	Gradient (%):	-	-
Site Visit Date:	02-Jul-13		Bankfull Width (m):	-	-
Flow Conditions:	None		Bankfull Depth (m):	-	-
Barrier/Confirmed:	N/A		Wetted Widths (m):	-	-
Electrofished/Effort?:	N/A		Wetted Depth (m):	-	-
Gee Trapping:	N/A		Substrate Bed:	-	-
Fish Bearing?	N/A		Substrate Bank:	-	-
Site Length:	N/A		Riparian Vegetation:	-	-
			Meander Pattern:	-	-
			Cover:	-	-
Photo #s	u/s	x	d/s		
Areas of Erosion:	N/A		Temperature:	-	°C
Locations:			pH:	-	pH units
			Conductivity:	-	uS/cm
			DO:	-	mg/L
				-	% Sat
Comments: No visible channel					
Photo 141 shows nearby highflow channel - not sure if it will be crossed

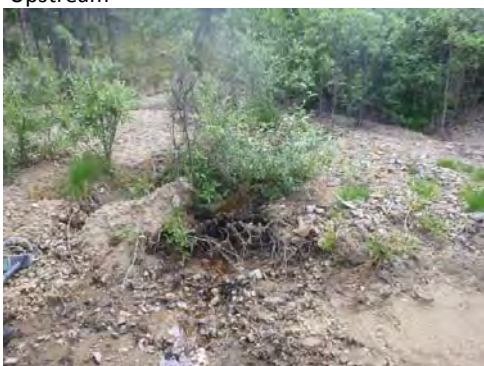
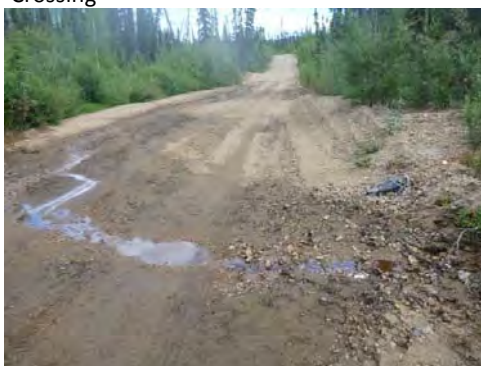
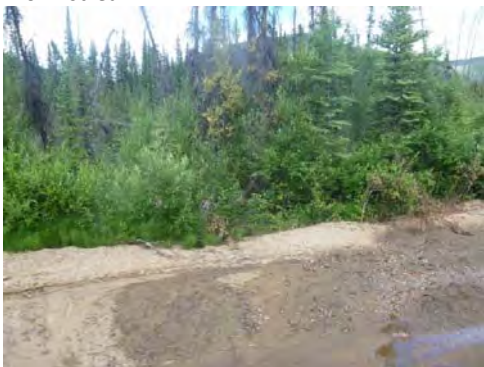
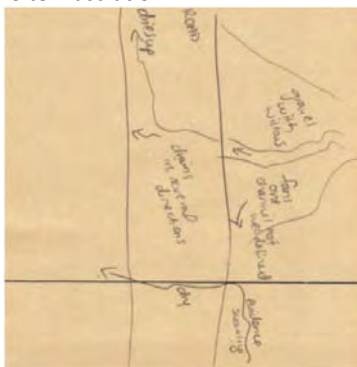
Freegold Road Upgrade Crossing # 46 - Big Creek Tributary

D/S	X	U/S
Coordinates:	6915155 N	385937 E	Gradient (%):	-	7
Site Visit Date:	02-Jul-13		Bankfull Width (m):	-	0.83
Flow Conditions:	Very low		Bankfull Depth (m):	-	0.23
Barrier/Confirmed:	Yes		Wetted Widths (m):	-	0.20
Electrofished/Effort?:	No		Wetted Depth (m):	-	0.01
Gee Trapping:	No		Substrate Bed:	-	F/G
Fish Bearing?:	Yes		Substrate Bank:	-	F/G
Site Length:	100 m		Riparian Vegetation:	-	SP/WI
			Meander Pattern:	-	IM
			Cover:	-	0
					90% / OV
Photo #s	152 u/s	153 x	154 d/s		
Areas of Erosion:	Yes		Temperature:	-	°C
Locations:	Scouring along road crossing		pH:	-	pH units
			Conductivity:	-	uS/cm
			DO:	-	mg/L
				-	% Sat
Comments:					
No culvert at road crossing - creating a barrier to fish passage

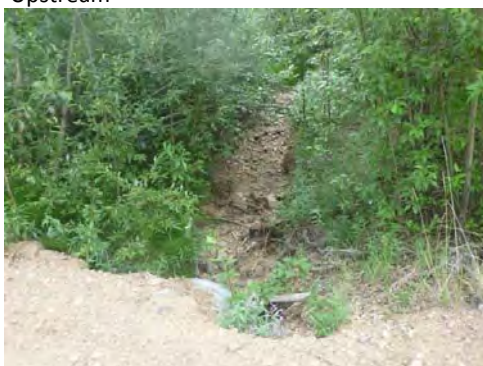
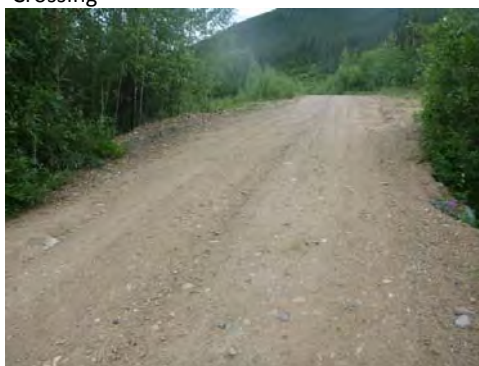
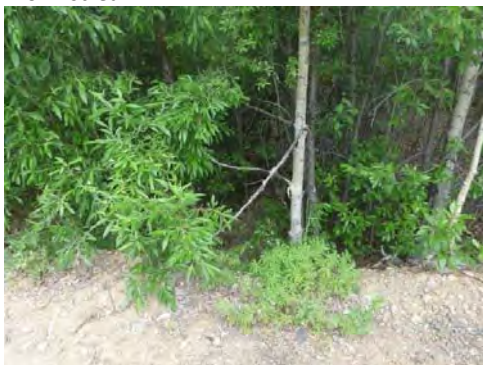
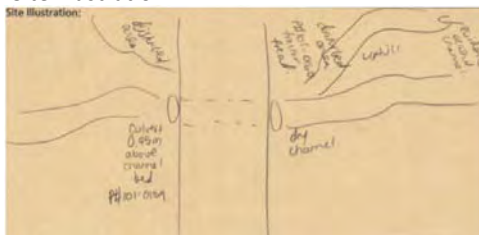
Freegold Road Upgrade Crossing # 47 - Big Creek Tributary

D/S	X	U/S	
Coordinates:	6914783 N	384948 E	Gradient (%):	3	4	6
Site Visit Date:	02-Jul-13		Bankfull Width (m):	0.95	1.15	1.30
Flow Conditions:	None		Bankfull Depth (m):	0.50	0.25	0.25
Barrier/Confirmed:	Yes		Wetted Widths (m):	-	-	-
Electrofished/Effort?:	No		Wetted Depth (m):	-	-	-
Gee Trapping:	No		Substrate Bed:	C/G	G/F	G/F
Fish Bearing?:	No		Substrate Bank:	F	F	F
Site Length:	100 m		Riparian Vegetation:	SP/PO/WI	SP/PO/WI	SP/PO/WI
			Meander Pattern:	SI	SI	IM
			Cover:	80 % / OV	90% / OV	70% / OV
Photo #s	156 u/s	157 x	158 d/s			
Areas of Erosion:	No		Temperature:	-	°C	
Locations:			pH:	-	pH units	
			Conductivity:	-	uS/cm	
			DO:	-	mg/L	
				-	% Sat	
Comments:						
Dry channel with culvert						
Large channel with no water, was pool habitat in downstream section						
Perched culvert on downstream side creating a barrier to fish passage

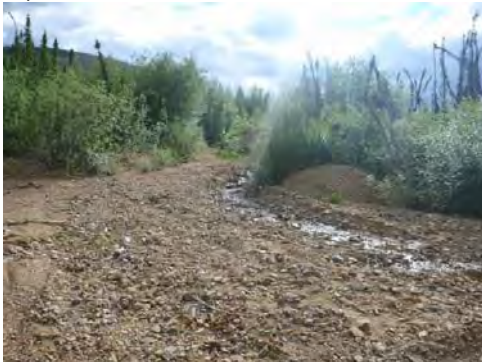
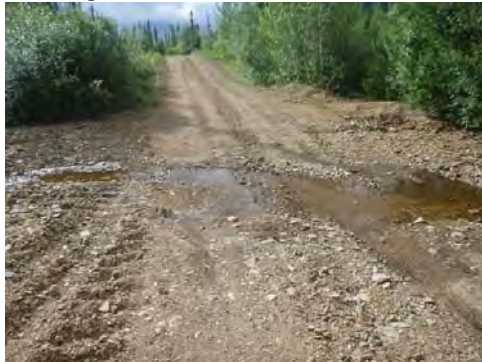
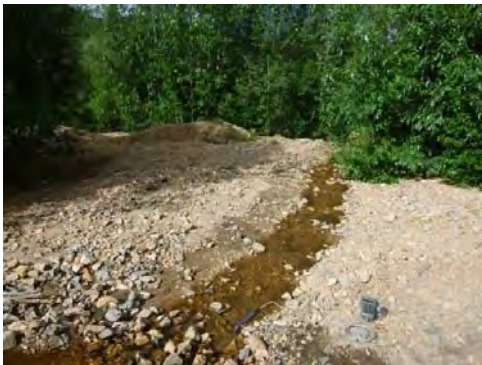
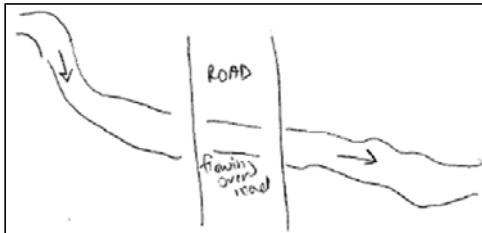
Freegold Road Upgrade Crossing # 47.5 (Unmapped Site) - Big Creek Tributary

D/S	X	U/S
Coordinates:	6914767 N	384266 E	Gradient (%):	3	2	4
Site Visit Date:	02-Jul-13		Bankfull Width (m):	0.76	1.40	1.40
Flow Conditions:	Low		Bankfull Depth (m):	0.07	0.13	0.32
Barrier/Confirmed:	Yes		Wetted Widths (m):	0.76	0.84	0.88
Electrofished/Effort?:	No		Wetted Depth (m):	0.02	0.03	0.04
Gee Trapping:	No		Substrate Bed:	F/G	G/C	G/C
Fish Bearing?	Yes		Substrate Bank:	F	F	F
Site Length:	100 m		Riparian Vegetation:	WI/SP	WI/SP	WI/SP
			Meander Pattern:	SI	SI	SI
			Cover:	80% / OV	5% / OV	50% / OV
Photo #s	183 u/s	184 x	185 d/s			
Areas of Erosion:	Yes		Temperature:	18.26	°C	
Locations:	Disturbed area, road washed out.		pH:	8.42	pH units	
			Conductivity:	603	uS/cm	
			DO:	9.4	mg/L

107.6	% Sat	
Comments:						
Looks re-aligned, not much riparian vegetation or cover						
About 35m above road: dramatic step-pool through area with 100% riparian vegetation						
Downstream site is not natural; runs through willows and trees without defined channel

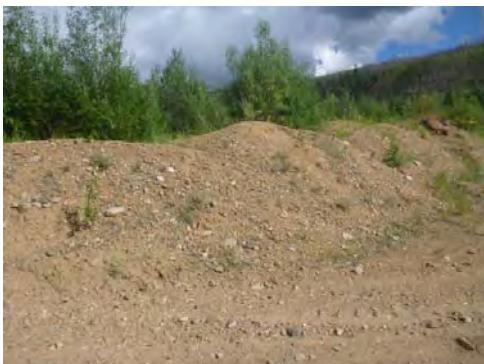
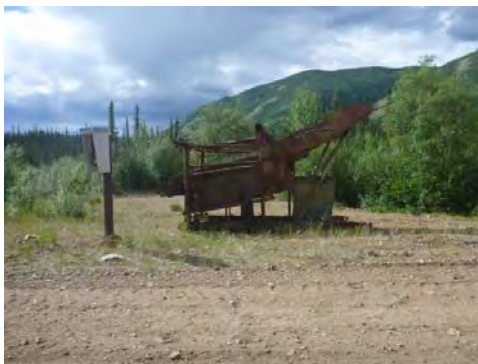
Freegold Road Upgrade Crossing # 48 - No Crossing

D/S	X	U/S
Coordinates:	6914718 N	384130 E	Gradient (%):	-	-
Site Visit Date:	02-Jul-13		Bankfull Width (m):	-	-
Flow Conditions:	None		Bankfull Depth (m):	-	-
Barrier/Confirmed:	N/A		Wetted Widths (m):	-	-
Electrofished/Effort?:	N/A		Wetted Depth (m):	-	-
Gee Trapping:	N/A		Substrate Bed:	-	-
Fish Bearing?:	N/A		Substrate Bank:	-	-
Site Length:	N/A		Riparian Vegetation:	-	-
			Meander Pattern:	-	-
			Cover:	-	-
Photo #s	u/s	x	d/s		
Areas of Erosion:	N/A		Temperature:	-	°C
Locations:			pH:	-	pH units
			Conductivity:	-	uS/cm
			DO:	-	mg/L
				-	% Sat
Comments: No visible channel. Disturbed area. Photos 178, 179

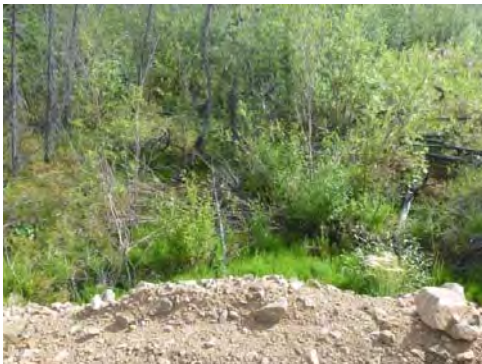
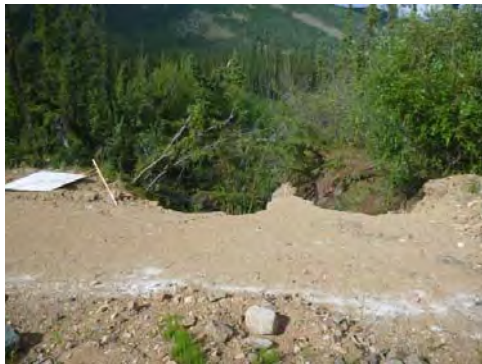
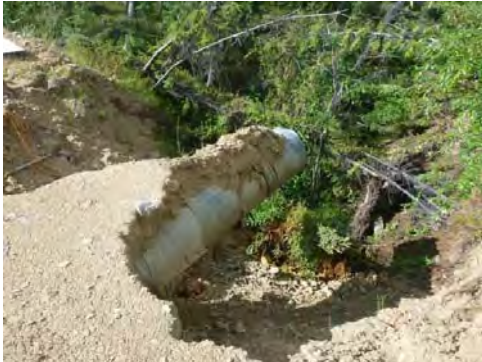
Freegold Road Upgrade Crossing # 48.5 (Unmapped Site) - Big Creek Tributary

D/S	X	U/S
Coordinates:	6914524 N	383284 E	Gradient (%):	-	-
Site Visit Date:	02-Jul-13		Bankfull Width (m):	-	-
Flow Conditions:	None		Bankfull Depth (m):	-	-
Barrier/Confirmed:	Yes		Wetted Widths (m):	-	-
Electrofished/Effort?:	No		Wetted Depth (m):	-	-
Gee Trapping:	No		Substrate Bed:	-	-
Fish Bearing?:	No		Substrate Bank:	-	-
Site Length:	100 m		Riparian Vegetation:	-	-
			Meander Pattern:	-	-
			Cover:	-	-
Photo #s	u/s	x	d/s		
Areas of Erosion:	Yes		Temperature:	-	°C
Locations:	Erosion of road crossing		pH:	-	pH units
			Conductivity:	-	uS/cm
			DO:	-	mg/L
				-	% Sat
Comments:					
Perched culvert downstream of crossing					
Dry channel

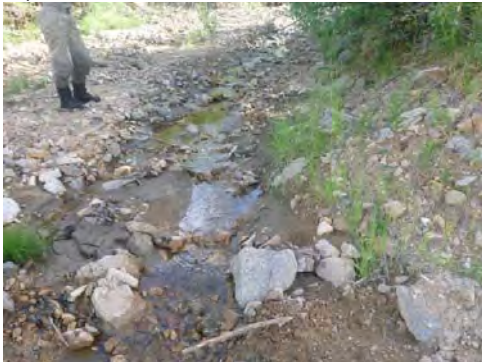
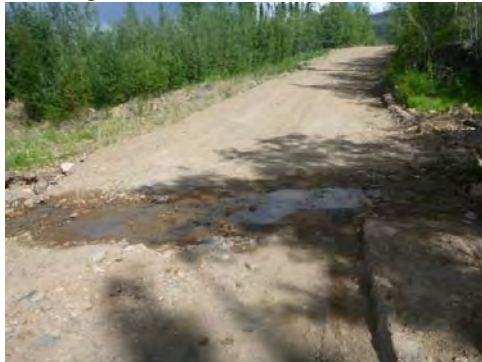
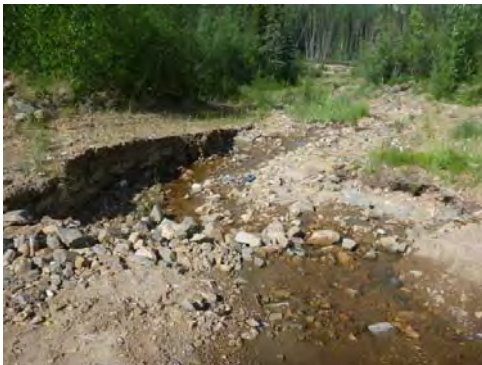
Freegold Road Upgrade Crossing # 49

D/S	X	U/S	
Coordinates:	6914666 N	383096 E	Gradient (%):	6	3	3
Site Visit Date:	02-Jul-13		Bankfull Width (m):	1.09	1.10	0.79
Flow Conditions:	Low		Bankfull Depth (m):	0.24	0.20	0.13
Barrier/Confirmed:	No		Wetted Widths (m):	0.37	0.47	0.25
Electrofished/Effort?:	No		Wetted Depth (m):	0.09	0.05	0.03
Gee Trapping:	No		Substrate Bed:	C/F	F/G	C/F
Fish Bearing?	Yes		Substrate Bank:	F	F	F
Site Length:	100 m		Riparian Vegetation:	GR/WI/SP	SP/WI	SP/WI
			Meander Pattern:	IM	IM	IM
			Cover:	5% / OV	0	0
Photo #s	171 u/s	172 x	173 d/s			
Areas of Erosion:	Yes		Temperature:	19.39	°C	
Locations:	Stream crossing road with no culvert		pH:	8.45	pH units	
			Conductivity:	1093	uS/cm	
			DO:	8.43	mg/L	
				98.5	% Sat	
Comments:						
Heavy machinery and large sand piles present						
Creek possibly re-aligned? No immediate riparian vegetation or cover, those mentioned						
were only nearby

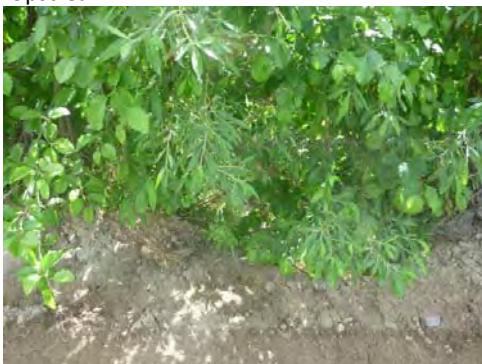
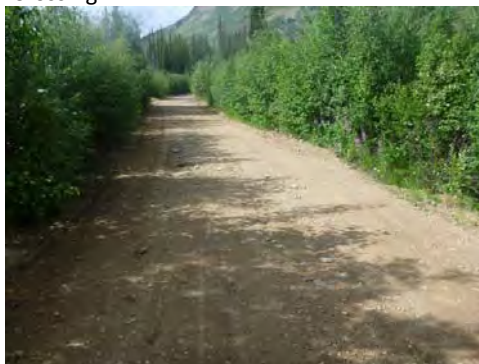
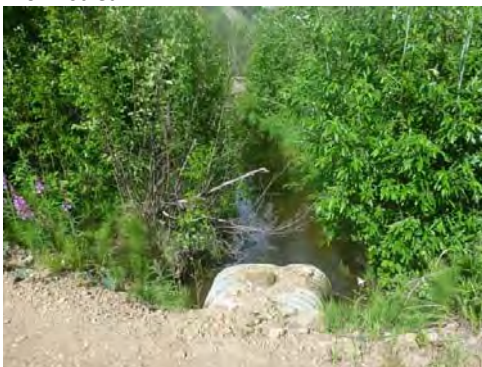
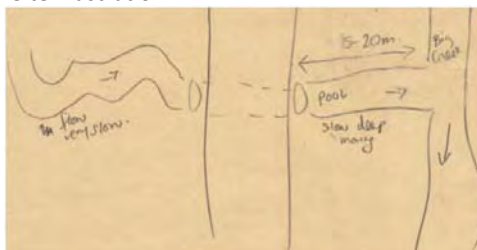
Freegold Road Upgrade Crossing # 50 - Big Creek Tributary

D/S	X	U/S
Coordinates:	6914869 N	382277 E	Gradient (%):	<1	1
Site Visit Date:	02-Jul-13		Bankfull Width (m):	2.00	0.85
Flow Conditions:	Med		Bankfull Depth (m):	0.66	0.54
Barrier/Confirmed:	None		Wetted Widths (m):	2.00	0.85
Electrofished/Effort?:	No		Wetted Depth (m):	0.53	0.39
Gee Trapping:	No		Substrate Bed:	F	F/G
Fish Bearing?	Yes		Substrate Bank:	F	F
Site Length:	100 m		Riparian Vegetation:	AL/GR/SP	AL/GR
			Meander Pattern:	ST	IM
			Cover:	15% / OV	80% / OV
Photo #s	101-0168 u/s	101-0169 x	101-0170 d/s		
Areas of Erosion:	No		Temperature:	7.27	°C
Locations:			pH:	7.34	pH units
			Conductivity:	105	uS/cm
			DO:	4.99	mg/L
				45	% Sat
Comments:					
Backwatering from mainstem					
Drop pool downstream of culvert

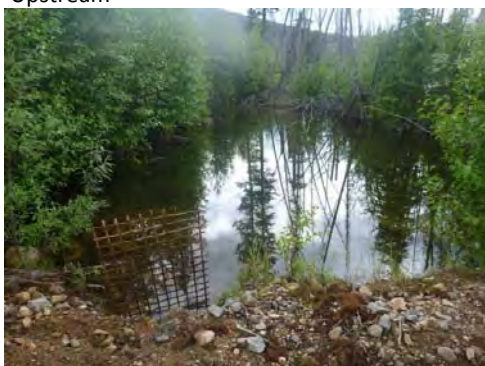
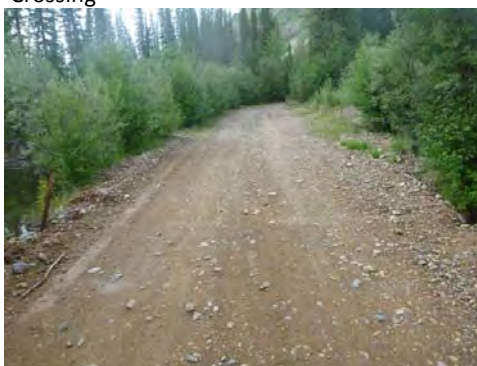
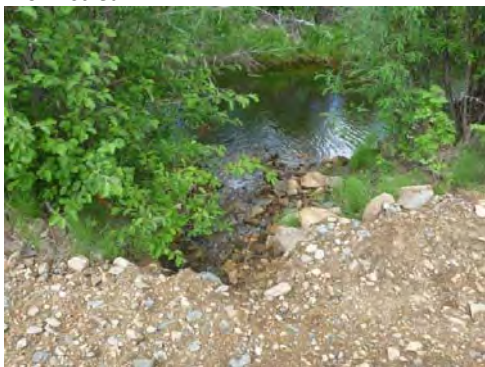
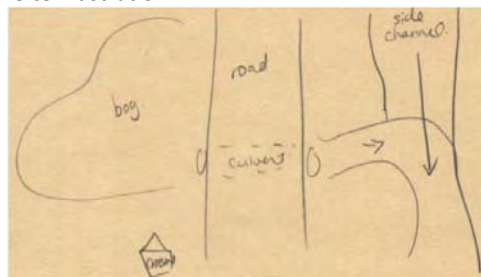
Freegold Road Upgrade Crossing # 50.5 (Unmapped Site) - Bog Near Big Creek

D/S	X	U/S
Coordinates:	6915023 N	382209 E	Gradient (%):	-	-
Site Visit Date:	02-Jul-13		Bankfull Width (m):	-	-
Flow Conditions:	No Flowing Water		Bankfull Depth (m):	-	-
Barrier/Confirmed:	Yes		Wetted Widths (m):	-	-
Electrofished/Effort?:	No		Wetted Depth (m):	-	-
Gee Trapping:	No		Substrate Bed:	-	-
Fish Bearing?:	No		Substrate Bank:	-	-
Site Length:	50 m		Riparian Vegetation:	-	-
			Meander Pattern:	-	-
			Cover:	-	-
Photo #s	165 u/s	166 x	167 d/s		
Areas of Erosion:	No		Temperature:	-	°C
Locations:			pH:	-	pH units
			Conductivity:	-	uS/cm
			DO:	-	mg/L
				-	% Sat
Comments:					
Culvert present for water seeping from bog into a side channel.					
Grate present over culvert to block passage

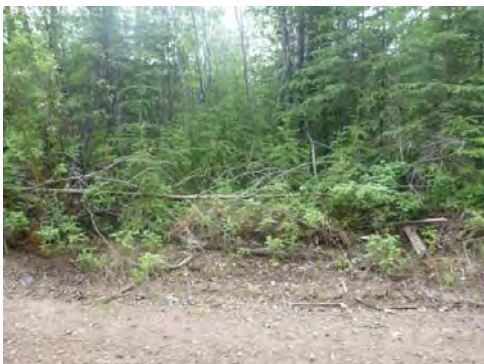
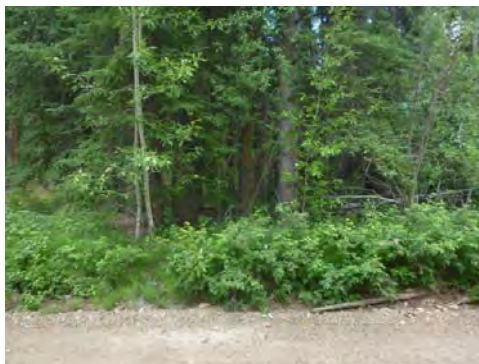
Freegold Road Upgrade Crossing # 51 - No Crossing

D/S	X	U/S
Coordinates:	6915035 N	381481 E	Gradient (%):	-	-
Site Visit Date:	02-Jul-13		Bankfull Width (m):	-	-
Flow Conditions:	None		Bankfull Depth (m):	-	-
Barrier/Confirmed:	N/A		Wetted Widths (m):	-	-
Electrofished/Effort?:	N/A		Wetted Depth (m):	-	-
Gee Trapping:	N/A		Substrate Bed:	-	-
Fish Bearing?	N/A		Substrate Bank:	-	-
Site Length:	N/A		Riparian Vegetation:	-	-
			Meander Pattern:	-	-
			Cover:	-	-
Photo #s	u/s	x	d/s		
Areas of Erosion:	N/A		Temperature:	-	°C
Locations:			pH:	-	pH units
			Conductivity:	-	uS/cm
			DO:	-	mg/L
				-	% Sat
Comments:	No visible channel

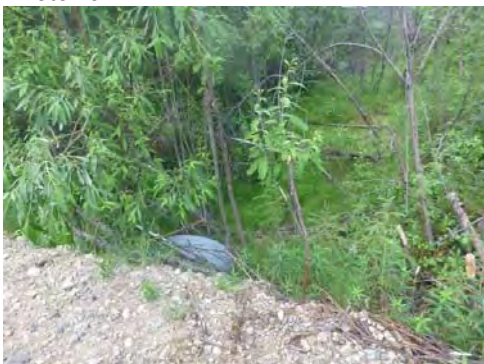
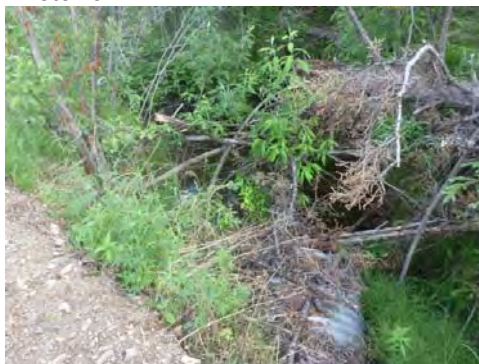
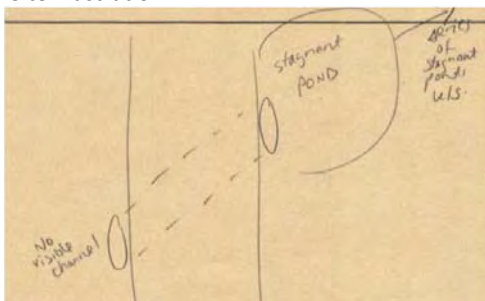
Freegold Road Upgrade Crossing # 52 - Big Creek Tributary

D/S	X	U/S
Coordinates:	6915218 N	381366 E	Gradient (%):	-	-
Site Visit Date:	02-Jul-13		Bankfull Width (m):	-	-
Flow Conditions:	None		Bankfull Depth (m):	-	-
Barrier/Confirmed:	N/A		Wetted Widths (m):	-	-
Electrofished/Effort?:	N/A		Wetted Depth (m):	-	-
Gee Trapping:	N/A		Substrate Bed:	-	-
Fish Bearing?	N/A		Substrate Bank:	-	-
Site Length:	N/A		Riparian Vegetation:	-	-
			Meander Pattern:	-	-
			Cover:	-	-
Photo #s	u/s	x	d/s		
Areas of Erosion:	N/A		Temperature:	-	°C
Locations:			pH:	-	pH units
			Conductivity:	-	uS/cm
			DO:	-	mg/L
				-	% Sat
Comments: No visible channel - stagnant pond near crossing location

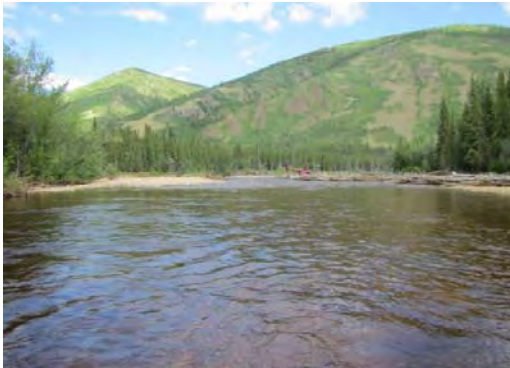
Photo 68

D/S	X	U/S	
Coordinates:	6915200 N	380797 E	Gradient (%):	3	0	2
Site Visit Date:	June 19, 2013		Bankfull Width (m):	58.00	24.00	40.00
Flow Conditions:	Low		Bankfull Depth (m):	1.00	1.40	3.00
Barrier/Confirmed:	None		Wetted Widths (m):	24.00	16.00	16.00
Electrofished/Effort?:	No		Wetted Depth (m):	0.38	1.10	2.00
Gee Trapping:	No		Substrate Bed:	C/G	C/G	C/G
Fish Bearing?	Yes		Substrate Bank:	C/S	C/S	C/S
Site Length:	100 m		Riparian Vegetation:	SP/WI/PO	SP/WI/PO	SP/WI/PO
			Meander Pattern:	IM	IM	IM
			Cover:	20% / LWD	5% / OV	5% / LWD
Photo #s	69 u/s	70 x	71 d/s			
Areas of Erosion:	Y		Temperature:	9.32	°C	
Locations:	Just upstream of Mechanic		pH:	7.22	pH units	
	Mechanic Creek		Conductivity:	170	uS/cm	
			DO:	11.9	mg/L	
				100	% Sat	
Comments: Pre-existing Habitat Card as 13+120						
Some deep pool/glide habitat, boulder/overhang vegetation cover, very limited						
Nice pool/ undercut bank on left bank. Log jam downstream, creek divides into several sections

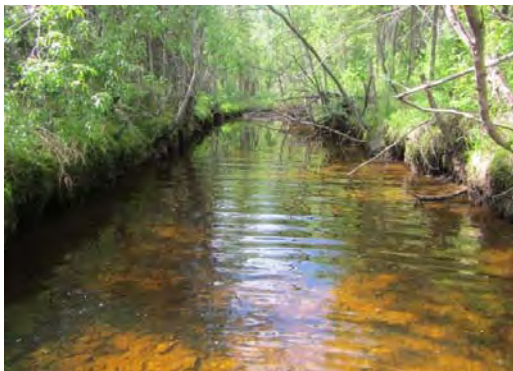
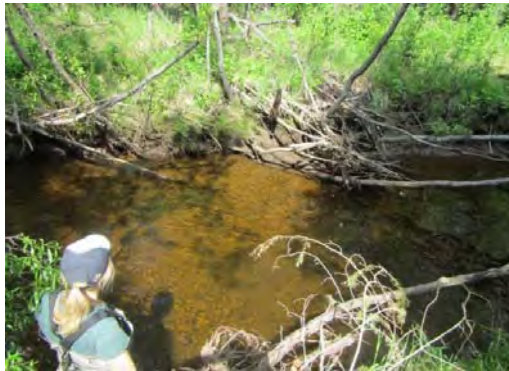
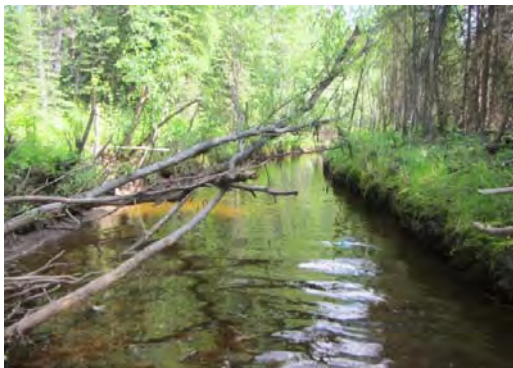
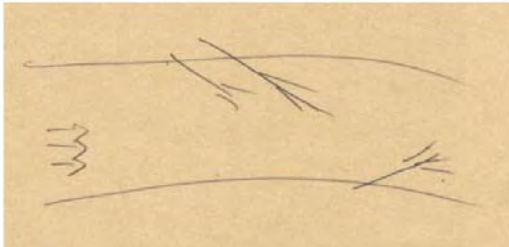
Freegold Road Extension Crossing # 13+470 - Big Creek Tributary

D/S	X	U/S
Coordinates:	6915437 N	380643 E	Gradient (%):	1	1
Site Visit Date:	19-Jun-13		Bankfull Width (m):	5.00	6.00
Flow Conditions:	Low		Average Depth (m):	0.80	1.20
Barrier/Confirmed:	None		Wetted Widths (m):	4.00	5.00
Electrofished/Effort?:	No		Substrate Bed:	G/C	G/C
Gee Trapping:	No		Substrate Bank:	-	-
Fish Bearing?:	Yes		Riparian Vegetation:	-	-
Site Length:	100 m		Meander Pattern:	-	-
			Cover:	60% / OV	60% / OV

Comments:
Pre-exisiting site card as 13+580 (Summit, 2011)
Good quality habitat

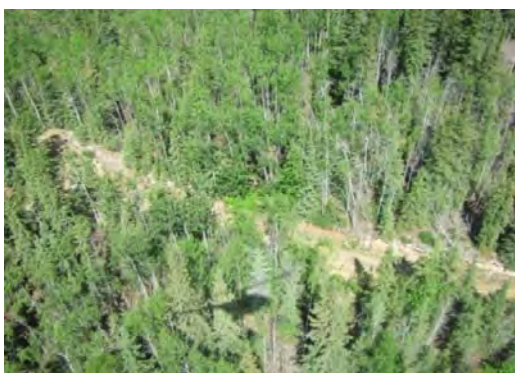
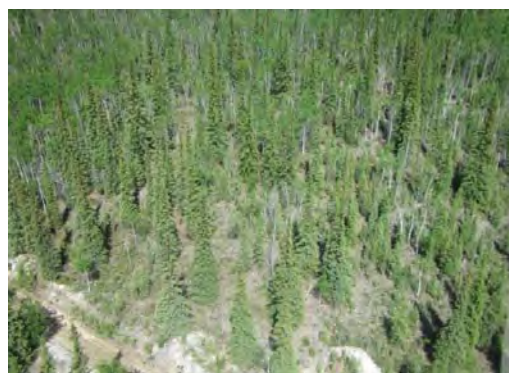
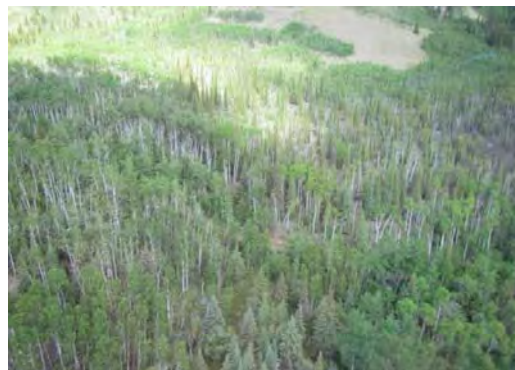
Freegold Road Extension Crossing # 15+500 - Big Creek Tributary

D/S	X	U/S
Coordinates:	6916772 N	379294 E	Gradient (%):	-	-
Site Visit Date:	19-Jun-13		Bankfull Width (m):	-	-
Flow Conditions:	Dry		Bankfull Depth (m):	-	-
Barrier/Confirmed:	N/A		Wetted Widths (m):	-	-
Electrofished/Effort?:	N/A		Wetted Depth (m):	-	-
Gee Trapping:	N/A		Substrate Bed:	-	-
Fish Bearing?	N		Substrate Bank:	-	-
Site Length:	-		Riparian Vegetation:	-	-
			Meander Pattern:	-	-
			Cover:	-	-
Photo #s	u/s	76 x	d/s		
Areas of Erosion:	N/A		Temperature:	-	°C
Locations:			pH:	-	pH units
			Conductivity:	-	uS/cm
			DO:	-	mg/L
				-	% Sat
Comments:					
Dry channel running straight off of hillside					
No permanent flow

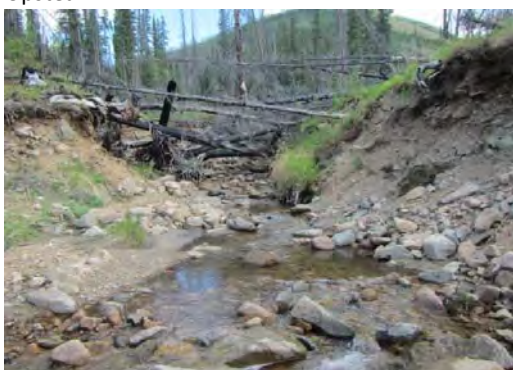
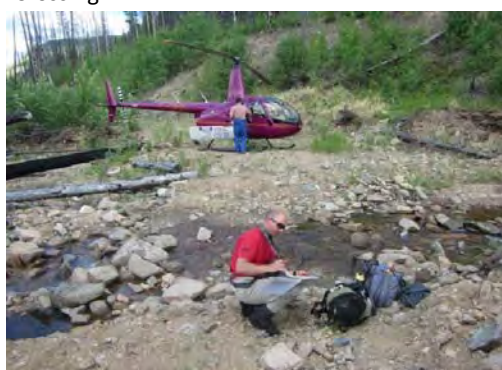
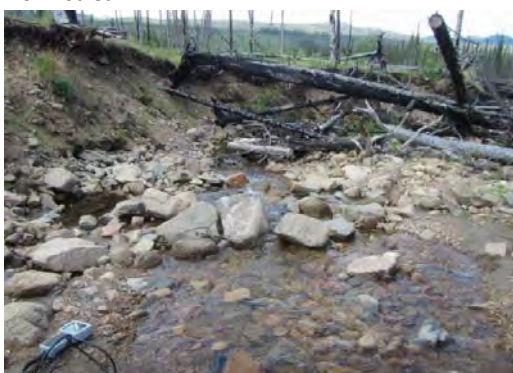
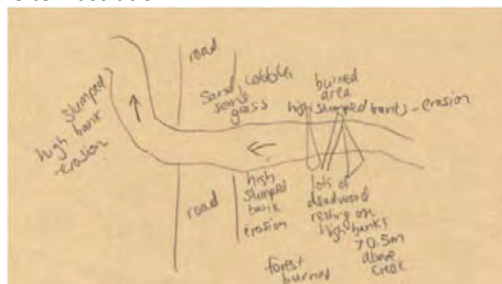
Freegold Road Extension Crossing # 16+560 - Big Creek Tributary

D/S	X	U/S	
Coordinates:	6917122 N	378313 E	Gradient (%):	3	6	9
Site Visit Date:	19-Jun-13		Bankfull Width (m):	3.40	4.00	3.50
Flow Conditions:	Low		Bankfull Depth (m):	0.20	0.26	0.27
Barrier/Confirmed:	None		Wetted Widths (m):	1.80	1.90	2.60
Electrofished/Effort?:	Yes (2011)		Wetted Depth (m):	0.10	0.16	0.17
Gee Trapping:	No		Substrate Bed:	C/B	C/B	C/B
Fish Bearing?	Yes		Substrate Bank:	C/S	B/S	C/S
Site Length:	100 m		Riparian Vegetation:	GR/SH	GR	GR
		Meander Pattern:	RM	RM	RM	
		Cover:	5% / B	10% / B	15% / U	
Photo #s	73 u/s	74 x	75 d/s			
Areas of Erosion:	Yes		Temperature:	6	°C	
Locations:	Slumped bank at crossing		pH:	7.8	pH units	
			Conductivity:	377	uS/cm	
			DO:	13.15	mg/L	
				105	% Sat

Comments:
Slumping/erosion upstream and downstream of current ford

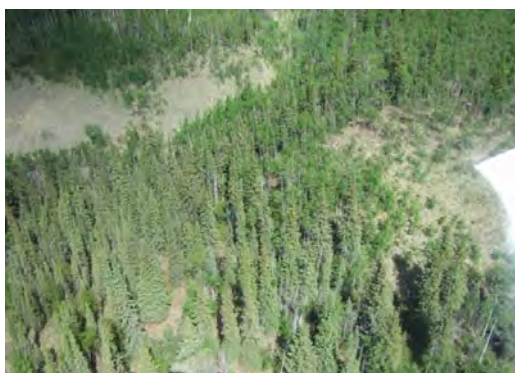
Air photo from 18+080

D/S	X	U/S
Coordinates:	6918147 N	377298 E	Gradient (%):	-	-
Site Visit Date:	19-Jun-13		Bankfull Width (m):	-	-
Flow Conditions:	Dry		Bankfull Depth (m):	-	-
Barrier/Confirmed:	N/A		Wetted Widths (m):	-	-
Electrofished/Effort?:	N/A		Wetted Depth (m):	-	-
Gee Trapping:	N/A		Substrate Bed:	-	-
Fish Bearing?	No		Substrate Bank:	-	-
Site Length:	N/A		Riparian Vegetation:	-	-
			Meander Pattern:	-	-
			Cover:	-	-
Photo #s	u/s	x	d/s		
Areas of Erosion:	N/A		Temperature:	-	°C
Locations:			pH:	-	pH units
			Conductivity:	-	uS/cm
			DO:	-	mg/L
				-	% Sat
Comments:					
Dry - no visible channel

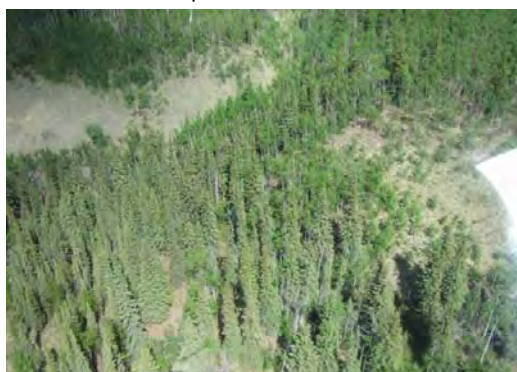
Photo from helicopter

D/S	X	U/S
Coordinates:	6918167 N	377264 E	Gradient (%):	-	-
Site Visit Date:	19-Jun-13		Bankfull Width (m):	-	-
Flow Conditions:	Dry		Bankfull Depth (m):	-	-
Barrier/Confirmed:	N/A		Wetted Widths (m):	-	-
Electrofished/Effort?:	N/A		Wetted Depth (m):	-	-
Gee Trapping:	N/A		Substrate Bed:	-	-
Fish Bearing?:	No		Substrate Bank:	-	-
Site Length:	N/A		Riparian Vegetation:	-	-
			Meander Pattern:	-	-
			Cover:	-	-
Photo #s	u/s	82 x	d/s		
Areas of Erosion:	N/A		Temperature:	-	°C
Locations:			pH:	-	pH units
			Conductivity:	-	uS/cm
			DO:	-	mg/L
				-	% Sat
Comments:					
Dry gully - no channel/water

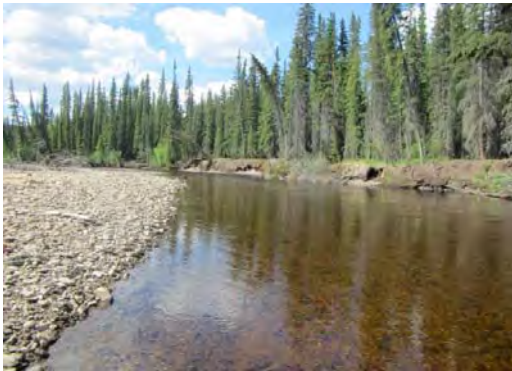
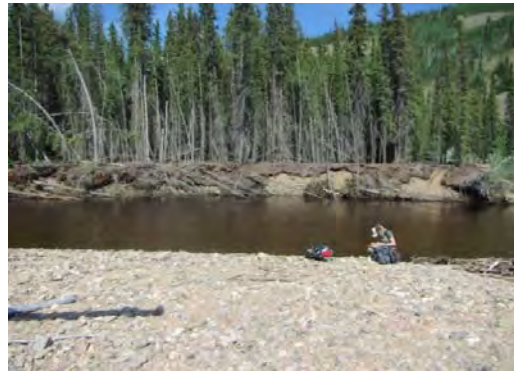
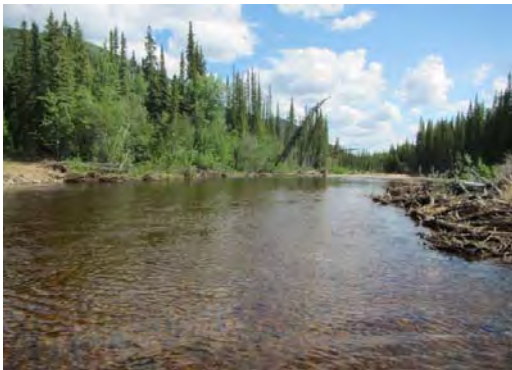
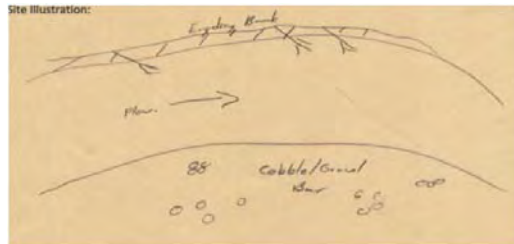
Freegold Road Extension Crossing # 18+370 - Big Creek

D/S	X	U/S
Coordinates:	6918095 N	377007 E	Gradient (%):	0.5	0.5
Site Visit Date:	19-Jun-13		Bankfull Width (m):	24.00	23.00
Flow Conditions:	Low		Average Depth (m):	1.00	0.90
Barrier/Confirmed:	None		Wetted Widths (m):	22.00	19.00
Electrofished/Effort?:	No		Substrate Bed:	G/C	G/C
Gee Trapping:	No		Substrate Bank:	-	-
Fish Bearing?	Yes		Riparian Vegetation:	-	-
Site Length:	100 m		Meander Pattern:	-	TS
			Cover:	30% / DP	30% / DP
				45% / DP/LWD

Comments:
Pre-existing site card (Summit, 2011)
High quality spawning and rearing habitat
