APPENDIX 10B: FREEGOLD ROAD FISH AND AQUATIC BASELINE

Casino Project

Fish and Aquatic Resources Baseline Report:

Freegold Road Extension, Freegold Road Upgrade, and Casino Airstrip and Airstrip Access Road

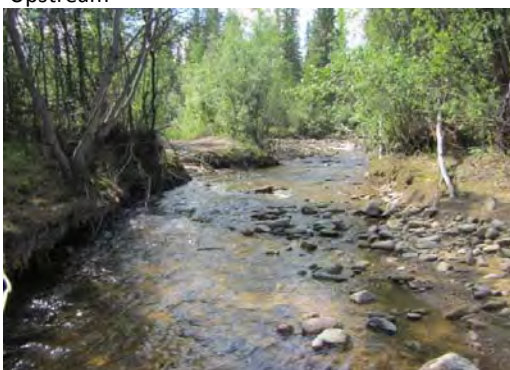
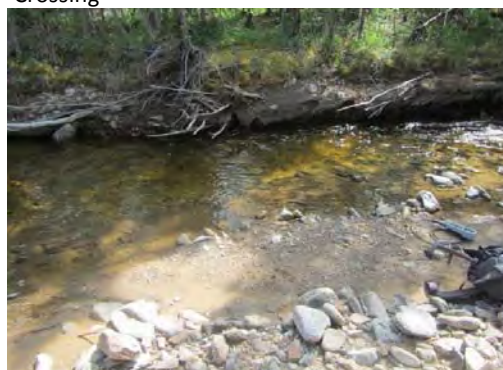
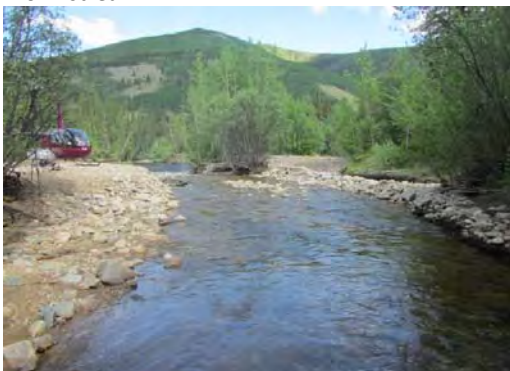
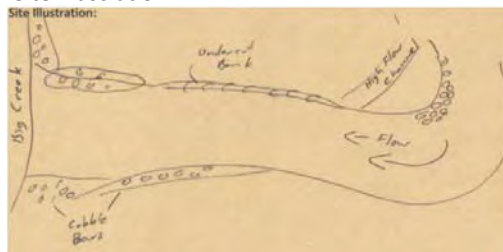
Freegold Road Extension Crossing # 18+900 - Big Creek Tributary

D/S	X	U/S	
Coordinates:	6918099 N	376573 E	Gradient (%):	3	1	2
Site Visit Date:	19-Jun-13		Bankfull Width (m):	10.60	6.00	7.50
Flow Conditions:	Low		Bankfull Depth (m):	0.83	0.60	0.65
Barrier/Confirmed:	None		Wetted Widths (m):	6.40	3.30	4.50
Electrofished/Effort?:	No		Wetted Depth (m):	0.27	0.30	0.24
Gee Trapping:	No		Substrate Bed:	C/G	C/G	C/G
Fish Bearing?	Yes		Substrate Bank:	C/S	C/S	C/S
Site Length:	100 m		Riparian Vegetation:	WI	WI/PO	WI/PO
		Meander Pattern:	RM	RM	RM	
		Cover:	5% / B	5% / U	10% / B	
Photo #s	86 u/s	87 x	88 d/s			
Areas of Erosion:	N		Temperature:	9.93	°C	
Locations:			pH:	7.52	pH units	
			Conductivity:	129	uS/cm	
			DO:	11.93	mg/L	
				105.6	% Sat

Comments:
High quality rearing habitat
Distinct lack of pool habitat in this otherwise high quality channel

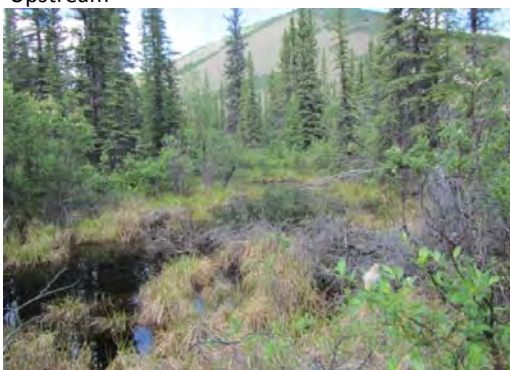
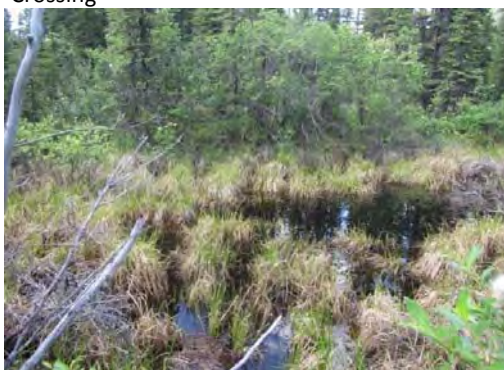
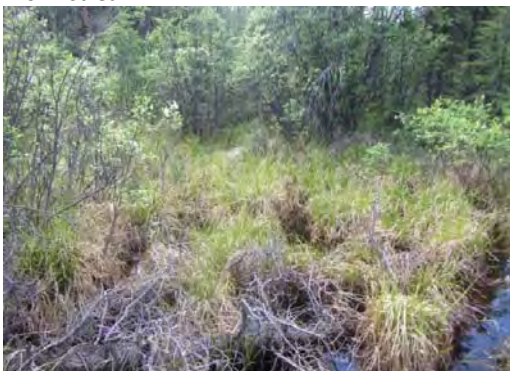
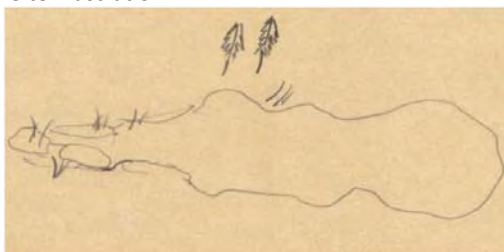
Freegold Road Extension Crossing # 19+570 - Big Creek Tributary

D/S	X	U/S
Coordinates:	6918534 N	376059 E	Gradient (%):	-	0
Site Visit Date:	19-Jun-13		Bankfull Width (m):	-	9.00
Flow Conditions:	No Flow		Bankfull Depth (m):	-	0.70
Barrier/Confirmed:	Yes		Wetted Widths (m):	-	9.00
Electrofished/Effort?:	No		Wetted Depth (m):	-	0.70
Gee Trapping:	No		Substrate Bed:	-	F
Fish Bearing?:	No		Substrate Bank:	-	F
Site Length:	50 m		Riparian Vegetation:	-	SP/WI
			Meander Pattern:	-	-
			Cover:	-	-
Photo #s	89 u/s	90 x	91 d/s		
Areas of Erosion:	N/A		Temperature:	13.3	°C
Locations:			pH:	6	pH units
			Conductivity:	73	uS/cm
			DO:	3.57	mg/L
				34	% Sat
Comments:					
Disconnected old oxbow, now shallow marsh					
Not connected to Big Creek and does not support fish

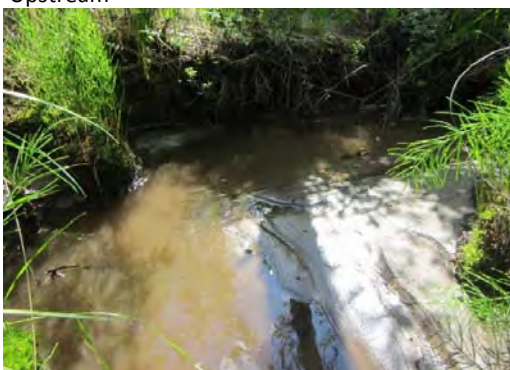
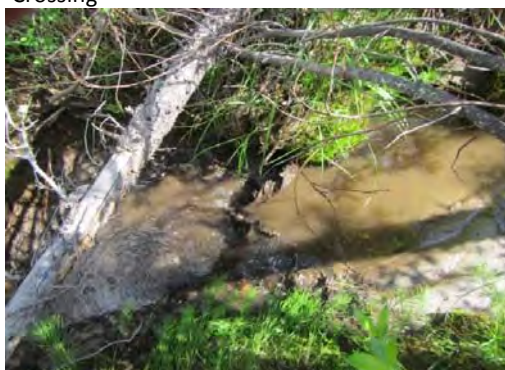
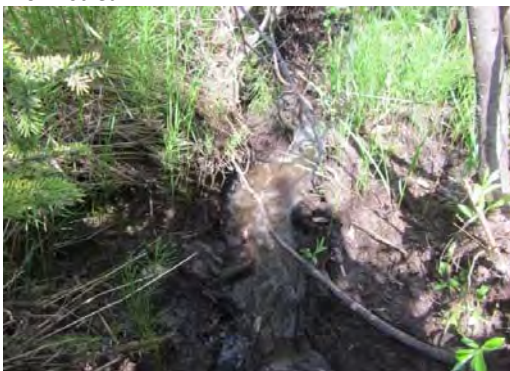
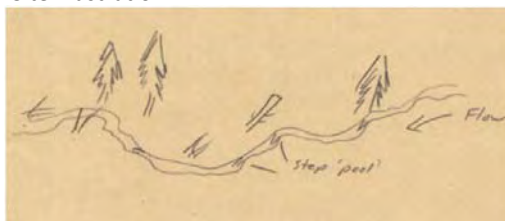
Freegold Road Extension Crossing # 20+390 - Big Creek Tributary

D/S	X	U/S
Coordinates:	6918907 N	375373 E	Gradient (%):	5	3
Site Visit Date:	19-Jun-13		Bankfull Width (m):	1.35	0.70
Flow Conditions:	Low		Bankfull Depth (m):	0.25	0.14
Barrier/Confirmed:	Yes		Wetted Widths (m):	0.90	0.45
Electrofished/Effort?:	Yes (2011)		Wetted Depth (m):	0.05	0.09
Gee Trapping:	No		Substrate Bed:	F	F
Fish Bearing?	No		Substrate Bank:	F	F
Site Length:	100 m		Riparian Vegetation:	WI/SP	WI/SP
			Meander Pattern:	SI	SI
			Cover:	0	50% / OV
Photo #s	92 u/s	93 x	94 d/s		
Areas of Erosion:	No		Temperature:	9.69	°C
Locations:			pH:	5.97	pH units
			Conductivity:	123	uS/cm
			DO:	11.93	mg/L
				104.8	% Sat

Comments:
Small incised creek cutting through organics - very turbid even at low flow
Non-fish bearing in all likelihood
Some small step pools identified

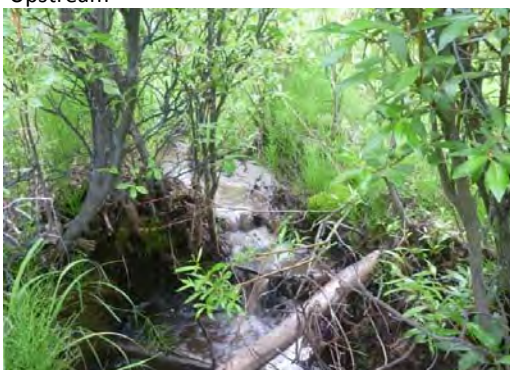
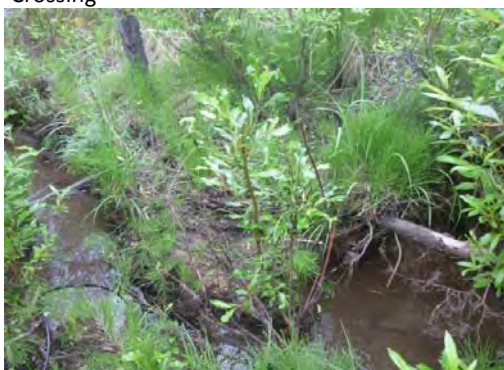
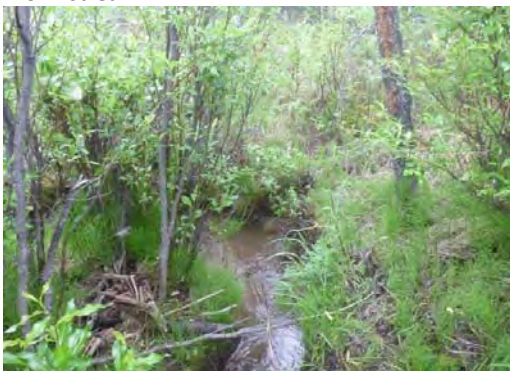
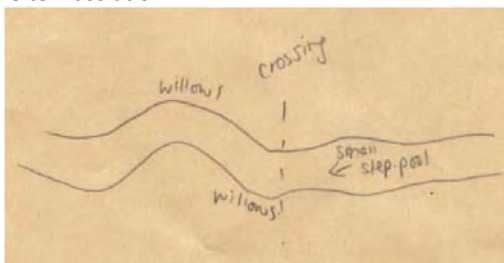
Freegold Road Extension Crossing # 21+580 - Big Creek Tributary

D/S	X	U/S
Coordinates:	6919673 N	374514 E	Gradient (%):	3.5	5
Site Visit Date:	23-Jun-13		Bankfull Width (m):	1.50	1.35
Flow Conditions:	Low		Bankfull Depth (m):	0.17	0.17
Barrier/Confirmed:	None		Wetted Widths (m):	0.70	0.23
Electrofished/Effort?:	No		Wetted Depth (m):	0.08	0.05
Gee Trapping:	No		Substrate Bed:	F	F
Fish Bearing?	Yes		Substrate Bank:	F	F
Site Length:	100 m		Riparian Vegetation:	WI/GR/SP	WI/SP/GR
			Meander Pattern:	IM	IM
			Cover:	70% / OV	60% / OV
Photo #s	896 u/s	897 x	898 d/s		
Areas of Erosion:	No		Temperature:	5.07	°C
Locations:	None but moderate potential		pH:	3.97 (no)	pH units
			Conductivity:	126	uS/cm
			DO:	13.5	mg/L
				106	% Sat
Comments:					
No noticeable disturbance or barrier					
Small muddy creek

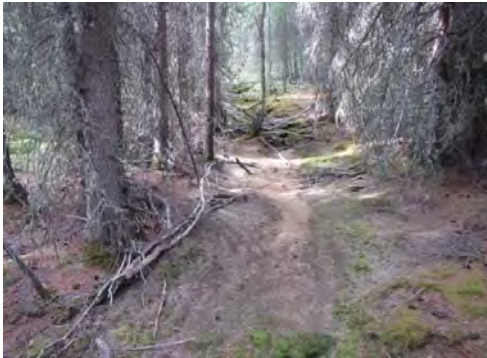
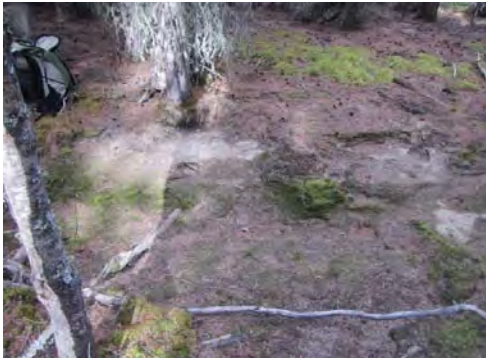
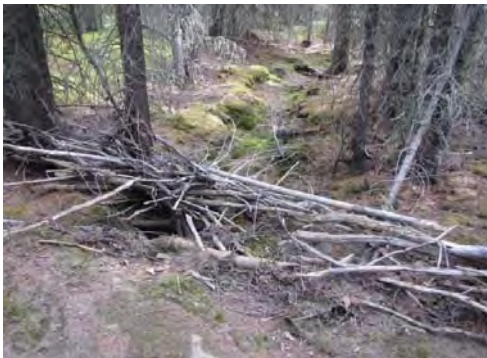
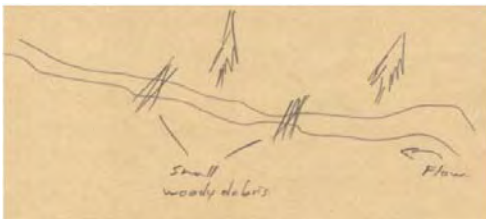
Freegold Road Extension Crossing # 22+960 - Big Creek Tributary

D/S	X	U/S	
Coordinates:	6920786 N	373732 E	Gradient (%):	-	5	-
Site Visit Date:	23-Jun-13		Bankfull Width (m):	-	1.00	-
Flow Conditions:	None		Bankfull Depth (m):	-	0.22	-
Barrier/Confirmed:	Yes		Wetted Widths (m):	-	-	-
Electrofished/Effort?:	N/A		Wetted Depth (m):	-	-	-
Gee Trapping:	N/A		Substrate Bed:	-	S/F	-
Fish Bearing?:	No		Substrate Bank:	-	F	-
Site Length:	N/A		Riparian Vegetation:	-	SP	-
			Meander Pattern:	-	SI	-
			Cover:	-	-	-
Photo #s	34 u/s	35 x	36 d/s			
Areas of Erosion:	No		Temperature:	-	°C	
Locations:			pH:	-	pH units	
			Conductivity:	-	µS/cm	
			DO:	-	mg/L	
				-	% Sat

Comments:
Dry intermittent creek - no connection to Big Creek downstream
No fish habitat
Large pockets of sand in channel from intermittent flows

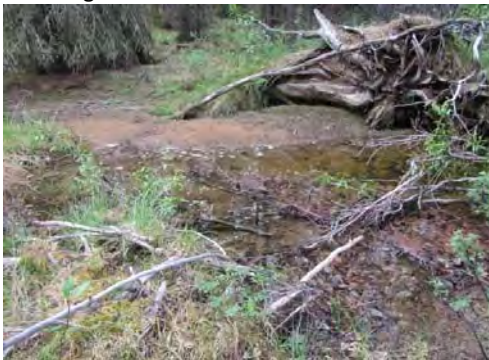
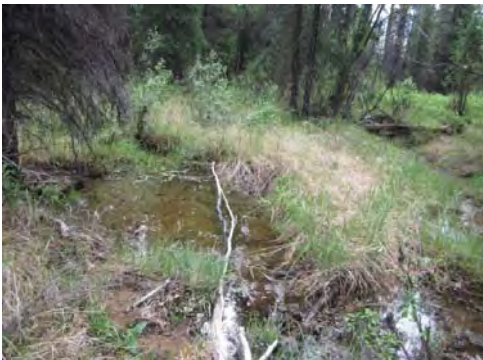
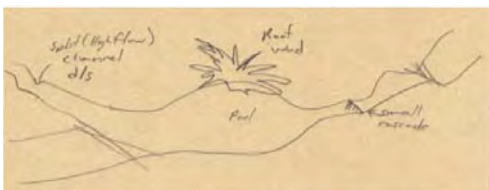
D/S	X	U/S	
Coordinates:	6920741 N	373693 E	Gradient (%):	6	3	3
Site Visit Date:	23-Jun-13		Bankfull Width (m):	2.00	2.05	1.40
Flow Conditions:	Low		Bankfull Depth (m):	0.18	0.60	0.16
Barrier/Confirmed:	Yes		Wetted Widths (m):	0.54	2.05	1.30
Electrofished/Effort?:	No		Wetted Depth (m):	0.08	0.54	0.09
Gee Trapping:	No		Substrate Bed:	F	S/F	F
Fish Bearing?:	No		Substrate Bank:	F	F/S	F
Site Length:	N/A		Riparian Vegetation:	SP/WI	SP/WI	SP/WI
		Meander Pattern:	SI	SI	SI	
		Cover:	10% / LWD	30% / LWD	-	
Photo #s	37 u/s	38 x	39 d/s			
Areas of Erosion:	No		Temperature:	3.62	°C	
Locations:			pH:	7.45	pH units	
			Conductivity:	69	µS/cm	
			DO:	8.5	mg/L	
				70.7	% Sat

Comments:
Dry intermittent creek - no connection to Big Creek downstream
No fish habitat
Unmapped in original crossing list

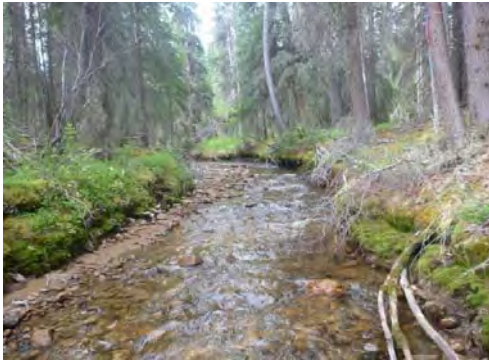
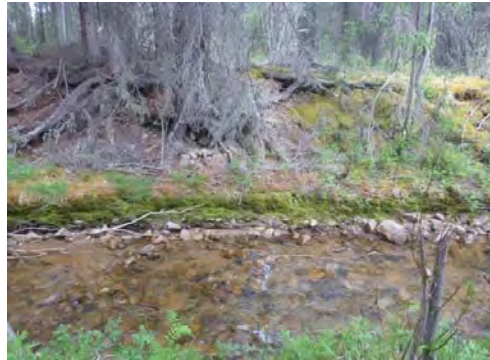
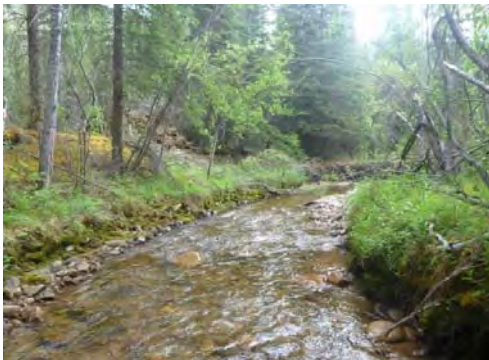
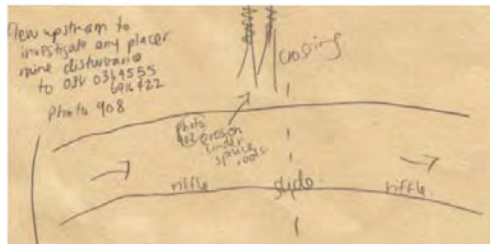
Freegold Road Extension Crossing # 23+320 - Big Creek Tributary

D/S	X	U/S	
Coordinates:	6921078 N	373521 E	Gradient (%):	3.5	2	3.5
Site Visit Date:	23-Jun-13		Bankfull Width (m):	4.60	3.60	4.20
Flow Conditions:	Low		Bankfull Depth (m):	0.74	0.54	0.43
Barrier/Confirmed:	None		Wetted Widths (m):	3.60	3.00	3.90
Electrofished/Effort?:	Yes (2010)		Wetted Depth (m):	0.25	0.19	0.16
Gee Trapping:	No		Substrate Bed:	C/G	C/G	C/G
Fish Bearing?	Yes		Substrate Bank:	F/C	F/C	F/C
Site Length:	100 m		Riparian Vegetation:	SP/WI/PO	SP/PO/WI	SP/WI
			Meander Pattern:	SI	RM	RM
			Cover:	5% / SWD	10% / SWD	5% / LWD

Comments:	Pre-existing habitat card (Summit, 2011)
Potential for enhancement:	increase cover (large woody debris) and create pool habitat
40m upstream of crossing, S/C/B bar:	photo 903-904. Lots of sand/gravel bars multiple channels
Flew upstream investigating placer mine disturbance to 08 V 0369555 6916422,	photo 908
No current activity, some evidence of previous digging further downstream.

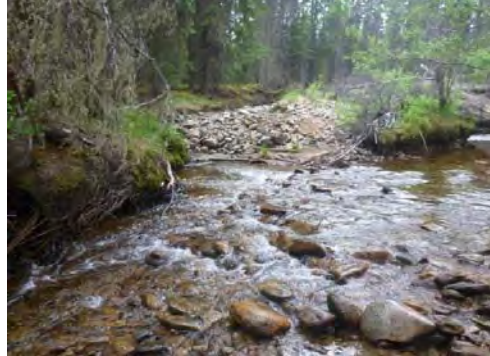
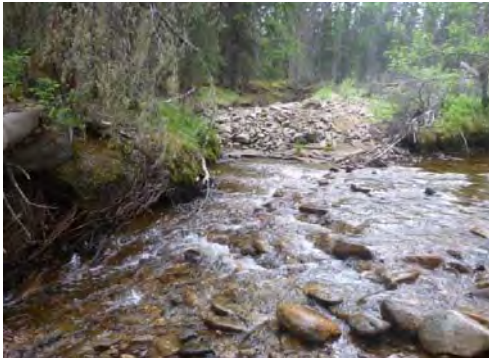
Photo 903

Photo 904

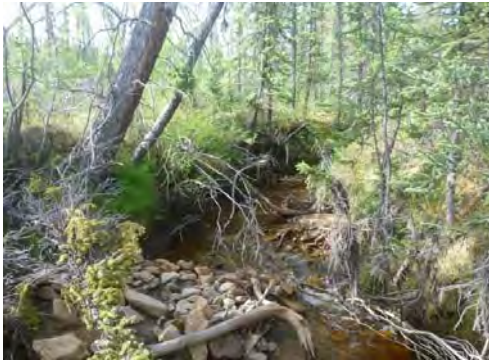
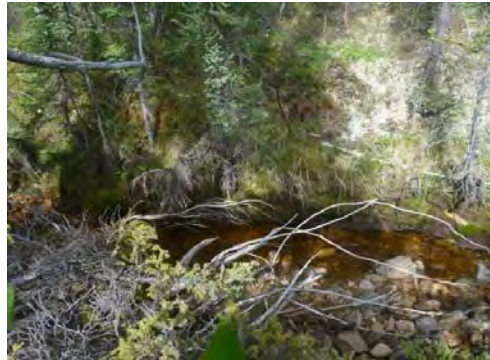
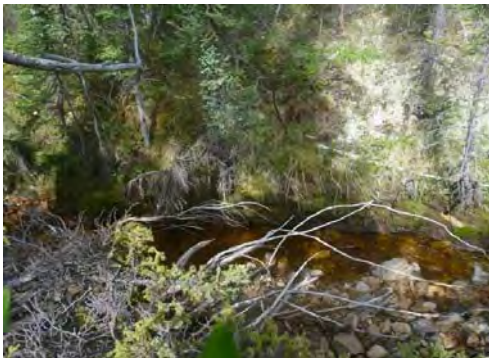
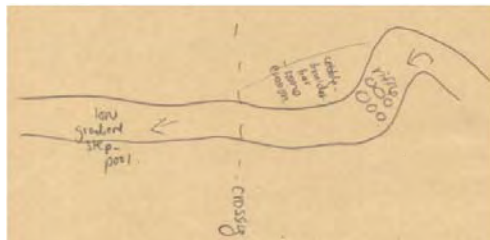
Freegold Road Extension Crossing # 24+380 - Big Creek Tributary

D/S	X	U/S
Coordinates:	6921290 N	372497 E	Gradient (%):	3.5	5	7
Site Visit Date:	23-Jun-13		Bankfull Width (m):	2.50	2.50	1.49
Flow Conditions:	Low		Bankfull Depth (m):	0.48	0.55	0.54
Barrier/Confirmed:	None		Wetted Widths (m):	1.29	0.92	1.22
Electrofished/Effort?:	Yes (2011)		Wetted Depth (m):	0.09	0.11	0.13
Gee Trapping:	No		Substrate Bed:	G/C	C/G	C/G
Fish Bearing?:	Yes		Substrate Bank:	F	F	F
Site Length:	100 m		Riparian Vegetation:	SP/WI	SP/WI	SP/WI
			Meander Pattern:	RM	IM	RM
			Cover:	15% / LWD	10% / LWD	20% / LWD
Photo #s	905 u/s	906 x	907 d/s			
Areas of Erosion:	Yes		Temperature:	6	°C	
Locations:	Minor erosion on west bank		pH:	4.44	pH units	
			Conductivity:	38	µS/cm	
			DO:	13.22	mg/L	
				106.2	% Sat

Comments:
Low gradient step pool identified
Low conductivity relative to typical values in the area

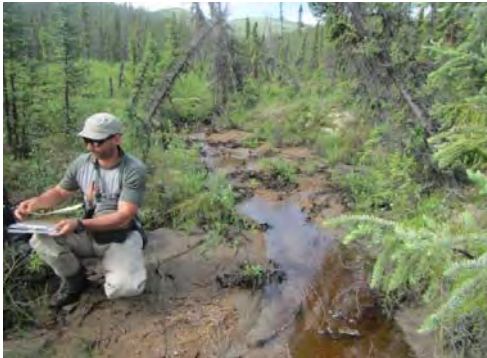
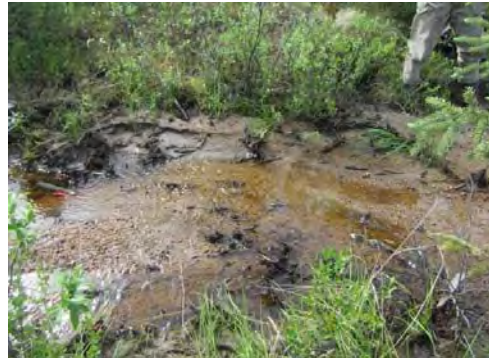
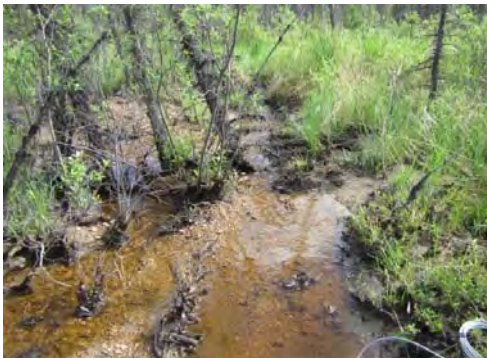
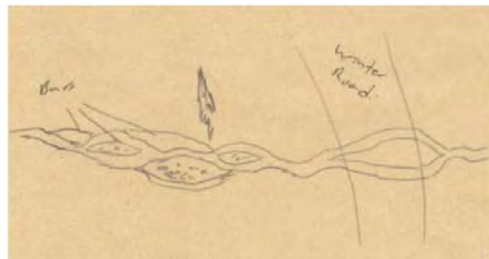
Freegold Road Extension Crossing # 25+700 (Unmapped Site, 25+900) - Big Creek Tributary

D/S	X	U/S	
Coordinates:	6921921 N	371452 E	Gradient (%):	3	2	9
Site Visit Date:	23-Jun-13		Bankfull Width (m):	1.00	1.90	1.05/1.14
Flow Conditions:	Low		Bankfull Depth (m):	0.25	0.24	0.35/0.15
Barrier/Confirmed:	None		Wetted Widths (m):	0.60	1.30	0.58
Electrofished/Effort?:	No		Wetted Depth (m):	0.10	0.10	0.22
Gee Trapping:	No		Substrate Bed:	G/S	G/S	S/G
Fish Bearing?:	Yes		Substrate Bank:	F/S	F/S	S/F
Site Length:	100 m		Riparian Vegetation:	GR/WI	WI/SP	WI/SP
			Meander Pattern:	SI	SI	SI
		Cover:	10% / OV	5% / SWD	10% / SWD	
Photo #s	40 u/s	41 x	42 d/s			
Areas of Erosion:	No		Temperature:	6.5	°C	
Locations:			pH:	6.8	pH units	
			Conductivity:	5	µS/cm	
			DO:	12.3	mg/L	
				110	% Sat

Comments:
Large amount of gravel/sand bars, medial and lateral for a small stream
Previously Upmapped Site
Very shallow, braided stream
Provides marginal habitat

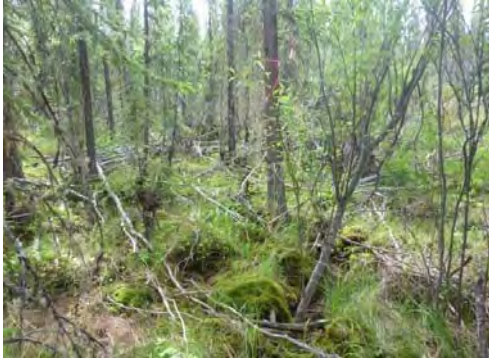
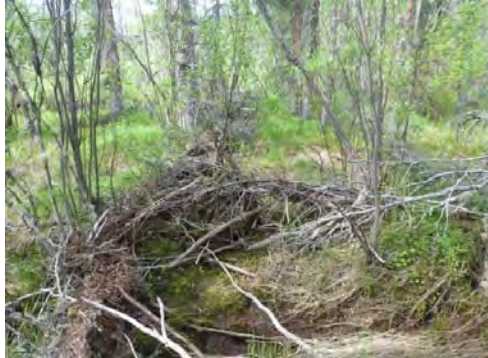
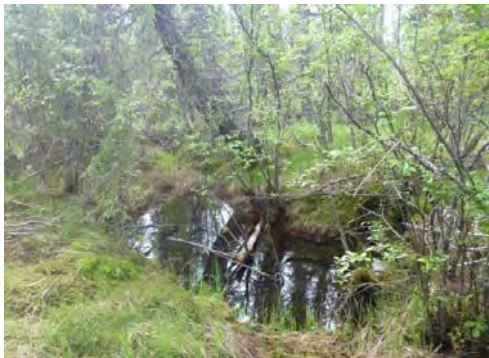
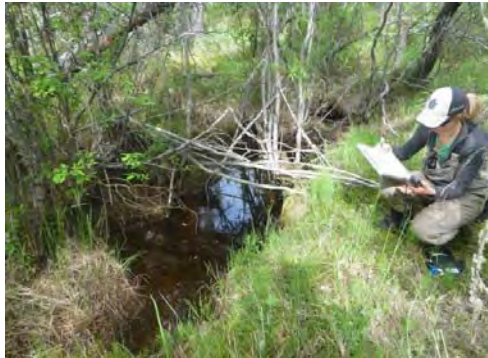
Freegold Road Extension Crossing # 26+740 - Big Creek Tributary

D/S	X	U/S
Coordinates:	6922617 N	370963 E	Gradient (%):	-	-
Site Visit Date:	23-Jun-13		Bankfull Width (m):	-	-
Flow Conditions:	None		Bankfull Depth (m):	-	-
Barrier/Confirmed:	Yes		Wetted Widths (m):	-	-
Electrofished/Effort?:	No		Wetted Depth (m):	-	-
Gee Trapping:	No		Substrate Bed:	-	-
Fish Bearing?:	No		Substrate Bank:	-	-
Site Length:	N/A		Riparian Vegetation:	-	-
			Meander Pattern:	-	-
			Cover:	-	-
Photo #s	u/s	909, 910, 911 x	d/s		
Areas of Erosion:	N		Temperature:	-	°C
Locations:			pH:	-	pH units
			Conductivity:	-	µS/cm
			DO:	-	mg/L
				-	% Sat
Comments:					
No visible channel					
Standing pool of water to the west at 08 V 0370966 6922632					
Photos of pool: 912 and 913, measurements: 0.5-2m wide, 15m long

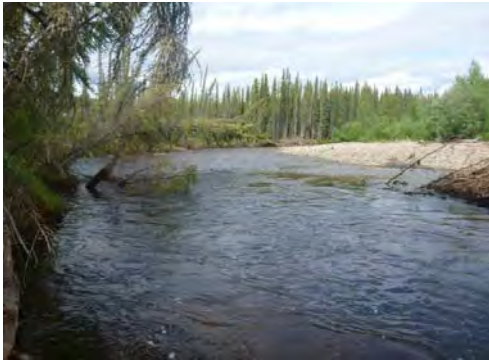
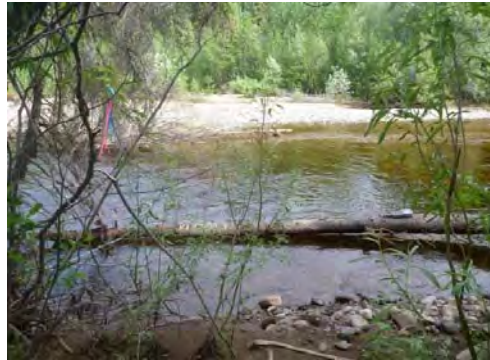
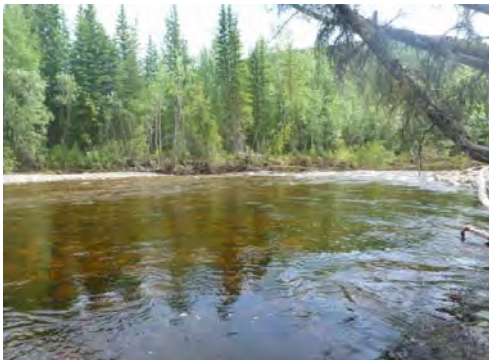
Freegold Road Extension Crossing # 26+820 - Big Creek

D/S	X	U/S	
Coordinates:	6922687 N	370986 E	Gradient (%):	0.5	1	1
Site Visit Date:	23-Jun-13		Bankfull Width (m):	31.00	43.00	45.00
Flow Conditions:	Low		Average Depth (m):	0.70	0.40	0.50
Barrier/Confirmed:	None		Wetted Widths (m):	16.00	26.00	19.00
Electrofished/Effort?:	Yes (2010)		Substrate Bed:	G/C	C/G	C/G
Gee Trapping:	No		Substrate Bank:	-	-	-
Fish Bearing?:	Yes		Riparian Vegetation:	-	-	-
Site Length:	100 m		Meander Pattern:	-	-	-
			Cover:	20% / OV	15% / OV	15% / OV

Comments:	Pre-existing Habitat Card as 26+840 (Summit, 2011)
	Large side bar on the left bank, woody debris build up.
	Creek enters on left bank approximately 100m downstream of crossing
	Photo 920 is of large side channel upstream of the crossing, does not connect to the creek

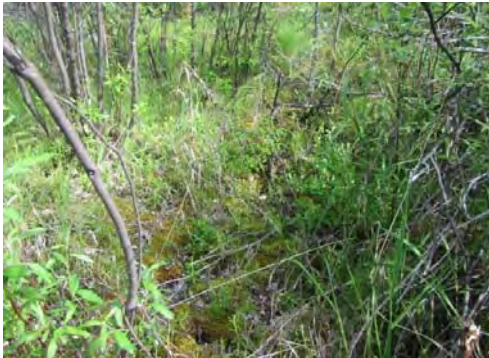
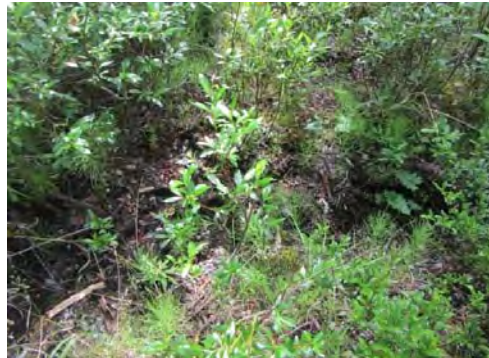
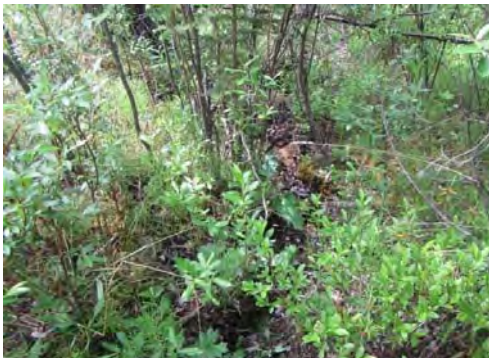
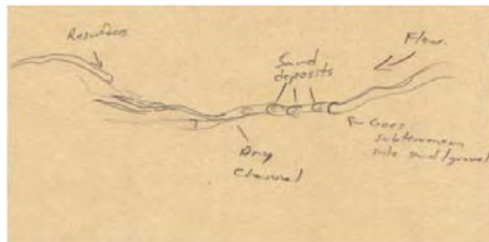
Freegold Road Extension Crossing # 28+210 - Big Creek Tributary

D/S	X	U/S	
Coordinates:	6923623 N	370172 E	Gradient (%):	13	11	18
Site Visit Date:	23-Jun-13		Bankfull Width (m):	0.35	0.41	0.13
Flow Conditions:	Low		Bankfull Depth (m):	0.24	0.13	0.35
Barrier/Confirmed:	Low Flow		Wetted Widths (m):	0.29	-	0.07
Electrofished/Effort?:	No		Wetted Depth (m):	0.09	-	0.15
Gee Trapping:	No		Substrate Bed:	F/G	F	G/S
Fish Bearing?:	Yes		Substrate Bank:	F	F	F
Site Length:	100 m		Riparian Vegetation:	WI/SP	WI/SP	WI/SP
			Meander Pattern:	ST	ST	ST
		Cover:	20% / U	-	30% / OV	
Photo #s	43 u/s	44 x	45 d/s			
Areas of Erosion:	Y		Temperature:	2.82	°C	
Locations:	From existing winter road		pH:	7.4	pH units	
			Conductivity:	144	µS/cm	
			DO:	9.9	mg/L	
				80.8	% Sat

Comments:
Existing road releasing sand and gravel into channel
Creek subterranean at crossing. Resurfaces about 20m downstream.
Too shallow to provide direct fish habitat
Culvert would provide a continuous channel

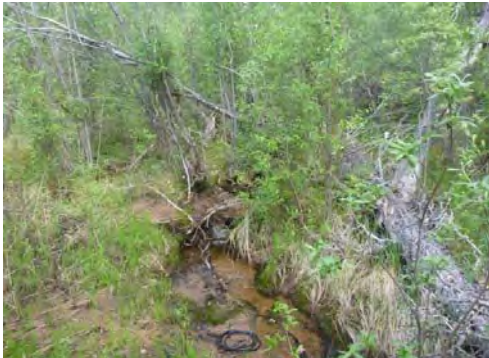
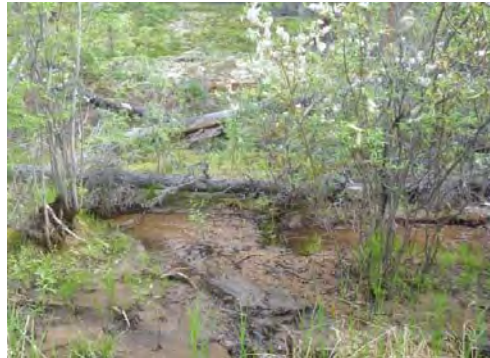
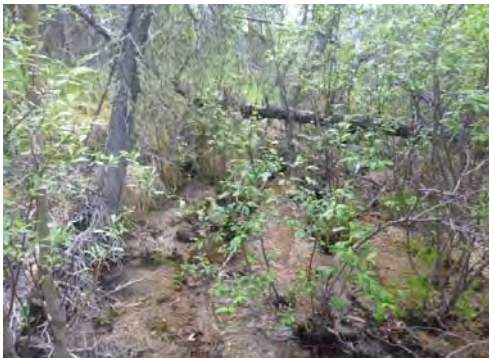
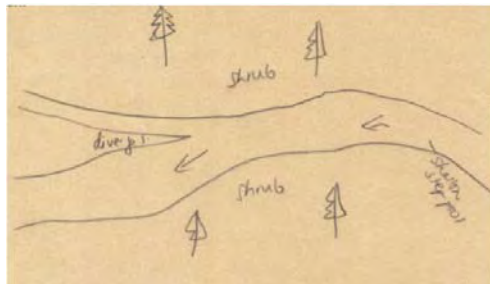
Freegold Road Extension Crossing # 28+730 - Big Creek Tributary

D/S	X	U/S	
Coordinates:	6923860 N	369719 E	Gradient (%):	3.5	5	10.5
Site Visit Date:	23-Jun-13		Bankfull Width (m):	0.63	0.80	0.38
Flow Conditions:	Low		Bankfull Depth (m):	0.12	0.14	0.28
Barrier/Confirmed:	None		Wetted Widths (m):	0.39	0.53	0.31
Electrofished/Effort?:	No		Wetted Depth (m):	0.06	0.05	0.06
Gee Trapping:	No		Substrate Bed:	G/F	G/F	G/F
Fish Bearing?	Yes		Substrate Bank:	F	F	F
Site Length:	100 m		Riparian Vegetation:	WI/SP	WI/SP	WI/SP
		Meander Pattern:	IM	IM	IM	
		Cover:	90% / OV	20% / OV	90% / U	
Photo #s	917 u/s	918 x	919 d/s			
Areas of Erosion:	N		Temperature:	3.15	°C	
Locations:			pH:	7.6	pH units	
			Conductivity:	256	µS/cm	
			DO:	14.16	mg/L	
				105.9	% Sat

Comments:
Shallow wetted depth but flows within a defined channel

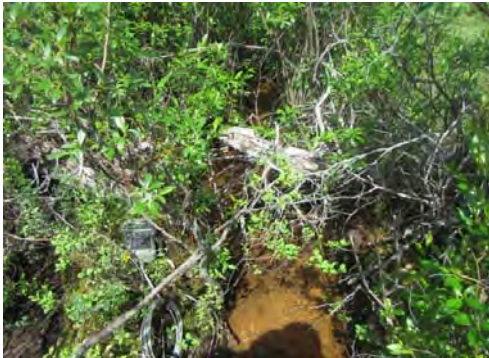
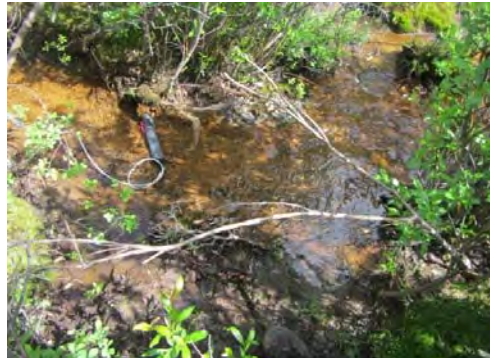
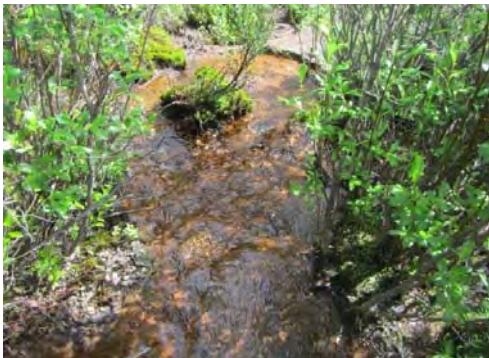
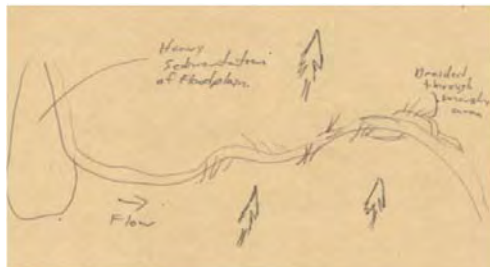
Freegold Road Extension Crossing # 29+240 - Big Creek Tributary

D/S	X	U/S	
Coordinates:	6924178 N	369328 E	Gradient (%):	5	8	5
Site Visit Date:	23-Jun-13		Bankfull Width (m):	1.80	0.60	0.77
Flow Conditions:	Low		Bankfull Depth (m):	0.32	0.26	0.22
Barrier/Confirmed:	None		Wetted Widths (m):	1.00	0.47	0.70
Electrofished/Effort?:	No		Wetted Depth (m):	0.12	0.07	0.10
Gee Trapping:	No		Substrate Bed:	F	F/S	S/F
Fish Bearing?	Yes		Substrate Bank:	F	F/S	F
Site Length:	100 m		Riparian Vegetation:	WI/SP	WI/SP	WI/SP
			Meander Pattern:	SI	SI	SI
			Cover:	30% / OV	80% / OV	40% / OV
Photo #s	46 u/s	47 x	48 d/s			
Areas of Erosion:	Y		Temperature:	3.41	°C	
Locations:	Deposition downstream		pH:	6.81	pH units	
			Conductivity:	99	µS/cm	
			DO:	9.04	mg/L	
				74.5	% Sat

Comments:
Heavy sedimentation of creeks flood plain
Material from existing winter road in creek bed
Shallow with some very small pools
Creek bed mostly soft organics

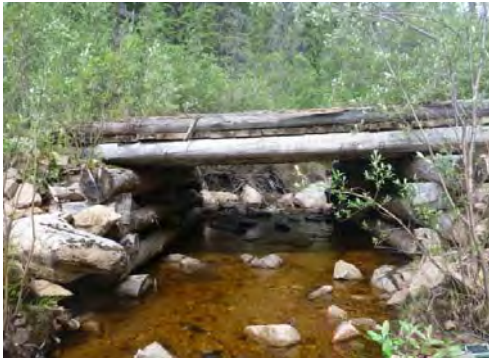
Freegold Road Extension Crossing # 30+880 (Unmapped Site) - Big Creek Tributary

D/S	X	U/S	
Coordinates:	6925355 N	368206 E	Gradient (%):	7	5	5
Site Visit Date:	23-Jun-13		Bankfull Width (m):	2.73	3.30	2.45
Flow Conditions:	Low		Bankfull Depth (m):	0.70	0.34	0.86
Barrier/Confirmed:	None		Wetted Widths (m):	2.73	2.40	1.65
Electrofished/Effort?:	No		Wetted Depth (m):	0.20	0.14	0.19
Gee Trapping:	No		Substrate Bed:	B/C	C/G	C/G
Fish Bearing?:	Yes		Substrate Bank:	F	F	F
Site Length:	100 m		Riparian Vegetation:	WI/PO/SP	SP/WI	SP/PO/WI
			Meander Pattern:	IM	IM	IM
		Cover:	25% / LWD	5% / B	20% / SWD	
Photo #s	921 u/s	922 x	923 d/s			
Areas of Erosion:	Y		Temperature:	6.06	°C	
Locations:	see comments below		pH:	6.73	pH units	
			Conductivity:	168	µS/cm	
			DO:	12.84	mg/L

103.5	% Sat	
Comments: Crossing at a bridge. Still snow melting at this site.						
At 08 V 0368219 6925393, big mud/debris jam: photo 924 (upstream of it)						
Creek is flowing through trees, not in the channel (photo 925)						
Upstream site - surveyed main channel but water is pouring off the banks due to debris jam						
Right bank of downstream site was very eroded

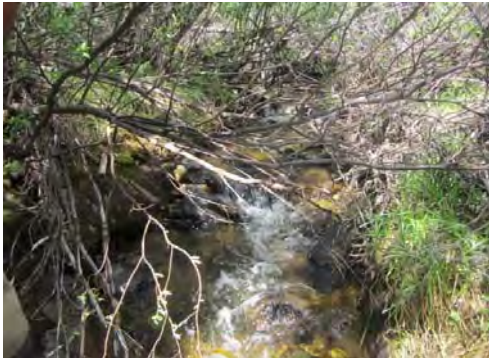
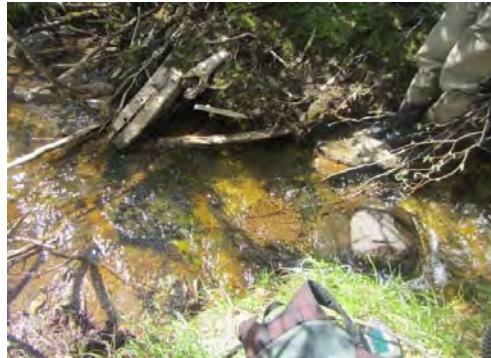
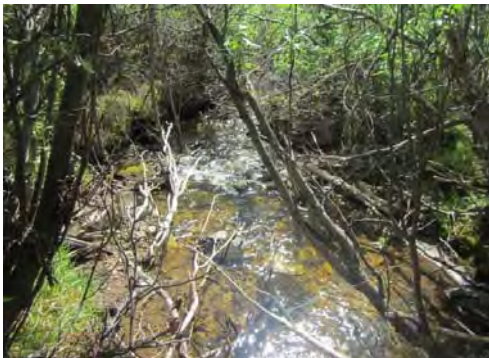
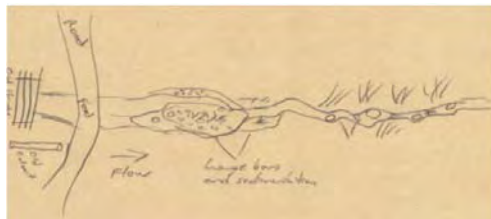
Freegold Road Extension Crossing # 33+230 - Big Creek Tributary

D/S	X	U/S	
Coordinates:	6925798 N	365959 E	Gradient (%):	7	7	7
Site Visit Date:	23-Jun-13		Bankfull Width (m):	1.40	1.20	1.05
Flow Conditions:	Low		Bankfull Depth (m):	0.35	0.57	0.48
Barrier/Confirmed:	None		Wetted Widths (m):	1.33	1.40	1.10
Electrofished/Effort?:	Yes (2011)		Wetted Depth (m):	0.20	0.38	0.23
Gee Trapping:	None		Substrate Bed:	C/G	C/B	C/B
Fish Bearing?:	Yes		Substrate Bank:	F	F/C	F
Site Length:	100 m		Riparian Vegetation:	WI	WI	WI
			Meander Pattern:	SI	SI	SI
			Cover:	10% / U	40% / B	10% / LWD
Photo #s	57 u/s	58 x	59 d/s			
Areas of Erosion:	Y		Temperature:	5.83	°C	
Locations:	Existing road		pH:	4.62	pH units	
			Conductivity:	166	µS/cm	
			DO:	13.09	mg/L	
				115	% Sat

Step-pool creek, good cover.

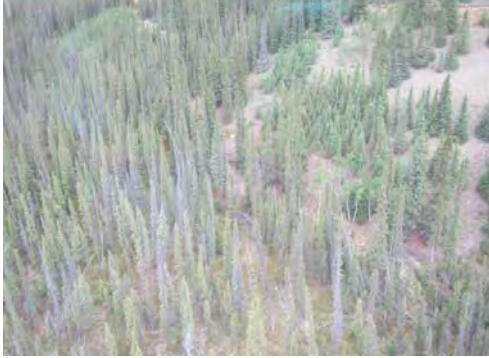
Photo 55

Photo 55: dry gully, no channel. To east, photo 56: disturbance at existing road crossing, bridge approaches washed out, now using ford.

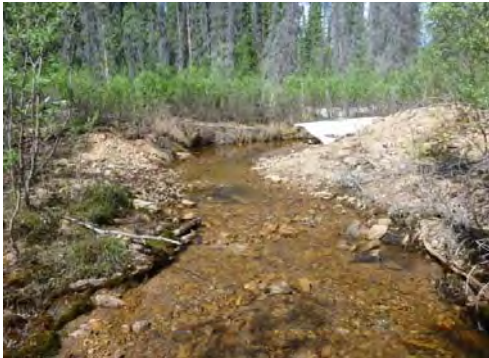
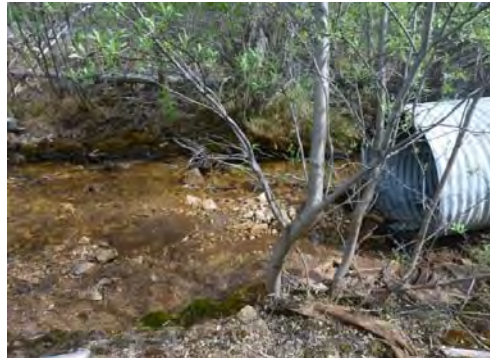
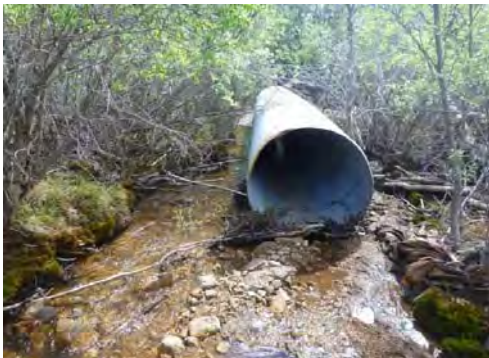
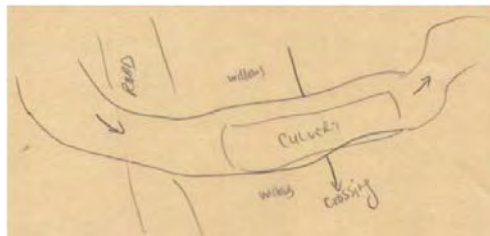
Freegold Road Extension Crossing # 37+700 - Big Creek Tributary

D/S	X	U/S
Coordinates:	6928102 N	362891 E	Gradient (%):	5	3.5	3.5
Site Visit Date:	23-Jun-13		Bankfull Width (m):	1.90	3.30	2.20
Flow Conditions:	Low		Bankfull Depth (m):	0.50	0.21	0.40
Barrier/Confirmed:	None		Wetted Widths (m):	0.85	2.00	1.90
Electrofished/Effort?:	Yes (2010)		Wetted Depth (m):	0.10	0.08	0.23
Gee Trapping:	No		Substrate Bed:	G/C	G/C	G/F
Fish Bearing?	Yes		Substrate Bank:	F	F	F
Site Length:	100 m		Riparian Vegetation:	WI/SP	WI/SP	WI/SP
			Meander Pattern:	IM	IM	IM
			Cover:	15% / OV	20% / OV	15% / OV
Photo #s	927 u/s	928 x	929 d/s			
Areas of Erosion:	Y		Temperature:	6.58	°C	
Locations:	Erosion around current road		pH:	7.21	pH units	
			Conductivity:	0.52	µS/cm	
			DO:	13.03	mg/L	
				100.5	% Sat

Comments:
1500 mm CSP culvert located within channel
Lacks pool habitat

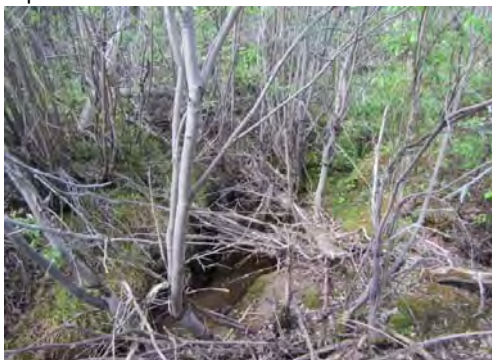
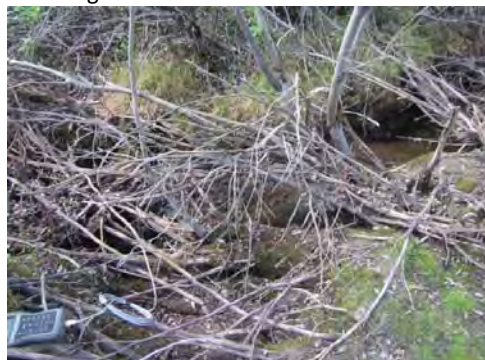
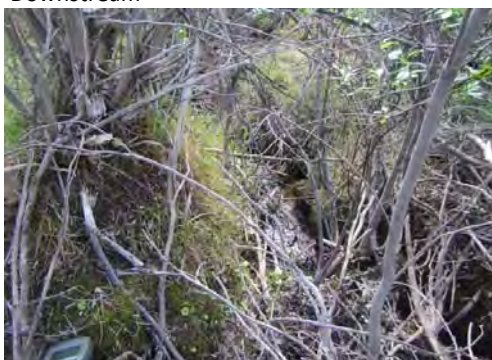
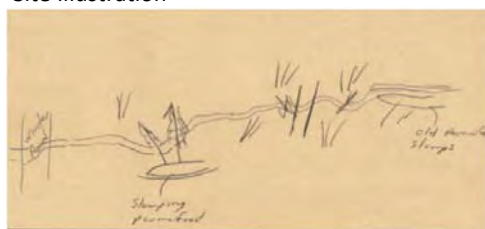
Freegold Road Extension Crossing # 39+280 - Big Creek Tributary

D/S	X	U/S	
Coordinates:	6929090 N	361702 E	Gradient (%):	-	12	5
Site Visit Date:	23-Jun-13		Bankfull Width (m):	0.85	0.40	0.98
Flow Conditions:	Low		Bankfull Depth (m):	0.30	0.25	0.38
Barrier/Confirmed:	None		Wetted Widths (m):	0.65	0.29	0.74
Electrofished/Effort?:	Yes (2011)		Wetted Depth (m):	0.07	0.10	0.08
Gee Trapping:	No		Substrate Bed:	S/G	S/G	S/G
Fish Bearing?:	Yes		Substrate Bank:	F	F	F
Site Length:	100 m		Riparian Vegetation:	WI	WI/SP	WI/SP
			Meander Pattern:	SI	SI	SI
		Cover:	20% / SWD	40% / SWD	70% / U	
Photo #s	62 u/s	63 x	64 d/s			
Areas of Erosion:	Yes		Temperature:	3.96	°C	
Locations:	At 08 v 0361692 6929051,		pH:	7.88	pH units	
	Permafrost slump		Conductivity:	254	µS/cm	
	Photos 60 and 61		DO:	11.4	mg/L	
				98	% Sat	
Comments:						
Small, shallow creek with a drop pool						
Multiple areas of slumping - permafrost

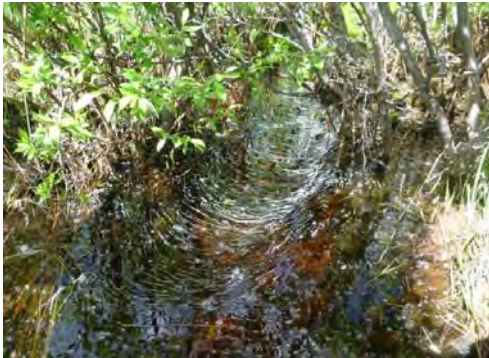
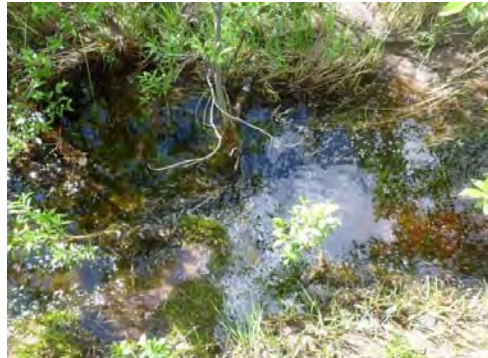
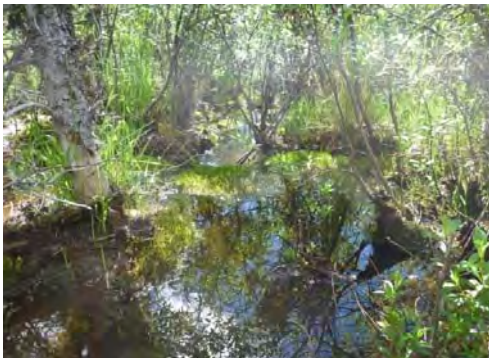
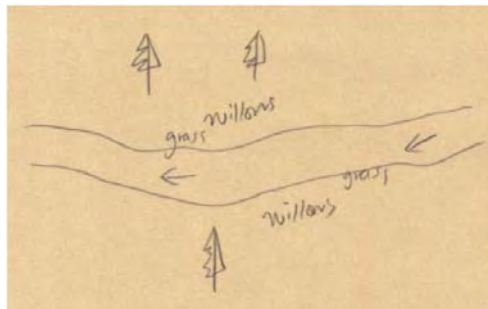
Freegold Road Extension Crossing # 40+630 (Unmapped Site) - Big Creek Tributary

D/S	X	U/S
Coordinates:	6929810 N	360672 E	Gradient (%):	7	3.5	5
Site Visit Date:	23-Jun-13		Bankfull Width (m):	0.81	1.00	0.92
Flow Conditions:	Low		Bankfull Depth (m):	0.23	0.85	0.78
Barrier/Confirmed:	Yes		Wetted Widths (m):	0.40	1.00	0.92
Electrofished/Effort?:	No		Wetted Depth (m):	0.08	0.73	0.65
Gee Trapping:	No		Substrate Bed:	F	F	F
Fish Bearing?	Yes		Substrate Bank:	F	F	F
Site Length:	100		Riparian Vegetation:	WI/SP	WI/SP/GR	WI/SP/GR
			Meander Pattern:	IM	IM	IM
			Cover:	85% / OV	95% / OV	90% / OV
Photo #s	930 u/s	931 x	932 d/s			
Areas of Erosion:	N		Temperature:	7.27	°C	
Locations:			pH:	7.92	pH units	
			Conductivity:	340	µS/cm	
			DO:	11.65	mg/L	
				96.9	% Sat

Comments:
At 08 V 0360669 6929758 (downstream): large drop and then flow goes underground
Photo: 934. Re-emerges further downstream, does this a few more times
At downstream site, 15% of flow is through another channel
Culvert crossing may improve connectivity of this channel

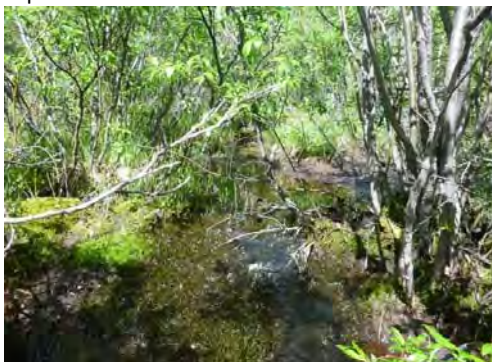
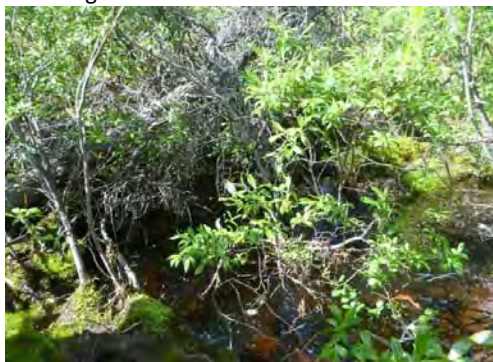
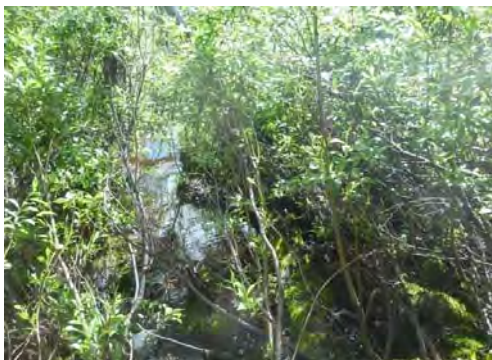
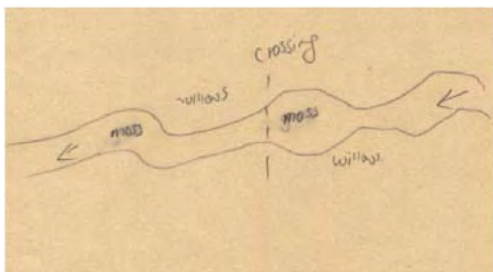
Freegold Road Extension Crossing # 41+340 - Big Creek Tributary

D/S	X	U/S	
Coordinates:	6930102 N	359971 E	Gradient (%):	5	5	5
Site Visit Date:	23-Jun-13		Bankfull Width (m):	1.35	0.95	0.37
Flow Conditions:	Low		Bankfull Depth (m):	0.25	0.43	0.35
Barrier/Confirmed:	None		Wetted Widths (m):	0.93	0.80	0.33
Electrofished/Effort?:	No		Wetted Depth (m):	0.12	0.30	0.26
Gee Trapping:	No		Substrate Bed:	F	F	F
Fish Bearing?:	Yes		Substrate Bank:	F	F	F
Site Length:	100 m		Riparian Vegetation:	WI/SP	SP/WI	SP/WI
			Meander Pattern:	IM	IM	IM
		Cover:	75% / OV	90% / OV	50% / OV	
Photo #s	935 u/s	936 x	937 d/s			
Areas of Erosion:	Y		Temperature:	9.29	°C	
Locations:			pH:	7.07	pH units	
			Conductivity:	117	µS/cm	
			DO:	7.79	mg/L	
				67.6	% Sat

Comments:
Channel not well developed
Downstream of site channel widens out and flow decreases

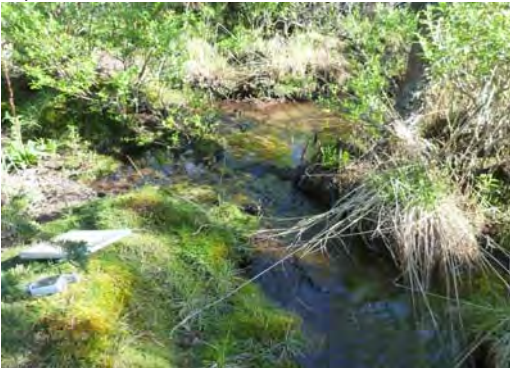
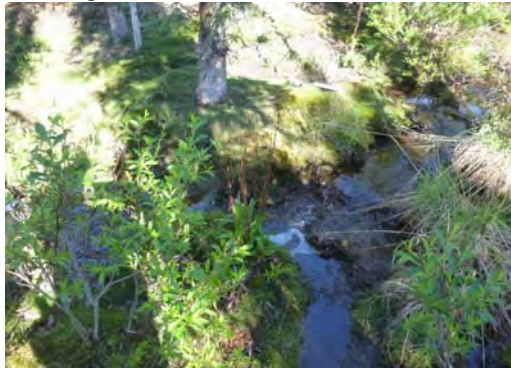
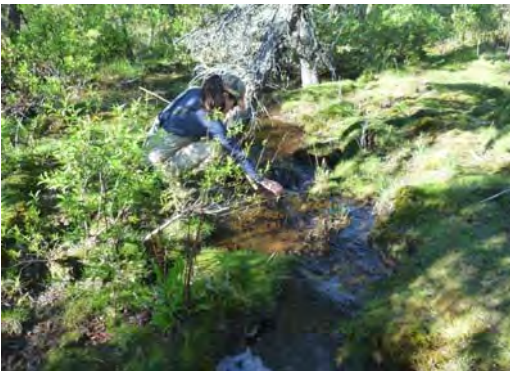
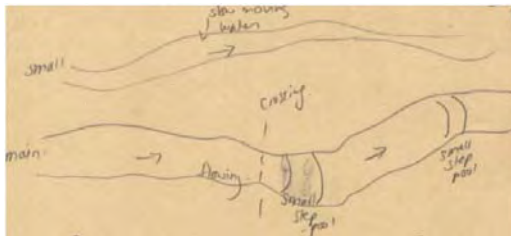
Freegold Road Extension Crossing # 43+110 - Hayes Creek Tributary

D/S	X	U/S
Coordinates:	6931260 N	358985 E	Gradient (%):	-	7	5
Site Visit Date:	24-Jun-13		Bankfull Width (m):	-	0.84	0.98
Flow Conditions:	Low		Bankfull Depth (m):	-	0.24	0.35
Barrier/Confirmed:	Yes		Wetted Widths (m):	-	0.68	0.85
Electrofished/Effort?:	No		Wetted Depth (m):	-	0.12	0.08
Gee Trapping:	No		Substrate Bed:	-	F	F
Fish Bearing?:	No		Substrate Bank:	-	F	F
Site Length:	50 m		Riparian Vegetation:	-	SP/WI/GR	SP/WI/GR
			Meander Pattern:	-	IM	IM
			Cover:	-	10% / OV	90% / OV
Photo #s	100 u/s	101 x	102 d/s			
Areas of Erosion:	N		Temperature:	1.96	°C	
Locations:			pH:	8.08	pH units	
			Conductivity:	440	µS/cm	
			DO:	14.19	mg/L	
				102.6	% Sat

Comments:
Flow goes underground approximately 10m downstream of crossing on main branch: photo 103.
Tributary dries up 10m downstream of crossing, with a few disconnected stagnant pools below it.
Seasonal Barrier at low flow confirmed.

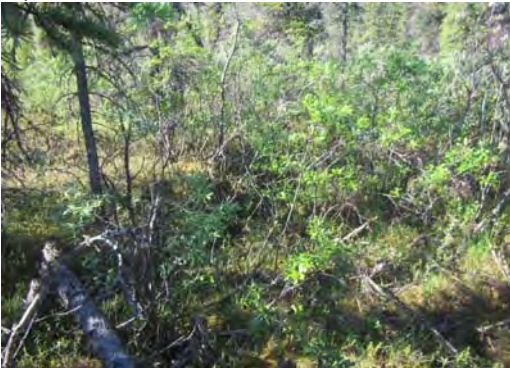
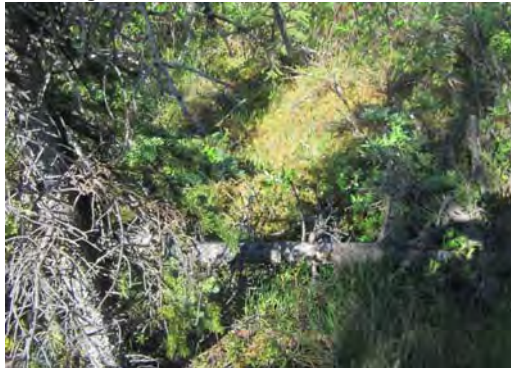
D/S	X	U/S
Coordinates:	6932851 N	357738 E	Gradient (%):	-	-
Site Visit Date:	24-Jun-13		Bankfull Width (m):	0.85 / 0.55	-
Flow Conditions:	None		Bankfull Depth (m):	0.43 / 0.45	-
Barrier/Confirmed:	Yes		Wetted Widths (m):	0	-
Electrofished/Effort?:	N/A		Wetted Depth (m):	0	-
Gee Trapping:	N/A		Substrate Bed:	F	-
Fish Bearing?:	No		Substrate Bank:	F	-
Site Length:	25 m		Riparian Vegetation:	WI/SP	-
			Meander Pattern:	SI	-
			Cover:	-	-
Photo #s	1 u/s	2 x	3 d/s		
Areas of Erosion:	No		Temperature:	-	°C
Locations:			pH:	-	pH units
			Conductivity:	-	µS/cm
			DO:	-	mg/L
				-	% Sat

Comments:
Dry, intermittent creek, poorly defined channel with vegetation throughout
No direct fish habitat
Second dry channel, 8m west
Another intermittent creek crossed at 08 V 0357702 6932863, photos: 4, 5 and 6

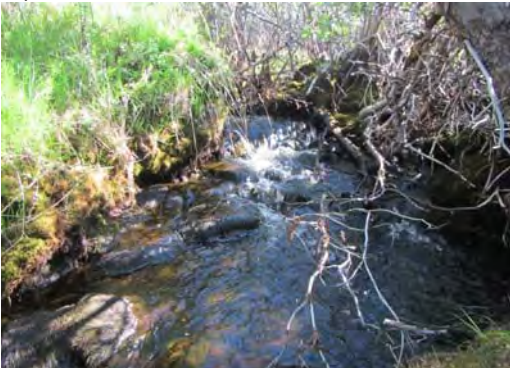
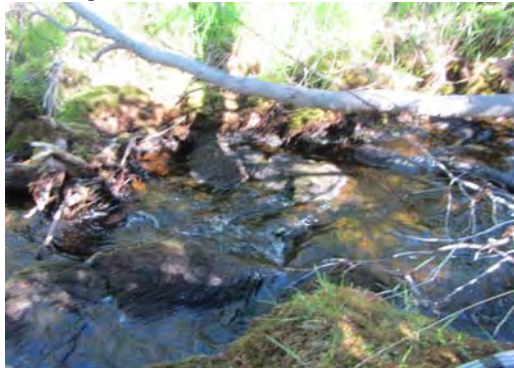
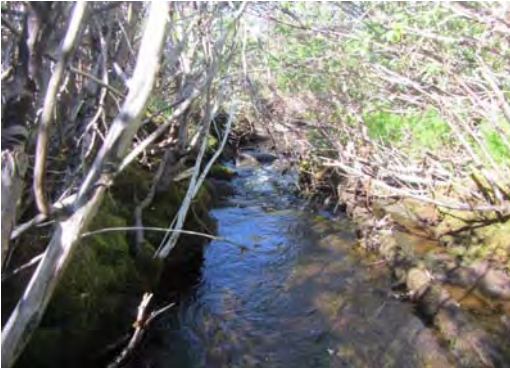
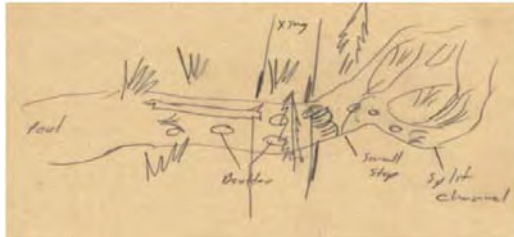
Freegold Road Extension Crossing # 45+230 - Hayes Creek Tributary

D/S	X	U/S
Coordinates:	6932917 N	357680 E	Gradient (%):	7	8
Site Visit Date:	24-Jun-13		Bankfull Width (m):	1.6	0.9
Flow Conditions:	Low		Bankfull Depth (m):	0.8	0.39
Barrier/Confirmed:	None		Wetted Widths (m):	1.55	1
Electrofished/Effort?:	Yes (2011)		Wetted Depth (m):	0.6	0.24
Gee Trapping:	No		Substrate Bed:	F	B/C
Fish Bearing?	Yes		Substrate Bank:	F	F
Site Length:	100 m		Riparian Vegetation:	WI/SP	WI/SP
			Meander Pattern:	SI	SI
			Cover:	30% / LWD	30% / SUB
Photo #s	7 u/s	8 x	9 d/s		
Areas of Erosion:	N		Temperature:	2.82	°C
Locations:			pH:	8.17	pH units
			Conductivity:	72	µS/cm
			DO:	10.52	mg/L
				88.4	% Sat
Comments:					
Split channel 10m upstream of crossing					
Pool habitat identified 20m downstream of crossing

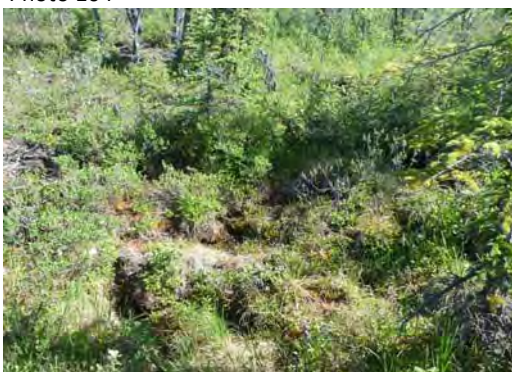
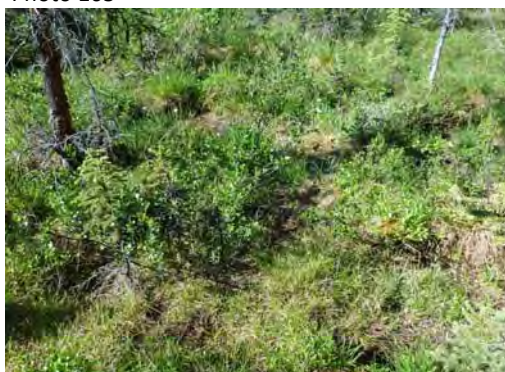
Freegold Road Extension Crossing # 46+740 - Hayes Creek Tributary

D/S	X	U/S
Coordinates:	6933680 N	356405 E	Gradient (%):	-	-
Site Visit Date:	24-Jun-13		Bankfull Width (m):	-	-
Flow Conditions:	None		Bankfull Depth (m):	-	-
Barrier/Confirmed:	Yes		Wetted Widths (m):	-	-
Electrofished/Effort?:	N/A		Wetted Depth (m):	-	-
Gee Trapping:	N/A		Substrate Bed:	-	-
Fish Bearing?:	N/A		Substrate Bank:	-	-
Site Length:	N/A		Riparian Vegetation:	-	-
			Meander Pattern:	-	-
			Cover:	-	-
Photo #s	u/s	x	d/s		
Areas of Erosion:	No		Temperature:	-	°C
Locations:			pH:	-	pH units
			Conductivity:	-	µS/cm
			DO:	-	mg/L
				-	% Sat
Comments:					
No visible channel within >100m of site

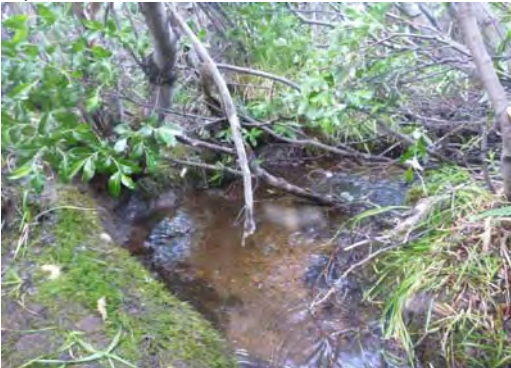
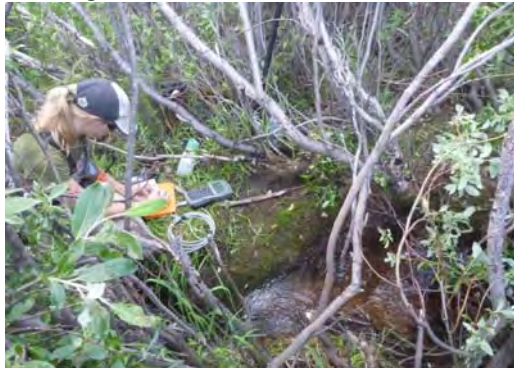
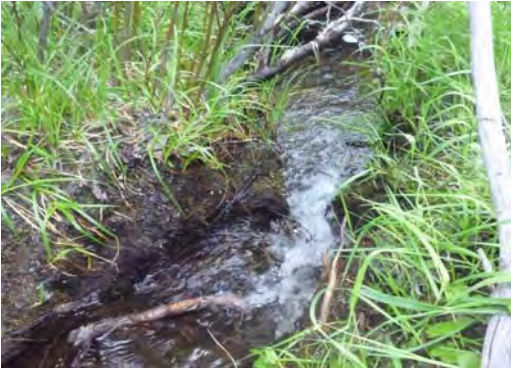
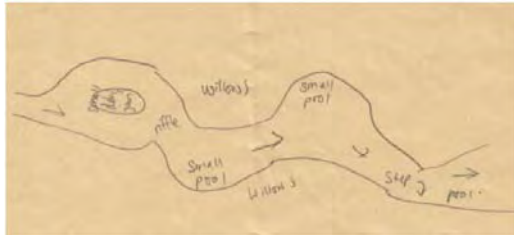
Freegold Road Extension Crossing # 47+050 - Hayes Creek Tributary

D/S	X	U/S	
Coordinates:	6933948 N	356254 E	Gradient (%):	12	10.5	9
Site Visit Date:	27-Jun-13		Bankfull Width (m):	0.55 / 0.90	0.8	1
Flow Conditions:	Low		Bankfull Depth (m):	0.24 / 0.30	0.3	0.2
Barrier/Confirmed:	None		Wetted Widths (m):	0.34 / 0.60	0.75	0.9
Electrofished/Effort?:	Yes (2013)		Wetted Depth (m):	0.10 / 0.11	0.12	0.07
Gee Trapping:	Yes (2013)		Substrate Bed:	G/F	F/G	G/F
Fish Bearing?	Yes		Substrate Bank:	F	F	F
Site Length:	200m		Riparian Vegetation:	WI/SP	WI/SP	WI/SP
			Meander Pattern:	IM	IM	IM
		Cover:	100% / OV	100% / OV	100% / OV	
Photo #s	101-0036 u/s	101-0037 x	101-0038 d/s			
Areas of Erosion:	No		Temperature:	2.85	°C	
Locations:			pH:	7.42	pH units	
			Conductivity:	207	µS/cm	
			DO:	8.69	mg/L	
				71.9	% Sat

Comments:
Moderate gradient stream that was sampled for fish to confirm presence/absence
Downstream site splits into 2 channels, separated by a vegetated island
Pool-riffle sequence
