APPENDIX 10B: FREEGOLD ROAD FISH AND AQUATIC BASELINE

Casino Project

Fish and Aquatic Resources Baseline Report:

Freegold Road Extension, Freegold Road Upgrade, and Casino Airstrip and Airstrip Access Road

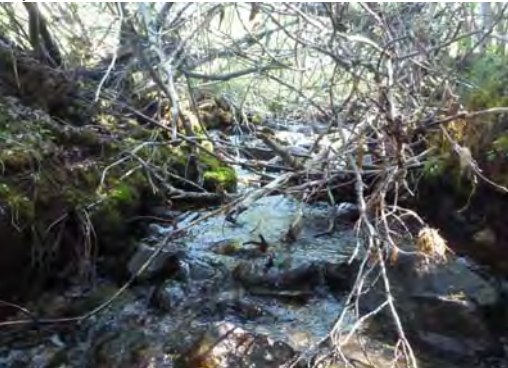
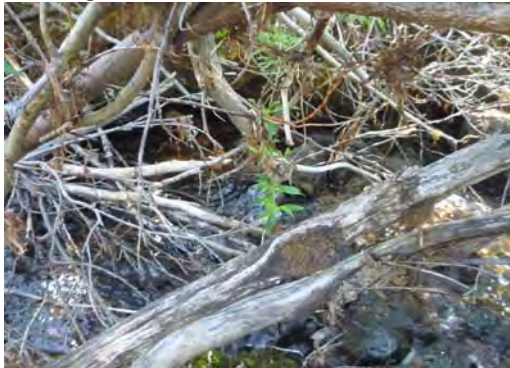
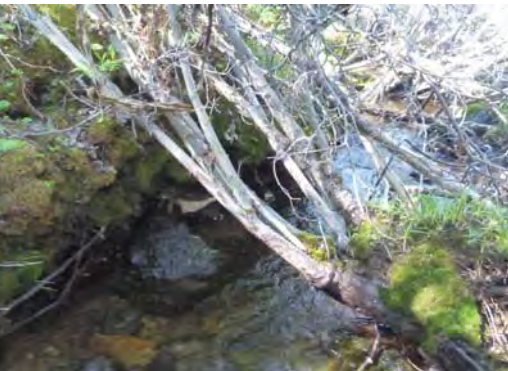
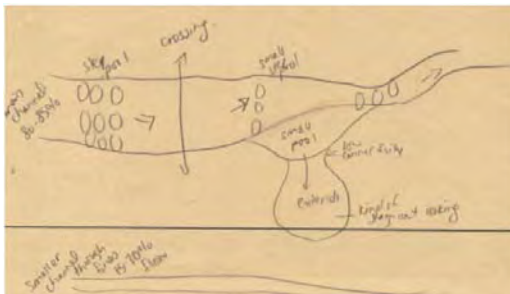
Freegold Road Extension Crossing # 49+000 - Hayes Creek Tributary

D/S	X	U/S
Coordinates:	6935425 N	355019 E	Gradient (%):	9	7	10.5
Site Visit Date:	24-Jun-13		Bankfull Width (m):	1.34	1.15	1.5
Flow Conditions:	Low		Bankfull Depth (m):	0.41	0.4	0.55
Barrier/Confirmed:	None		Wetted Widths (m):	1.34	1.5	1.5
Electrofished/Effort?:	No		Wetted Depth (m):	0.21	0.15	0.12
Gee Trapping:	No		Substrate Bed:	B/C	B/C	B/C
Fish Bearing?:	Yes		Substrate Bank:	F	F	F
Site Length:	100 m		Riparian Vegetation:	WI/SP	WI/SP	WI/SP
			Meander Pattern:	IM	IM	IM
		Cover:	90% / OV	90% / OV	95% / OV	
Photo #s	106 u/s	107 x	108 d/s			
Areas of Erosion:	No		Temperature:	2.63	°C	
Locations:			pH:	7.44	pH units	
			Conductivity:	365	µS/cm	
			DO:	14.18	mg/L	
				104.5	% Sat

At the downstream site, more water was draining to the west

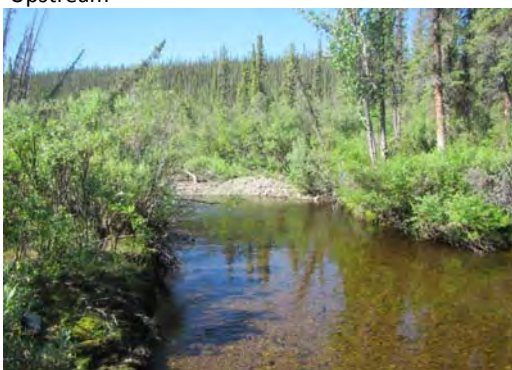
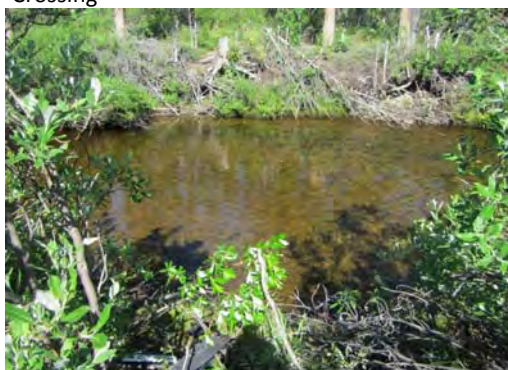
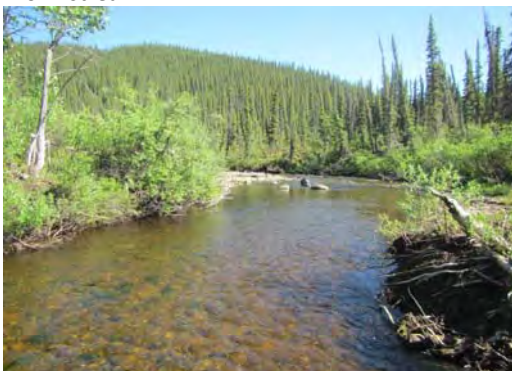
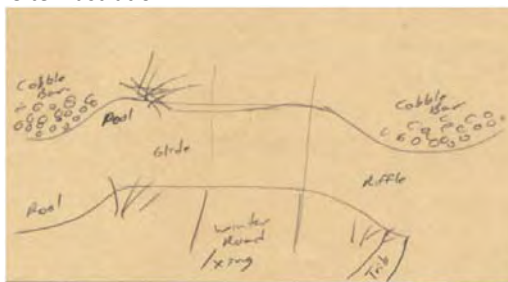
Freegold Road Extension Crossing # 51+170 - Hayes Creek

D/S	X	U/S
Coordinates:	6936828 N	353491 E	Gradient (%):	4	1	2
Site Visit Date:	24-Jun-13		Bankfull Width (m):	12.9	6.8	8.85
Flow Conditions:	Low		Bankfull Depth (m):	0.6	0.43	0.76
Barrier/Confirmed:	None		Wetted Widths (m):	7.2	6.6	3.6
Electrofished/Effort?:	Yes (2010)		Wetted Depth (m):	0.4	0.22	0.3
Gee Trapping:	No		Substrate Bed:	C/B	G/C	C/G
Fish Bearing?	Yes		Substrate Bank:	F/C	F/C	F/C
Site Length:	100 m		Riparian Vegetation:	WI/SP	SP/WI	WI/SP
			Meander Pattern:	RM	RM	RM
		Cover:	10% / SUB	10% / OV	20% / LWD	
Photo #s	10 u/s	11 x	12 d/s			
Areas of Erosion:	Y		Temperature:	5.61	°C	
Locations:	50m upstream of crossing,		pH:	8.07	pH units	
	actively eroding bank		Conductivity:	64	µS/cm	
			DO:	12.1	mg/L	
				107	% Sat

Comments:
Crossing location on straight section, even flow, high quality habitat
Riparian previously disturbed by winter road access
1 Arctic grayling spotted
Picture 13: eroding bank

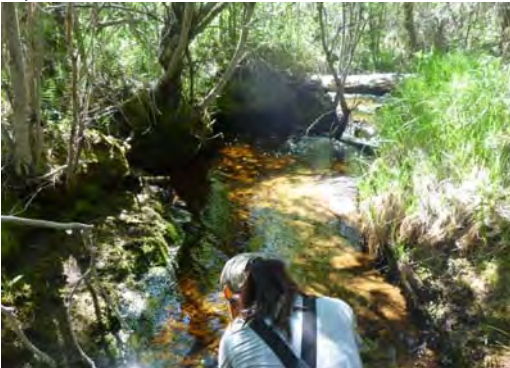
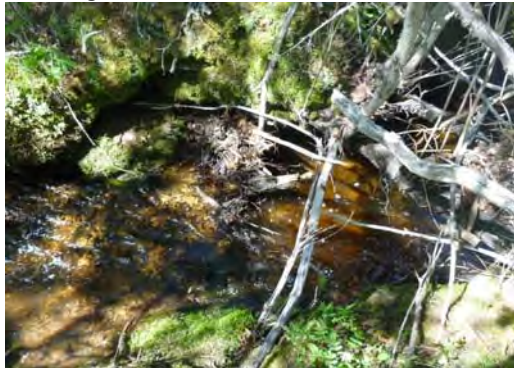
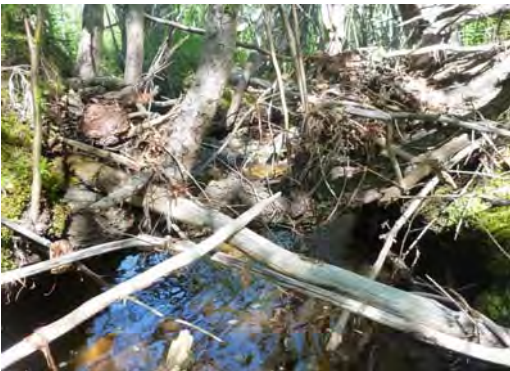
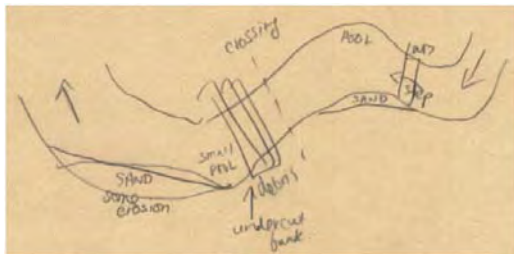
Freegold Road Extension Crossing # 52+330 - Hayes Creek Tributary

D/S	X	U/S
Coordinates:	6937376 N	352489 E	Gradient (%):	3.5	3.5
Site Visit Date:	24-Jun-13		Bankfull Width (m):	1	1.54
Flow Conditions:	Low		Bankfull Depth (m):	0.37	0.4
Barrier/Confirmed:	None		Wetted Widths (m):	0.85	1.25
Electrofished/Effort?:	Yes (2011)		Wetted Depth (m):	0.19	0.11
Gee Trapping:	No		Substrate Bed:	G/F	G/F
Fish Bearing?	Yes		Substrate Bank:	F	F
Site Length:	100 m		Riparian Vegetation:	WI/PO/SP	SP/WI/PO
			Meander Pattern:	IM	IM
			Cover:	85% / OV	15% / LWD
Photo #s	947 u/s	948 x	949 d/s		
Areas of Erosion:	Y		Temperature:	5.53	°C
Locations:	Med erosion potential		pH:	8.82	pH units
			Conductivity:	161	µS/cm
			DO:	13.66	mg/L
				108.4	% Sat

Maybe potential to re-align creek here to previous downstream direction. At 08 V 0352291 6937549, flow enters winter road from the east, runs down it until 08 V 0349205 6941847 and then seeps into Hayes tributary.

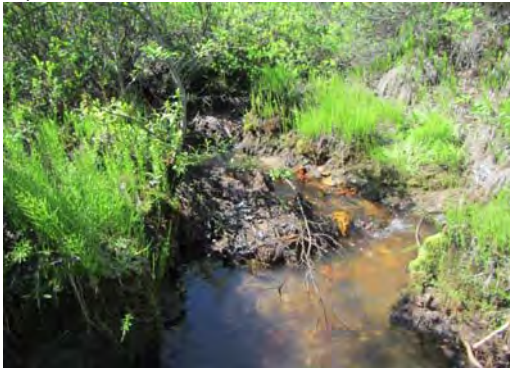
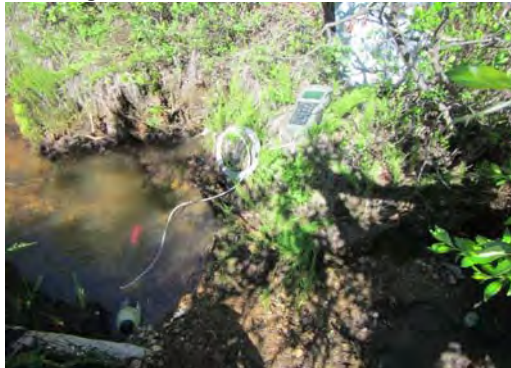
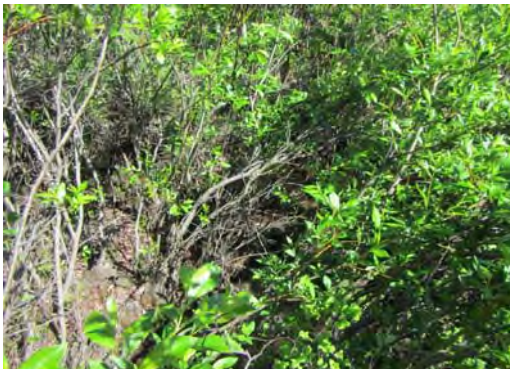
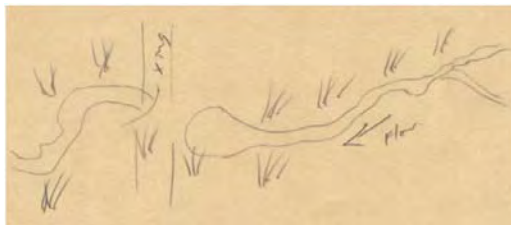
Freegold Road Extension Crossing # 53+590 - Hayes Creek Tributary

D/S	X	U/S	
Coordinates:	6938195 N	351534 E	Gradient (%):	4	7	9
Site Visit Date:	24-Jun-13		Bankfull Width (m):	1.19	0.85	0.98 / 0.52
Flow Conditions:	Low		Bankfull Depth (m):	0.34	0.47	0.55 / 0.08
Barrier/Confirmed:	Yes		Wetted Widths (m):	0.77	0.81	0.66 / 0.46
Electrofished/Effort?:	No		Wetted Depth (m):	0.12	0.25	0.15 / 0.04
Gee Trapping:	No		Substrate Bed:	G/S	G/F	G/S
Fish Bearing?	No		Substrate Bank:	F/G	F/G	F/G
Site Length:	100 m		Riparian Vegetation:	WI/SP	WI/SP	WI/SP
			Meander Pattern:	SI	SI	SI
		Cover:	40% / OV	40% / OV	30% / U	
Photo #s	14 u/s	15 x	16 d/s			
Areas of Erosion:	N		Temperature:	3.41	°C	
Locations:			pH:	7.42	pH units	
			Conductivity:	177	µS/cm	
			DO:	11.42	mg/L

94.8	% Sat	
Comments:						
Creek intermittently flowing subterraneous at crossing						
Split channel upstream and downstream						
08 V 0351539 6938213 potential barrier: creek underground for 0.75m: photo 17

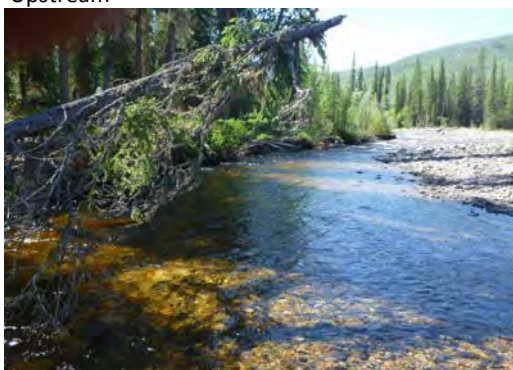
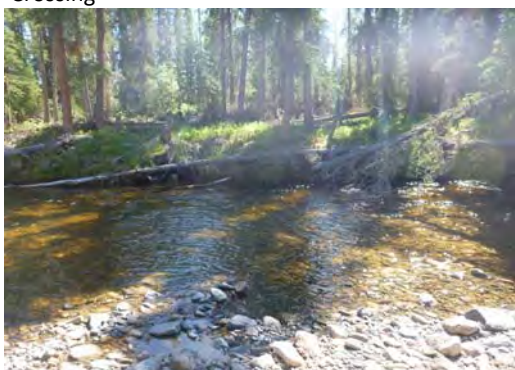
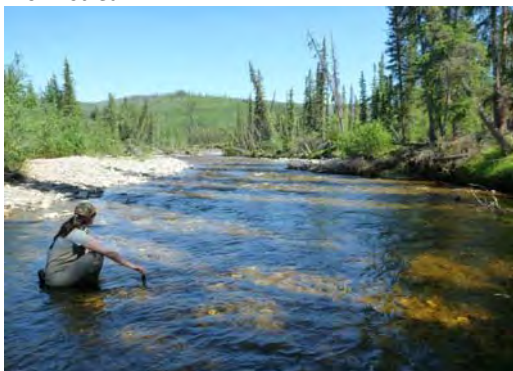
Freegold Road Extension Crossing # 56+790 - Apex Creek

D/S	X	U/S	
Coordinates:	6940628 N	349556E	Gradient (%):	1	0.5	1
Site Visit Date:	24-Jun-13		Bankfull Width (m):	27	16	37
Flow Conditions:	Low		Average Depth (m):	0.4	0.5	0.3
Barrier/Confirmed:	None		Wetted Widths (m):	15	9	16
Electrofished/Effort?:	Yes (2010)		Substrate Bed:	C/G	C/G	C/G
Gee Trapping:	No		Substrate Bank:	-	-	-
Fish Bearing?	Yes		Riparian Vegetation:	-	-	-
Site Length:	100 m		Meander Pattern:	-	-	-
			Cover:	30% / LWD	25% LWD	30% / LWD

Comments:
Pre-existing Site Card as 56+820
A few large gravel bars on the right bank
Could add more in-stream cover/pool habitat
Area is mostly riffle

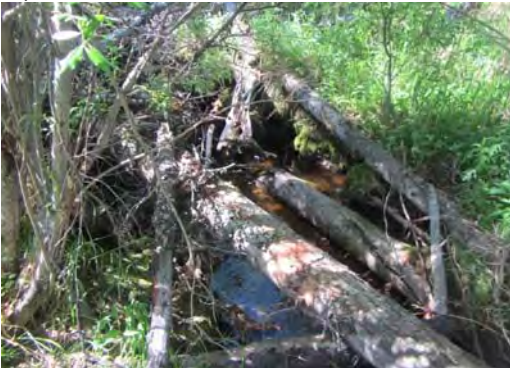
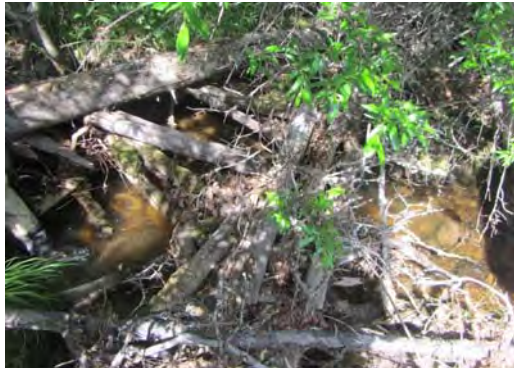
Freegold Road Extension Crossing # 57+420 - Hayes Creek Tributary

D/S	X	U/S
Coordinates:	6941194 N	349309 E	Gradient (%):	3	4	7
Site Visit Date:	24-Jun-13		Bankfull Width (m):	0.89	1.8	2
Flow Conditions:	Low		Bankfull Depth (m):	0.65	0.4	0.27
Barrier/Confirmed:	None		Wetted Widths (m):	0.89	1.58	1.6
Electrofished/Effort?:	Yes (2011)		Wetted Depth (m):	0.52	0.24	0.1
Gee Trapping:	No		Substrate Bed:	F	G/C	C/B
Fish Bearing?	Yes		Substrate Bank:	F	F	F/C
Site Length:	100 m		Riparian Vegetation:	SP/WI	PO/WI	PO/WI
			Meander Pattern:	SI	SI	SI
		Cover:	30% / U	60% / LWD	10% / SUB	
Photo #s	18 u/s	19 x	20 d/s			
Areas of Erosion:	N		Temperature:	6.99	°C	
Locations:			pH:	8.1	pH units	
			Conductivity:	6.98	µS/cm	
			DO:	12.76	mg/L	
				115.2	% Sat

Comments:
Crossing location has a large amount of debris from an old burn
Large build up of LWD in creek leading to backwater conditions in some cases (photo 21)

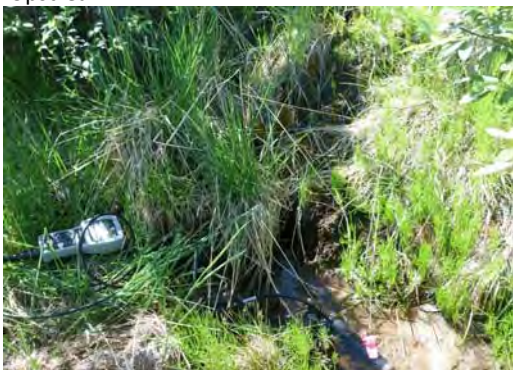
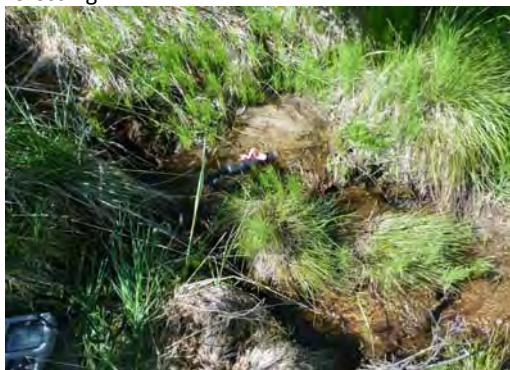
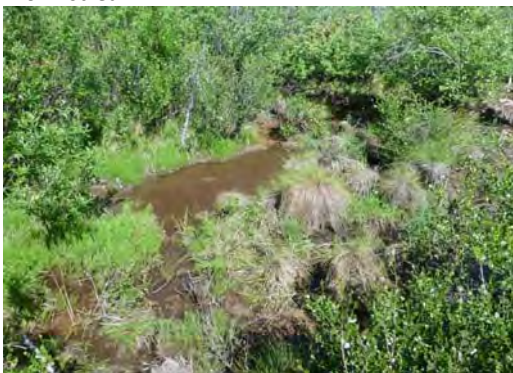
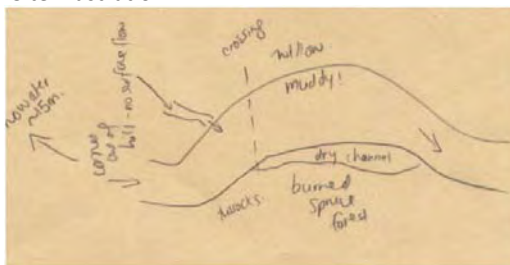
Freegold Road Extension Crossing # 58+070 - Hayes Creek Tributary

D/S	X	U/S	
Coordinates:	6941798 N	349138 E	Gradient (%):	9	14	5
Site Visit Date:	24-Jun-13		Bankfull Width (m):	1.50	0.83	1.60
Flow Conditions:	Low		Bankfull Depth (m):	0.15	0.08	0.09
Barrier/Confirmed:	Yes		Wetted Widths (m):	0.21	0.53	1.22
Electrofished/Effort?:	N/A		Wetted Depth (m):	0.07	0.03	0.04
Gee Trapping:	N/A		Substrate Bed:	F	F	F
Fish Bearing?	No		Substrate Bank:	F	F	F
Site Length:	100 m		Riparian Vegetation:	WI/SP	WI/SP	WI/SP
			Meander Pattern:	IM	IM	IM
		Cover:	50% / OV	15% / OV	50% / OV	
Photo #s	117 u/s	118 x	119 d/s			
Areas of Erosion:	N		Temperature:	6.33	°C	
Locations:			pH:	9.2	pH units	
			Conductivity:	682	µS/cm	
			DO:	11.66	mg/L	
				94.8	% Sat

Comments:
Upstream site, above, dry 15m. Submerges underground immediately after crossing.

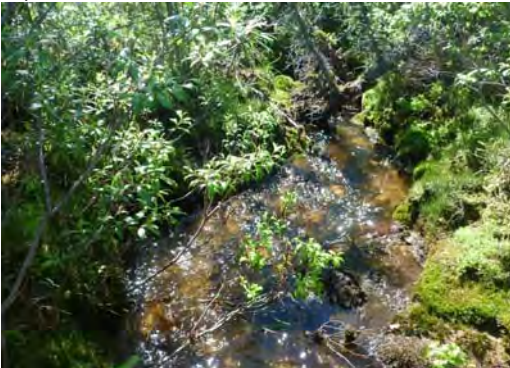
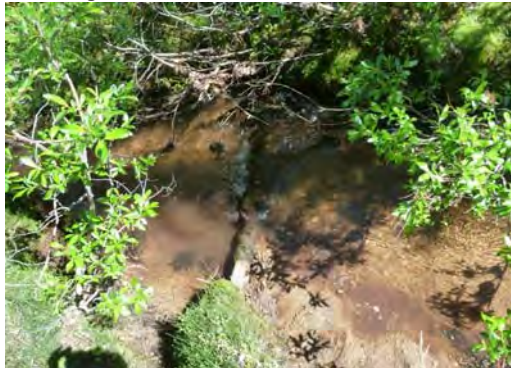
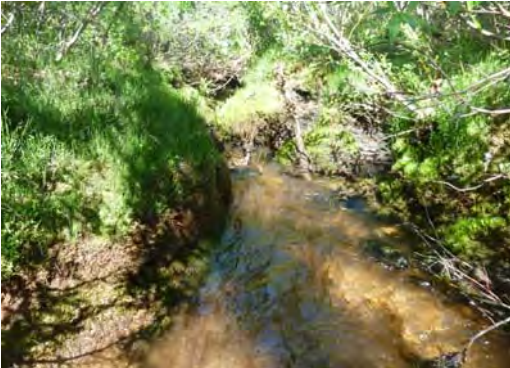
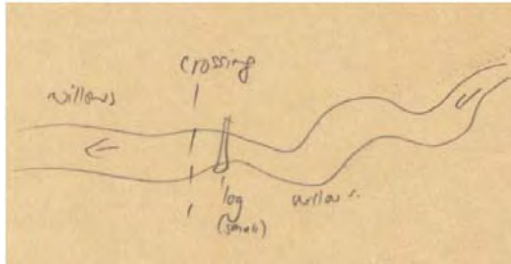
Freegold Road Extension Crossing # 58+980 - Hayes Creek Tributary

D/S	X	U/S	
Coordinates:	6942396 N	348450 E	Gradient (%):	5	3.5	5
Site Visit Date:	24-Jun-13		Bankfull Width (m):	1.03	1.20	0.76
Flow Conditions:	Low		Bankfull Depth (m):	0.38	0.34	0.38
Barrier/Confirmed:	None		Wetted Widths (m):	0.77	1.10	0.76
Electrofished/Effort?:	No		Wetted Depth (m):	0.27	0.14	0.22
Gee Trapping:	No		Substrate Bed:	G/F	G/F	G/F
Fish Bearing?	Yes		Substrate Bank:	F	F	F
Site Length:	100 m		Riparian Vegetation:	WI/SP	WI/SP	WI/SP
			Meander Pattern:	IM	IM	IM
			Cover:	100% / OV	85% / OV	95% / OV
Photo #s	958 u/s	959 x	960 d/s			
Areas of Erosion:	N		Temperature:	4.7	°C	
Locations:			pH:	9.21	pH units	
			Conductivity:	250	µS/cm	
			DO:	14.26	mg/L	
				111.2	% Sat	
Comments:

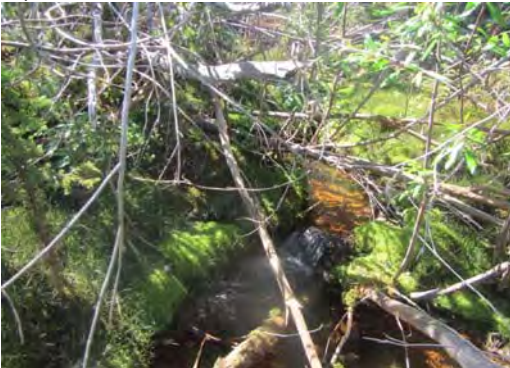
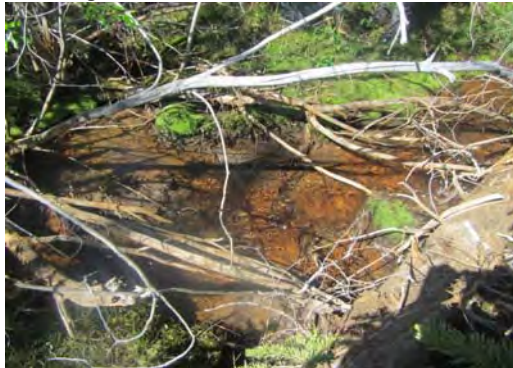
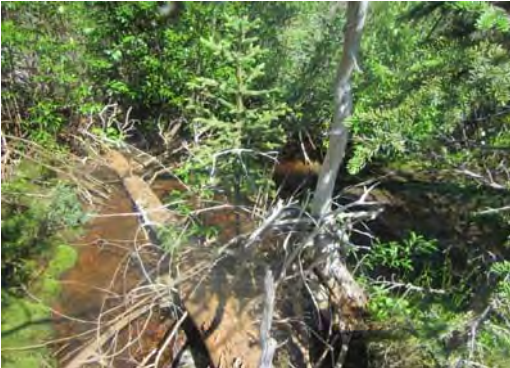
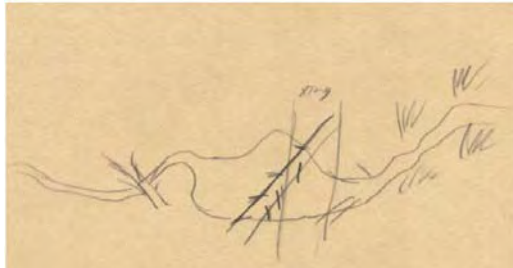
Freegold Road Extension Crossing # 60+220 - Hayes Creek Tributary

D/S	X	U/S
Coordinates:	6943310 N	347629 E	Gradient (%):	13	10
Site Visit Date:	June 24, 2013		Bankfull Width (m):	0.43	0.53
Flow Conditions:	Low		Bankfull Depth (m):	0.34	0.32
Barrier/Confirmed:	Yes		Wetted Widths (m):	0.43	0.47
Electrofished/Effort?:	No		Wetted Depth (m):	0.30	0.20
Gee Trapping:	No		Substrate Bed:	F/G	F/G
Fish Bearing?	No		Substrate Bank:	F	F
Site Length:	100 m		Riparian Vegetation:	WI/SP	WI/SP
			Meander Pattern:	SI	SI
			Cover:	40% / OV	30% / LWD
Photo #s	22 u/s	23 x	24 d/s		
Areas of Erosion:	N		Temperature:	1.95	°C
Locations:			pH:	8.24	pH units
			Conductivity:	250	µS/cm
			DO:	13.25	mg/L
				103.5	% Sat
Comments:					
Crossing location (original) at 08 V 0347625 6943309					
Low flow barriers upstream and downstream of crossing

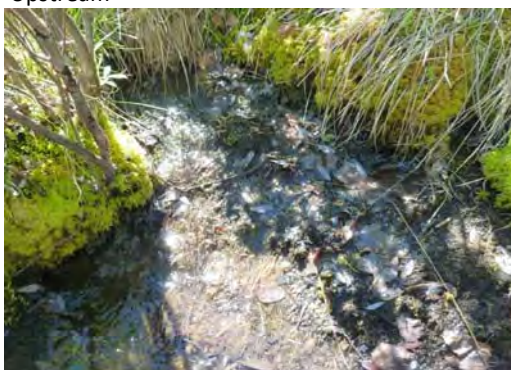
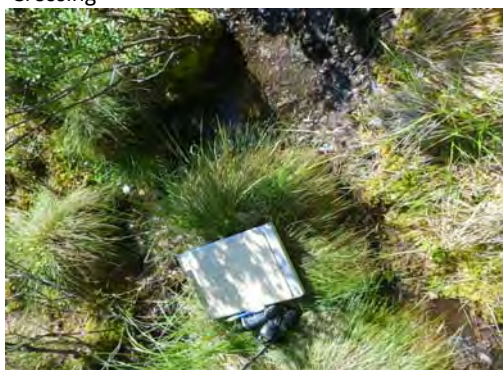
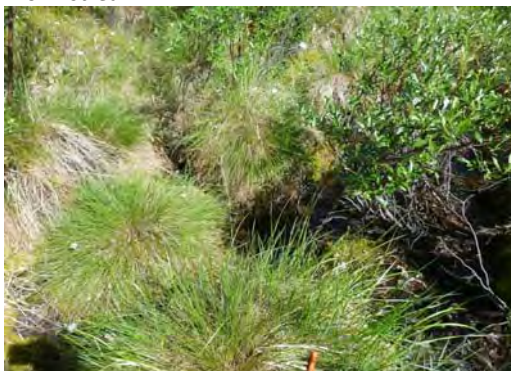
Freegold Road Extension Crossing # 60+870 (Unmapped) - Hayes Creek Tributary

D/S	X	U/S	
Coordinates:	6943776 N	347277 E	Gradient (%):	-	17.5	-
Site Visit Date:	24-Jun-13		Bankfull Width (m):	-	0.41	-
Flow Conditions:	Low to None		Bankfull Depth (m):	-	0.15	-
Barrier/Confirmed:	Yes		Wetted Widths (m):	-	0.30	-
Electrofished/Effort?:	No		Wetted Depth (m):	-	0.05	-
Gee Trapping:	No		Substrate Bed:	-	F	-
Fish Bearing?	No		Substrate Bank:	-	F	-
Site Length:	100 m		Riparian Vegetation:	-	WI/BI	-
		Meander Pattern:	-	IM	-	
		Cover:	-	75% / OV	-	
Photo #s	123 u/s	124 x	125 d/s			
Areas of Erosion:	N		Temperature:	-	°C	
Locations:			pH:	-	pH units	
			Conductivity:	-	µS/cm	
			DO:	-	mg/L	
				-	% Sat

Comments:
Water very low, barely any flow - stagnant puddle with very low flow
Channel dry upstream and downstream of crossing

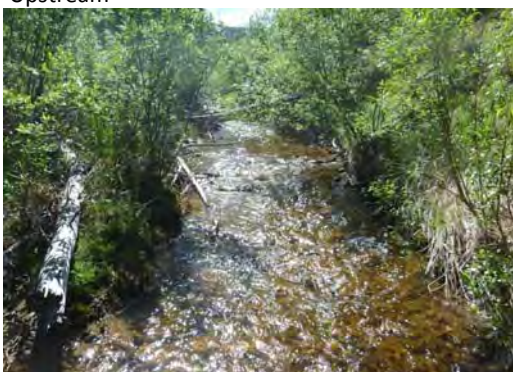
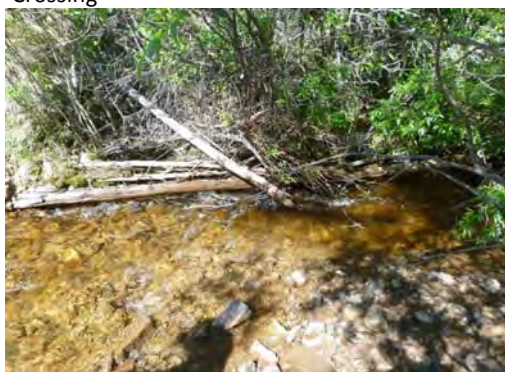
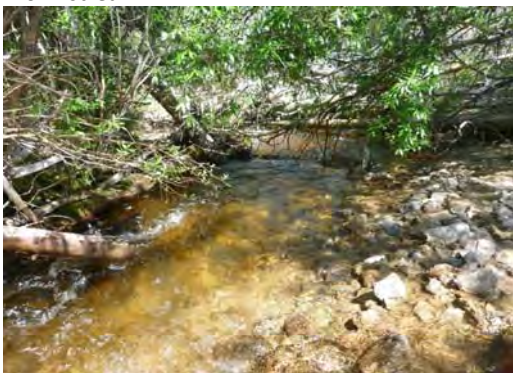
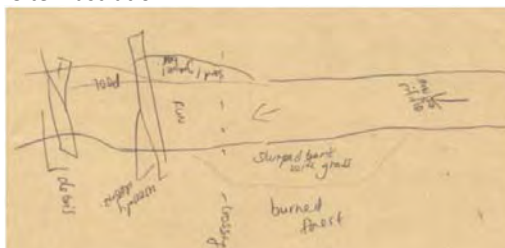
Freegold Road Extension Crossing # 61+830 - Fourmile Creek

D/S	X	U/S
Coordinates:	6944654 N	346888 E	Gradient (%):	3.5	3.5
Site Visit Date:	24-Jun-13		Bankfull Width (m):	3.50	2.80
Flow Conditions:	Low		Bankfull Depth (m):	0.31	0.30
Barrier/Confirmed:	None		Wetted Widths (m):	2.80	2.20
Electrofished/Effort?:	Yes (2011)		Wetted Depth (m):	0.19	0.20
Gee Trapping:	No		Substrate Bed:	C/G	C/G
Fish Bearing?	Yes		Substrate Bank:	F	F
Site Length:	100 m		Riparian Vegetation:	WI/SP/BI	WI/SP/AS
			Meander Pattern:	IM	SI
			Cover:	50% / OV	20% / OV
				50% / OV	
Photo #s	126 u/s	127 x	128 d/s		
Areas of Erosion:	Y		Temperature:	8.38	°C
Locations:	Slumped left bank near crossing		pH:	9.43	pH units
			Conductivity:	118	µS/cm
			DO:	12.87	mg/L
				109.7	% Sat
Comments:					
Lots of woody debris from burn					
Riffle-pool habitat

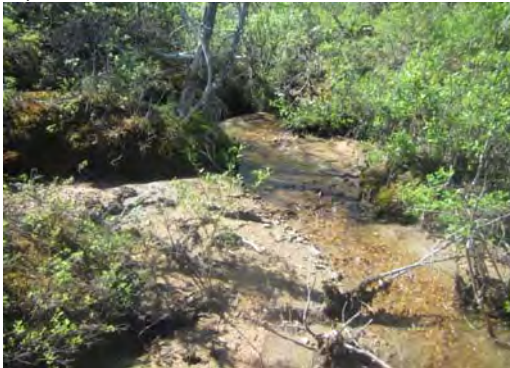
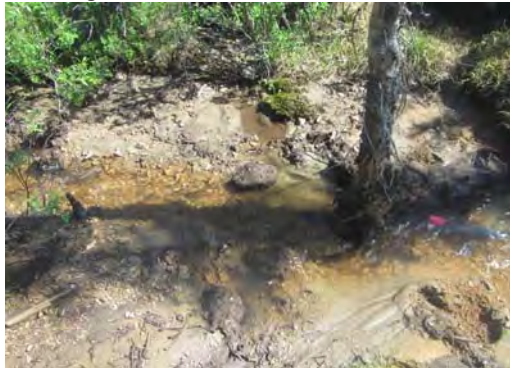
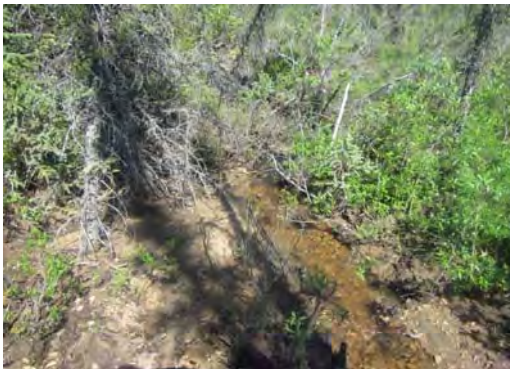
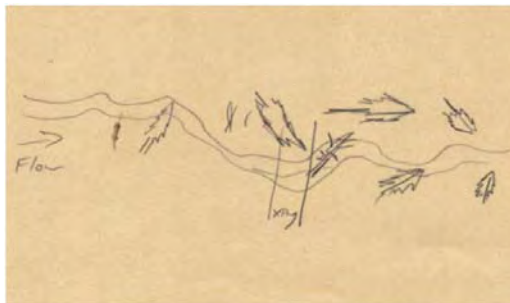
Freegold Road Extension Crossing # 62+170 - Hayes Creek Tributary

D/S	X	U/S	
Coordinates:	6944960 N	346743 E	Gradient (%):	6	7	9
Site Visit Date:	24-Jun-13		Bankfull Width (m):	1.02	1.00	0.95
Flow Conditions:	Low		Bankfull Depth (m):	0.17	0.17	0.37
Barrier/Confirmed:	None		Wetted Widths (m):	0.48	0.82	0.32
Electrofished/Effort?:	No		Wetted Depth (m):	0.09	0.05	0.17
Gee Trapping:	No		Substrate Bed:	G/F	G/F	G/F
Fish Bearing?	Yes		Substrate Bank:	F/S	F/G	S/F
Site Length:	100 m		Riparian Vegetation:	WI	SP/WI	WI/SP
			Meander Pattern:	SI	SI	SI
			Cover:	10% / U	0	30% / U
Photo #s	26 u/s	27 x	28 d/s			
Areas of Erosion:	Y		Temperature:	6.12		°C
Locations:	Permafrost slumping upstream and		pH:	7.73		pH units
	downstream of crossing		Conductivity:	58		µS/cm
			DO:	10.71		mg/L
				93.7		% Sat
Comments:						
Photo 25: overview of creek, slump						
exposed gravel hillside 400m upstream

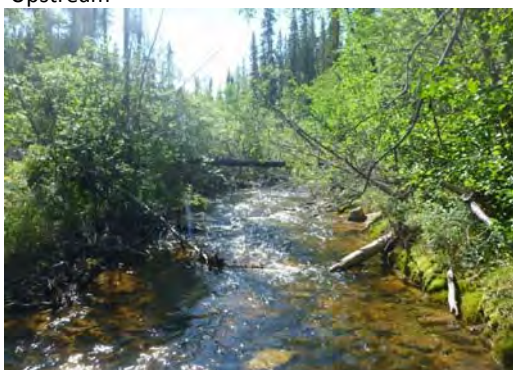
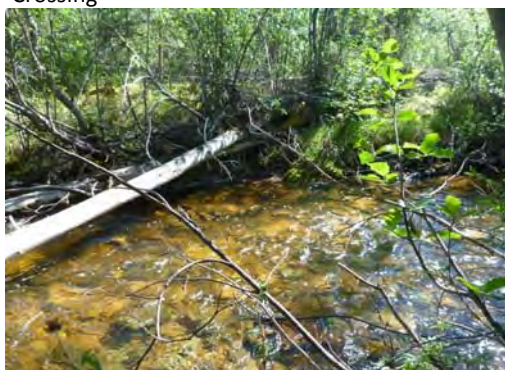
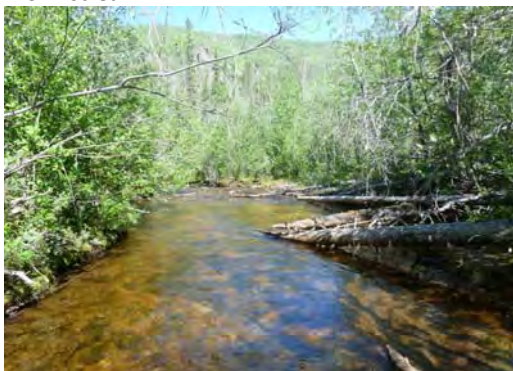
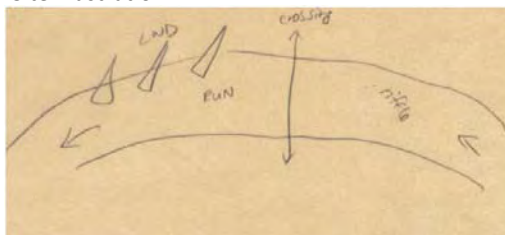
Freegold Road Extension Crossing # 63+870 - Butterfield Creek

D/S	X	U/S	
Coordinates:	6946576 N	346593 E	Gradient (%):	2	3.5	2
Site Visit Date:	24-Jun-13		Bankfull Width (m):	4.00	4.60	5.90
Flow Conditions:	Low		Bankfull Depth (m):	0.46	0.48	0.25
Barrier/Confirmed:	None		Wetted Widths (m):	2.90	3.80	6.00
Electrofished/Effort?:	Yes (2011)		Wetted Depth (m):	0.30	0.29	0.35
Gee Trapping:	No		Substrate Bed:	C/G	C/G	G/C
Fish Bearing?	Yes		Substrate Bank:	F	F	F
Site Length:	100 m		Riparian Vegetation:	WI/PO/SP	WI/SP/PO	WI/AL/SP
		Meander Pattern:	SI	SI	SI	
		Cover:	30% / OV	15% / LWD	45% / OV	
Photo #s	967 u/s	968 x	969 d/s			
Areas of Erosion:	N		Temperature:	7.77	°C	
Locations:			pH:	4	pH units	
			Conductivity:	164	µS/cm	
			DO:	13.1	mg/L	
				110.1	% Sat

Comments:
Riffle-run sequence with a lack of pool habitat
Grayling spotted (TL = ~220mm) at upstream site

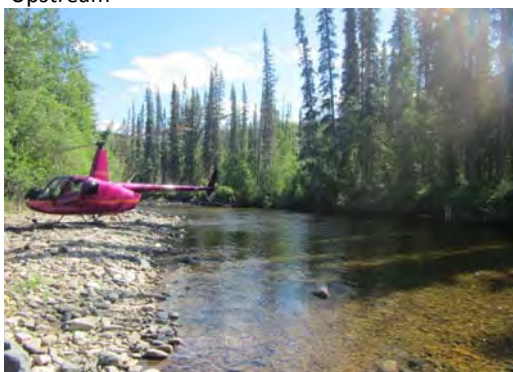
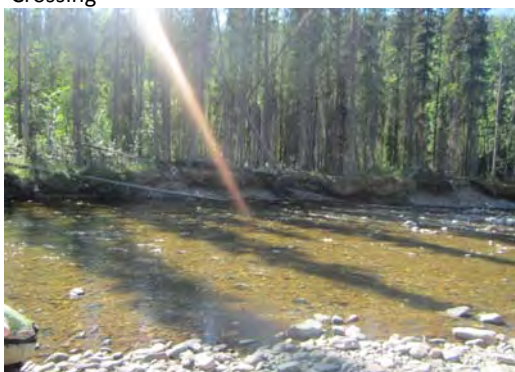
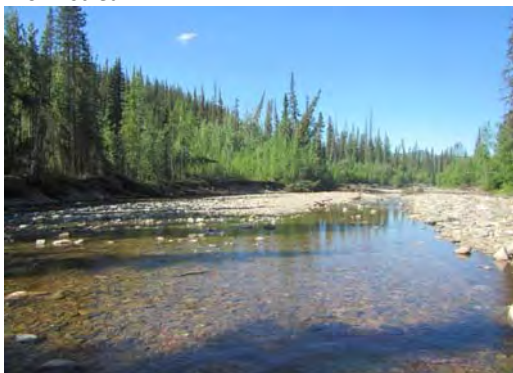
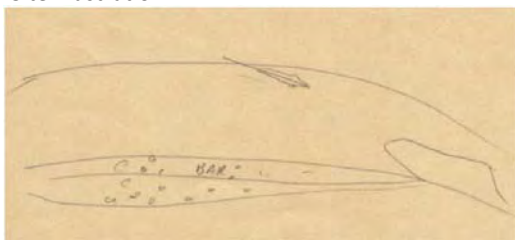
Freegold Road Extension Crossing # 64+700 - Hayes Creek

D/S	X	U/S	
Coordinates:	6947271 N	346380 E	Gradient (%):	0.5	1	1.5
Site Visit Date:	24-Jun-13		Bankfull Width (m):	17.00	17.00	19.00
Flow Conditions:	Low		Average Depth (m):	0.45	0.65	0.50
Barrier/Confirmed:	None		Wetted Widths (m):	14.00	14.00	15.00
Electrofished/Effort?:	No		Substrate Bed:	C/B	C/G	B/C
Gee Trapping:	No		Substrate Bank:	-	C/F	-
Fish Bearing?	Yes		Riparian Vegetation:	-	SP/WI	-
Site Length:	100 m		Meander Pattern:	-	RM	-
			Cover:	25% / OV	10% / U	25% / OV

Comments:
Pre-existing Site Card as 64+710
Riffle-run habitat with few pools
High quality gravel substrate

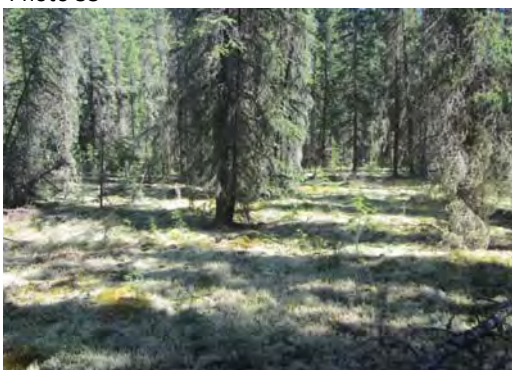
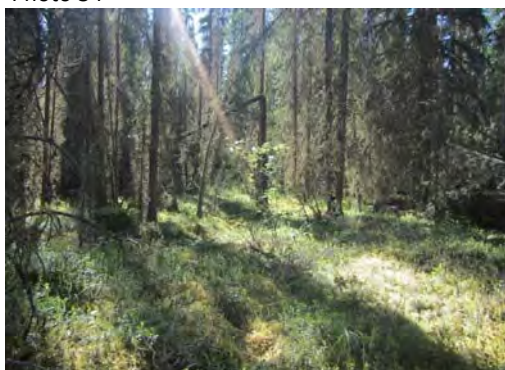
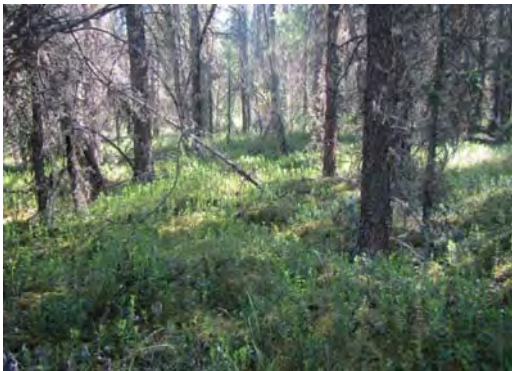
Freegold Road Extension Crossing # 65+640 - No Crossing

D/S	X	U/S
Coordinates:	6948131 N	346640 E	Gradient (%):	-	-
Site Visit Date:	24-Jun-13		Bankfull Width (m):	-	-
Flow Conditions:	No Channel		Bankfull Depth (m):	-	-
Barrier/Confirmed:	N/A		Wetted Widths (m):	-	-
Electrofished/Effort?:	N/A		Wetted Depth (m):	-	-
Gee Trapping:	N/A		Substrate Bed:	-	-
Fish present?:	N/A		Substrate Bank:	-	-
Site Length:	N/A		Riparian Vegetation:	-	-
			Meander Pattern:	-	-
			Cover:	-	-
Photo #s	u/s	x	d/s		
Areas of Erosion:	N/A		Temperature:	-	°C
Locations:			pH:	-	pH units
			Conductivity:	-	µS/cm
			DO:	-	mg/L
				-	% Sat
Comments:					
GPS location in a spruce forest - no watercourse

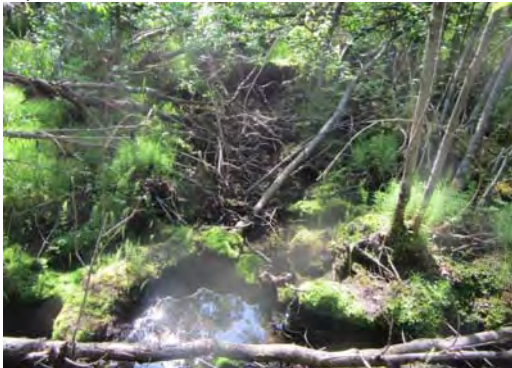
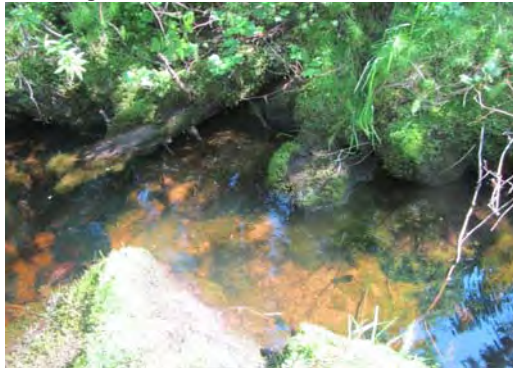
Freegold Road Extension Crossing # 66+080 - Hayes Creek Tributary

D/S	X	U/S
Coordinates:	6948573 N	346547 E	Gradient (%):	2	1
Site Visit Date:	25-Jun-13		Bankfull Width (m):	3.00	2.10
Flow Conditions:	Typical		Bankfull Depth (m):	0.60	0.25
Barrier/Confirmed:	None		Wetted Widths (m):	-	1.15
Electrofished/Effort?:	No		Wetted Depth (m):	-	0.14
Gee Trapping:	No		Substrate Bed:	C/S	F
Fish Bearing?:	Yes		Substrate Bank:	F	F
Site Length:	100 m		Riparian Vegetation:	WI	SP/WI
			Meander Pattern:	SI	SI
			Cover:	20% / U	20% / LWD
Photo #s	51 u/s	52 x	53 d/s		
Areas of Erosion:	No		Temperature:	5.05	°C
Locations:			pH:	7.81	pH units
			Conductivity:	297	µS/cm
			DO:	8.02	mg/L
				68	% Sat
Comments:					
Deeply incised creek through permafrost/ fines					
Potential for seasonal barriers downstream of crossing

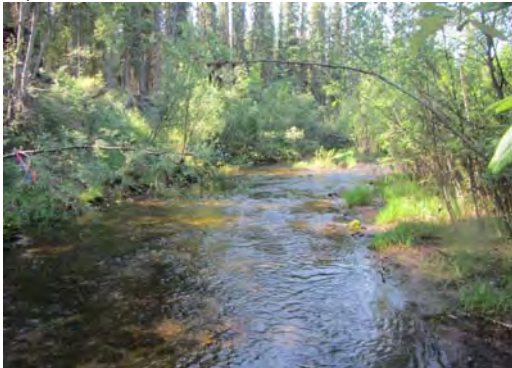
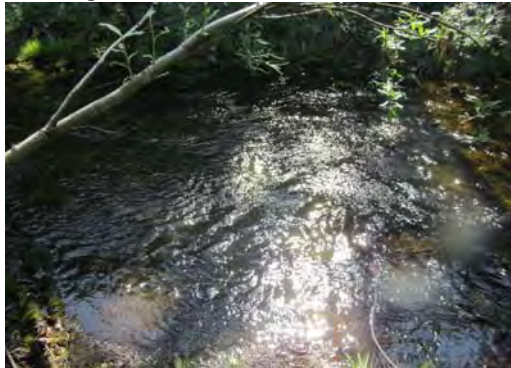
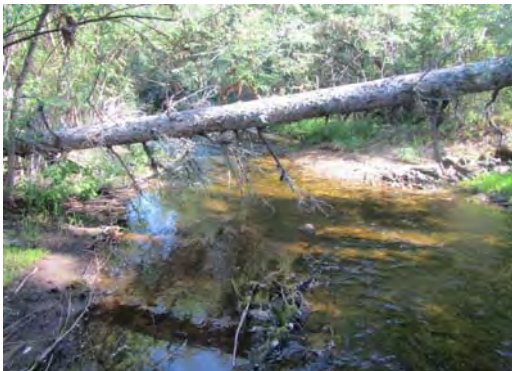
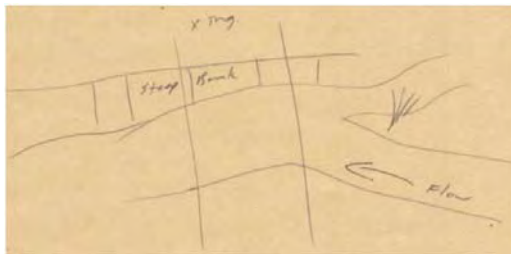
Freegold Road Extension Crossing # 66+170 - Hayes Creek Side Channel

D/S	X	U/S
Coordinates:	6948653 N	346537 E	Gradient (%):	0.5	1
Site Visit Date:	25-Jun-13		Bankfull Width (m):	8.00	3.50
Flow Conditions:	Typical		Average Depth (m):	0.20	0.20
Barrier/Confirmed:	None		Wetted Widths (m):	4.00	3.25
Electrofished/Effort?:	Yes (2010)		Substrate Bed:	G/F	G/F
Gee Trapping:	No		Substrate Bank:	-	-
Fish Bearing?	Yes		Riparian Vegetation:	-	-
Site Length:	100 m		Meander Pattern:	-	-
			Cover:	25% / OV	45% / SWD
				35% / OV

Comments:
Pre-existing site card as 66+200
Low temperature and conductivity for a major tributary

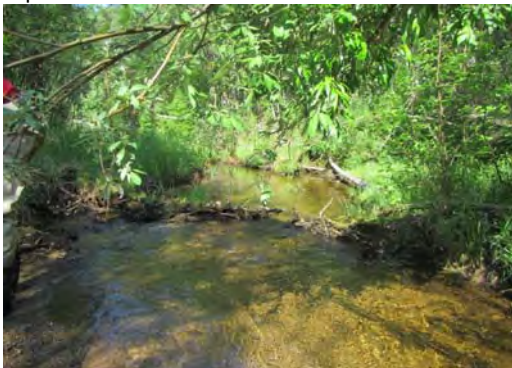
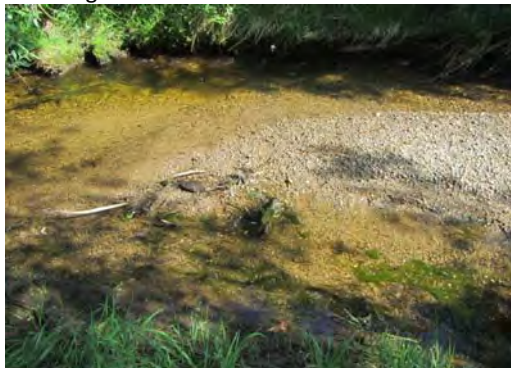
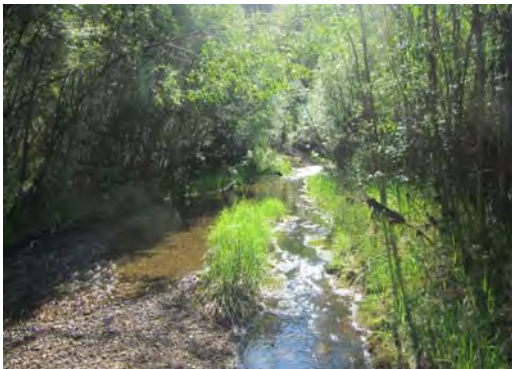
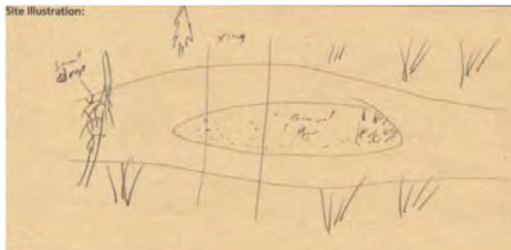
Freegold Road Extension Crossing # 66+310 - Hayes Creek Side Channel Tributaries

D/S	X	U/S	
Coordinates:	6948781 N	346529 E	Gradient (%):	1	2	1
Site Visit Date:	25-Jun-13		Bankfull Width (m):	4.70	3.70	2.50
Flow Conditions:	Low		Bankfull Depth (m):	1.00	0.46	0.25
Barrier/Confirmed:	None		Wetted Widths (m):	4.70	2.40	2.50
Electrofished/Effort?:	No		Wetted Depth (m):	0.50	0.35	0.20
Gee Trapping:	No		Substrate Bed:	G/S	G	C/G
Fish Bearing?	Yes		Substrate Bank:	S/C	F	S
Site Length:	100 m		Riparian Vegetation:	WI/SP	WI	WI/GR
			Meander Pattern:	SI	SI	SI
			Cover:	20% / LWD	20% / LWD	10% / LWD
Photo #s	45 u/s	46 x	47 d/s			
Areas of Erosion:	No		Temperature:	1.43	°C	
Locations:			pH:	7.64	pH units	
			Conductivity:	159	µS/cm	
			DO:	7.67	mg/L	
				59.2	% Sat	
Comments:						
Low DO and temperature implies permafrost fed

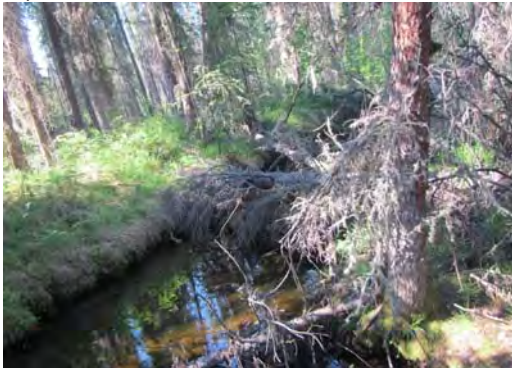
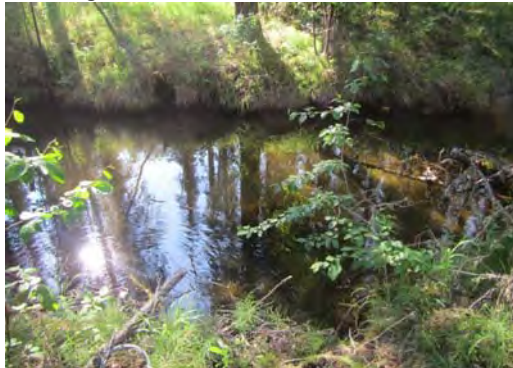
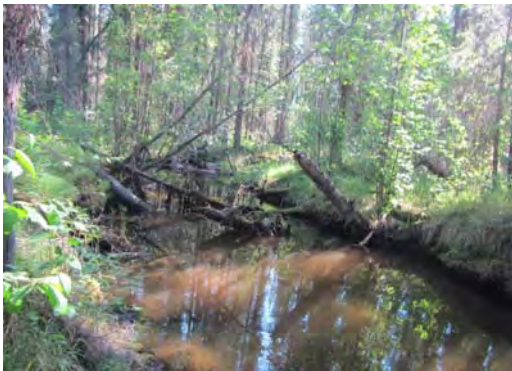
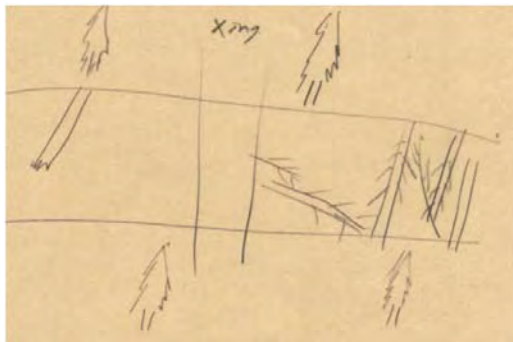
Freegold Road Extension Crossing # 67+500 - Hayes Creek Side Channel

D/S	X	U/S	
Coordinates:	6949915 N	346712 E	Gradient (%):	0	0	1
Site Visit Date:	25-Jun-13		Bankfull Width (m):	8.20	4.00	2.60
Flow Conditions:	Typical		Bankfull Depth (m):	0.94	0.80	0.22
Barrier/Confirmed:	None		Wetted Widths (m):	8.20	4.00	1.57
Electrofished/Effort?:	No		Wetted Depth (m):	0.84	0.60	0.12
Gee Trapping:	No		Substrate Bed:	F	F	C/G
Fish Bearing?	Yes		Substrate Bank:	F	F	F/C
Site Length:	100 m		Riparian Vegetation:	SP/AL	SP/AL	SP/AL
			Meander Pattern:	-	-	-
		Cover:	10% / LWD	20% / LWD	20% / LWD	
Photo #s	42 u/s	43 x	44 d/s			
Areas of Erosion:	No		Temperature:	1.42	°C	
Locations:			pH:	7.04	pH units	
			Conductivity:	82	µS/cm	
			DO:	3.33	mg/L	
				25.9	% Sat	
Comments:						
Old oxbow of Hayes Creek						
Connected via a small stream on the downstream side to Hayes Creek						
Temperature and DO make for a poor habitat

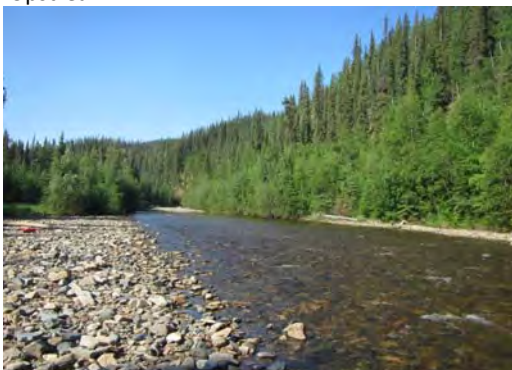
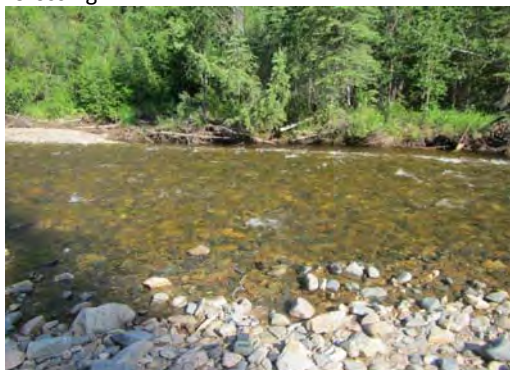
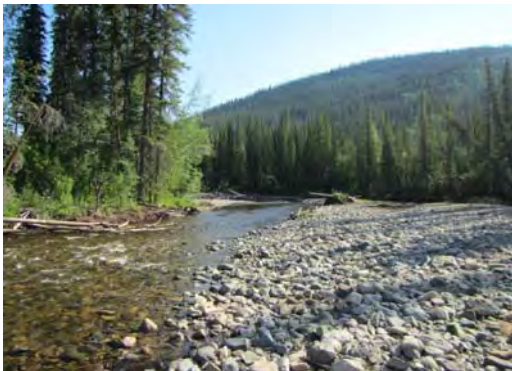
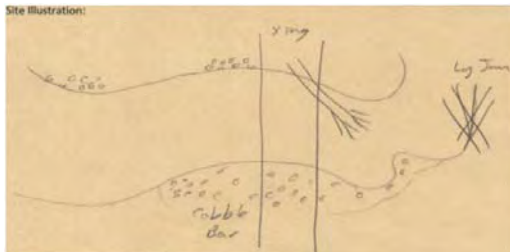
Freegold Road Extension Crossing # 67+570 - Hayes Creek

D/S	X	U/S
Coordinates:	6949993 N	346696 E	Gradient (%):	1.5	0.5
Site Visit Date:	25-Jun-13		Bankfull Width (m):	44.00	21.00
Flow Conditions:	Low		Average Depth (m):	0.50	0.40
Barrier/Confirmed:	None		Wetted Widths (m):	14.00	21.00
Electrofished/Effort?:	Yes (2010)		Substrate Bed:	C/B	G/C
Gee Trapping:	No		Substrate Bank:	-	-
Fish present?:	Yes		Riparian Vegetation:	-	-
Site Length:	100 m		Meander Pattern:	-	-
			Cover:	35% / OV	15% / OV

Comments:
Pre-existing site card as 67+600
High quality habitat

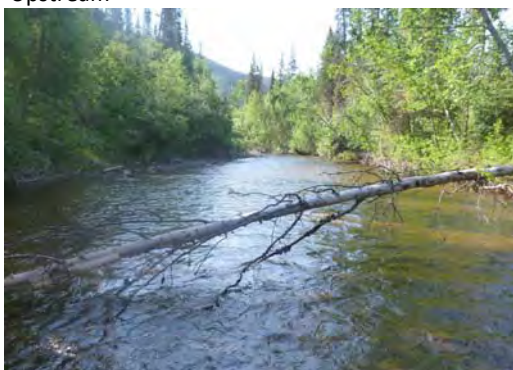
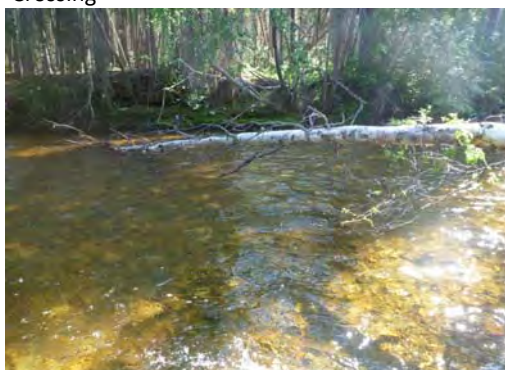
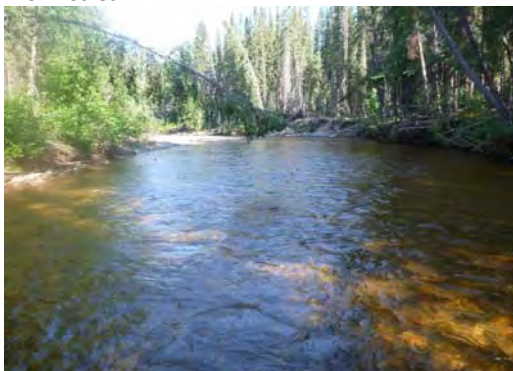
Freegold Road Extension Crossing # 68+450 - Hayes Creek

D/S	X	U/S
Coordinates:	6950819 N	346819 E	Gradient (%):	0.8	0.5
Site Visit Date:	25-Jun-13		Bankfull Width (m):	18.00	17.00
Flow Conditions:	Typical		Average Depth (m):	0.70	0.70
Barrier/Confirmed:	None		Wetted Widths (m):	17.00	16.00
Electrofished/Effort?:	No		Substrate Bed:	G/C	G/C
Gee Trapping:	No		Substrate Bank:	-	-
Fish present?:	Yes		Riparian Vegetation:	-	-
Site Length:	100 m		Meander Pattern:	-	-
			Cover:	25% / OV	30% / U/OV

Comments:
Pre-existing Site Card as 68+470
Riffle-run sequence with little pool habitat

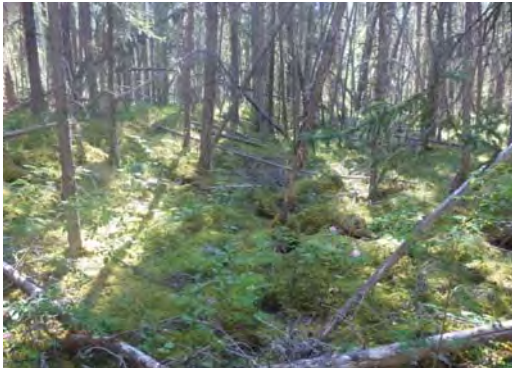
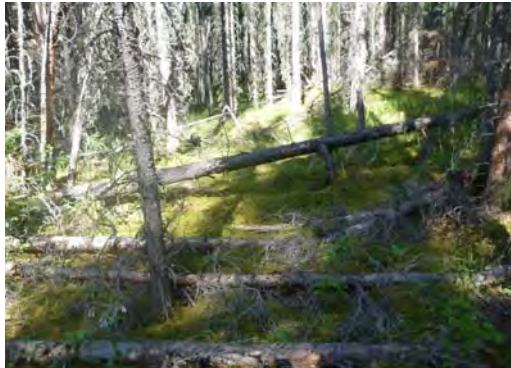
Freegold Road Extension Crossing # 68+850 - No Channel

D/S	X	U/S
Coordinates:	6951179 N	346896 E	Gradient (%):	-	-
Site Visit Date:	25-Jun-13		Bankfull Width (m):	-	-
Flow Conditions:	No Channel		Bankfull Depth (m):	-	-
Barrier/Confirmed:	N/A		Wetted Widths (m):	-	-
Electrofished/Effort?:	N/A		Wetted Depth (m):	-	-
Gee Trapping:	N/A		Substrate Bed:	-	-
Fish present?:	N/A		Substrate Bank:	-	-
Site Length:	N/A		Riparian Vegetation:	-	-
			Meander Pattern:	-	-
			Cover:	-	-
Photo #s	u/s	x	d/s		
Areas of Erosion:	N/A		Temperature:	-	°C
Locations:			pH:	-	pH units
			Conductivity:	-	µS/cm
			DO:	-	mg/L
				-	% Sat
Comments:					
No channel or evidence of flow

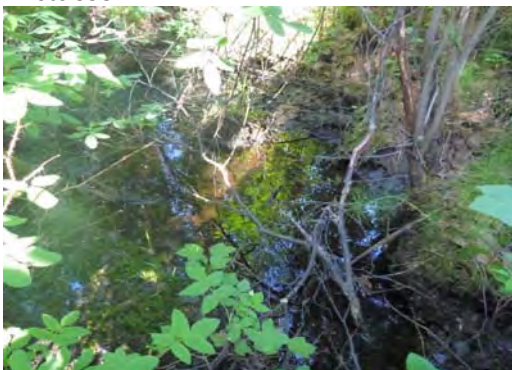
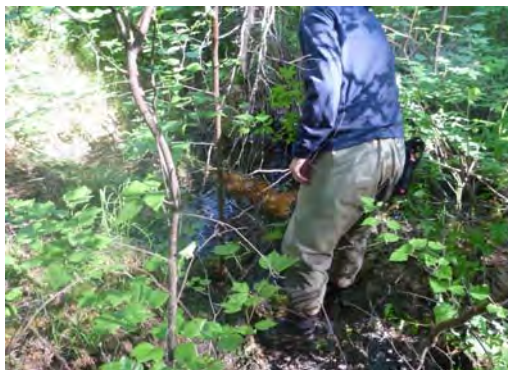
Freegold Road Extension Crossing # 69+110 - Hayes Creek Tributary

D/S	X	U/S
Coordinates:	6951323 N	346691 E	Gradient (%):	-	-
Site Visit Date:	25-Jun-13		Bankfull Width (m):	-	-
Flow Conditions:	Low		Bankfull Depth (m):	-	-
Barrier/Confirmed:	Yes		Wetted Widths (m):	-	1.20
Electrofished/Effort?:	No		Wetted Depth (m):	-	0.11
Gee Trapping:	No		Substrate Bed:	-	F
Fish Bearing?:	No		Substrate Bank:	-	F
Site Length:	25 m		Riparian Vegetation:	-	SP/BI
			Meander Pattern:	-	None
			Cover:	-	-
Photo #s	u/s	x	d/s		
Areas of Erosion:	No		Temperature:	-	°C
Locations:			pH:	-	pH units
			Conductivity:	-	µS/cm
			DO:	-	mg/L
				-	% Sat
Comments:					
No flow					
Dry channel with stagnant pool

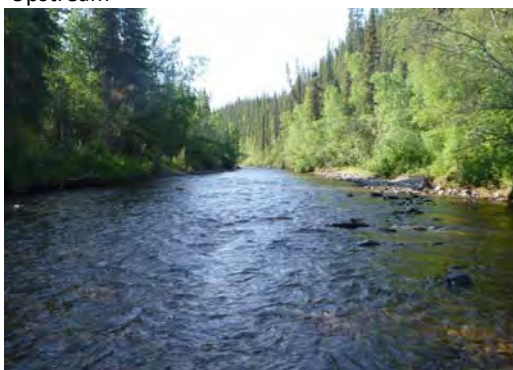
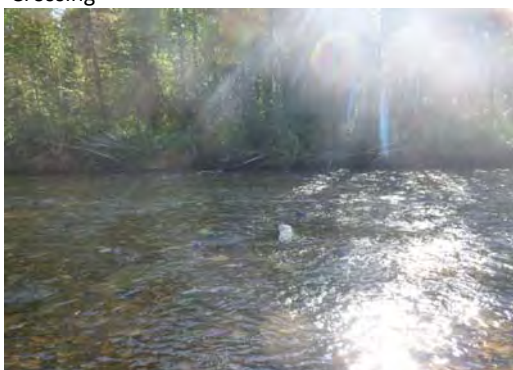
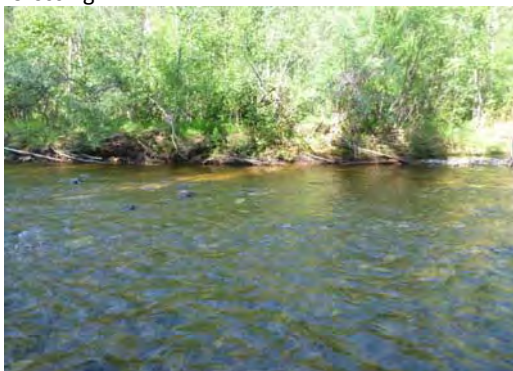
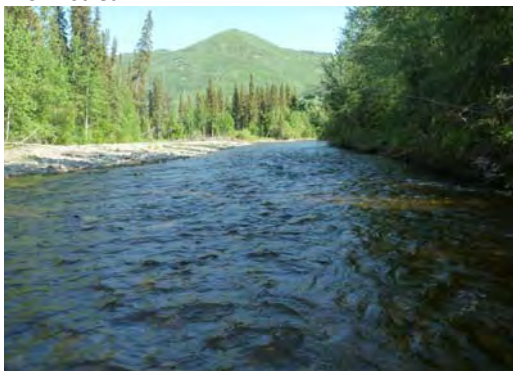
Freegold Road Extension Crossing # 69+340 - Hayes Creek

D/S	X	U/S
Coordinates:	6951425 N	346481 E	Gradient (%):	1	1
Site Visit Date:	25-Jun-13		Bankfull Width (m):	21.00	20.00
Flow Conditions:	Typical		Average Depth (m):	0.60	0.60
Barrier/Confirmed:	None		Wetted Widths (m):	16.00	19.00
Electrofished/Effort?:	Yes (2010)		Substrate Bed:	C/B	C/B
Gee Trapping:	No		Substrate Bank:	-	-
Fish Bearing?	Yes		Riparian Vegetation:	-	-
Site Length:	100 m		Meander Pattern:	-	-
			Cover:	20% / OV	20% / OV

Comments:
Pre-existing Site Card as 69+510
Could add some side pool habitat below bridge
Saw grayling in a pool, approximately 200m downstream
Crossing is one large riffle

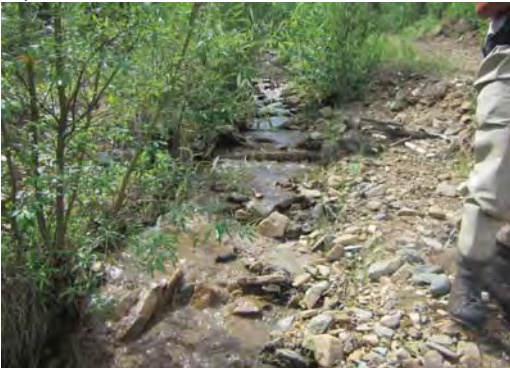
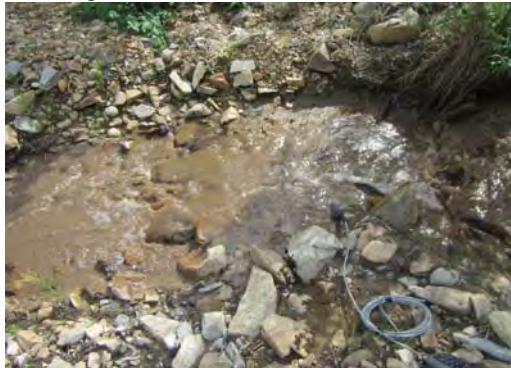
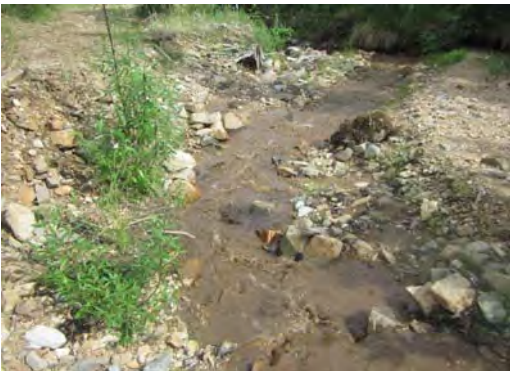
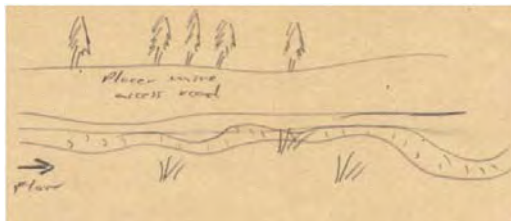
Freegold Road Extension Crossing # 71+100 - Hayes Creek Tributary

D/S	X	U/S	
Coordinates:	6951828 N	652181 E	Gradient (%):	11	7	10
Site Visit Date:	22-Jun-13		Bankfull Width (m):	1.53	1.18	1.05
Flow Conditions:	Low		Bankfull Depth (m):	0.20	0.25	0.23
Barrier/Confirmed:	None		Wetted Widths (m):	0.90	0.80	0.55
Electrofished/Effort?:	No		Wetted Depth (m):	0.12	0.14	0.10
Gee Trapping:	No		Substrate Bed:	C/G	C/G	C/G
Fish present?:	Yes		Substrate Bank:	C/S	C/S	C/S
Site Length:	100 m		Riparian Vegetation:	PO/GR	WI	None
			Meander Pattern:	ST/SI	ST/SI	ST/SI
		Cover:	0	5% / OV	-	
Photo #s	16 u/s	17 x	18 d/s			
Areas of Erosion:	Yes		Temperature:	10.96	°C	
Locations:	Entire upstream stretch		pH:	7.45	pH units	
	Placer and road		Conductivity:	337	uS/cm	
	Sonura Gulch		DO:	11.4	mg/L	
				110	% Sat

Comments:
Sparse willow cover at crossing
Active placer upstream - very turbid
Cascade in ditch at crossing

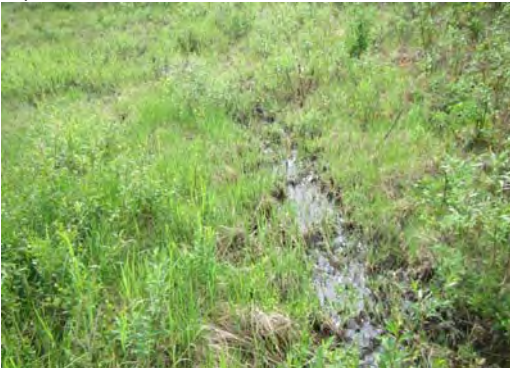
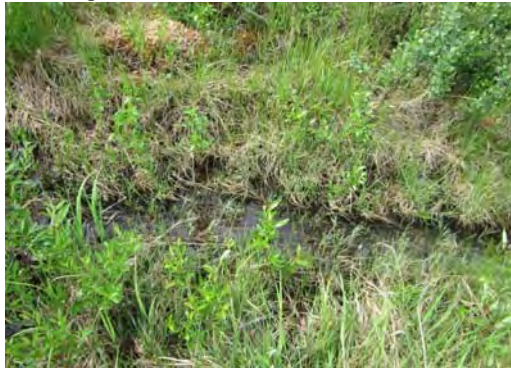
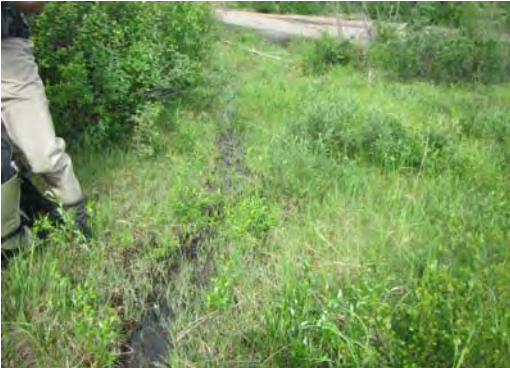
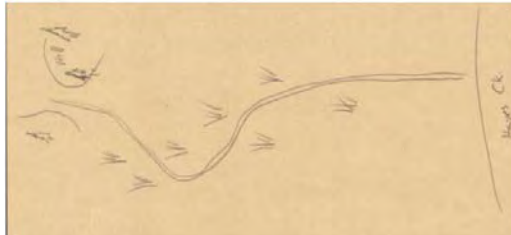
Freegold Road Extension Crossing # 71+290 (Unmapped Site) - Hayes Creek Tributary

D/S	X	U/S	
Coordinates:	6951933 N	651968 E	Gradient (%):	-	9	-
Site Visit Date:	22-Jun-13		Bankfull Width (m):	-	-	-
Flow Conditions:	Low		Bankfull Depth (m):	-	-	-
Barrier/Confirmed:	Yes		Wetted Widths (m):	-	0.22	-
Electrofished/Effort?:	No		Wetted Depth (m):	-	0.06	-
Gee Trapping:	No		Substrate Bed:	-	F	-
Fish present?:	No		Substrate Bank:	-	F	-
Site Length:	100 m		Riparian Vegetation:	-	GR	-
			Meander Pattern:	-	SI	-
			Cover:	-	-	-
Photo #s	19 u/s	20 x	21 d/s			
Areas of Erosion:	No		Temperature:	-	°C	
Locations:			pH:	-	pH units	
			Conductivity:	-	uS/cm	
			DO:	-	mg/L	
				-	% Sat

Comments:
Unmapped creek
No defined channel, flowing through grass
No direct fish habitat
