APPENDIX 10B: FREEGOLD ROAD FISH AND AQUATIC BASELINE

Casino Project

Fish and Aquatic Resources Baseline Report:

Freegold Road Extension, Freegold Road Upgrade, and Casino Airstrip and Airstrip Access Road

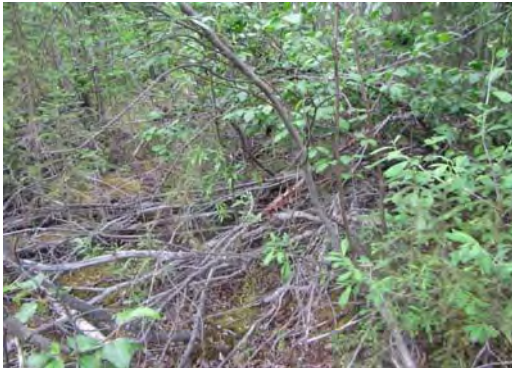
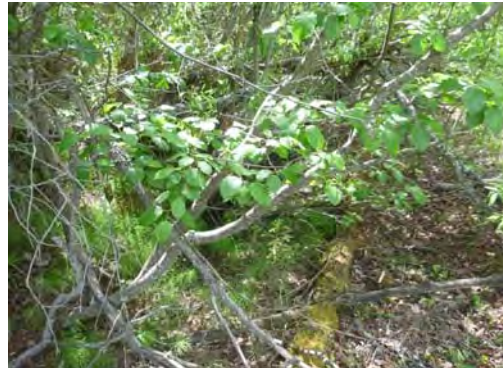
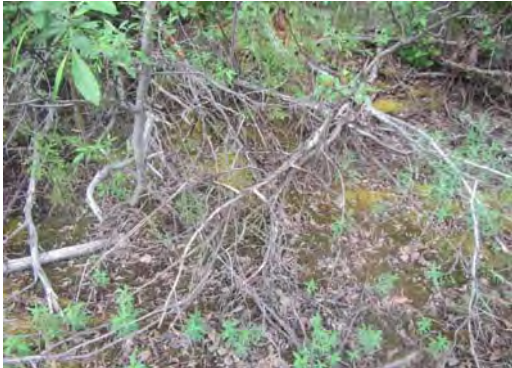
Freegold Road Extension Crossing # 71+600 - Hayes Creek Tributary

D/S	X	U/S
Coordinates:	6951973 N	651716 E	Gradient (%):	-	-
Site Visit Date:	22-Jun-13		Bankfull Width (m):	-	-
Flow Conditions:			Bankfull Depth (m):	-	-
Barrier/Confirmed:	/		Wetted Widths (m):	-	-
Electrofished/Effort?:	/		Wetted Depth (m):	-	-
Gee Trapping:			Substrate Bed:	-	-
Fish present?:	Y/N		Substrate Bank:	-	-
Site Length:			Riparian Vegetation:	-	-
	(200m)		Meander Pattern:	-	-
			Cover:	-	-
Photo #s	25/878 u/s	26/879 x	7/880-881 d/s		
Areas of Erosion:	N	Temperature:	-	°C	
Locations:		pH:	-	pH units	
		Conductivity:	-	uS/cm	
		DO:	-	mg/L	
			-	% Sat	
Comments:	This site was overlapped by both teams - 2 sets of confirming information				
	No flow at site, appears to be an old high water side channel of Hayes Creek				
	No habitat				
	No visible channel; nearby creek was assessed instead				
	Saw another dry drainage area nearby - no visible channel

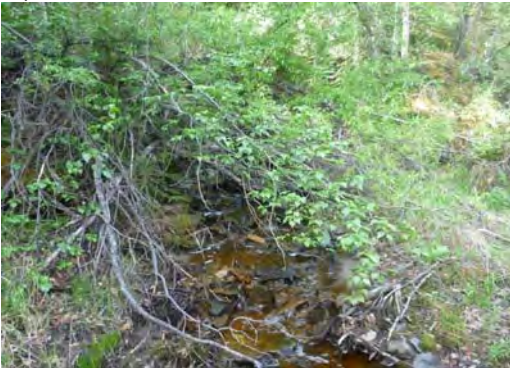
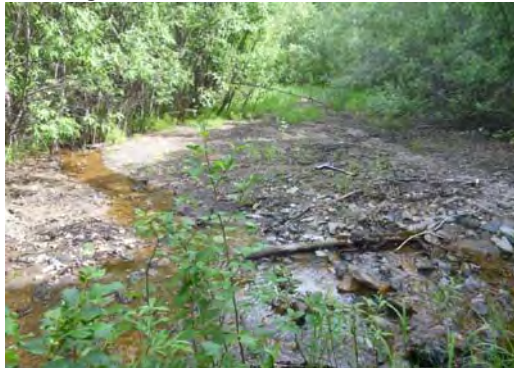
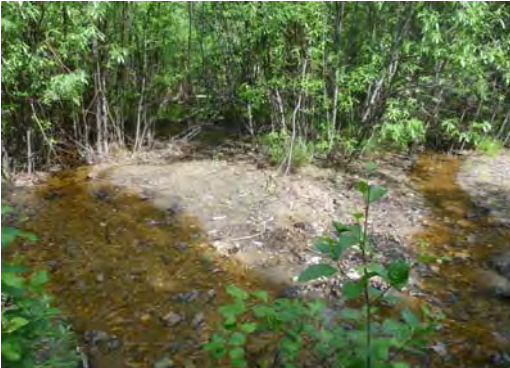
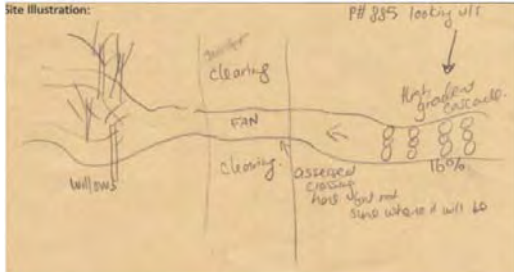
Freegold Road Extension Crossing # 71+625 - Hayes Creek Tributary

D/S	X	U/S	
Coordinates:	6951959 N	651678 E	Gradient (%):	3.5	5	5
Site Visit Date:	22-Jun-13		Bankfull Width (m):	1.50	2.50	1.55
Flow Conditions:	Low		Bankfull Depth (m):	0.13	0.13	0.43
Barrier/Confirmed:	Low Flow		Wetted Widths (m):	0.74	1.24	0.96
Electrofished/Effort?:	Yes (2011)		Wetted Depth (m):	0.05	0.05	0.06
Gee Trapping:	No		Substrate Bed:	G/F	G/C	C/G
Fish Bearing?	Yes		Substrate Bank:	F	F	F
Site Length:	100 m		Riparian Vegetation:	WI/AL/GR	WI/PO	PO/WI/SP
			Meander Pattern:	IM	IM	IM
		Cover:	10% / OV	5% / OV	90% / LWD	
Photo #s	882 u/s	883 x	884 d/s			
Areas of Erosion:	No		Temperature:	4.7	°C	
Locations:			pH:	-	pH units	
			Conductivity:	57	uS/cm	
			DO:	14.18	mg/L	
				110.2	% Sat

Comments:
Bankfull width is an underestimate, area fans out at high flow
Photo 885 looking upstream at high gradient cascade that may act as a low flow barrier

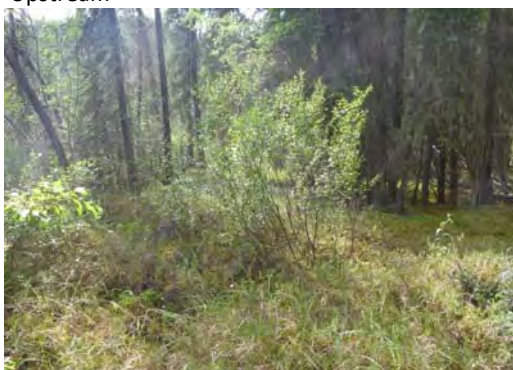
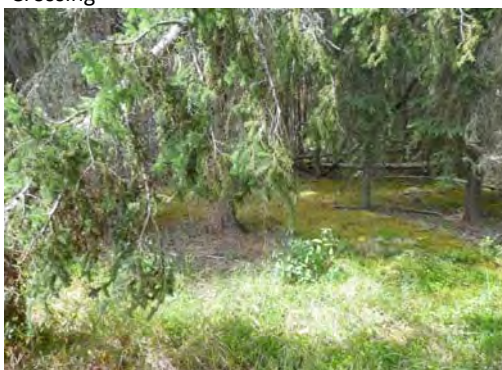
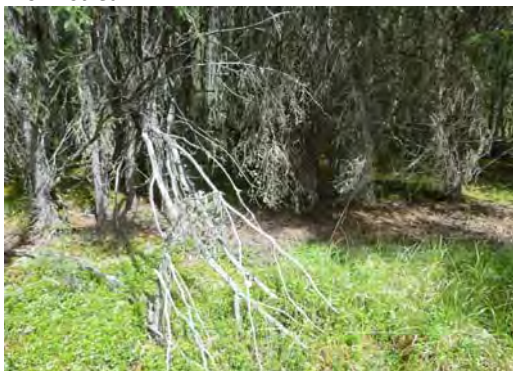
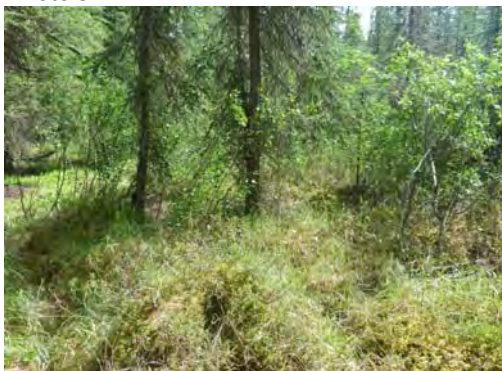
Freegold Road Extension Crossing # 71+760 - Hayes Creek Tributary

D/S	X	U/S
Coordinates:	6952033 N	651564 E	Gradient (%):	-	-
Site Visit Date:	22-Jun-13		Bankfull Width (m):	-	-
Flow Conditions:	None		Bankfull Depth (m):	-	-
Barrier/Confirmed:	N/A		Wetted Widths (m):	-	-
Electrofished/Effort?:	N/A		Wetted Depth (m):	-	-
Gee Trapping:	N/A		Substrate Bed:	-	-
Fish Bearing?:	N/A		Substrate Bank:	-	-
Site Length:	N/A		Riparian Vegetation:	-	-
			Meander Pattern:	-	-
			Cover:	-	-
Photo #s	874 u/s	875 x	876 d/s		
Areas of Erosion:	N/A		Temperature:	-	°C
Locations:			pH:	-	pH units
			Conductivity:	-	uS/cm
			DO:	-	mg/L
				-	% Sat
Comments:					
No visible channel

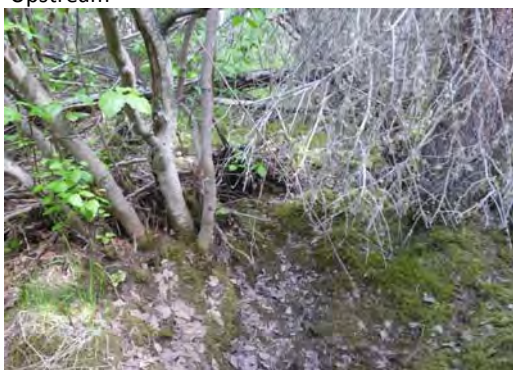
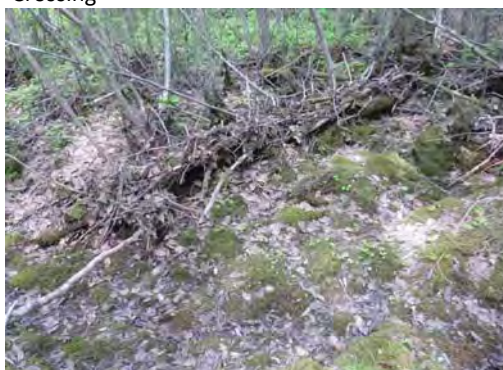
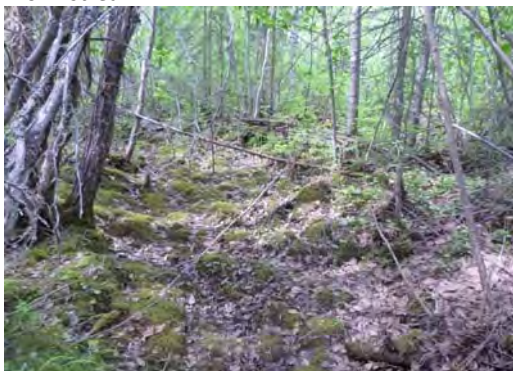
Freegold Road Extension Crossing # 71+810 - Hayes Creek Tributary

D/S	X	U/S
Coordinates:	6952052 N	651512 E	Gradient (%):	-	-
Site Visit Date:	22-Jun-13		Bankfull Width (m):	-	-
Flow Conditions:	None		Bankfull Depth (m):	-	-
Barrier/Confirmed:	N/A		Wetted Widths (m):	-	-
Electrofished/Effort?:	N/A		Wetted Depth (m):	-	-
Gee Trapping:	N/A		Substrate Bed:	-	-
Fish present?:	N/A		Substrate Bank:	-	-
Site Length:	N/A		Riparian Vegetation:	-	-
			Meander Pattern:	-	-
			Cover:	-	-
Photo #s	873 u/s	872 x	871 d/s		
Areas of Erosion:	N/A		Temperature:	-	°C
Locations:			pH:	-	pH units
			Conductivity:	-	uS/cm
			DO:	-	mg/L
				-	% Sat
Comments:					
Dry channel					
Likely ephemeral drainage feature

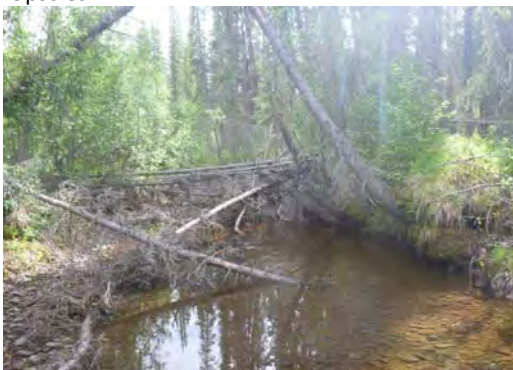
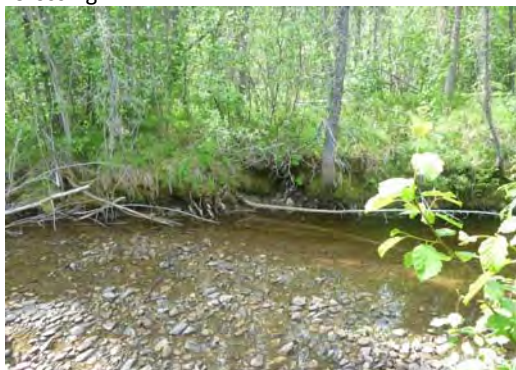
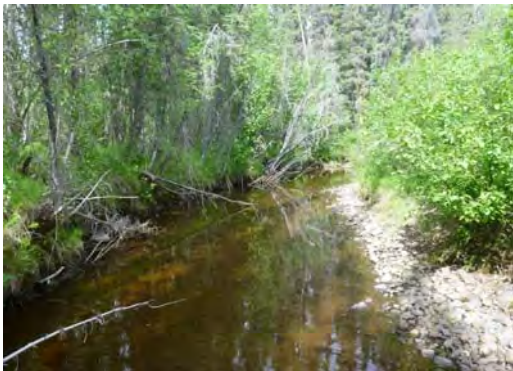
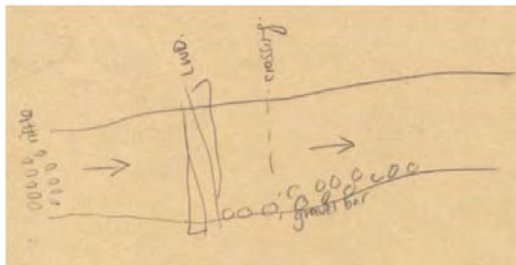
Freegold Road Extension Crossing # 71+980 - Hayes Creek Tributary

D/S	X	U/S
Coordinates:	6952110 N	651353 E	Gradient (%):	2	2
Site Visit Date:	22-Jun-13		Bankfull Width (m):	7.50	6.50
Flow Conditions:	Low		Bankfull Depth (m):	0.97	0.34
Barrier/Confirmed:	None		Wetted Widths (m):	6.80	3.70
Electrofished/Effort?:	No		Wetted Depth (m):	0.58	0.07
Gee Trapping:	No		Substrate Bed:	G/F	G
Fish Bearing?	Yes		Substrate Bank:	F	F
Site Length:	100 m		Riparian Vegetation:	SP/PO/WI/AL	SP/PO/WI
			Meander Pattern:	SI	SI
			Cover:	10% / LWD	10% / LWD
Photo #s	868 u/s	869 x	870 d/s		
Areas of Erosion:	N		Temperature:	3.73	°C
Locations:			pH:	-	pH units
			Conductivity:	152	uS/cm
			DO:	7.75	mg/L
				73.9	% Sat

Comments:
Slow-moving wide channel, almost stagnant but some flow
Velocity barely above zero except at very shallow riffles

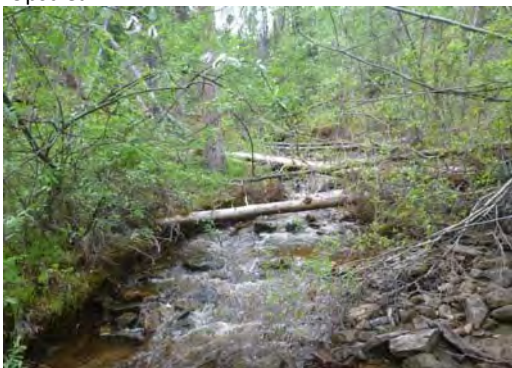
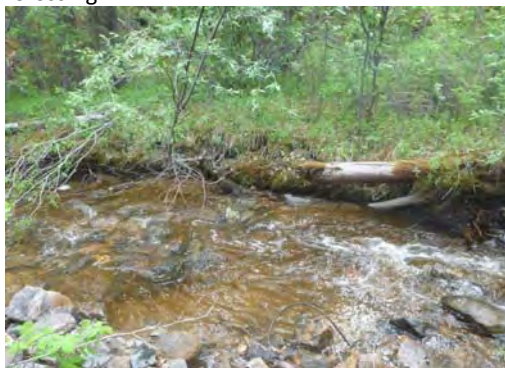
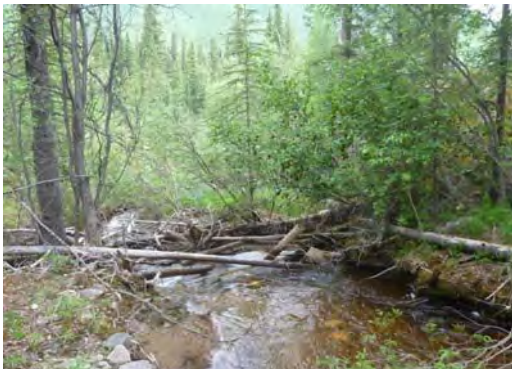
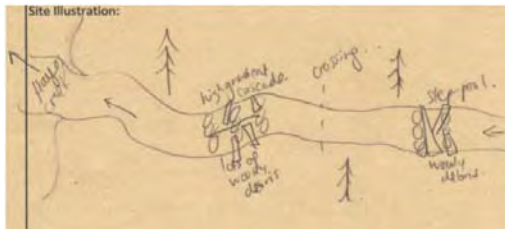
Freegold Road Extension Crossing # 72+200 - Senora Gulch

D/S	X	U/S	
Coordinates:	6952170 N	651145 E	Gradient (%):	7	10.5	7
Site Visit Date:	22-Jun-13		Bankfull Width (m):	1.75	3.30	4.00
Flow Conditions:	Low		Bankfull Depth (m):	0.64	0.50	0.70
Barrier/Confirmed:	None		Wetted Widths (m):	1.75	2.10	2.60
Electrofished/Effort?:	No		Wetted Depth (m):	0.15	0.23	0.18
Gee Trapping:	No		Substrate Bed:	C/B	C/B	G/C
Fish Bearing?	Yes		Substrate Bank:	F	F	F/C
Site Length:	100 m		Riparian Vegetation:	SP/WI	SP/WI/PO	SP/WI
			Meander Pattern:	IM	IM	IM
			Cover:	45% / LWD	25% / LWD	30% / LWD
Photo #s	865 u/s	866 x	867 d/s			
Areas of Erosion:	No		Temperature:	3.05	°C	
Locations:			pH:	-	pH units	
			Conductivity:	159	uS/cm	
			DO:	15.27	mg/L	
				113.7	% Sat	
Comments:						
Lots of LWD present						
Pool-riffle sequence at crossing

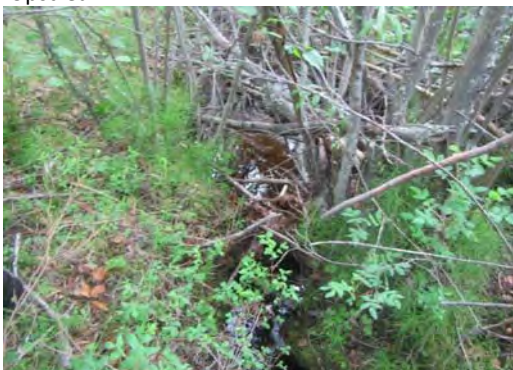
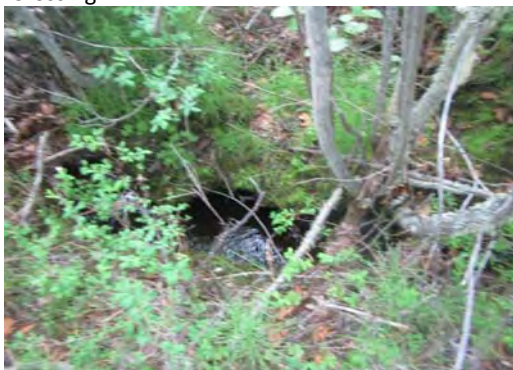
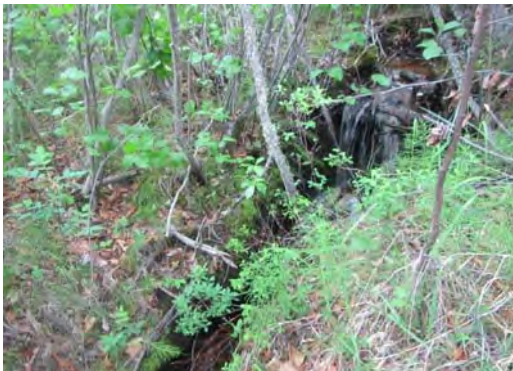
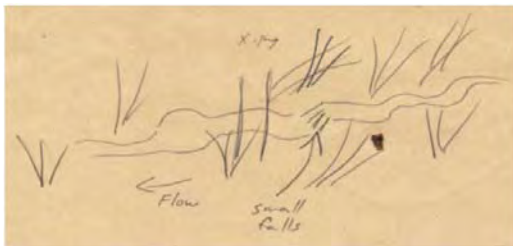
Freegold Road Extension Crossing # 73+500 - Hayes Tributary

D/S	X	U/S	
Coordinates:	6952558 N	649980 E	Gradient (%):	13	18	8
Site Visit Date:	22-Jun-13		Bankfull Width (m):	0.20	0.28	0.95
Flow Conditions:	Low		Bankfull Depth (m):	0.45	0.36	0.30
Barrier/Confirmed:	Yes		Wetted Widths (m):	0.40	0.35	0.75
Electrofished/Effort?:	No		Wetted Depth (m):	0.16	0.23	0.15
Gee Trapping:	No		Substrate Bed:	G/C	G	C/G
Fish Bearing?	No		Substrate Bank:	F	F	F
Site Length:	100 m		Riparian Vegetation:	AL/WI	AL/WI	AL/WI
			Meander Pattern:	SI	SI	SI
		Cover:	60% / U	90% / OV	50% / OV	
Photo #s	28 u/s	29 x	30 d/s			
Areas of Erosion:	No		Temperature:	-	°C	
Locations:			pH:	-	pH units	
			Conductivity:	-	uS/cm	
			DO:	-	mg/L	
				-	% Sat

Comments:
1 meter tall falls located just upstream of the crossing
Multiple barriers identified
Incised deeply, with a large amount of small woody debris

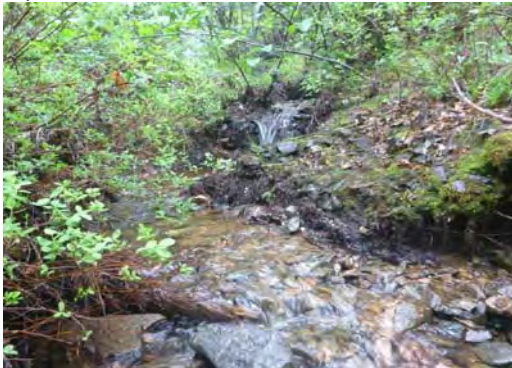
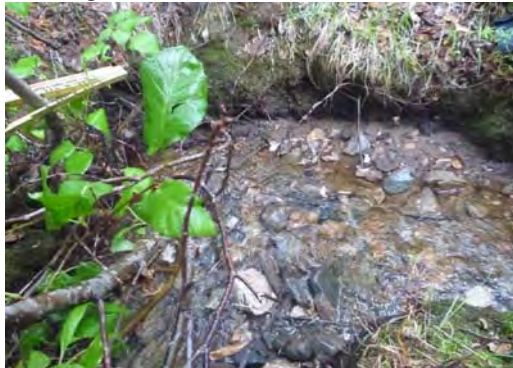
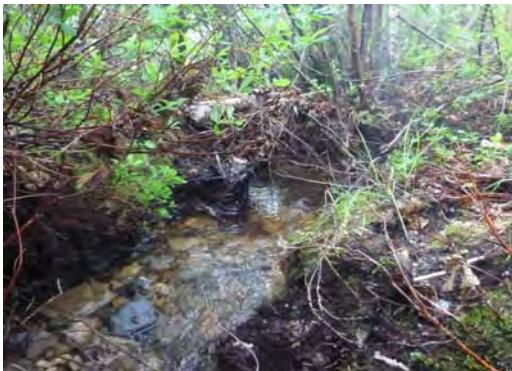
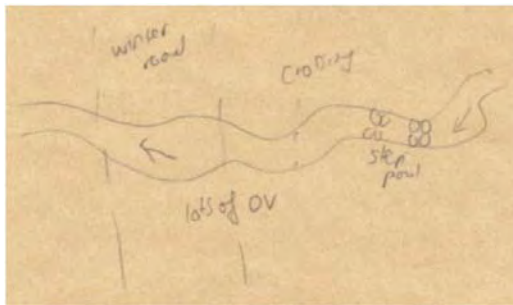
Freegold Road Extension Crossing # 74+770 (Unmapped Site) - Hayes Creek Tributary

D/S	X	U/S	
Coordinates:	6952594 N	648829 E	Gradient (%):	9	17.5	9
Site Visit Date:	22-Jun-13		Bankfull Width (m):	0.70	0.75	1.25
Flow Conditions:	Low		Bankfull Depth (m):	0.53	0.37	0.35
Barrier/Confirmed:	Yes		Wetted Widths (m):	0.40	0.67	1.25
Electrofished/Effort?:	No		Wetted Depth (m):	0.22	0.05	0.03
Gee Trapping:	No		Substrate Bed:	G/C	G/C	G/C
Fish Bearing?	Yes		Substrate Bank:	F	F	F
Site Length:	100 m		Riparian Vegetation:	WI/AL/PO/SP	WI/AL/PO	WI/AL/PO
			Meander Pattern:	IM	IM	IM
		Cover:	100% / OV	80% / OV	100% / OV	
Photo #s	889 u/s	890 x	891 d/s			
Areas of Erosion:	No		Temperature:	5.94	°C	
Locations:			pH:	-	pH units	
			Conductivity:	200	uS/cm	
			DO:	13.5	mg/L	
				108.5	% Sat	
Comments:						
High waterfall at upstream site (at least 5'6") - photo 892						
Creates an unstream barrier to fish passage, however downstream appears to be clear

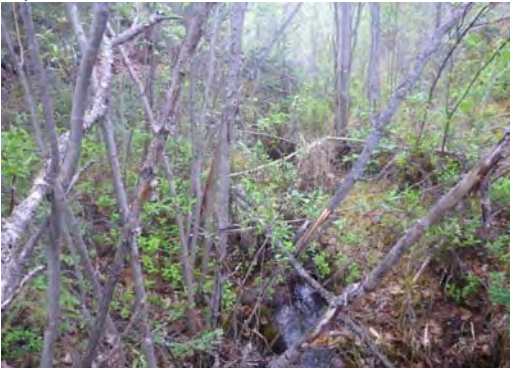
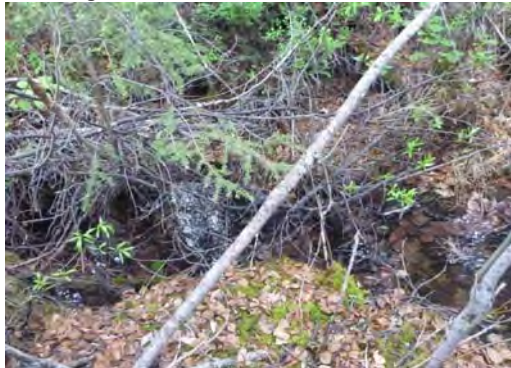
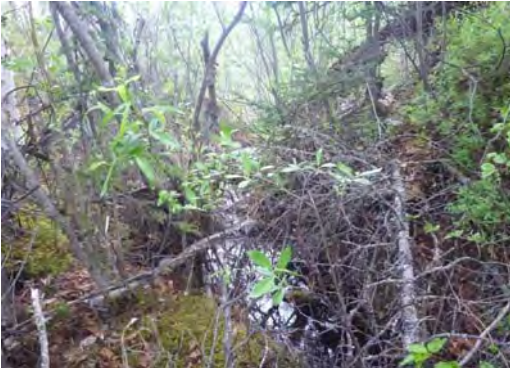
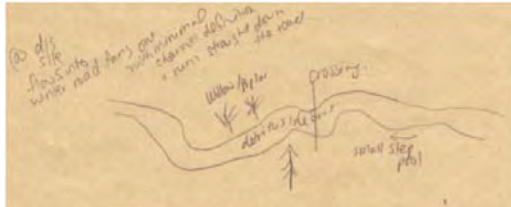
Freegold Road Extension Crossing # 74+810 - Hayes Creek Tributary

D/S	X	U/S
Coordinates:	6952529 N	648749 E	Gradient (%):	3.5	9	3.5
Site Visit Date:	22-Jun-13		Bankfull Width (m):	0.94	0.95	1.26
Flow Conditions:	Low		Bankfull Depth (m):	0.31	0.29	0.55
Barrier/Confirmed:	None		Wetted Widths (m):	0.58	0.42	0.36
Electrofished/Effort?:	Yes (2011)		Wetted Depth (m):	0.14	0.12	0.31
Gee Trapping:	No		Substrate Bed:	F	F	F
Fish Bearing?	Yes		Substrate Bank:	F	F	F
Site Length:	100 m		Riparian Vegetation:	SP/PO/WI	WI/PO/SP	SP/WI/PO
			Meander Pattern:	IM	IM	IM
			Cover:	50% / OV	80% / SWD	60% / OV
Photo #s	886 u/s	887 x	888 d/s			
Areas of Erosion:	No		Temperature:	3.05	°C	
Locations:			pH:	-	pH units	
			Conductivity:	161	uS/cm	
			DO:	14.71	mg/L	
				109.8	% Sat

Comments:
At the downstream site, water flows into winter road.
Channel fans out with minimal definition and runs straight down the road

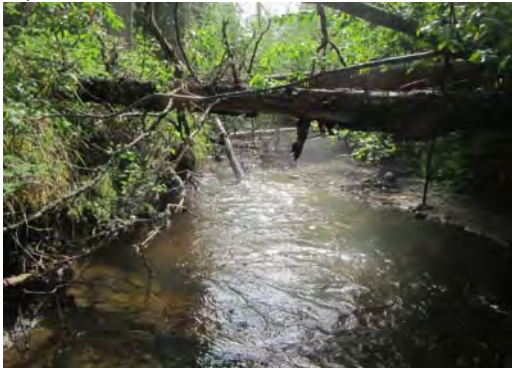
Upstream

Freegold Road Extension Crossing # 75+410 - Hayes Creek Tributary

D/S	X	U/S	
Coordinates:	6952532 N	648162 E	Gradient (%):	3	2	5
Site Visit Date:	22-Jun-13		Bankfull Width (m):	3.80	3.70	6.80
Flow Conditions:	Low		Bankfull Depth (m):	0.54	0.57	0.96
Barrier/Confirmed:	None		Wetted Widths (m):	3.80	3.50	4.50
Electrofished/Effort?:	Yes (2011)		Wetted Depth (m):	0.36	0.27	0.66
Gee Trapping:	No		Substrate Bed:	C/G	G/C	C/G
Fish Bearing?	Yes		Substrate Bank:	F	F	F
Site Length:	100 m		Riparian Vegetation:	SP/AL	WI/AL/SP	SP/AL
			Meander Pattern:	IM	IM	IM
		Cover:	40% / LWD	30% / LWD	30% / LWD	
Photo #s	31 u/s	32 x	33 d/s			
Areas of Erosion:	No		Temperature:	-	°C	
Locations:			pH:	7.3	pH units	
			Conductivity:	58	uS/cm	
			DO:	13.6	mg/L	
				120	% Sat	
Comments:						
Ample large woody debris						
Crossing at grove of large spruce						
High quality rearing habitat

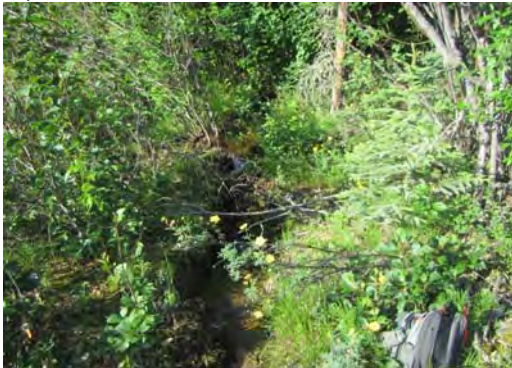
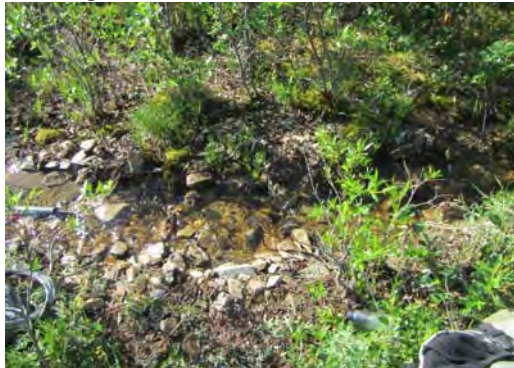
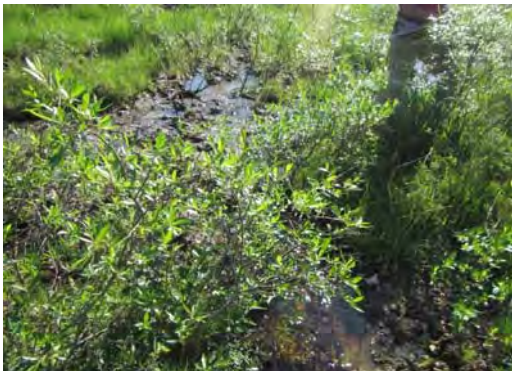
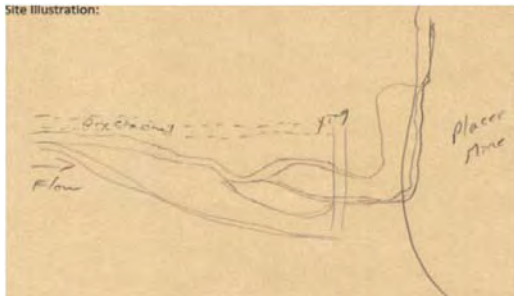
Freegold Road Extension Crossing # 77+220 - Hayes Creek Tributary

D/S	X	U/S	
Coordinates:	6953097 N	646520 E	Gradient (%):	1	11	17
Site Visit Date:	25-Jun-13		Bankfull Width (m):	-	0.59/0.47	0.83
Flow Conditions:	Low		Bankfull Depth (m):	-	0.10/0.14	0.27
Barrier/Confirmed:	None		Wetted Widths (m):	-	0.39/0.41	0.66
Electrofished/Effort?:	Yes (2011)		Wetted Depth (m):	-	0.06/0.09	0.15
Gee Trapping:	No		Substrate Bed:	F	G/S	G/S
Fiah Bearing?	Yes		Substrate Bank:	F	F	F
Site Length:	100 m		Riparian Vegetation:	GR	WI/GR	SP/AL
			Meander Pattern:	SI	SI	SI
		Cover:	0	0	20% / OV	
Photo #s	36 u/s	37 x	38 d/s			
Areas of Erosion:	Yes		Temperature:	2.81	°C	
Locations:	25m downstream of station,		pH:	7.1	pH units	
	new placer operation		Conductivity:	56	uS/cm	
			DO:	10.01	mg/L	
				79	% Sat	
Comments:						
Small creek draining directly into new placer operation on Hayes Creek floodplain						
Creek is ditched and managed downstream of the crossing						
Split channel at the crossing

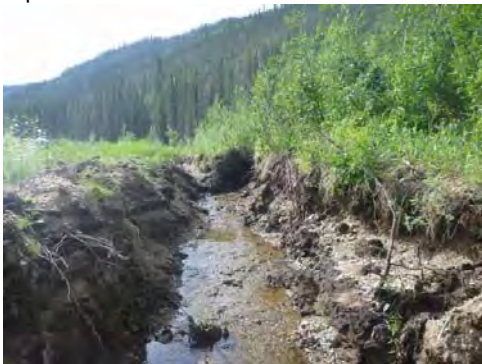
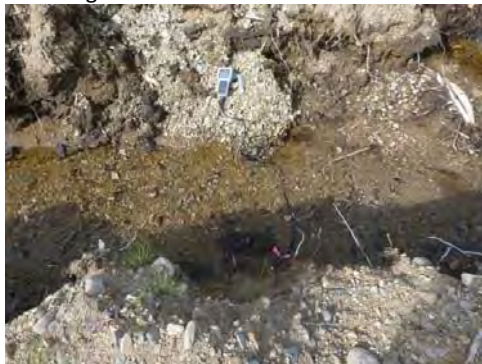
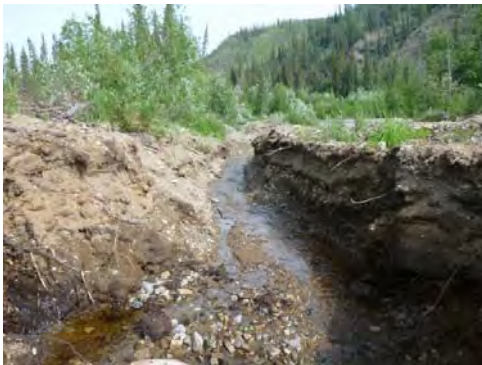
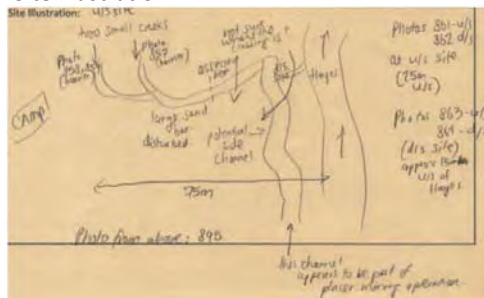
Freegold Road Extension Crossing # 77+770 (Unmapped site) - Hayes Creek Tributary

D/S	X	U/S	
Coordinates:	6953305 N	646068 E	Gradient (%):	2	3.5	19
Site Visit Date:	21-Jun-13		Bankfull Width (m):	4.00	2.70	3.00
Flow Conditions:	Low		Bankfull Depth (m):	1.10	1.41	0.60
Barrier/Confirmed:	Yes		Wetted Widths (m):	2.50	0.30	0.90
Electrofished/Effort?:	No		Wetted Depth (m):	0.34	0.05	0.10
Gee Trapping:	No		Substrate Bed:	G/C	G	C/B
Fish Bearing?	Yes		Substrate Bank:	F/G	F/G	F
Site Length:	100 m		Riparian Vegetation:	WI/PO	WI	SP/PO
			Meander Pattern:	SI	SI	IM
		Cover:	5% /	0	60% / OV	
Photo #s	854 u/s	855 x	856 d/s			
Areas of Erosion:	Yes		Temperature:	3.58	°C	
Locations:	Placer mining activities at crossing		pH:	-	pH units	
			Conductivity:	153	uS/cm	
			DO:	14.8	mg/L	
				111.8	% Sat

Comments:
Channel runs through a previous placer mining operation
This has artificially created some drop barriers
Watercourse would benefit from restoration and addition of pool habitat

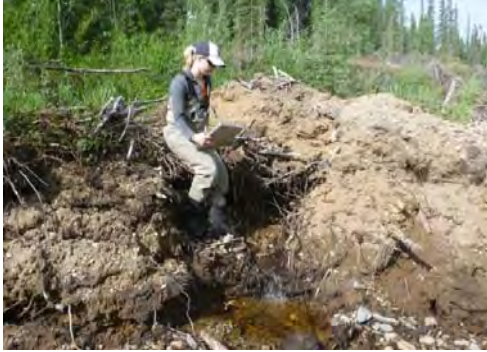
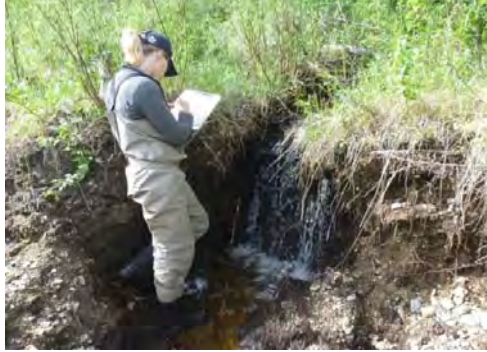
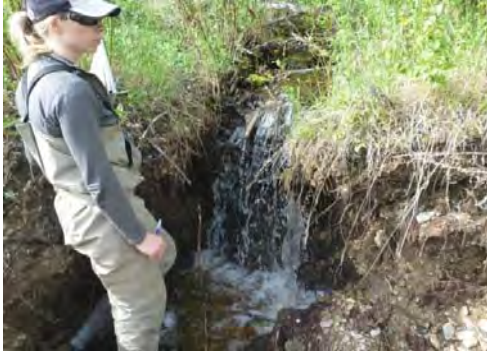
Freegold Road Extension Crossing # Unmapped site between 77+220 and 78+420 - Pg. 2

Photo 857 - Barrier

Photo 858 - Barrier

Photo 859 - Barrier

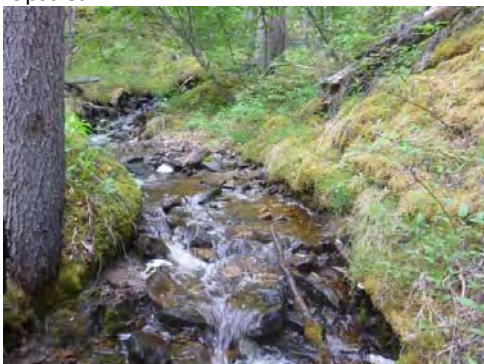
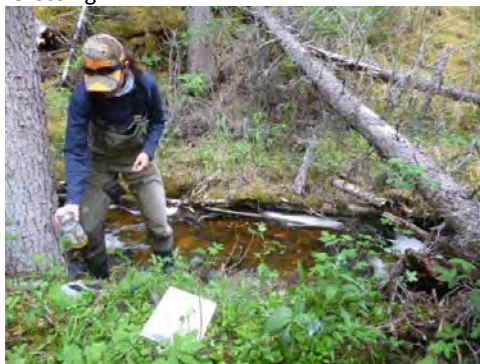
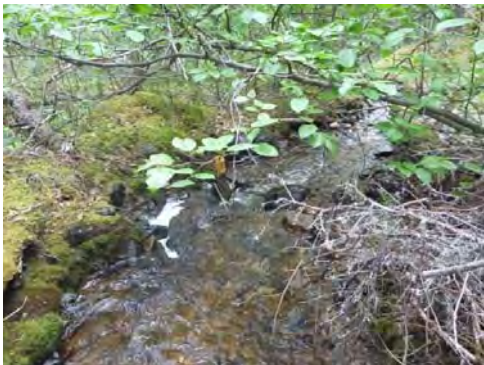
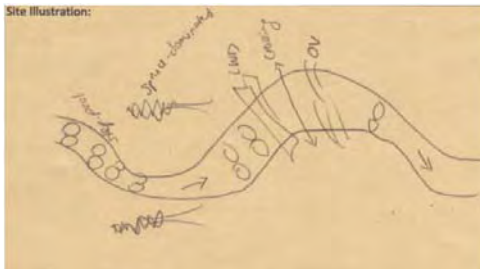
Freegold Road Extension Crossing # 78+420 - Hayes Creek Tributary

D/S	X	U/S	
Coordinates:	6953565 N	645495 E	Gradient (%):	14	16	14
Site Visit Date:	21-Jun-13		Bankfull Width (m):	2.50	1.60	1.83
Flow Conditions:	Low		Bankfull Depth (m):	0.50	0.49	0.49
Barrier/Confirmed:	None		Wetted Widths (m):	1.70	1.10	1.80
Electrofished/Effort?:	yes (2011)		Wetted Depth (m):	0.12	0.17	0.13
Gee Trapping:	No		Substrate Bed:	C/G	C/B	C/B
Fish Bearing?	Yes		Substrate Bank:	F/C	F/C	F/C
Site Length:	100 m		Riparian Vegetation:	SP/PO	SP/PO	SP/PO
			Meander Pattern:	IM	IM	IM
		Cover:	15% / LWD	25% / LWD	15% / LWD	
Photo #s	851 u/s	852 x	853 d/s			
Areas of Erosion:	N		Temperature:	3.9	°C	
Locations:			pH:	5.5	pH units	
			Conductivity:	114	uS/cm	
			DO:	14.44	mg/L	
				110	% Sat	
Comments:						
Good step-pool cover with LWD

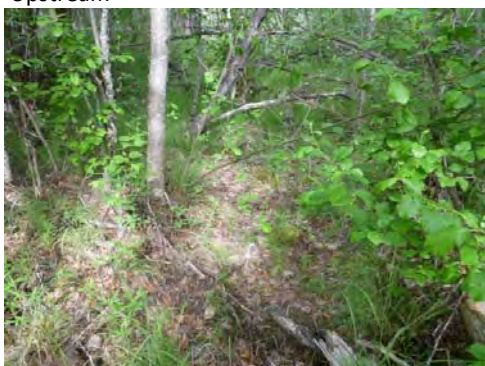
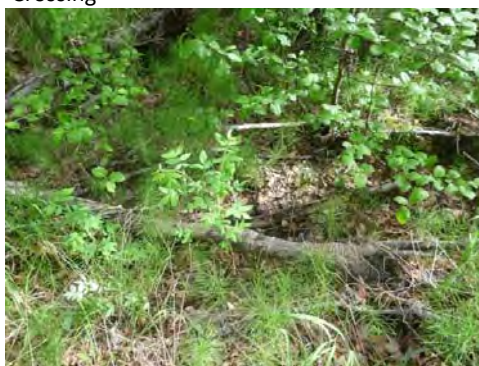
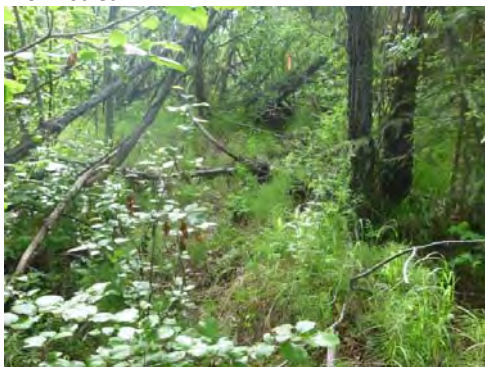
Freegold Road Extension Crossing # 78+540 - Hayes Creek Tributary

D/S	X	U/S
Coordinates:	6953658 N	645437 E	Gradient (%):	-	-
Site Visit Date:	21-Jun-13		Bankfull Width (m):	-	-
Flow Conditions:	None		Bankfull Depth (m):	-	-
Barrier/Confirmed:	N/A		Wetted Widths (m):	-	-
Electrofished/Effort?:	N/A		Wetted Depth (m):	-	-
Gee Trapping:	N/A		Substrate Bed:	-	-
Fish Bearing?:	N/A		Substrate Bank:	-	-
Site Length:	N/A		Riparian Vegetation:	-	-
			Meander Pattern:	-	-
			Cover:	-	-
Photo #s	848 u/s	849 x	850 d/s		
Areas of Erosion:	N/A		Temperature:	-	°C
Locations:			pH:	-	pH units
			Conductivity:	-	uS/cm
			DO:	-	mg/L
				-	% Sat
Comments:					
Potential ephemeral drainage feature

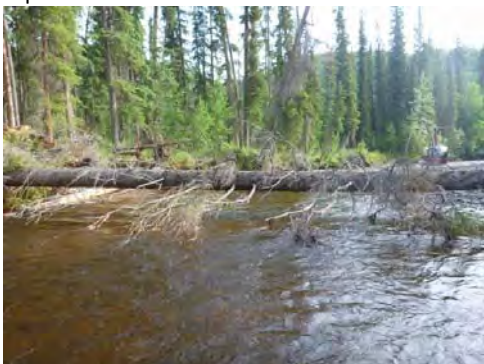
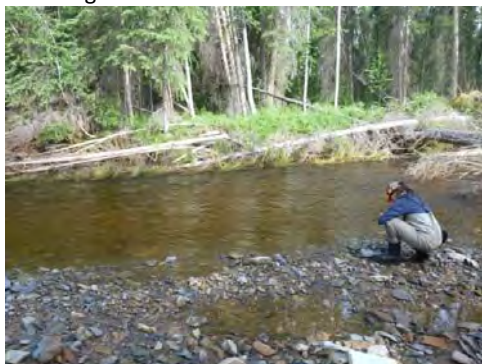
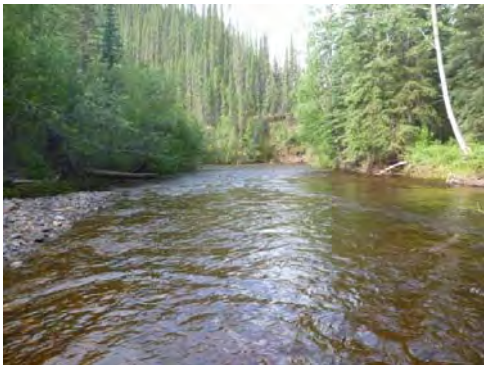
Freegold Road Extension Crossing # 78+980 - Hayes Creek

D/S	X	U/S	
Coordinates:	6953951 N	645113 E	Gradient (%):	0.5	0.5	1
Site Visit Date:	21-Jun-13		Bankfull Width (m):	22.00	22.00	23.00
Flow Conditions:	Low		Average Depth (m):	0.80	0.80	0.70
Barrier/Confirmed:	None		Wetted Widths (m):	19.00	16.00	16.00
Electrofished/Effort?:	No		Substrate Bed:	C/G	C/G	C/G
Gee Trapping:	No		Substrate Bank:	-	-	-
Fish Bearing?	Yes		Riparian Vegetation:	-	-	-
Site Length:	100 m		Meander Pattern:	-	-	-
			Cover:	30% / OV	40% / LWD	30% / OV

Photo #s	845 u/s	846 x	847 d/s	
Areas of Erosion:	Yes		Temperature:	6.64 °C
Locations:	Slumping noted on both banks		pH:	~ 7 pH units
			Conductivity:	164 uS/cm
			DO:	12.98 mg/L
				105.9 % Sat

Comments:
Pre-existing site card as 79+090
High erosion potential
High quality rearing habitat

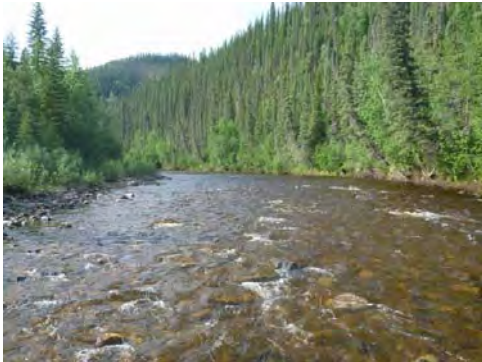
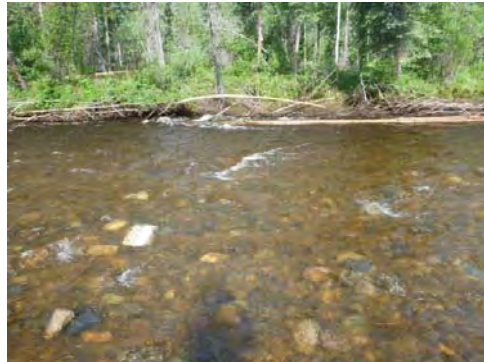
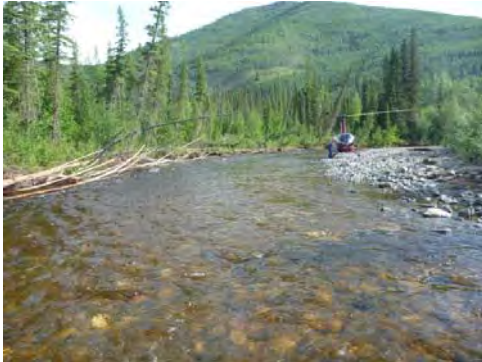
Freegold Road Extension Crossing # 79+380 - Hayes Creek

D/S	X	U/S
Coordinates:	6954264 N	644886 E	Gradient (%):	1.5	1
Site Visit Date:	21-Jun-13		Bankfull Width (m):	26	22
Flow Conditions:	Low		Average Depth (m):	0.9	0.7
Barrier/Confirmed:	None		Wetted Widths (m):	22	20
Electrofished/Effort?:	Yes (2010)		Substrate Bed:	C/G	C/G
Gee Trapping:	No		Substrate Bank:	-	-
Fish Bearing?	Yes		Riparian Vegetation:	-	-
Site Length:	100 m		Meander Pattern:	-	-
			Cover:	50% / OV/LWD	40% / OV

Comments:
Pre-existing Site Card as 79+380
Small amount of erosion on left bank
Riffle sequence with only a small amount of slow refuge areas

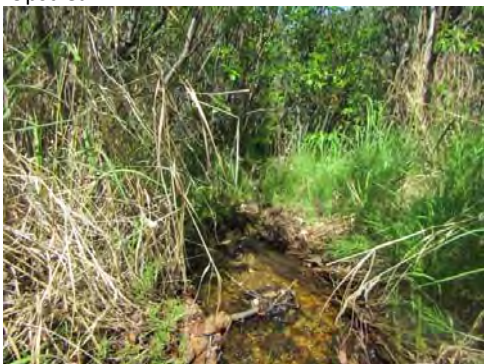
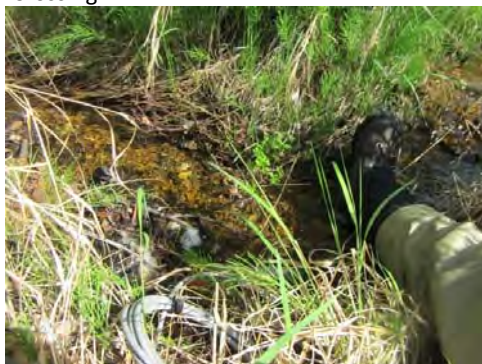
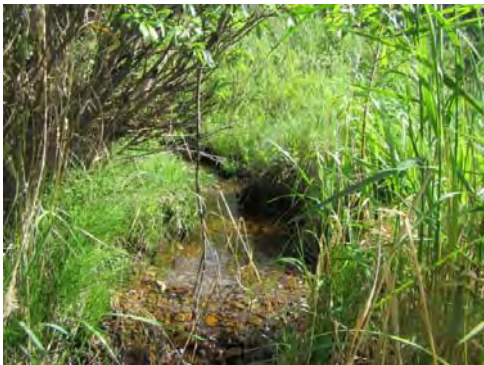
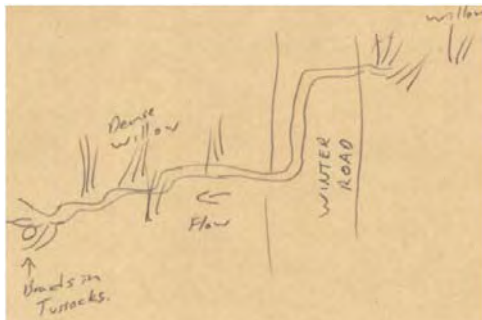
Freegold Road Extension Crossing # 80+620 (Unmapped Site) - Hayes Creek Tributary

D/S	X	U/S	
Coordinates:	6954779 N	643808 E	Gradient (%):	9	8	9
Site Visit Date:	21-Jun-13		Bankfull Width (m):	0.28	0.42	0.25
Flow Conditions:	Low		Bankfull Depth (m):	0.10	0.13	0.12
Barrier/Confirmed:	None		Wetted Widths (m):	0.25	0.30	0.25
Electrofished/Effort?:	No		Wetted Depth (m):	0.07	0.09	0.10
Gee Trapping:	No		Substrate Bed:	F	C/S	G
Fish Bearing?	Yes		Substrate Bank:	F	F/C	F
Site Length:	100 m		Riparian Vegetation:	GR	WI/BI	WI
		Meander Pattern:	SI	SI	SI	
		Cover:	0	80% / OV	100% OV	
Photo #s	22 u/s	23 x	24 d/s			
Areas of Erosion:	No		Temperature:	5.05	°C	
Locations:			pH:	6.84	pH units	
			Conductivity:	52	uS/cm	
			DO:	8.79	mg/L	
				72.8	% Sat

Comments:
Small creek running from drainage to site
Previously unmapped watercourse
Crosses winter road

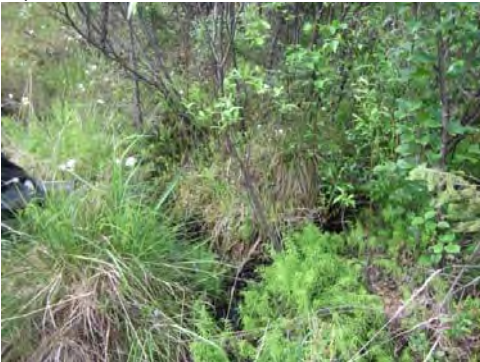
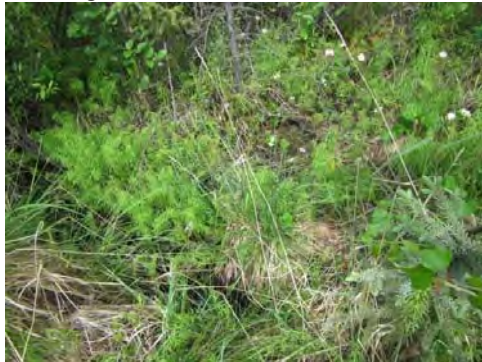
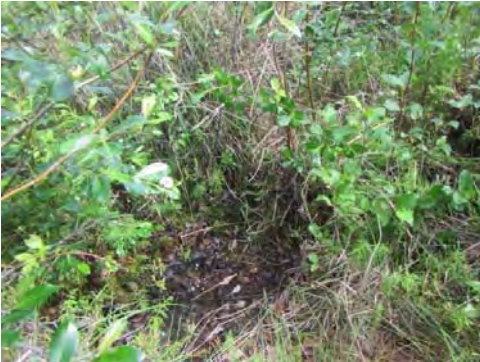
Freegold Road Extension Crossing # 81+120 - Hayes Creek Tributary

D/S	X	U/S
Coordinates:	6954697 N	643317 E	Gradient (%):	-	-
Site Visit Date:	22-Jun-13		Bankfull Width (m):	0.23	-
Flow Conditions:	Low/None		Bankfull Depth (m):	0.08	-
Barrier/Confirmed:	Yes		Wetted Widths (m):	0.08	-
Electrofished/Effort?:	No		Wetted Depth (m):	0.02	-
Gee Trapping:	No		Substrate Bed:	F	-
Fish Bearing?	No		Substrate Bank:	F	-
Site Length:	100 m		Riparian Vegetation:	SP/GR	-
	(200m)		Meander Pattern:	SI	-
			Cover:	80% / OV	-
Photo #s	13 u/s	14 x	15 d/s		
Areas of Erosion:	No		Temperature:	-	°C
Locations:			pH:	-	pH units
			Conductivity:	-	uS/cm
			DO:	-	mg/L
				-	% Sat

Comments:
Intermittent creek
No flow at this time
No direct fish habitat

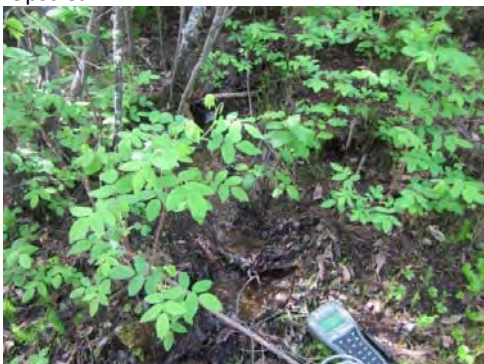
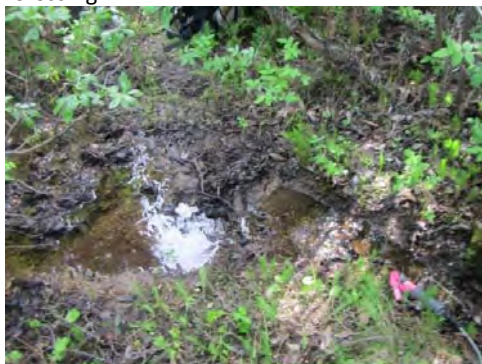
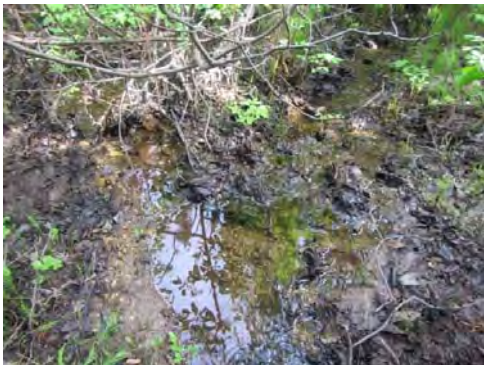
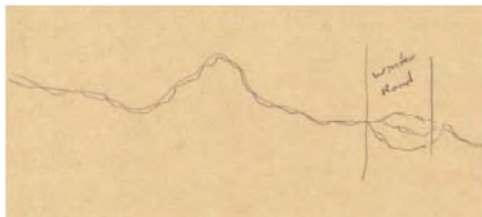
Freegold Road Extension Crossing # 81+570 - Hayes Creek Tributary

D/S	X	U/S	
Coordinates:	6954859 N	642903 E	Gradient (%):	-	15	13
Site Visit Date:	22-Jun-13		Bankfull Width (m):	0.18	0.35	0.37
Flow Conditions:	Low		Bankfull Depth (m):	0.06	0.08	0.07
Barrier/Confirmed:	Yes		Wetted Widths (m):	0.13	0.28	0.18
Electrofished/Effort?:	No		Wetted Depth (m):	0.03	0.06	0.05
Gee Trapping:	No		Substrate Bed:	S/G	S/F	S/G
Fish Bearing?	No		Substrate Bank:	F/S	F/S	F/S
Site Length:	100 m		Riparian Vegetation:	SP/WI	SP/WI	SP/WI
			Meander Pattern:	SI	SI	SI
		Cover:	20% / OV	30% / OV	50% / OV	
Photo #s	7 u/s	8 x	9 d/s			
Areas of Erosion:	No		Temperature:	4.77	°C	
Locations:			pH:	7.51	pH units	
			Conductivity:	791	uS/cm	
			DO:	12.4	mg/L	
				103	% Sat

Comments:
Very shallow, small creek
No direct fish habitat

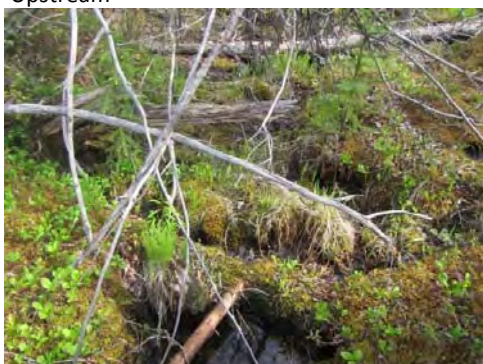
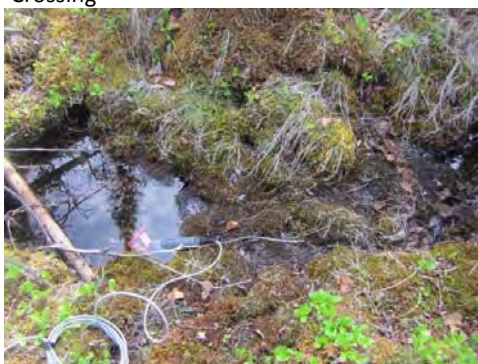
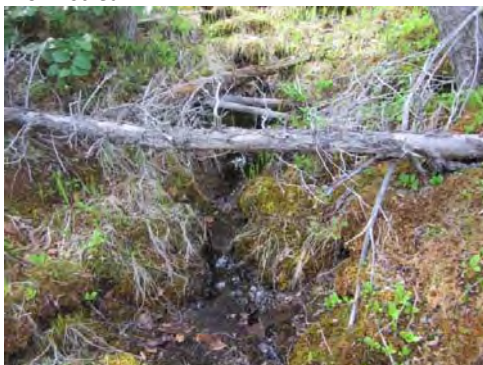
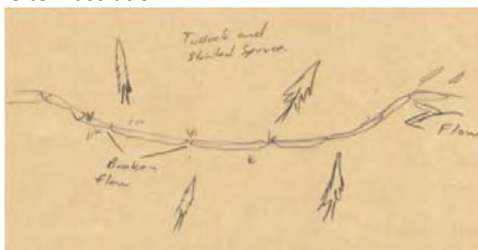
Freegold Road Extension Crossing # 81+680 (Unmapped Site) - Hayes Creek Tributary

D/S	X	U/S	
Coordinates:	6954913 N	642808 E	Gradient (%):	12	10	11
Site Visit Date:	22-Jun-13		Bankfull Width (m):	1.00	0.50	-
Flow Conditions:	Low		Bankfull Depth (m):	0.05	0.13	-
Barrier/Confirmed:	Yes		Wetted Widths (m):	-	0.40	-
Electrofished/Effort?:	No		Wetted Depth (m):	-	0.09	-
Gee Trapping:	No		Substrate Bed:	F	F	-
Fish Bearing?	No		Substrate Bank:	F	F	-
Site Length:	100 m		Riparian Vegetation:	SP/GR	SP/GR	-
			Meander Pattern:	Si	Si	-
		Cover:	-	5% / LWD	-	
Photo #s	4 u/s	5 x	6 d/s			
Areas of Erosion:	No		Temperature:	-	°C	
Locations:			pH:	6.87	pH units	
			Conductivity:	366	uS/cm	
			DO:	5.05	mg/L	
				39.2	% Sat

Comments:
Unmapped creek, over shallow permafrost
Intermittent, flowing through tussocks
No direct fish habitat
No channel upstream, no flow - subterranean

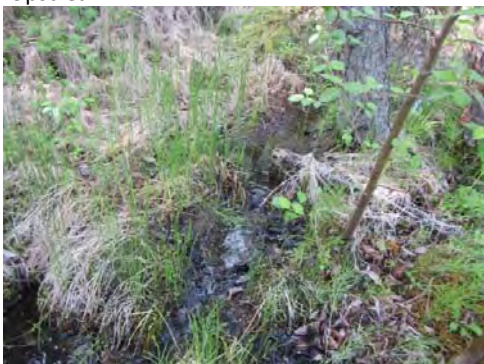
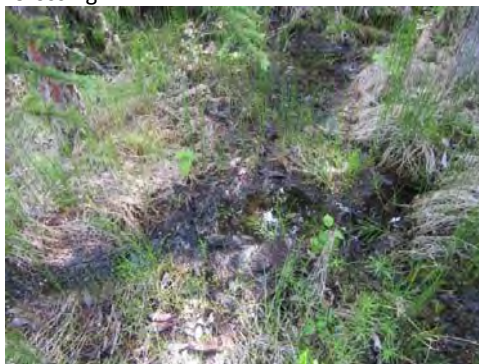
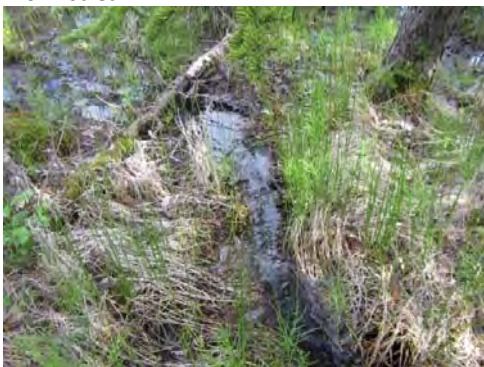
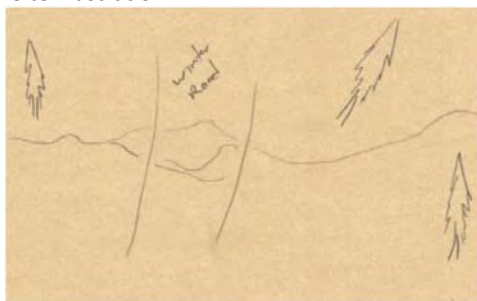
Freegold Road Extension Crossing # 81+610 (Unmapped Site) - Hayes Creek Tributary

D/S	X	U/S	
Coordinates:	6954911 N	642897 E	Gradient (%):	-	12	-
Site Visit Date:	22-Jun-13		Bankfull Width (m):	-	0.18	-
Flow Conditions:	Low		Bankfull Depth (m):	-	0.04	-
Barrier/Confirmed:	Yes		Wetted Widths (m):	-	0.11	-
Electrofished/Effort?:	No		Wetted Depth (m):	-	0.02	-
Gee Trapping:	No		Substrate Bed:	-	F	-
Fish Bearing?	No		Substrate Bank:	-	F	-
Site Length:	100 m		Riparian Vegetation:	-	SP/WI	-
			Meander Pattern:	-	SI	-
		Cover:	-	-	-	
Photo #s	10 u/s	11 x	12 d/s			
Areas of Erosion:	No		Temperature:	5.04	°C	
Locations:			pH:	7.06	pH units	
			Conductivity:	839	uS/cm	
			DO:	8.35	mg/L	
				69.5	% Sat

Comments:
Small permafrost melt creek - unmapped
No direct fish habitat

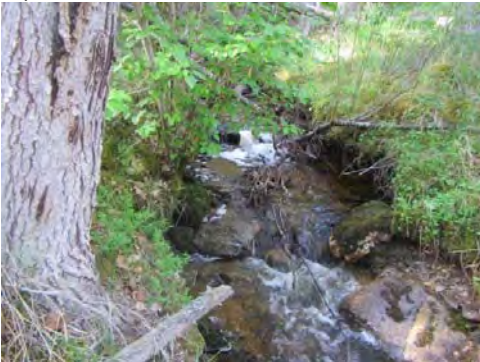
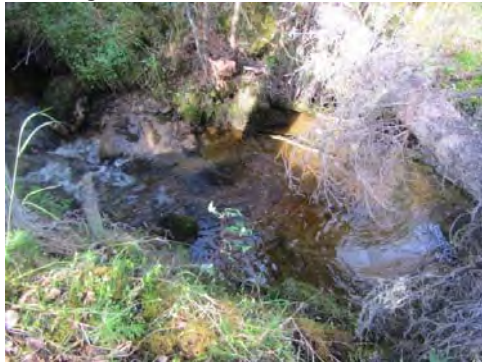
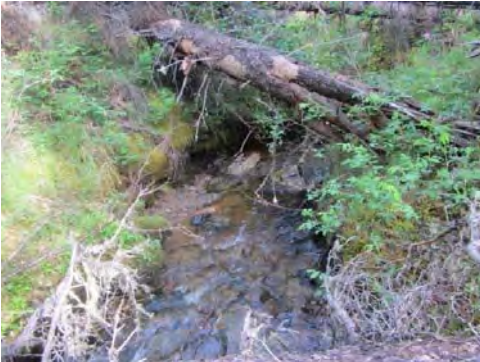
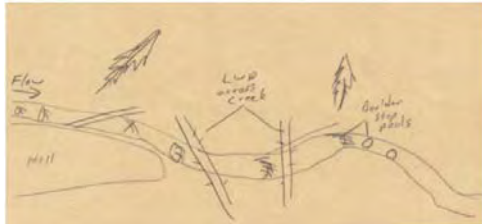
Freegold Road Extension Crossing # 81+750 - Hayes Creek Tributary

D/S	X	U/S
Coordinates:	6954938 N	642743 E	Gradient (%):	4	8	5
Site Visit Date:	22-Jun-13		Bankfull Width (m):	2.00	2.00	1.40
Flow Conditions:	Low		Bankfull Depth (m):	0.53	0.60	0.63
Barrier/Confirmed:	None		Wetted Widths (m):	2.00	1.80	1.70
Electrofished/Effort?:	No		Wetted Depth (m):	0.23	0.40	0.28
Gee Trapping:	No		Substrate Bed:	B/C	S/B	S/B
Fish Bearing?:	Yes		Substrate Bank:	F/G	F/G	F
Site Length:	100 m		Riparian Vegetation:	SP/WI	SP/WI	SP/WI
			Meander Pattern:	IM	IM	IM
			Cover:	20% / B	40% / U	20% / U
Photo #s	01 u/s	02 x	03 d/s			
Areas of Erosion:	No		Temperature:	2.84	°C	
Locations:			pH:	6.93	pH units	
			Conductivity:	61	uS/cm	
			DO:	14	mg/L	
				111.1	% Sat

Comments:
Abundant woody debris
Boulder/G with some step pools
Ample cover, good nursery habitat

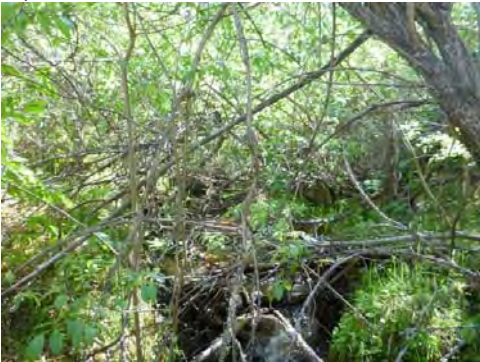
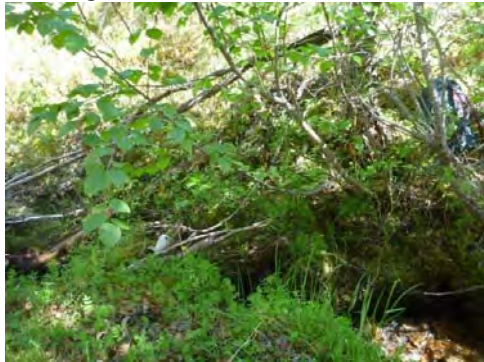
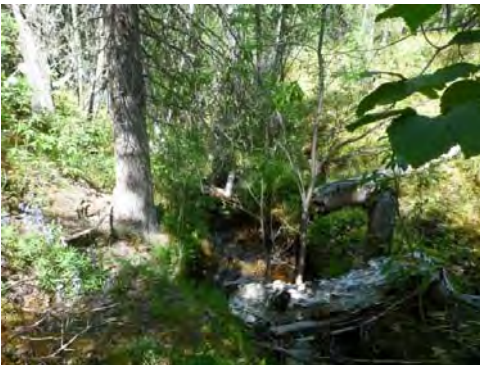
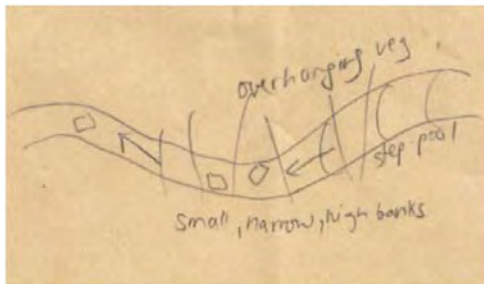
Freegold Road Extension Crossing # 83+550 - Hayes Creek Tributary

D/S	X	U/S	
Coordinates:	6955434 N	641077 E	Gradient (%):	14	21	14
Site Visit Date:	21-Jun-13		Bankfull Width (m):	0.71	1.07	0.92
Flow Conditions:	Low		Bankfull Depth (m):	0.72	0.64	0.96
Barrier/Confirmed:	No		Wetted Widths (m):	1.01	1.02	1.25
Electrofished/Effort?:	Yes (2013)		Wetted Depth (m):	0.17	0.15	0.25
Gee Trapping:	Yes (2013)		Substrate Bed:	C/B	C/B	C/G
Fish Bearing?	No		Substrate Bank:	F	F	F
Site Length:	100 m		Riparian Vegetation:	WI/PO/SP	WI/PO/SP	WI/PO/SP
			Meander Pattern:	IM	IM	IM
		Cover:	25% / LWD	70% / OV	60% / OV	
Photo #s	835 u/s	836 x	837 d/s			
Areas of Erosion:	No		Temperature:	3.5	°C	
Locations:			pH:	7.36	pH units	
			Conductivity:	197	uS/cm	
			DO:	15.82	mg/L	
				119.5	% Sat

Comments:
High gradient channel with no fish present
Vertical Falls (0.94m length) identified downstream of crossing
Falls at 07 V 0641116 6955570

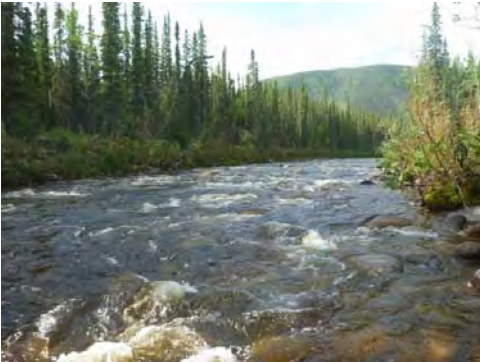
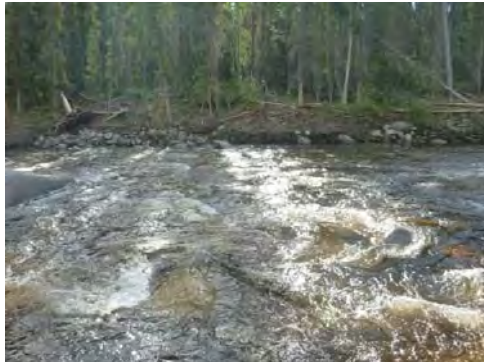
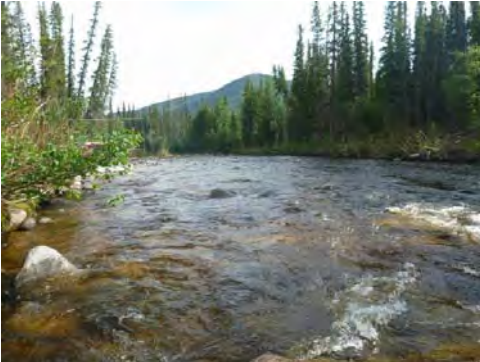
Freegold Road Extension Crossing # 85+160 - Selwyn River

D/S	X	U/S	
Coordinates:	6956507 N	639993 E	Gradient (%):	2	2	2.5
Site Visit Date:	21-Jun-13		Bankfull Width (m):	25	19	20
Flow Conditions:	Typical		Average Depth (m):	0.8	0.8	0.9
Barrier/Confirmed:	None		Wetted Widths (m):	23	18	18
Electrofished/Effort?:	No		Substrate Bed:	B/C	B/C	B/C
Gee Trapping:	No		Substrate Bank:	-	-	-
Fish Bearing?	Yes		Riparian Vegetation:	-	-	-
Site Length:	100 m		Meander Pattern:	-	-	-
			Cover:	45% / B	45% / B	45% / B

Comments:
Pre-existing Site Card as 85+280
High quality habitat for many life stages

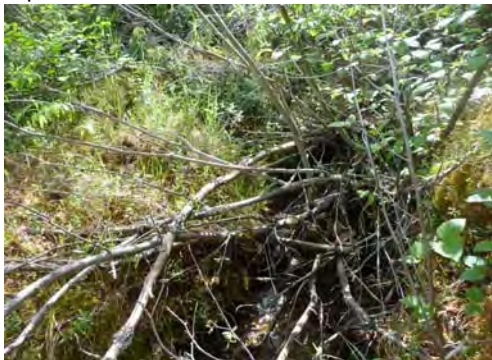
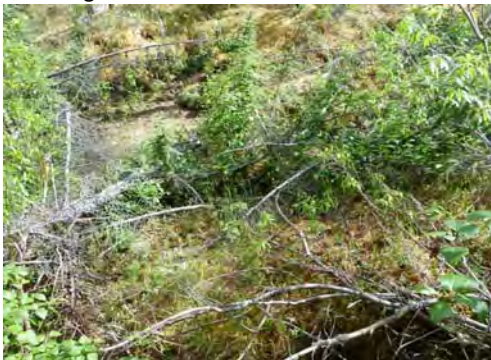
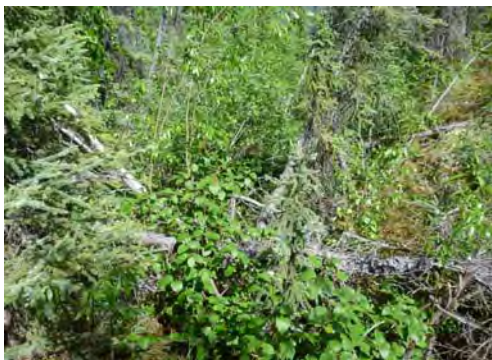
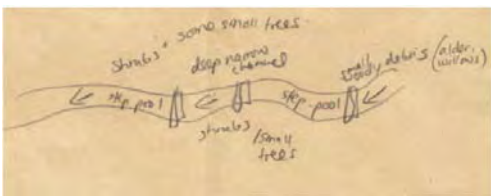
Freegold Road Extension Crossing # 87+920 - Selwyn River Tributary

D/S	X	U/S	
Coordinates:	6958246 N	638494 E	Gradient (%):	23	30.5	21
Site Visit Date:	21-Jun-13		Bankfull Width (m):	0.82	1.15	0.47
Flow Conditions:	Low		Bankfull Depth (m):	0.45	0.81	0.80
Barrier/Confirmed:	Yes		Wetted Widths (m):	0.58	0.62	0.39
Electrofished/Effort?:	Yes (2013)		Wetted Depth (m):	0.04	0.03	0.07
Gee Trapping:	Yes (2013)		Substrate Bed:	C/G	C/G	C/G
Fish Bearing?:	No		Substrate Bank:	F	F	F
Site Length:	100 m		Riparian Vegetation:	SP/PO	PO/ SP	SP/PO
			Meander Pattern:	IM	IM	IM
		Cover:	80% / SWD	85% / SWD	100% / U	
Photo #s	830 u/s	831 x	832-833 d/s			
Areas of Erosion:	No		Temperature:	2.75	°C	
Locations:			pH:	6.7	pH units	
			Conductivity:	70	uS/cm	
			DO:	15.6	mg/L	
				115	% Sat

Comments:
Barrier: vertical drop at 07 V 0638515 6958273
Sparse vegetation at crossing

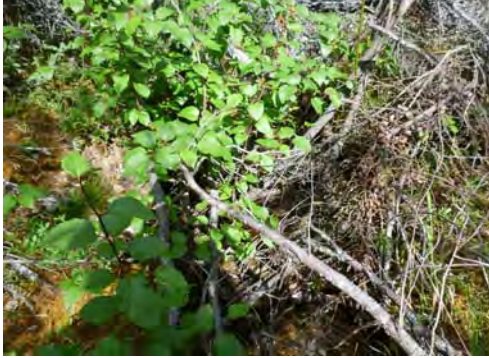
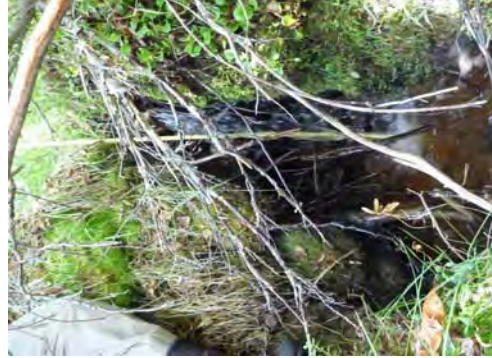
Freegold Road Extension Crossing # 87+920 - Pg. 2

Vertical Drop
