APPENDIX 10B: FREEGOLD ROAD FISH AND AQUATIC BASELINE

Casino Project

Fish and Aquatic Resources Baseline Report:

Freegold Road Extension, Freegold Road Upgrade, and Casino Airstrip and Airstrip Access Road

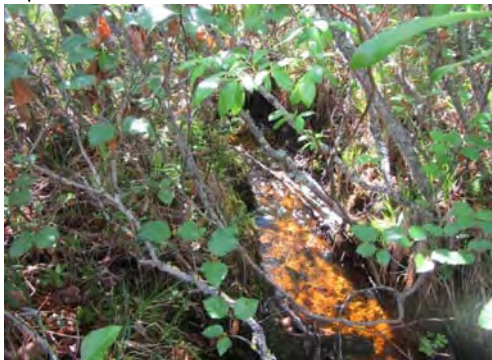
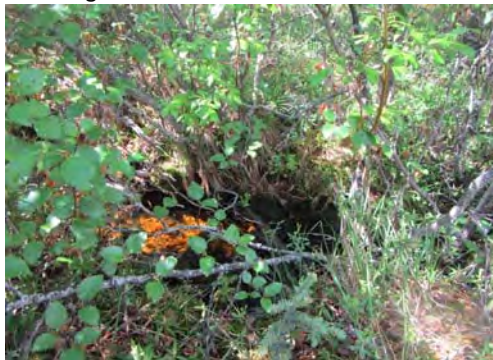
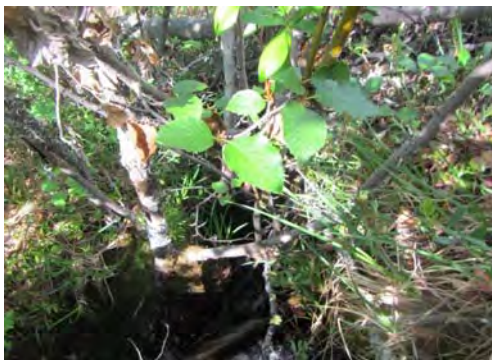
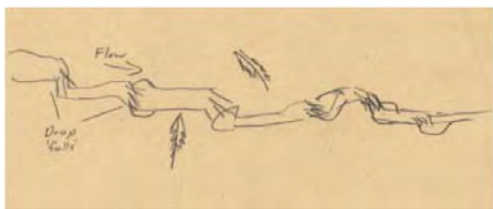
Freegold Road Extension Crossing # 89+330 - Selwyn River Tributary

D/S	X	U/S	
Coordinates:	6958668 N	637646 E	Gradient (%):	22	21	20
Site Visit Date:	21-Jun-13		Bankfull Width (m):	1.00	0.40	0.50
Flow Conditions:	Low		Bankfull Depth (m):	0.50	0.24	0.40
Barrier/Confirmed:	Yes		Wetted Widths (m):	0.80	0.40	0.43
Electrofished/Effort?:	No		Wetted Depth (m):	0.19	0.17	0.11
Gee Trapping:	No		Substrate Bed:	S/C	S/C	C/B
Fish Bearing?:	No		Substrate Bank:	F/C	F/C	F/S
Site Length:	100 m		Riparian Vegetation:	WI/SP	BI/WI	WI/BI
			Meander Pattern:	Si	Si	Si
		Cover:	20% / U	20% / U	70% / U	
Photo #s	16 u/s	17 x	18 d/s			
Areas of Erosion:	No		Temperature:	2.67	°C	
Locations:			pH:	8.09	pH units	
			Conductivity:	15	uS/cm	
			DO:	10.57	mg/L	
				80.5	% Sat

Comments:
Continuous drop/pool sequence
> 20% gradient throughout and continuing downstream
No direct fish habitat

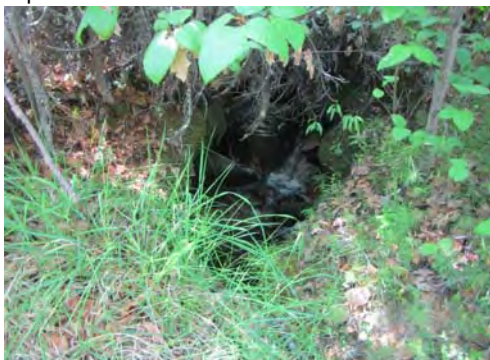
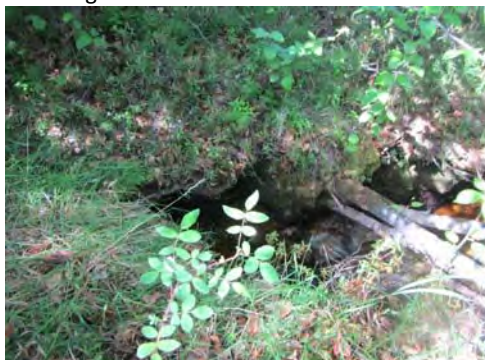
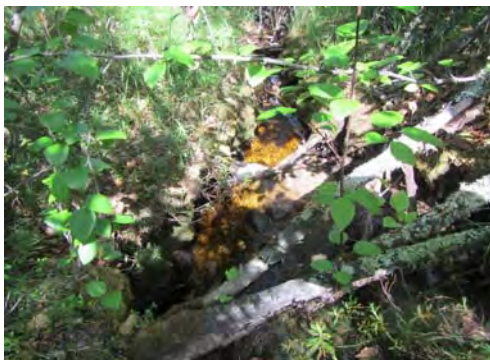
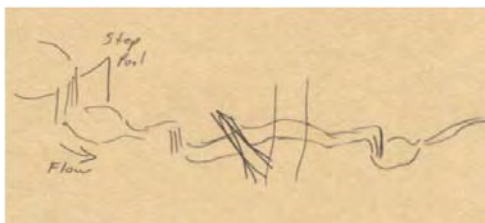
Freegold Road Extension Crossing # 89+410 - Selwyn River Tributary

D/S	X	U/S	
Coordinates:	6958702 N	637585 E	Gradient (%):	21	23	29
Site Visit Date:	21-Jun-13		Bankfull Width (m):	0.85	1.00	0.85
Flow Conditions:	Low		Bankfull Depth (m):	0.46	0.47	0.40
Barrier/Confirmed:	Yes		Wetted Widths (m):	0.85	1.00	0.80
Electrofished/Effort?:	No		Wetted Depth (m):	0.20	0.16	0.22
Gee Trapping:	No		Substrate Bed:	B/S	C/S	B/S
Fish Bearing?:	No		Substrate Bank:	F	F/C	F/C
Site Length:	100 m		Riparian Vegetation:	BI/SP	BI/SP	BI/SP
		Meander Pattern:	ST	ST	ST	
		Cover:	30% / U	50% / U	20% / U	
Photo #s	20 u/s	19 x	21 d/s			
Areas of Erosion:	No		Temperature:	3.37	°C	
Locations:			pH:	7.5	pH units	
			Conductivity:	8	uS/cm	
			DO:	9.8	mg/L	
				79.5	% Sat

Comments:
Step pool sequence
>20 % throughout

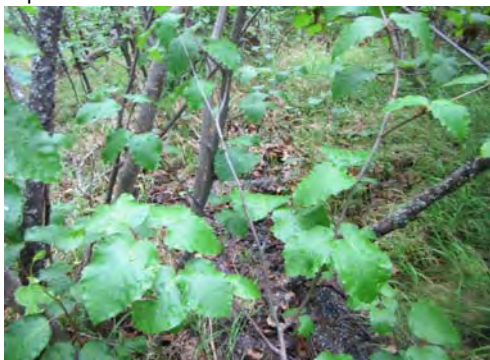
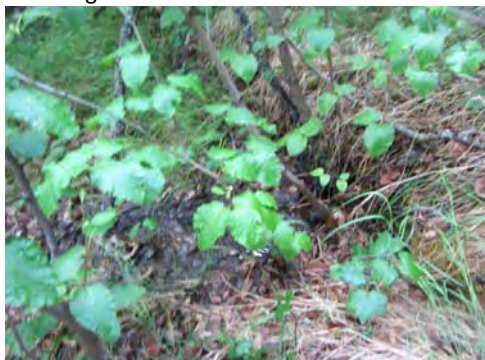
Freegold Road Extension Crossing # 90+410 - Selwyn River Tributary

D/S	X	U/S	
Coordinates:	6959511 N	637143 E	Gradient (%):	-	50	-
Site Visit Date:	21-Jun-13		Bankfull Width (m):	-	0.33	-
Flow Conditions:	Low		Bankfull Depth (m):	-	0.02	-
Barrier/Confirmed:	Yes		Wetted Widths (m):	-	0.17	-
Electrofished/Effort?:	No		Wetted Depth (m):	-	0.02	-
Gee Trapping:	No		Substrate Bed:	-	F/Organics	-
Fish Bearing?:	No		Substrate Bank:	-	F/Organics	-
Site Length:	100 m		Riparian Vegetation:	-	AL	-
			Meander Pattern:	-	ST	-
			Cover:	-	-	-
Photo #s	10 u/s	11 x	12 d/s			
Areas of Erosion:	No		Temperature:	-	°C	
Locations:			pH:	-	pH units	
			Conductivity:	-	uS/cm	
			DO:	-	mg/L	
				-	% Sat

Comments:
Tiny creek at upper edge of watershed
No fish habitat
50% gradient

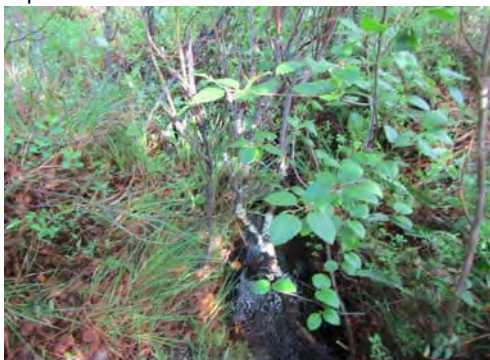
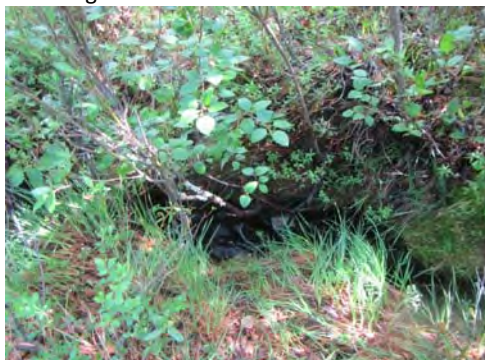
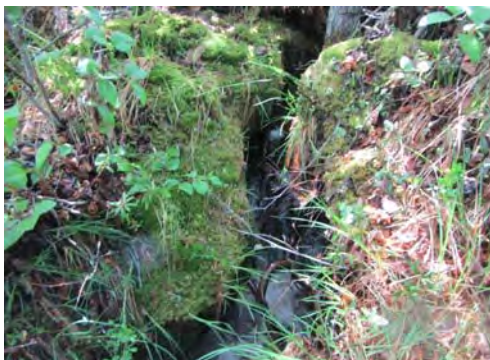
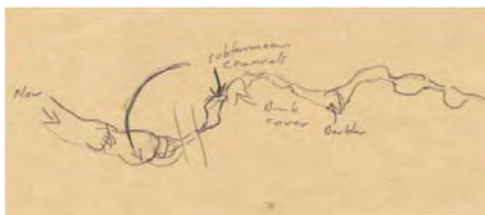
Freegold Road Extension Crossing # 91+570 - Selwyn River Tributary

D/S	X	U/S	
Coordinates:	6959588 N	636430 E	Gradient (%):	15	25	22
Site Visit Date:	21-Jun-13		Bankfull Width (m):	0.85	0.50	0.60
Flow Conditions:	Low		Bankfull Depth (m):	0.22	0.34	0.40
Barrier/Confirmed:	Yes		Wetted Widths (m):	0.79	0.80	0.70
Electrofished/Effort?:	No		Wetted Depth (m):	0.14	0.20	0.08
Gee Trapping:	No		Substrate Bed:	S/B	B/C	B/G
Fish Bearing?:	No		Substrate Bank:	F/C	F/C	B/F
Site Length:	100 m	Riparian Vegetation:	BI/AL	BI/AL	BI/AL	
		Meander Pattern:	SI	SI	SI	
		Cover:	20% /U	60% /U	70% /U	
Photo #s	07 u/s	08 x	09 d/s			
Areas of Erosion:	No		Temperature:	1.66	°C	
Locations:			pH:	7.03	pH units	
			Conductivity:	4	uS/cm	
			DO:	9.82	mg/L	
				-	% Sat

Comments:
Step pool, boulders with very little flow
Creek subterranean in places for short periods
Very steep overall and no direct fish habitat

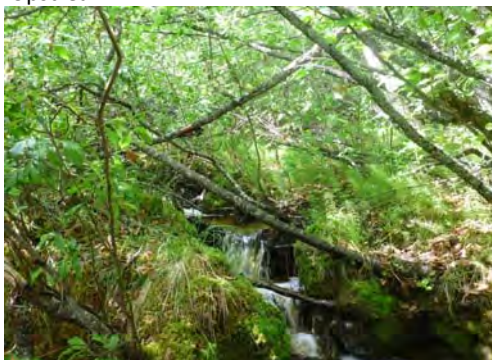
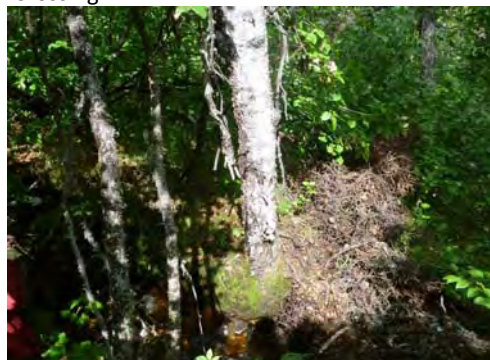
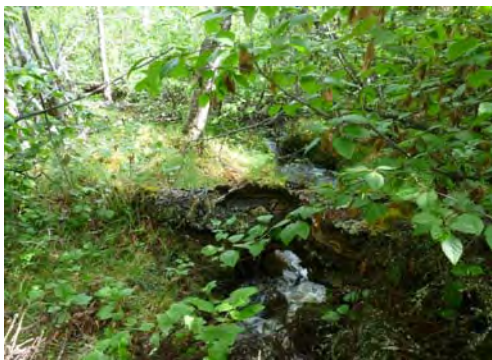
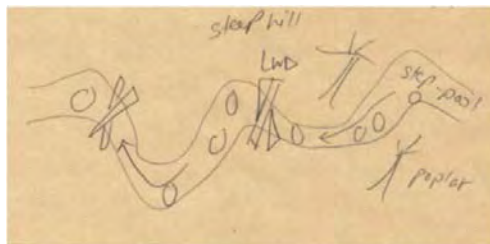
Freegold Road Extension Crossing # 93+040 - Selwyn River Tributary

D/S	X	U/S	
Coordinates:	6959563 N	635624 E	Gradient (%):	21	35	30.5
Site Visit Date:	21-Jun-13		Bankfull Width (m):	0.46	0.72	0.64
Flow Conditions:	Low		Bankfull Depth (m):	0.26	0.49	0.69
Barrier/Confirmed:	Yes		Wetted Widths (m):	0.74	0.96	0.73
Electrofished/Effort?:	Yes (2013)		Wetted Depth (m):	0.07	0.08	0.10
Gee Trapping:	Yes (2013)		Substrate Bed:	G/C	C/G	B/C
Fish Bearing?:	No		Substrate Bank:	F	F	B/F
Site Length:	100 m		Riparian Vegetation:	PO/AL	WI/BI	PO
			Meander Pattern:	IM	IM	IM
			Cover:	80% / LWD	50% / LWD	70% / OV
Photo #s	823 u/s	824 x	825 d/s			
Areas of Erosion:	No		Temperature:	1.93	°C	
Locations:			pH:	4.56	pH units	
			Conductivity:	26	uS/cm	
			DO:	15.29	mg/L

110.5	% Sat	
Comments:						
High gradient watercourse with a high potential to act as a fish barrier						
At 07 V 0635845 6959968 vertical drop of 1.12m from top to substrate (photos: 826 and 827)

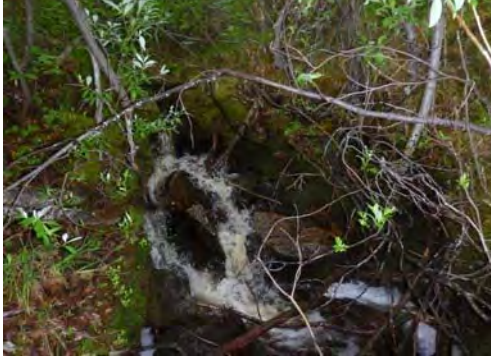
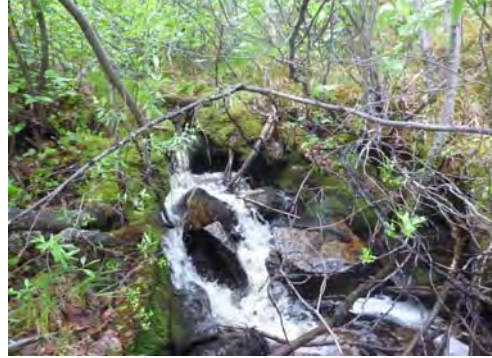
826 - Vertical Drop

827 - Vertical Drop

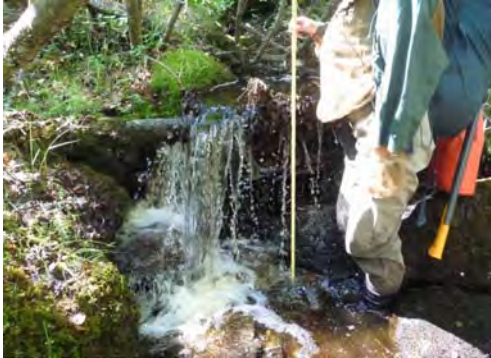
828 - Vertical Drop

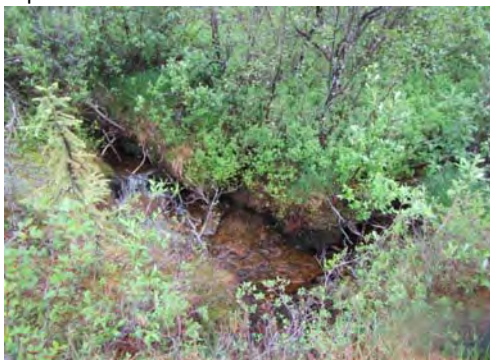
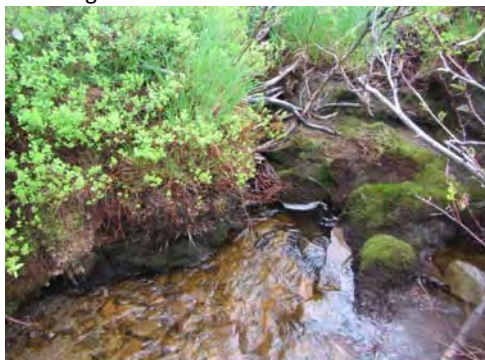
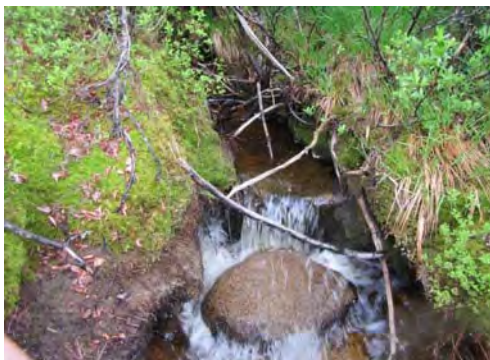
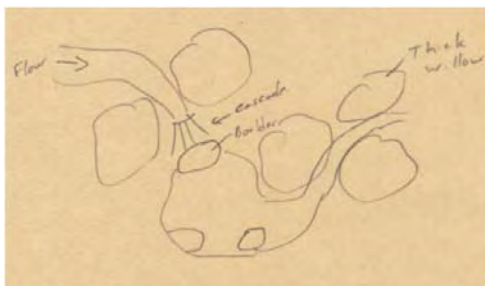
Freegold Road Extension Crossing # 94+550 - Selwyn River Tributary

D/S	X	U/S	
Coordinates:	6959720 N	634674 E	Gradient (%):	10	10	8
Site Visit Date:	21-Jun-13		Bankfull Width (m):	1.20	1.70	1.00
Flow Conditions:	Low		Bankfull Depth (m):	0.50	0.60	0.57
Barrier/Confirmed:	None		Wetted Widths (m):	1.20	1.80	0.80
Electrofished/Effort?:	Yes (2013)		Wetted Depth (m):	0.19	0.20	0.17
Gee Trapping:	Yes (2013)		Substrate Bed:	B/C	C/B	C/B
Fish Bearing?:	Yes		Substrate Bank:	F/C	F/C	F/C
Site Length:	100 m	Riparian Vegetation:	WI/BI	WI/BI	WI/BI	
		Meander Pattern:	Si	Si	Si	
		Cover:	40% / U	40% /U	40% /U	
Photo #s	4 u/s	5 x	6 d/s			
Areas of Erosion:	No		Temperature:	2.26	°C	
Locations:			pH:	7.05	pH units	
			Conductivity:	4	uS/cm	
			DO:	9.68	mg/L	
				78.3	% Sat

Comments:
Step pool, cobble boulder, well undercut banks

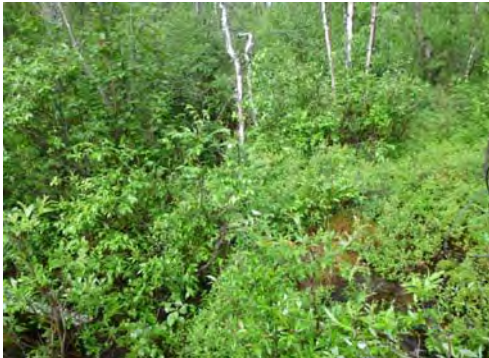
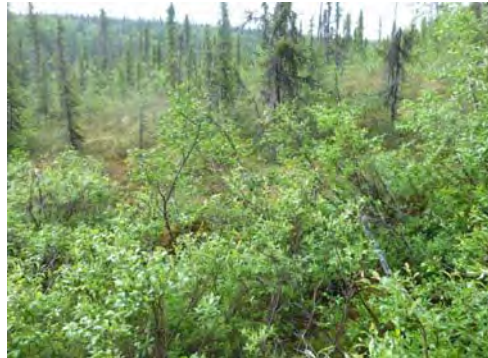
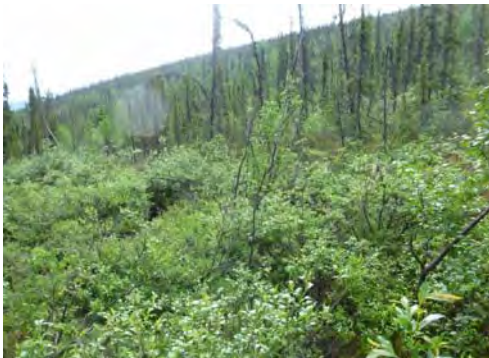
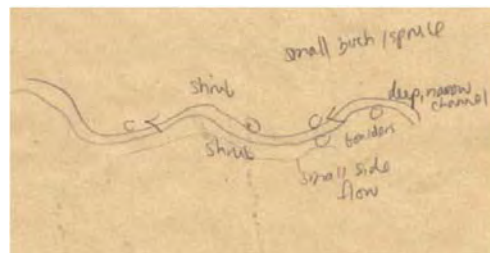
Freegold Road Extension Crossing # 94+660 - Selwyn River Tributary

D/S	X	U/S	
Coordinates:	6959780 N	634592 E	Gradient (%):	17.5	9	21
Site Visit Date:	21-Jun-13		Bankfull Width (m):	0.42	0.75	0.55
Flow Conditions:	Low		Bankfull Depth (m):	0.65	0.72	0.70
Barrier/Confirmed:	None		Wetted Widths (m):	0.32	0.65	0.33
Electrofished/Effort?:	Yes (2013)		Wetted Depth (m):	0.08	0.09	0.15
Gee Trapping:	Yes (2013)		Substrate Bed:	B/G	B/C	F/B
Fish Bearing?:	Yes		Substrate Bank:	F	B/F	F
Site Length:	100 m		Riparian Vegetation:	SH/BI/SP	SH/BI/SP	SH/BI/AL/SP
			Meander Pattern:	IM	IM	IM
			Cover:	95% / OV	95% / OV	95% / OV
Photo #s	820 u/s	821 x	822 d/s			
Areas of Erosion:	No		Temperature:	3.13	°C	
Locations:			pH:	4.43	pH units	
			Conductivity:	34	uS/cm	
			DO:	13.66	mg/L	
				101.9	% Sat

Comments:
Deep narrow channel, small side flow
Very large amount of overhanging cover

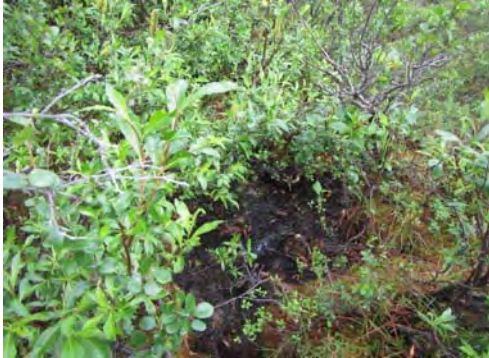
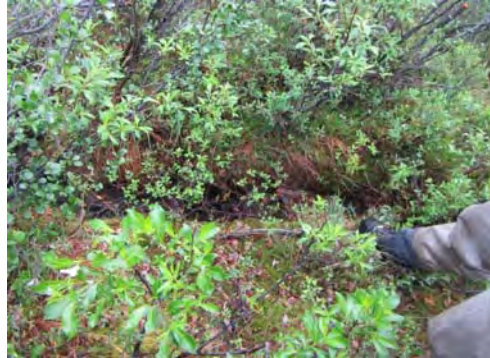
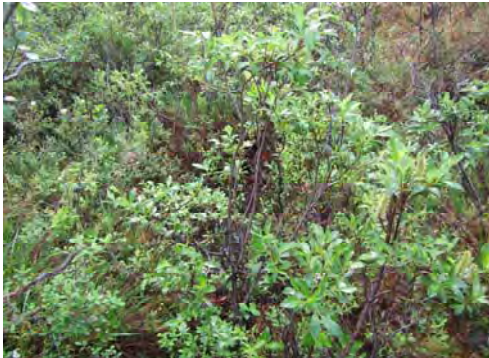
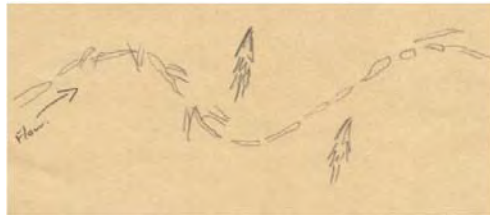
Freegold Road Extension Crossing # 96+190 - Yukon River Tributary

D/S	X	U/S	
Coordinates:	6960539 N	634193 E	Gradient (%):	-	20	-
Site Visit Date:	21-Jun-13		Bankfull Width (m):	-	0.30	-
Flow Conditions:	Low		Bankfull Depth (m):	-	0.17	-
Barrier/Confirmed:	Yes		Wetted Widths (m):	-	0.08	-
Electrofished/Effort?:	No		Wetted Depth (m):	-	0.04	-
Gee Trapping:	No		Substrate Bed:	-	F	-
Fish present?:	No		Substrate Bank:	-	F	-
Site Length:	100 m		Riparian Vegetation:	-	WI/GR	-
			Meander Pattern:	-	SI	-
			Cover:	-	-	-
Photo #s	01 u/s	02 x	03 d/s			
Areas of Erosion:	No		Temperature:	-	°C	
Locations:			pH:	-	pH units	
			Conductivity:	-	uS/cm	
			DO:	-	mg/L	
				-	% Sat

Comments:
Intermittent at crossing, 20% or greater slope for entire length of the creek
Poorly defined channel
No direct fish habitat

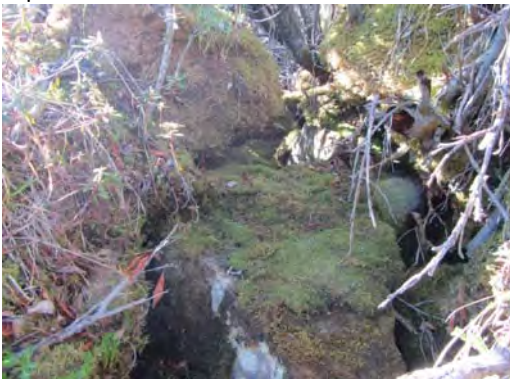
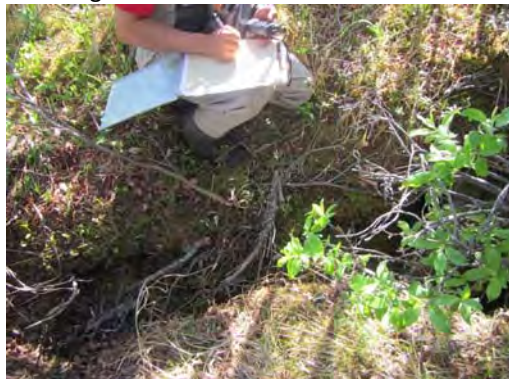
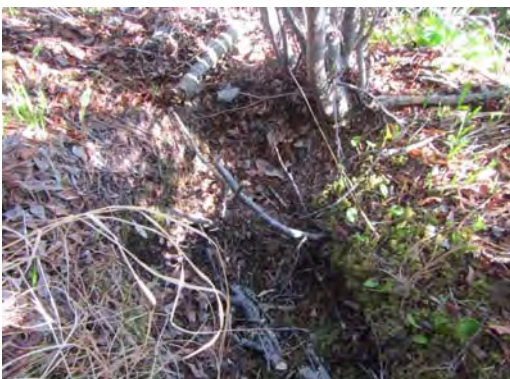
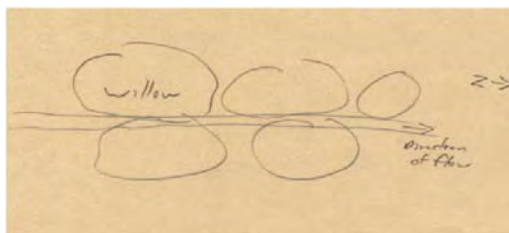
Freegold Road Extension Crossing # 105+620 - Mascot Creek

D/S	X	U/S
Coordinates:	6956936 N	628781 E	Gradient (%):	-	-
Site Visit Date:	19-Jun-13		Bankfull Width (m):	-	0.37
Flow Conditions:	None		Bankfull Depth (m):	-	0.45
Barrier/Confirmed:	Yes		Wetted Widths (m):	-	0
Electrofished/Effort?:	No		Wetted Depth (m):	-	0
Gee Trapping:	No		Substrate Bed:	-	B
Fish Bearing?:	Yes		Substrate Bank:	-	F/B
Site Length:	100 m		Riparian Vegetation:	-	WI
			Meander Pattern:	-	SI
			Cover:	-	-
Photo #s	65 u/s	66 x	67 d/s		
Areas of Erosion:	No		Temperature:	-	°C
Locations:			pH:	-	pH units
			Conductivity:	-	uS/cm
			DO:	-	mg/L
				-	% Sat
Comments:					
Intermittent stream, some small pools of water but channel generally dry

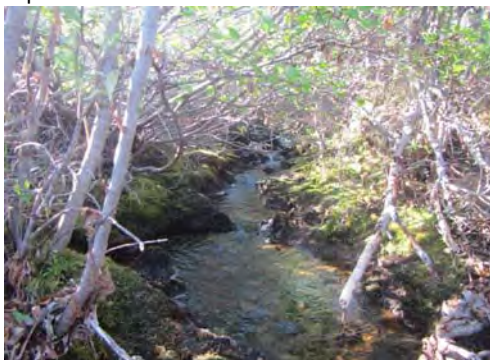
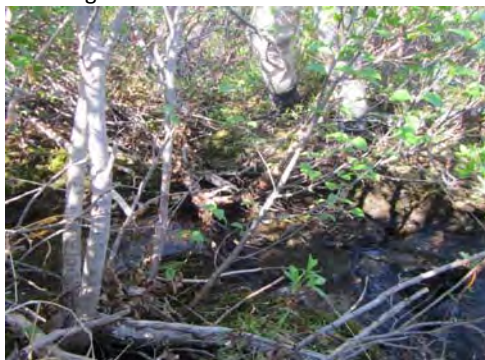
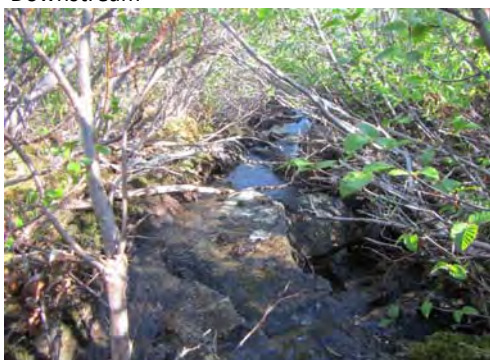
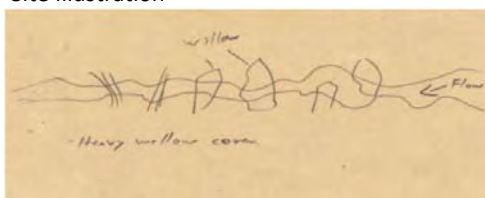
Freegold Road Extension Crossing # 107+920 - Idaho Creek (Isaac Creek Tributary)

D/S	X	U/S	
Coordinates:	6956753 N	627290 E	Gradient (%):	-	5	-
Site Visit Date:	June 19, 2013		Bankfull Width (m):	-	0.7	-
Flow Conditions:	Low		Bankfull Depth (m):	-	0.18	-
Barrier/Confirmed:	Yes		Wetted Widths (m):	-	0.5	-
Electrofished/Effort?:	No		Wetted Depth (m):	-	0.1	-
Gee Trapping:	No		Substrate Bed:	-	B/C	-
Fish Bearing?:	No		Substrate Bank:	-	C/F	-
Site Length:	100 m		Riparian Vegetation:	-	WI	-
		Meander Pattern:	-	SI	-	
		Cover:	-	A / Will	-	
Photo #s	62 u/s	63 x	64 d/s			
Areas of Erosion:	No		Temperature:	-	°C	
Locations:			pH:	-	pH units	
			Conductivity:	-	uS/cm	
			DO:	-	mg/L	
				-	% Sat

Comments:
Barrier confirmed at 07 V 0626312 6958420, 28% gradient, photos: 60 and 61
Heavy, willow cover at crossing

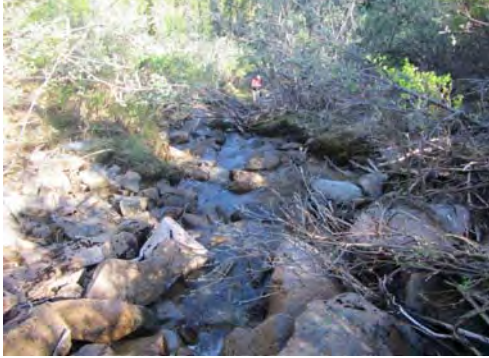
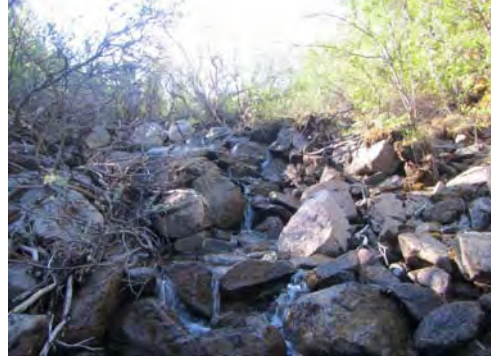
Photo 60 - Barrier

Photo 61 - Barrier

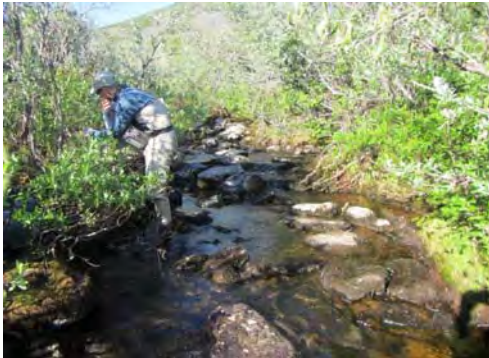
Freegold Road Extension Crossing # 109+800 - Idaho Creek (Isaac Creek Tributary)

D/S	X	U/S	
Coordinates:	6956577 N	625829 E	Gradient (%):	12	7	10
Site Visit Date:	19-Jun-13		Bankfull Width (m):	3	3	2.5
Flow Conditions:	Low		Bankfull Depth (m):	0.48	0.38	0.45
Barrier/Confirmed:	None		Wetted Widths (m):	3	2.6	2
Electrofished/Effort?:	Yes (2013)		Wetted Depth (m):	0.28	0.18	0.25
Gee Trapping:	Yes (2013)		Substrate Bed:	B/C	B/C	B/C
Fish Bearing?	Yes		Substrate Bank:	F	F	F
Site Length:	220 m		Riparian Vegetation:	WI	WI	WI
			Meander Pattern:	SI	SI	SI
		Cover:	-	80% / B/OV	100% / OV/B	
Photo #s	57 u/s	58 x	59 d/s			
Areas of Erosion:	No		Temperature:	1.65	°C	
Locations:			pH:	5.94	pH units	
			Conductivity:	73	uS/cm	
			DO:	13.7	mg/L	
				98.2	% Sat

Comments:
Very high cover, boulders and willows

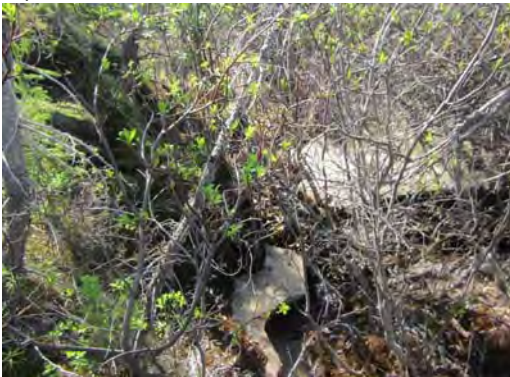
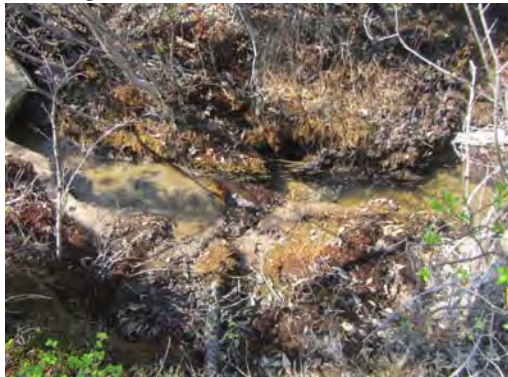
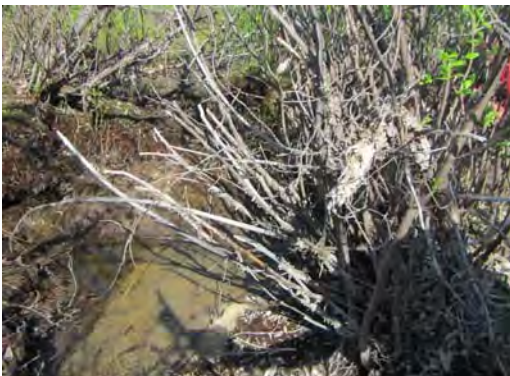
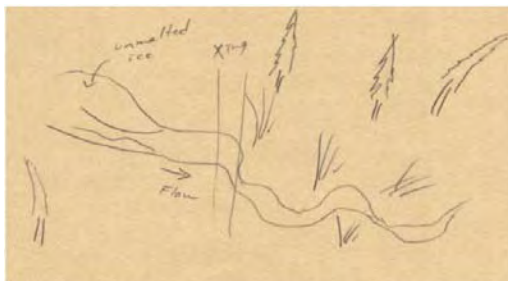
Freegold Road Extension Crossing # 20+300 - Brynelson Creek Tributary

D/S	X	U/S	
Coordinates:	6951968 N	610283 E	Gradient (%):	-	11	9
Site Visit Date:	25-Jun-13		Bankfull Width (m):	-	0.49	0.49
Flow Conditions:	Low		Bankfull Depth (m):	-	0.27	0.33
Barrier/Confirmed:	None		Wetted Widths (m):	-	0.49	0.49
Electrofished/Effort?:	No		Wetted Depth (m):	-	0.22	0.23
Gee Trapping:	No		Substrate Bed:	-	F/S	F
Fish Bearing?	Yes		Substrate Bank:	-	F	F
Site Length:	100 m		Riparian Vegetation:	-	WI/SP	WI/SP
			Meander Pattern:	-	SI	SI
			Cover:	-	30% / U	10% / OV
Photo #s	62 u/s	63 x	64 d/s			
Areas of Erosion:	Yes		Temperature:	4.92	°C	
Locations:	Some permafrost slumping		pH:	7.29	pH units	
	along creek length		Conductivity:	185	µS/cm	
			DO:	7.55	mg/L	
				64.2	% Sat	
Comments:						
Small tributary to Brynelson - 100% fines/sand substrate fed by melting permafrost						
No direct fish habitat

Upstream

Crossing

Downstream

Site Illustration

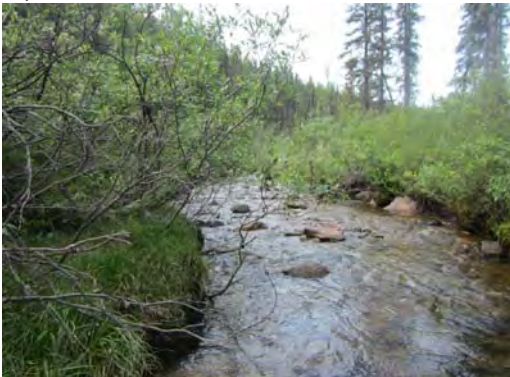
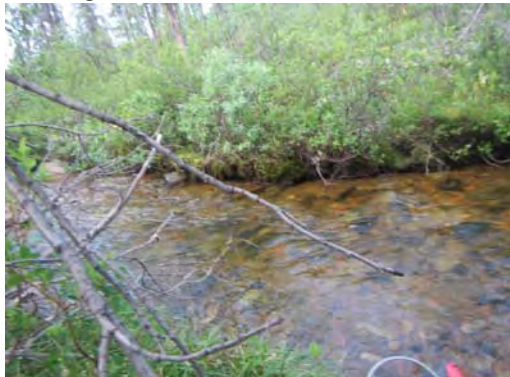
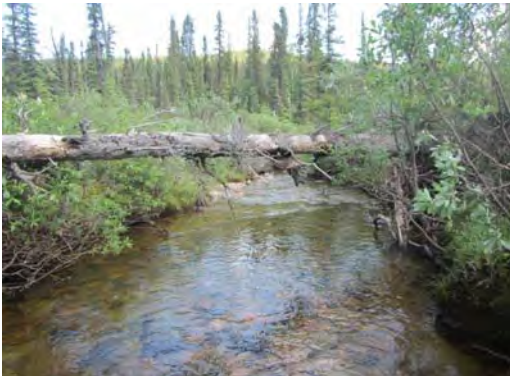
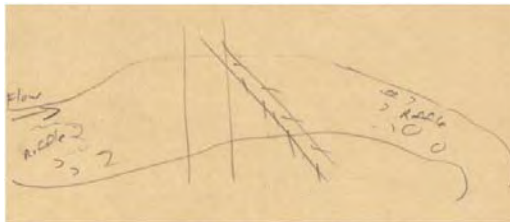
Freegold Road Extension Crossing # 20+750 - Brynolson Creek

D/S	X	U/S	
Coordinates:	6952411 N	610133 E	Gradient (%):	2	3	4
Site Visit Date:	25-Jun-13		Bankfull Width (m):	2.55	2.83	2.17
Flow Conditions:	Low		Bankfull Depth (m):	0.52	0.54	0.66
Barrier/Confirmed:	None		Wetted Widths (m):	2.55	2.80	2.40
Electrofished/Effort?:	Yes (2011)		Wetted Depth (m):	0.31	0.29	0.40
Gee Trapping:	No		Substrate Bed:	C/B	C/S	B/G
Fish Bearing?	Yes		Substrate Bank:	F	F	F/B
Site Length:	100 m		Riparian Vegetation:	WI	WI	WI
			Meander Pattern:	SI	SI	SI
		Cover:	30% / OV	20% / OV	30% / SWD	
Photo #s	65 u/s	66 x	67 d/s			
Areas of Erosion:	No		Temperature:	11.2	°C	
Locations:			pH:	7.62	pH units	
			Conductivity:	92	µS/cm	
			DO:	8.69	mg/L	
				85.5	% Sat	
Comments:						
Riffle-run morphology						
Good habitat, 1 adult and 1 juvenile arctic grayling spotted 25m upstream of crossing

Upstream

Crossing

Downstream

Site Illustration

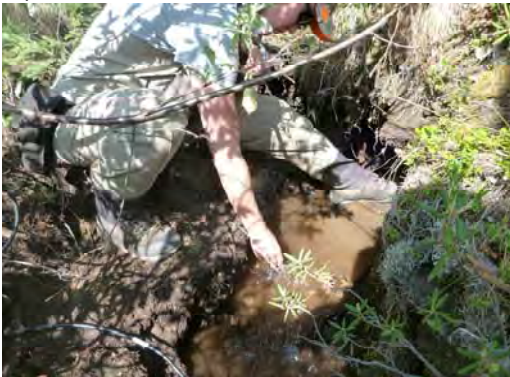
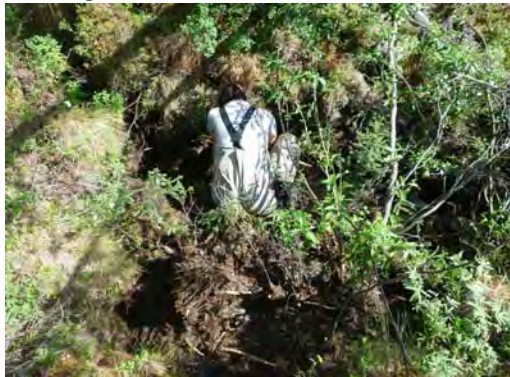
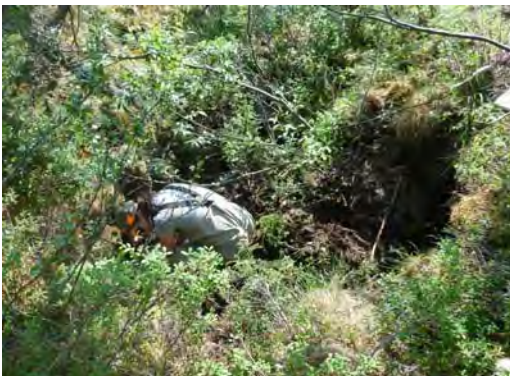
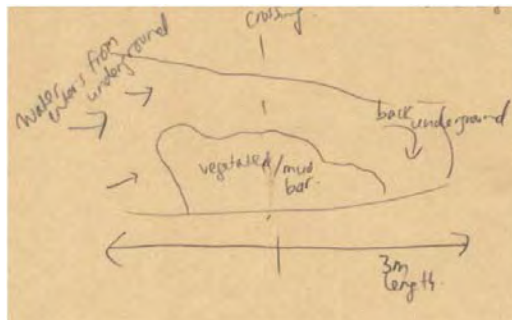
Freegold Road Extension Crossing # 20+960 - Brynolson Creek Tributary

D/S	X	U/S	
Coordinates:	6952522 N	610239 E	Gradient (%):	9	-	12
Site Visit Date:	25-Jun-13		Bankfull Width (m):	1.20	2.00	1.10
Flow Conditions:	Low		Bankfull Depth (m):	0.25	0.53	0.28
Barrier/Confirmed:	Yes		Wetted Widths (m):	0.58	0.35	0.75
Electrofished/Effort?:	No		Wetted Depth (m):	0.05	0.07	0.05
Gee Trapping:	No		Substrate Bed:	F	F	F / G
Fish Bearing?	No		Substrate Bank:	F	F	F
Site Length:	100 m		Riparian Vegetation:	SP/WI	SP/WI	SP/WI
			Meander Pattern:	IM	IM	IM
		Cover:	60% / OV	75% / OV	60% / OV	
Photo #s	101-0031 u/s	101-0032 x	101-0033 d/s			
Areas of Erosion:	Yes		Temperature:	4.05	°C	
Locations:	Erosion of muddy substrate and bank		pH:	10.91	pH units	
			Conductivity:	398	µS/cm	
			DO:	14.31	mg/L	
				109.3	% Sat

Comments:
No surface flow for 50m upstream of the crossing - upstream site measured
Flows underground at 07 V 0610292 6952559
No Surface flow for 60m downstream of the crossing (downstream measurements),
re-emerges at 07 V 0610200 6952462

Upstream

Crossing

Downstream

Site Illustration

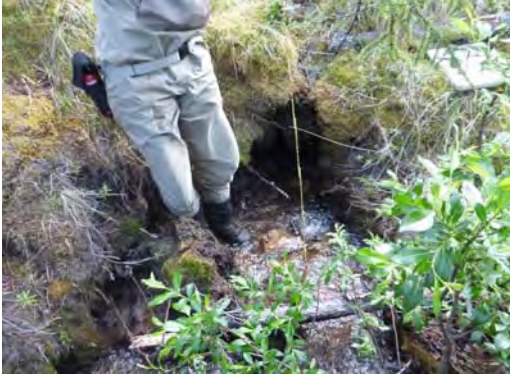
Photo 101 -0034

Freegold Road Extension Crossing # 20+960 - Pg. 2

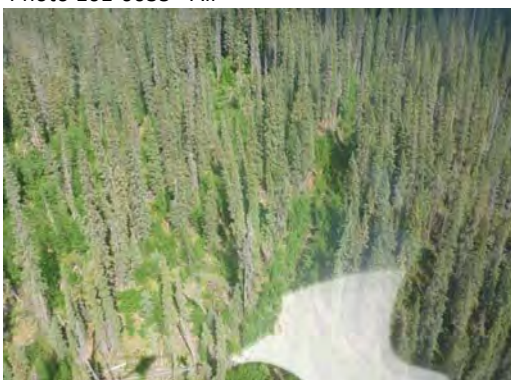
Photo 101-0035 - Air

Freegold Road Extension Crossing # 21+310 - No Crossing

D/S	X	U/S
Coordinates:	6952327 N	610518 E	Gradient (%):	-	-
Site Visit Date:	25-Jun-13		Bankfull Width (m):	-	-
Flow Conditions:	None		Bankfull Depth (m):	-	-
Barrier/Confirmed:	N/A		Wetted Widths (m):	-	-
Electrofished/Effort?:	N/A		Wetted Depth (m):	-	-
Gee Trapping:	N/A		Substrate Bed:	-	-
Fish Bearing?	N/A		Substrate Bank:	-	-
Site Length:	N/A		Riparian Vegetation:	-	-
			Meander Pattern:	-	-
			Cover:	-	-
Photo #s	u/s	x	d/s		
Areas of Erosion:	N/A		Temperature:	-	°C
Locations:			pH:	-	pH units
			Conductivity:	-	µS/cm
			DO:	-	mg/L
				-	% Sat
Comments:					
No watercourse identified at or near crossing location
