Phase V/VI Ridgetop South & Area 118 Backfill Dumps Physical Stability Assessment

Minto Explorations Ltd.

SRK Consulting (Canada) Inc.
1CM002.012.012
November 2013

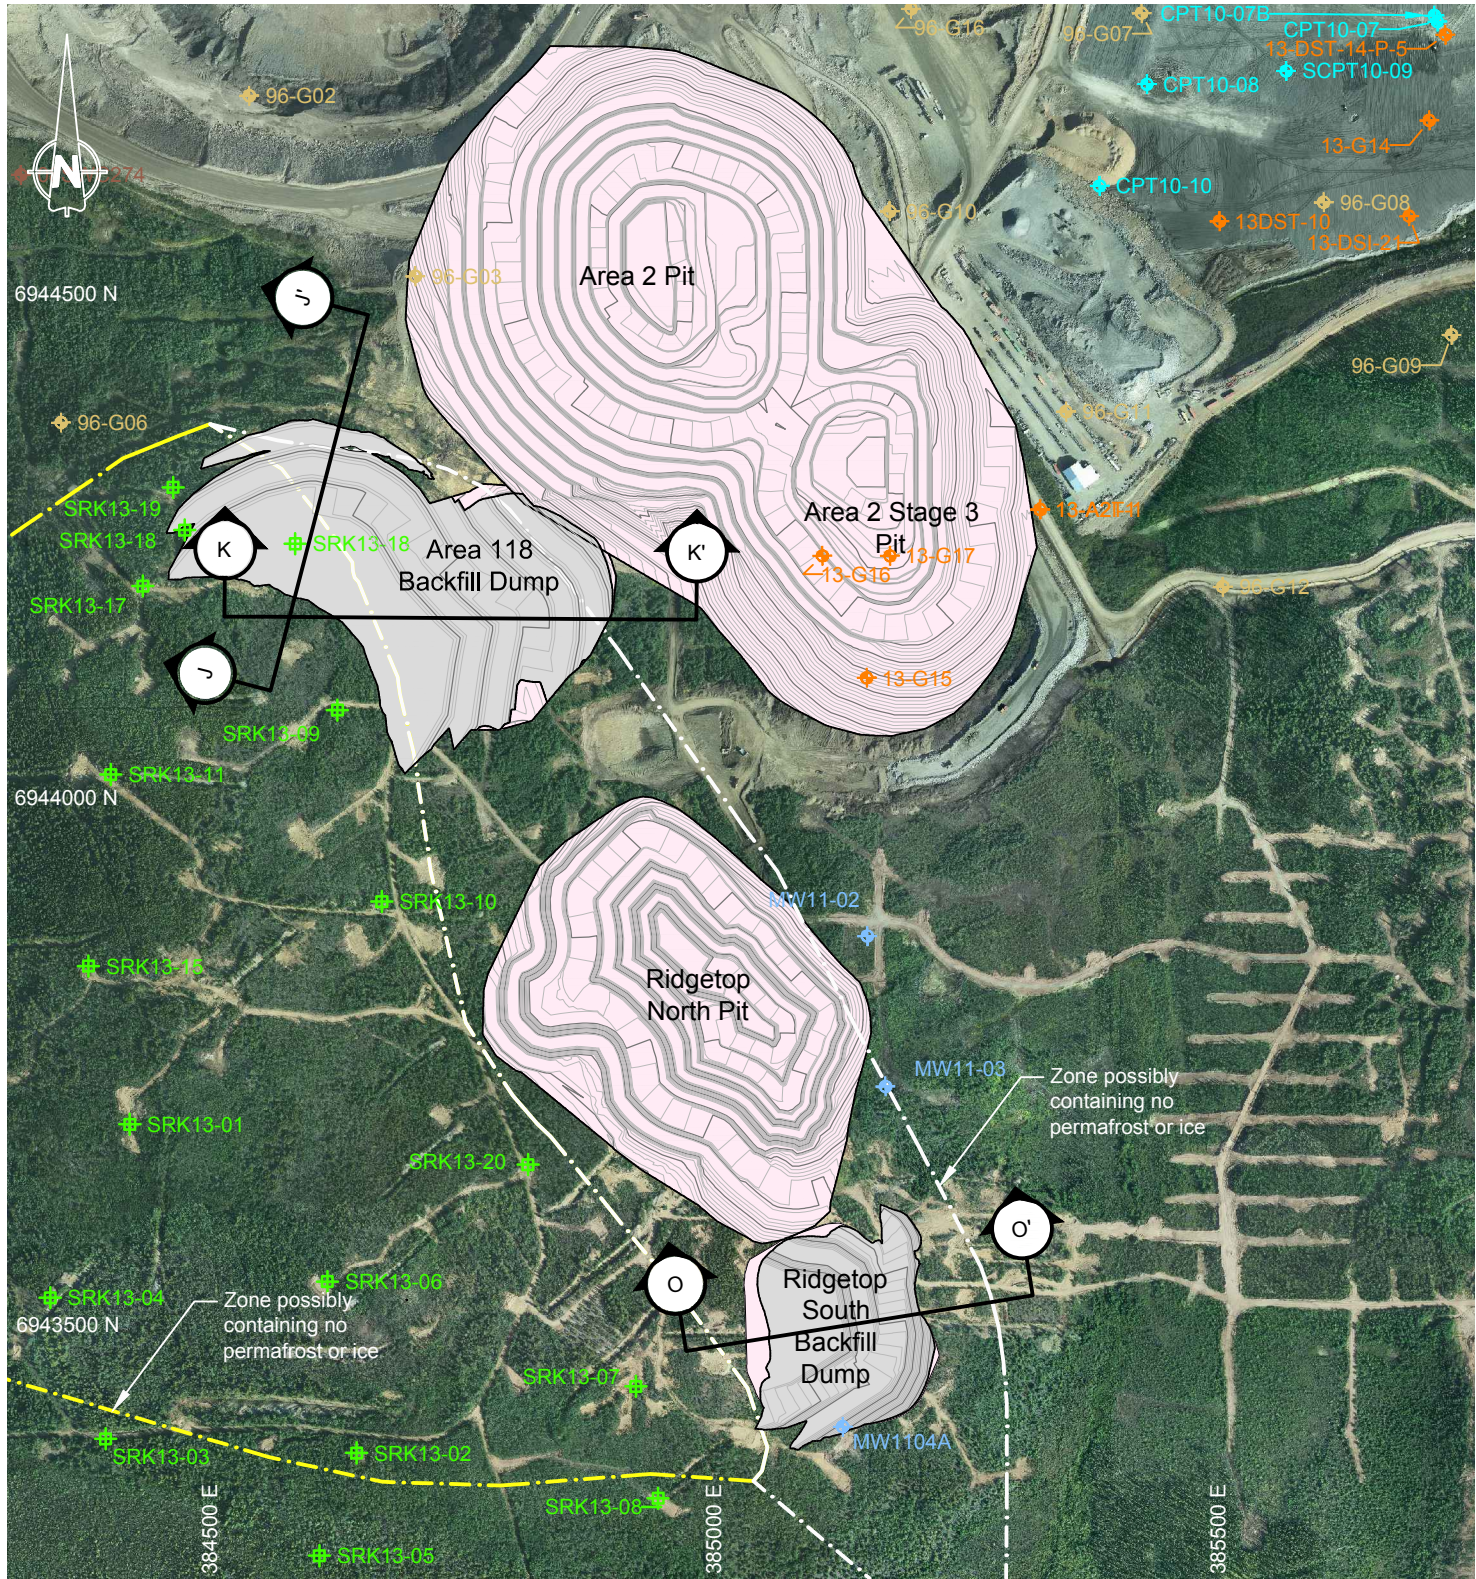
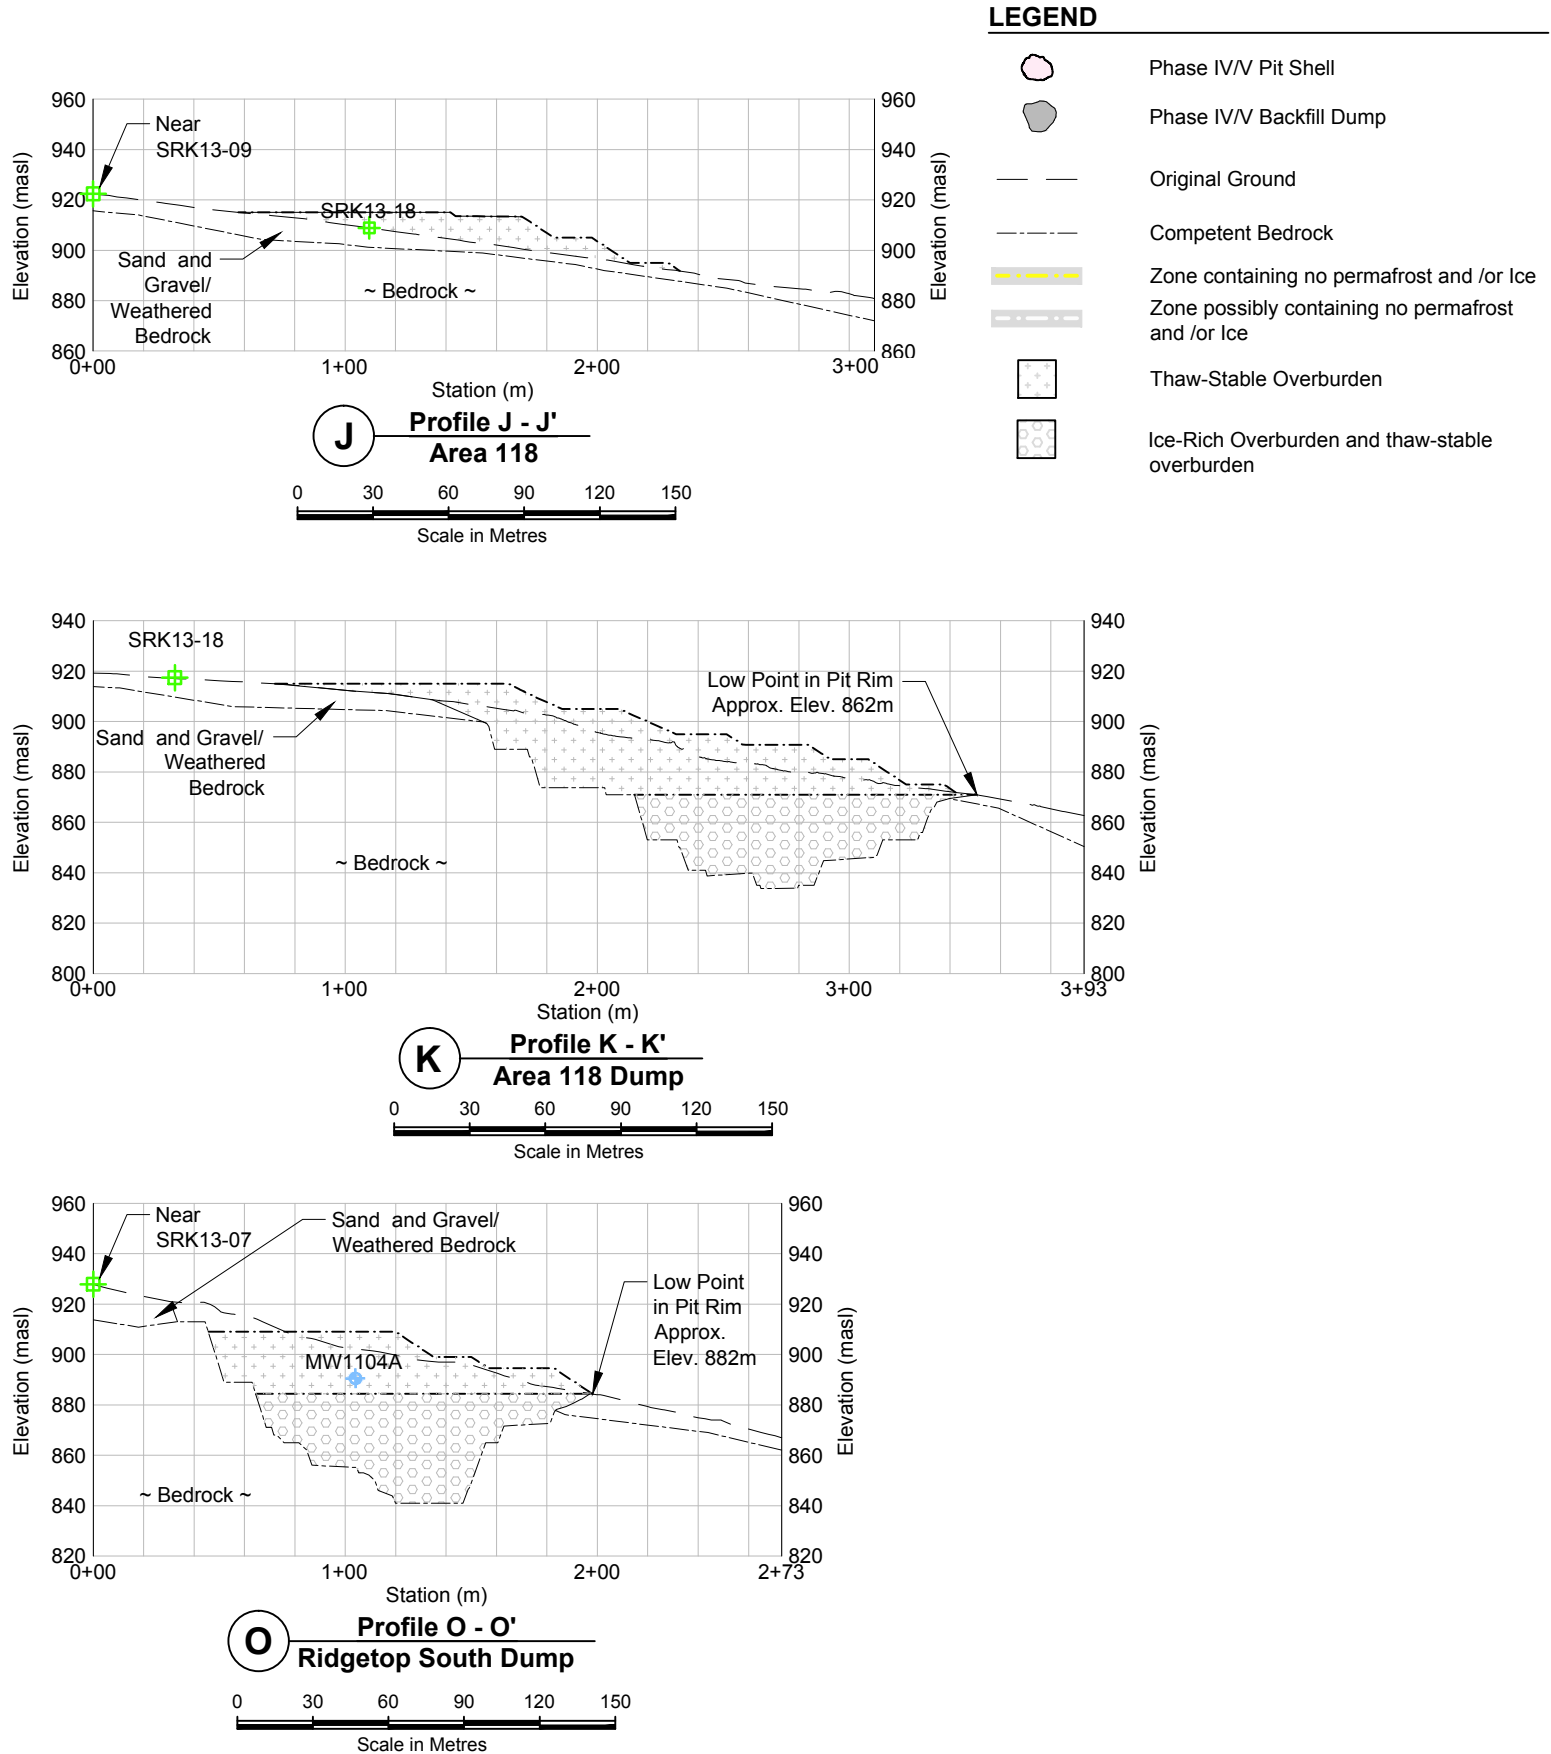
SRK JOB NO.: 1CM002.012.012 FILE NAME: Site Layout-RdGS Backfill Dump.dwg	 Minto Mine	Main Dam Conceptual Design		
		Ridgetop South and Area 118 Backfill Dumps Plan and Sections		
		DATE: September 2013	APPROVED: JBK	FIGURE: RS118-3

Figure RS118-3: Ridgetop South and Area 118 Backfill Dumps - Plan and Sections

1. Data presented in NAD 1983 UTM Zone 8N
2. Base Orthophoto provided by Minto Mine, August 2012
3. Phase V/VI pit shells provided by Minto Mine, March 2013
4. Phase V/VI 118 Backfill Dump design provided by Minto Mine, March 2013
5. Phase V/VI Ridgetop South Backfill Dump design provided by Minto Mine, August 2013
6. See drawings RS118-02 for more detailed test pit and borehole descriptions.

No field investigation has been completed for the RSBD and Area 118 dump as they will be located in mined out pits and founded primarily on bedrock. Field investigation programs (EBA 1996, 2011b; SRK 2013a, 2013e) have been completed in adjacent areas encountered primarily shallow overburden soils (typically less than 10 m) consisting of sand and gravel to sandy silt soils or weathered bedrock. Locations of past investigation points (e.g. drill holes and test pits) can be found on Figure RS118-3.

One critical section for the RSBD and two critical sections for the Area 118 Backfill Dump were selected for analysis. These sections are taken at locations with less favourable dump geometries or foundation conditions. One of the two sections for each dump are located in areas with larger pit backfill and ultimate dump heights, and the other Area 118 Backfill Dump section is located

though the portion of the dump where the dump is built outside the pit, i.e. directly over the overburden foundation.

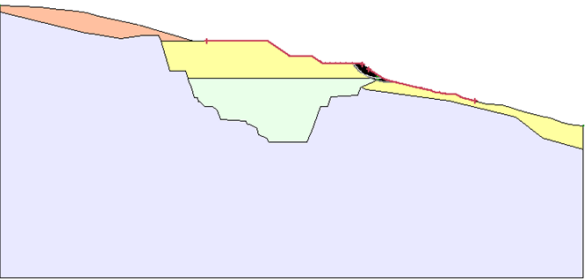
Run	Section	Case	Software Used	Search	Pore Water Pressures	Seismic	Minimum FOS	Comments	
5	O-O'	1 (General Material Properties)	Slope/W	Entry & Exit	No	No	1.2	Small scale bench failure in overburden bench.

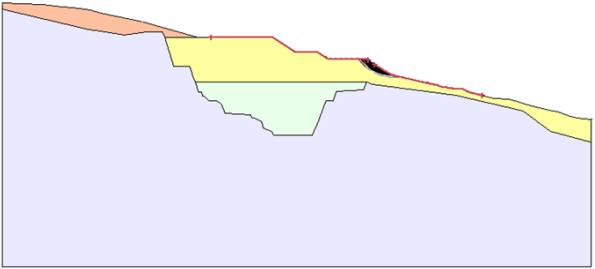
6	O-O'	2 (Undrained, Ice-Rich with no friction only Su)	Slope/W	Entry & Exit	No	No	1.1	Small scale bench failure in overburden bench.

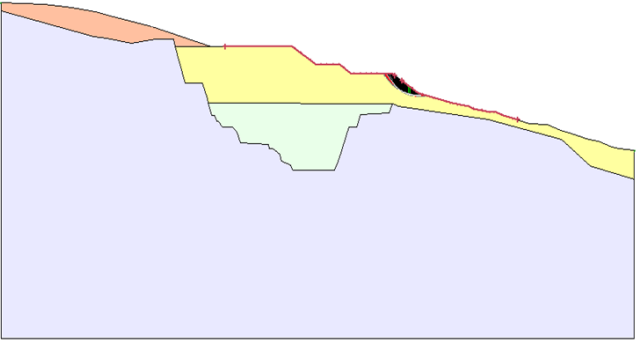
7	O-O'	3 (Semi frozen ice-rich material)	Slope/W	Entry & Exit	No	No	1.8	Small scale bench failure in thaw-stable overburden bench

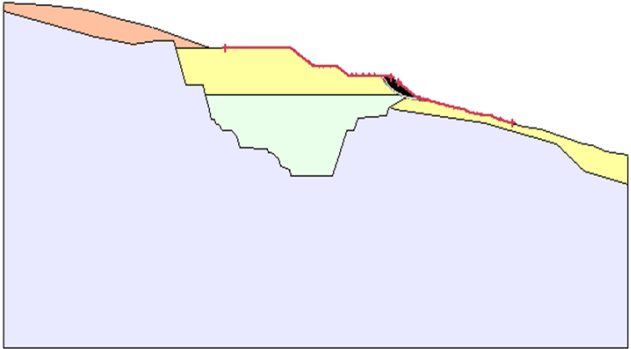
8	O-O'	1 Fatal Flaw Review (General Material Properties)	Slope/W	Entry & Exit	No	Yes	1.0	Small scale bench failure in thaw-stable overburden bench

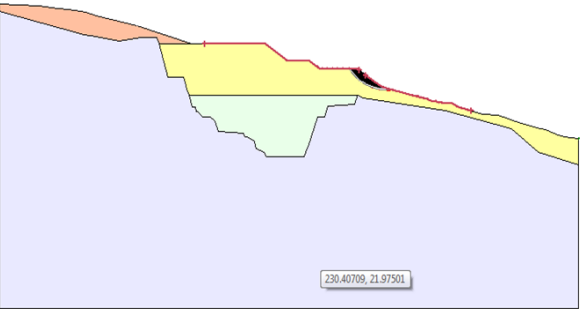
Run	Section	Case	Software Used	Search	Pore Water Pressures	Seismic	Minimum FOS	Comments	
9	O-O'	2 (Undrained, Ice-Rich with no friction only Su)	Slope/W	Entry & Exit	No	Yes	1.0	Small scale bench failure in thaw-stable overburden bench

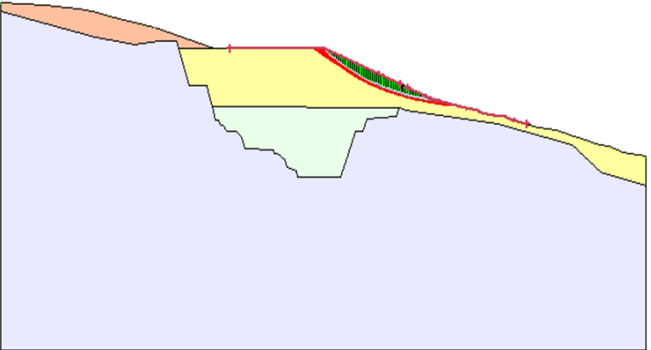
10	O-O'	1 (General Material Properties)	Slope/W	Entry & Exit	No	Yes	1.2	CLOSURE CASE (2.5H:1V) with seismic. Long shallow failure along slope in thaw-stable overburden

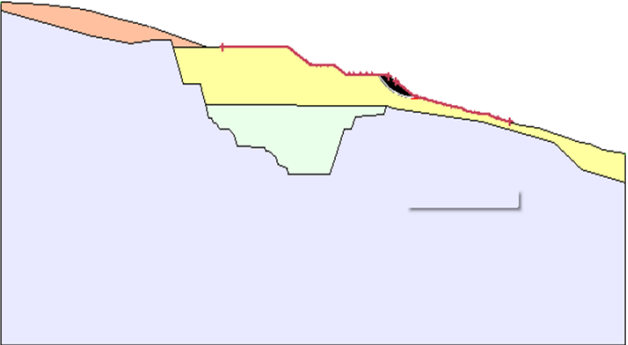
11	O-O'	3 (Semi frozen ice-rich material)	Slope/W	Entry & Exit	No	Yes	1.6	Small scale bench failure in thaw-stable overburden bench

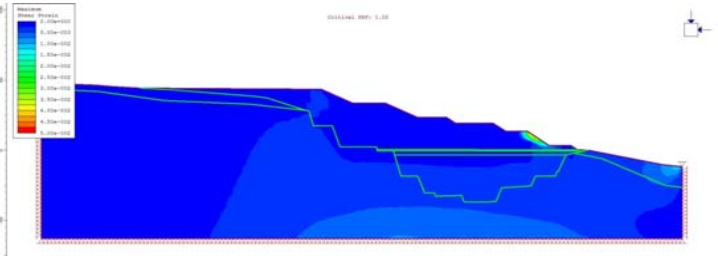
Run	Section	Case	Software Used	Search	Pore Water Pressures	Seismic	Minimum FOS	Comments
10	K-K'	1 Fatal Flaw Review (General Material Properties)	Phase ² 8.0	Shear Strength Reduction	No	No	1.0	Inputs based on Slide 6.0 model. Shear strain contours shown in screenshot. Lighter / hotter (more red) colours indicate areas with higher shear strain. Shear strain development support smaller bench failure models. <div>

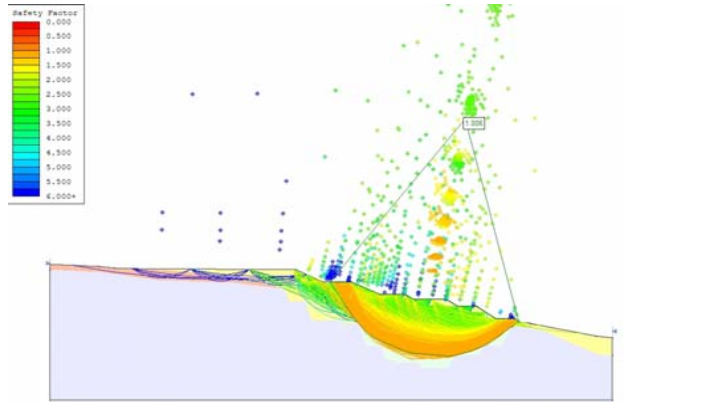
</div>
11	K-K'	2 (Undrained, Ice-Rich with no friction only Su)	Slide 6.0	Optimized Auto-locate	No	No	1.0	UNEXPECTED CASE. Assumes all material below pit is ice-rich material with low material properties. Ice-rich material to top of pit rim (i.e. above rock in pit). Deep-seated / global failure through weak ice-rich pit backfill. <div>

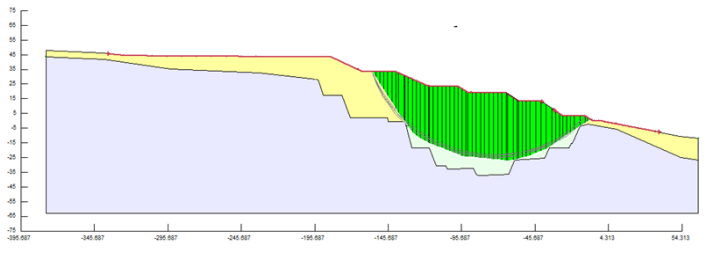
</div>
12	K-K'	2 (Undrained, Ice-Rich with no friction only Su)	Slope/W	Entry & Exit	No	No	1.0	UNEXPECTED CASE. Global failure through to bottom of ice-rich material <div>

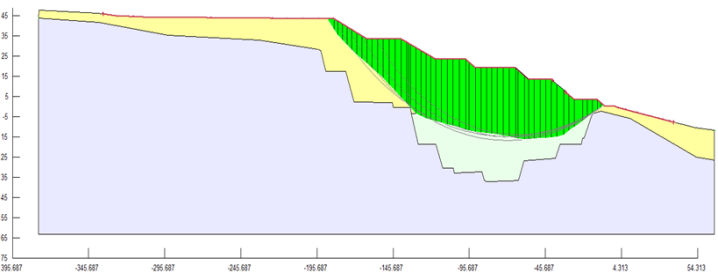
13	K-K'	3 (Semi frozen ice-rich material)	Slope/W	Entry & Exit	No	No	2.0	Deep global failure through ice-rich material starting at top of pit and through to toe of slope above pit <div>

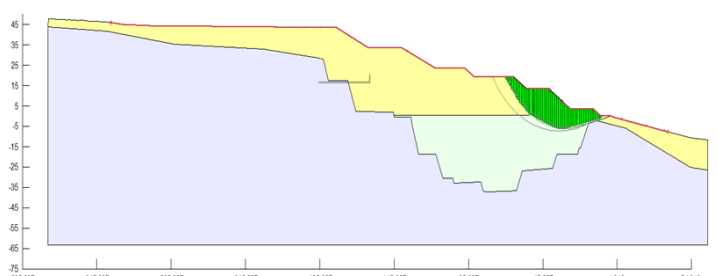
</div>
14	K-K'	3 (Semi frozen ice-rich material)	Slope/W	Entry & Exit	No	No	1.6	Multi-bench failure through both thaw-stable and ice-rich overburden <div>

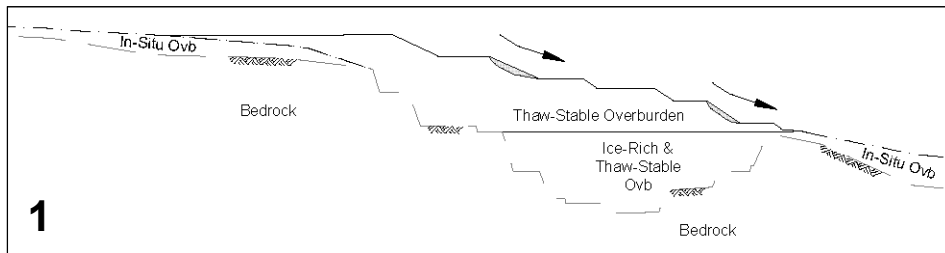
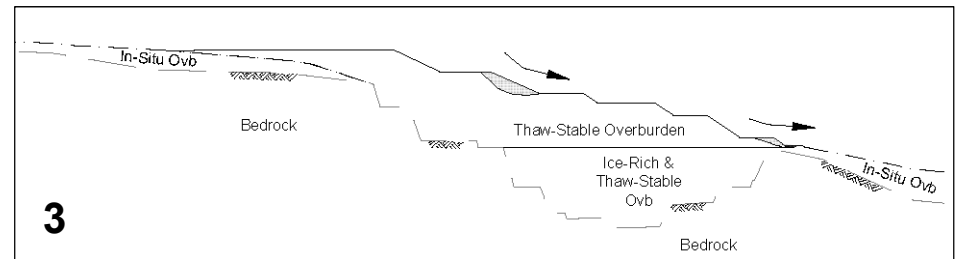
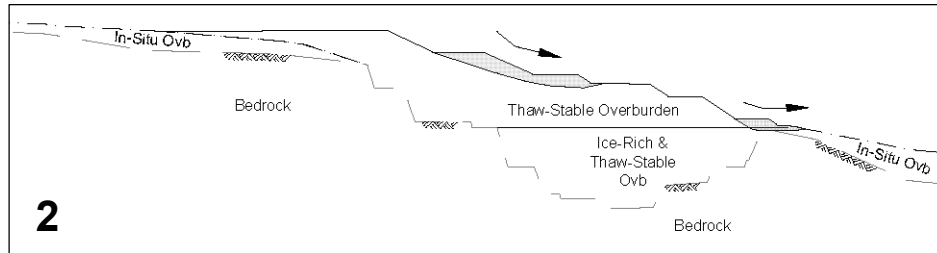
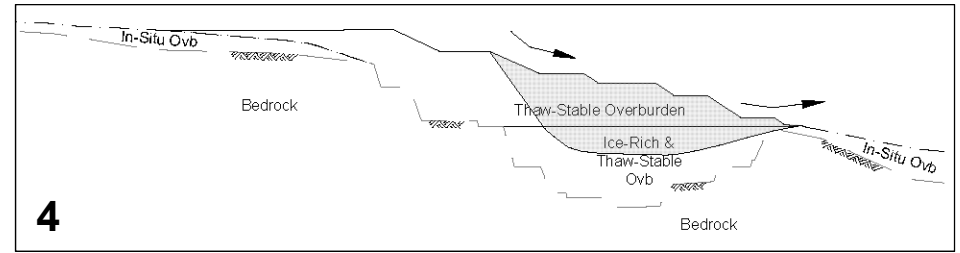
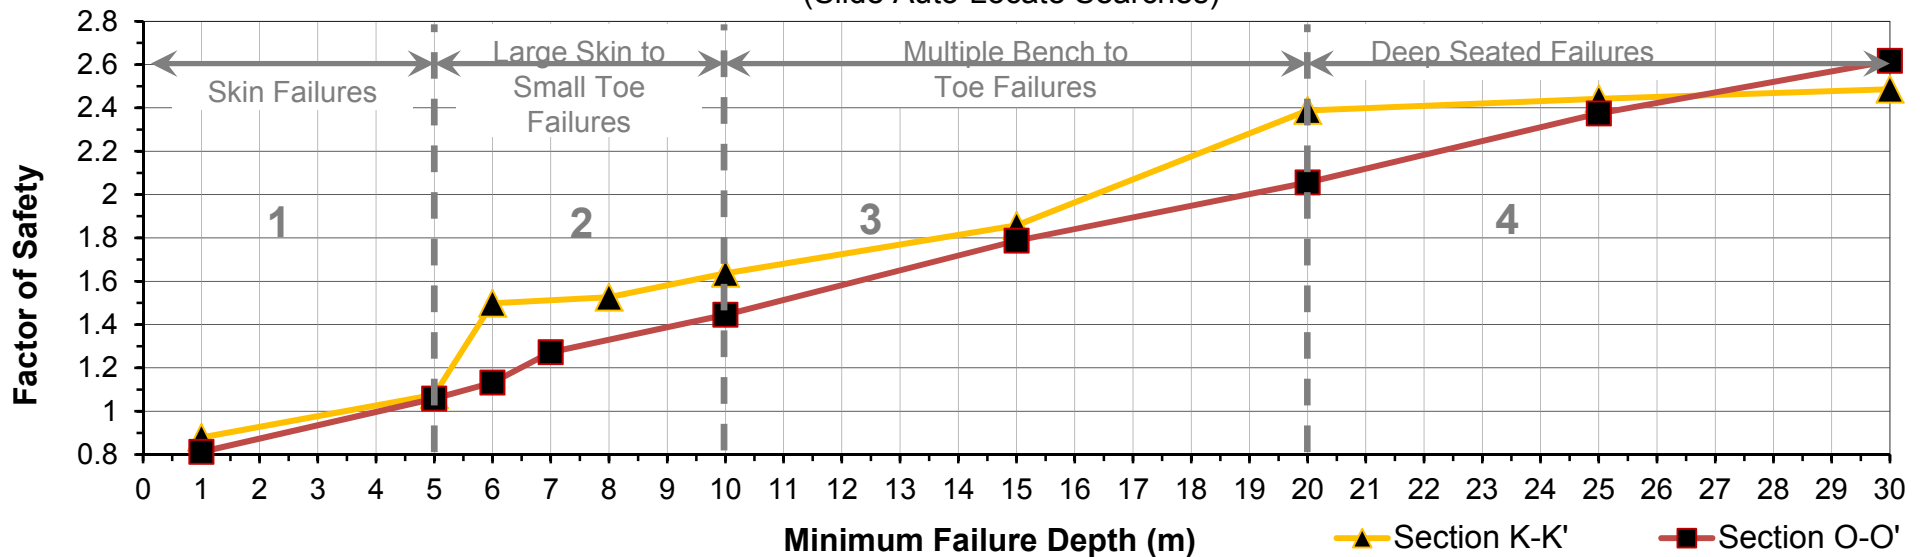
Figure:
C1

Minimum Depth of Slip Surface Search (Slide Auto-Locate Searches)

Note: Overburden backfill dump sensitivity analysis results run on Case 1 model set-up.

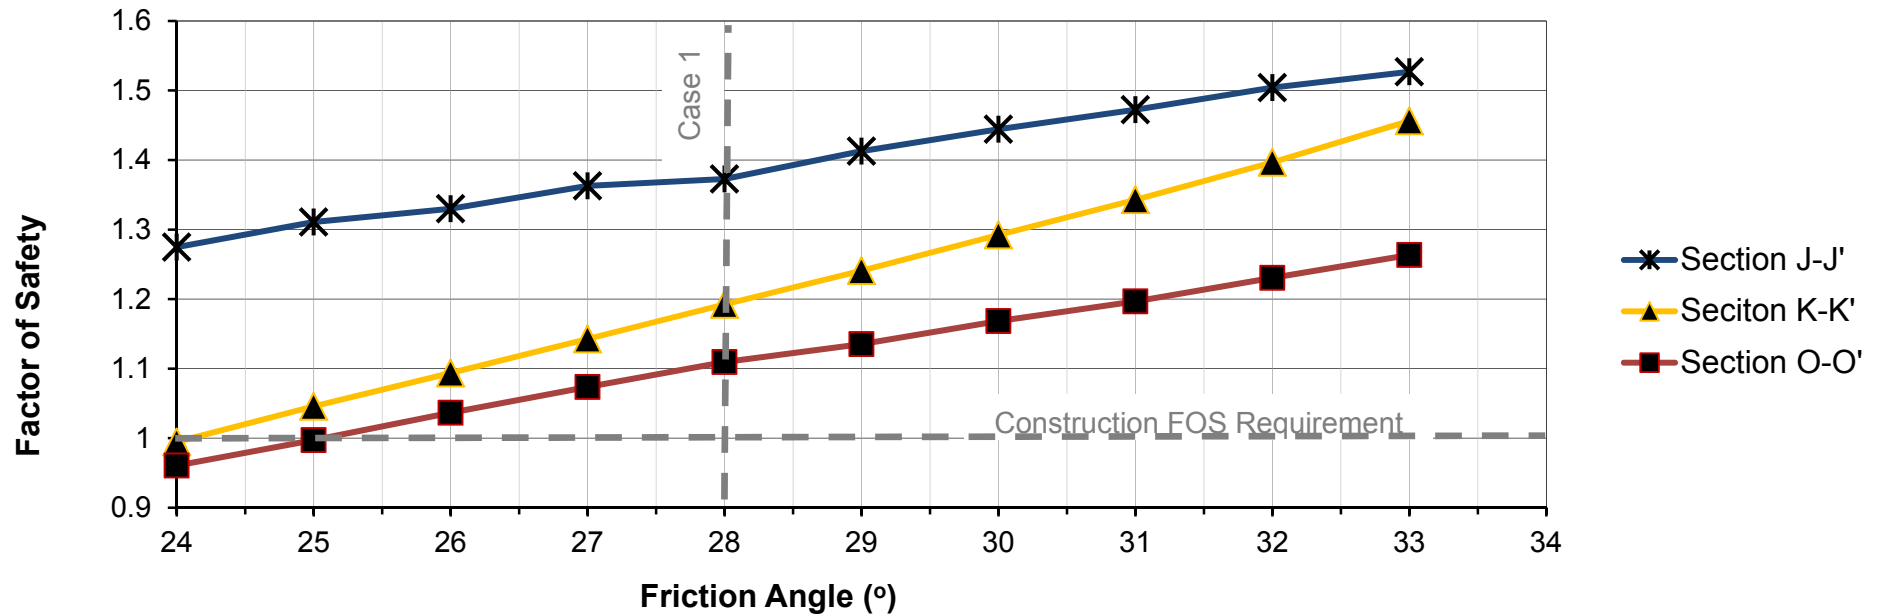
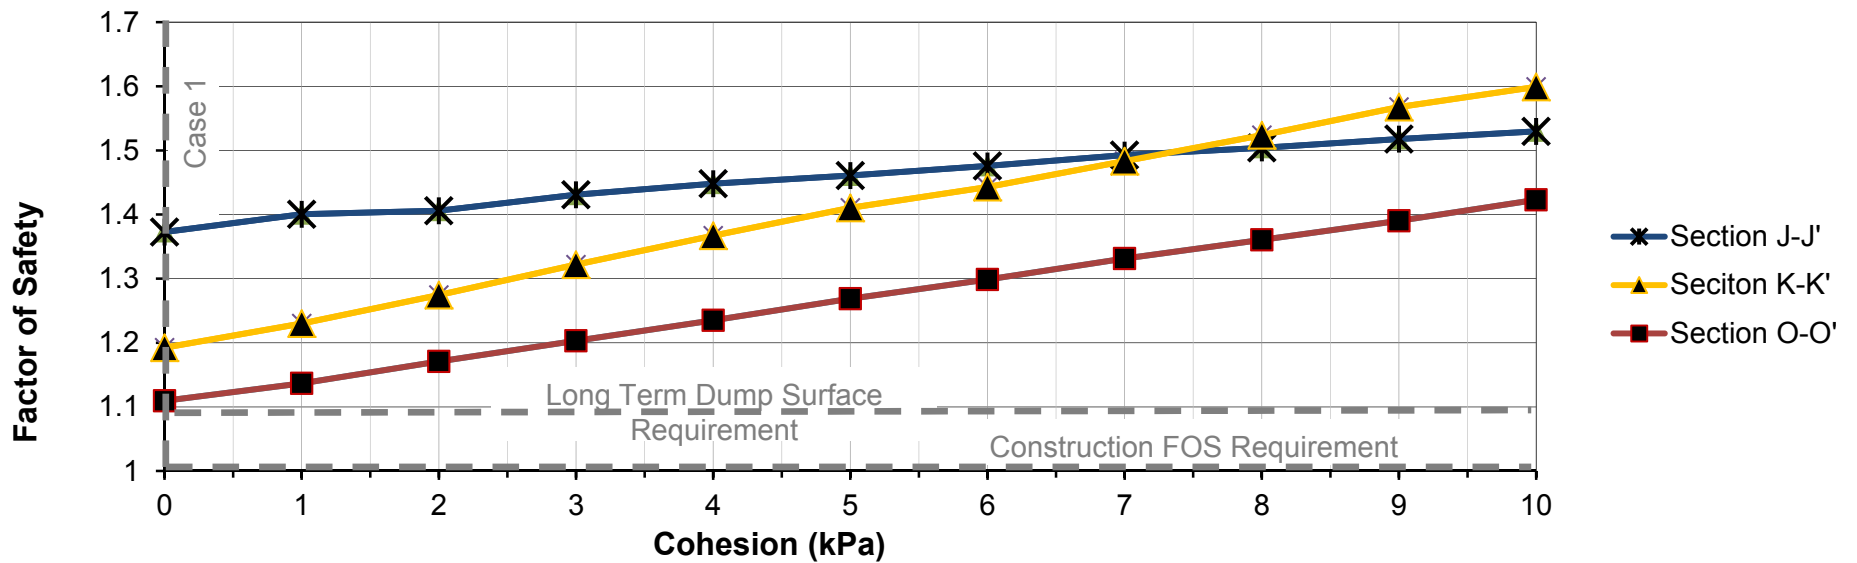
Figure:
C2

Thaw-Stable Overburden

Note: Steeper sloped lines indicate greater sensitivity to changes in material strength properties. Failure more through dump and less large deep failures through foundation, thus relatively insensitive.

Overall the stability models were found to be moderately sensitive to changes in the thaw-stable and ice-rich overburden material properties, while the models were relatively insensitive to changes in material cohesion. As the material properties for the overburden and waste rock are conservative, no notable cause for concern was identified in the stability models if small variations from the modelled material strength values are encountered in the field.

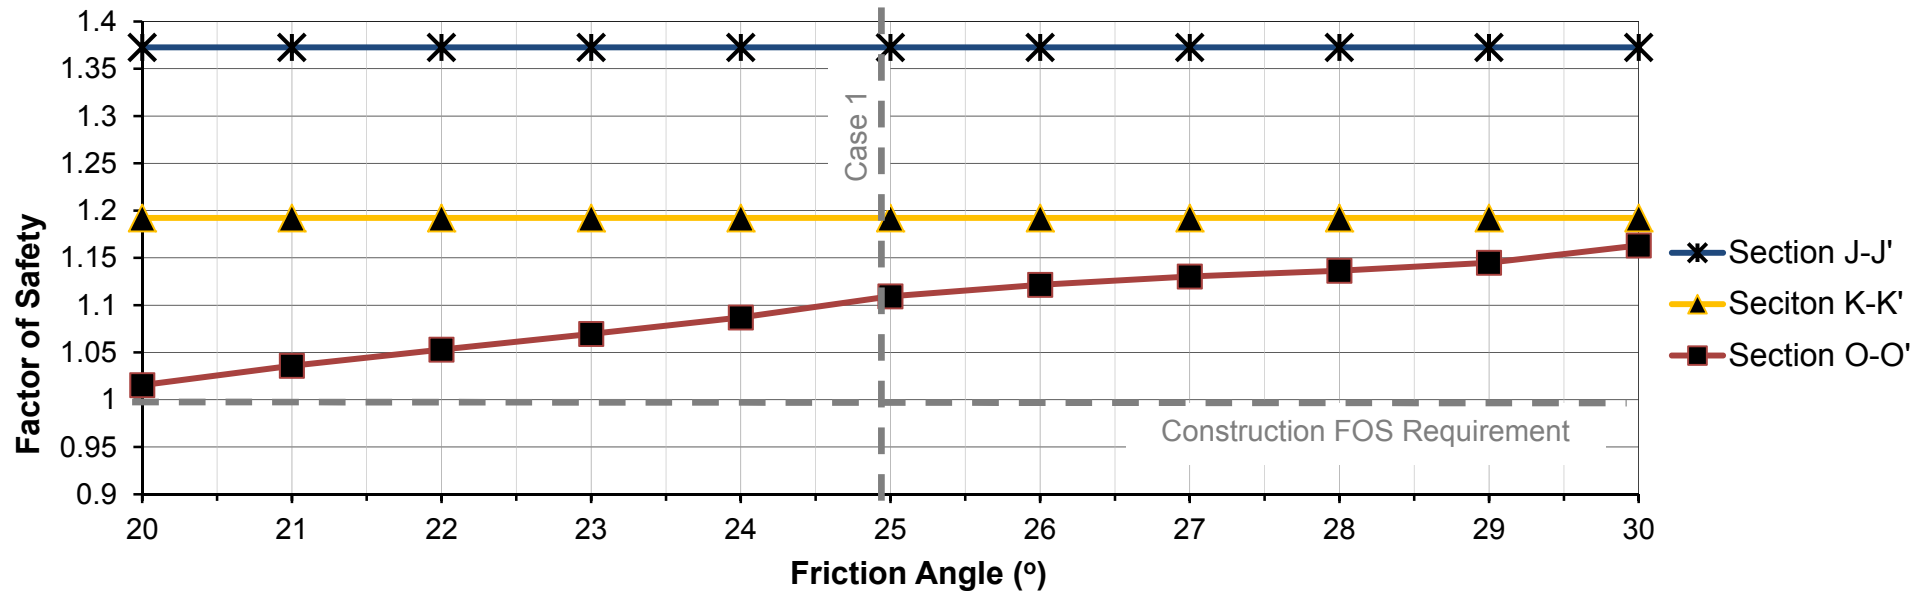
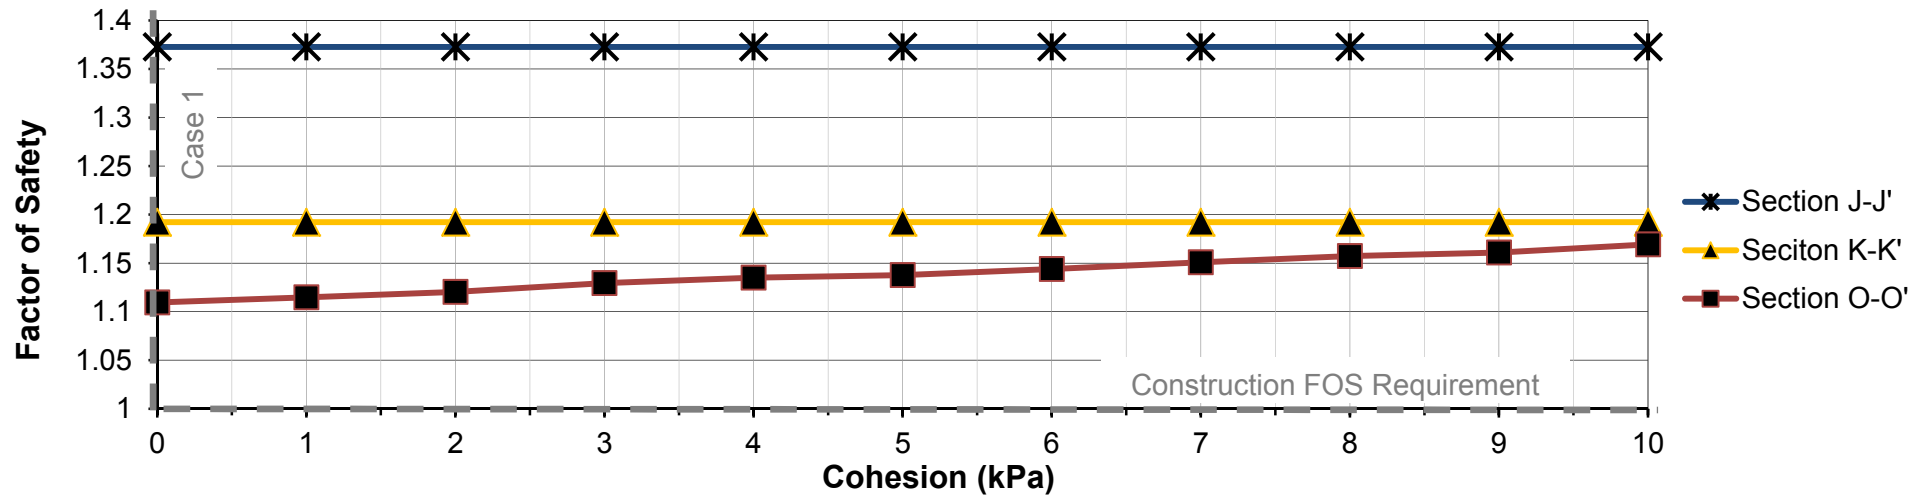
Figure:
C3

Ice-Rich Overburden

Note: Steeper sloped lines indicate greater sensitivity to changes in material strength properties. Failure more though dump and less large deep failures though foundation, thus relatively insensitive.

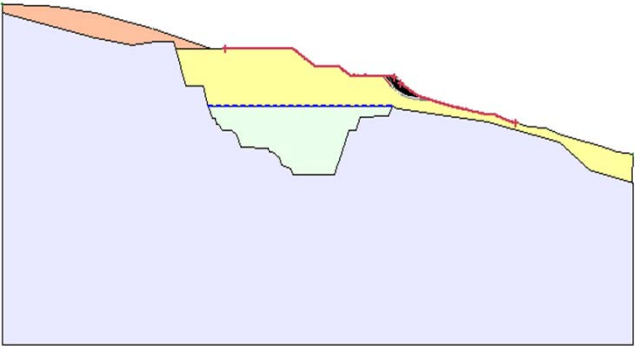
Run	Section	Case	Software Used	Search	Pore Water Pressures	Seismic	Minimum FOS	Comments	
1	O-O'	1 (General Material Properties)	Slope/W	Entry & Exit	Yes Fully Saturated up to Top of Pit	No	1.1	Small scale bench failure in overburden bench.

For the pore water pressure sensitivity analysis, the Phase V/VI Hydrogeological Characterization report (SRK 2013b) was consulted. For these analyses the water level was assumed to be at the base of the pit and then varied up to the top of the bedrock in the pit (i.e. pit near full saturated state) to see effect. FOS of 1.0 or greater was found for all model runs. In addition, a mounded water table within the overburden dump was assessed. Even in these unexpected conditions, FOS in the range of 1.0-1.1 were noted in the models. The monitoring plan (Section □) has proactively incorporated further consideration to monitor water levels in the pit backfill and around these overburden backfill dump toes.

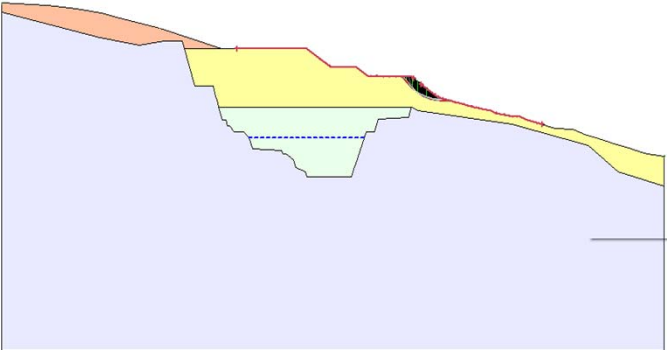
2	O-O'	1 (General Material Properties)	Slope/W	Entry & Exit	Yes Saturated Halfway up Pit	No	1.1	Small scale bench failure in overburden bench.

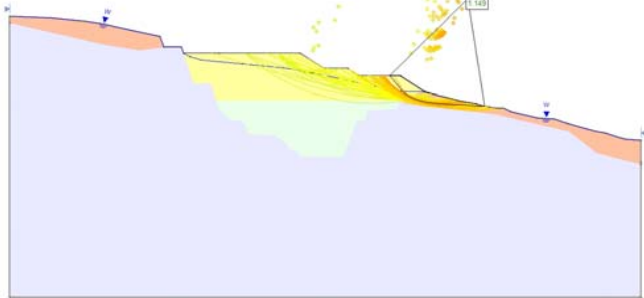
3	O-O'	1 (General Material Properties)	Slide 6.0	Optimized Auto-locate	Yes Mounded water table though dump, exits at toe of dump	No	1.1	Toe failure though overburden dump, progressing though natural / in-situ overburden. Assume weathered bedrock to sand and gravel foundation properties near pit rim. Water table along surface then though dump and back along top of surface.

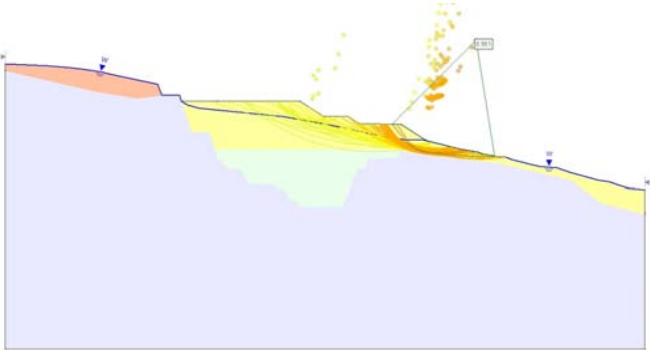
Run	Section	Case	Software Used	Search	Pore Water Pressures	Seismic	Minimum FOS	Comments	
4	O-O'	1 (General Material Properties)	Slide 6.0	Optimized Auto-locate	Yes Mounded water table though dump, exits at toe of dump	No	1.0	Toe failure though overburden dump, progressing though natural / in-situ overburden. Assume conservatively low material properties near pit rim in natural ground. Water table along surface then though dump and back along top of surface.

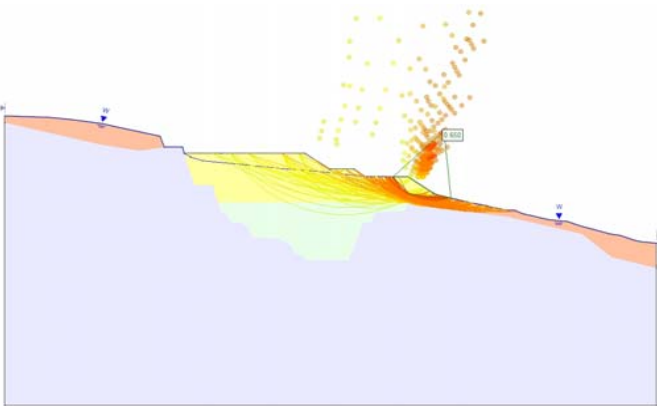
5	O-O'	1 (General Material Properties)	Slide 6.0	Optimized Auto-locate	Yes Mounded water table though dump, exits at toe to middle bench	No	0.7	NOT EXPECTED. Used to assist with developing monitoring recommendations. Part of monitoring to look for seepage exiting above the toe of dump and inform the engineer. Result sin toe failure, through lower bench of the dump and exiting natural ground overburden outside of pit,

- Additional runs were completed by assuming a mounded water level within the dump, which exited at the overburden dump toe (i.e. by the pit rim).
- Runs to assist with developing monitoring recommendations were completed. This was done by assuming an unexpected worst case scenario with a mounded water table within the dump which exits the dump at the toe of the middle bench.
- Depth of failure / slip surface
 - Completed by utilizing various slip search methods on each modelled section and by forcing failure surfaces to progress deeper into the dump and foundation. Provided a better understanding of the overall failure mechanisms and the progression of failures from shallow skin failures, to smaller bench and toe failures, and finally to deep seated failures.

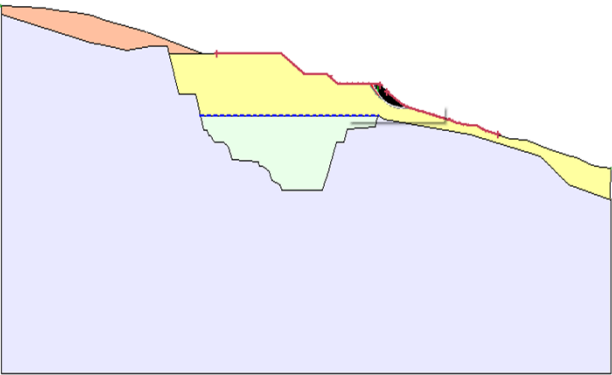
6	O-O'	3 (Semi frozen ice-rich material)	Slope/W	Entry & Exit	Yes Fully Saturated up to Top of Pit	No	1.8	Small scale bench failure in thaw-stable overburden bench

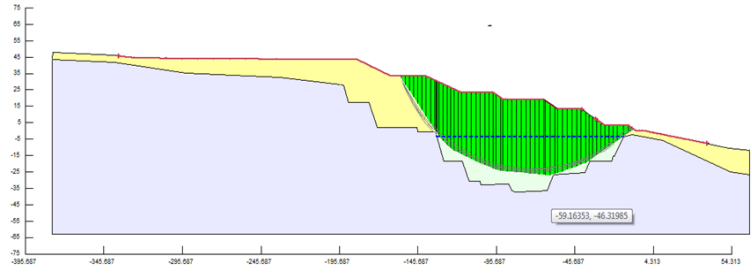
Run	Section	Case	Software Used	Search	Pore Water Pressures	Seismic	Minimum FOS	Comments	
1	K-K'	1 (General Material Properties)	Slope/W	Entry & Exit	Fully Saturated up to end of Pit	No	1.0	Deep seated global failure through saturated pit, ice-rich materials.

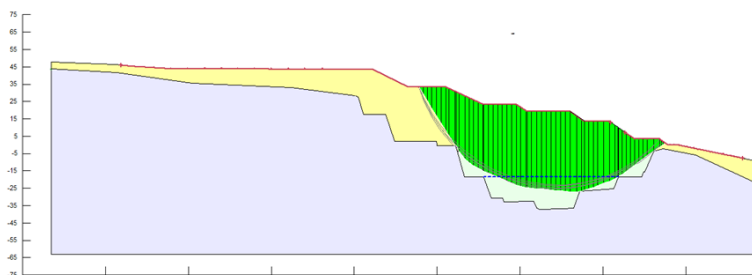
2	K-K'	1 (General Material Properties)	Slope/W	Entry & Exit	Saturated Halfway up Pit	No	1.0	Deep seated global failure through saturated pit, ice-rich materials.

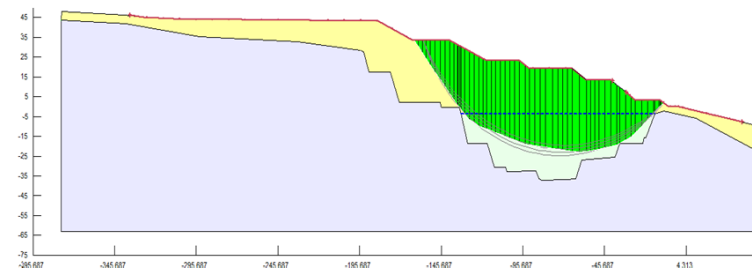
3	K-K'	3 (Semi frozen ice-rich material)	Slope/W	Entry & Exit	Fully Saturated up to end of Pit	No	1.8	Deep seated global failure through saturated pit, ice-rich materials.

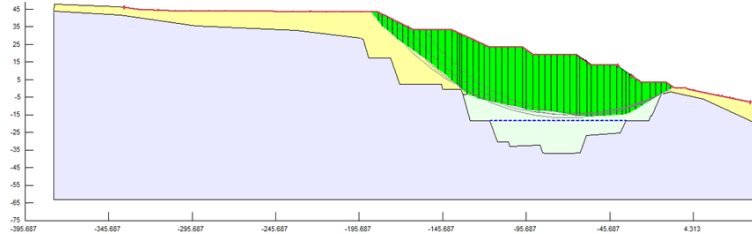
4	K-K'	3 (Semi frozen ice-rich material)	Slope/W	Entry & Exit	Saturated Halfway up Pit	No	2.0	Deep seated global failure through ice-rich material but not under water table
