**2000 GEOCHEMICAL STUDIES
SA DENA HES MINE**

COMNICO LTD
200 Burrard Street
Vancouver, BC

STEFFEN ROBERTSON AND KIRSTEN (CANADA) INC.

NOVEMBER, 2000

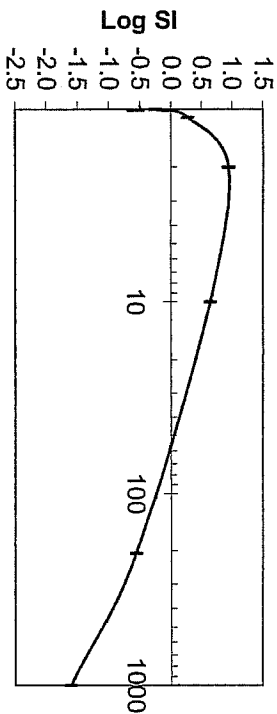
Log SI vs Mix Ratio for $ZnCO_3 \cdot H_2O$

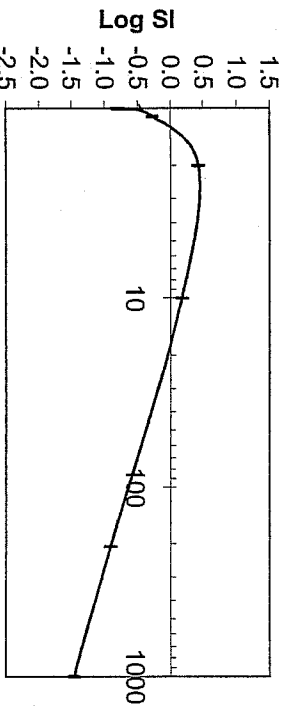
Log SI vs Mix Ratio for Otavite

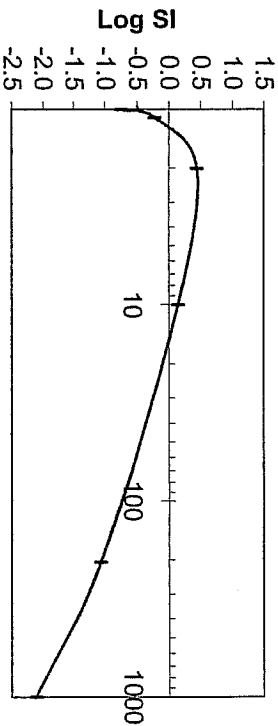
Log SI vs Mix Ratio for Smithsonite

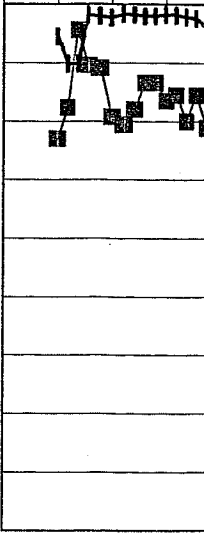
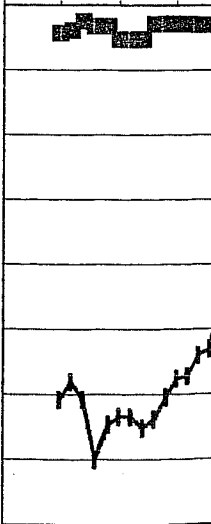
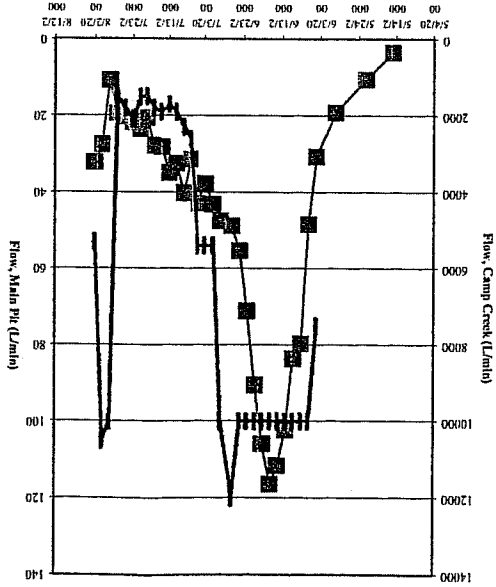
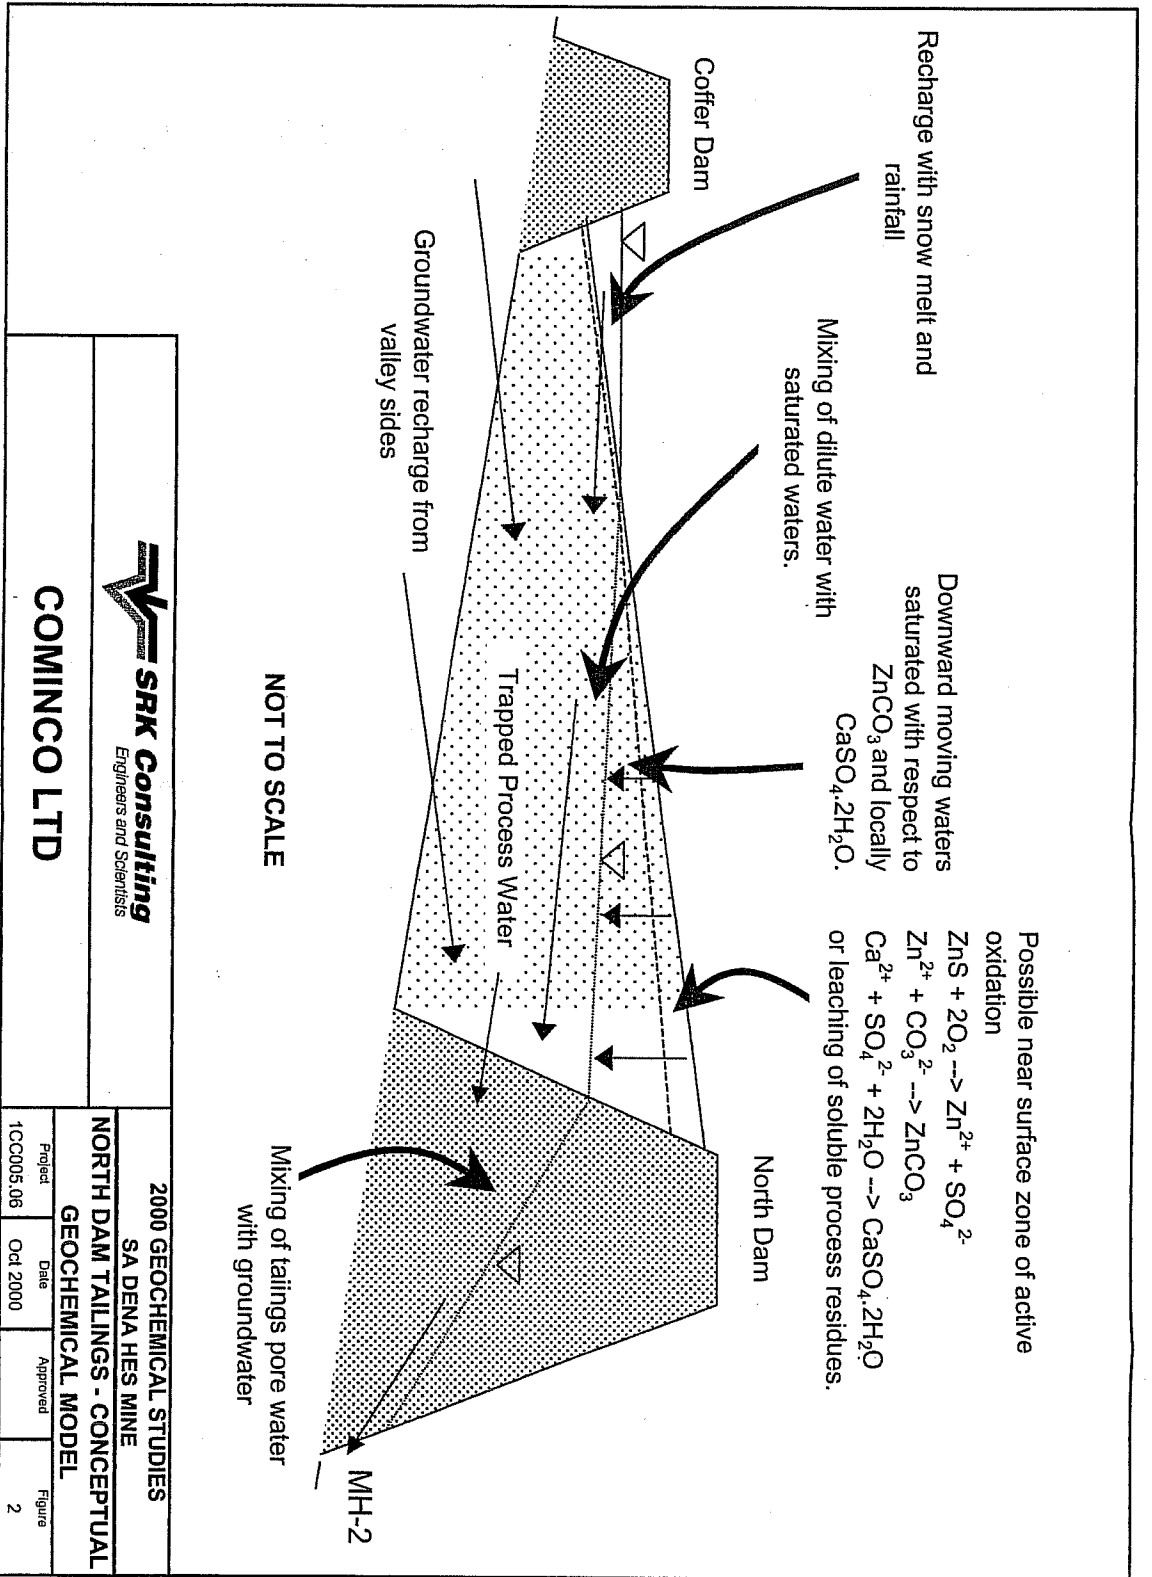
Project	Date	Approved	Figure
IC005.04	Oct 2000		3

—■— Camp Creek
—+— Main Zone Pit

Flows

FIGURE 1	Site Map
FIGURE 2	North Dam Tailings - Conceptual Geochemical Model
FIGURE 3	Results of Summer 2000 Monitoring - Camp Creek and Main Zone Pit
FIGURE 4	Saturation Indices for Mixed Camp Creek and Main Zone Pit Water
