# Annual Quartz Mining License Report for 2021

Property: Sä Dena Hes Mine

Permit #: QML-0004

Company: Sä Dena Hes Operating Corporation c/o  
Teck Resources Limited

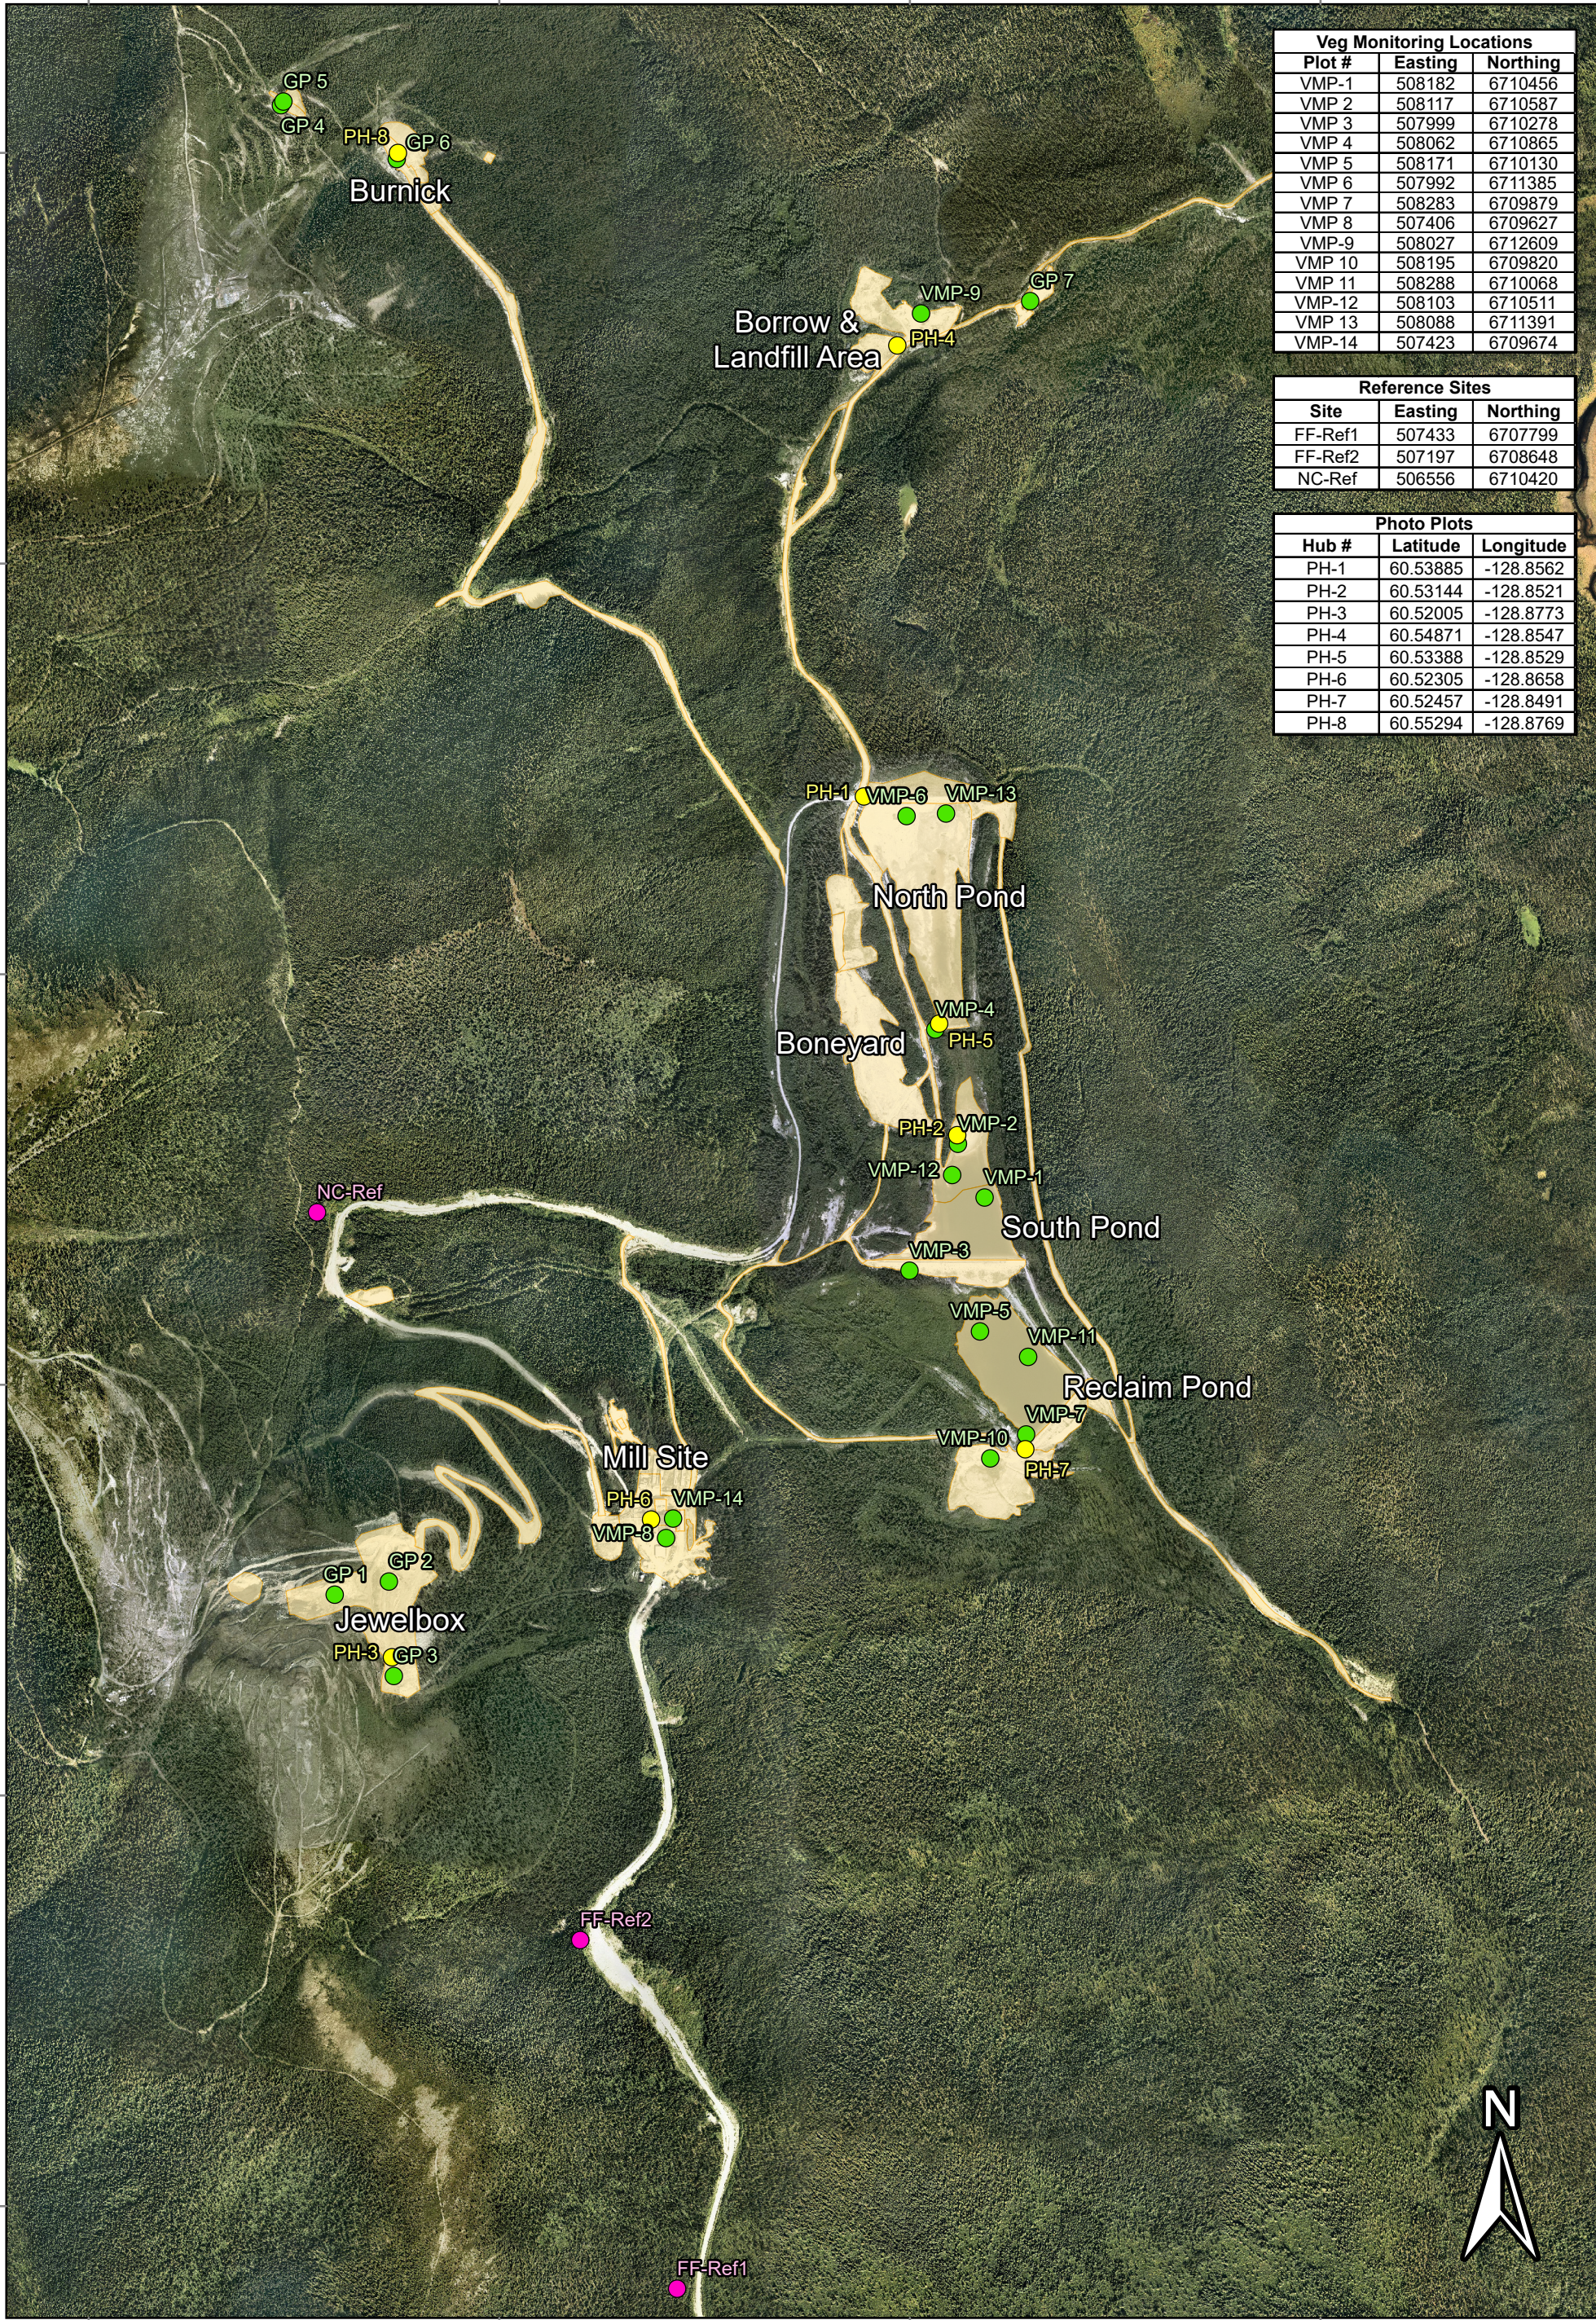
**Sa Dena Hes Vegetation Monitoring Plots**

- Vegetation Monitoring Locations
- Reference Sites
- Photo Plots
- Reclaimed Areas

\*\*\* Aerial photography was obtained from McElhanney from August 15, 2012 LiDAR survey and represents the site prior to reclamation.

Reference Sites		
Site	Easting	Northing
FF-Ref1	507433	6707799
FF-Ref2	507197	6708648
NC-Ref	506556	6710420

Photo Plots		
Hub #	Latitude	Longitude
PH-1	60.53885	-128.8562
PH-2	60.53144	-128.8521
PH-3	60.52005	-128.8773
PH-4	60.54871	-128.8547
PH-5	60.53388	-128.8529
PH-6	60.52305	-128.8658
PH-7	60.52457	-128.8491
PH-8	60.55294	-128.8769

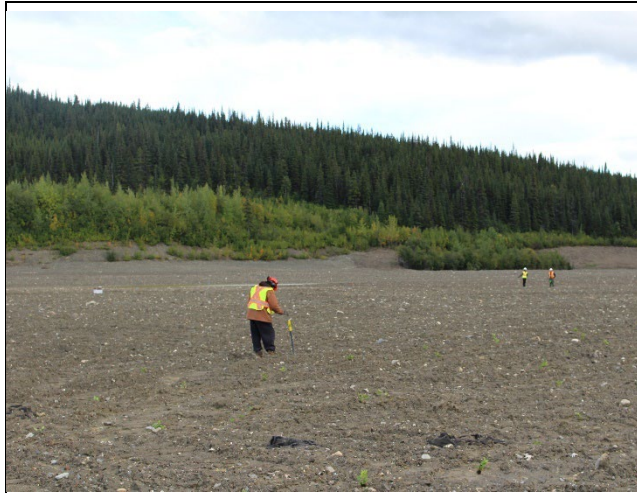
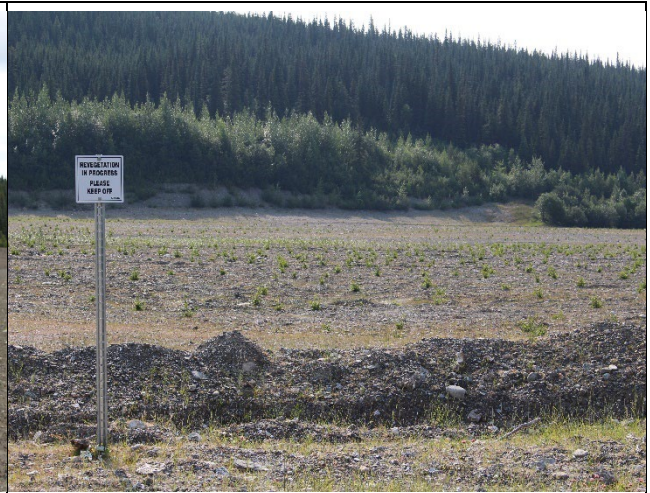
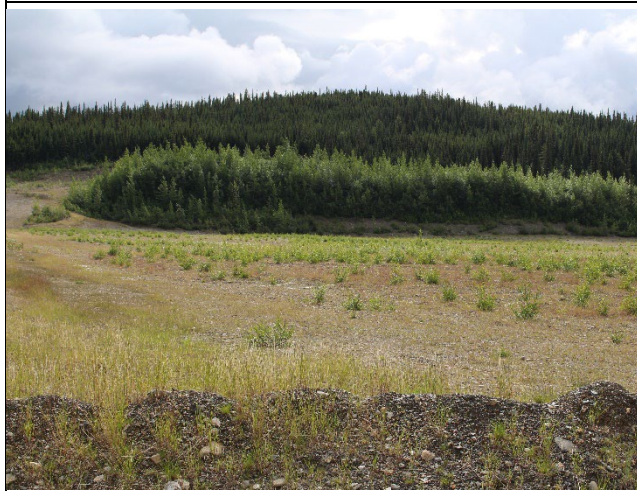
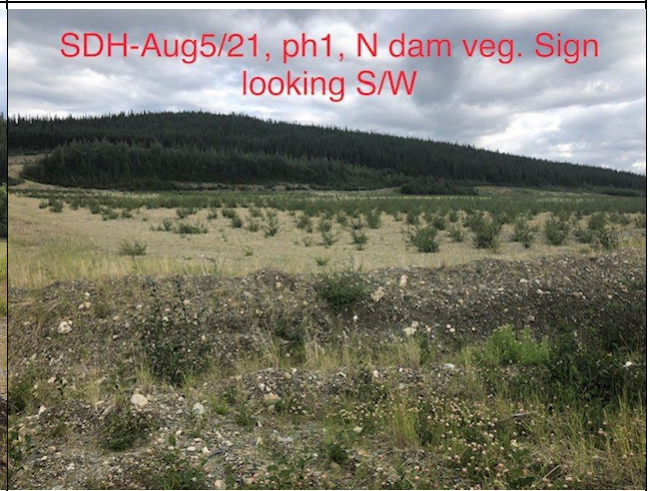
# Photo Hub 1 – At Revegetation Sign at the North Dam

August 2015 planting

August 2018

July 2020

August 2021

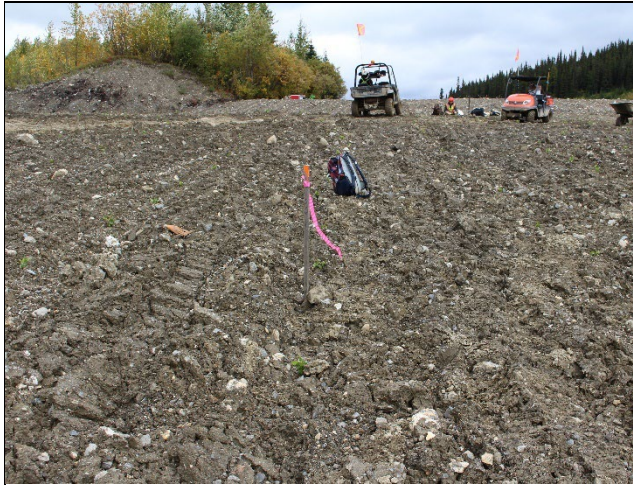
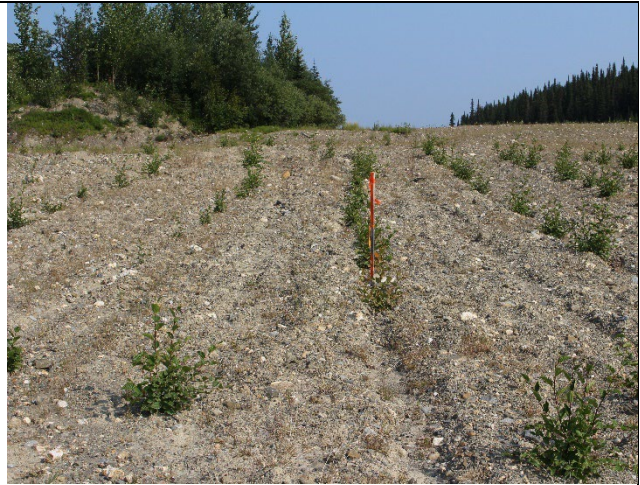
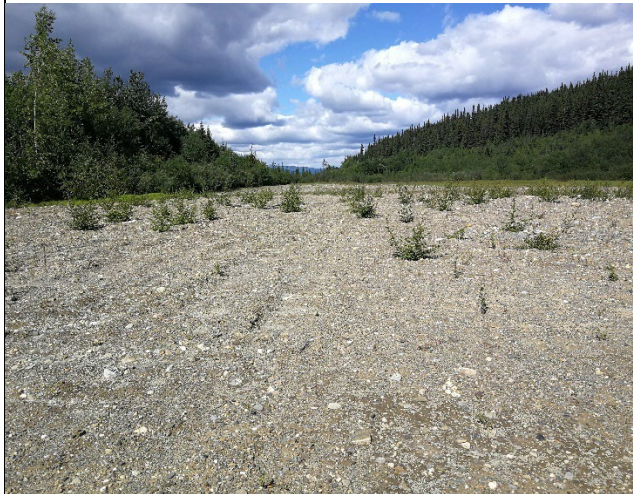
## Photo Hub 2 – North End of South Tailings Facility Near VMP-2

Aug 2015, planting alder

July 2018

July 2020

August 2021

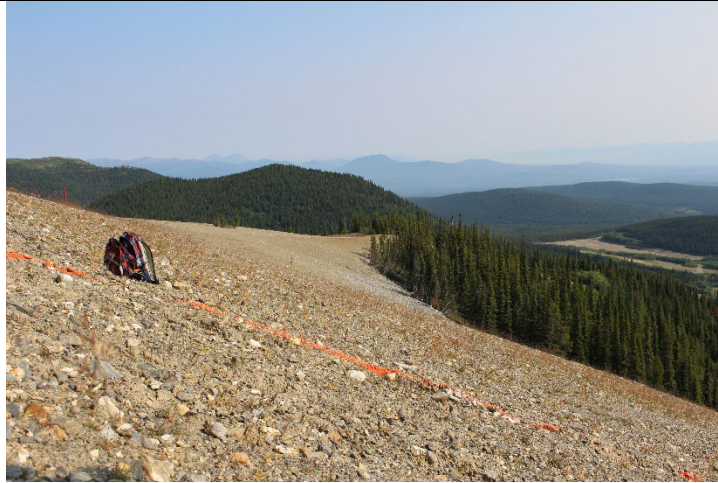
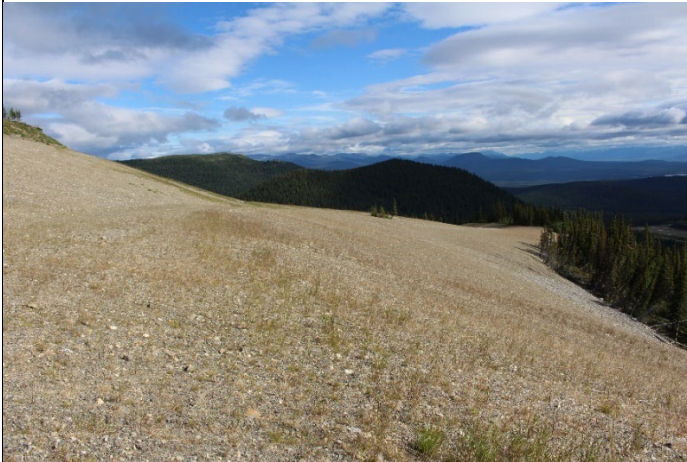
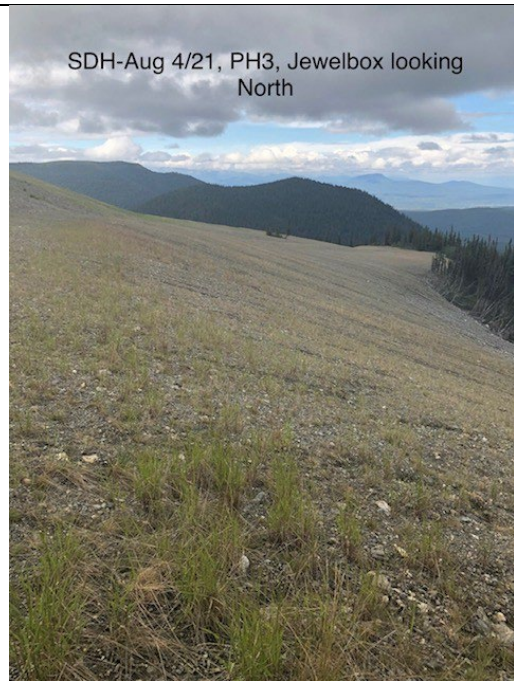
## Photo Hub 3 – Jewelbox Near GP3 and MW13-02

August 2018

July 2020

August 2021

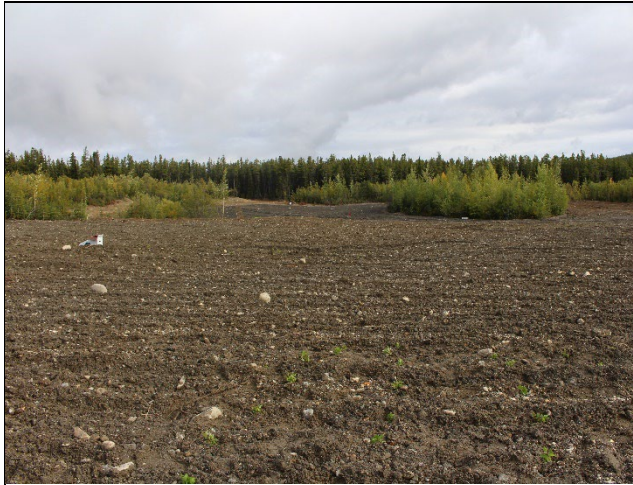
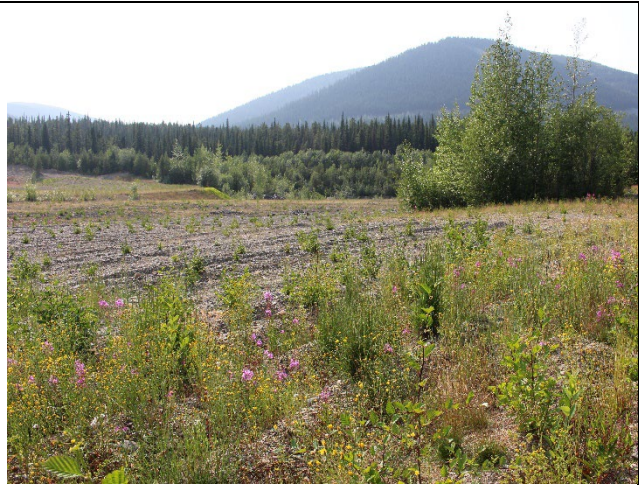
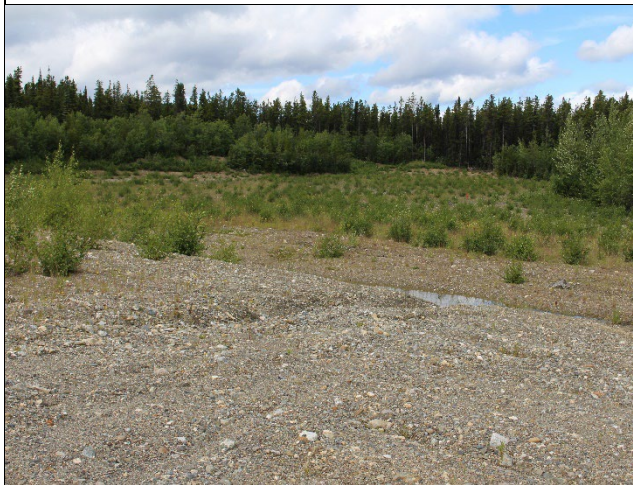
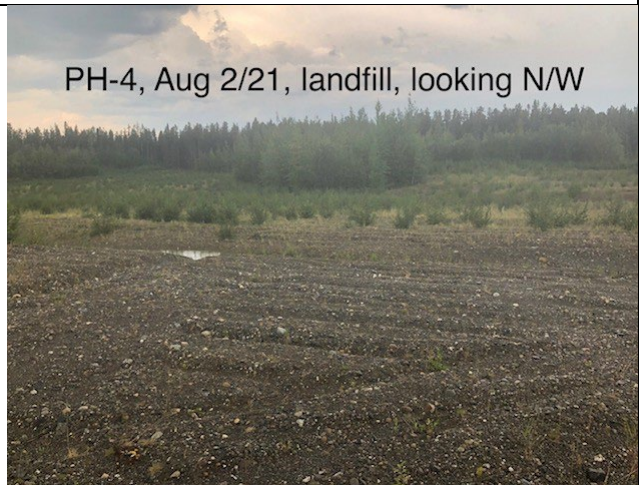
## Photo Hub 4 – Landfill at MW14-02 and VMP-9

August 2015 Planting

August 2018

July 2020

August 2021

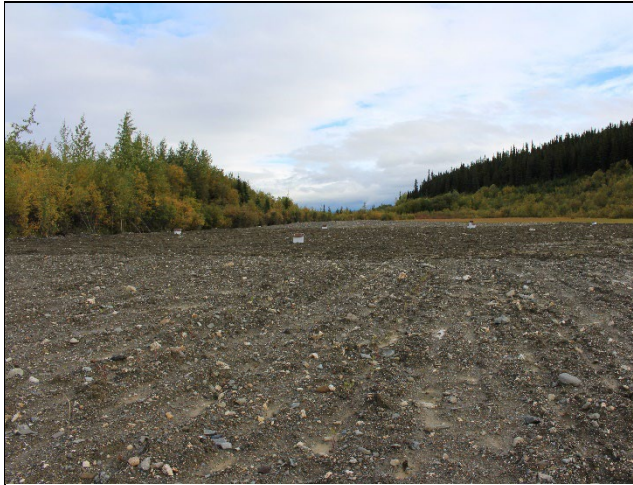
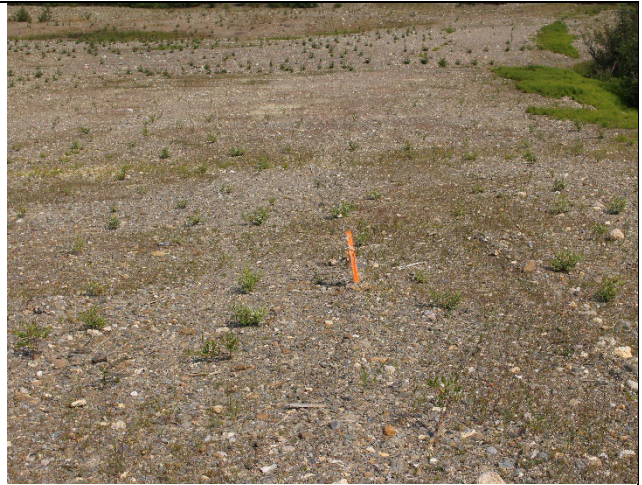
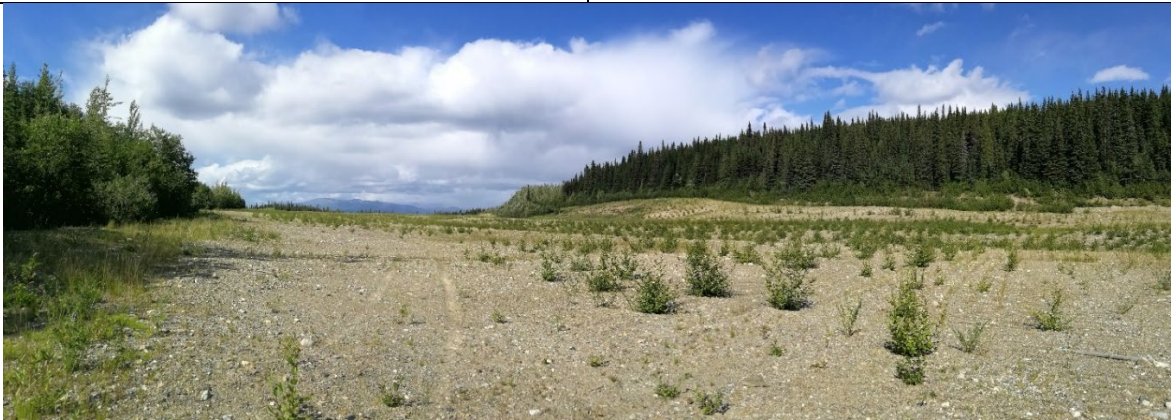
## Photo Hub 5 – South End of North Tailings Facility (VMP-4)

August 2015 planting

August 2018

July 2020

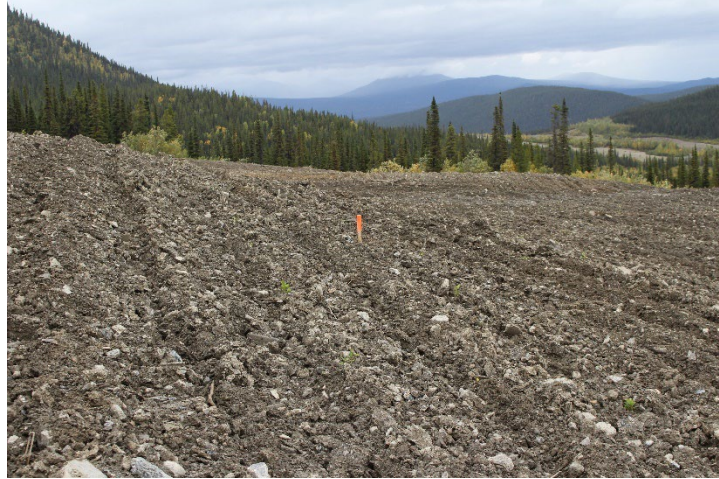
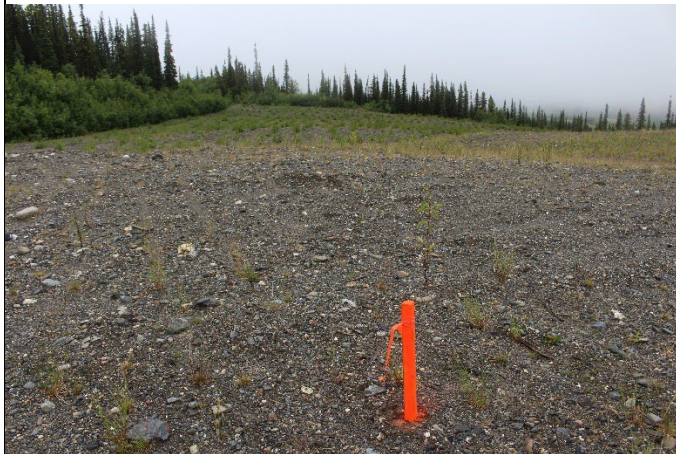
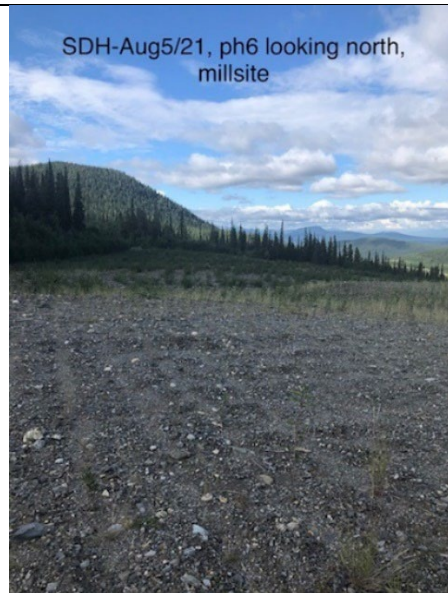
## Photo Hub 6 – Mill Site

August 2015 planting

July 2020

August 2021

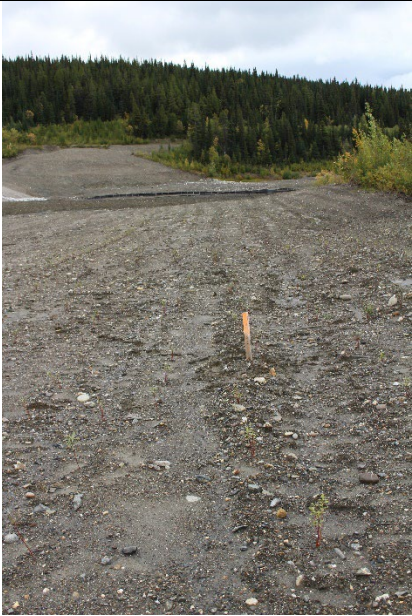
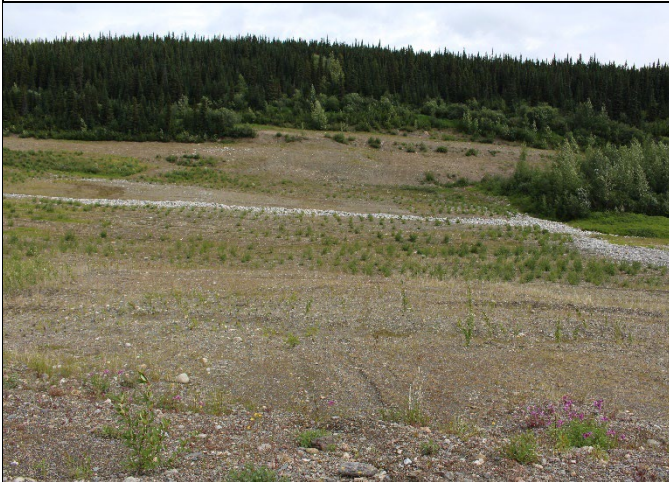
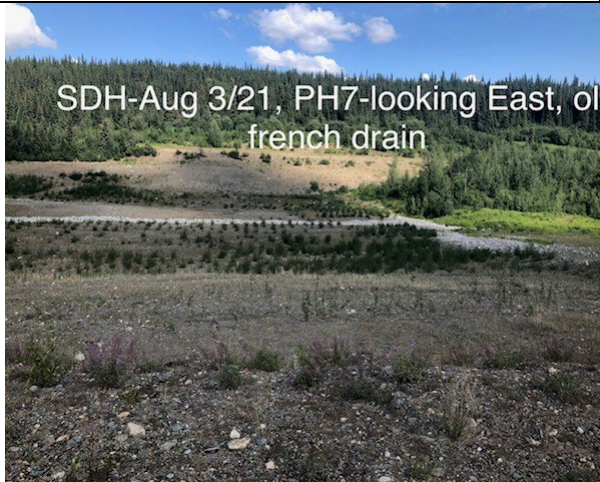
Photo Hub 7 – Reclaim Pond

August 2015 planting

July 2020

August 2021

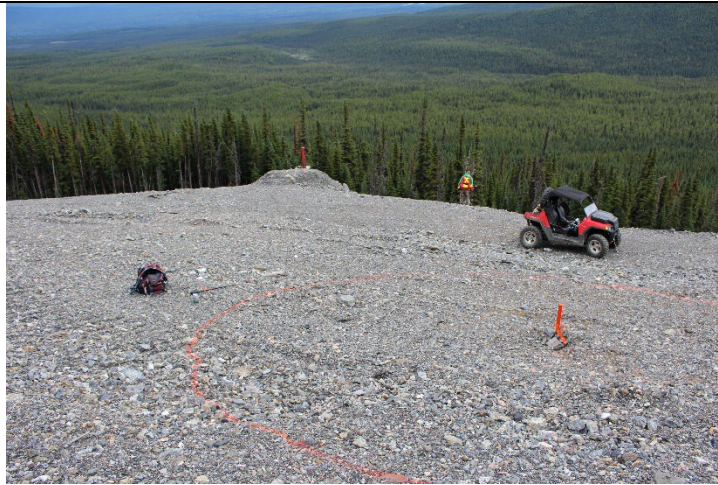
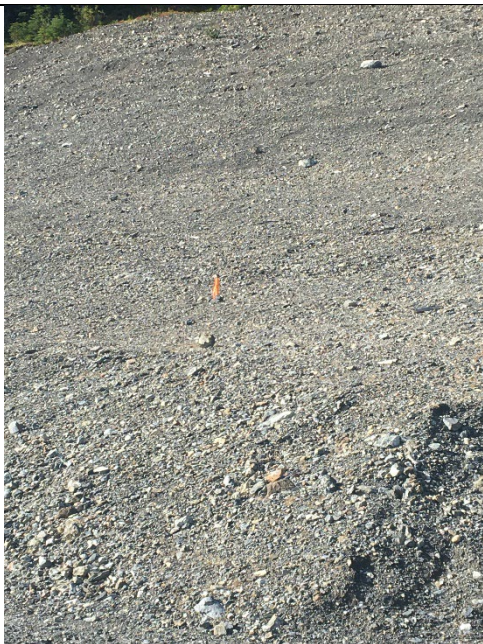
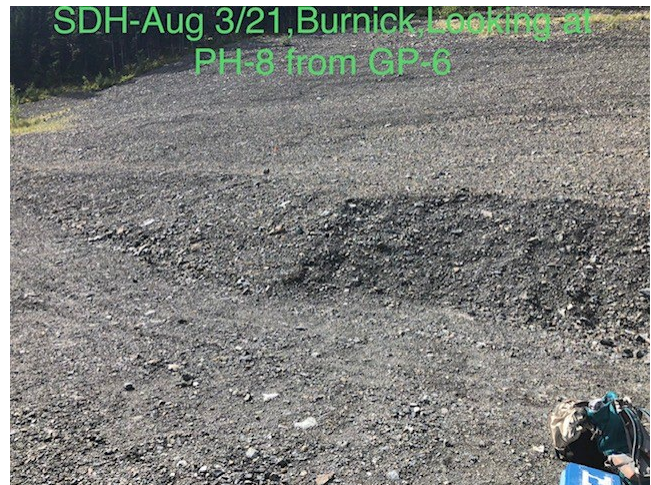
Photo Hub 8 – Burnick, GP-6, and MW13-06

July 2016

July 2020

August 2021

The Burnick 1200 and 1300 Portals were capped in 2015 with locally available waste rock and graded with a gently sloped face to provide long term stability. The crests of the associated waste rock dumps were recontoured to provide added stability. No resloping of the downstream face of the dumps was required.
