Sä Dena Hes

North Embankment Upgrade Project Plan

March 1, 2024

QUARTZ MINE LICENCE QML-0004

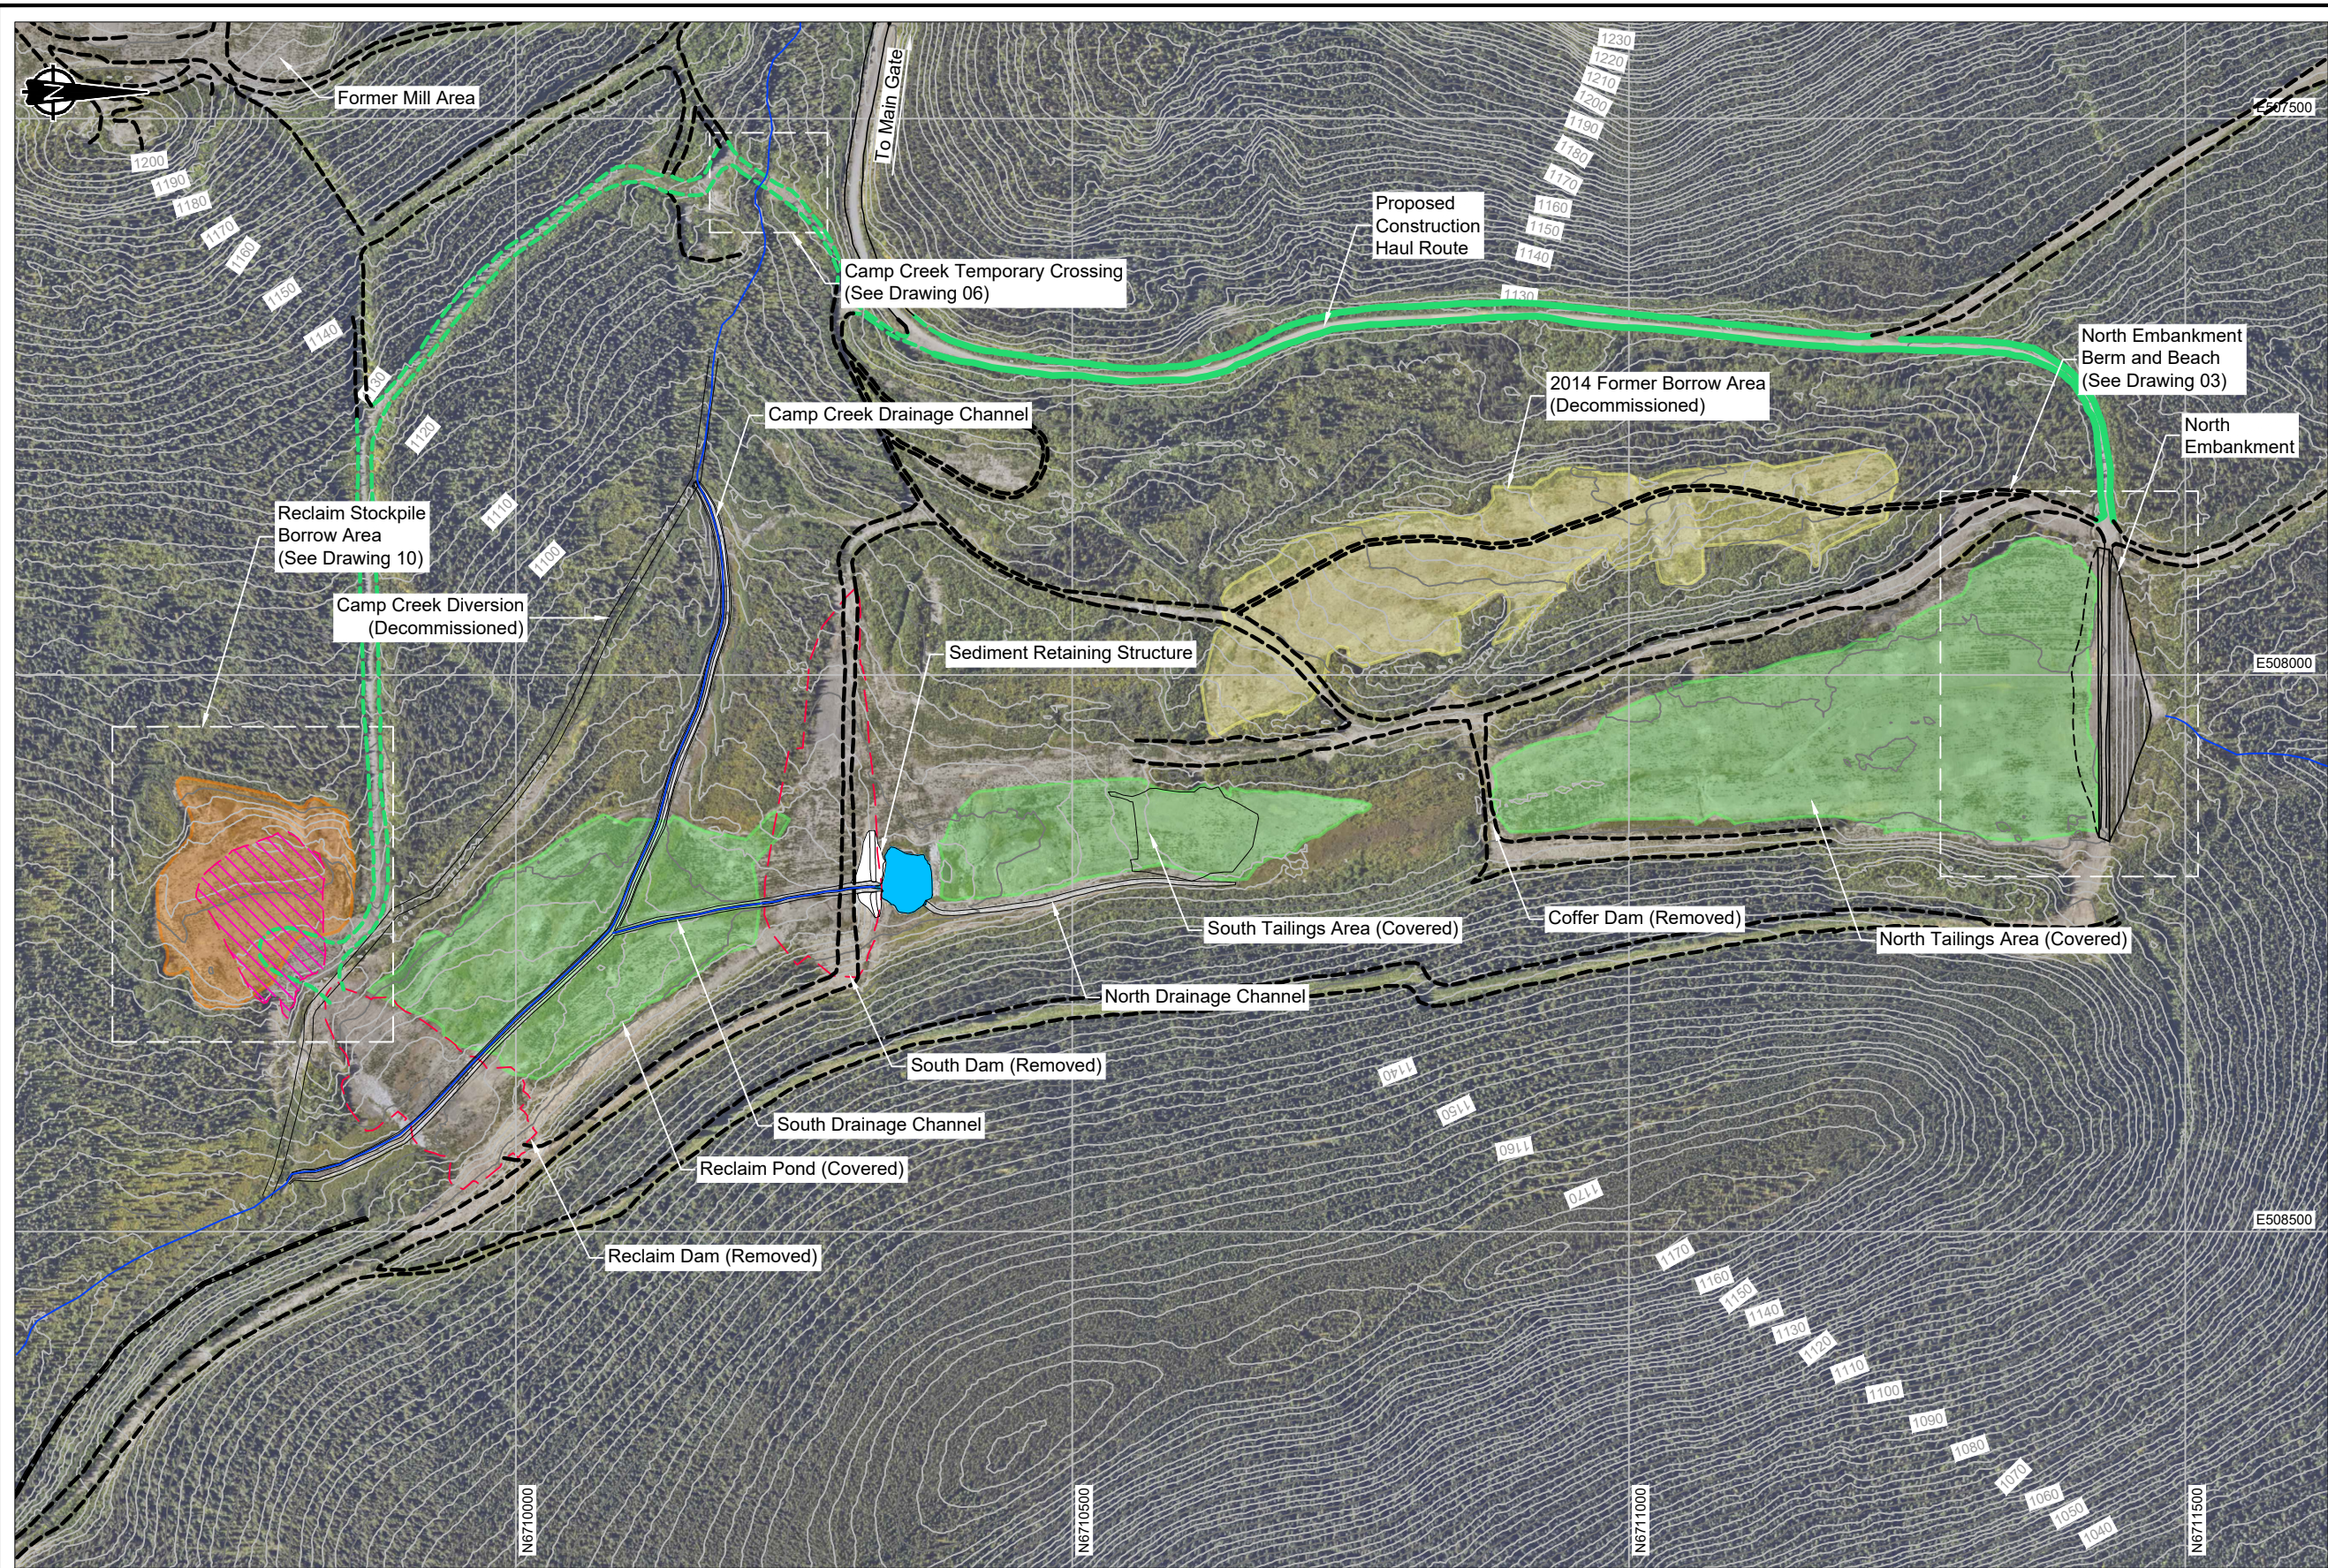
General Arrangement

- NOTES**
1. All units are in meters unless otherwise specified.
 2. Contours are shown at 2.0 m intervals.
 3. Fill required for the the North Embankment Berm, Beach and Tailings Cover to be sourced from the Reclaim Borrow Stockpile.
 4. The Contractor is responsible for upgrading all haul roads to meet Yukon Occupational Health and Safety (OHS) Regulation requirements.
 5. Coarse rock and riprap materials required for the project are to be sourced from the rock quarry located at KM17 of the access road to the site (not shown in this drawing) or an alternate source as directed by the Engineer.
