To:	Michelle Unger,	Client:	Teck Resources
From:	Peter Healey	Project No:	1CT005.046
Cc:	Gerry Murdoch	Date:	September 11, 2014
Subject:	Proposed Post Reclamation Geotechnical Monitoring Program

SRK Consulting (Canada) Inc has been requested by Teck Resources Limited (Teck) to prepare this post-closure Geotechnical Monitoring Program for structures and features that would form part of the closed Sa Dena Hes mine located near Watson Lake, Yukon. This memo provides a description of each of the mine components, the type of inspections, reviews and plans that would be completed and their frequency over the years following closure of the mine.

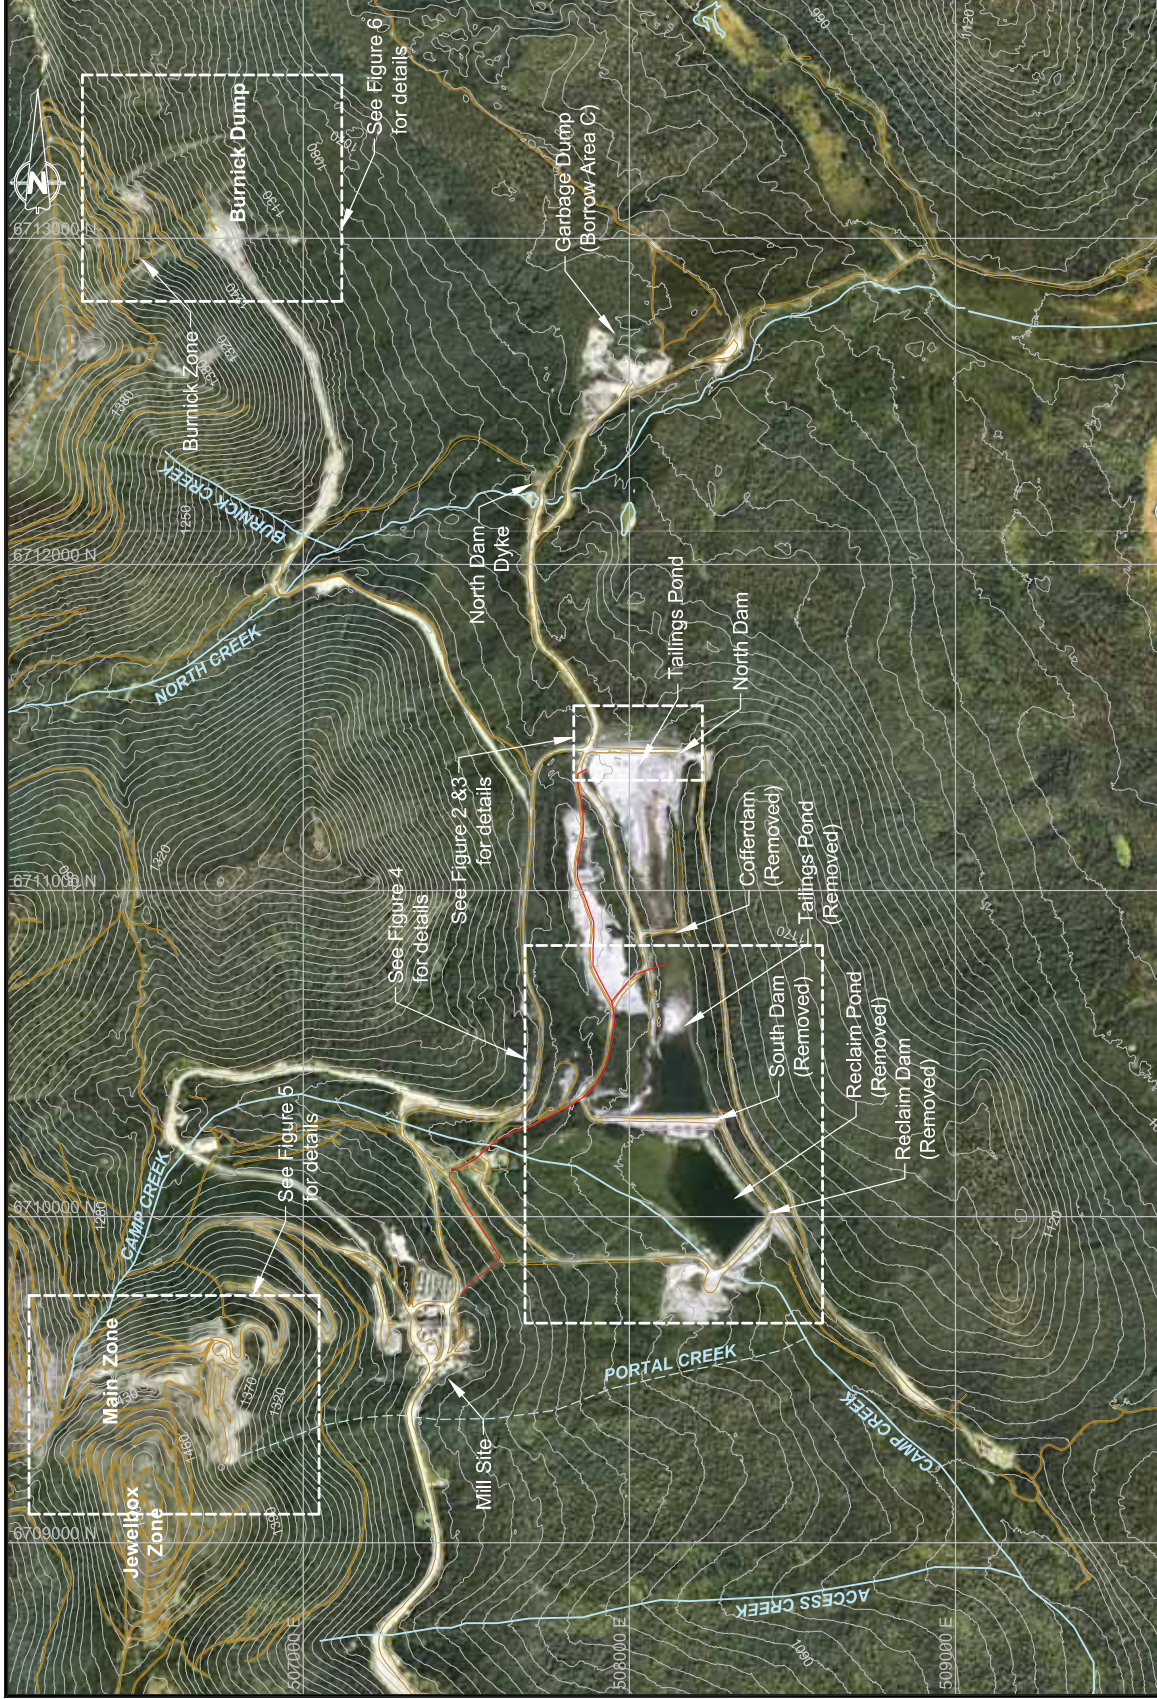
Geotechnical Monitoring Program	
Vicinity Map	
DATE: August, 29, 2014	APPROVED: PH
FIGURE: 1

Figure 1 shows a general location map of the mine site and identifies the components that will be inspected.

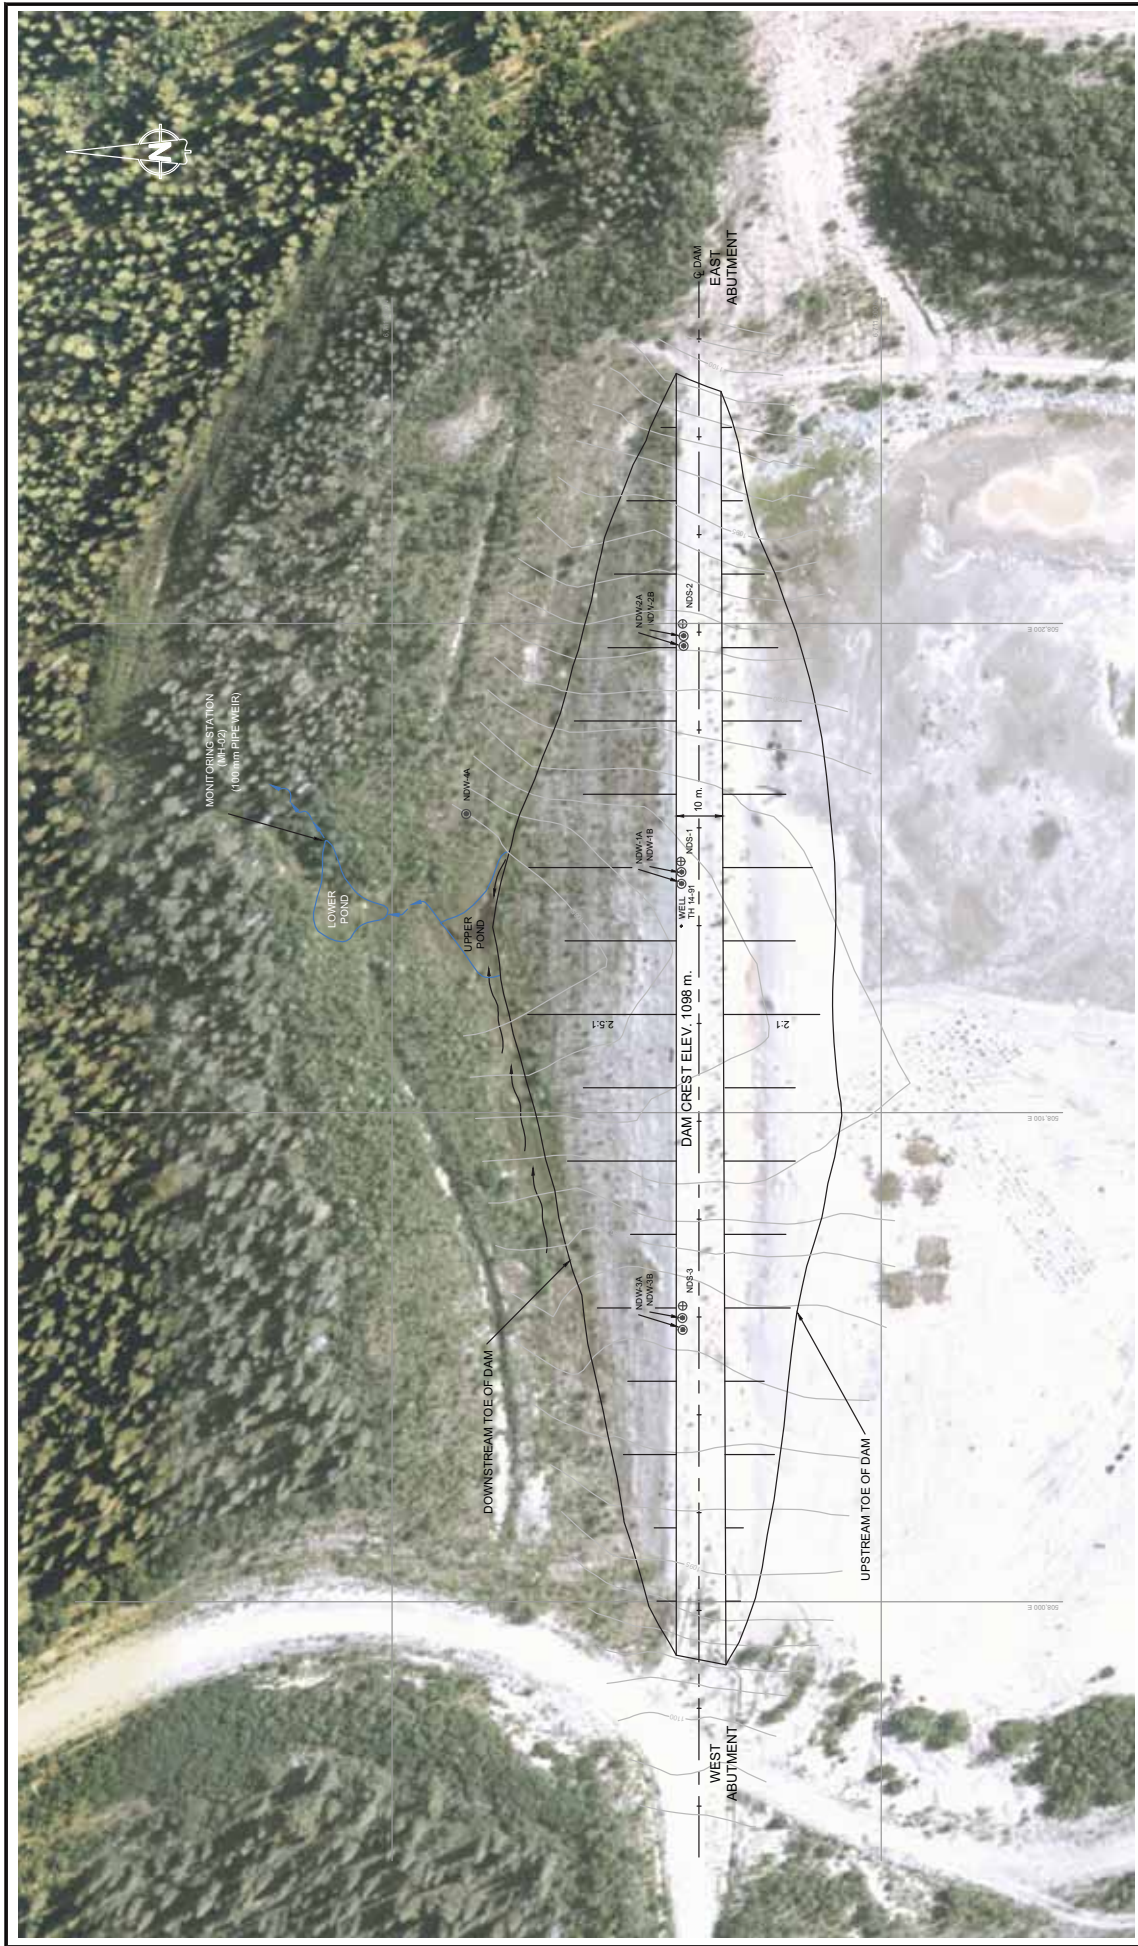
Teck		Geotechnical Monitoring Program	
srk consulting		North Dam Site Plan	
Sa Dena Hes Mine		DATE:	August, 2014
SRK JOB NO.: 1CT008.046		APPROVED:	P.M.H.
FILE NAME: 1CT008046_Fig2.dwg		FIGURE:	2

A site plan of the North Dam is presented on Figure 2 and a typical section through the dam is shown in Figure 3. The North Dam is approximately 15 m high, with a crest elevation of 1098 m, a crest length of about 260m and a crest width of 10 m. Based on the original tailings storage curve (SRK, 1990b), the total storage for the overall impoundment would be about 1 million m³ at an assumed elevation of 1097 m. As part of the closure conditions, a 0.5m soil cover will be placed over the tailings with no ponded water.

Standpipe piezometers are located within the crest of the dam. Settlement gauges, which were installed during construction of the dam, can also be found on the crest of the dam.

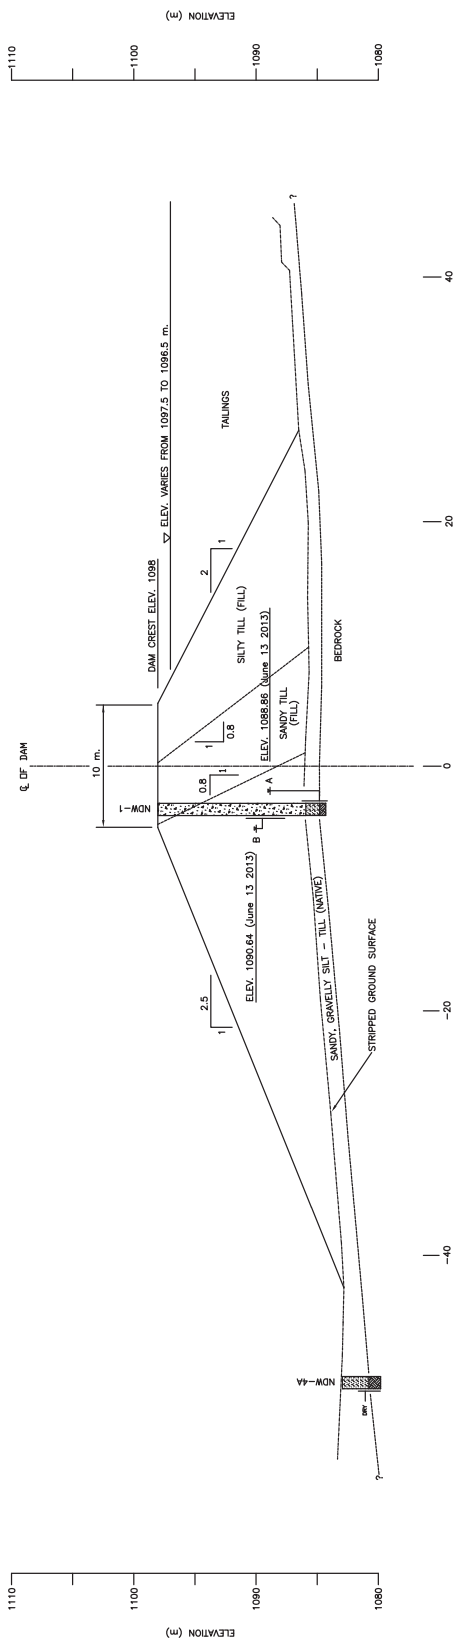
FIGURE: 3

DATE	T.O.P.	READING	ELEV.
June 13 2013	1098.57	7.93	1090.64
June 13 2013	1098.69	9.83	1088.86

Section 0+400
North Dam

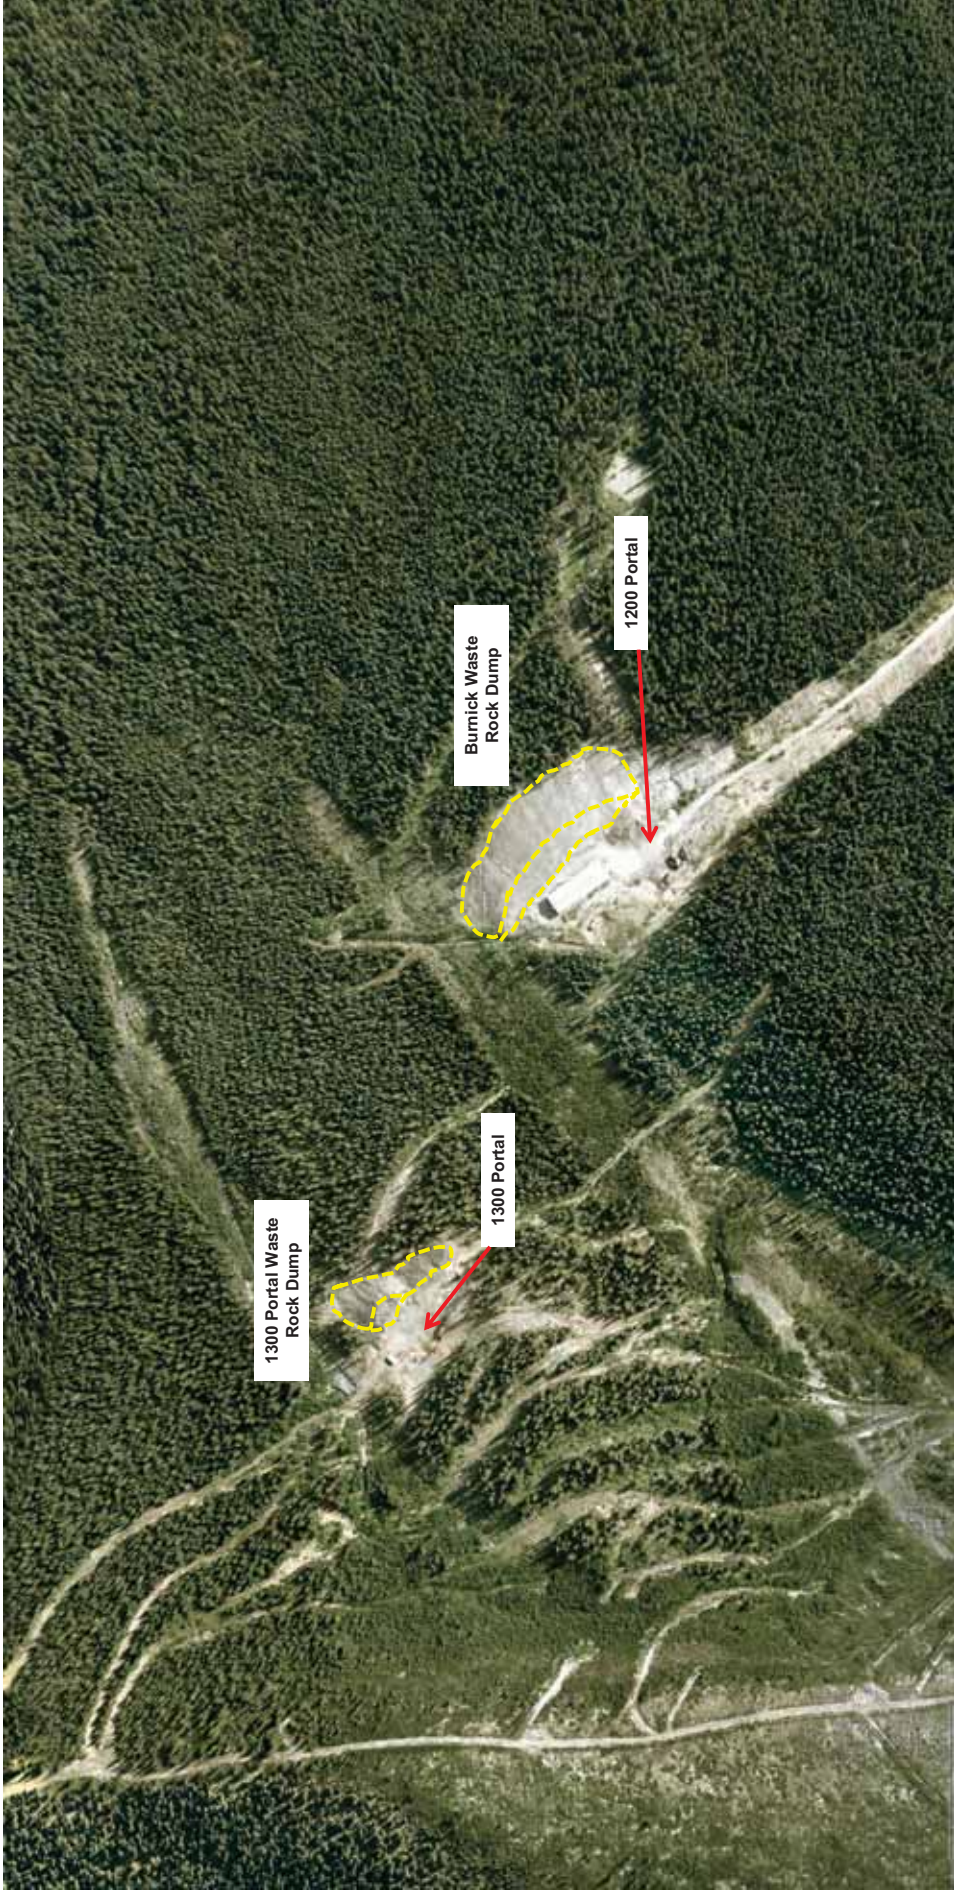
Burnick Zone Plan View

At closure, the crest of the Burnick dump (see Figure 6) will be pulled back to further reduce loading on the crest to improve stability. The bench of the dump will be recontoured to provide positive drainage away from the hillside.

1300 Portal Waste
Rock Dump

1300 Portal

Burnick Waste
Rock Dump
