## **7 Tailings Facility**

## 7.1 Introduction

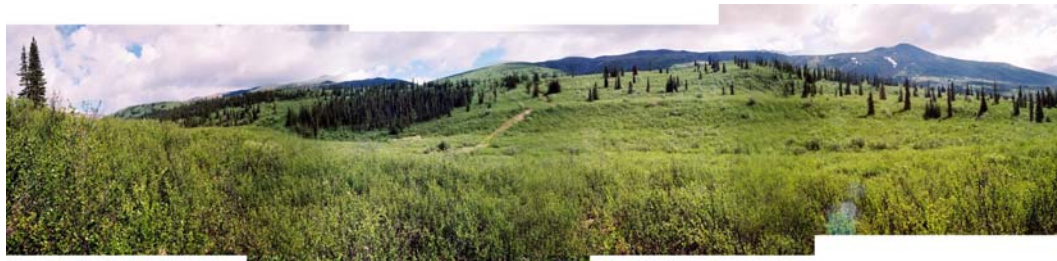
**Picture 7.2-1 Photograph of Tailings Facility General Area**

Picture 7.2-1 presents a photograph of the tailings facility area looking northeast, with the tailings impoundment to the left and the right abutment ridge on the left of the photo.

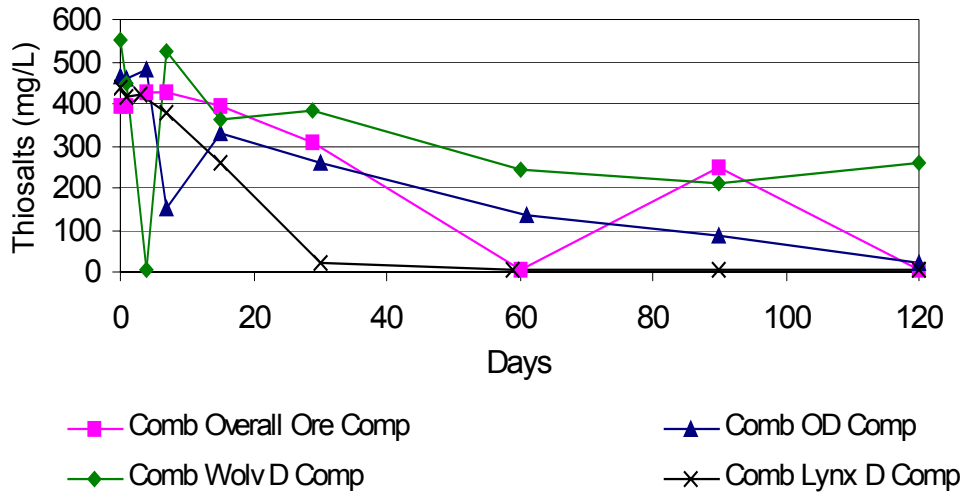
**Figure 7.4-1 Variation in Thiosalt concentration over time**

The four composite tailing samples were “aged” in the laboratory for up to 120 days, to assess the water chemistry changes in the tailings pond over time. During aging, the supernatant was exposed to atmospheric oxygen and carbon dioxide, as would be the case in the tailings impoundment during temporary suspension of milling activities (e.g., maintenance shutdowns) or post-closure. A clear trend was observable in the behaviour of several of the parameters, most notably, thiosalts, pH, Cd, Se and Zn as shown in Figures 7.4-1 to 7.4-5.

At closure, or during sustained shutdown, there will be a short lag time (up to 9 months) until the remaining thiosalts are oxidized and water quality stabilizes. During this period there is a slight depression in pH, which then rises after the thiosalts are oxidized.
