7 Tailings Facility

7.1 Introduction

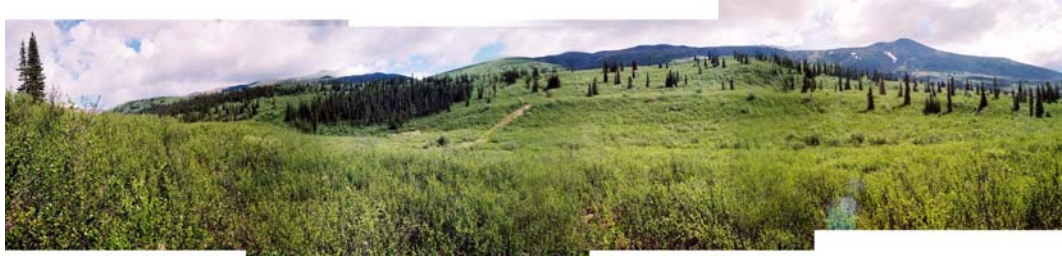
Picture 7.2-1 Photograph of Tailings Facility General Area

Picture 7.2-1 presents a photograph of the tailings facility area looking northeast, with the tailings impoundment to the left and the right abutment ridge on the left of the photo.

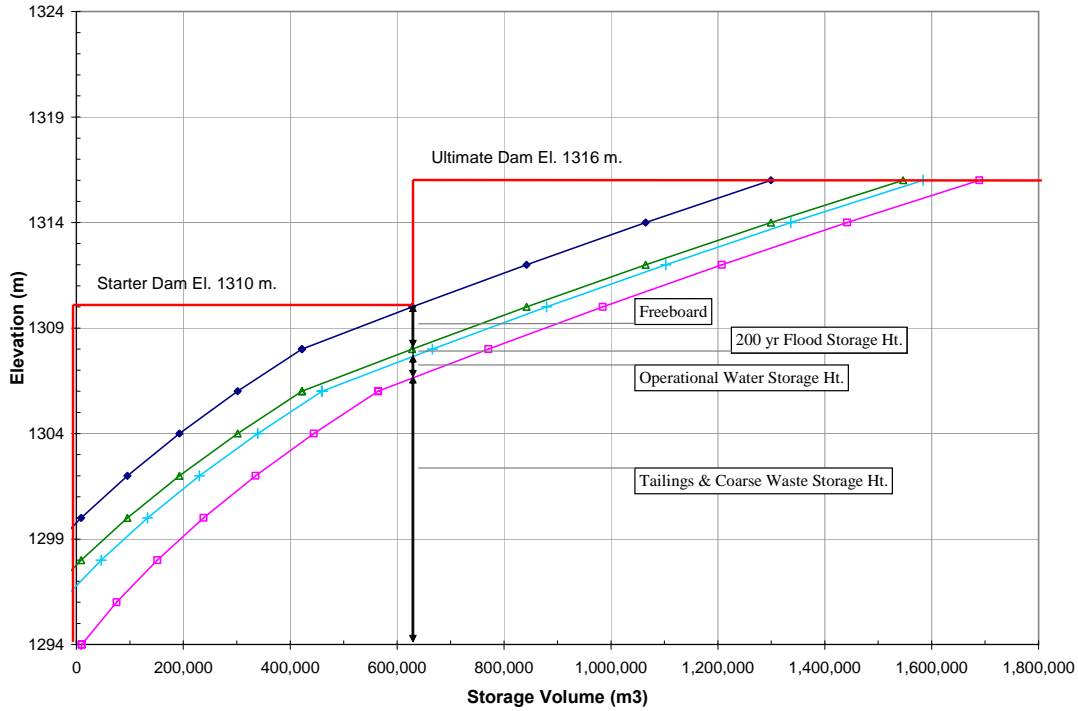
Figure 7.6-1 Stage Storage Curve – Tailings Impoundment

The storage capacity of the impoundment is shown in Figure 7.6.1 and, in addition to storage of solids, will provide for the following:

- minimum operational water volume for settling of solids and operation of pumps of 30,000 m³;
- seasonal storage for average conditions of 75,000 m³;
- 200 year flood storage consisting of 200 yr wet month precipitation with snowmelt of 37,500 m³; and
- 2 m of freeboard, which provides for routing of the 10,000 year return period flood event through the spillway (0.5m) and 1.5 m of freeboard.
