SUMMARY REPORT

PLACER GOLD DEPOSITS AND OPERATIONS ON GOODMAN CREEK IN SOUTH MCQUESTEN RIVER AREA

MAYO MINING DISTRICT

1995 SEASON

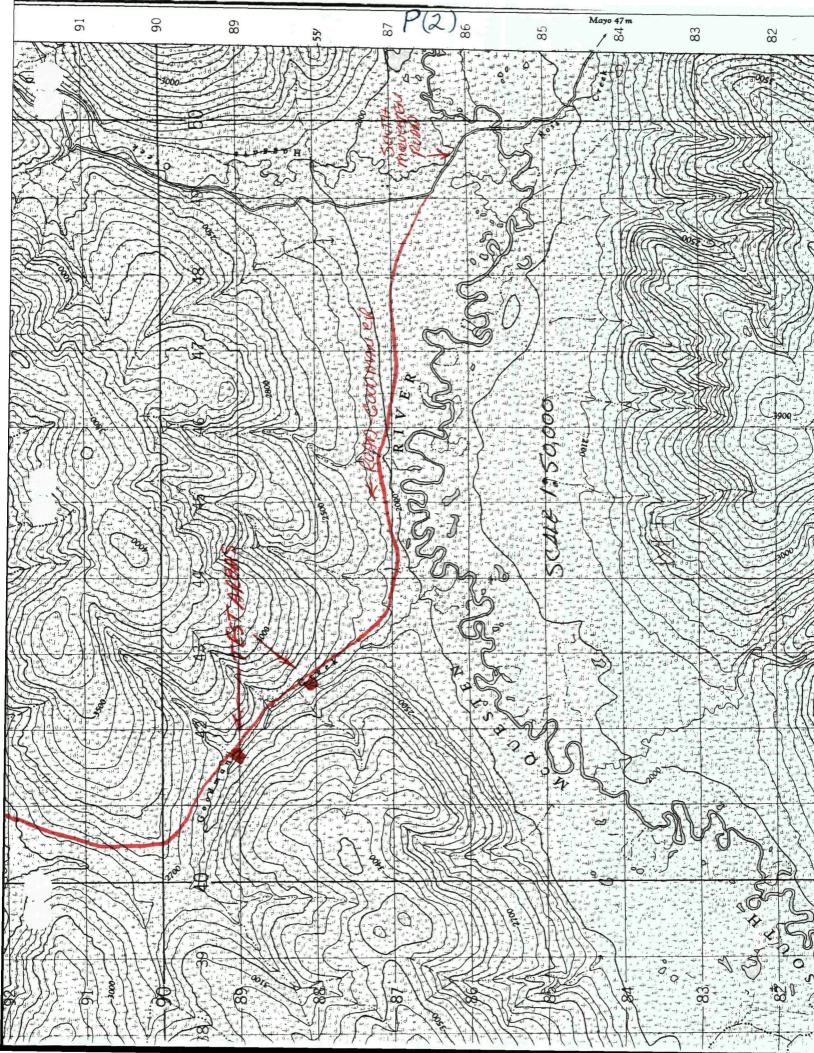
Map Enclosed.

To access Goodman Creek, follow the silver trail north towards Elsa, Keno area approx. 24 miles north of Mayo. On your left hand side you will see a sign (South McQuesten Road), follow road until you get to South McQuesten bridge, after crossing bride (1 mile approx.), you then come to a junction with one road straight through to Haggert Creek and one turning left which accesses Goodman Creek, Rodin Creek, and where North and South McQuesten River joins. Goodman Creek is the first creek you will encounter on this road.

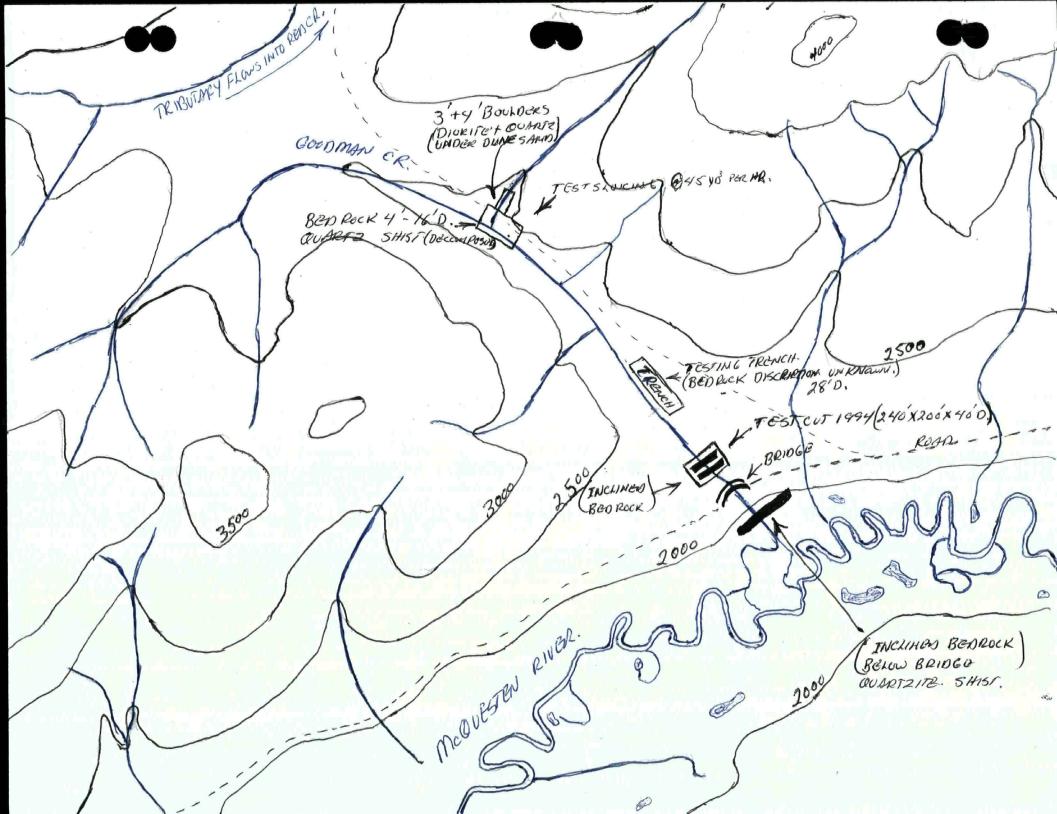
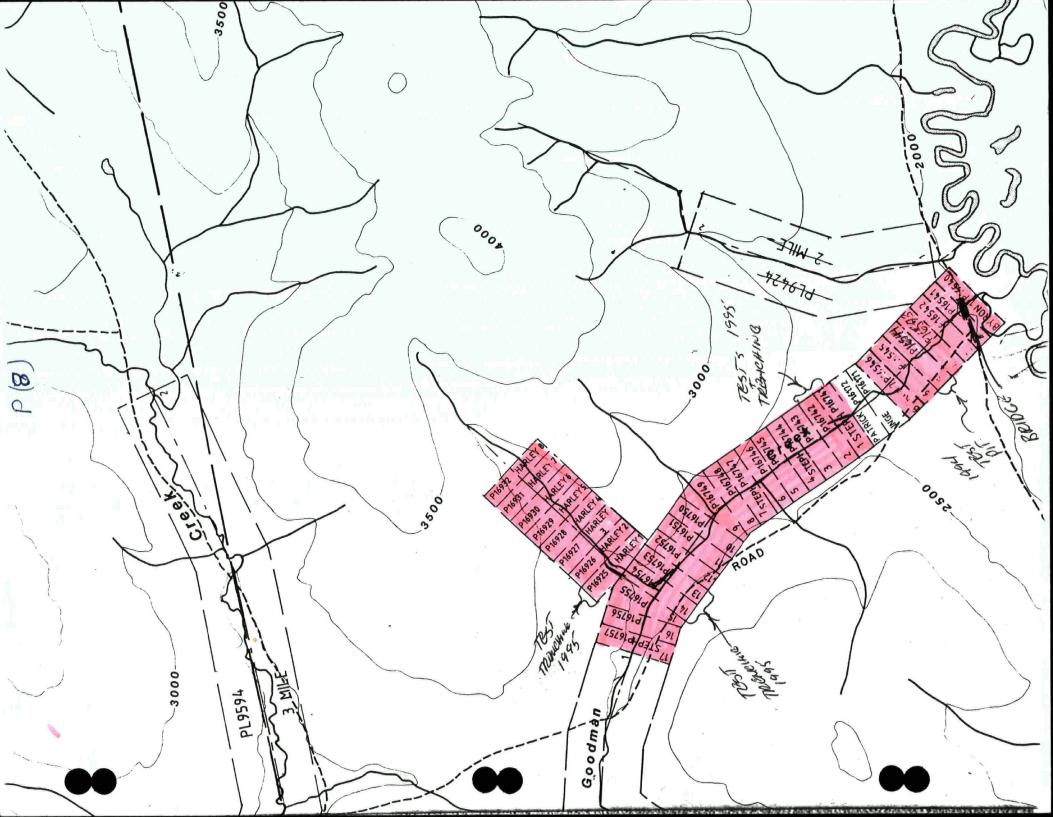
- 9. Moved plant, pump, and machinery up to claim P16754 once again after testing sluice results appeared no greater than \$3.00 a cubic yard on bedrock. From this point on in the program, only test holes dug to bedrock and the use of a small hand sluice box and panning methods were used to test pit gravels.

- 7. A wash plant was set up to process material of greater volumes.
- 8. The wash plant consisted of a 12 ft wide by 10 ft long grizzly bars set, with an 18 by 9 ft dump box above grizzly. Classifing to 1 3/4-the material passed throught into a 6 ft wide by 8 ft long sluice box with hydrolic riffles on the top 4 ft of sluice runs. Water pressure was set at 7 psi, a 8" by 6" pressure pump supplied water to the plant. The wash plant was set up to be fed by an 8 yard loader and for removing tailings. The material was excavated from the bottom of the cut to the stock pile for the loader. A settling pond was constructed close to the wash plant so water could be used to recirculate due to low water volumes. A feed rate of 45 cubic yards per hour was put through the wash plant. Results on claims P17653 prove to be no greater than P16741 (down stream).
