Yukon Placer Mining Industry

2010 to 2014

Compiled by S. Van Loon and J.D. Bond
Yukon Geological Survey
Energy, Mines and Resources
Government of Yukon

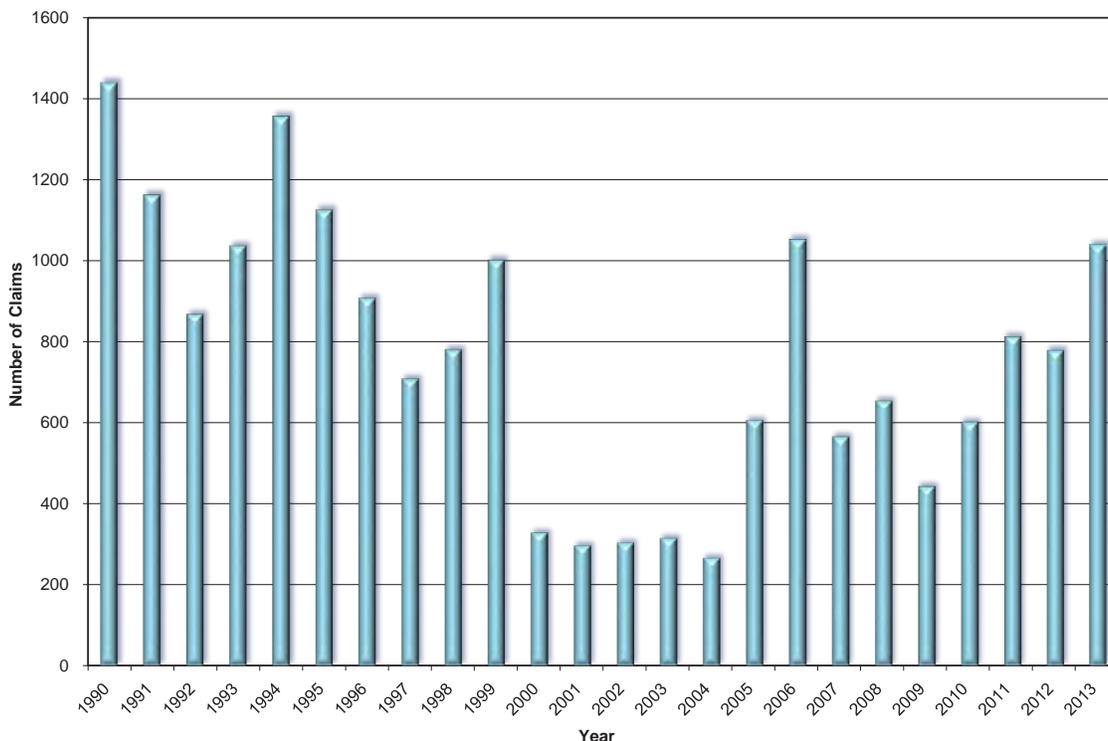
Figure 1. Yukon placer claims staked, 1990-2013.

The number of placer claims staked increased steadily from 602 in 2010 to 1040 in 2013 (Fig. 1). Placer leases staked during that same time period remained steady at around 89 to 112 leases per year (Fig. 2). Placer claims in good standing showed a steady increase; a trend that has continued since 2004 (Fig. 3). As of 2013, 20295 placer claims were in good standing, which is the highest number in our database going back to 1973. The number of placer leases in good standing for the reporting period rose from 130 in 2010 and peaked at 217 in 2012 (Fig. 4). A decrease to 177 leases in good standing occurred in 2013, which is likely linked to claim conversion, which fueled the upswing in claims staked.

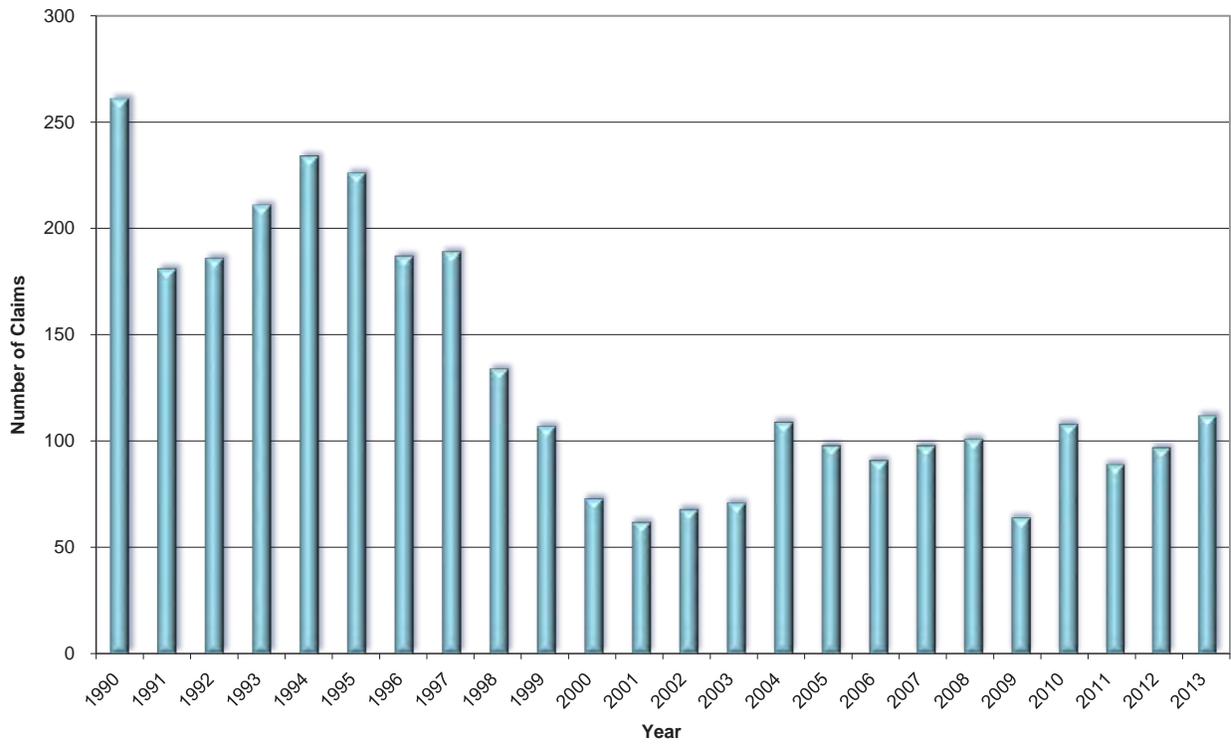
Figure 2. Yukon placer leases staked, 1990-2013.

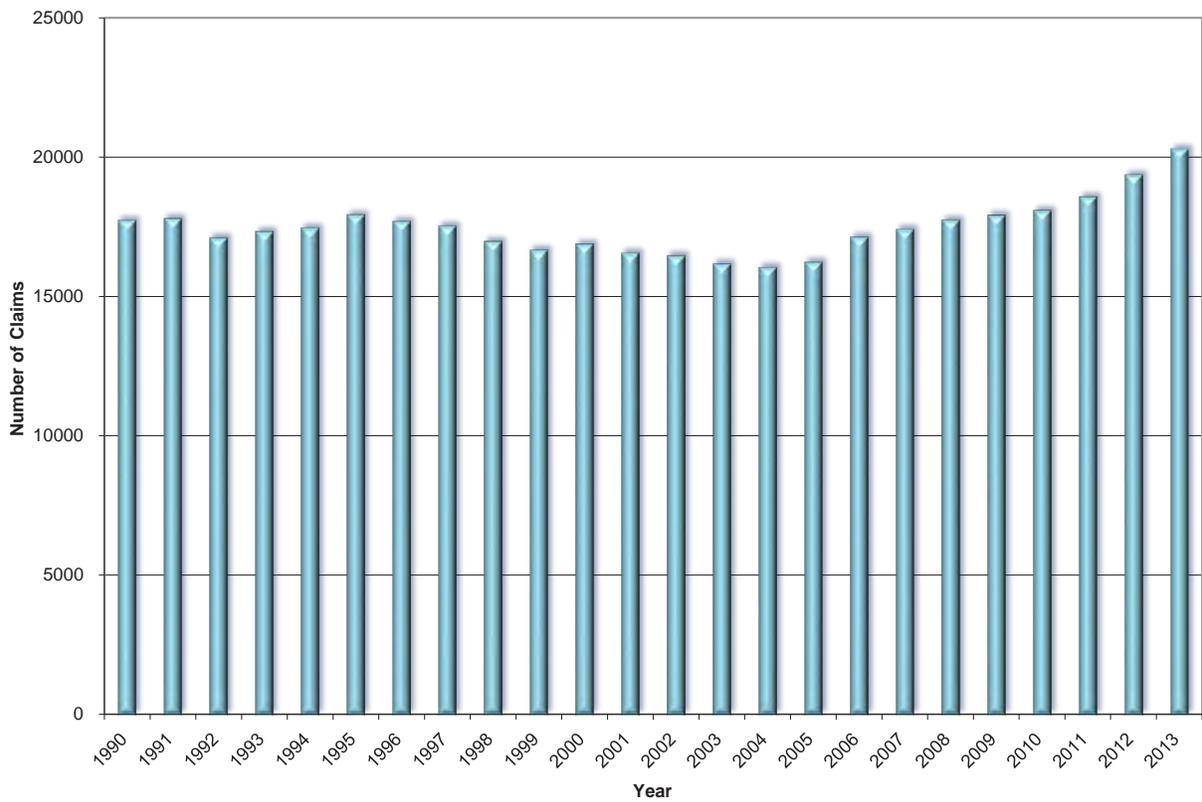
Figure 3. Yukon placer claims in good standing, 1990-2013.

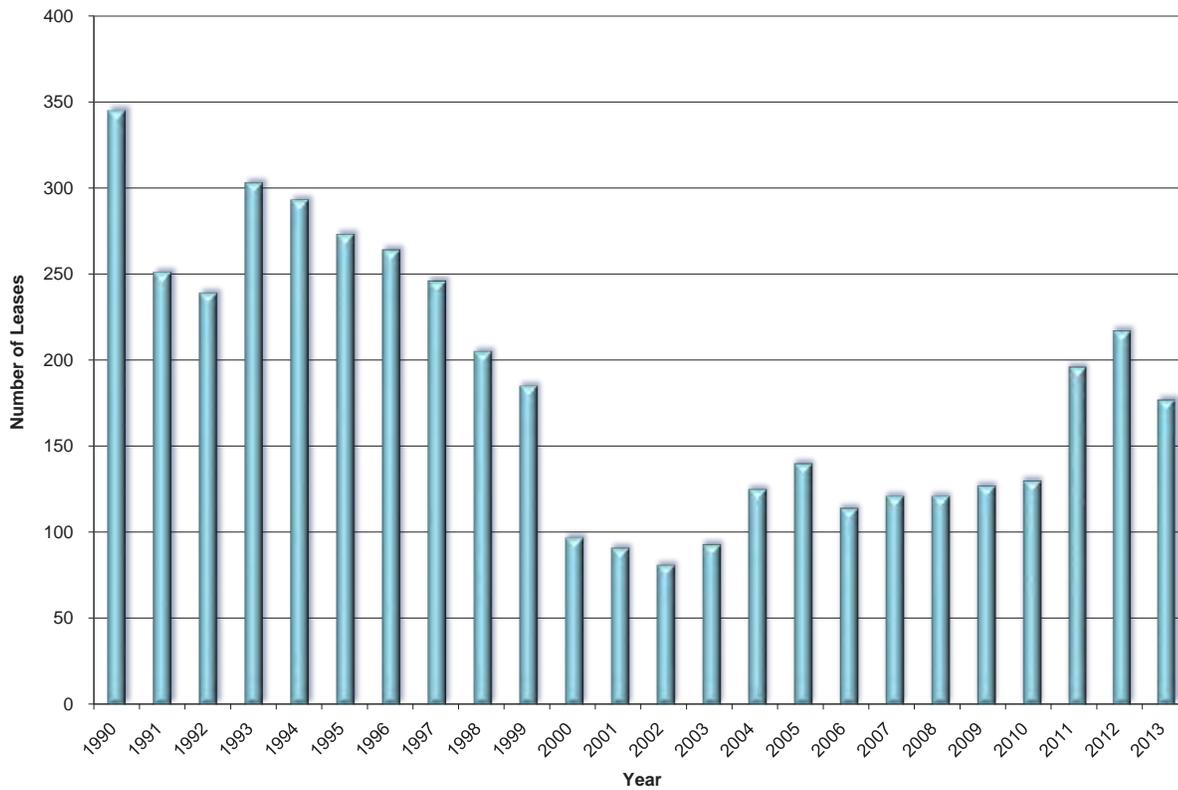
Figure 4. Yukon placer leases in good standing, 1990-2013.

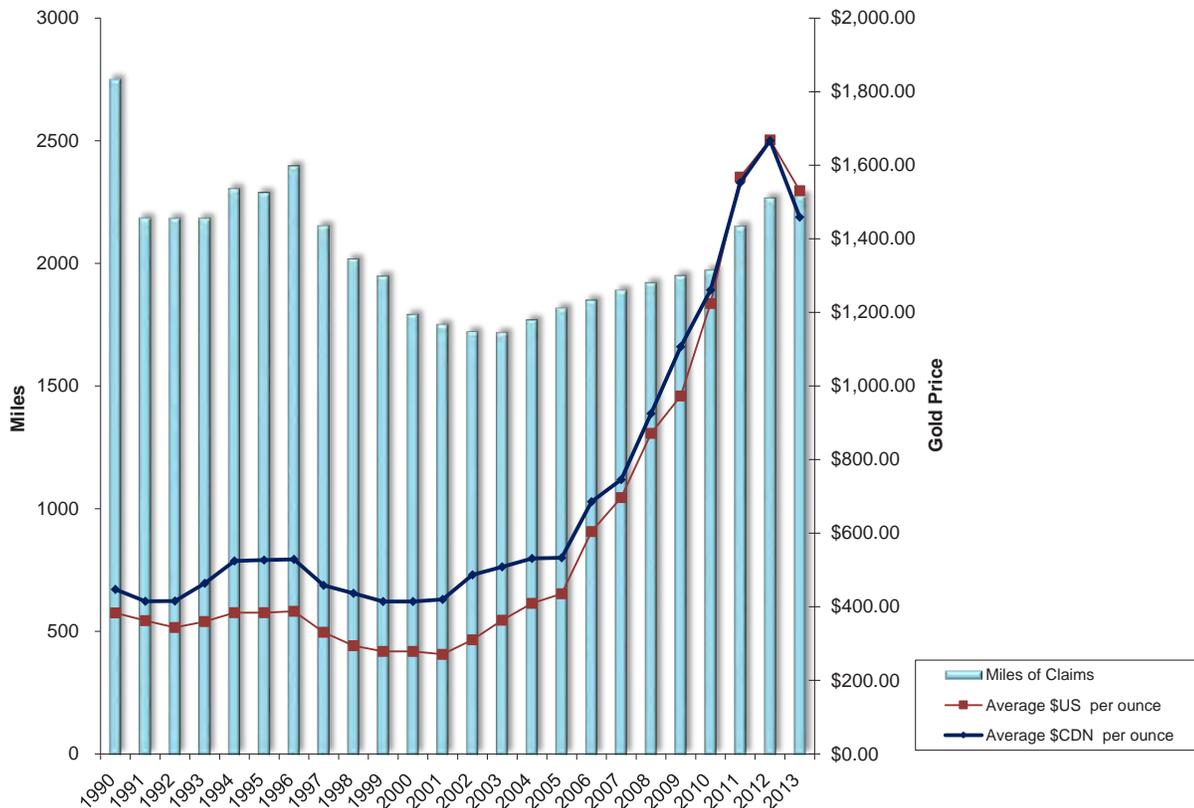
Figure 5. Miles of Yukon placer ground held versus world gold price in US and Canadian dollars, 1990-2013.

When comparing the gold price to the total miles of ground held (as claims or leases) we are seeing a general positive relationship (Fig. 5). Perhaps the more interesting trend is that the sustained high gold price has not resulted in a drastic increase in ground held. In fact, there are fewer miles of ground held now than in 1996 when gold was \$386 US/oz. The main factors responsible for this discrepancy are likely related to a reduction in gold grades, resulting in less revenue dedicated to exploration and the staking of large leases, industry down-sizing resulting from the sustained low gold prices in the 1990's, a strong Canadian dollar, and high diesel prices. It takes time for a privately funded industry to rebuild itself and for newcomers to become strong producers. If this is the case then the overall trends indicate that we should expect some strong production in the coming years.

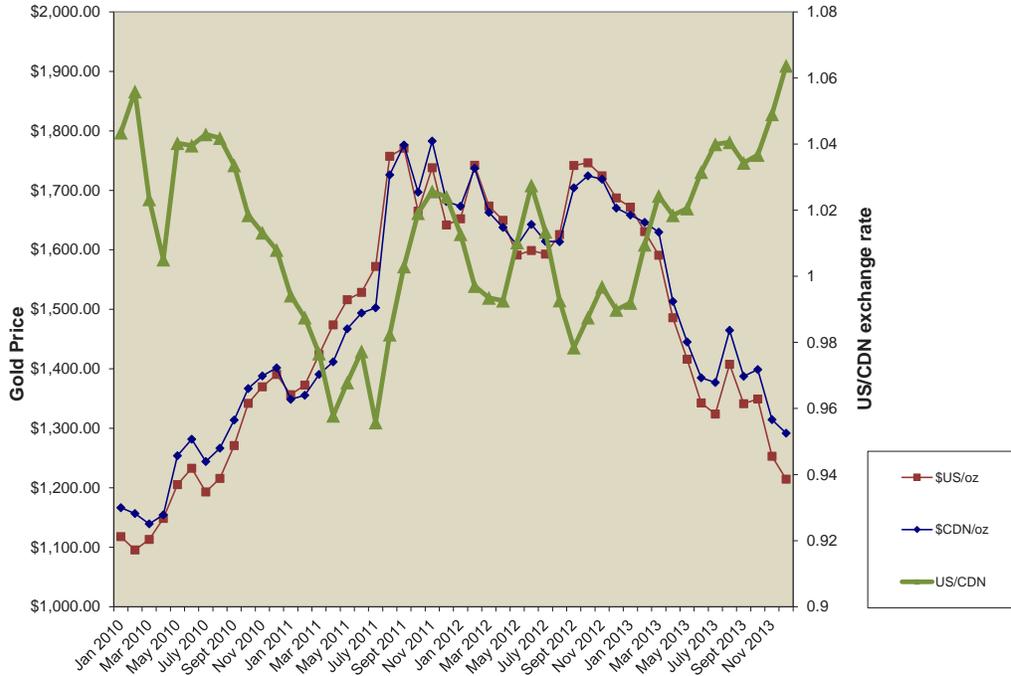
Figure 6. Average monthly gold price in US and Canadian Dollars, and US/CDN exchange rate, 2010-2013.

Yukon placer miners have enjoyed strong gold prices throughout the reporting period (Fig. 6). In May 2010 the gold price was \$1,253.98 CDN/oz and climbed to a high of \$1,782.80 CDN/oz in November 2011. Even more impressively the gold price stayed above \$1,500.00 CDN/oz for 22 months between July 2011 and April 2013 (Fig. 6). The average gold price in 2012 was \$1,667.25 CDN/oz.

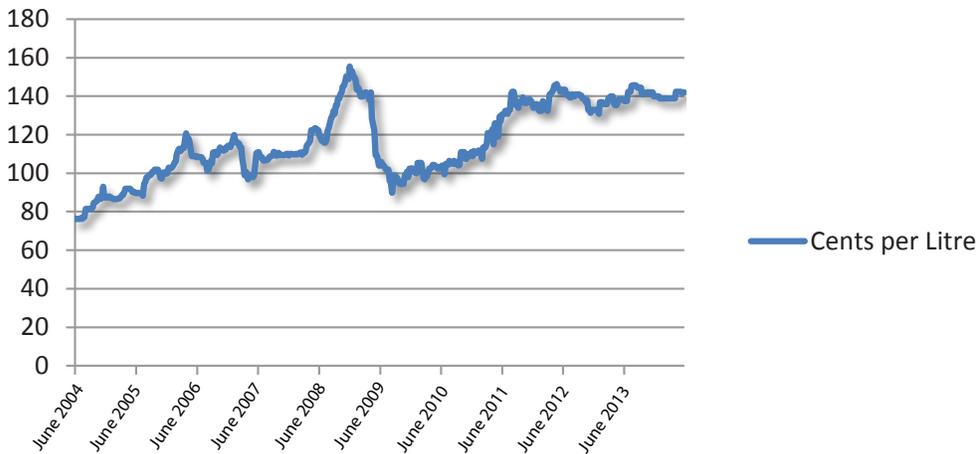
Figure 7. Annual diesel price in Whitehorse from 2004 to 2013.

Counteracting the strong gold price has been the high local price of diesel. From 2004 to 2013 the price of diesel climbed from \$0.76 per litre to \$1.42 per litre in Whitehorse (Fig. 7). This fundamental cost to operate has forced placer miners to find ways to become more efficient. Common examples of this include the use of conveyors for moving overburden and increased use of articulated dump trucks.

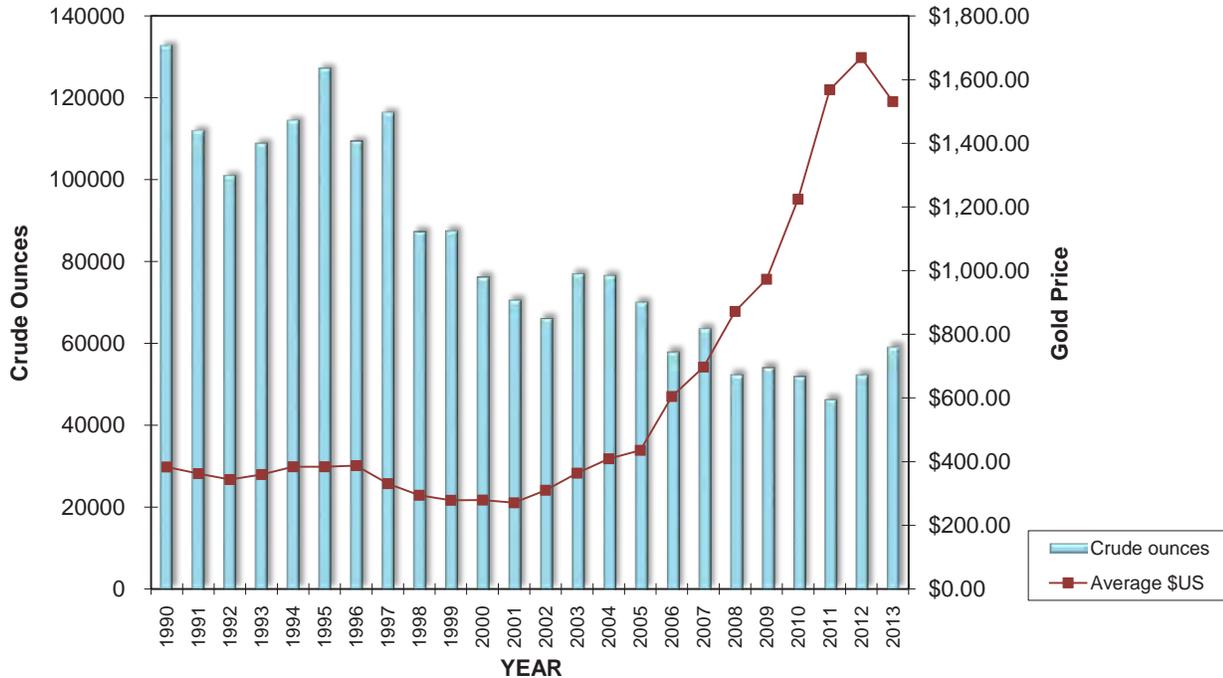
Figure 8. Yukon placer gold production vs. US gold price, 1990-2013.

The production figures discussed in the following section are based on royalty records submitted to the Yukon Mining Recorder. Placer gold production appears to be gaining some momentum after reaching a low in 2011 (Fig. 8). Despite the increases in the last two years the overall production is down considerably from the production highs in the mid 1990s. The production and equivalent value in Canadian dollars for the reporting period is summarized in Table 1 below.

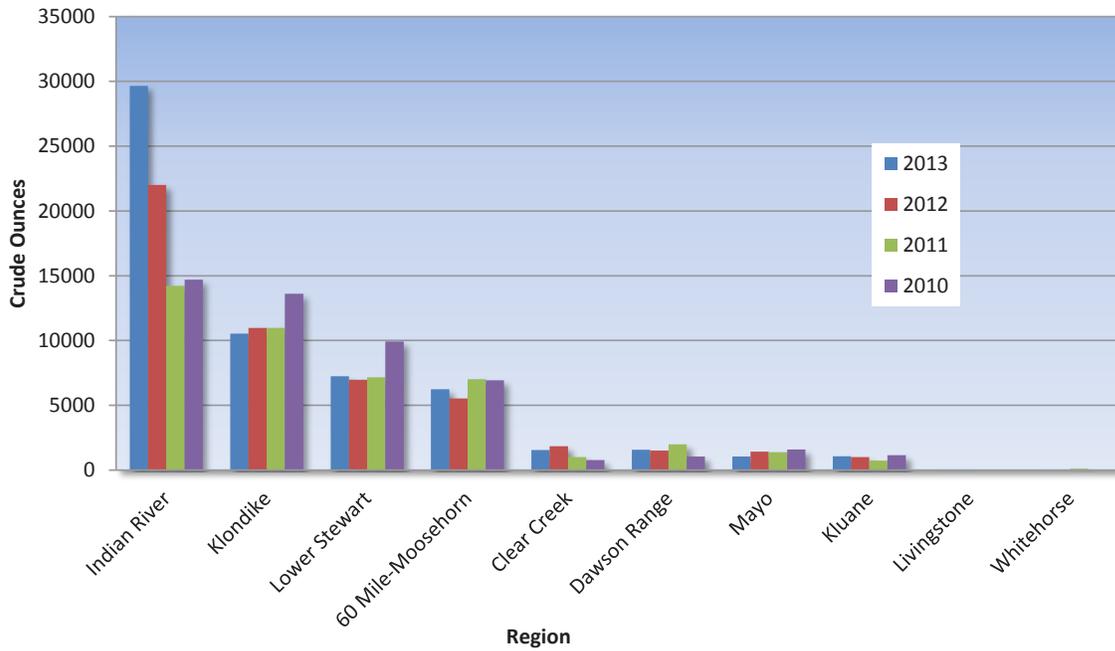
Figure 9. Regional gold production 2010-2013.

The regional production during the reporting period is summarized in Figure 9. The top producing region continues to be the Indian River drainage for all four years. Impressively, Indian River drainage production increased by 7000 crude ounces or 25% from 2012 to 2013. This increase is significant and accounts for much of the production increase observed in 2013. Production increases from Quartz and Eureka creeks are largely responsible for the change. We expect this trend to continue with the restarting of the old Ross Mine on Dominion Creek by Dominion Gold Resources Ltd.

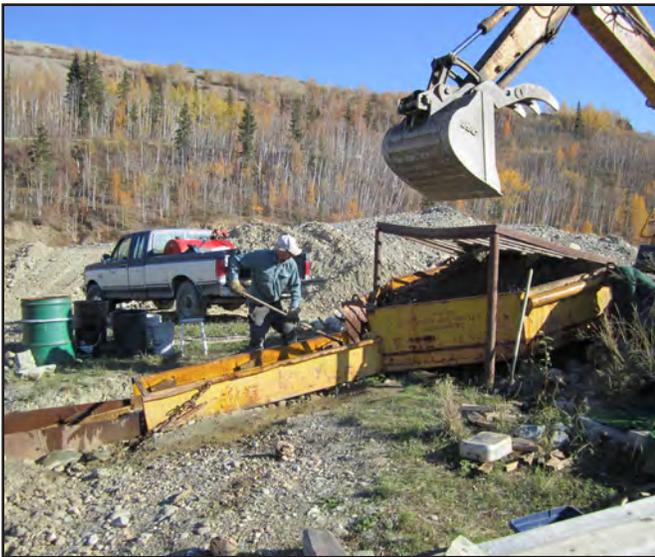
Active sluicing at Slinky Placer Mine in 2010. (Photo credit: Jim Leary).

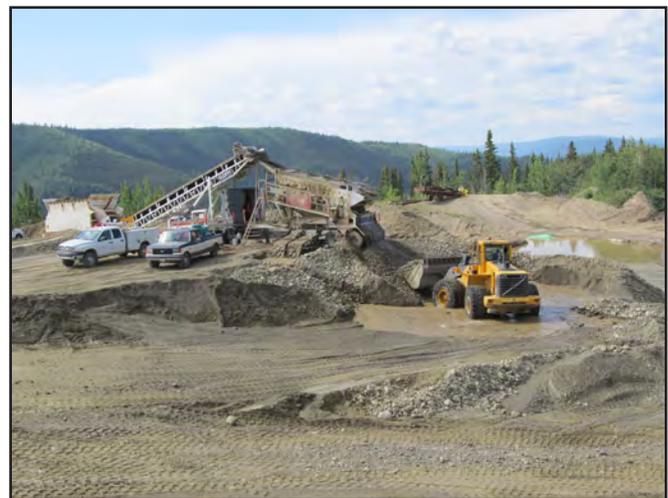
Mr. Carey's wash plant on the right limit bench in 2013 (Photo credit: Jim Leary).

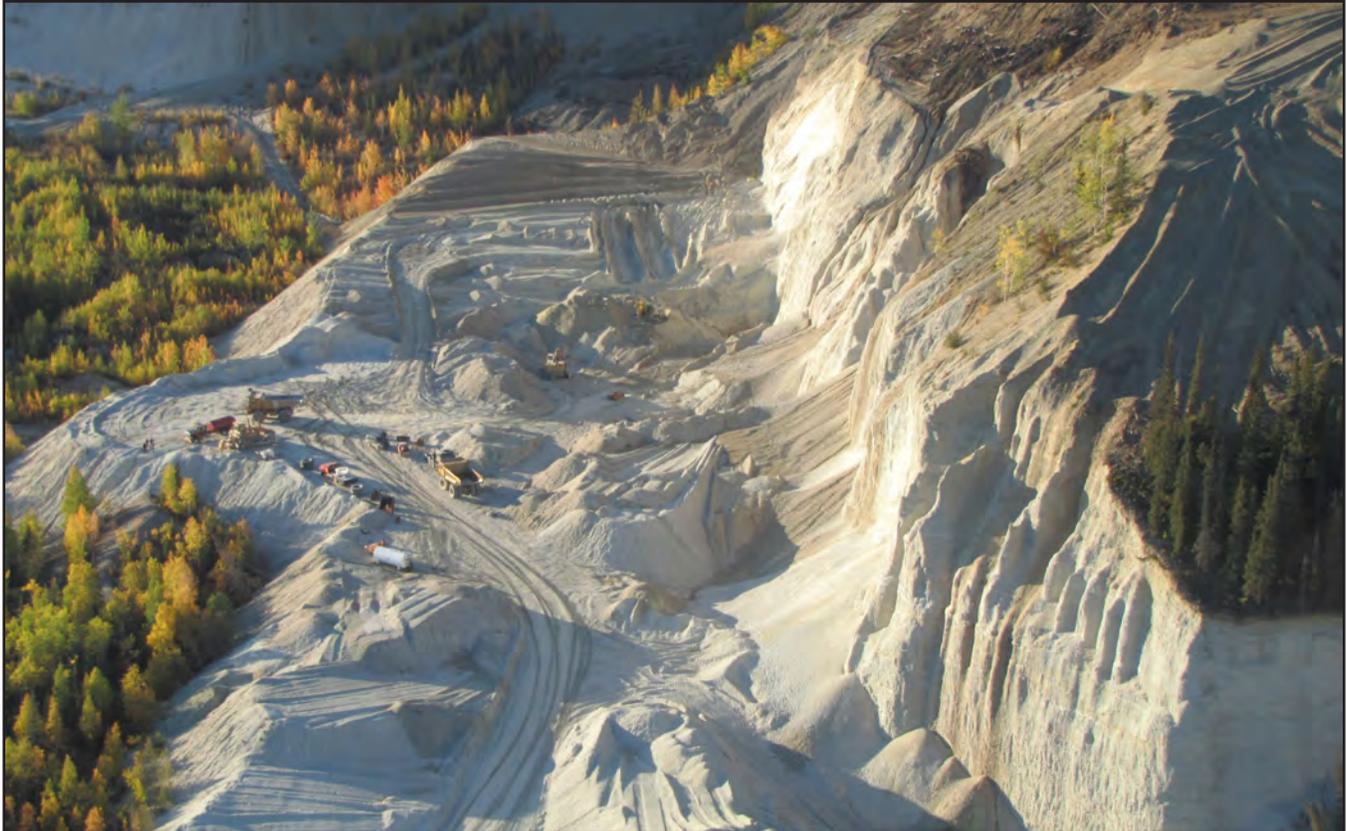
Mr. Crawford's operation on the south side of Jackson Hill. Narrow slices of White Channel pay gravel were mined at the base of the face.

SURFICIAL GEOLOGY AND STRATIGRAPHY The general stratigraphy of the Jackson Hill site includes approximately 20 m (66 ft) of Klondike wash (glacial outwash) gravel overlying 30 m (98 ft) of White Channel gravel. The lower 6.1 m (20 ft) of White Channel gravel was sluiced.

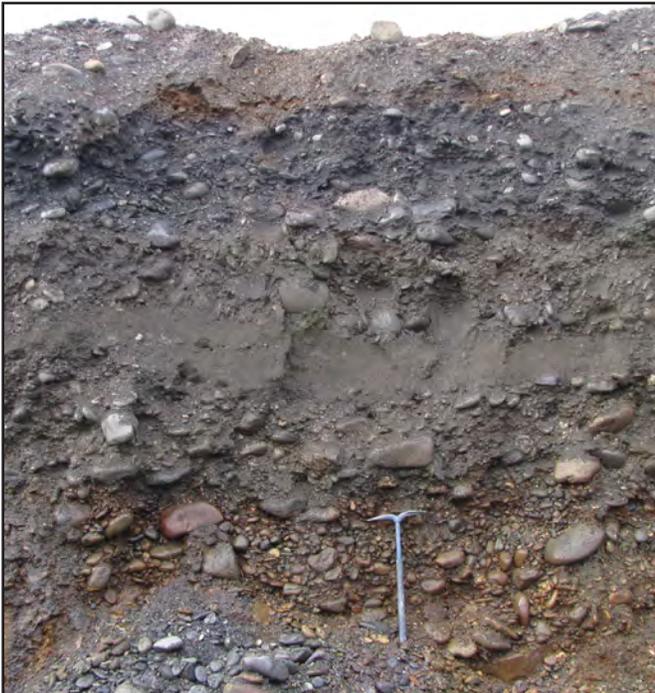
The gravel exposed by Northern Shoveller's operation at the base of Jackson Hill on the left limit of the Klondike River. This gravel was missed by YCGC dredging so it provides a good example of intact Klondike River gravel near Dawson. The section is about 3 m (10 ft) tall and bedrock is exposed at the base.

On the Klondike River the stratigraphy consists of 2.1 to 3.6 m (7 to 12 ft) of virgin Klondike River gravel overlain by 7.3 m (24 ft) of dredge tailings and fine-grained mine tailings (slickens). The Klondike River gravel is very coarse and imbricated. The clasts are fairly mature with a subrounded to rounded shape and smooth surfaces. Boulders can be as large as 35 cm. High energy channels appear on bedrock where boulders are common and the gravel contains 85% clasts. This basal gravel appears packed very tightly and is clast-rich, consistent with a high energy stream deposit. Oxidation is pervasive at the base of the section and relatively absent in the middle part of the Klondike River gravel sequence.

Overall the gravel is described as a moderately sorted pebble-cobble gravel with sand lenses. The bedrock surface undulates with a relief of 1 m (3 ft) and 0.6 to 1.5 m (2 to 5 ft) of bedrock along with 2 to 3.5 m (7 to 12 ft) of gravel was mined.

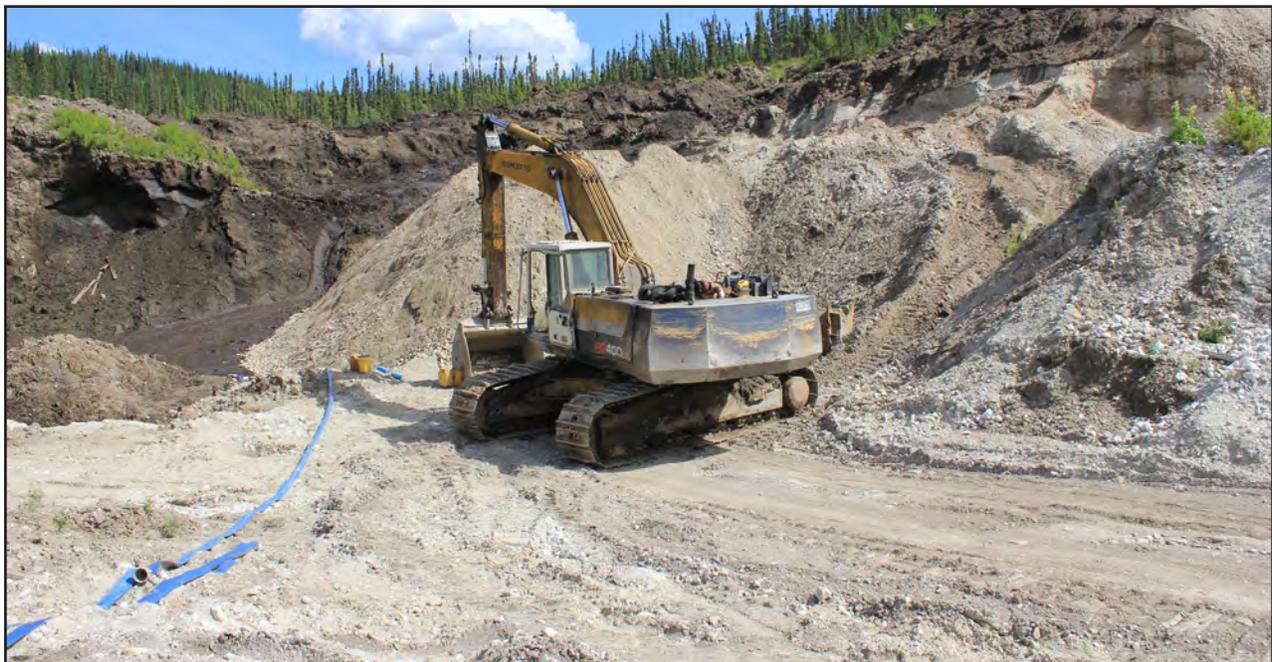
Mr. Brickner's active cut on left limit Lovett Gulch in 2014.

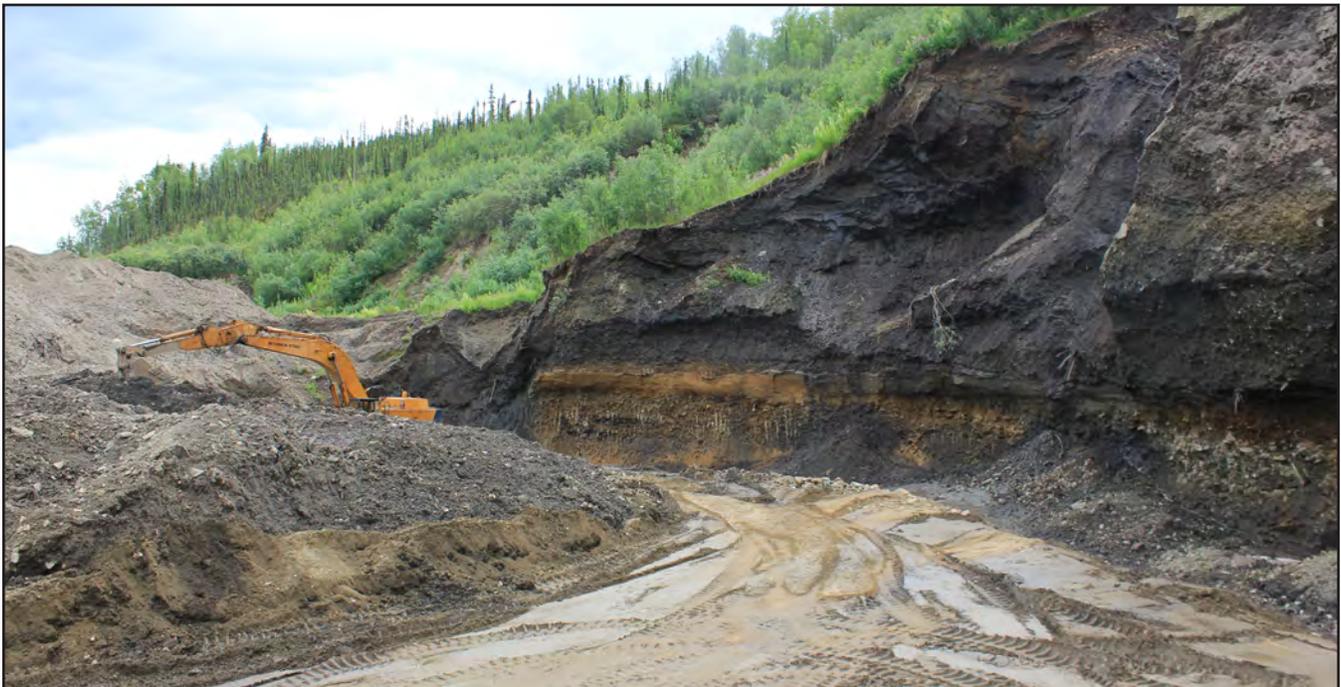
Upstream view of the left limit cut at the Kohlman Explorations Ltd. operation.

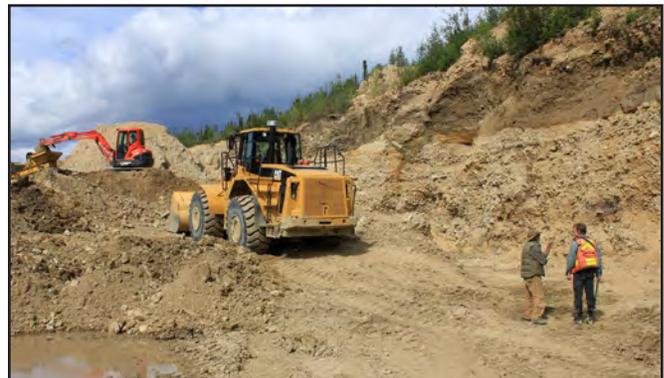
Mr. Nibbecker's bench cut in 2014, on the right limit of Bonanza Creek.

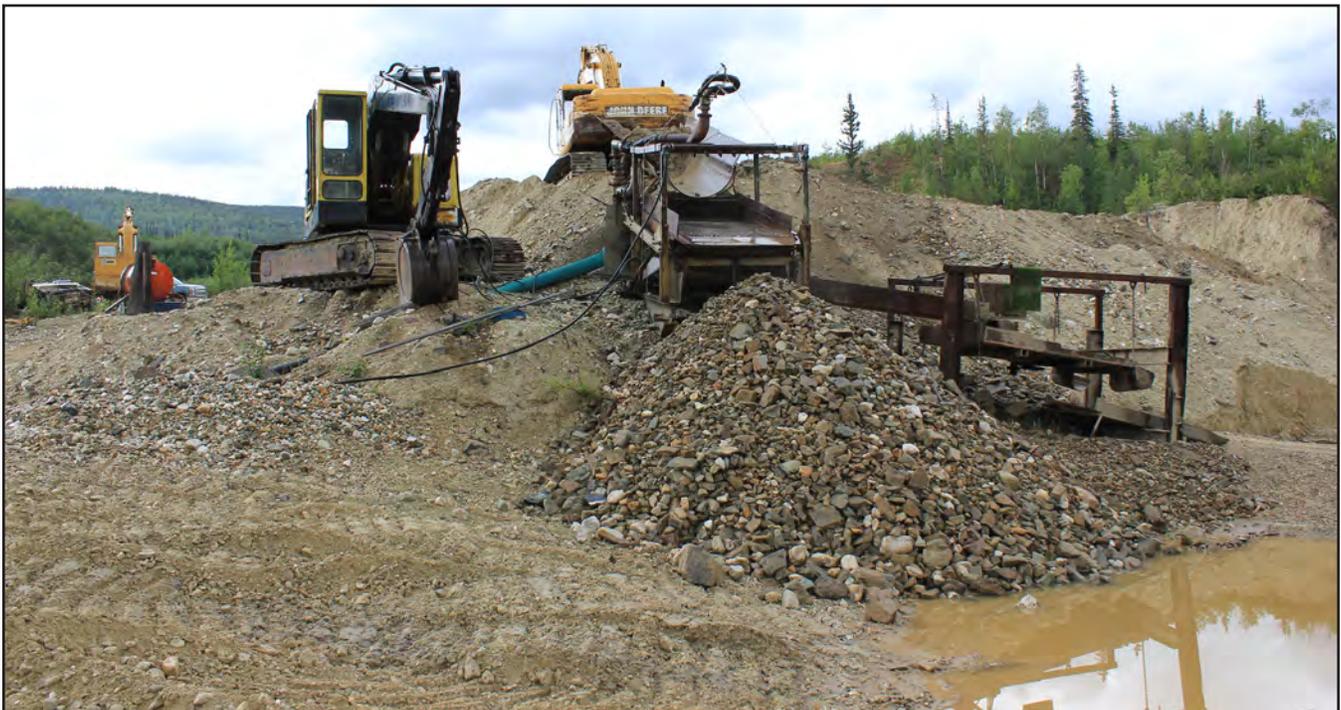
Mr. Van Bibber's wash plant beside the Bonanza Creek road in 2014.

EQUIPMENT AND WATER TREATMENT Equipment included a Caterpillar 235 excavator, Caterpillar 966 loader, and rock truck. The wash plant had a 5 by 30 ft trommel that classified to 1" and discharged into a 2 by 18 ft sluice run, with expanded metal and thick mats. Three 6" pumps were used to supply the wash plant with water, allowing the trommel to process 75 loose cubic yards (57 m³) per hour. Water was 100% recycled through a series of two ponds/reservoirs.

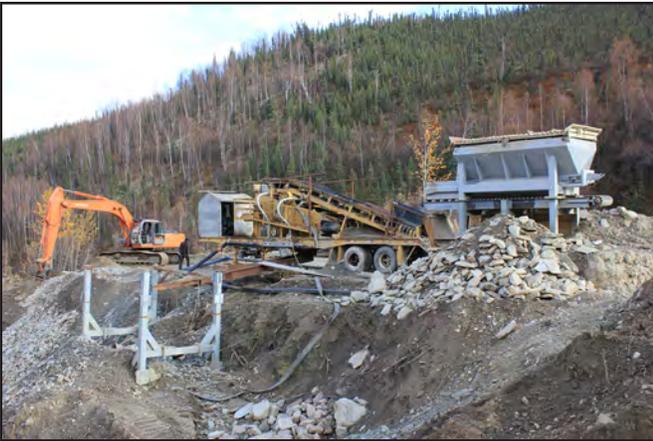
The Gardiner's wash plant in 2014.

EQUIPMENT AND WATER TREATMENT Equipment included a Hitachi 270 excavator, John Deere 500C excavator, Caterpillar 966 wheel loader, John Deere 450C bulldozer, and an International fire truck for the pumps. A 6" Gorman Rupp pump powered by a John Deere 600 engine supplied the screen deck with water through a 100% recycled system. The 2.5 by 16 ft screen deck had a 3/4" punch plate with a 12 by 12 ft vibrating table at the end of three sluice runs, each 4 ft wide. Runs were expanded metal with an upper boil box, all lined with unbacked nomad matting. Clean-ups were conducted using a long tom and completed on a table in town.

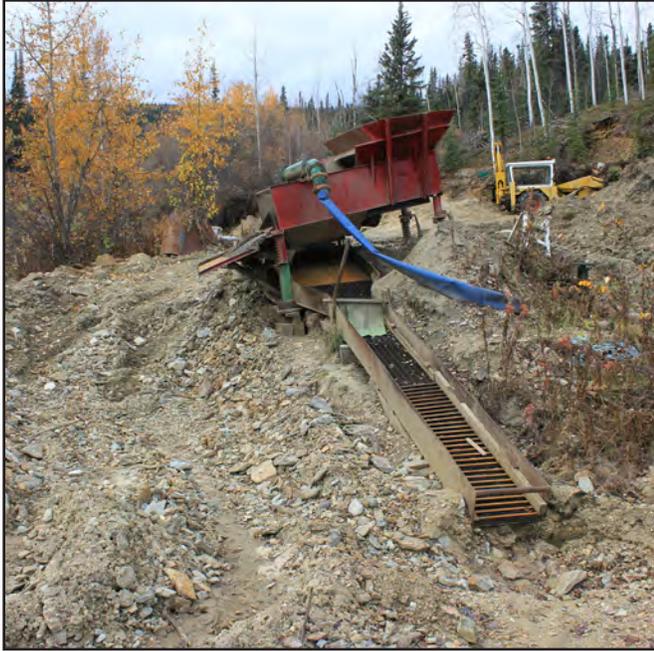
Mr. Daunt's wash plant on Big Skookum Gulch in 2014.

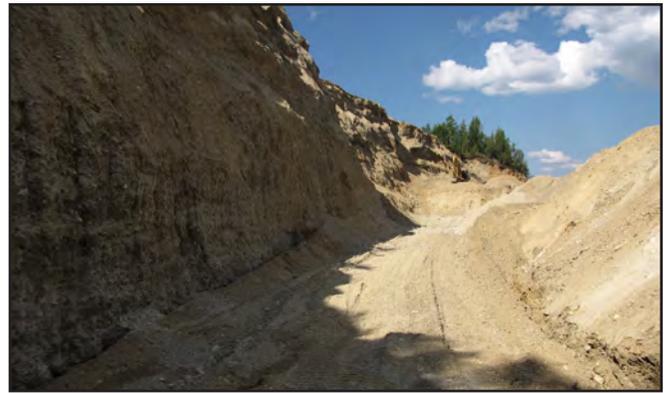
Upper bench cut on Gold Hill in 2013.

SURFICIAL GEOLOGY AND STRATIGRAPHY The upper bench on Gold Hill consisted of approximately 18 m (60 ft) of White Channel gravel, massive to crudely stratified pebble-cobble gravel with weakly imbricated clasts and grading throughout.

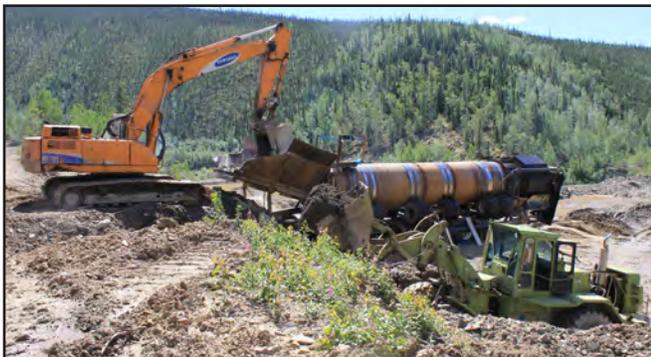
Mr. Arkininstall's trommel on upper Bonanza Creek in 2014.

EQUIPMENT AND WATER TREATMENT Equipment present included a Samsung 350 excavator, Liebherr 981 excavator, Caterpillar HD 41 bulldozer, and Caterpillar 980 loader. The 6 ft diameter by 47 ft trommel screened material down to 1/2", had four 4 ft oscillating sluice runs, and a final 20 ft long sluice run. It was able to process 125 loose cubic yards (96 m³) of gravel per hour. Water was 100% recycled in a series of three out-of-stream ponds.

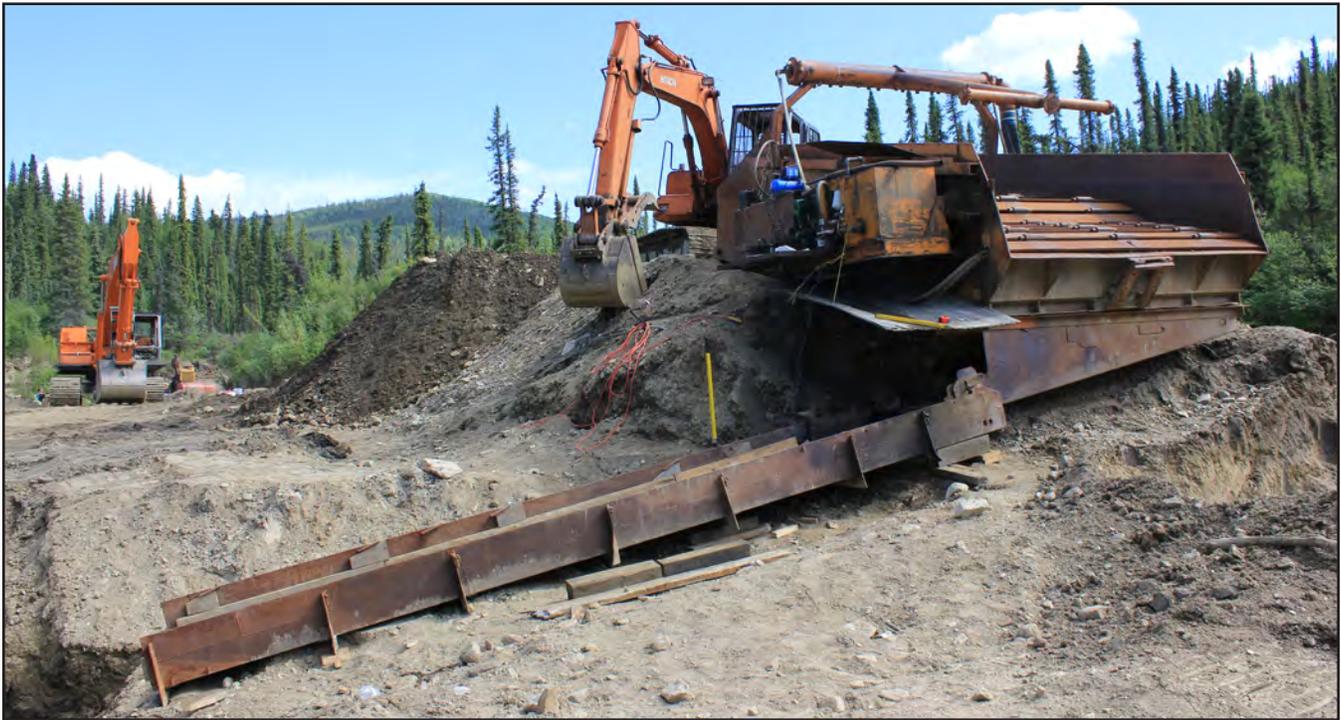
Titan-West Explorations Inc. Derocker in 2014.

EQUIPMENT AND WATER TREATMENT Equipment present included a Caterpillar D8 bulldozer, Caterpillar 235C excavator, Caterpillar 980B loader, and 40-ton Caterpillar 730 rock truck. The Derocker wash plant had a 4 ft wide by 20 ft long sluice run with angle iron and expanded metal, processing 120 loose cubic yards (92 m³) per hour. Water was acquired from two reservoir ponds and effluent was settled in a series of ponds downstream.

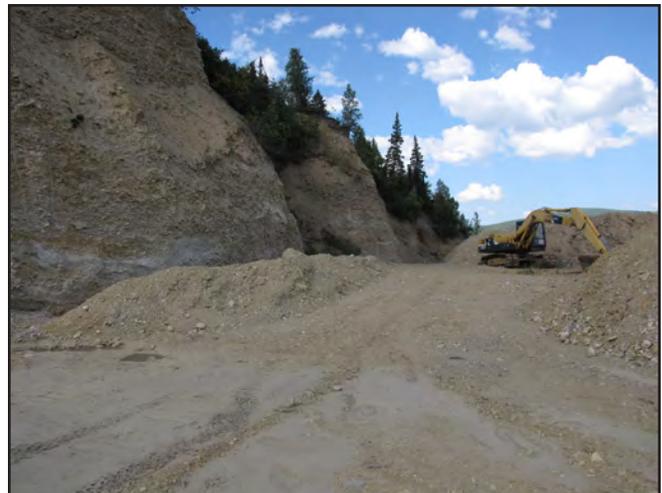
Exposure on French Gulch at Mr. Archibald's in 2013.

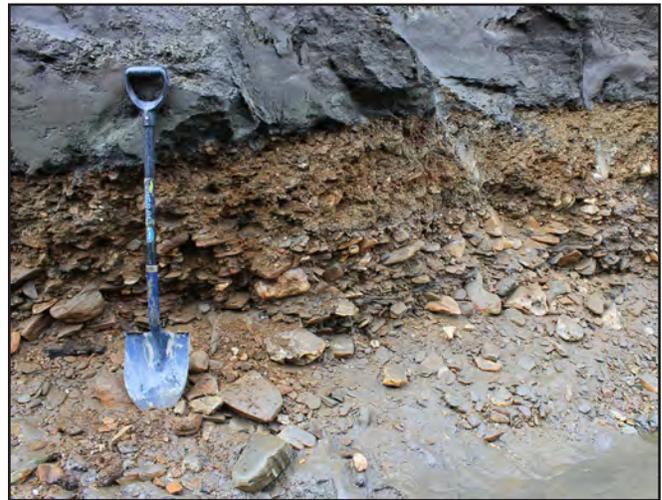
Virgin Eldorado Creek gravels exposed in 2014 by Mr. McKinnon.

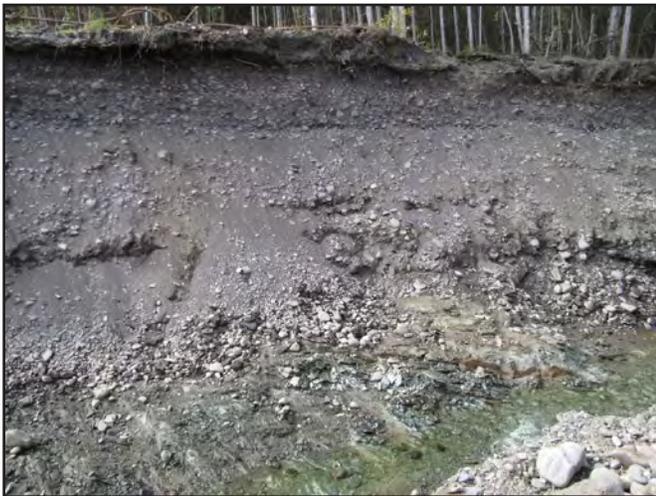
A view of Mr. Brown's left limit Klondike River exposure below Bear Creek. Virgin Klondike River gravel is preserved in this area due to the high bedrock (relatively thin gravel), which was problematic for the dredge to mine. Bedrock is exposed in the base of the cut. This section is 4.5 m (15 ft) in height.

SURFICIAL GEOLOGY AND STRATIGRAPHY The section mined in 2011 and 2012 consisted of 3.6 to 6.1 m (12 to 20 ft) of stratified and cross-bedded Klondike River gravel with large

cobbles at the bedrock contact. The gravel is overlain by 1.2 to 2.4 m (4 to 8 ft) of mud and organics. The sluiced section included 1.2 to 1.5 m (4 to 5 ft) of gravel and 0.3 to 1.2 m (1 to 4 ft) of bedrock.

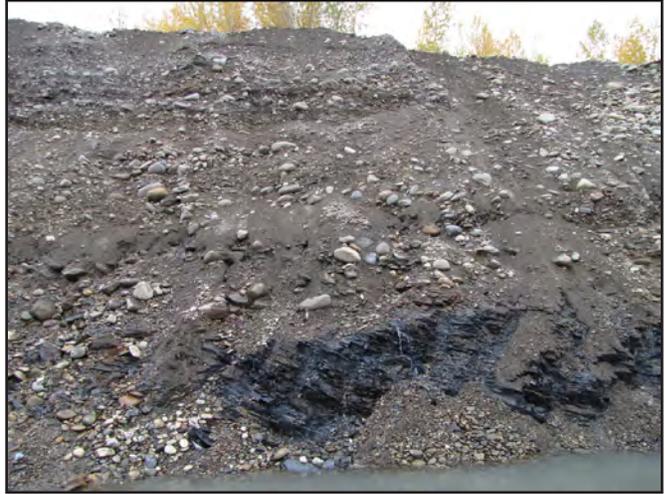
A complete section of Klondike River gravel exposed at Tatra Ventures operation in 2014. The gravel and exposed bedrock section is about 8.5 m (28.5 ft) thick.

Additionally, striations were noted on a large boulder near the base of the cut. Striations are scratches that develop through glacial transport, but quickly erode off the clast surface when transported in a stream. The presence of a striated boulder at this location suggests a glacial outwash origin for the lower gravel, rather than a gravel deposited during an interglacial period. The early Pleistocene ice front must have been relatively close to this location in order for the striations to be preserved on the boulder surface. The closest evidence of pre-Reid glacial deposits in the vicinity is near Rock Creek in the Tintina Trench.

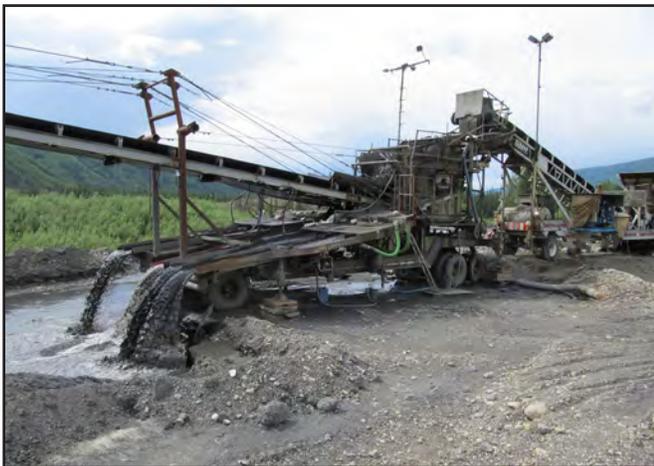
T.D. Oilfields Services Ltd.'s wash plant on Hunker Creek in 2012 (Photo credit: Jim Leary).

plant processed 80 to 100 loose cubic yards (61 to 76 m³) of gravel per hour and water was supplied at 1500 igpm by a 6 by 6" Indeng pump, powered by a Isuzu engine. In 2012 and 2013, an 8 by 10" Paco pump powered by a Caterpillar engine supplied water at 1500 igpm. On the right limit bench claim in 2010, water was pumped from an old mined out area on the right limit of Hunker Creek valley and 100% recycled out-of-steam in a 30 by 152 by 4.6 m (110 by 500 by 15 ft) pond. Later becoming a settling pond, the cut on the left limit of Hunker Creek, near the mouth, acquired water from an in-stream rock weir that directed water to two large pump ponds on demand, in 2010 and 2011. Out-of-stream settling occurred through a 46 by 91 by 3.6 m (150 by 300 by 12 ft) pond in 2010 and a 76 by 61 by 4.6 m (250 by 200 by 15 ft) pond in 2011. On Hattie Gulch, in 2011 and 2012, make-up water was acquired from Hunker Creek into two recycling ponds and settled in a series of three out-of-stream settling ponds each 24 by 46 by 3.6 m (80 by 150 by 12 ft). An in-stream rock weir directing water into two large pump ponds was used from 2012 to 2014 with effluent settled out-of-stream. A long tom over a two-cell jig and 3 ft gold wheel was used for clean-ups.

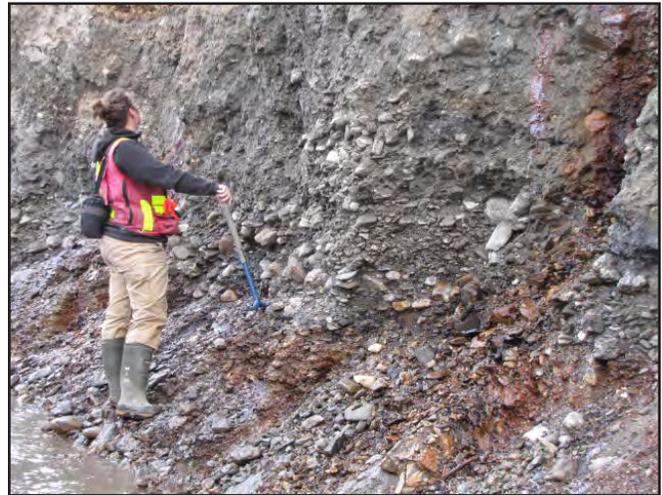
View of the left limit fluvial geology on Hunker Creek at Henry Gulch Explorations Ltd.'s cut in 2014. The pay gravel is overlain by 5 m (16.4 ft) of diamicton, gravel, and tailings overburden. The rusty brown bedrock exposed at the base of the cut is schist.

sluiced. In 2013 and 2014, mining continued on the left limit of Hunker Creek under an apron of thick muck. At the downstream end of the claim block, a section of Hunker Creek gravel was exposed under a veneer of tailings. The bedrock is a brown to grey, blocky schist and is overlain by 6 m (20 ft) of coarse gravel units, grey diamictons, and tailings. Unit 1, directly above bedrock, consists of 0.5 m (1.6 ft) of imbricated cobble gravel with minor boulders and about 24% vein quartz clasts. This unit is the main pay gravel. Unit 2, from 0.5 to 1.6 m (1.6 to 5.2 ft), is a grey diamicton (silt-rich deposit) with some quartz clasts and washed gravelly lenses. Unit 3, from 1.6 to 3.1 m (5.2 to 10.2 ft), is an oxidized, poorly sorted, pebble-cobble gravel. Some open-work lenses are present and are heavily stained from groundwater depositing iron. Unit 4 is another diamict deposit similar to unit 2 and extends from 3.1 to 3.6 m (10.2 to 12.1 ft). The final unit consists of YCGC dredge tailings from 3.6 to 4.8 m (12.1 to 17.7 ft).

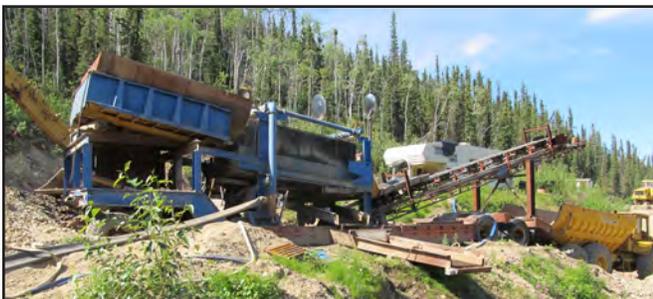
The sluice plant of Mr. Gillespie's mining operation on Henry Gulch in 2013 (Photo credit: Jim Leary).

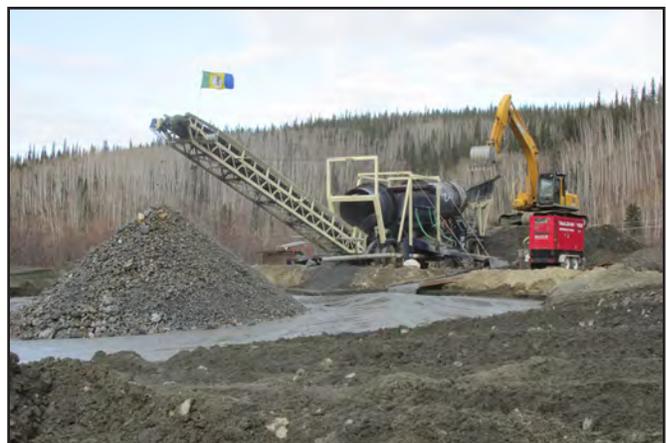
Tatra Ventures Ltd. trommel at the mouth of Last Chance in 2014 (Photo credit: Jim Leary).

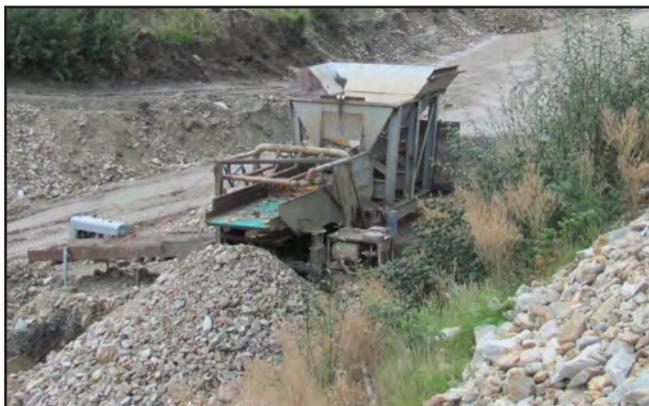
Wash plant and 2013 cut at WAM Exploration on Last Chance Creek (Photo credit: Jim Leary).

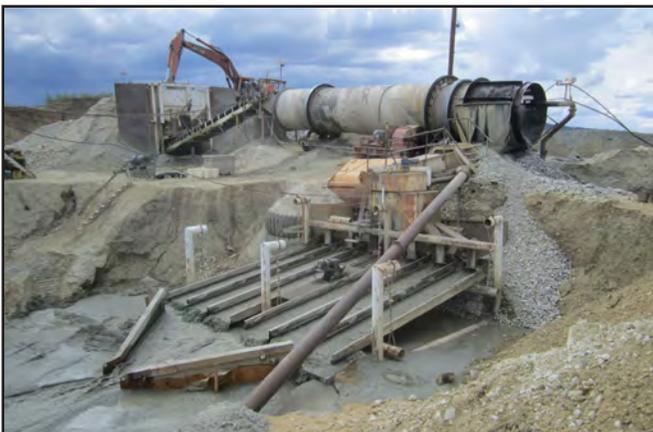
Active wash plant at Tamarack Inc.'s operation on Hunker Creek in 2011 (Photo credit: Jim Leary).

EQUIPMENT AND WATER TREATMENT The wash plant consisted of an 8 ft diameter land trommel, with six 2 by 15 ft oscillating sluice runs, able to process 200 loose cubic yards (150 m³) of gravel per hour. The water was collected from an in-stream reservoir on Hunker Creek and effluent was released into a series of settling ponds in the Hunker Creek valley.

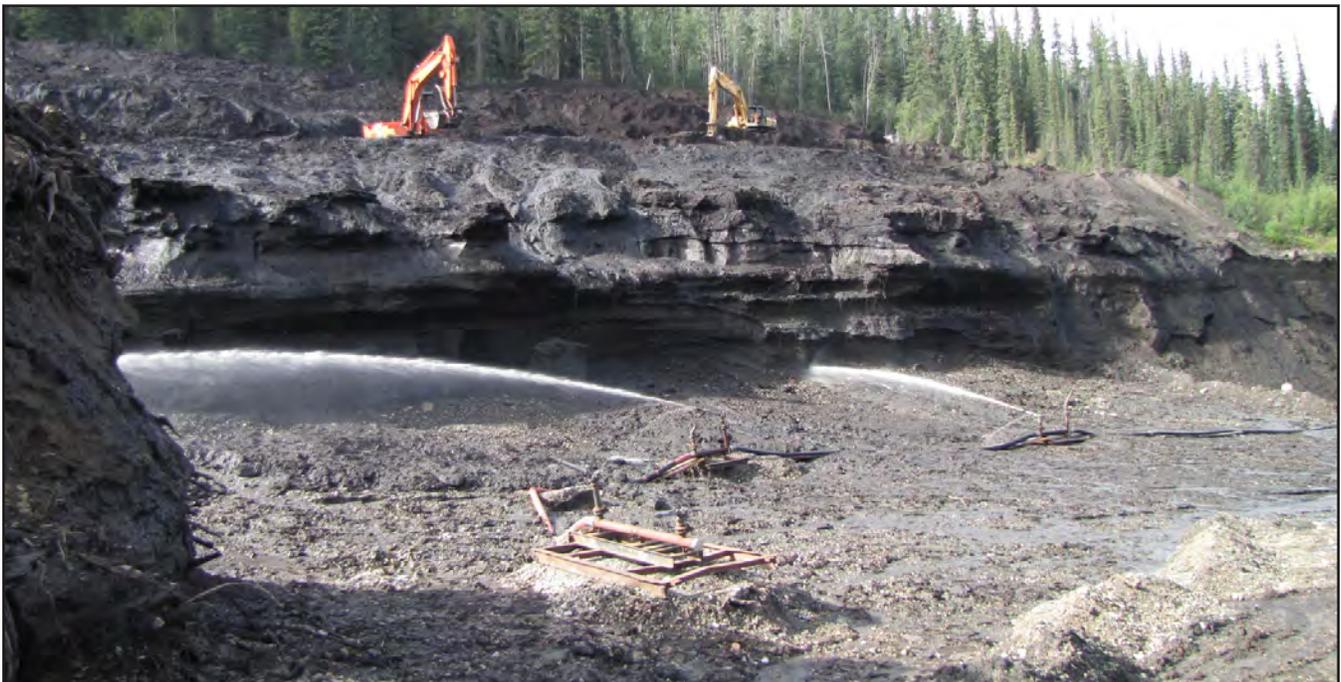
A view of the left limit bank of Independence Creek. The thick muck section was removed using irrigation sprinklers and mechanical excavation.

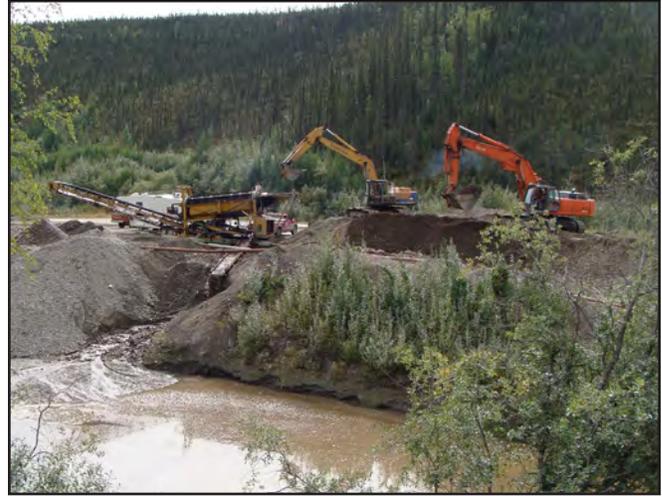
Daval Mining's trommel on Hunker Creek in 2013 (Photo credit: Jim Leary).

EQUIPMENT AND WATER TREATMENT Equipment included a Komatsu PC220 excavator, Caterpillar 245, Hitachi Zaxis 450 excavator, Caterpillar D10 bulldozer, and two Caterpillar 769B haul trucks. The wash plant consisted of a 5 by 20 ft trommel with a 1/2" screen over a 10 ft wide by 8 ft long sluice run of hydraulic riffles and expanded metal. The trommel was able to process 60 loose cubic yards (46 m³) of gravel per hour. A cell mining system has been successfully used on the property for many years. This is where pay is sluiced back into mine cuts with a full recycle system that generates no direct effluent discharge to Hunker Creek.
