Yukon Placer Mining Industry

2010 to 2014

Compiled by S. Van Loon and J.D. Bond
Yukon Geological Survey
Energy, Mines and Resources
Government of Yukon

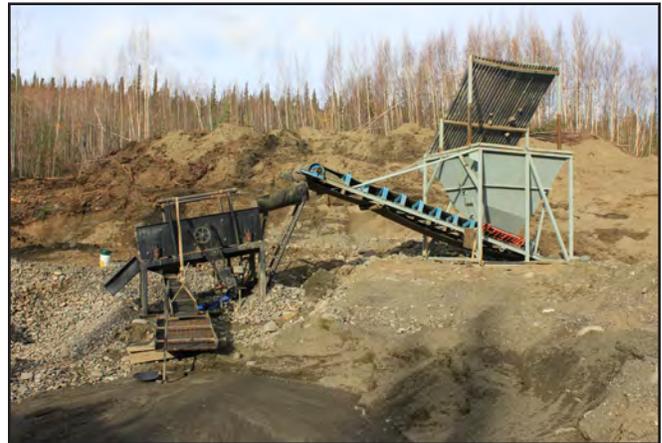
Wash plant at the Duggan's property.

EQUIPMENT AND WATER TREATMENT Equipment included a John Deere 270 excavator and a grizzly feeder wash plant that screened to 1/2". Water was 100% recycled and circulated by a 3 by 5" Cornell pump powered by a Perkins diesel engine. For clean-ups, concentrates were rerun on a slick plate.

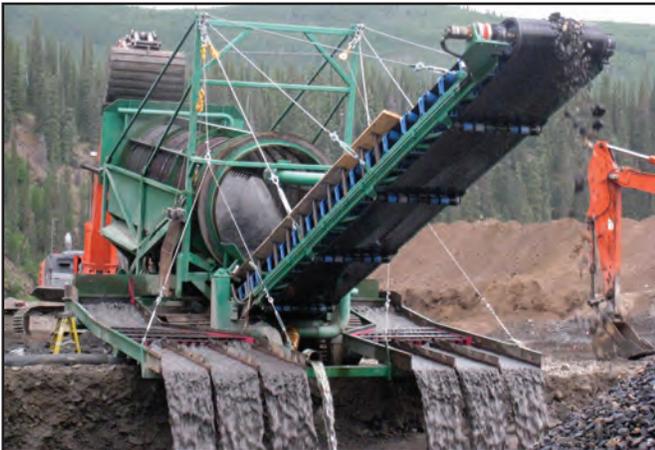
Trommel plant that M2 Gold Mines Ltd. fabricated and used in 2013 (Photo credit: Michael Cawood).

EQUIPMENT AND WATER TREATMENT Equipment located on site included a Caterpillar D9N bulldozer with u-blade and ripper, a Hitachi 290 excavator with a 1.1 m³ (1.45 yd³) bucket, and a Hitachi 240 excavator with a 1.3 m³ (1.65 yd³) bucket. In 2013, a Hitachi 330 excavator with a 1.4 m³ (1.8 yd³) bucket was acquired. The 5 ft diameter New Zealand style trommel plant with hydraulic riffles was replaced by a 7 ft diameter mobile New Zealand style trommel plant. The new plant had a total sluice length of 4.9 m (16 ft) and expanded metal and 1" wide angle iron riffles underlain by Nomad matting. The plant is self-propelled and mounted on tracks with a hydraulic drive. The 2012 plant processed up to 100 loose cubic yards (76 m³) per hour, while the larger 2013 plant processed 100 to 140 loose cubic yards (76 to 107 m³) per hour. Water was supplied at 800 to 1200 igpm by a 6 by 6" Cornell 6HNTA pump

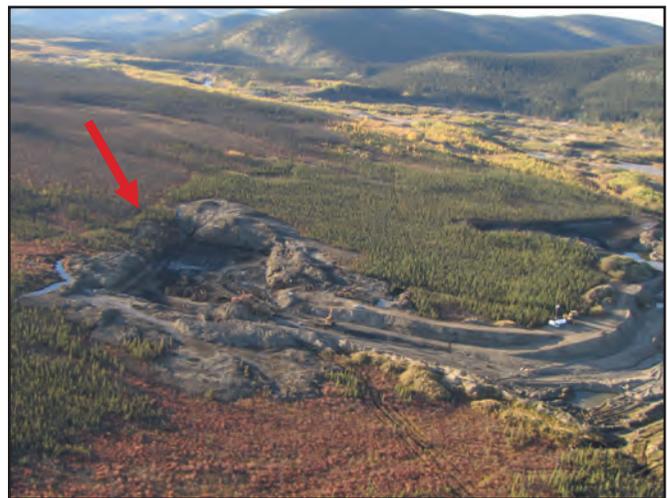
View to the northwest looking over Northern Exposure's left limit cut (see arrow) on Kathleen Creek in 2014. The Indian River is in the background.

with silty-sand matrix; the clasts were dominantly quartz, subangular to subrounded and pervasively oxidized at the bedrock contact. The left limit bench on Kathleen Creek, exposed in 2014, consists of 1.0 to 2.7 m (3 to 9 ft) of clast-supported pebble-cobble gravel overlain by up to 3 m (10 ft) of muck overburden. A coarse, muddy gravel that is 34 cm thick, rests on bedrock and contains large cobbles and small boulders up to 30 cm in length. Flow orientations preserved in the structure of the gravel suggests multiple sources may have contributed to its origin. In the upper gravel section, clast imbrication and cross-bedding support an eastward flow, particularly on the south and west wall of the cut. In the northeast corner of the cut the flow orientation is clearly to the north, sub-parallel to Kathleen Creek. In the northwest corner of the cut the gravel nearly pinches out. An analysis of satellite imagery indicates that the cut was excavated near the mouth of a small east-northeast trending tributary to Kathleen Creek (582721 E, 7070874 N). A component of the gravel in the cut is likely sourced from this tributary, especially the upper sections of the gravel, although it is unknown if it supplies placer gold. The thin, coarse, muddy gravel on bedrock did not have a clear flow direction and is assumed to be sourced from Kathleen Creek.

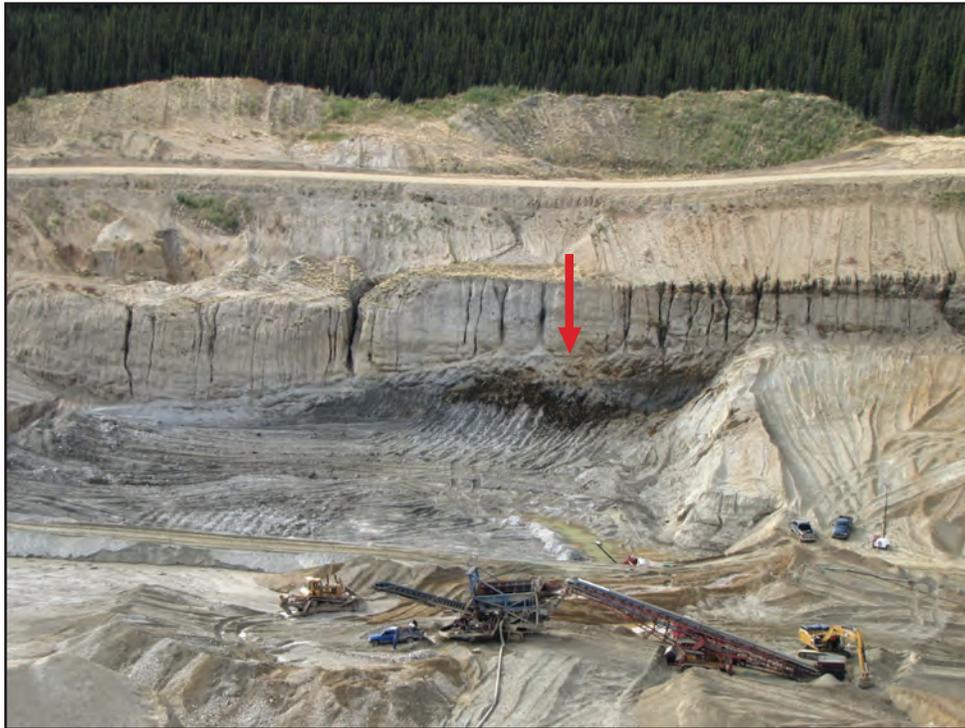
An aerial photograph from 2014 with a view to the west of Schmidt Mining's Quartz Creek bench. The mafic dike is visible in the lower White Channel gravel behind the wash plant (see arrow). Prolific old timer workings were present in this area.

could be subdivided into two general units consisting of an upper yellow gravel and a lower grey gravel on bedrock. The yellow gravel is up to 13 m (42.5 ft) thick and is a matrix supported cobble-pebble gravel with crude bedding. The lower grey gravel is a decomposed, matrix supported gravel that is 10 m (33 ft) thick. Continuation of work on the cut, in 2014, exposed a 3 to 4 m (10 to 13 ft) wide, vertically oriented, mafic dike extending 10 m (33 ft) into the lower grey gravel. The dike edges are weathered whereas the interior of the dike contains spheriodally weathered dike clasts and unweathered resistant components. The orientation of the dike is 44 to 224° and has drawn up the orthogneiss country rock and decomposed White Channel gravel along its margins. It is uncertain whether the dike is a bedrock slice tectonically thrust into the lower White Channel or

is an igneous intrusion. The top of the dike is overlain by a layer of grus that appears to be a colluviated equivalent of it. This would suggest that the dike was emplaced into the paleo-surface of the floodplain and occurred prior to deposition of the overlying yellow gravel. Where the dike is in contact with the grey gravel there appears to be flow-like features encasing quartz clasts. In addition, some quartz clasts are fractured near the contact with the dike. This evidence supports an intrusion history rather than a tectonic thrust emplacement into the lower White Channel gravel. This has implications for potentially dating the lower White Channel gravel and will be the focus of additional research.

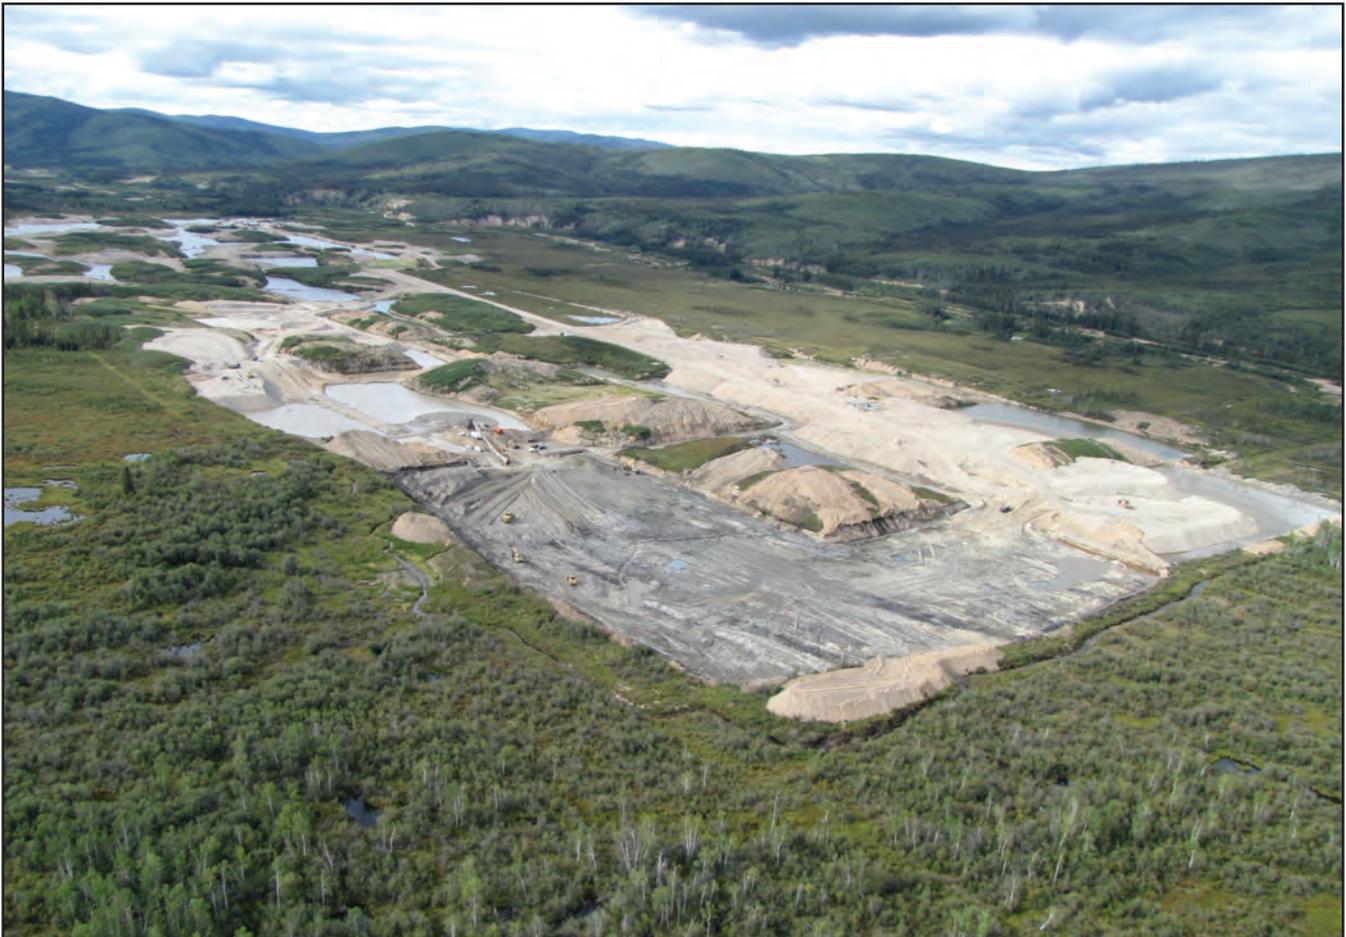
Aerial view over Gimlex Enterprises Ltd. mine on the Indian River valley. Through comprehensive exploration auger drilling, low grade "islands" are avoided and used for storing fine-grained overburden. This method limits peripheral disturbance and facilitates reclamation.

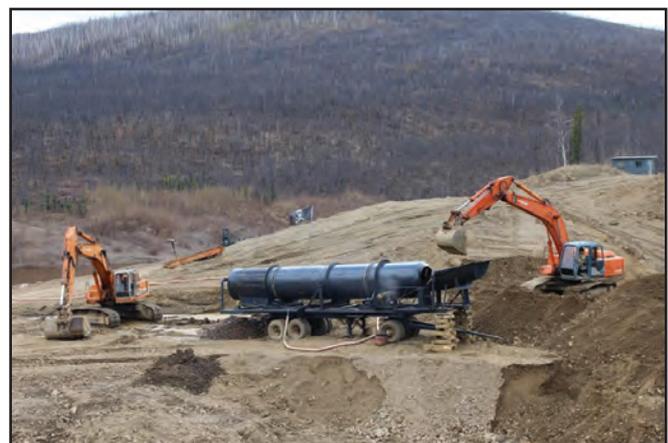
Them R Gold Ltd. wash plant on Eureka Creek (Photo credit: Marie Charbonneau).

EQUIPMENT AND WATER TREATMENT Equipment present on site in 2014 included a Caterpillar D8K bulldozer, D9H bulldozer, Caterpillar D9G bulldozer, Hitachi 220 excavator and Hitachi 400 excavator. The wash plant consisted of a 40 ft trommel with a 5 ft barrel, processing 60 loose cubic yards (45 m³) per hour. Water was acquired from the right fork of Eureka Creek using a 6" Indeng pump powered by a Detroit diesel engine. Effluent was treated in-stream and was 100% recycled using four ponds each measuring 30.5 by 70.0 m (100 by 200 ft). Clean-ups were conducted using a jig and table.

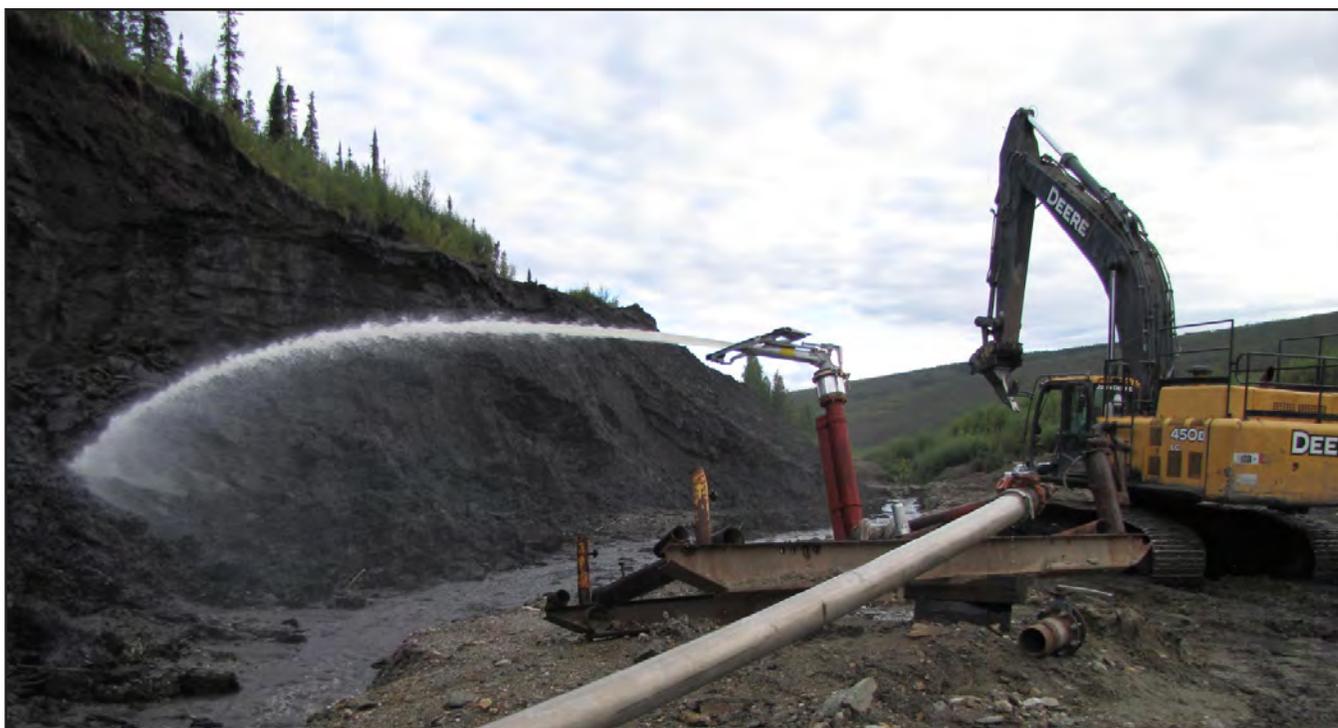
Monitoring with an irrigation sprinkler at Mr. Klippert's Sulphur Creek operation in 2014.

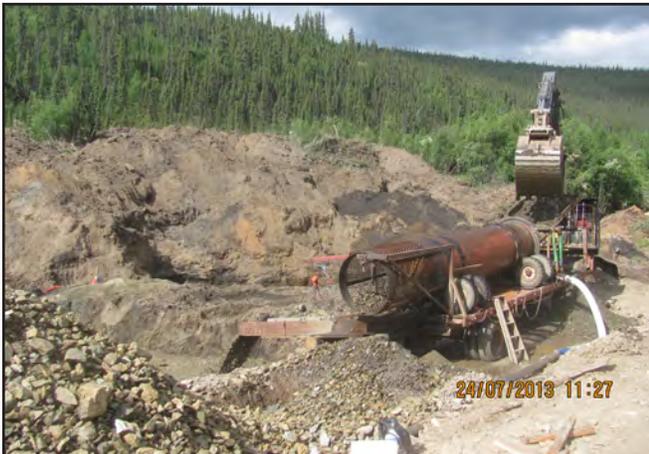
Mr. Mintz's wash plant on Lombard Creek in 2013 (Photo credit: Lee Mierau).

EQUIPMENT AND WATER TREATMENT Equipment documented in 2013 included a small excavator and a trommel.

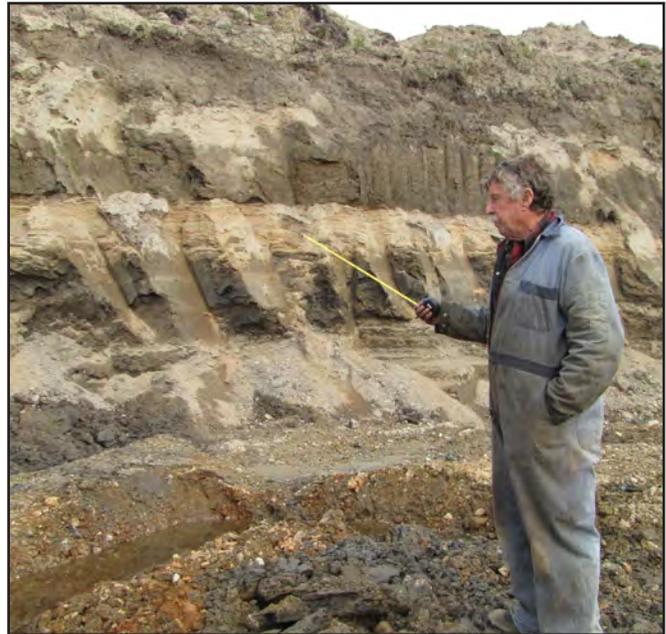
A view of the left limit overburden geology on Dominion Creek. Mr. Hollis is standing on the paleo-Dominion Creek pay gravel.

from 0 to 0.3 m (0 to 1 ft) consists of stratified medium to coarse-grained sand and quartz-rich pebble-cobble gravel with bedrock fragments and variable oxidation throughout. Lenses of buried muck with woody debris are present in the upper portion of this unit. Unit 2, from 0.3 to 2.8 m (1 to 9.2 ft) is dominantly coarse-grained sand and granules and contains minor, undulating lenses of pebble-cobble gravel with subangular clasts. Stratified coarse-grained sand, loess with organic inclusions, and thin bands of pebbly sand is present in the upper 1.5 m (4.9 ft) of the unit. Unit 3 consists of organic-rich loess from 2.8 to 4.1 m (9.2 to 13.5 ft) with a wavy bottom contact. On average, in 2013 and 2014, 0.6 to 0.9 m (2 to 3 ft) of unit 1 gravel and 0.6 m (2 ft) of bedrock was sluiced, with up to 9 m (30 ft) of muck stripped prior to mining.

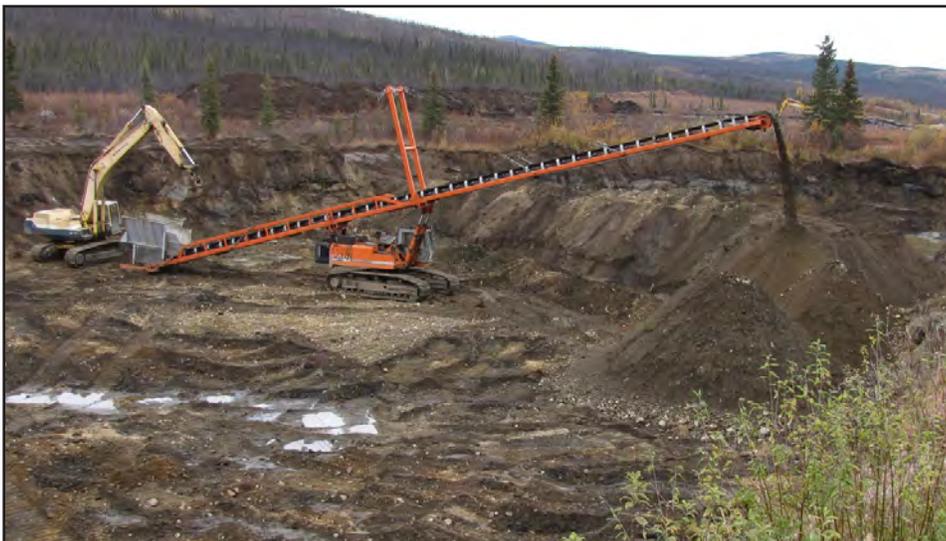
Mr. Hollis' operation on Dominion Creek in 2013, showing his custom-built track mounted conveyor.

EQUIPMENT AND WATER TREATMENT In 2014, equipment on site included a John Deere 370 excavator, John Deere 450 excavator, Komatsu PC400LC excavator, and two conveyors - 110 and 130 ft long - mounted on Hitachi EX450LCH excavator bodies, which were custom designed and built by Mr. Hollis. The wash plant consisted of a 5 by 11 ft oscillating screen deck with 7/16" screen, able to process 80 loose cubic yards (61 m³) per hour. Water was acquired from Kentucky Creek with a 5 by 5" Cornell pump powered by a Caterpillar 3208 at 1100 gpm. Effluent was settled out-of-stream and through old dredge tailings. Clean-ups were conducted using a wheel.

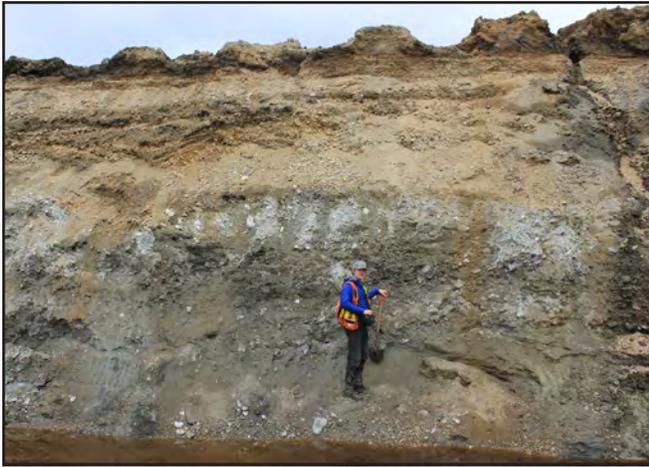
Alluvial gravel units exposed at Dominion Gold Resources' operation on Dominion Creek in 2014.

SURFICIAL GEOLOGY AND STRATIGRAPHY The stratigraphy exposed in the 2014 cut consisted of three units. Unit 1, from 0 to 3.3 m (11 ft) at the base of the section, is the Ross gravel as described by Froese *et al.* (2001). According to this previous research, the Ross gravel is >780 000 years old, and in the 2014 cut is characterized as a quartz-rich pebble-cobble gravel containing rare boulders up to 100 to 150 cm in diameter. The bottom 1.2 m (4 ft) of the Ross gravel and

0.3 m (1 ft) of decomposed green (chlorite) schist bedrock is considered pay. Unit 2, from 3.3 to 5.8 m (11 to 19 ft), consists of the Dominion Creek gravel, which is an oxidized (brown) quartz-rich gravel that fines upward from a pebble-cobble gravel to a sandy pebble gravel. Organic material in the Dominion Creek gravel contains a variety of radiocarbon ages from >46 000 years old to 6000 years old (Froese *et al.*, 2001). Unit 3, from 5.8 to 10.7 m (19 to 35 ft), is transported loess (silt) containing reworked organic material.

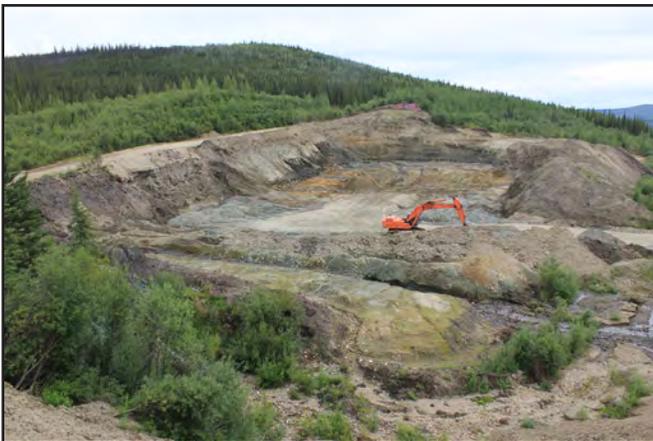
Cut at the mouth of Whitman Gulch mined in 2013 and 2014.

The ground, at the mouth of Whitman Gulch, consists of 0.2 m (0.6 ft) of clast supported, pebble gravel with subangular clasts, an abundance of quartz, and a sandy-granule matrix. Coarse sand and granules with 3% clasts is present from 0.2 to 0.6 m (0.6 to 2.0 ft) overlain by 0.6 to 0.7 m (2.0 to 2.3 ft) of pebble gravel. From 0.7 to 14.2 m (2.3 to 46.6 ft) reworked loess and organics with woody debris is present.

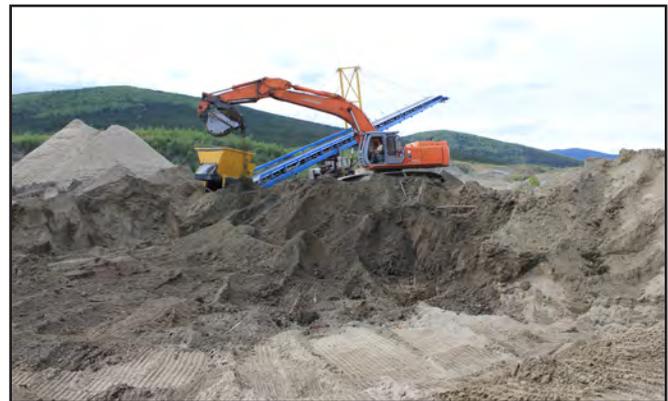
Rical Mining Ltd. moving overburden with their custom fabricated track-mounted conveyor on lower Gold Run Creek in 2014.

EQUIPMENT AND WATER TREATMENT Equipment in 2014 included a Hitachi 450 excavator, Hitachi 225 excavator, 40 ton rock truck, and a 120 ft track-mounted conveyor. A New Zealand 5 ft diameter by 28 ft long trommel with a 1/2" screen was used in 2013 and processed 50 loose cubic yards (38 m³) per hour. Water was supplied by a 6" pioneer pump powered by a Deutz engine and 100% recycled in a settling pond that measured 182.9 by 45.7 m (600 by 150 ft).

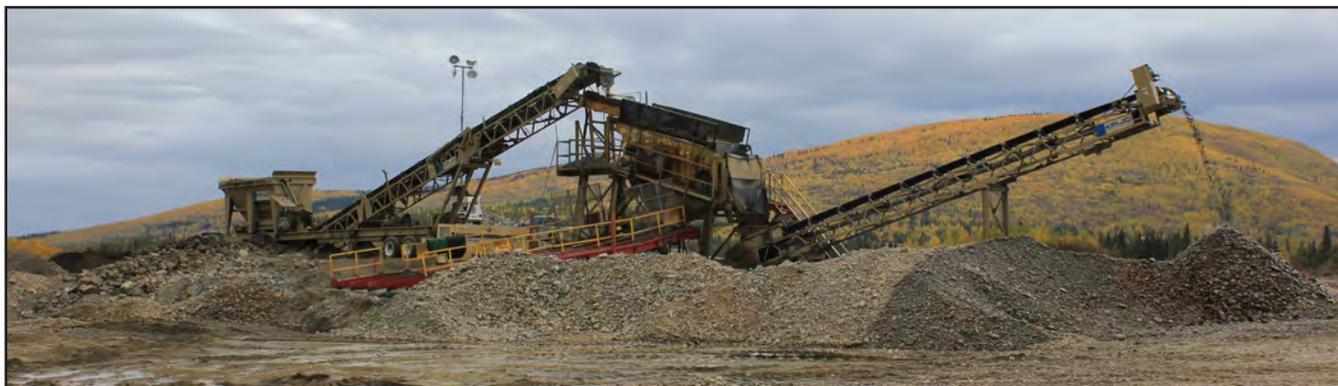
Mr. Schnabel's wash plant on Dominion Creek in 2014.

EQUIPMENT AND WATER TREATMENT Equipment present on site in 2014 included two Volvo A35D articulated rock trucks, two Volvo 460 excavators, one Volvo 700 excavator, four Volvo 220F wheel loaders, and two Caterpillar D10 bulldozer. The wash plant consisted of a 6 by 10 ft hydraulic hopper with grizzly feeding a vibrating screen deck, with 2" upper and 1/2" lower screen. One conveyor was used to feed the screen deck and another was used to displace tailings. A total of four upper sluice runs, 8 ft wide by 30 ft long flared out and split into five runs, 16 ft wide by 6 ft long, with a combination of hydraulic riffles, Hungarian riffles and expanded metal. Processing rate of the plant varied from 70 to 125 loose cubic yards (53 to 95 m³) per hour, depending upon material. Water was acquired from previous cuts and effluent was settled in a series of four ponds. A jig and table were used for clean-ups.

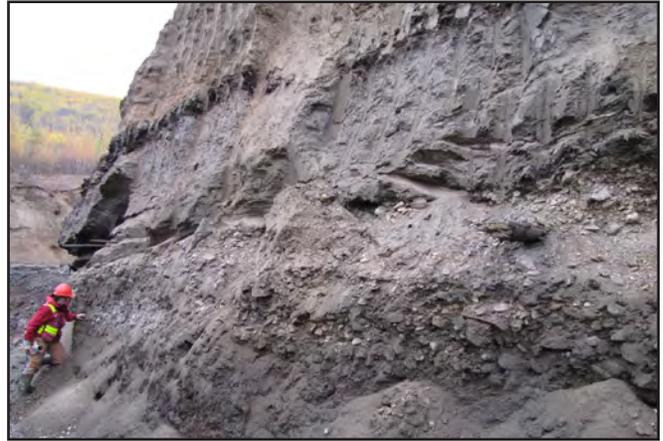
2014 cut near the right limit of Dominion Creek, upstream from the mouth of Scribner Creek. The lower-most muddy gravel is considered pay.

SURFICIAL GEOLOGY AND STRATIGRAPHY The stratigraphy of the 2013 right limit cut downstream from the mouth of Scribner Creek consists of two units. Unit 1, from 0 to 2.4 m (8 ft), is a massive to crudely bedded gravel containing moderate oxidation and sand lenses in the lower half of the unit. Unit 1 is on bedrock, however, the best pay and the layer that was sluiced is located between 0.6 to 1.2 m (2 to 4 ft) above the oxidized gravel. Unit 2, from 2.4 to 3.6 m (8 to 12 ft), is loess overburden. In 2014 the main cut was located above the mouth of Scribner Creek on the right limit of Dominion Creek. The stratigraphy consists of three units. Unit 1 from 0 to 1.8 m (6 ft) is a compact grey pebble-cobble gravel with organic-rich mud. The fine component in the gravel is silty, which makes the gravel relatively compact. The lower 0.6 m (2 ft) of unit 1 and 1 m (3 ft) of bedrock is sluiced. Unit 2 from 1.8 to 3.6 m (6 to 12 ft) is an oxidized sandy gravel that has a general fining upward structure from a pebble-cobble gravel to a dominantly sandy unit at the

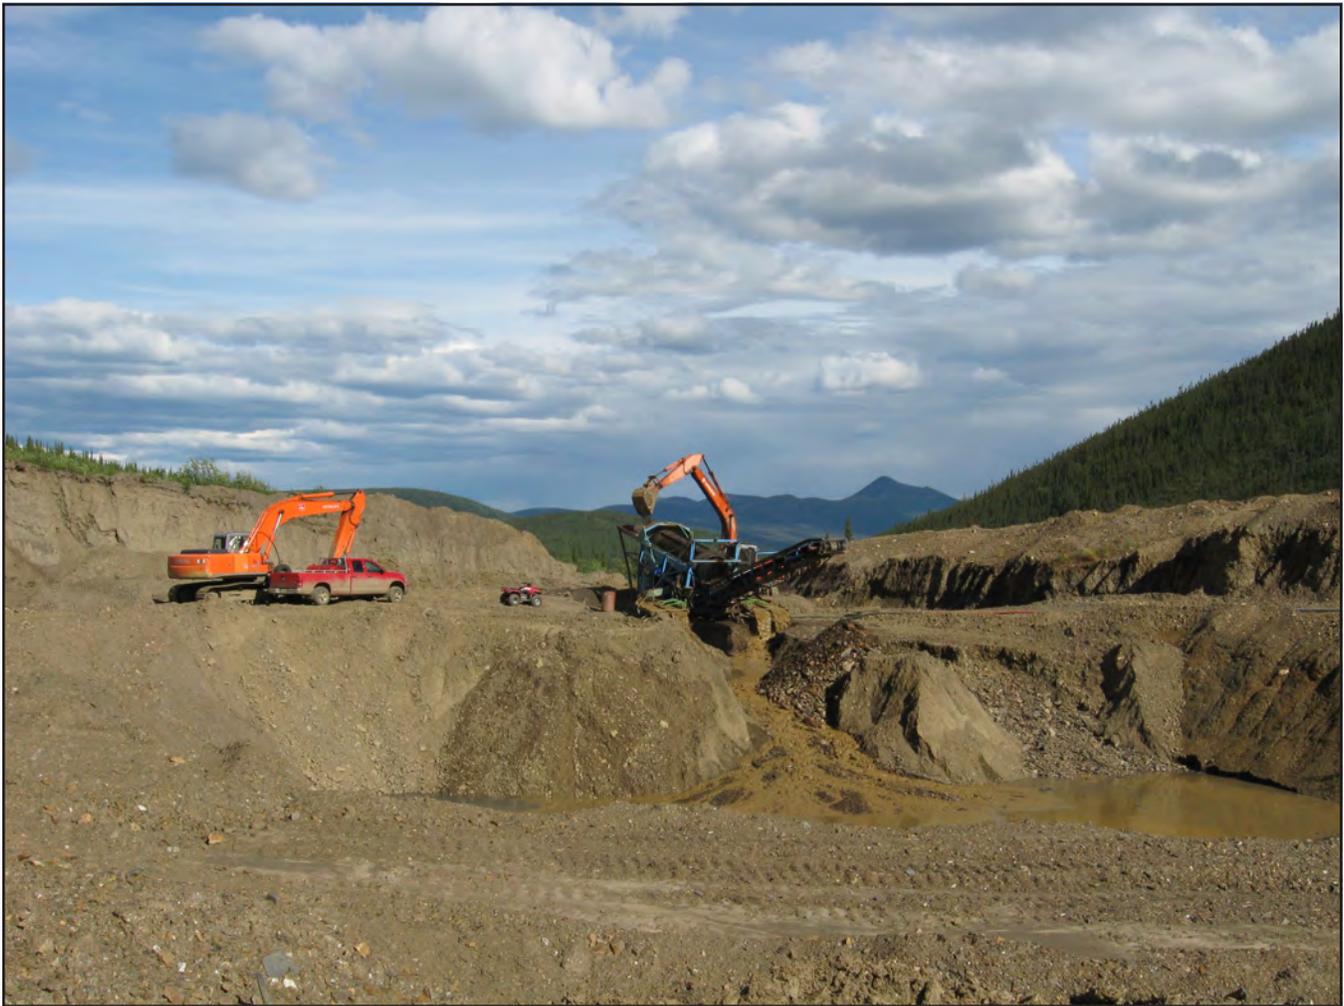
K-1 Mining's sluice operation in 2010 on left limit upper channel, Glacier Creek (Photo credit: M. McDougall).

EQUIPMENT AND WATER TREATMENT Equipment in 2012 to 2013 included two Hitachi EX200 excavators, one Hitachi ZX270LC excavator, one Hitachi ZX450 LC-3 excavator, one 30 tonne Komatsu HM300-2 dump truck, one 20 tonne Moxy 5552B dump truck and one Komatsu D375A-2 crawler tractor with a Ublade and 4 BBL ripper. The wash plant consisted of a 5 ft diameter New Zealand trommel with 3/4" mesh and expanded metal over nomad carpet and hydraulic riffles. Tailings were stacked with a 35 ft long conveyor. An Isuzu diesel engine powered a 6 by 6" Indeg pump at 800 igpm was able to process 50 to 65 loose cubic yards (38 to 50 m³) of gravel per hour. Water was acquired out of a stream pond on either Glacier Creek or Sixtymile River, depending upon mining location, and effluent was treated out of stream in old mine cuts in a series of three ponds approximated 76 by 46 m (250 by 150 ft). Clean ups were completed using a two-cell jig, followed by a long tom, and final upgrade by a gold wheel and hand panning.

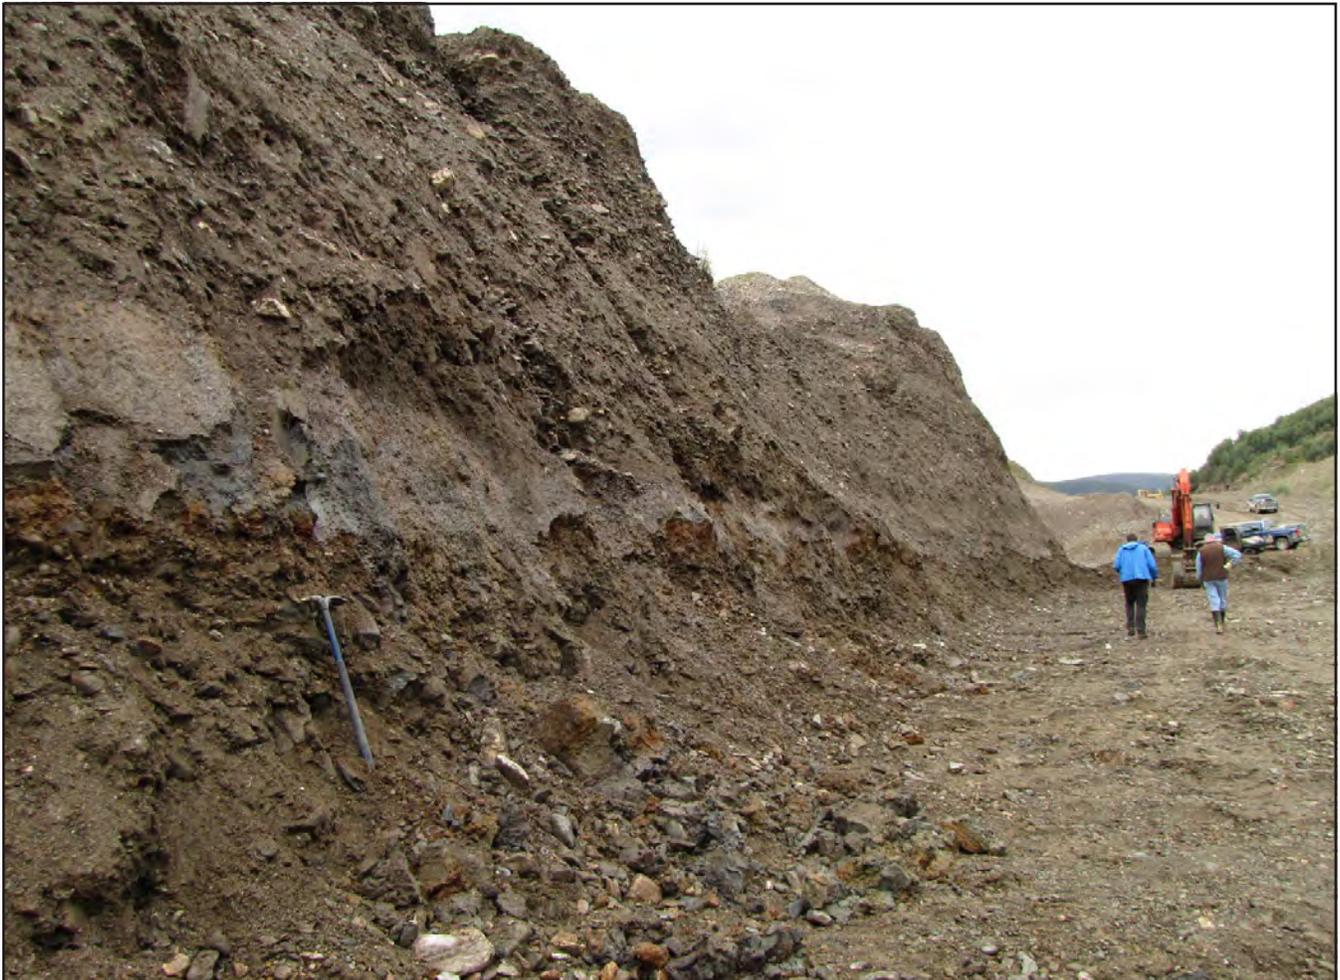
Exposure of the left limit bench gravel in lower Miller Creek. The pick is leaning against the pay gravel which is overlain by a laterally continuous silt and upwards of 24 m (80 ft) of gravel.

by overbank flooding. The pay gravel under the silt is poorly sorted, coarse, contains abundant subangular clasts and generally is a clast supported gravel. The pay gravel and 1.8 m (6 ft) of bedrock is sluiced. An increase in the pay concentration occurs where bedrock highs cause the pay gravel to thin. The total width of the high-grade pay channel is 45 m (150 ft).

The description of the overburden stratigraphy for the lower Miller Creek bench in 2014 is similar to that described by Hughes and Morison (1986). They describe the overburden gravel as an alluvial fan sequence with a general lack of sedimentary structures. The lack of concentrating stream flow that deposited this unit is likely tied to a climatic event that caused rapid sedimentation in the drainage. Typically this occurs during glacial periods, which would suggest the thick overburden gravel sequence may represent an early Pleistocene pre-Reid glacial or periglacial gravel. This would imply that the pay gravel could be associated with a non-glacial climate perhaps from the late Pliocene or early Pleistocene. Additional geological studies are recommended to understand the origin of these deposits.

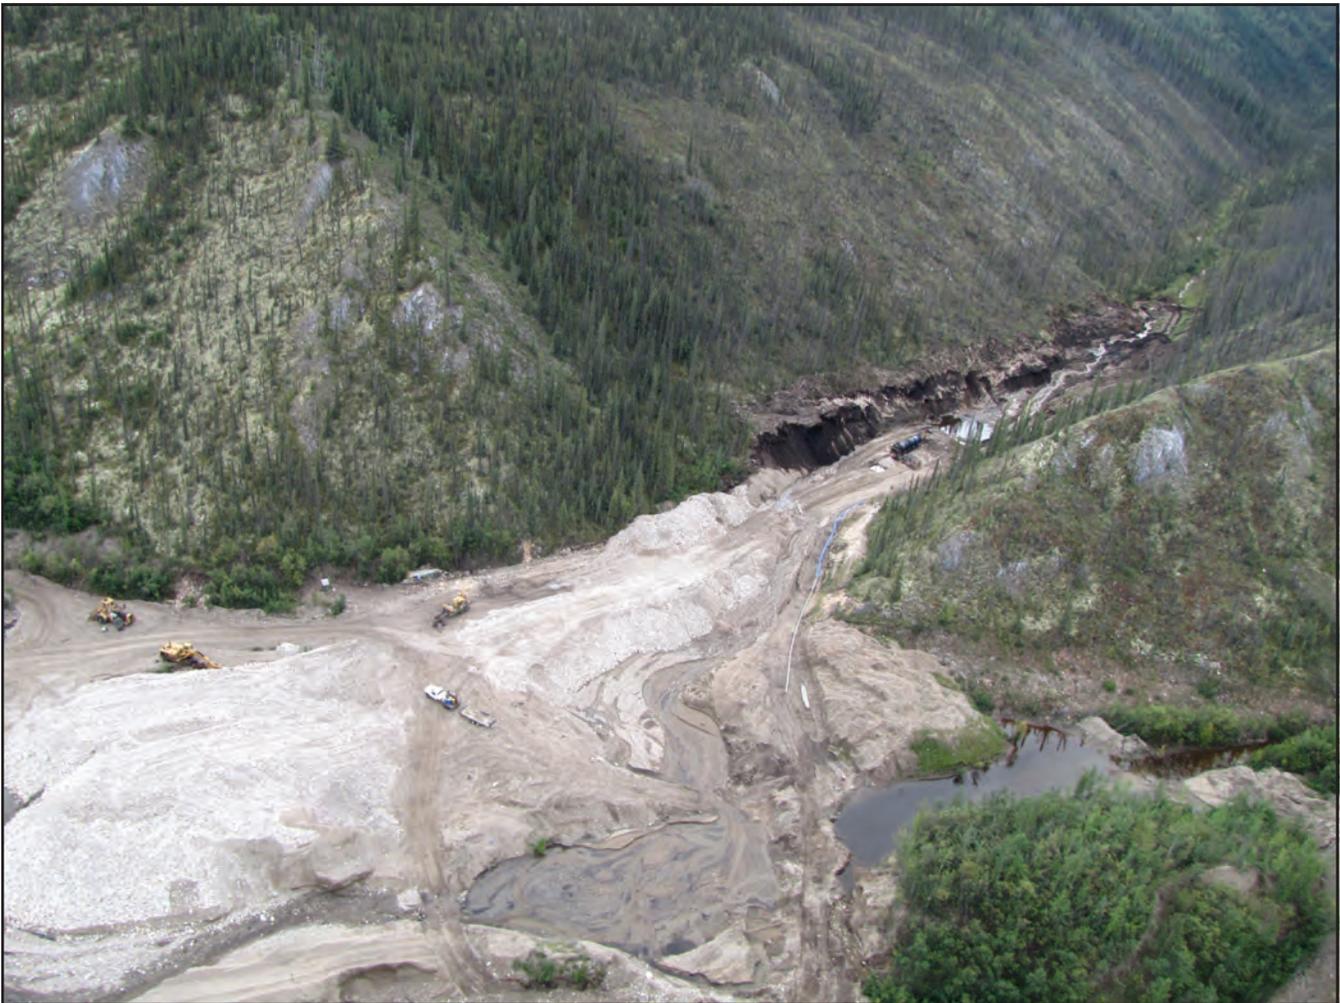
View looking up Donovan Pup from its confluence with 10 Mile Creek. Outcrops of marble are visible on the ridges on either side of the pup. Marble is a relatively resistant rock and creates a narrow valley in the lower part of the drainage.

bottom. Gold was mined near the mouth where the marble unit is fractured creating a rough surface and is in contact with sandstone and thin dykes. At the upstream end of the cut the marble unit becomes more resistant and rises causing the fluvial gravel to become thin and less auriferous.

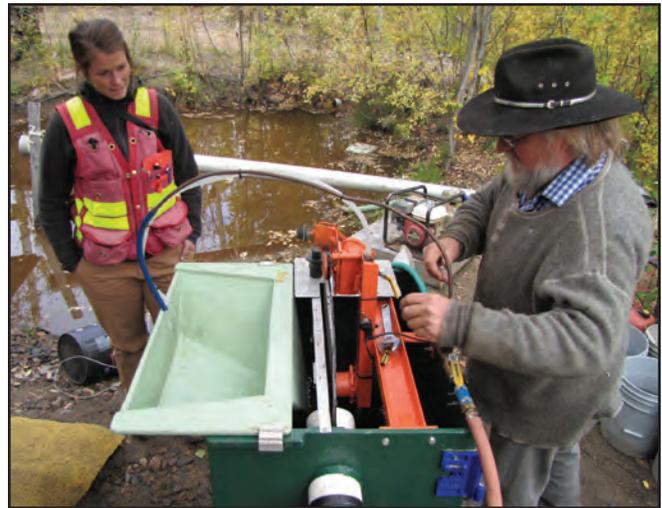
Ian Warrick demonstrates his custom-built magnetic separator used for cleaning concentrates.

The plant processed 60 loose cubic yards (46 m³) per hour. Water was 100% recycled. Clean-ups were completed after 30 hours of sluicing using a jig and custom built magnetic separator.

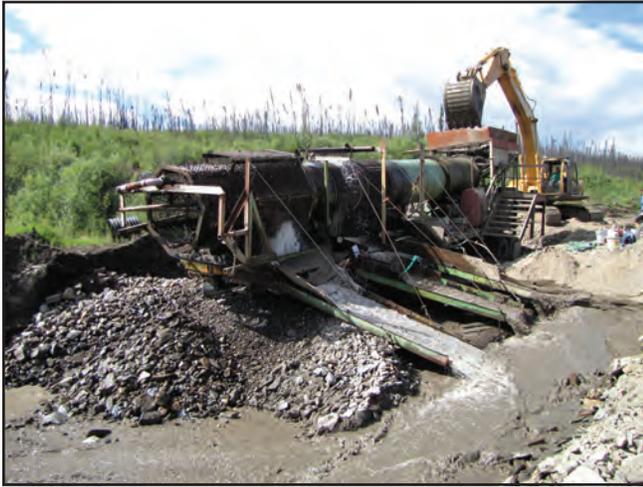
Mr. Smith's wash plant on Black Hills in 2011.

riffles, and 1½" angle-iron riffles. Water was acquired from Black Hills Creek at 1000 igpm using a 6 by 6" pump, powered by a Ford industrial diesel engine. Discharge was to Black Hills Creek with no recirculation. The wash plant processed 60 loose cubic yards (46 m³) of gravel per hour. The final stages of clean-up were done using a long tom, gold wheel, and pan.

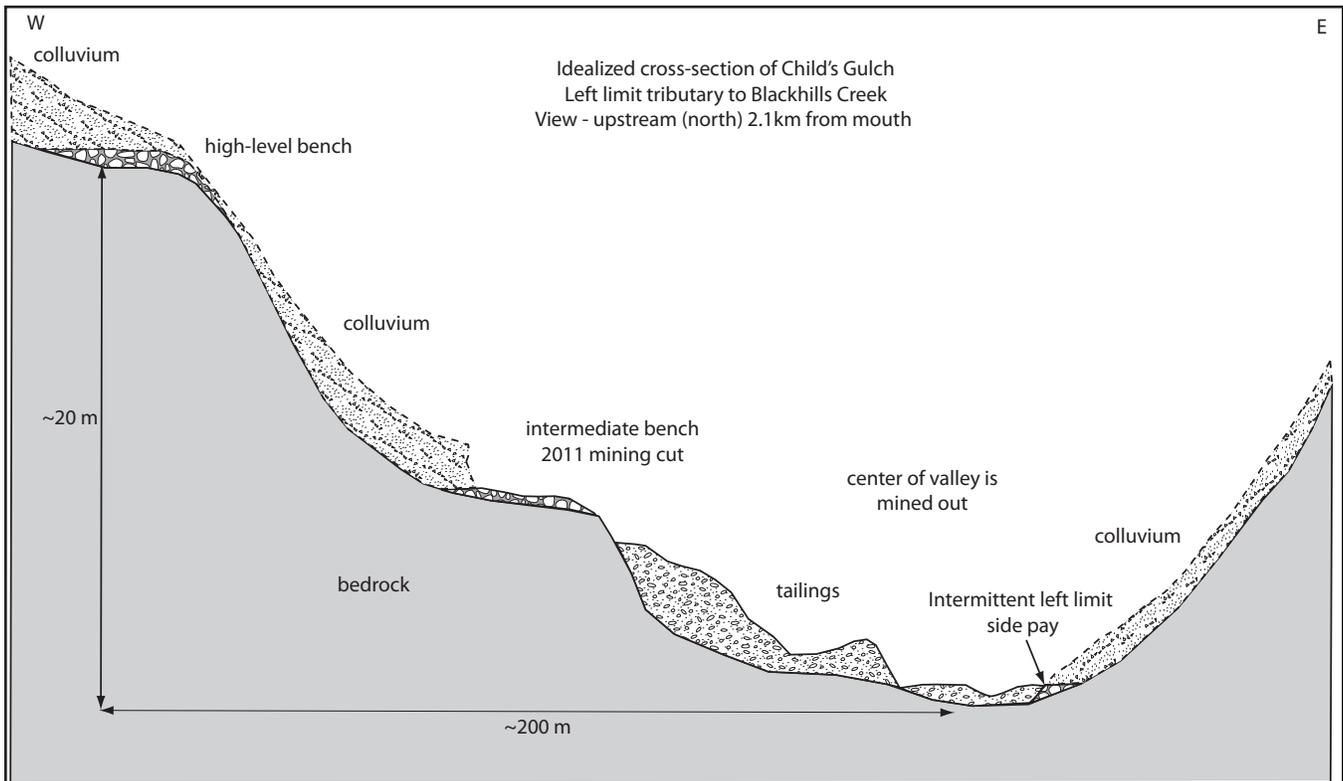
Idealized cross section of Childs Gulch (Source: Jeff Bond).

which consists of gravel and overbank mud ranging between 1.5 and 5.5 m (4.9 and 18.0 ft) thick. Thickness seems to be controlled by the resistance variations of the bedrock surface. Gravel appears to be eroded in places by colluviation (slide rock processes) resulting in thinner accumulations of gravel in places. Bench gravel and bench landforms are masked or buried by colluvium that is composed of weathered bedrock, loess, and minor bench gravel eroded from a high-level bench (approximately 20 m (65 ft) above creek level). Unit 1 on the lower bench section consists of 0.75 m (2.5 ft) of pay which is cobble-pebble fluvial gravel with crude imbrication in the down valley direction. Unit 2, a lower energy fluvial deposit compared to unit 1, extends from 0.75 to 1.3 m (2.5 to 4.3 ft). This unit was deposited in an overbank flood setting and consists of olive-grey mud with lenses of gravel, thin sand, and granule lenses up to 20 cm (0.6 ft) thick and 2 m (7 ft) long. Diamicton (slide rock), consisting of 60% cobbles and pebbles and 40% micaceous mud comprise unit 3 at 1.3 to 1.8 m (4.3 to 5.9 ft).

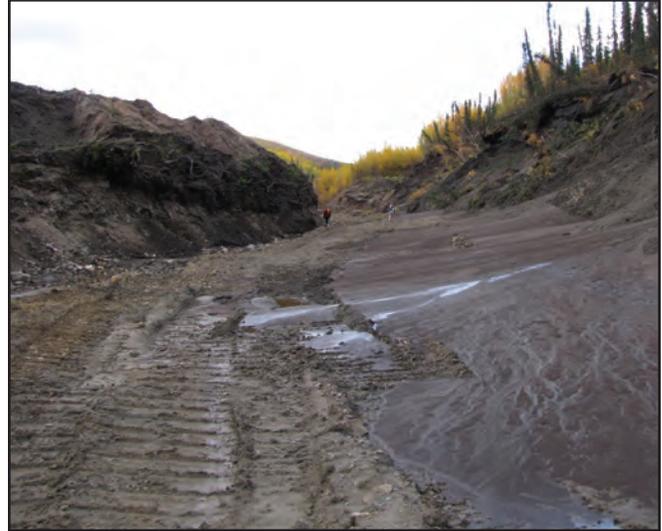
Mining cut at the mouth of Childs Gulch looking northeast during the 2013 season.

SURFICIAL GEOLOGY AND STRATIGRAPHY A stratigraphic section at the mouth of Childs Gulch (left limit) was exposed in 2013. The section consists of 0 to 1.75 m (0 to 5.7 ft) of interbedded medium grained sand, granules, and pebble-cobble gravels with minimal boulders. Loess with substantial woody debris and organics composes the upper unit from 1.75 to 7.5 m (5.7 to 24.6 ft). All of the gravel in the left limit

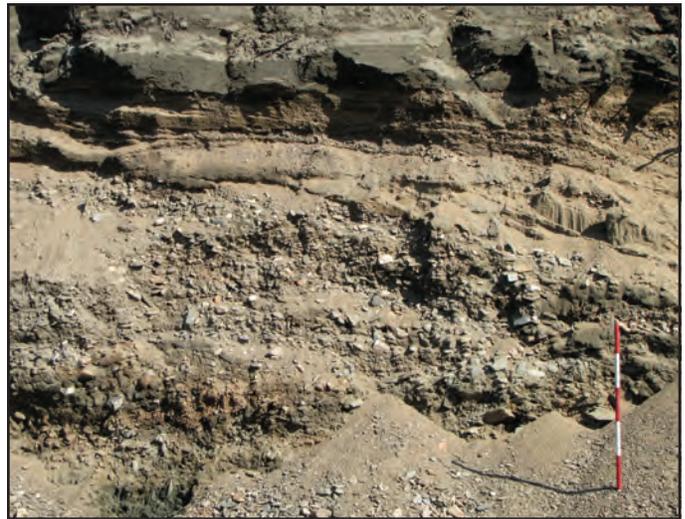
Stuart Placer Ltd. right limit pit from 2011. The section view is looking north up the Black Hills Creek valley. The section exposes the complete stratigraphy consisting of resedimented loess (silt) capping a gravel that increases in coarseness with depth. The main component of the pay is the mixing zone between the weathered green schist bedrock and the lowermost fluvial gravel. Increments on the pogo stick are 25 cm.

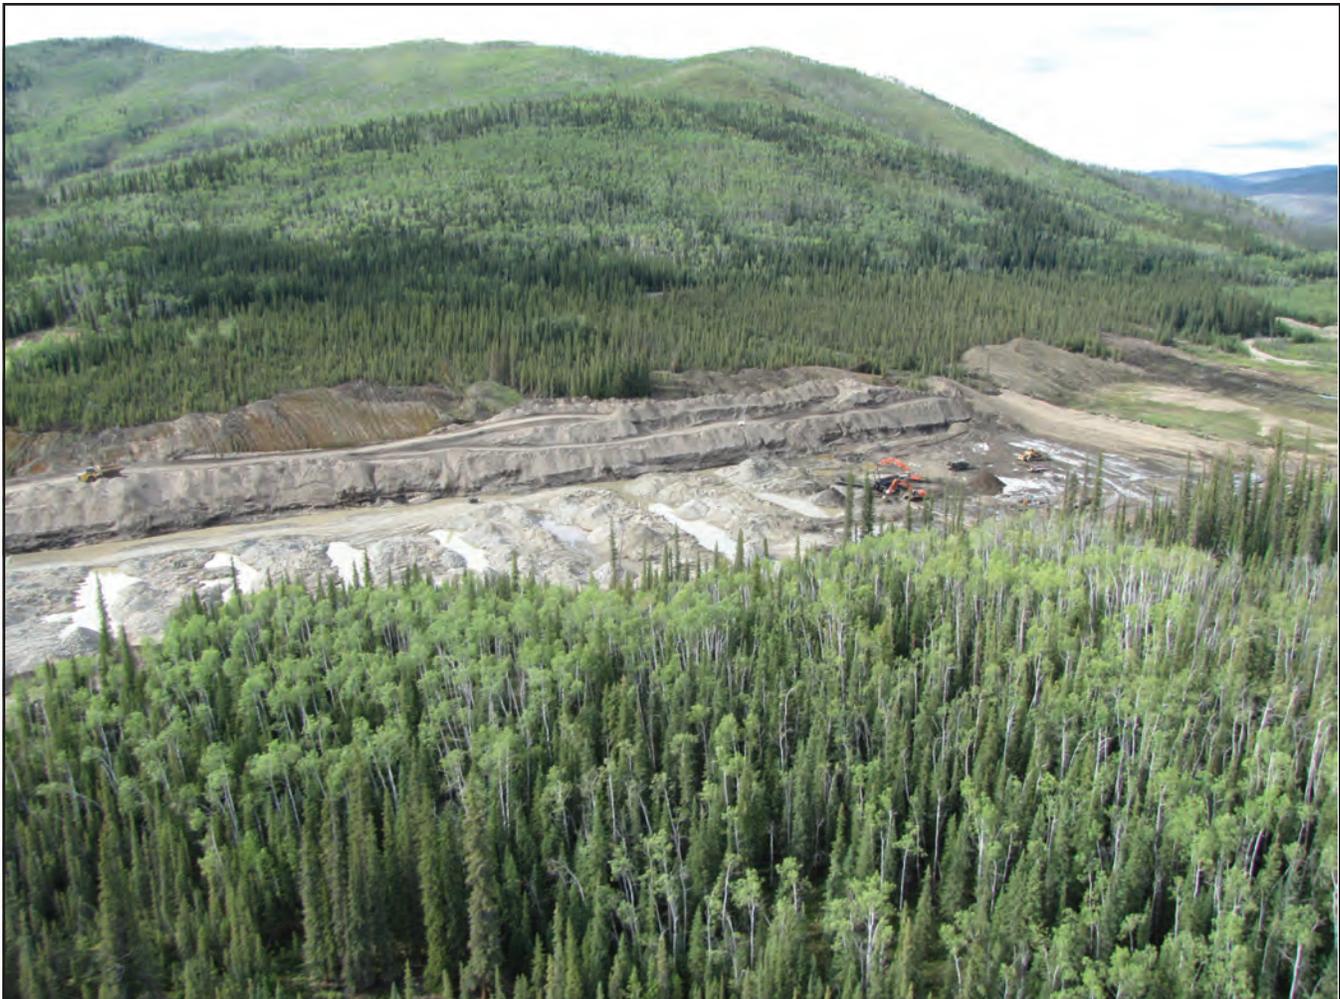
Aerial view from 2014 looking northwest over the Hambrook's operation on Black Hills Creek. A right limit bench is visible immediately above the tailings piles on the far side of the valley. This landform was mined further downstream in 2012.

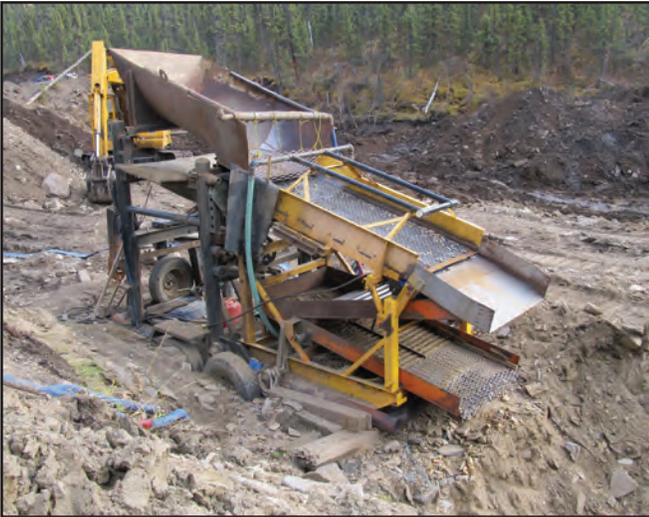
Mr. Haines' wash plant in 2012 (Photo credit: Jim Leary).

EQUIPMENT AND WATER TREATMENT Equipment included a John Deere 690B excavator and a shaker plant able to process 30 loose cubic yards (23 m³) per hour. Clean-ups were conducted using a shaker table.

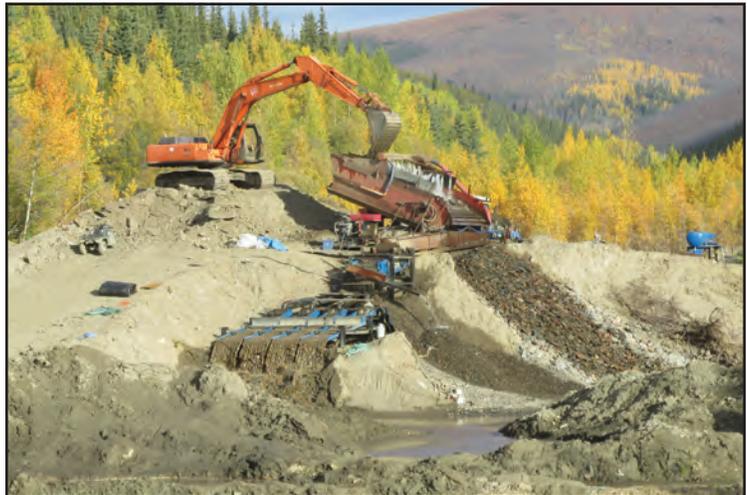
Derocker used by Northern Gold Resources ULCs in 2014 (Photo credit: Jim Leary).

EQUIPMENT AND WATER TREATMENT Equipment in 2014 included a Hitachi Zaxis 330 excavator, Caterpillar 988 wheel loaders, Caterpillar 235C excavator, and Caterpillar D8 and D9. A Derocker was used to process up to 40 loose cubic yards (31 m³) of gravel per hour, with 200 to 300 loose cubic yards (153 to 230 m³) processed a day. The top sluice run was 3 ft wide by 12 ft long with riffles and expanded metal. This fed a 4 ft wide by 8 ft long screen run and split into four - 4 ft wide by 12 ft long runs with angle iron and expanded metal. Water was supplied by a 10 by 8" pump and 100% recycled in a series of four ponds. A jig was used for clean-ups.

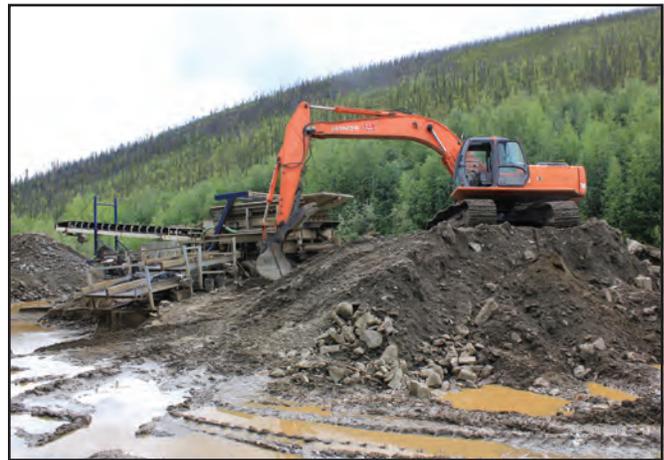
Mr. Neudorf's wash plant in 2014, mining under PM10-071.

EQUIPMENT AND WATER TREATMENT Equipment at Mr. Neudorf's operation included a Caterpillar 345C excavator, Hiatachi 270 excavator, Caterpillar B400 rock truck, and a vibrating screen deck with 8 ft wide by 12 ft long sluice run, lined with expanded metal and unbacked nomad, able to process 70 loose cubic yards (53 m³) per hour.

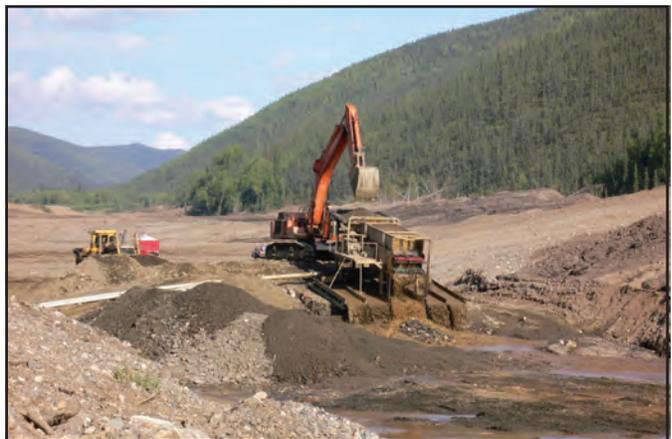
Sluicing at the Midas Rex Mining Inc. operation on Barker Creek (Photo credit: Stuart Schmidt).

EQUIPMENT AND WATER TREATMENT Equipment on site included two Caterpillar D10N bulldozers, one Hitachi 700 excavator, and one Caterpillar 345 excavator. The wash plant comprised a 6 by 20 ft El Russ screen deck with a 20 ft total sluice run width and was capable of processing 200 loose cubic yards (152 m³) per hour.
