Yukon Placer Mining Industry

2010 to 2014

Compiled by S. Van Loon and J.D. Bond
Yukon Geological Survey
Energy, Mines and Resources
Government of Yukon

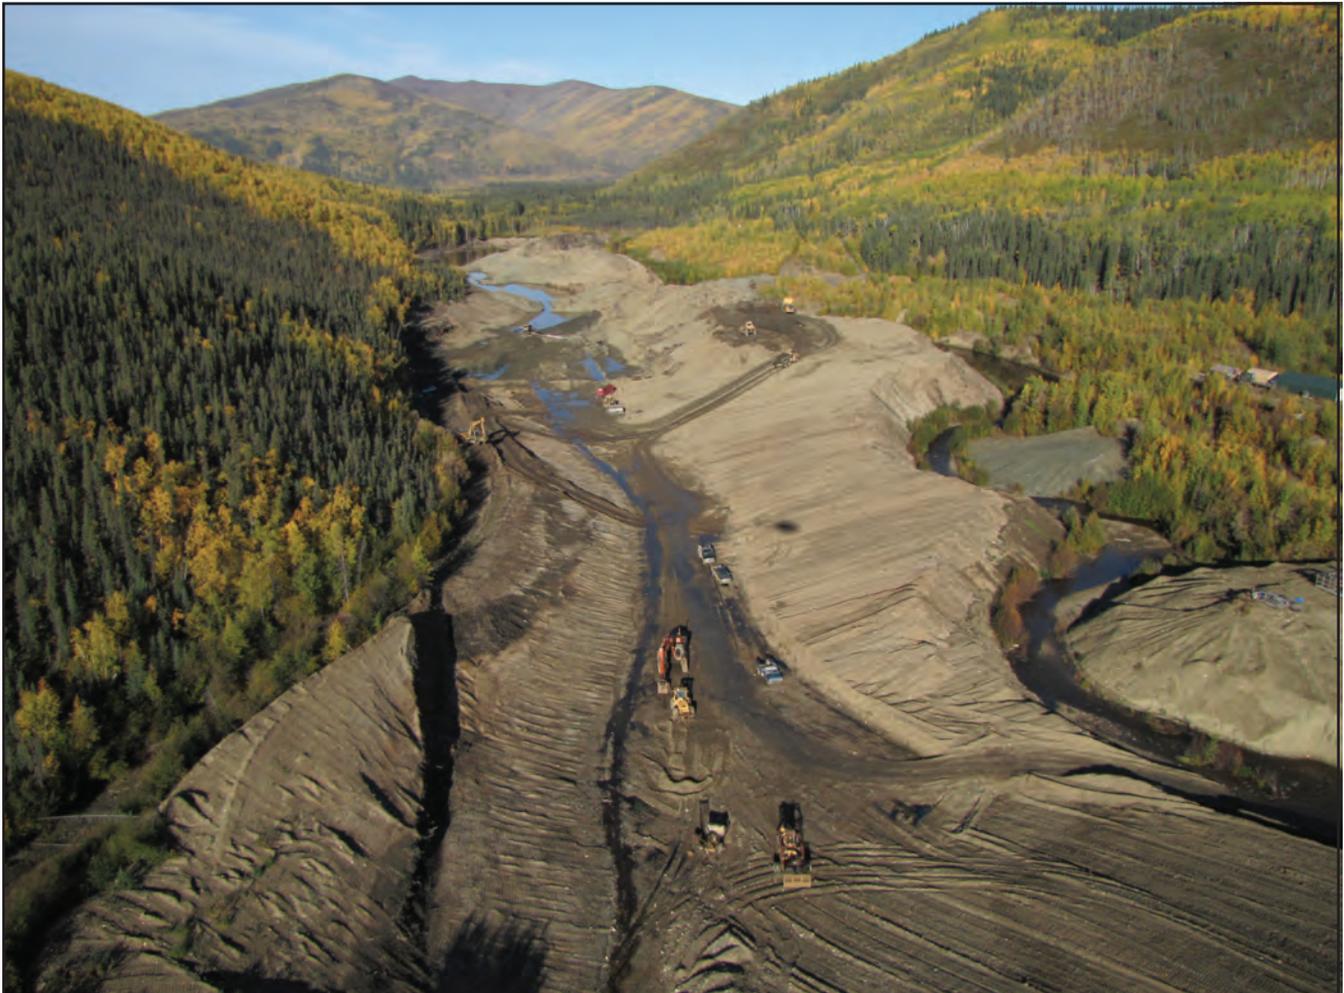
A view looking downstream of Mr. Schmidt's mining operation on the left limit of Thistle Creek in 2014.

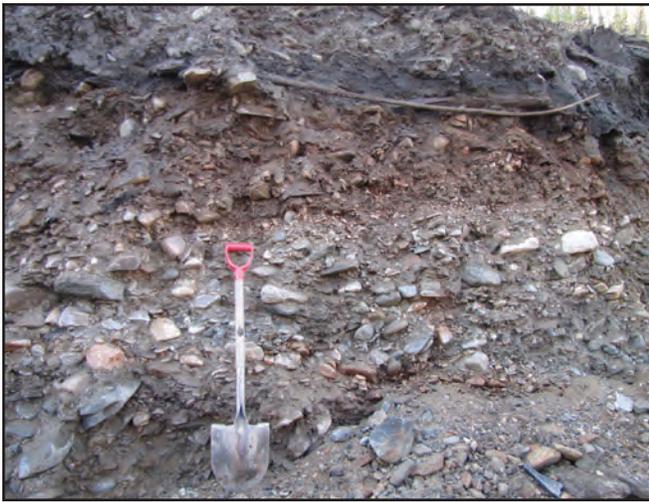
A left limit bank exposure on Mr. Schmidt's Thistle Creek mine operation. Note the abundance of clasts versus matrix in the gravel. This suggests a relatively high energy stream flow was the depositional environment.

SURFICIAL GEOLOGY AND STRATIGRAPHY The stratigraphy consists of fluvial gravel buried by resedimented loess and weathered bedrock colluvium. The fluvial pay gravel is a clast-supported, pebble-cobble gravel with minor boulders and a sand matrix. The clasts make up approximately 75% and the sand matrix accounts for the remaining 25%. Bedrock surface undulations up to 3 m (10 ft) were observed as mining progressed closer to the hill side.

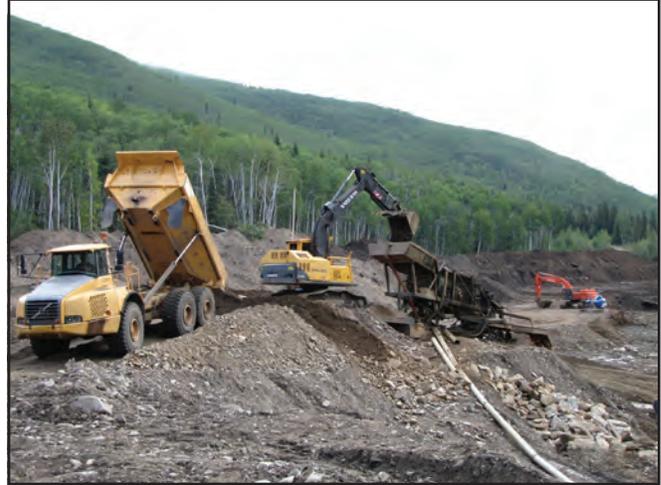
The Sager's mining operation on Kirkman Creek in 2014.

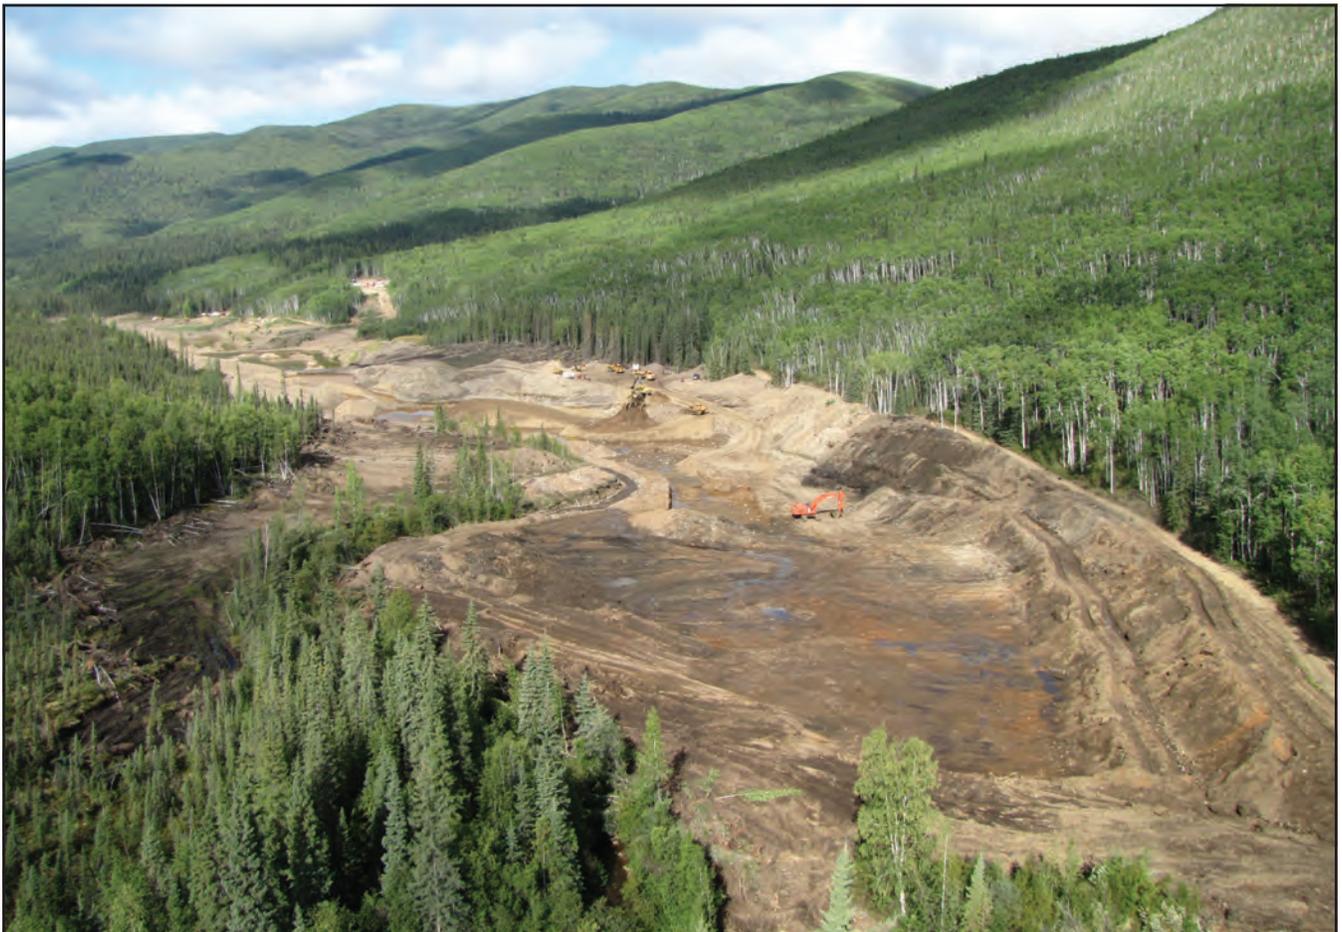
View looking west (downstream) of the Sager operation on Kirkman Creek in 2014.

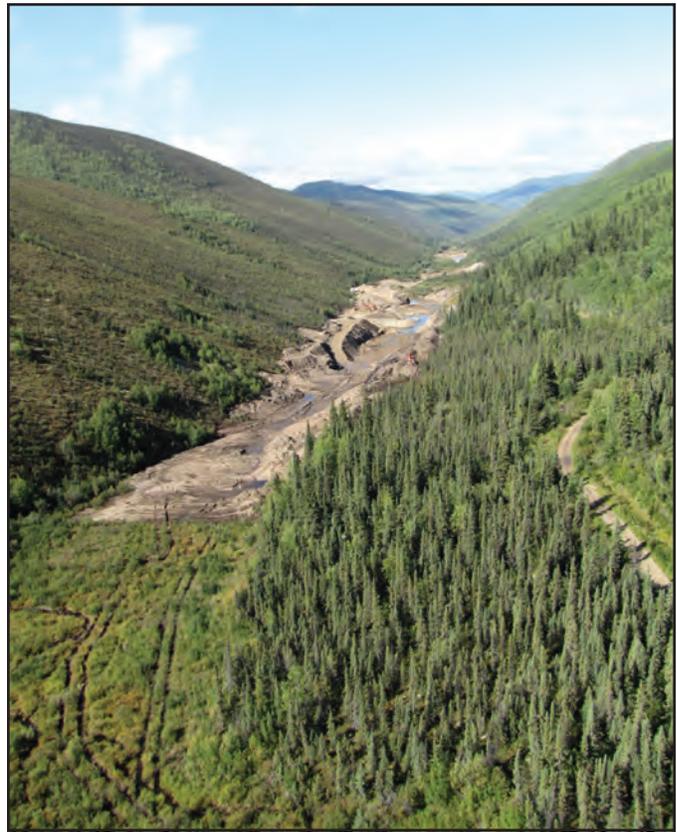
View looking west at Fell-Hawk Placers operation on upper Kirkman Creek in 2014.

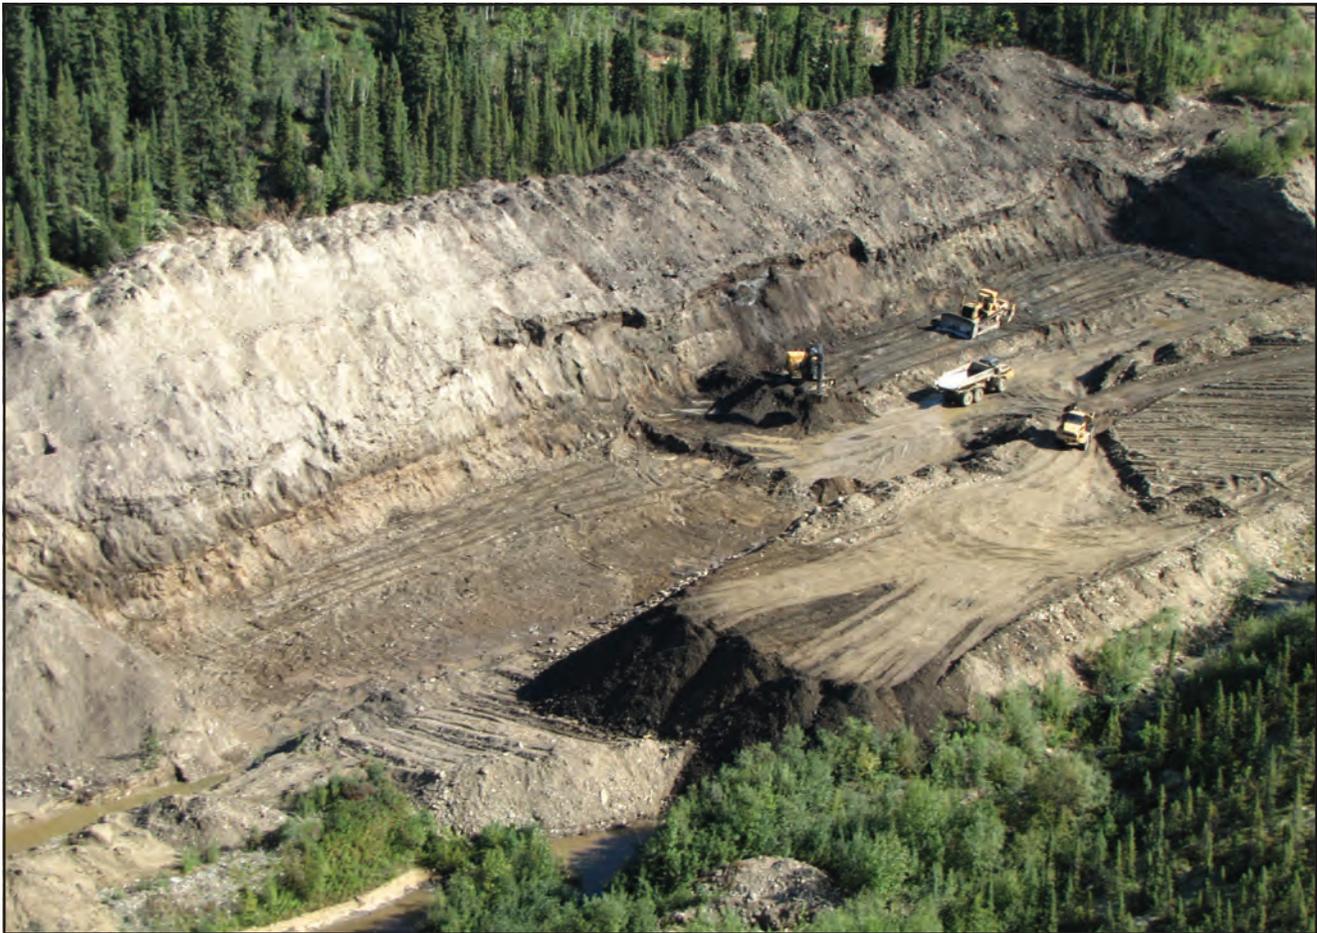
The right-limit lower cut at Fell-Hawk Placers operation on upper Kirkman Creek in 2014. The cut has been stripped down to the pay layer at the left end of the cut. The overburden thickens from 4 to 10 m (13 to 32 ft) as stripping progressed towards the hillside.

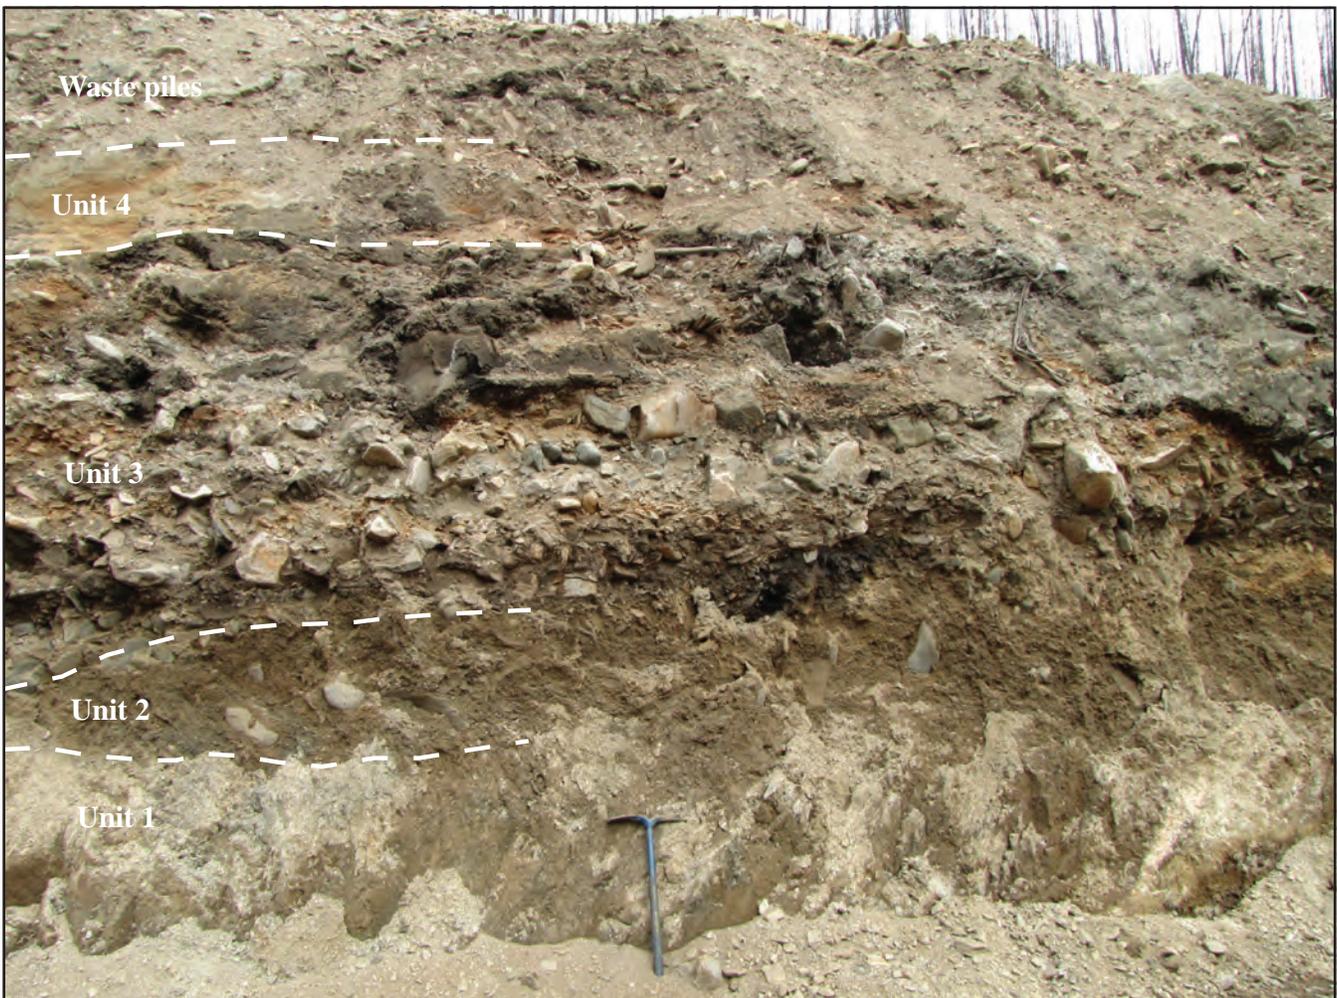
The right-limit section at Mr. Bidrman's operation on upper Scroggie Creek in 2014. The pick used for scale is 0.6 m (2 ft) long.

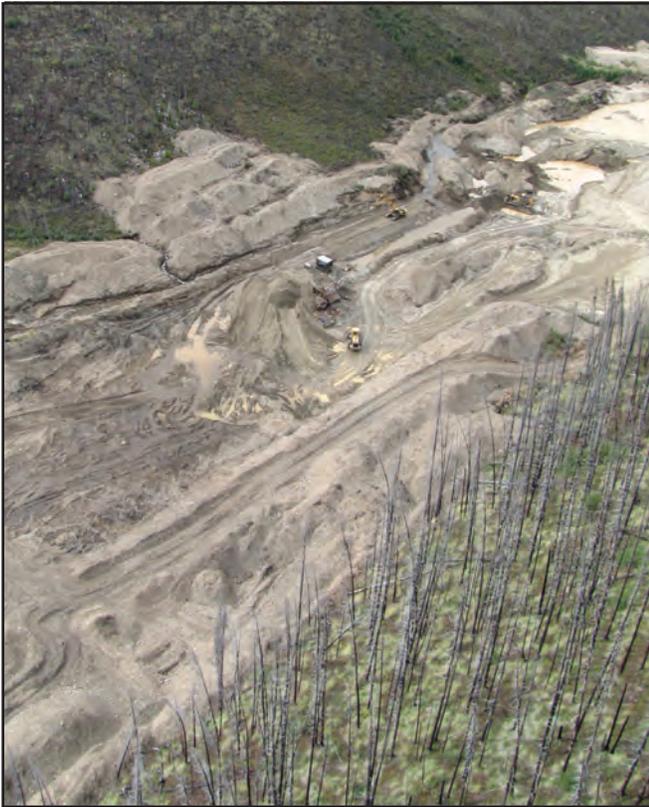
View looking west at Mr. Bidrman's operation on upper Scroggie Creek in 2014.

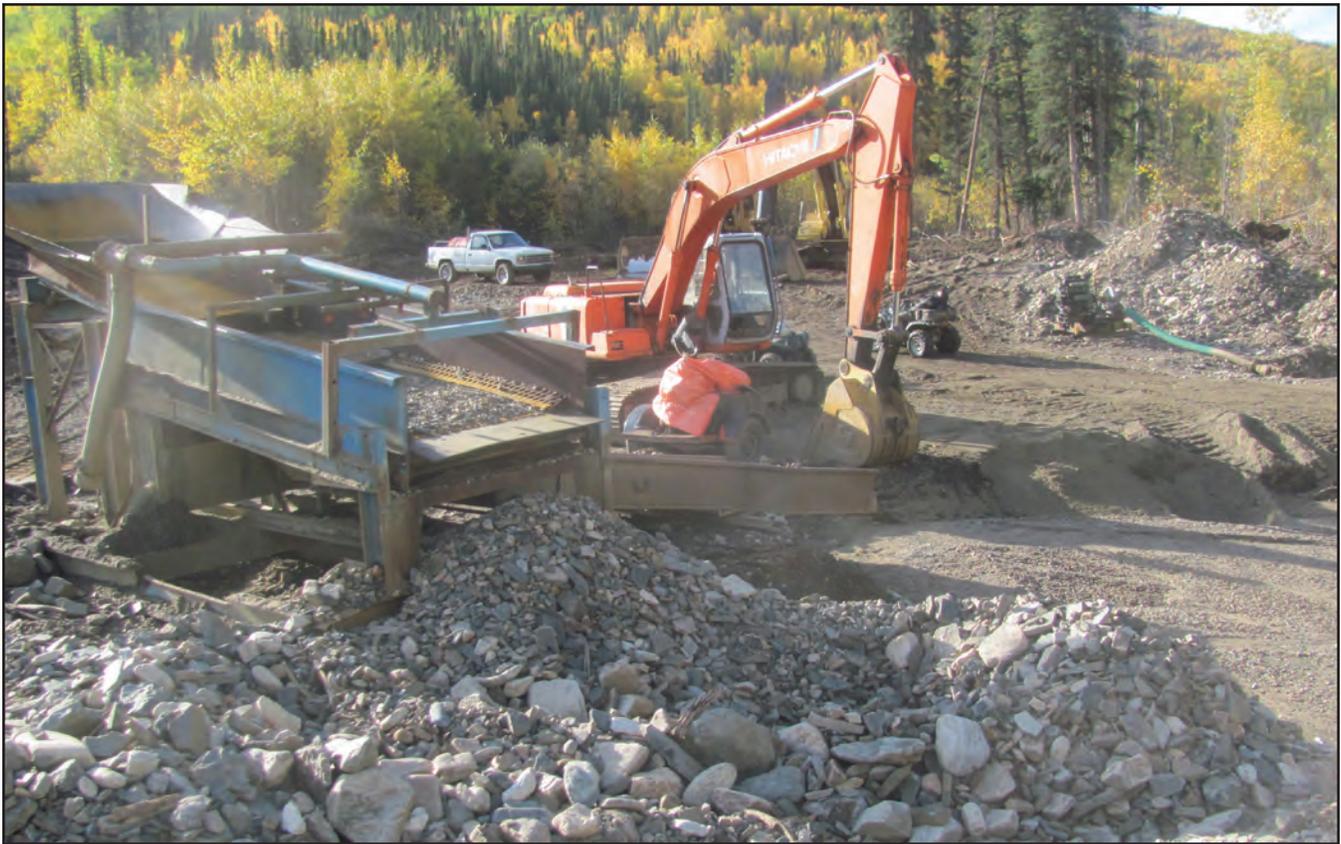
Mr. Weber's operation on Ballart Creek (Photo credit: Lee Mierau).

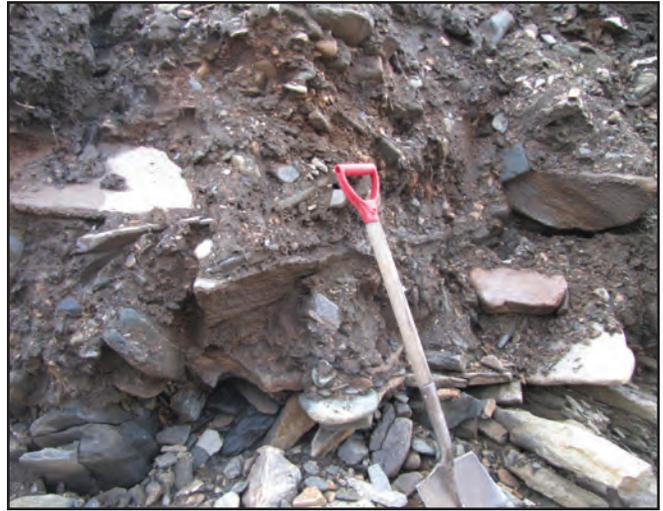
A left limit exposure on Frisco Creek shows mixing between coarse angular slide rock and fluvial gravel. Blocky-weathering quartz-mica schist is exposed in the bottom of the cut and makes an excellent trap for the placer gold.

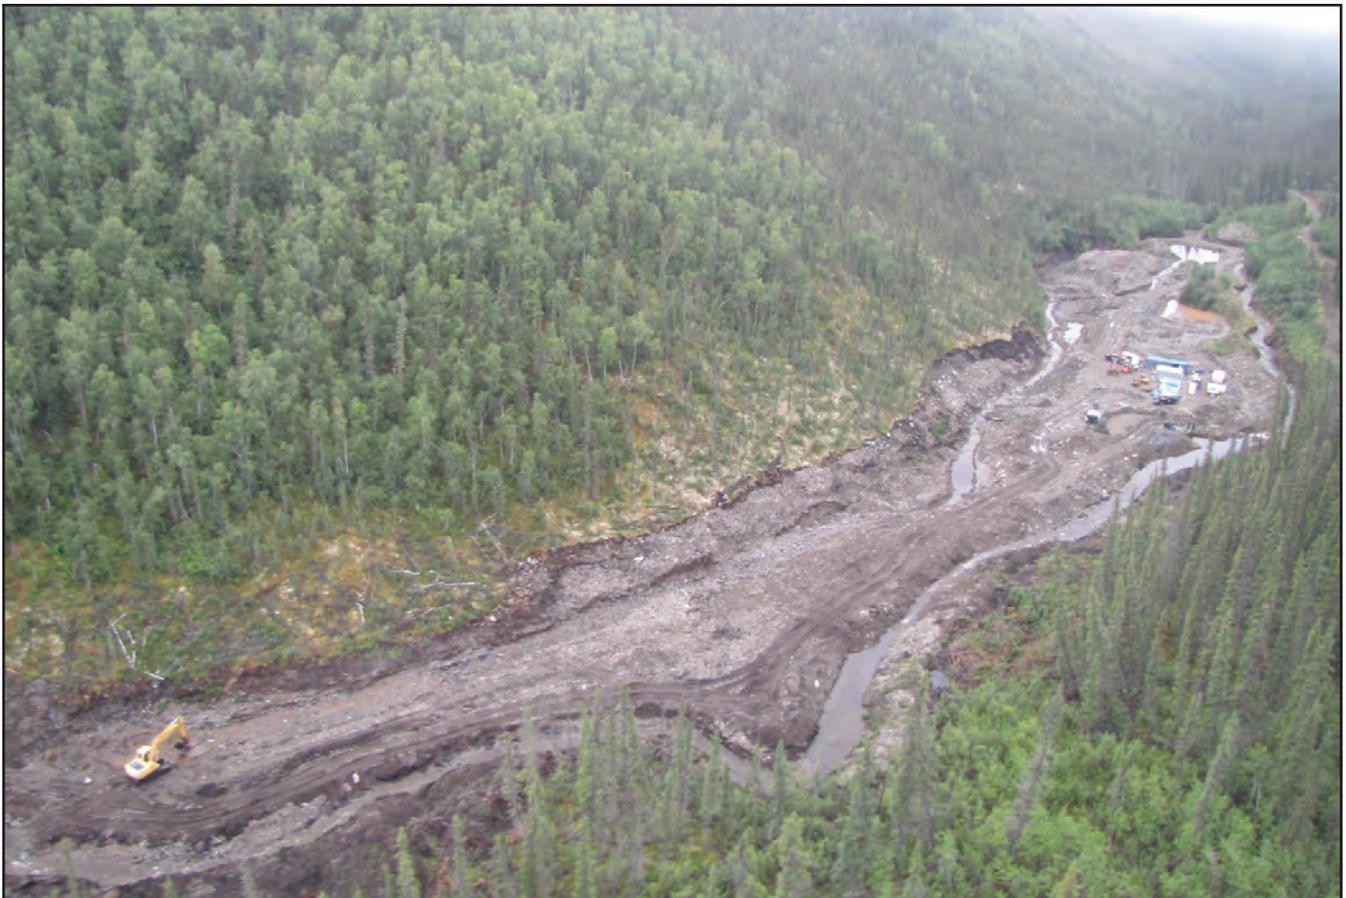
A view down valley of New Age Drilling and Mining's operation on Frisco Creek.

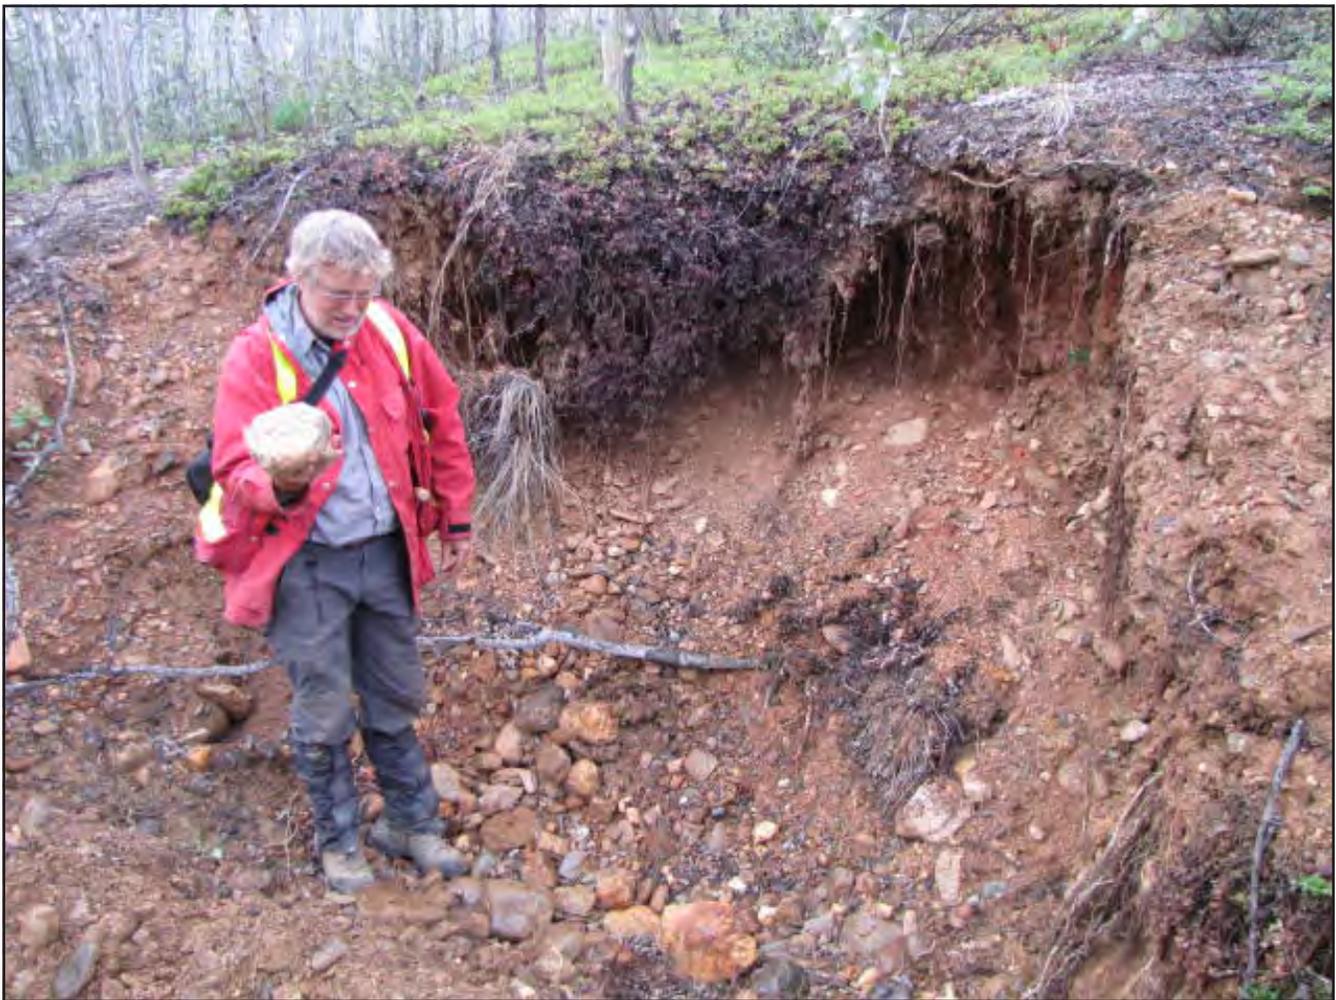
A test pit on the Big Alex bench at Clear Creek. Oxidation of the near surface gravel is the result of soil processes occurring on the relatively stable surface since the early Pleistocene. This is a typical Wounded Moose paleosol found in Tintina Trench.

into the Tintina Trench glacial fill. The bench gravel at surface is the primary pay unit and is described as oxidized, clast dominated, pebble-cobble gravel. Most of the clasts are subround to well-round. The gravel is interbedded with sand beds near the surface. The thickness of the Big Alex bench gravel is estimated to be 8 m (26 ft) and overlies sand-rich pre-Reid pebbly gravel likely derived from glaciation. The thickness of the underlying pre-Reid unit is unknown.

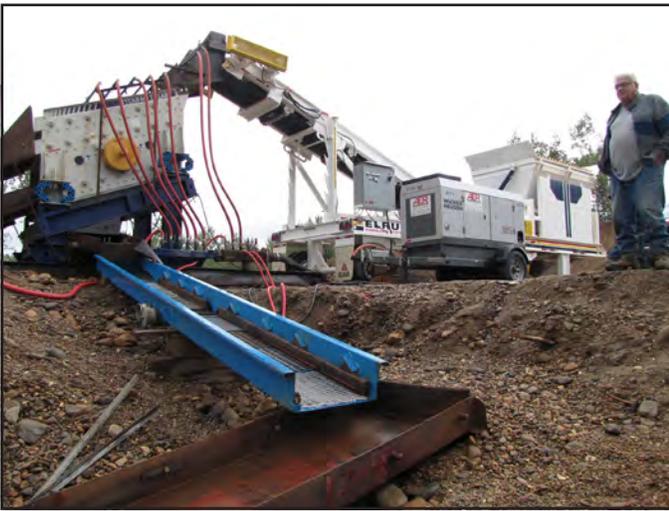
Wolf Head Discovery and Mining's plant on the Big Alex bench at Clear Creek.

building roads and preparing ground. The wash plant has an Elrus hopper with a 4" grizzly and an Elrus M6394 40 ft conveyor all electrically powered by a Wacker Neuson 38 kW generator. The conveyor feeds a Tycan 660 T-Class screen deck that classifies to 3/16". The sluice run consists of a 36" by 5 ft initial run with expanded metal and a boil box. This run feeds a 24" by 26 ft run with expanded metal, Nomad matting and two mid-run boil boxes. A third sluice run was added that measures 30" by 30 ft and is lined with expanded metal and Nomad matting. Water is supplied from Clear Creek and recycled through a 9 by 152 m (30 by 500 ft) holding/settling pond at the base of the bench. Water is supplied at 1800 igpm and the plant is capable of handling 70 yd/hr.

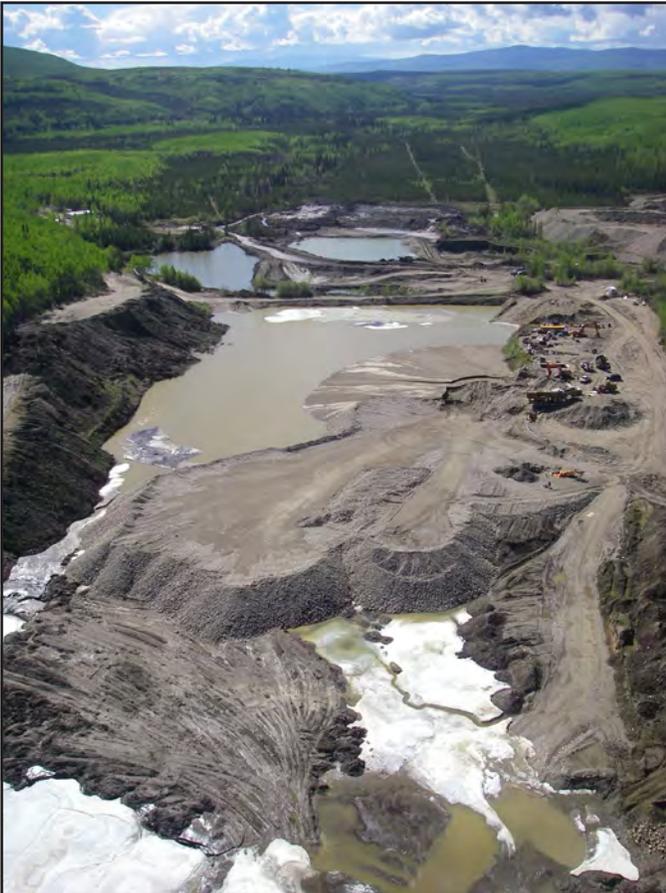
Caw Mining and Exploration Ltd. operation, in 2013, on lower Barlow Creek near its confluence with Clear Creek (Photo credit: Bill Leary).

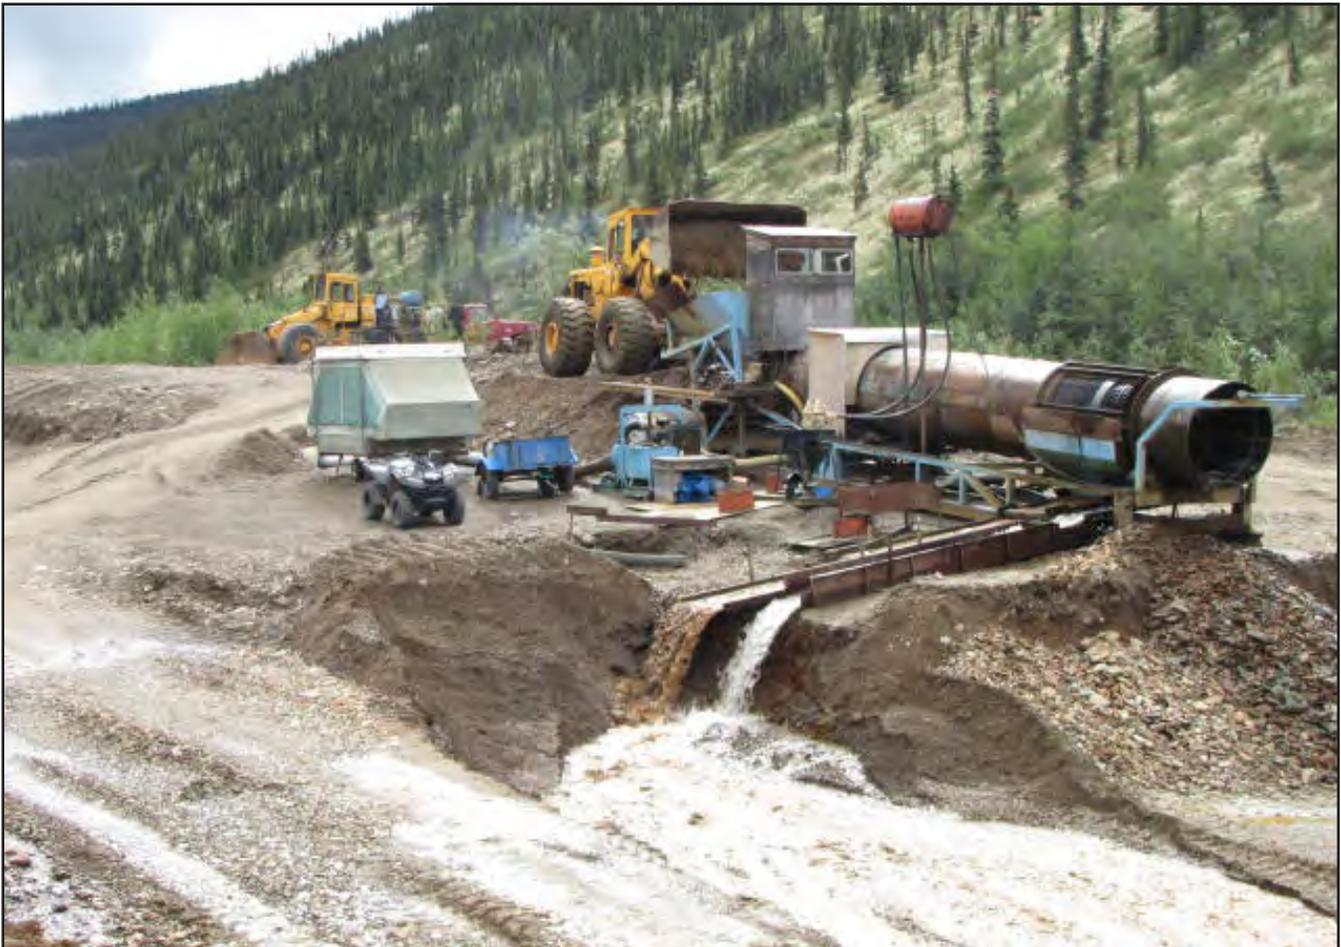
Blackstone Placer Mining's wash plant on Left Clear Creek.

stripping overburden. The wash plant consisted of a five cubic yard wet hopper that has a controlled discharge into a 40 ft trommel. The trommel feeds a double screen deck with a 1½" screen over a 1/2" screen. The oversize from the 1/2" screen empties into a sluice run which is 2 ft wide by 20 ft long and lined with 2" angle iron riffles for the first 2 ft, followed by a nugget trap and expanded metal on Nomad matting. The undersize from the 1/2" screen flows into a sluice run that is 4 ft wide by 20 ft long with expanded metal riffles.

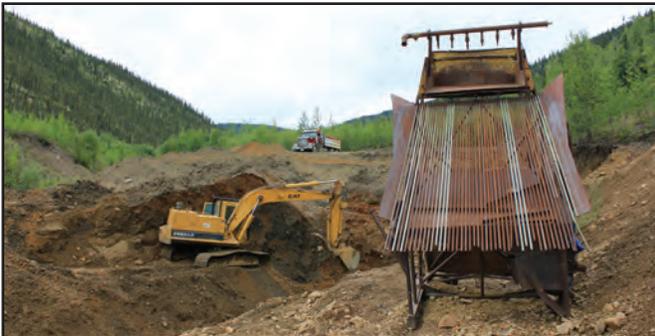
O.H. Transport Inc.'s 2014 cut and wash plant.

EQUIPMENT AND WATER TREATMENT Equipment in 2014 included a John Deere 225D excavator, Caterpillar D7 bulldozer, wheel loader, and dump truck. The wash plant consisted of a static grizzly, able to process 40 loose cubic yards (31 m³) of gravel per hour. A 4" Gorman-Rupp pump powered by a 2 cylinder diesel engine supplied the plant with water. Water was 100% recycled in a series of two ponds, each (50 by 100 ft). A long tom and gold wheel were used for clean-ups.

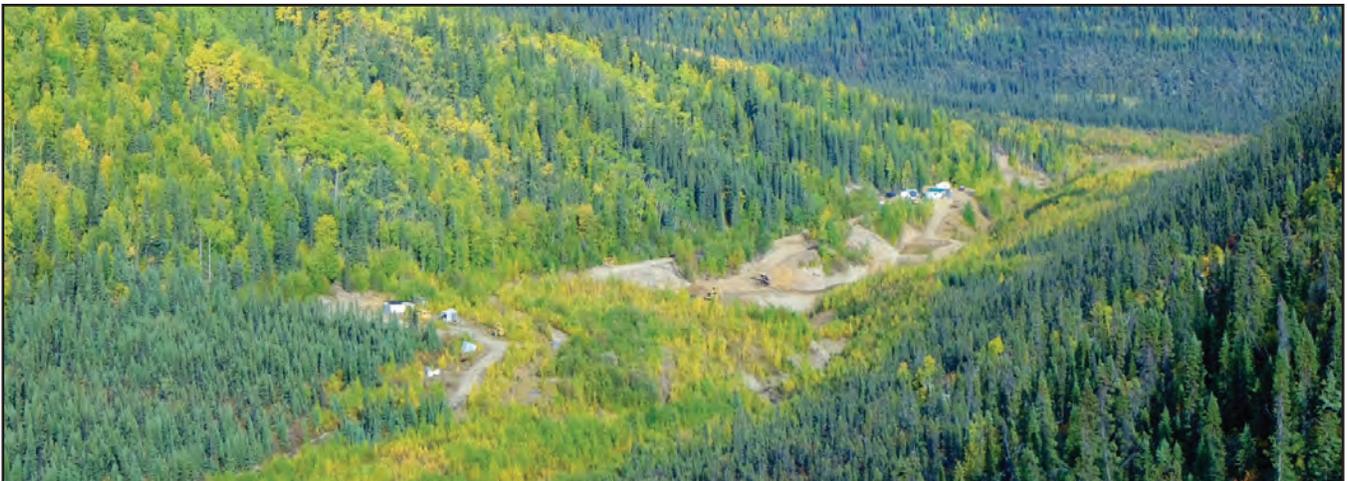
Aerial view of Fisher Gulch in 2014 (Photo credit: Helena Kuikka).

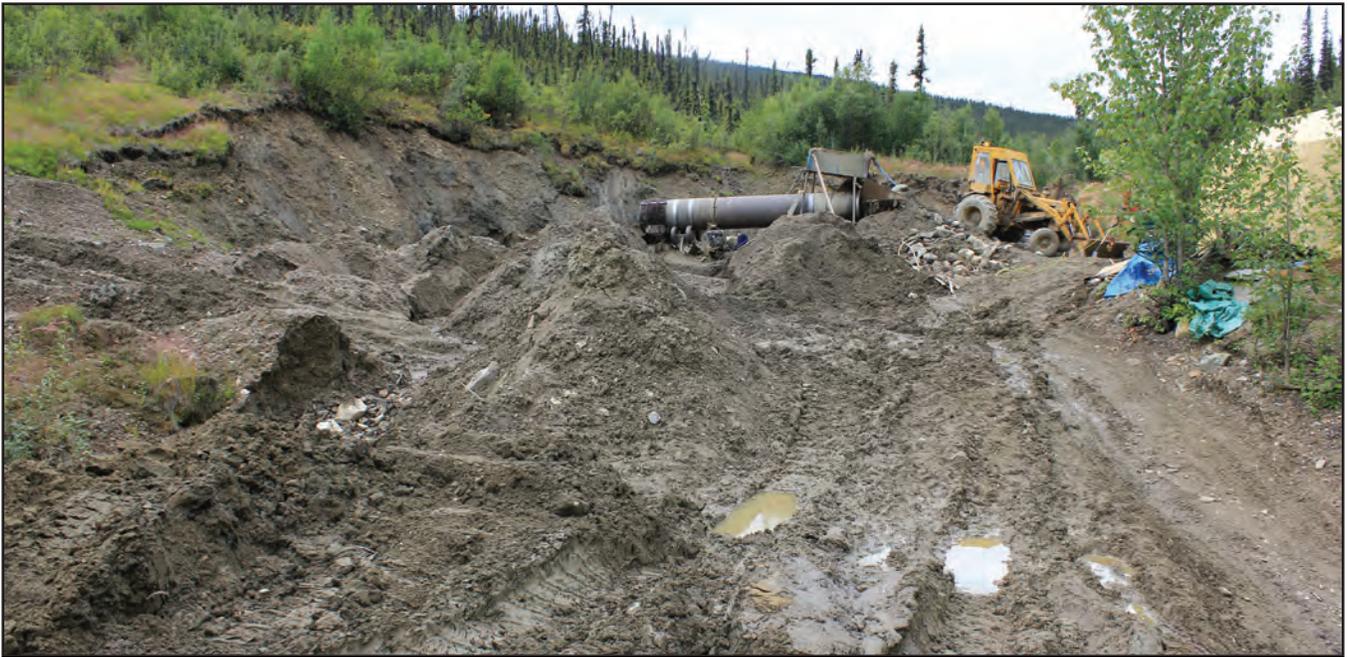
Upstream view of Keith and Betty Dye's cut on Fifteen Pup in 2014.

SURFICIAL GEOLOGY AND STRATIGRAPHY The right limit section in 2014 consists of three units. Unit 1, from 0 to 2.5 m (0 to 8.2 ft), is a cobble dominated, clay rich diamicton, with subangular to angular clasts, minimal boulders but the largest reported is over 1 m (3.3 ft). Unit 2 is an undulating, poorly sorted, boulder layer, is present from 2.5 to 3.5 m (8.2 to 11.5 ft) and consists of 50% boulders, 35% cobbles, and 15% pebbles. Oxidation is pervasive throughout, and clasts are subangular. Unit 3, from 3.5 to 7 m (11.5 to 23 ft), is similar to unit 1 except it includes more organics (roots). Overlying the section is a moss mat up to 0.5 m (1.6 ft) thick. Up to 2.4 m (8 ft) of gravel and 1.2 m (4 ft) of bedrock was sluiced.

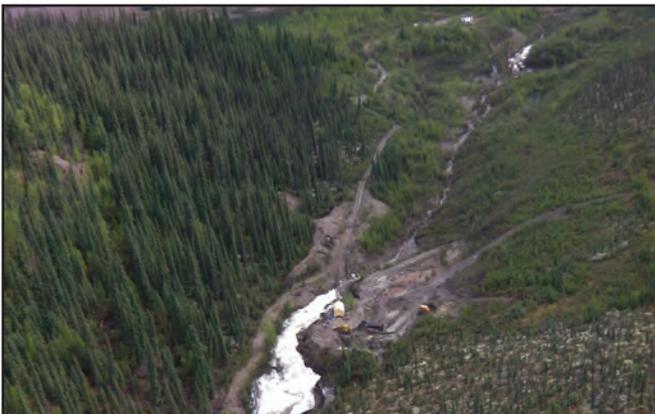
Aerial view of the Dye's operation on Fifteen Pup in 2013 (Photo Credit: Bill Leary).

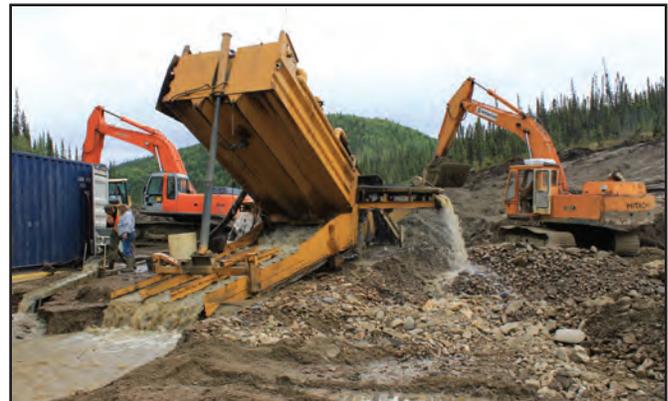
Custom fabricated wash plant on Secret Creek in 2014.

EQUIPMENT AND WATER TREATMENT Equipment on site in 2013 included two Caterpillar 330 excavators with 3 yd buckets, one Caterpillar 220 excavator with a 2 yd bucket, one Komatsu bulldozer, and one 747 track loader with a 5 yd bucket. The wash plant consisted of a conveyor fed gravity Derocker with a 10 by 8 ft hopper, a 20 ft long by 8 ft wide Derocker, and three sluice runs 2 ft wide and 17 ft long. Riffle size varied from 1.0 to 1.5" with drop slots 2" apart with an open grid pattern 2" over 2 pads. Water was supplied by an 8 by 6" John Deere pump at 1200 igpm, processing 250 to 300 loose cubic yards (190 to 230 m³) gravel per hour, depending on the feed rate. Water was acquired from Secret Creek and recycled after discharge through a settling pond 200 by 45 m (656 by 147 ft). Clean-ups were done in two stages, using wheels and tables.

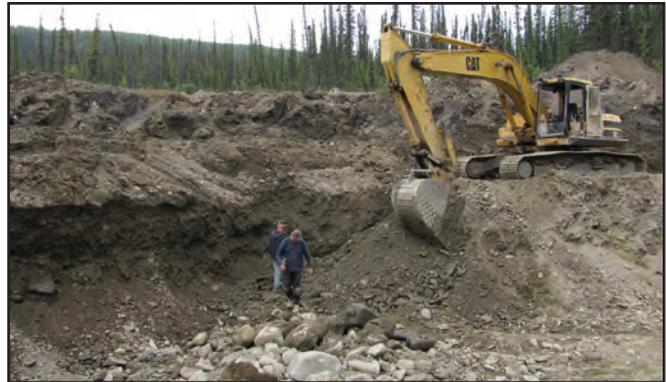
Left-limit cut on lower Murphy's Pup in 2013.

SURFICIAL GEOLOGY AND STRATIGRAPHY Four units are exposed in the left limit cut completed in 2014. Unit 1, at a minimum thickness of 0.6 m (2.0 ft), consists of massive, medium-grained sand, with up to 10% pebbles. From 0.6 to 1.7 m (2.0 to 5.6 ft), unit 2 is an undulating, boulder-cobble gravel that fines upwards, with a boulder lense present in the lowermost 0.5 m (1.5 ft) of the section. It has a fine-grained sand and granules matrix, an abundance of highly weathered clasts, is weakly oxidized in patches, and imbricated downstream. Unit 3, a pebble gravel from 1.7 to 2.2 m (5.6 to 7.2 ft), is a clast supported, well sorted, fine-grained sandy matrix gravel, dominated by flat, subangular pebbles and weakly imbricated in the downstream direction. Overlying the lower three units is unit 4, a 2.2 m (7.2 ft) thick unit; the overall thickness is unknown due to stripping. Unit 4 consists of silt with large organics (woody debris) and approximately 5% enriched in pebble-sized clasts. All gravel was sluiced.

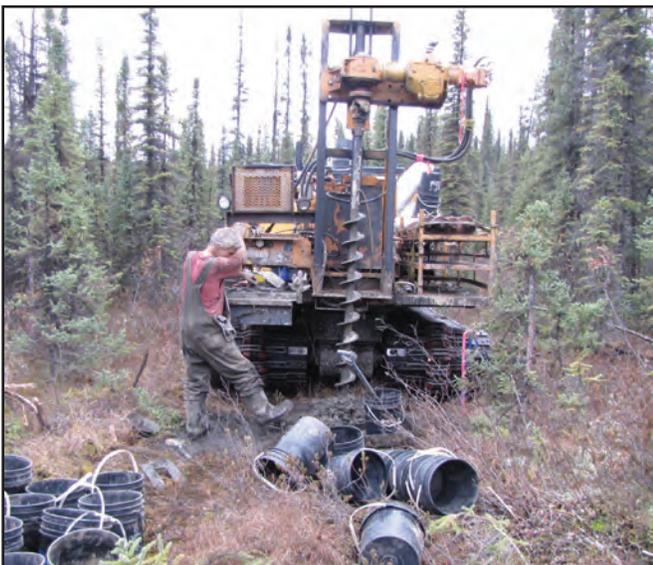
Auger drilling into Reid glacial sediments on Goodman Creek.

EQUIPMENT AND WATER TREATMENT Drilling was completed using an 8" auger drill mounted on a Nodwell. A Komatsu PC60 excavator was used for building trails and test pitting, and a Bombardier was used as a service vehicle to transport crew and samples. Sample processing was completed using a long tom.

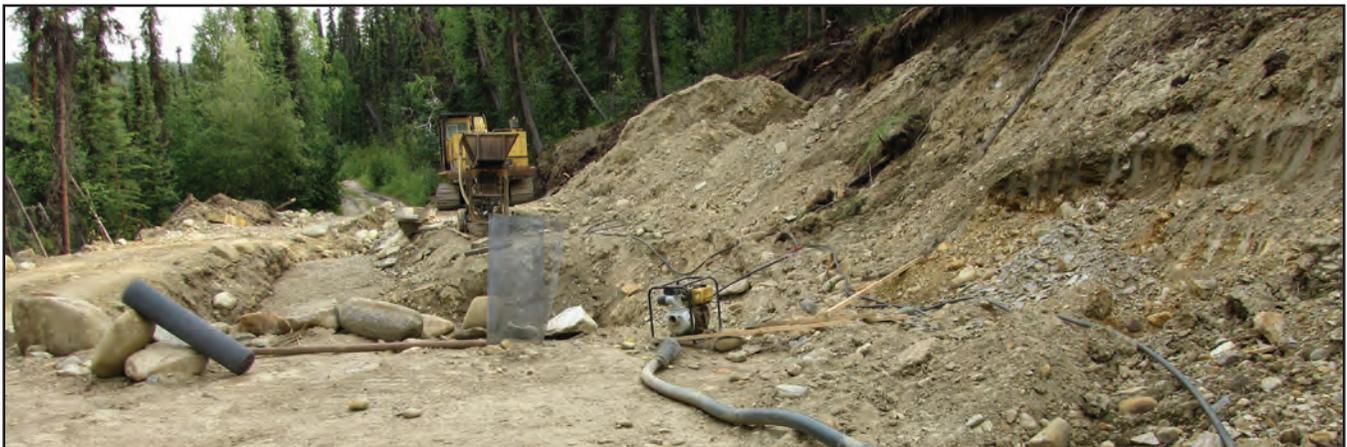
McIntyre Creek cut along the access road in 2013.

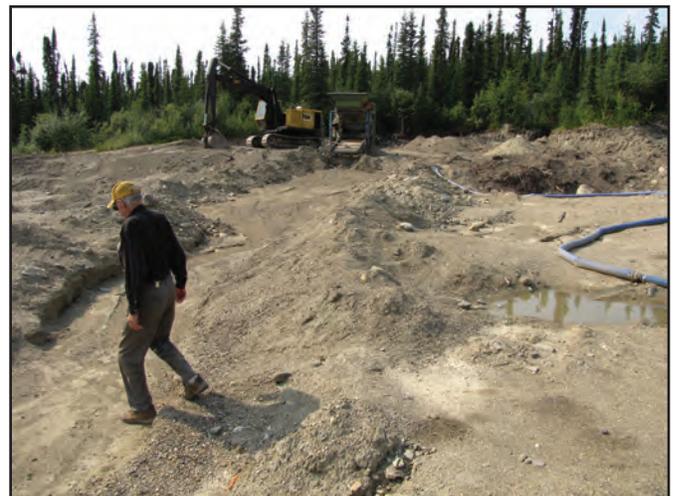
Mr. Jardine at his wash plant and active cut on the bench above Minto Lake in 2013.

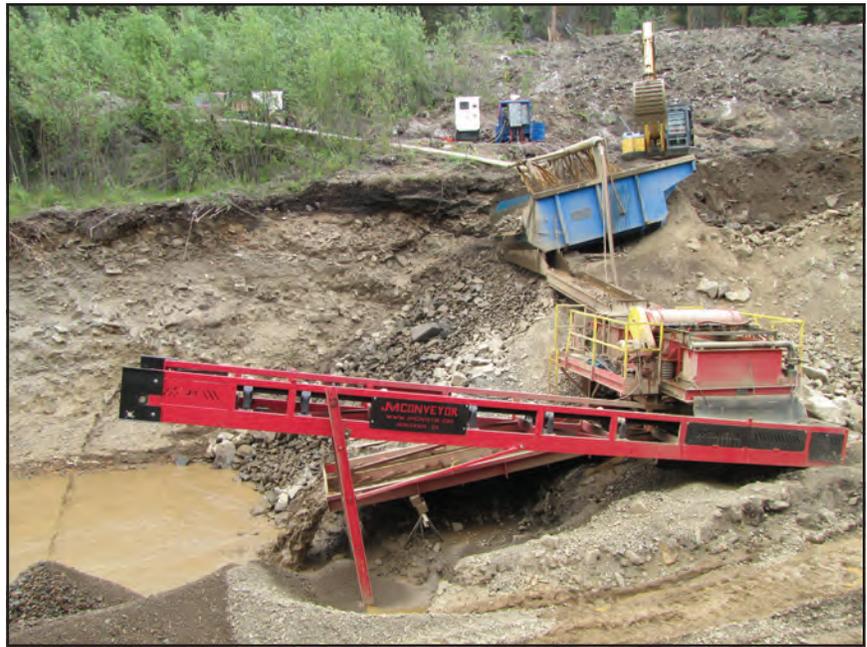
A view of the wash plant used on Guder Creek in 2014. The plant was processing 70 loose cubic yards per hour.

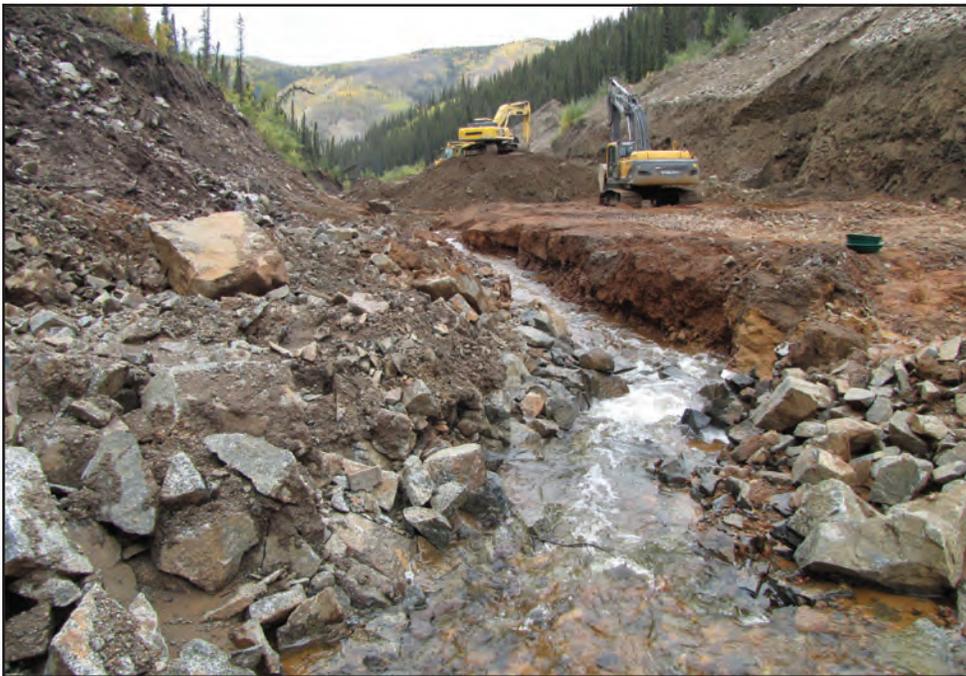
View looking downstream of the 2014 cut on Guder Creek. Unaltered granodiorite is exposed in the foreground whereas a highly altered contact zone is visible further downstream. The pay unit includes the lower 2.2 m (7.5 ft) visible in the section on the right hand side of the photograph (right limit). The overlying units are primarily colluviated weathered bedrock (slide rock).

left limit where the overburden is thinnest and progressed upstream where a wider cut was feasible. Much of the right limit pay gravel is overlain by stripped material and weathered bedrock colluvium. The stratigraphic section on the right limit consists of 2.2 m (7.5 ft) of poorly sorted cobble-boulder gulch gravel with angular to subrounded boulders on bedrock. This unit is composed of approximately 70% clasts and 30% silty coarse sand matrix and is the pay gravel. Overlying the pay is 30 cm (1 ft) of buried soil consisting of silty fine sand, angular clasts, and minor organics. This soil unit is continuous along the right limit section. Deposited on the soil is 2 m (7 ft) of weathered bedrock colluvium (slide rock) that varies from being clast supported and slightly washed to matrix supported and dense. This unit represents the toe of a sediment apron and thickens towards the right limit valley margin.

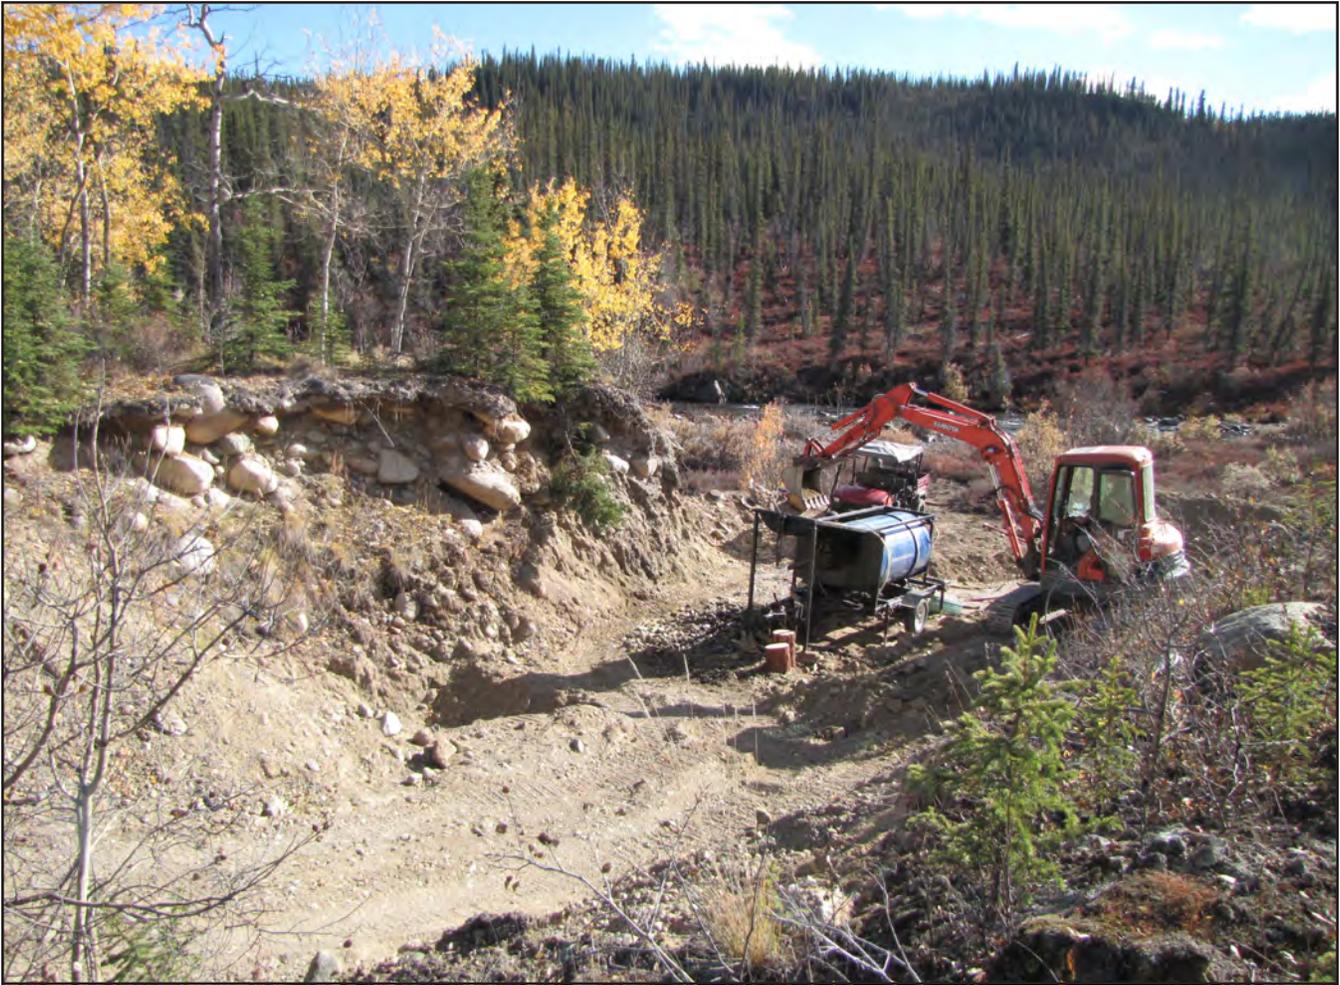
A trench exposure of the gravel in the lowest terrace of Incised Creek. Granitic bedrock is near the base of the cut and Mr. Brown is sluicing a pebble-cobble dominant gravel below the near surface boulder gravel.

matrix of granules and silty sand on decomposed granite. Overlying the gravel on bedrock, and forming the surface of the terrace is 2.2 to 3 m (5 - 10 ft) of very coarse boulder gravel. The boulder gravel contains between 40 and 70% boulders whereas the remaining sediment consists of cobbles, minor pebbles, and a matrix of silty coarse sand. The maximum boulder size observed was 80 by 170 cm.
