Yukon Placer Mining Industry

2010 to 2014

Compiled by S. Van Loon and J.D. Bond
Yukon Geological Survey
Energy, Mines and Resources
Government of Yukon

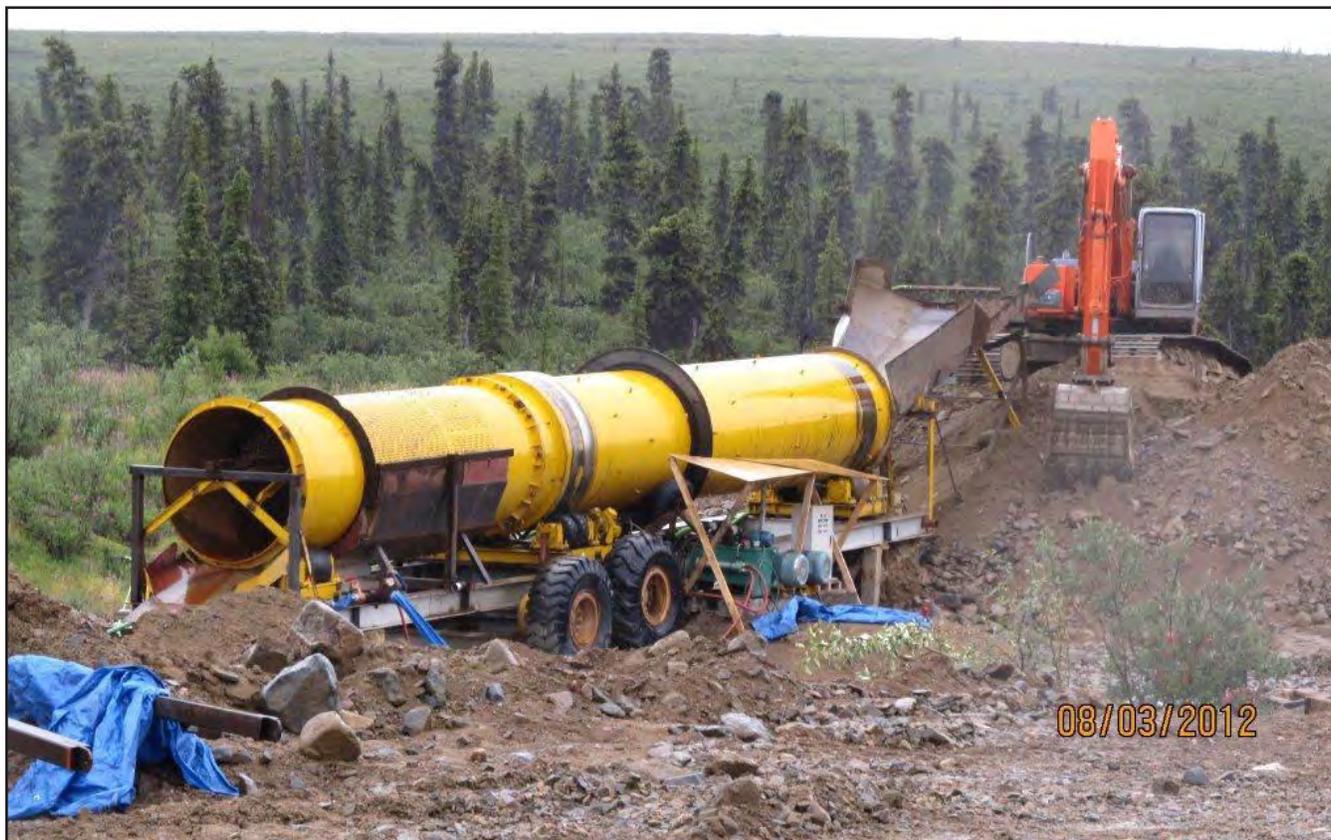
Canaan Gold Resources Inc. wash plant in 2012. (Photo credit: Steve Beaulieu).

EQUIPMENT AND WATER TREATMENT Pishon Gold Resources tested a new plant including dual centrifuges to capture their fine gold. The plant consisted of a dump box followed by a three-phase, vibrating, classification deck that includes a grizzly with 3 cm (1") openings and two polyurethane screens that classify to <15 mm (0.6") and <5 mm (0.2").

Material <5 mm is then split and fed into two 80 cm (31") diameter Chinese-built centrifuges. The centrifuges are similar to a Nelson and capable of processing 50 tonnes per hour using a 20 hp engine. The two centrifuges operate at 480 rpm and can capture gold as small as 10 microns. It was found that the polyurethane screens were too thick and sediment plugged up the openings. Gold recovery within the centrifuges was also problematic and further classification was required for optimization. The plant was reconfigured with a 1/2" metal screen on the vibrating deck and a single 4 ft by 15 ft sluice run. The sluice run was lined with expanded metal and Chinese matting that features a thicker profile enabling better water movement through the mat. A Cat D8L was used for stripping and pushing pay, which was subsequently loaded onto a Caterpillar D400D haul truck using a Hitachi Zaxis 330 excavator. A Hitachi 270 LC excavator was used for feeding the plant and a Caterpillar 988B loader removed tailings.

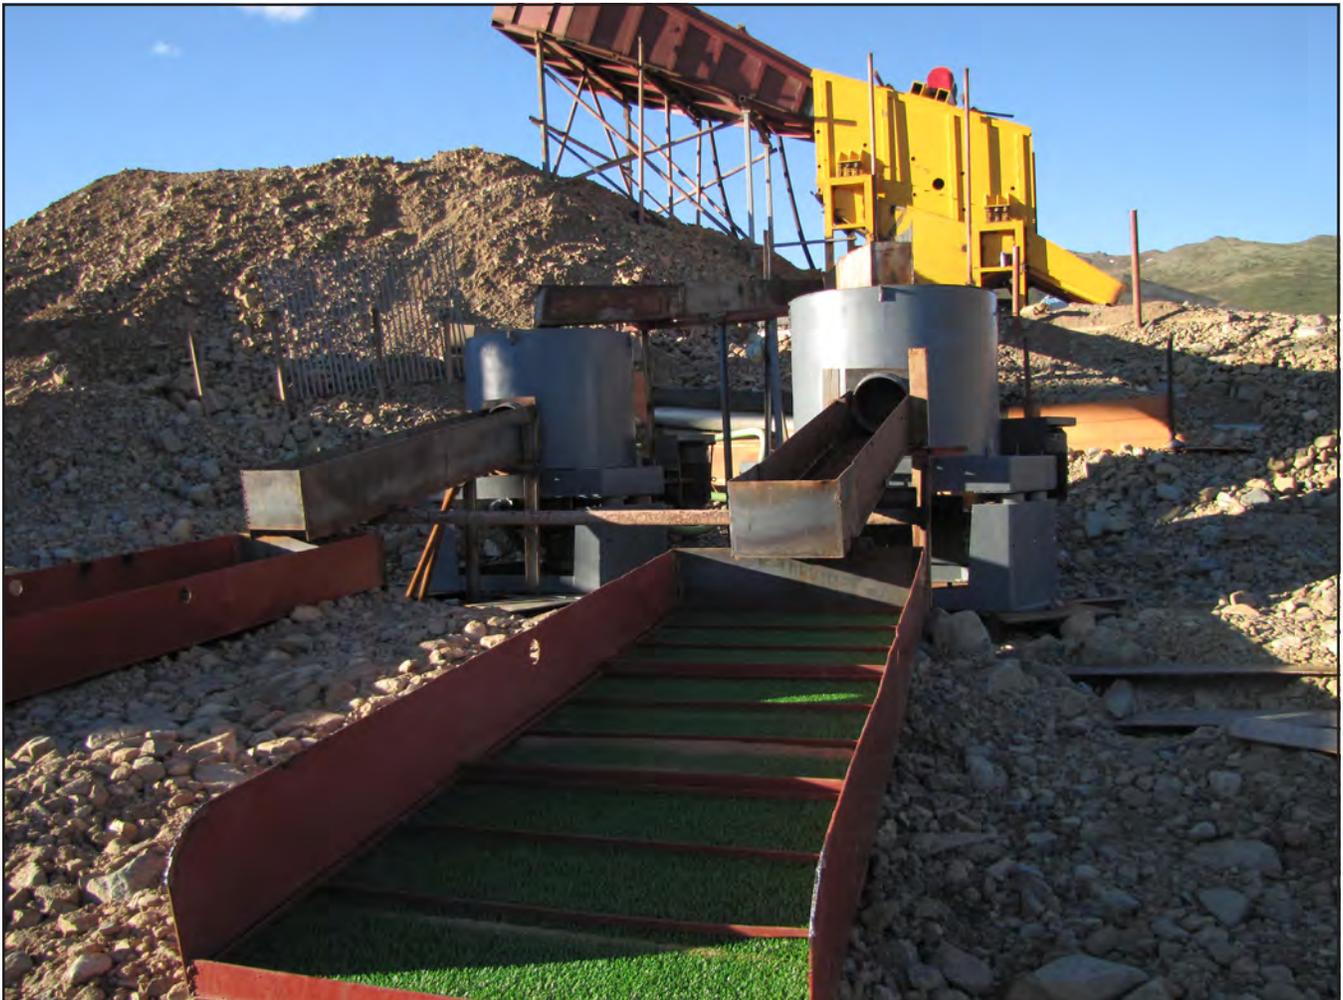
Processing plant operated by Pishon Gold Resources on upper Nansen Creek.

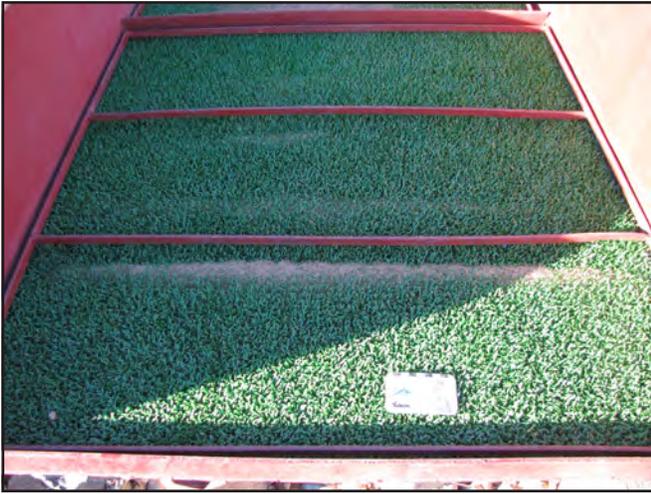
A close-up photo of the matting used by Pishon Gold Resources in upper Nansen Creek drainage. The matting has a relatively thick profile, approximately 2 cm, and is effective at trapping the fine gold.

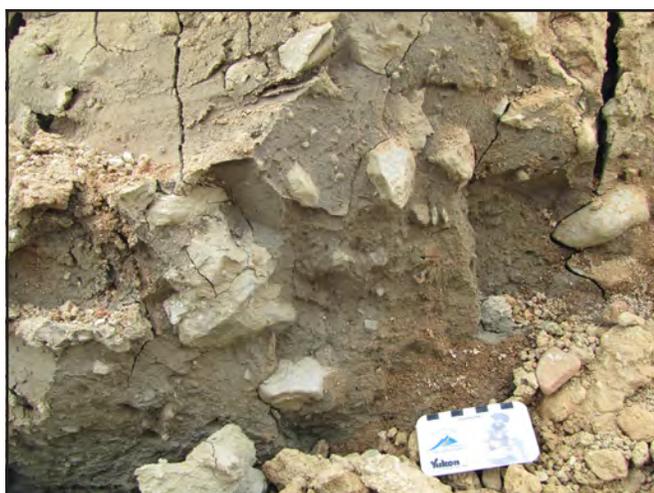
A close-up photo of the basal till false bedrock in Nansen Creek. The till is very compact, contains polished foreign clasts, and likely masks a pre-glacial channel in Nansen Creek.

The fine-grained nature and abundance of foreign clasts in the basal till false bedrock suggests the pre-Reid glacier responsible for its deposition was advancing up-valley from the Nisling River. This is supported by up-valley trending meltwater channels on the valley side above Nansen Creek near its confluence with the Nisling River. Up-valley flowing ice would have dammed Nansen Creek valley and caused a protective layer of fine-grained glacial lake sediment to be deposited on the pre-glacial fluvial deposits. As the ice thickened and advanced over a glacial lake it would have incorporated some of the glacial lake silt and clay into the basal till. This process would account for the fine-grained and consolidated nature of the till exposed at the base of the modern cut. Previous drilling in Nansen Creek indicates

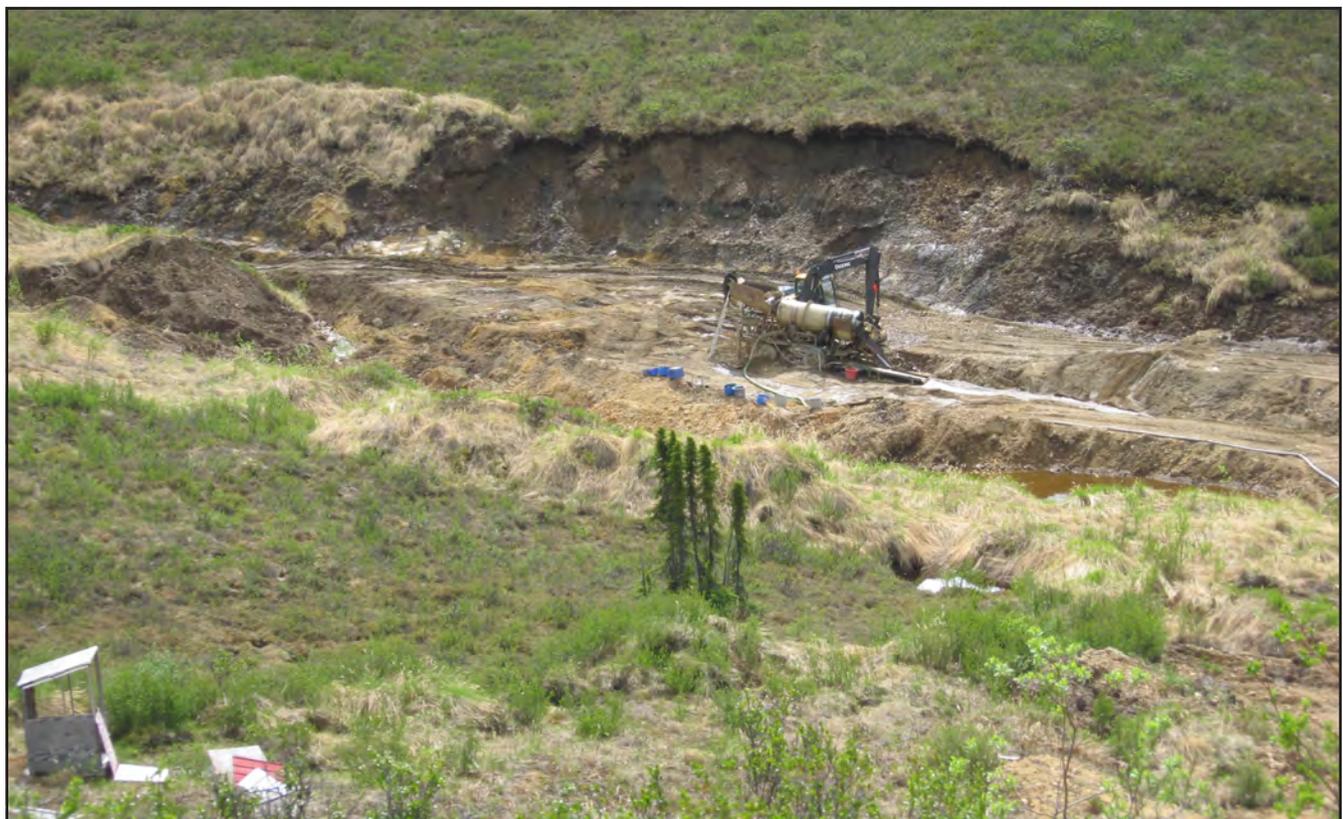
Wash plant on Discovery Creek under PM04-410-2 in 2011 (Photo credit: Steve Beaulieu).

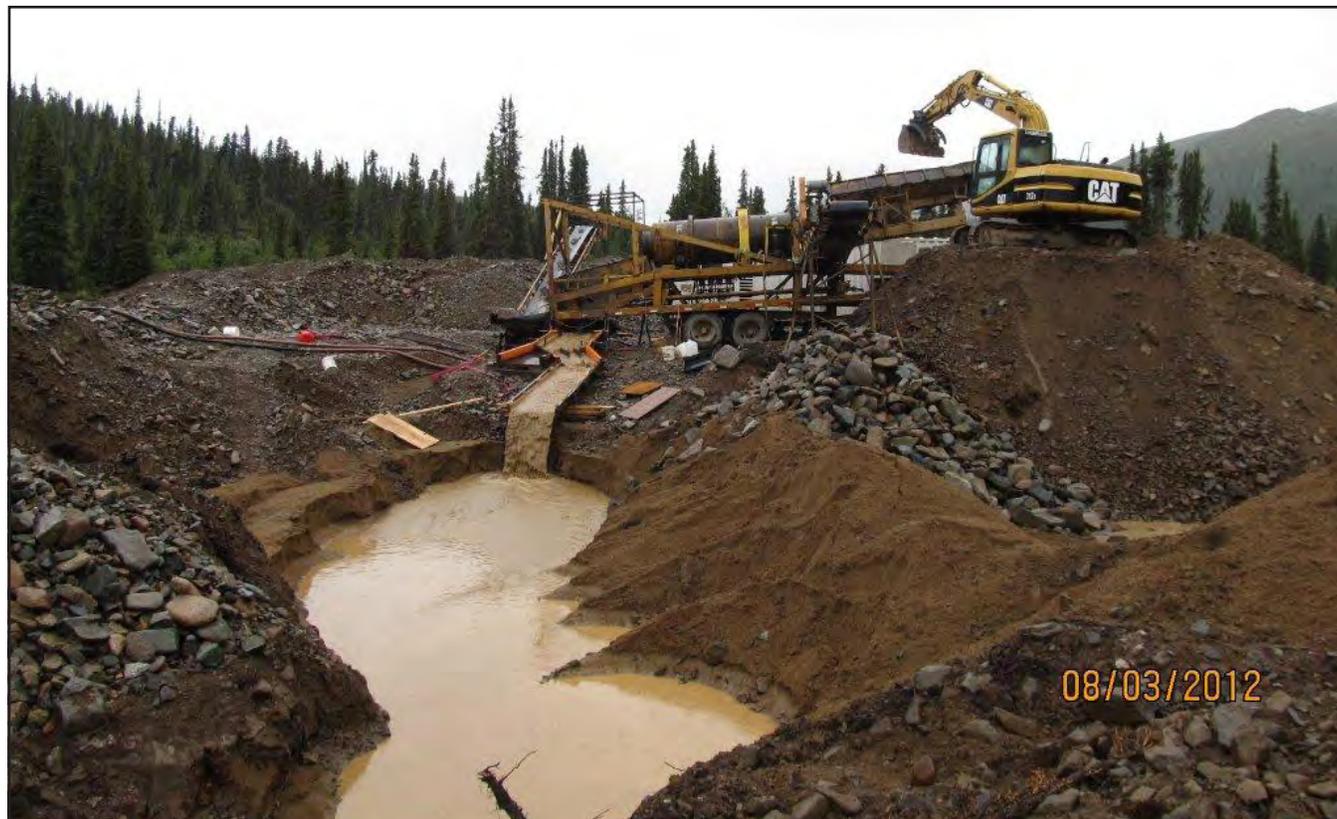
Wash plant on Victoria Creek at Mr. Harasimiuk's operation in 2012 (Photo credit: Steve Beaulieu).

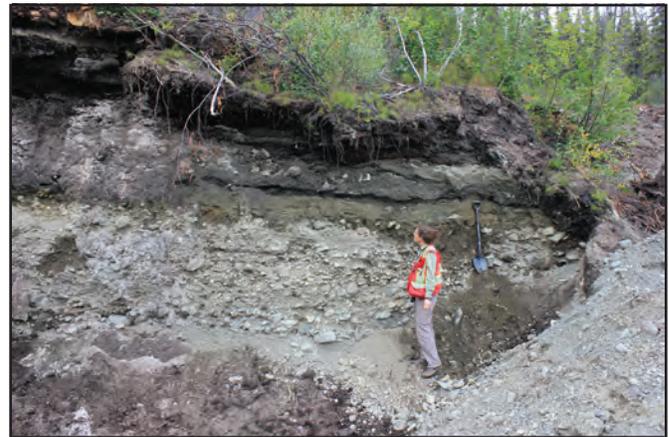
Mine cut exposed on the left limit of Quill Creek in 2014.

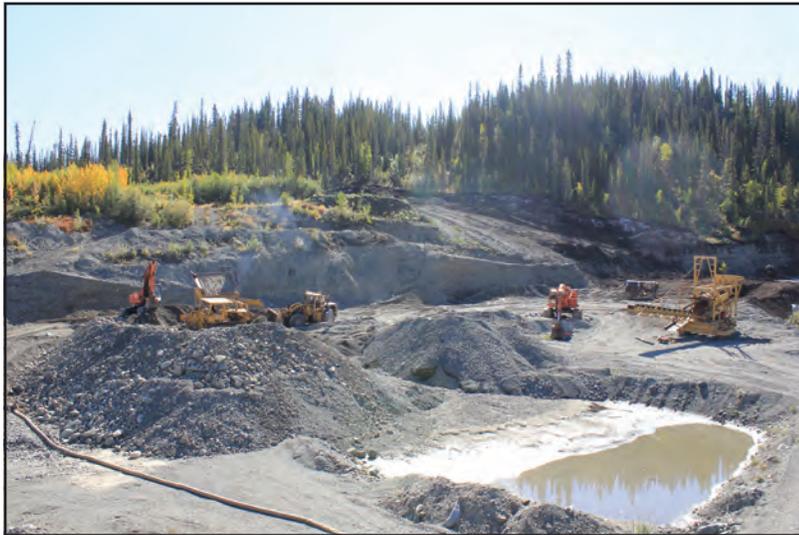
Cut and wash plant at Sam Johnson's operation in 2014.

Equipment present in 2014 included a Hitachi 200 excavator, a Koehring 666 excavator, a Caterpillar C966B wheel loader, and a Caterpillar D7 bulldozer. The wash plant processed 25 to 30 loose cubic yards (19 to 23 m³) per hour and consisted of a 3 ft diameter trommel with 2 ft wide by 12 ft long sluice run with expanded metal and angle iron. Clean-ups were conducted with a jig and finished on a wheel.

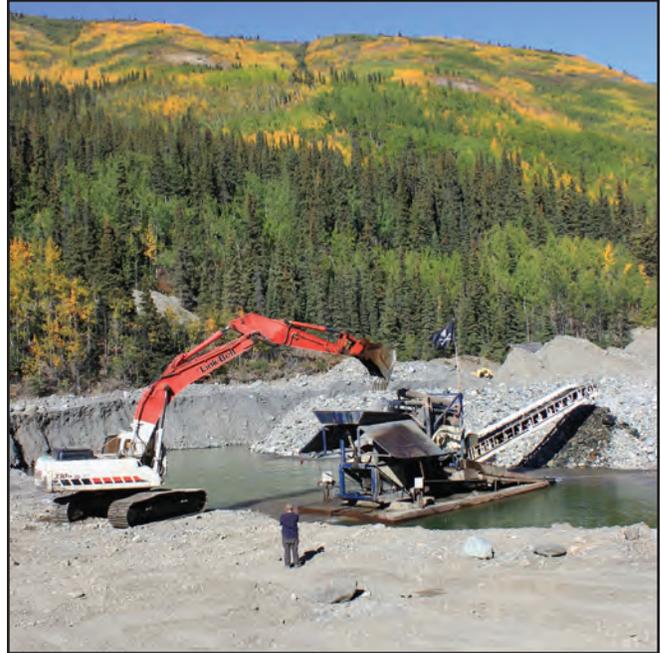
Steve Johnson's floating plant on Burwash Creek in 2014.

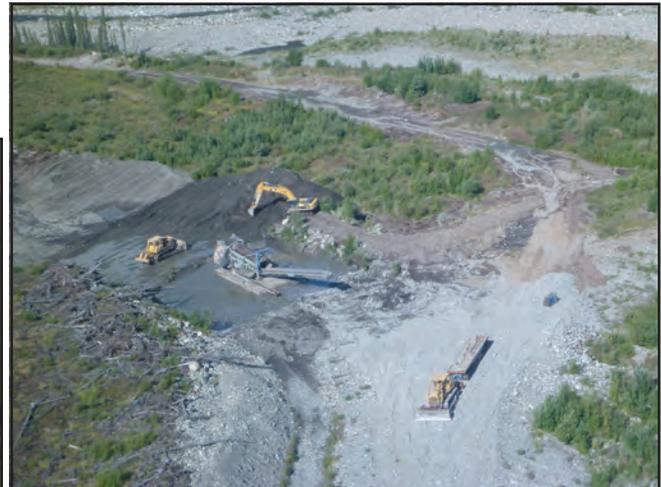
Tic Exploration's stripping and sluicing activity on Gladstone Creek in 2013 (Photo credit: Justin Hooper).

WORK HISTORY AND MINING CUTS Tic Exploration mined at various locations on Gladstone Creek in 2010, 2012 and 2013. No activity was recorded in 2011 and no activity occurred in 2014. In 2010, sluicing occurred on the left limit of Gladstone Creek with two wash plants, the first located against the valley wall and the second situated closer to the creek. The left limit of the valley, slightly downstream of Cyr Creek, was stripped for future mining. The left limit of Gladstone Creek, downstream from camp was mined in 2012. Stripping and sluicing occurred upstream of camp in 2013.

EQUIPMENT AND WATER TREATMENT Equipment included three Caterpillar 330 excavators, a Caterpillar 325 excavator, a Caterpillar 350 excavator, two Caterpillar D9H bulldozers, and a Caterpillar D10N bulldozer. Two wash plants were located on site: a 5 ft diameter floating trommel with 6 by 6 ft sluice run and a 30" wide tailings conveyor; and a 6 ft diameter floating trommel with a 9 by 6 ft sluice run and a 36" wide tailings conveyor.

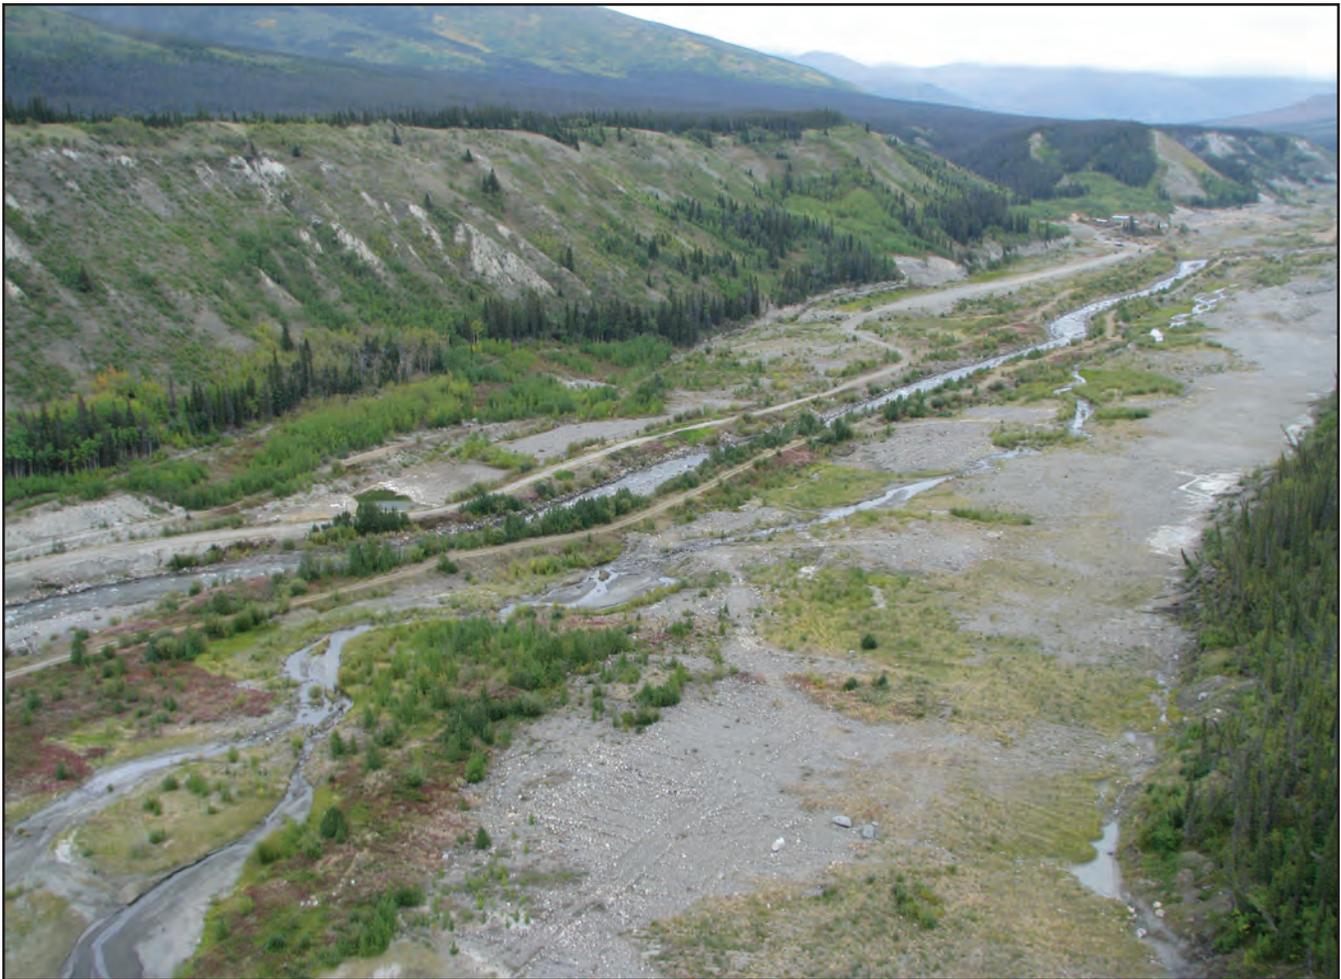
Upstream view of lower Gladstone Creek. Tic Exploration’s base camp is situated in the background on the right limit (Photo credit: Panya Lipovsky).

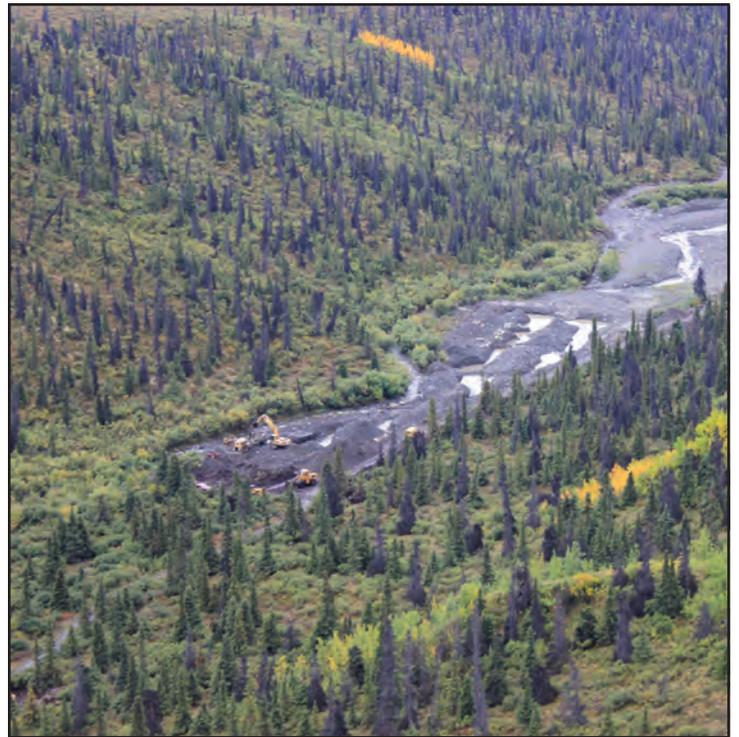
Mining activity at Mr. Brewster's operation on upper Ruby Creek in August 2014.

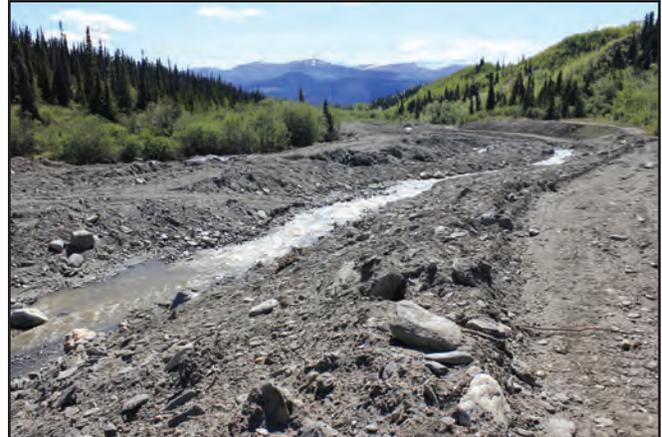
Mr. MacKinnon's mining location from 2010 to 2014, near his base camp on Ruby Creek.

SURFICIAL GEOLOGY AND STRATIGRAPHY Exposures near Mr. MacKinnon's camp consist of an impermeable clay unit overlain by 3.0 m (10 ft) of a coarse cobble-dominated sandy gravel and capped by 0.6 to 0.9 m (2 to 3 ft) of sand. Up to 3.0 m (10 ft) of gravel was sluiced, with the highest grades yielded from clay-rich gravel extracted from the base of the unit. The clay unit acts as a false bedrock surface, so no mining occurred below it.

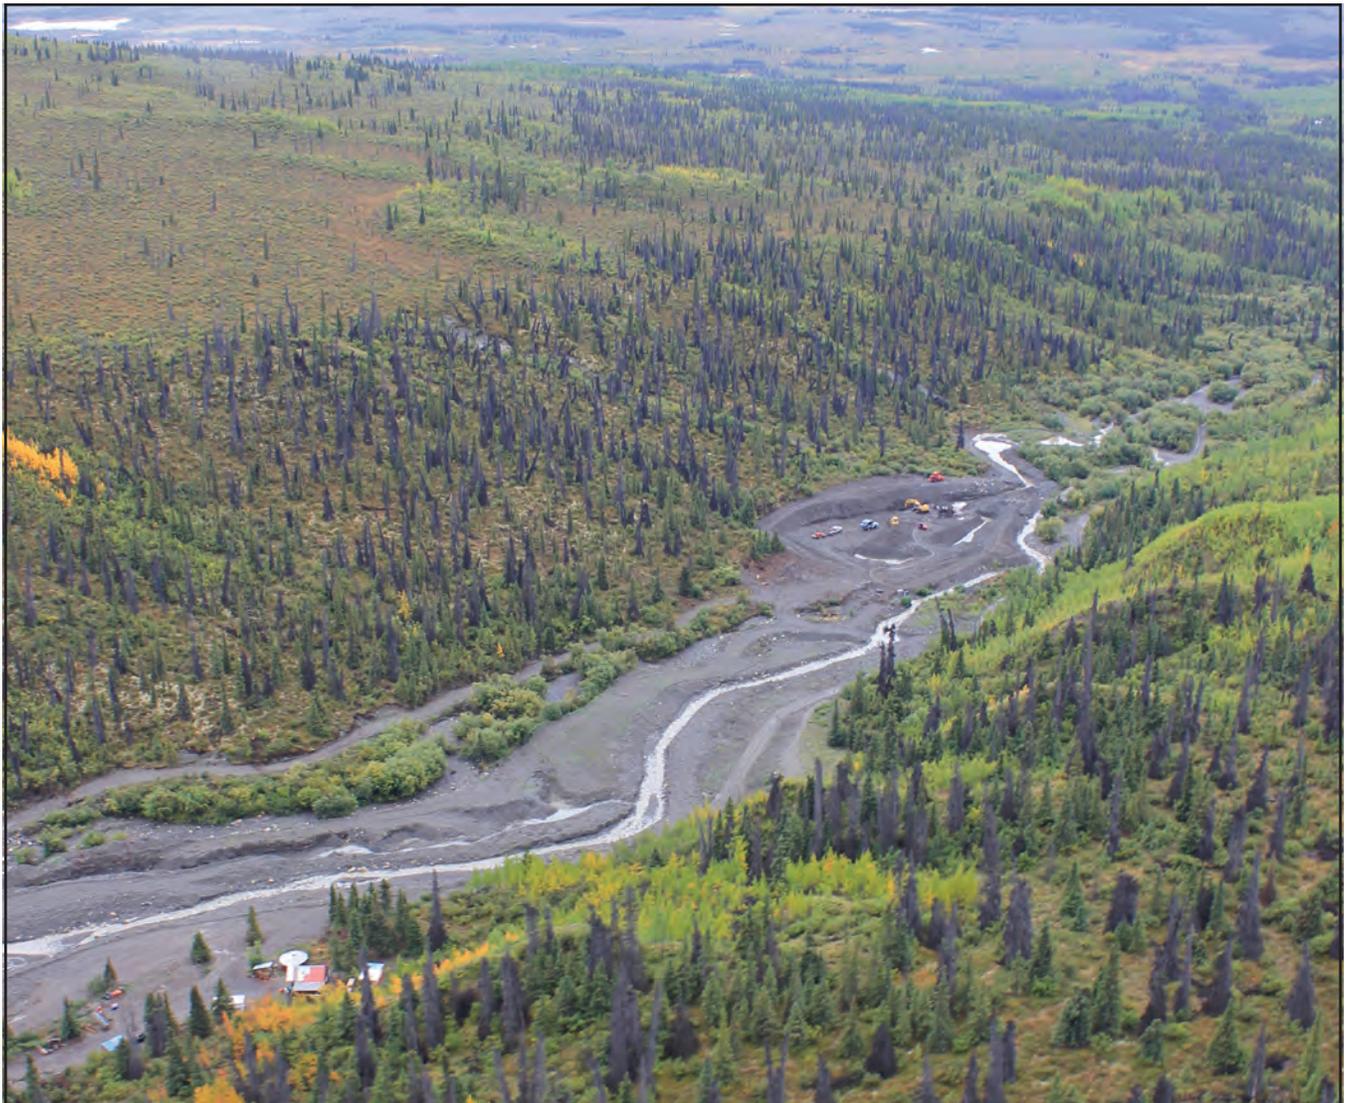
Downstream view of Mr. MacKinnon's operation in 2014, with his camp visible in the lower left corner.

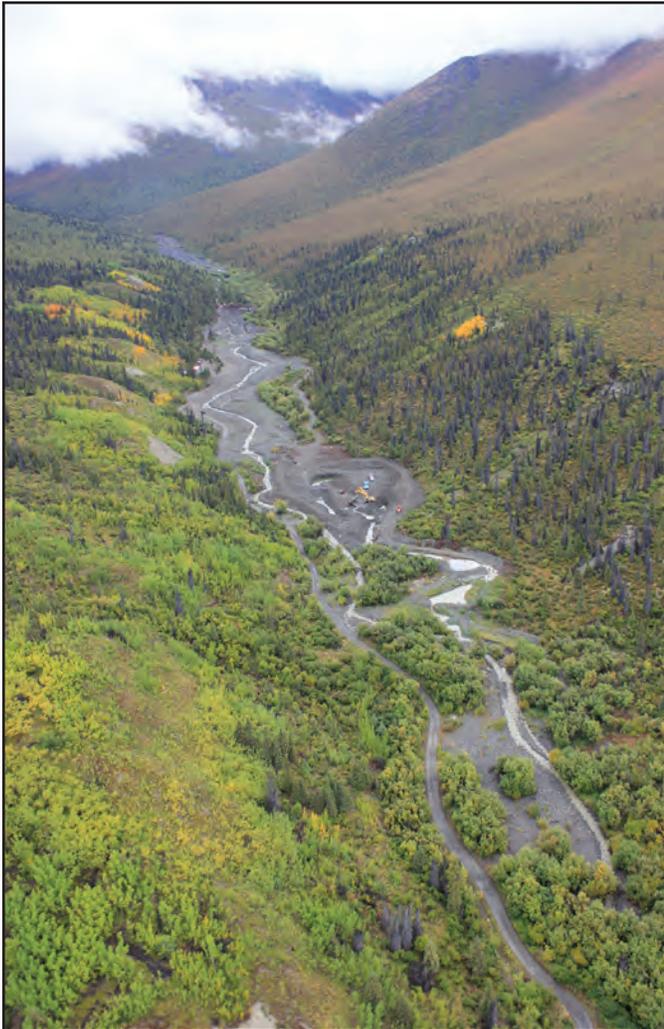
Upstream view of Ruby Creek in 2014 with Mr. MacKinnon's operation shown in the center of the photo, and Mr. Brewster and Mr. Bjork's operation farther upstream in the background.

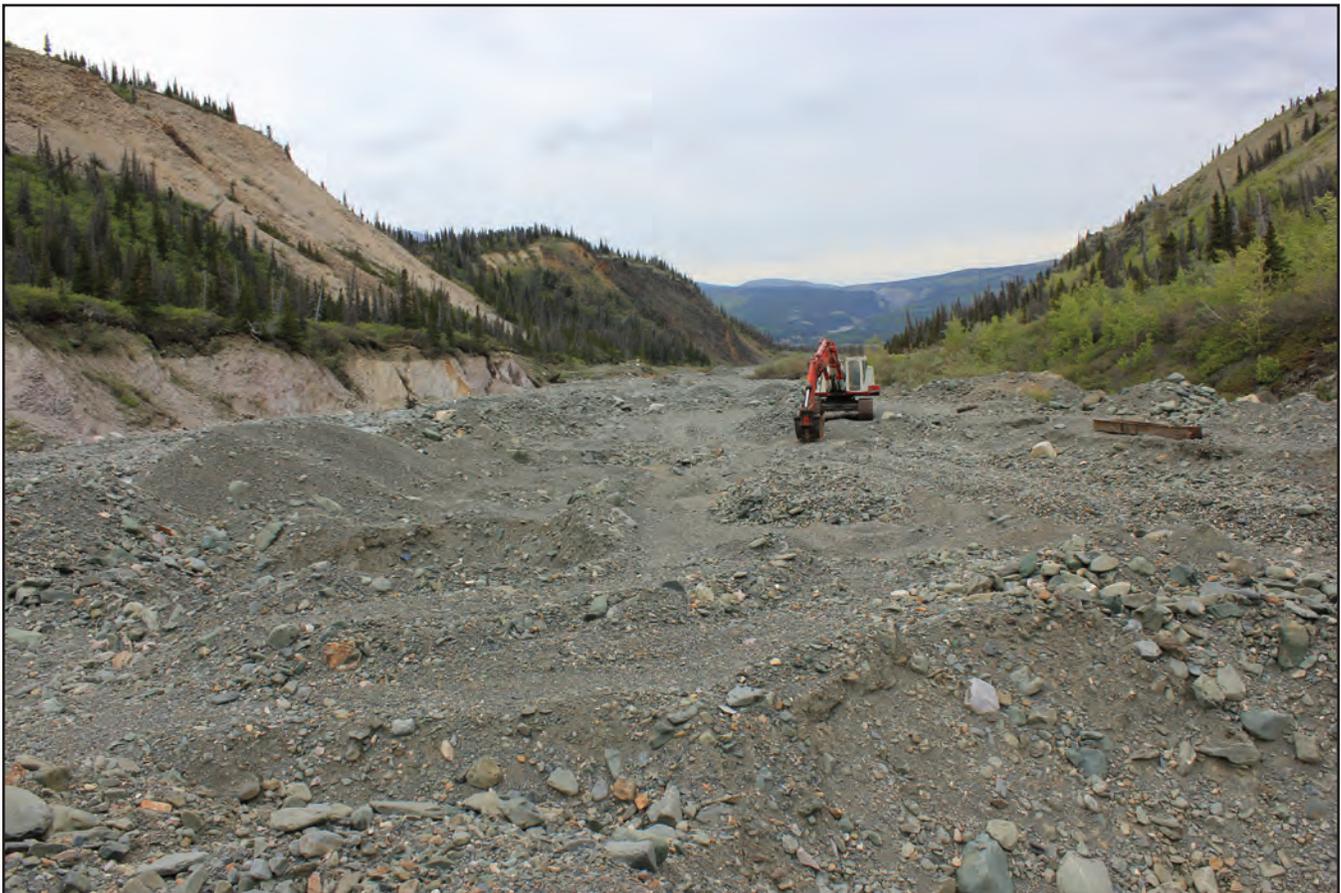
Downstream view of uppermost claims under PM09-648 in 2014, with historic test pits in foreground.

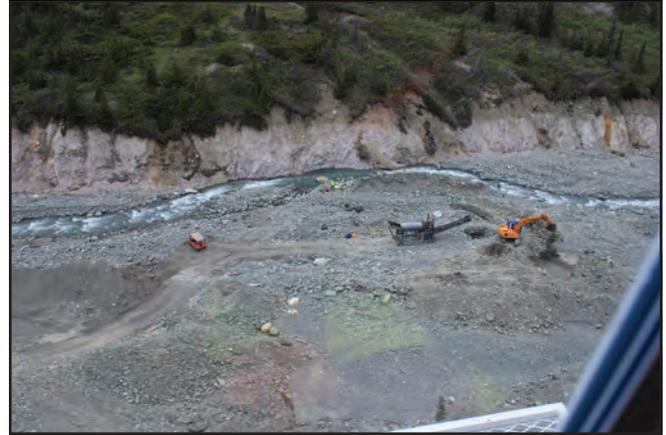
Mr. Brueckner's active operation on Kimberley Creek in 2014.

EQUIPMENT AND WATER TREATMENT Equipment present in 2014 included a Samsung SE130LC excavator and a trommel wash plant approximately 5 ft in diameter by 12 ft long with a 1" screen and 6 ft long sluice run. With the trommel and high banker they processed 15 to 20 loose cubic yards (12 to 15 m²) of gravel per hour. Water was acquired from Kimberley Creek and settled in a series of downstream ponds on the right limit. Clean-ups were conducted using a high banker.

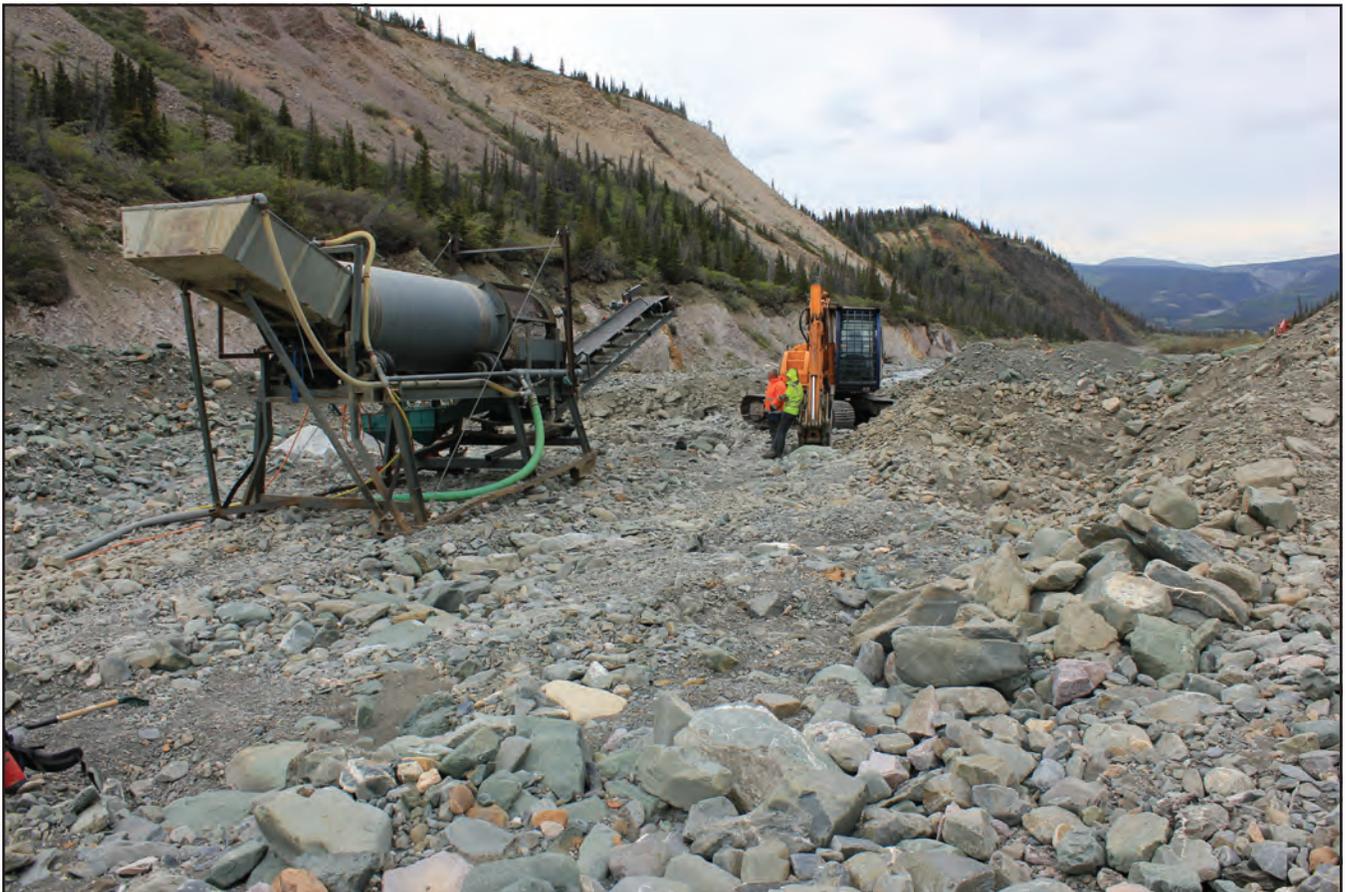
Downstream view of Mr. Brueckner's wash plant and test pit in 2014.

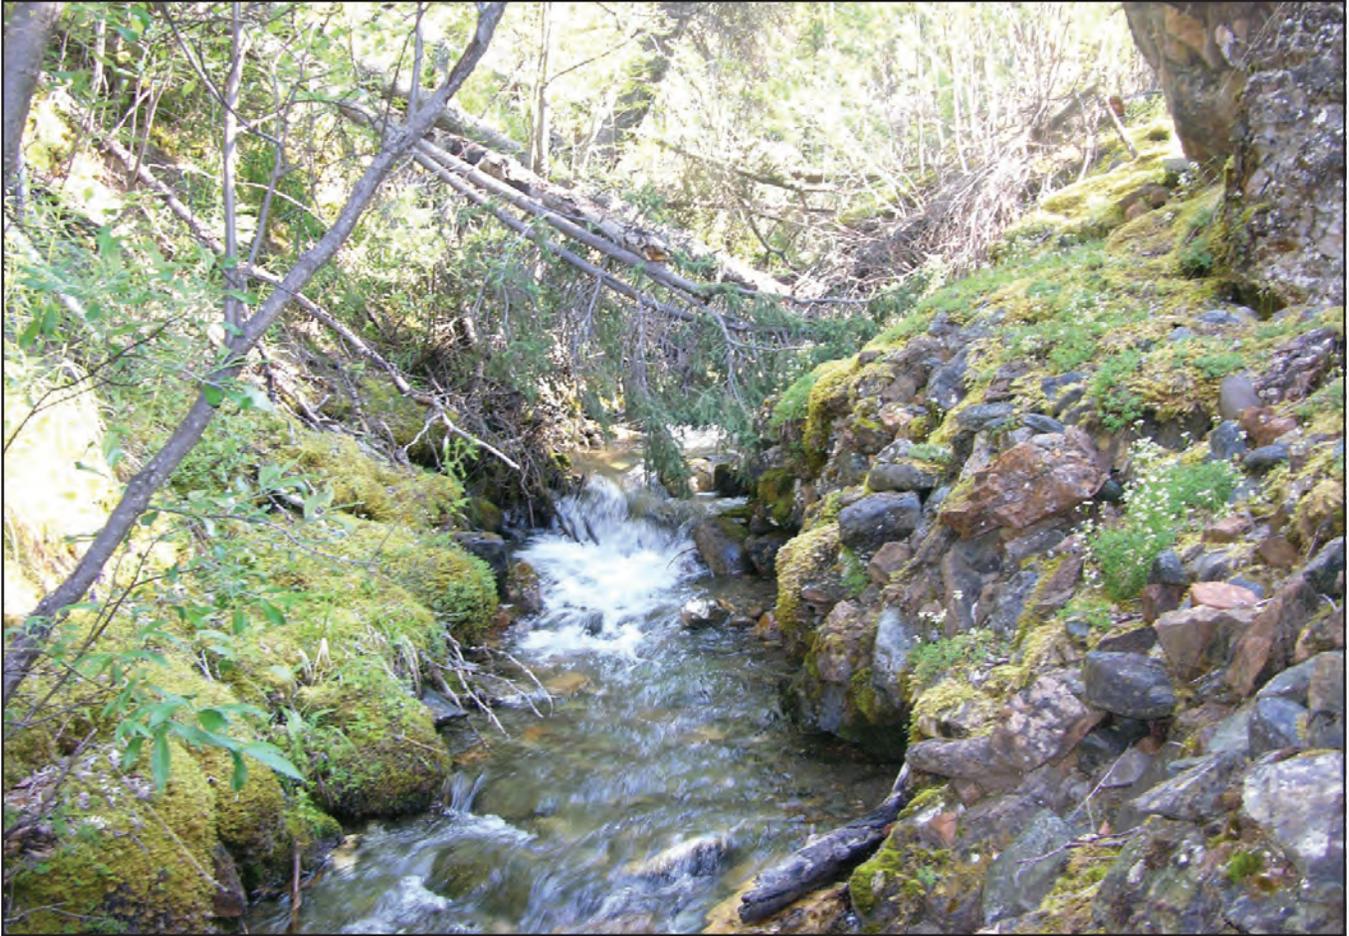
A view looking upstream of the canyon on Little Bear Creek. The stacked cobbles on the right hand side of the stream are some of the old-timer workings in Little Bear Creek.

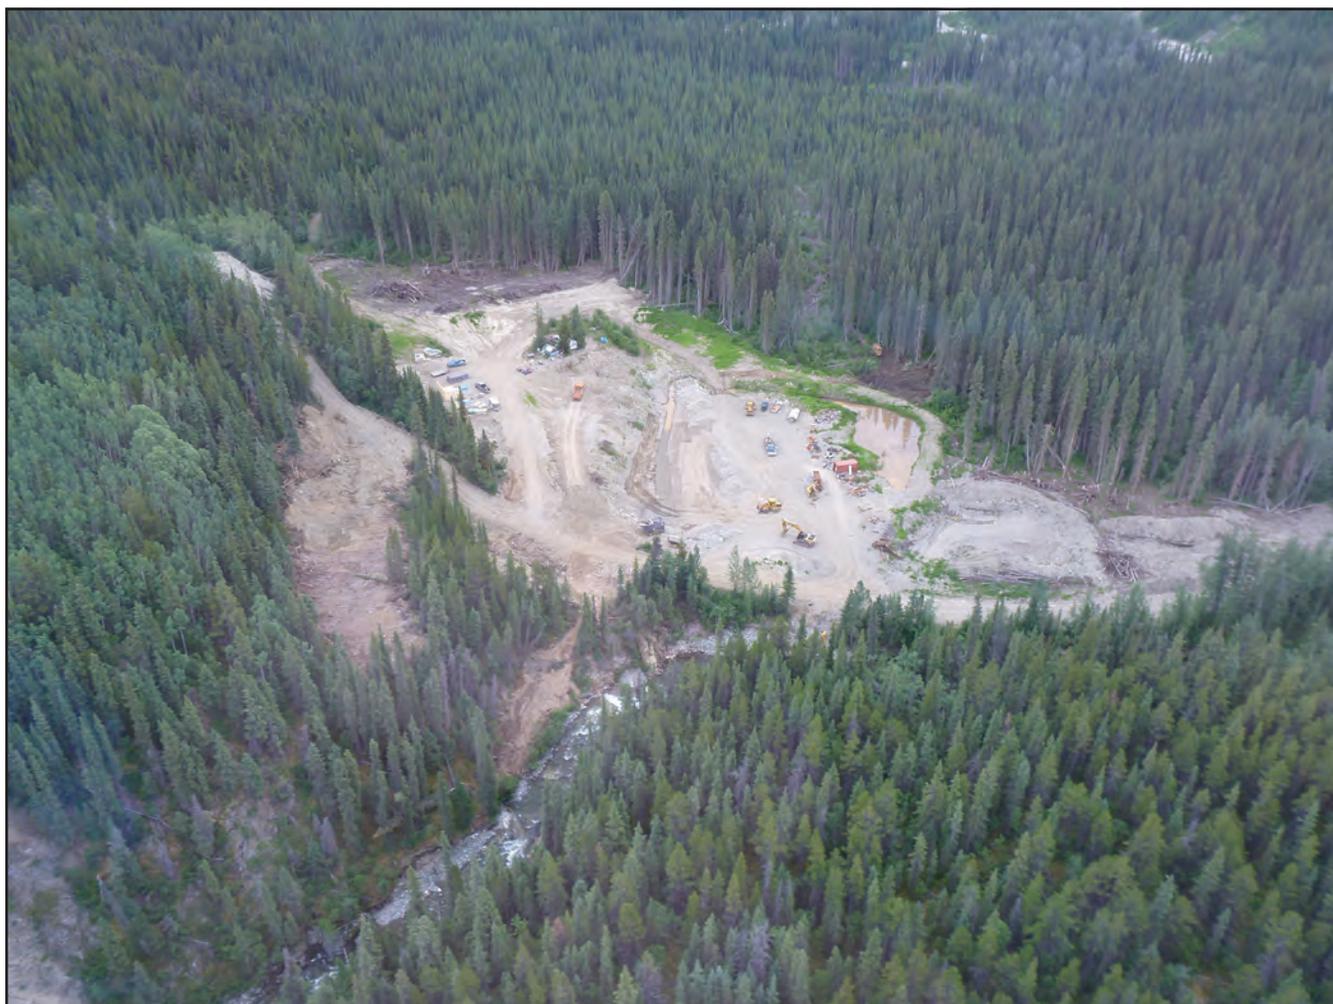
Mr. Hrehirchek's operation on Sydney and Iron creeks in 2012 (Photo credit: Sevn Bohnet).

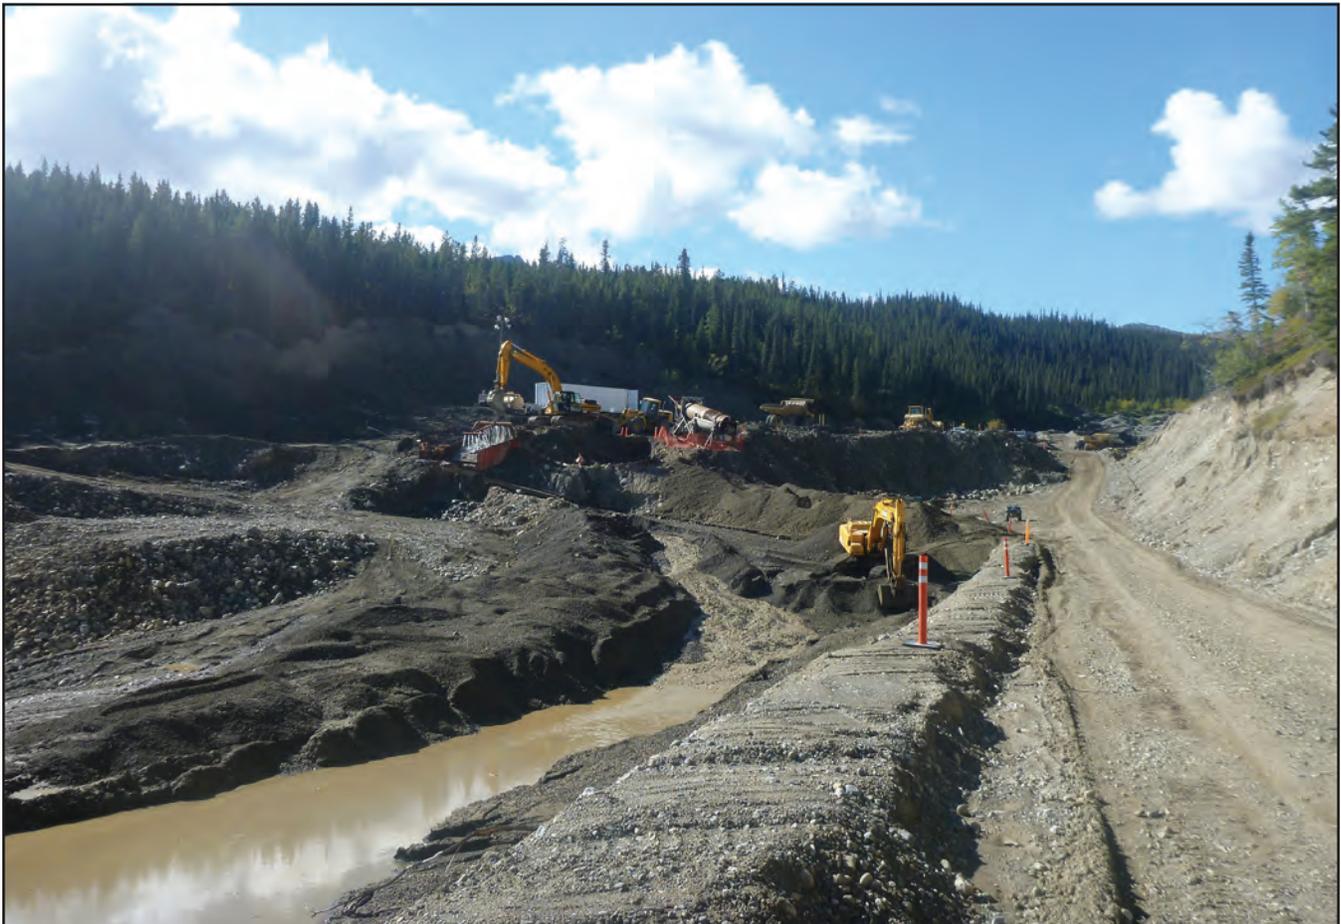
Active sluicing in 2013 at Tusk Exploration on Moose Brook Creek (Photo credit: Justin Hooper).

EQUIPMENT AND WATER TREATMENT Equipment noted in 2012 included Komatsu 450 loader, Caterpillar 966 wheel loader, Caterpillar 235 excavator, bulldozer, two haul trucks, and trommel wash plant. Equipment on-site in 2013, as seen in the property photo, included two John Deere excavators, a loader, rock truck, bulldozer and trommel wash plant.

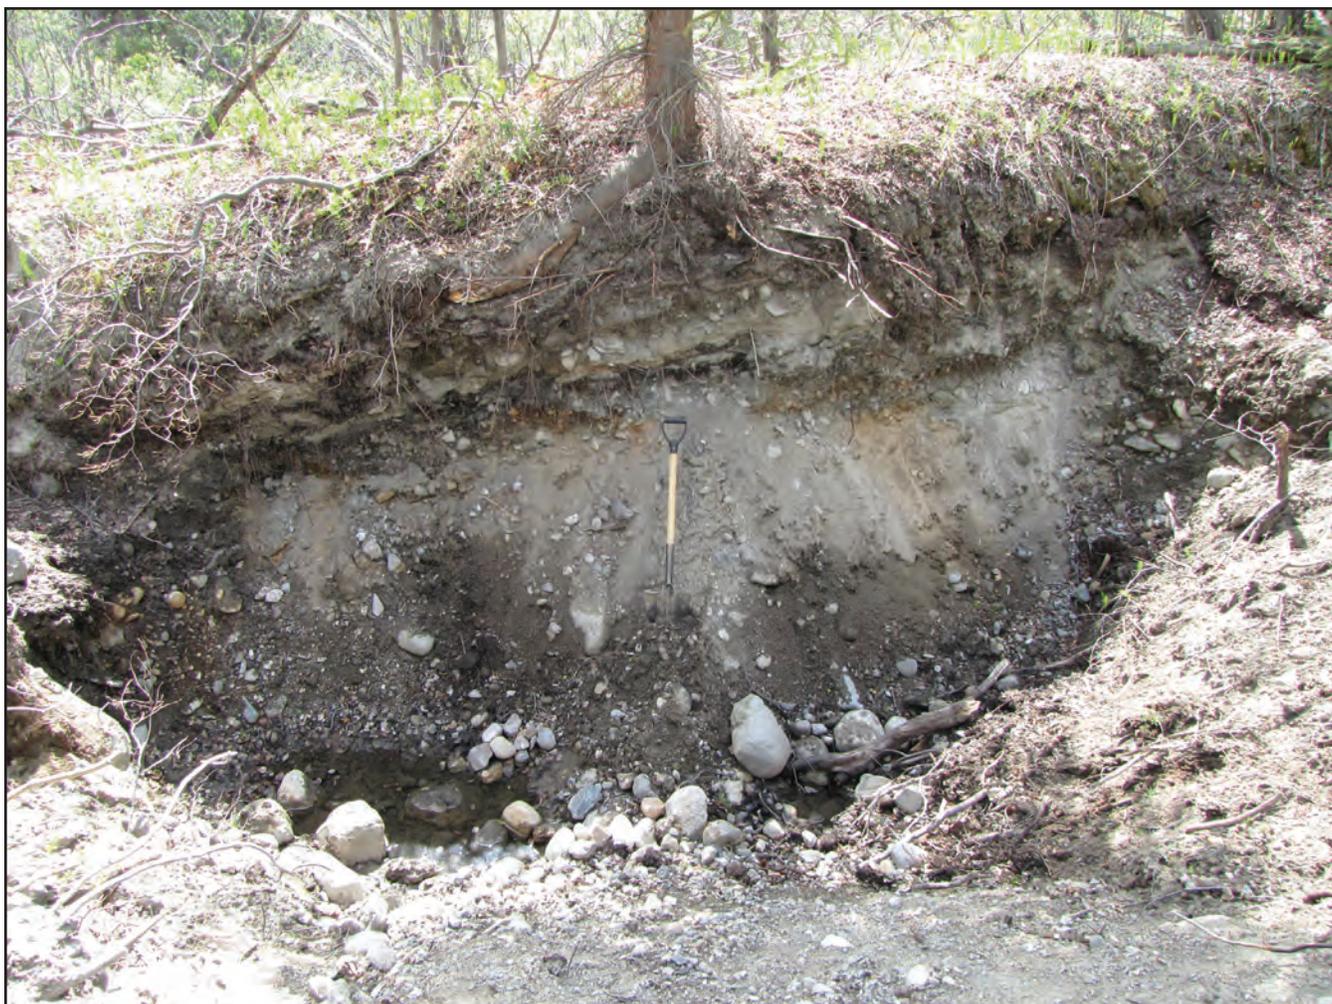
A view to the west of the test pit excavated in the Moose Brook Creek fluvial gravel.

conducted testing near the upper forks of Moose Brook Creek. The exploration was focused on the left limit. An area 10 by 10 m (33 by 33 ft) was stripped to access pay gravel, and then processed using a small sluice. Test pitting and sluicing occurred in 2014, no specific work history is known.

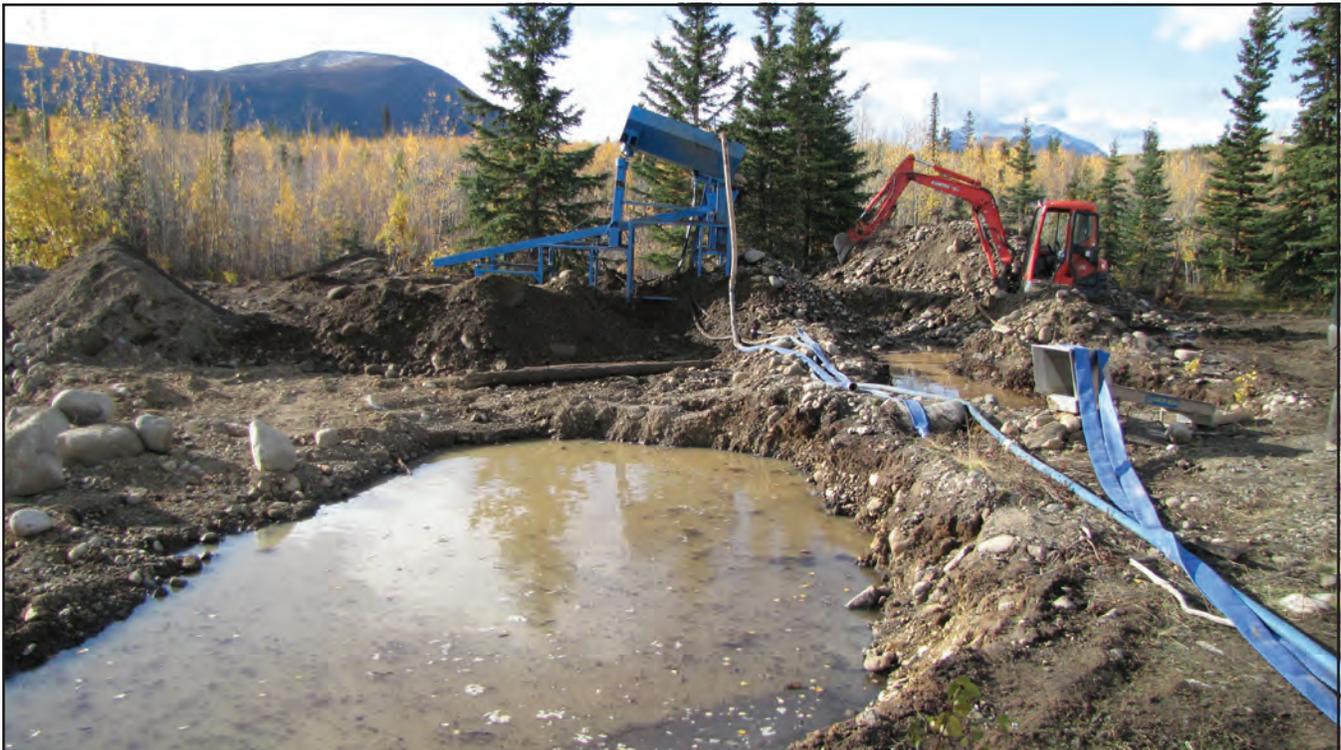
Black Mountain Mining's wash plant and former test pit now used as a settling pond in 2011.

EQUIPMENT AND WATER TREATMENT Equipment used in 2011 included a Kubota KX121-3 excavator to mine and feed the wash plant. In 2013 a Caterpillar 304 excavator replaced the Kubota for mining and feeding the plant. The wash plant screened to 1" minus which fed onto an upper 4 by 7 ft sluice run with 3/4" riffles and further fed a section with 5 point expanded metal and split the sluice material into two 2 by 10 ft runs with 3/4" riffles, expanded metal and nomad matting. The plant used 900 gpm and is capable of processing 30 yd³ (23 m³) of gravel per hour. Water was acquired from the neighboring beaver pond.
