# AN ASSESSMENT OF FISH HABITAT AND FISH UTILIZATION WITHIN NORTH FORK, ROSE CREEK

# ANVIL RANGE MINE SITE FARO, YUKON June and August 2005

Prepared For: Deloitte and Touche Inc. November, 2005

Prepared By; White Mountain Environmental Consulting

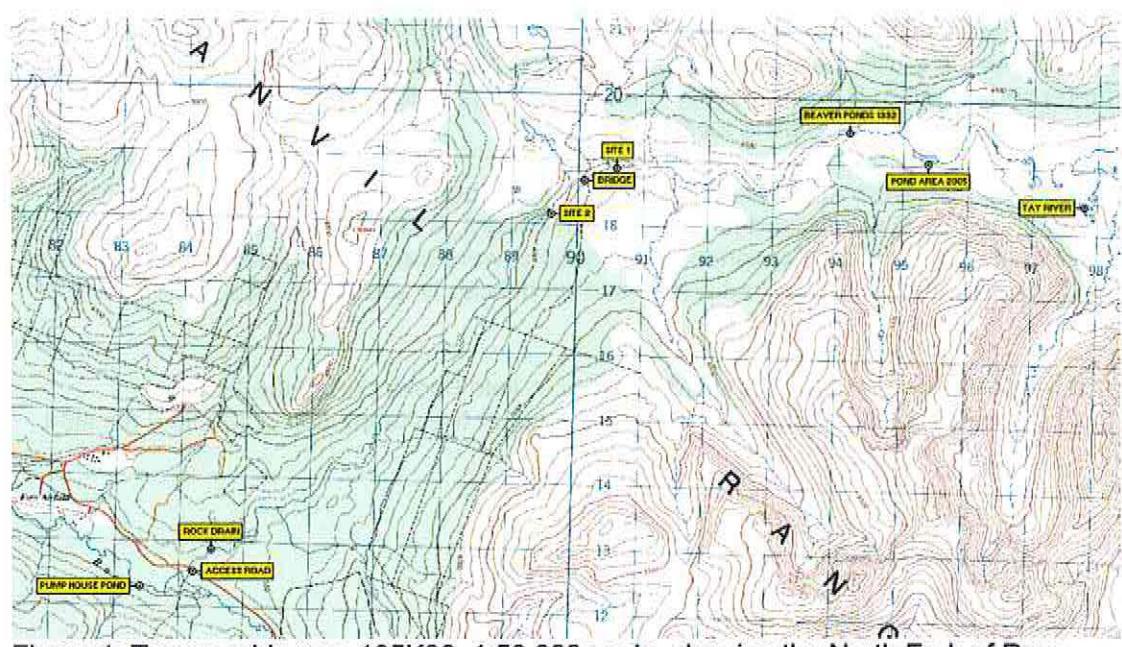
Figure 1: Topographic map 105K06, 1:50,000 scale, showing the North Fork of Rose Creek and sample locations from June and August, 2005 investigations (*image has been reduced by* 50%, *for computer viewing view at 200%*).

The North Fork of Rose Creek has 3 distinct reaches each divided by man made structures associated with the Faro mine (Figure 1). The reaches are; 1) below the main mine access road to the confluence with the South Fork of Rose Creek, 2) between the main access road and the Vangorda haul road, and 3) above the haul road. Fish passage was interrupted during 1987 at the haul road where a Rock or French Drain (barrier to fish passage) was constructed as a part of the haul road. The North Fork of Rose Creek has a drainage basin area of 102 sq km, 98% of the drainage basin is up stream of the Rock Drain.

Reach 3: the upper reaches of the creek at three separate locations (Figure 1); the bridge site (spring), site 1 and site 2 (summer)

A ground assessment was conducted at the site of an exploration road bridge crossing, this site is named Bridge site (Figure 1). The channel at this location is deeply entrenched with velocities exceeding 1 meter per second and depths of 2 to 3 meters in a channel less than 5 meters wide. At the time of investigation the water was turbid and turbulent resulting in poor visibility. Angling at this site for 20 minutes did not capture any fish; however a single sub adult Arctic grayling was observed (Table 3).

Two sites in the upper reaches of the North Fork of Rose Creek were investigated for the presence of fish during the summer investigations (Figure 1, sites 1 and 2). The Bridge site evaluated during the spring investigation was not re-investigated as it was not possible to land the helicopter.

Site 1 is located at the down stream end of a set of beaver ponds documented by past investigators (Harder 1989 and Leverton et al, 1986). The beaver pond areas noted in the 1986 and 1989 investigations have since washed out resulting in the pond areas greatly reduced in size from those shown in photographs by Harder in 1992. The area of discussion has been identified in Figure 1 as "beaver ponds 1992.

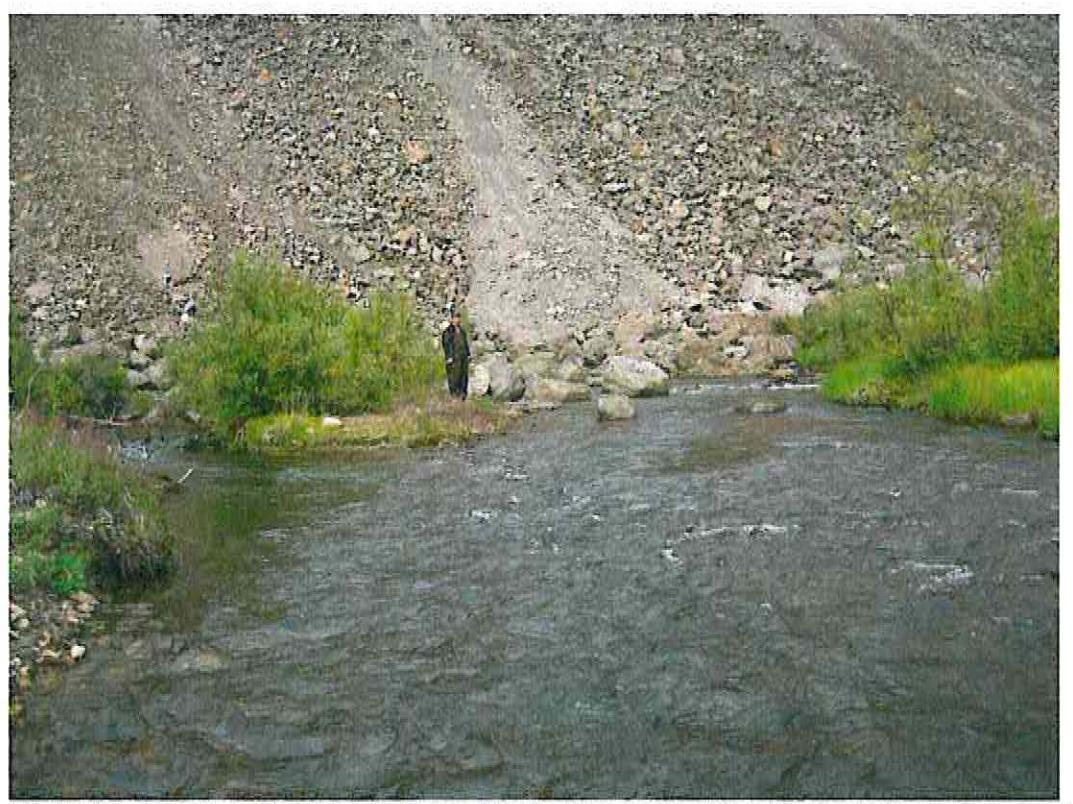
Photo #1. Reach 1, North Fork Rose Creek. The base of the Rock Drain on the Down Stream side during August sampling

During the spring investigation in June, flows issued from the base of the Rock Drain for a distance 58 meters along the rock face, before converging into the natural channel 40 meters down stream (Photo #1). The average wetted width of the natural channel was 10 meters and it was bank full. Some of the outflow from the Rock Drain flooded the alder covered riparian zone of the left bank. The flow through the vegetation entered the creek channel as rivulets along the creek bank. The average depth of the creek at this site was 0.4 meters with pools 0.7 meters in depth. Pools with depths greater than 2 meters were common in the native channel below the Rock drain face. The water temperature at the time of investigation (@1720 hrs) was 6.6°C.

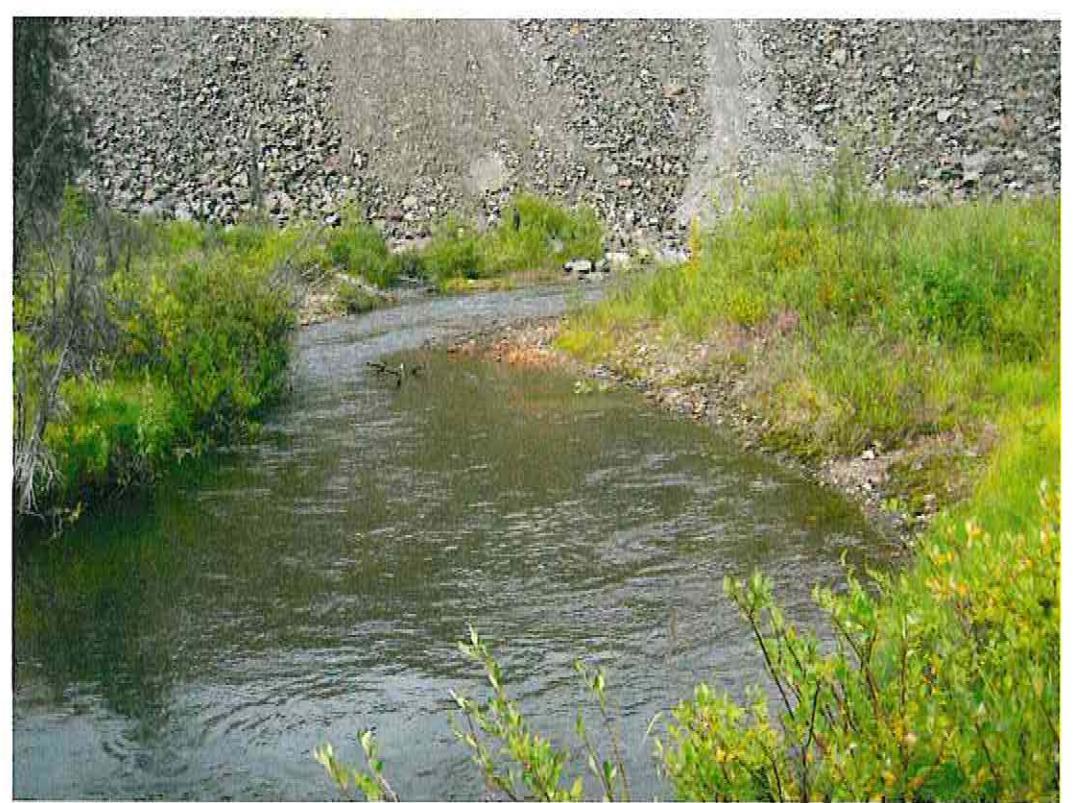
Three distinct zones of fish habitat occur along the face of the drain.

Along the face of the drain water wells up from deep interstitial spaces between the blast rock in a strong and turbulent manner.

For 20 meters downstream of the face an altered channel with some blast rock and converging channels.

The natural channel unaffected by the drain materials

Significant numbers of fish were found in all three of these zones during summer investigations; however species composition varied between zones (see Photo #2). Both minnow trapping and electro-fishing showed the base of the drain to be extensively utilized by one year old Arctic grayling and for very large slimy sculpin (Tables 1 and 2). The largest sculpin captured at this site was 147 mm and is one of the largest sculpin specimens the investigators have ever encountered. The significant numbers of large sculpin found along the edges of the Rock Drain implies the habitat may provide over winter habitat for slimy sculpins and potentially for juvenile Arctic grayling.

Photo #2: Downstream of the Rock Drain the channel converges into the natural channel within 40 meters of the rock face. This photo shows all 3 sample zones during August flow conditions.

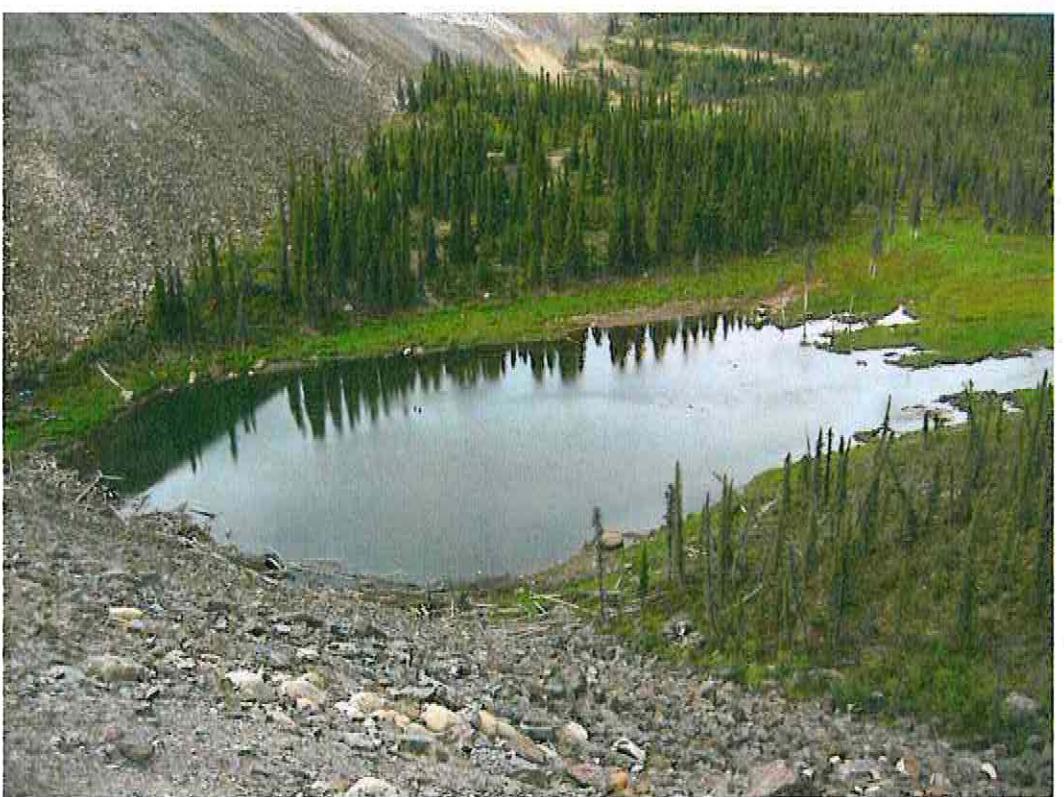
During summer investigations, the water level within the pond on the upstream side of the rock drain was 3 meters lower than during the spring investigation and the pond had changed shape and was less than 50% of the size observed in early June (Photo #3).

Photo #3: The pond on the up stream side of the Rock Drain during August was 3 meters lower than observed during June investigations.

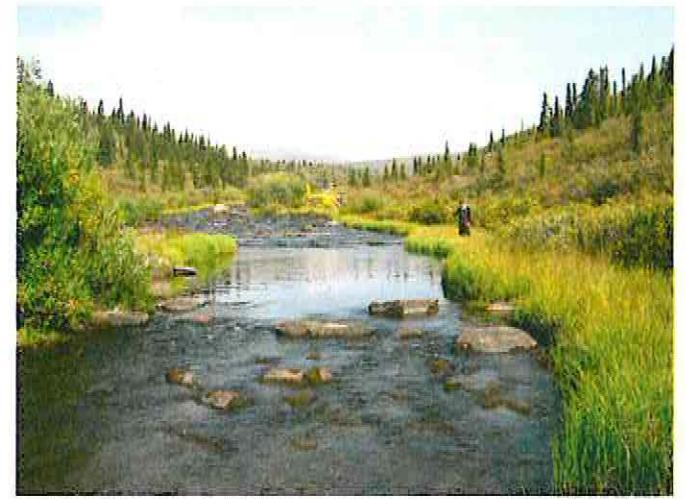
Site 2 is located approximately 700 meters downstream of the bridge site and consists of a broad area of the creek. The channel has some braiding and flows as a wide flat glide over large boulders with deep interstitial spaces. Some pooling occurs near shore edges and near very large boulders. Depths vary between 0.2 and 0.8 meters and velocities ranged causing rapids, riffles and glides to occur within the same reach (Photo #4). Visual observations of juvenile Arctic grayling accompanied by electro-fishing results (Tables 1 and 4) indicated that the site was well used by several year classes of rearing grayling. Angling effort showed that arctic grayling sub adults and adults were also present (table 3).

Photo #4: Site 2 in the upper reaches of the North Fork.

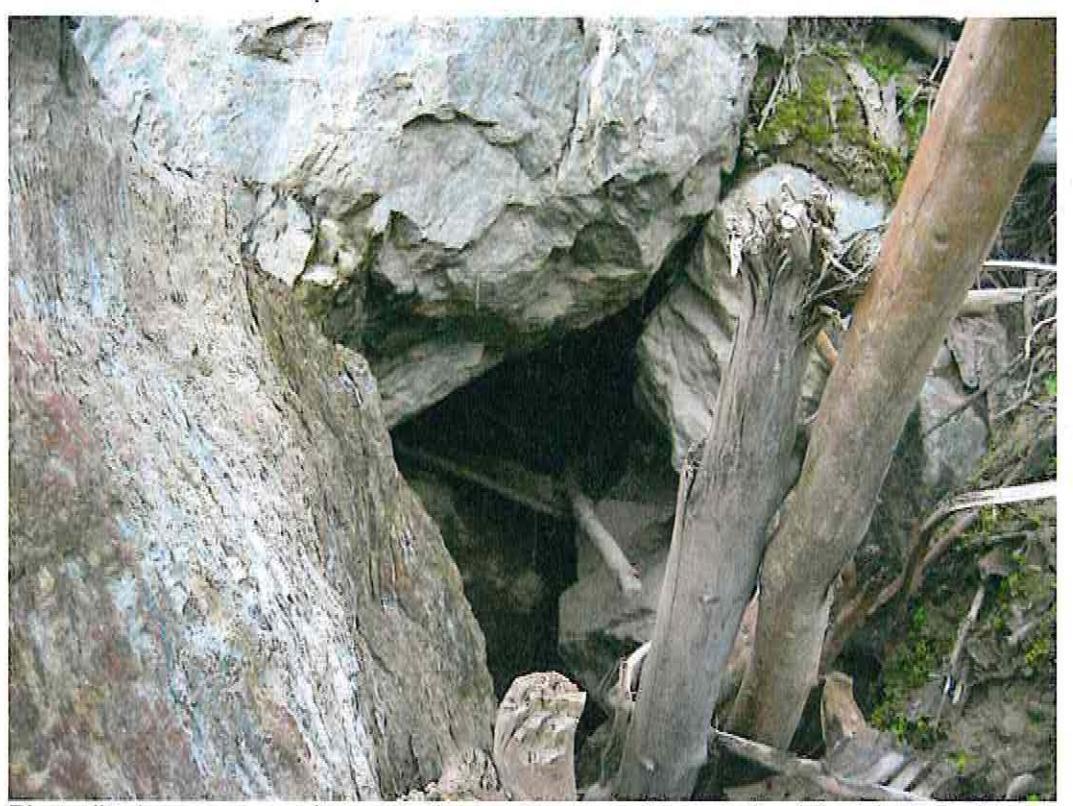
The Rock Drain likely may impede passage to some species and or life stages however may not restrict fish passage entirely as large spacing between boulders is obvious from both the upper and lower side faces (Photo #5). The distance through the drain likely precludes all but accidental fish passage.

Photo #5: Large spaces between the boulders used to construct the Rock Drain may allow accidental fish passage and does create potential over-winter habitat.
