Elsa Reclamation and Development Company Keno Hill Mine Keno Hill Silver District Site Investigation and Improvements, Special Projects Fisheries Assessment Project September 17 – 19, 2008

March 31, 2009

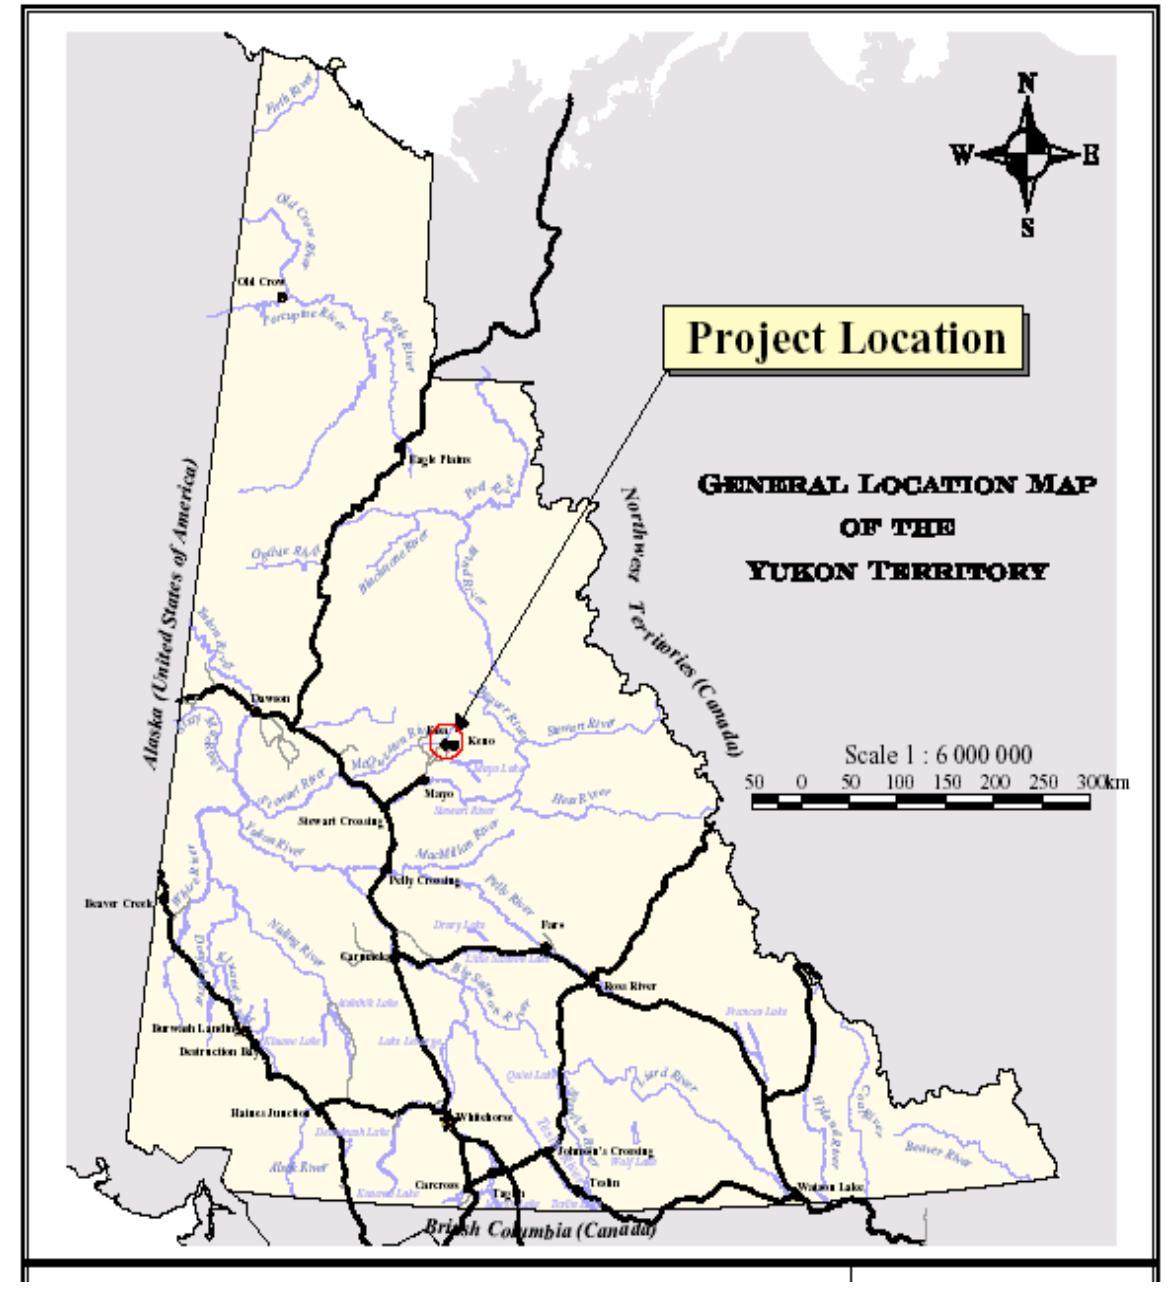
An investigation into fish presence, fish habitat and metal uptake in fish tissue, in the vicinity of Elsa/Keno, Yukon (Figure 1), was conducted in September of 2008. This investigation was part of a project being conducted as part of overall closure planning activities in the mining district. Documentation of previous fisheries investigations includes reports prepared by White Mountain Environmental Consulting in 2006 (White Mountain Environmental Consulting, 2006) and 1995 (White Mountain Environmental Consulting, 1995). The current study investigated fish and fish habitat at numerous sites including Christal Lake, Christal Creek, Lightning Creek and Flat Creek. Analyses of fish tissue for metal uptake was conducted on fish captured in this study. Results were compared to fish tissue analyses conducted in previous studies (identified above). Barriers to fish movement, previously identified on Christal Creek, were investigated further in this assessment, and recommendations regarding their removal are included in this report.

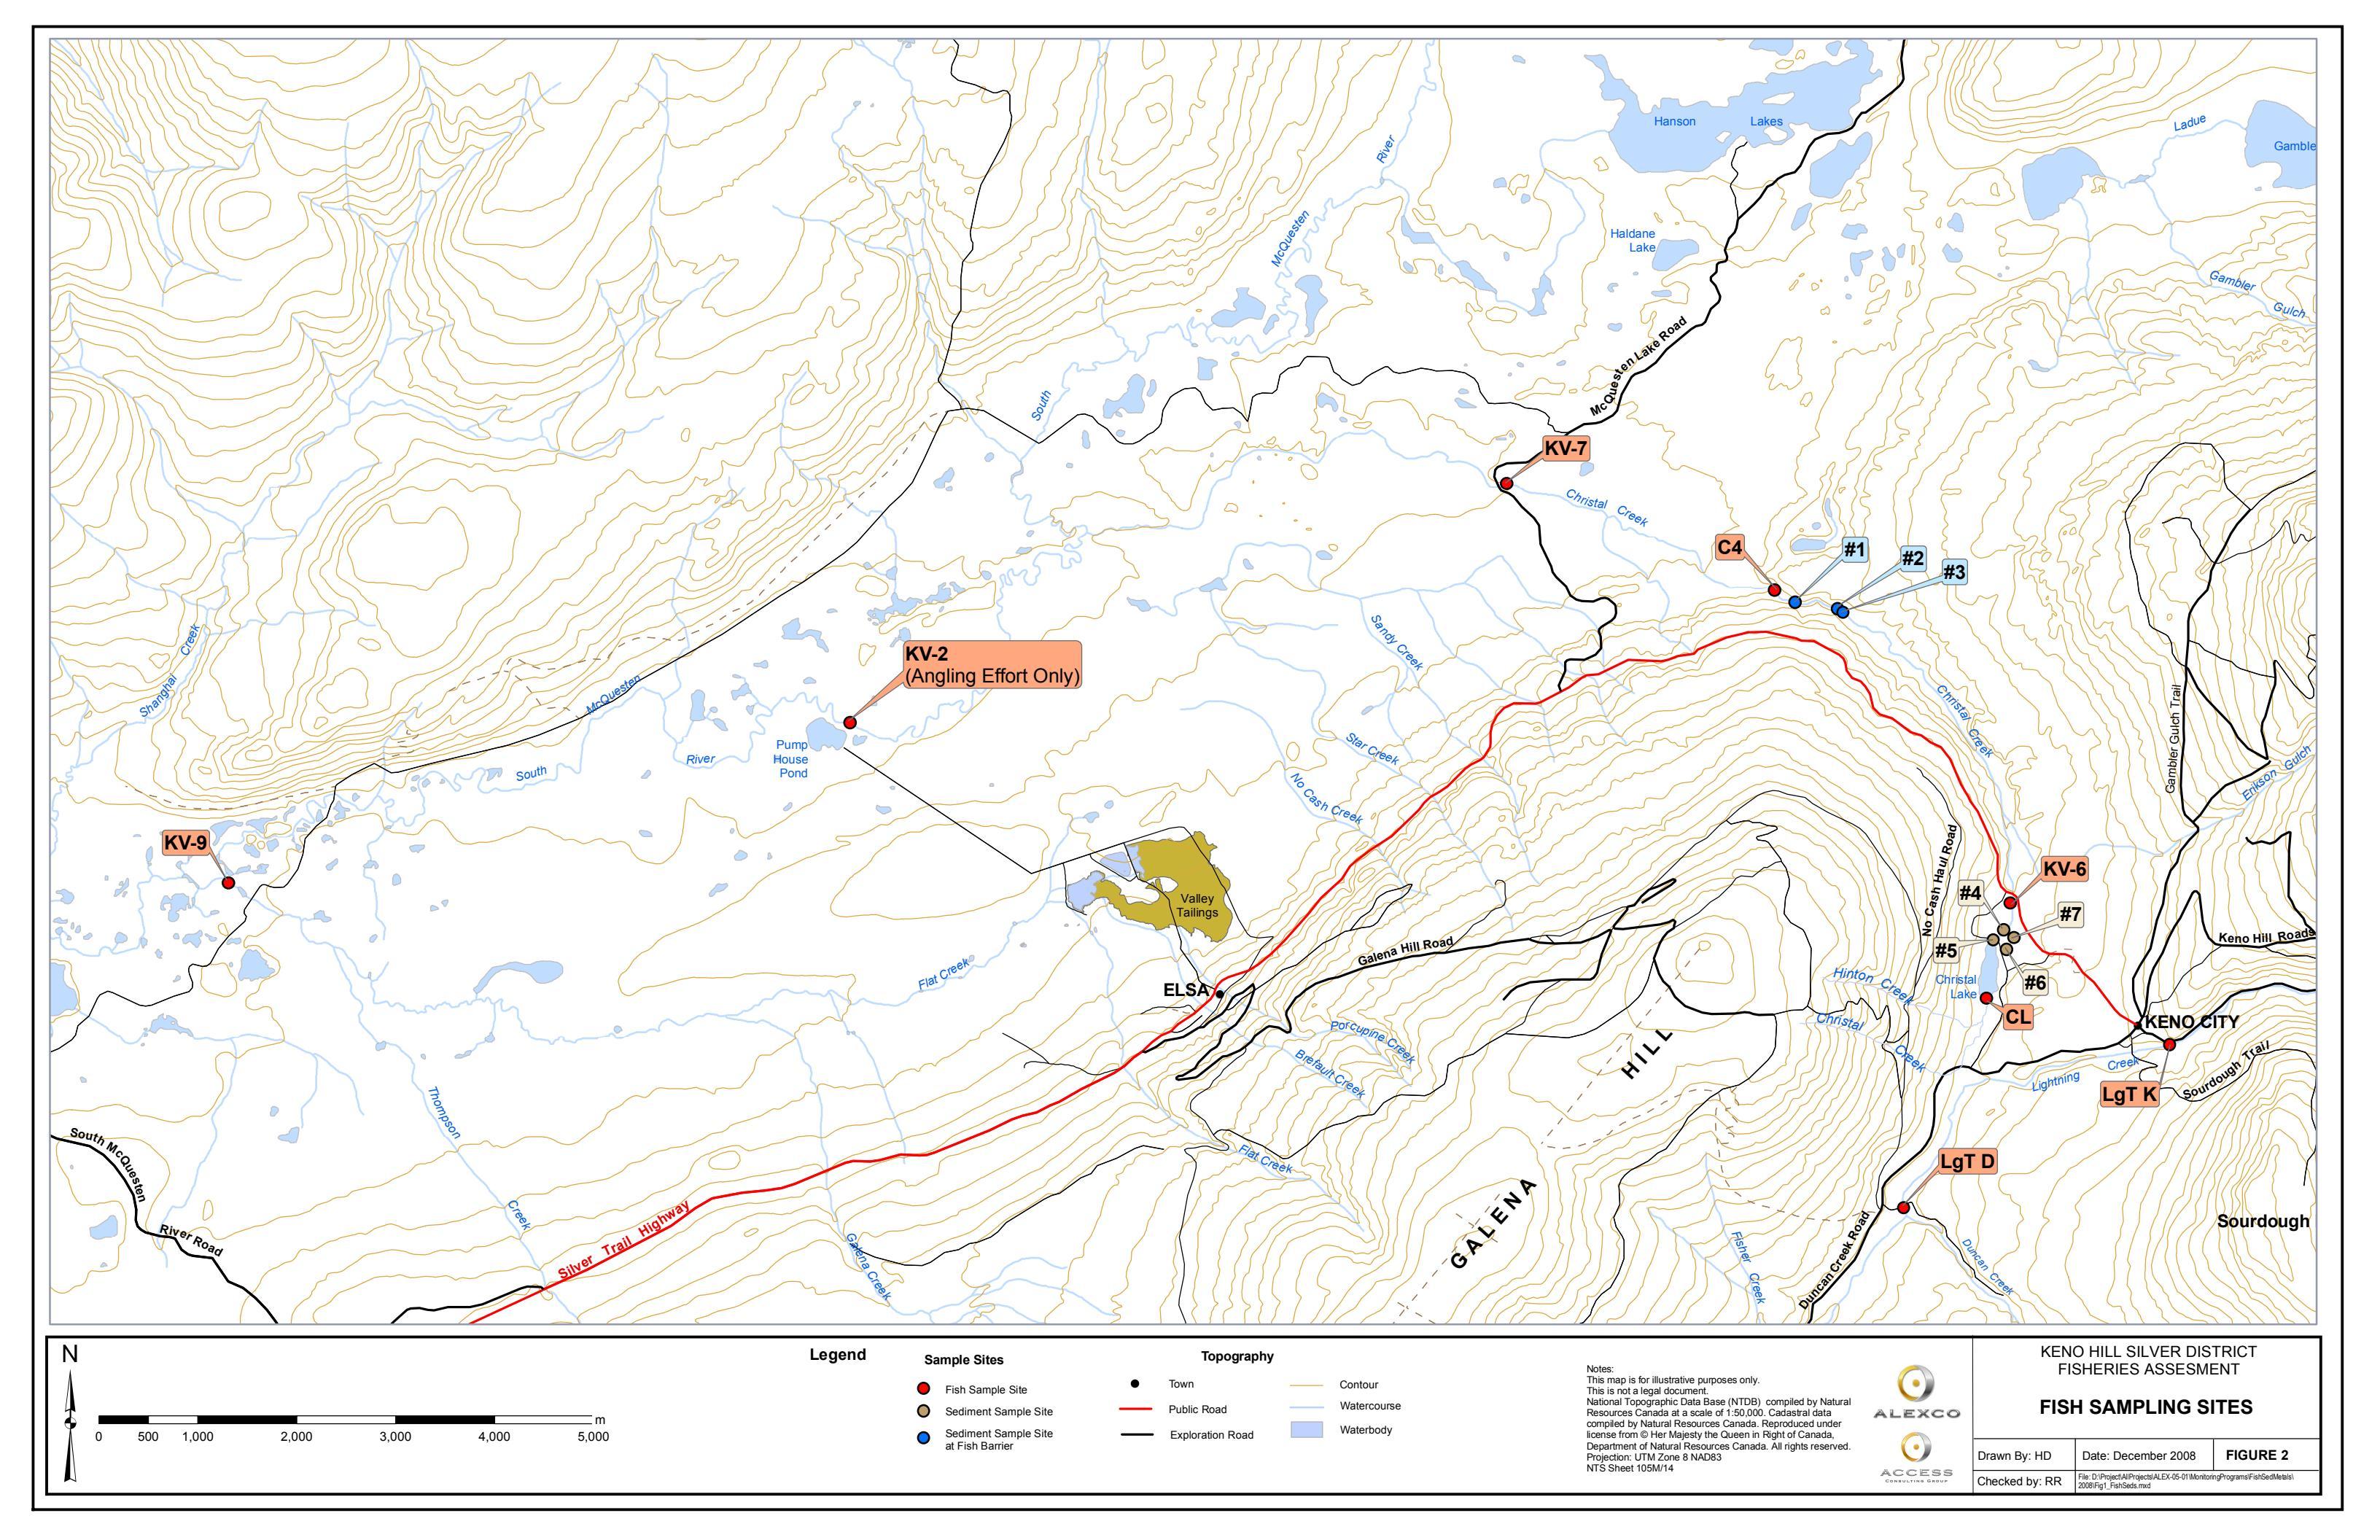
Fish and fish habitat investigations were conducted during September 17 - 19, 2008 at seven sites which included Christal Lake, Christal Creek, Flat Creek and Lightning Creek (Figure 2). The primary method of assessment was via Gee's minnow trapping. Electrofishing was conducted at only three sites due to the lack of suitable electrofishing habitat and conditions. Electrofishing sites were limited to two locations on Lightning Creek and one on Christal Creek.

Sites sampled during this assessment included LgT K & LgT D (Lightning Creek sites), Christal Lake (CL - north and south ends), KV6 (Christal Creek), C4 (Christal Creek), KV7 (Christal Creek) and KV9 (Flat Creek). The sample area had just undergone a considerable period of above normal precipitation and, as a result, most sample locations were experiencing elevated flow rates, above normal discharge and increased turbidity. These three factors limited the extent of electrofishing attempted during this investigation, and to some extent, limited effective minnow trap placement.

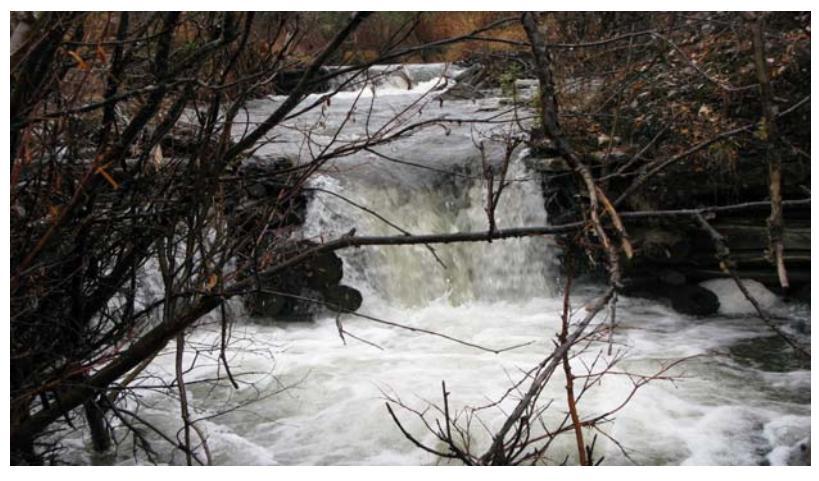
Approximately 300 metres upstream of the first barrier, a double barrier set was encountered. Two barriers, approximately 12 metres apart, are present. The downstream aspect barrier was estimated to constitute a drop of one metre while the upstream barrier was estimated to have a drop of 0.4 metres. Taken in conjunction, the two obstacles provided a formidable barrier to upstream fish movement."

Plate 1 Upstream Barriers #2 & #3 – Christal Creek associated with Site C4. (Photo was taken during a high water event - 2008.)

In order to restore this portion of Christal Creek to a natural unobstructed state, there is the option to have these barriers removed. In order to perform this task in such a manner that minimal disturbance to the creek habitat is produced, available procedural guidelines have been referenced and will be adhered to. Of particular concern is the possible release of accumulated sedimentation that has been deposited upstream of each barrier. Analyses for stream sediment metals were conducted from these three barrier sites in 2008. The results for these analyses and four additional sites associated with the outlet of Christal lake are included in this document in Appendix II.

The two uppermost barriers are several metres apart. Opposing sides will be removed, in hopes that a resting pool will form naturally in between the two barriers, similar to that found in a vertical alternating-slot fish ladder.

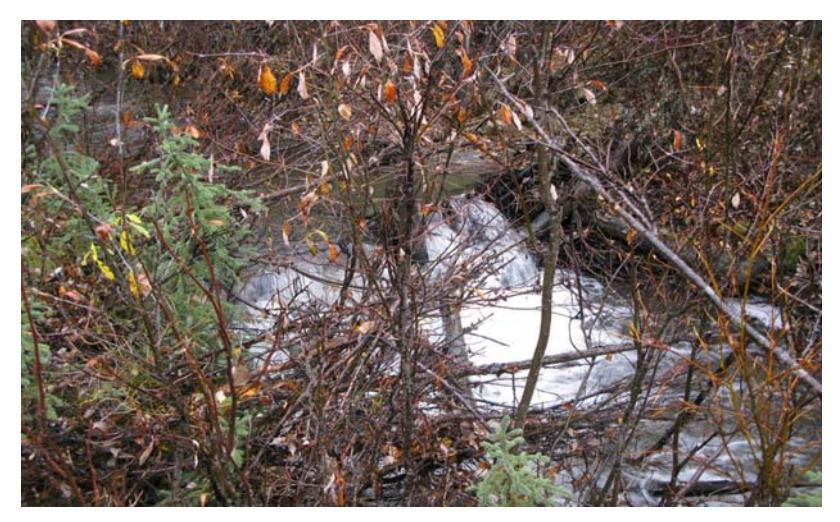
Approximately 250 metres upstream of the C4 site (non-barrier) was a debris barrier apparently formed around the remnants of an old bridge. It formed a blockage that was likely complete for most fish species, with an approximate one metre differential in water elevation.

Plate 2 Downstream Barrier #1 – Christal Creek associated with Site C4. (Photo was taken during a high water event - 2008.)

Only one side of each barrier will be removed, allowing adequate migratory access during virtually any time of the year. Only up to a meter of width or less should be removed in order to allow for fish movement. This will reduce the amount of sediment/materials flushed downstream over a contracted period. Once a section of the barrier is removed, it will begin to degrade naturally over time, minimizing downstream loading of suspended solids.
