Mount Nansen Dome Creek and Victoria Creek Surface Water Quality Evaluation and Preliminary Aquatic Effects Assessment

Prepared for: Little Salmon Carmacks First Nation Carmacks, Yukon

Prepared by: Lorax Environmental Services Ltd. 2289 Burrard St. Vancouver, B.C., Canada, V6J 3H9

> Project No. A399-1 January 31, 2017

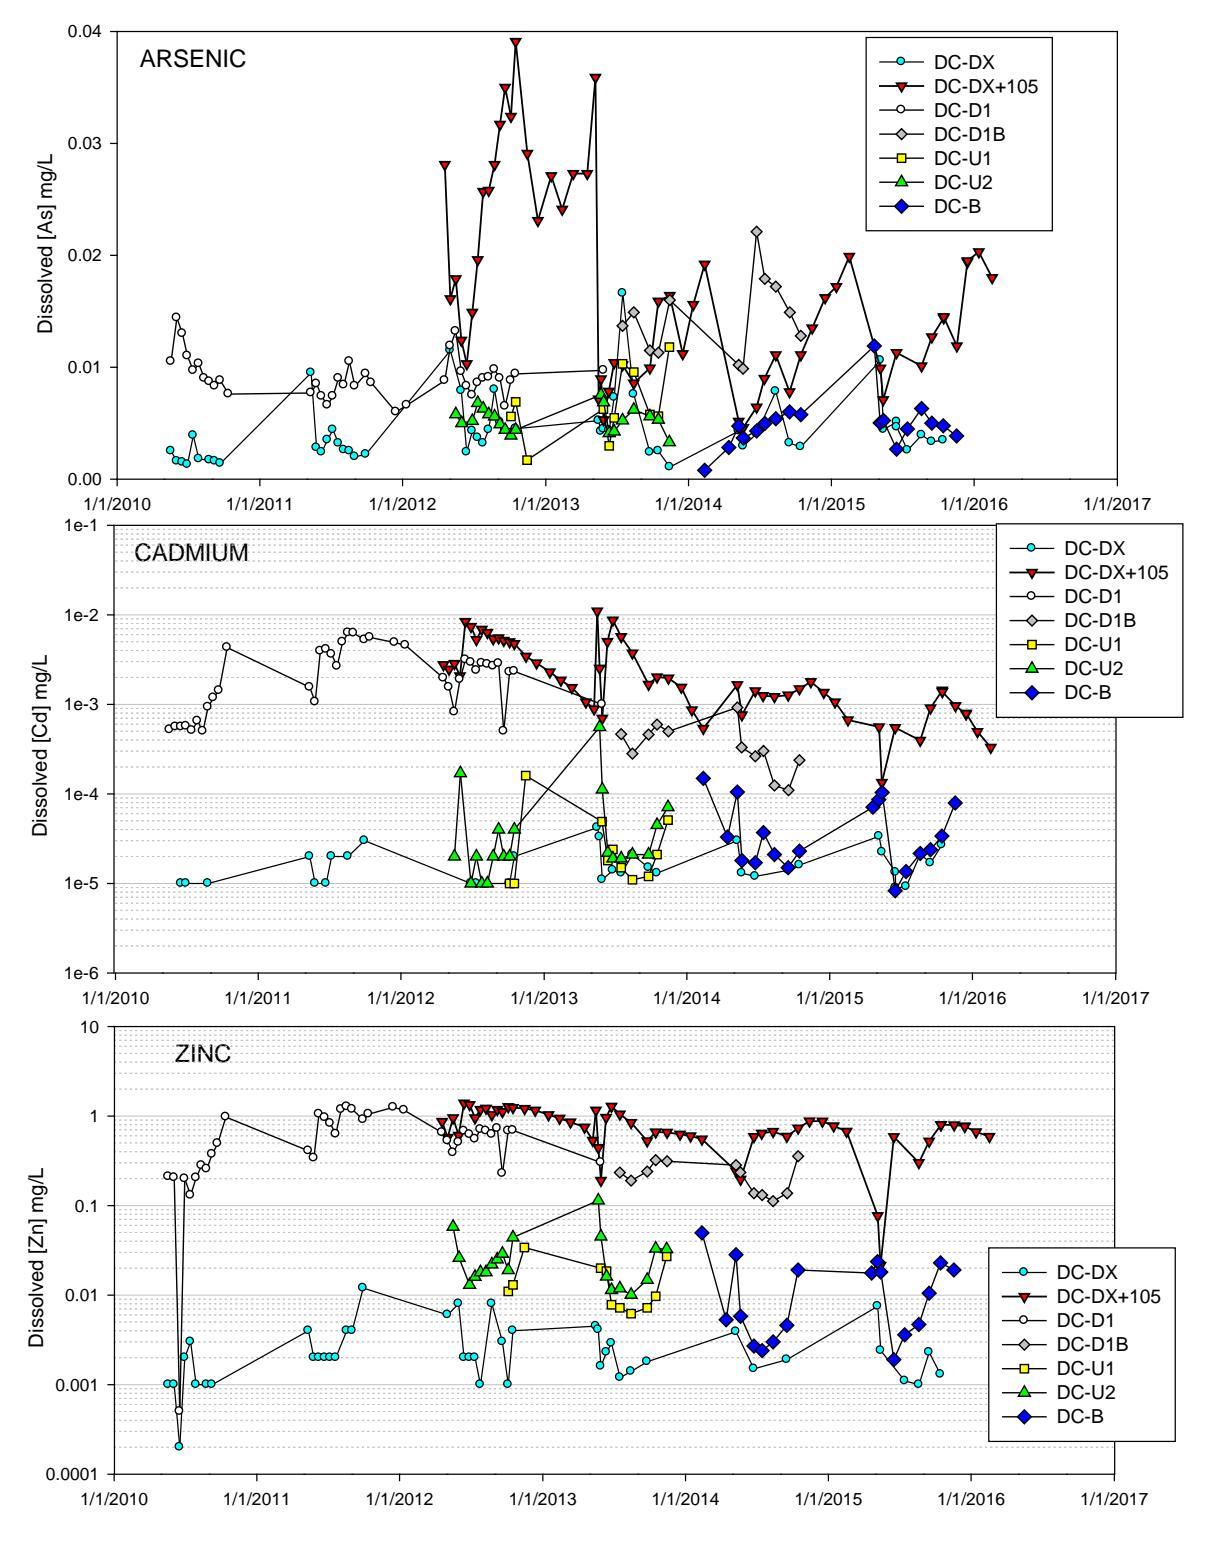
Figure 2-2: Time series profiles for dissolved As, Cd and Zn for surface water stations in Upper Dome Creek (2009-2015 data). Note log scales on Y axes for Cd and Zn.

With respect to redox-related parameters in Upper Dome Creek, dissolved Fe and Mn show the highest values at DC-B. Flows at DC-B merge with seepage flows from the TSF upstream of DC-U (Figure 2-1). Given the circum-neutral pH conditions, the elevated levels of Fe and Mn are predicted to reflect the input of suboxic waters to the creek system, which may relate to both natural and mine-related inputs. Cadmium and Zn concentrations measured at DC-B are lower than values measured in discharge from the Tailings Seepage Pond (Seep) and downstream at DC-U and DC-R, indicating that upper Dome Creek contributes negligibly to the Cd and Zn signatures in lower Dome Creek (Figure 2-2).

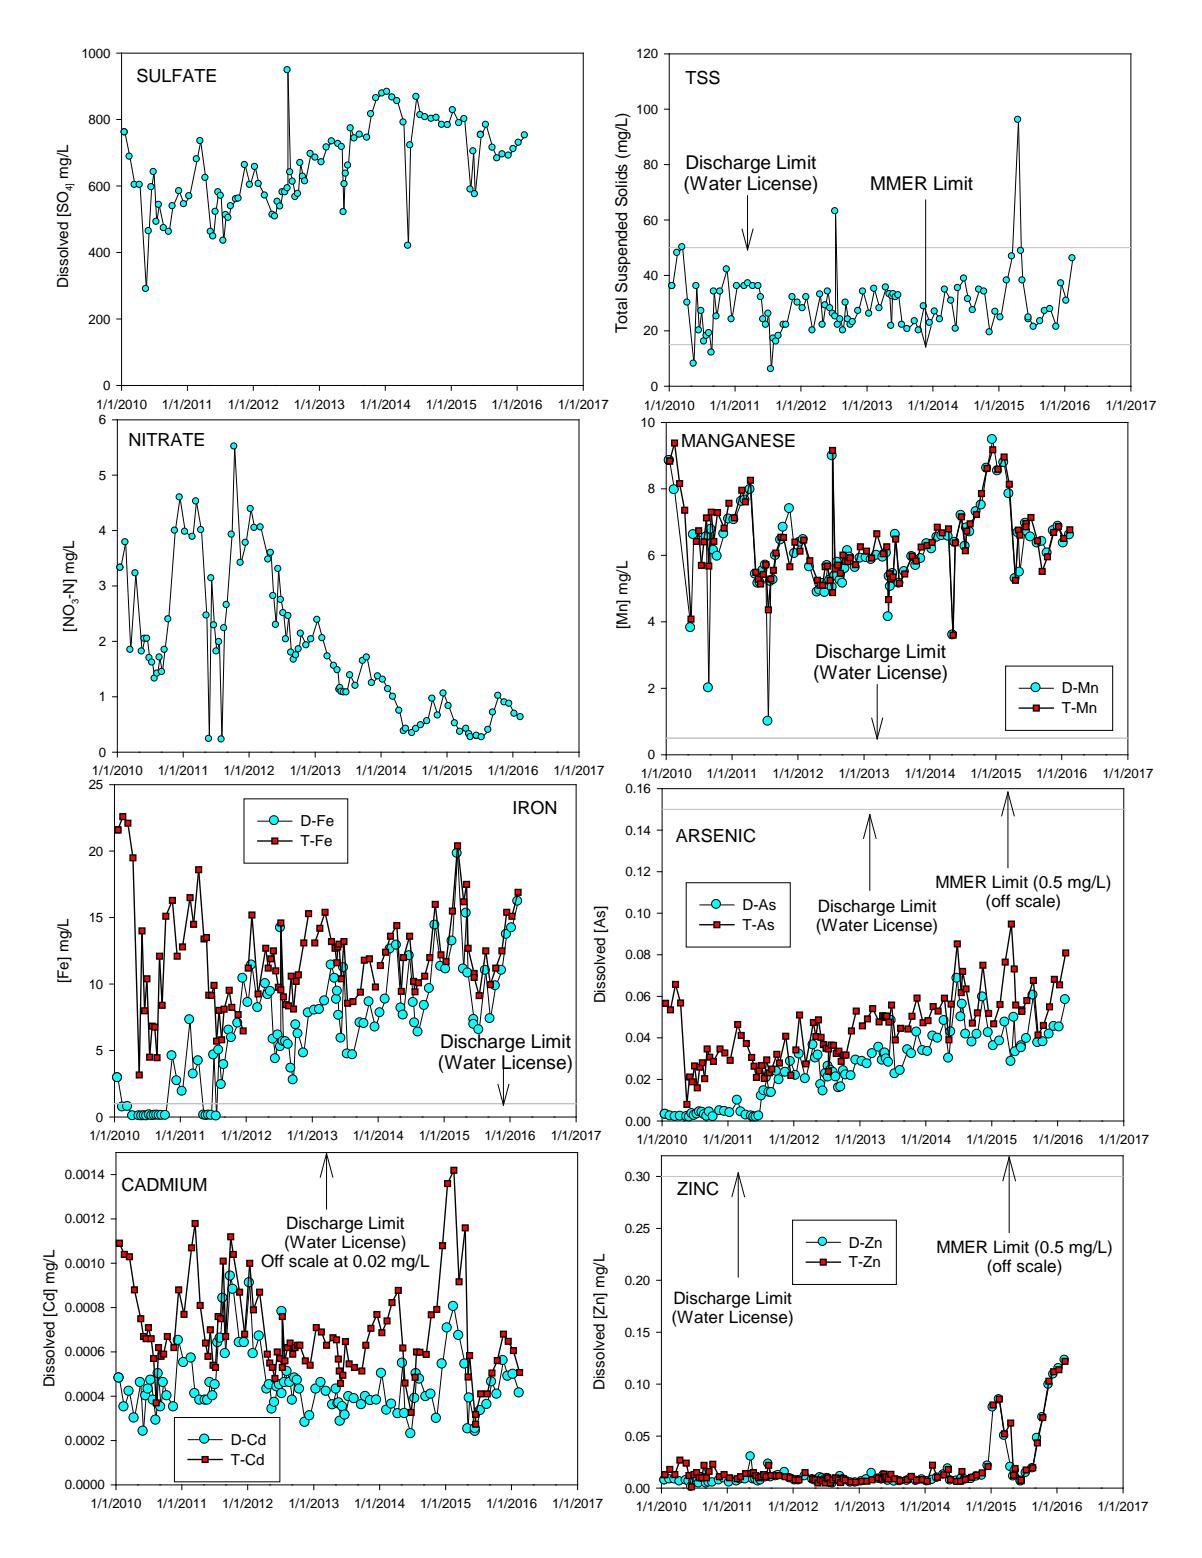
Figure 2-3: Time series profiles for SO₄, total suspended solids, nitrate-N, Mn, Fe, As, Cd and Zn for the Seepage Pond (2010-February 2016 data). Discharge limits (Water License) and MMER limits shown for comparison.

Seepage Pond data for dissolved As show a similar pattern of increase to that of Fe (Figure 2-3), suggesting that the increased mobilization of As is related to the inferred transition towards more reducing conditions within the tailings impoundment. Dissolved Zn and Cd also show pronounced increases in Seep discharge in 2015-2016 (Figure 2-3). However, the Zn and Cd peaks do not correlate with Fe and As, suggesting other process contribute to the observed increases in the Seepage Pond. For example, these observations could relate to enhanced sulfide mineral oxidation and/or early onset of localized acid mine drainage, as illustrated by data for SO₄, Ca and alkalinity in groundwater.

In relation to discharge limits as defined by the Water Licence (Table 2-1), Seepage Pond waters show consistent exceedances with respect to both Fe and Mn (Figure 2-3). Infrequent exceedances have also been recorded for TSS. Note, however, that TSS is typically above Canada's metal mine effluent regulation (MMER) for TSS (15 mg/L). While MMER limits are only applicable to operating mines, they do provide an industry standard for end of pipe effluent discharged to the environment. Values for dissolved As, total Cd, and total Zn have consistently remained below their respect discharge limits (Figure 2-3).

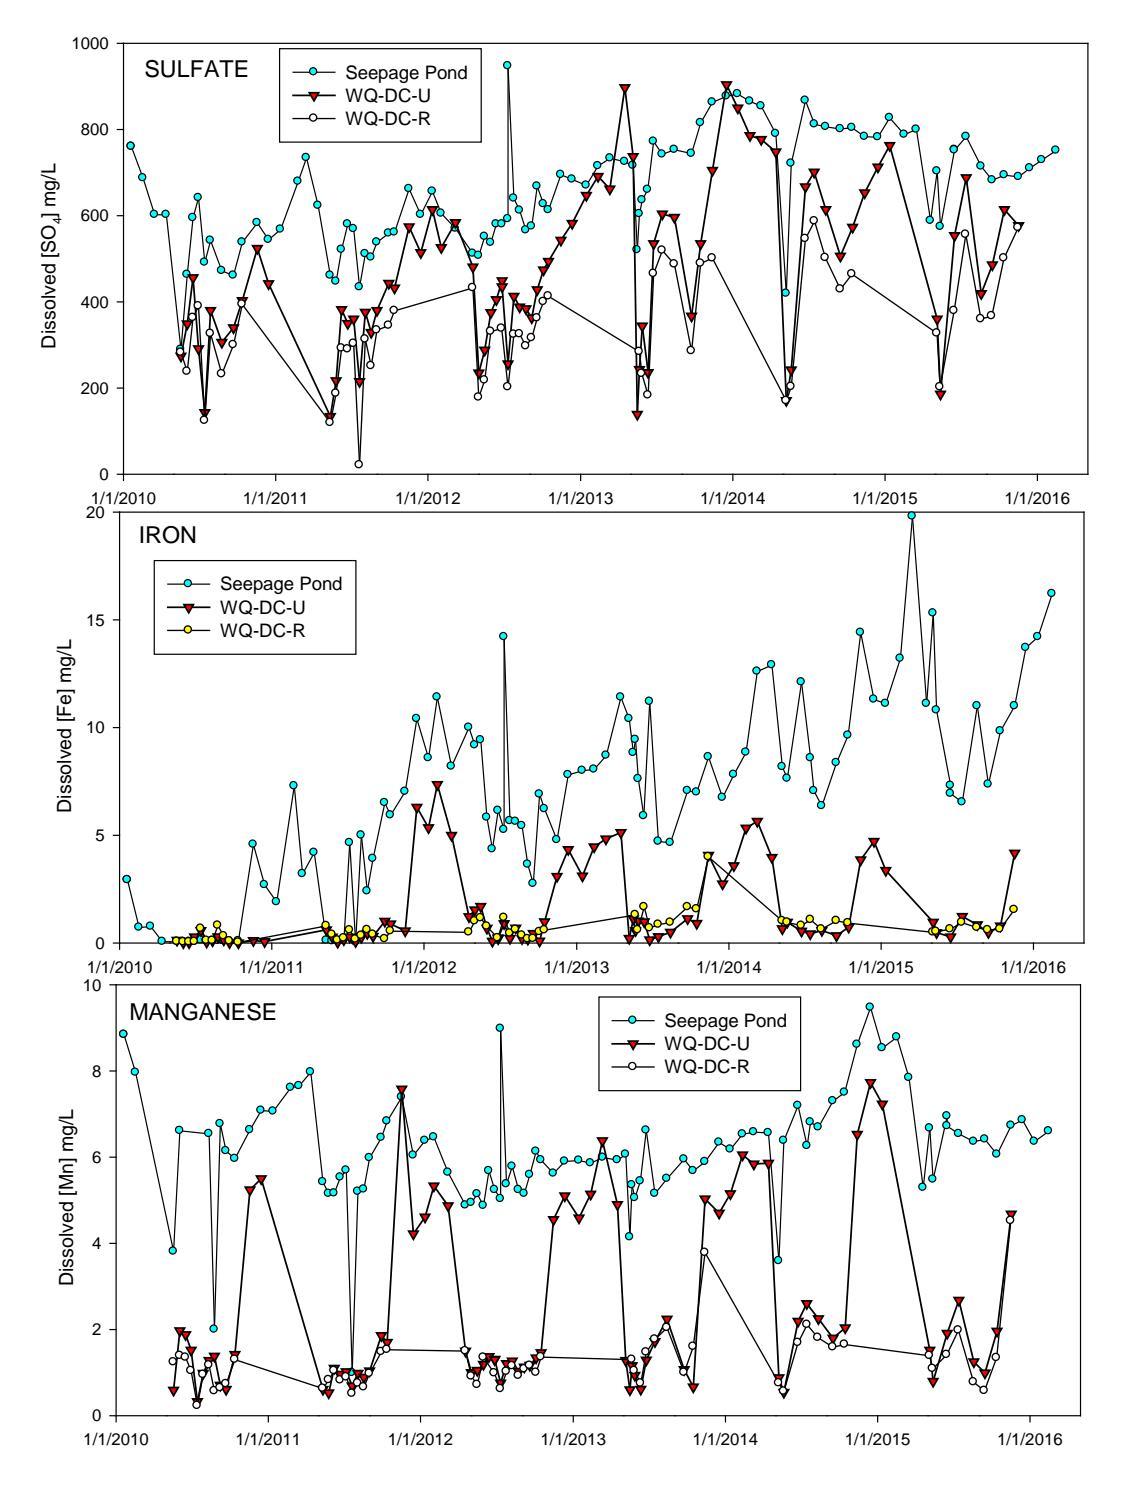
Figure 2-4: Time series profiles for dissolved SO4, and dissolved Fe and Mn for Lower Dome Creek in comparison to Tailings Seepage Pond (2010-2015 data).

The SO₄ increase observed for the Seep between 2012 and 2014 coincides with increases in lower Dome Creek at both DC-U and DC-R (Figure 2-4). With respect to redoxsensitive parameters, the dissolved Mn peak in the Seep in 2014 is congruent with peak values at DC-U, although not evident further downstream at DC-R (Figure 2-4). In contrast, the rise in dissolved Fe concentrations in the Seep since 2010 is not manifested at any of the downstream stations (Figure 2-4), which can likely be attributed to the attenuation of dissolved Fe in close proximity to the tailings facility.

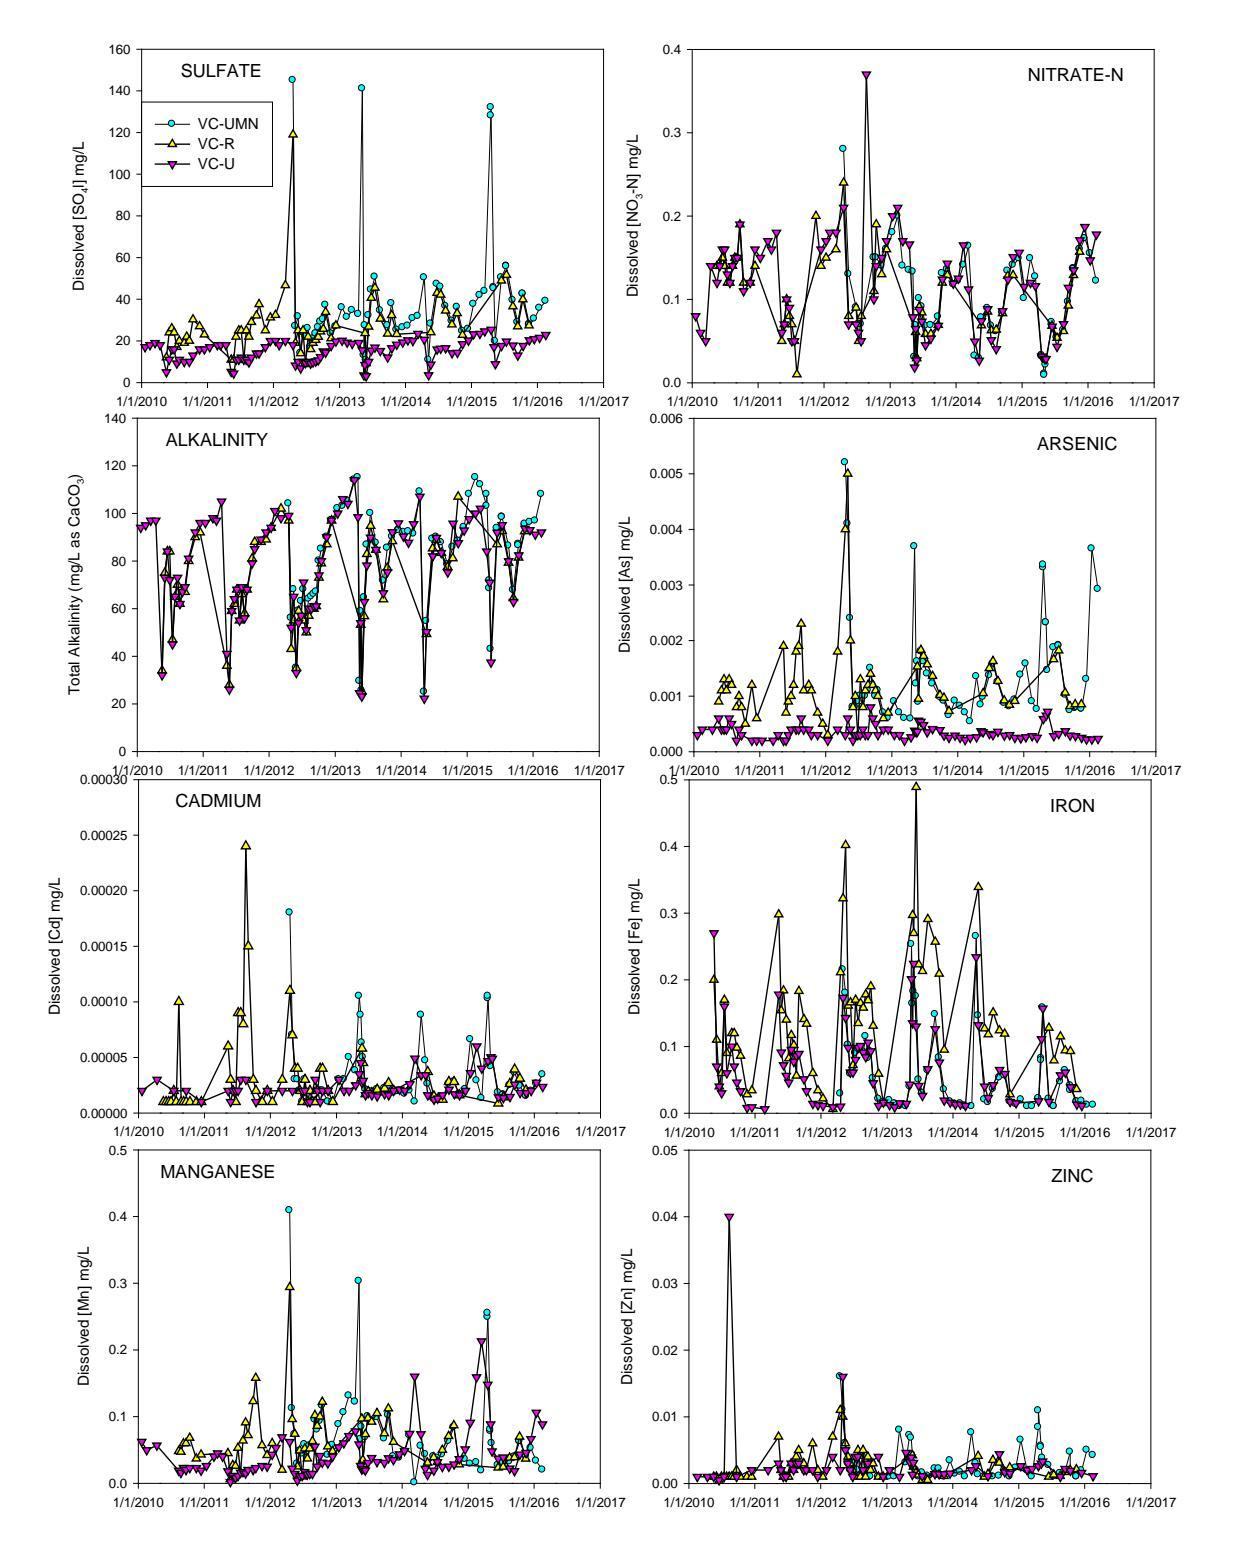
Figure 2-5: Time series profiles for dissolved SO₄, nitrate-N, alkalinity and various dissolved trace elements (As, Cd, Fe, Mn and Zn) for Victoria Creek downstream of Dome Creek confluence, both upstream (VC-UMN) and downstream (VC-R) of Minnesota Creek. Data compared to control site VC-U.

Downstream of the Dome Creek confluence, mine-related signatures are evident in Victoria Creek (Stations VC-R and VC-UMN) with respect to SO₄, Fe, Mn, As, Cd and Zn (Figure 2-5). Increases in SO₄ concentrations since 2010 cannot be linked to upstream inputs to Victoria Creek, as illustrated by the invariant values at DC-U (Figure 2-5). Rather, such increases are consistent with the higher values observed over the same time period in the Seepage Pond and lower Dome Creek, suggesting a tailings-related source. No discernible inter-annual trends are evident for other parameters of concern (*e.g.*, As, Fe, Mn and Zn) in Victoria Creek since 2010, with the possible exception of dissolved Cd,

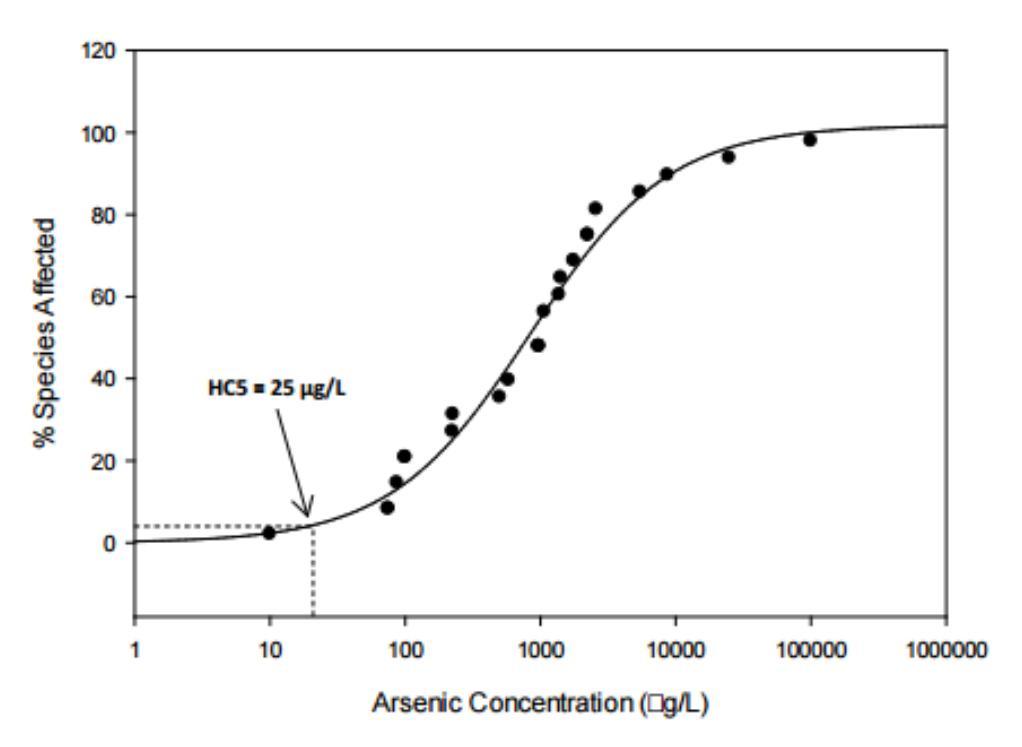
Figure 2-6: Species sensitivty distribution for affects to freshwater aquatic life from arsenic (from Golder, 2013).

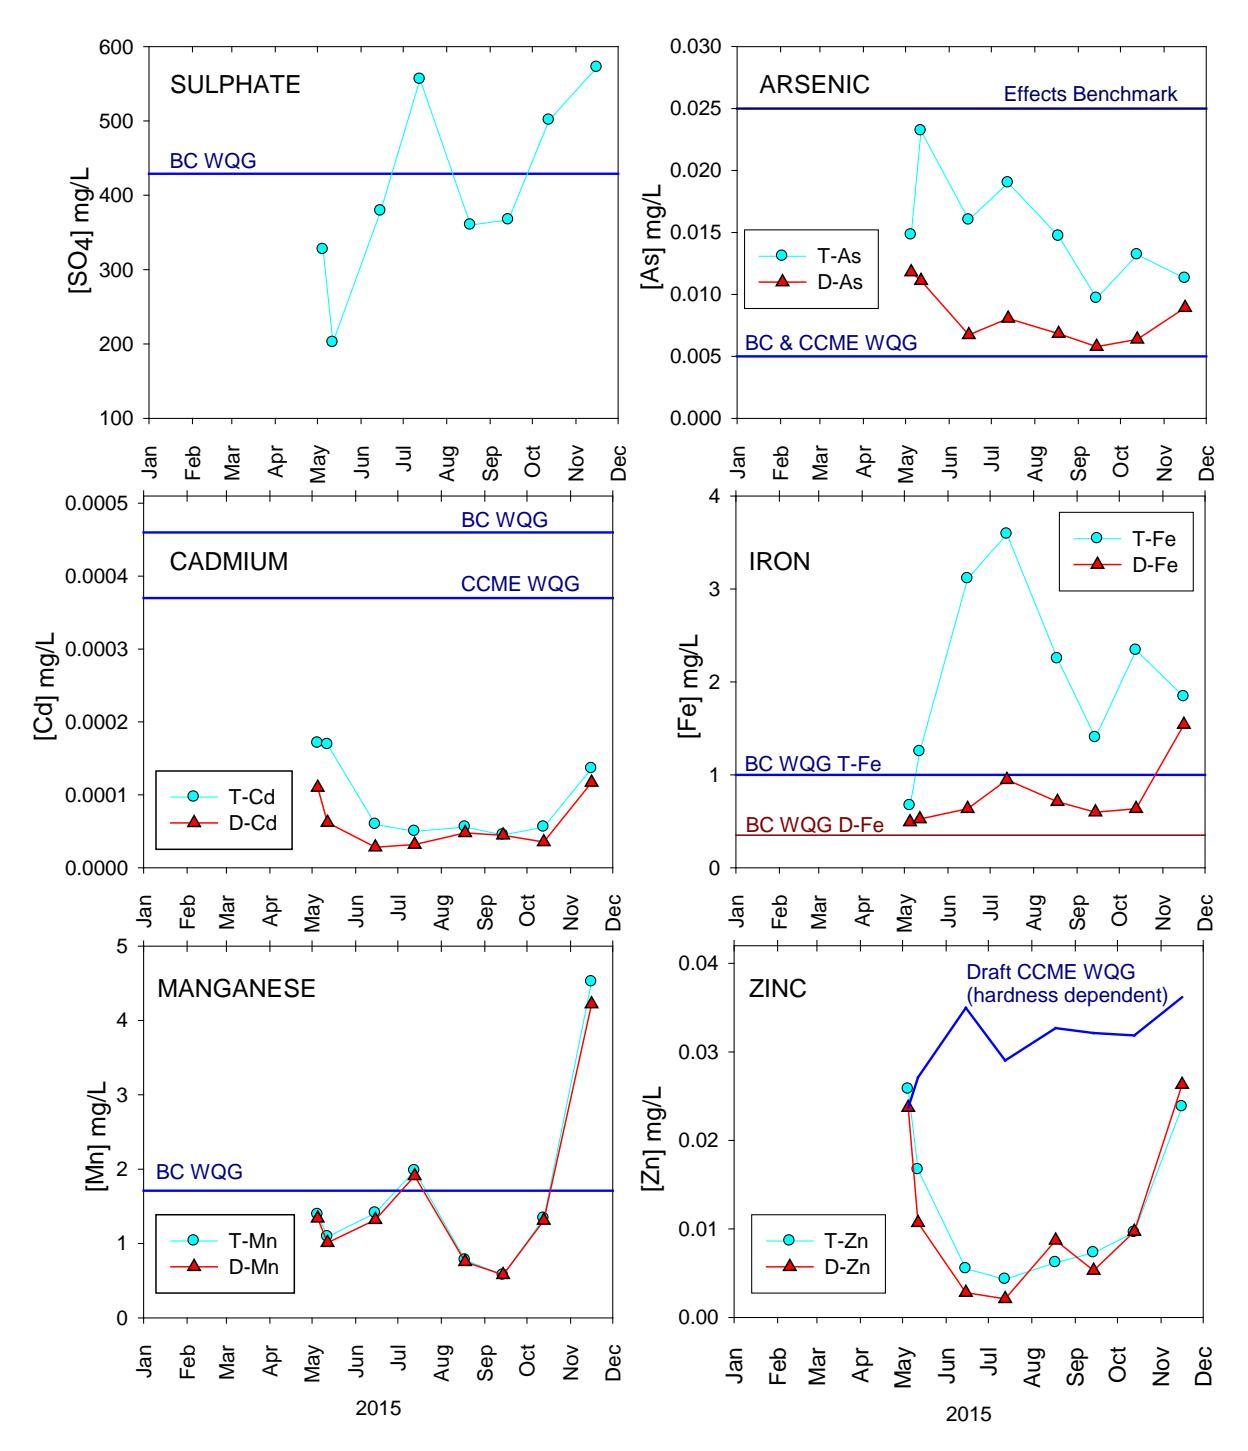
Figure 2-7: Time series profiles for SO4 and total/dissolved As, Cd, Fe, Mn and Zn for surface waters in Lower Dome Creek (DC-R) in comparison to effects benchmarks (2015 data).

2015 water quality data for lower Dome Creek (site DC-R) for parameters of potential concern are shown in comparison to effects benchmarks in Figure 2-7. Note that due to frozen conditions in the winter months, there are no winter water quality data shown. Cadmium and Zn concentrations fell below WQGs in all 2015 samples, with the exception of the May T-Zn measurement which matched the guideline value. Conversely, As values were above the WQG (0.005 mg/L) and below the effects benchmark (0.025 mg/L) in all samples. Since As, Cd, and Zn show measurements consistently less than their respective effects benchmarks, adverse effects to aquatic biota in Dome Creek are not predicted from exposure to these parameters.

Fe concentrations, both total and dissolved, were consistently greater than their WQGs in 2015. The T-Fe WQG was derived from a study that determined that long-term exposure to 1.7 mg/L resulted in a slight change to benthic invertebrate community structure. Given that the annual average T-Fe concentration at DC-R was 2.1 mg/L in 2015, it is possible that Fe has a negative effect on sensitive benthic invertebrate species in lower Dome Creek.

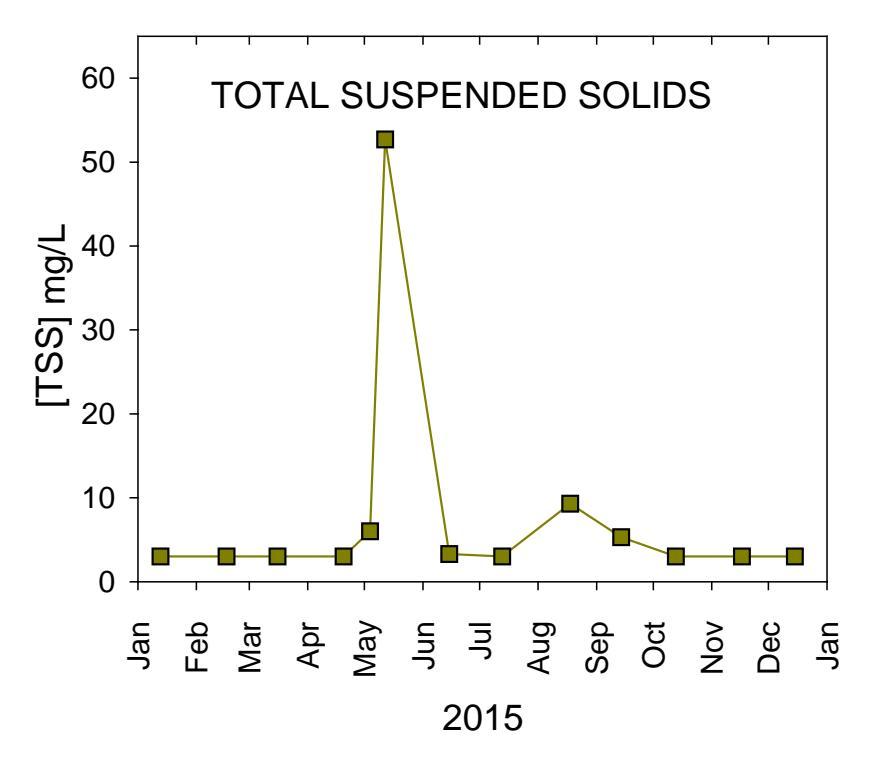
Figure 2-8: Total suspended solids at Victoria Creek site VC-UMN during 2015.

At VC-UMN, the only exceedances of effects benchmarks in 2015 occurred in association with the TSS maximum in May, reflecting elevated particulate metal levels during this time. This seasonal increase in TSS and total metals during freshet in Victoria Creek is a natural process that aquatic life in Victoria Creek experience on an annual basis and was observed upstream of Dome Creek. Overall, adverse effects to aquatic life in Victoria Creek are not predicted. This conclusion relates to: 1) lack of benchmark exceedances outside of freshet periods; 2) the natural occurrence of bench mark exceedances in association with freshet flows; and 3) decreased bioavailability of particulate-bound metals in comparison to dissolved metals.

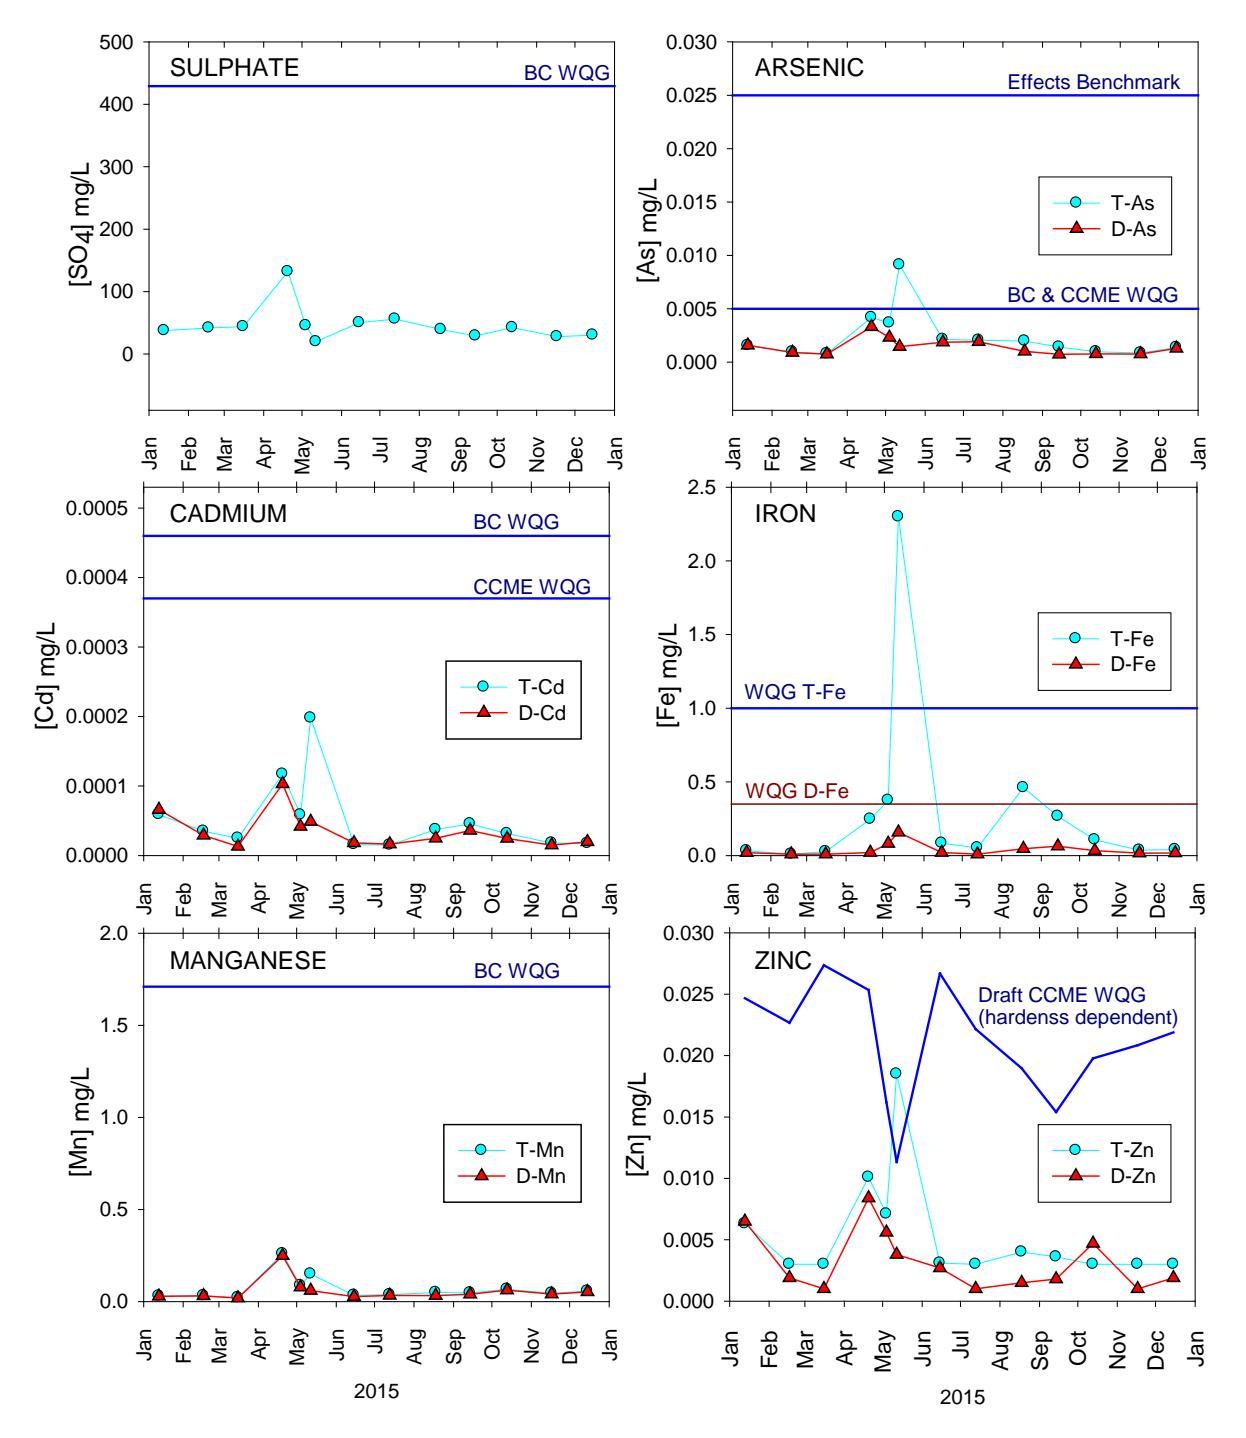
Figure 2-9: Time series profiles for SO₄ and total/dissolved As, Cd, Fe, Mn and Zn for surface waters in Victoria Creek downstream of Dome Creek confluence (VC-UMN) in comparison to effects benchmarks (2015 data).

In contrast to Dome Creek, Victoria Creek is fish bearing, hosting populations of Arctic grayling, slimy sculpin, and burbot (EDI, 2009). Victoria Creek flows year-round, and water quality samples were collected in each month during 2015. Freshet occurred in May in 2015, and caused a large increase in total suspended solids (TSS) concentration (Figure 2-8). The May TSS peak can be linked to concentration maxima in total metals associated with suspended sediments (T-As, T-Cd, T-Fe, and T-Zn) (Figure 2-9).

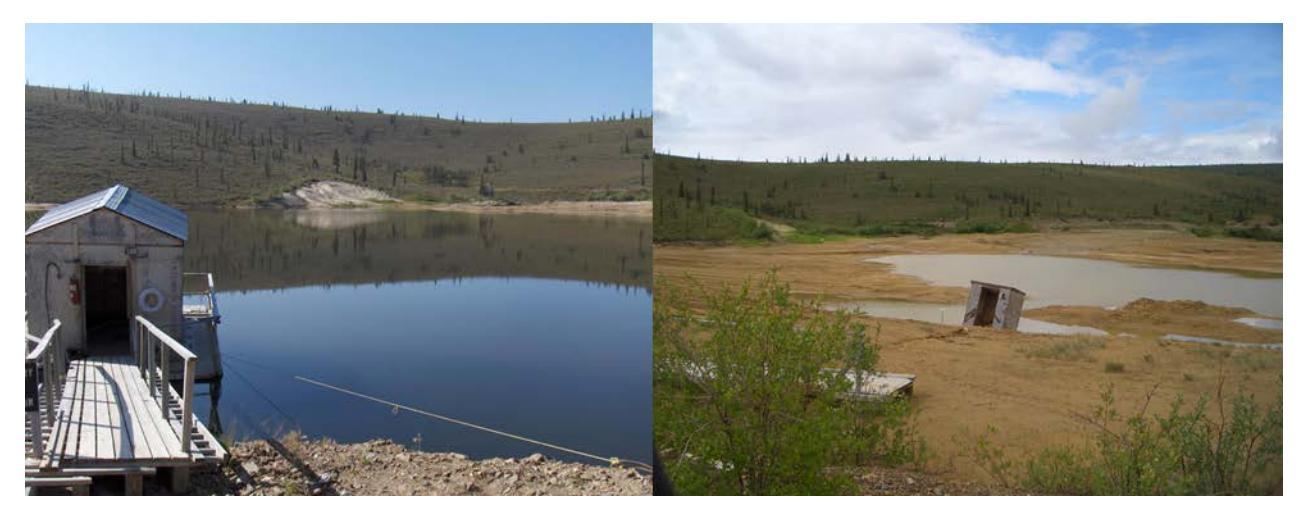
Figure 3-1: Pictures of flooded tailings impoundment (left, 2005) and drained tailings impoundment (right, 2010).

Predicting the timing of AMD is difficult; however, examination of past water management practices provides some insight. Beginning in 2005, water was discharged seasonally from the Tailings Pond due to improved water quality. After this time, water levels were kept at a minimum in the pond to help mitigate geotechnical risks associated with concerns over dam stability. The changes in water level in the Tailings Pond are clearly illustrated in Figure 3-1, which shows images for 2005 and 2010. Following these changes to water management practices in 2005, a greater proportion of tailings within the impoundment have been exposed to oxygen, allowing for enhanced sulfide oxidation within the unsaturated materials. This enhanced oxidation regime, which may lead to AMD, has been on-going for approximately ten years.

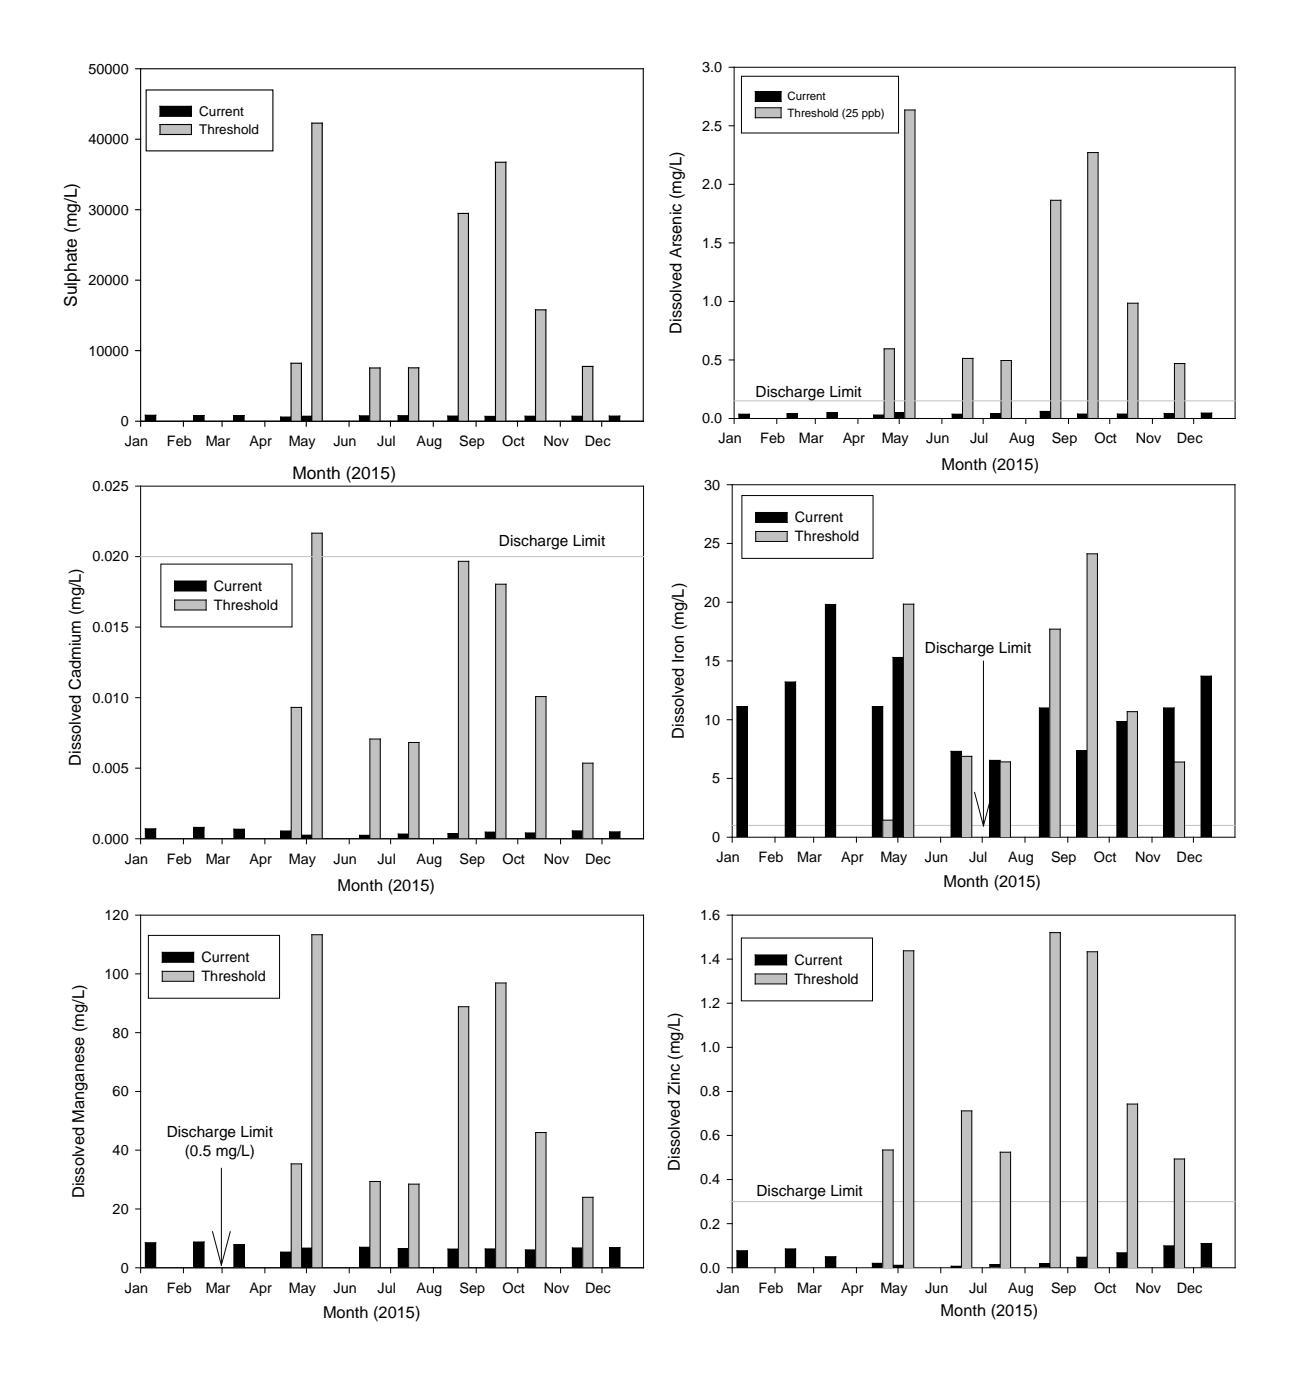
Figure 3-2: Modeled Tailings Seepage Pond discharge concentrations (Threshold) that would exceed WQ guidelines in Victoria Creek for key parameters (SO4, As, Cd, Fe, Mn and Zn). 2015 observations (Current) and Discharge Limits shown for comparison. Threshold values were not calculated for months with no measurable flow in lower Dome Creek (December through April).

Overall, the results of the loading model exercise illustrate that Fe, Mn and Zn represent the primary parameters of concern for water quality management in Victoria Creek. The results specifically imply that for any further increases in tailings-related loadings to Dome Creek, these parameters pose the greatest risk for exceedances of aquatic life benchmarks in Victoria Creek. As such, Fe, Mn and Zn can be viewed as limiting parameters.

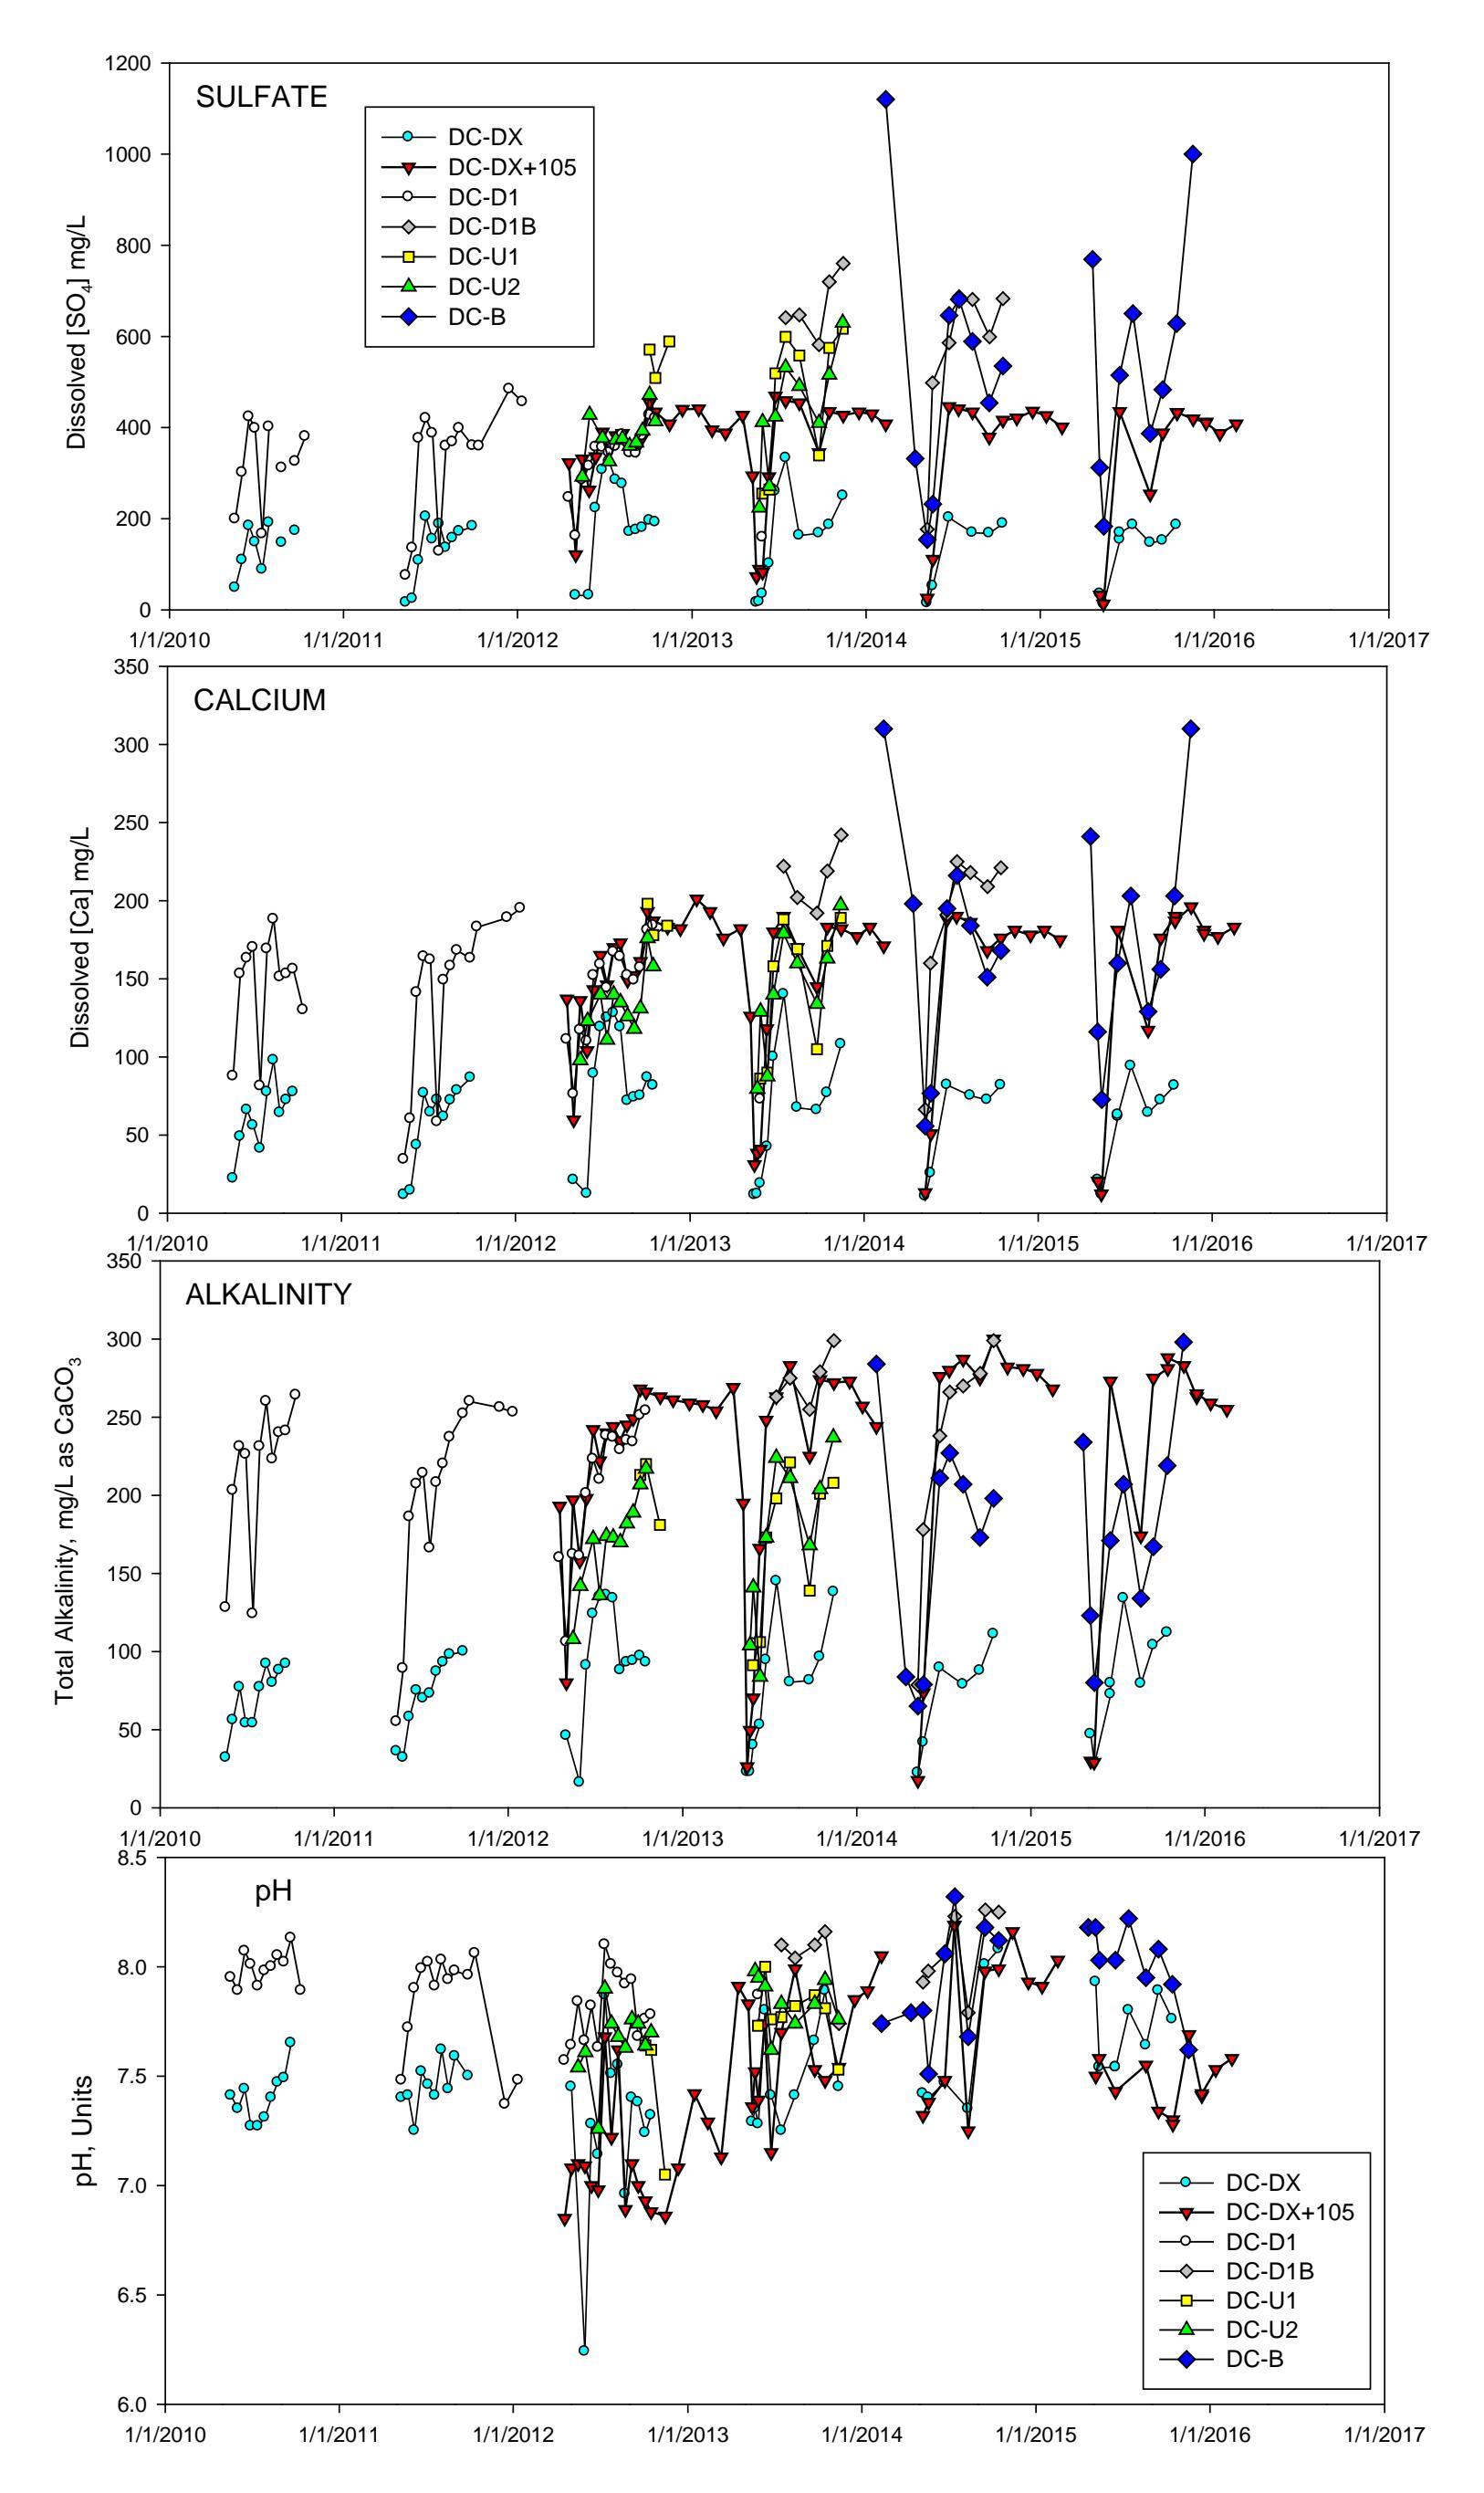
Figure 3: Time series profiles for major ions and pH for surface water stations in Upper Dome Creek (2009-2015 data).

At the upstream control location (DC-DX), time series profiles for major ions (Figure 3) and trace elements (Figure 5) show generally stable seasonal cycles, with pronounced minima observed during freshet. In contrast, the data for dissolved Mn and Fe at DC-DX show episodic spikes in concentration that are not observed for other parameters.
