Mount Nansen Dome Creek and Victoria Creek Surface Water Quality Evaluation and Preliminary Aquatic Effects Assessment

Prepared for: Little Salmon Carmacks First Nation Carmacks, Yukon

Prepared by: Lorax Environmental Services Ltd. 2289 Burrard St. Vancouver, B.C., Canada, V6J 3H9

> Project No. A399-1 January 31, 2017

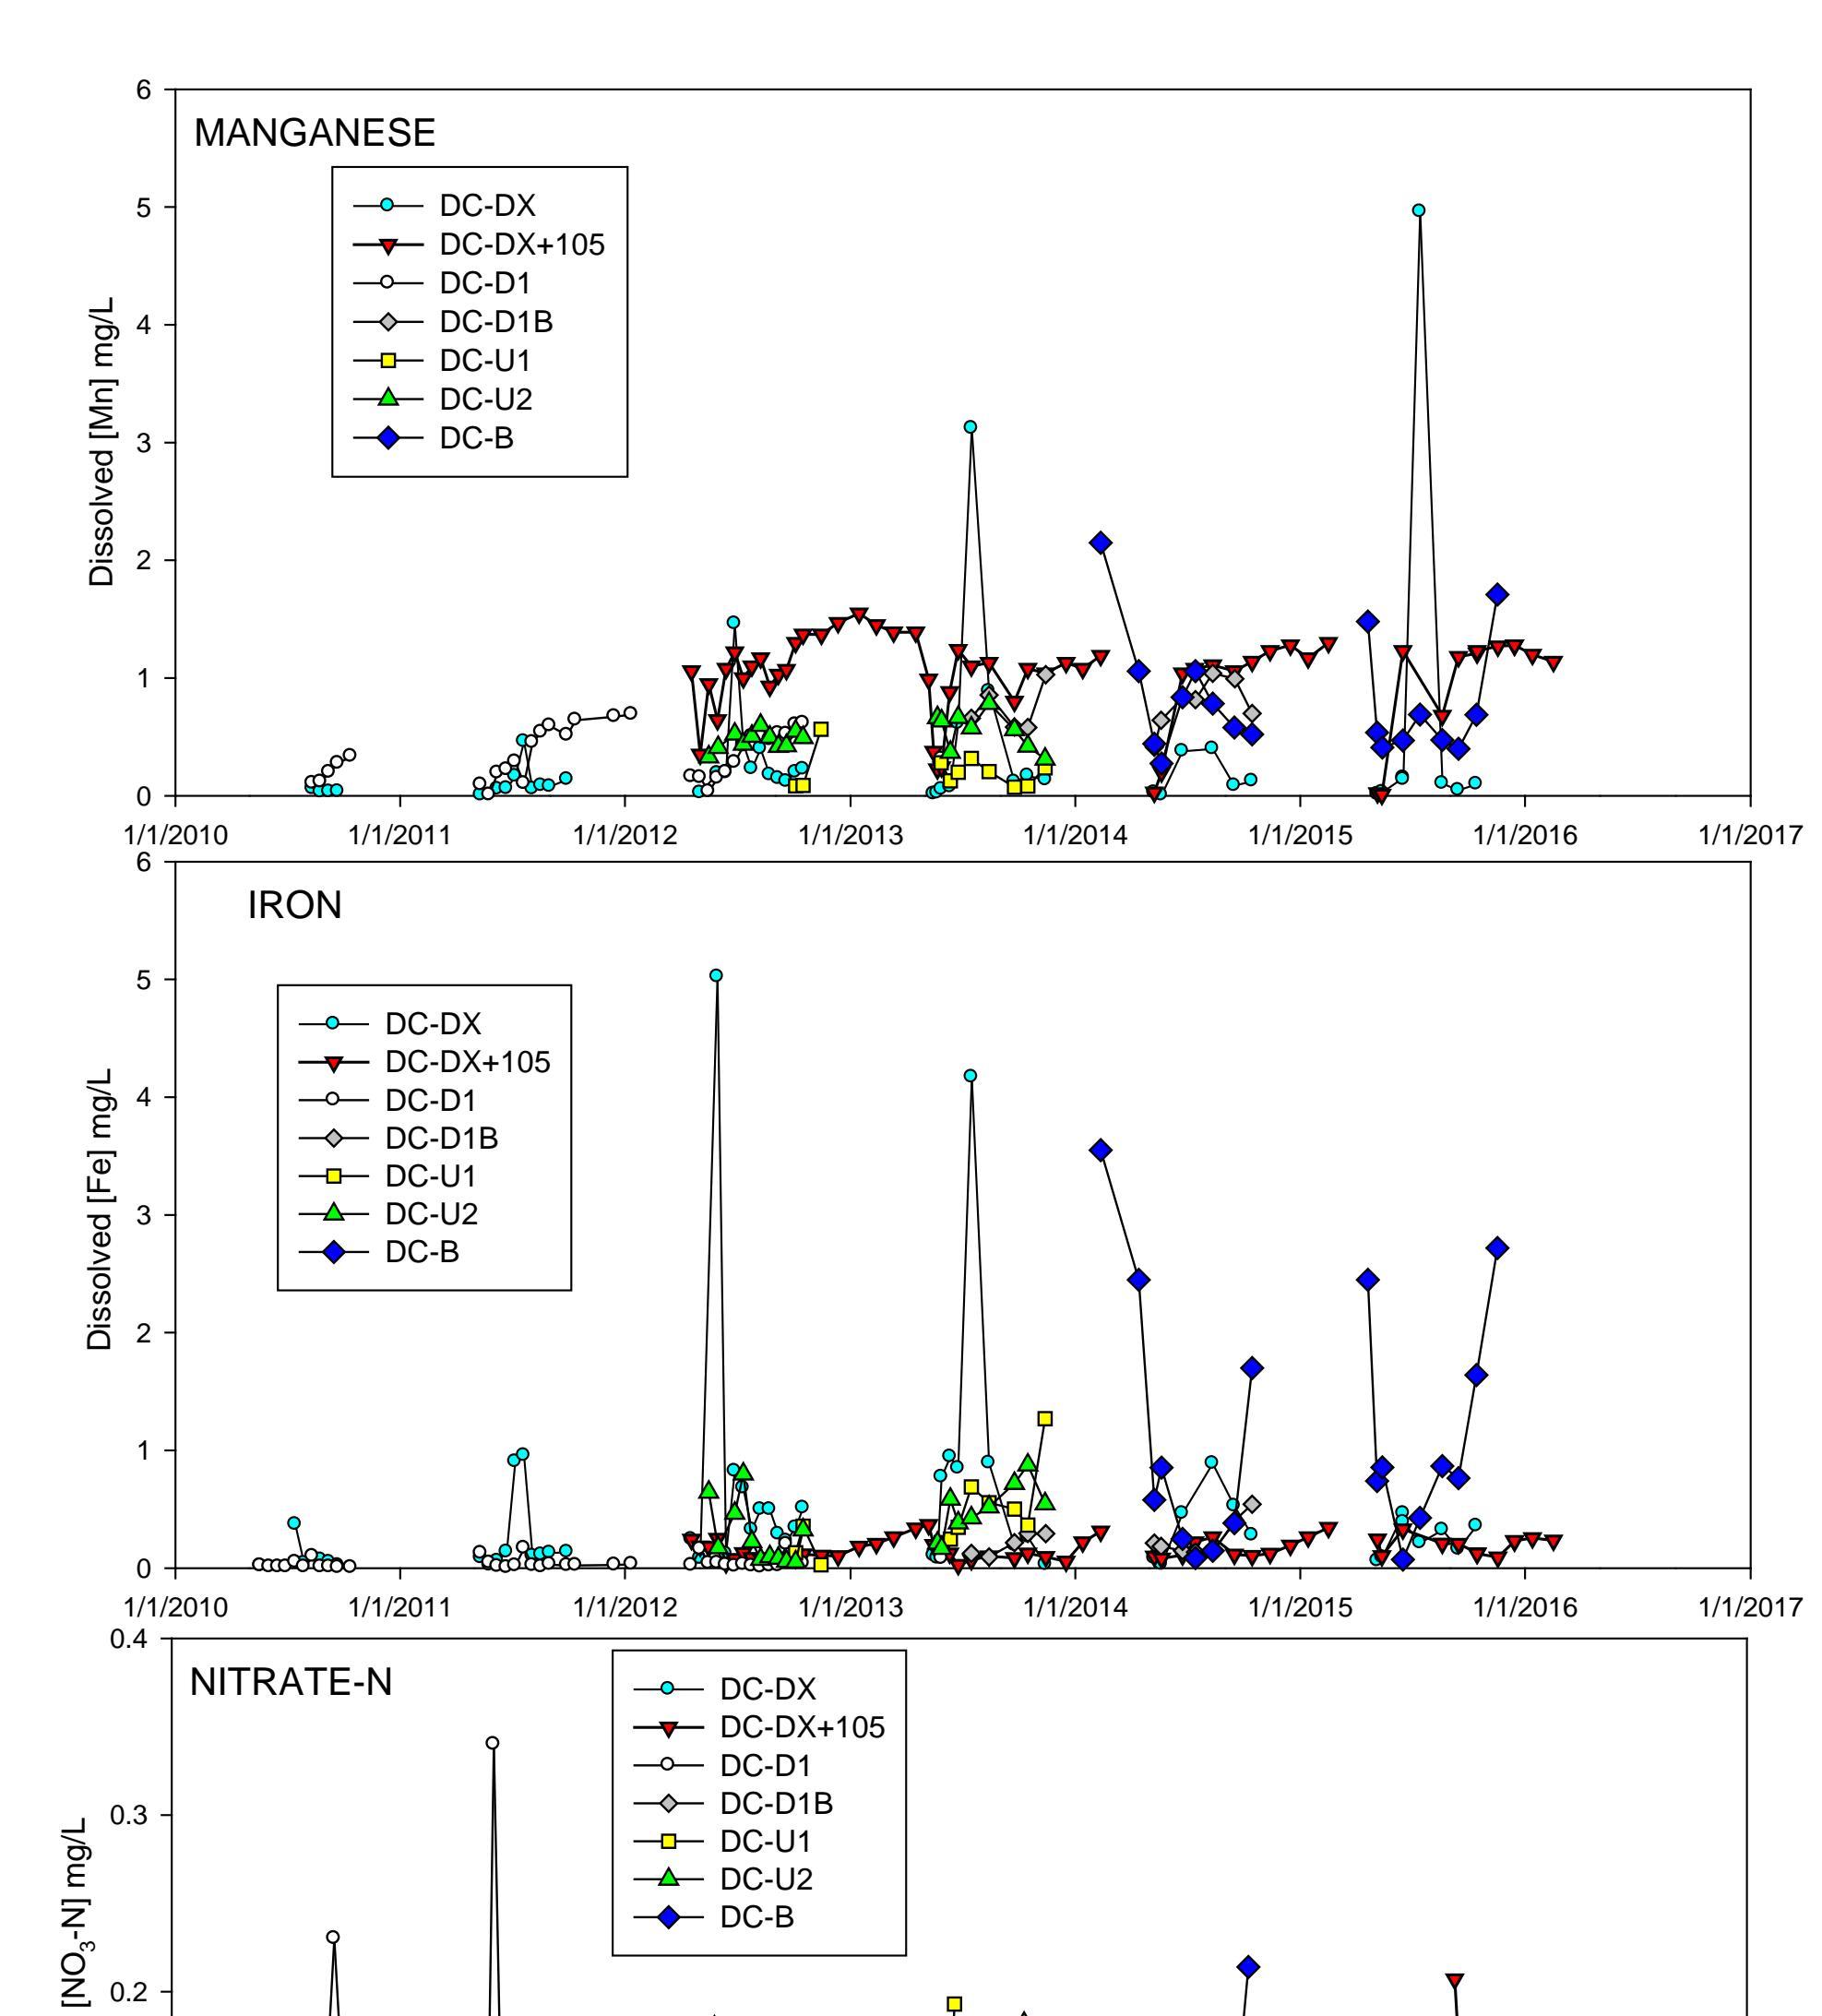
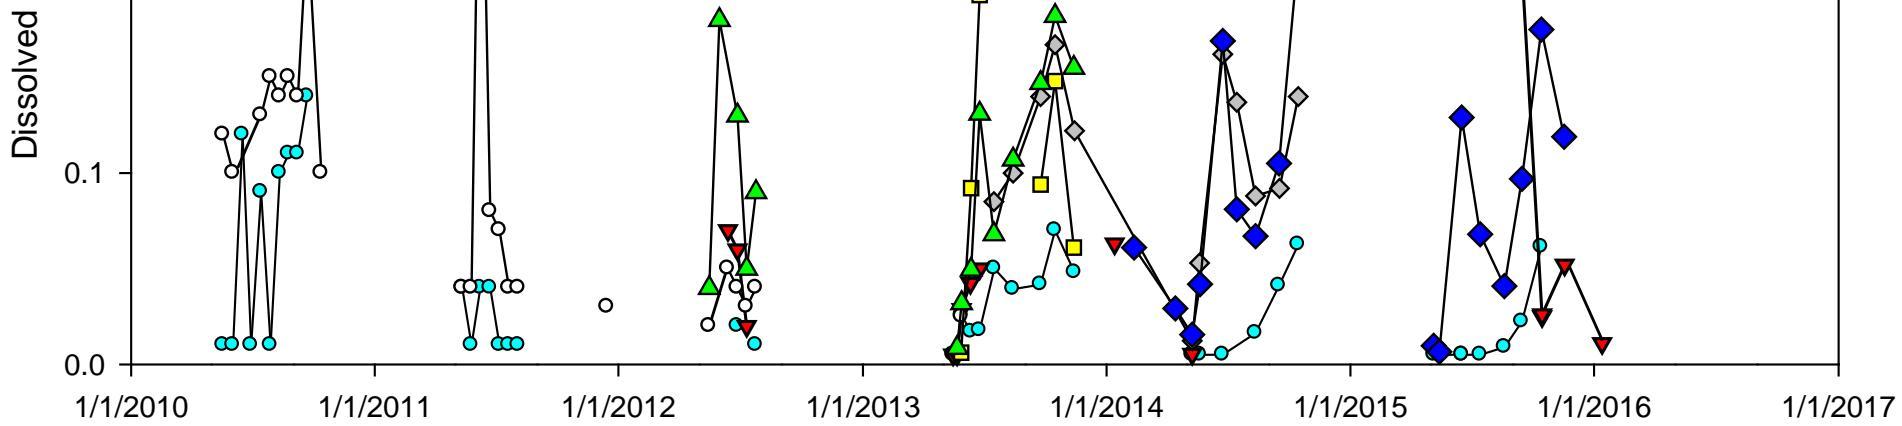
Figure 4: Time series profiles for redox-related parameters for surface water stations in Upper Dome Creek (2009-2015 data).

With respect to redox-related parameters, dissolved Fe and Mn show the highest values at DC-B. Dissolved Fe and Mn are not stable in neutral, aerated waters. Given the circum-neutral pH conditions, the elevated levels of Fe and Mn are predicted to reflect the input of suboxic (reduced) waters to the creek system (Figure 4).

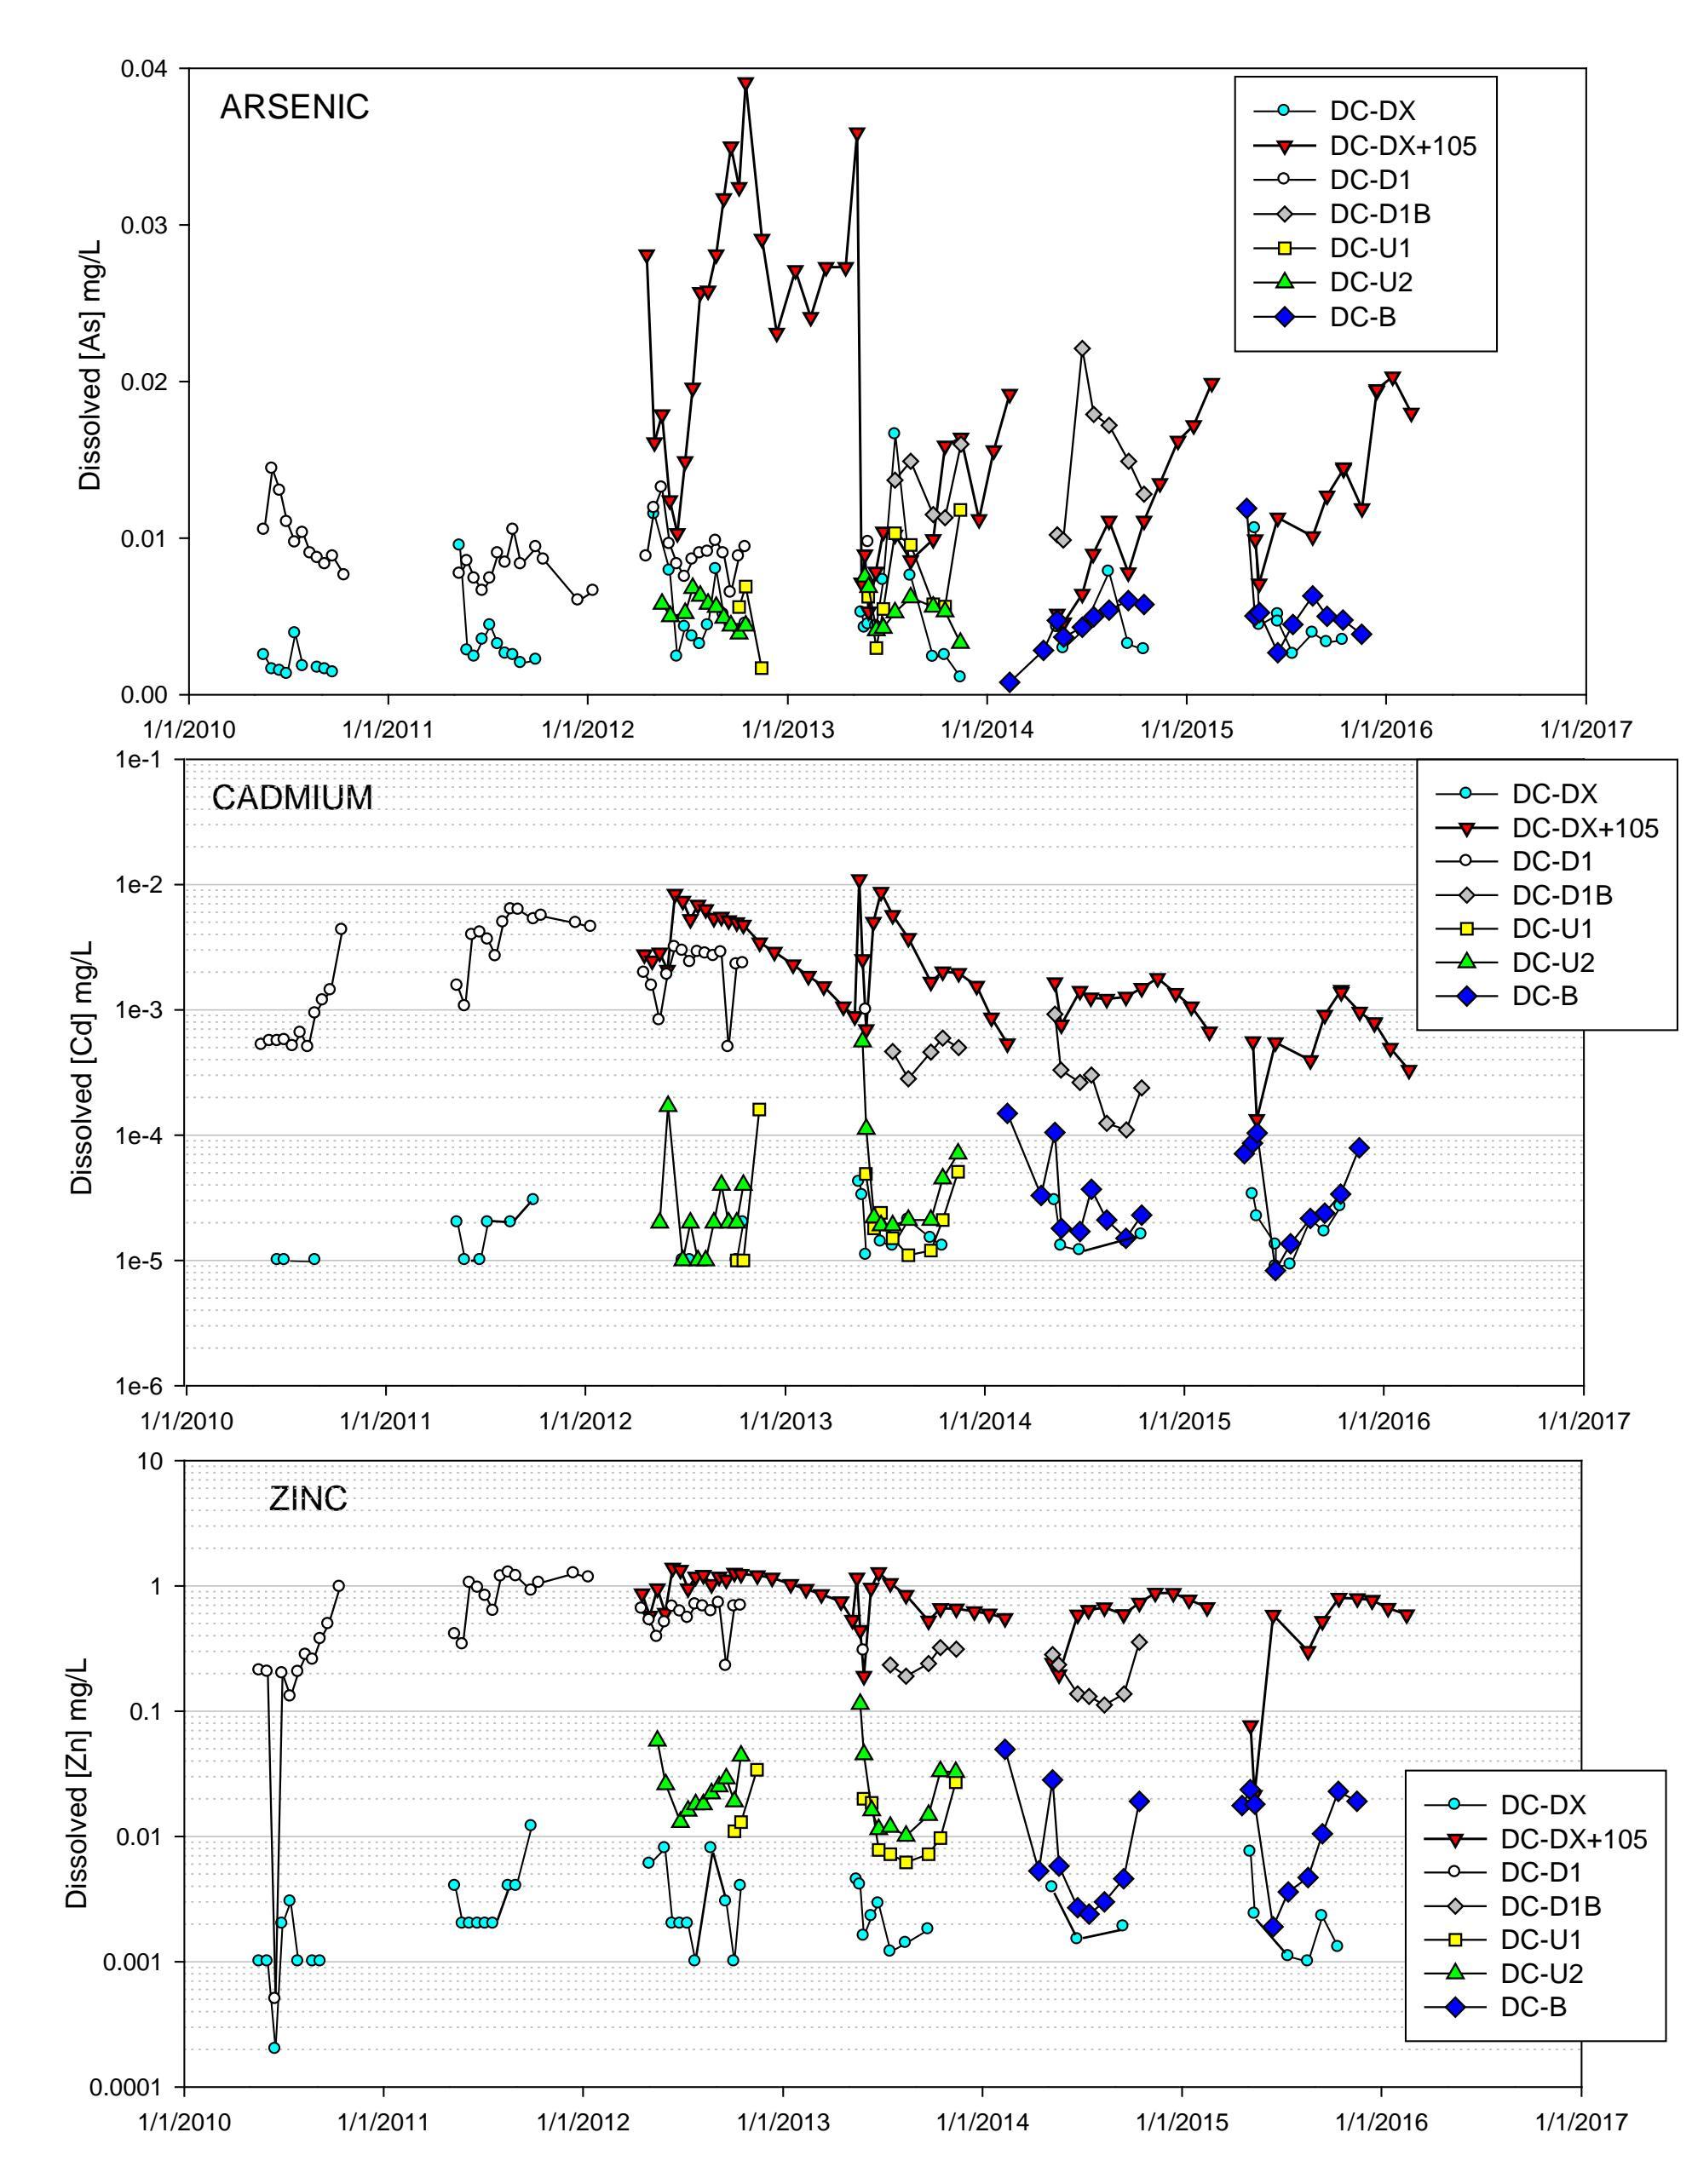
Figure 5: Time series profiles for dissolved As, Cd and Zn for surface water stations in Upper Dome Creek (2009-2015 data). Note log scales on Y axes for Cd and Zn.

illustrating that similar processes govern their remobilization and attenuation within Upper Dome Creek (Figure 5). For both parameters, the highest values are observed at DC-DX+105, with progressively lower values occurring with distance downstream to minima at DC-B. Dilution may play a role in the observed decrease as flows increase by roughly a factor of 10 between the two sites, however other mine signatures (e.g., SO₄ and Ca) show increasing trends with distance downstream (Figure 3). Based on these combined observations, the decrease in Cd and Zn between DC-DX+105 and DC-B is interpreted to reflect the attenuation processes along the creek system flowpath and is consistent with the data and interpretations provided in Lorax (2010) and SLR (2015b). The exact nature of the attenuation processes has not been defined, but likely include to some degree, adsorption/co-precipitation with Fe/Mn oxides, and possibly adsorption to organic substrates.

The magnitude of attenuation in Lower Dome Creek is significant, with values for As, Cd, and Zn at DC-B being very similar to background ranges observed at DC-DX (Figure 5). The concentrations measured at DC-B are also lower than values measured in the Tailings Seepage Pond and downstream at DC-U and DC-R, indicating that Upper Dome Creek contributes negligibly to the Cd and Zn signatures in Lower Dome Creek.

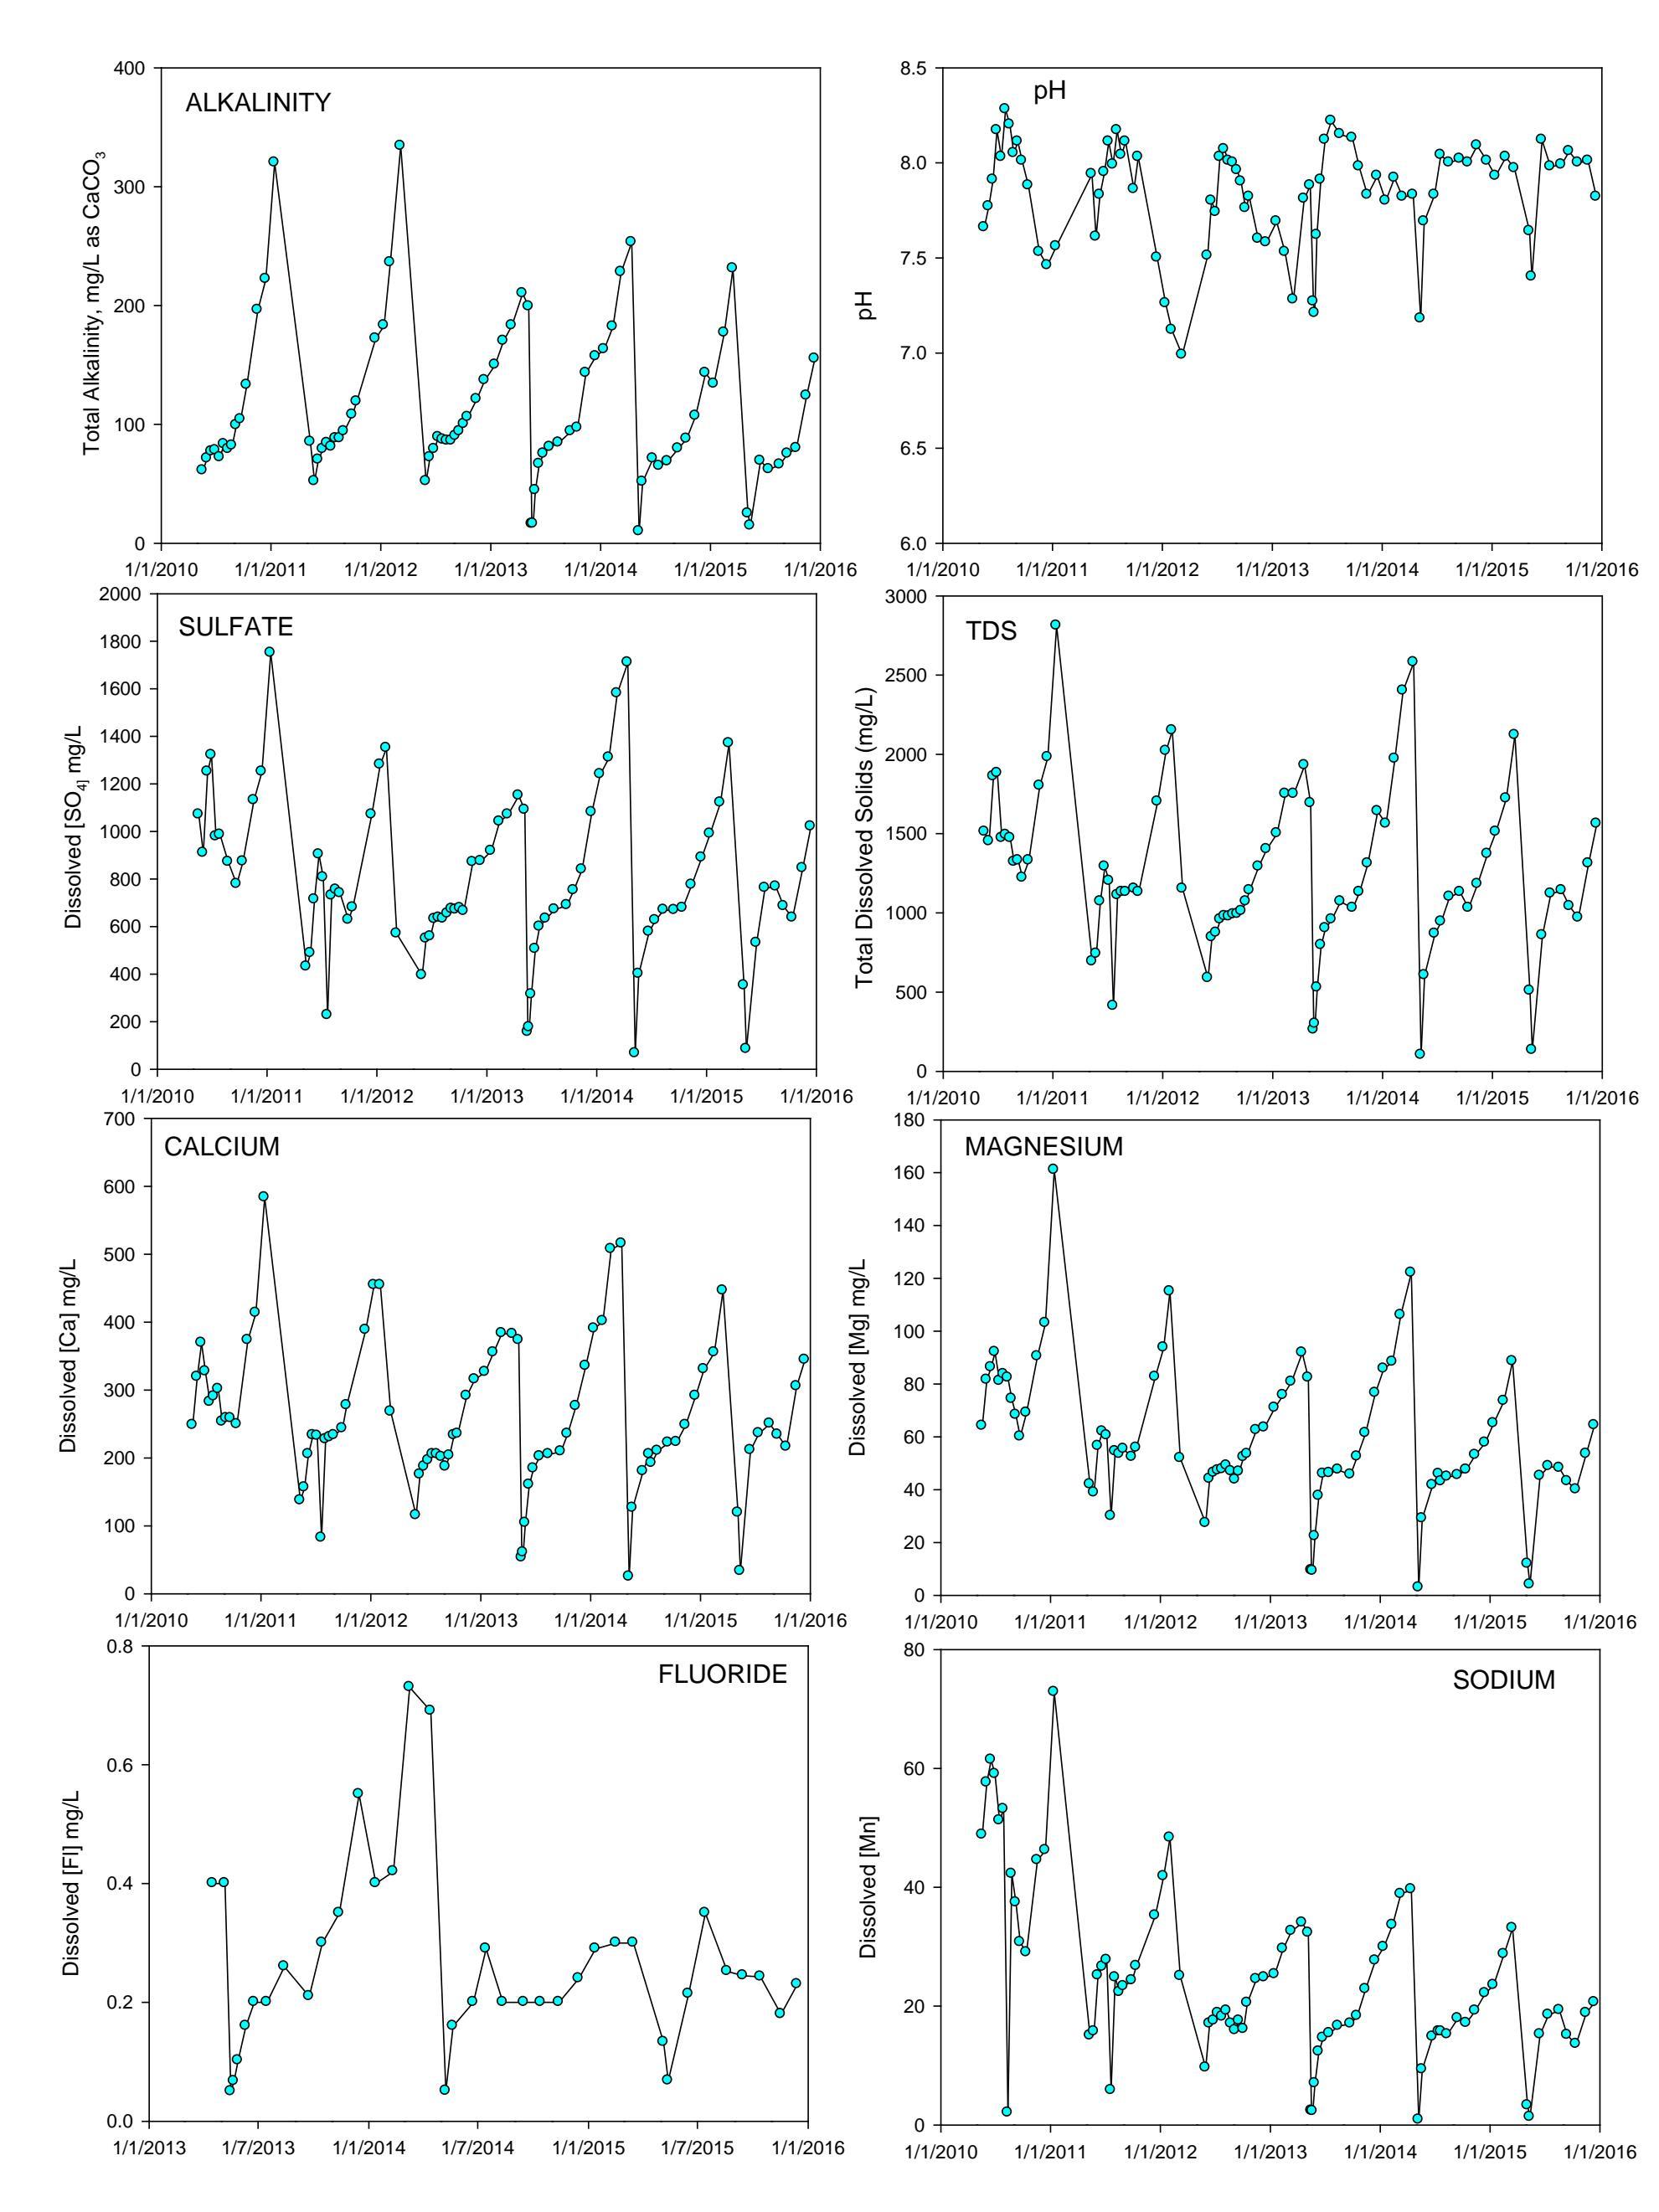
Figure 6: Time series profiles for major ions, TDS and pH for the Tailings Pond.

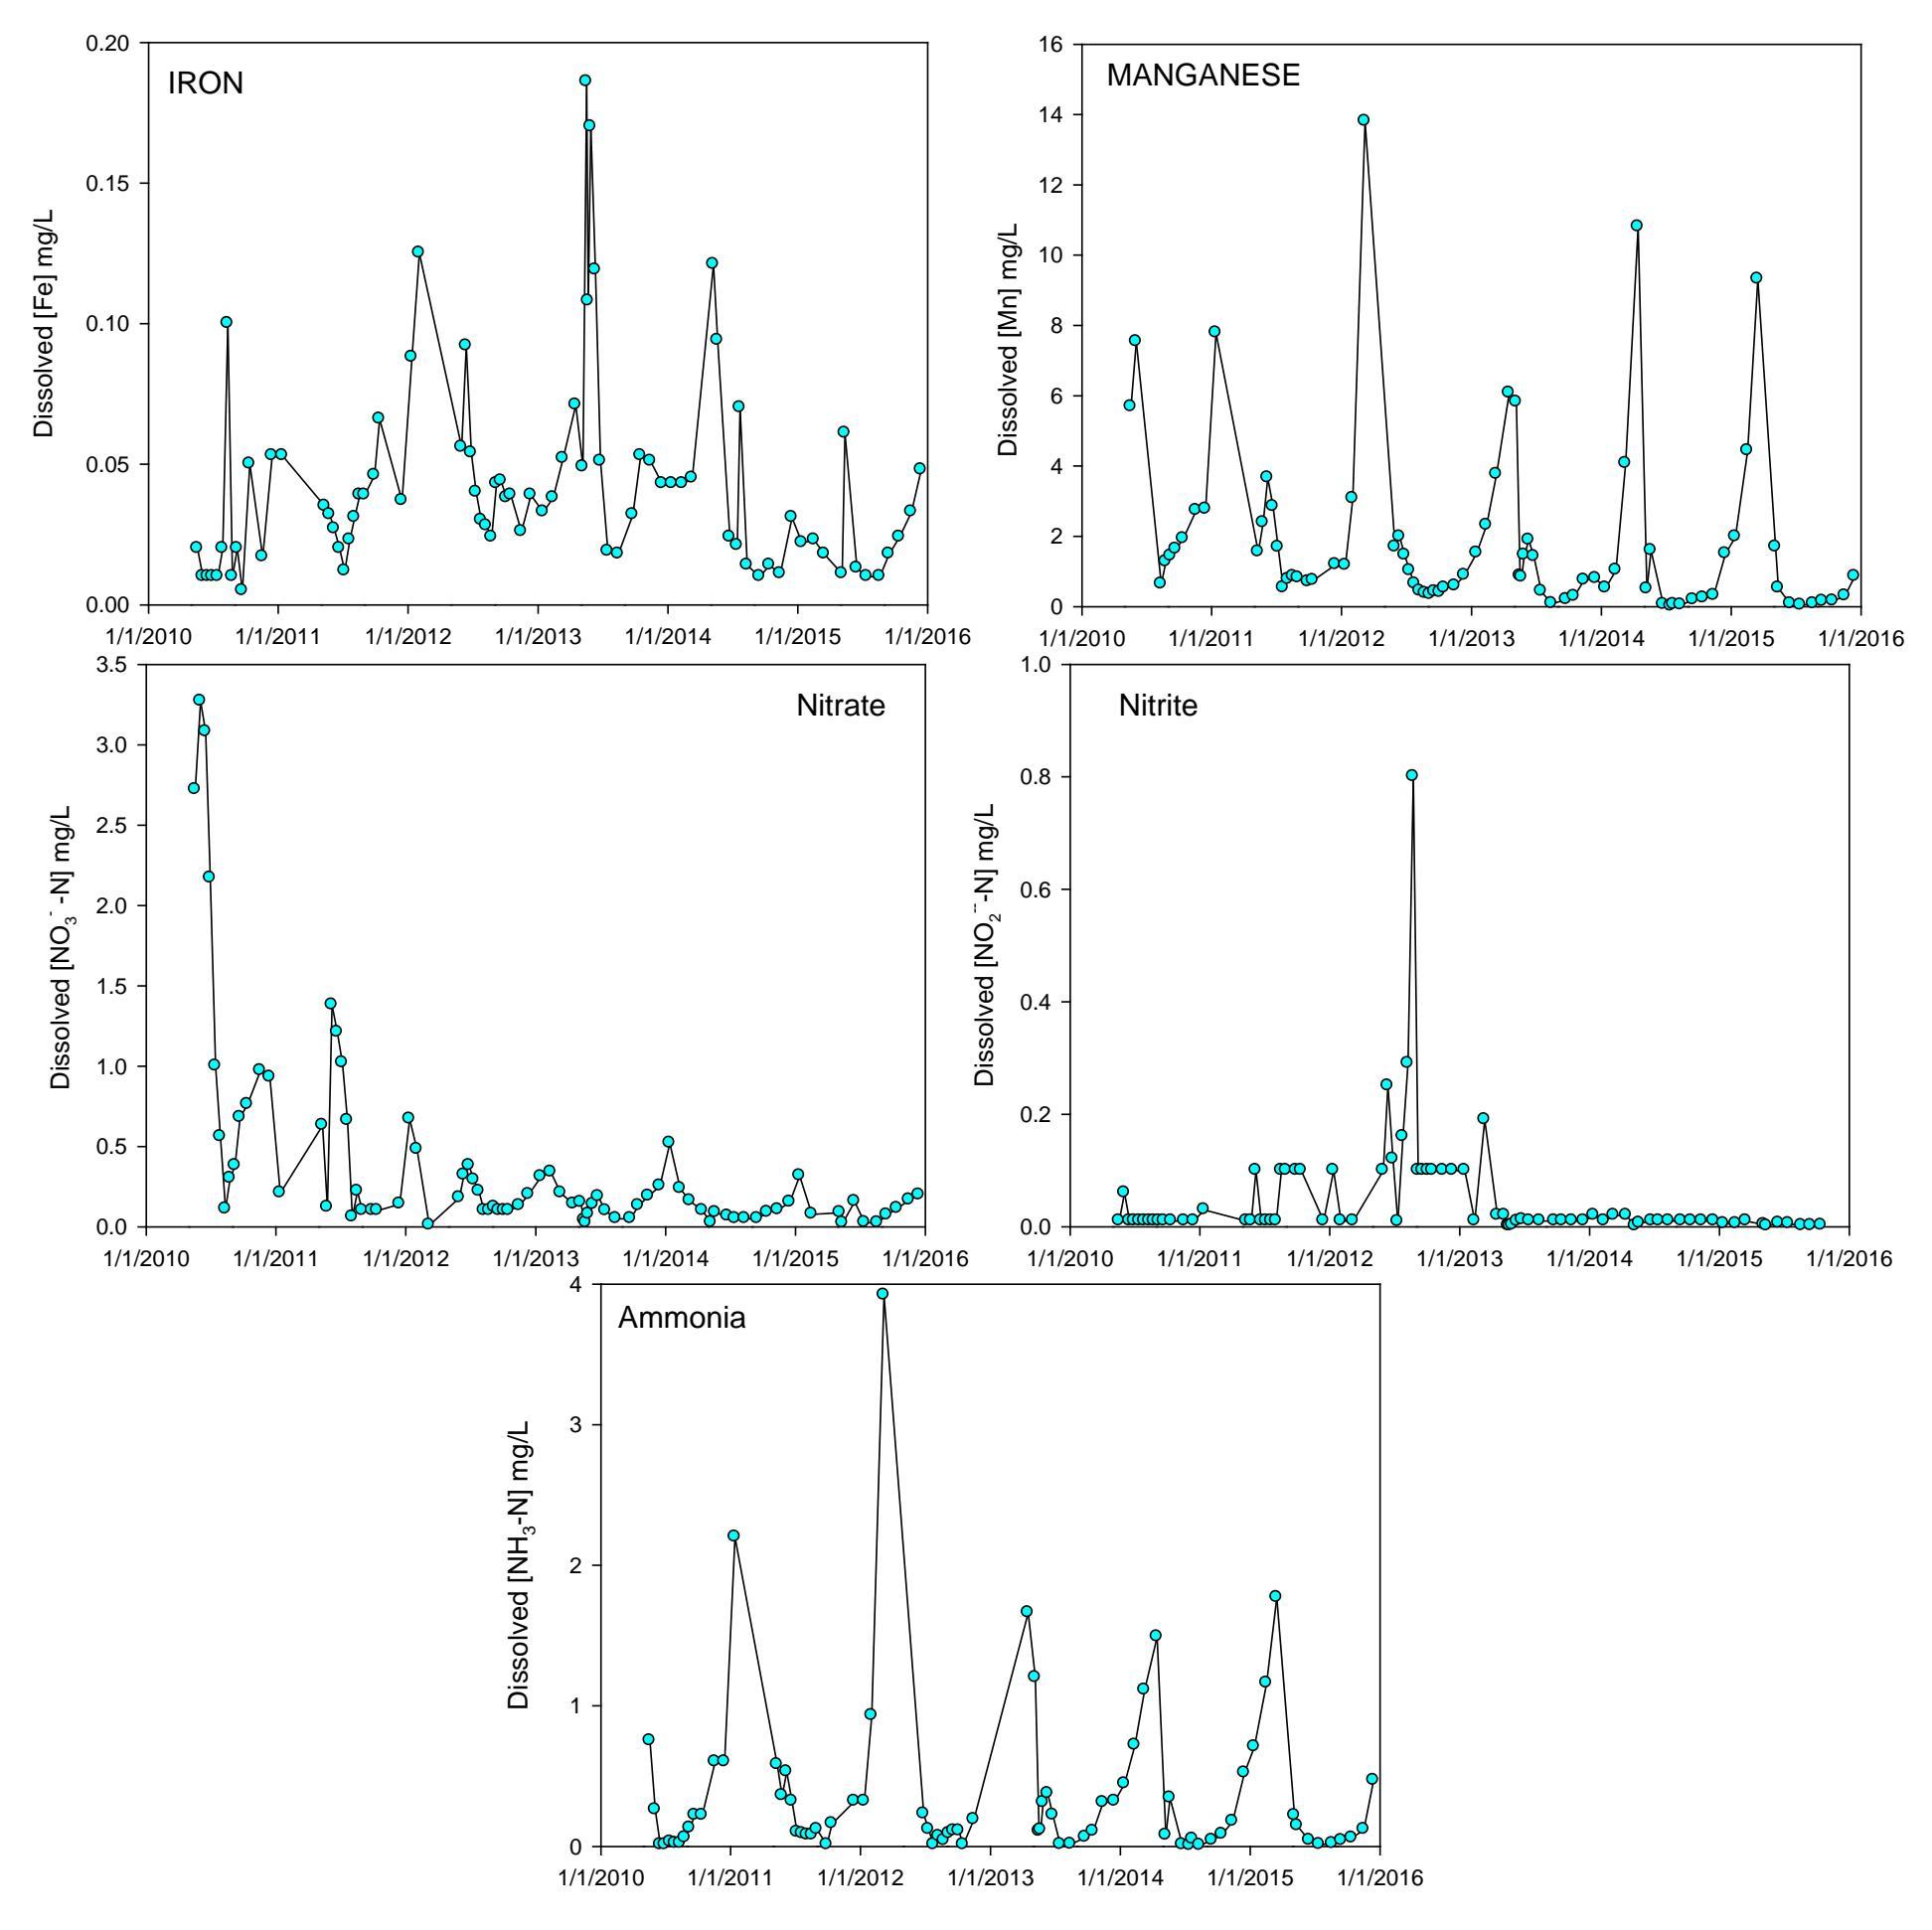
Figure 7: Time series profiles for redox-related parameters for the Tailings Pond.

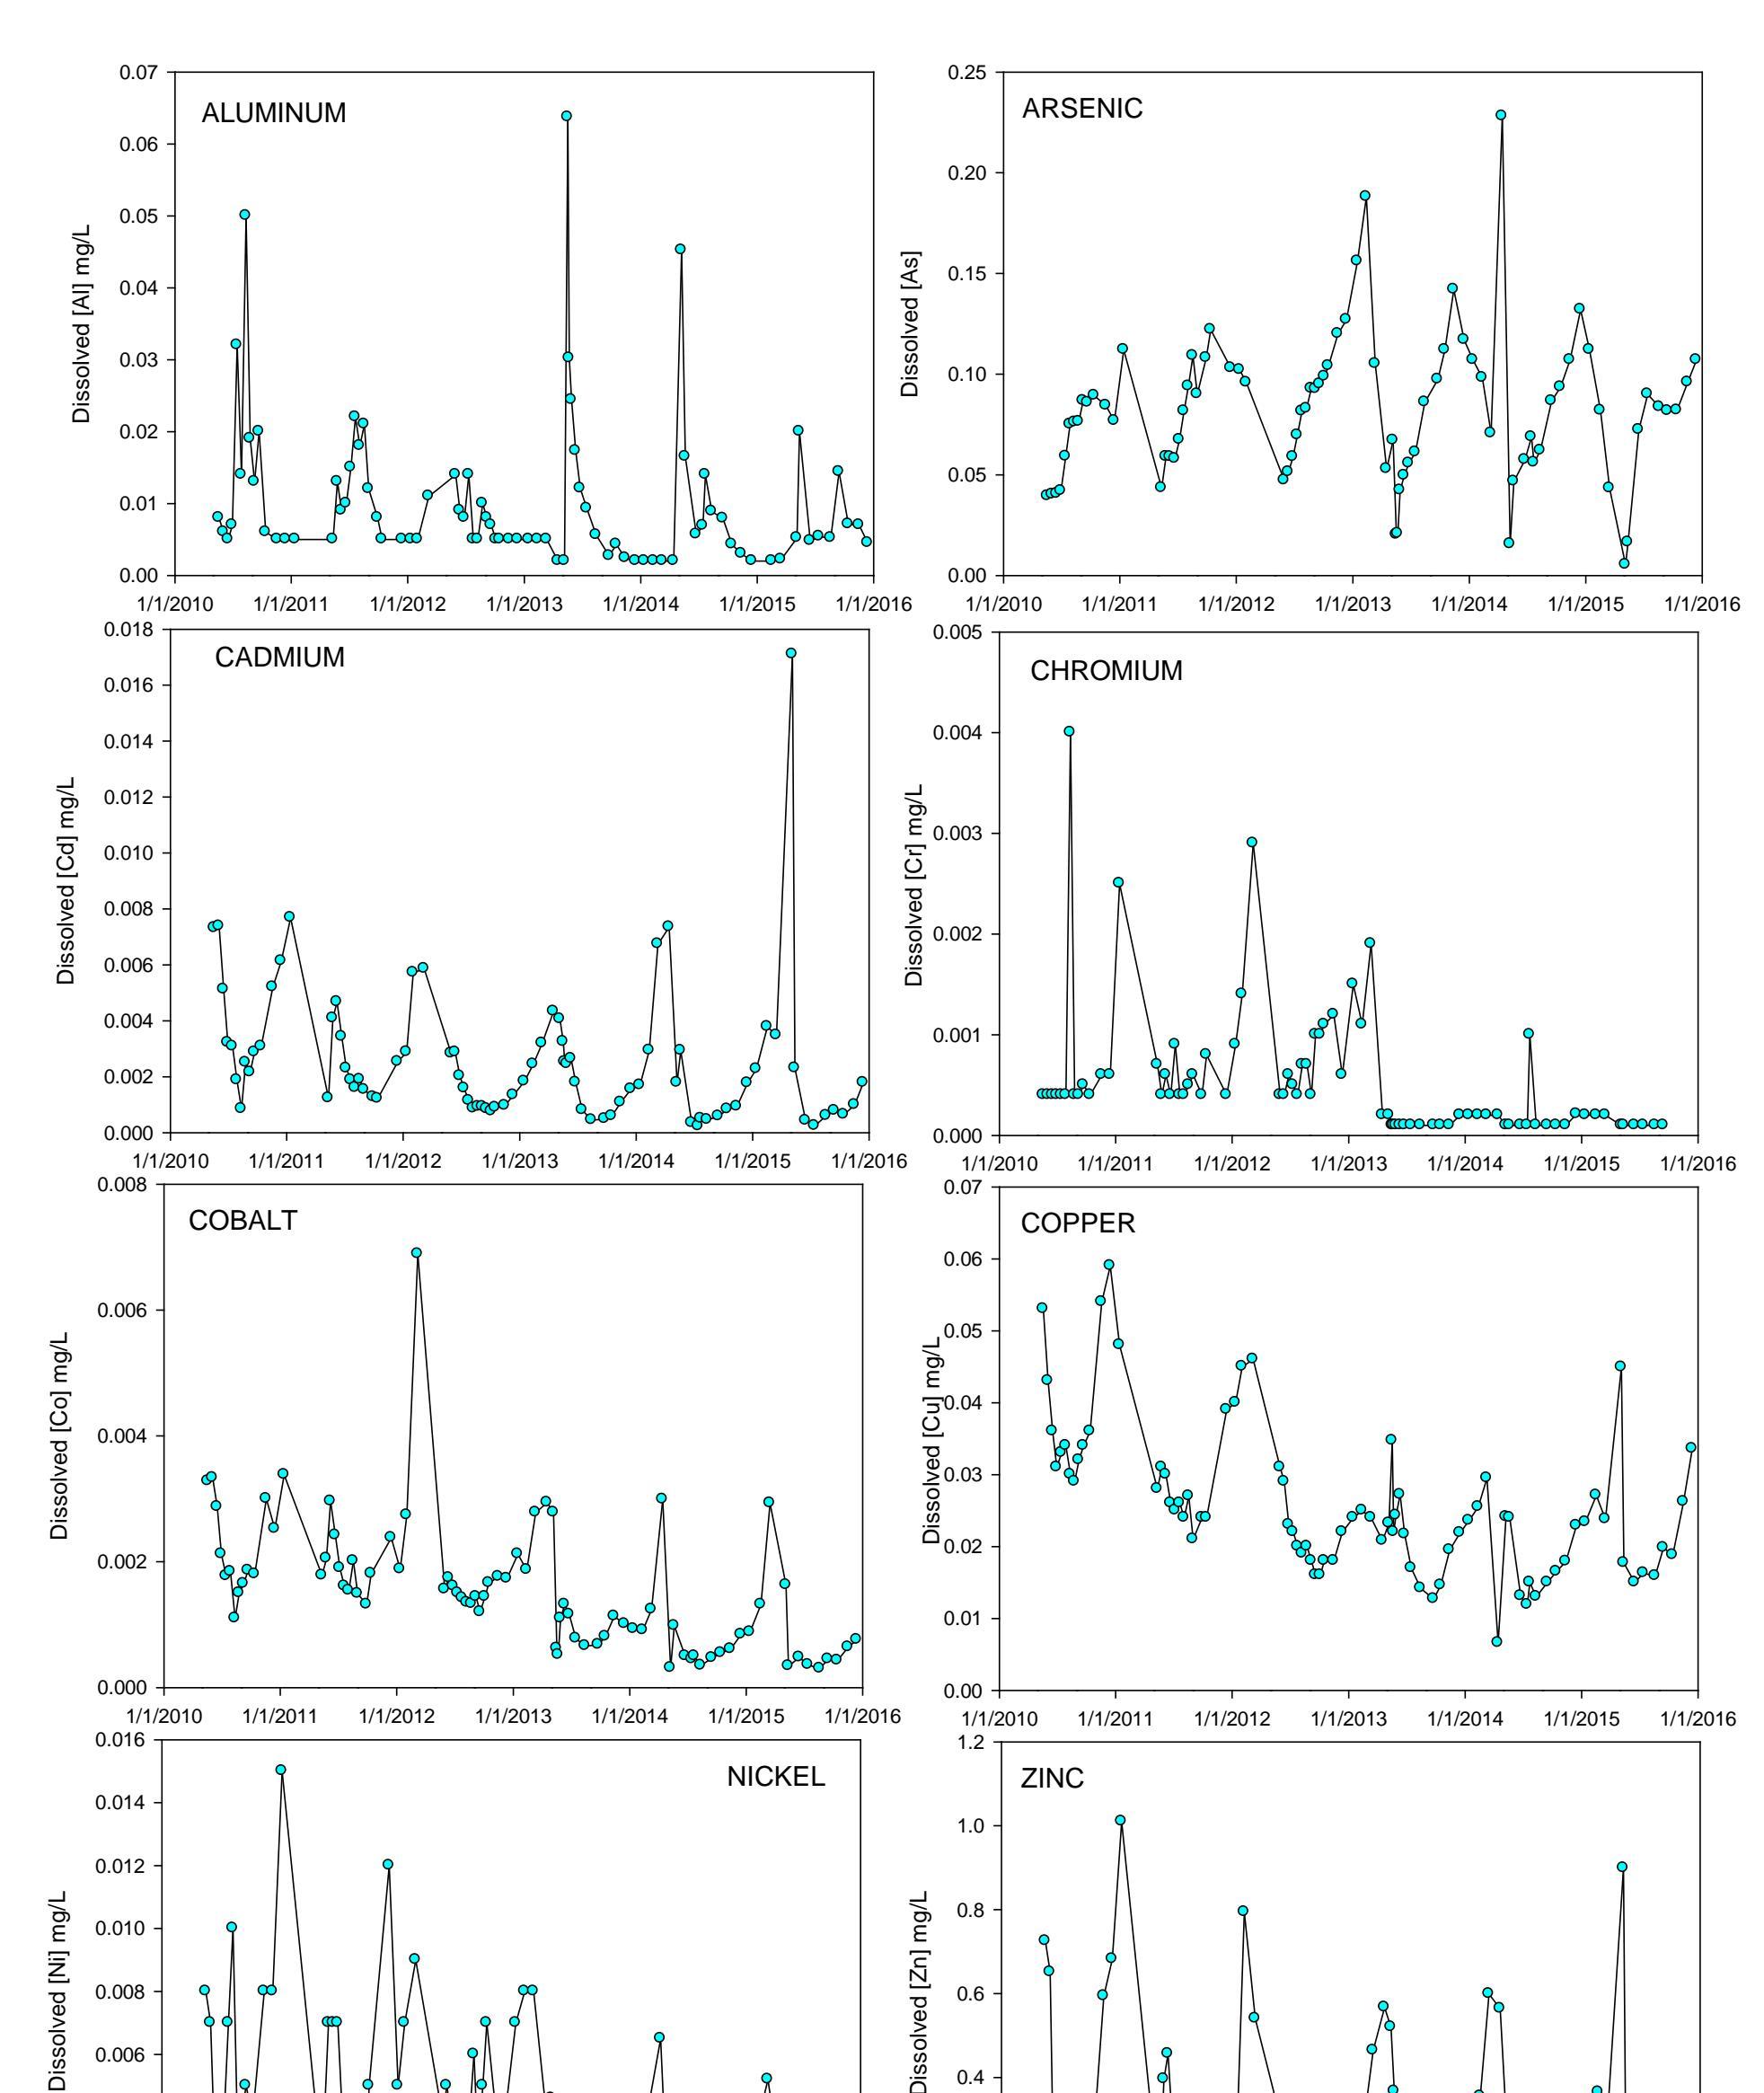
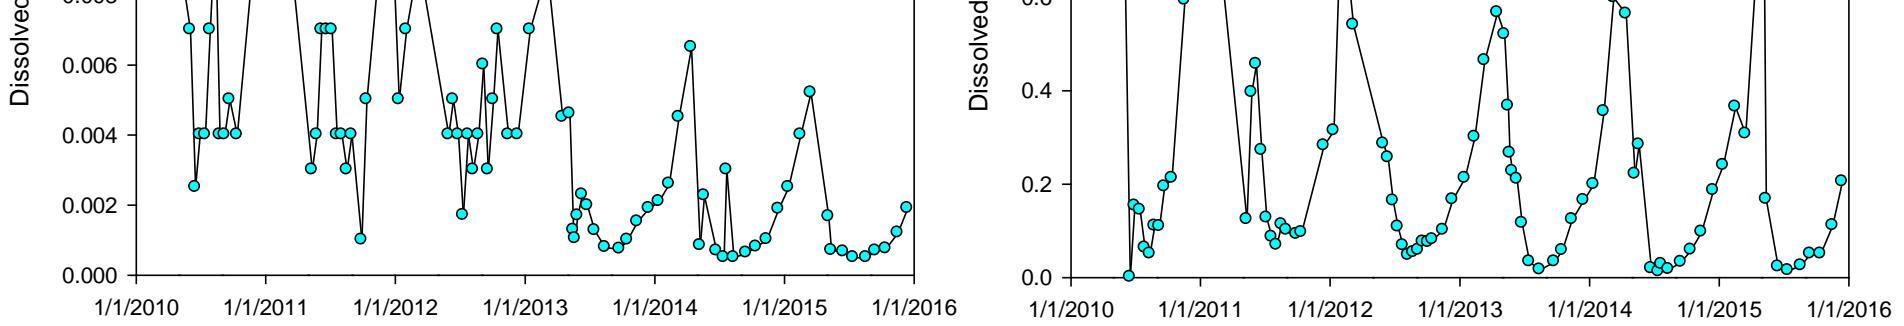
Figure 8: Time series profiles for trace elements for the Tailings Pond.

not show any definitive inter-annual trends, with the exception of decreasing annual minima since 2010 (Figure 8). Chromium shows a pronounced decline in concentration beginning on April 17, 2013. This date coincides with decreases for other trace elements (Pb and Se) and NO₂-N, as well as a transition to higher detection limits for chloride, thiocyanate and cyanate. These observed changes may reflect a systemic analytical change (e.g., laboratory, instrument or methodology change) and are assumed to not be related to changes in the natural environment.
