Mount Nansen Dome Creek and Victoria Creek Surface Water Quality Evaluation and Preliminary Aquatic Effects Assessment

Prepared for: Little Salmon Carmacks First Nation Carmacks, Yukon

Prepared by: Lorax Environmental Services Ltd. 2289 Burrard St. Vancouver, B.C., Canada, V6J 3H9

> Project No. A399-1 January 31, 2017

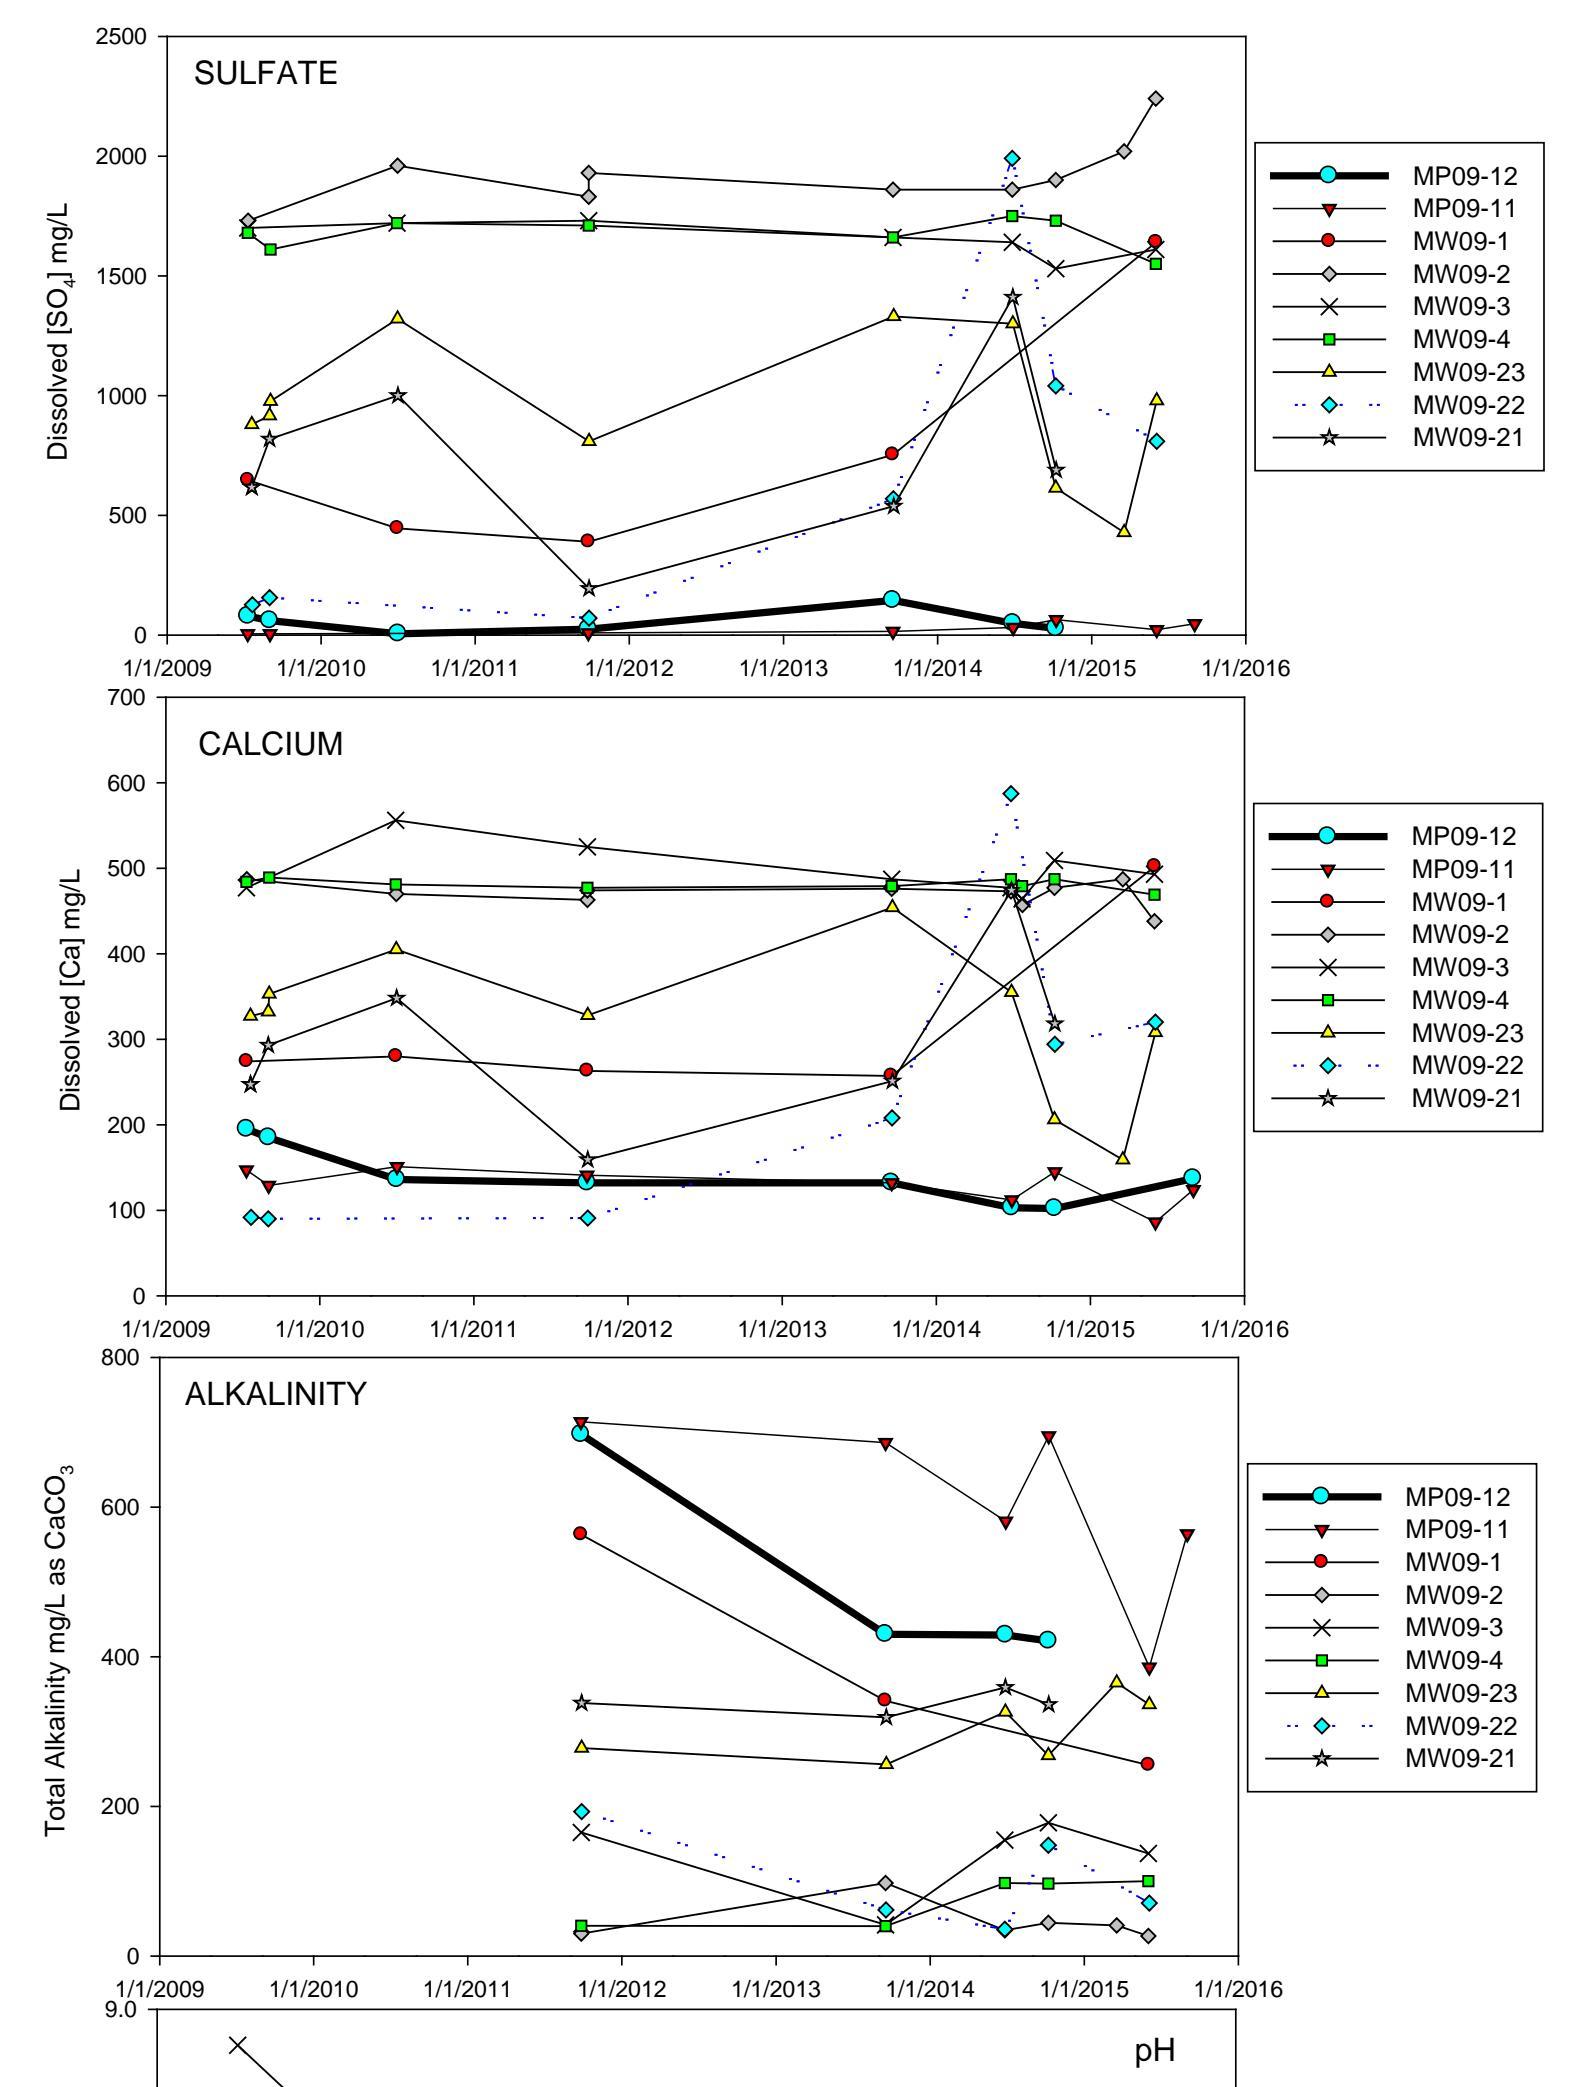
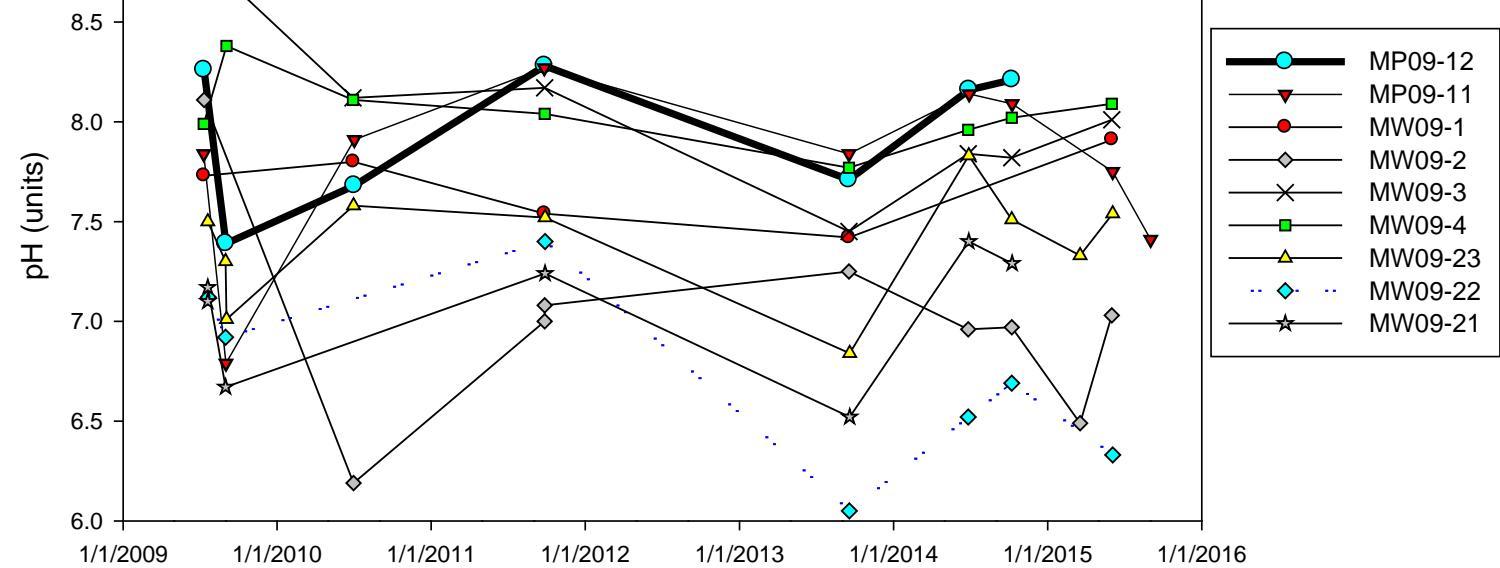
Figure 9: Time series profiles for major ions and pH for Tailings Management Area groundwater wells.

Water quality data for groundwater wells in the tailings facility are shown for major ions and pH (Figure 9), trace elements (Figure 10) and redox-related parameters (Figure 11). In general, major ions show seasonal and spatial variability. Data from piezometer MP09-12 are generally interpreted to be representative of background conditions and are shown in bold for comparison to other locations. With respect to major ions, SO₄ shows significant temporal variability with some evidence of increasing concentrations at MW09-1, MW09-2, and MW09-22. Data from MW09-1 should be viewed with caution, however, as the well head is reportedly cracked at surface (Hemmera, 2016) and likely has been contaminated by near-surface tailings and/or pond water. Possible SO₄ increases are evident at MW09-22, which shows a trend towards higher values in 2014 and 2015 (809 to 1990 mg/L) in comparison to values in 2009 and 2011 (70 to 156 mg/L).

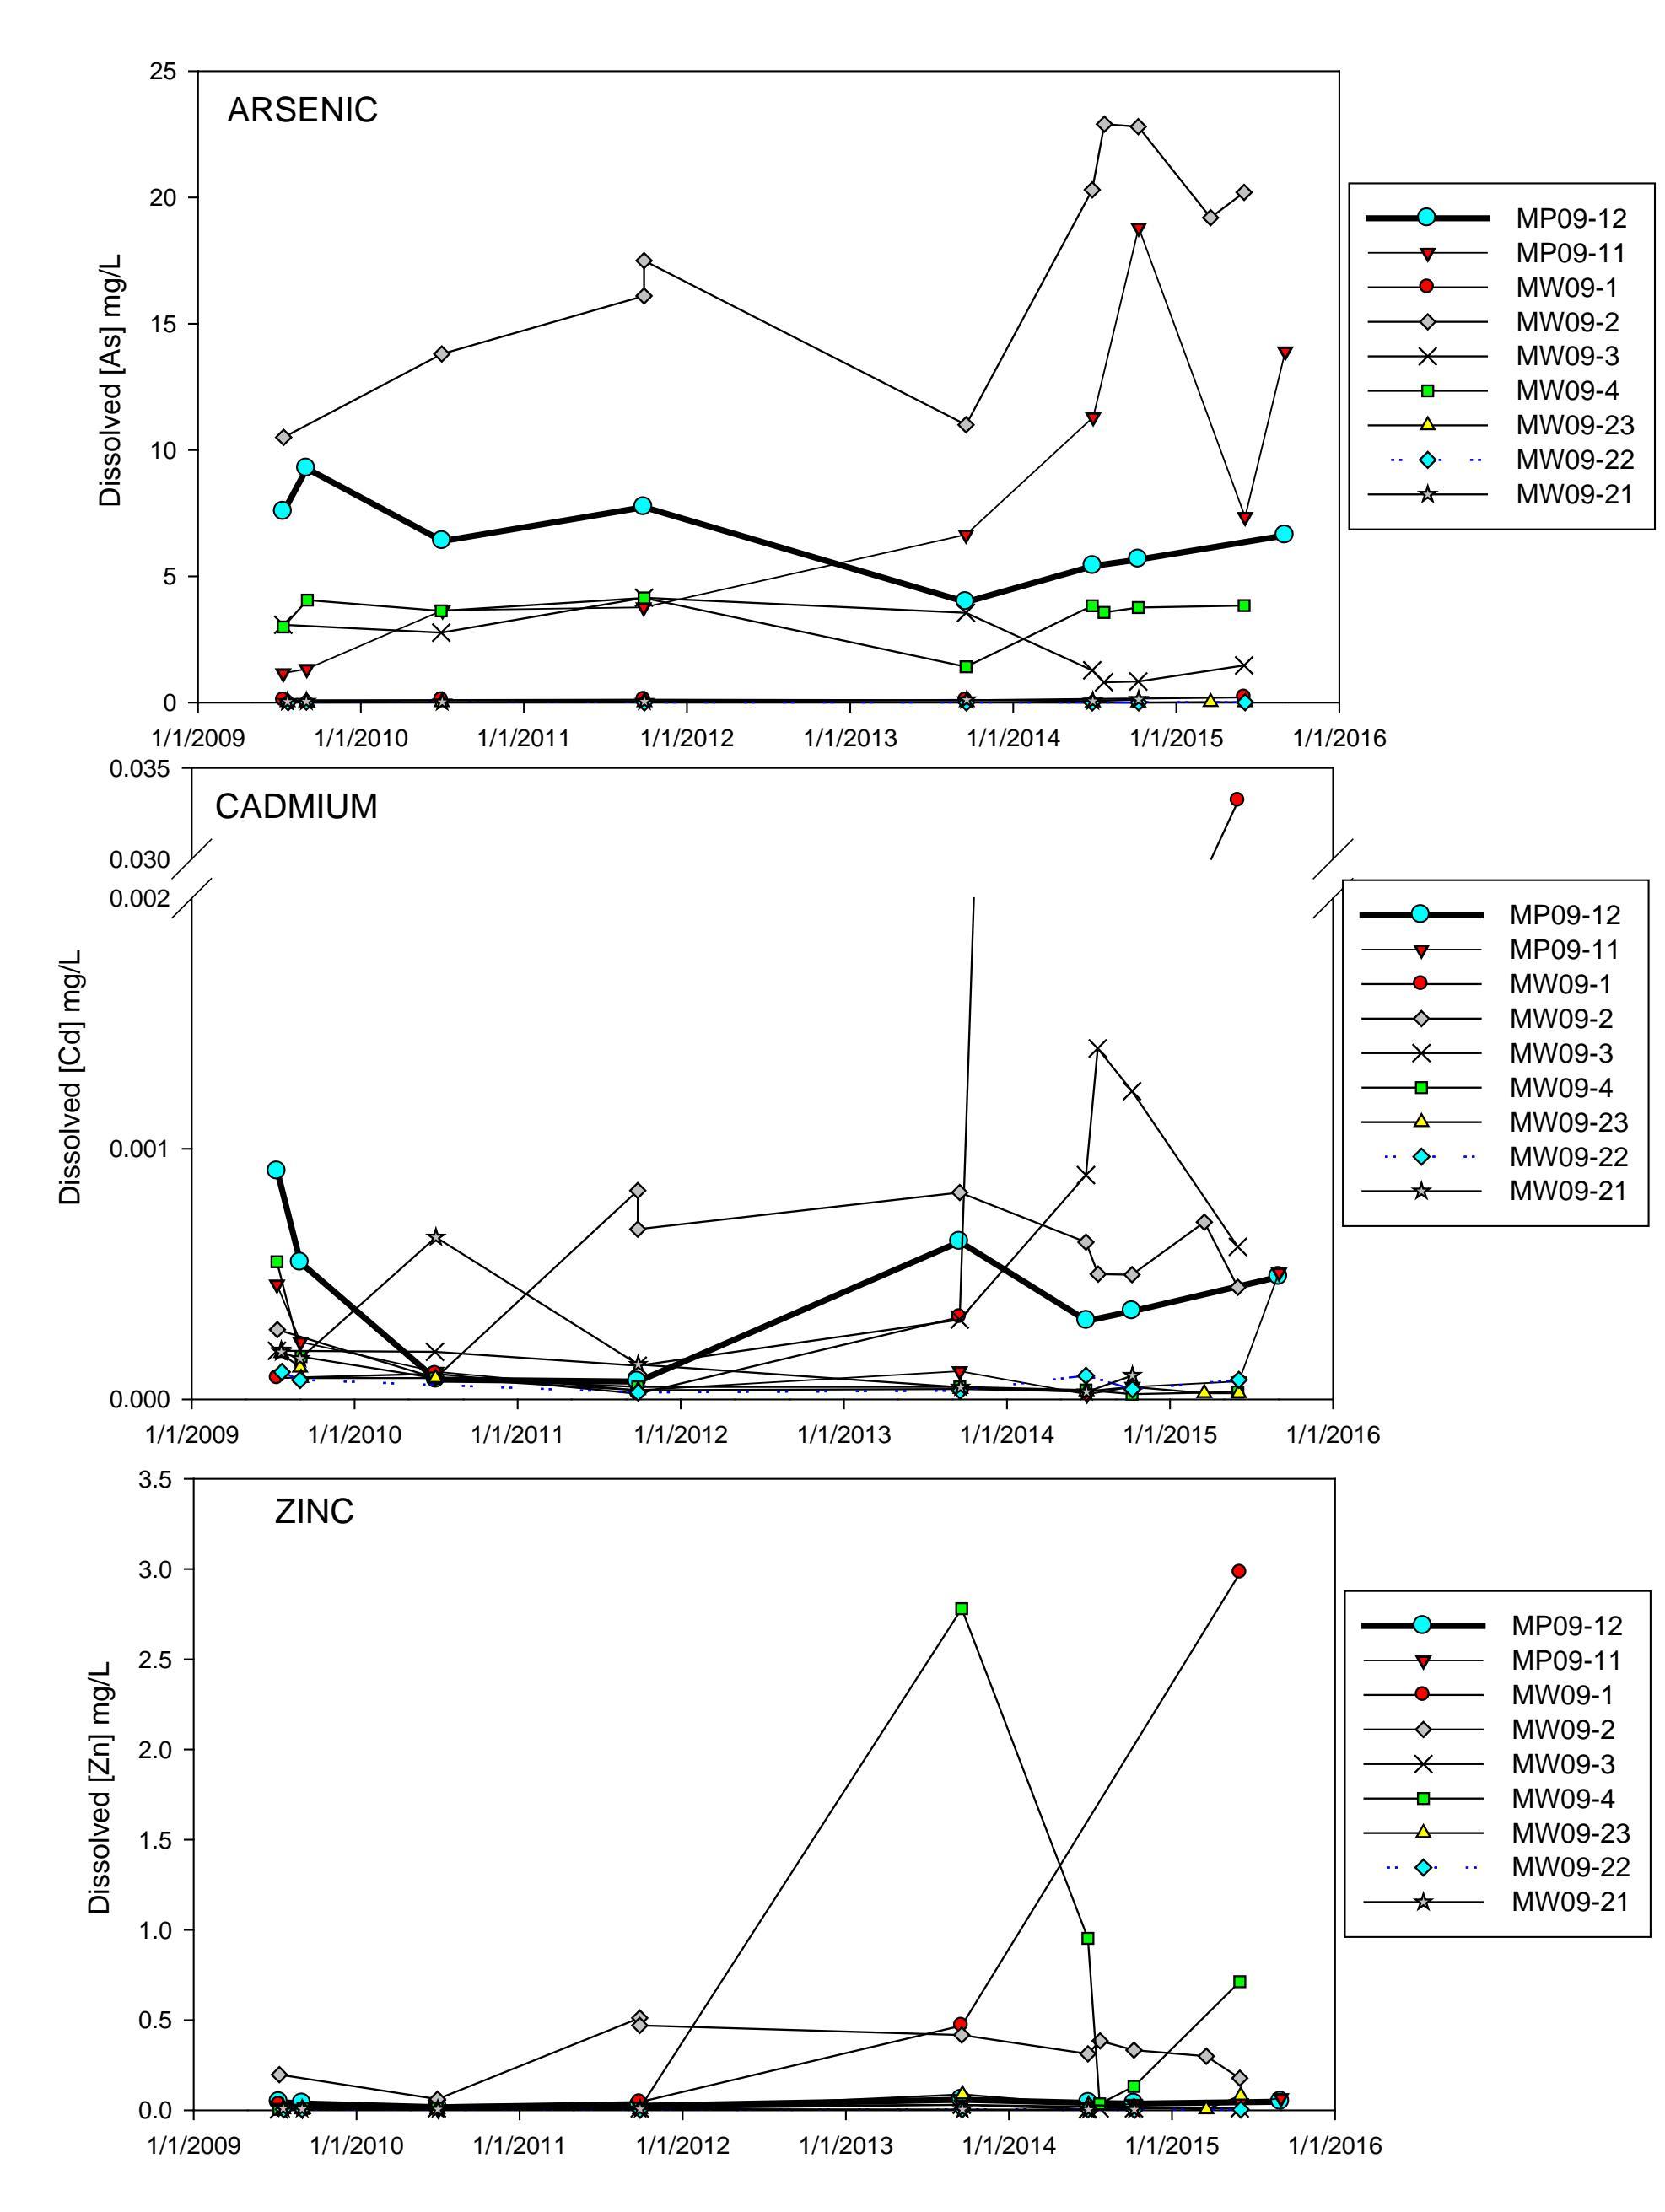
Figure 10: Time series profiles of dissolved As, Cd and Zn for Tailings Management Area groundwater wells. Note break in scale for Cd on Y-axis.

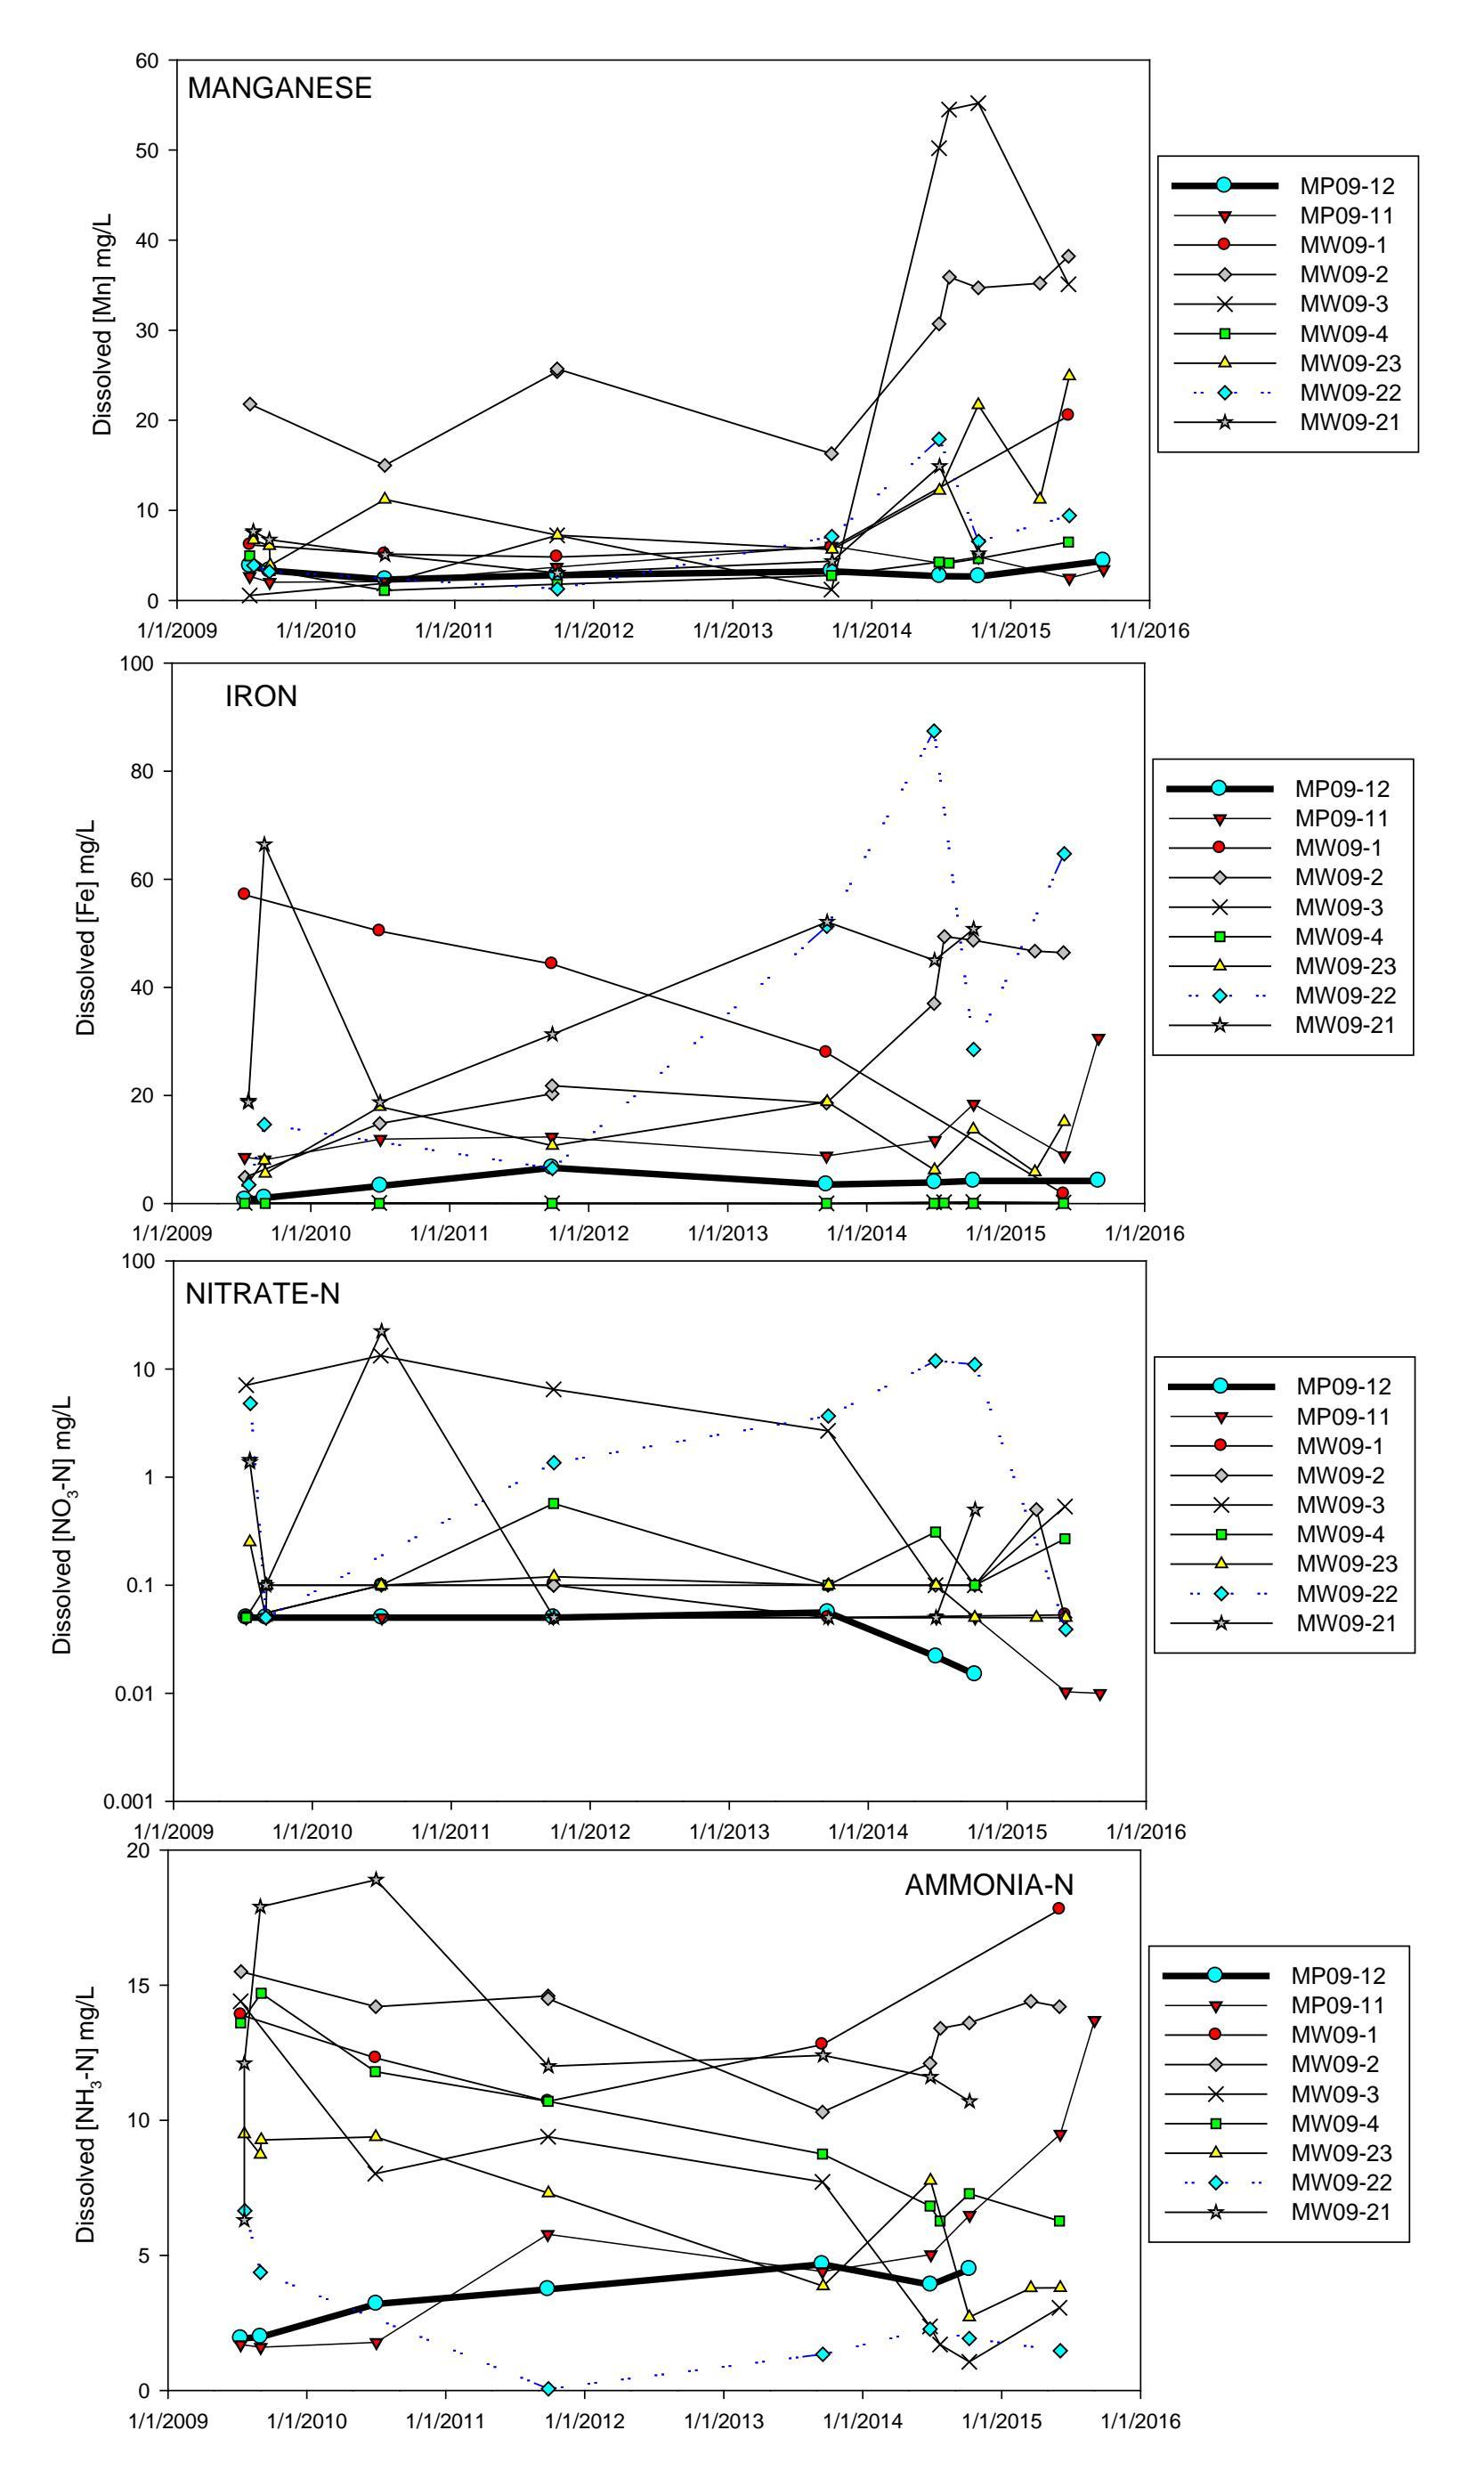
Figure 11: Time series profiles of redox-related parameters for Tailings Management Area groundwater wells.

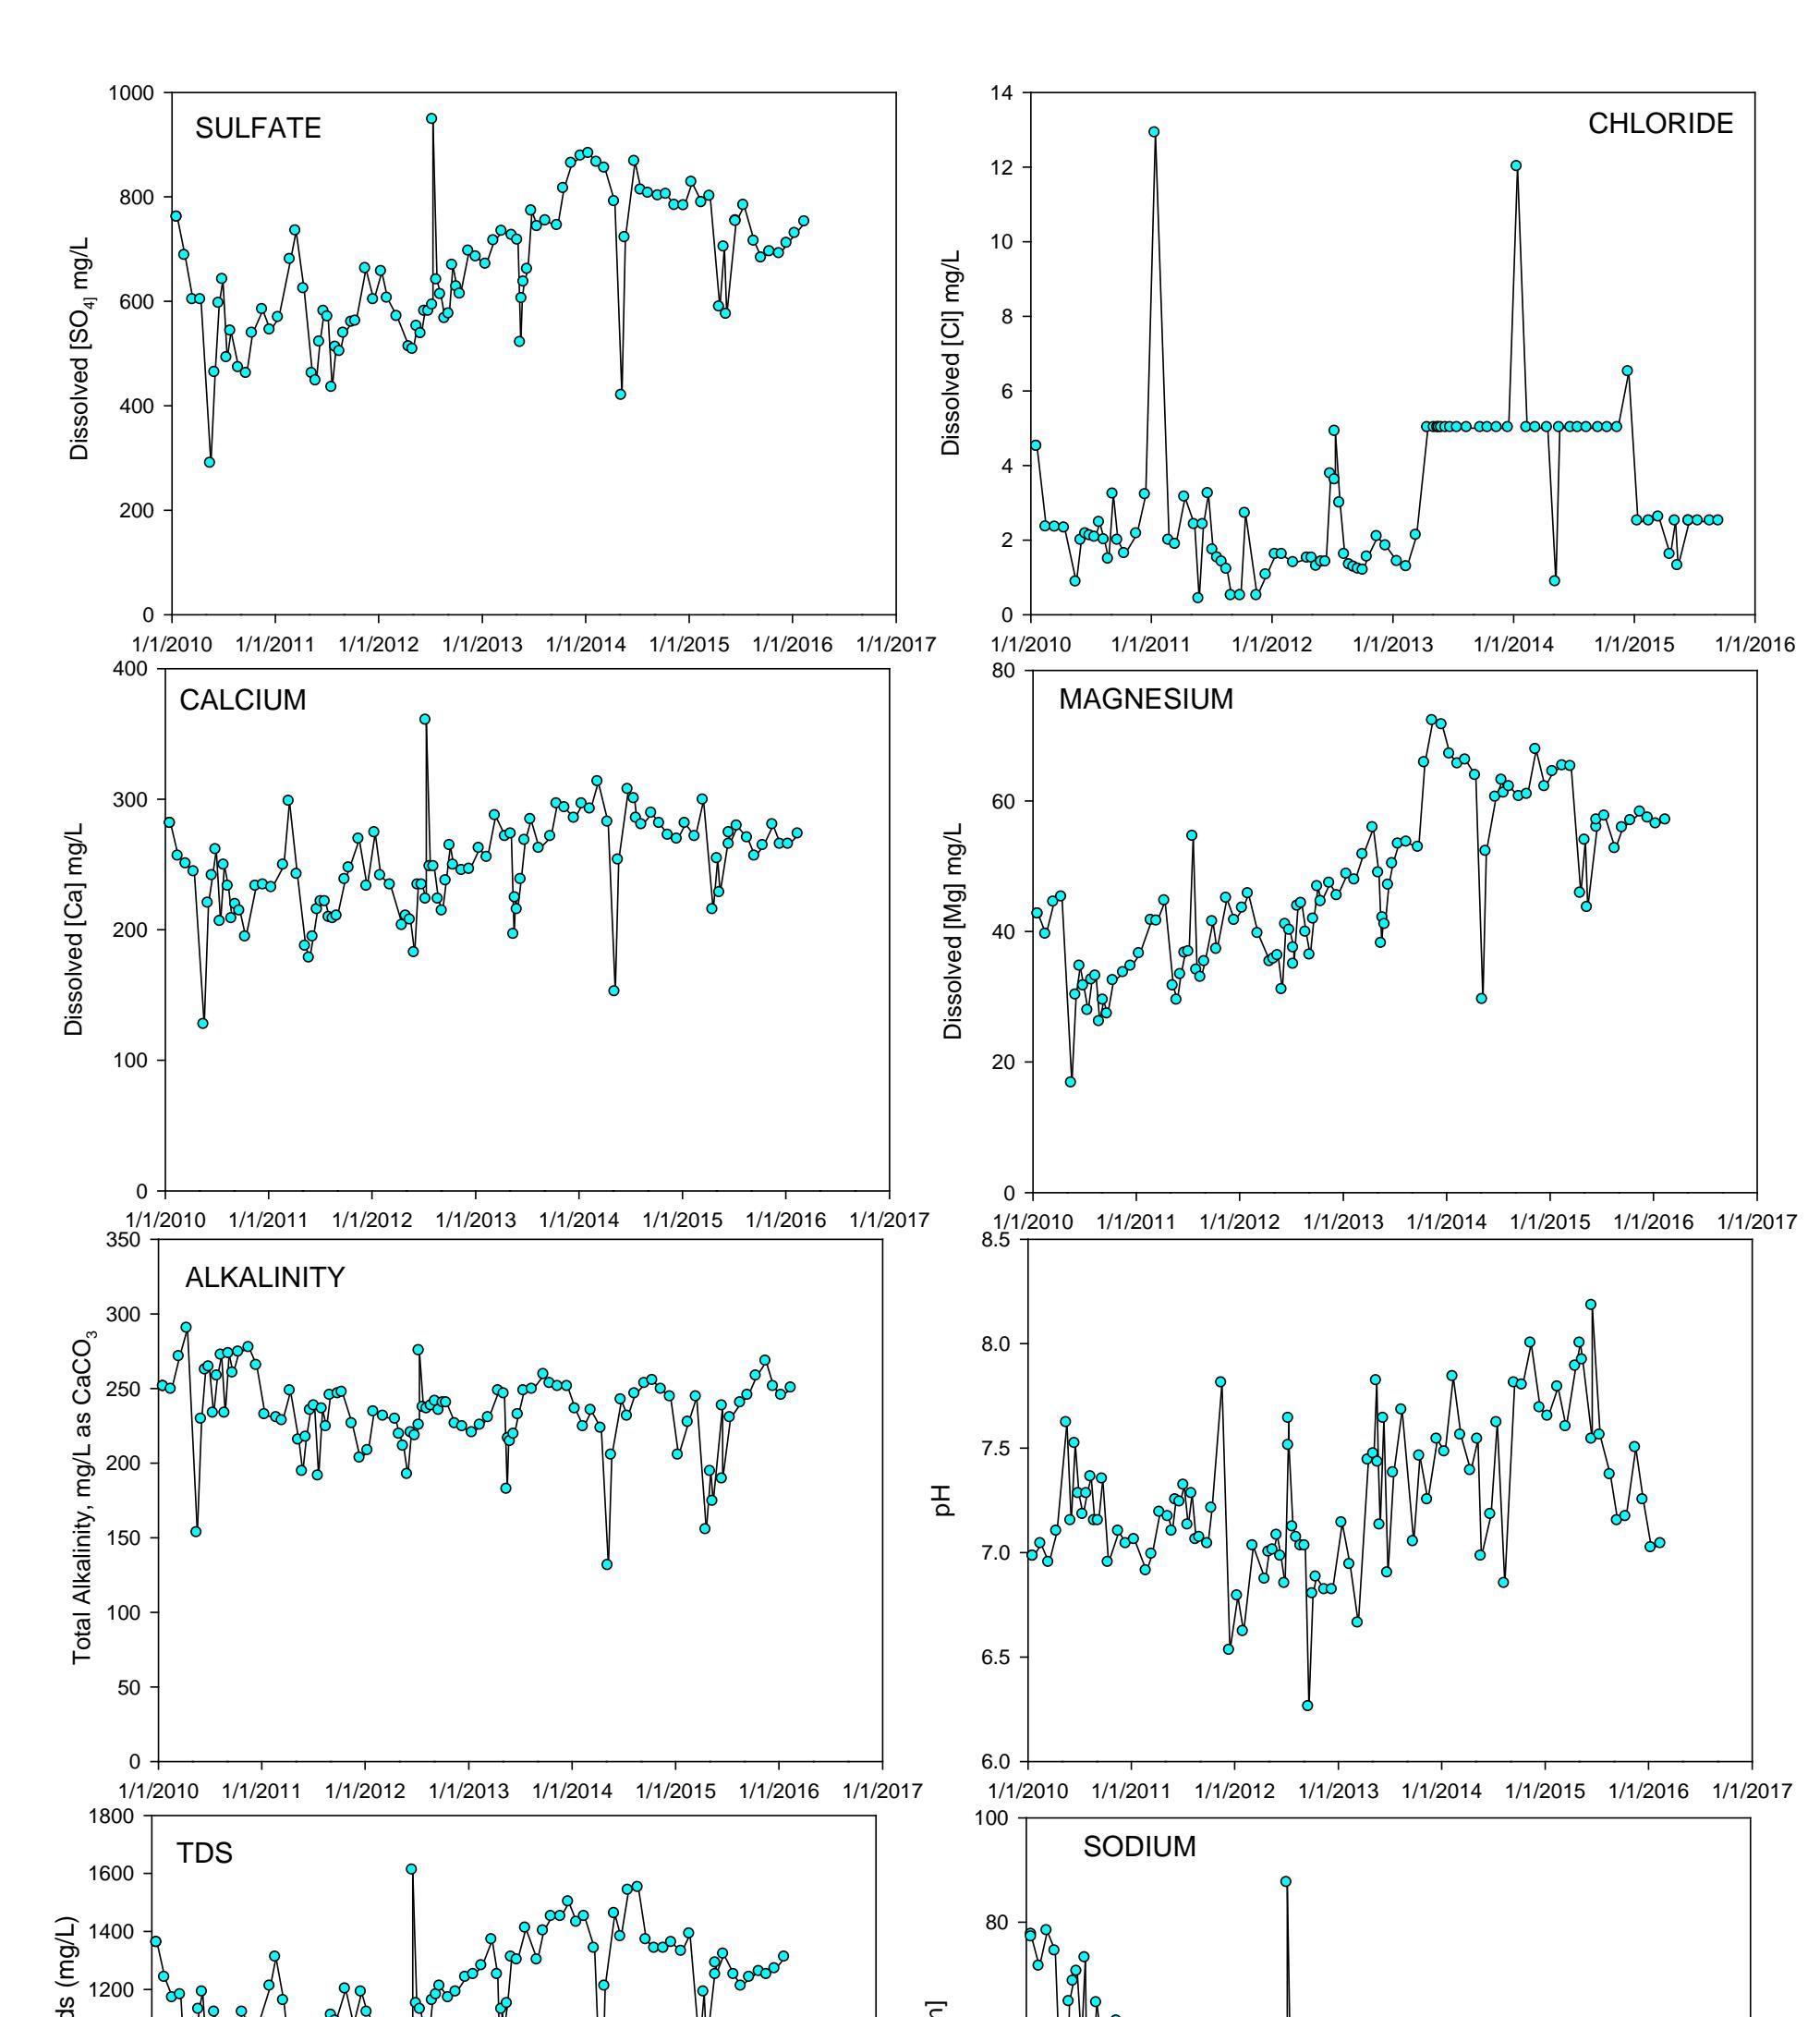
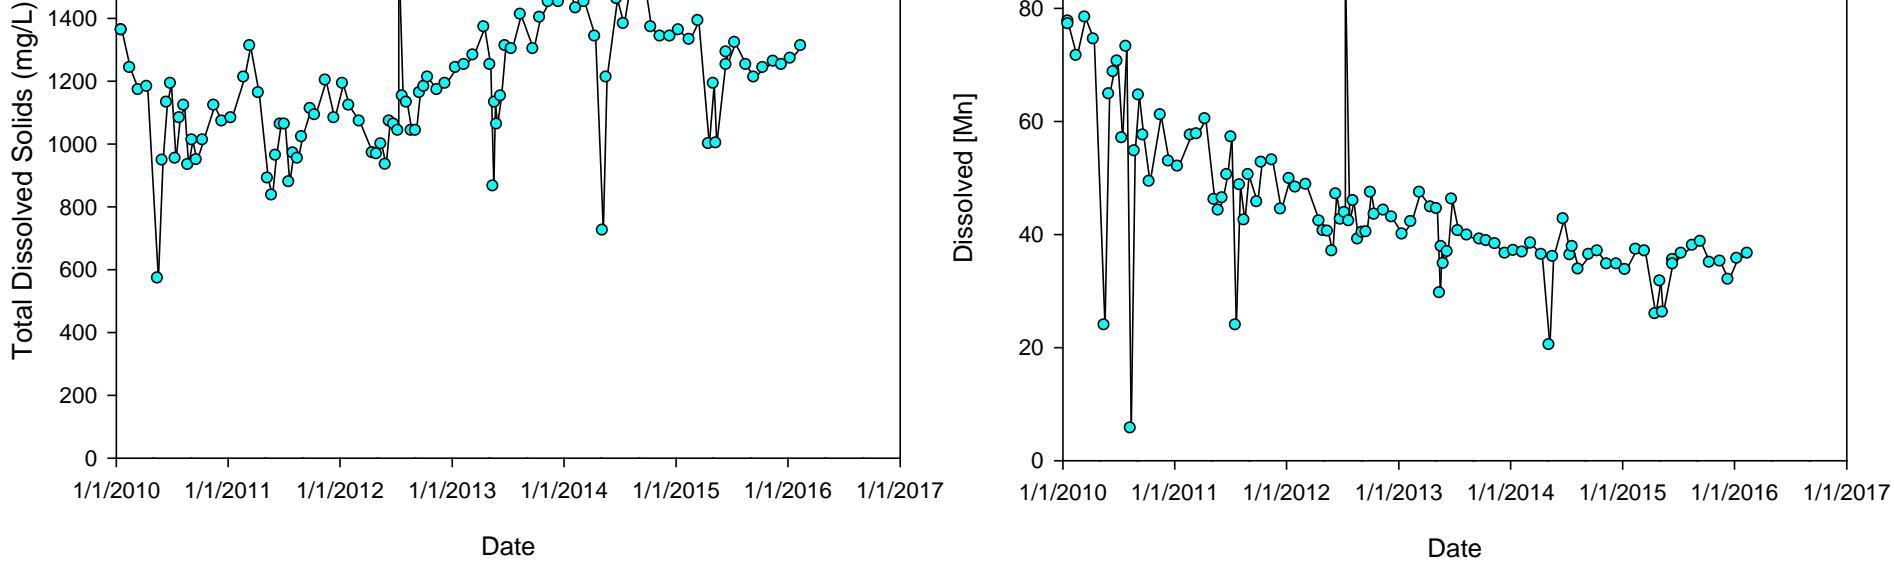
Figure 12: Time series profiles for major ions and pH for the Seepage Pond (2010-February 2016 data).

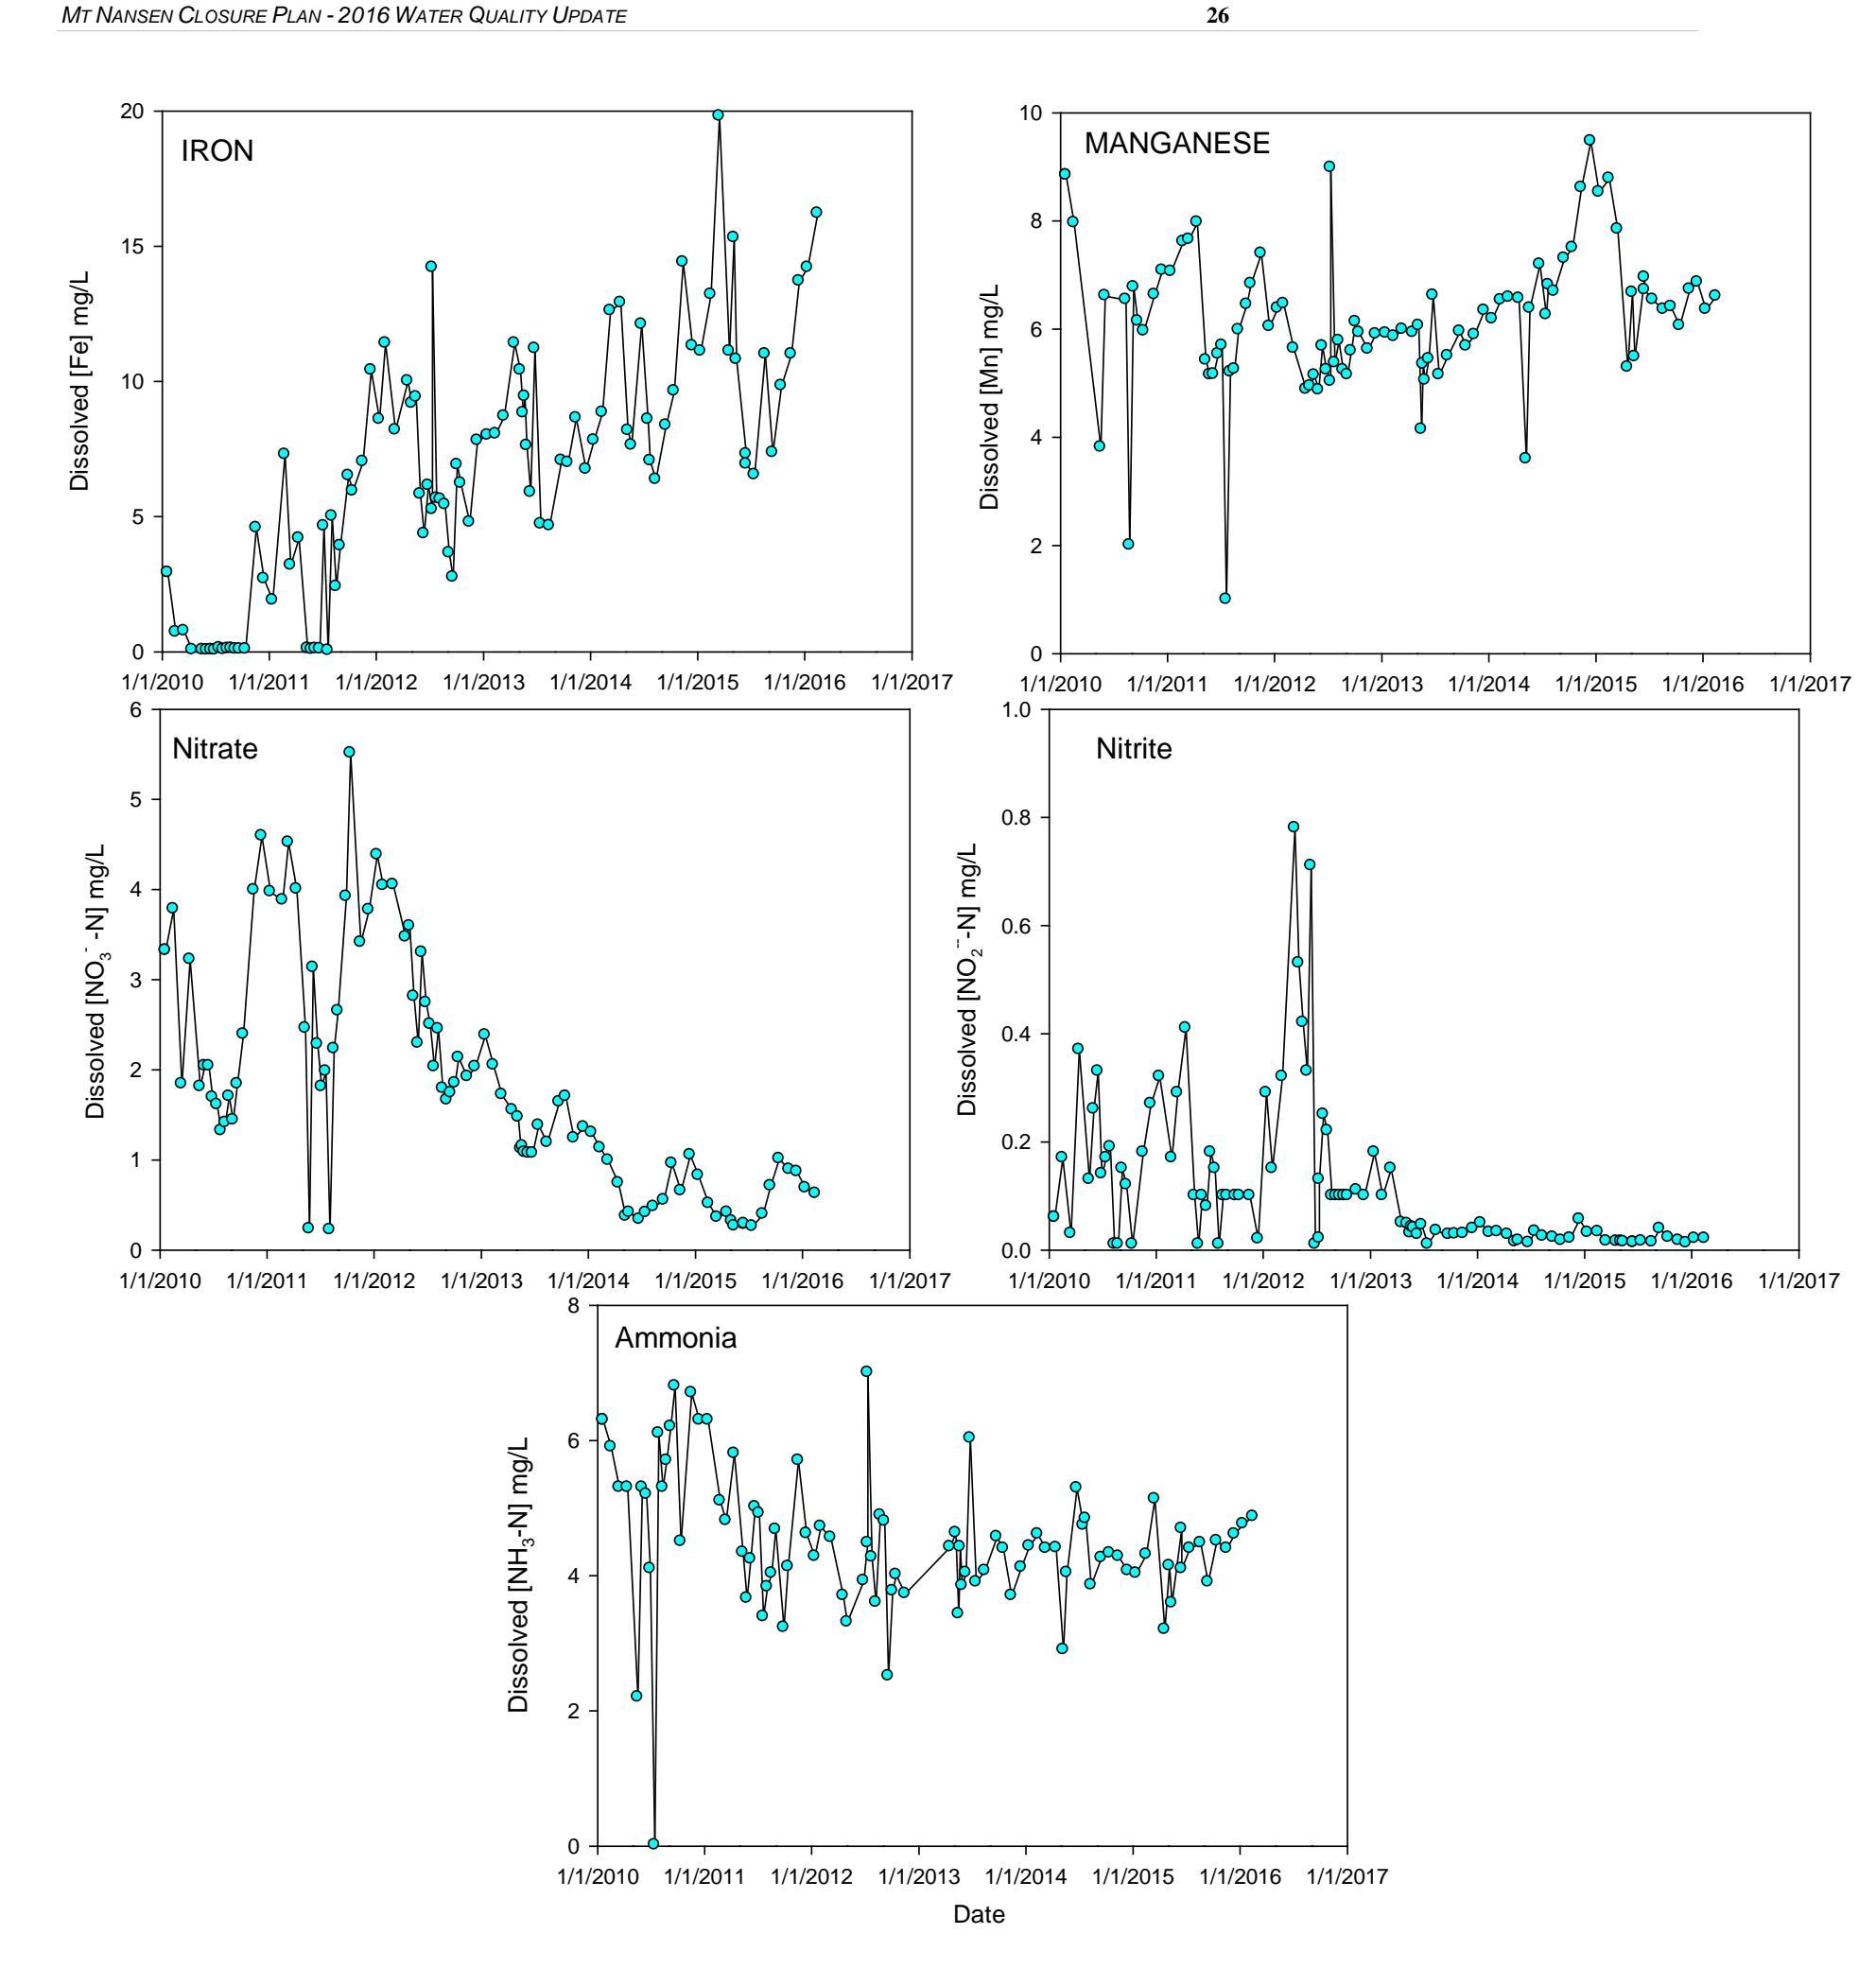
Figure 13: Time series profiles for redox-related parameters for the Seepage Pond (2010-February 2016 data).
