Mount Nansen Dome Creek and Victoria Creek Surface Water Quality Evaluation and Preliminary Aquatic Effects Assessment

Prepared for: Little Salmon Carmacks First Nation Carmacks, Yukon

Prepared by: Lorax Environmental Services Ltd. 2289 Burrard St. Vancouver, B.C., Canada, V6J 3H9

> Project No. A399-1 January 31, 2017

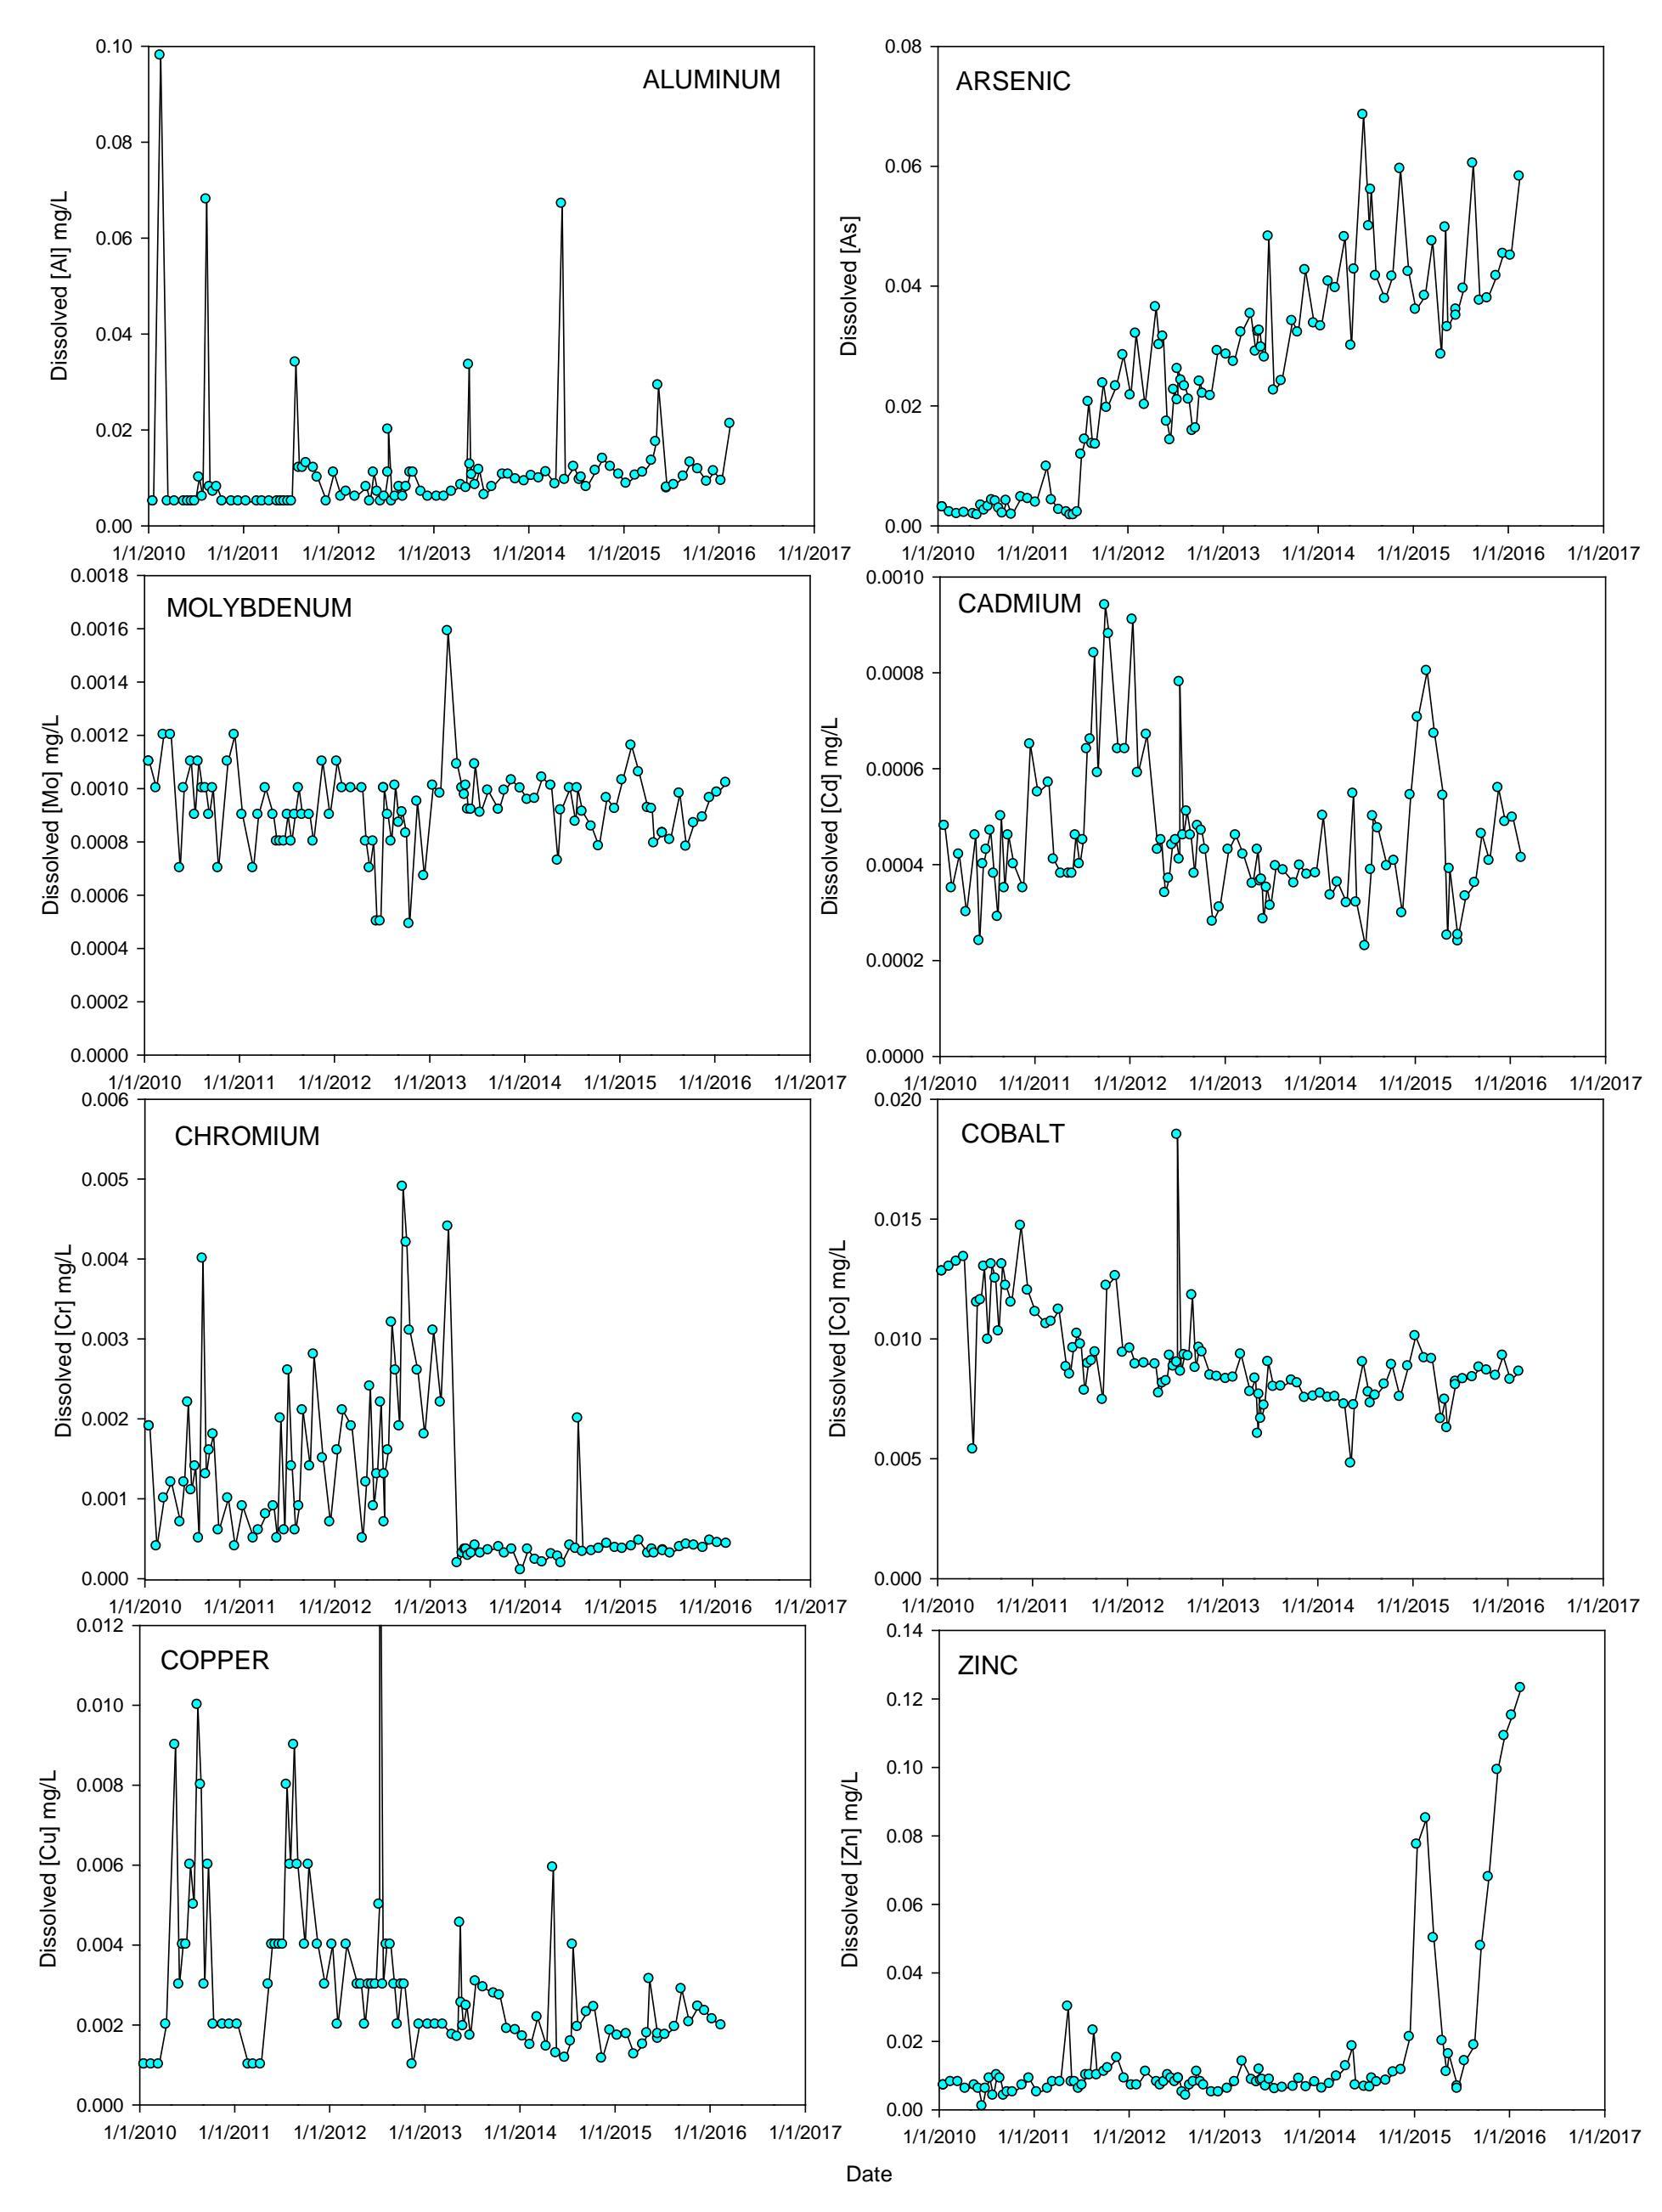
Figure 14: Time series profiles for trace elements for the Seepage Pond (2010-February 2016 data).

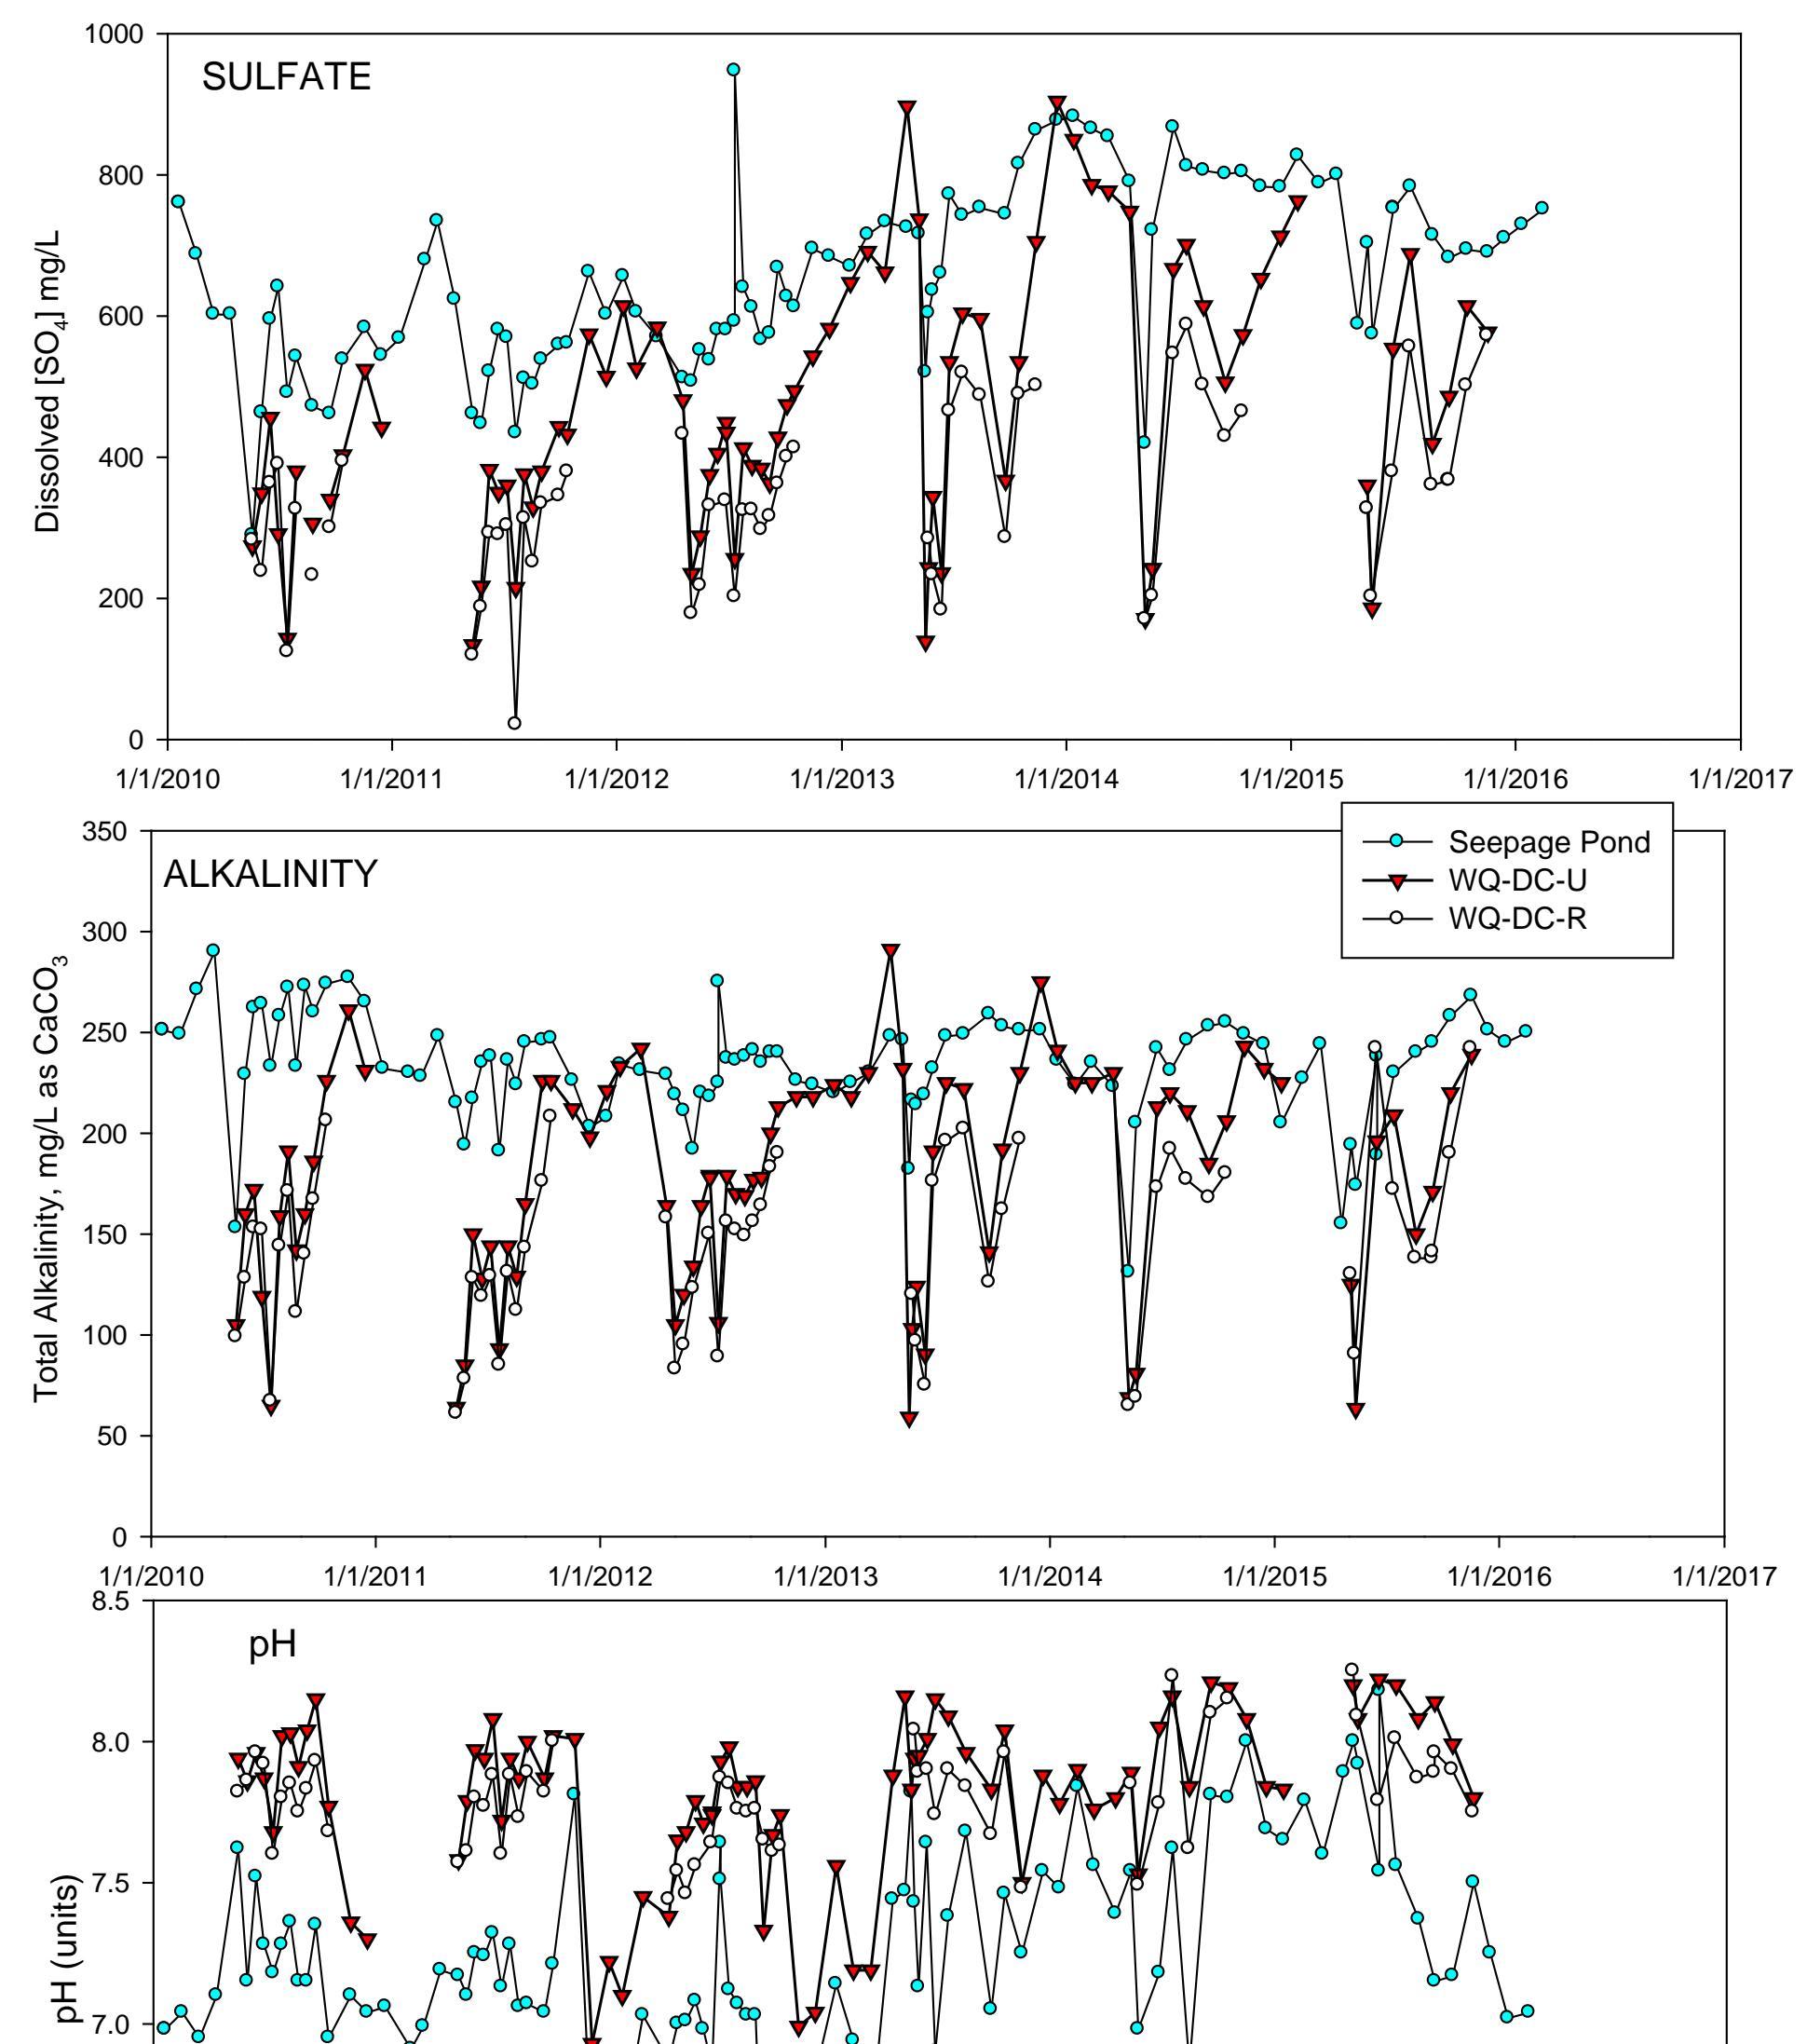
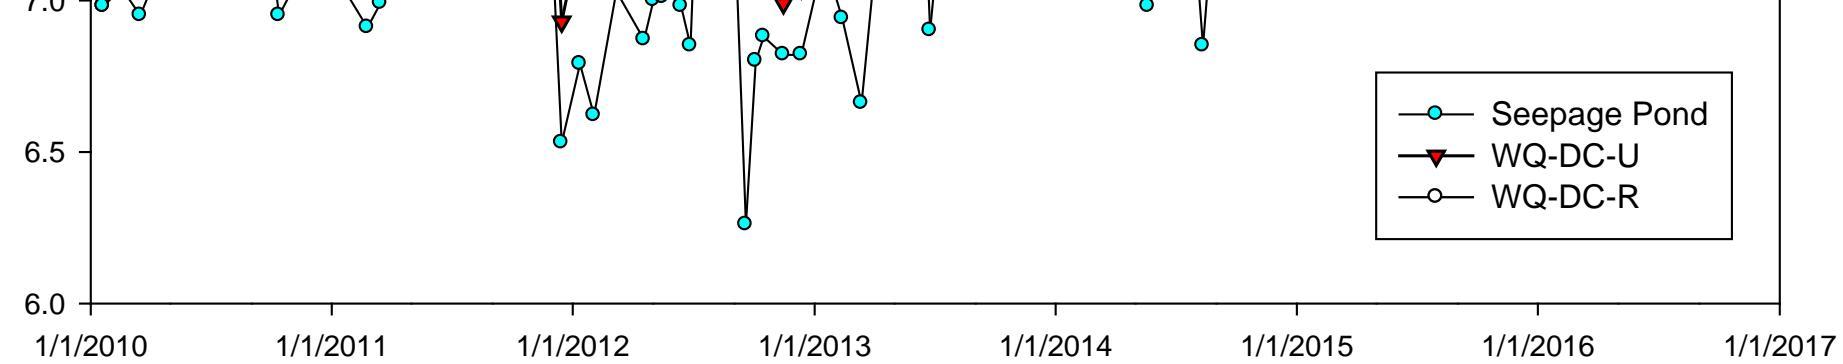
Figure 15: Time series profiles for SO4, alkalinity and pH for Seepage Pond and Lower Dome Creek (2010-2015 data).

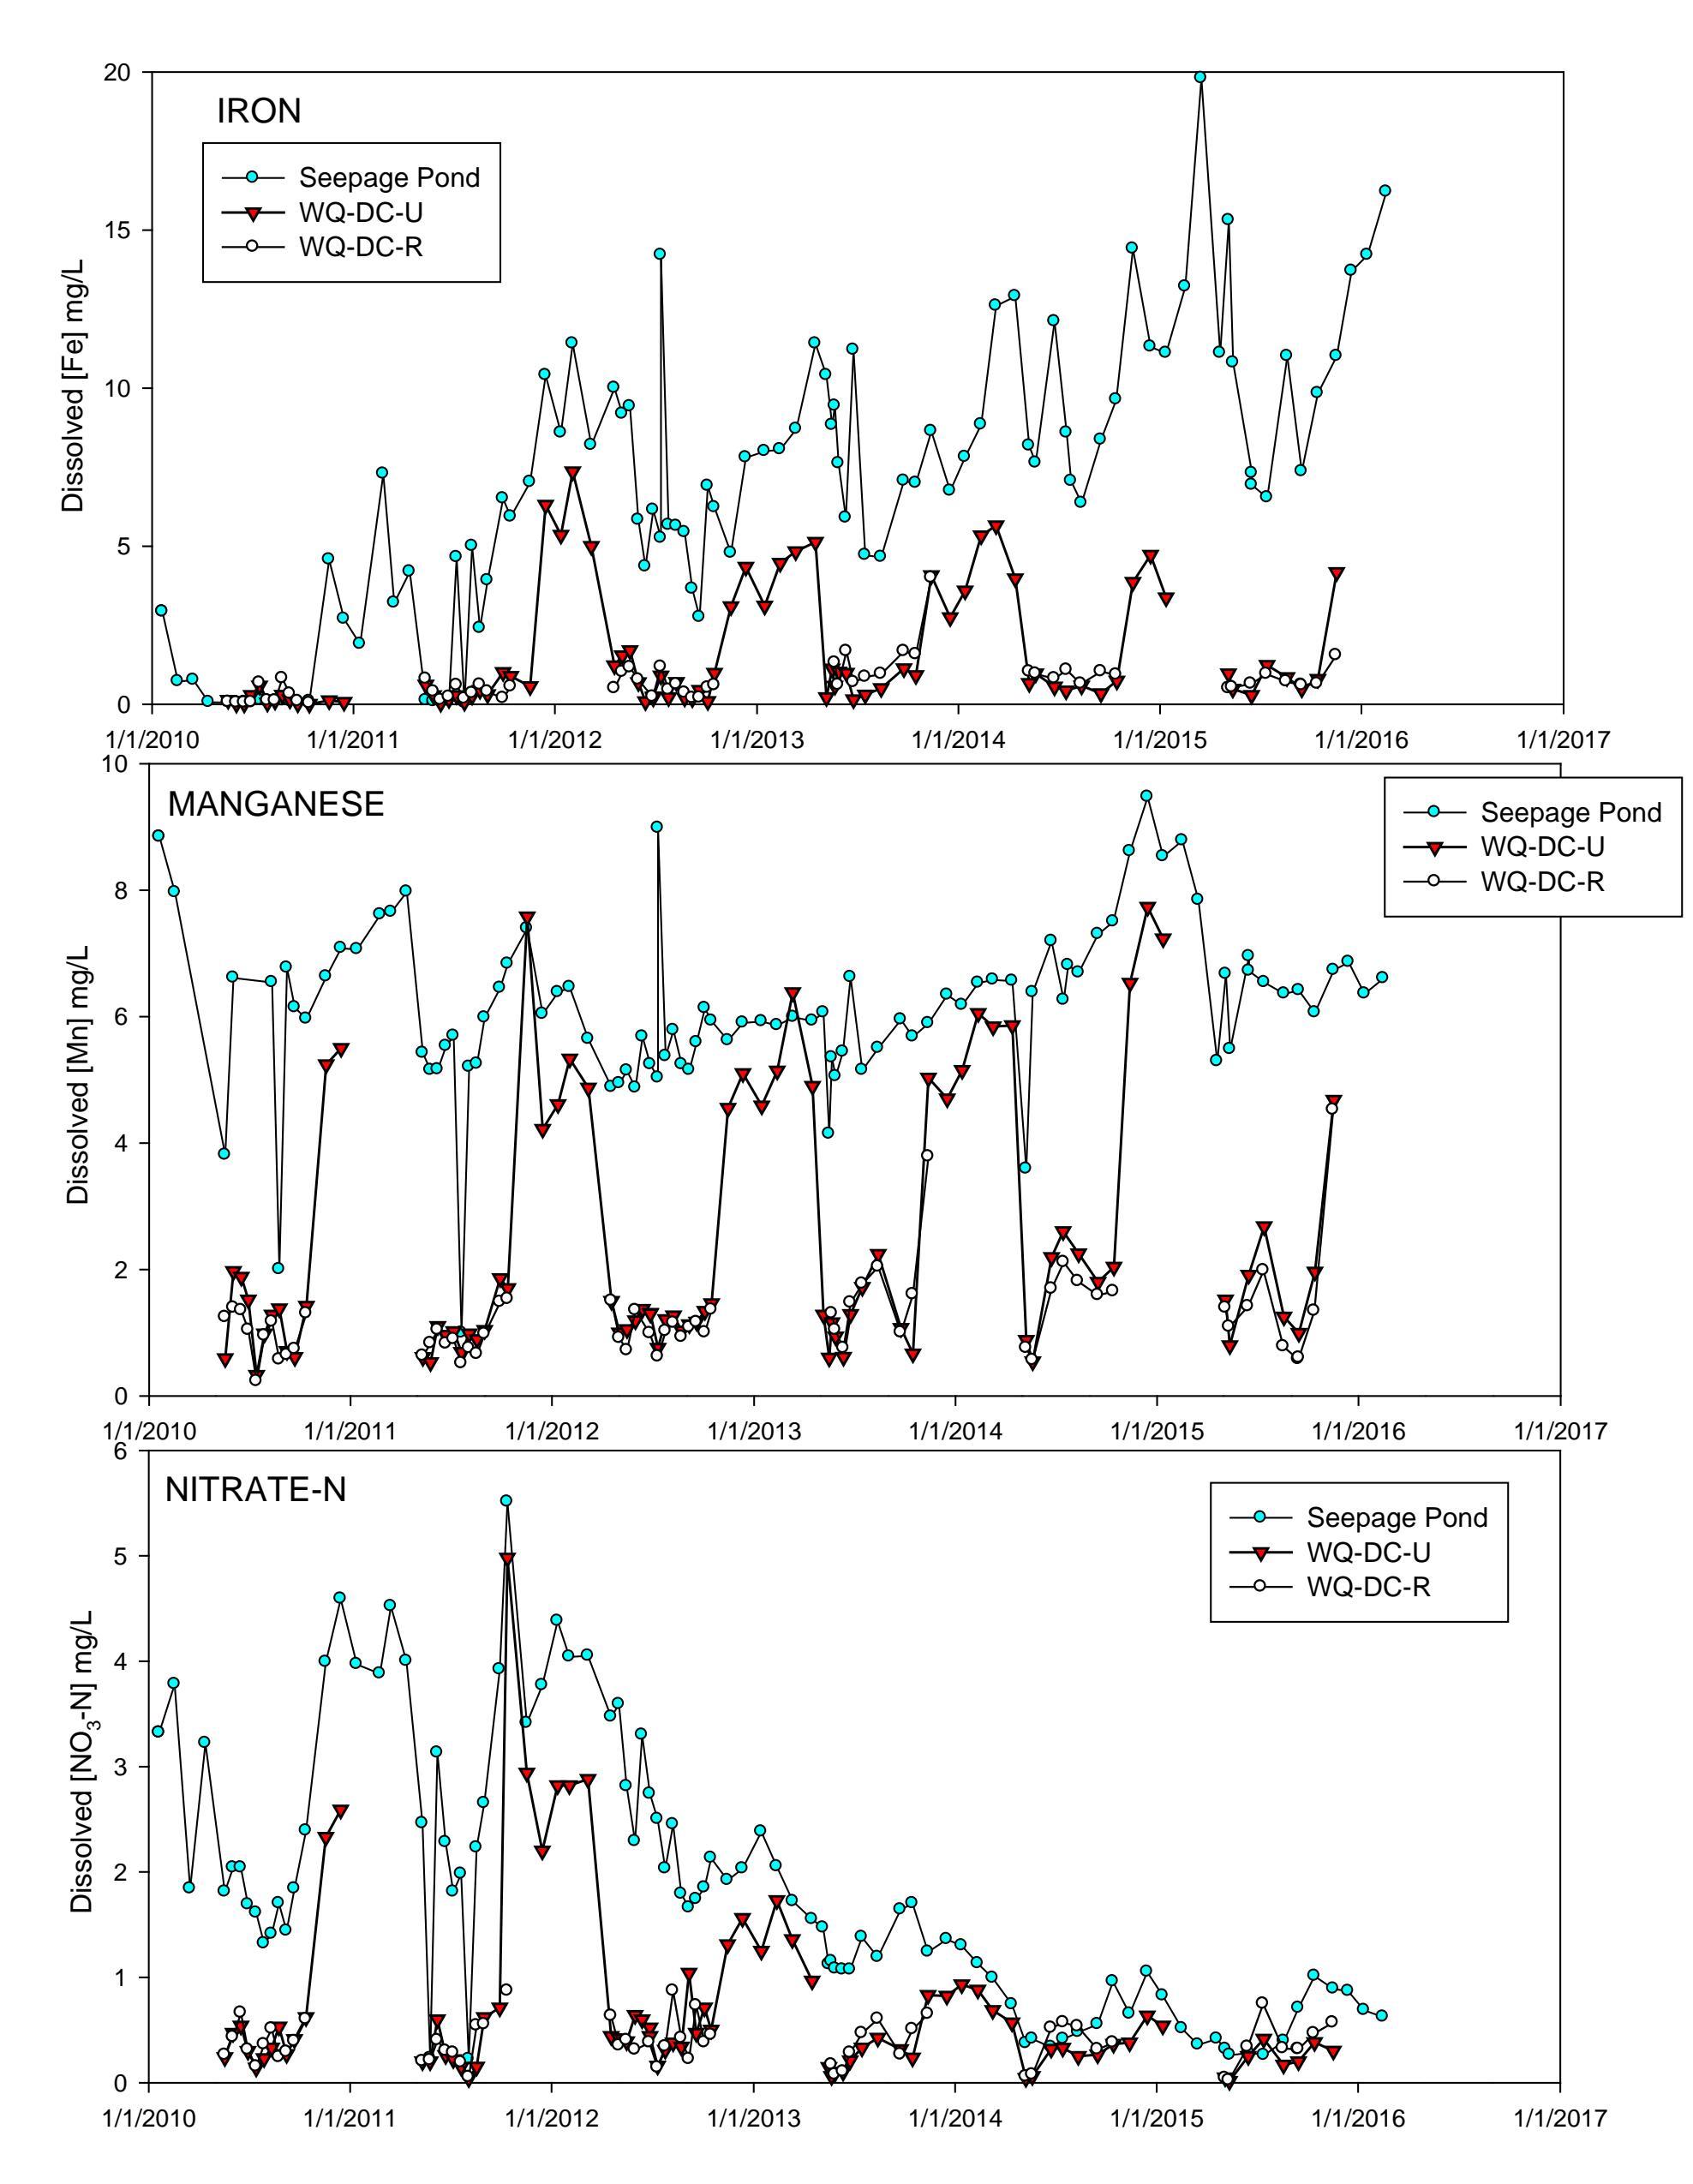
Figure 16: Time series profiles for redox-related parameters for Seepage Pond and Lower Dome Creek (2010-2015 data).

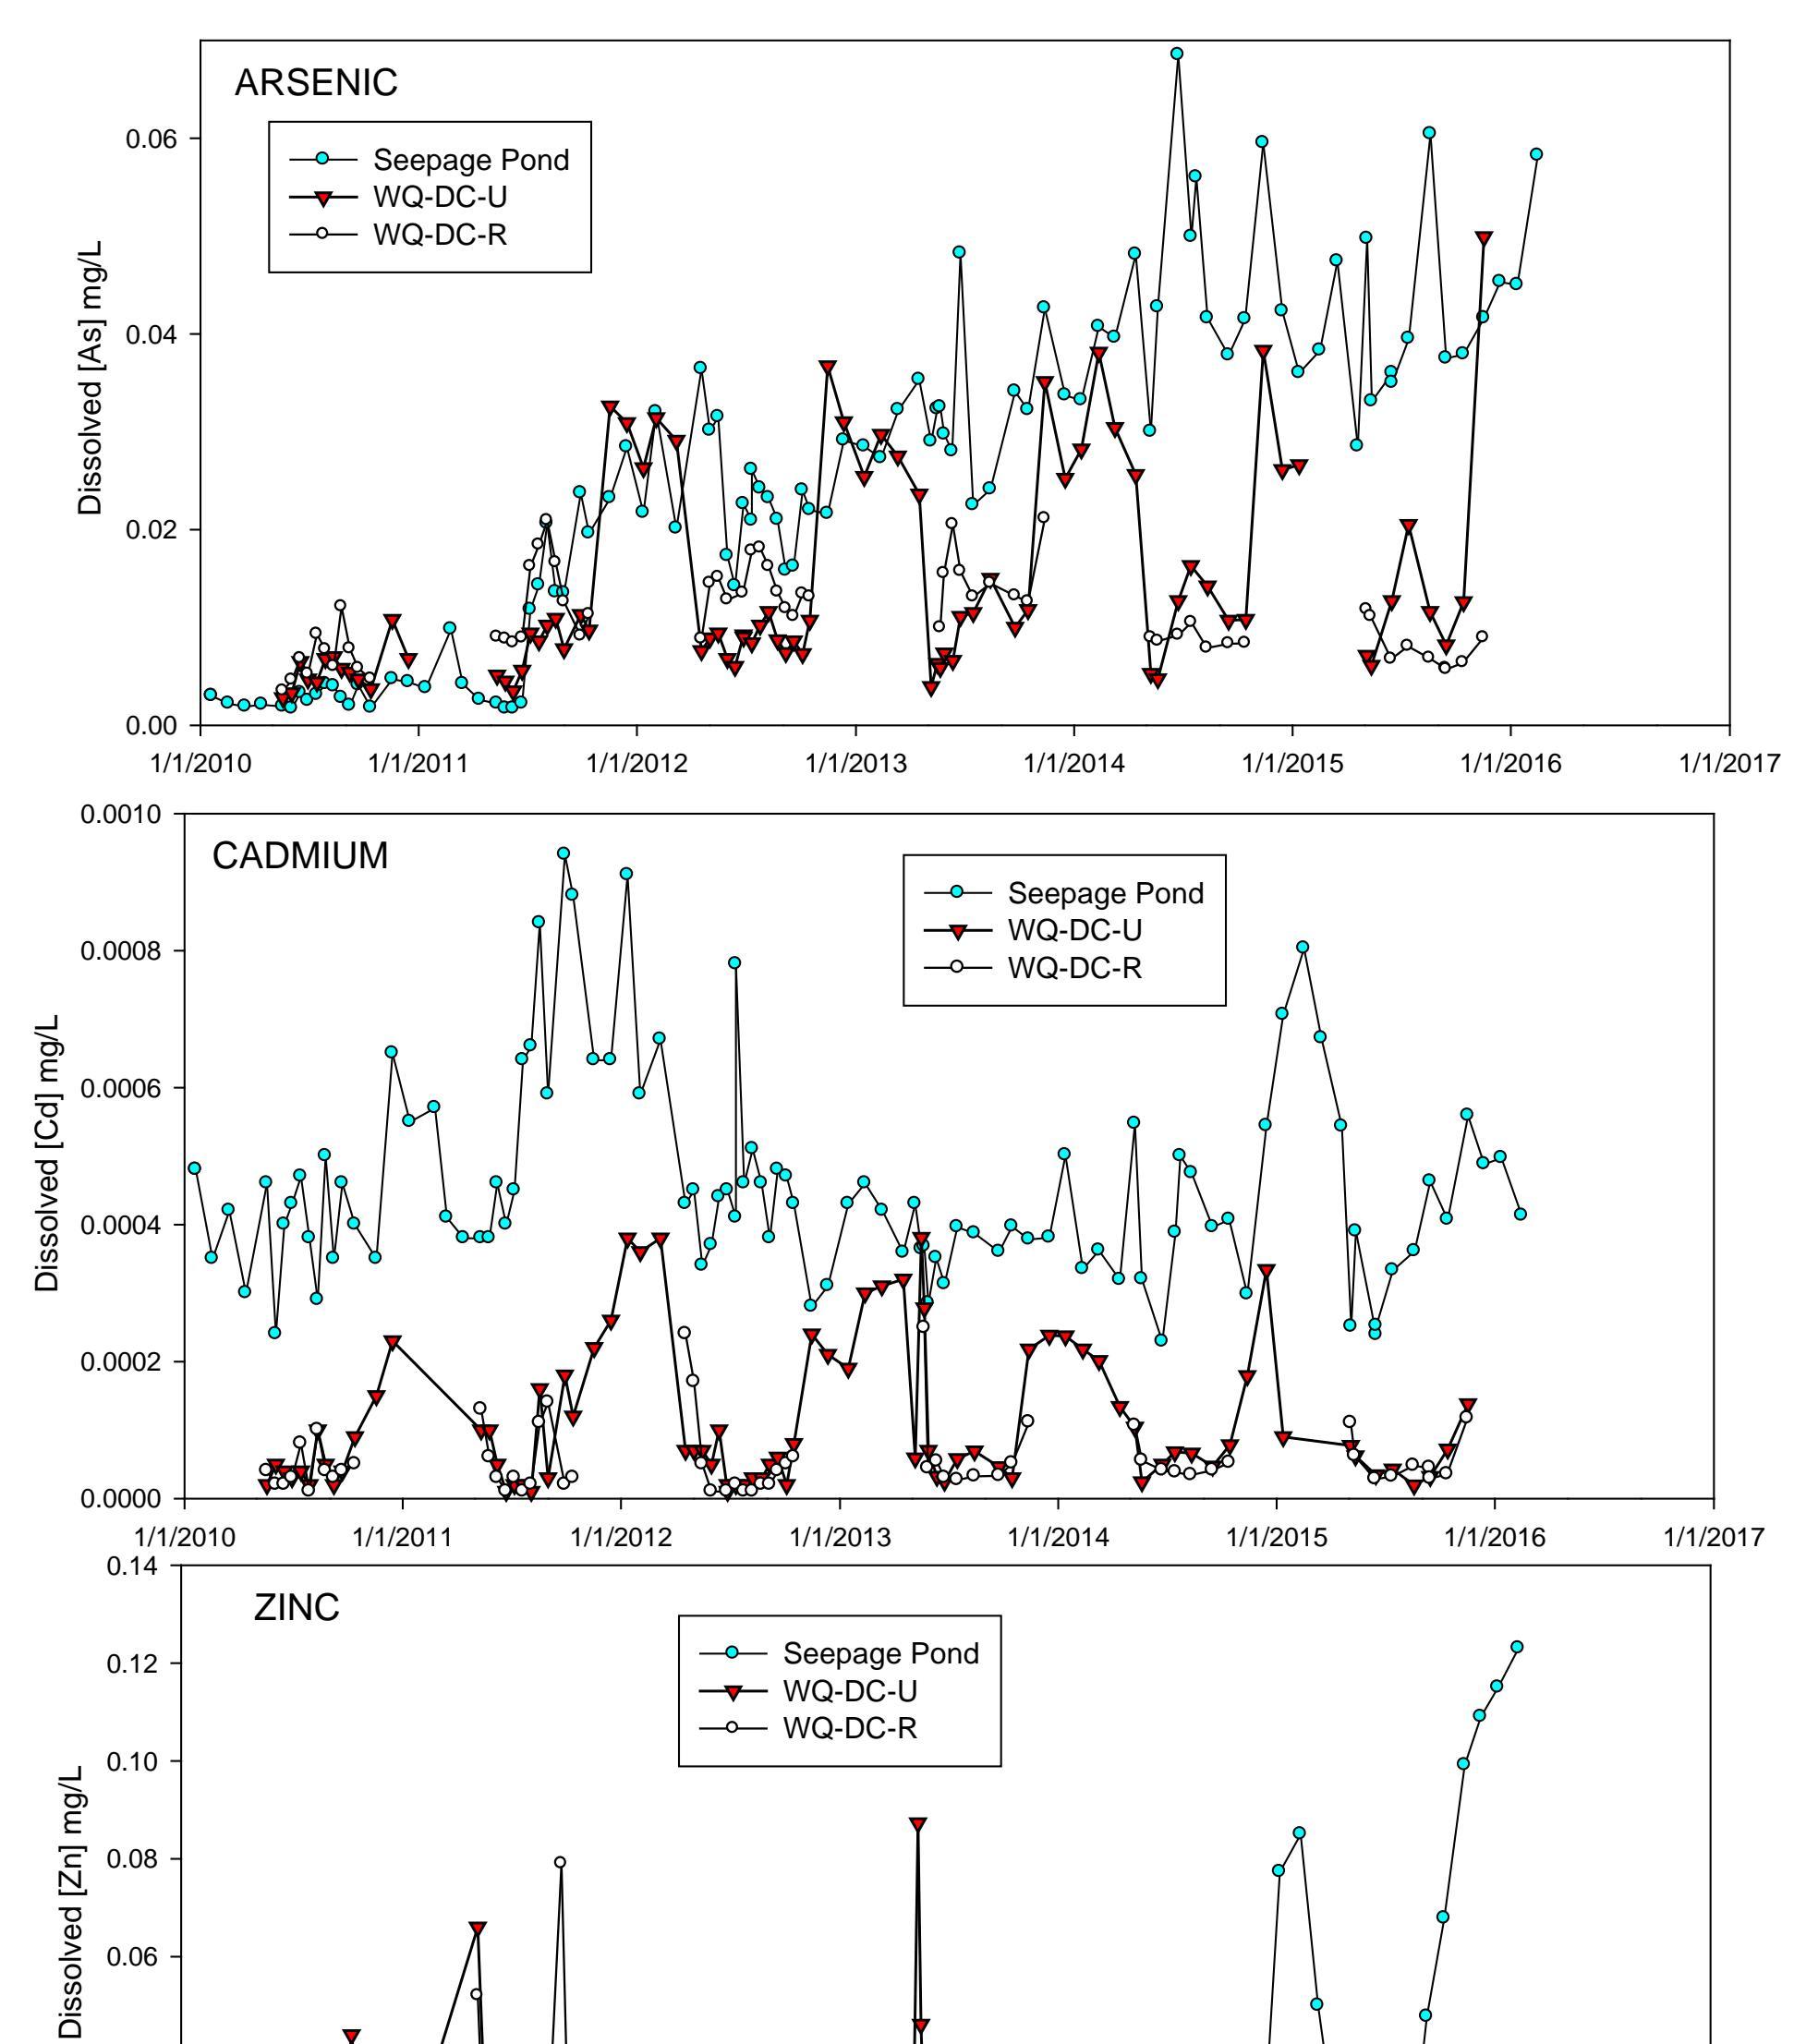
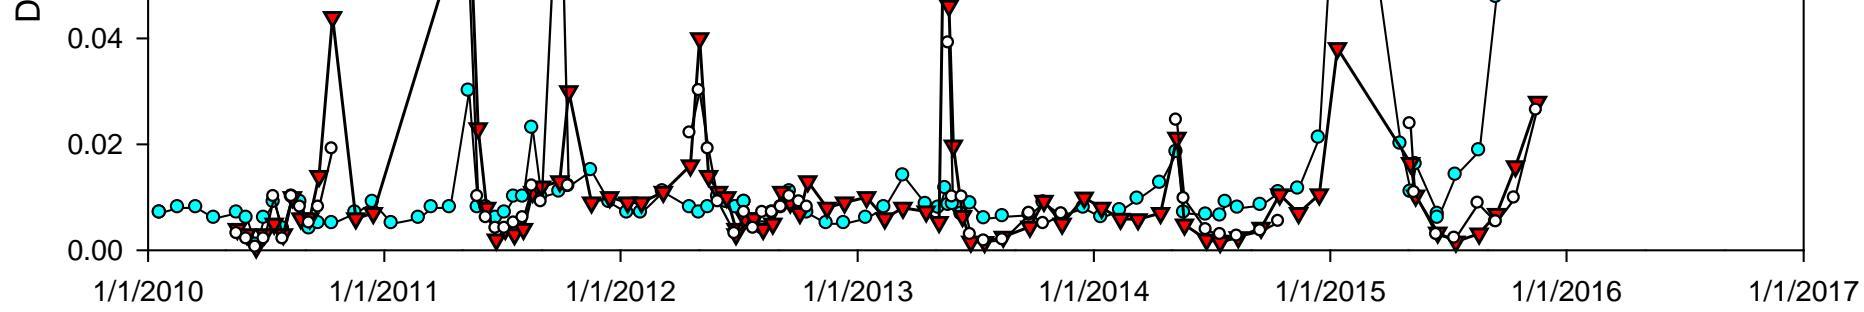
Figure 17: Time series profiles for dissolved As, Cd and Zn for Seepage Pond and Lower Dome Creek (2010-2015 data).

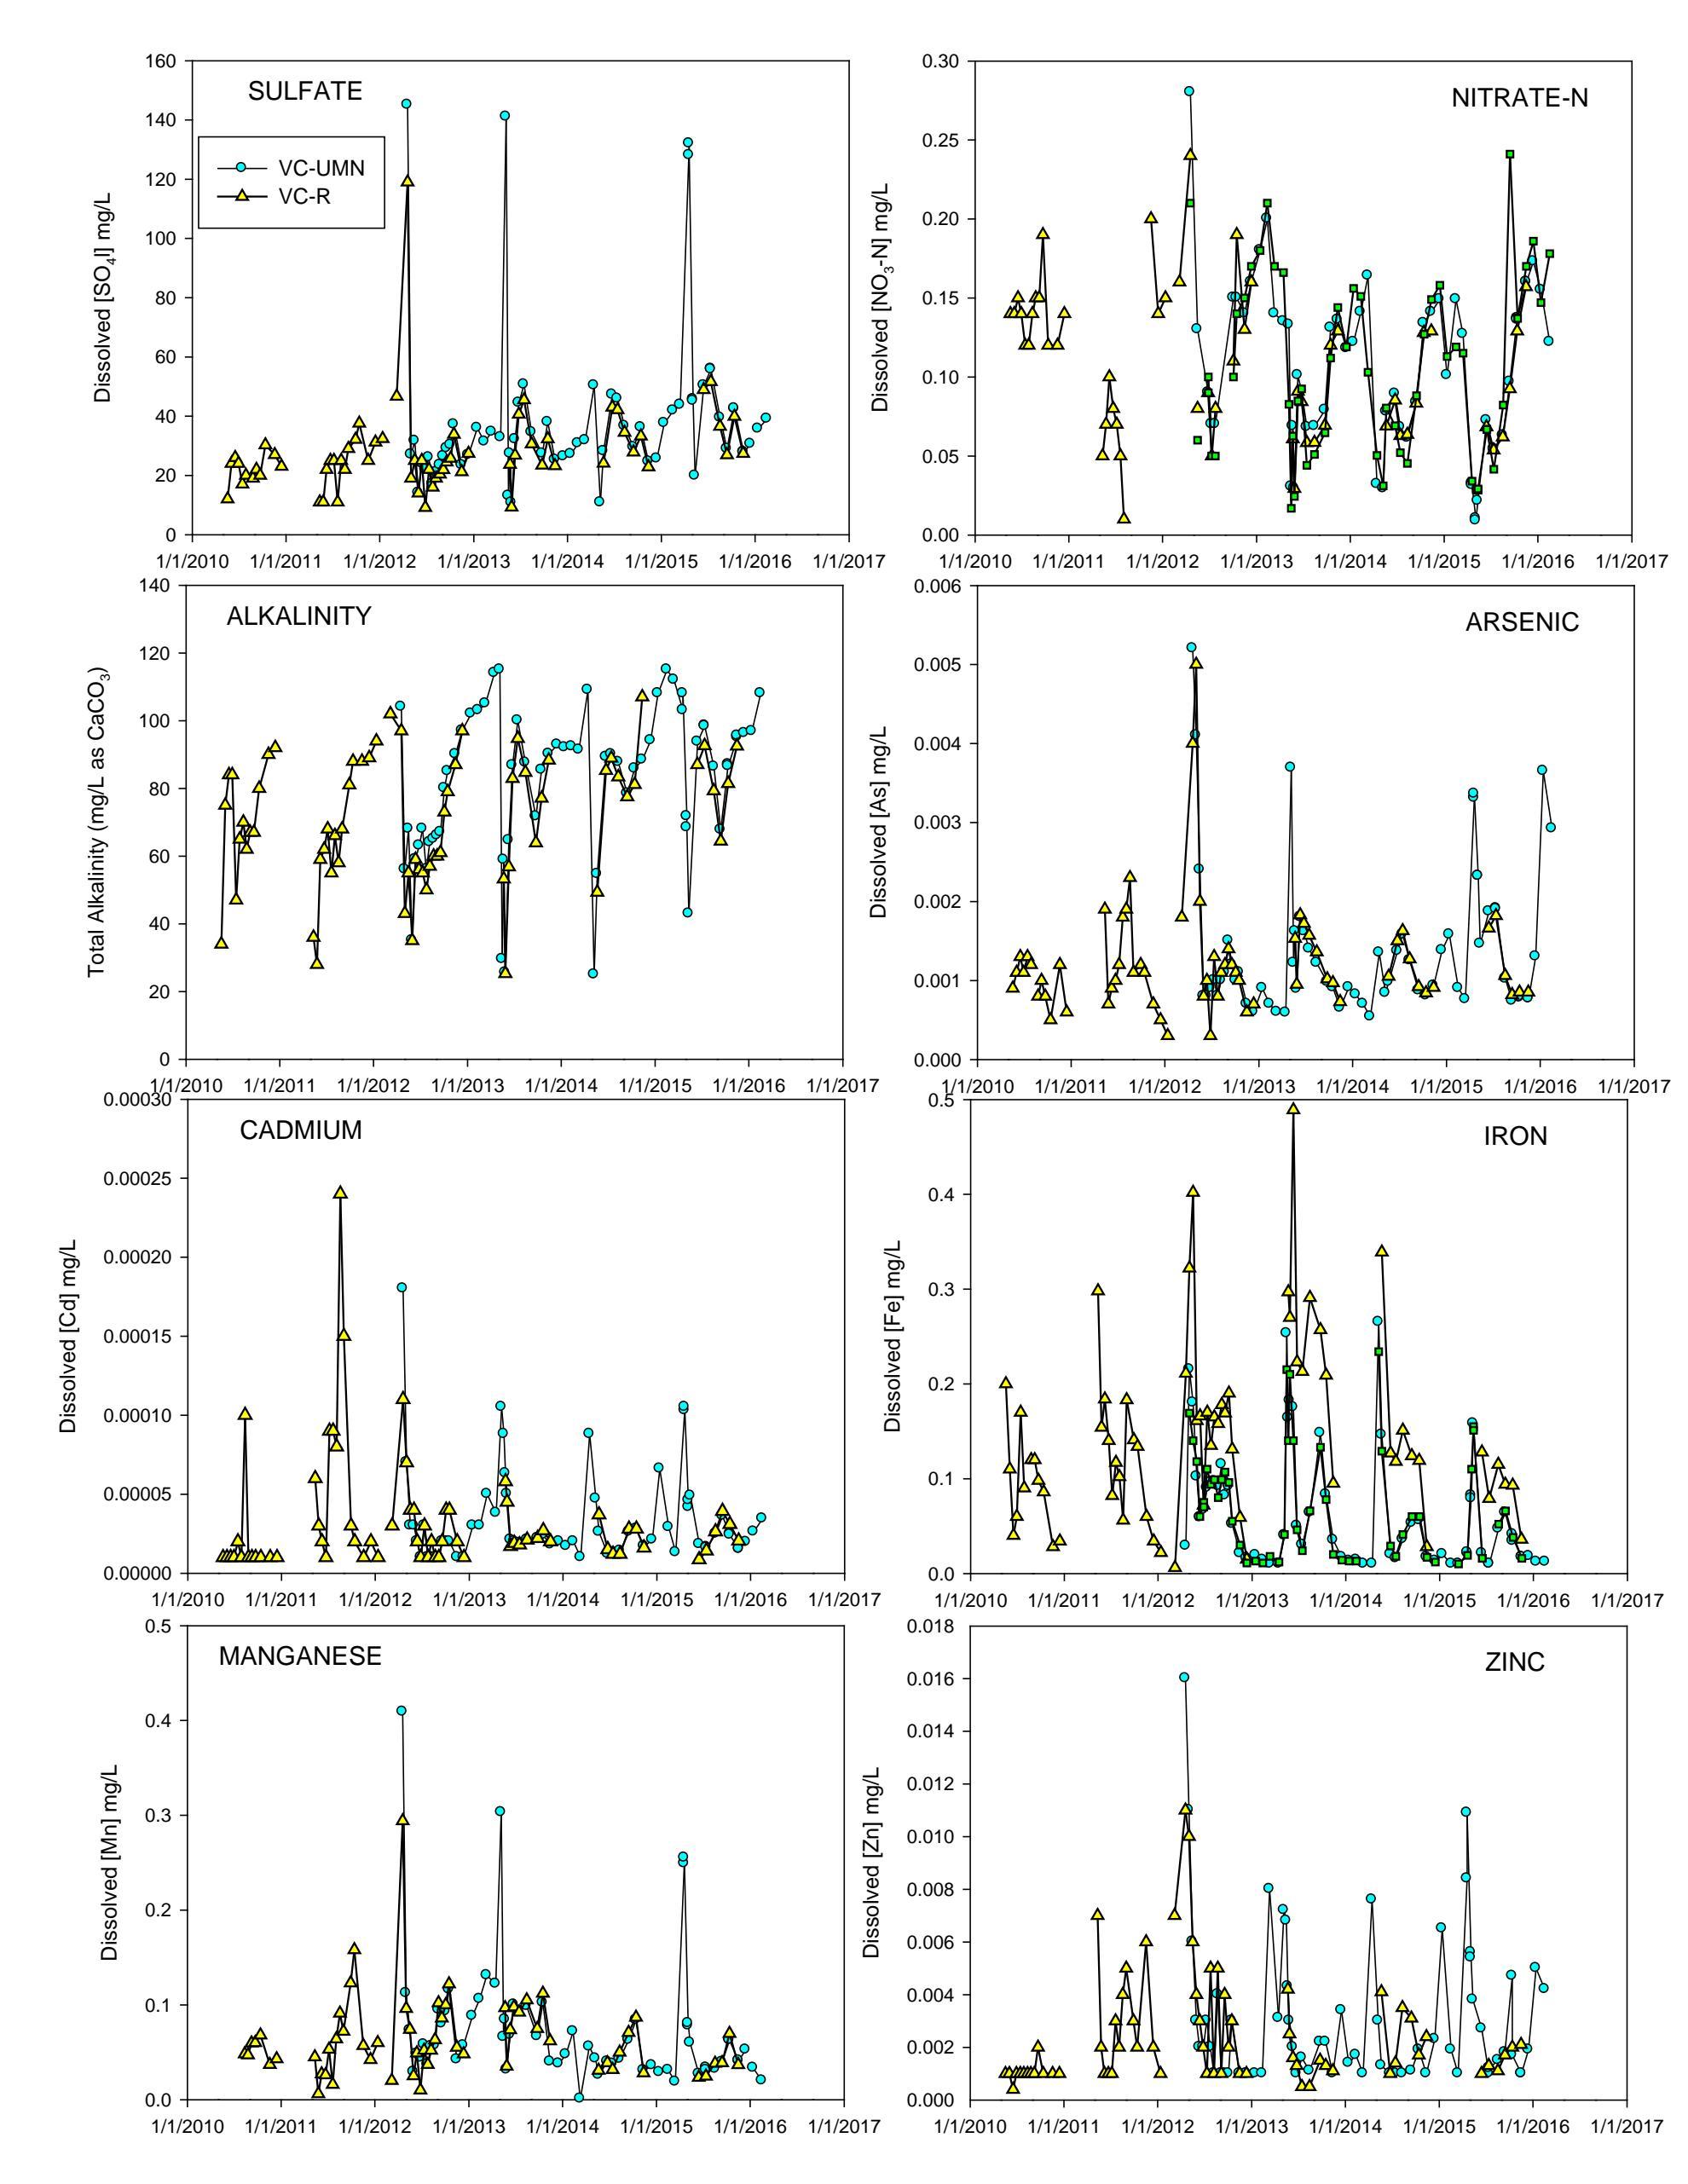
Figure 18: Time series profiles for dissolved sulfate, nitrate-N, alkalinity and various trace elements (As, Cd, Fe, Mn and Zn) for Victoria Creek downstream of Dome Creek confluence, both upstream (VC-UMN) and downstream (VC-R) of Minnesota Creek. Data compared to control site VC-U.
