Mount Nansen Dome Creek and Victoria Creek Surface Water Quality Evaluation and Preliminary Aquatic Effects Assessment

Prepared for: Little Salmon Carmacks First Nation Carmacks, Yukon

Prepared by: Lorax Environmental Services Ltd. 2289 Burrard St. Vancouver, B.C., Canada, V6J 3H9

> Project No. A399-1 January 31, 2017

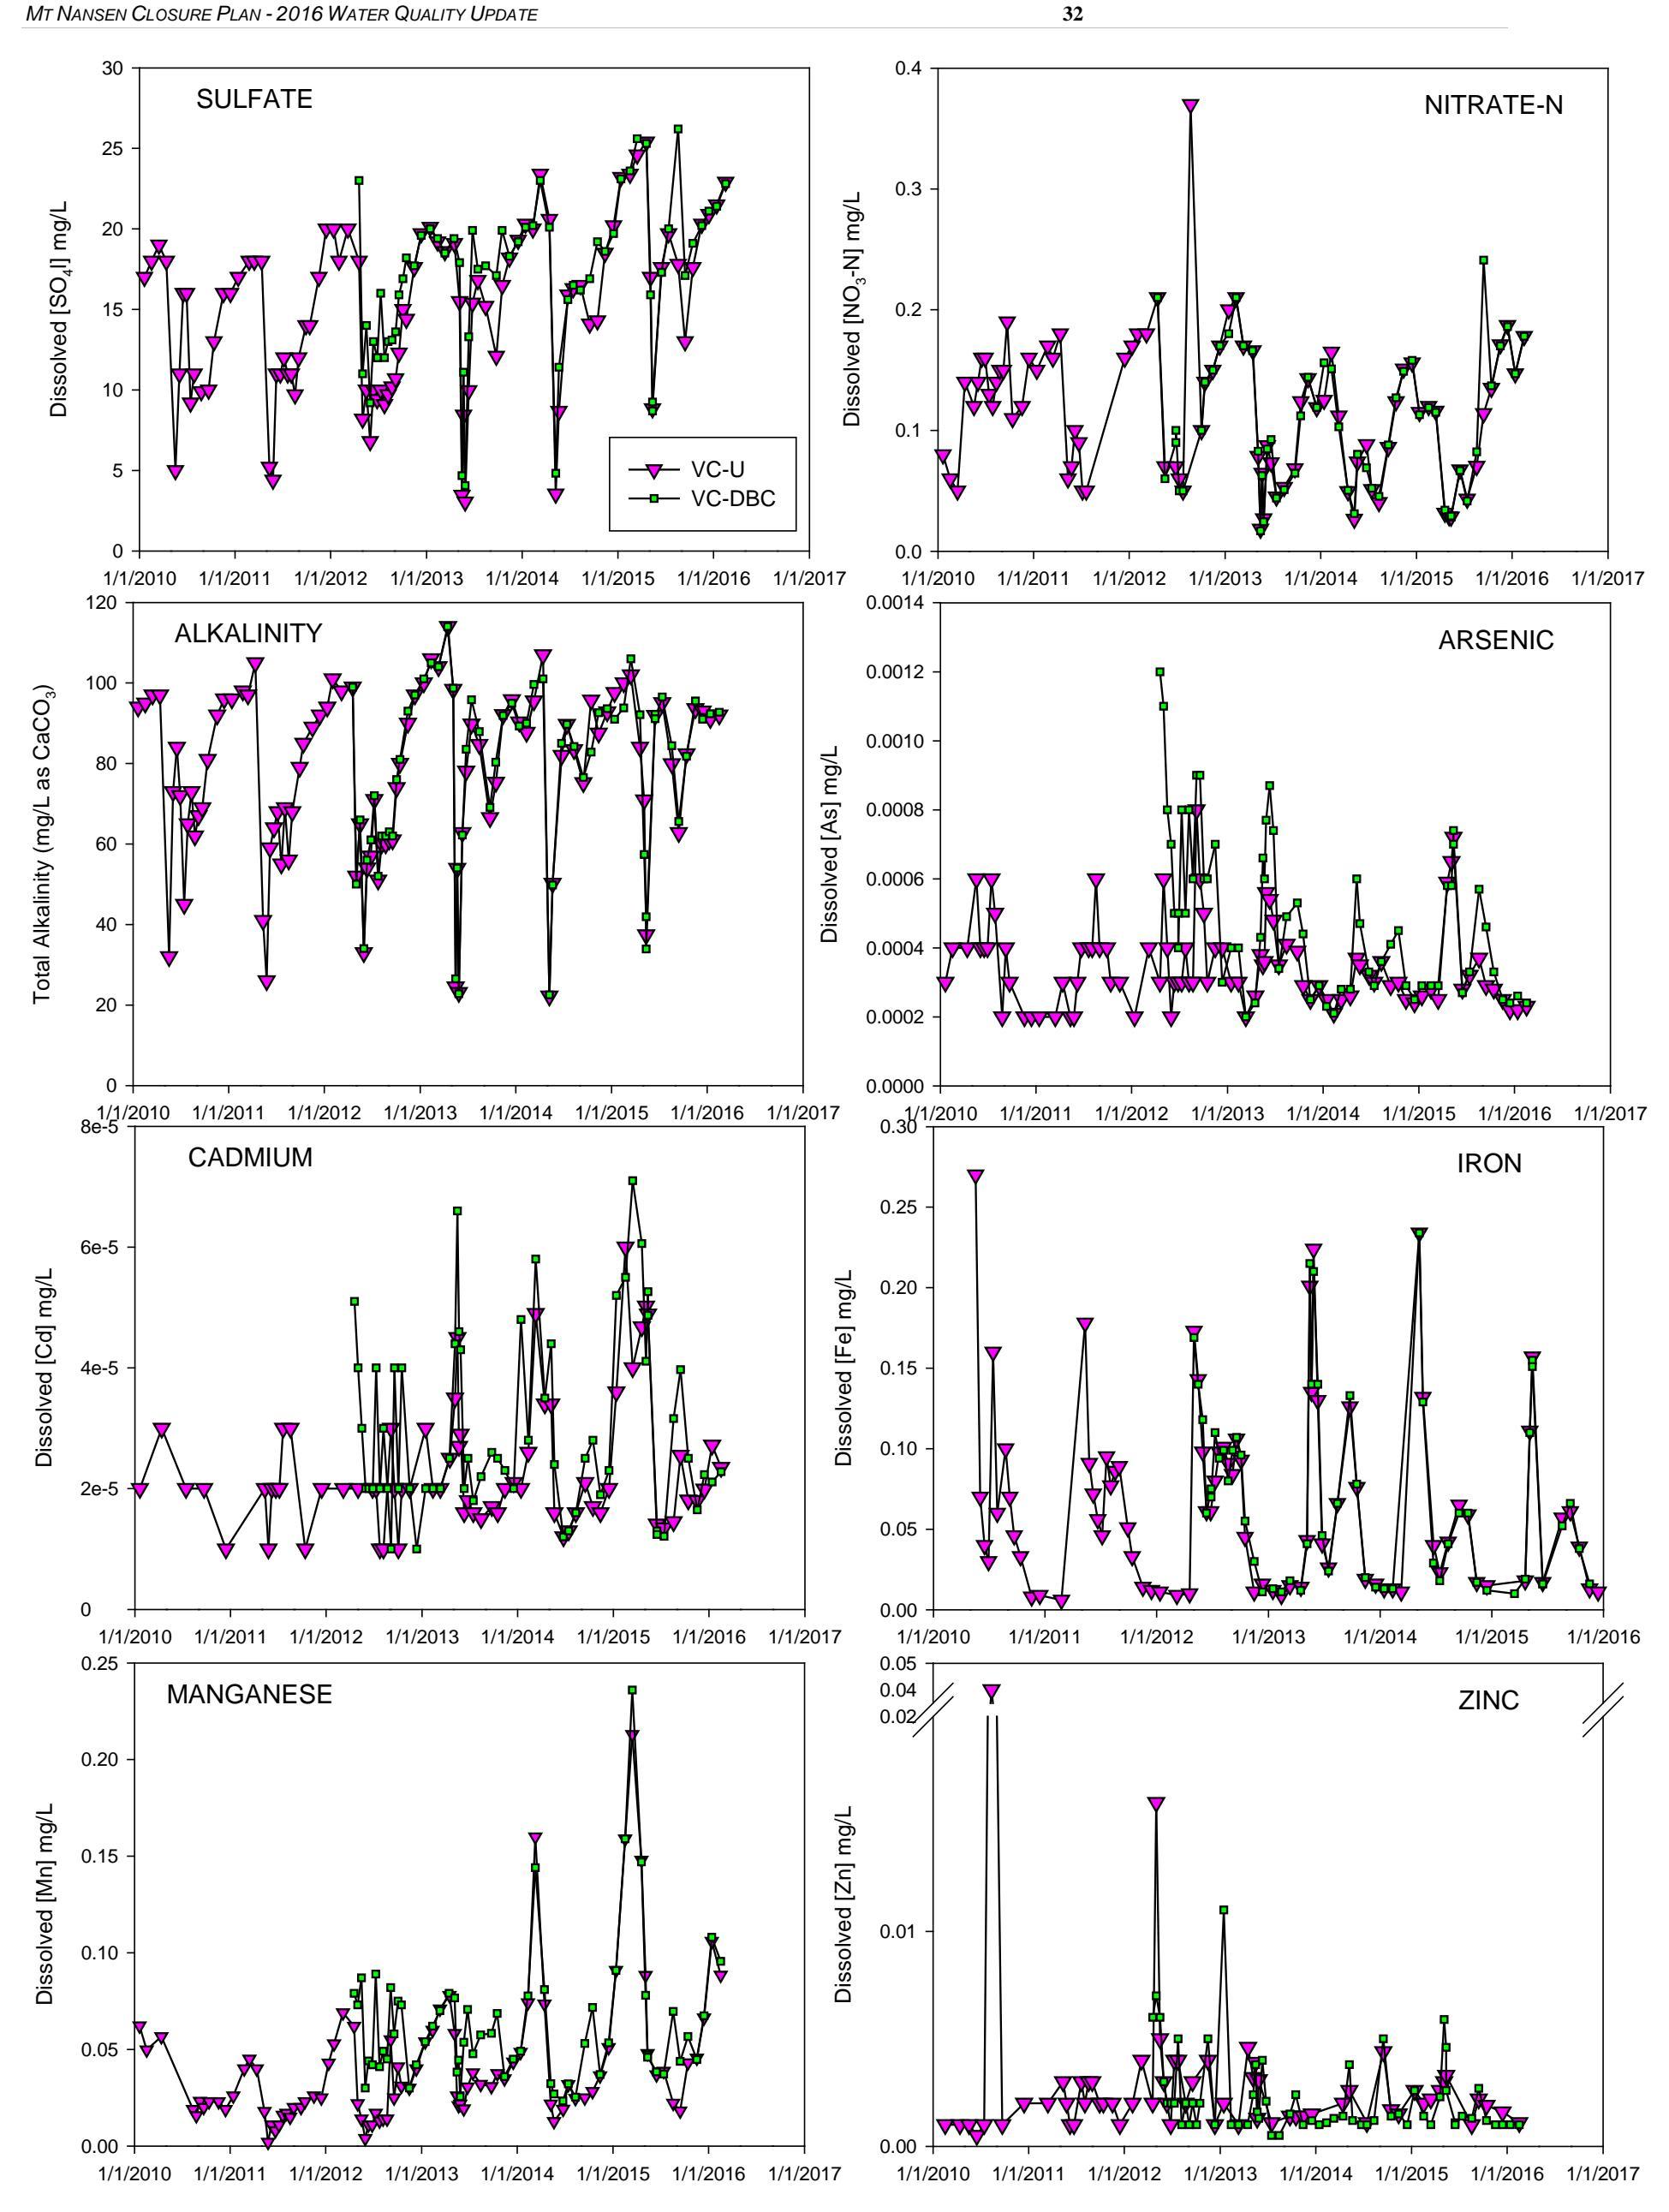
Figure 19: Time series profiles for dissolved sulfate, nitrate-N, alkalinity and various trace elements (As, Cd, Fe, Mn and Zn) for Victoria Creek upstream of Dome Creek confluence, both upstream (VC-U) and downstream (VC-DBC) of **Back Creek.**
1.1 Introduction
