Wolverine Mine

2014 ANNUAL REPORT

LAND TREATMENT FACILITY

PERMIT 24-022

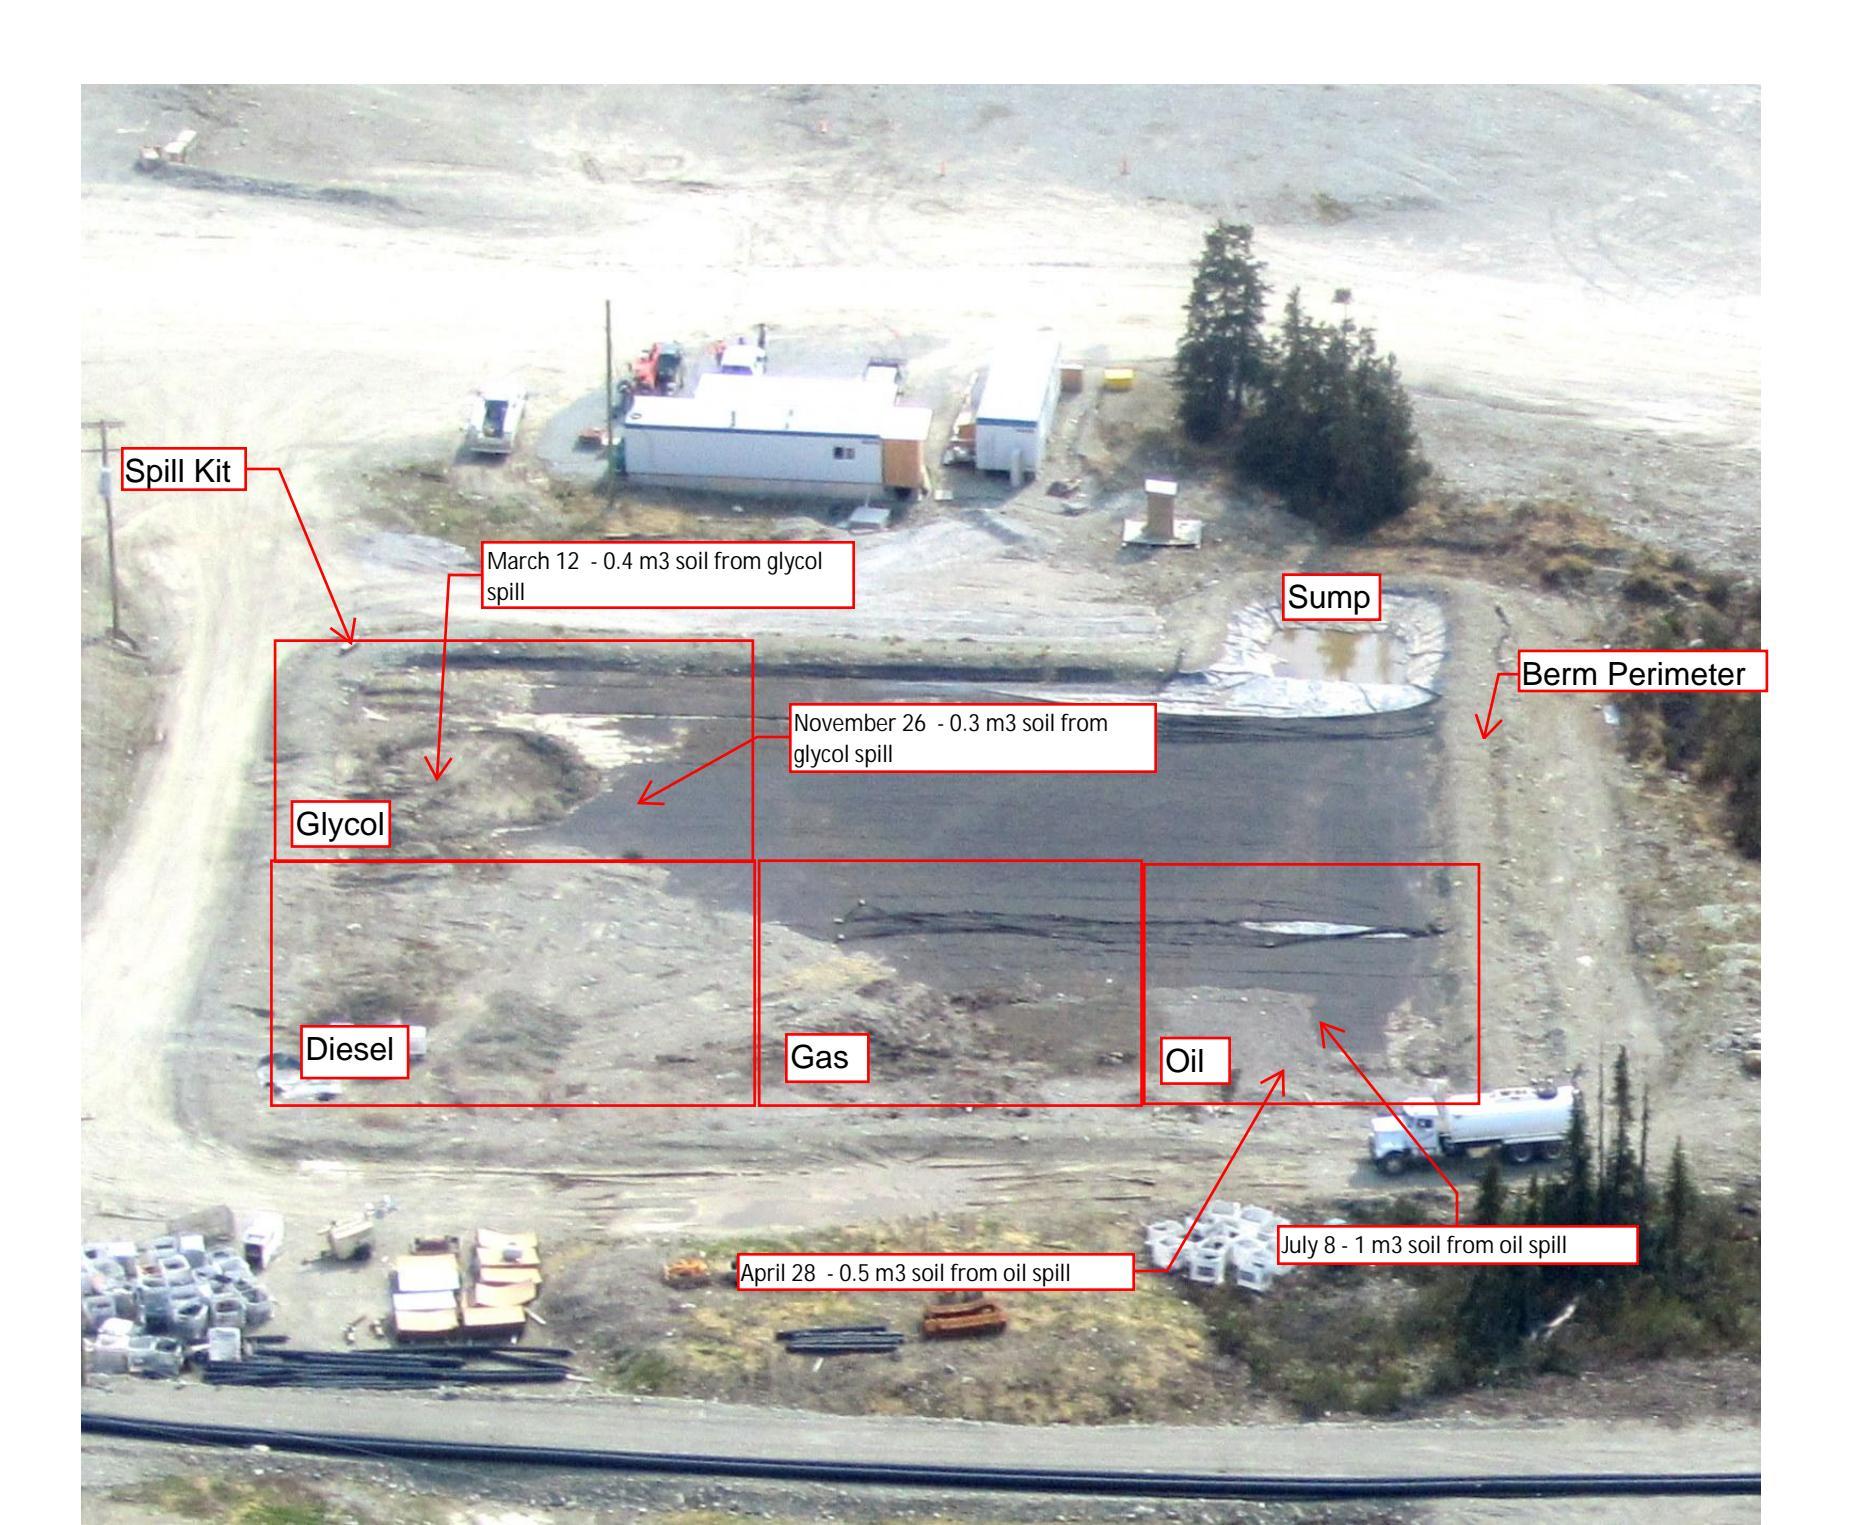
17. Attachment 7.1: Figure showing the entire facility and the location of contaminated material deposited

As indicated in Table 3.1, material that was suspected to be contaminated was deposited into the LTF in 2014 includes ~1.5 m³ of waste oil contaminated material and ~0.7 m³ of glycol contaminated soil. These deposits were placed in the appropriate labelled sections of the LTF, and levelled out to below the berm height of 0.5 m.

7. Figure attached showing the entire facility and the location of contaminated material from each source:

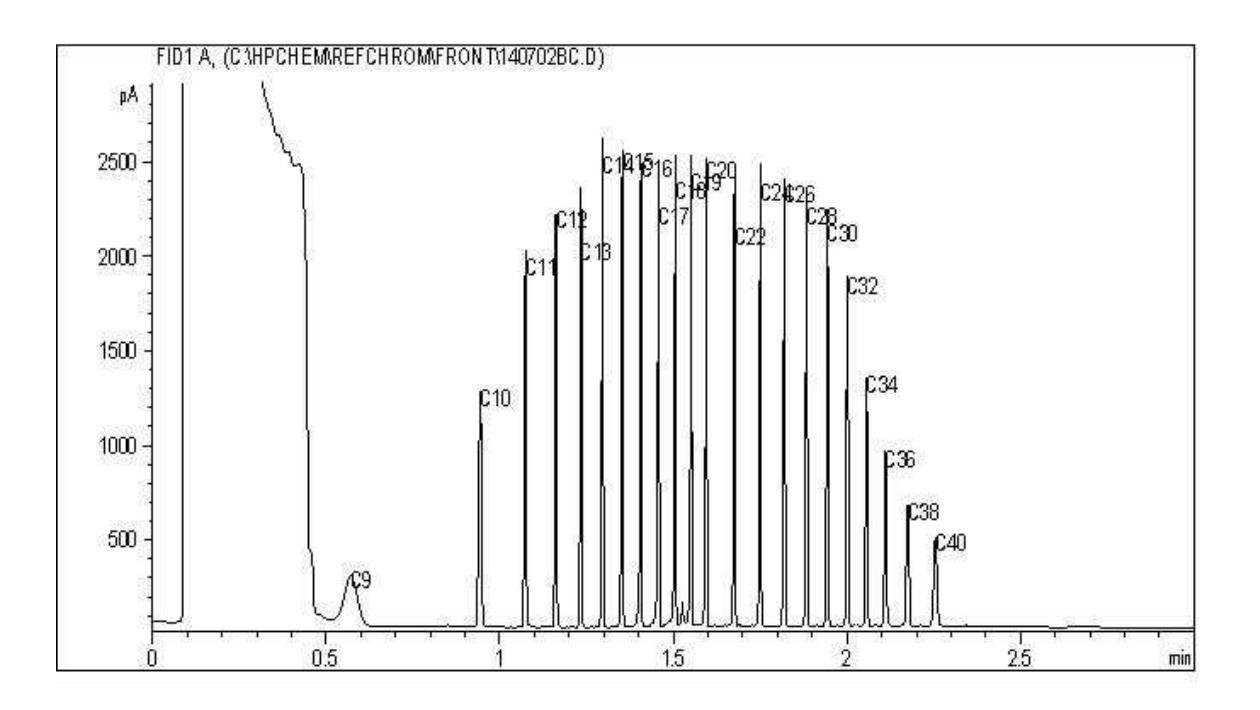
Carbon Range Distribution - Reference Chromatogram

TYPICAL PRODUCT CARBON NUMBER RANGES

Note: This information is provided for reference purposes only. Should detailed chemist interpretation or fingerprinting be required, please contact the laboratory.
