DELOITTE & TOUCHE INC.

**ANVIL RANGE MINE SITE
TAILINGS DUST CONTROL
TEST PROJECT**

FARO MINE, YT

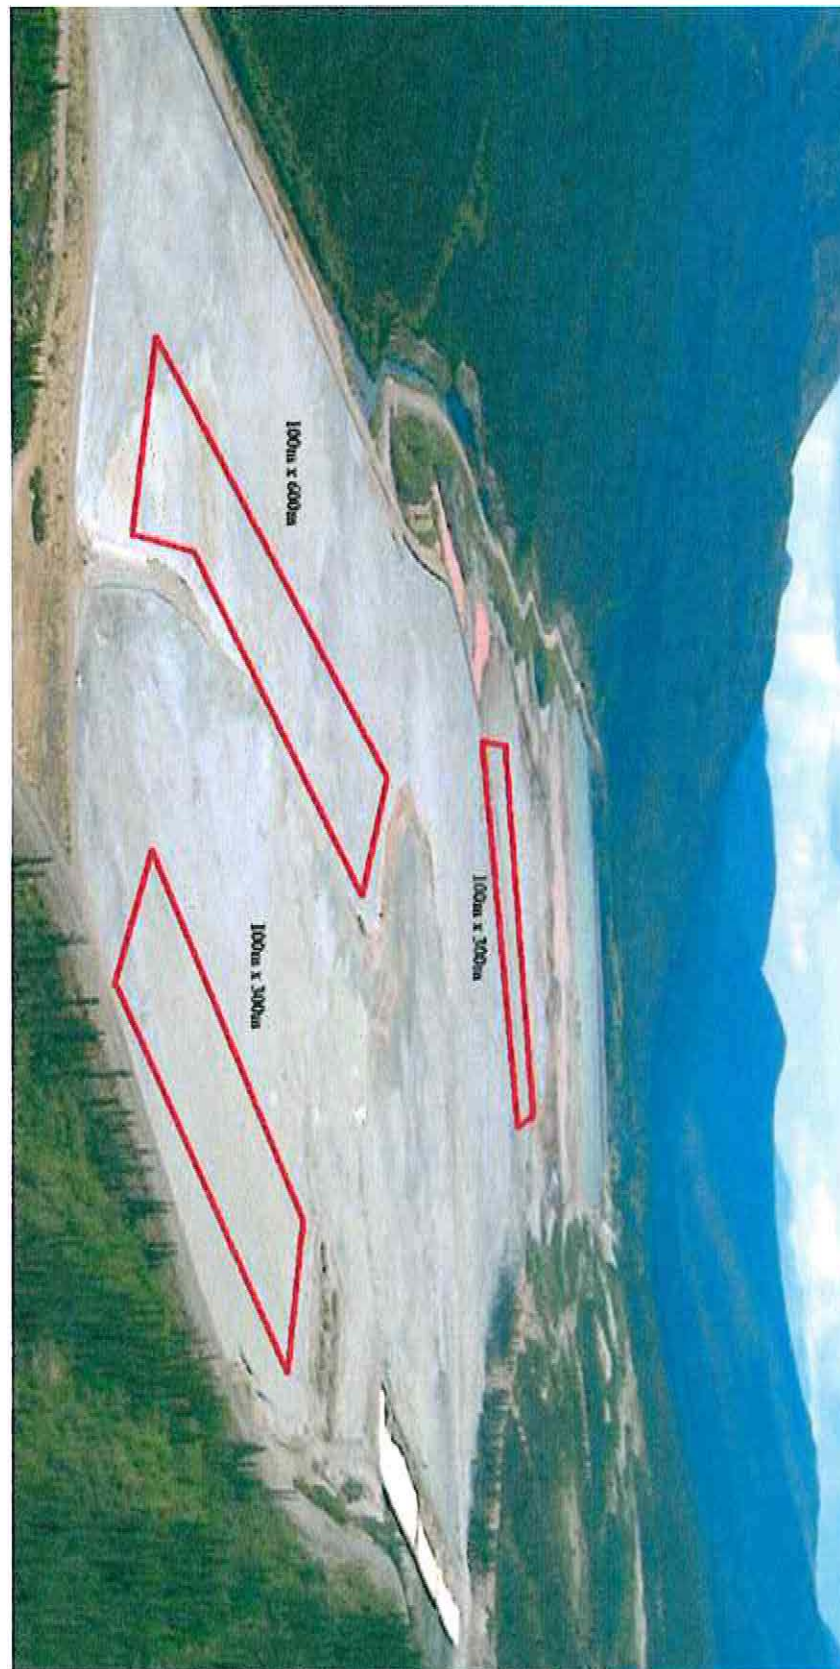
APPENDIX B:
TAILINGS PERIMETERS

The three selected areas of the tailings impoundments, which can be seen in Appendix B, were staked out for testing. At all three of the areas identified the stakes were placed in rows spaced at intervals of 6.5m marking the path that should be followed when spraying to ensure the best coverage. Rows of stakes were placed every 25m along the bottoms of the different impoundment dams.

The staking out of the three areas began on July 17th, and carried on into the following week. One at the toe of the first impoundment has a length of 600m resulting in a 6ha area. Another along the toe of the damn at the second impoundment running 300m, contributes another 3ha of test area. The final area was staked out alongside the main road to the Guard House going past the first tailings impoundment at a length of 300m. The total area identified for test coverage is 12ha.
