The Continuing Rehabilitation of the Kam Kotia Mine: An Acid- Generating Abandoned Tailings Area.

Dawn Spires

Ontario Ministry of Northern Development, Mines & Forestry

The Northern Latitudes Workshop,

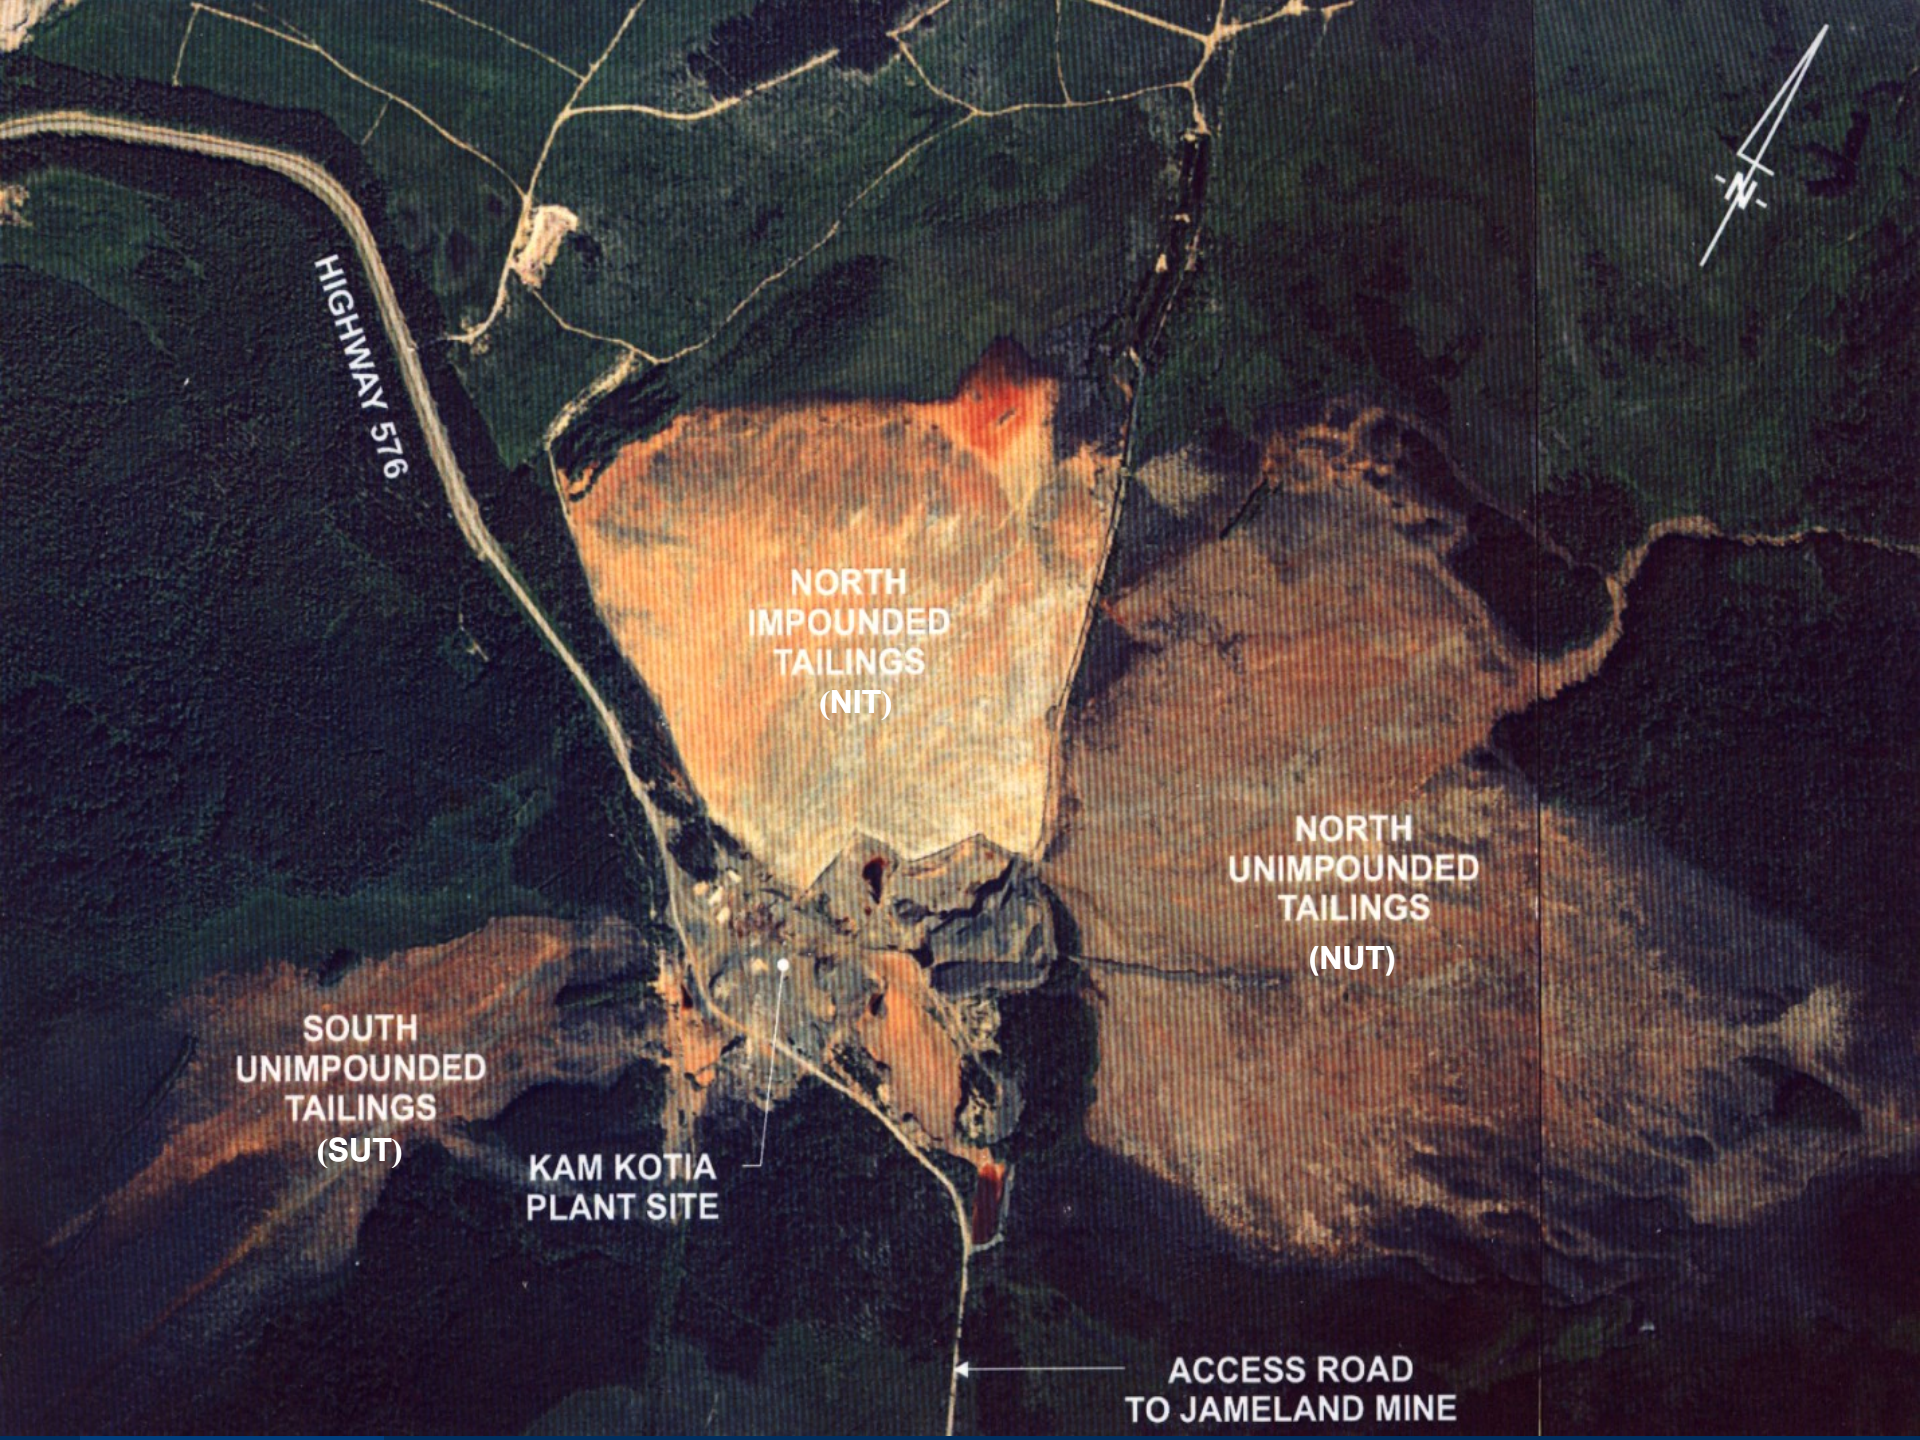
HIGHWAY 5176

NORTH
IMPOUNDED
TAILINGS
(NIT)

NORTH
UNIMPOUNDED
TAILINGS
(NUT)

SOUTH
UNIMPOUNDED
TAILINGS
(SUT)

KAM KOTIA
PLANT SITE

ACCESS ROAD
TO JAMELAND MINE

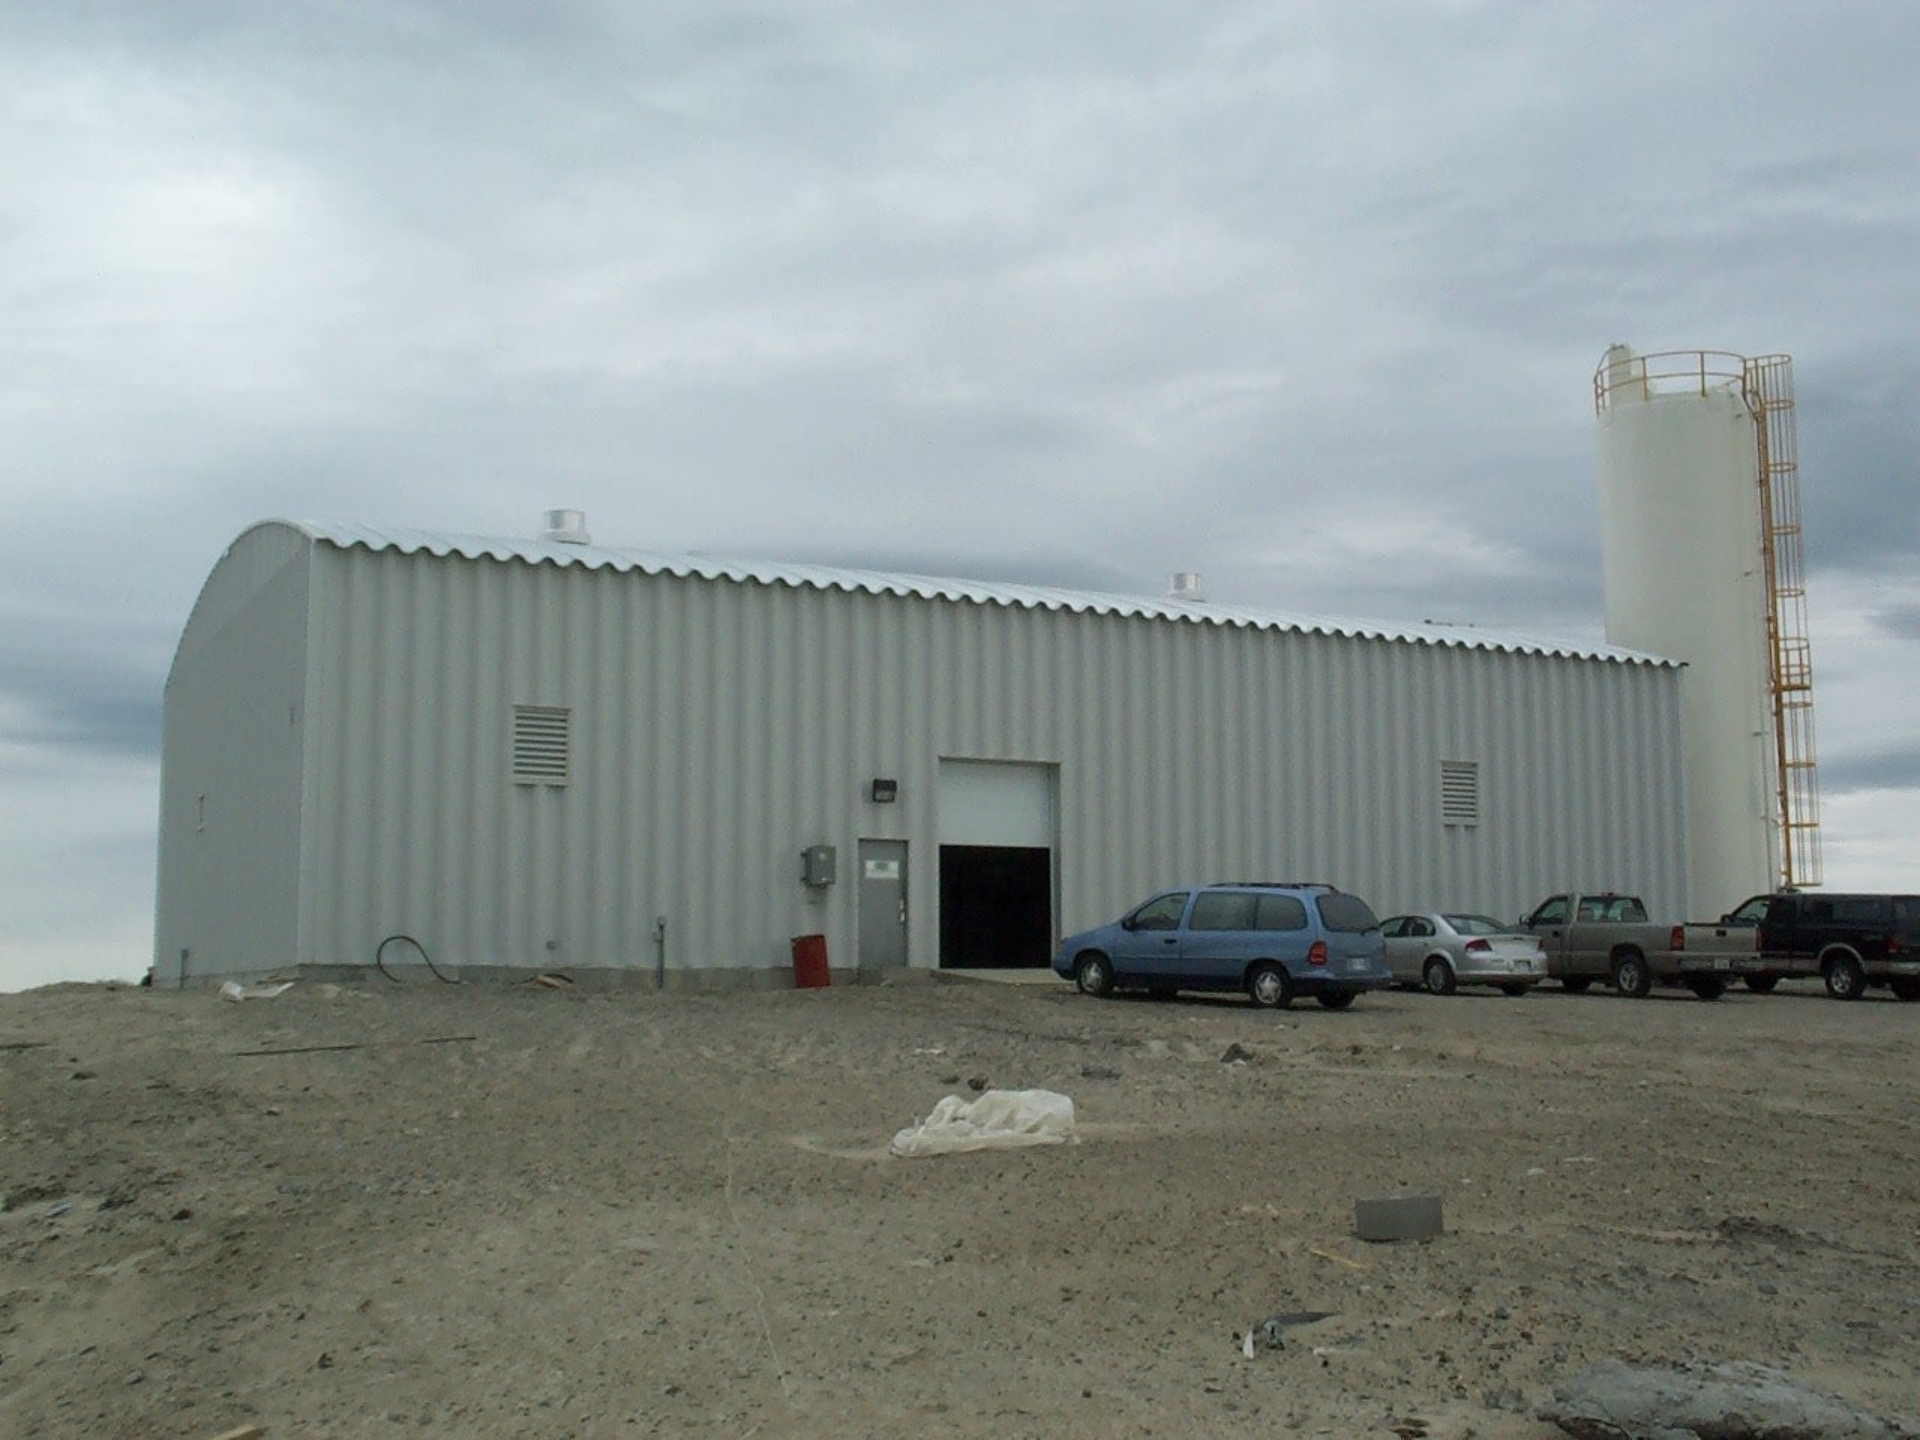
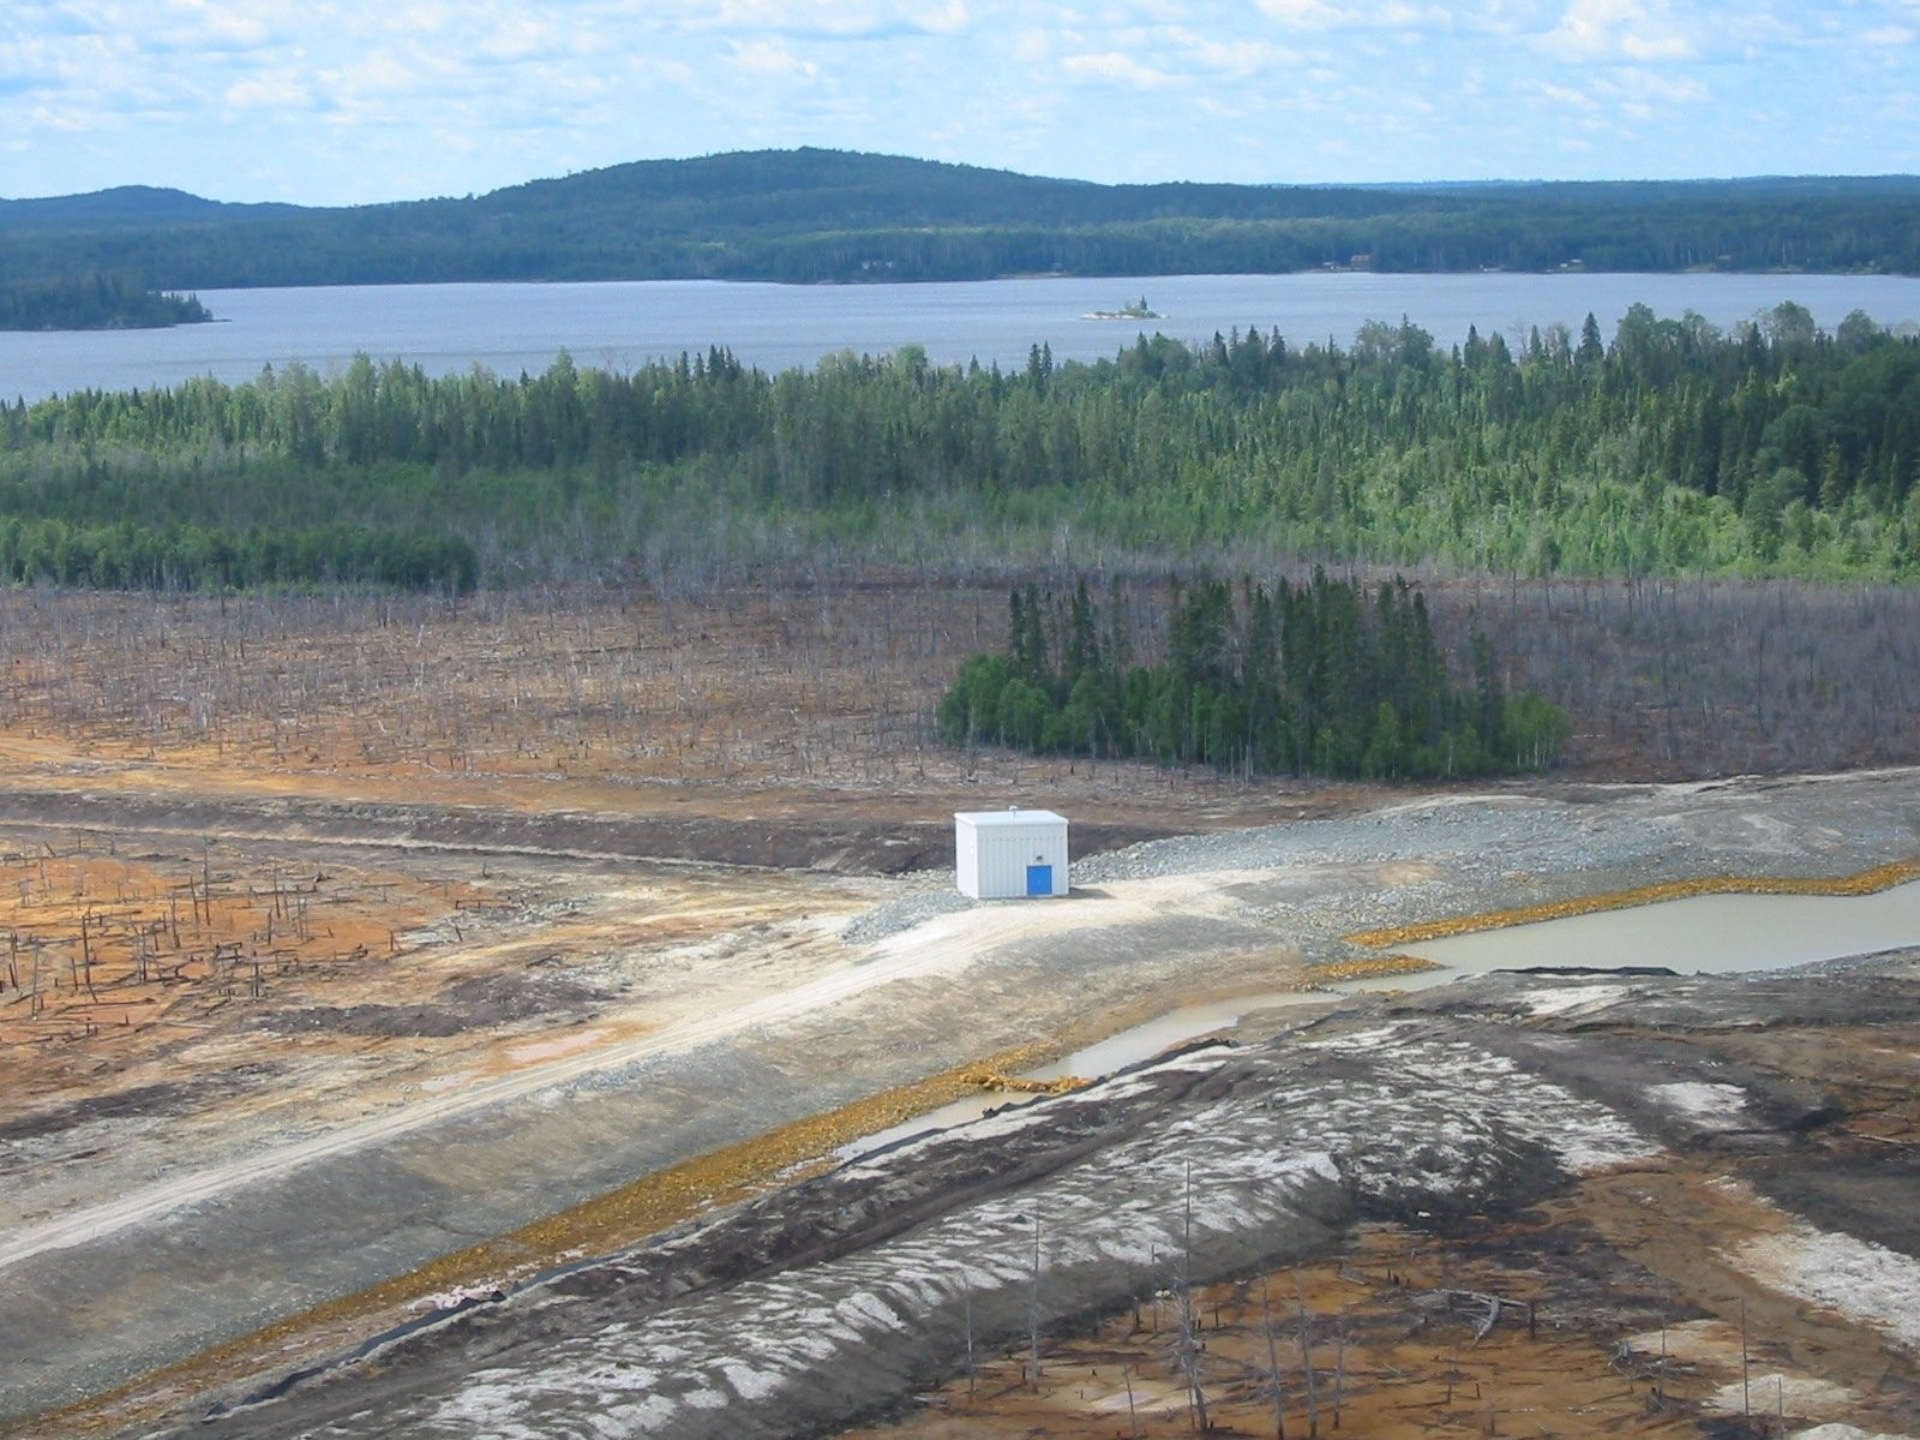
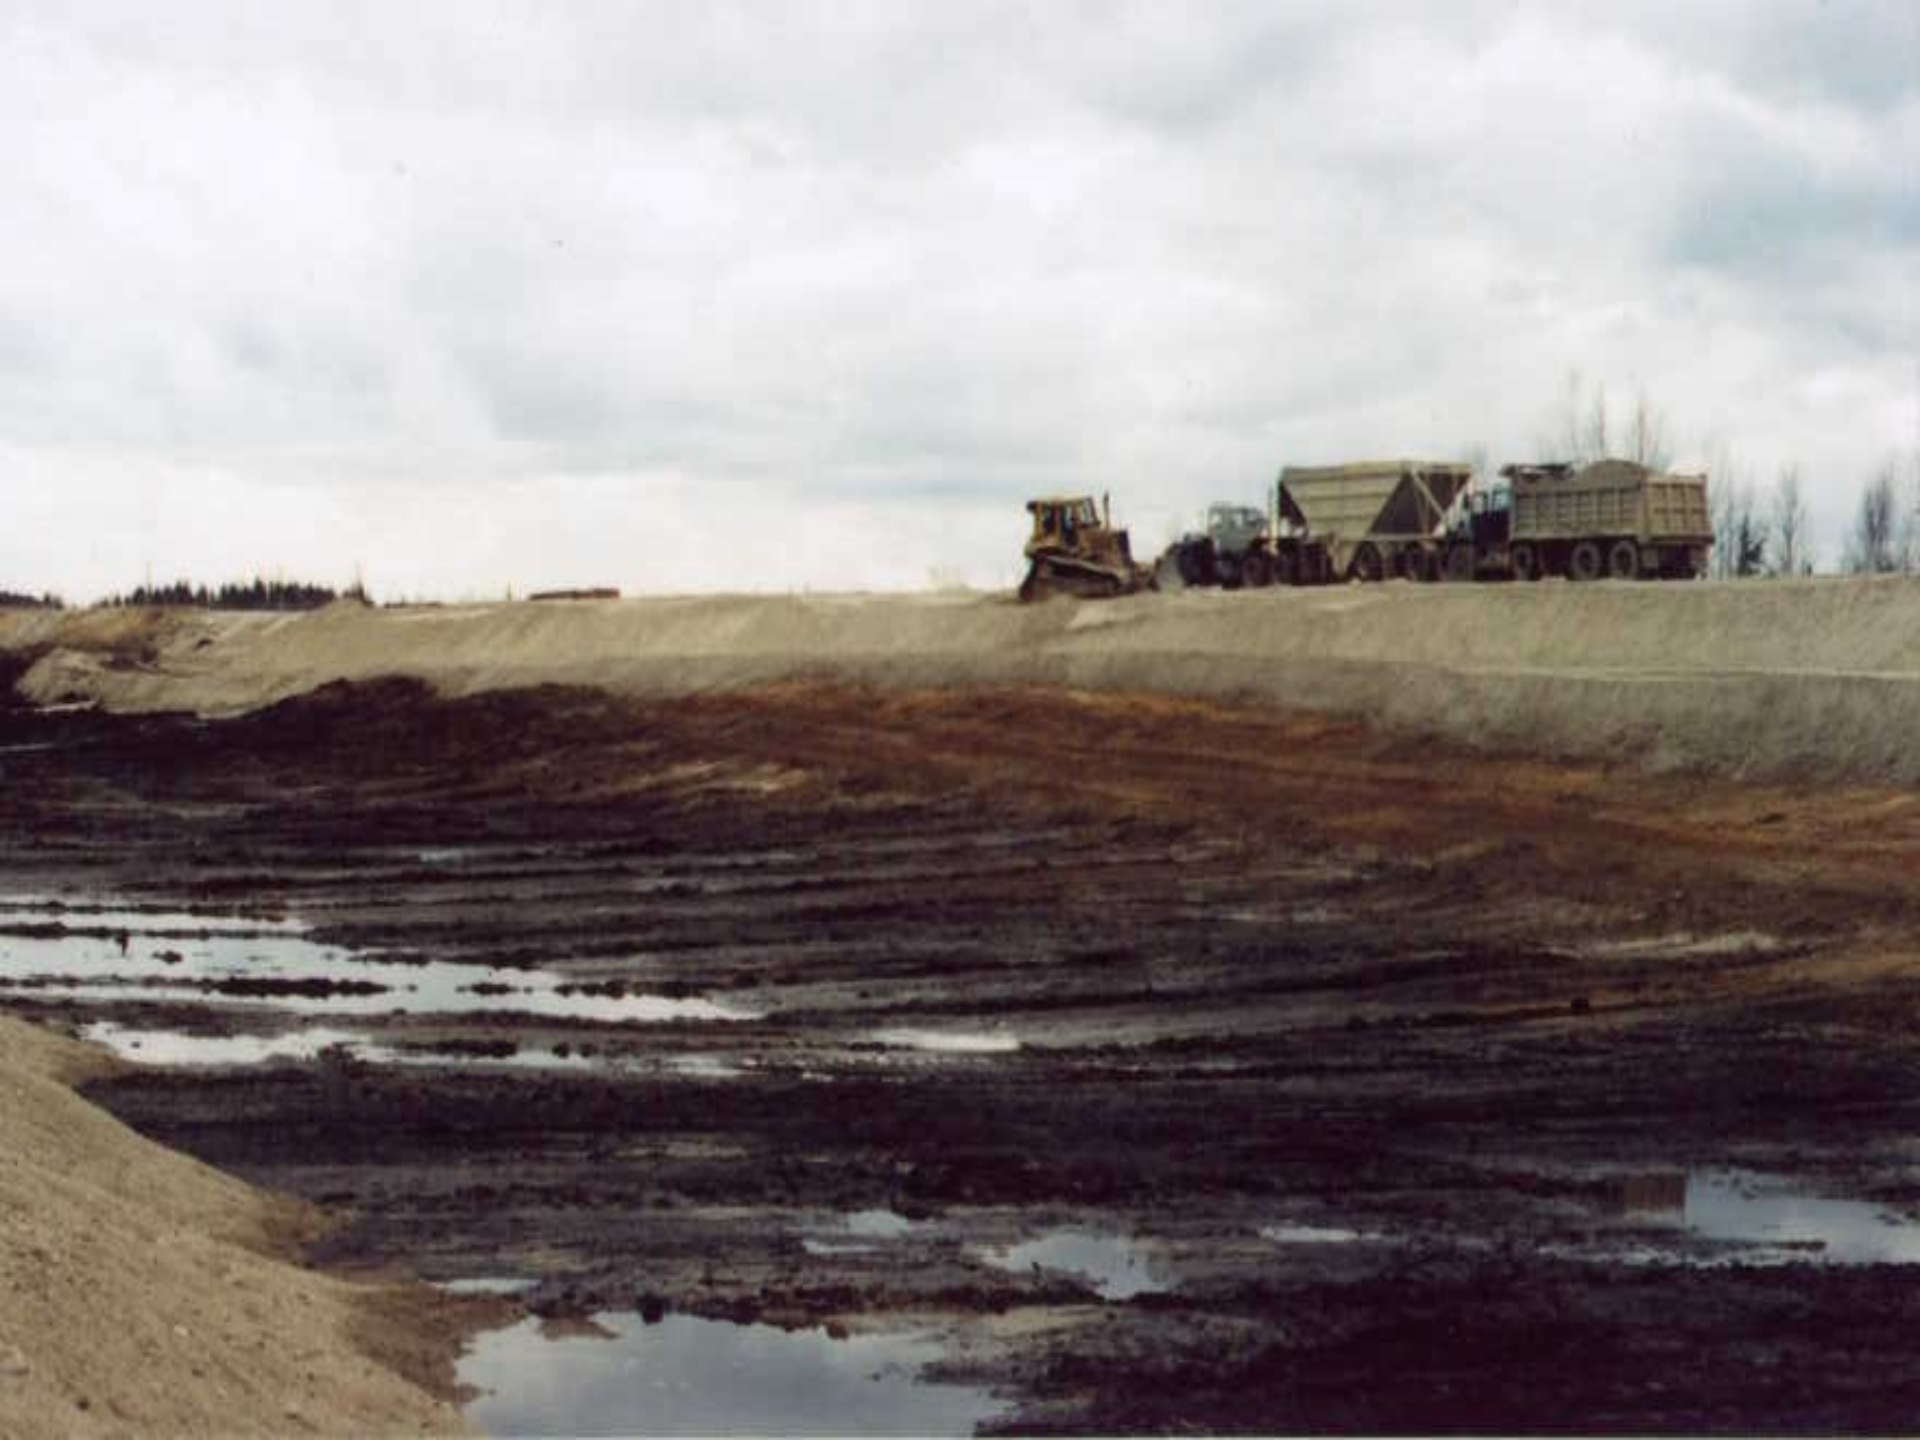
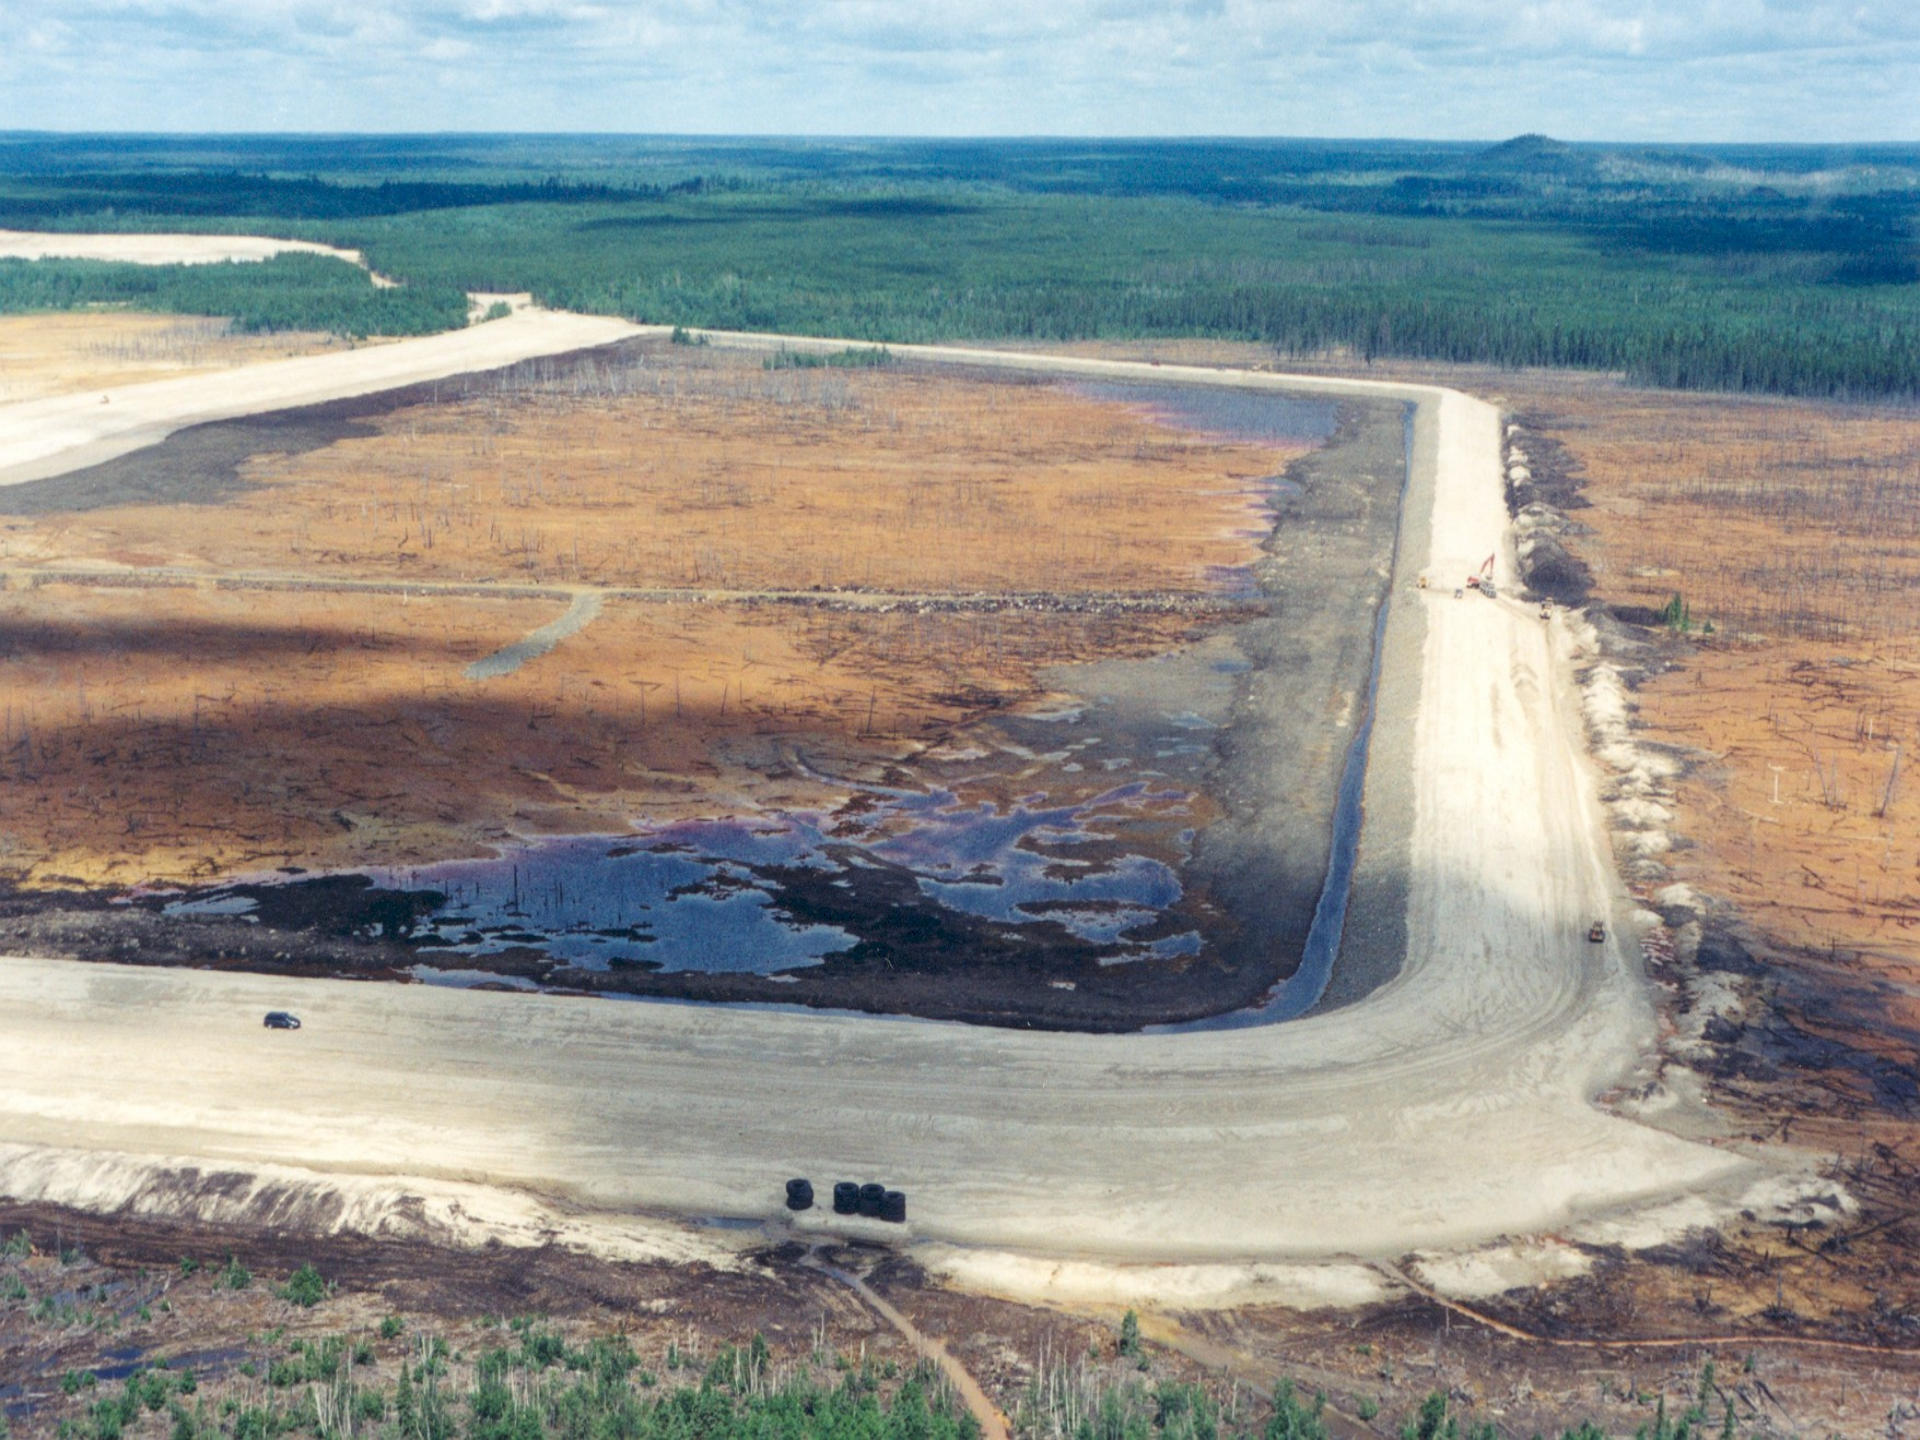
- Phase “A” involved the construction of a Lime Addition Treatment Plant, as well as all of its required infrastructure, and the construction of a new NUT impoundment dam structure.
- The combined cost of the Phase “A” bids was \$9.85 million.
- The funding was eventually approved and the work was completed by July 2002.
- **Realized that the combined costs of Phases “A” and “B” would approach \$14 million.**

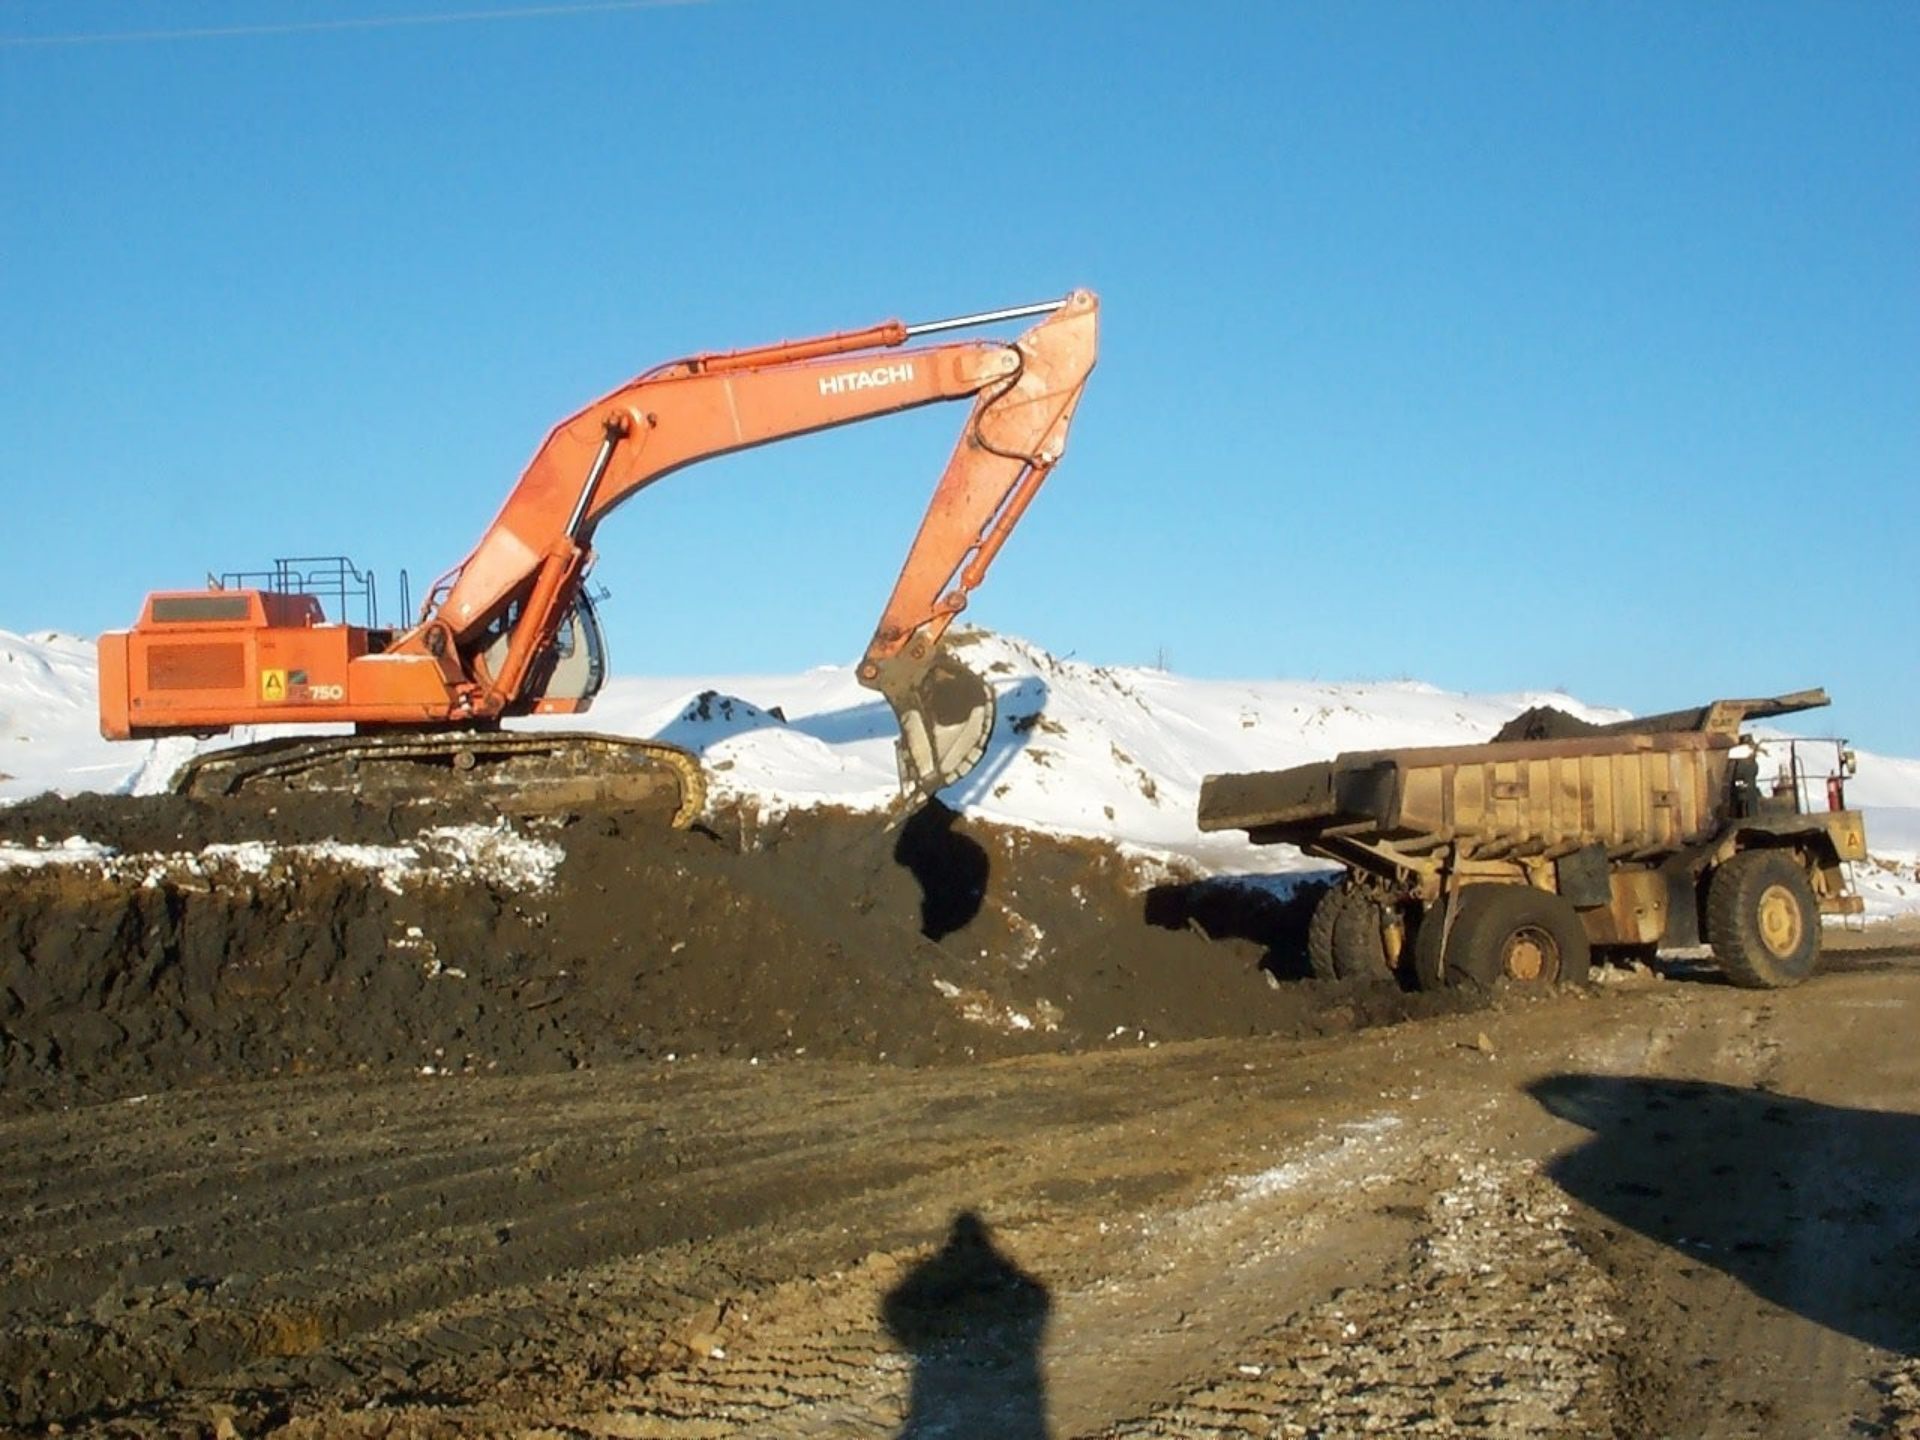
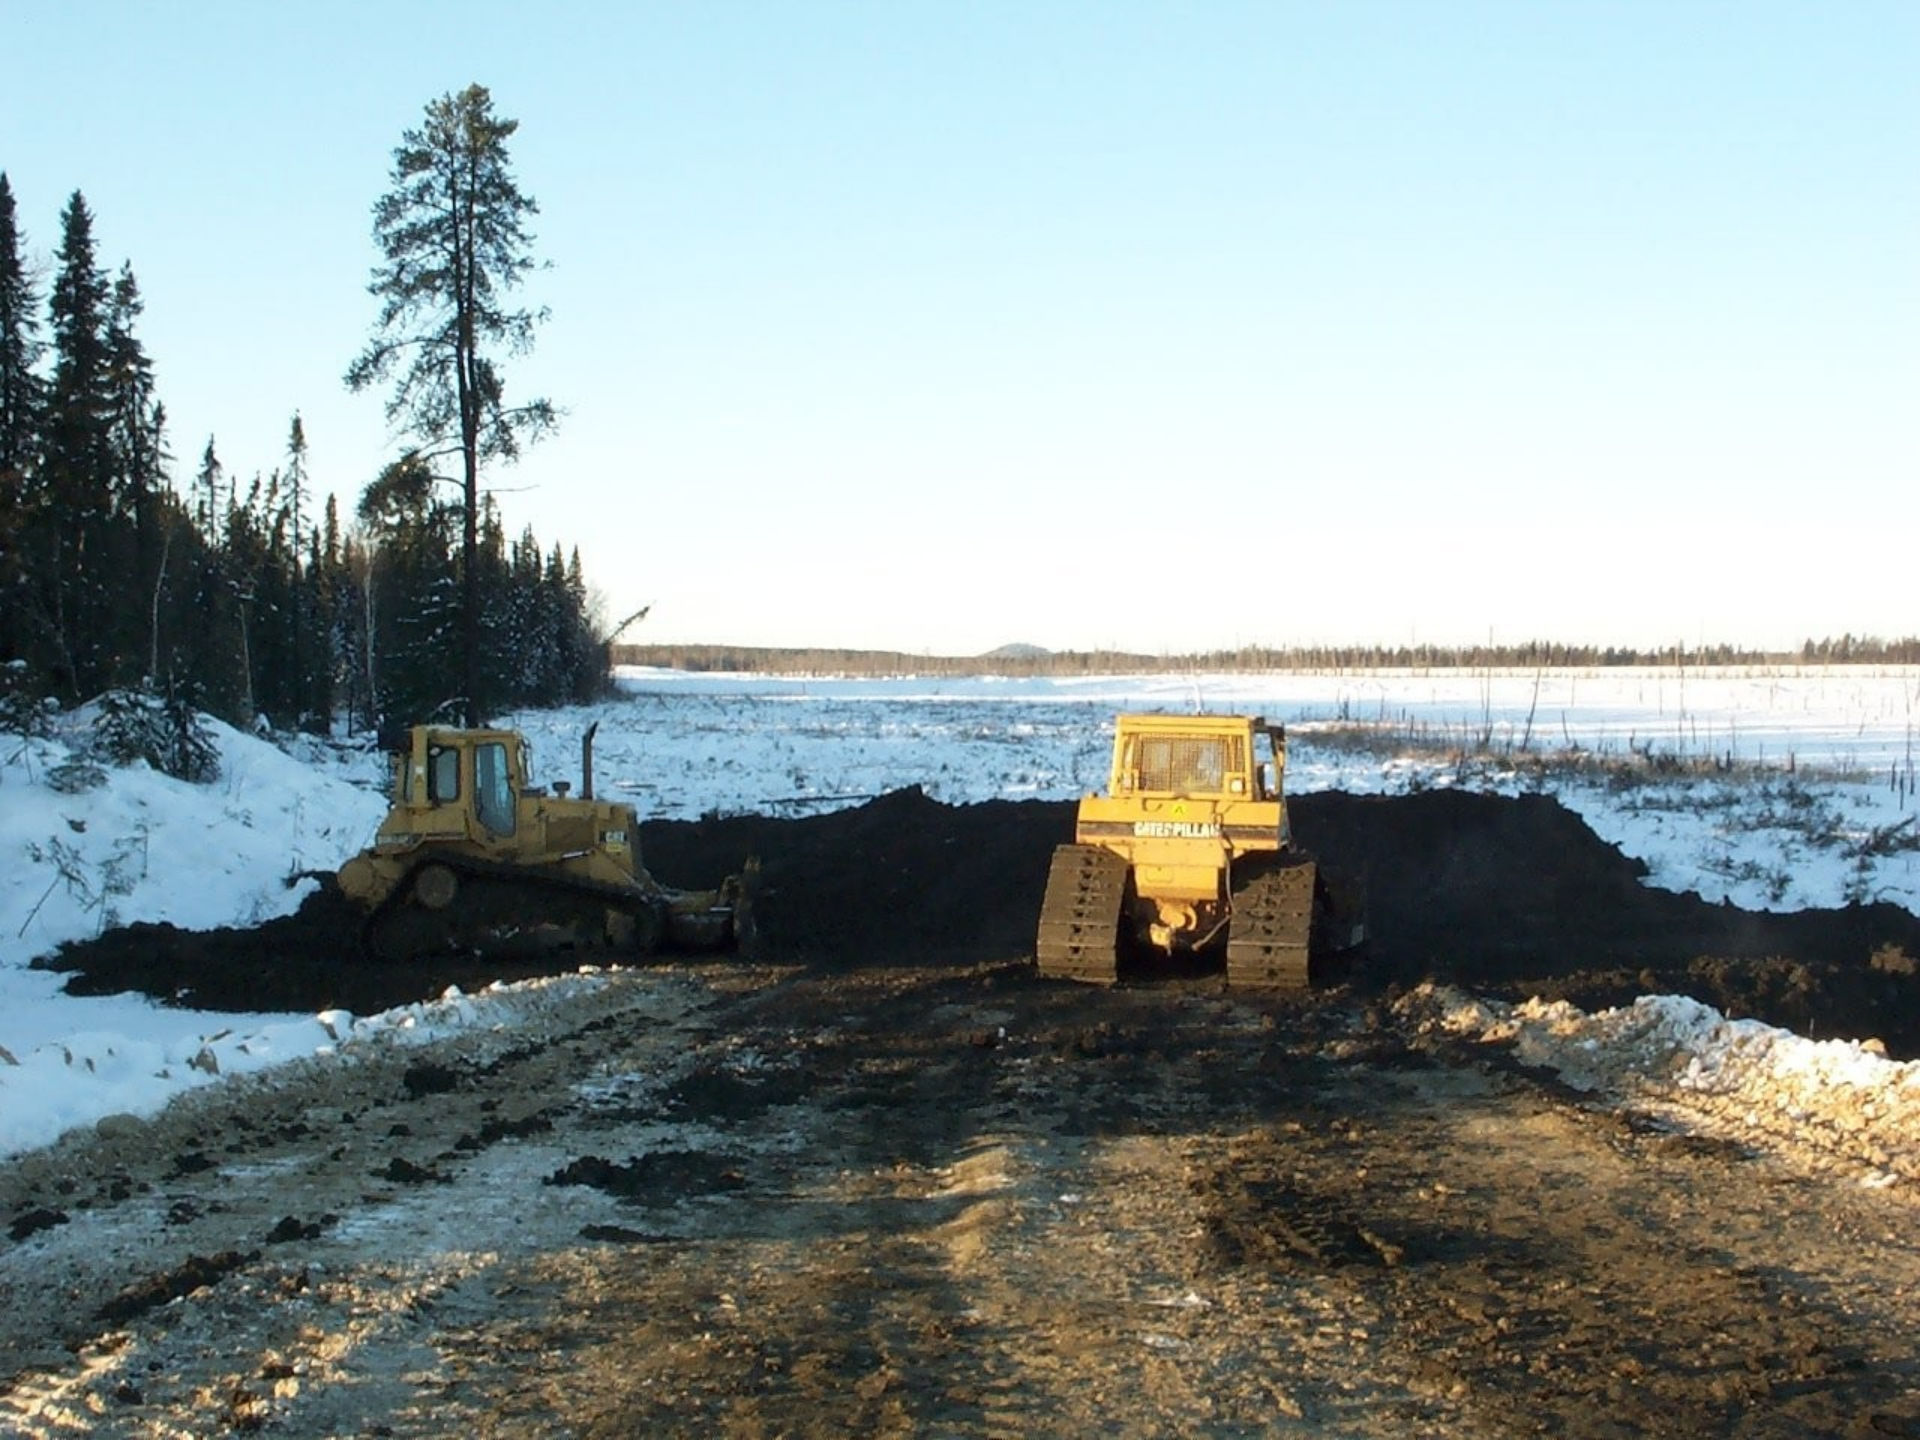
- Phase “B” involved the relocation of the SUT tailings to within the new NUT impoundment area.
- Upon completion of the work, more than 340,000 m³ of SUT tailings had been relocated and buffered with Envirolime, at a cost of \$3.4 million.
- Phase “B” work was completed by mid-March 2003.

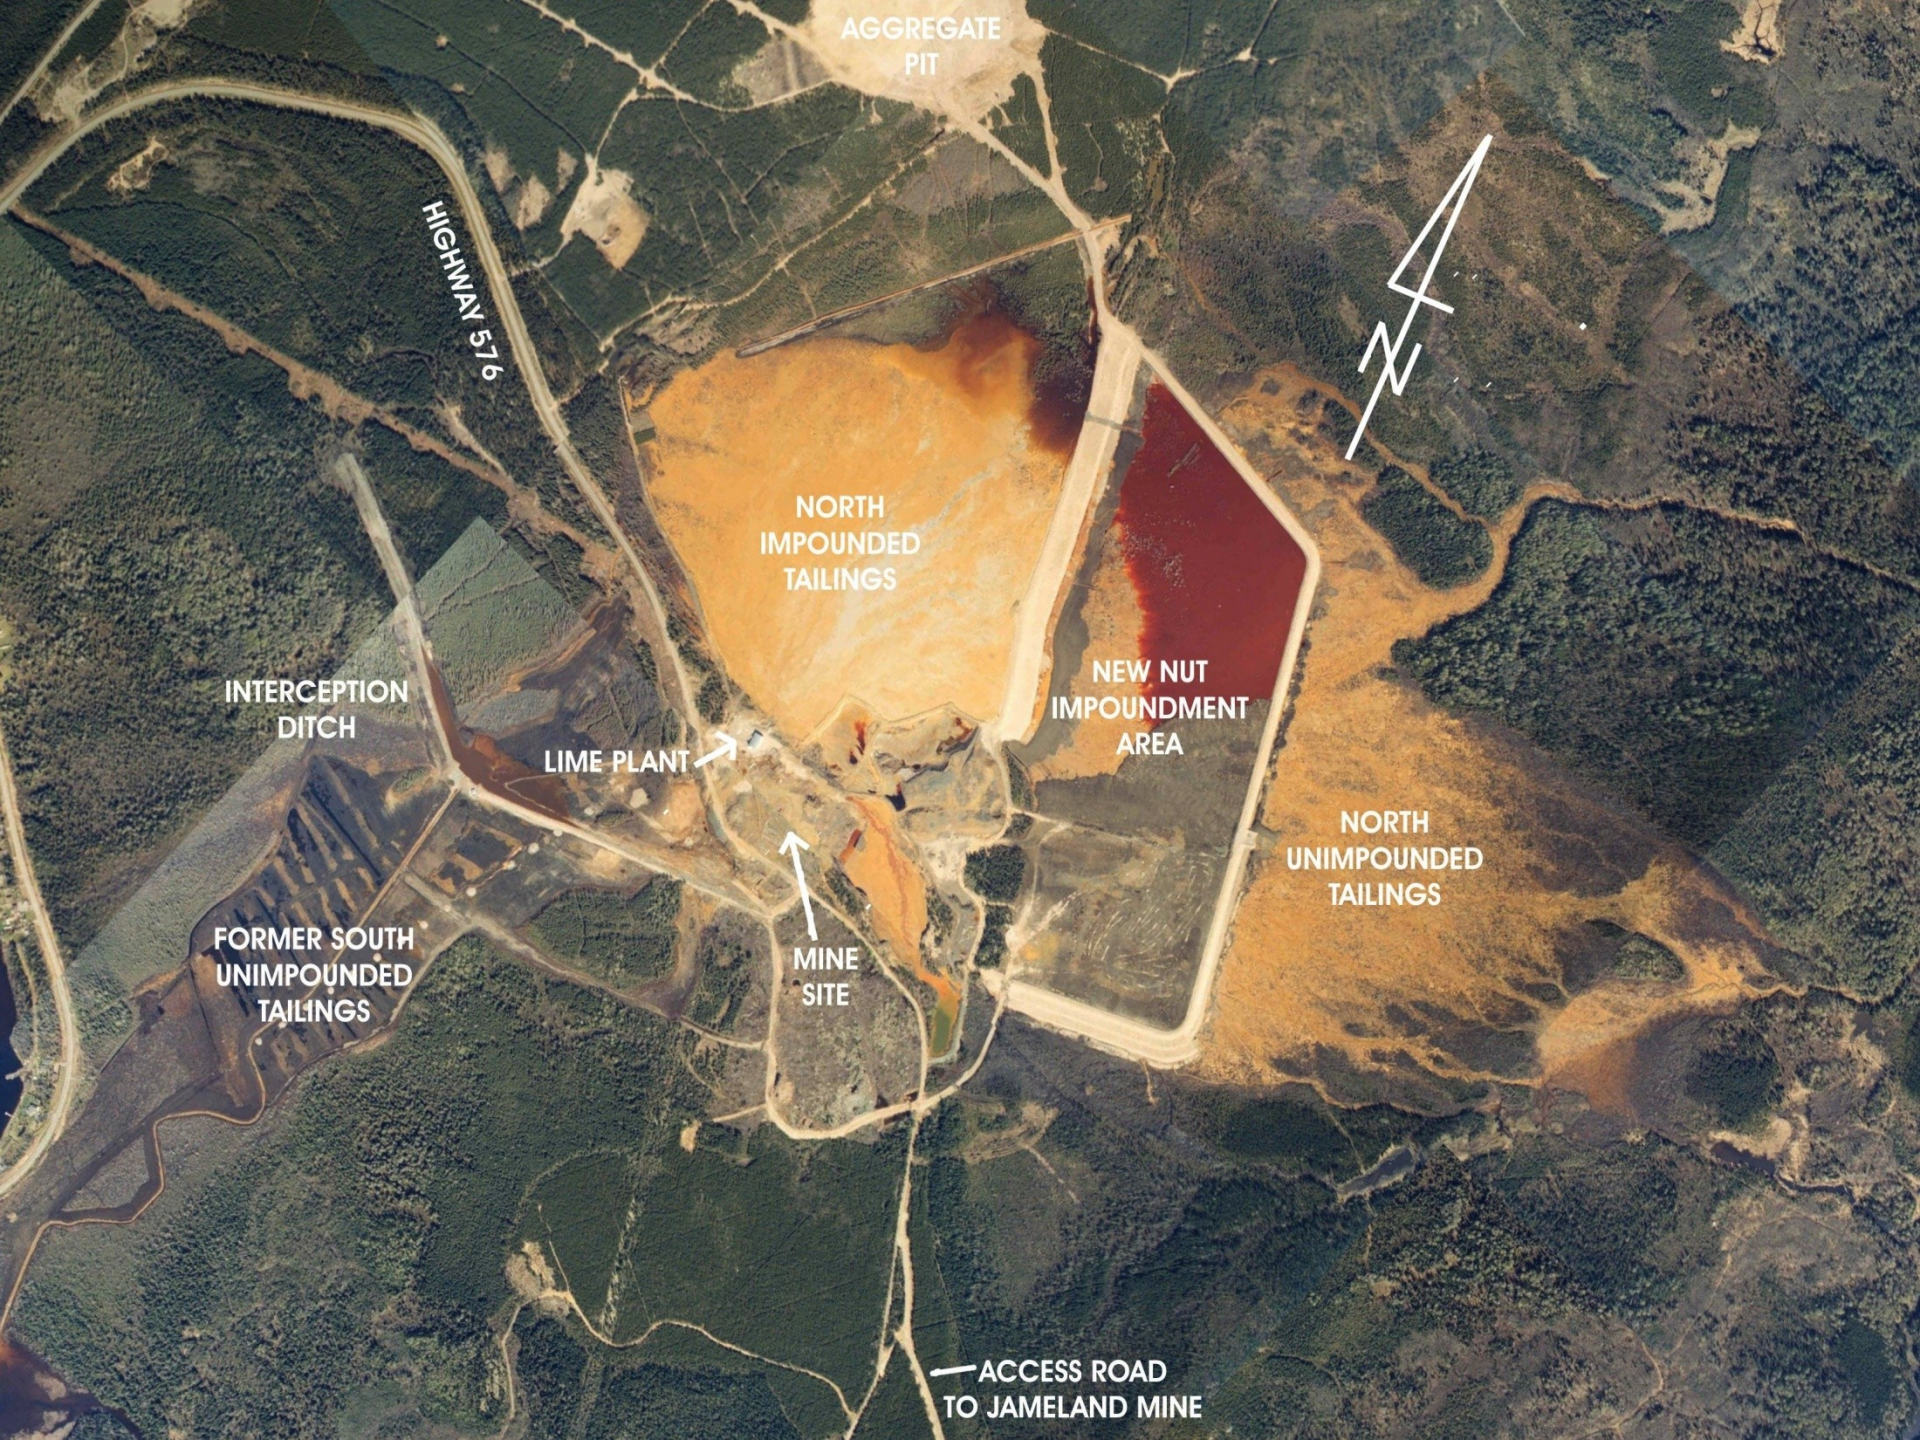
AGGREGATE
PIT

HIGHWAY 576

NORTH
IMPOUNDED
TAILINGS

NEW NUT
IMPOUNDMENT
AREA

NORTH
UNIMPOUNDED
TAILINGS

INTERCEPTION
DITCH

LIME PLANT

MINE
SITE

FORMER SOUTH
UNIMPOUNDED
TAILINGS

ACCESS ROAD
TO JAMELAND MINE

PHASE “C”

- Phase “C” involved the relocation of the NUT tailings to within the new NUT impoundment area.
- Upon completion of the work, more than 611,000 m³ of NUT tailings had been relocated and buffered with Envirolime, at a cost of \$ 13.4 million.
- The Phase “C” work was completed by late-March, 2004.
