The Continuing Rehabilitation of the Kam Kotia Mine: An Acid- Generating Abandoned Tailings Area.

Dawn Spires

Ontario Ministry of Northern Development, Mines & Forestry

The Northern Latitudes Workshop,

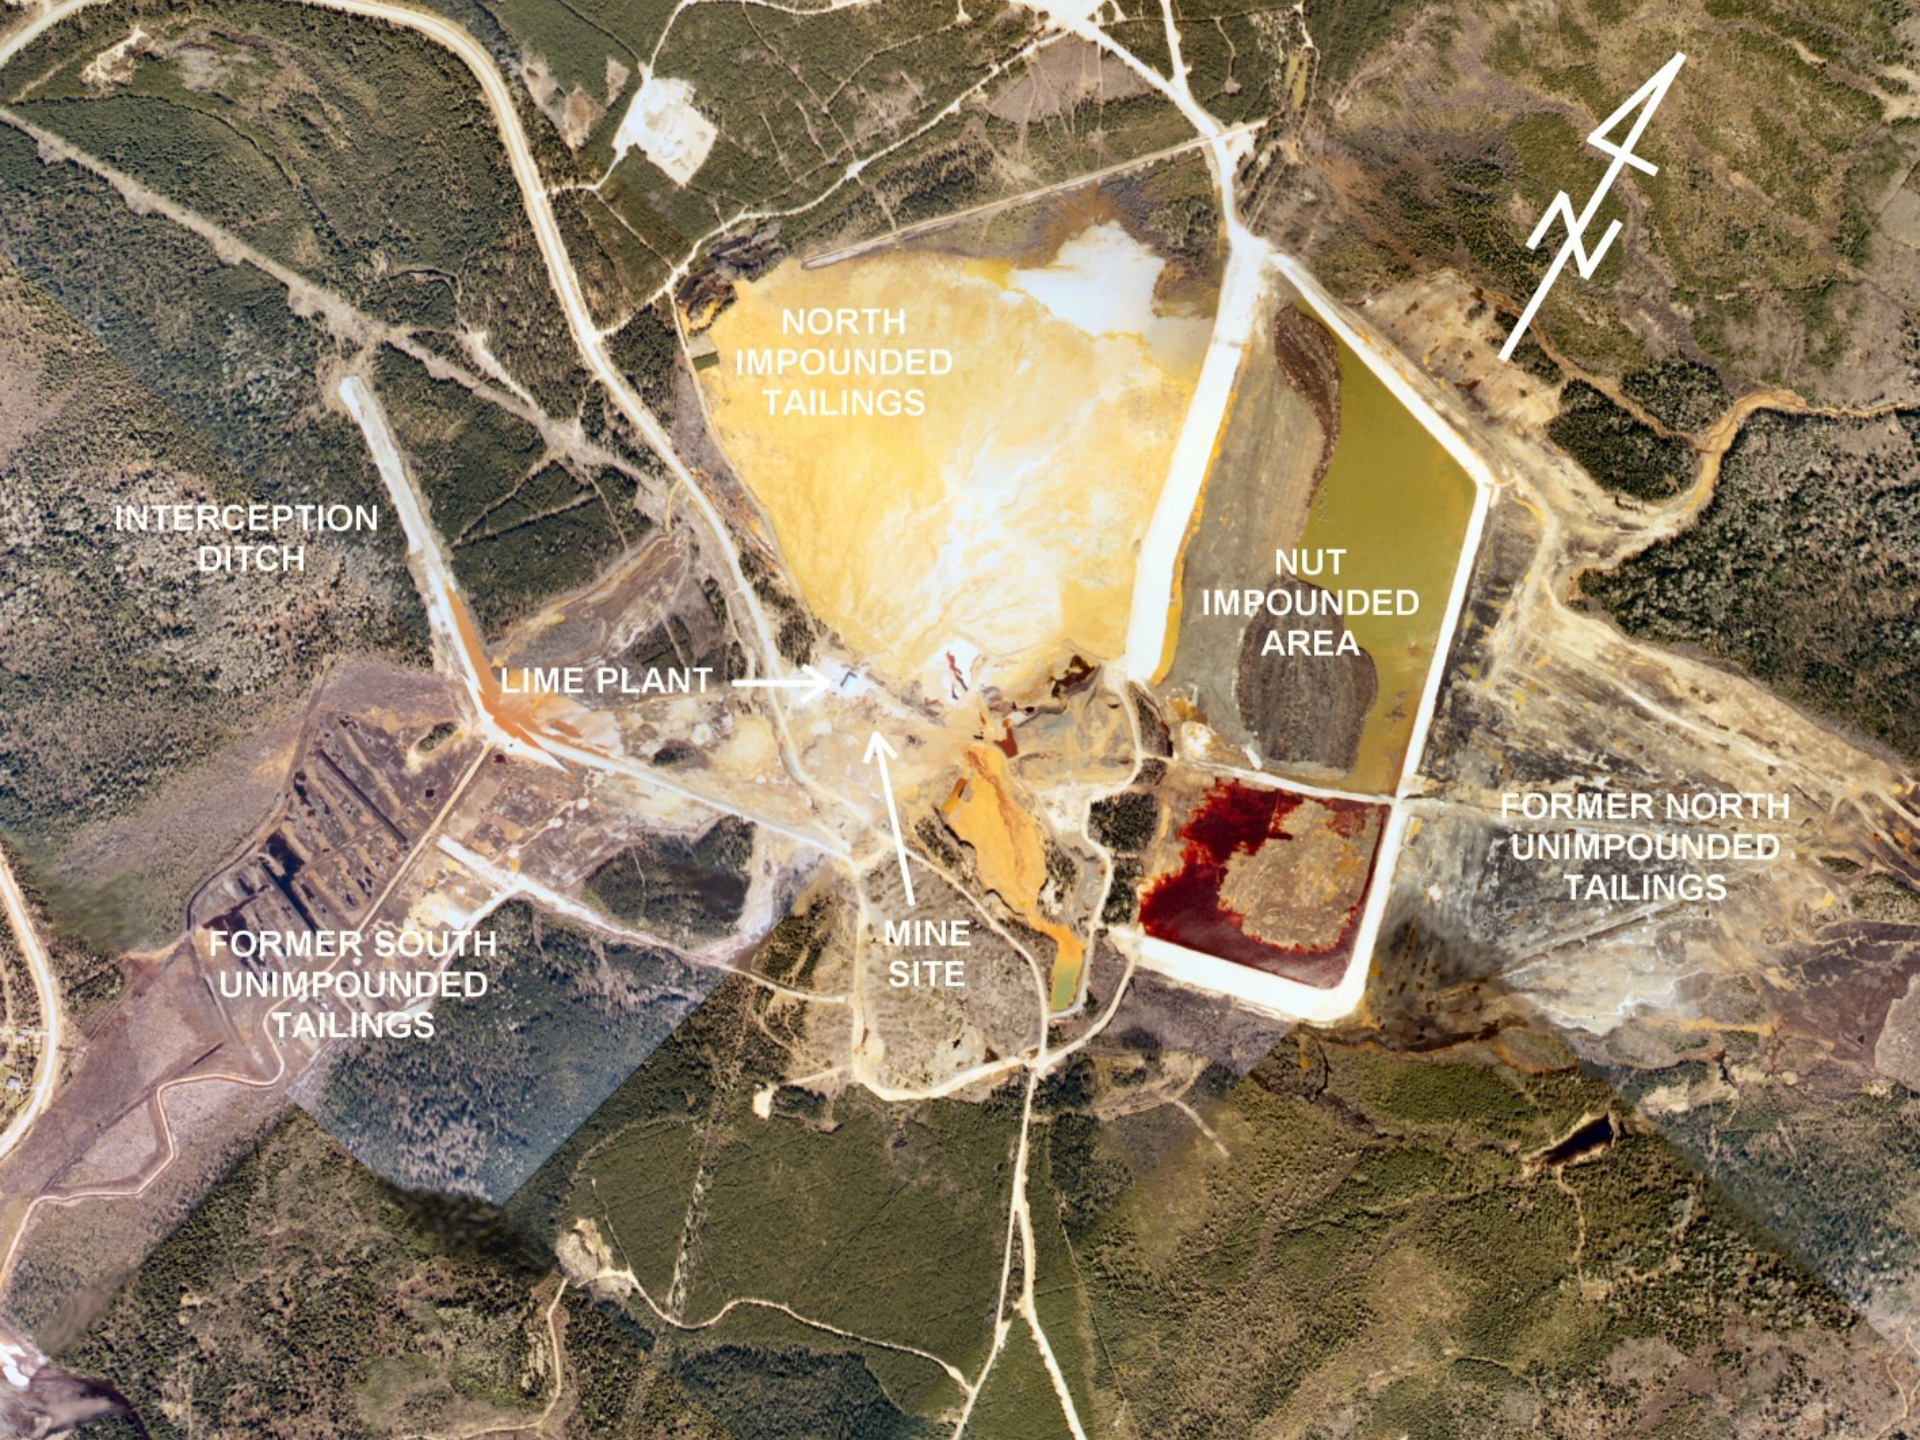
NORTH
IMPOUNDED
TAILINGS

INTERCEPTION
DITCH

LIME PLANT

NUT
IMPOUNDED
AREA

FORMER NORTH
UNIMPOUNDED
TAILINGS

FORMER SOUTH
UNIMPOUNDED
TAILINGS

MINE
SITE

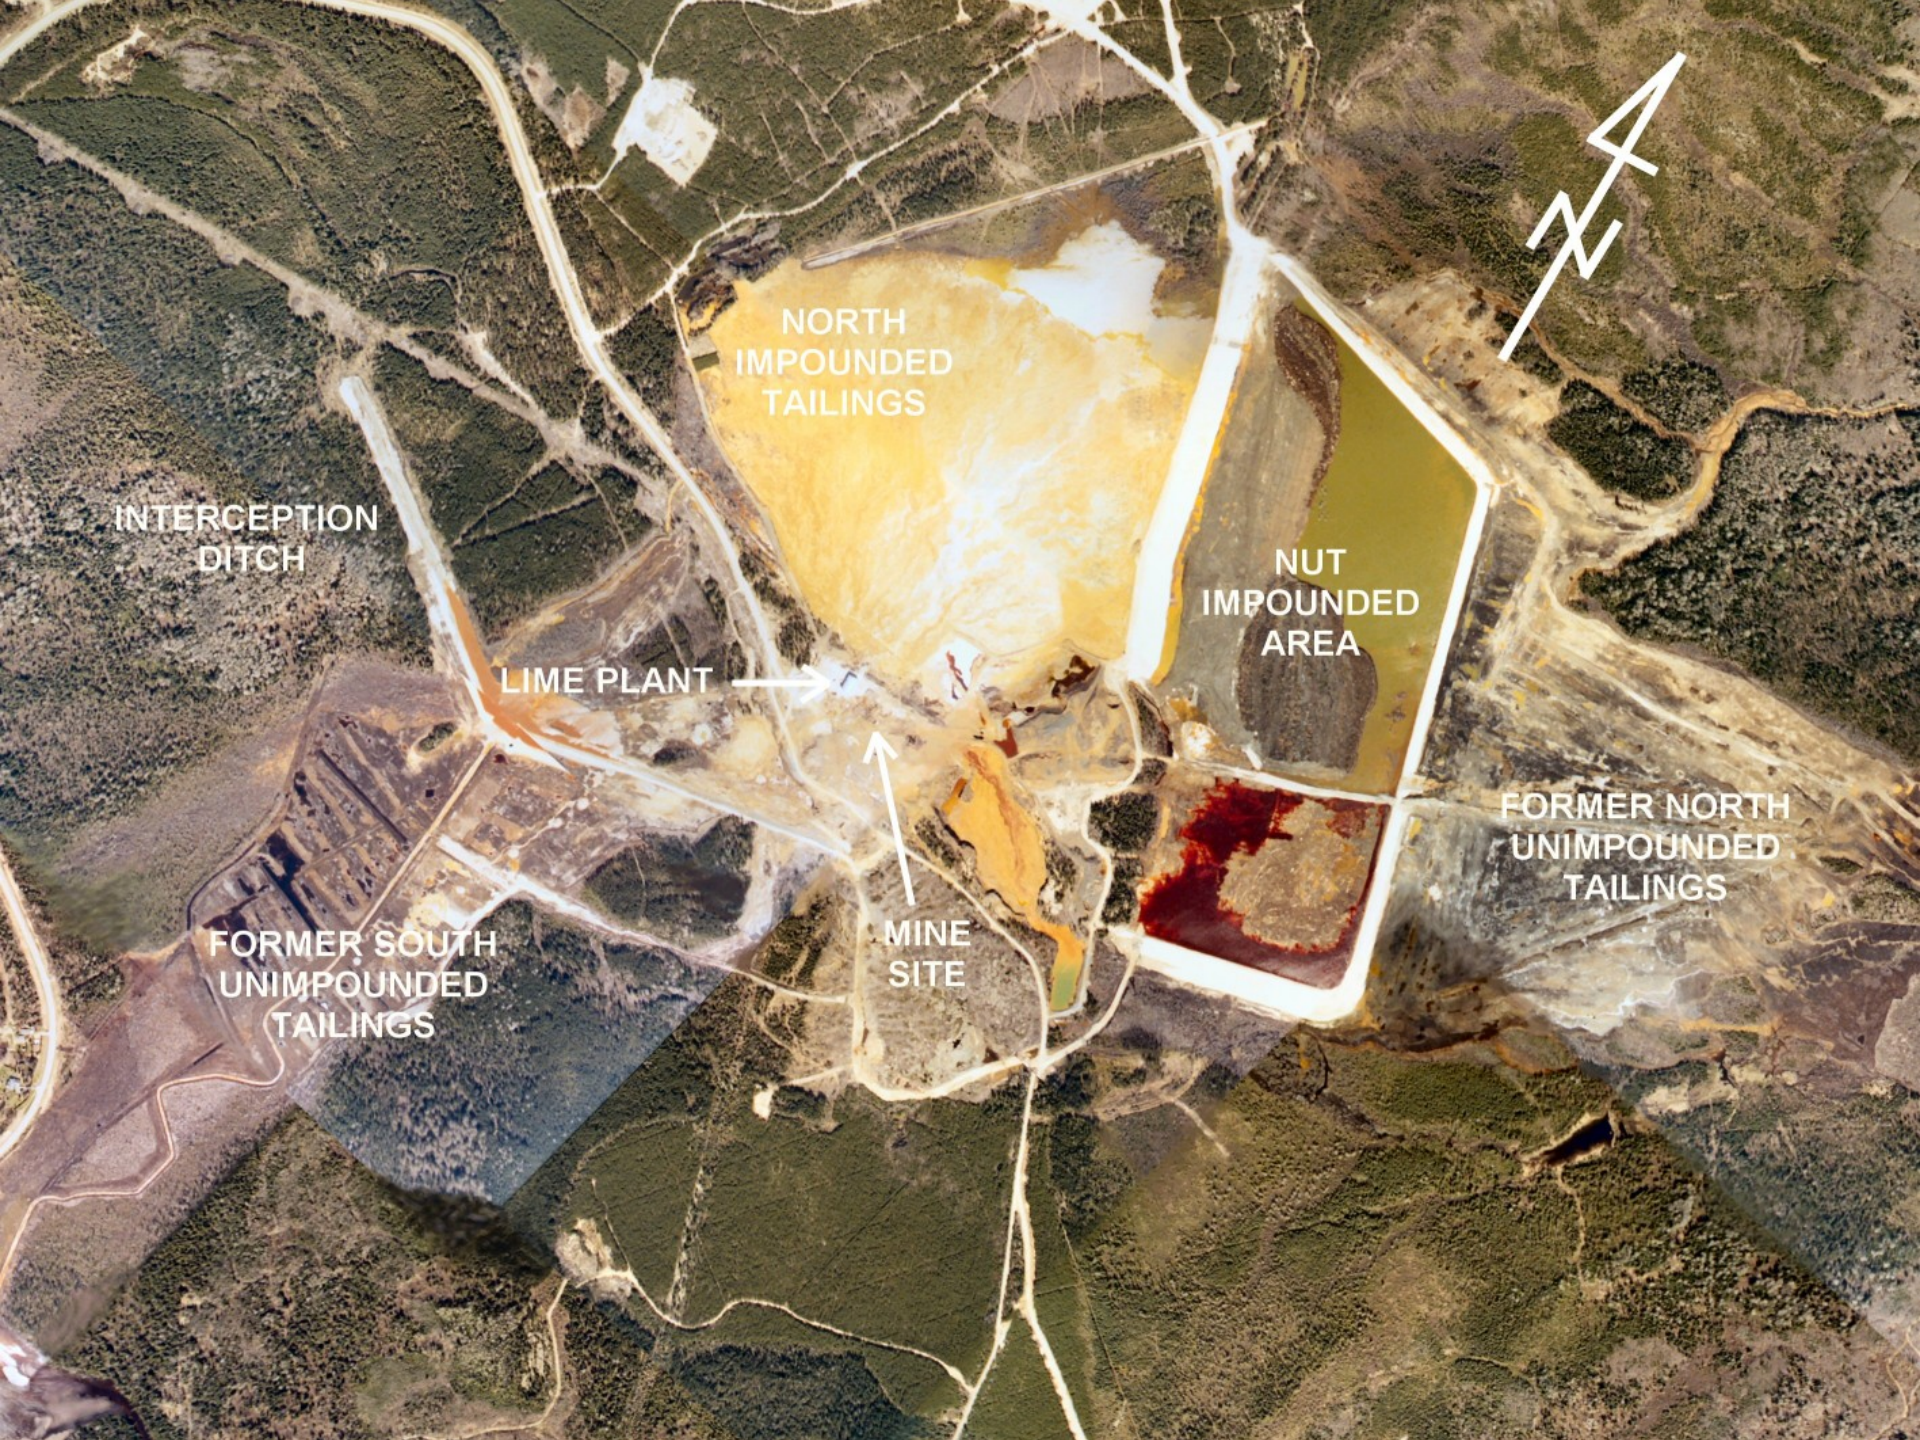
NORTH
IMPOUNDED
TAILINGS

INTERCEPTION
DITCH

NUT
IMPOUNDED
AREA

LIME PLANT

FORMER NORTH
UNIMPOUNDED
TAILINGS

FORMER SOUTH
UNIMPOUNDED
TAILINGS

MINE
SITE

- Timmins received two years of anomalously high precipitation.
- The NUT Impoundment Area filled with approximately 600,000 m³ of water at a pH 2.8, and containing high concentrations of metals .
- In order not to delay the project, a decision was made to stack the NUT tailings in the impoundment area during Phase “C”.

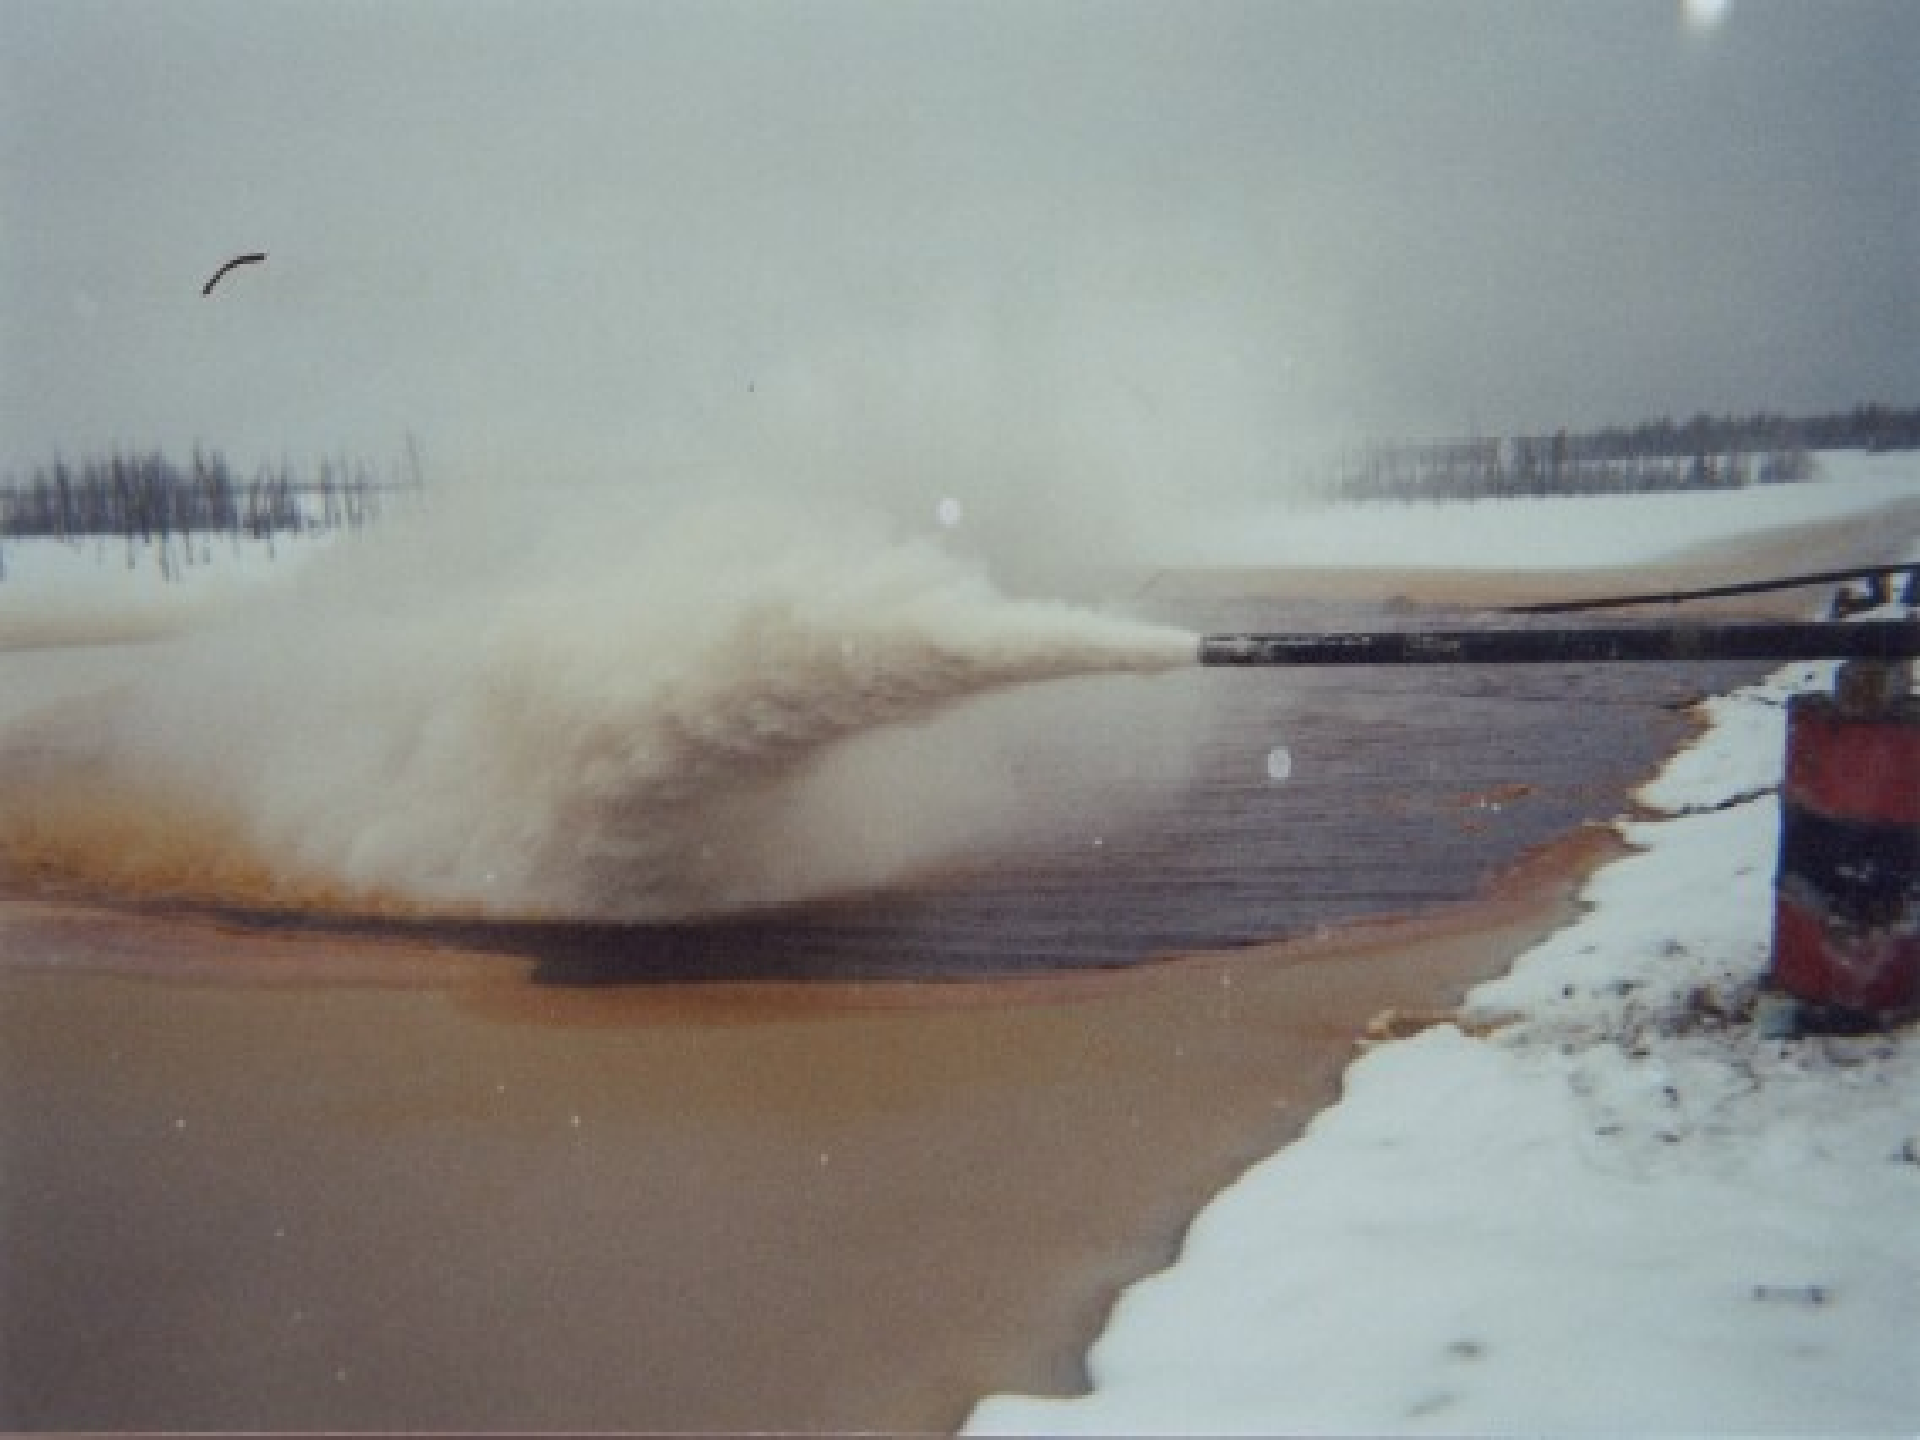
- Efforts were made to conduct the “in-situ” treatment of the NUT “Pond” during the winter of 2003/04.
- After 706 tonnes of lime were added to the Pond, caustic (e.g. Sodium Hydroxide) was used.
- Over 2,000 tonnes of caustic were also added.
- Managed to raise the pH sufficiently to allow the discharge of the contaminated water for ~ 3 hours.
- Eventually ceased the treatment after having spent \$1.8 million.

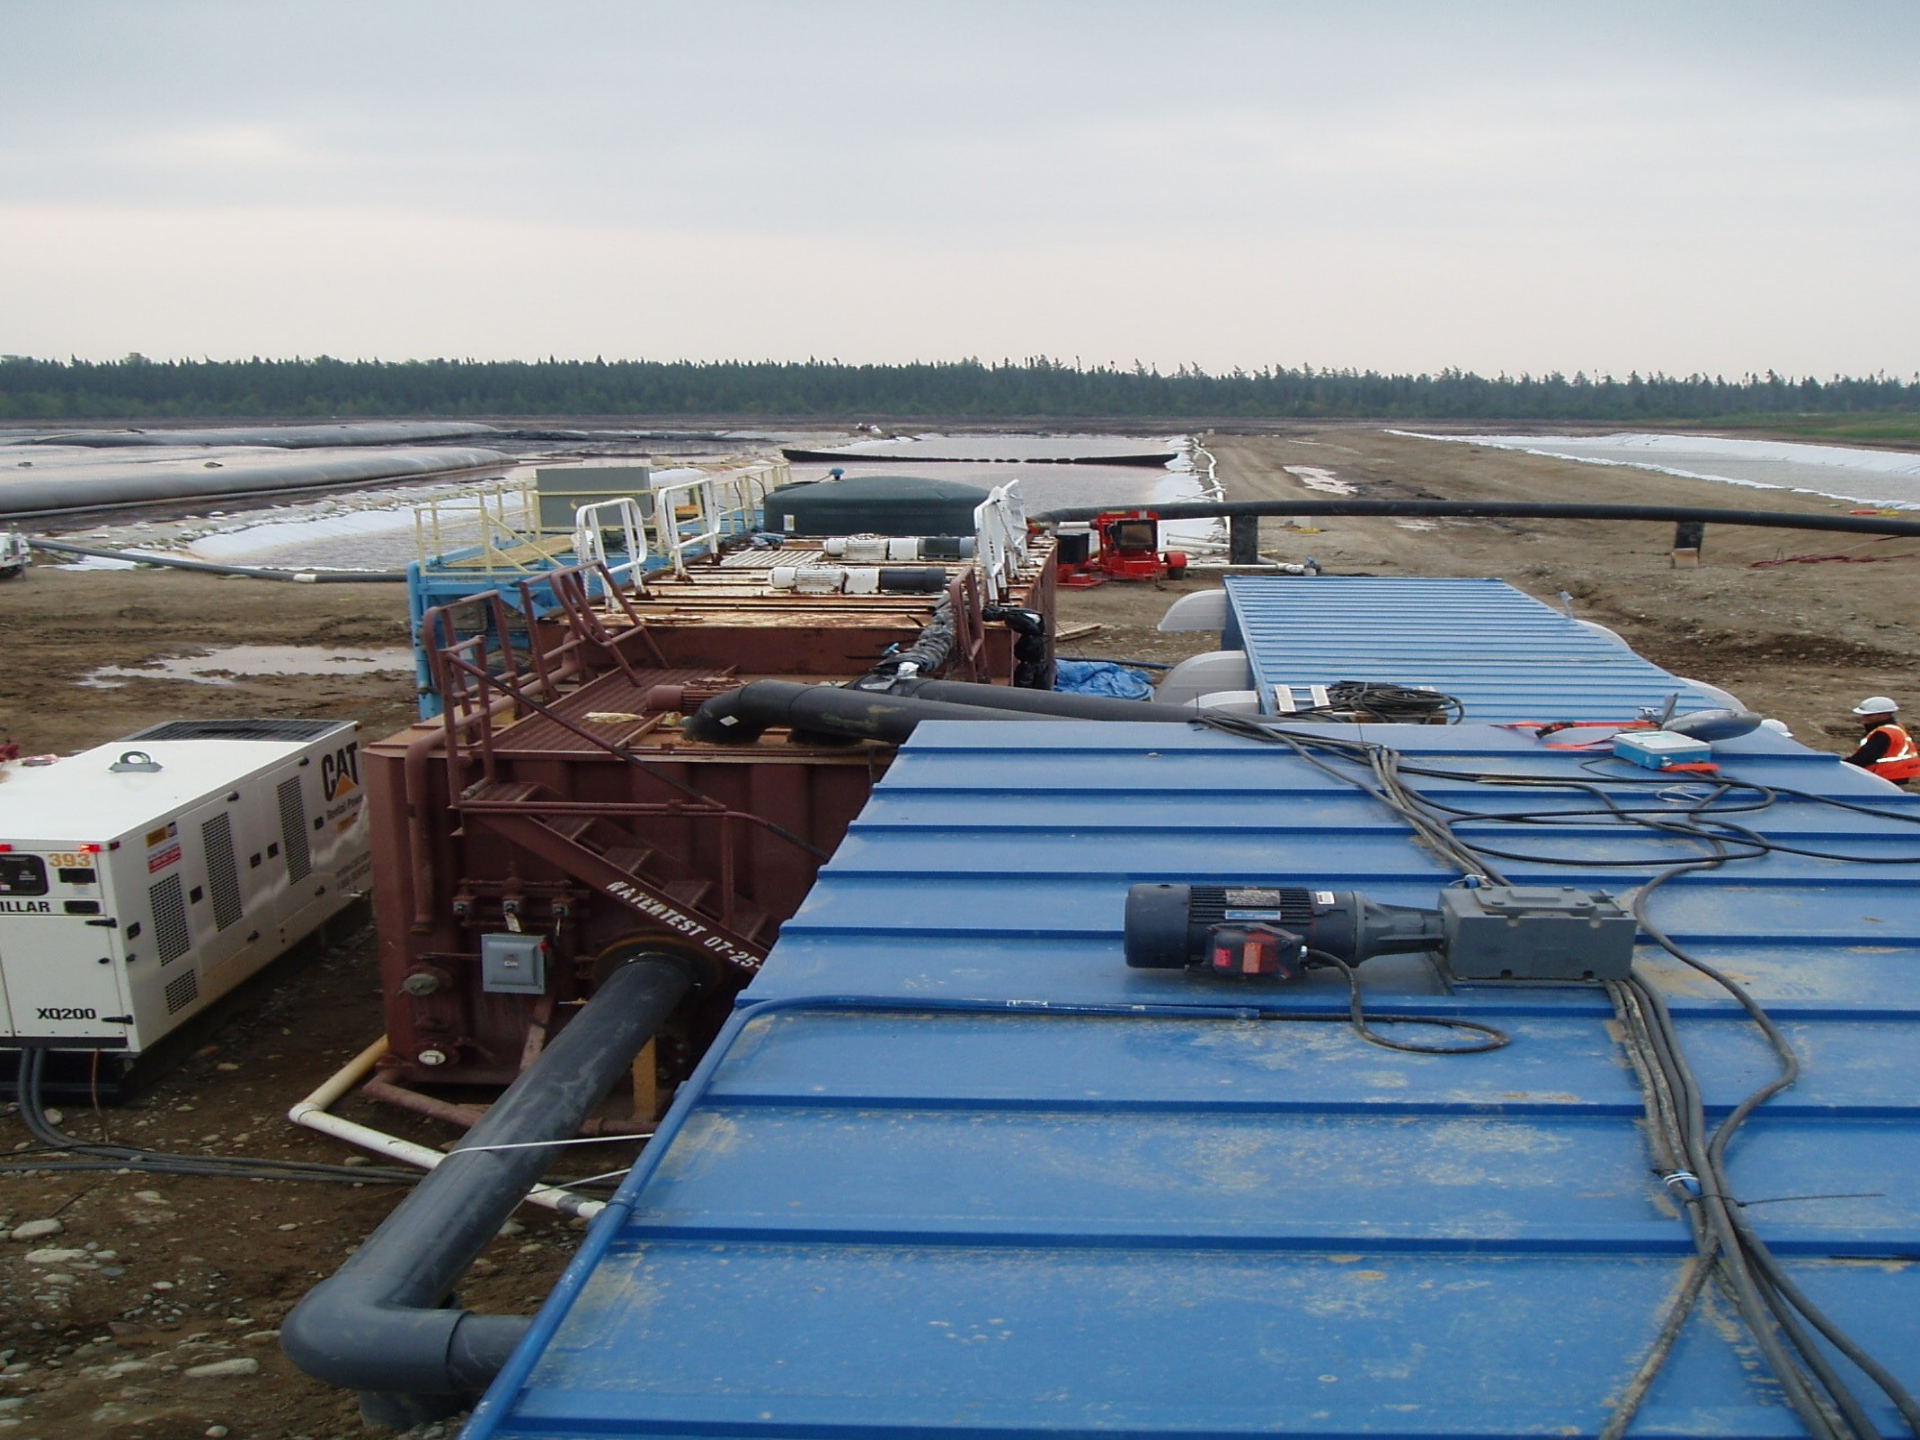
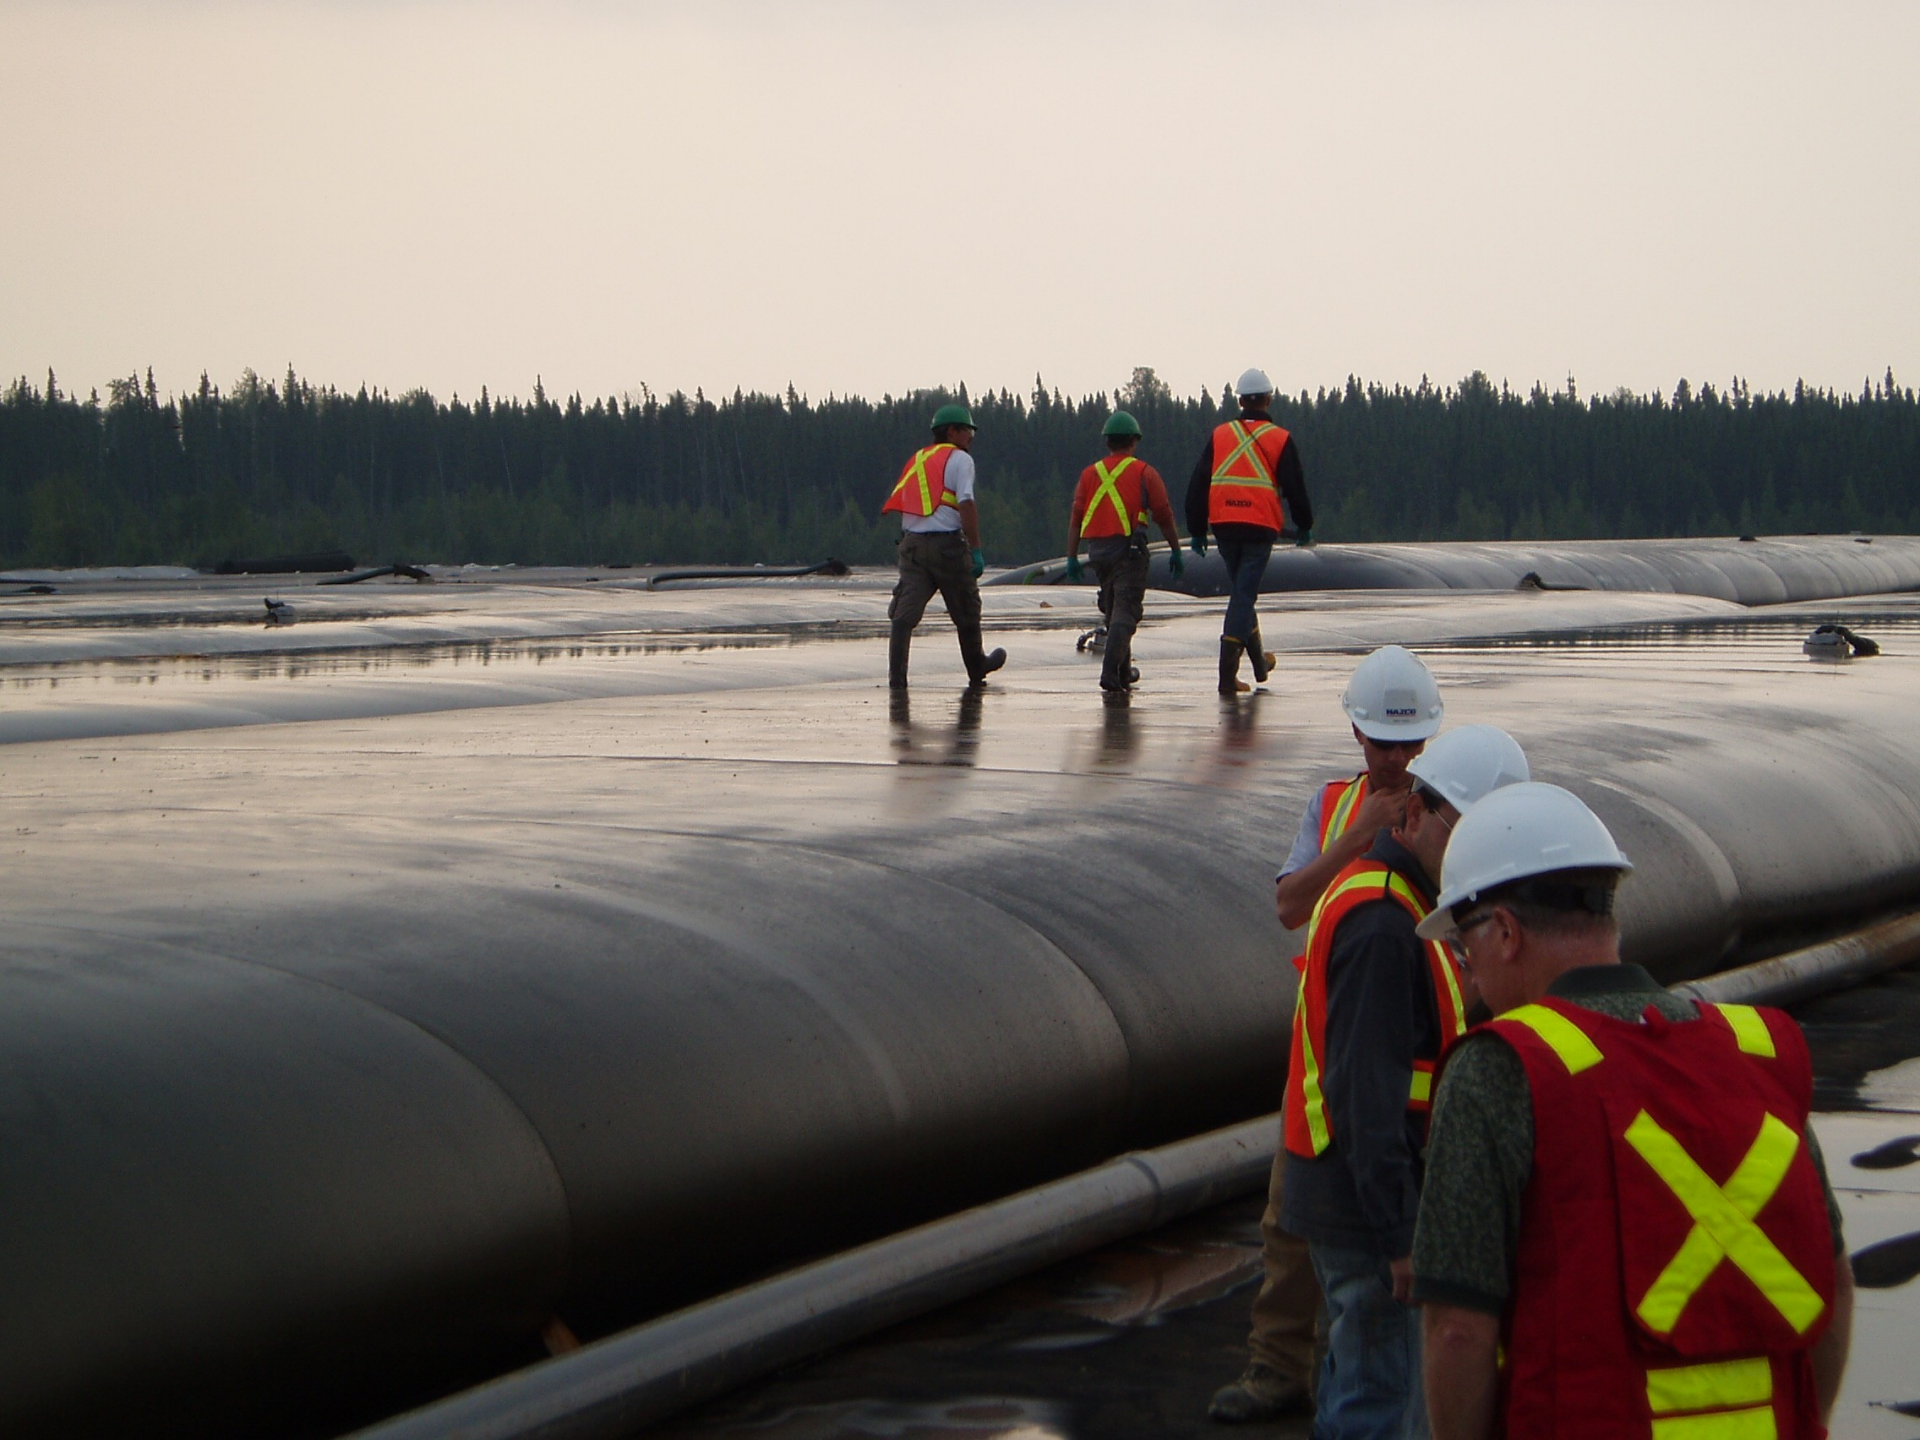
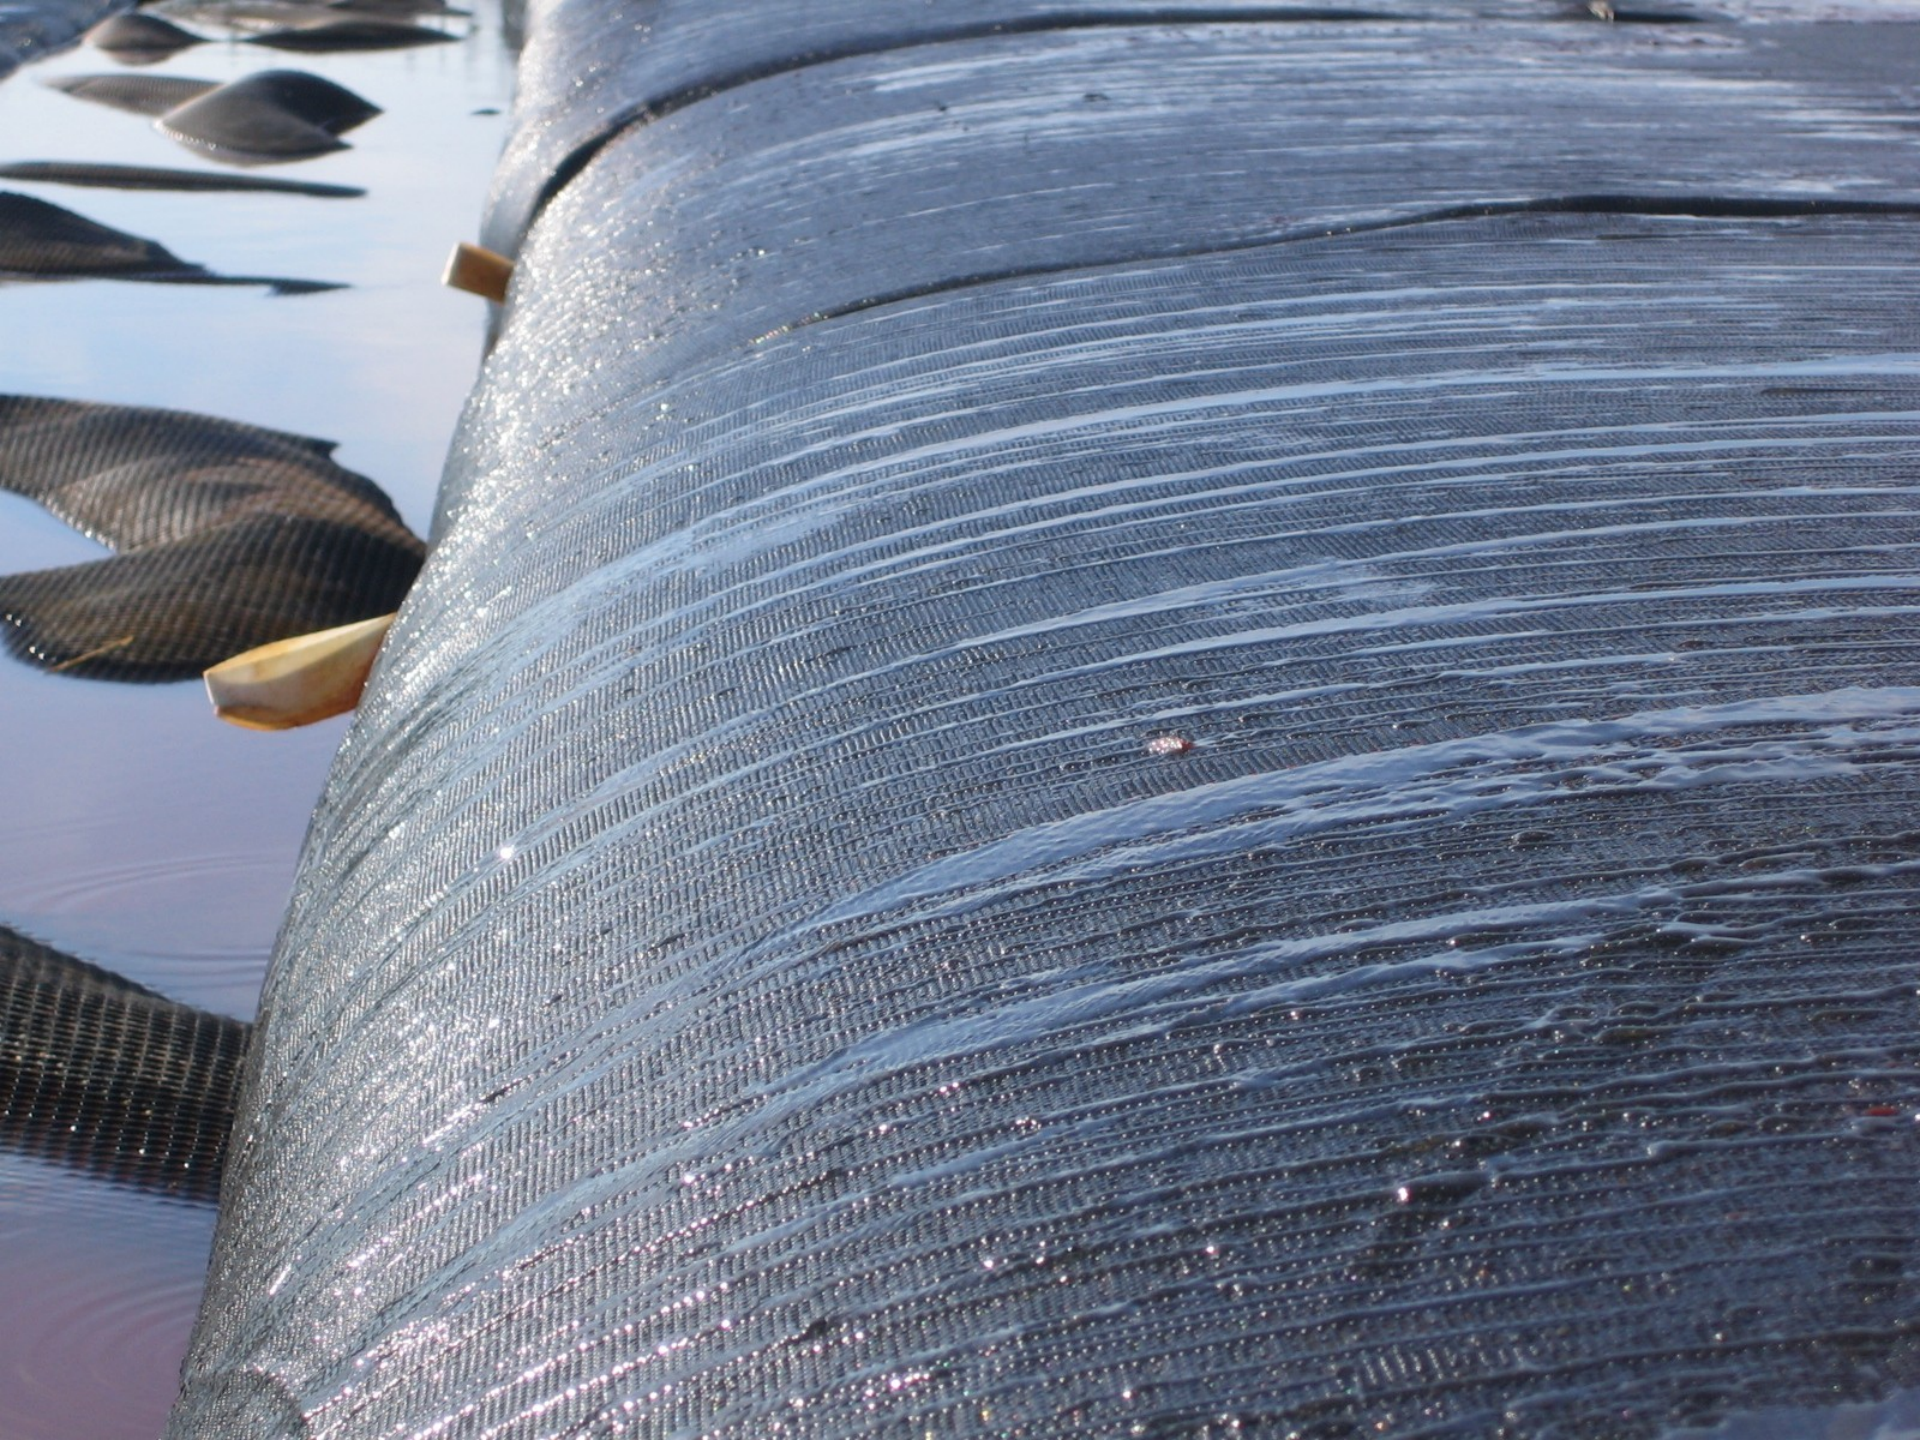
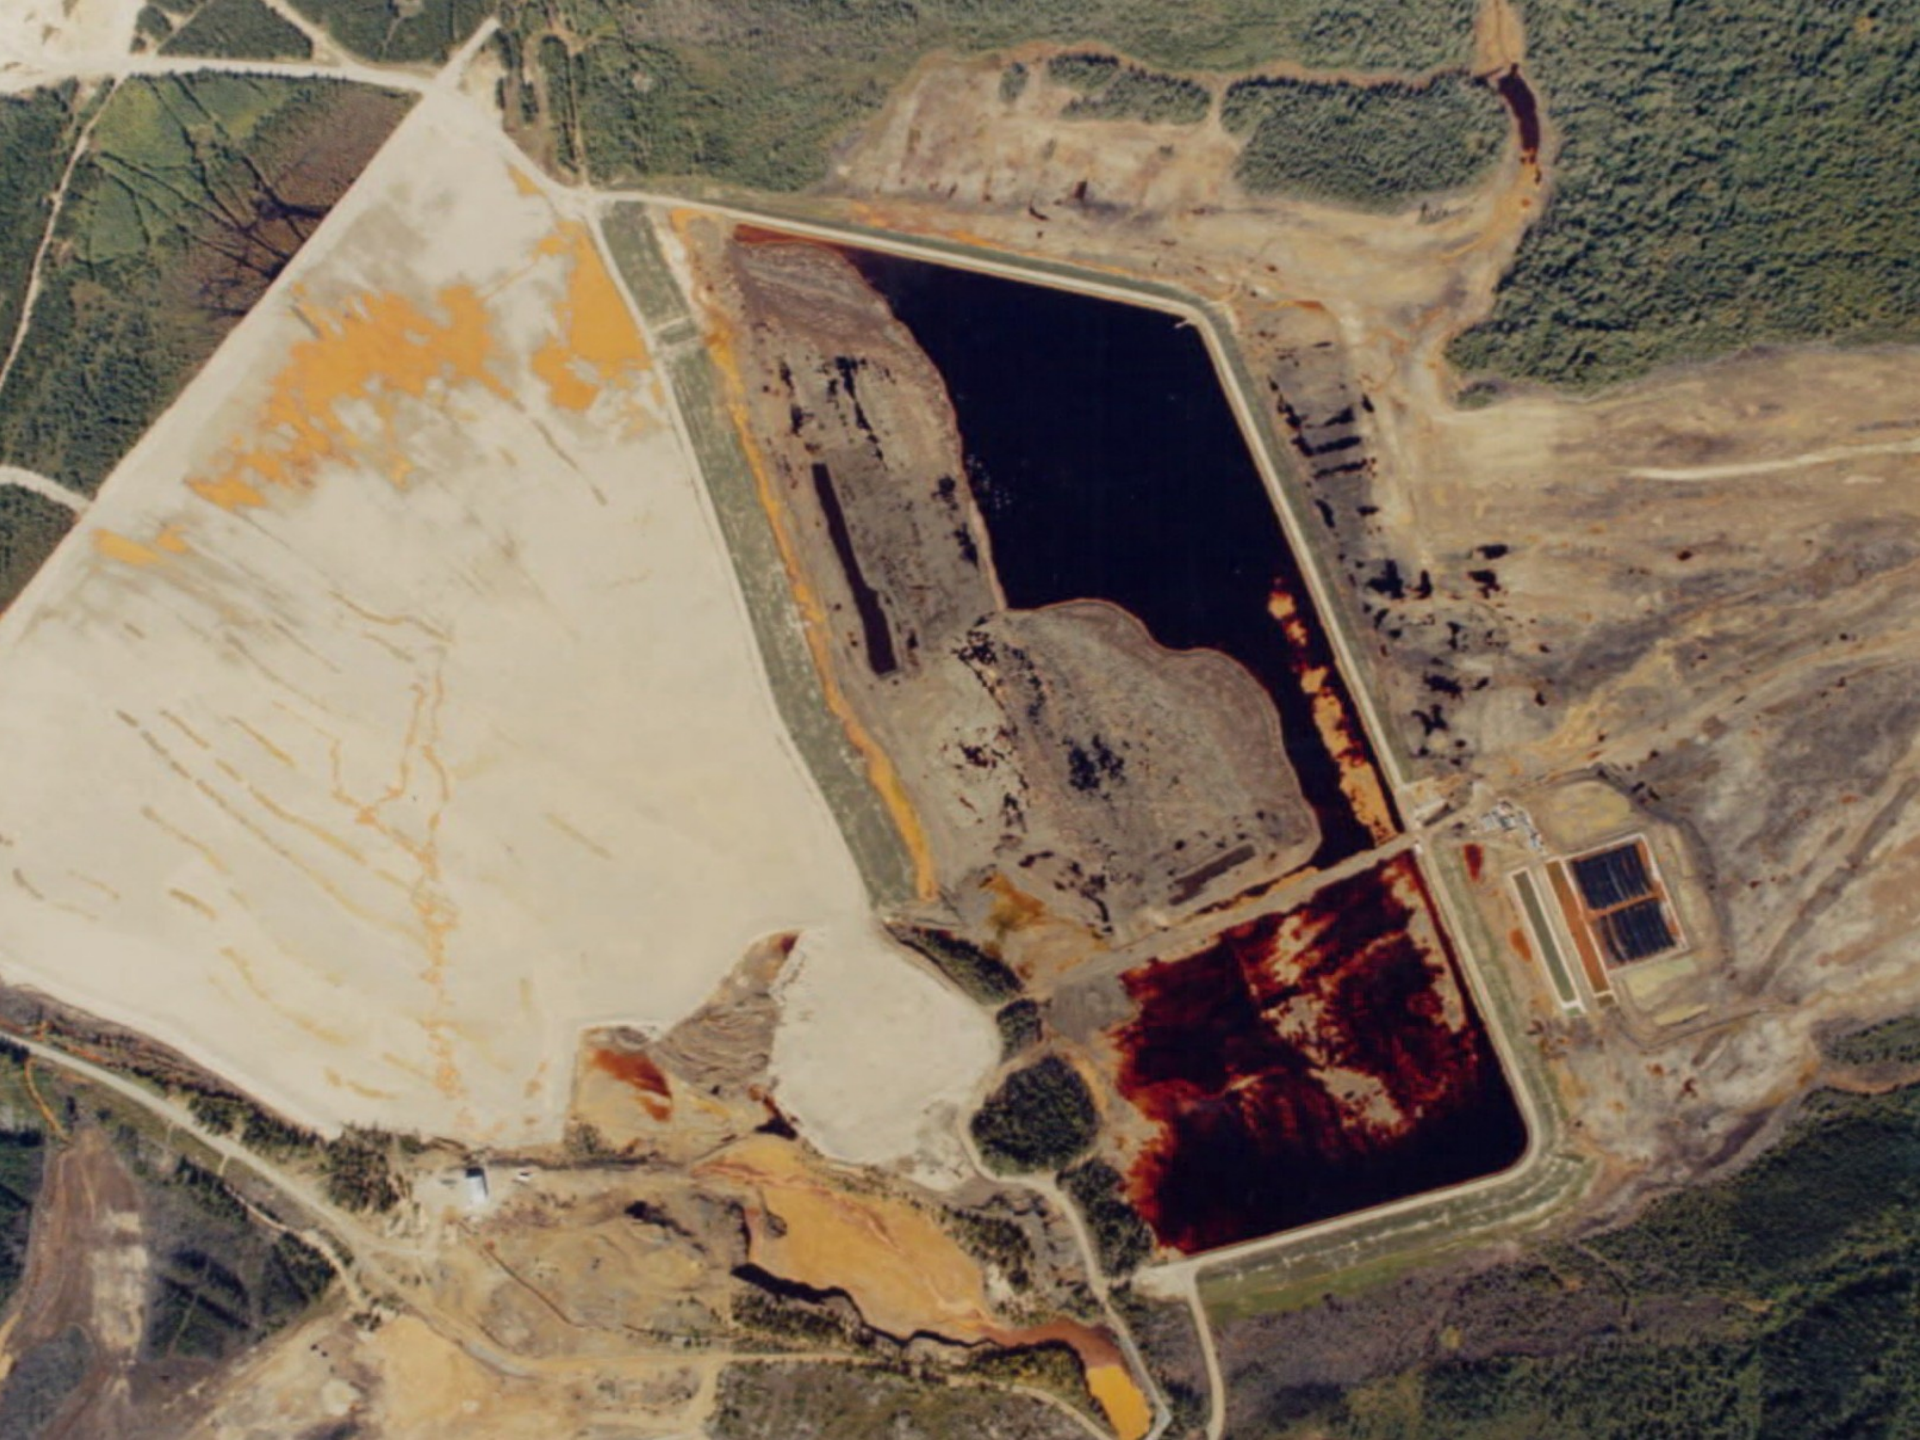
- In 2005 a contract was awarded to conduct the treatment and level the stacked NUT tailings
- The work was completed successfully by winter 2005/2006
- The final cost of this contract was \$9.4 million.

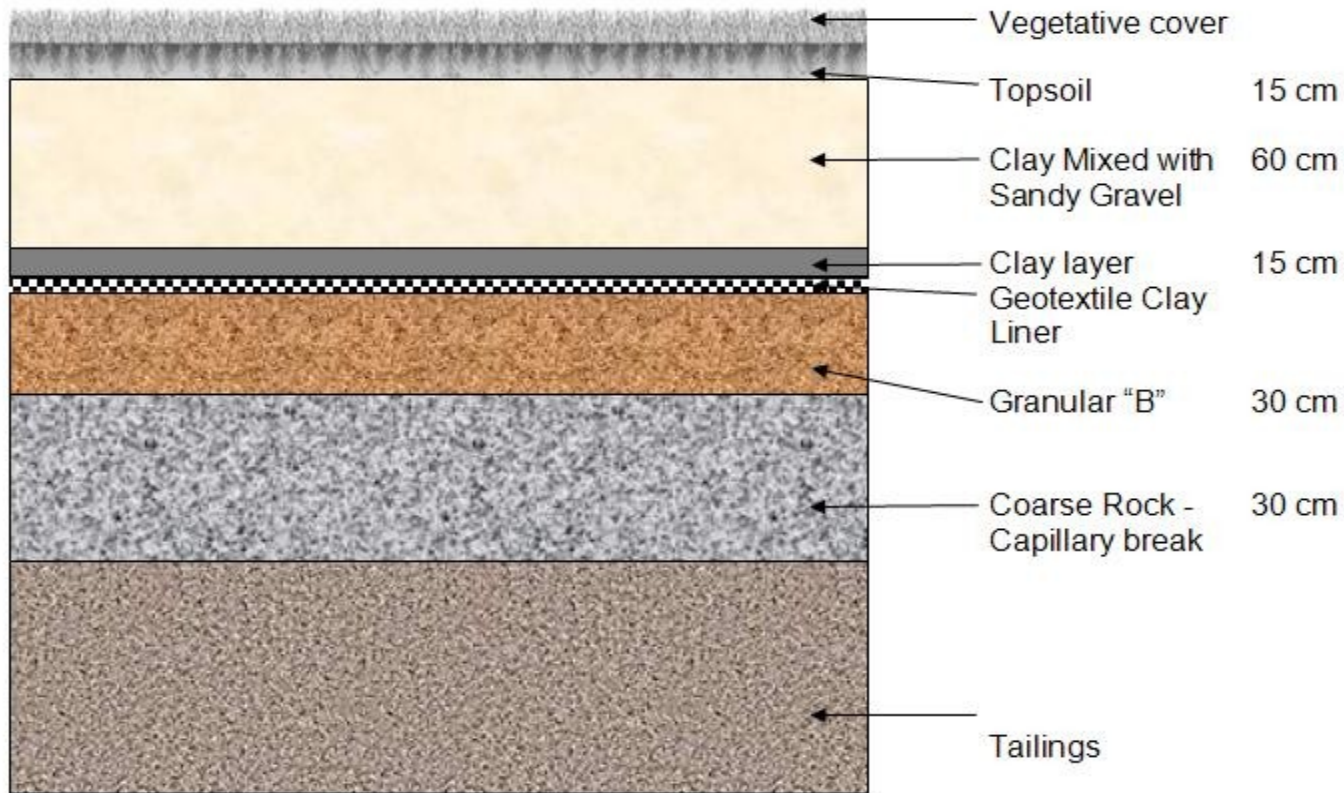
KAM KOTIA COVER PROFILE

NIT Area Cover

- The construction of the NIT area engineered “dry” cover is part of the Phase “E” for the rehabilitation plan
- The KKM rehabilitation work continued for the NIT cover until the contaminated water was dealt with
- The first two layers of that cover: the capillary break and Granular “B” were constructed during the winter of 2004/05, at a cost of \$3.4 million.
- The NIT area cover project is now nearing completion, at an additional cost of \$12.6 million.
