The Continuing Rehabilitation of the Kam Kotia Mine: An Acid- Generating Abandoned Tailings Area.

Dawn Spires

Ontario Ministry of Northern Development, Mines & Forestry

The Northern Latitudes Workshop,

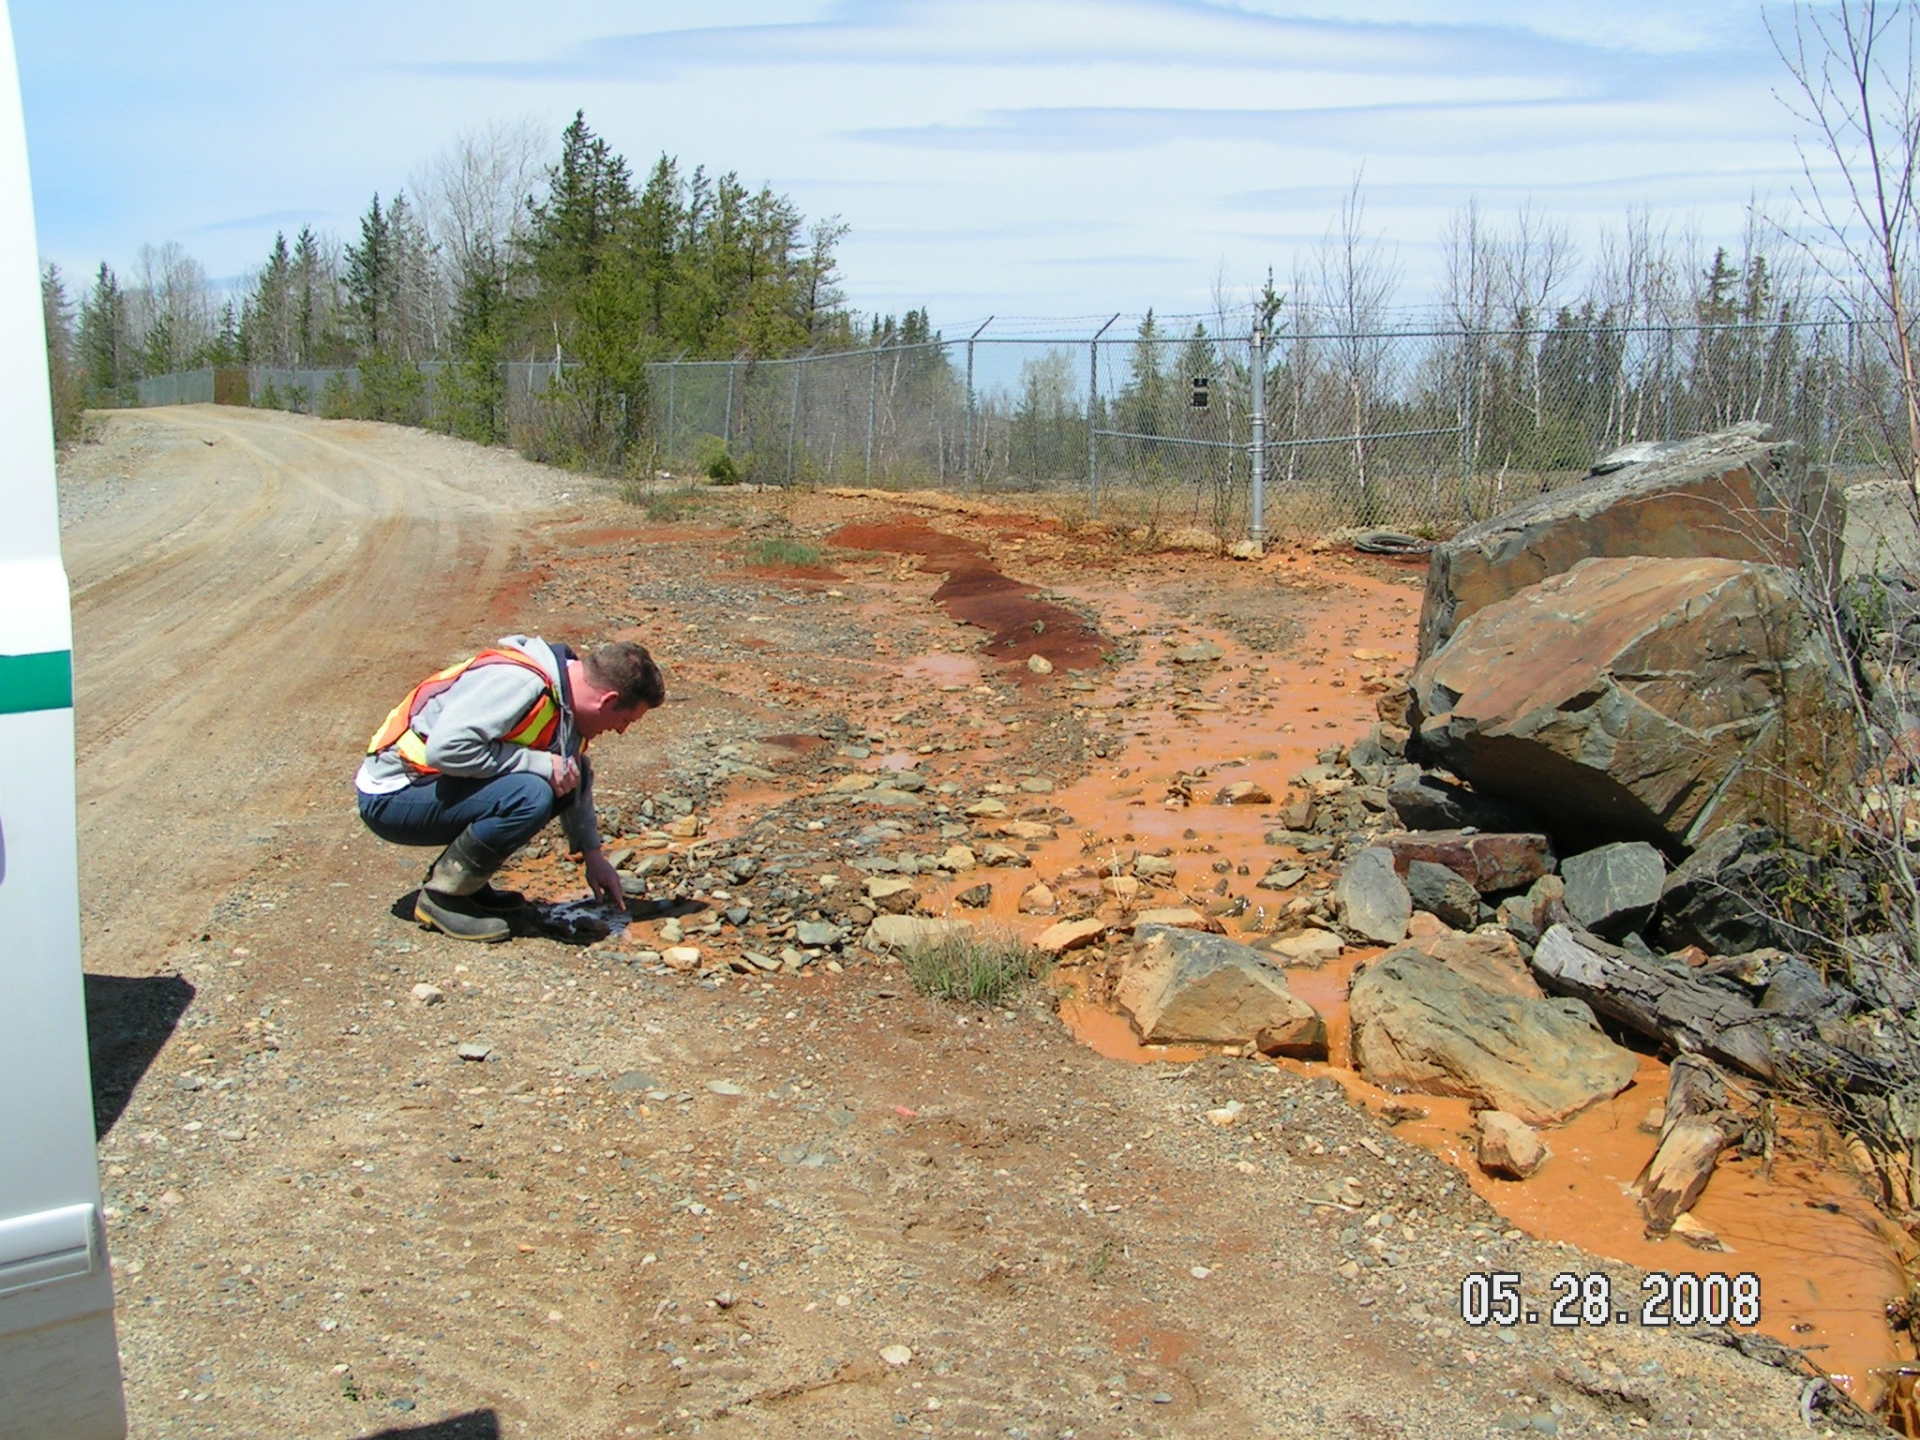
Sludge Discharge Point

Proposed Ditch to Discharge at this Location

Excavate New Ditch Along this Line

Old Kam Kotia Pit Full of Tailings (& Sludge)

Use This Pond as a Temporary Decant Area. Note that the pond elevation is a few feet lower than the tailings in the pit

Construct Small Berm from Roadbed Material to Facilitate Silt Screen Installation for Controlling any Remaining Sludge Discharge

4. Be prepared to “think outside of the box”.
 - Sometimes you have to improvise.
