Alaska Highway East Interpretive Plan

Yukon Department of Tourism
Heritage Branch
March, 1999

Inukshuk Planning & Development
In Association with Aasman Design Inc.

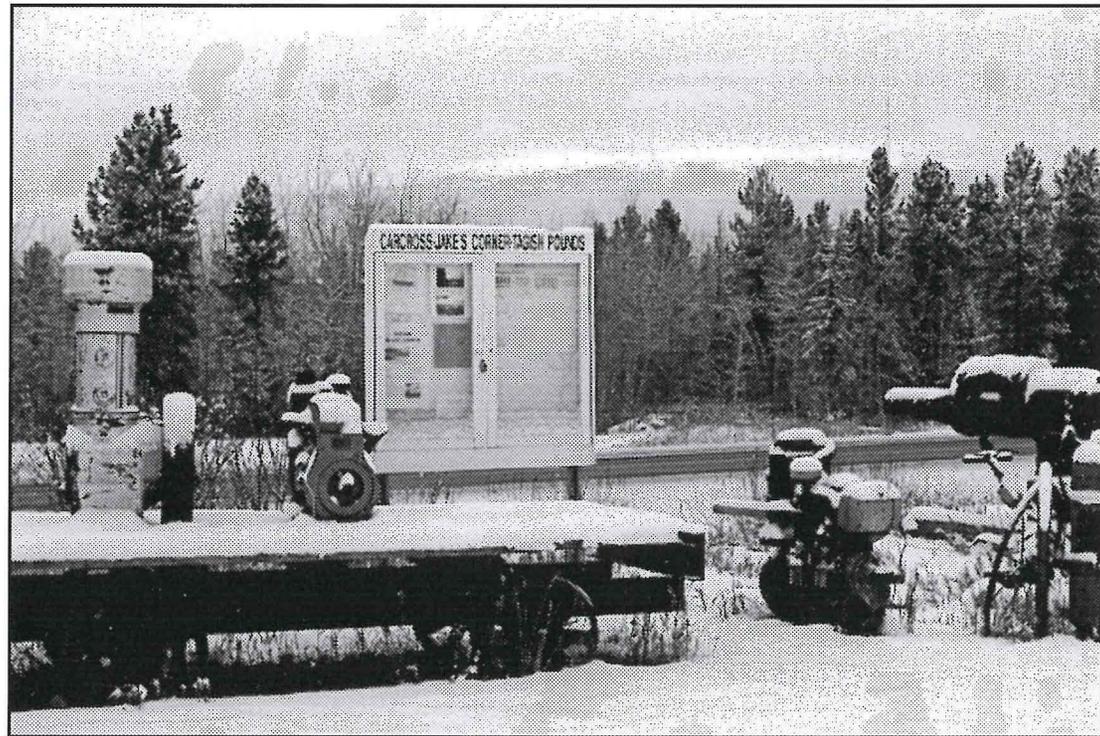
Sign and artifacts at Jake's Corner, km 1392.4.

The highway right-of-way comes quite close to the existing buildings, so it is possible to position interpretive signage where it can be seen. However, this would have to be done with care to clearly differentiate between the regional orientation site and the adjoining commercial property. With careful site planning and directional signage, it should be possible to develop a site that could complement the commercial facilities already present.

In this situation, the message on the talking sign should identify the location of the interpretive site because it is above the highway and will appear to be part of the adjoining commercial property. The actual entrance and exit locations should be marked clearly. The site should also be planned for year round use.

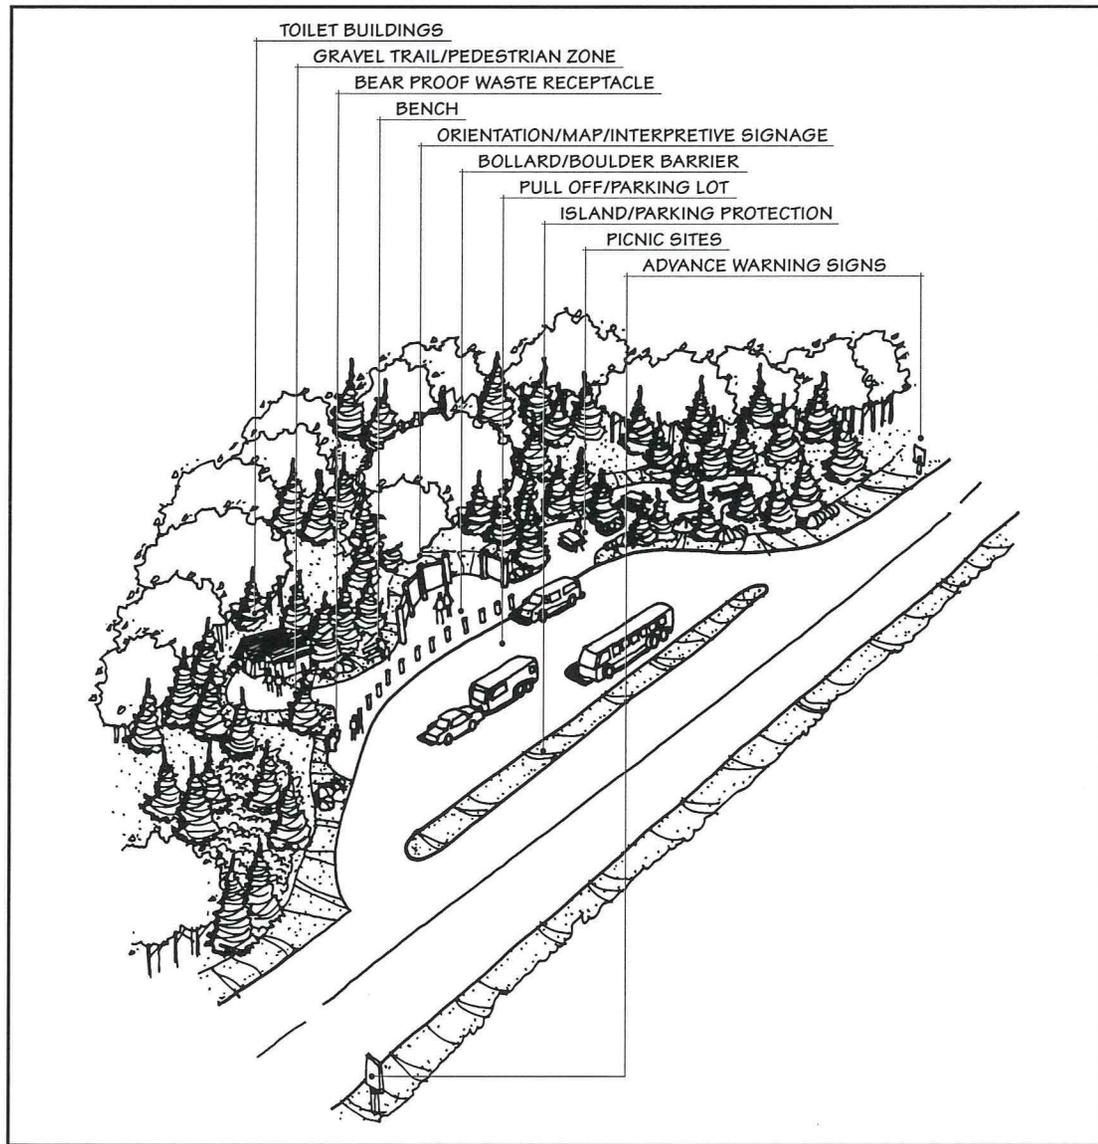
Components of a typical Regional Site concept

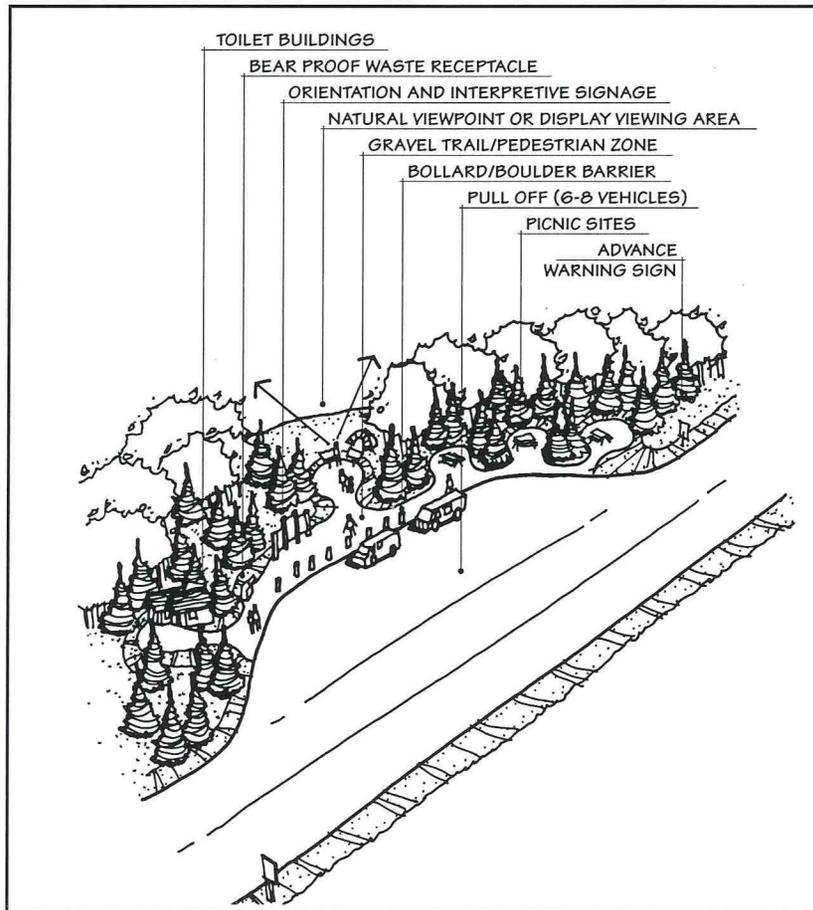
Typical components of a Major Site

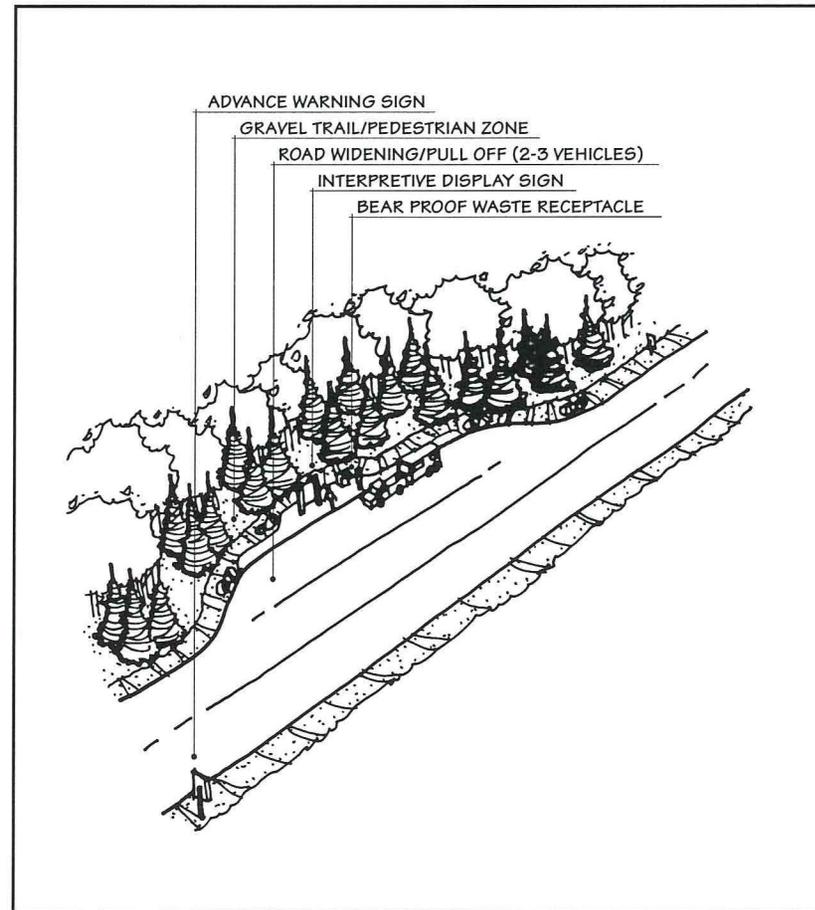
Typical components of a Minor Site

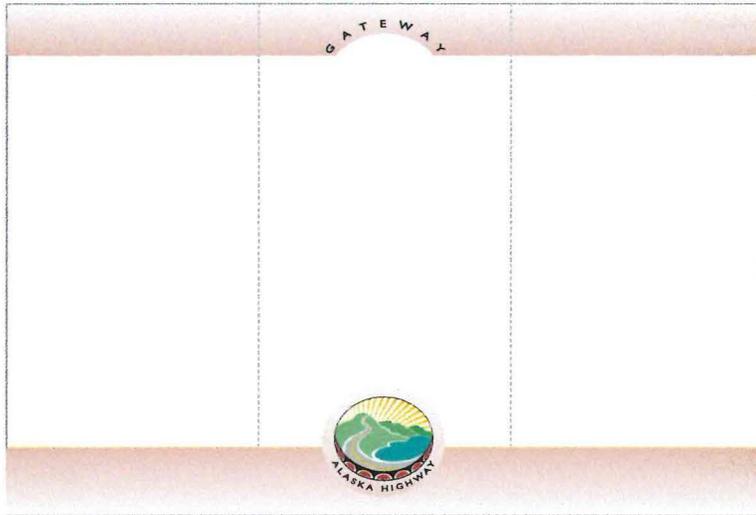
Typical panel design elements

The Yukon Government wordmark with “Tourism” signature will be located on the substrate of the dominant panel within a grouping of panels. In the case of a lone panel, it may be centred at the bottom of the third column, as illustrated to the right.

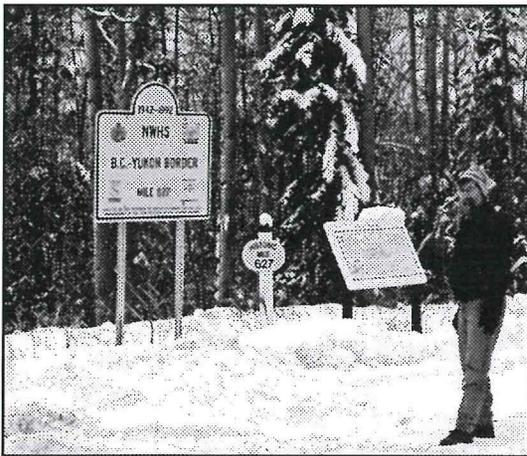
Typical highway commemorative signage.

This study has concluded that once a number of these signs have reached the end of their physical life they should not be replaced. It is recommended that the highway construction theme be concentrated at the Sign Post Forest site in Watson Lake and at the junction of the South Canol Road. It is also recommended that the brochure not be reprinted.

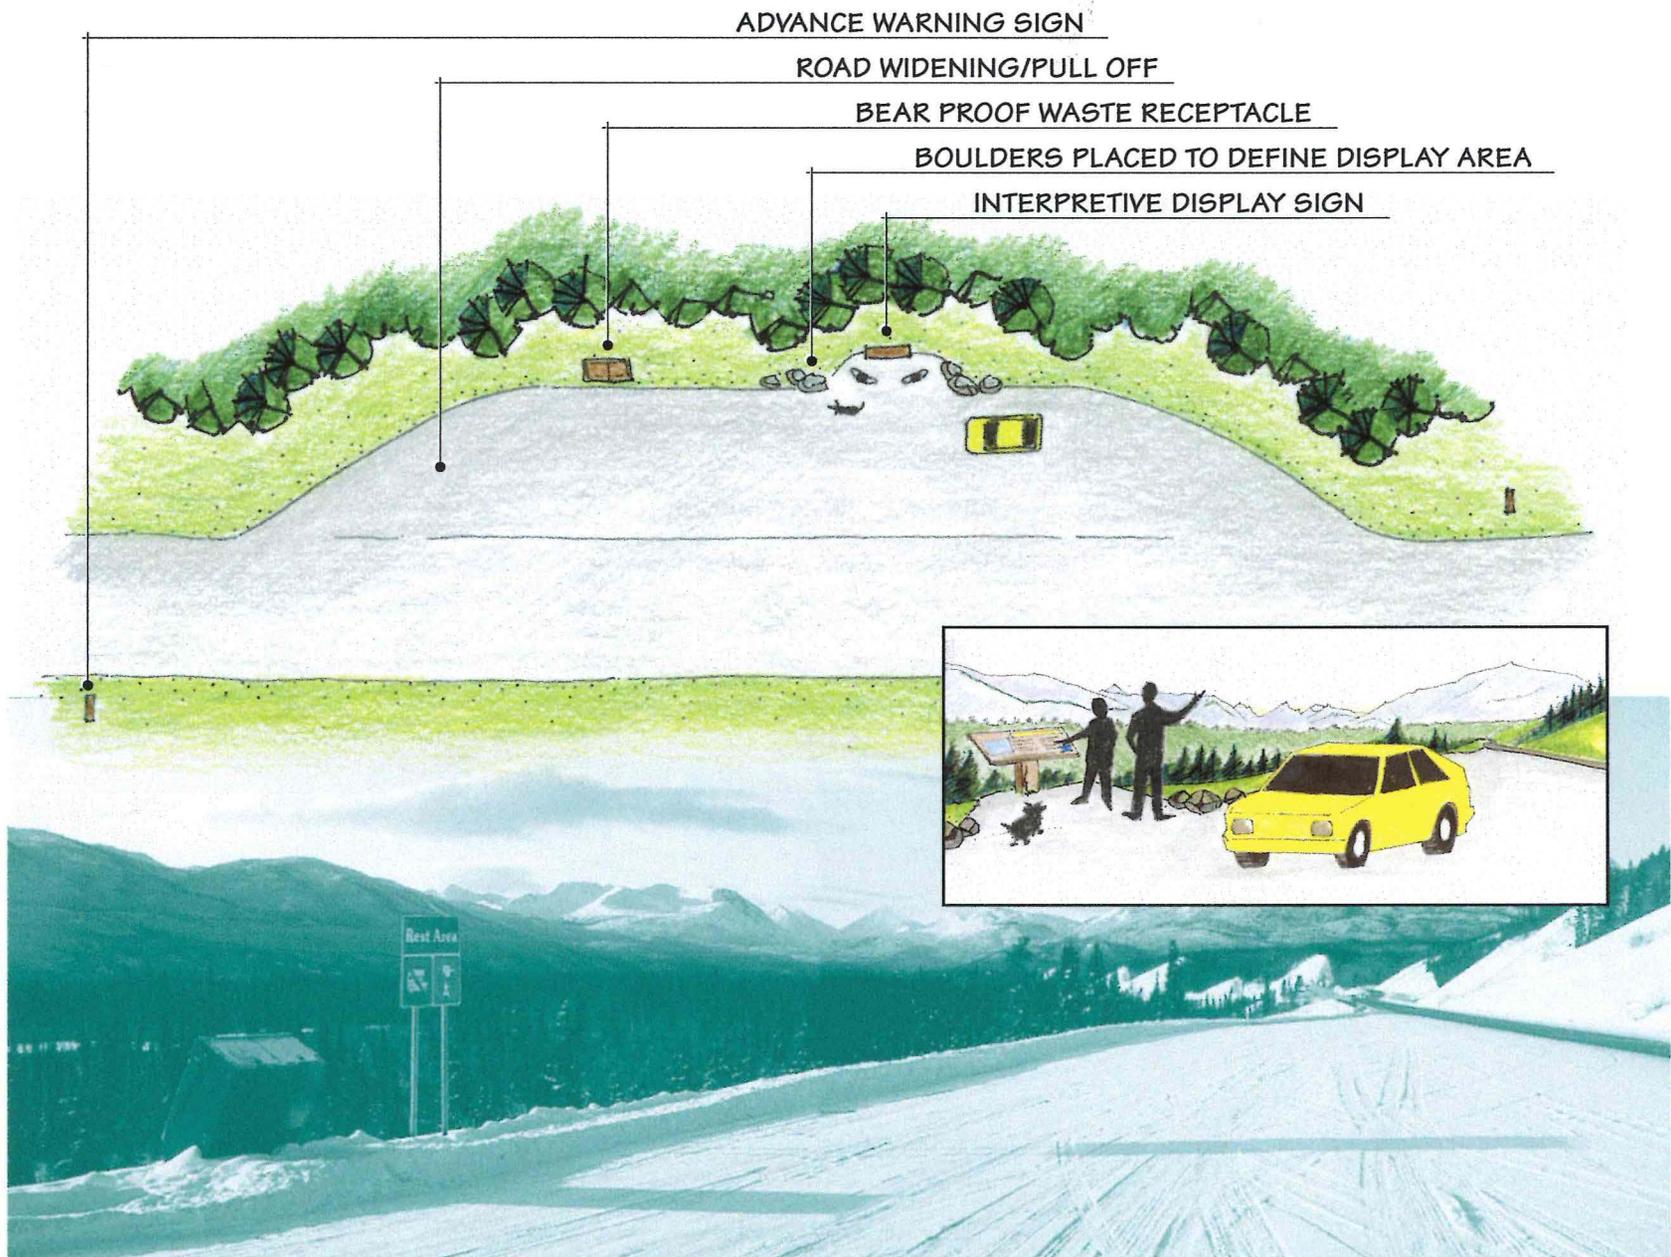
Rancheria River, km 1127—example of proposed minor site development.

A minor site will usually only contain a single sign highlighting a particular feature such as a view or the significance of a place or event. The traveller stops, reads the sign and leaves.

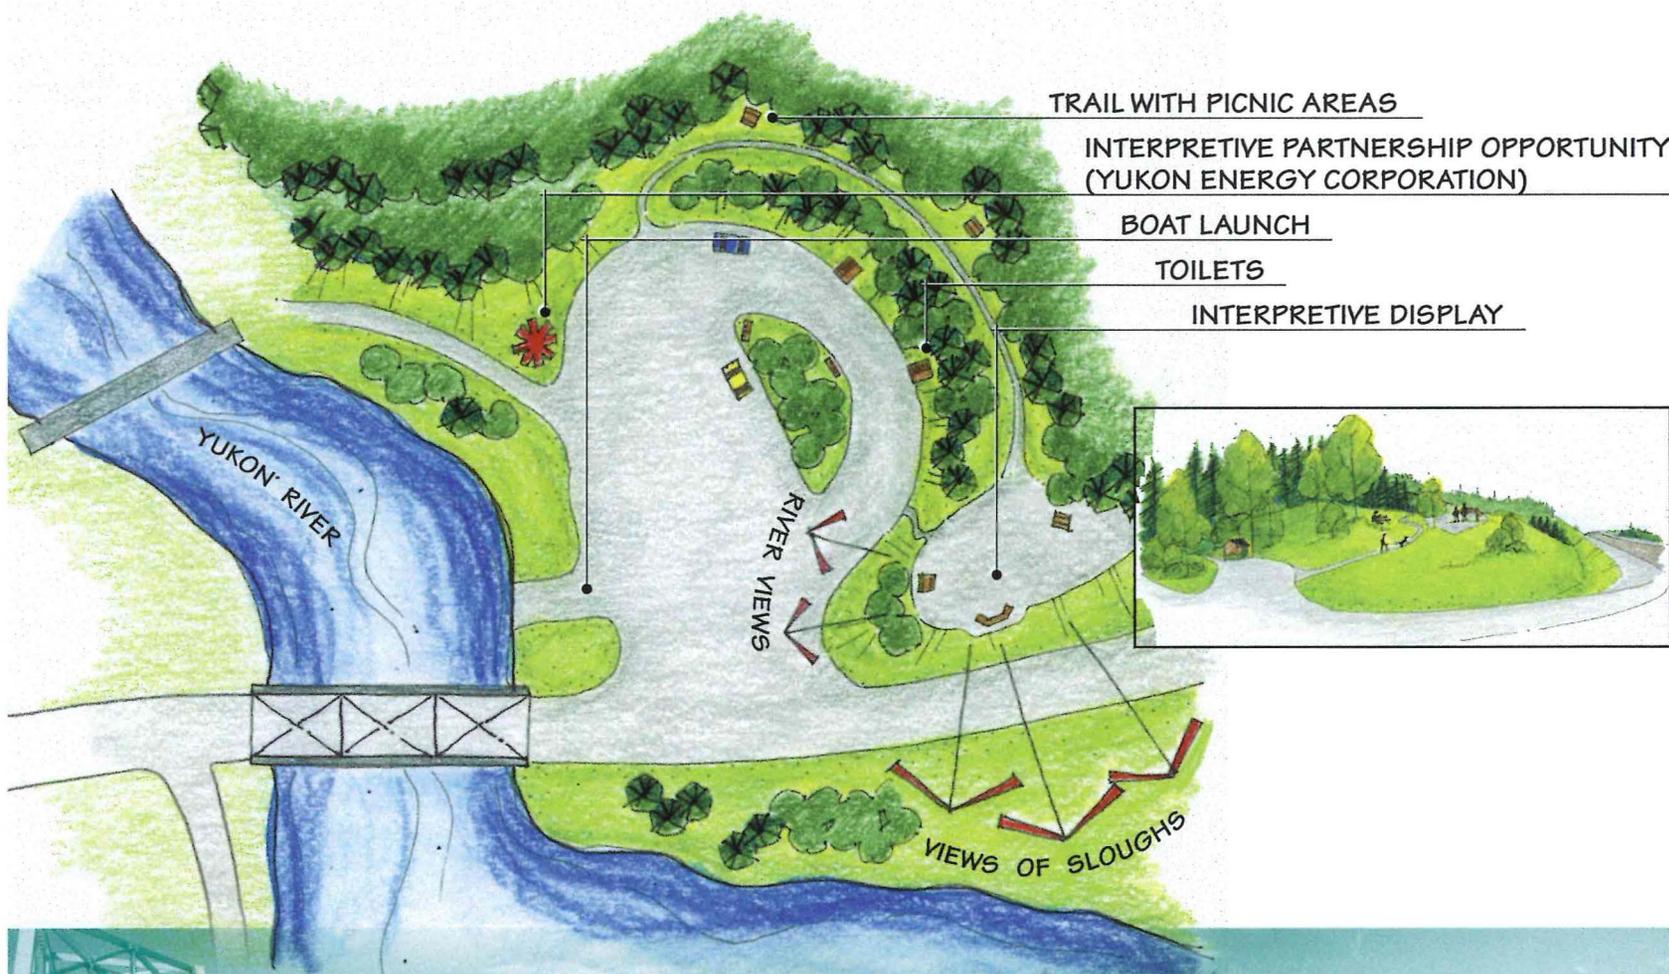
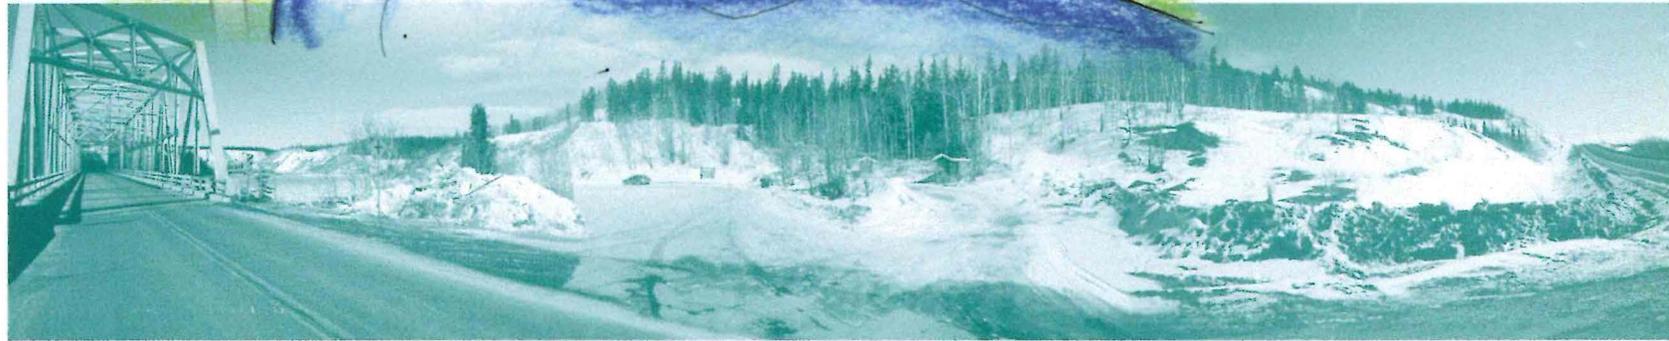
Yukon River Bridge, km 1444—example of proposed Major site development.

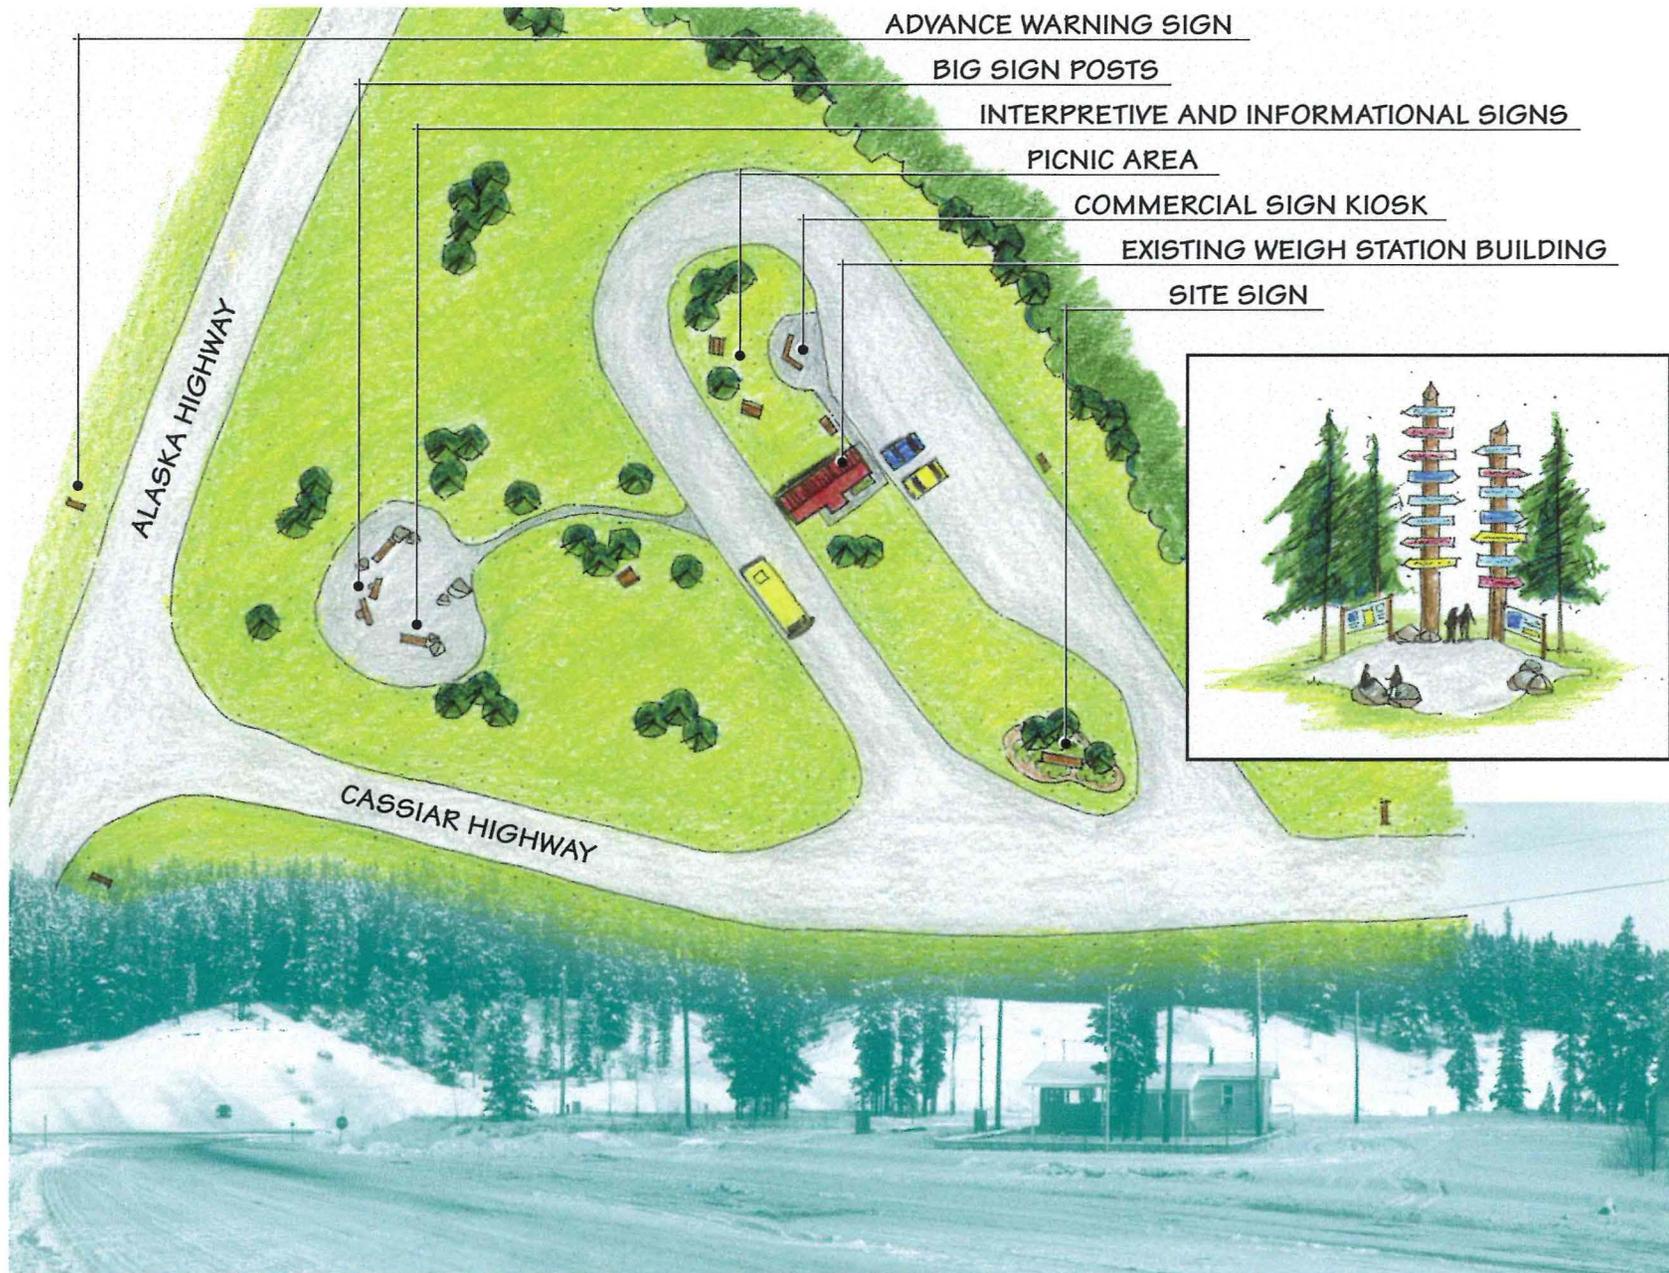
Alaska and Cassiar Highway Junction, km 1042.8—example of proposed Regional site development.

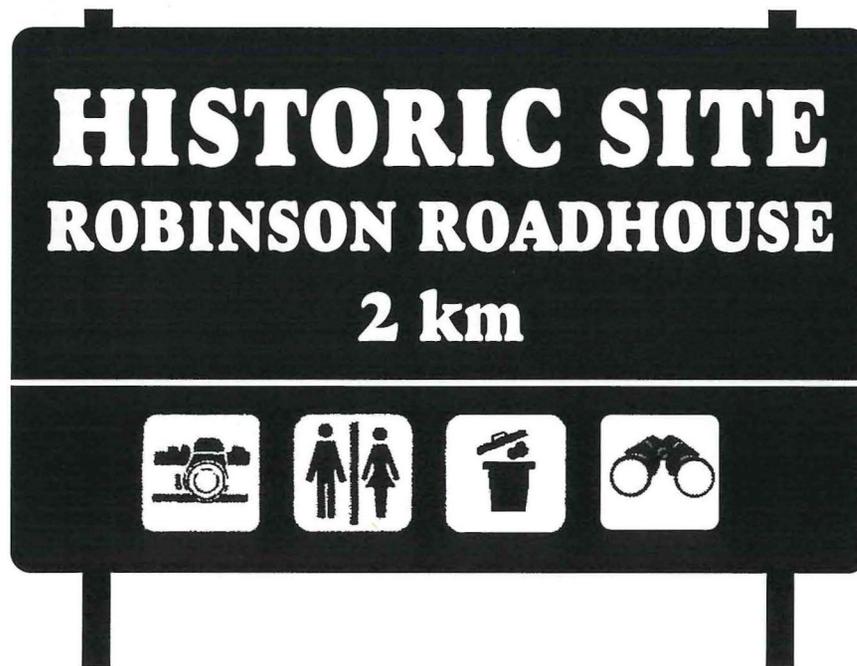
Major site advance warning sign, 2 km

In the case of those sites developed primarily for interpretive purposes, either the camera or binocular symbol will be used at 2km with the same symbol and a directional arrow tab at the 250m mark. Historic sites will have a larger sign at the 2km point which identifies the name of the site with services available indicated by symbol tabs.

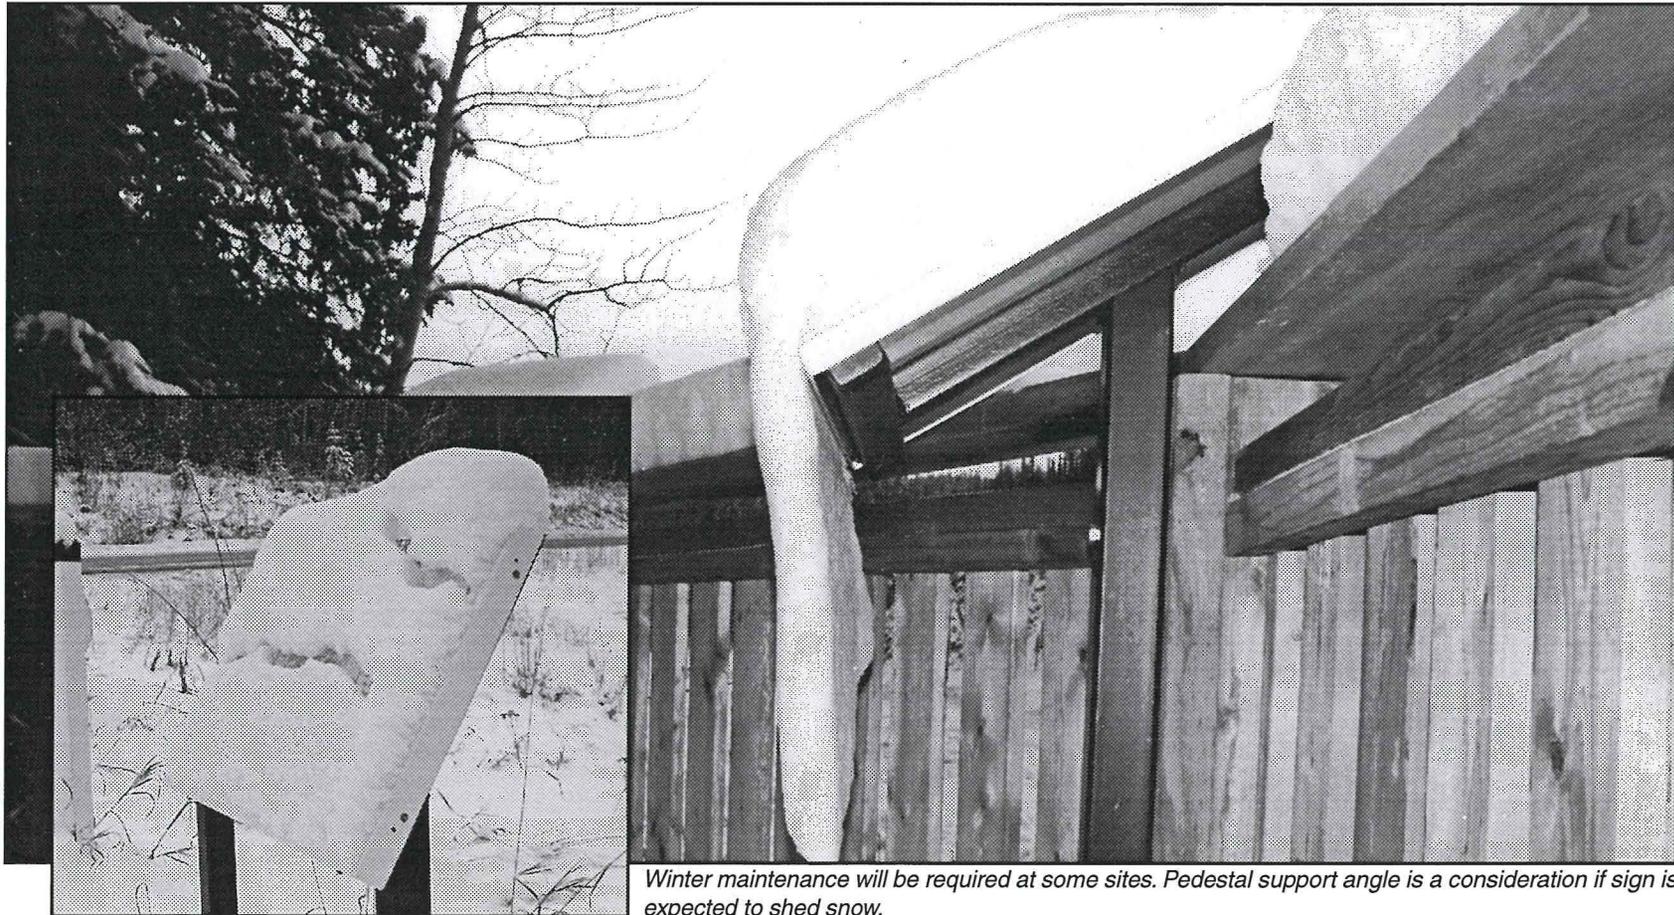
Winter maintenance will be required at some sites. Pedestal support angle is a consideration if sign is expected to shed snow.
