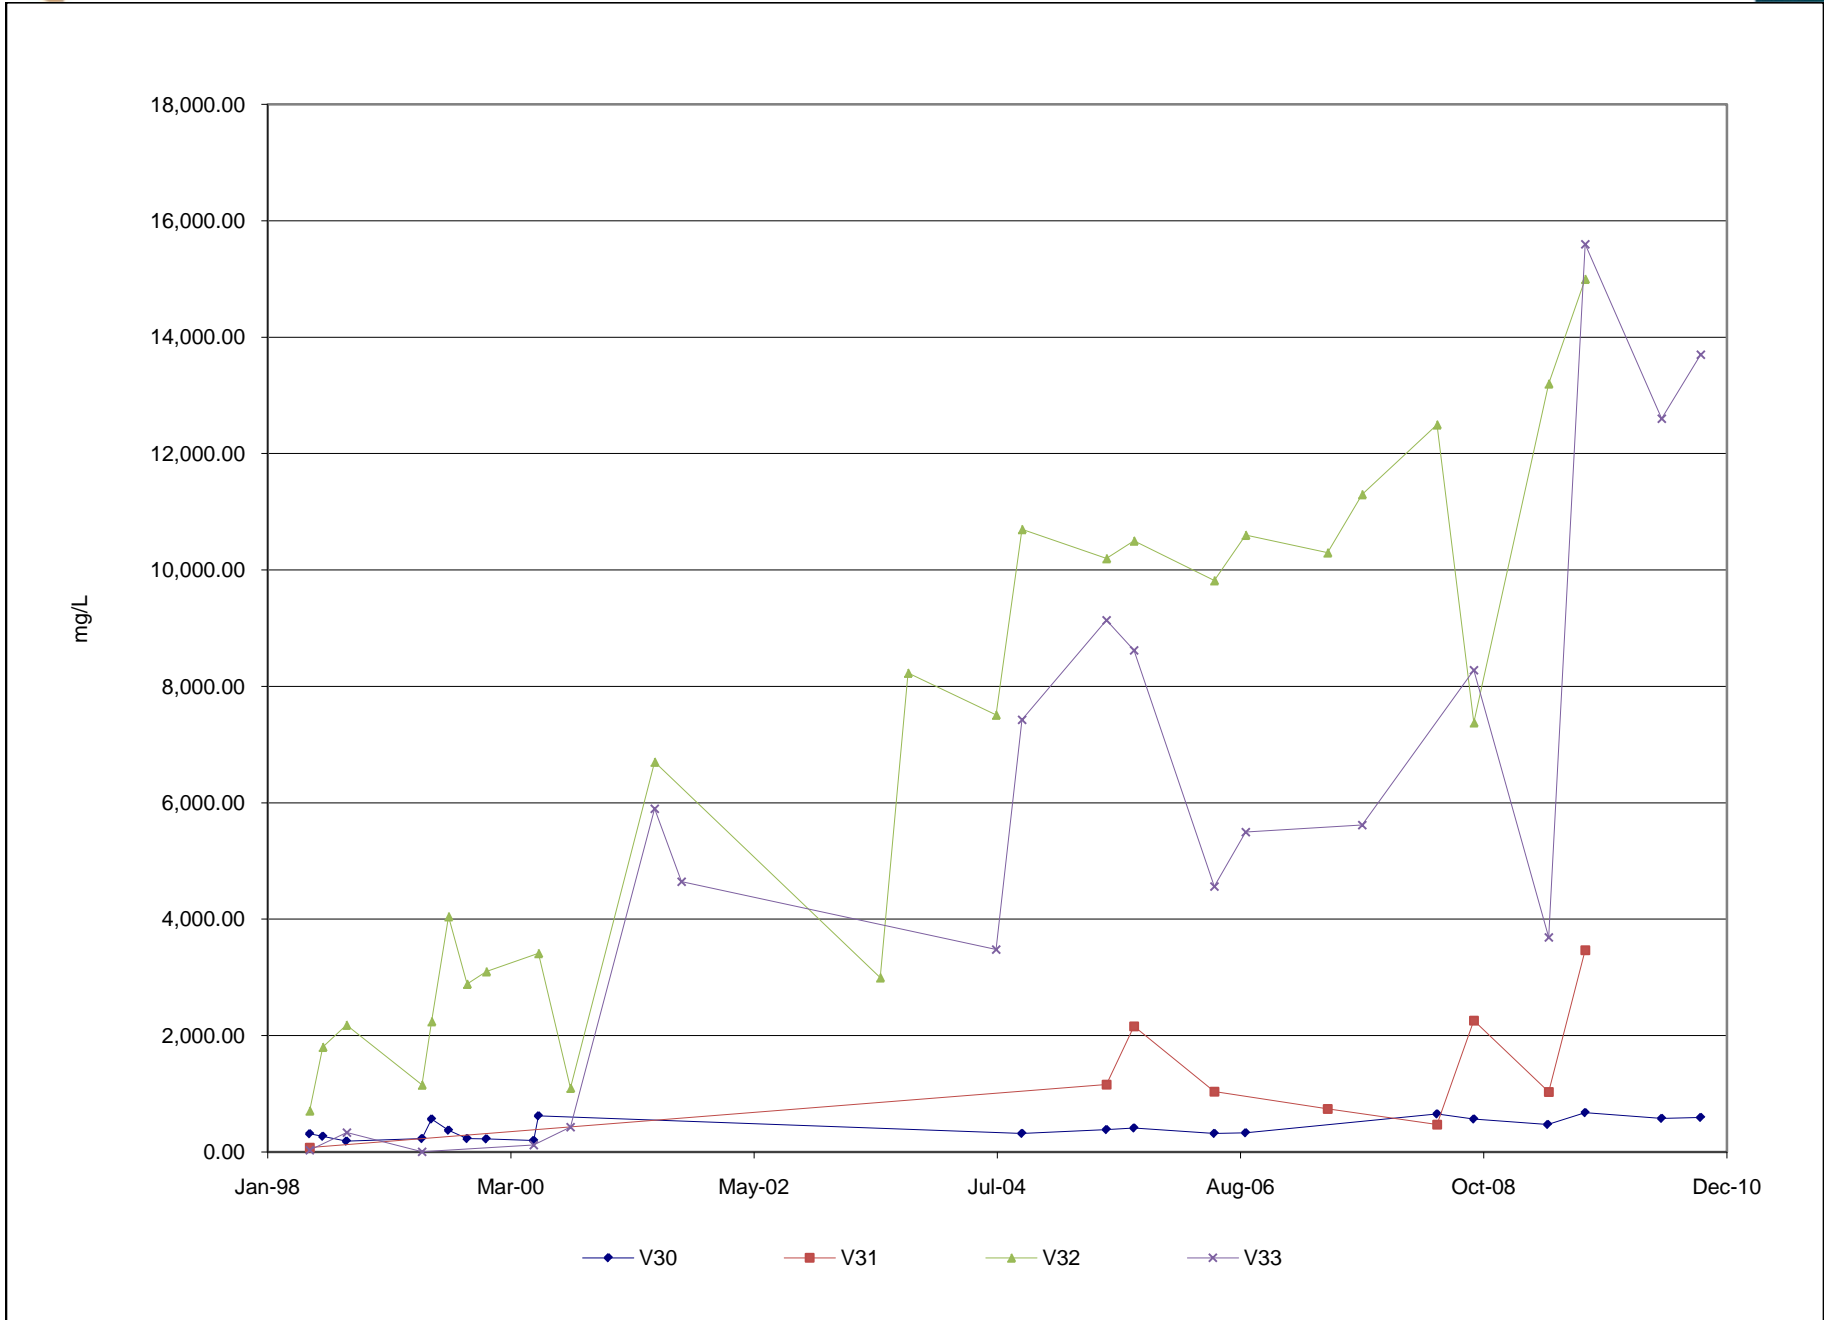
Figure D-22: Zinc (Dissolved) in Vangorda Waste Rock Dumps Toe Drains
