Clinton Creek Site: Fish Utilization and Passage

March 2017 revision

Prepared for: Yukon Government
Energy, Mines and Resources
Assessment and Abandoned Mines

Prepared by: A. von Finster, AvF R&D

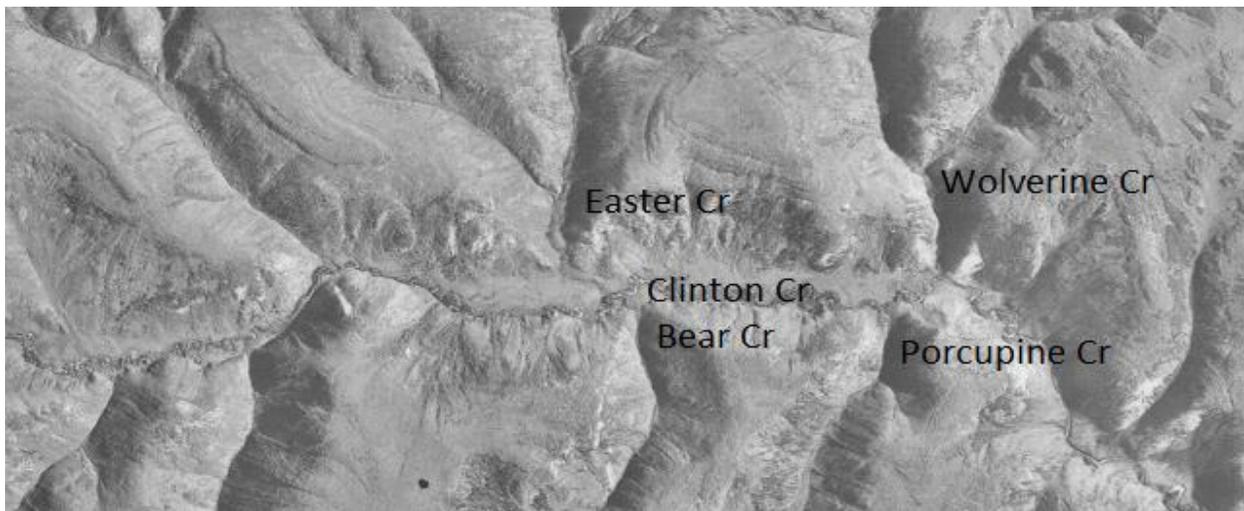
Photograph A-1. 1951 - the Clinton Creek valley prior to mine development.

Clinton Creek had a sinuous- to meandering channel, with a few short, straight sections. Stream side vegetation that escaped the wildfire was dominated by large spruce. Vegetation along the burned area was at an early stage of development. The 1951 aerial photograph was taken in the morning, with the sun in the east. The shadow of the stream bank in the burned area where the channel was aligned north-west is visible as a fine dark line, implying that the bank was high- and steep enough to cast a shadow. This is consistent with the steep, high banks typical of streams in unglaciated areas. The light tone of much of the channel bottom, where visible, is consistent with dry gravel exposed during a summer low flow period. The wetted area at the time of photography would have only taken a small portion of the channel bottom. These characteristics are consistent with stream channels in unglaciated areas. There were no obstructions to the upstream migration of fish such as water falls or beaver dams. This is also consistent with streams in unglaciated areas.

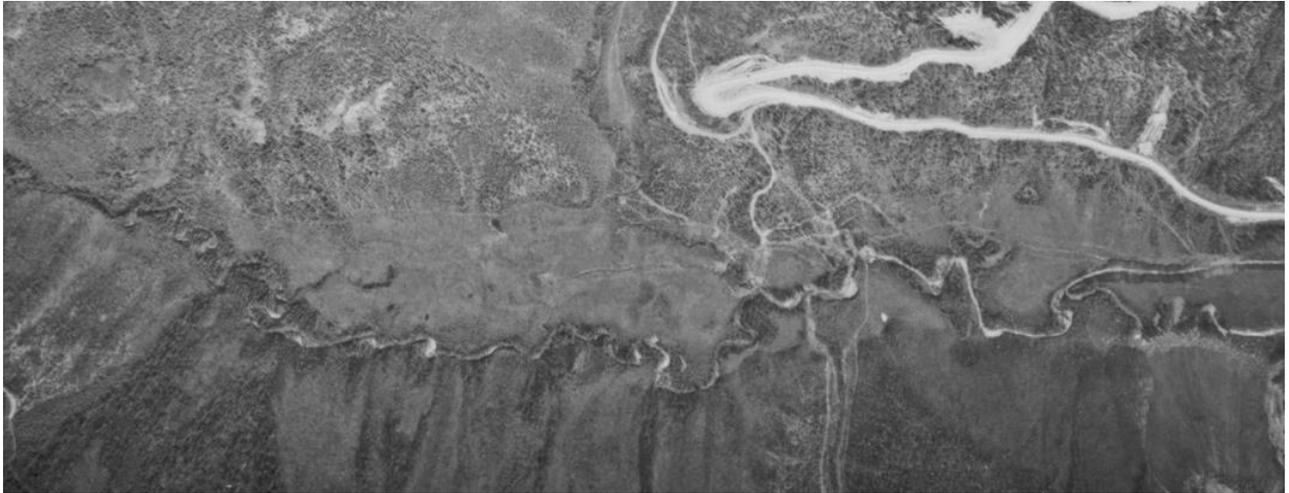
Photograph A-2. 1970. Clinton Creek valley, during early production.

Photograph A-2 shows the valley bottom in 1970, shortly after the mine started production. Easter Creek enters from the top center of the photograph. In the right side of the photograph Clinton Creek flows through the second diversion, as the waste rock has already buried parts of the original creek channel.

The channel upstream of the mouth of Easter Creek was undisrupted in 1970. The channel remained in virtually the same location it had been 19 years before, indicating a high degree of lateral stability. The channel bottom continued to be wide and composed of dry gravels. Stream side vegetation had become well established in the burned areas: the emergent deciduous vegetation has a lighter tone than spruce.

The channel downstream of Easter Creek had been disturbed by various mine-related activities including roads and trails.

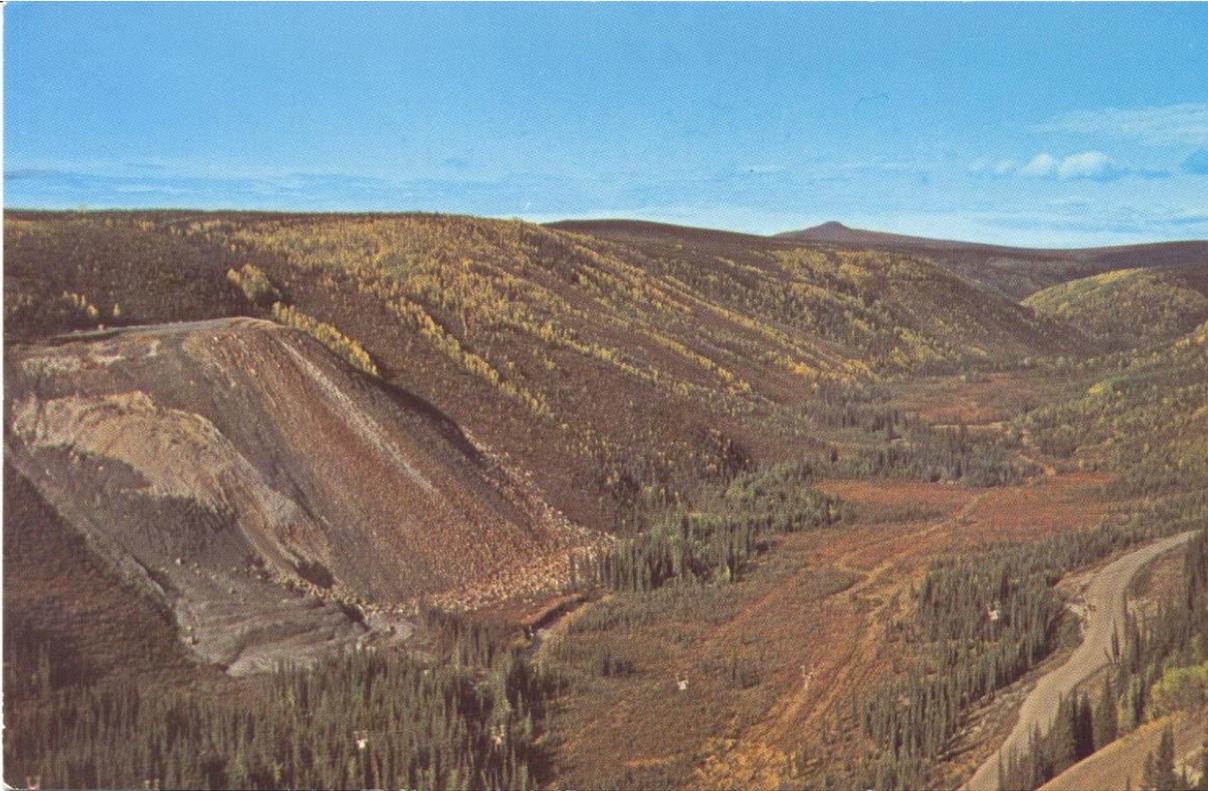
Photograph A-3 was probably taken in autumn 1969 and shows the Clinton Creek valley in the area of what would later become Hudgeon Lake. Easter Creek enters from the right at mid photo. A waste rock dump on the south valley wall in the left foreground has already started to fail. A section of the creek has been buried under the advancing toe of the waste rock dump and the creek is flowing through the first diversion. The second diversion will follow the Cat trail extending along the toe of the right valley wall in the foreground. The mature spruce forest in the foreground corresponds to the spruce dominated stream side vegetation to the left of the mouth of Porcupine Creek in Photograph A-1. The emergent deciduous stream side vegetation is visible further along the creek. Past surface layer detachments on the north facing valley wall have been colonized by deciduous trees. Most detachments start near the top of the slope and some extend to the valley bottom.

Photograph A-3 – Clinton Creek valley, possibly early autumn 1969.

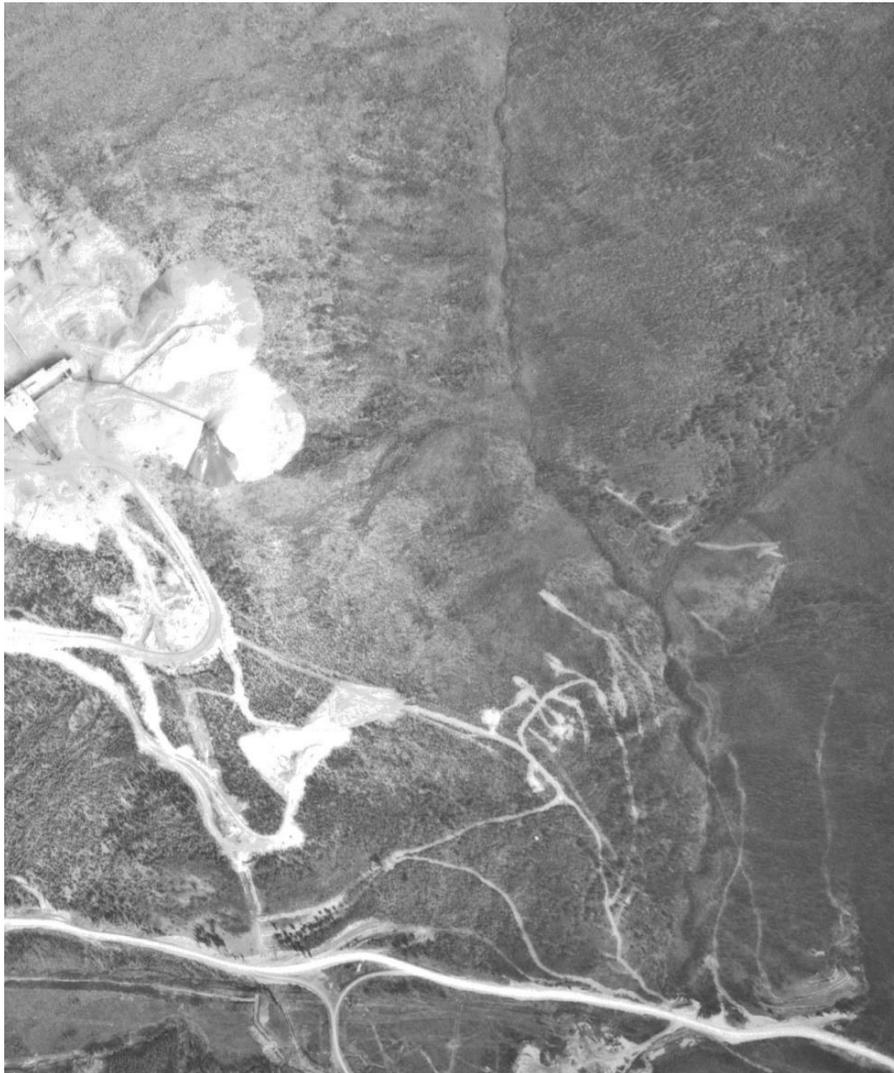
Photograph A-4 - Lower Wolverine Creek.

Photograph A-4 was taken in 1970, before substantive disturbance to the watershed occurred. The creek flowed through a "V" shaped valley. The section of the creek downstream of the first tributary entering from the right (east) was not actively incised in bedrock but had developed a narrow, relatively flat valley bottom through which it flowed. Stream side vegetation in this section of the creek appeared to be dominated by spruce near the creek. Access roads are generally located on the side hills beside the valley rather than the valley bottom, implying that soft ground conditions existed along the creek.

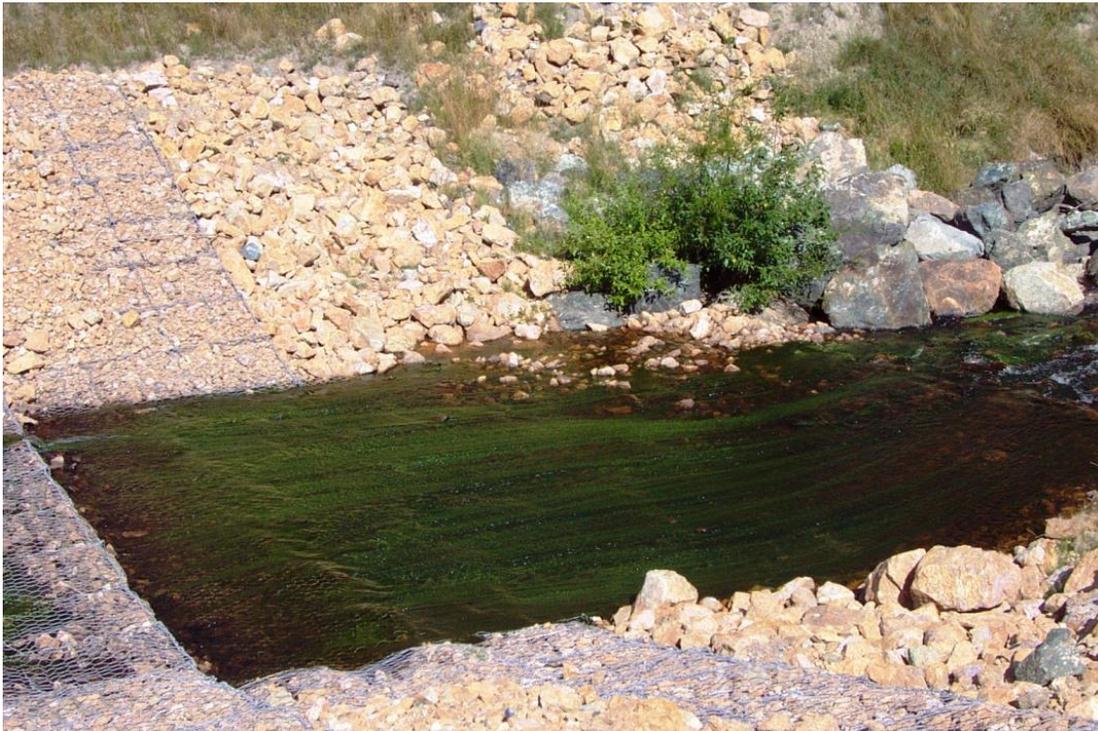
Photograph C-1. Filamentous algae at the downstream end of Drop Structure 4.

The main effect of the lake on downstream water quality has been an increase in nutrients. Support for this includes the heavy growth of algae in the outlet channel.

Seeps entering the channel bed and banks within the gabion structure can be identified by the early growth of algae at the discharge site. Later in the summer, the area covered by algae is greatest when the flows from the lake have been low and relatively constant. Photograph C-1 shows this effect.

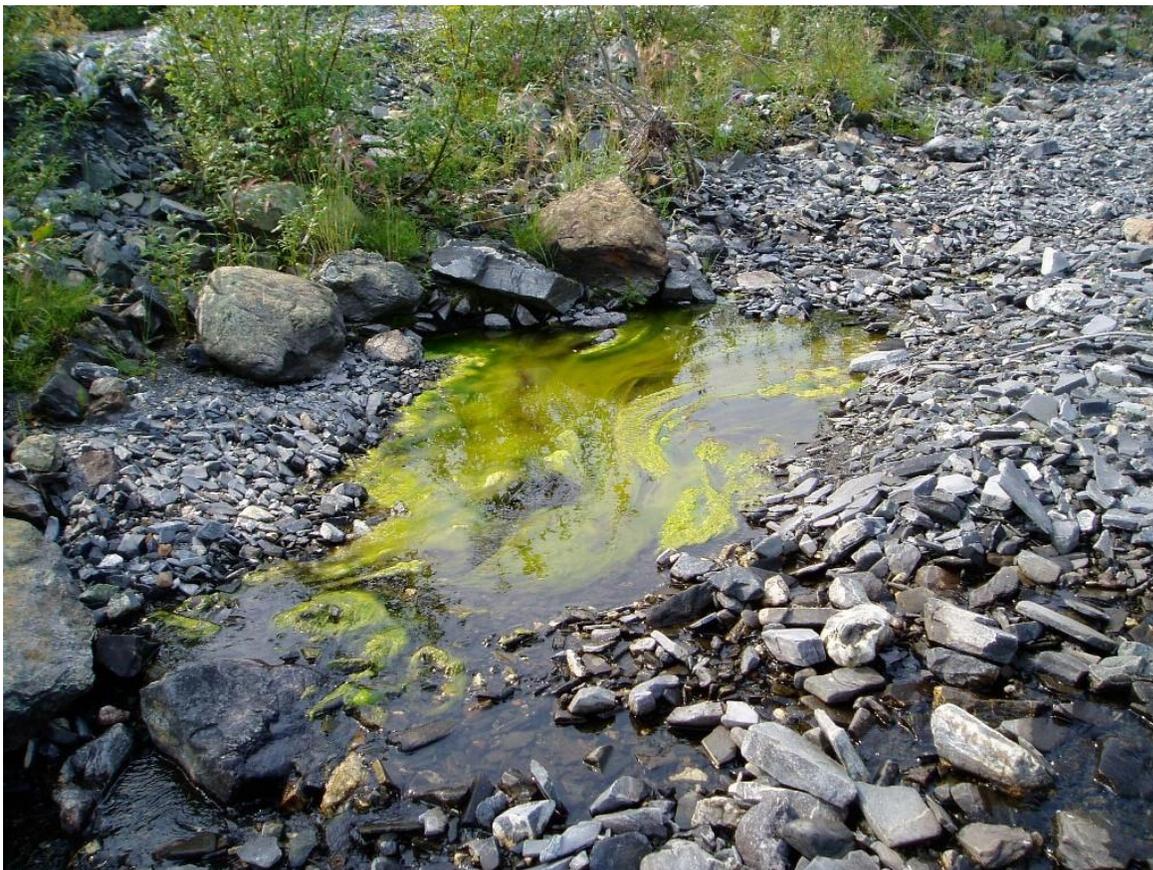
A number of seeps or larger ground water discharges occur on the surface of the developing alluvial fan downstream of the canyon, and more along the southern margin of the valley wall (LES, 2011; ELR, 2015). The discharge zones on the surface of the fan have generally been subject to the cycle of deposition and erosion by which the fan is developing. They have appeared and then been buried by subsequent flood events. Photograph C-2 shows a typical seep and the algal response of related to nutrient rich water. Of note, the seepage shown was buried by material transported downstream in the August 2010 flood.

Photograph C-2 July 26, 2005. Filamentous green algae in a seep on the developing alluvial fan, indicating the rapid assimilation of available nutrients by algae.

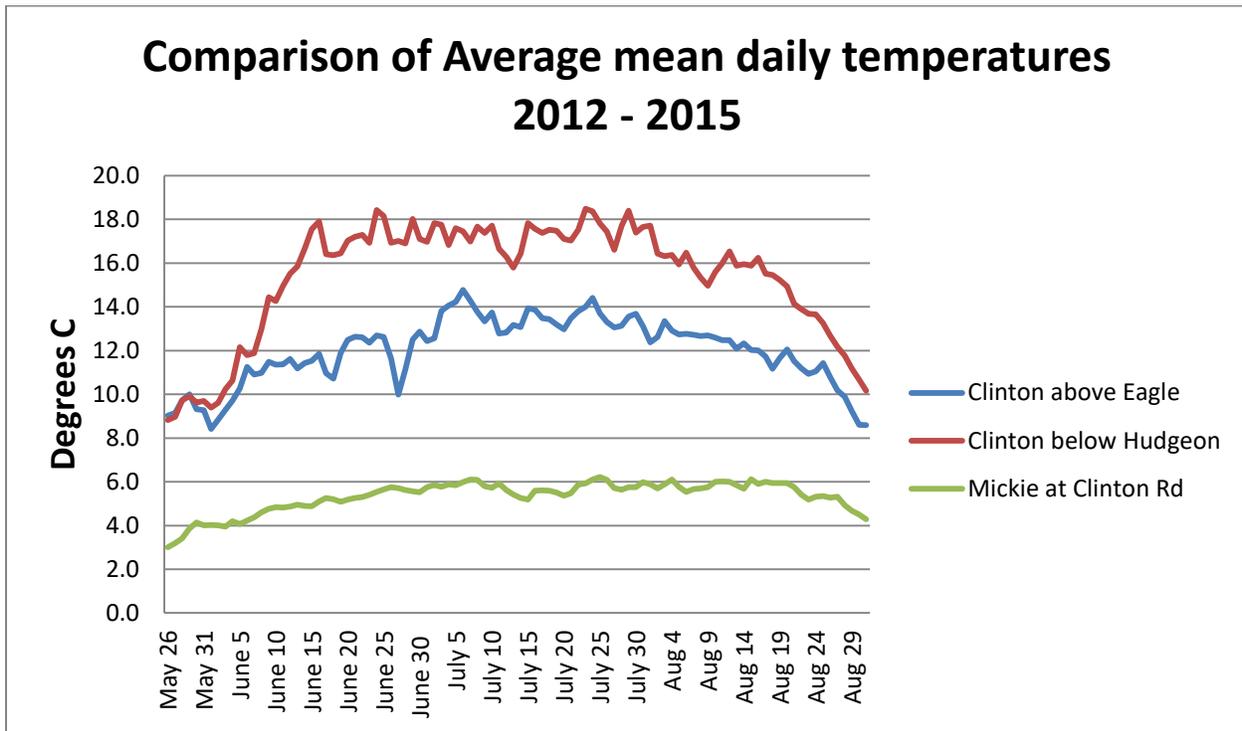
Hudgeon Lake effects downstream temperatures of Clinton Creek. Figure 3-1 demonstrates this effect. Data loggers recorded hourly temperatures in Clinton Creek below Hudgeon Lake, Clinton Creek above Eagle Creek and Mickie Creek below the Clinton Road crossing. The mean daily temperatures were calculated annually for 2012 – 2015 and then averaged to produce the graph. Summer temperatures at the outlet

of Hudgeon Lake were generally 2 – 4⁰C above those upstream of Eagle Creek and 10 – 12⁰C above those of Mickie Creek.

Graph C-1. Averages (2012 – 2015) of Mean daily temperatures of Clinton Creek below Hudgeon Lake; above the mouth of Eagle Creek; and in Mickie Creek.

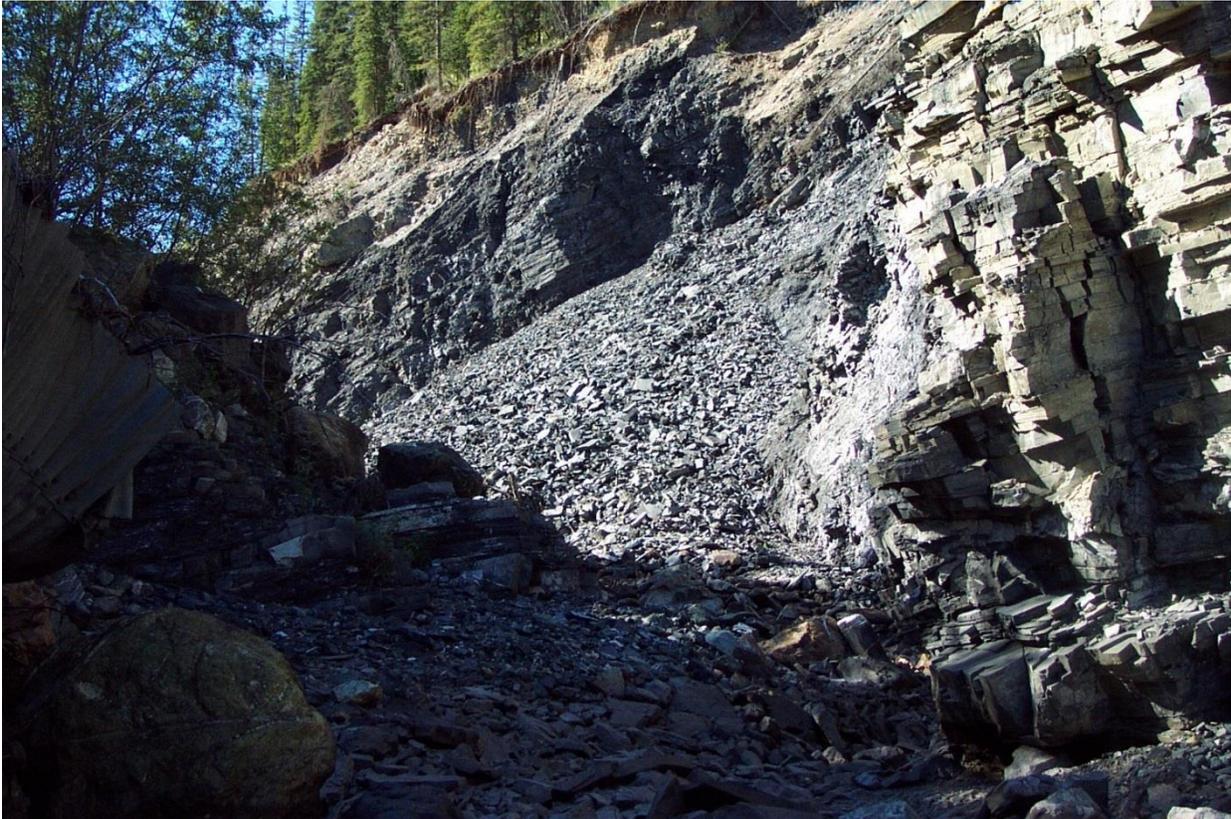
Photograph D-1. 2003. Rockfall in canyon section, showing how the capacity of the channel can be reduced.

Effects of North valley wall instability. The north valley wall is unstable through the length of the canyon section downstream of the existing gabion structure. In the absence of stabilization measures it is likely to remain so. The typical channel design appears to have sufficient capacity to hold most material sliding down or falling from the valley wall and to allow it to be conveyed downstream by the creek over time. Portions of the north valley wall have been subject to rock falls such as that shown in Photograph D-1. Note the rock column to the right, which will soon fall forward: this has been a typical mode of failure from the north valley wall in the lower canyon. An assessment of the risk of a rock fall reducing the capacity of the channel is advised for options utilizing the present channel location through the canyon. If considered appropriate, local adjustments to channel design could address this concern.

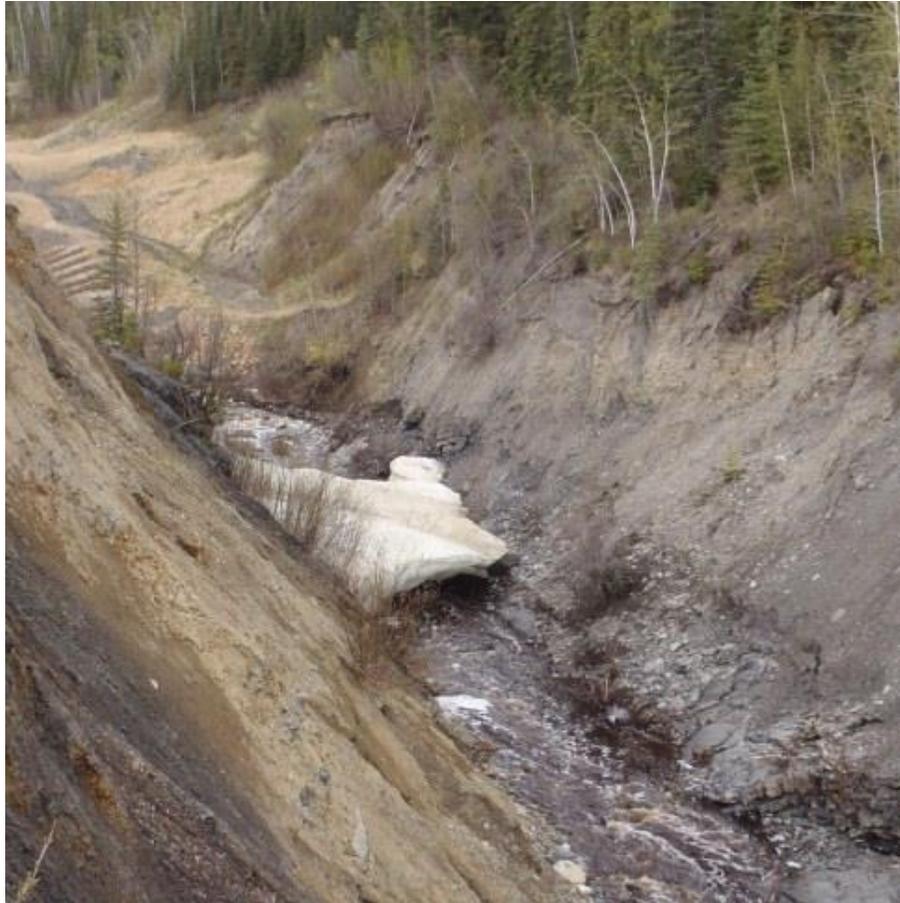
Effect of augeis. Significant augeis build up has occurred in the upper canyon downstream of the present gabion structure in some years. Spring freshet flows, at least initially, have been over the top of the augeis. Photograph D-2 was taken on May 20, 2010. It shows the augeis remaining in the channel below Drop Structure 4, a

portion of which is visible in the background. Note the recent erosion and high water mark above- and downstream of the surface of the remaining aufeis. Signs of flow were more than 3 meters above the channel bottom. The risk of aufeis formation and build up and the potential effects on the capacity of the downstream channel should be a consideration in channel design. Aufeis accumulation may reduce the channel capacity to such an extent that the spring freshet flows could not be conveyed within the as-built channel.

Photograph D-2. May 20, 2010. Aufeis remaining after spring freshet.

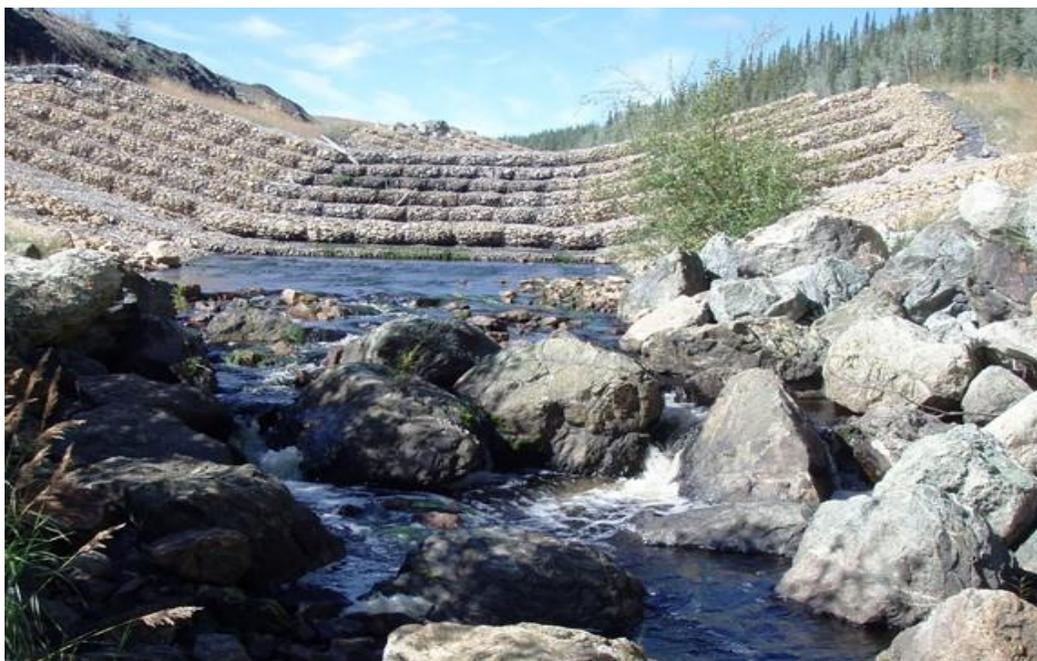
the ground water discharging at these locations has not been determined. If the source of some of the ground water is Hudgeon Lake, water entering aquifers in the waste rock will not leave the lake as surface flow. This may further aggravate the existing issue of periodic very low summer flows at the outlet of the lake and the channel downstream. Any reduction of in-stream flow during low flow periods between the lake outlet and seepage zones downstream will result in reduced area and volume of fish habitat. Where sections of stream dry completely, such as in July of 1998 and again in 2005, fish that are in the creek may be isolated in small sections of stream where flow continues. An example of low lake outlet flows is illustrated in Photograph D-3.

Photo D-3. August 8, 2007. Summer low flows at the downstream end of Drop Structure 4.

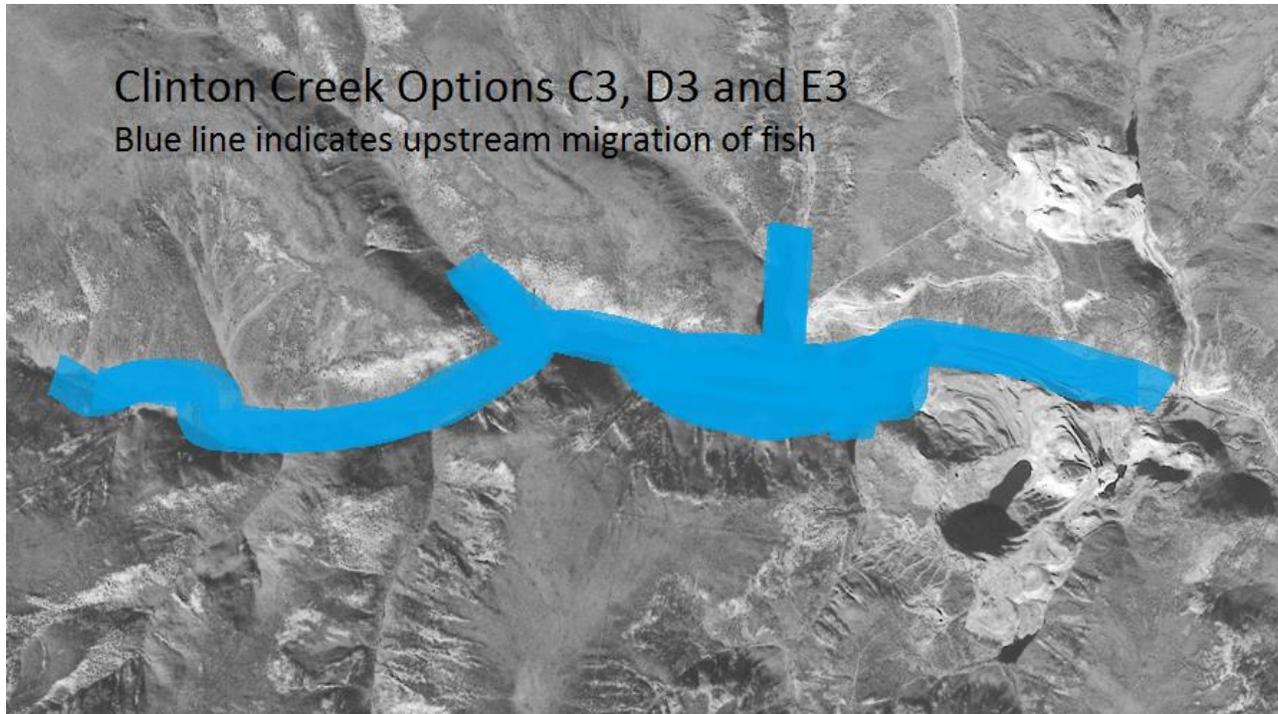
Maintenance of channel and related structures. In Option C3 and D3 the new channel would be constructed almost entirely on top of waste rock. The design channel is at or below the 2010 grade for only a few meters. If the channel performs as designed at all times, fish access will be maintained. If the channel does not, locally steeper areas may form along the channel profile until maintenance allows the channel to perform as its design intended. This could cause an interruption in the ability for some fish species

and sizes to be able to migrate upstream. Adult Arctic Grayling and larger juvenile Chinook Salmon might not be affected, while sub-adult Arctic Grayling and smaller juvenile Chinook would be more likely not be able to migrate as far upstream.

Figure 4-1. Potential usage by fish, Options C3, D3 & E3

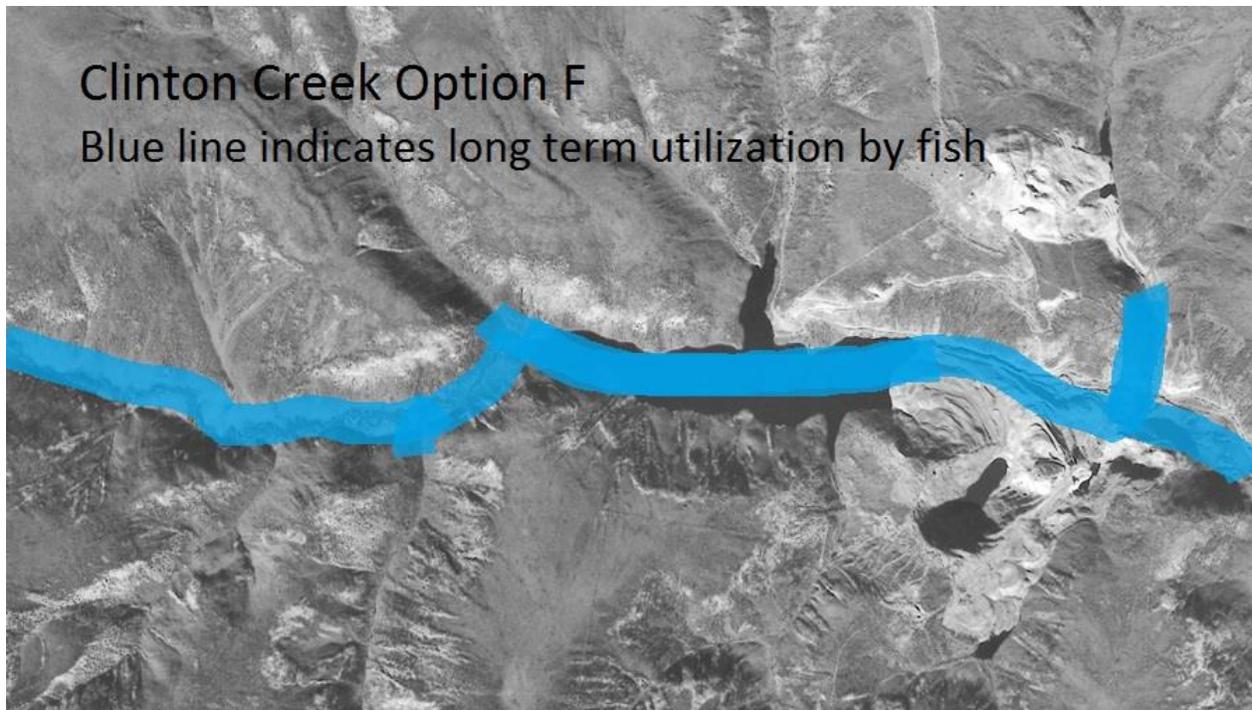
Potential usage by fish. This Option will result in a reduction in the volume of potential fish habitat in Hudgeon Lake and in the amount of thermal energy that the lake can store and release: however, it would also be the first step in restoring Clinton Creek to a naturally functioning aquatic environment typical of a non-glaciated area. Surface waters of the lake are expected to aerate annually, although the depth (or thickness) of the aerated layer is expected to change to some extent, at least in the short term. Some of the sediments that were deposited over the last 40 years and now form the current deltas of upper Clinton and Easter Creek will be mobilized as stream channels are re-established. The eroded sediments will be transported further into the lake and deposited there. As the existing sediments are unconsolidated, erosion in these areas should be rapid. Fish may not be able to access upper Clinton Creek until the channel develops. A wave cut bench has been eroded along the south side of the lake, and no landslides have occurred as a result. This addresses the concern that lowering the lake will result in slides extending above the current lake level, although some downslope movement of the newly exposed shoreline will occur. There may be slumps of saturated material into the lake from the waste rock deposits bordering it, but this should have little effect on fish utilization.

Figure 4-2. Potential usage by fish, Option F

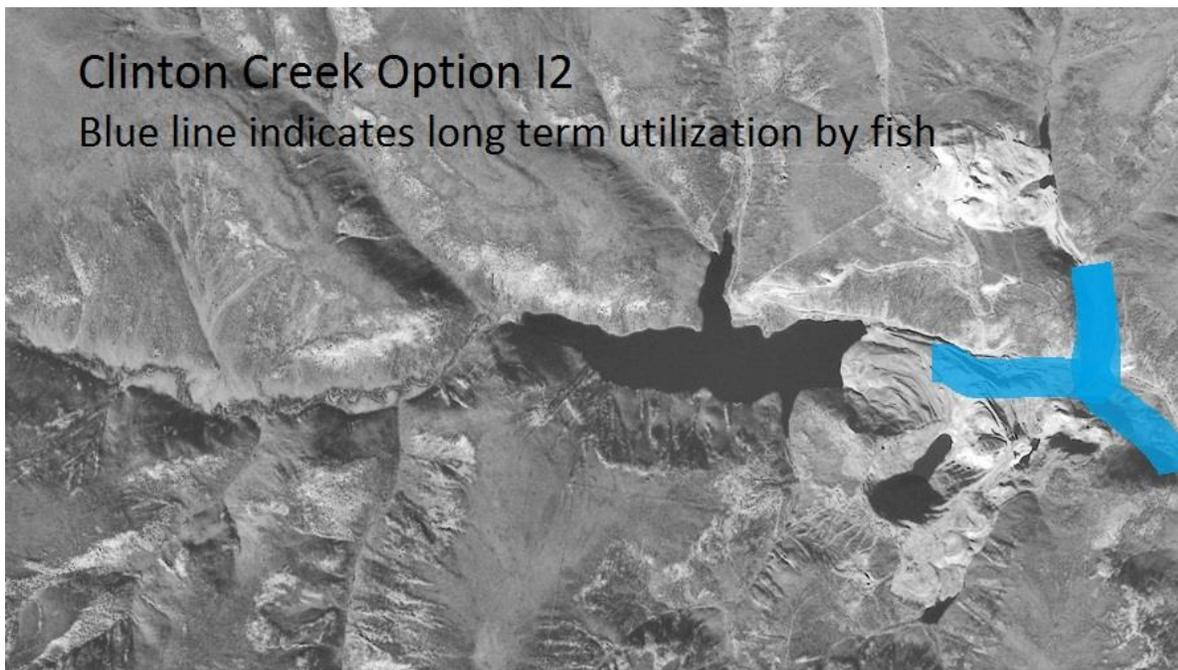
Figure 4-3. Potential usage by fish, Option I2

Potential usage by fish. This Option will allow fish access to the limits of pre-mine distributions. However, it is likely that it will take an extended period for the full

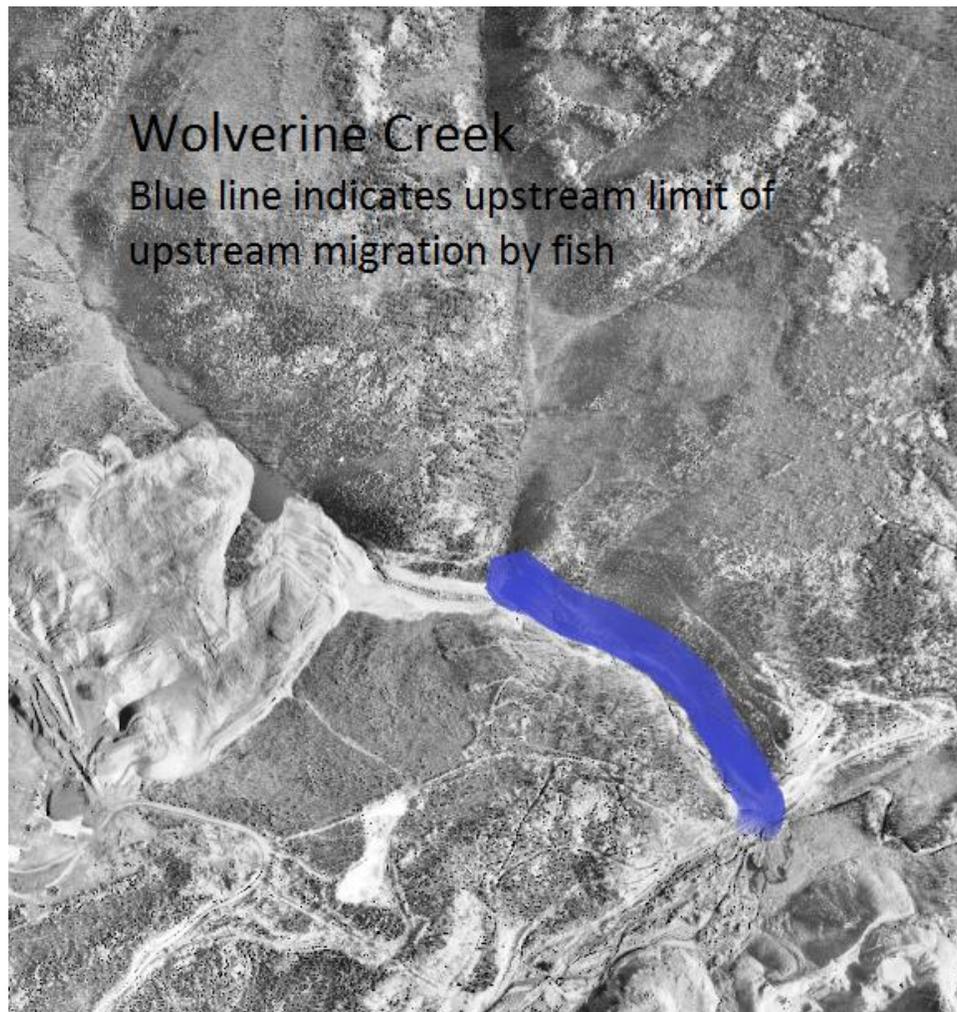
The gradient of lower Wolverine Creek increases slowly from the mouth to the confluence with the first tributary entering from the east. The rock lined channel starts immediately above this confluence has a gradient of $\sim 15\%$ for ~ 150 meters. This gradient is considered to be well beyond the ability of Arctic Grayling and juvenile Chinook Salmon to ascend.

Figure E-1 Upstream limit of utilization of Wolverine Creek by fish.

The limit of upstream migration in Wolverine Creek is therefore considered to be the confluence with the first tributary entering from the East. The tributary itself has a drainage basin of less than 7 km^2 , which is insufficient to produce flows capable of supporting fish.
