ARCTIC ALPINE RECLAMATION GROUP

MT NANSEN MINE RECLAMATION REPORT

OCTOBER 2006

SCOPE OF WORK – Huestis Portal Area Pilot Project

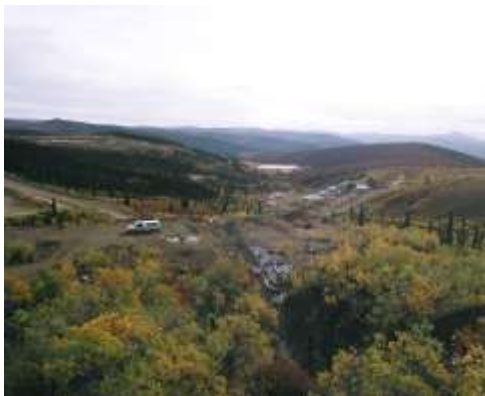
Huestis Portal Area

- Removal and storage in a designated area of debris (rail, timbers, metal and other waste) in front of the Huestis portal
- Storage was designated in areas adjacent to the mill complex along with other materials already on site

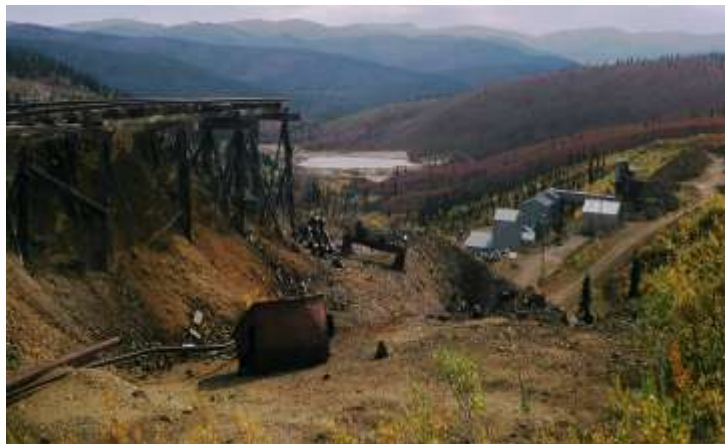
Portal Area – Rail Removal

- Removal of Debris: old structures were dismantled
 - Salvageable materials (rails and ore cars) were stored in a designated area at the mill site
 - Other materials were hauled to the waste disposal site and burned by the mine maintenance manager

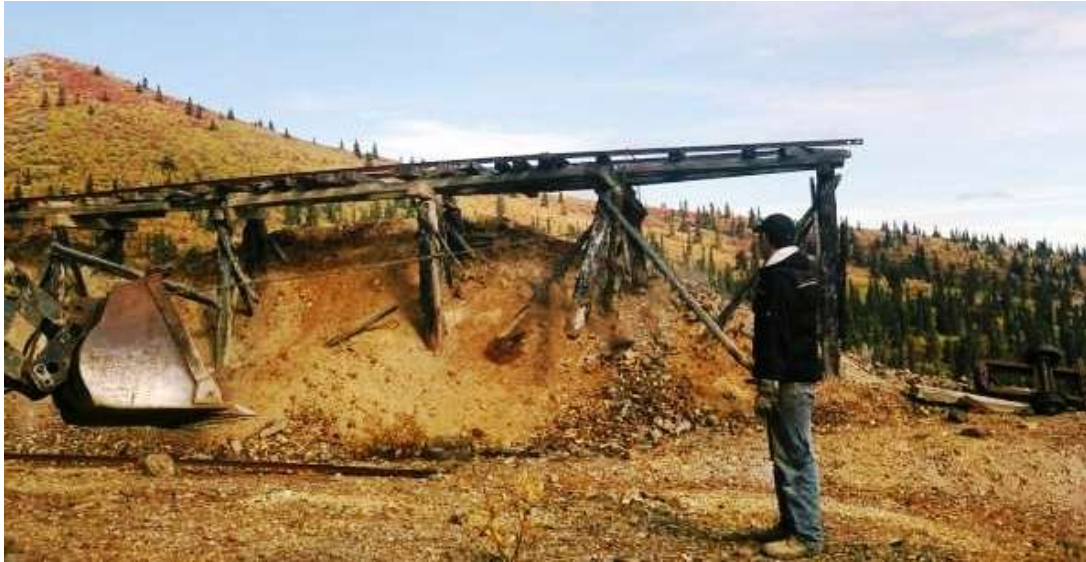
Removal of Debris and Salvage Materials

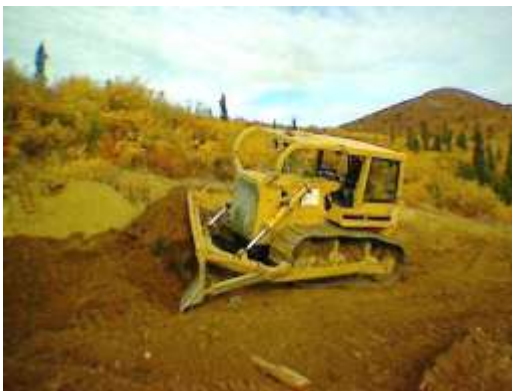
Sealing Huestis Portal and Contouring

- Sealing of Huestis portal with coarse waste rock, to prevent access but allow free draining of any water from the adit;

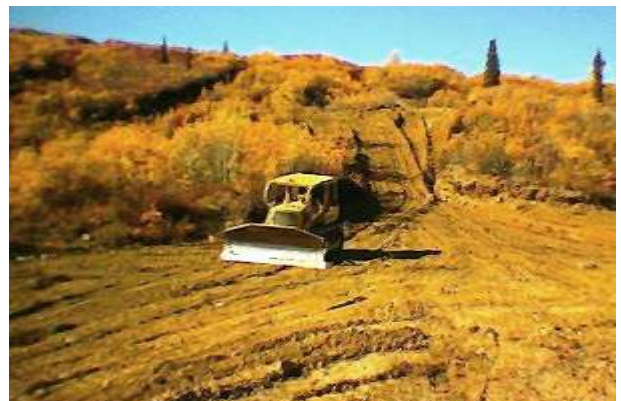
Huestis Portal area before contouring

- Contouring of Huestis portal and waste rock dump;

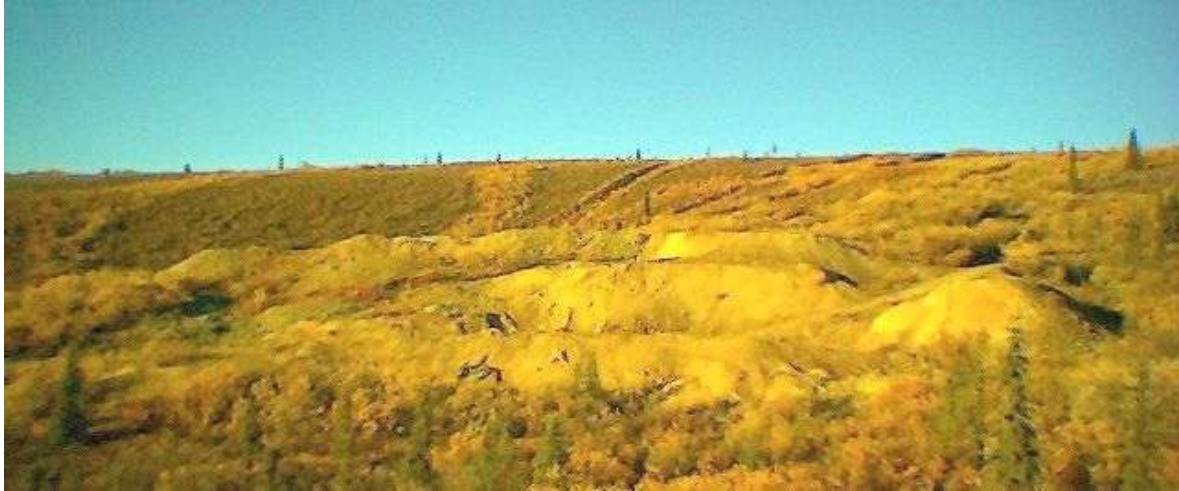
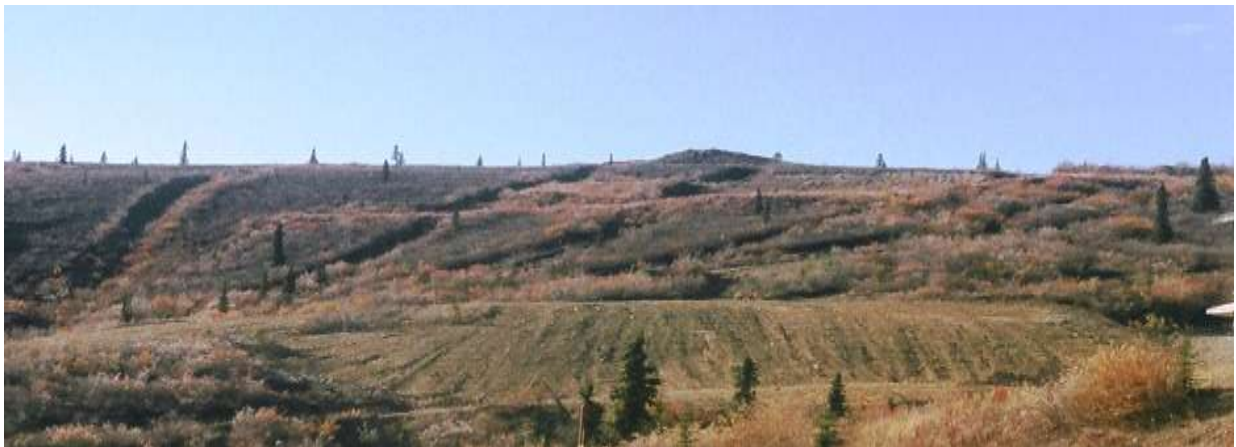
Huestis Portal after contouring

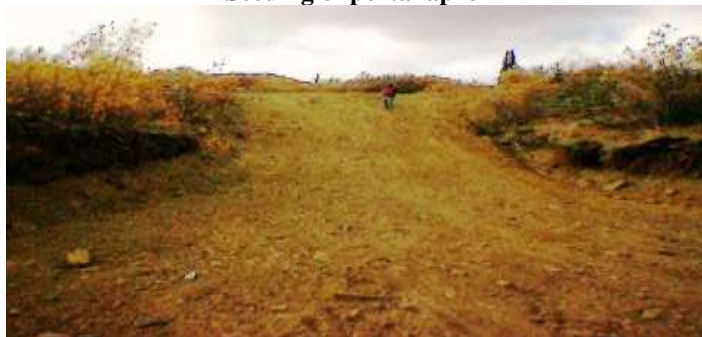
Seeding of portal apron

- Seeding of portal apron, waste rock, and access trails at the Huestis adit with an indigenous

- Recommended rate of seeding – 25 kg /hectare
- Seeding rate was based on site / soils examination and the proposed methodology for installation
 - Seed was to be manually broadcast
 - Project areas were to be harrowed to incorporate the seed into the local soil materials

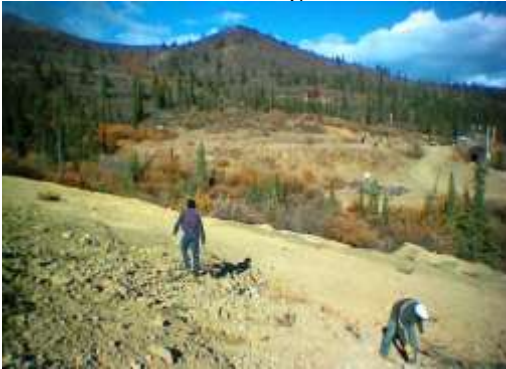
Planting

- Planting of indigenous plant material (locally collected) to aid in the stabilization of the site

Planting Method 1: Plant bundles (1 to 3 stems) of locally harvested plant material approximately 75 cm in length were planted horizontally in manually dug trenches to a depth of 15 cm.

Planting Method 2: Plant cuttings (stakes) of locally harvested plant material approximately 50 cm to 1.5 meters in length were planted vertically to a depth of 50 cm to 1 meter with a weighted metal probe due to the soil structure and porosity.

Planting Method 3: Plant bundles (3 to 4 stems) of locally harvested plant material approximately 50 cm in length were bundled together and planted horizontally in trenches to a depth of 15 to 30 cm. due to the soil structure and porosity.

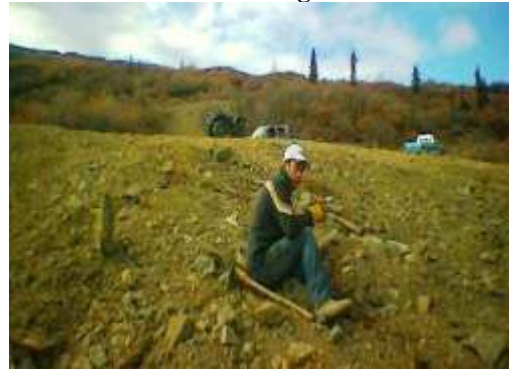
Planting

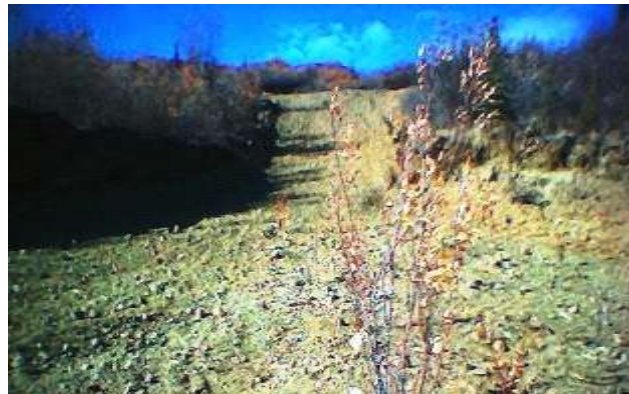
Planted

Five (5) different woody plant species were harvested and planted as an overall test of the various plant materials available on the mine site.
