**MT. NANSEN TERRESTRIAL  
AND AQUATIC EFFECTS  
STUDY 2005-06**

**VOLUME 1 OF 3 – REPORT**

**Government of Yukon**  
Abandoned Mines Branch (Type II)  
Energy, Mines and Resources  
Box 2703  
Whitehorse, YT  
Y1A 2C6

June 2007

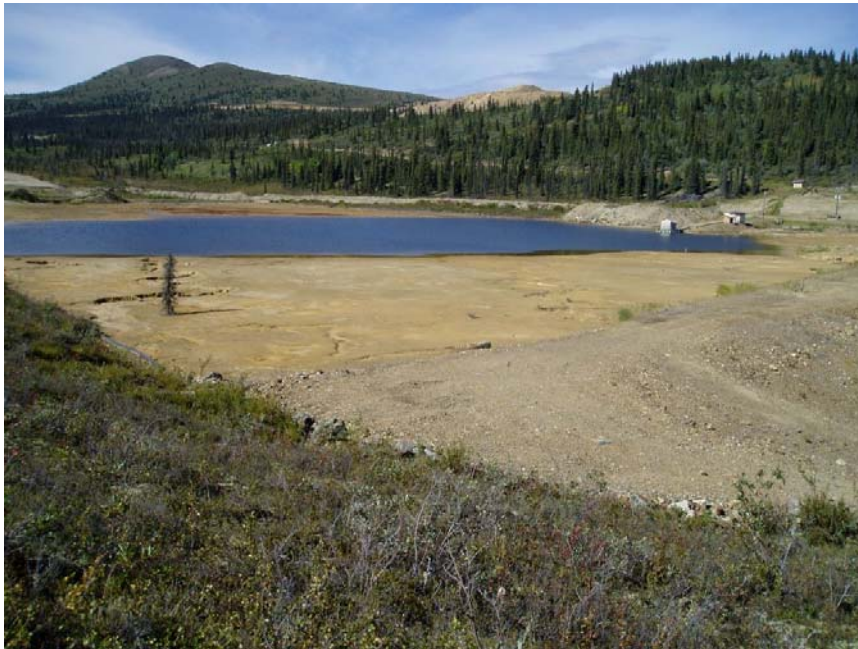
***Tailings Pond***

**Photo 2.1.** Northwest view of main tailings pond during low to moderate water levels (late Aug 2005). Waste dumps around the Brown-McDade Pit in background.

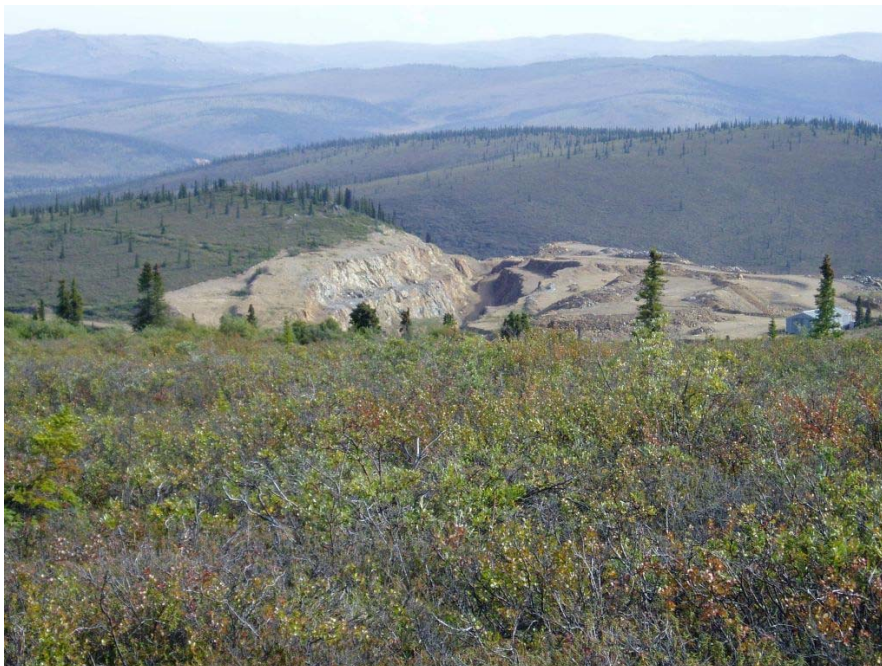
***Brown-McDade Pit***

**Photo 2.2.** Southeast view of the Brown-McDade Pit and the surrounding area.

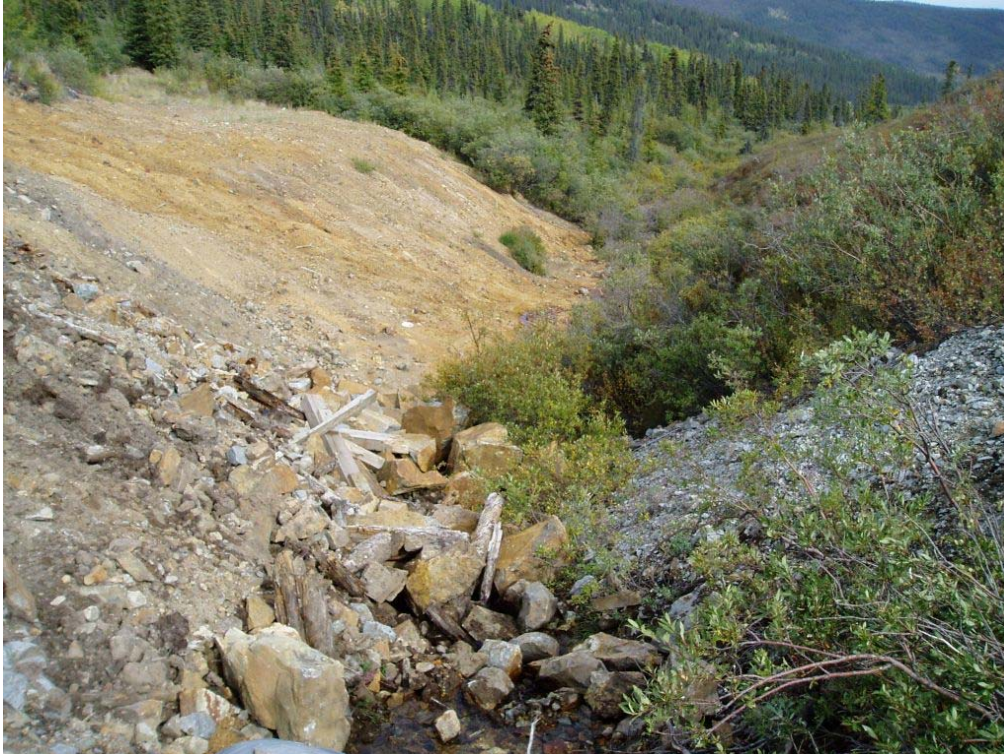
*Pony Creek  
Waste Rock*

**Photo 2.5.** View of ‘Pony Waste Rock Pile’ adjacent to Pony Creek, photo taken from road near the Adit location. Pony Creek located in the valley.

Pathways for movement of contaminants from the three sources include aerial (from wind) or aquatic (water). Dome Creek, and to a lesser extent, Pony Creek, are potential receivers and transport pathways of contamination. Dome Creek originates from the hill slope adjacent to the mill, flows past the mill and past mill workings and is diverted around the tailings facilities. Pony Creek is a potential receiver due to a waste rock pile adjacent to the creek (Photo 2.5) and a connection via a 200 m (approximate) adit which

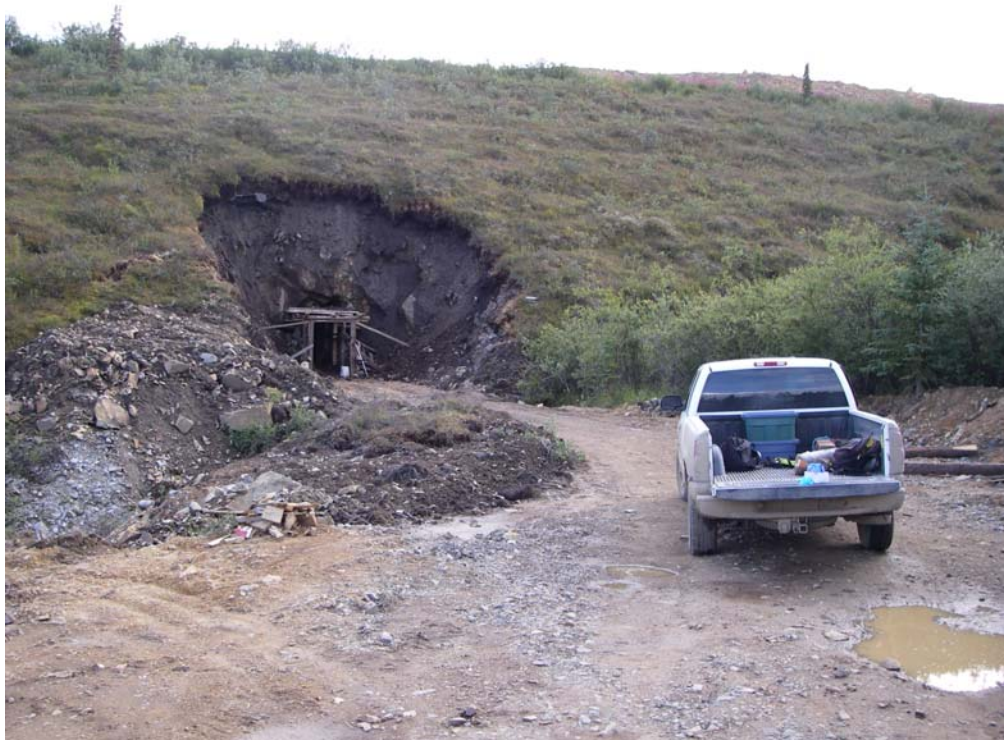
*Pony Creek  
Adit*

**Photo 2.6.** View of adit adjacent to Pony Creek (crosses road between truck and adit), prior to installation of hydraulic bulkhead.

used to connect to the Brown McDade Pit (Photo 2.6). In 2006, a hydraulic bulkhead was installed in the adit to prevent surface flow from the pit into Pony Creek.

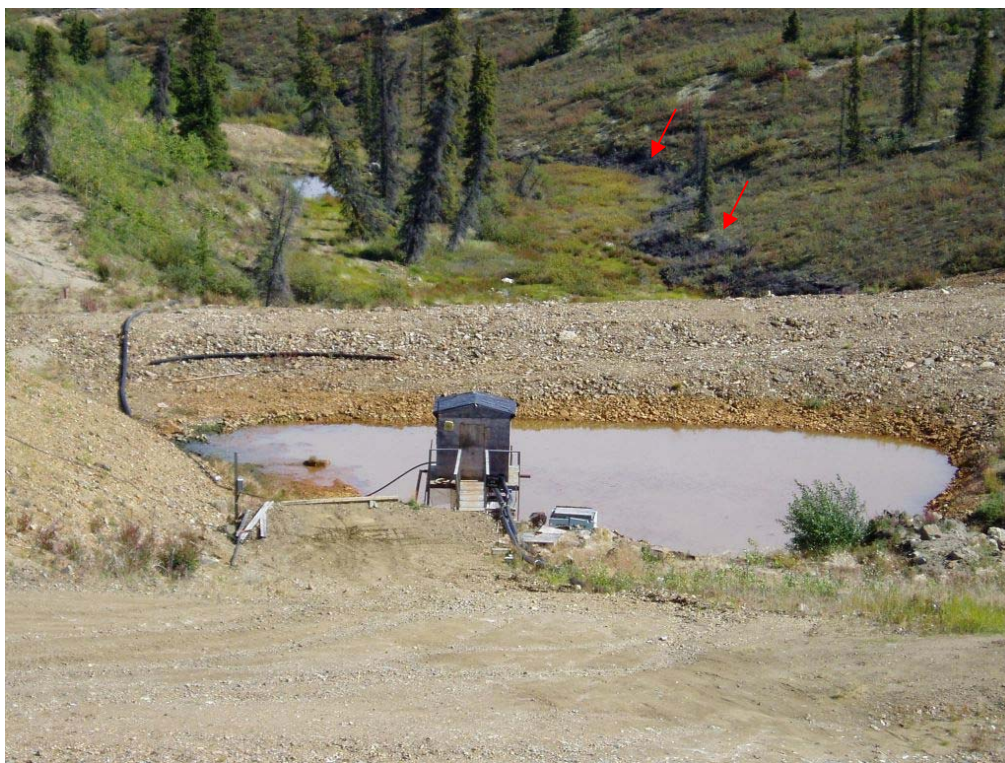
**Photo 2.7.** Downstream view of Dome Creek below seepage pond. Note the blackened vegetation on the right bank.

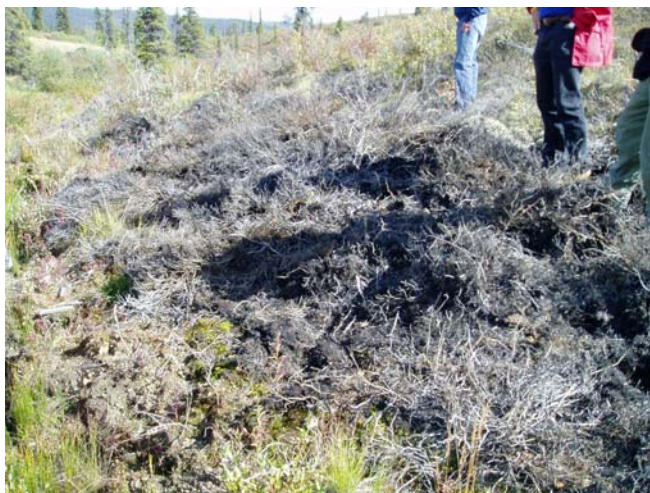
**Photo 2.8.** Up-close view of blackened vegetation on right bank of Dome Creek.

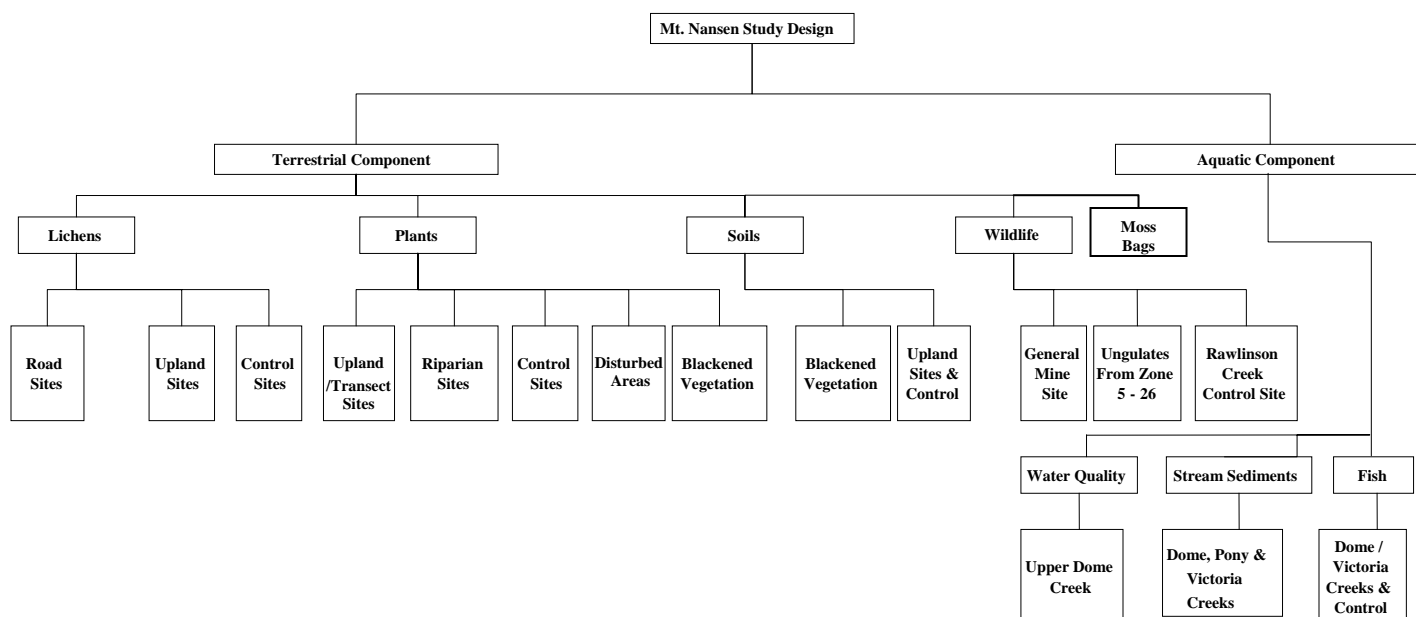
**Figure 2.1.** Summary of the structure of the Terrestrial and Aquatic Effects study.

The study included both terrestrial and aquatic components. Each component required the collection of samples that would be later analyzed for metal concentrations. Members of the LSCFN worked with Project Team members to collect the samples during the summer and fall of 2005 and 2006. First Nation workers were trained in proper sampling protocols, and while in the field provided additional insight into the dynamics of plants, animals, and human use relating to the area. The rationale and specifics of each sampling component of the study is presented in the following sections. Figure 2.1 summarizes the sampling components.

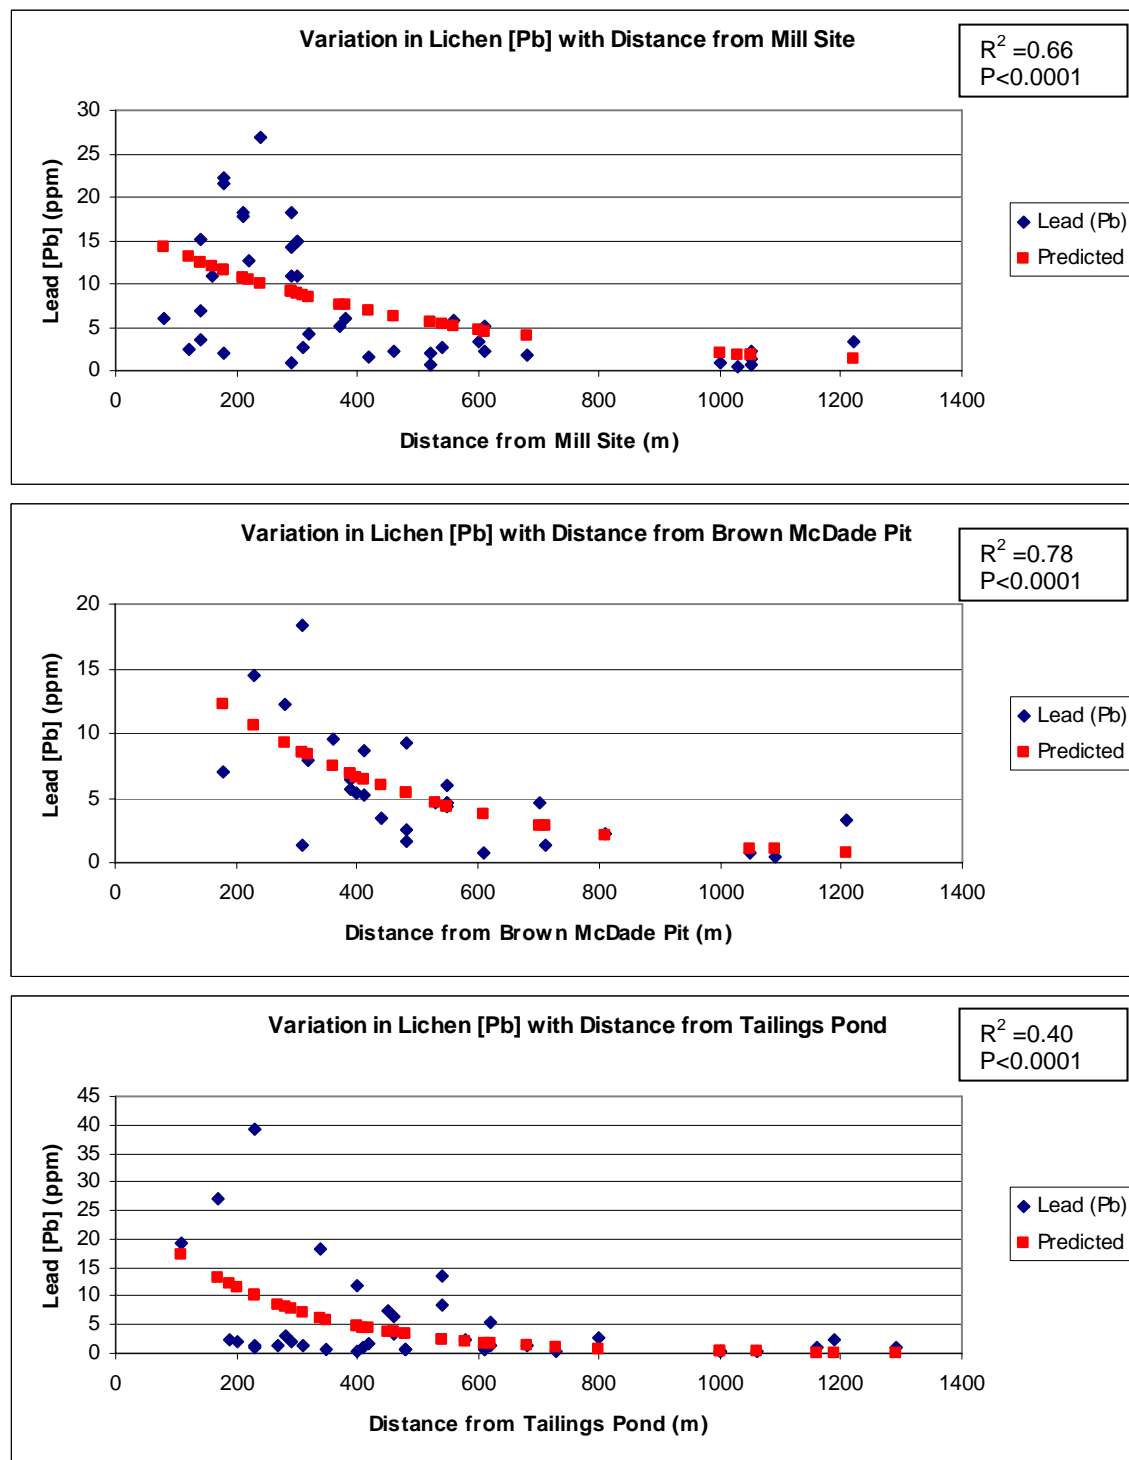
*Lead levels in lichen were generally higher near the mill site, pit and pond.*

**Figure 3.1.** Non-linear regressions of lead (Pb) and distance from contamination sources.

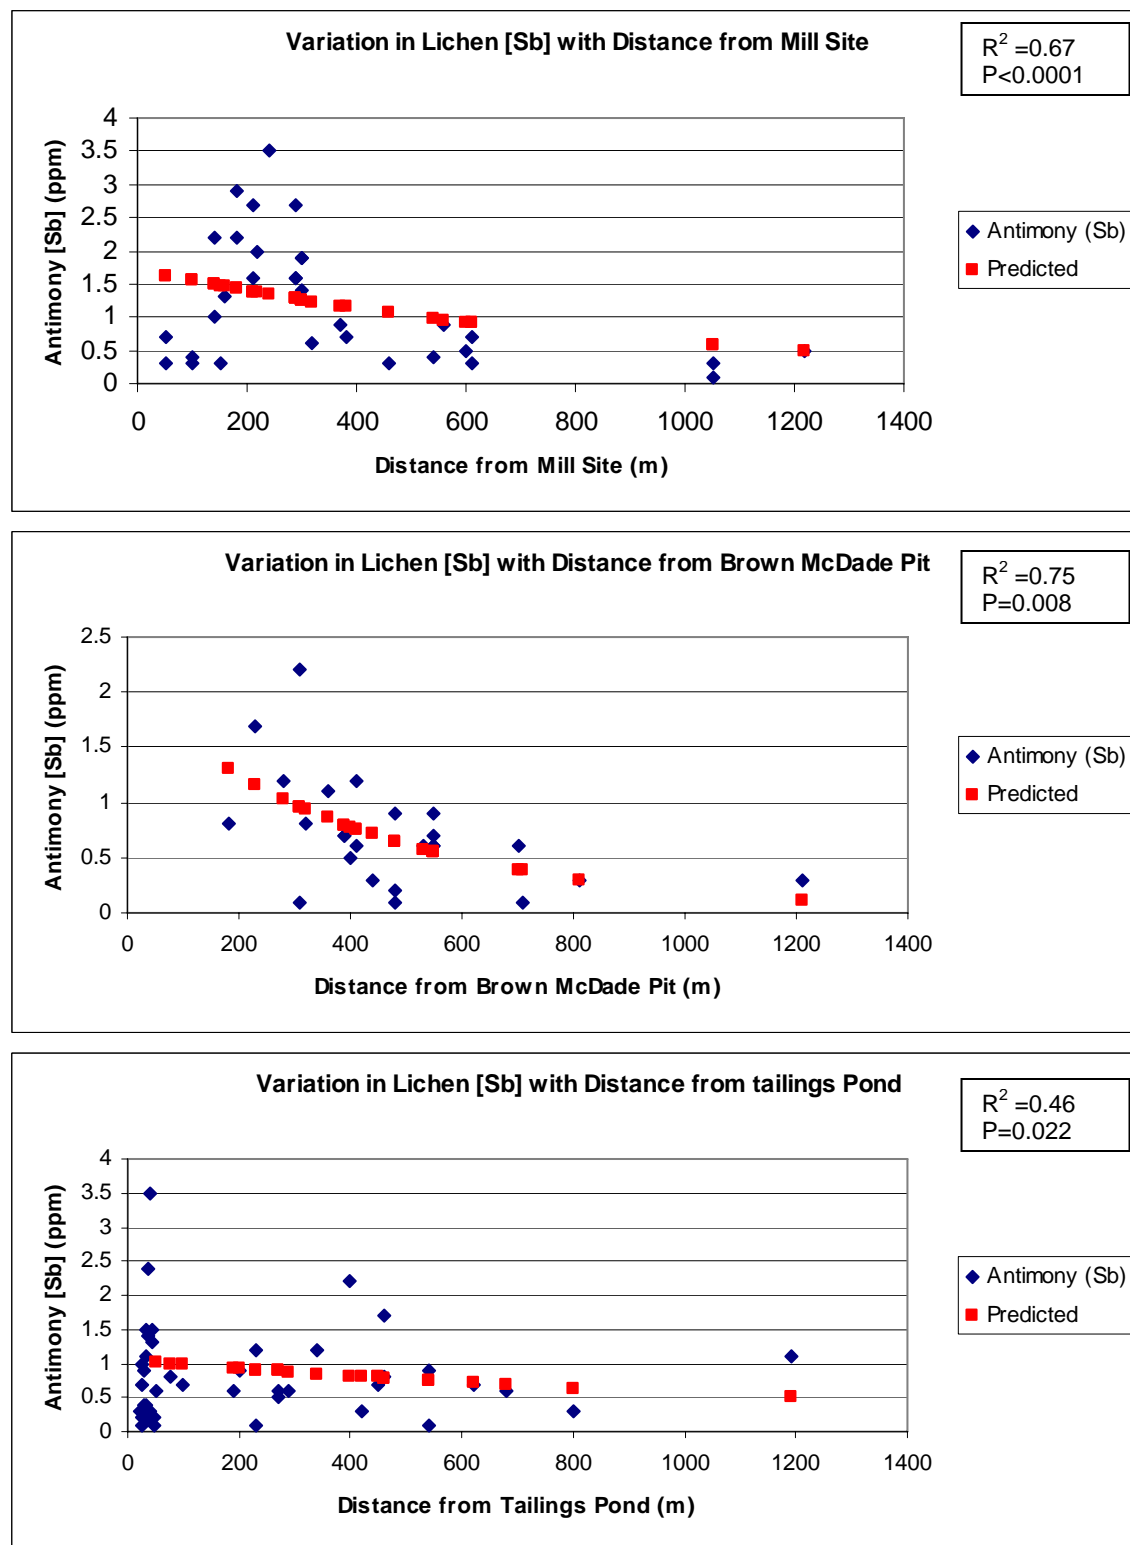
*The highest antimony levels in lichen were typically found in locations near the mill site, pit and to a lesser extent, the pond.*

Figure 3.5. Non-linear regressions of antimony (Sb) and distance from contamination sources.

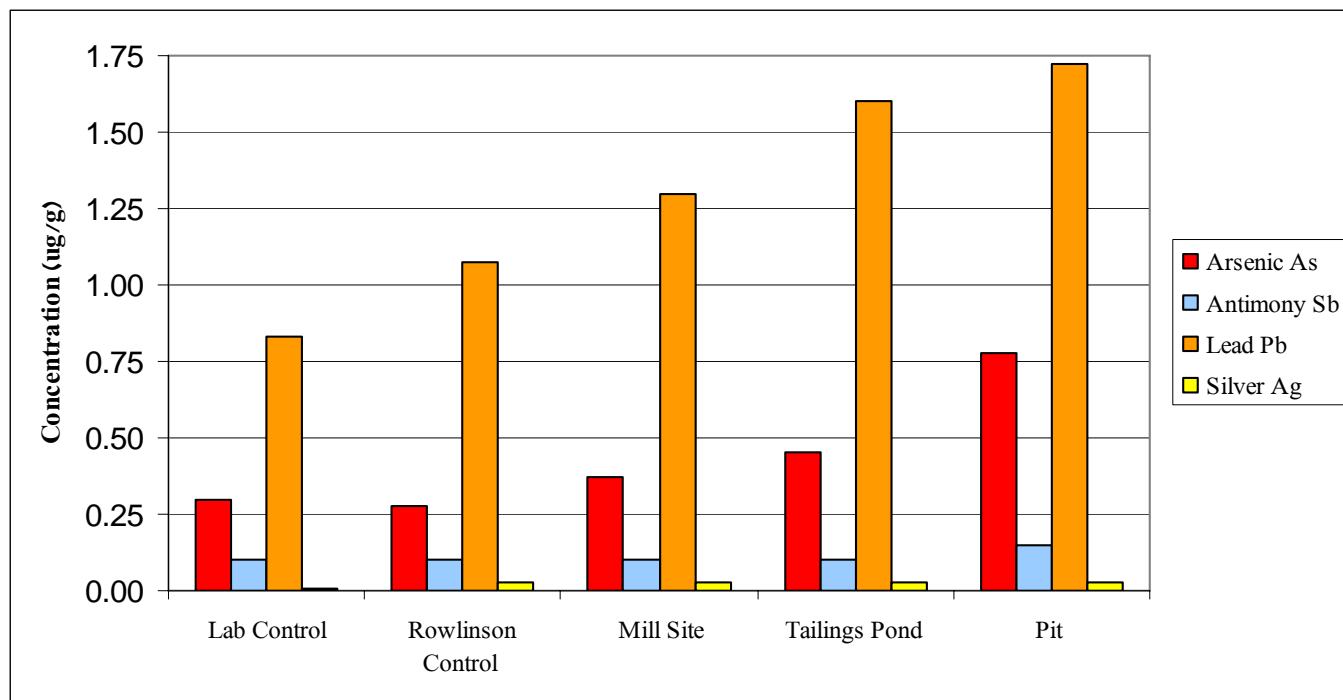
**Figure 3.13.** Average arsenic, antimony, lead, and silver concentrations (ug/g) around each site (October 2005 – May 2006).

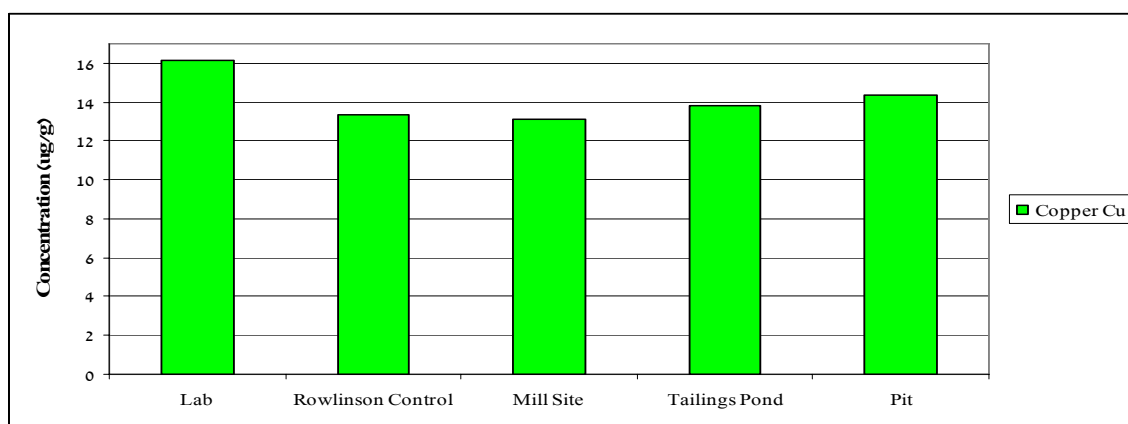
**Figure 3.14.** Average copper concentrations (ug/g) around each site (October 2005 – May 2006).

*These results indicate that copper does not appear to be transported by dust around the mine site during the winter.*

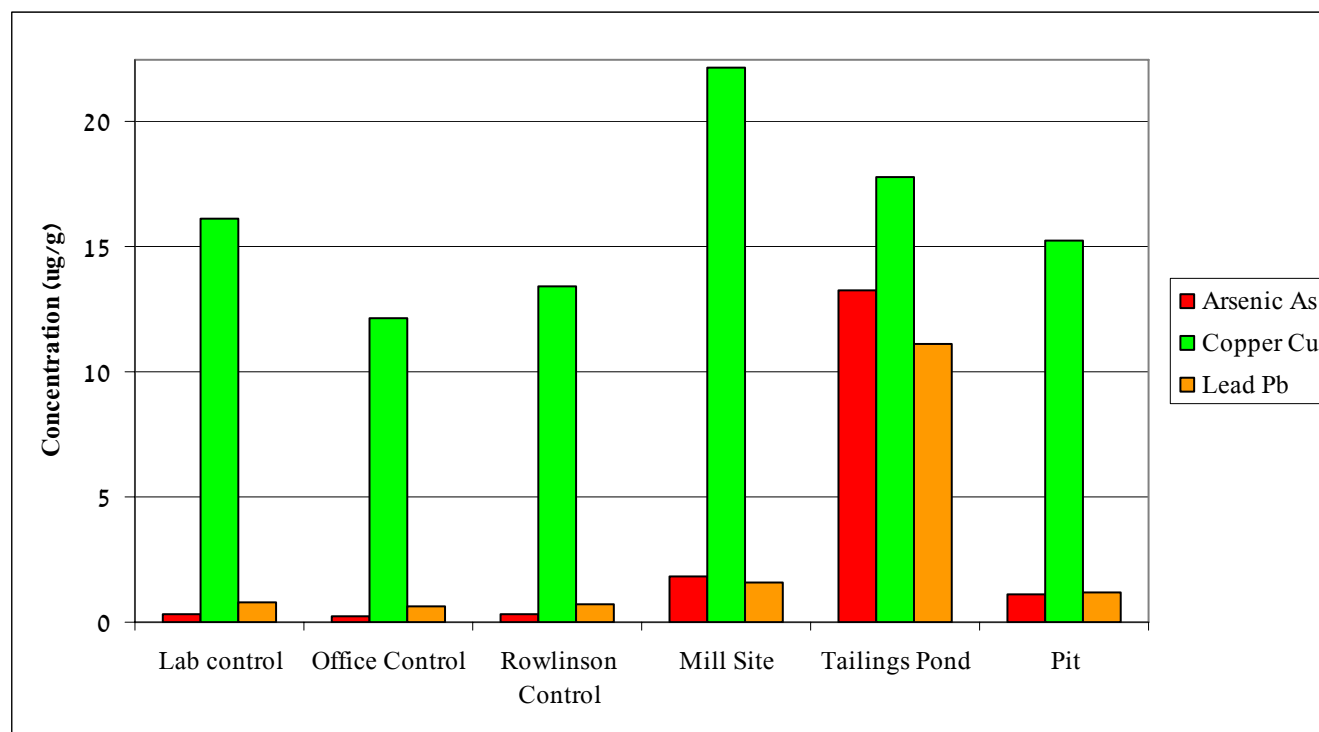
*During the 'spring, early summer' deployment, arsenic, antimony, cadmium, lead and silver levels were highest in moss bags around the tailings pond.*

**Figure 3.15.** Average arsenic, copper and lead concentrations (ug/g) in moss bags around each site (May – July 2006).

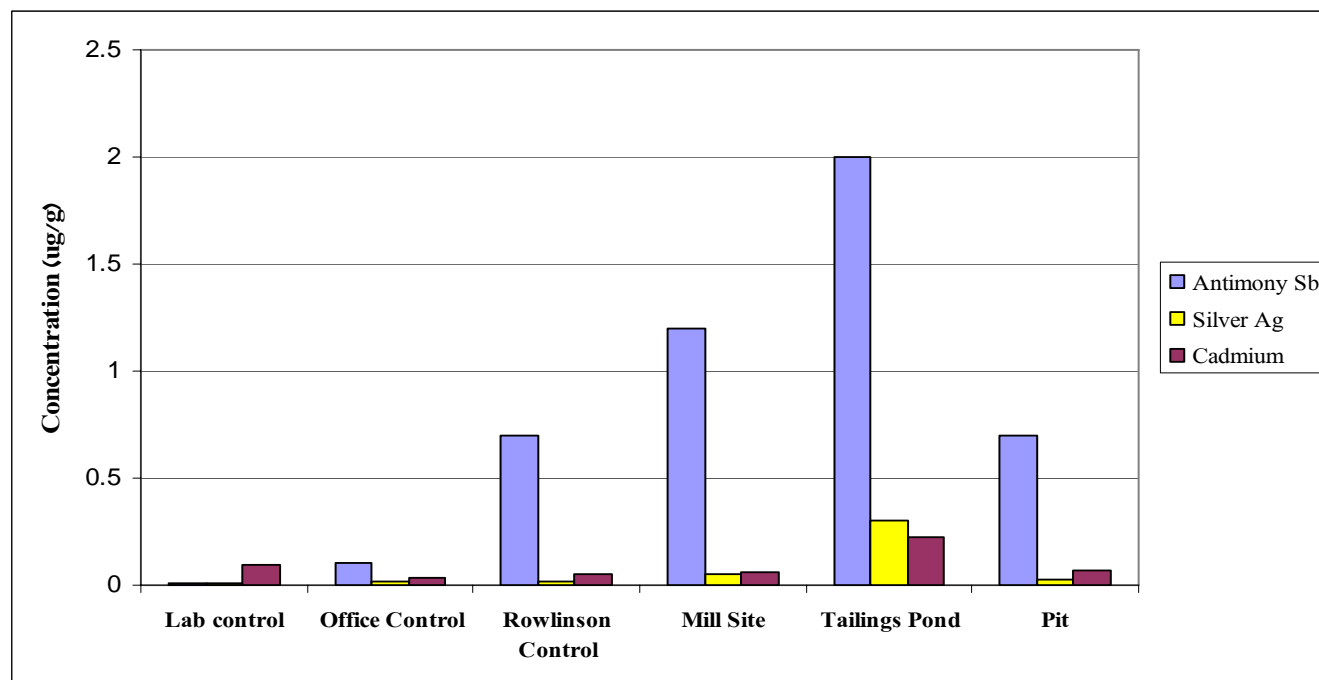
**Figure 3.16.** Antimony, silver and cadmium concentrations (ug/g) in moss bags around each site (May 2006 – July 2006).

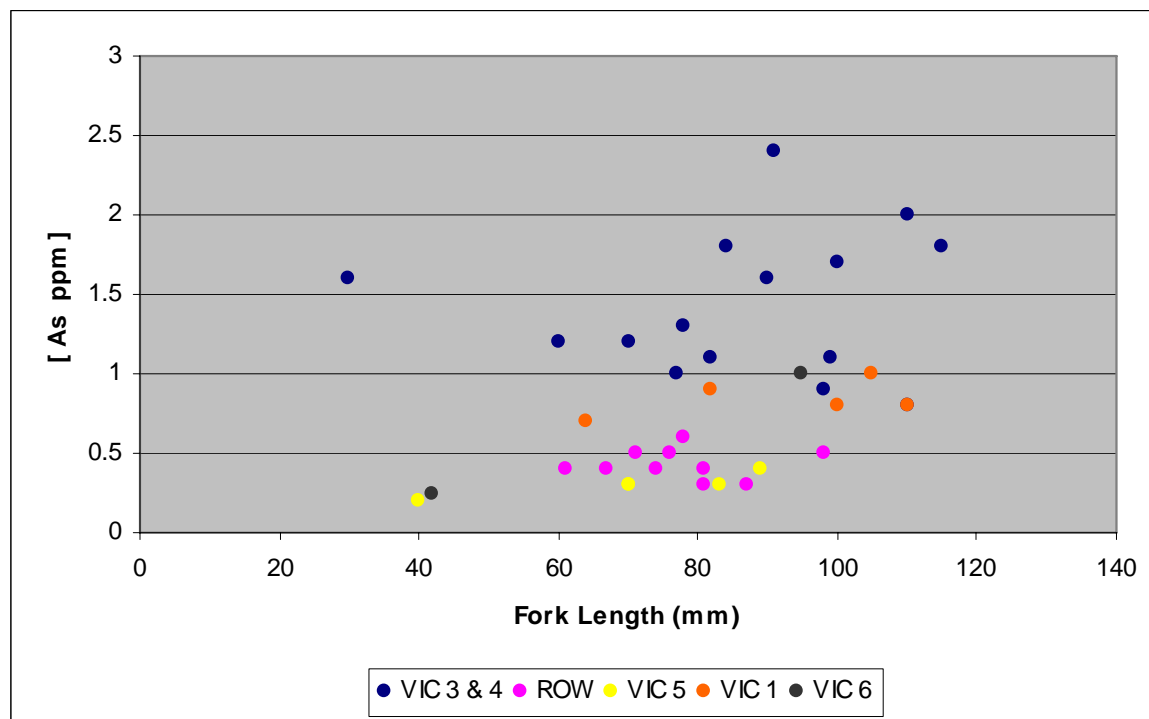
*Arsenic concentrations in slimy sculpin were generally highest in fish from Victoria Creek downstream of Dome and Pony creeks (Vic 3 & 4).*

**Figure 3.23.** Arsenic (As) concentrations in slimy sculpin collected at all sites.

Review of the above-noted metals at all sites provides some insight into the variability between sites. Levels of arsenic (Figure 3.23) were generally lowest in sculpin at the outlet of Victoria Lake (VIC 5), followed by Rowlinson. Sculpin captured upstream of Victoria Creek (VIC 1) appeared to have arsenic levels in between the levels found at the
