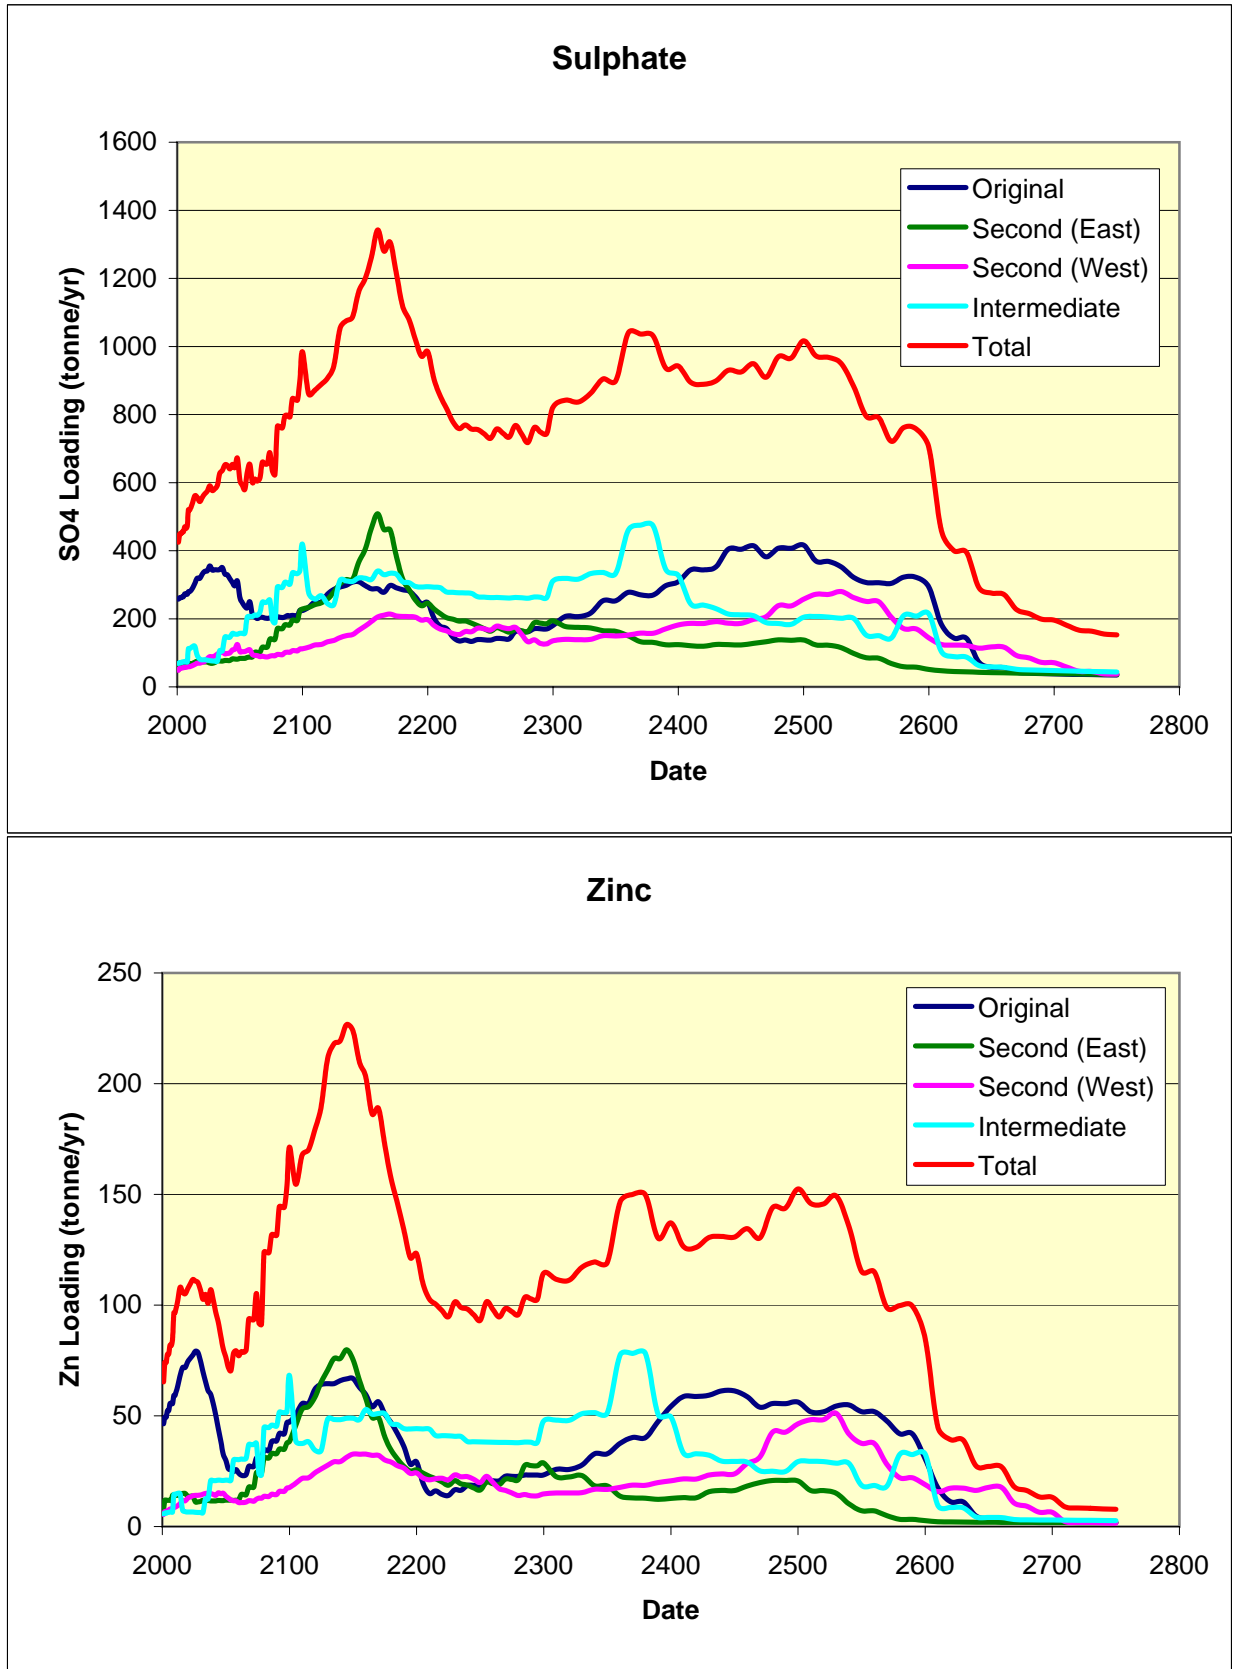
Figure 5.1 Predicted breakthrough of sulphate and zinc loads at base of tailings for average propagation rates.

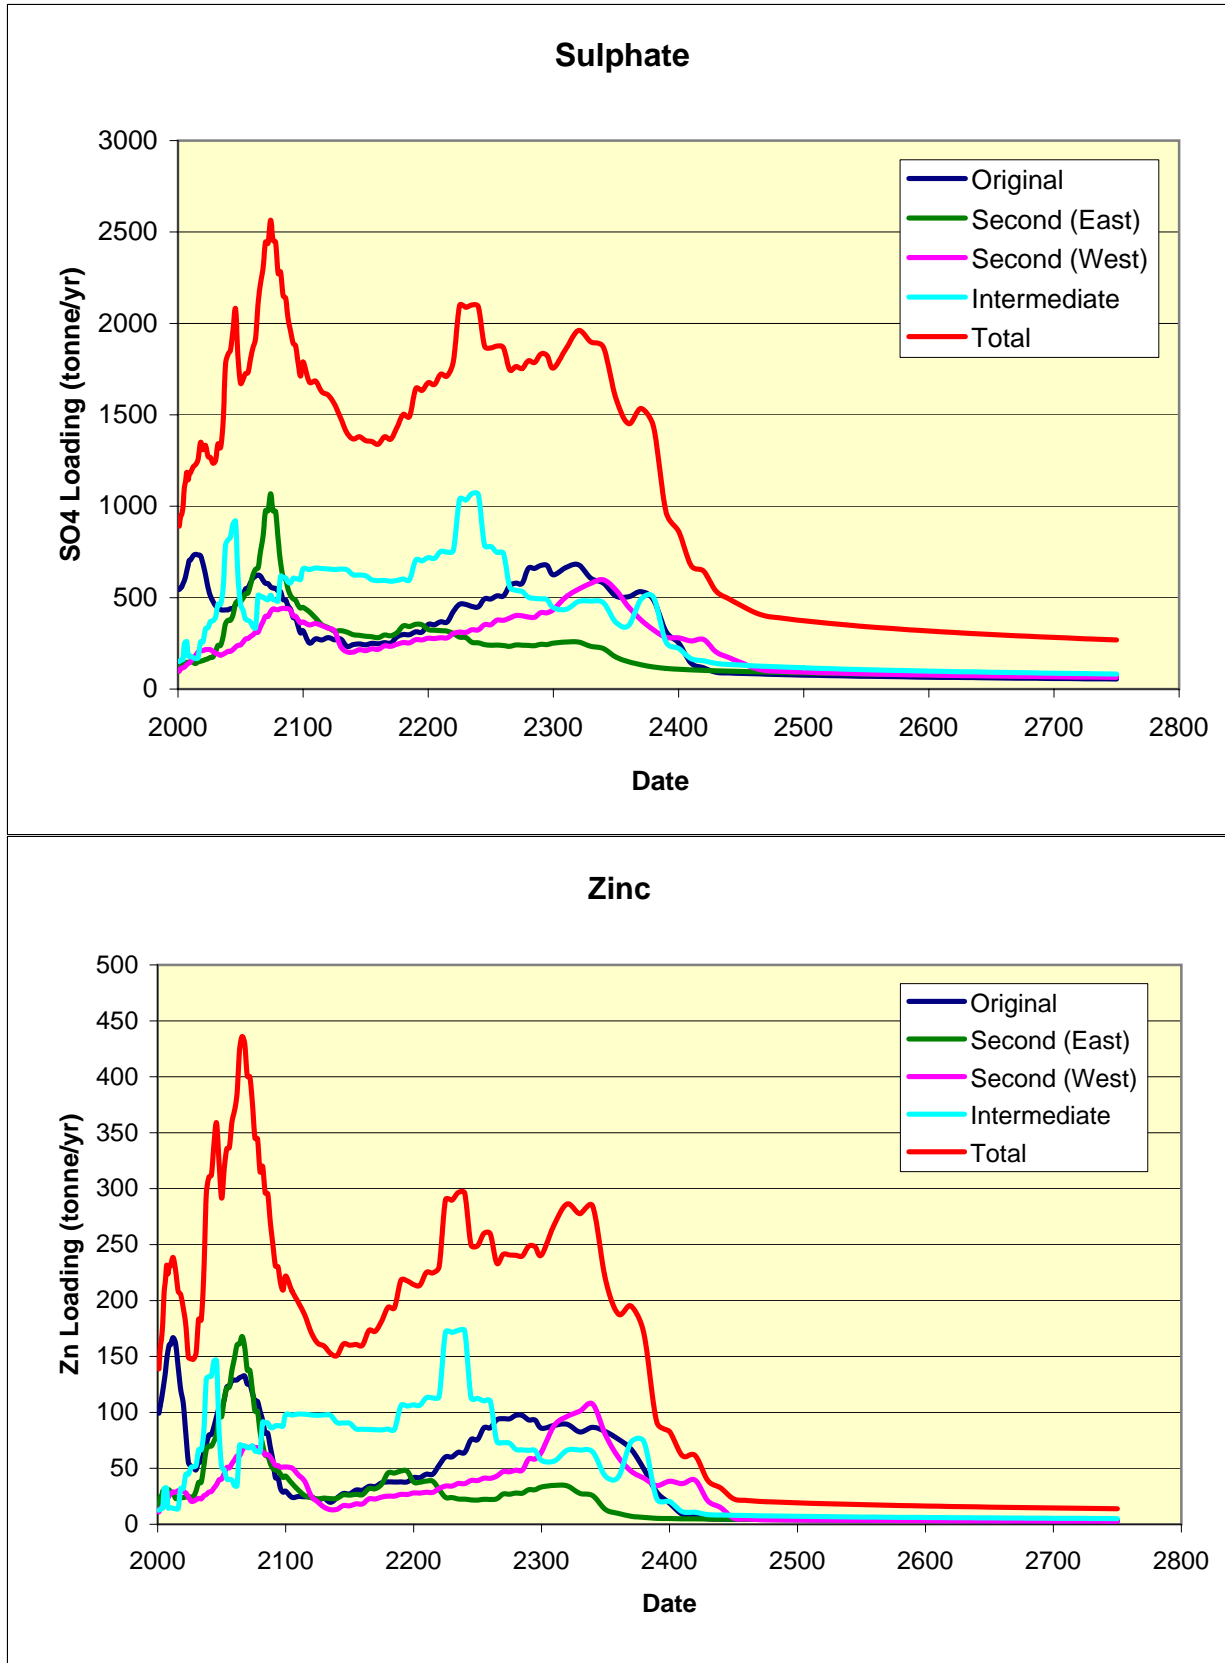
Figure 5.2 Predicted breakthrough of sulphate and zinc loads at base of tailings for maximum propagation rates.

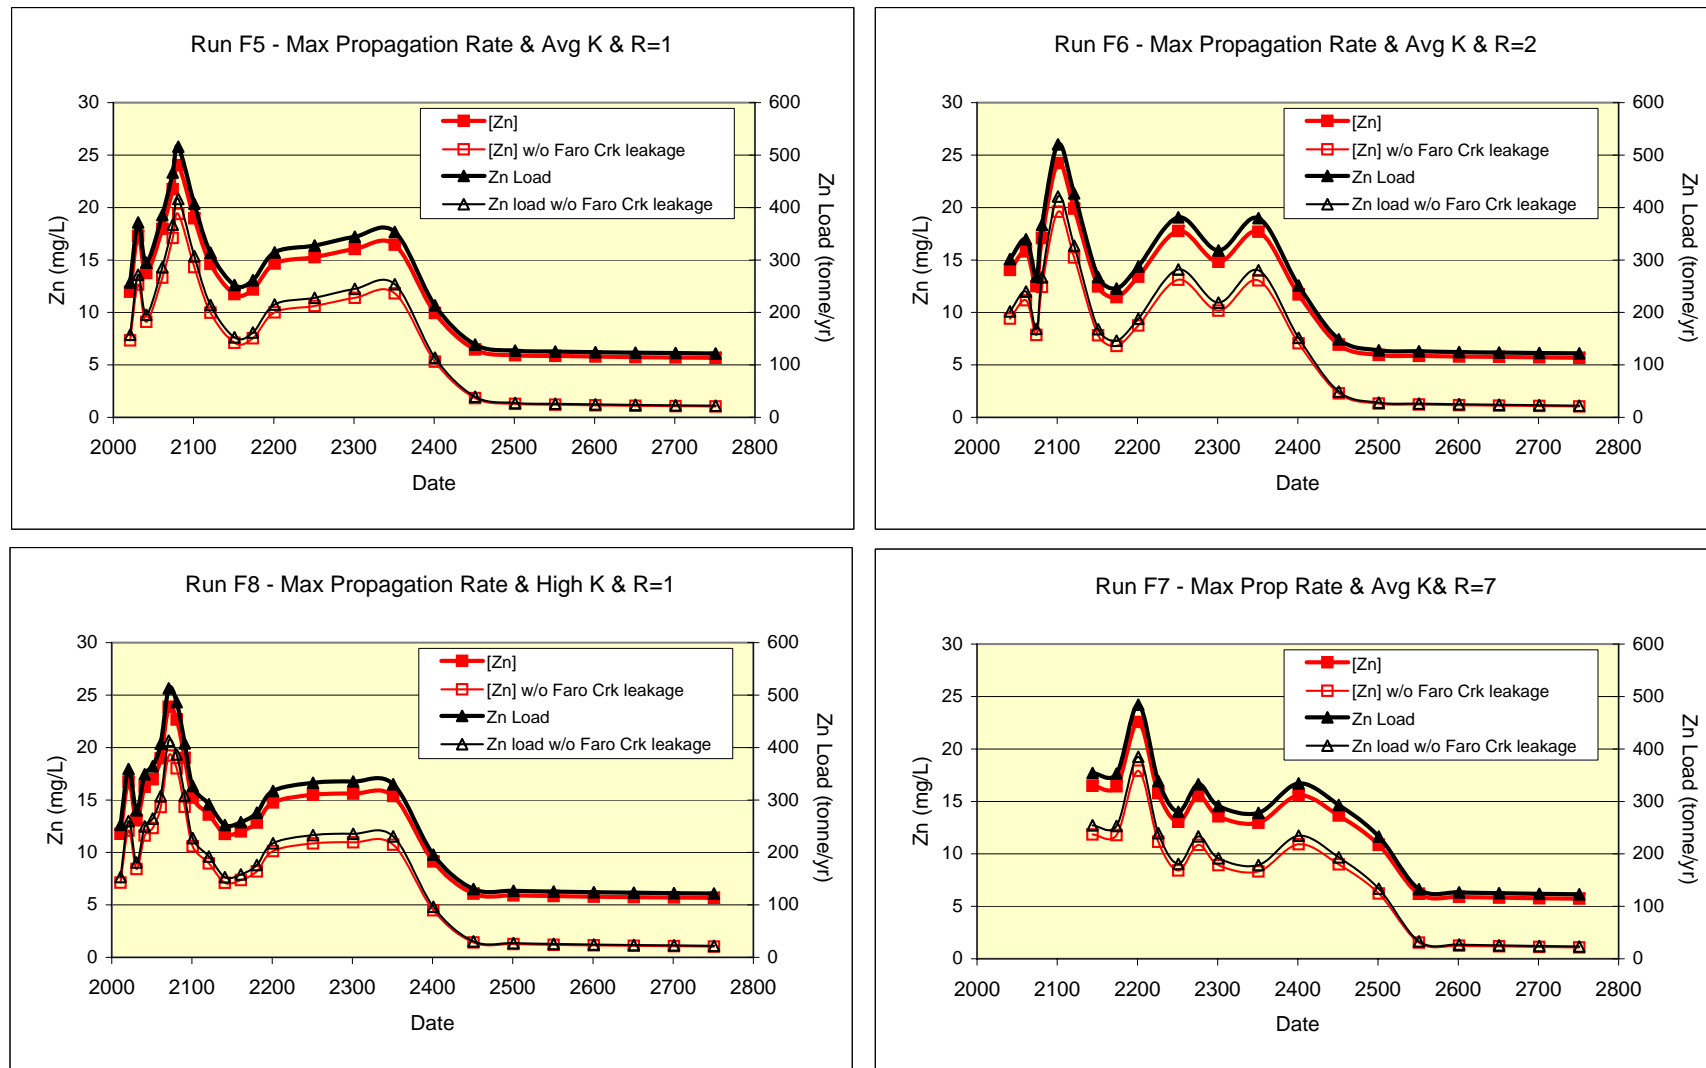
Figure 5.5 Predicted zinc load in Rose Creek (RC9) assuming maximum propagation rates and no remediation.
