**RAINY HOLLOW AND BORDER PUMP STATION,
BRITISH COLUMBIA, CANADA:
SUMMARY REPORT FOR SITE REMEDIATION
AND ANNUAL MONITORING PROGRAM**

Indian and Northern Affairs Canada
Waste Management Program, Whitehorse, Yukon

Royal Roads University
Applied Research
Science Technology & Environment Division

September 2002

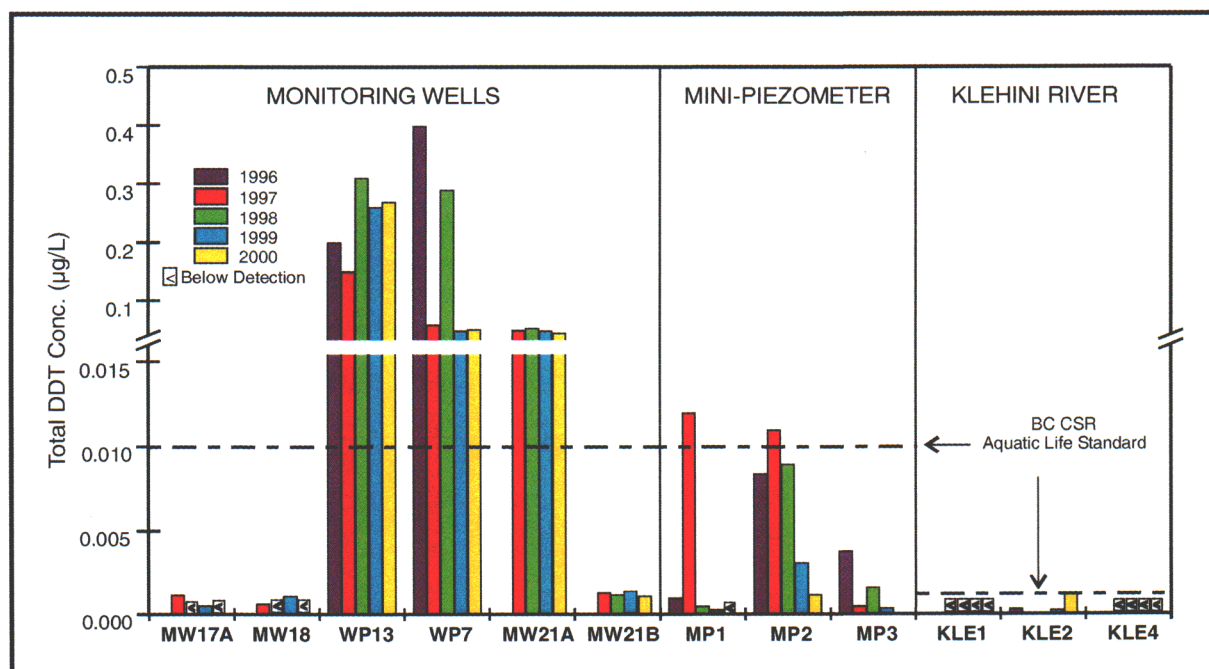
Figure 4.3: Total DDT Concentrations in Groundwater and Surface Water Samples Collected Annually at Rainy Hollow from 1996 to 2000

Detectable levels of p,p'-DDD, o,p'-DDD and p,p'-DDE (maximum of 0.00067 µg/L) were found in MW-17A over the monitoring period. This well is located up gradient of the Trench where the DDT containing canisters were recovered in 1994. The three isomers listed above were also detected in MW-18, which is located west of the Trench and is not directly influenced by contamination from either the Trench or the upper bench. The maximum total concentration detected in these two wells was 0.0011 µg/L. As depicted in Figure 4.3, concentrations in these two wells were generally comparable to each other over the monitoring period. Commercial DDT pesticide formulations usually contain 70 – 80% of the p,p'-DDT isomer and up to 30% of the o,p'-DDT isomer. Both DDE and DDD isomers occur in small quantities as impurities in technical DDT mixtures. Once introduced into the environment, the parent DDT isomers undergo transformations through biotic and abiotic processes to yield more DDD and DDE isomers. DDD is produced through reductive dechlorination under anaerobic conditions while oxidative dehydrochlorination under aerobic conditions yields DDE (Foght et al. 2001; Jing F. 2001). It is believed that DDE is the most recalcitrant of the three and the ratio of DDE to DDT increases with time following release into the environment; i.e., a more recent spill would have a greater proportion of DDT compared to DDD and DDE. The low concentrations of DDD and DDE detected in MW-17 and MW-18 may have been generated from the anaerobic

Total DDT concentrations in excess of the BC CSR standard for aquatic life use (AW) of 0.01 µg/L were found in groundwater samples obtained from the two wells located immediately down gradient of the Trench (WP-7 and WP-13) over the monitoring period. The principal isomer in samples from both these wells was p,p'-DDD, the initial degradation product of DDT by anaerobic dechlorination. The levels in WP-13 were relatively uniform over the entire monitoring period whereas there was a slight inter-annual variation in DDT concentrations for WP-7. The 1999 and 2000 data for WP-7 were, however, comparable to the 1997 result.

Detectable concentrations of DDT were also found in the nested wells located along the groundwater migration pathway to the Klehini River. Comparable levels (around 0.05 µg/L) were found in the shallow well (MW-21A: screen set at between 0.5 to 2 m below ground surface). The concentrations in the deeper well (MW-21B), with the screen set at 2.5 to 5 m below the ground surface, were an order of magnitude lower (about 0.001 µg/L).

Samples from the mini-piezometer installed to intercept groundwater flow from the Trench before it enters the Klehini River had an average of 0.009 µg/L of total DDT between 1996 and 1998. This average was comparable to the concentration of 0.007 µg/L predicted by the conceptual model. There was a decrease in 1999 (0.003 µg/L) and in 2000 (0.001 µg/L). Thus no significant increase in DDT concentration was noted over the five-year period. This is consistent with the groundwater model predictions that "Temporal changes in DDT fluxes at the interface are predicted to occur relatively slowly, and a substantial short-term increase in DDT inputs to the river is not predicted to occur".

DDT concentrations in the surface water samples collected from the Klehini River are also included in Figure 4.3. Total DDT at KLE-1 (upstream of the site) and KLE-4 (downstream of the site) were generally below detection or less than 0.001 µg/L, which is the BC CSR AW standard of 0.001 µg/L, taking into account a ten-fold dilution of groundwater in the actual aquatic receiving environment. Similar results were also obtained for KLE-2 except for the 2000 data. A total DDT concentration of 0.0013 µg/L was found in the sample obtained from KLE-2 in September 2000. The sampling location was near the mini-piezometer MP-2 in an overflow channel separated from the main river by a gravel bar. The concentrations of DDT detected in the surface water sample was similar to that obtained from groundwater in MP-2 (see Table 6). This suggested that there was virtually no dilution of groundwater discharge into the side channel. Water level in the main river channel was very low at the time of sampling as such flow through

the side channel was very slow and effectively stagnant. It should be noted that the concentration of 0.0013 µg/L detected in the surface water sample is less than the maximum concentration of 0.002 µg/L predicted to occur in the river immediately adjacent to the groundwater outflow face at some time in the future, when steady state conditions are established.

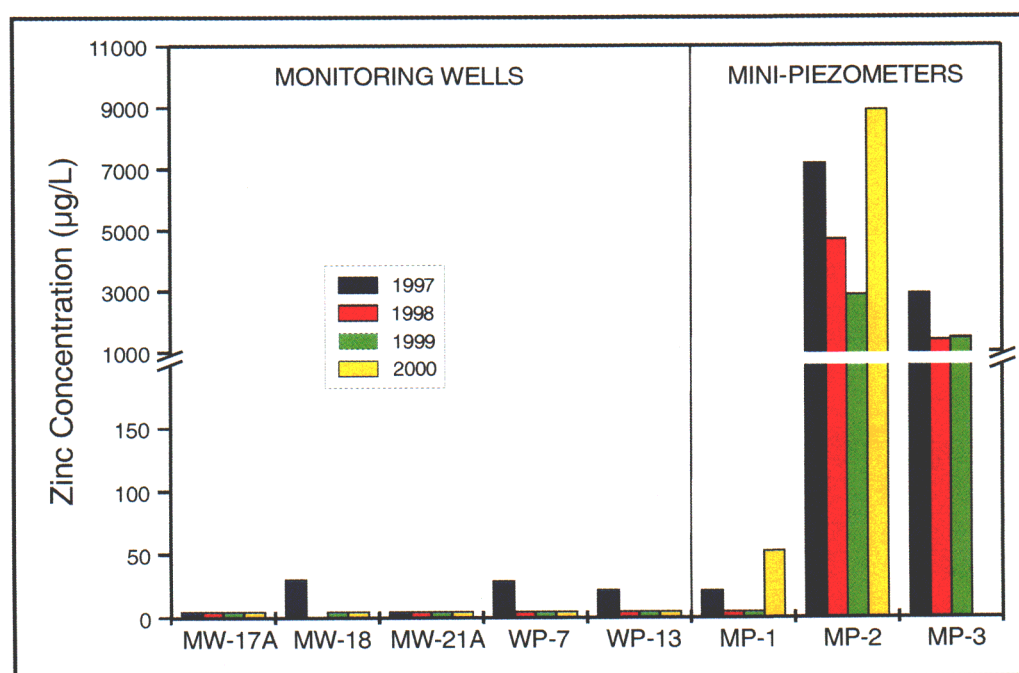
The concentrations of dissolved metals in groundwater samples are tabulated in Tables 10 to 14. Antimony, arsenic, beryllium, cadmium, chromium, cobalt, copper, lead, molybdenum, nickel, selenium, silver and thallium were all below their respective detection limits. Detectable concentrations of the remaining metals were all below the CSR Generic Numerical Water Standards for freshwater Aquatic Life (AW) except for zinc. The distribution of dissolved zinc in samples collected from the monitoring wells and mini-piezometer is depicted in Figure 4.5. For concentrations below detection the absolute value of the detection limit ($5 \mu\text{g/L}$) was used to generate the plot. Zinc concentrations were generally below detection or less than the CSR AW standard except for MP-2 and MP-3. A closer examination of the up-risers indicated that the pipes for MP-2 and MP-3 had galvanized coatings and this accounted for the elevated levels in samples from these two mini-piezometers. The up-riser for MP-1 was composed of stainless steel as opposed to the galvanized ones used for the other two.

Figure 4.5: Zinc Concentration in Groundwater Water Samples Collected at Annually Rainy Hollow from 1997 to 2000

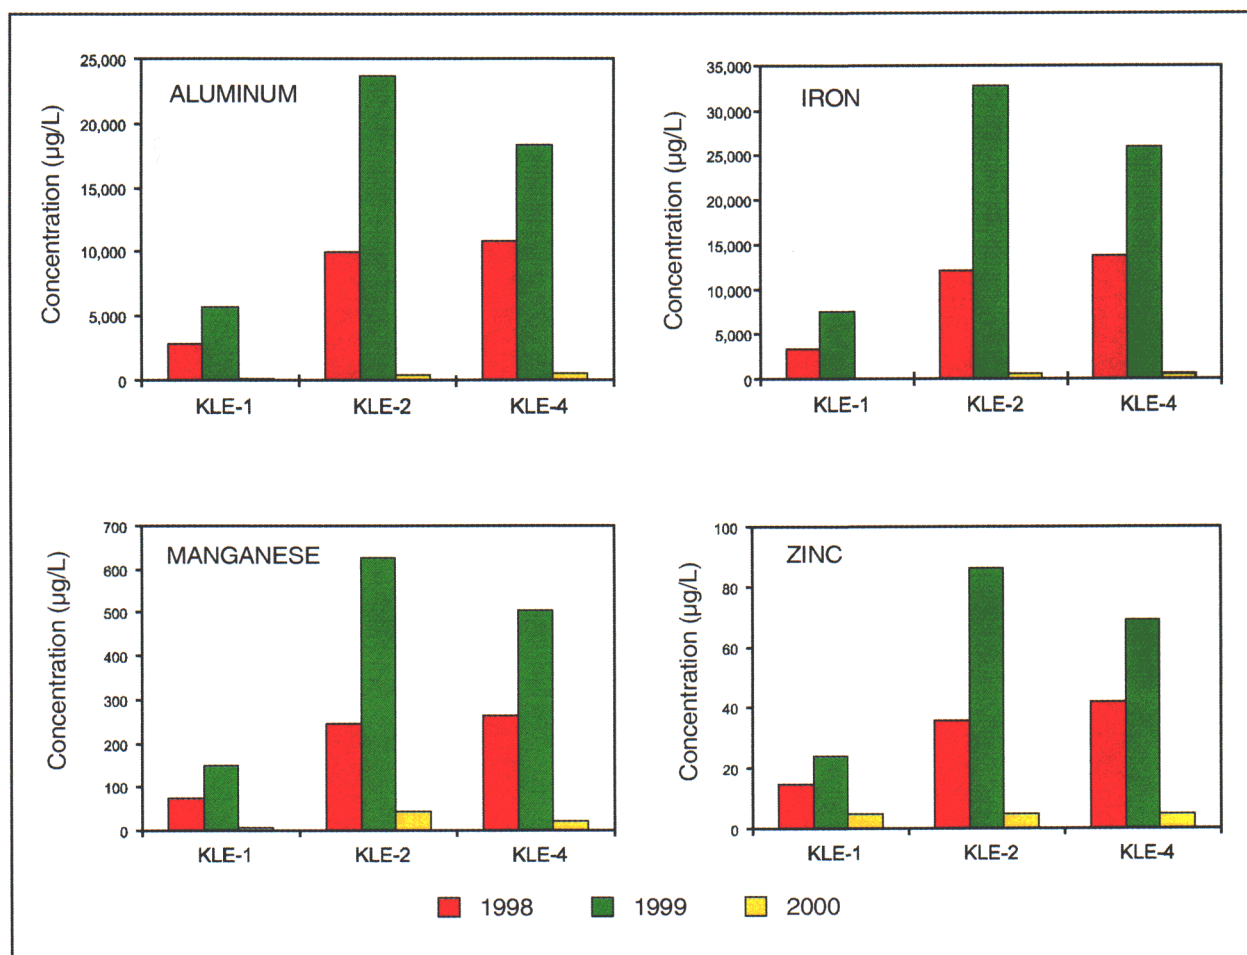
The monitoring of total metals in surface water was initiated in 1998 pursuant to discussions at the Rainy Hollow Working Group meeting of March 1998. Total metals concentrations obtained over the monitoring period is given in Table 15. Most of the concentrations were either below detection or below their respective BC CSR aquatic life standard. Furthermore the concentrations detected in 2000 were significantly lower than those obtained in the preceding years. This is illustrated using aluminum, iron, manganese and zinc concentrations in Figure 4.8. Metal concentrations in samples from KLE-2, directly adjacent to the site and KLE-4 (downstream of the site) were higher compared to the up-stream background sample (KLE-1). A comparison of total metal to dissolved metal concentrations (Table 16) indicated that the elevated concentrations were associated with particulate matter. Samples collected in 1999 were highly turbid as a result of high water flow as such the elevated concentrations could be attributed to greater amount of particulate matter.

Figure 4.8: Total Metal Concentrations in Surface Water Samples Collected Annually from the Klehini River near Rainy Hollow

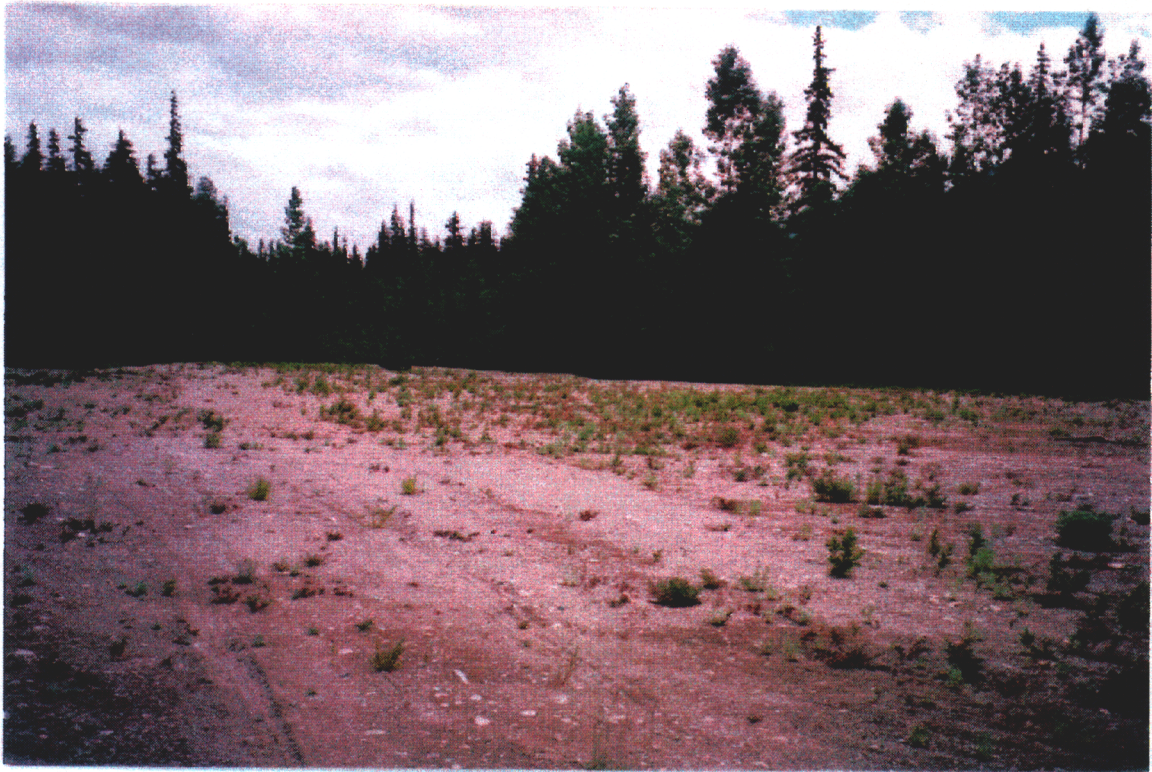
Rainy Hollow: Looking along the gravel cap.

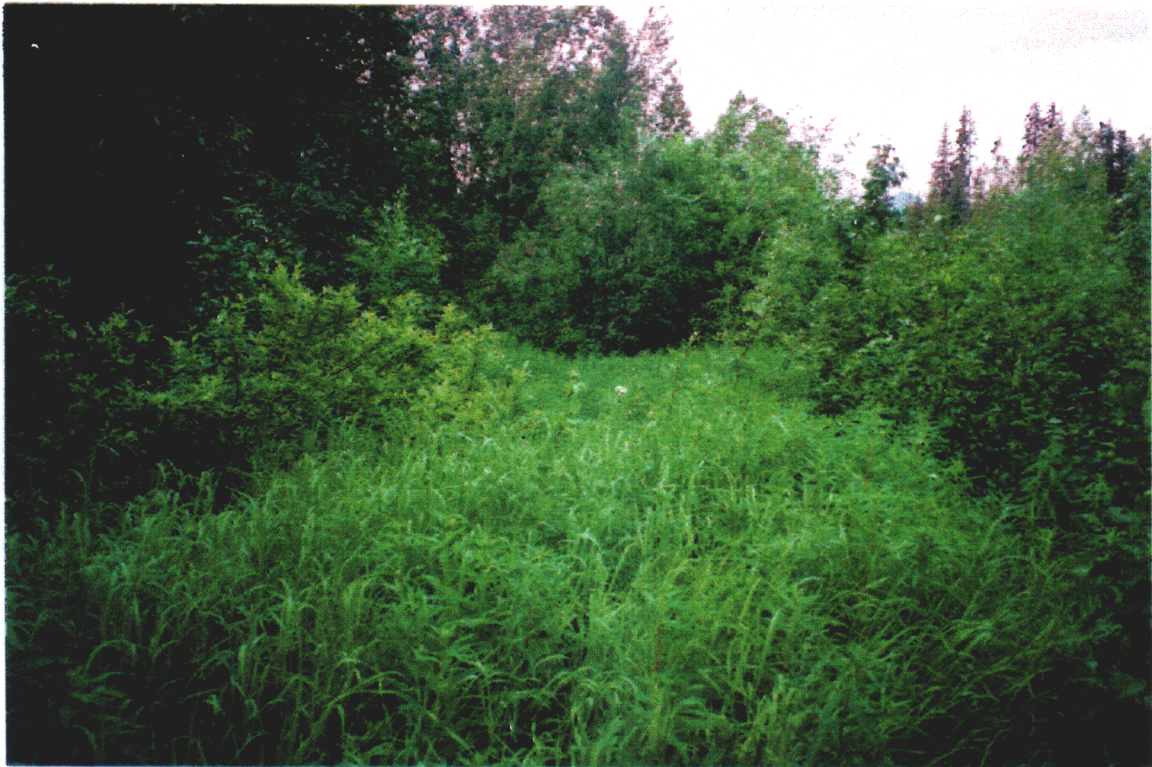
Rainy Hollow: Looking towards the Klehini River

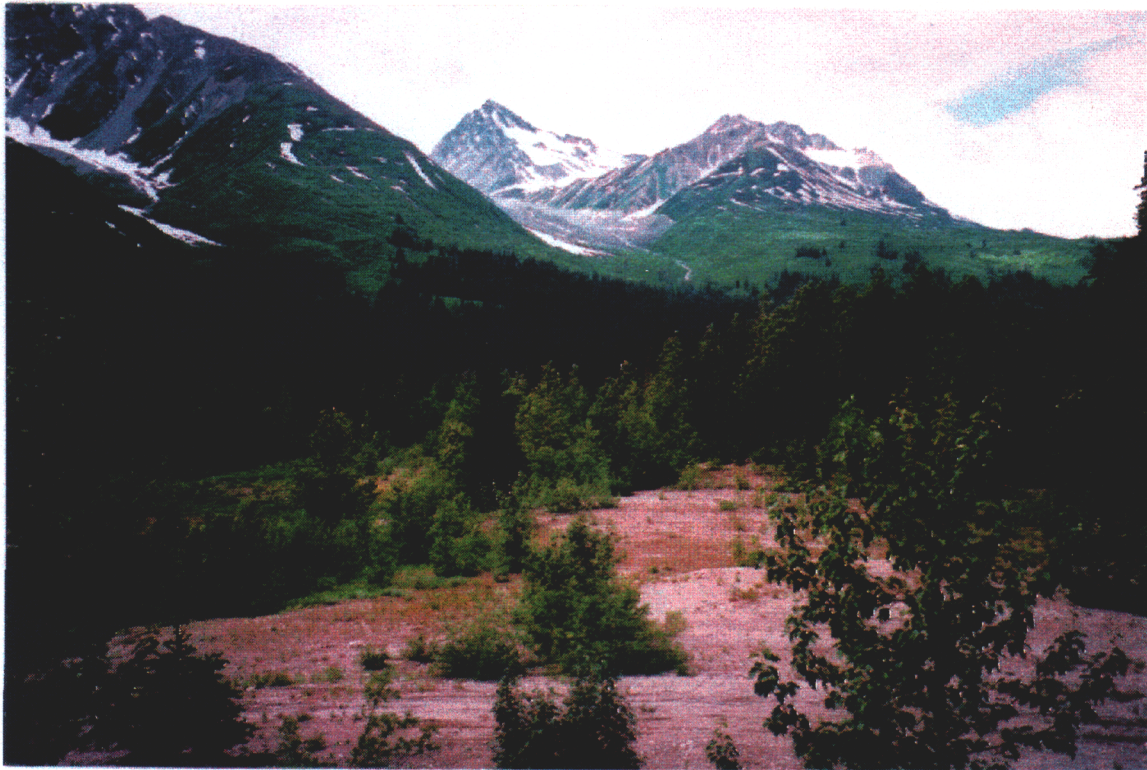
Border Station: Gravel cover over former Temporary Storage Area looking north

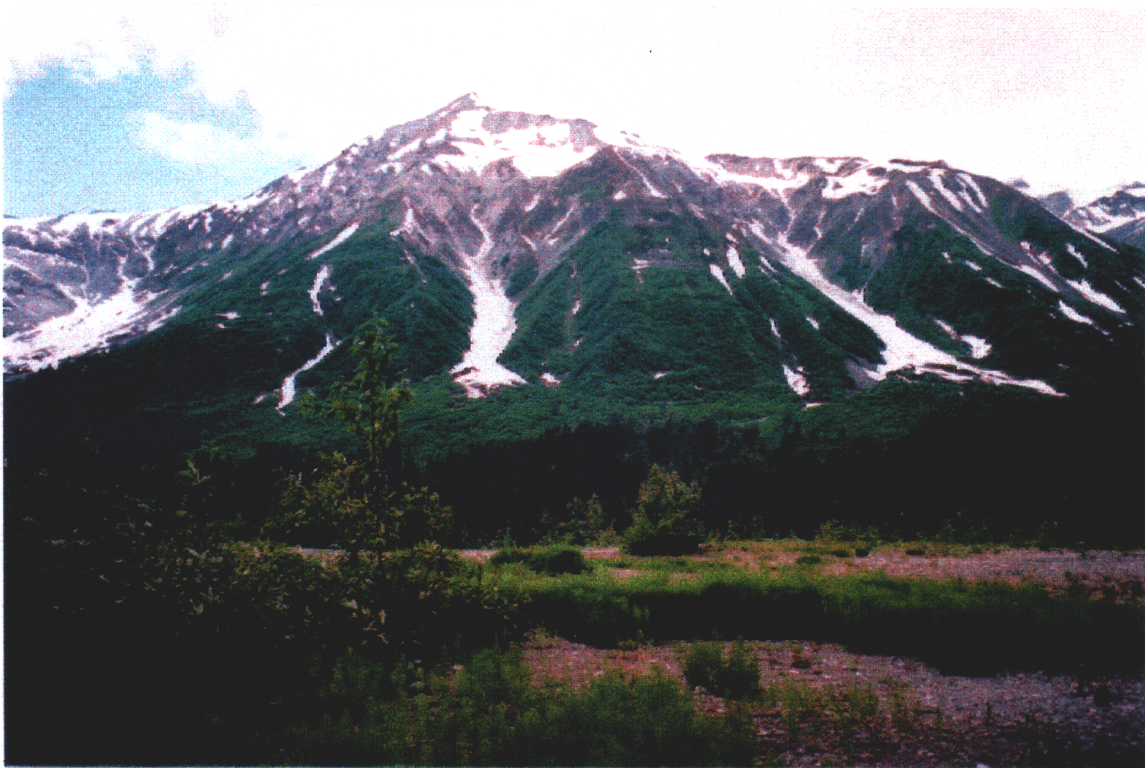
Border Station: View of gravel cover over form Temporary Storage facility from the POL area
