ARCTIC GOLD AND SILVER MINE

ARSENIC CONTAMINATION

Date:
March 2000

Prepared by:
Pat Roach
Emma Cunningham
Contaminants Division

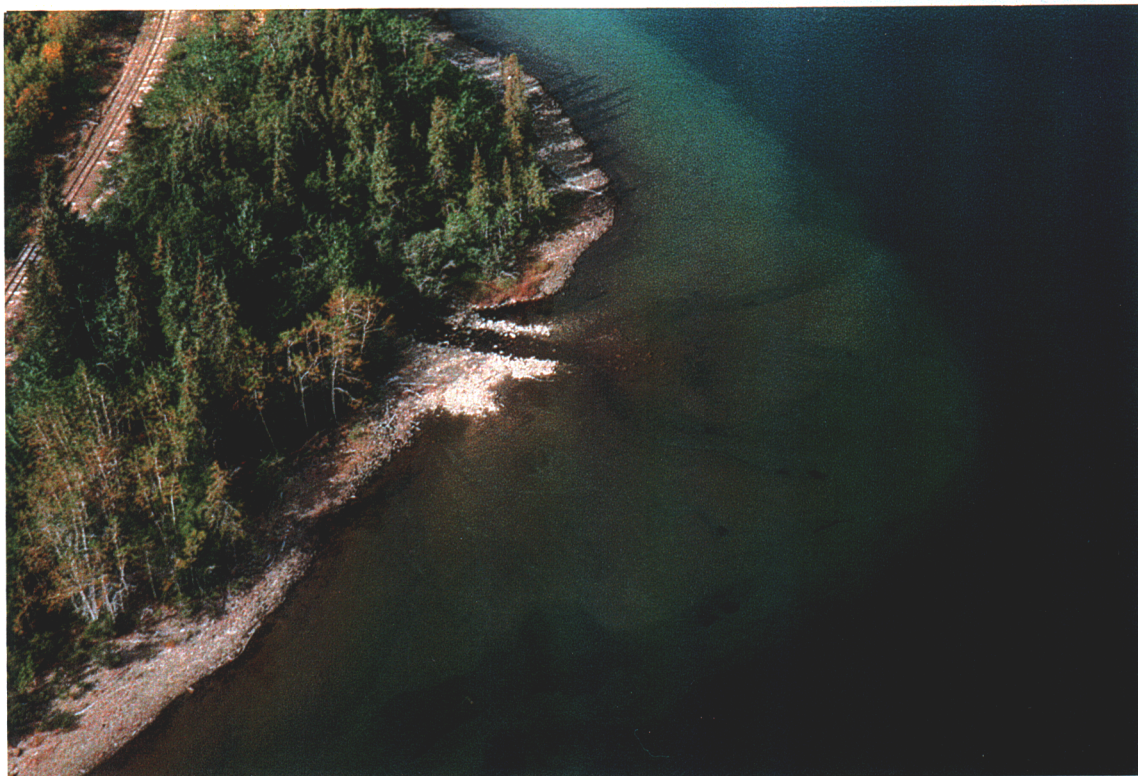
PHOTO A: TANK CREEK DELTA

The sediment samples in the delta of Tank Creek show a minimal transport of metals from the tailings at the Arctic Gold and Silver Mine mill and tailings site, to Bennett Lake. In comparison to the arsenic levels at the drainage, concentrations are significantly lower at the Creek mouth. The higher values obtained at the delta, at sites #3 and #4, may be related to the preferential deposit of sediment within the delta itself. This material may or may not be from the tailings site. With the rock of the mountain containing arsenic rich minerals, it may be a factor of material eroding in the steep Tank Creek channel, as it drops to the Creek mouth. The studies conducted since 1975, have shown that while sediment in the drainage from the tailings pond does contain tailings, there is no evidence that this material is being carried beyond the beaver pond.
