BARKER
SITE #85
(MINFILE #106D 022)

1. LOCATION AND ACCESS

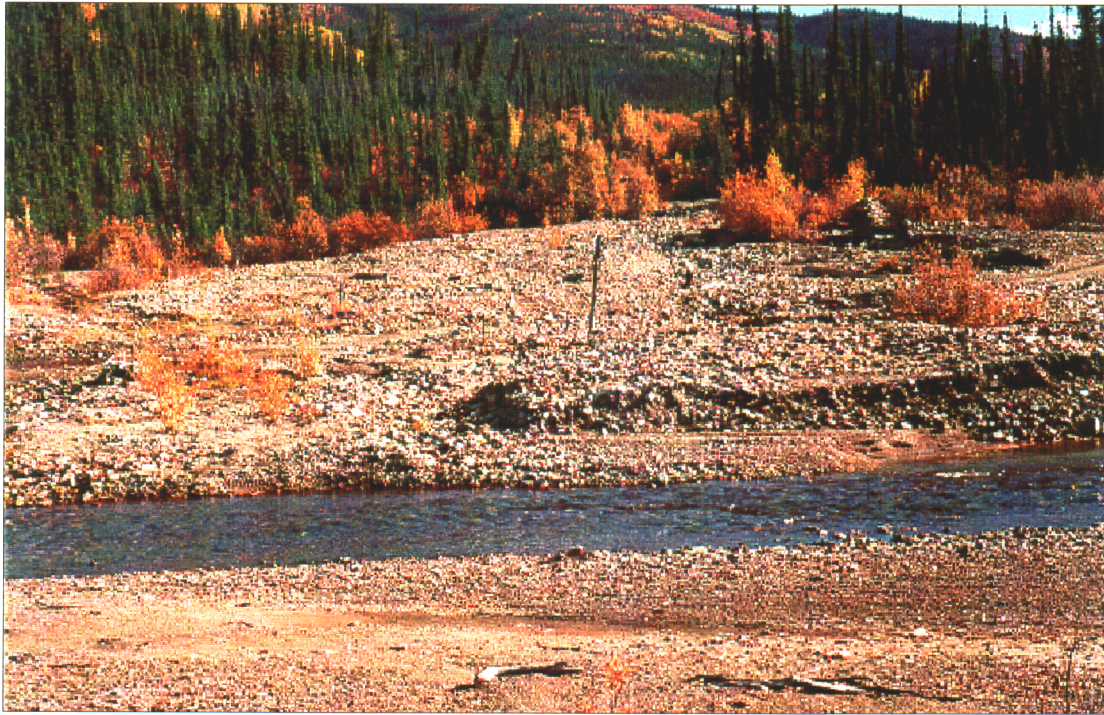
The site has been covered over by overburden from recent placer mining activities in Dublin Gulch. It's original location is believed to have been along the outwash floodplain of Haggart Creek at it's confluence with Gublin Gulch (proper, Photo 85-1) to the east. Over-burden from placer activities have also significantly altered surface hydrology in the area. The presence of permafrost soils could not be ascertained; however, the presence of small trees and the high elevation suggests the possibility of discontinuous permafrost.

Natural revegetation is being obscured by on-going placer mining activities along Haggart Creek which are also significantly altering surface drainage throughout the area (see Photo 85-1). There is no evidence of any reclamation measures at this site.

Photo 85-1 : Barker Site looking N.E. water sample location downstream of Dublin Gulch (general).

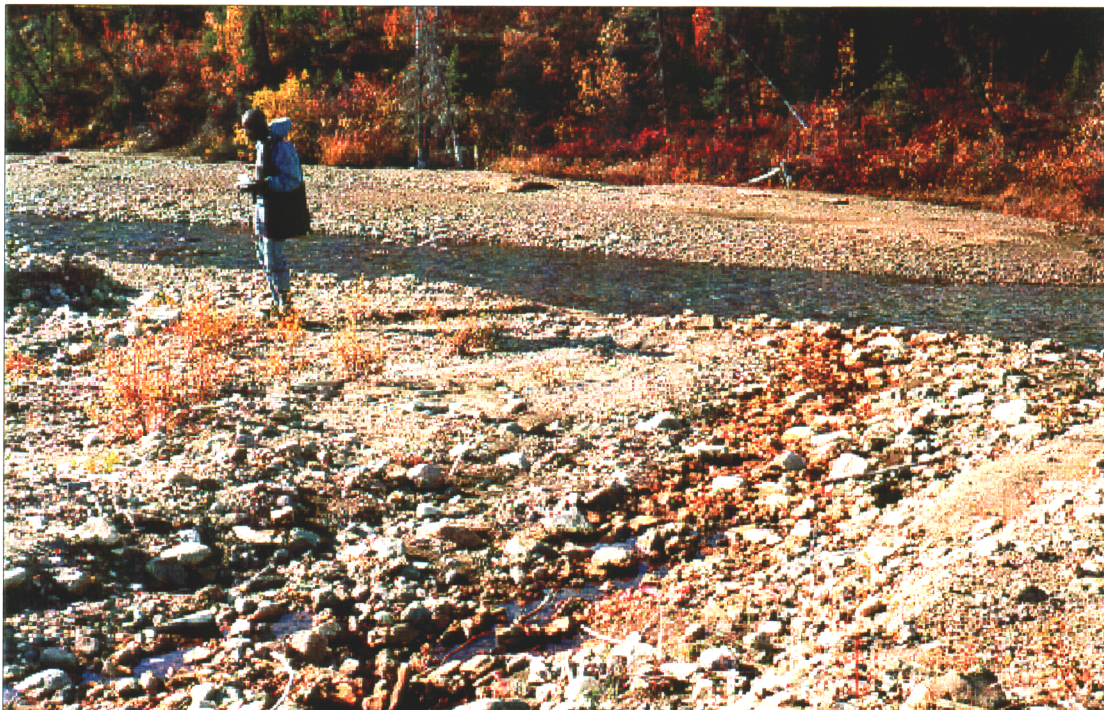
One surface water quality sample was collected just downstream of the confluence of Haggart Creek with Dublin Gulch (proper) (99-85-WQ-01, Photo 85-2). Results of the geochemistry are listed in Attachment 2.

Photo 85-2 : Barker Site looking S.W. water sample location downstream of Dublin Gulch (general).
