GARNET (RAY GULCH)
SITE #93
(MINFILE #106D 027)

1. LOCATION AND ACCESS

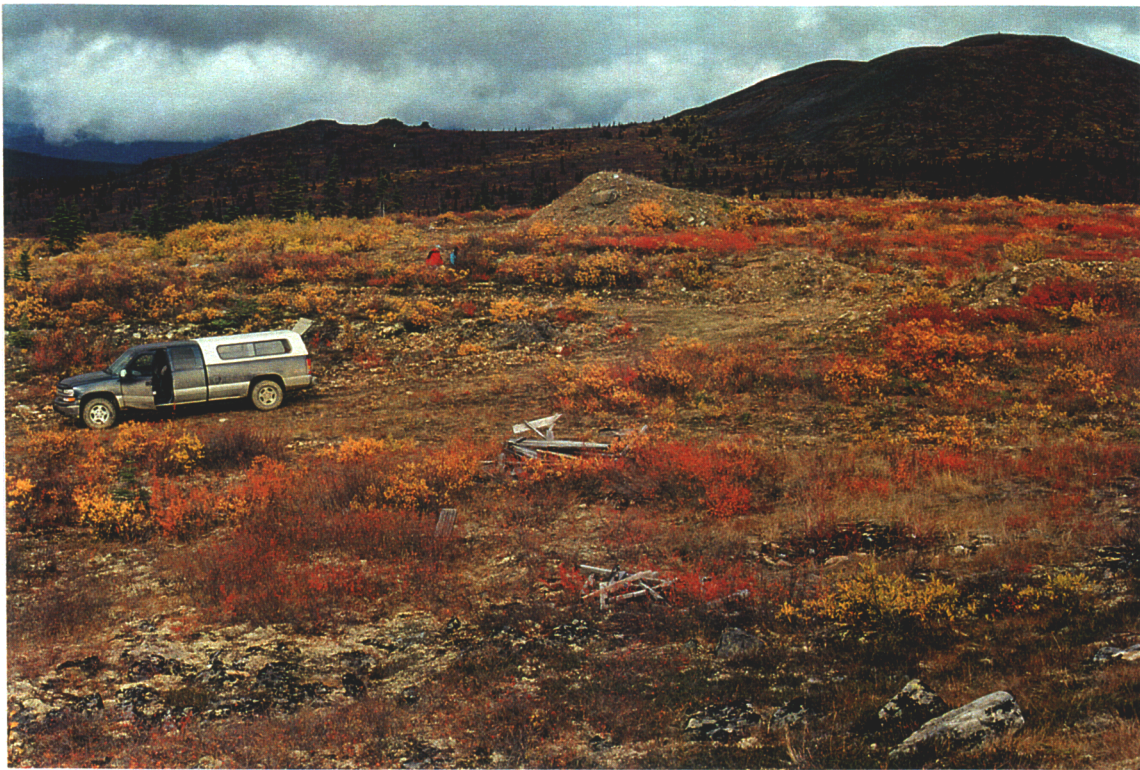
The site faces north along the edge of a plateau along at the top of the west slope of Ray Gulch, which drops to the south where it eventually meets Lynx Creek. Garnet is above the treeline, located in a relatively dry alpine tundra with characteristic vegetation. Raised frost-heave areas, polygons and the high altitude suggest the presence of continuous permafrost in the area (Photo 93-1).

Single rock pile consisting of overburden removed from the trenches. Several core boxes remain at the site. No apparent drainage in the area.

Location: Along Dublin Gulch road approximately 80 m northeast of surveying peak (see Photo 93-1).

Photo 93-1 : Garnet. Looking N. rom peak to camp debris, wash rock pile & Potato Hill (background).

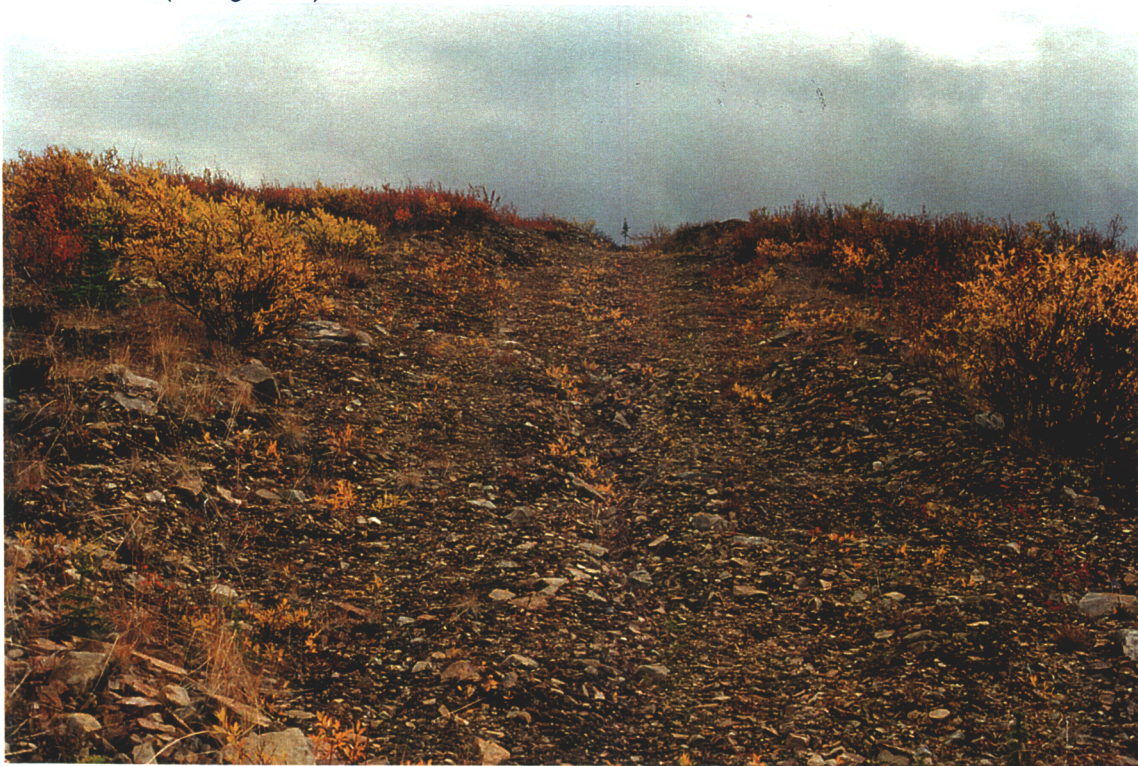
Extensive bulldozer trenching and shallow test-pitting has occurred throughout this site along the access road particularly through the early 1960s. The two largest are located near the surveying peak at the site near the top edge of Ray Gulch. (Photos 93-2 and 93-3).

Dimensions: (L x W x H): ~ 60 m x 3 m x 1 m

Condition: loose packed overburden; some natural re-colonization evident, appear to be stable

Photo 93-2 : Garnet. One of numerous bulldoze trenches along access road (looking N.E.).

Natural re-vegetation is beginning to occur at the site in the trench areas around site (Photo 93-3). The trench area along the east slope of the gulch, however, remains bare (see Photos 93-2 and 93-3). No evidence of any reclamation measures at this site.

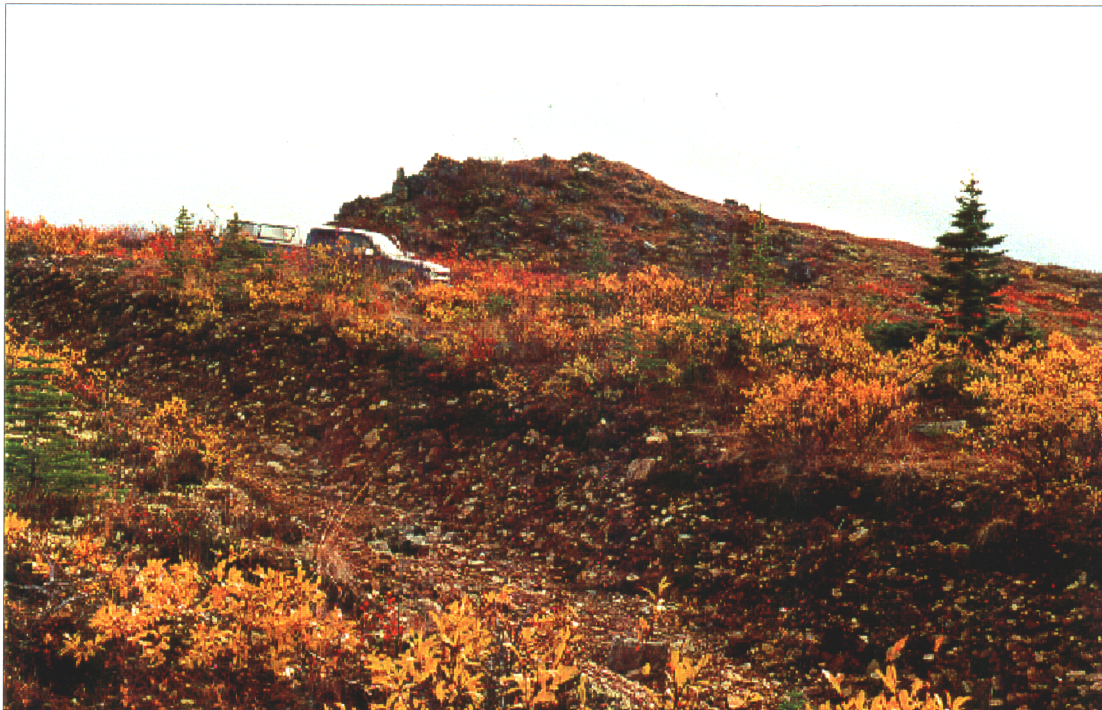
Photo 93-3 : Garnet. Bulldoze trench along access road looking S.E. to peak.
