# Anvil Range Mining Complex Continued Seepage Investigation Zone 2 Pit Outwash Area

**2005/06 Task 20e**

**Anvil Range Mining Complex**  
**Continue Seepage Investigation**  
**Zone 2 Pit Outwash Area**

**SRK Project Number 1CD003.073**

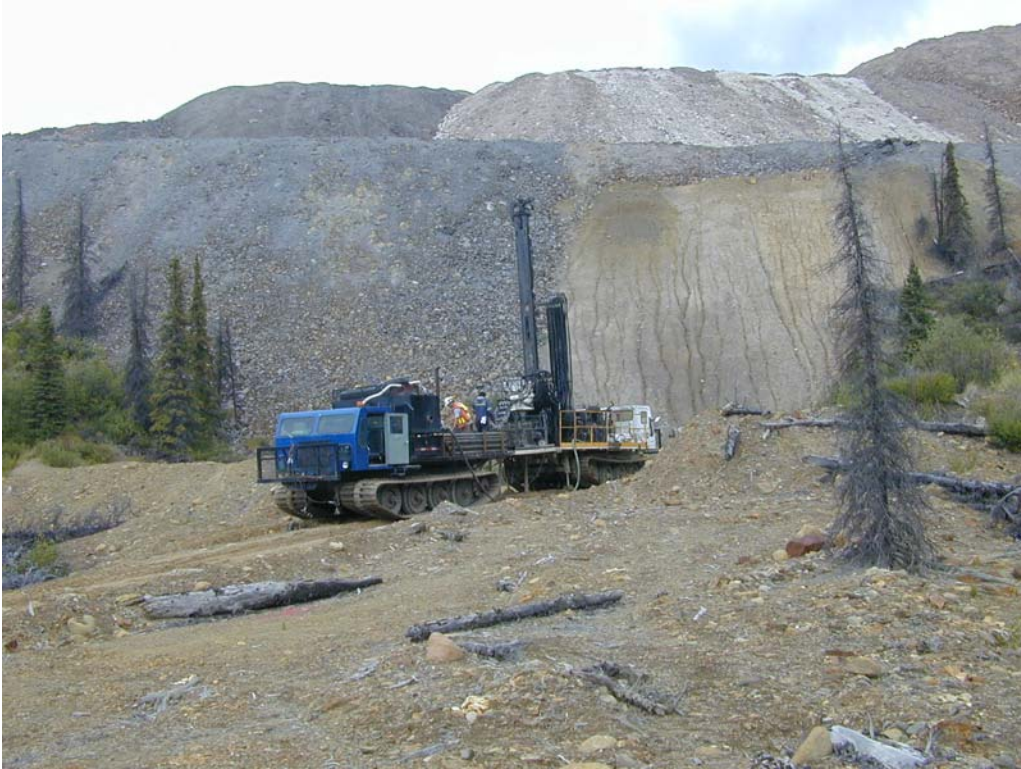
**Photo 1: Sonic Drill Rig set up in Zone 2 Outwash Area (at BH05-01)**

The monitoring wells were drilled first using a SONIC drill rig operated by Sonic Drilling Services, a division of Boart Longyear of Alberta using a Nodwell-mounted sonic drill (Photo 1). The sonic rig was equipped with a 4 x 6 system (4"/10 cm core barrel and 6"/15 cm casing) that allowed for continuous sampling in 3 meter runs (1 core barrel = 10 ft; approximately 3 metres) by advancing the core barrel using ultra-sonic vibrations. Casing is advanced over the core barrel to below the bit to keep the hole open during barrel retrieval. Water is only used during casing advancement to prevent heave between barrel and casing. Water use was kept to the minimum required to advance casing.

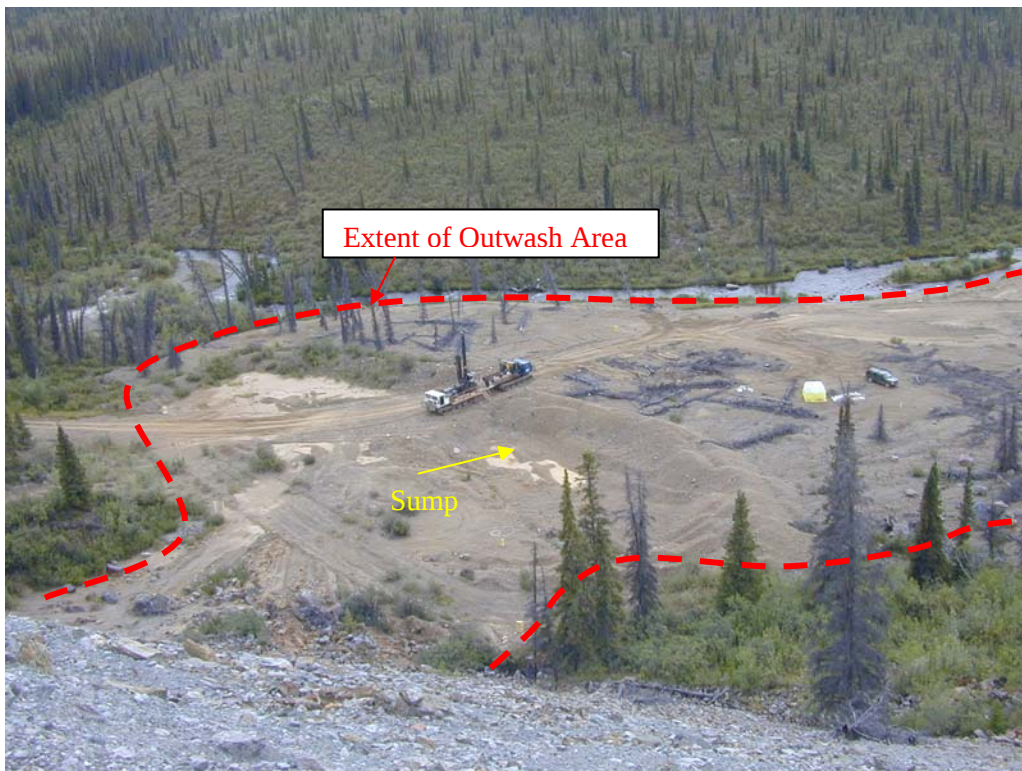
**Photo 2: Zone 2 Outwash Area (drilling in progress at BH05-01)**

The upper 2.5m of the soil profile at PW3 (and P05-04) represents material that appears to have been transported from the hill side into the flood plain (“outwash”). This outwash fan is clearly visible in the field due to vegetation “die-back” (Photo 2). Note that the outwash material appears to have been disturbed (to build a sump at the toe of the Zone 2 dump). Hence the thickness of this deposit varies throughout the area. The approximate extent of the outwash material (based on visual inspection) is shown in Photo 2 and Figure 3.

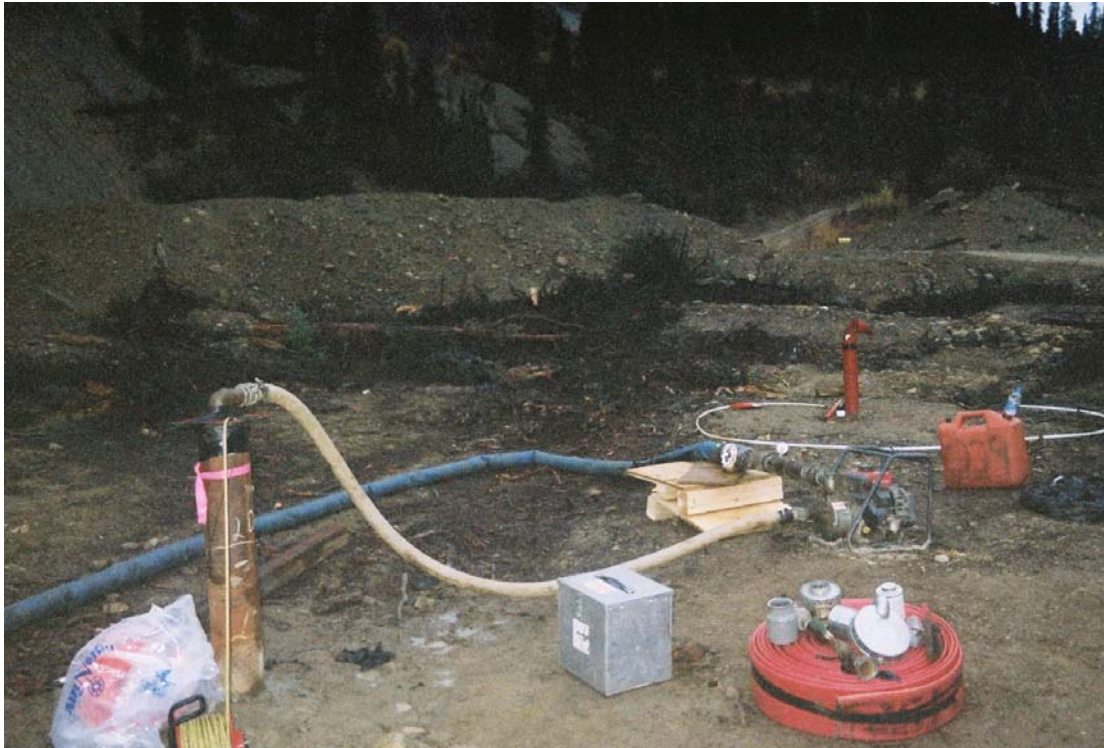
**Photo 3: Setup for 24 hour Pumping Test at PW-3**

A 24-hr constant rate pumping test was conducted in pumping well PW-3 at an average rate of 1.89 l/s (30 USGPM) between 14:00 on September 19, 2005 and 12:30 on September 20, 2005. The pumping test was conducted by Precision Services & Pumps (PSP), Abbotsford, B.C., with field supervision by RGC staff. Due to the potential for additional silt flushes (see Section 3.1.1), which might damage a submersible pump, the test was completed using a Kawasaki suction pump (KWS 20A rated to 200 USGPM) (Photo 3). The suction line was fitted with a check valve and placed above the screen. The flow rate was adjusted using a valve in the discharge line. The flow rates during the pumping tests were measured using an orifice setup at the end of the discharge line. Repeated discharge measurements showed only a small drift in the pumping rate from an initial reading of 30.6 USGPM to 28.8 USGPM during the later stages of the test (Appendix C).

Detailed water level monitoring was carried out prior to, during and following the 24-hour pumping test to determine the response of the North Fork Rose Creek aquifer to pumping. Water levels were recorded manually at the pumping well and at 10 monitoring wells located in the Zone 2 outwash area (see Figure 1 for locations). All monitoring data collected during the 24 hour pumping test are provided in Appendix C.

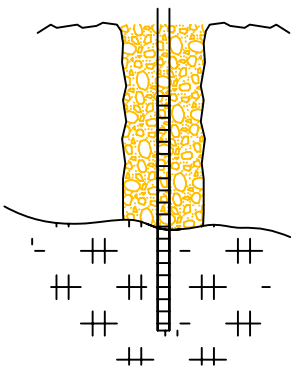
Permeable Trench  
Schematic Detail  
(showing extraction well)

The recommended initial SIS consists of a permeable trench installed down to bedrock combined with a fence of extraction wells screened in the permeable trench and the underlying weathered/fractured bedrock. The SIS is aligned along the toe of the waste rock dumps associated with the Zone 2 Pit and has a length of approximately 400 m. Prior to installation of the initial SIS, the mineralized outwash sediments should be removed and replaced with clean fill.

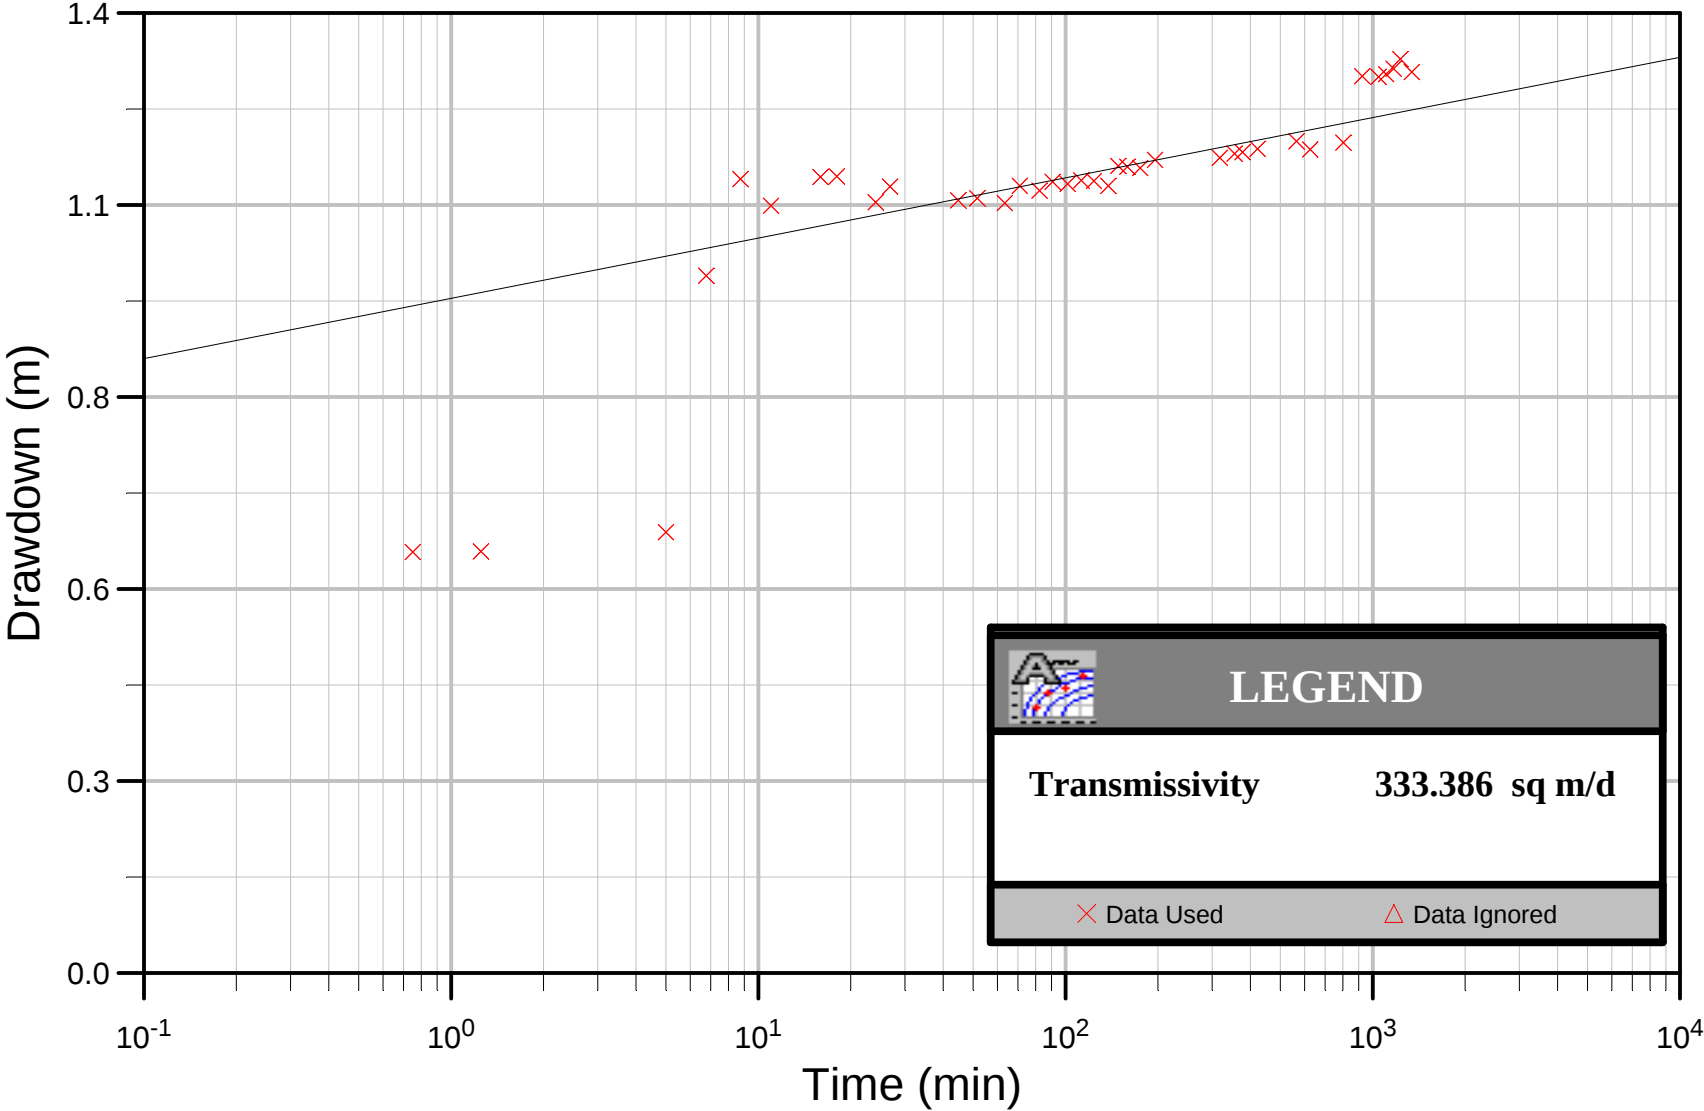
**PW3 Drawdown (PW3 - 30 gpm)**  
**Cooper and Jacob Method, 1946**

The pump test data were analysed using analytical solutions (with Aquifer Win32 V.2) to provide initial estimates of transmissivity (T) and storativity (S) for the aquifer. For the purpose of this exercise, the drawdown data were analysed using the Cooper-Jacob method and the recovery data were analysed using the Thesis method. Both analytical solutions assume a confined aquifer with “ideal properties” (infinite extent, no leakage). It is recognized that these conditions may not be strictly met for the NFRC aquifer. Nevertheless, these estimates were judged to be adequate for the purpose of this study.

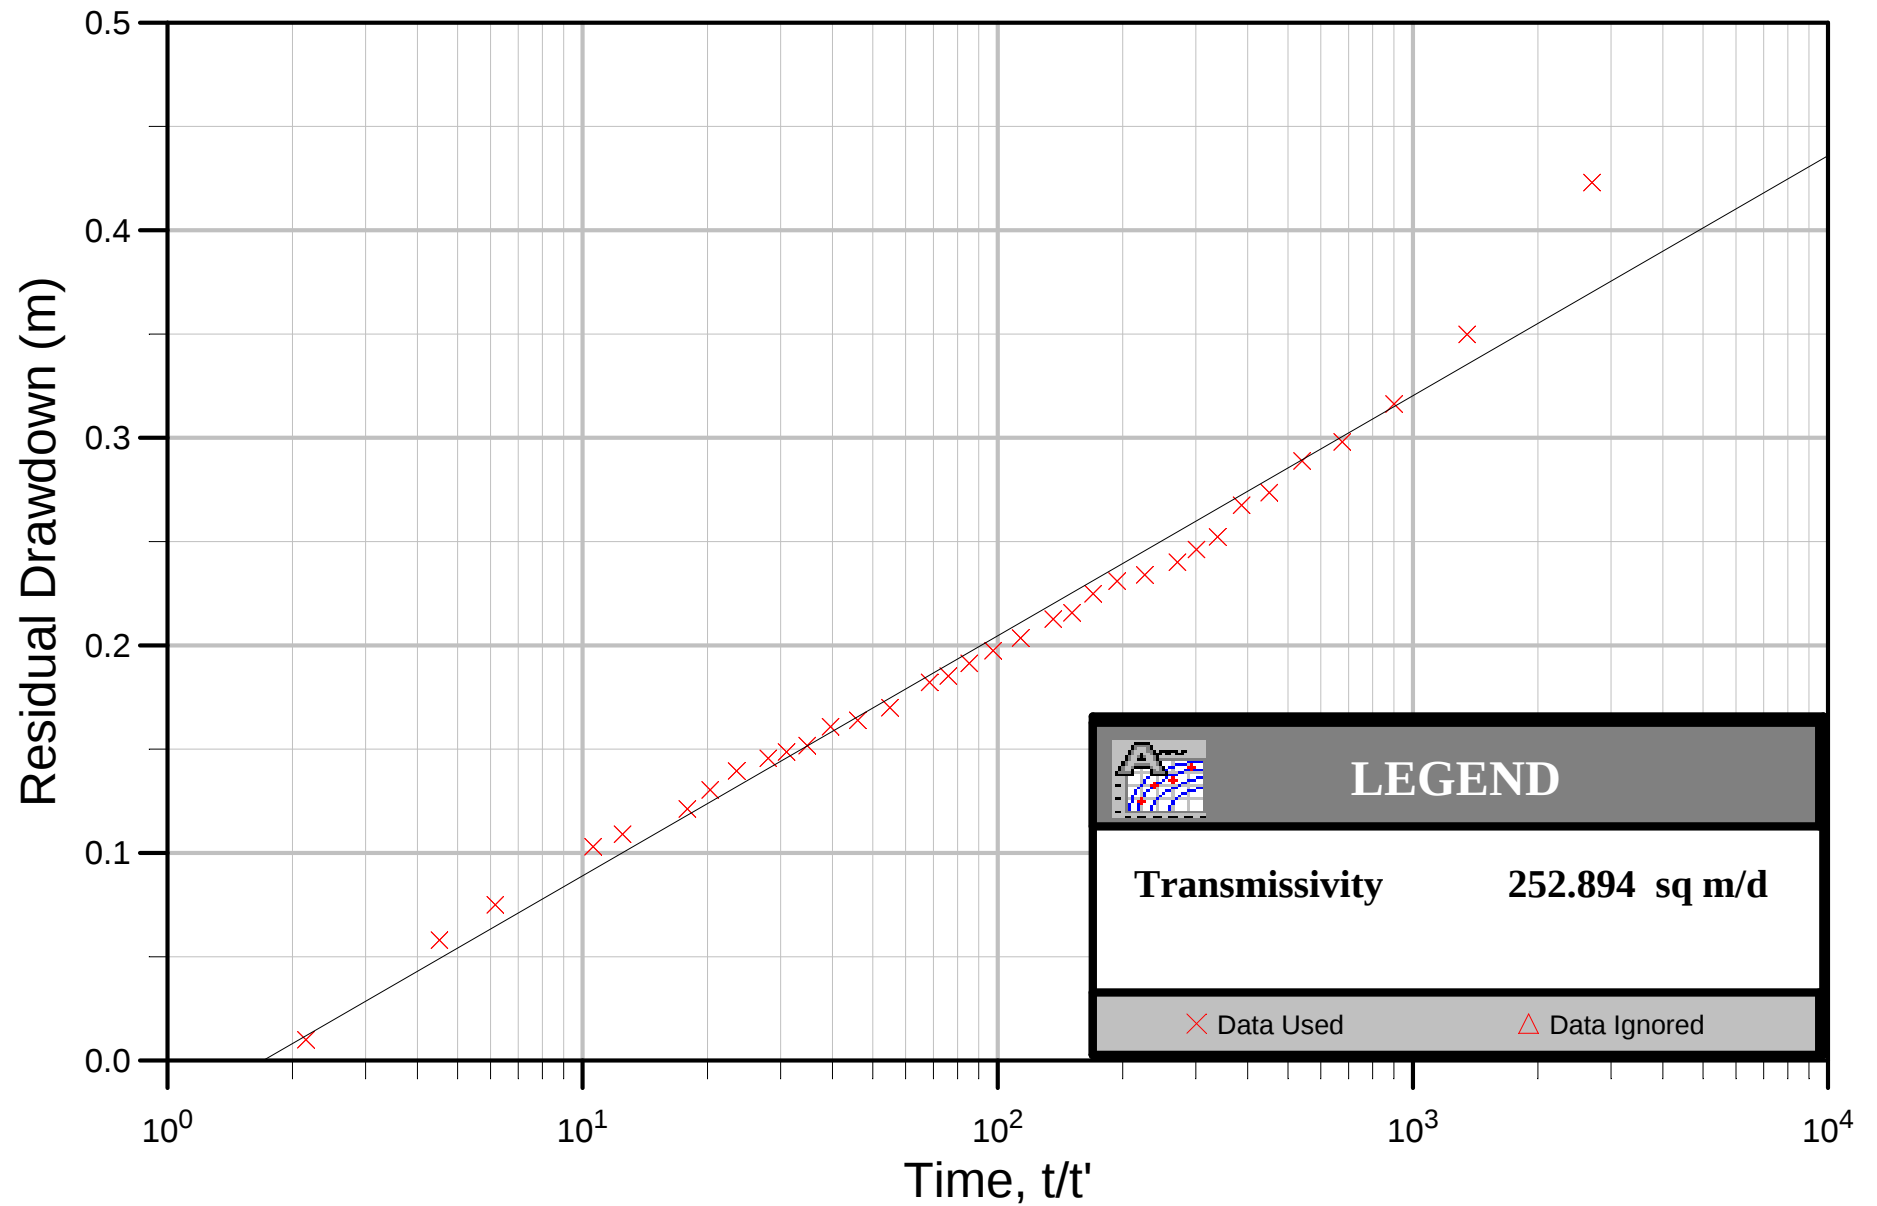
# PW3 Recovery (30 gpm)

Theis Recovery

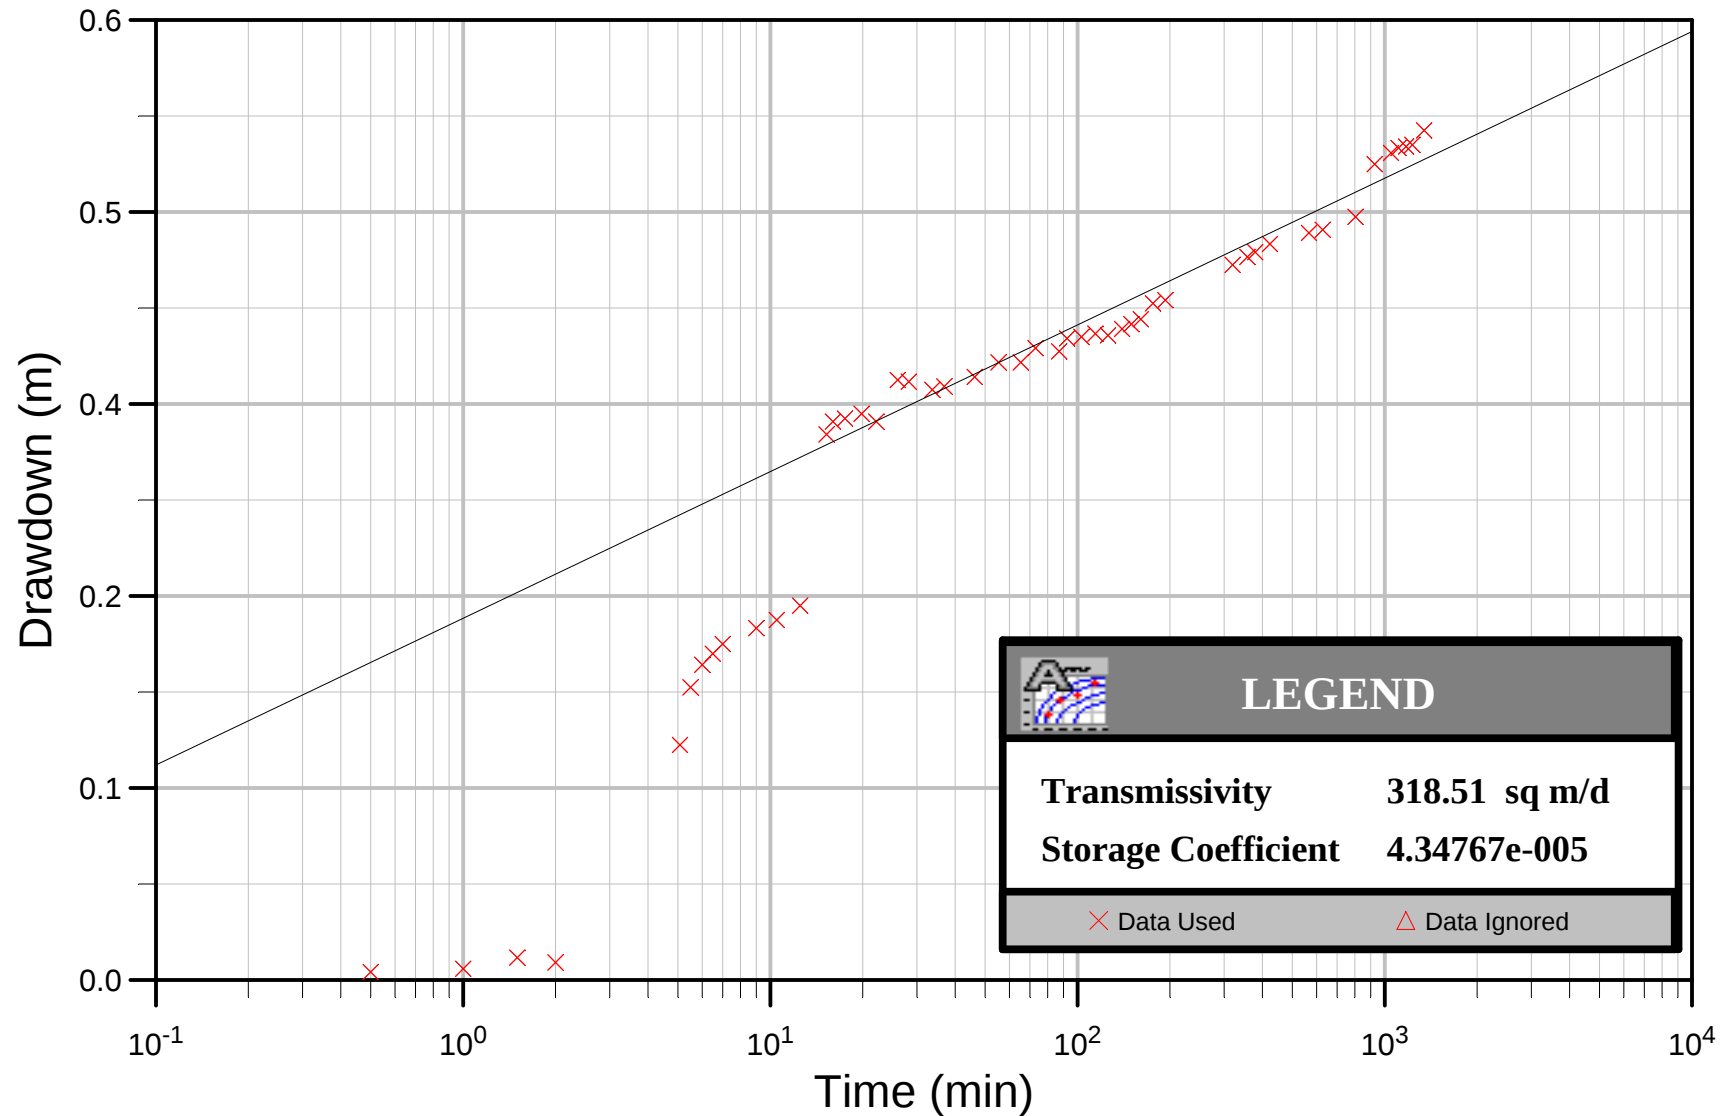
# P05-04 Drawdown (PW3 - 30 gpm)

Cooper and Jacob Method, 1946

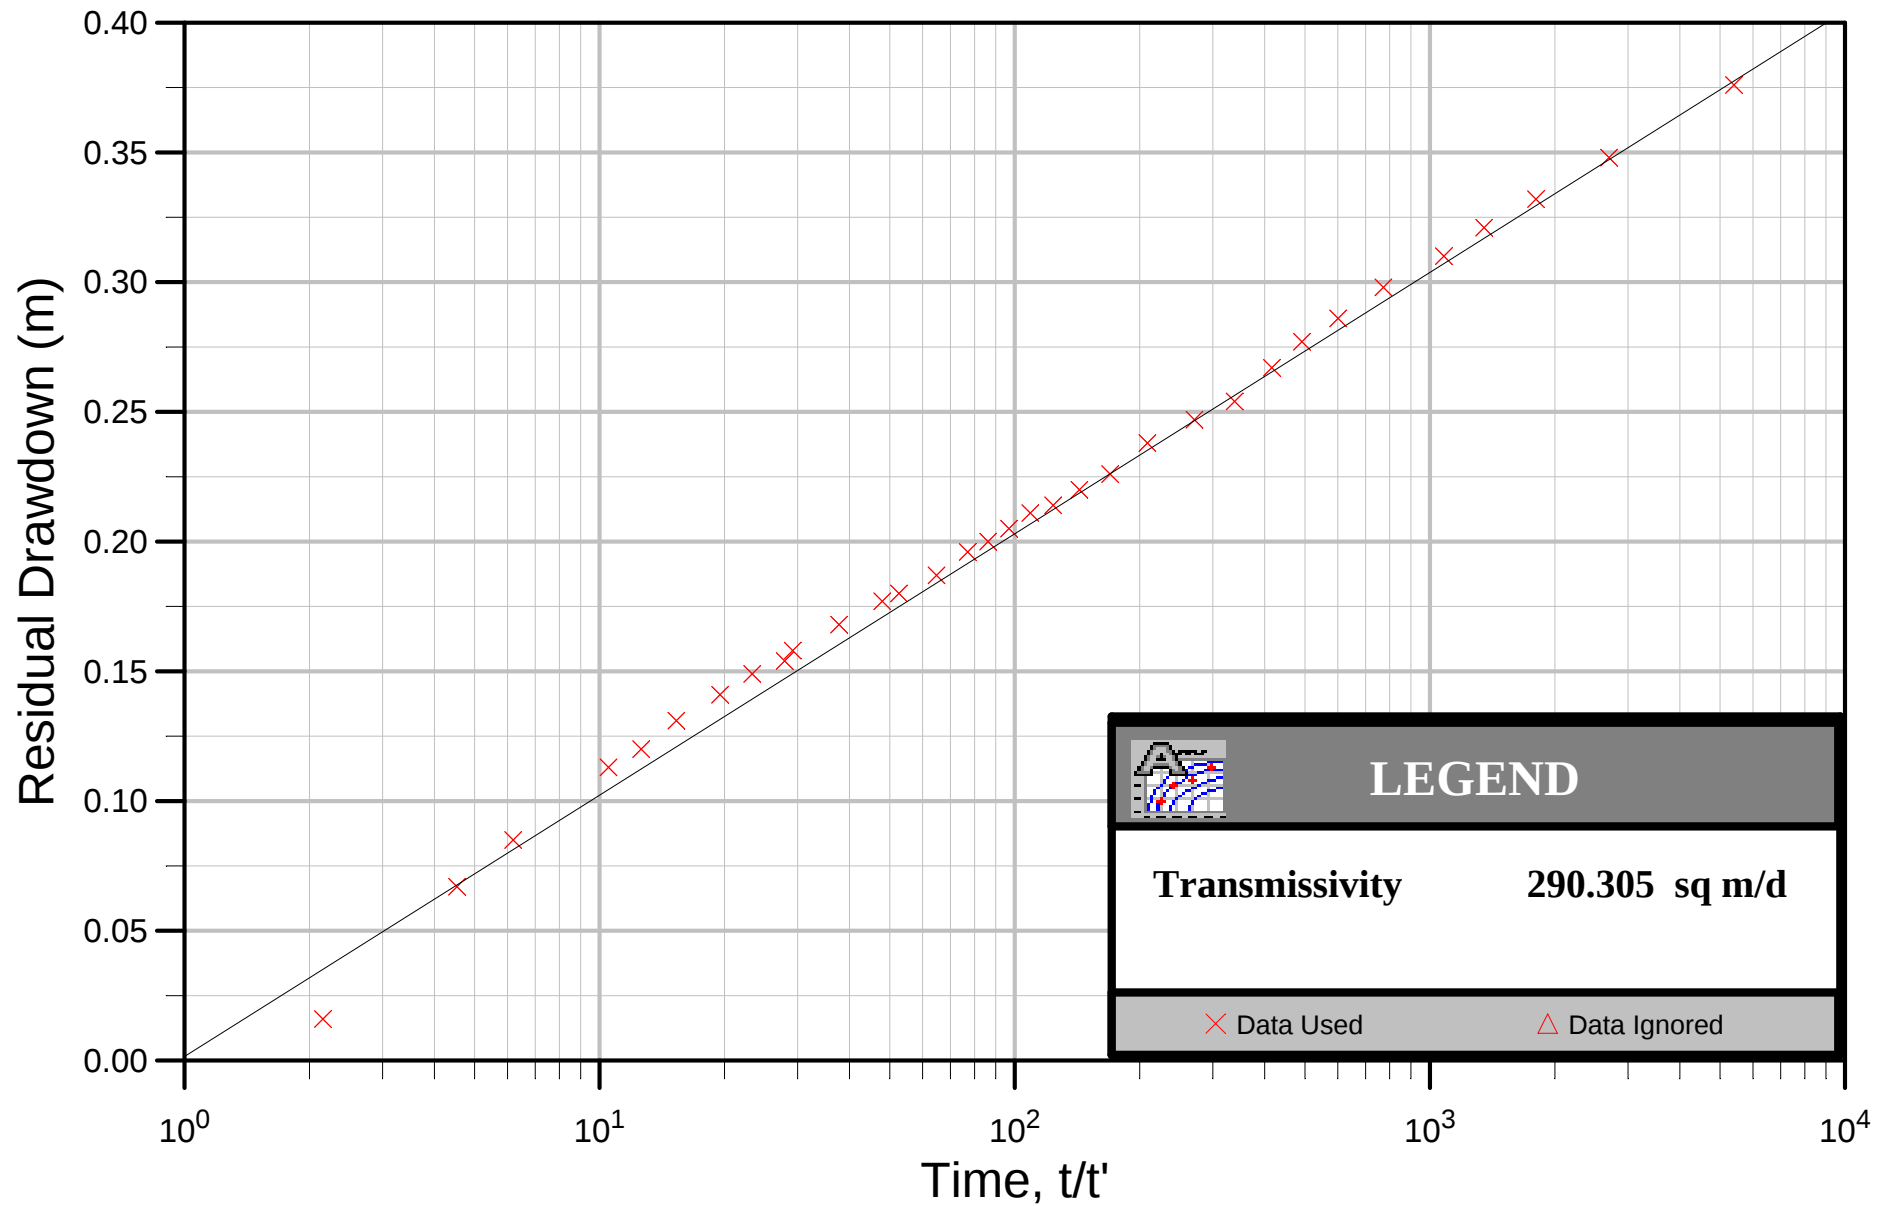
# P05-04 Recovery (30 gpm)

Theis Recovery

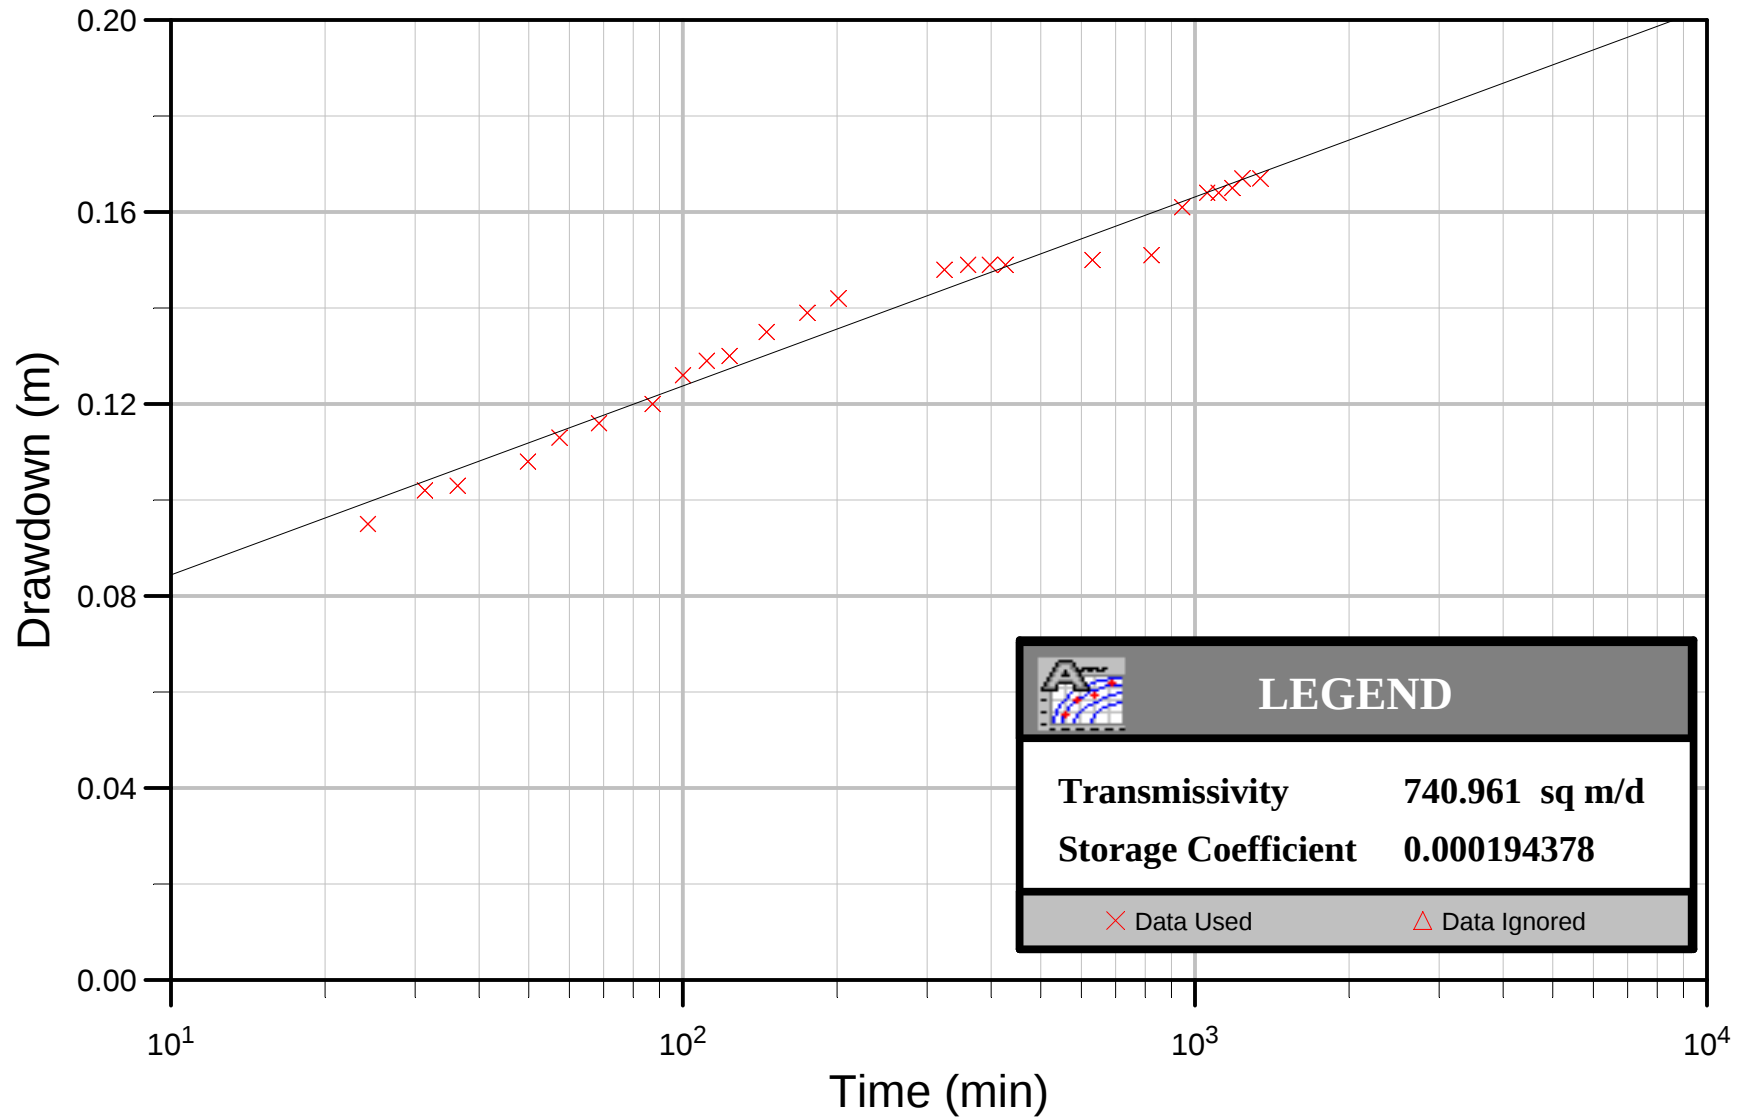
# BH6 Drawdown (PW3 - 30 gpm)

Cooper and Jacob Method, 1946

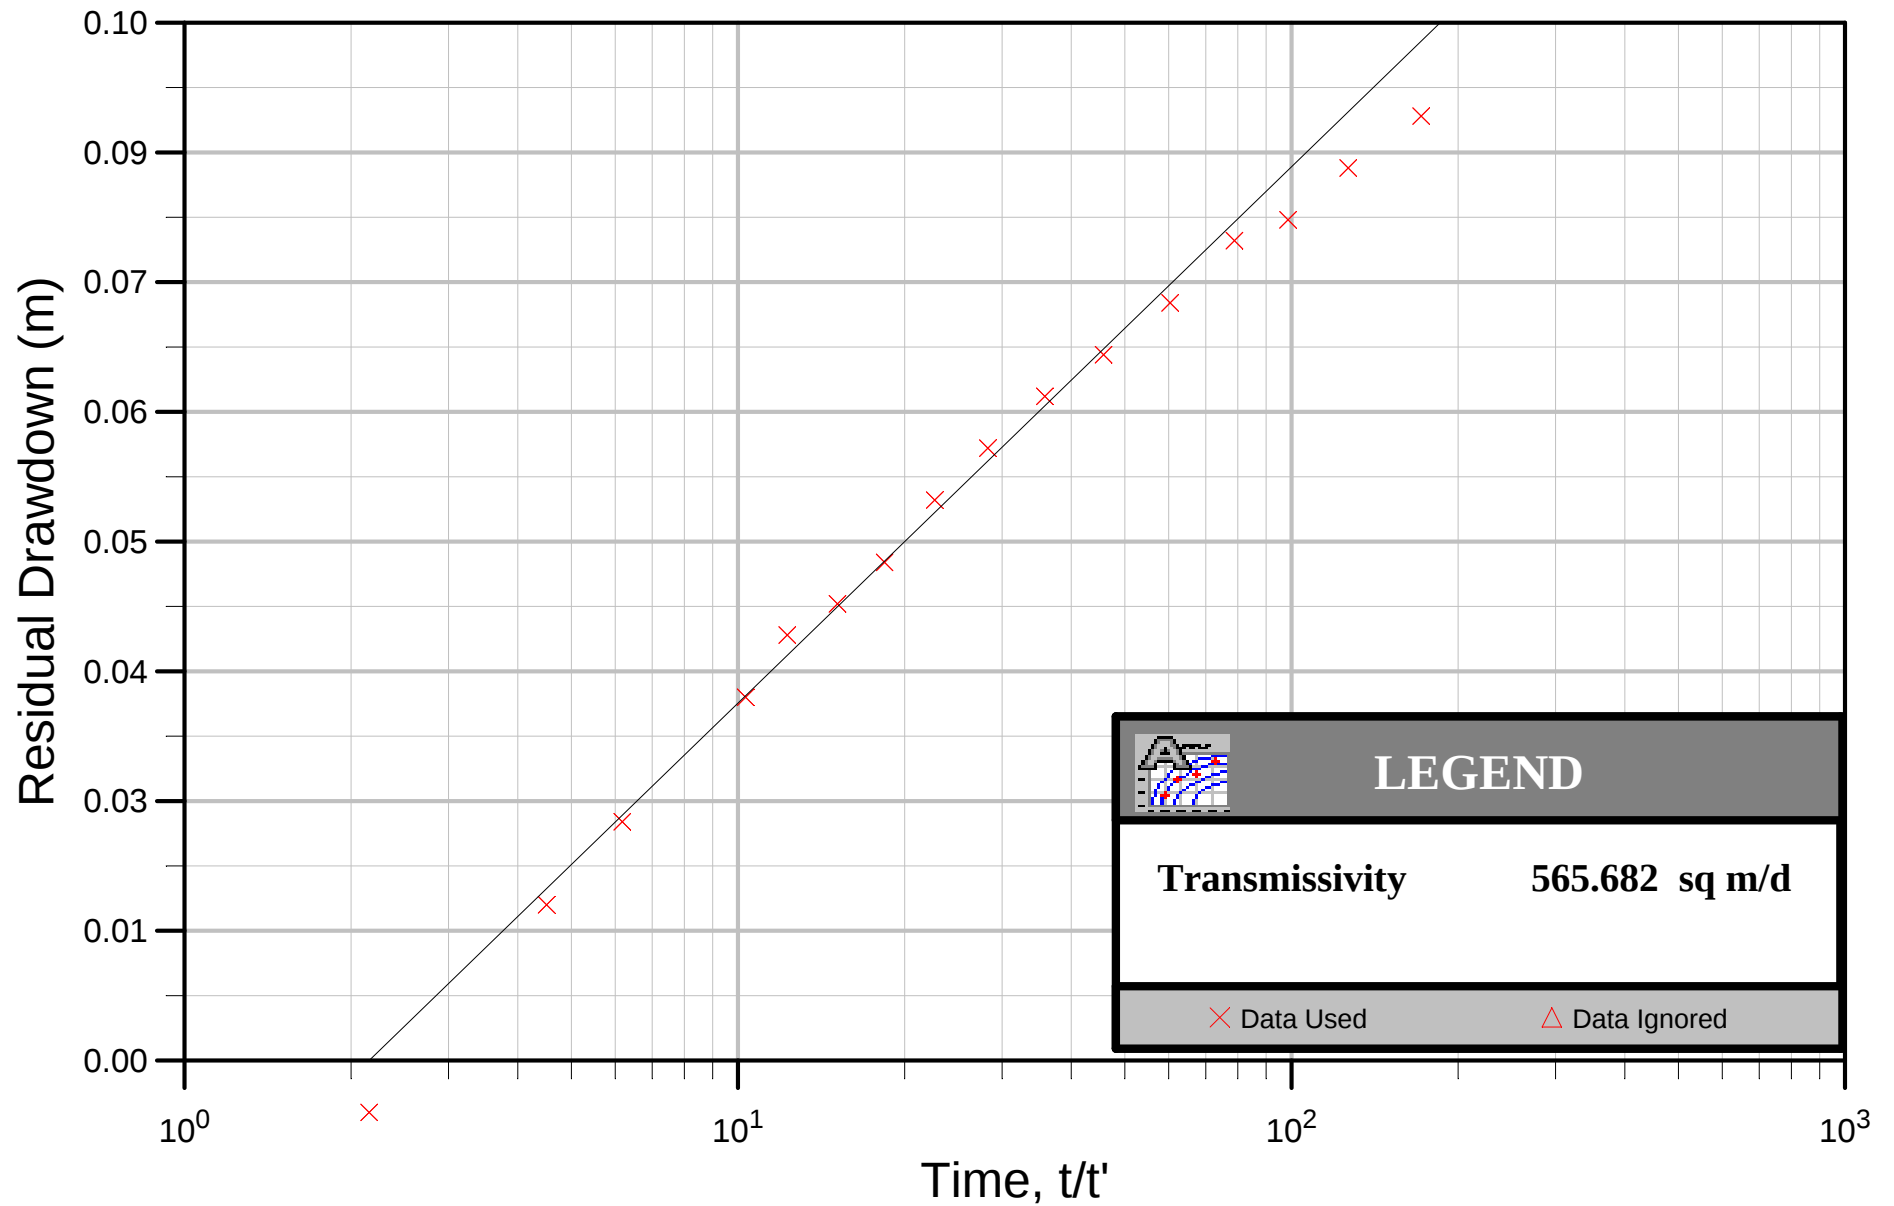
# BH6 Recovery (30 gpm)

Theis Recovery

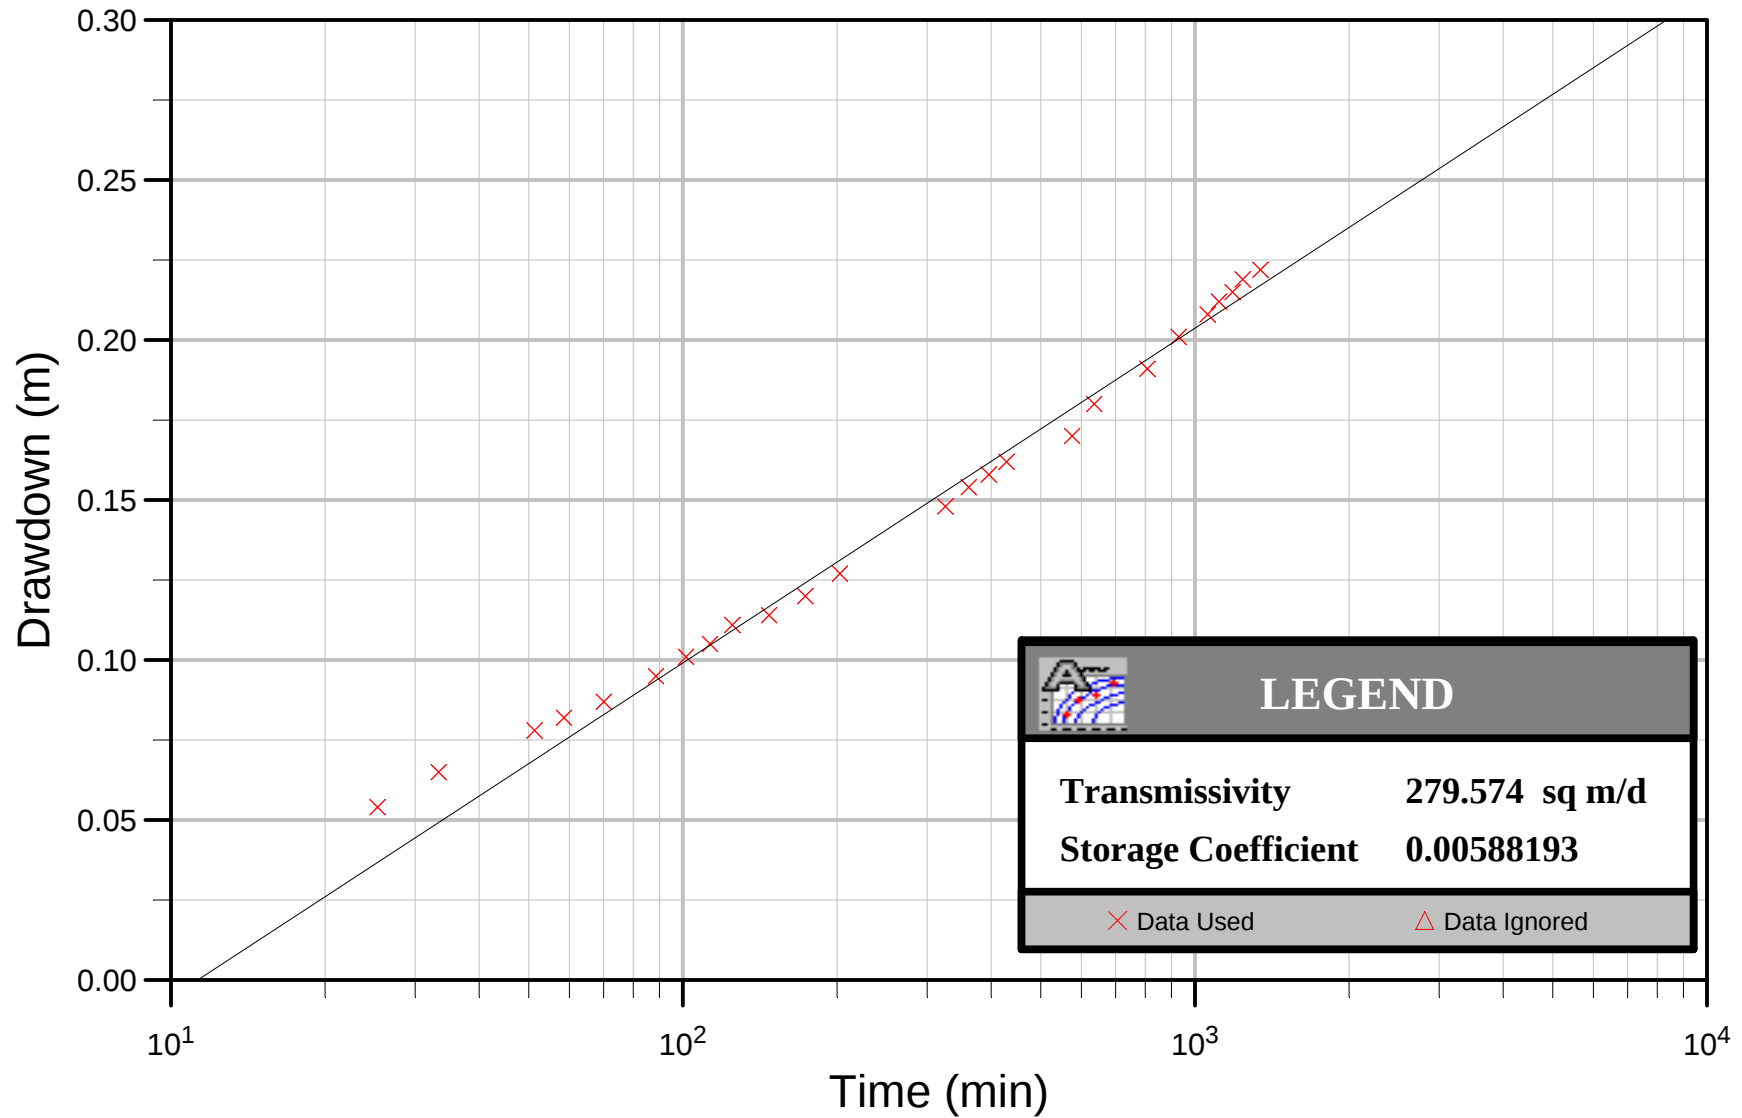
# BH4 Drawdown (PW3 - 30 gpm)

Cooper and Jacob Method, 1946

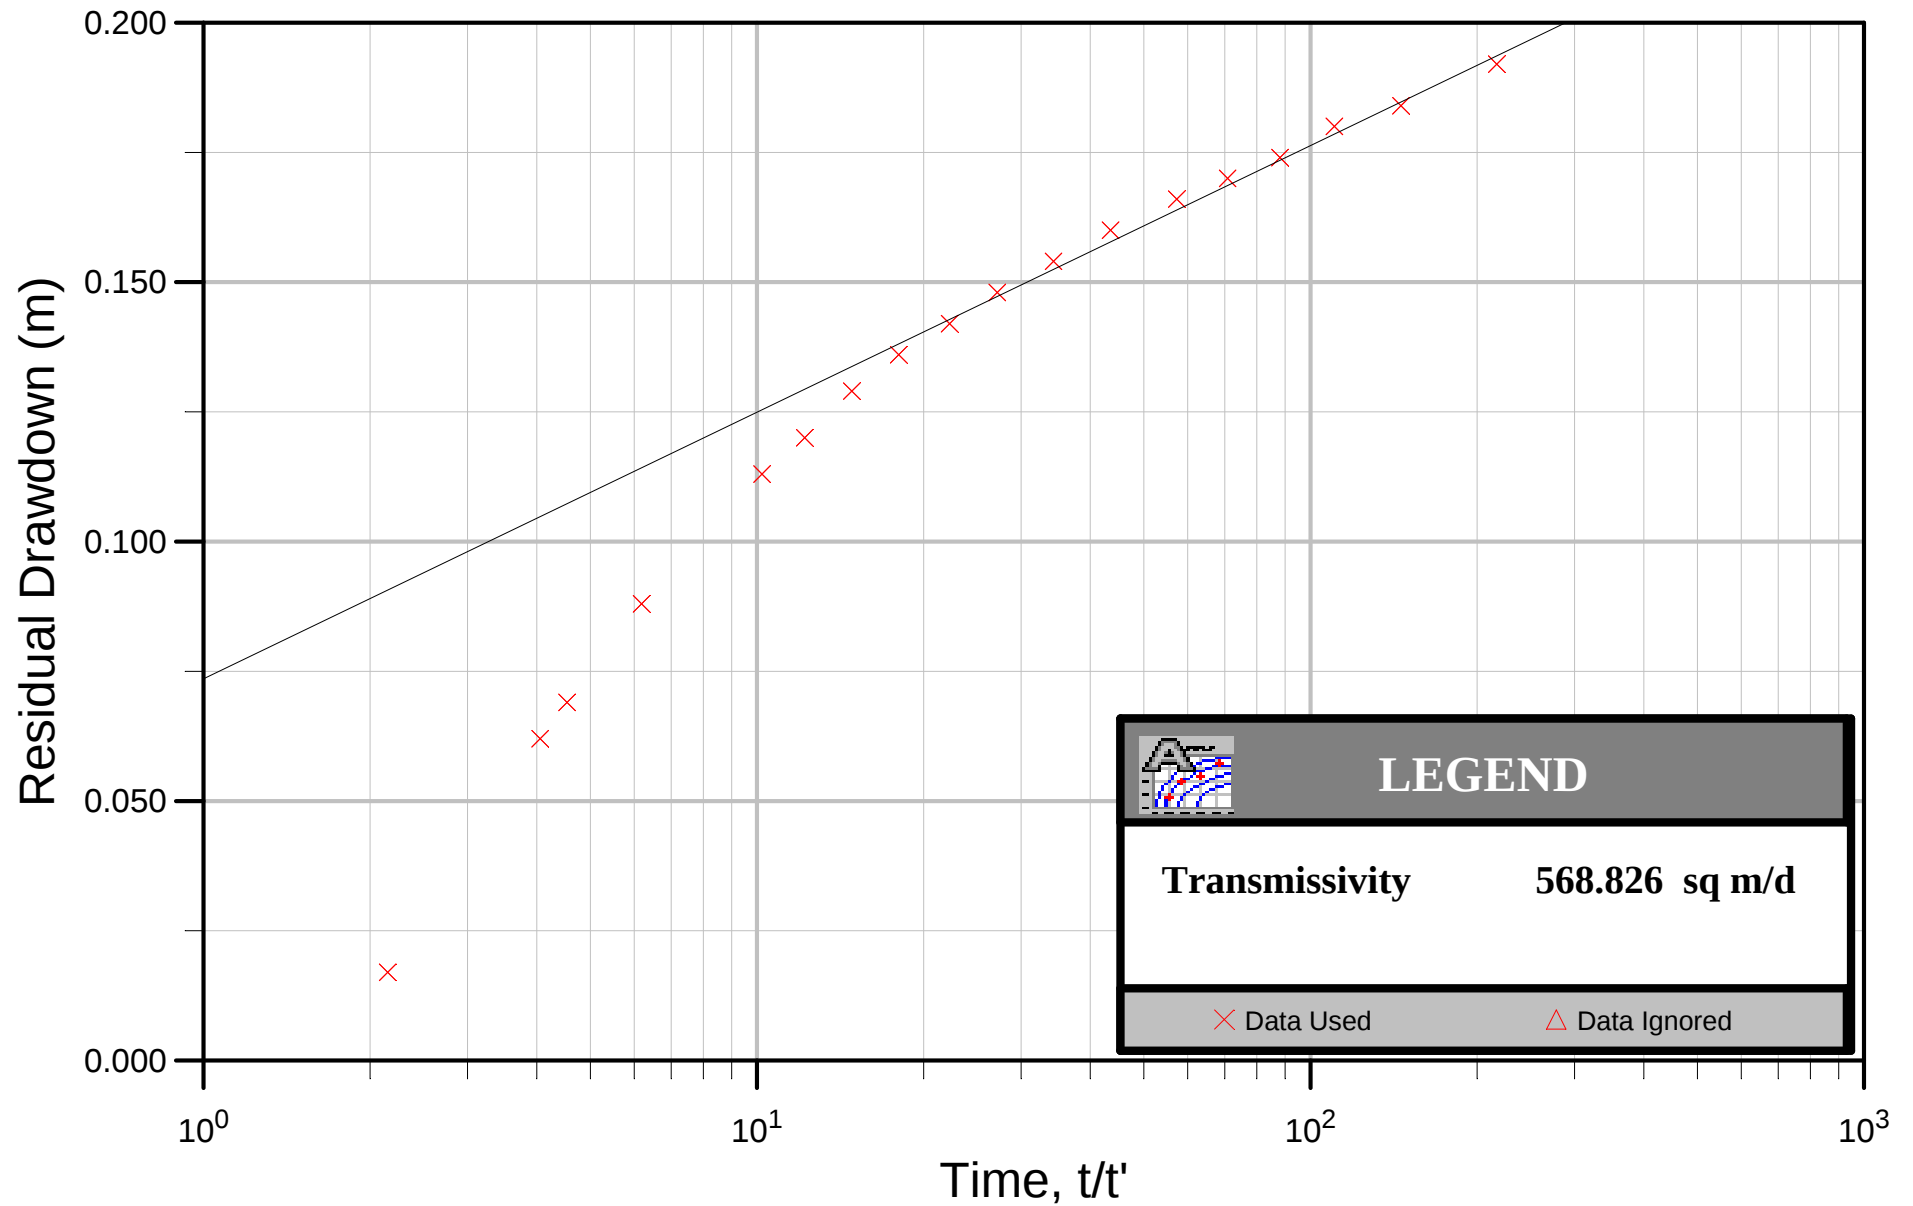
# BH4 Recovery (30 gpm)

Theis Recovery

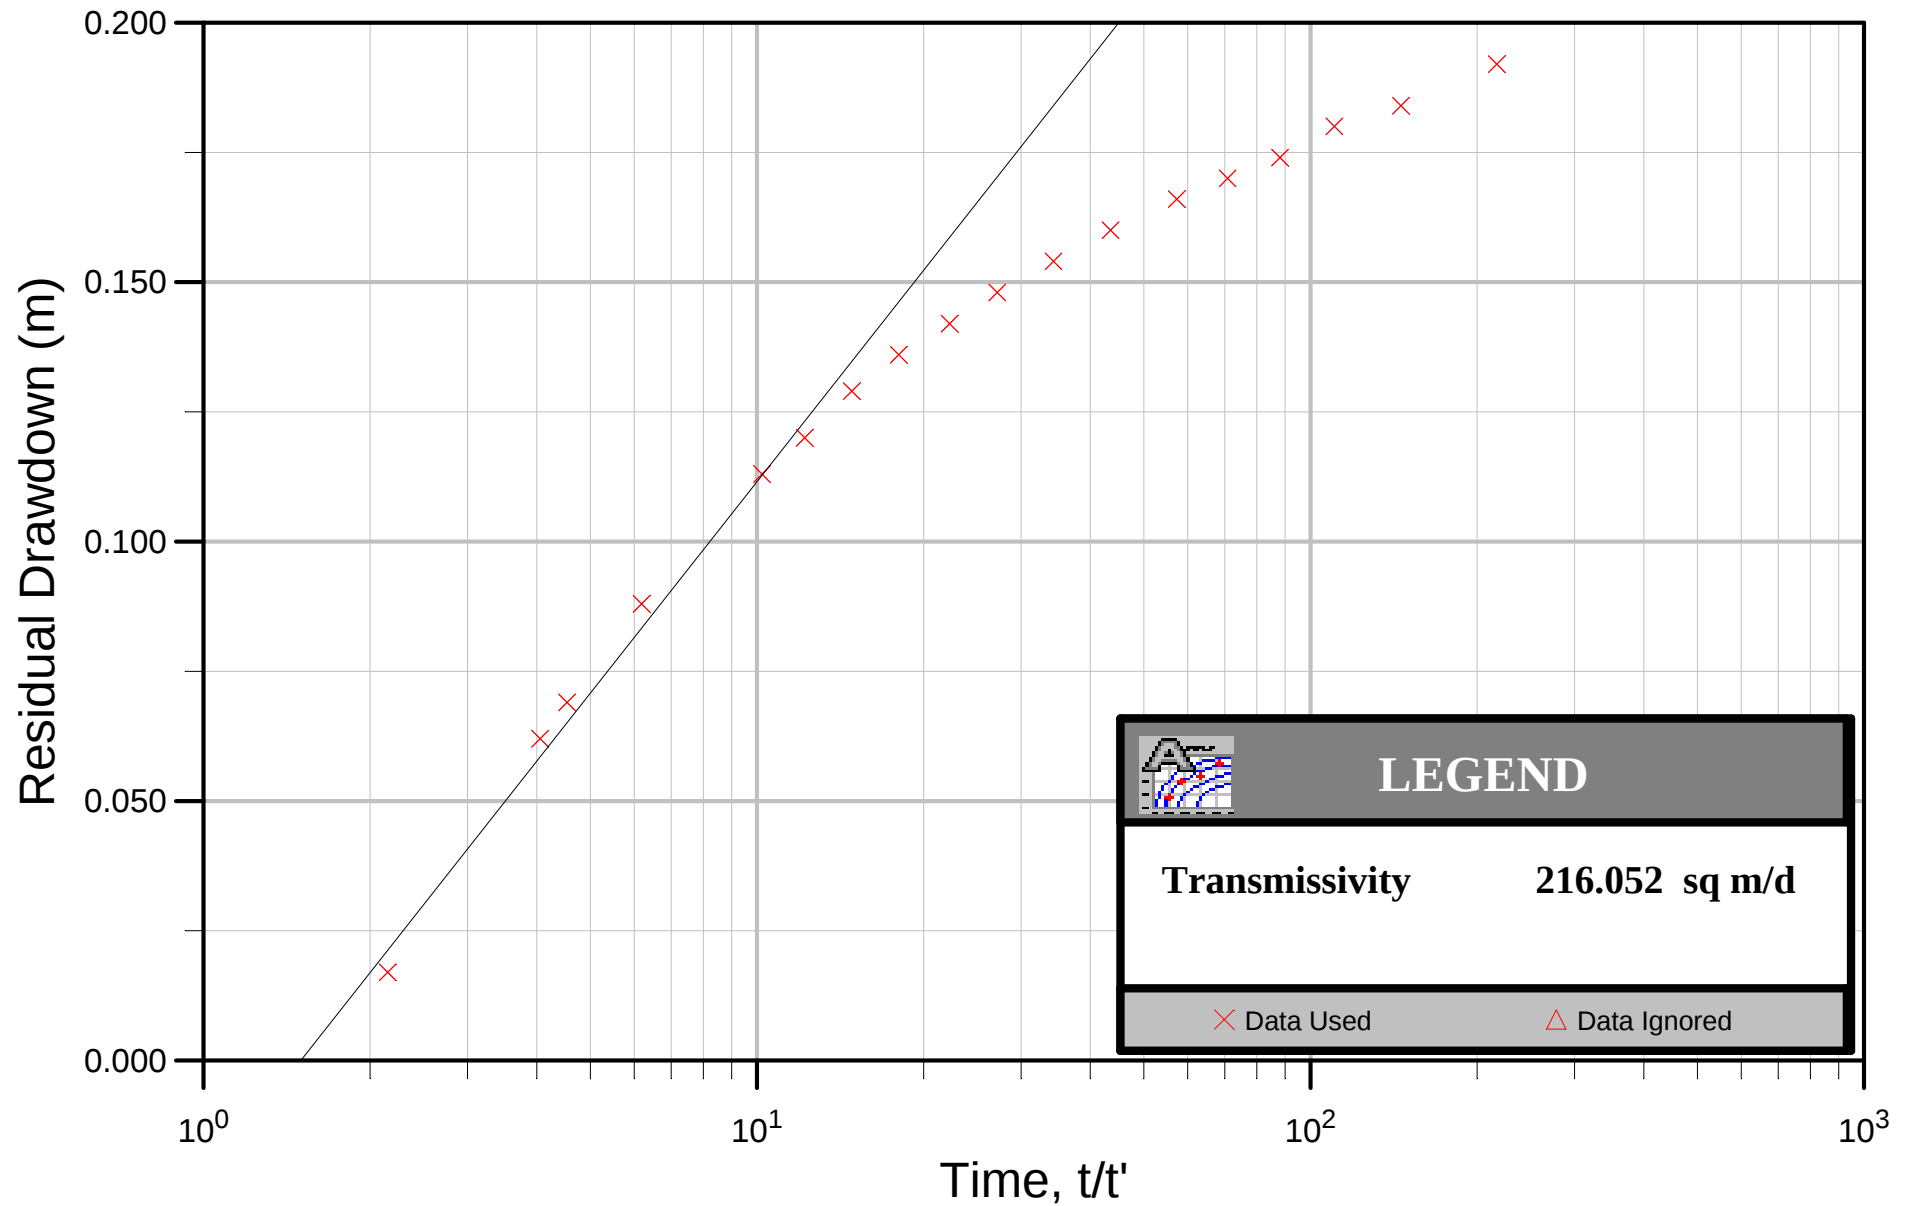
# BH4 Recovery (30 gpm)

Theis Recovery
