Project	Mount Nansen TA5 2013		
	Test	Government of Yukon - AAM		
	Location	N/A		
	Job No.	VM00605E.B001	Sample No.	GS5
	Hole No.	TP-T-13-04	Depth	3.0-3.1 m
ONE-DIMENSIONAL CONSOLIDATION TEST (ASTM D2435-90)	Reported by	CR/SH	Date Started	04-Feb-14

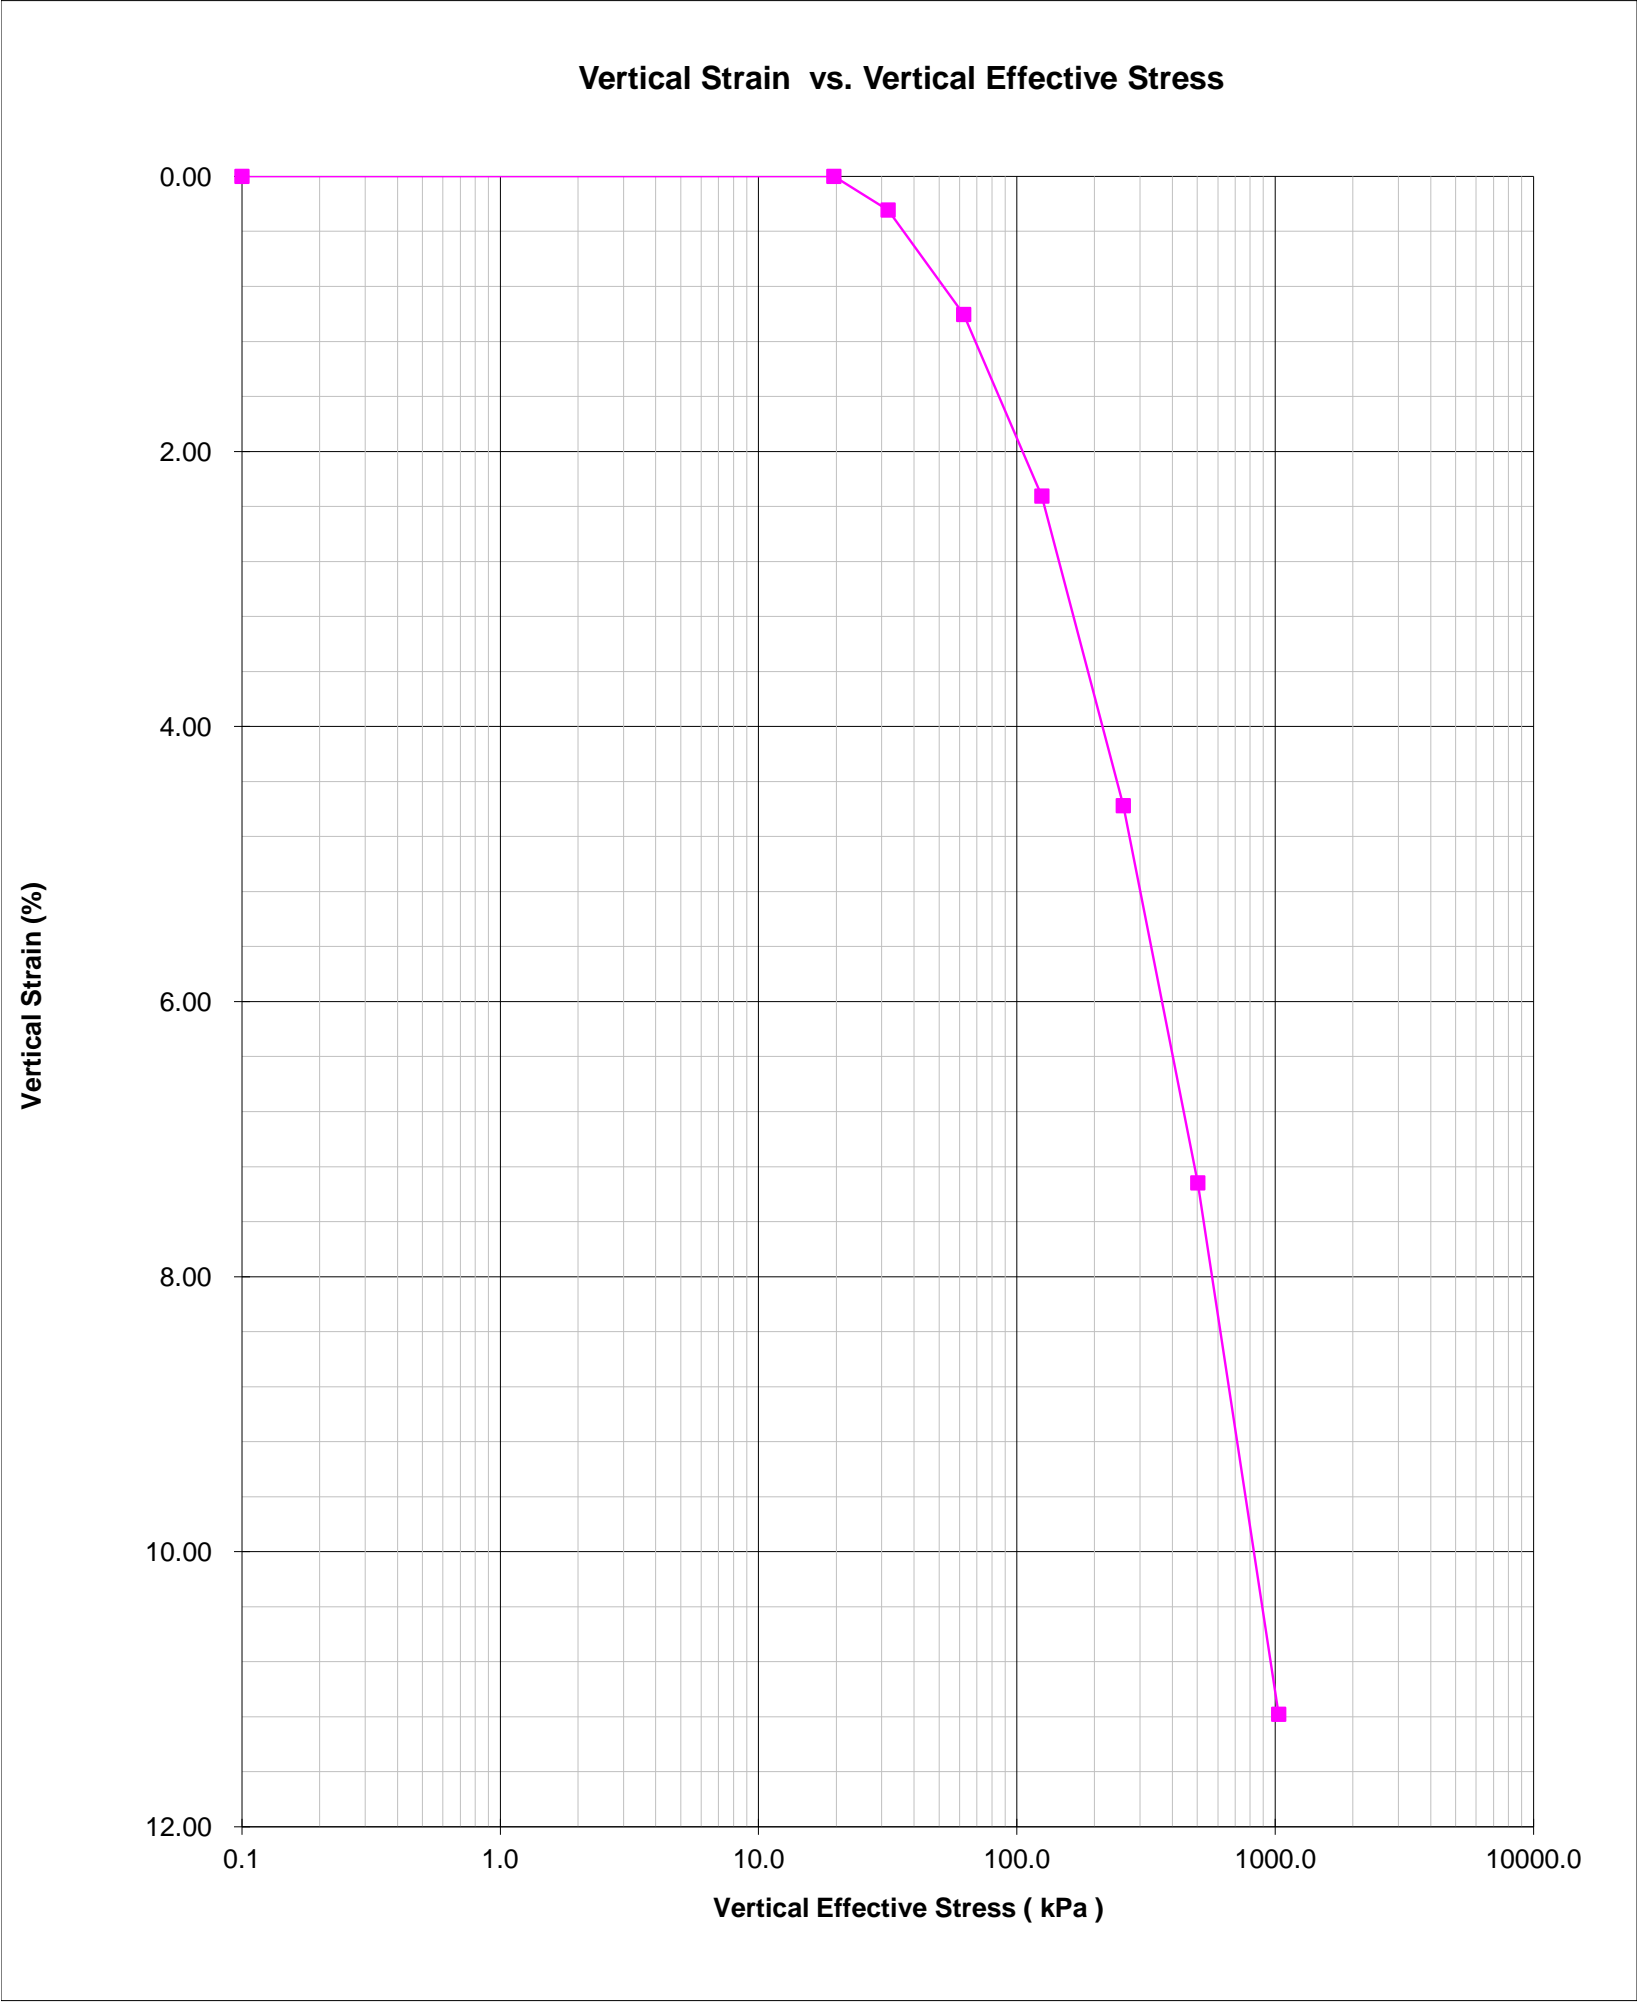
Project			Mount Nansen TA5 2013				
	Test			Government of Yukon - AAM				
	Location			N/A				
	Job No.		VM00605E.B001	Sample No.		GS5		
	Hole No.		TP-T-13-04	Depth		3.0-3.1 m		
ONE-DIMENSIONAL CONSOLIDATION TEST (ASTM D2435-90)			Reported by		CR/SH	Date Started		04-Feb-14

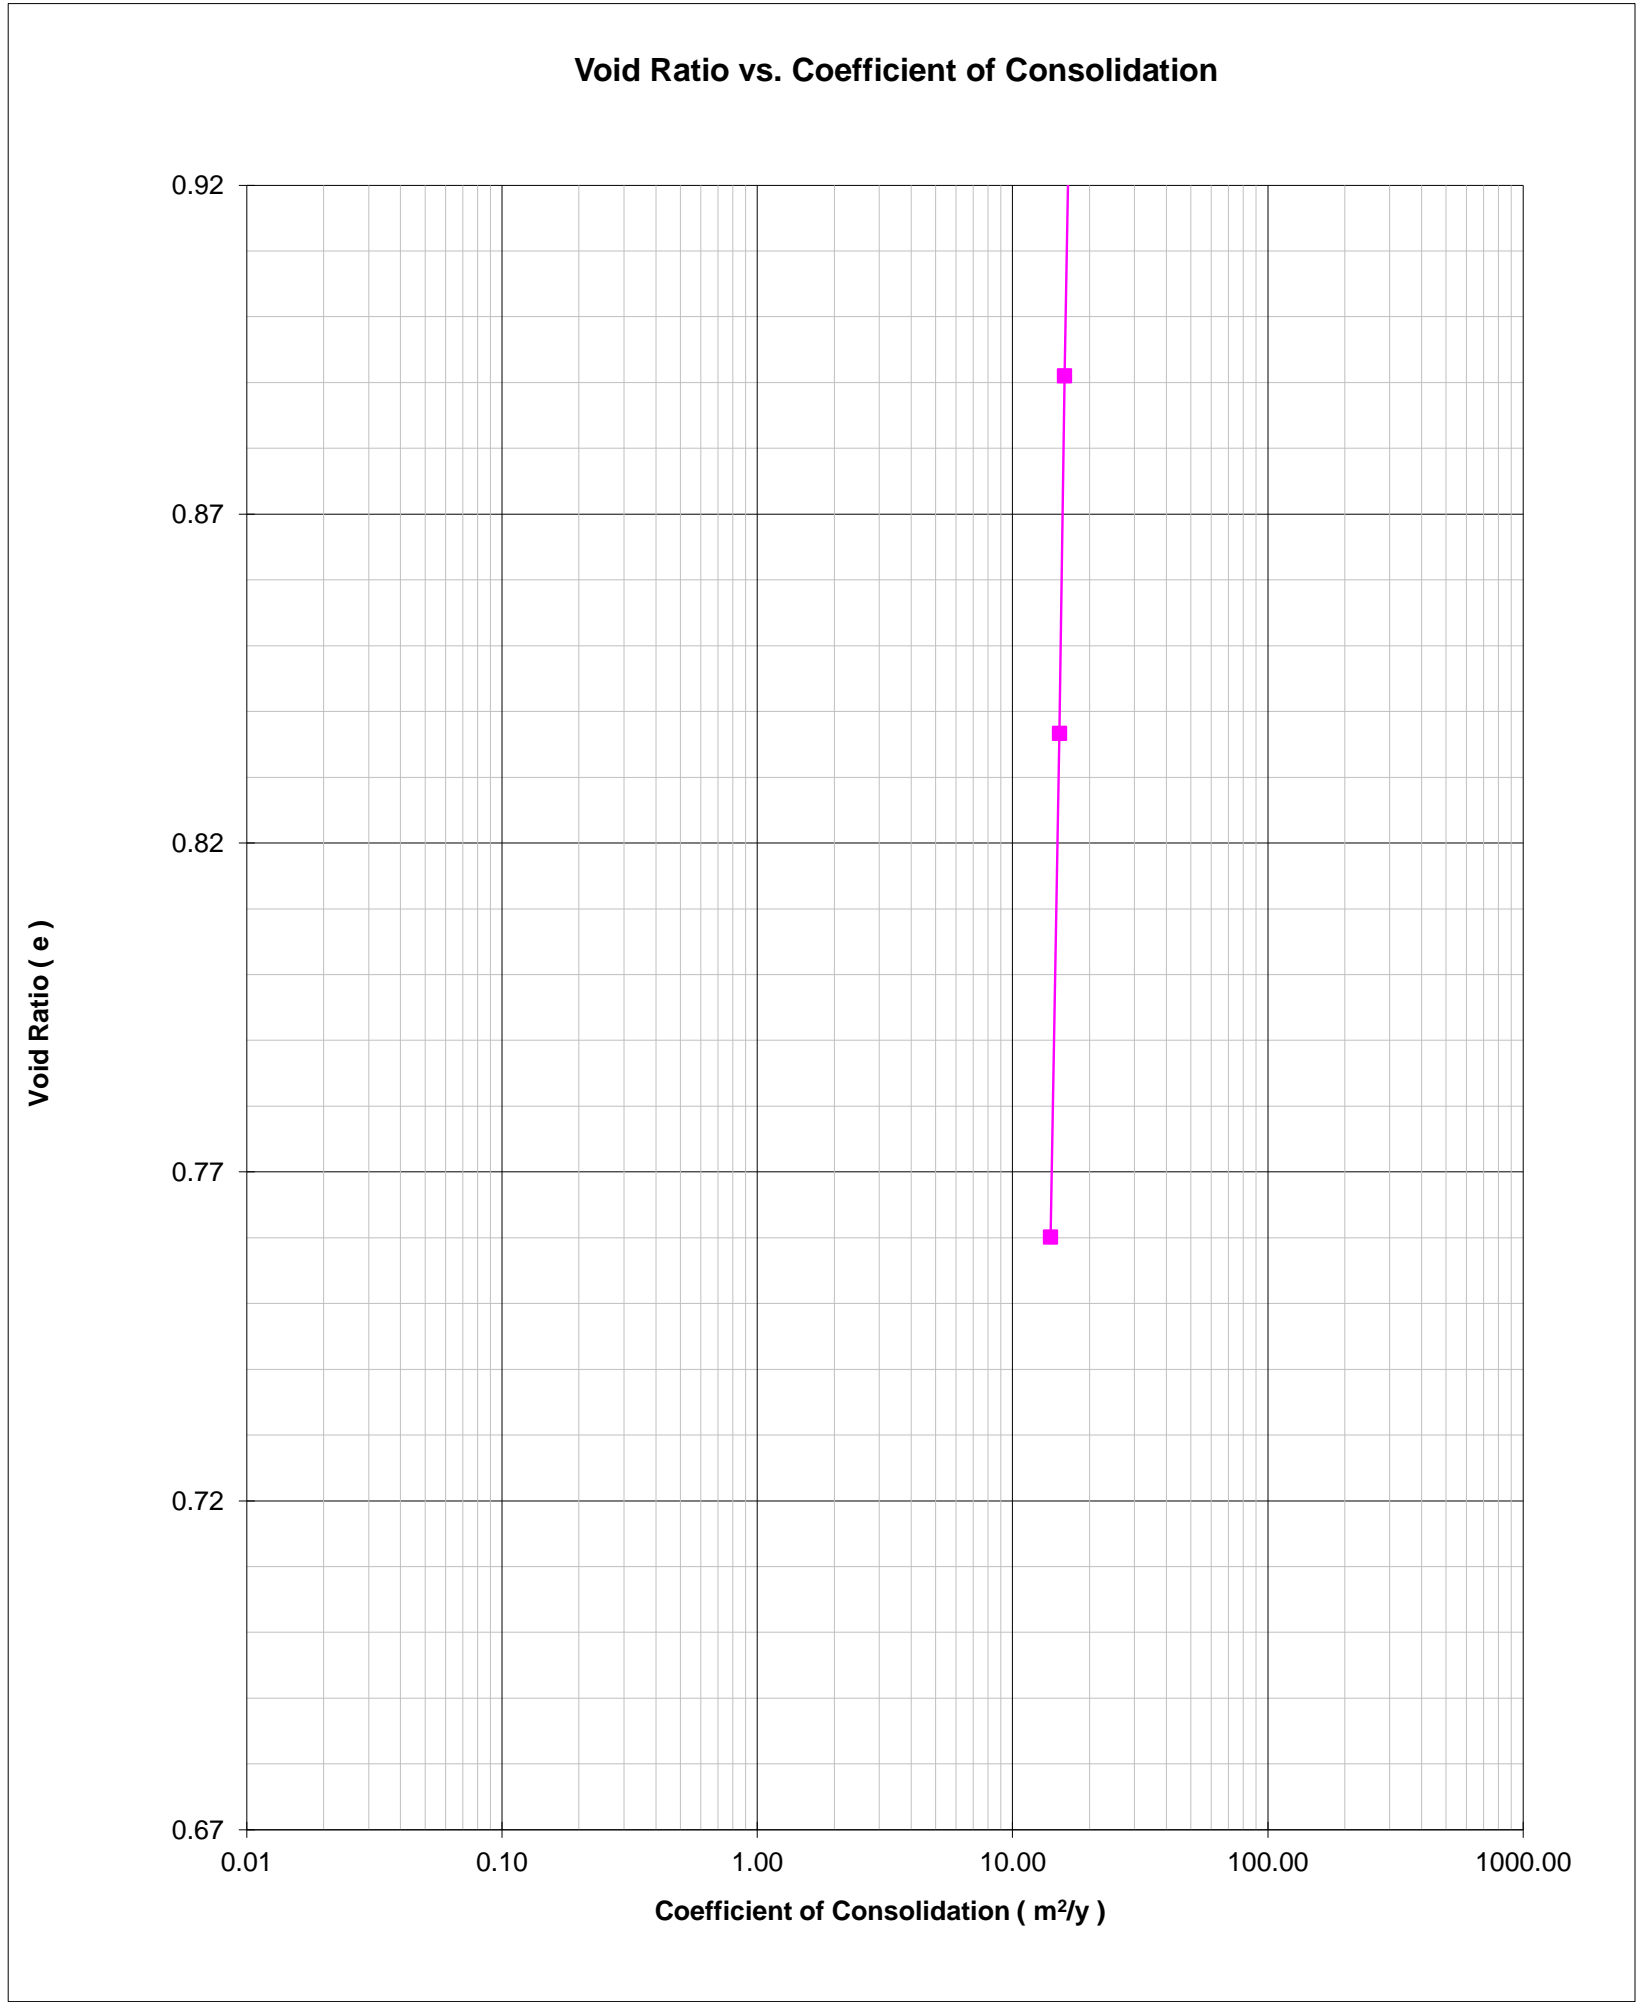
Project	Mount Nansen TA5 2013		
	Test	Government of Yukon - AAM		
	Location	N/A		
	Job No.	VM00605E.B001	Sample No.	GS5
ONE-DIMENSIONAL CONSOLIDATION TEST (ASTM D2435-90)	Hole No.	TP-T-13-04	Depth	3.0-3.1 m
	Reported by	CR/SH	Date Started	04-Feb-14
