# **Preliminary Seepage Collection Options**

## **Faro and Grum Waste Rock Dumps DRAFT**

**SRK Project Number 1CD003.53**

**November 2004**

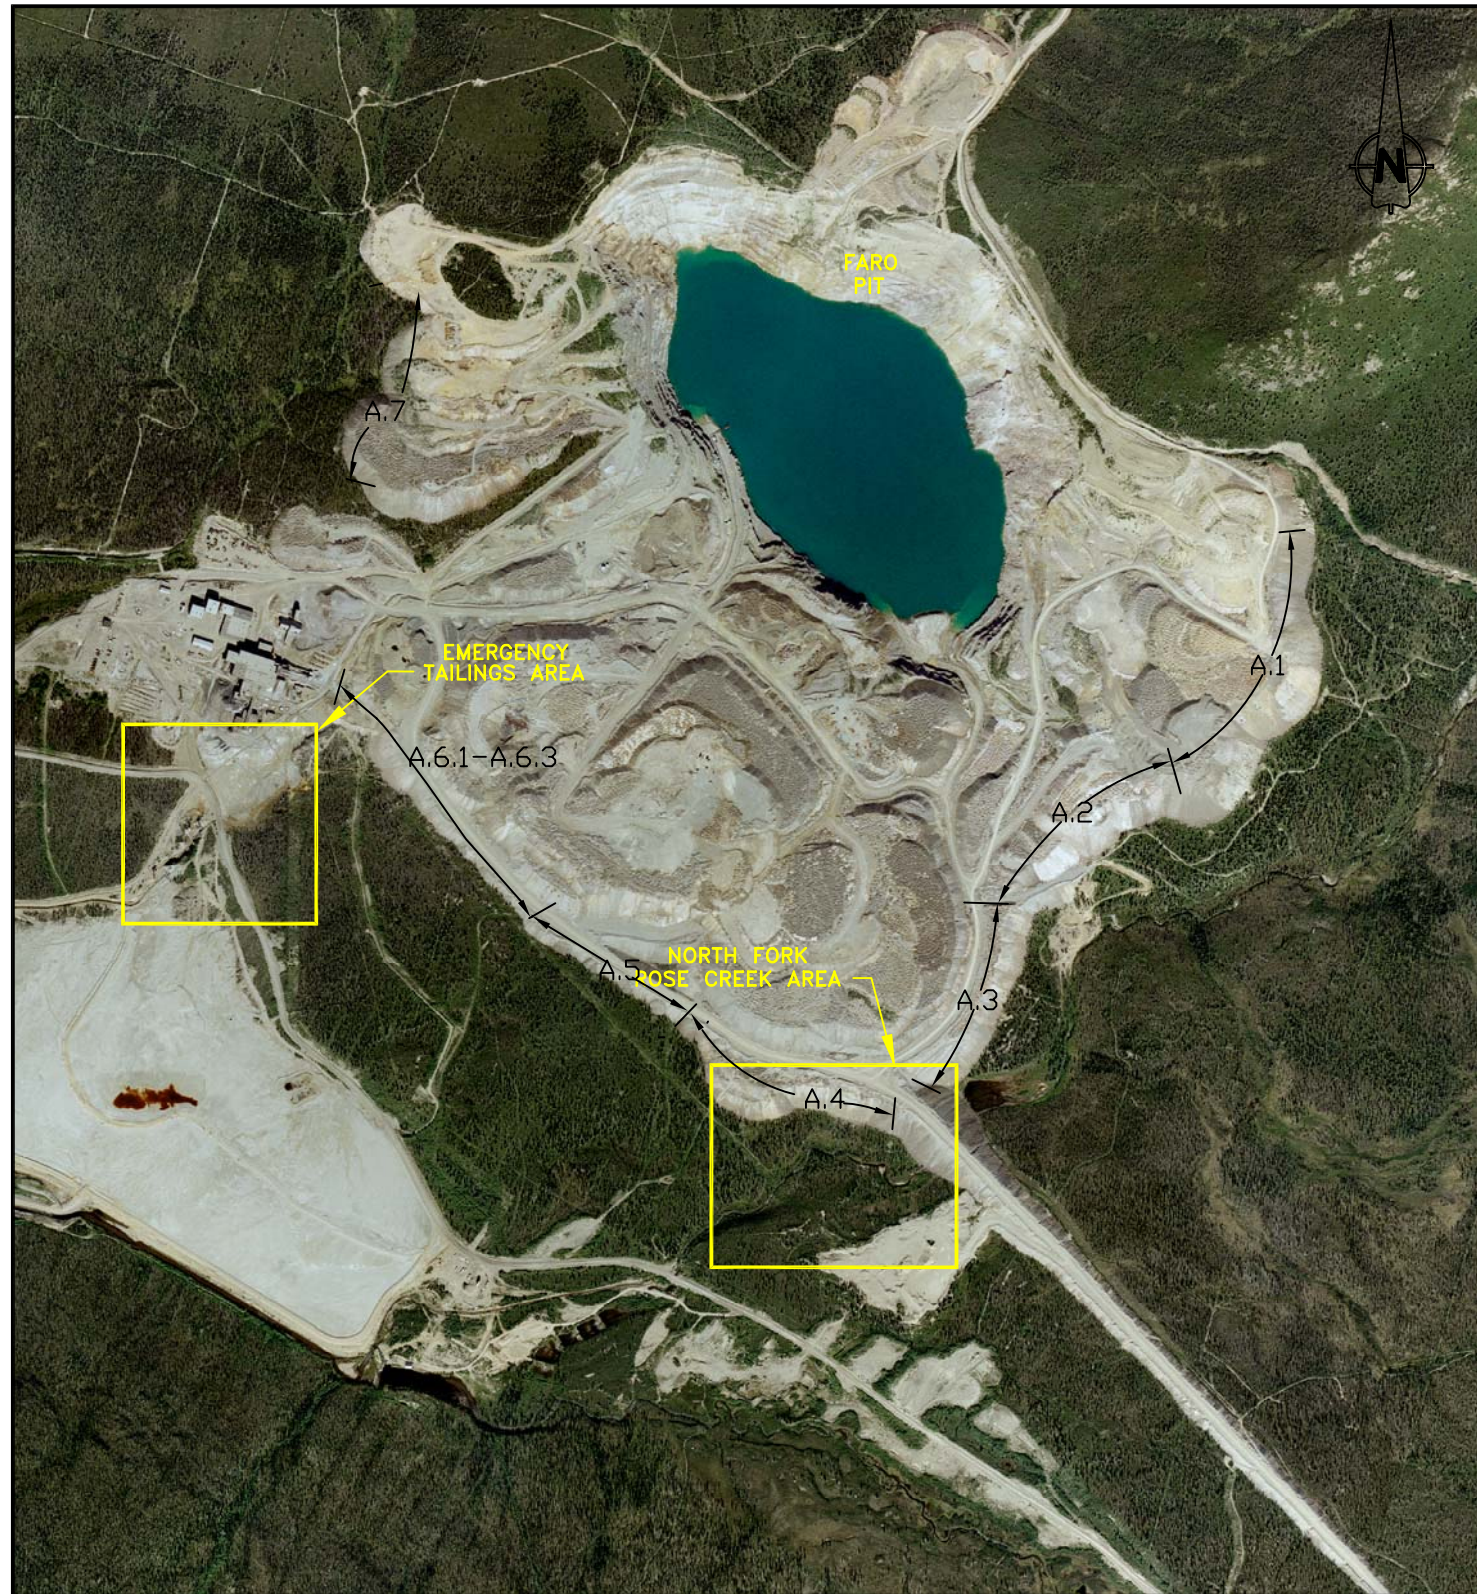
FARO PIT AREAS

GRUM PIT AREA

A recent review of available groundwater quality data at the Faro Mine site by Robertson GeoConsultants Inc. (RGC) indicated elevated levels of acid rock drainage (ARD) related contaminants in groundwater at various locations around the Faro and Grum mine sites. As part of the on-going closure planning for the site, SRK was retained by Deloitte Touche to carry out additional field investigations to better characterize local groundwater conditions and to assess options to intercept any ARD impacted seepage for collection and treatment. This report presents the results of the 2004 groundwater investigation and seepage collection assessment for three previously defined areas of waste rock dump seepage: (i) the Emergency Tailings Area (old Faro Creek valley), (ii) North Fork Rose Creek below the rock drain and (iii) the Grum Creek areas, which were identified during the initial review and planning stage as the areas with highest priority for seepage interception (Figure 1). Lower priority areas were not completed as part of this program.

Based on the results of this groundwater quality review, a preliminary priority listing of recommended hydrogeological field studies was developed, including test pitting, seismic surveying, drilling, well installation, and hydraulic testing (Table 1 in Appendix A). The three reaches given a high priority ranking for the 2004 field investigation included (i) the Emergency Tailings Area (old Faro Creek valley), (ii) North Fork Rose Creek below the rock drain and (iii) the Grum Creek areas, which were identified during the initial review and planning stage as the areas with highest priority for seepage interception (Figure 1).
