***RESEARCH OF FORMER  
MILITARY SITES & ACTIVITIES  
IN THE YUKON***

**Action on Waste Program  
Arctic Environmental Strategy (AES)  
Indian and Northern Affairs Canada**

**APRIL 1995**

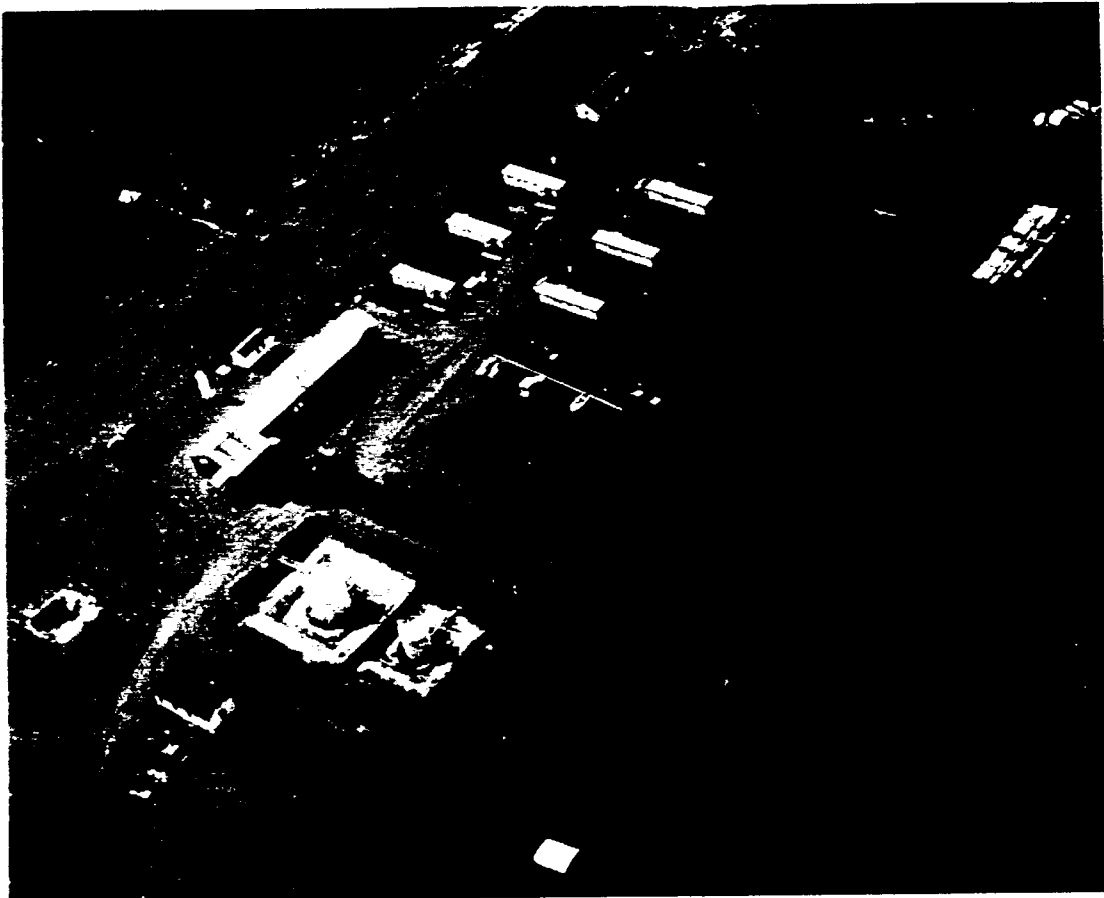
b. Two low pressure oil fired steam boilers and two 60 KW generators, which are powered by Caterpillar engines, are in the generator area.
4. FAMILY HOUSING. The housing facilities provided for these stations are comprised of six 10' by 50' trailers at each site. They are partially furnished and have steam heat piped in from the central heat plant. The utilities are furnished through an underground utilidor running from the utility building. Automatic heat controls are provided in each trailer.

*Destruction Bay Pump Station, 9.9 acres in area, is located at Milepost 1080 on the Alaska Highway.*
