# SNAG AIRSTRIP REMEDIATION/FOLLOW-UP

Snag, Yukon

March, 1999  
File: YT20501/281-004.02

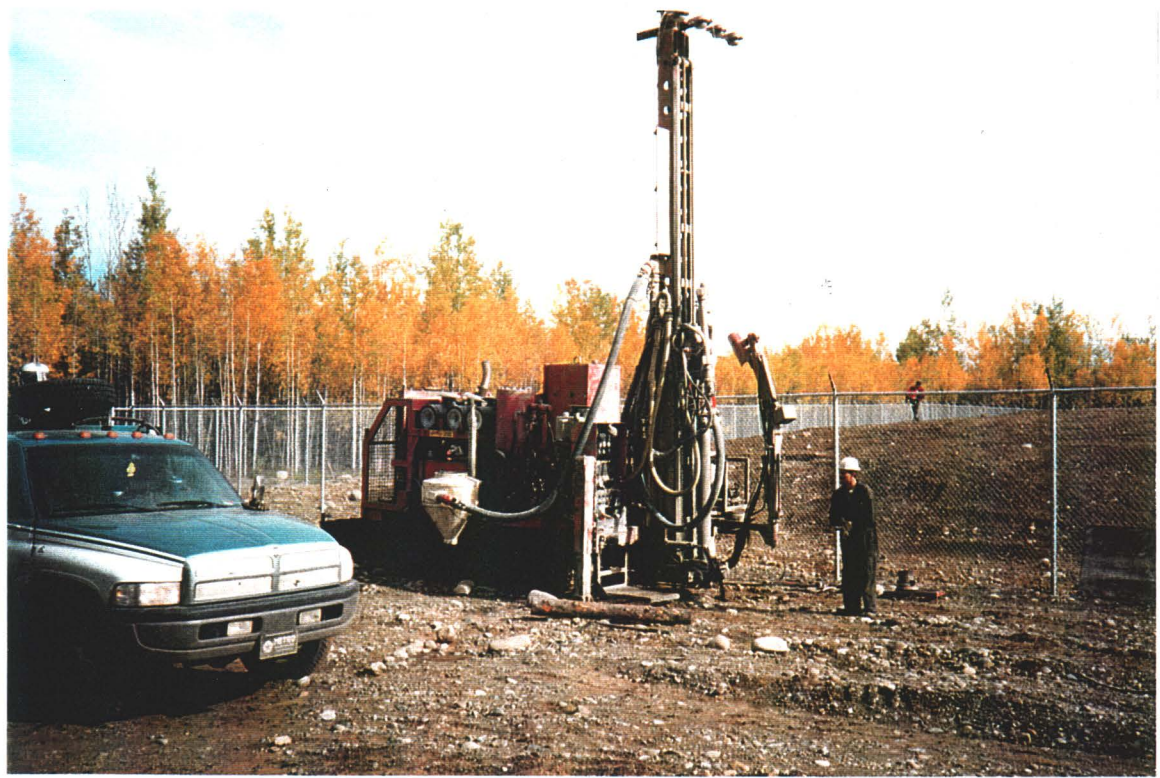
**PHOTO 1: Air Rotary Drill.**

Note: Seeding taking place in background, using manual broadcast seeder.

In September of 1997, an air rotary drill rig from Midnight Sun Drilling was mobilized to the site (Photo 1). Drill holes were advanced to the groundwater table on the four sides of the containment cell using the percussive action of an air hammer drill bit and monitoring wells were installed (monitoring wells H97-4, H97-5A, H97-6 and H97-7). Monitoring well H97-5 had to be re-drilled as the hole was lost during the installation due to bentonite falling into the standpipe. It was re-drilled 1 metre away and designated H97-5A. The standpipe for H97-5 was cut to ground level and backfilled. The cuttings were brought to surface using compressed air. Visual logging of the cuttings allowed for an assessment of the stratigraphy as well as the depth of the water table. No soil samples were submitted for analysis.

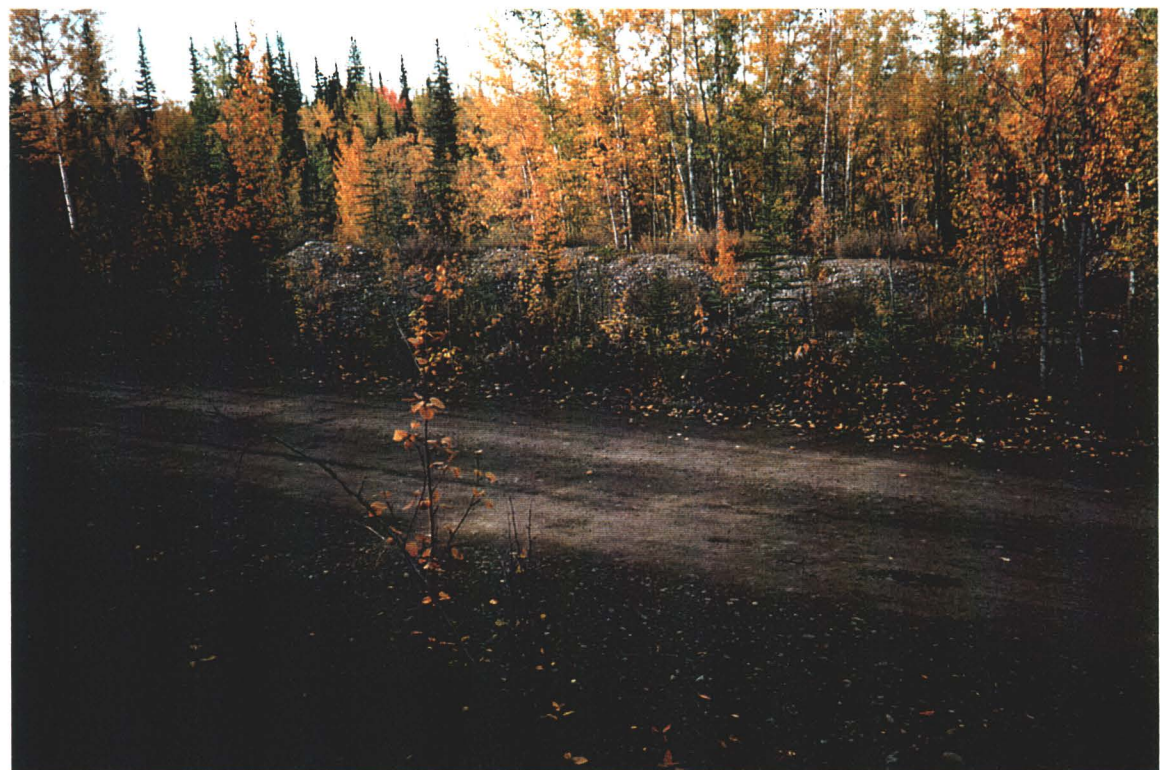
**PHOTO 2: Gravel Pit Above Newly Discovered Landfill.**

Gravel berm defines upper edge of landfill.

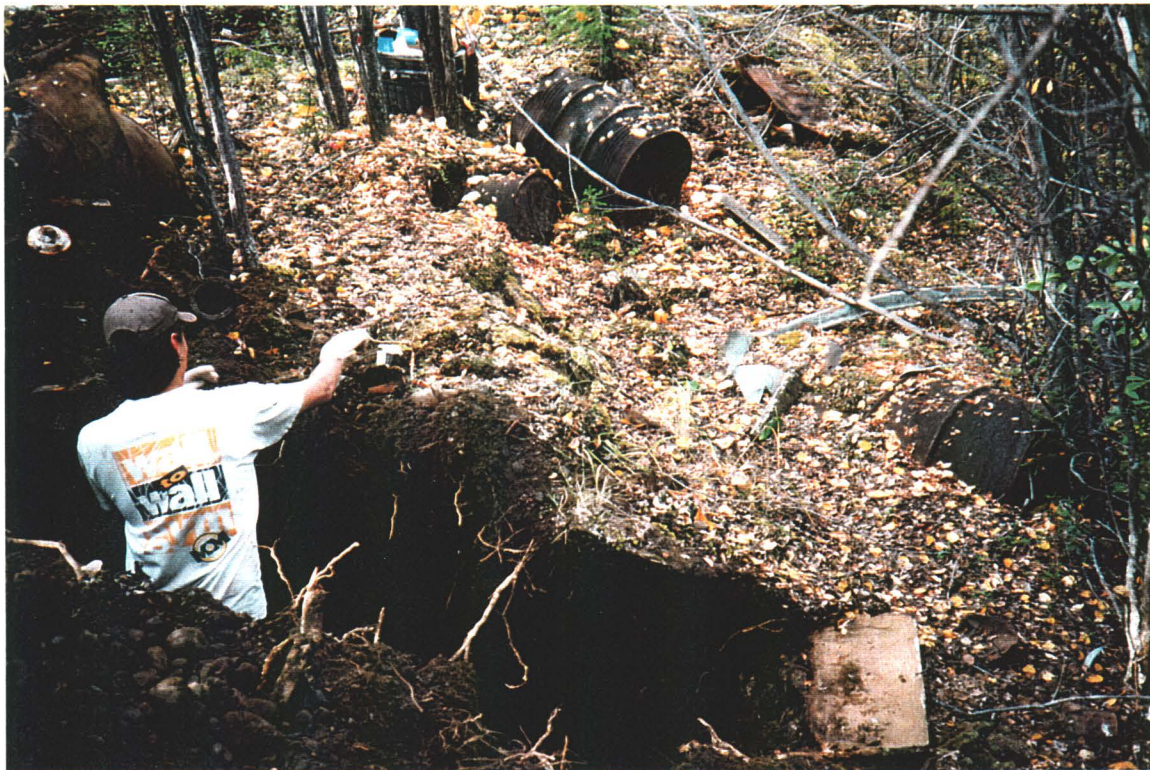
**PHOTO 3:** Drums & Other Metallic Debris Strewn Around Landfill.

The stratigraphy in the vicinity of the new landfill consisted of either sand and gravel, with cobbles to 0.18 m diameter, or landfill material over a clayey silty permafrost bearing soil (Photos 3 and 4). The sand and gravel soil was found in test pits located near the top of or above the landfill. The landfill material was likely characteristic of the activities taking place at the Snag airstrip. It consisted of cans, bottles, car and machinery parts, drums, pipes, lumber, clothing, tires, chains and wire, among other things.

In order to prevent any erosion of metallic debris and perhaps further contamination of soil with metals, it is recommended that the landfill be covered with a 0.5 m layer of sand and gravel. The area is fairly densely vegetated and the natural evolution and growth of this vegetation on the covered area will act to further reduce the risk of erosion of material from the landfill.
