**RAINY HOLLOW AND BORDER PUMP STATION,  
BRITISH COLUMBIA, CANADA:  
SUMMARY REPORT FOR SITE REMEDIATION  
AND ANNUAL MONITORING PROGRAM**

Indian and Northern Affairs Canada  
Waste Management Program, Whitehorse, Yukon

Royal Roads University  
Applied Research  
Science Technology & Environment Division

September 2002

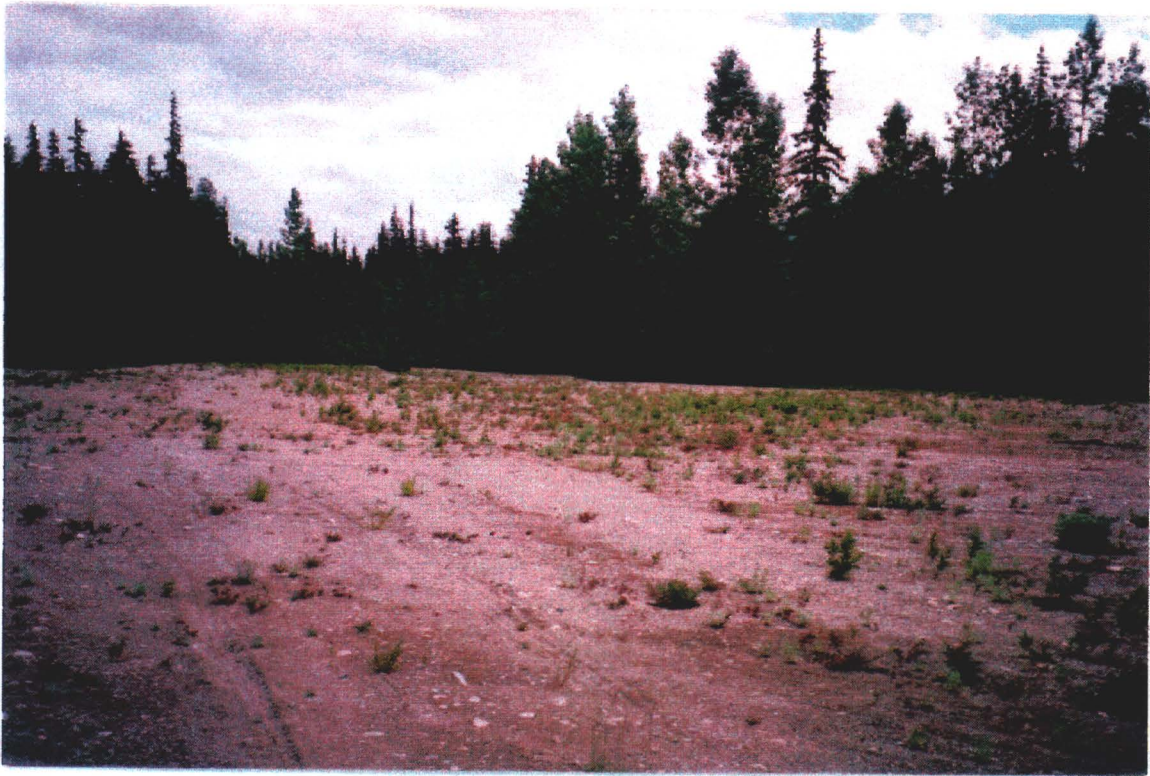
Rainy Hollow: Looking along the gravel cap.

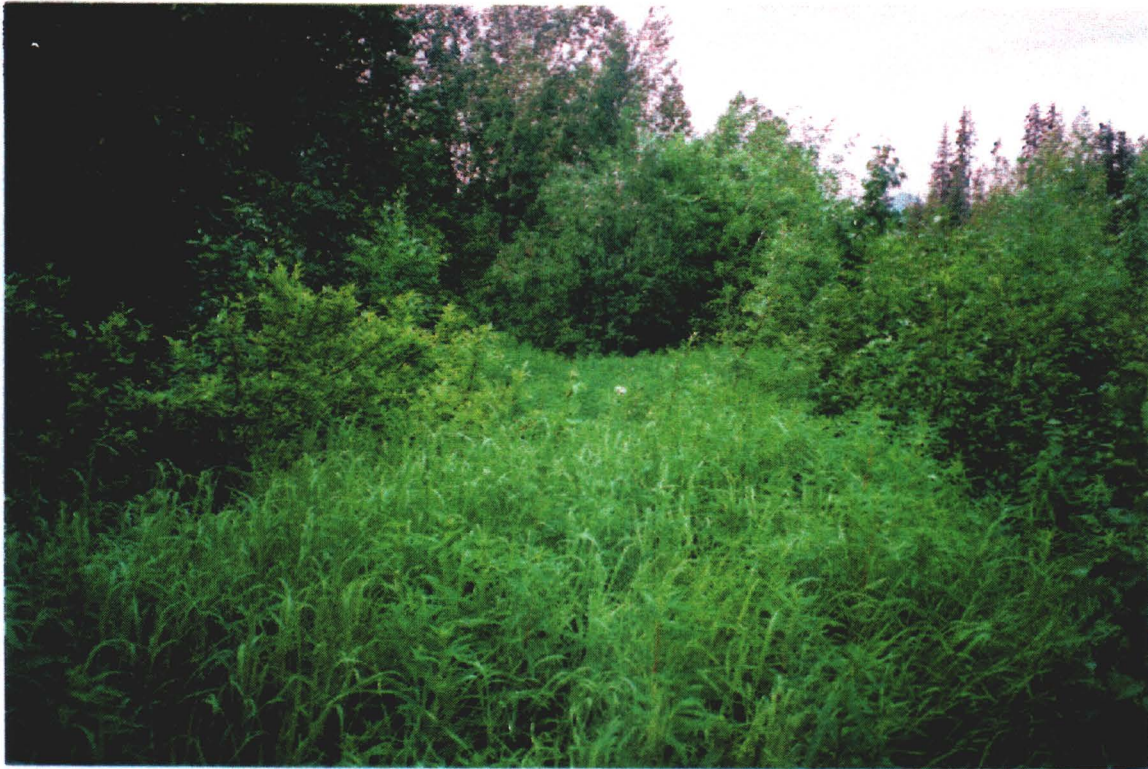
Rainy Hollow: Looking towards the Klehini River

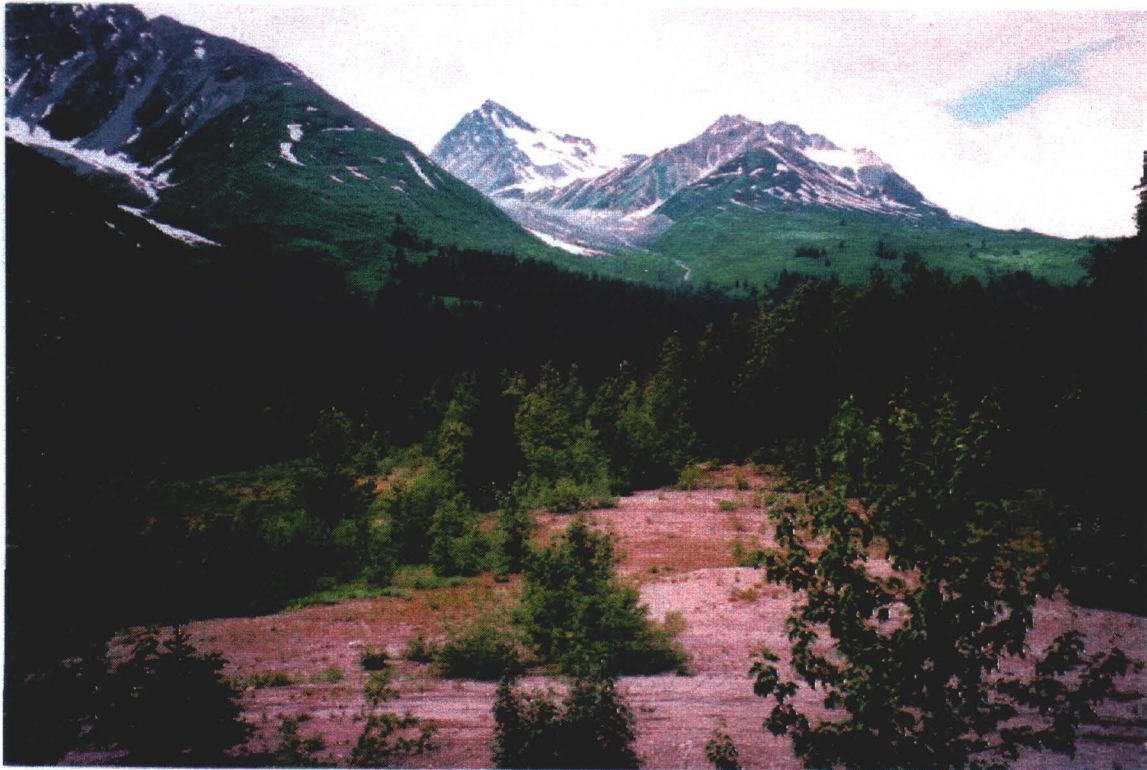
Border Station: Gravel cover over former Temporary Storage Area looking north

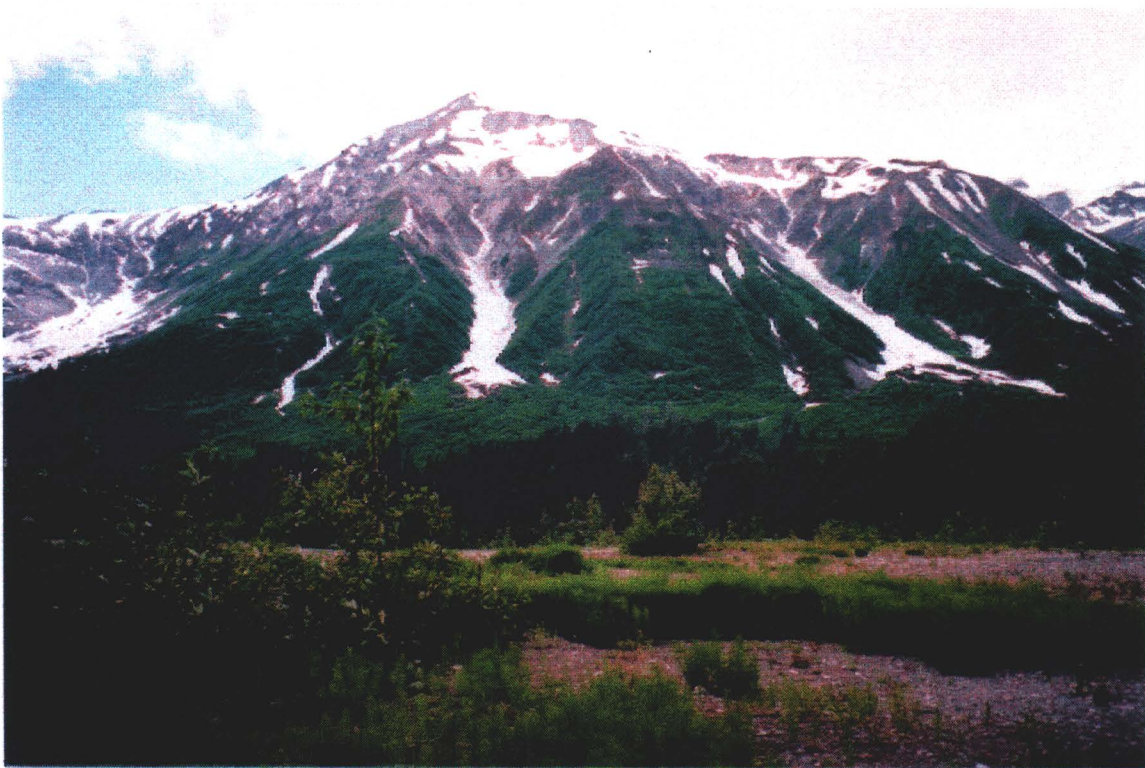
Border Station: View of gravel cover over form Temporary Storage facility from the POL area
