ASSESSMENT REPORT

116C-08-1

CALEY

DIAND TECHNICAL SERVICES

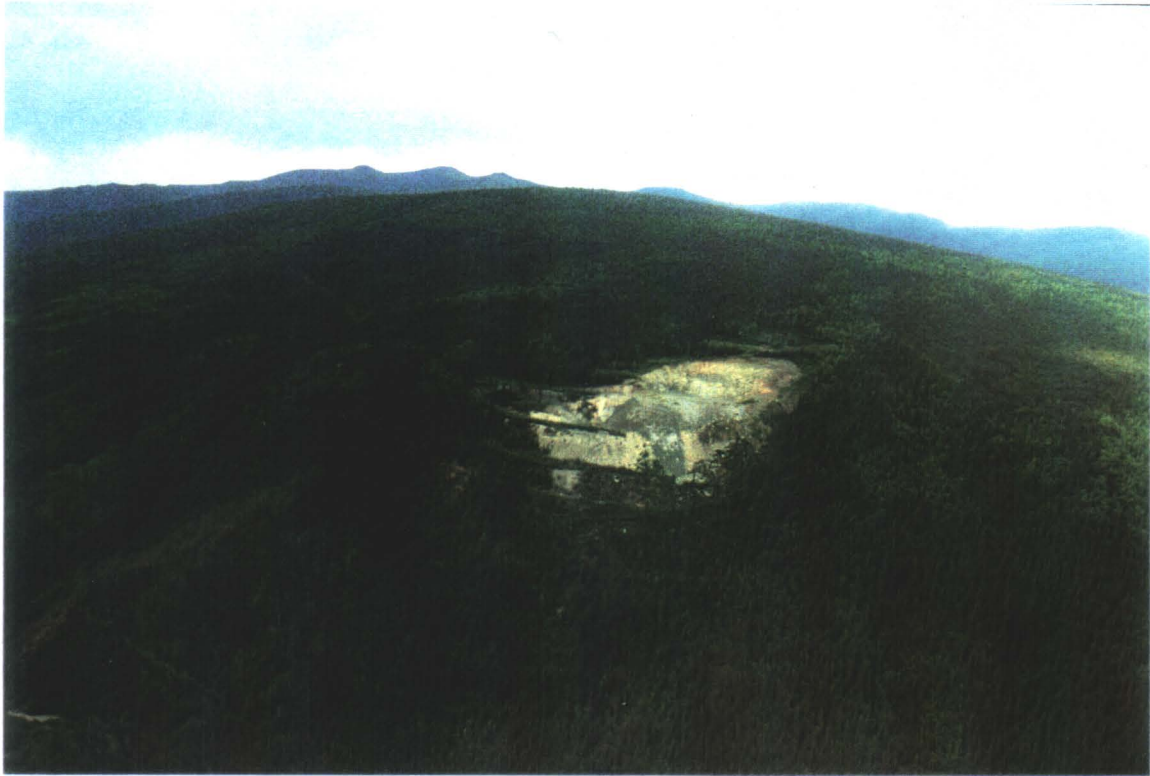
DISTANT VIEW OF MINE

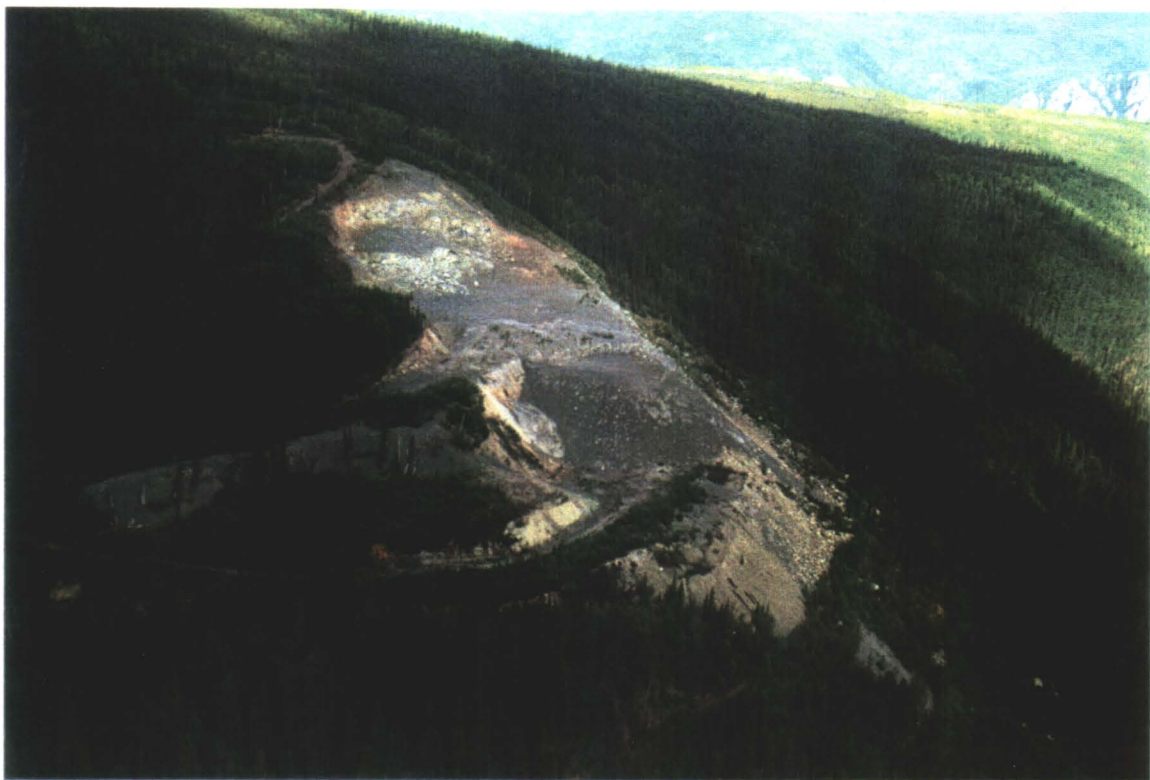
Disturbance is confined to the mine location which covers an area approximately 100x200m in size. All vegetation has been removed from this area with the surface material consisting of either competent bedrock or broken bedrock. Reshaping or revegetating the site is not considered practical as little will grow on the stripped areas. The only way of enhancing growth at this site would be to recover adequate amounts of surficial soils, spread it over this area, and seed it. No stockpiles of surficial soils were found at this site and this material would have to be imported at great cost. With this in mind it should be understood that this site is not expected to grow a cover of vegetation for a very long time at this remote site. It is recommended that the site be left to recover naturally. Attempting to revegetate the area would not likely be very effective in this remote dry location with a very harsh climate and short growing season.

OVERVIEW OF MINE

No additional work is recommended for this site. The site has experienced only surface disturbance and some of this area will eventually revegetate naturally. Site levelling is not recommended as it will disturb an even larger area that has been disturbed to date.

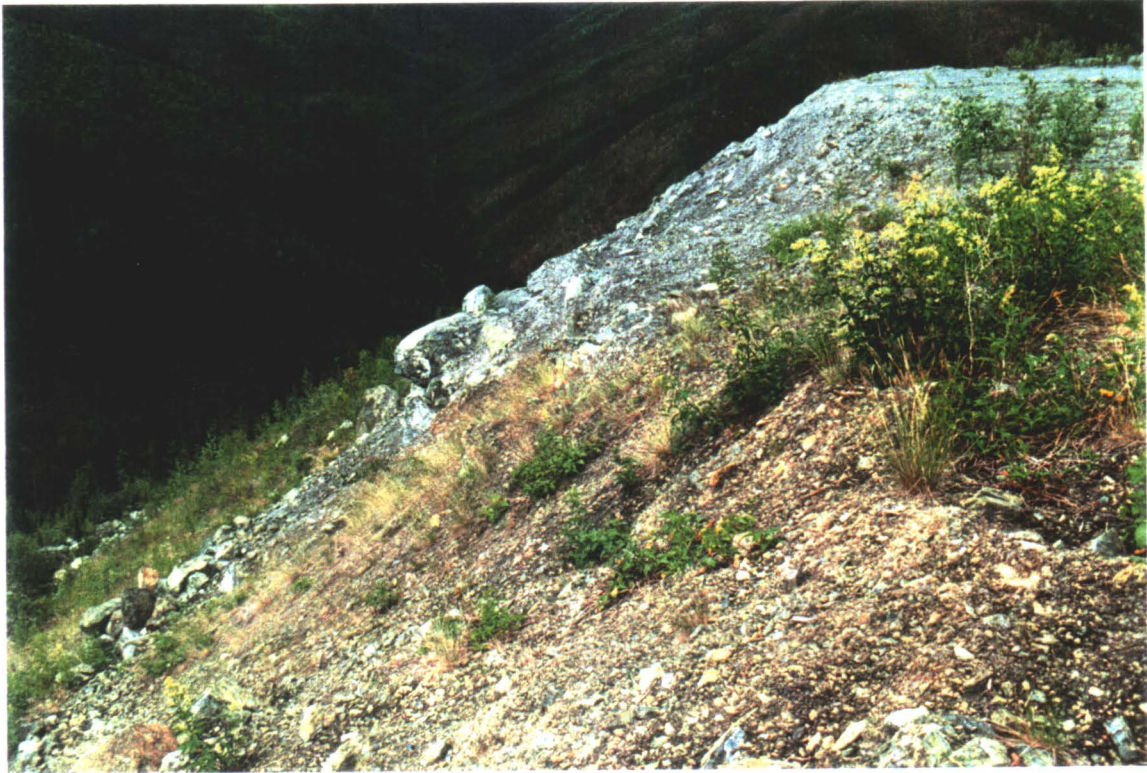
229073 tonnes of ore has been removed from an open pit and hauled off-site, leaving a large open pit. Waste material has been dumped downslope of the mine but is well above Cassiar Creek. The vegetation has been removed wherever the mining and placement of the waste rock took place.

WASTE ROCK DUMP

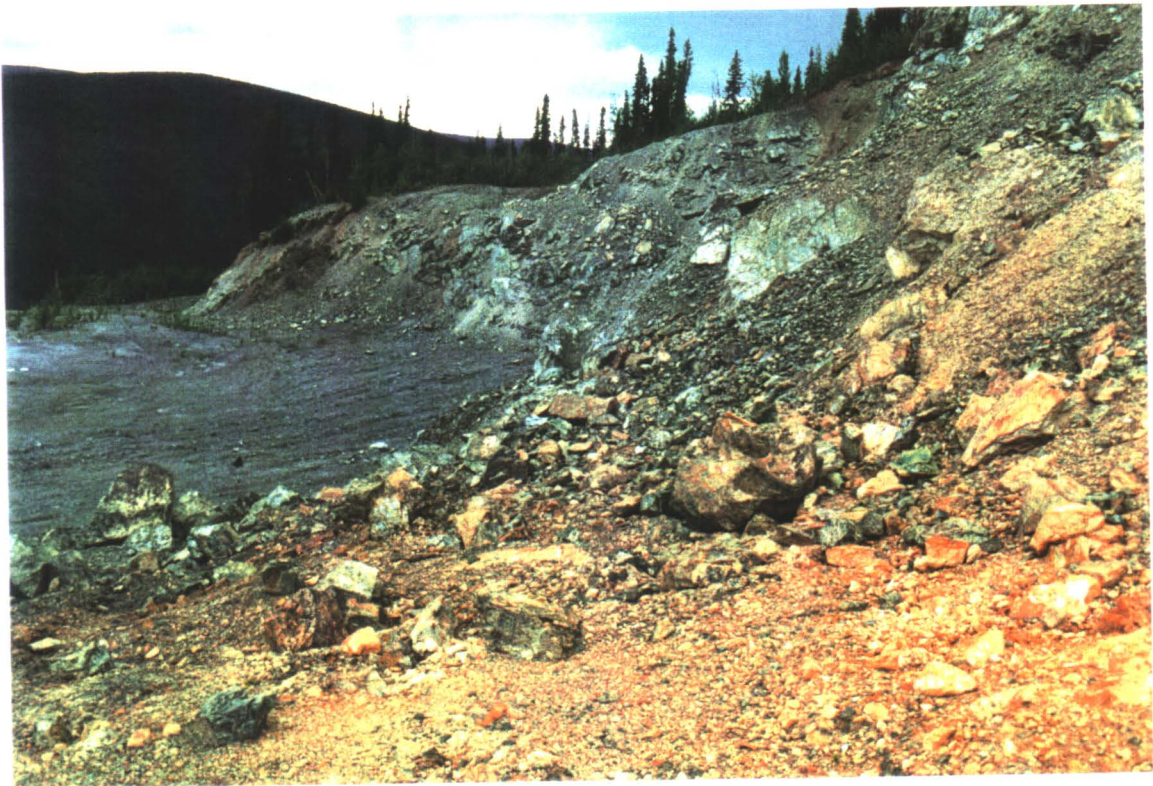
MINE EXCAVATION
