ASSESSMENT REPORT

105D-06-2

GOLD HILL

DIAND TECHNICAL SERVICES

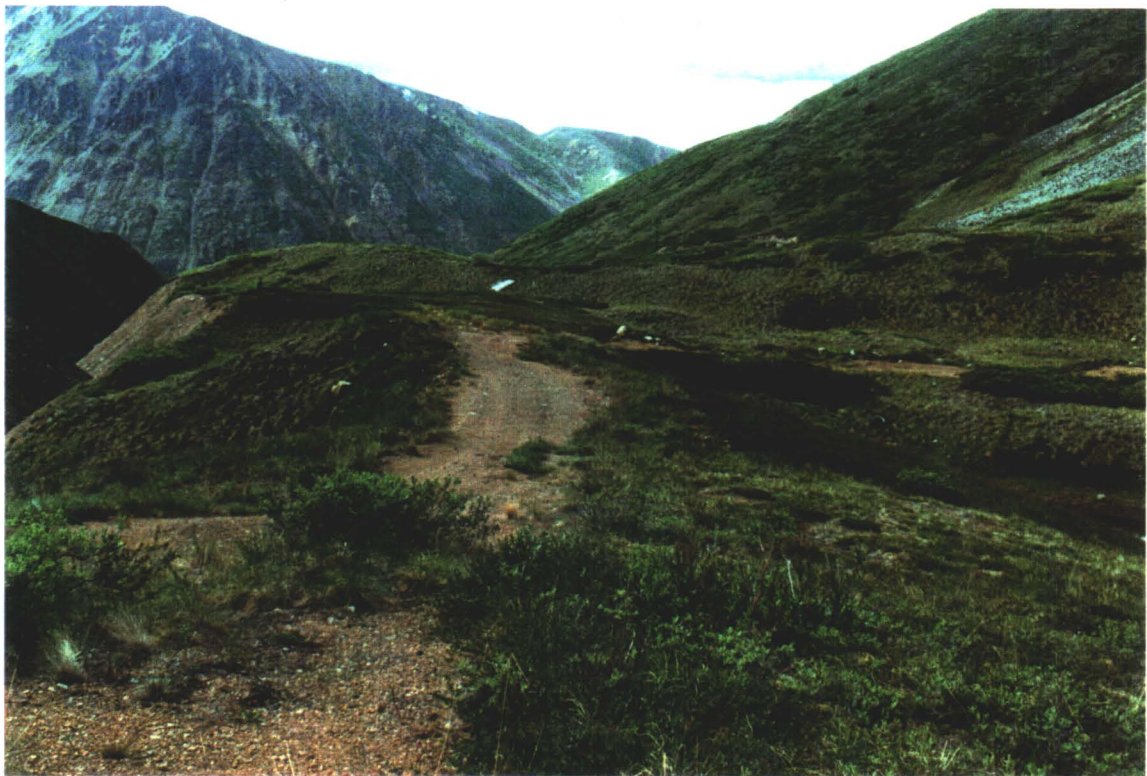
The predominant feature from the development is the trail up the steep valley. This trail has been constructed with minimal disturbance to the surrounding terrain. Only small "cut and fill" slopes are evident, with vegetation removed only on the driving surface. No terrain instability was apparent, and none is expected to be caused by the road development in this very dry area.

ROADS DOWNSLOPE FROM CAMP SITE

The most impact at this site has been caused by the road development in the area. These roads have been developed in the least damaging way, generally following the contours of the ground. Very little cutting or filling of the slopes resulted and no evidence of any slope instability or erosion was observed or expected. It is recommended that these trails not be touched and revegetation left to occur naturally at this remote site.

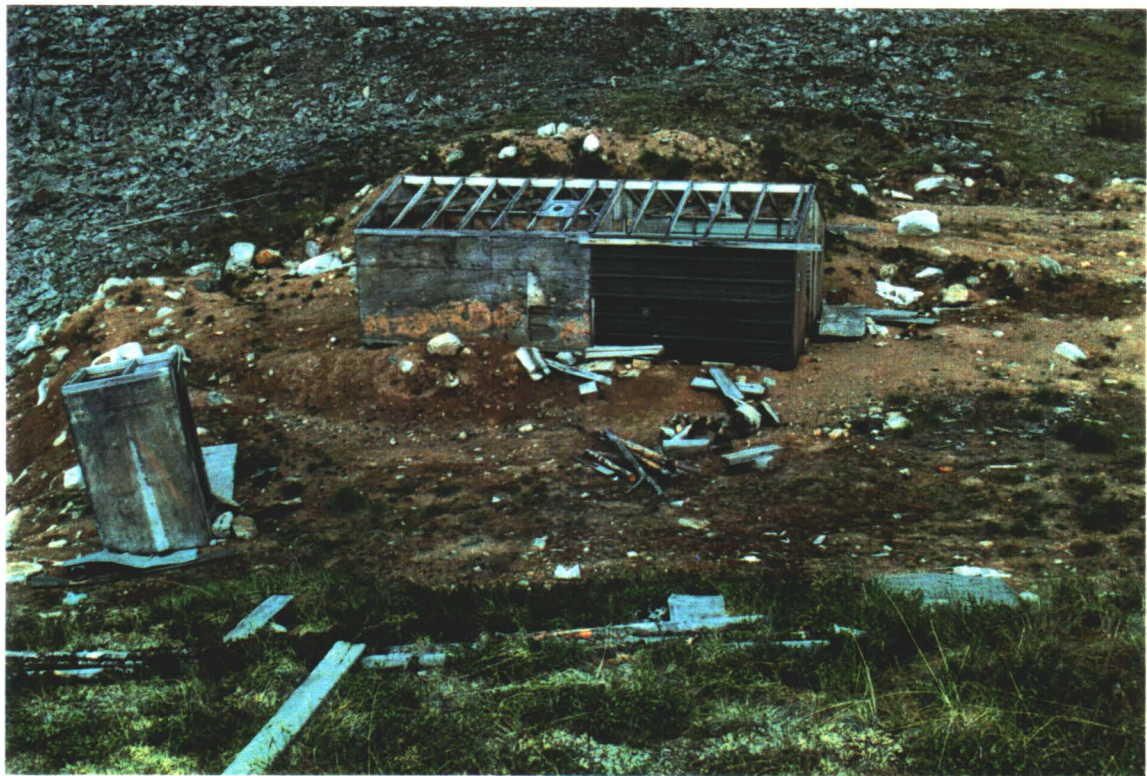
The only other site disturbance is from the remains of an exploration camp. An old wood frame building with plywood walls but no roof, two pieces of metal sheathing (each measuring 2x3m), and a plywood clad outhouse are the only remaining buildings on-site. Some scattered wood lumber and 10-15 old tires appears to be the only other remnants from the exploration activity left around the camp site.

EXPLORATION CAMP SITE

The only other remaining infrastructure impacting the environment at this site is the remaining building, tires, and wood waste. This material has a **VERY LOW** impact on the environment, with the major impact being visual. It is recommended that this material be removed from the site only if a clean-up program has been initiated in the area. The wood waste material, if it was disposed, should be piled and burned in an appropriate area. The tires and any metal waste should be gathered and removed from the site. This would constitute approximately one sling load using a 206B helicopter.

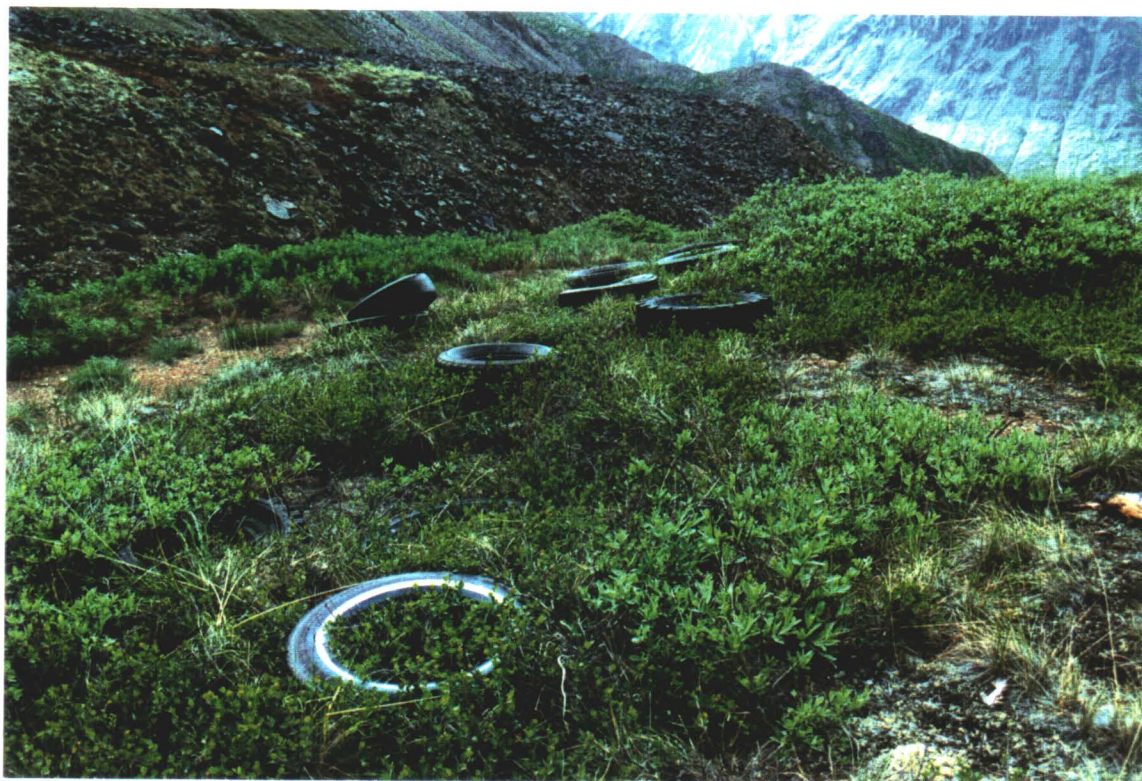
TIRES LEFT ON SITE

The waste that has been left around the site does not appear toxic in any way and is also considered to be having a **LOW** impact on the area. However the site should be included in any ongoing clean-up program initiated in the area.
