**ASSESSMENT AND CHARACTERIZATION
OF EFFLUENT ORIGINATING
FROM THE TOM MINING PROPERTY
(SEKIE CREEK #2) MAC PASS, YUKON**

ROSS RIVER DENA COUNCIL

B. Burns, Laberge Environmental Services
N. de Graff, Can-nic-a-nick Environmental

March 1999

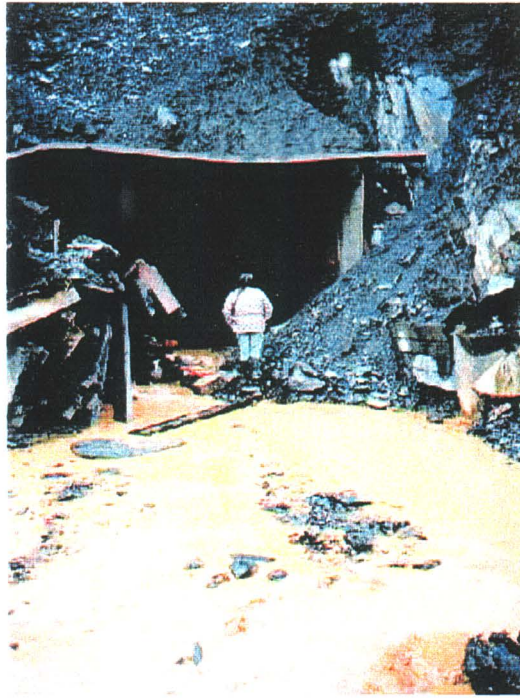
Figure 2 Discharge of adit, September 1998.

Seepage from the adit was initially utilized for the mining operations and excess water was lime treated in a settling pond located in the mine, before being pumped and discharged into Sekie Creek #2. Water characterization in 1981 at the discharge point after treatment resulted in pH neutralization (6.8 to 8.8) and a decrease in zinc concentration. Upon termination of the project, pumping and water treatment ceased. Lower drifts within the adit were allowed to fill and flow from the adit was anticipated to stabilize at 9 to 13.5 L/sec (Soroka and Jack, 1983). Measurements of flow during the winter of 1981-82 estimated a discharge of 17.25 L/sec (Soroka and Jack, 1983). Subsequent measurements since 1982 have ranged from 12 to 16 L/sec. Sporadic measurements of flow from the adit since 1982 have averaged 14 L/sec. Chemical composition of the adit flow since construction suggest a trend to more acidic conditions and increasing zinc content, typical of acid mine drainages (Table 2, Figure 2 and 3).

1. The adit flow within the Sekie Creek #2 drainage is a significant source of acid mine drainage that affects the water quality within the South Macmillan River. Remedial action should be taken to improve the water quality and/or reduce the flow at the source.

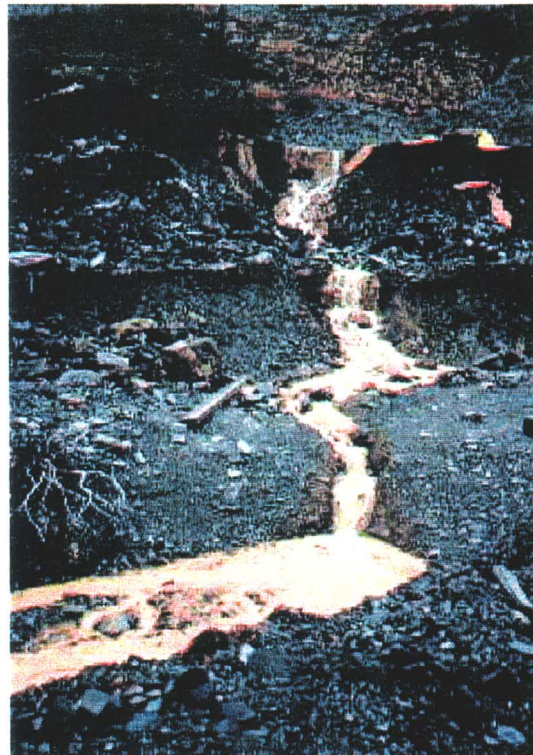
Figure 3 Flow 30 meters below adit, September 1998.

Biological baseline information within the Sekie Creek #2 drainage was collected only after considerable physical alteration occurred within the drainage (Figure 3 and 4). Impacts from early drilling programs, road and airport upgrading, gravel extraction, camp development, underground workings and other surface disturbances such as trenching are all contributing factors. Much of the riparian vegetation was removed that resulted in large amounts of suspended solids and debris entering the creek (Monenco, 1982). Impacts on the aquatic environment were compounded by release of treated and untreated flows from the adit. Soroka and Jack (1983) found low numbers and diversity of benthic organisms within Sekie Creek #2. No fish have ever been reported within this drainage. While no pre-adit baseline data could be found, it can be concluded that exploration activities have negatively affected the water quality within Sekie Creek #2.

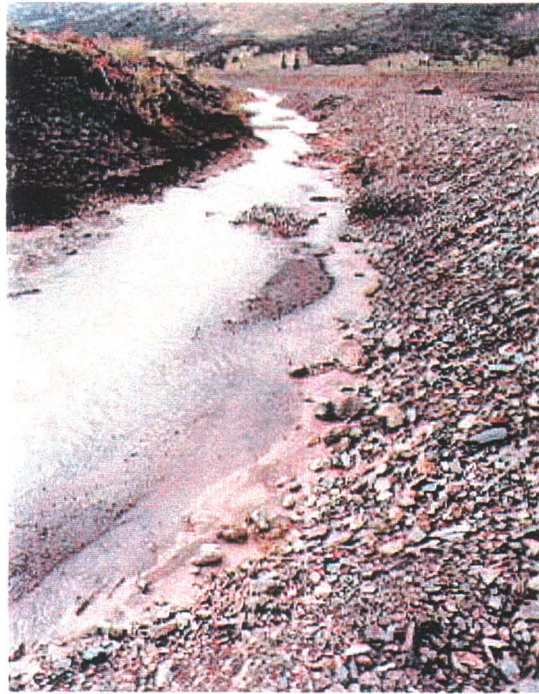
Figure 4 Active erosion and sediment of Rust (Sekie Creek #2) due to upstream road construction (Monenco, 1982).

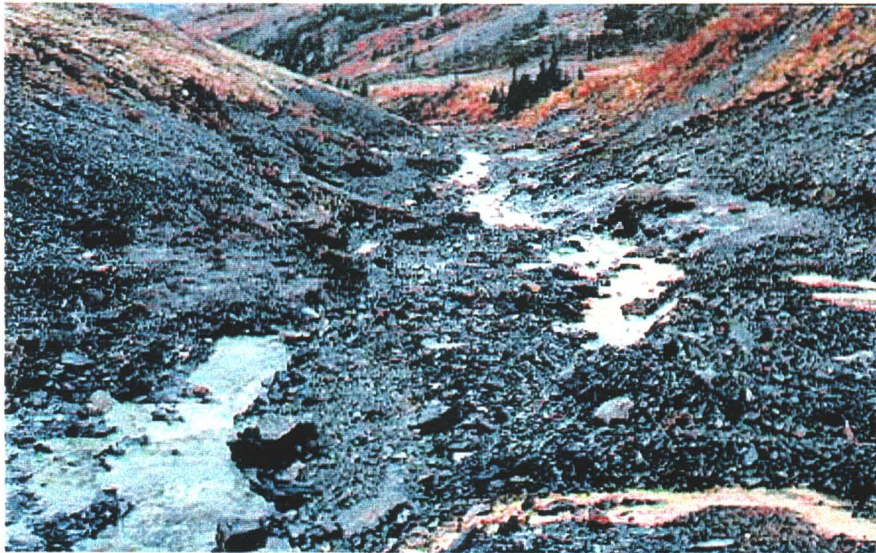
Figure 5 Lower reach of Sekie Creek #2 showing absence of riparian vegetation in September, 1998.
